**Flood Control Project Maintenance
Levee Inspections**

Fall 2019 Levee Maintenance Deficiency Summary Report

Sacramento River Basin

Reclamation District No. 2060 Hastings

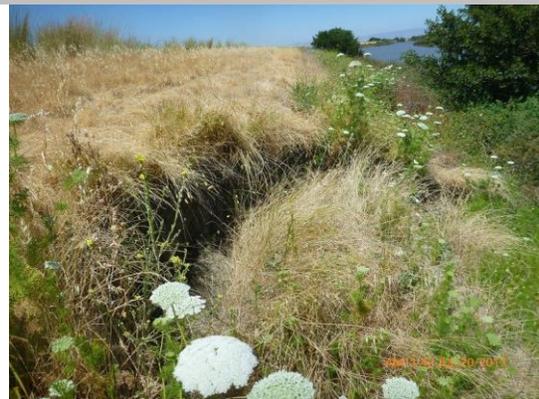
Photo 1 of 3 : FA_2019_RD2060_243_20_20190826_00014.jpg

LM Start	1.21	Rating **	M	Issue No.	20
LM End	1.23	Issue Type +	Ma	Location *	WS
Category	Supplemental			GPS Latitude/Longitude	
				Start	End
Item	2017 Storm Damage			38.290511 °	38.290486 °
				-121.729867 °	-121.729603 °
DWR ID	LMA-217				
Comment Code					
Inspector Comment					
Levee Evaluation Comments Description:Erosion commences 1/4 of the way down the slope with slippage towards the water side toe. Site ID No:390 Site Designation:LMA-217 Repair Type: Erosion Rating:Area of Concern Field Date:7/20/2017 Notes: Erosion halfway down WS slope. Monitor for progression.

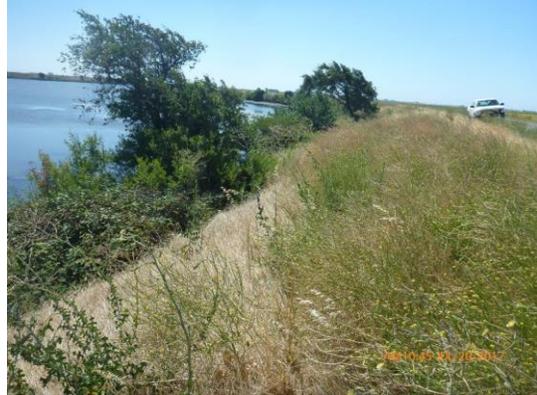
Photo 3 of 3 : FA_2019_RD2060_243_23_20190826_00025.jpg

LM Start	1.62	Rating **	A/W	Issue No.	23 (cont)
LM End	1.63	Issue Type +	Ma	Location *	WS
Category	Supplemental			GPS Latitude/Longitude	
				Start	End
Item	2017 Storm Damage			38.287336°	38.287222°
				-121.724364°	-121.724253°
DWR ID	LMA-220				
Comment Code					
Inspector Comment					
Levee Evaluation Comments Description: Erosion commences halfway down the slope and results in slippage into the waterside toe. Existing rip rap has sloughed into the water side toe. Site ID No: 393 Site Designation: LMA-220 Repair Type: Erosion Rating: Serious Field Date: 7/20/2017 Notes: Moderate sloughing 8ft from WS crown. Erosion at high water mark.

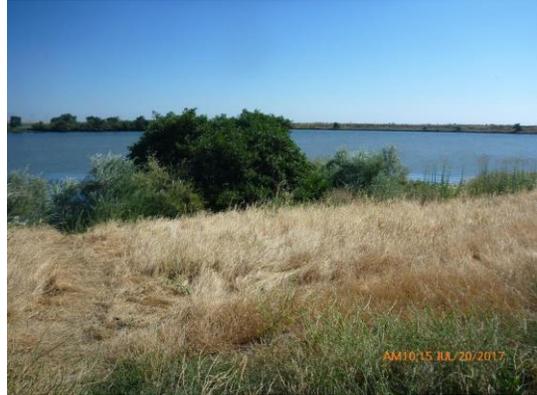
Photo 3 of 3 : FA_2019_RD2060_243_25_20190826_00028.jpg

LM Start	1.84	Rating **	M	Issue No.	25 (cont)
LM End	1.92	Issue Type +	Ma	Location *	WS
Category	Supplemental			GPS Latitude/Longitude	
				Start	End
Item	2017 Storm Damage			38.284825 °	38.284467 °
				-121.721764 °	-121.720339 °
DWR ID	LMA-222				
Comment Code					
Inspector Comment					
Levee Evaluation Comments Description: Erosion commences halfway down the slope and results in slippage into the waterside toe. Site ID No: 395 Site Designation: LMA-222 Repair Type: Erosion Rating: Area of Concern Field Date: 7/20/2017 Notes: Erosion halfway down slope. Monitor for progression.

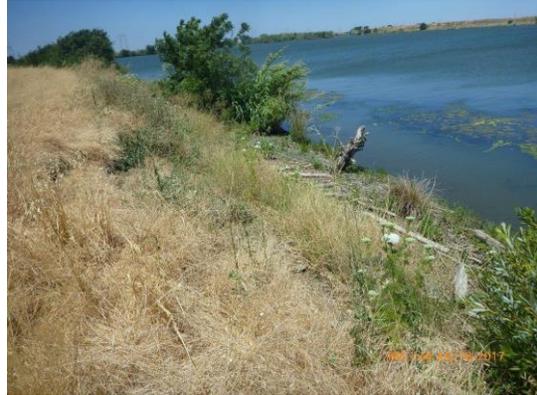
Photo 3 of 3 : FA_2019_RD2060_243_26_20190826_00031.jpg

LM Start	2.02	Rating **	M	Issue No.	26 (cont)
LM End	2.06	Issue Type +	Ma	Location *	WS
Category	Supplemental			GPS Latitude/Longitude	
				Start	End
Item	2017 Storm Damage			38.283914 °	38.283422 °
				-121.718614 °	-121.718206 °
DWR ID	LMA-223				
Comment Code					
Inspector Comment					
Levee Evaluation Comments Description: Erosion commences halfway down the slope and results in slippage into the waterside toe. Existing rip rap has sloughed into the water side toe. Site ID No: 396 Site Designation: LMA-223 Repair Type: Erosion Rating: Area of Concern Field Date: 7/18/2017 Notes: Erosion to high water line.

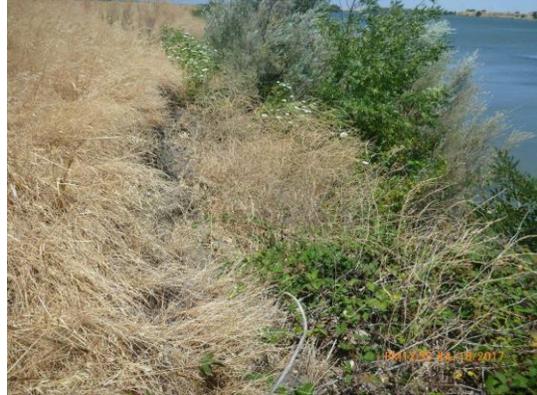
Photo 1 of 3 : FA_2019_RD2060_243_28_20190826_00035.jpg

LM Start	2.19	Rating **	A/W	Issue No.	28
LM End	2.22	Issue Type +	Ma	Location *	WS
Category	Supplemental		GPS Latitude/Longitude		
			Start	End	
Item	2017 Storm Damage		38.281839 °	38.281486 °	
			-121.716964 °	-121.716661 °	
DWR ID	LMA-225				
Comment Code					
Inspector Comment					
Levee Evaluation Comments					
Description: Erosion commences approximately 1/4 of the way down the slope and results in slippage into the waterside toe.					
Site ID No: 398					
Site Designation: LMA-225					
Repair Type: Erosion					
Rating: Serious					
Field Date: 7/18/2017					
Notes: Erosion is near vertical with light veg. Existing rip rap to the left of site.

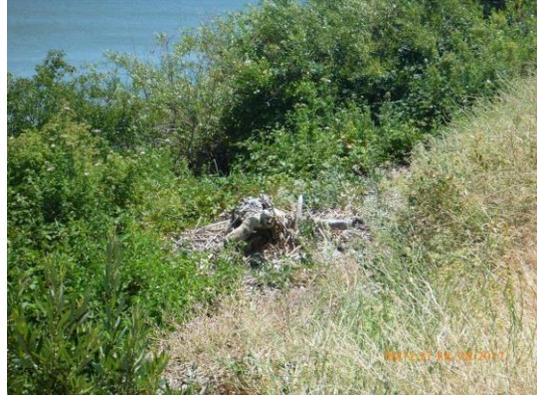
Photo 2 of 3 : FA_2019_RD2060_243_29_20190826_00039.jpg

LM Start	2.30	Rating **	M	Issue No.	29 (cont)
LM End	2.33	Issue Type +	Ma	Location *	WS
Category	Supplemental			GPS Latitude/Longitude	
				Start	End
Item	2017 Storm Damage			38.280667°	38.280467°
				-121.715664°	-121.715242°
DWR ID	LMA-226				
Comment Code					
Inspector Comment					
Levee Evaluation Comments					
Description: Erosion commences approximately halfway down the slope and results in slippage into the waterside toe.					
Site ID No: 399					
Site Designation: LMA-226					
Repair Type: Erosion					
Rating: Area of Concern					
Field Date: 7/18/2017					
Notes: Vertical erosion at high water mark.

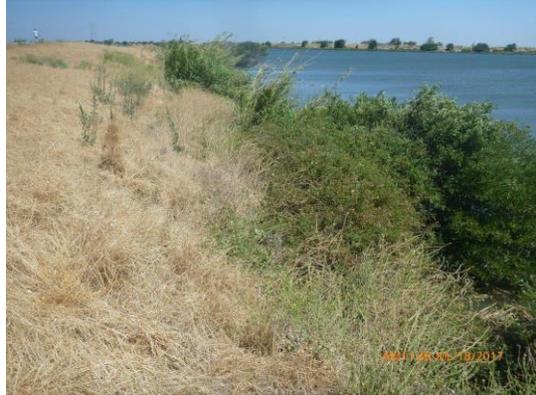
Photo 1 of 3 : FA_2019_RD2060_243_31_20190826_00041.jpg

LM Start	2.36	Rating **	M	Issue No.	31
LM End	2.43	Issue Type +	Ma	Location *	WS
Category	Supplemental			GPS Latitude/Longitude	
				Start	End
Item	2017 Storm Damage			38.280208°	38.279336°
				-121.714853°	-121.714172°
DWR ID	LMA-227				
Comment Code					
Inspector Comment					
Levee Evaluation Comments					
Description: Erosion commences approximately halfway down the slope and results in slippage into the waterside toe.					
Site ID No: 400					
Site Designation: LMA-227					
Repair Type: Erosion					
Rating: Area of Concern					
Field Date: 7/18/2017					
Notes: Steep cut but protected with heavy woody veg.

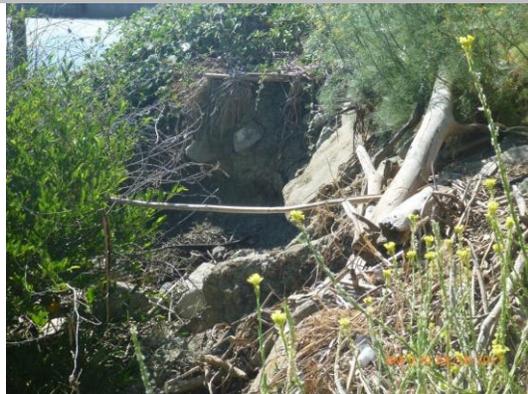
Photo 3 of 3 : FA_2019_RD2060_243_37_20190826_00061.jpg

LM Start	3.24	Rating **	M	Issue No.	37 (cont)
LM End	3.24	Issue Type +	Ma	Location *	WS
Category	Supplemental			GPS Latitude/Longitude	
				Start	End
Item	2017 Storm Damage			38.270231 °	38.270203 °
				-121.705897 °	-121.705856 °
DWR ID	LMA-233				
Comment Code					
Inspector Comment					
Levee Evaluation Comments Description: Erosion commences approximately halfway down the slope and results in sloughing into the waterside toe. Existing rip rap has been pulled off the slope at this site. Site ID No: 406 Site Designation: LMA-233 Repair Type: Erosion Rating: Area of Concern Field Date: 7/18/2017 Notes: Erosion is next to a pumphouse and slope is protected with rip rap.

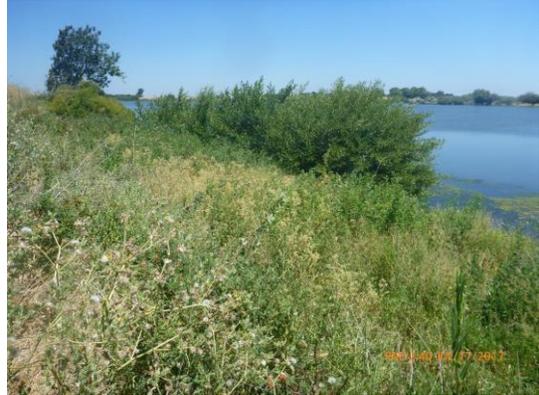
Photo 2 of 3 : FA_2019_RD2060_243_41_20190826_00069.jpg

LM Start	3.96	Rating **	A/W	Issue No.	41 (cont)
LM End	4.00	Issue Type +	Ma	Location *	WS
Category	Supplemental			GPS Latitude/Longitude	
				Start	End
Item	2017 Storm Damage			38.262114 °	38.261583 °
				-121.697978 °	-121.697647 °
DWR ID	LMA-238				
Comment Code					
Inspector Comment					
Levee Evaluation Comments Description: Erosion commences approximately halfway down the slope and results in sloughing into the waterside toe. Site ID No: 411 Site Designation: LMA-238 Repair Type: Erosion Rating: Serious Field Date: 7/18/2017 Notes: This site includes LMA-235. Wide erosion looks like several small sites merged. Heavy veg indicates slow erosion.
