**Flood Control Project Maintenance
Levee Inspections**

Maintenance Issue Types Only, Levee Inspection Report By Mile - Spring 2020

Reclamation District No. 2060 Hastings

Waterway	Bank	Unit Miles	Inspection Start/End	Inspector
Unit No. 01 Lindsey Slough	Left	6.97	04/17/2020 04/17/2020	David Julian

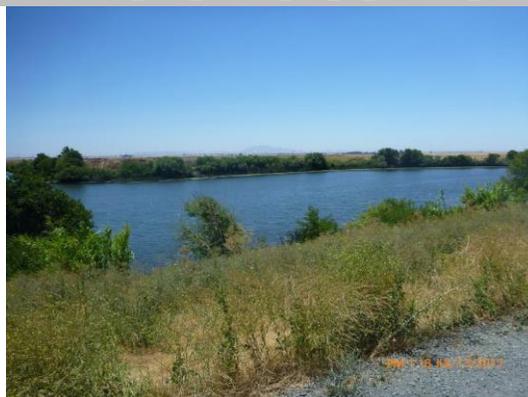
Photo 2 of 2 : SP_2020_RD2060_241_27_20200304_00047.jpg

LM Start	3.60	Rating **	A/W	Issue No.	27 (cont)
LM End	3.61	Issue Type +	Ma	Location *	WS
Category	Earthen Levee		GPS Latitude/Longitude		
			Start	End	
Item	Erosion / Bank Caving		38.261469 °	38.261464 °	
			-121.748389 °	-121.748442 °	
DWR ID	LMA-200

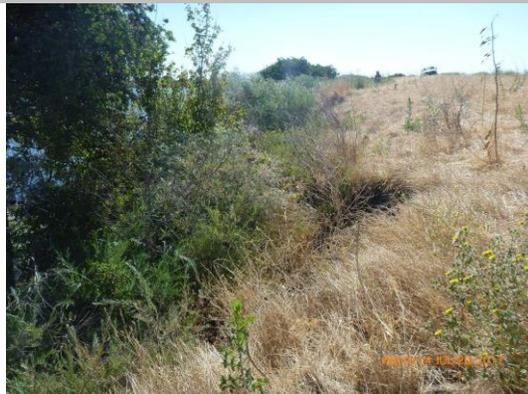
Photo 2 of 2 : SP_2020_RD2060_243_25_20200304_00026.jpg

LM Start	1.84	Rating **	M	Issue No.	25 (cont)
LM End	1.92	Issue Type +	Ma	Location *	WS
Category	Earthen Levee			GPS Latitude/Longitude	
				Start	End
Item	Erosion / Bank Caving			38.284825 °	38.284467 °
				-121.721764 °	-121.720339 °
DWR ID	LMA-222

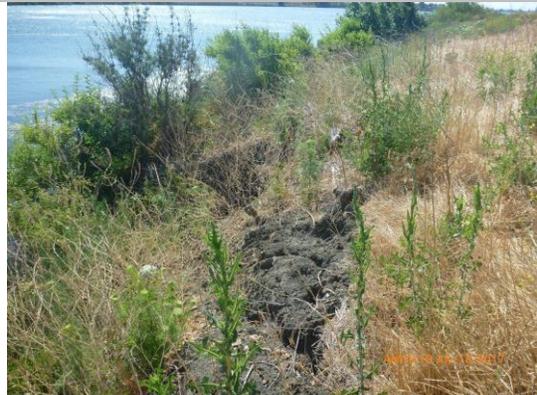
Photo 1 of 2 : SP_2020_RD2060_243_35_20200304_00052.jpg

LM Start	2.64	Rating **	A/W	Issue No.	35
LM End	2.64	Issue Type +	Ma	Location *	WS
Category	Earthen Levee		GPS Latitude/Longitude		
			Start	End	
Item	Erosion / Bank Caving		38.277106 °	38.277078 °	
			-121.711489 °	-121.711447 °	
DWR ID	LMA-231				
Comment Code					
E1 : Note and monitor erosion site.					
Inspector Comment					
This was a 2017 Storm Damage site. Erosion at the waterside toe. Site ID No:404 Site Designation:LMA-231 4/17/2020 Field Notes: Unable to observe erosion. Do boat inspection to verify. Monitor.

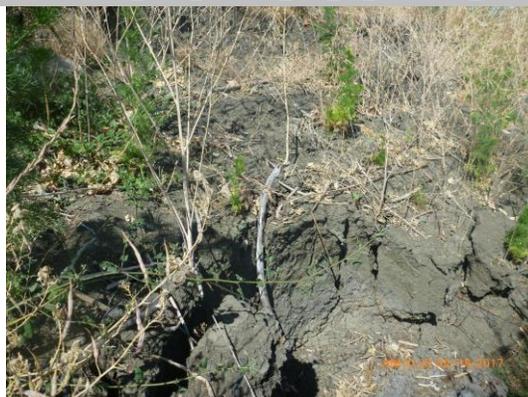
Photo 2 of 2 : SP_2020_RD2060_243_35_20200304_00053.jpg

LM Start	2.64	Rating **	A/W	Issue No.	35 (cont)
LM End	2.64	Issue Type +	Ma	Location *	WS
Category	Earthen Levee			GPS Latitude/Longitude	
				Start	End
Item	Erosion / Bank Caving			38.277106 °	38.277078 °
				-121.711489 °	-121.711447 °
DWR ID	LMA-231

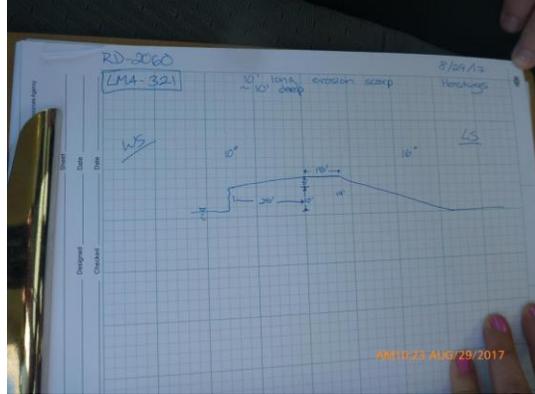
Photo 1 of 1 : SP_2020_RD2060_243_39_20200304_00063.jpg

LM Start	3.66	Rating **	A/W	Issue No.	39
LM End	3.71	Issue Type +	Ma	Location *	WS
Category	Earthen Levee			GPS Latitude/Longitude	
				Start	End
Item	Erosion / Bank Caving			38.265742 °	38.265342 °
				-121.700522 °	-121.699881 °
DWR ID	LMA-321				
Comment Code					
E1 : Note and monitor erosion site.					
Inspector Comment					
2017 Storm Damage Site MBK Delta Erosion Sites_6-29-2017 Site ID No:483 Site Designation:LMA-321 4/17/2020 Field Notes: Unable to view erosion. Verify with a boat survey. Monitor.
