**Flood Control Project Maintenance
Levee Inspections**

Fall 2019 Levee Maintenance Deficiency Summary Report

San Joaquin River Basin

Reclamation District No. 2062 Stewart

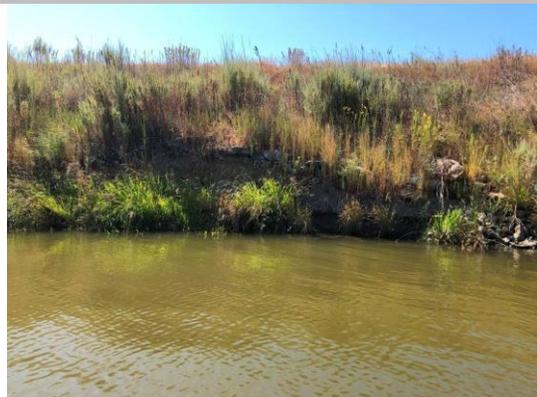
Photo 1 of 3 : SJR2019_RD2062U03RM30.10_3.jpg

LM Start	0.17	Rating **	M	Issue No.	3
LM End	0.17	Issue Type +	Ma	Location *	
Category	Supplemental			GPS Latitude/Longitude	
				Start	End
Item	DWR Erosion Survey			37.810268°	37.810268°
				-121.387495°	-121.387495°
DWR ID	RD2062U03RM30.1				
Comment Code					
Inspector Comment					
Site ID: RD2062U03RM30.1 08/14/2019: No significant change observed. 09/13/2017: No significant change observed. 07/25/2016: No significant change observed. 06/25/2015: No significant change observed. 07/02/2014: No significant change observed. 08/13/2013: No significant change observed. 08/07/2012: The site has been visited by boat survey. No significant change observed 08/23/2011: The protection at the levee toe has been washed away.

Direct view of the site.

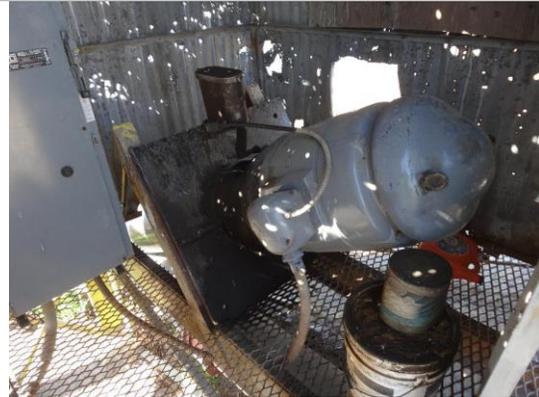
Photo 3 of 3 : UCIP_FA_2019_53377_40156.jpg

Comment Code					
Inspector Comment					
DS_ID:19200 FS_ID:53377 EP_NO: 2029 Repair Type: Urgent Crossing Status: Found UCIP Comments: 10/10/2018 Same as last inspection; erosion still present on LS slope, so keeping as Urgent (D. Sanoski - DWR UCIP).08/31/2016: Sloughing of LS slope beneath exposed section of pipe. Overflow pipe has been replaced on WS, though I could not locate a permit for that work. (K. Fazel - UCIP)10/22/2013:- pits and holes on overflow pipe on waterside.- underpinning at pump support.- slope erosion on both sides of the levee.- 2-inch electric conduit on waterside and power pole on landside. (P. Amatya - DWR) FIELD_STRUCT_DESC: 16-inch coated steel irrigation discharge pipe through the levee, 8 feet below the crown. Siphon breaker on the landside (LS) slope. Pump house on the waterside (WS) slope. Concrete distribution box on the LS. 2-inch electrical conduit on the WS. Service pole on the LS. Newly installed, as of 2016, overflow pipe with shutoff valve on the WS. (Plans for installation of an inclined irrigation pump on the bank authorized under Permit No. 2029, 1954 - Reclamation District No. 2062). [Additional Reference(s): DWR Levee Log, 2007. USACE San Joaquin O&M Manual 9, April 1964, (HLM 0.52)]. FS Date: 10/10/2018 11:25:00 AM

WS view: slant pump in pump house on levee slope.

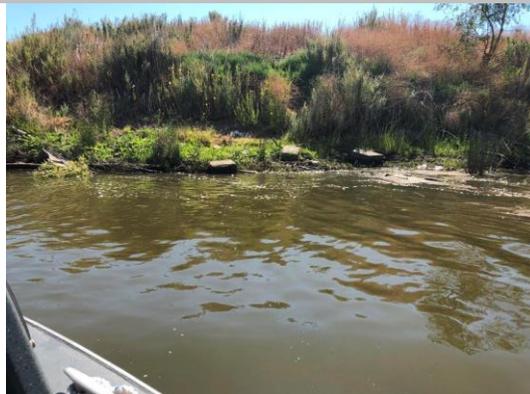
Photo 1 of 3 : SJR2019_RD2062U03RM30.43_3.jpg

Site ID: RD2062U03RM30.43
 08/14/2019: No significant change observed.
 09/13/2017: No significant change observed.
 07/25/2016: No significant change observed.
 06/25/2015: No significant change observed.
 07/02/2014: No significant change observed.
 08/13/2013: No significant change observed.
 08/07/2012: The site has been visited by boat survey. No significant change observed.
 08/23/2011: No significant change observed on site.
 09/07/2010: No significant change observed on site. Much of the placed rip rap revetment has slid. It is no longer adequately protecting the slope.
 08/06/2010: Recommended as local maintenance issue, per CLRO Report.
 03/09/2010: As discussed with Michael Moncrief of MBK, site will be 'addressed' this year.
 09/29/2009: No major change observed since last visit; a section of the rip rap has slipped, exposing a levee section that has eroded; recommended as local maintenance issue, per CLRO CES Evaluation 2008 Report; Site # is the same as RM30.43,LM0.63; previously rated "U".

Close-up view of the site.

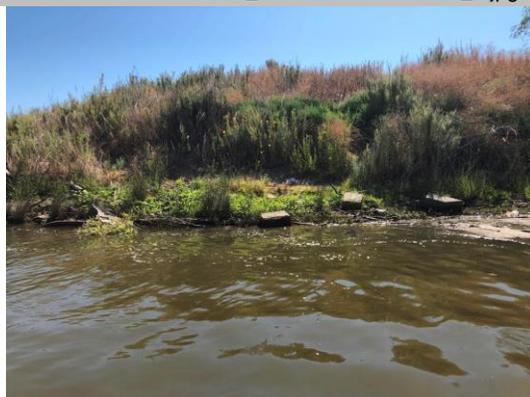
Photo 2 of 3 : SJR2019_RD2062U03RM30.43_2.jpg

Front view of the site.

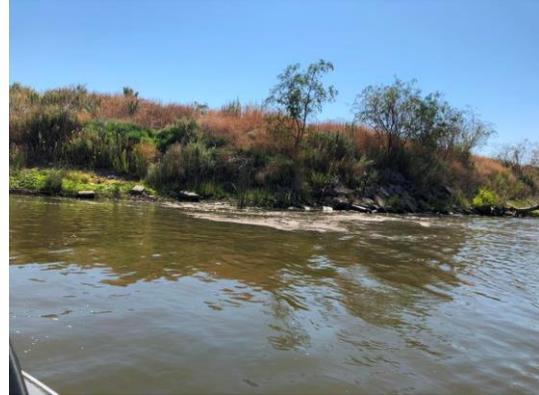
Photo 3 of 3 : SJR2019_RD2062U03RM30.43_4.jpg

Comment Code					
Inspector Comment					
Site ID: RD2062U03RM30.43 08/14/2019: No significant change observed. 09/13/2017: No significant change observed. 07/25/2016: No significant change observed. 06/25/2015: No significant change observed. 07/02/2014: No significant change observed. 08/13/2013: No significant change observed. 08/07/2012: The site has been visited by boat survey. No significant change observed. 08/23/2011: No significant change observed on site. 09/07/2010: No significant change observed on site. Much of the placed rip rap revetment has slid. It is no longer adequately protecting the slope. 08/06/2010: Recommended as local maintenance issue, per CLRO Report. 03/09/2010: As discussed with Michael Moncrief of MBK, site will be 'addressed' this year. 09/29/2009: No major change observed since last visit; a section of the rip rap has slipped, exposing a levee section that has eroded; recommended as local maintenance issue, per CLRO CES Evaluation 2008 Report; Site # is the same as RM30.43,LM0.63; previously rated "U". 11/05/2008: Site is located inside of a bend; scarp looks to be into the levee prism; piles of concrete chunks placed on the slope, with some of them already starting to slide.

Front view of the site.

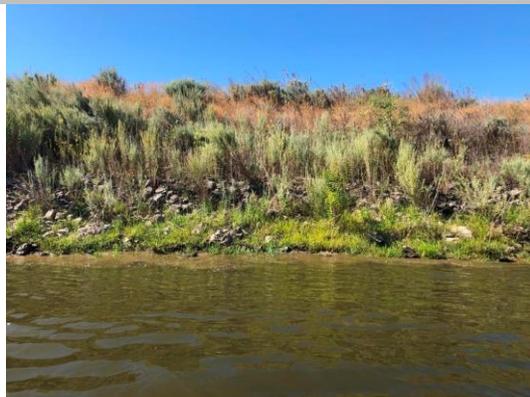
Photo 1 of 3 : SJR2019_RD2062U03RM31.12_5.jpg

Comment Code					
Inspector Comment					
<p>Site ID: RD2062U03RM31.12 08/14/2019: No significant change observed. 09/13/2017: No significant change observed. 07/25/2016: No significant change observed. 06/25/2015: No significant change observed. 07/02/2014: No significant change observed. 08/13/2013: No significant change observed. 08/07/2012: The site has been visited by boat survey. No significant change observed 08/23/2011: No significant change observed on site. 09/07/2010: No significant change observed on site. Much of the seasonal grass along the slope was cleared. Site consists of an existing scalloped erosion approximately 30 feet long by 5 feet wide at its widest opening. The lateral crack is extended outwards along the middle slope. There is a 1 to 2 feet of differential settlement that could further develop into a shallow slide. 08/06/2010: Recommended as local maintenance issue, per CLRO. 03/09/2010: As discussed with Michael Moncrief of MBK Engineer, site will be 'addressed' this year. 09/28/2009: No major change observed; section of rip rap has slipped, creating a terraced effect; dense vegetation growth; recommended as a local maintenance issue, per CLRO CES Evaluation 2008 Report; Site # is the same as RM31.12,LM1.25; previously rated "U". 09/14/2006: 1-2' into prism.</p>

Front view of the site.

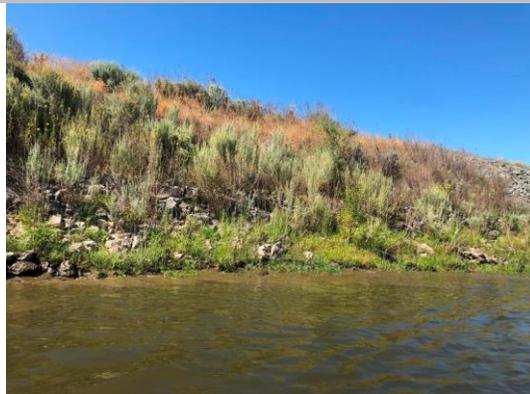
Photo 2 of 3 : SJR2019_RD2062U03RM31.12_2.jpg

Comment Code					
Inspector Comment					
Site ID: RD2062U03RM31.12 08/14/2019: No significant change observed. 09/13/2017: No significant change observed. 07/25/2016: No significant change observed. 06/25/2015: No significant change observed. 07/02/2014: No significant change observed. 08/13/2013: No significant change observed. 08/07/2012: The site has been visited by boat survey. No significant change observed 08/23/2011: No significant change observed on site. 09/07/2010: No significant change observed on site. Much of the seasonal grass along the slope was cleared. Site consists of an existing scalloped erosion approximately 30 feet long by 5 feet wide at its widest opening. The lateral crack is extended outwards along the middle slope. There is a 1 to 2 feet of differential settlement that could further develop into a shallow slide. 08/06/2010: Recommended as local maintenance issue, per CLRO. 03/09/2010: As discussed with Michael Moncrief of MBK Engineer, site will be 'addressed' this year. 09/28/2009: No major change observed; section of rip rap has slipped, creating a terraced effect; dense vegetation growth; recommended as a local maintenance issue, per CLRO CES Evaluation 2008 Report; Site # is the same as RM31.12,LM1.25; previously rated "U". 09/14/2006: 1-2' into prism.

Front view of the site.

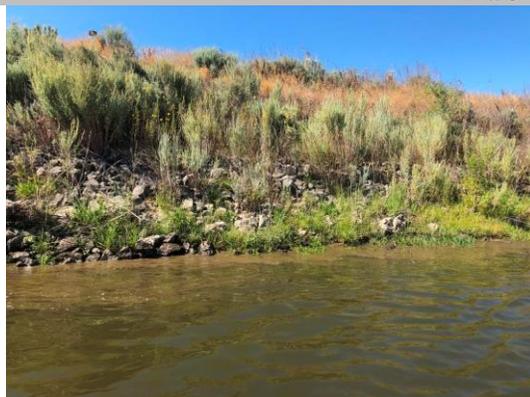
Photo 3 of 3 : SJR2019_RD2062U03RM31.12_1.jpg

Close-up view of the site.

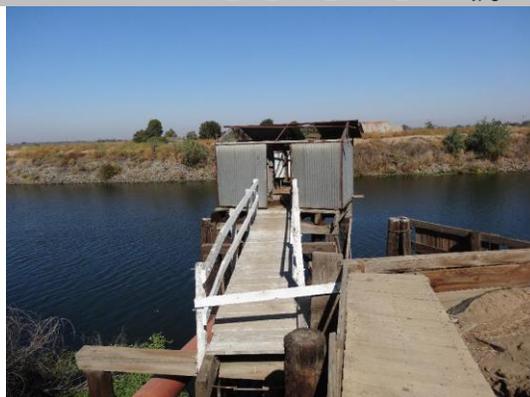
Photo 1 of 3 : UCIP_FA_2019_23311_40175.jpg

Comment Code					
Inspector Comment					
DS_ID:19202 FS_ID:23311 EP_NO: 2505 Repair Type: Non-Urgent Crossing Status: Found UCIP Comments: - pumphouse roof missing.- siphon breaker buried by dirt in CMP riser.- 2.25 inch electric conduit and power pole on landside. FIELD_STRUCT_DESC: 2 of 2: 16-inch irrigation discharge pipe of an unknown material through the levee, 6.5 feet below the crown. Pump in a pump house on a pile structure in the stream. Timber walkway to the pump. Siphon breaker in a corrugated metal pipe (CMP) riser on the landside (LS) slope. Concrete distribution box at the LS toe. Timber bulkhead and slab on the waterside (WS) slope. Installed by USACE in 1963. (Plans for the installation of two irrigation pumps on the bank to replace an existing pumping plant at this location authorized under Permit No. 2505, 1959 - Reclamation District No. 2062). [Additional Reference(s): DWR Levee Log, 2007. USACE San Joaquin O&M Manual 9, April 1964, (HLM 2.81)]. FS Date: 10/22/2013

WS view: wooden walkway to pumphouse, pumphouse on wooden pile structure in the stream.

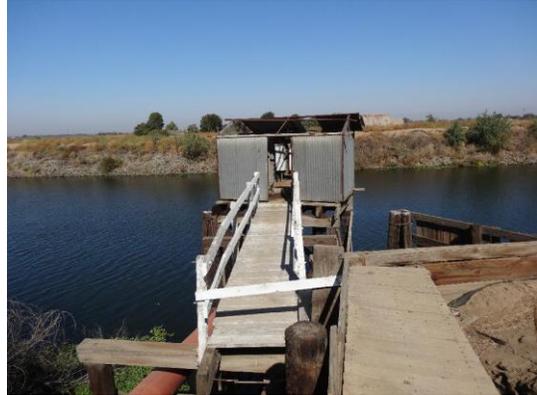
Photo 1 of 3 : UCIP_FA_2019_23312_40181.jpg

Comment Code					
Inspector Comment					
DS_ID:19205 FS_ID:23312 EP_NO: 2505 Repair Type: Non-Urgent Crossing Status: Found UCIP Comments: - pumphouse roof missing.- siphon breaker buried by dirt in CMP riser.- 2.25 inch electric conduit and power pole on landside. FIELD_STRUCT_DESC: 1 of 2: 14-inch irrigation discharge pipe of an unknown material through the levee, 6.5 feet below the crown. Pump in a pump house on a pile structure in the stream. Timber walkway to the pump. Siphon breaker in a corrugated metal pipe (CMP) riser on the landside (LS) slope. Concrete distribution box at the LS toe. Timber bulkhead and slab on the waterside (WS) slope. Installed by USACE in 1963. (Plans for the installation of two irrigation pumps on the bank to replace an existing pumping plant at this location authorized under Permit No. 2505, 1959 - Reclamation District No. 2062). [Additional Reference(s): DWR Levee Log, 2007. USACE San Joaquin O&M Manual 9, April 1964, (HLM 2.81)]. FS Date: 10/22/2013

WS view: wooden walkway to pumphouse, pumphouse on wooden pile structure in the stream.

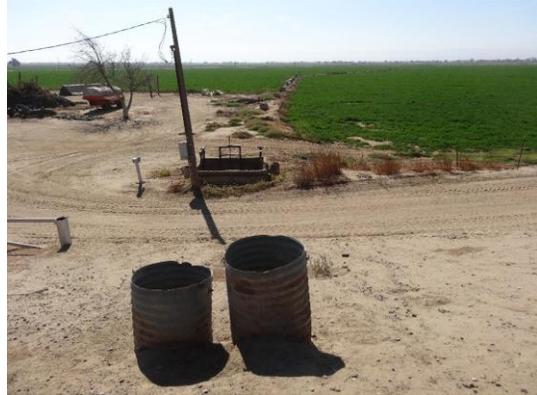
Photo 3 of 3 : UCIP_FA_2019_23312_40180.jpg

Comment Code					
Inspector Comment					
<p>DS_ID:19205 FS_ID:23312 EP_NO: 2505 Repair Type: Non-Urgent Crossing Status: Found UCIP Comments: - pumphouse roof missing.- siphon breaker buried by dirt in CMP riser.- 2.25 inch electric conduit and power pole on landside. FIELD_STRUCT_DESC: 1 of 2: 14-inch irrigation discharge pipe of an unknown material through the levee, 6.5 feet below the crown. Pump in a pump house on a pile structure in the stream. Timber walkway to the pump. Siphon breaker in a corrugated metal pipe (CMP) riser on the landside (LS) slope. Concrete distribution box at the LS toe. Timber bulkhead and slab on the waterside (WS) slope. Installed by USACE in 1963. (Plans for the installation of two irrigation pumps on the bank to replace an existing pumping plant at this location authorized under Permit No. 2505, 1959 - Reclamation District No. 2062). [Additional Reference(s): DWR Levee Log, 2007. USACE San Joaquin O&M Manual 9, April 1964, (HLM 2.81)]. FS Date: 10/22/2013</p>

LS view: two CMP risers on levee slope, concrete distribution box, and service pole across the dirt road, off the levee toe.

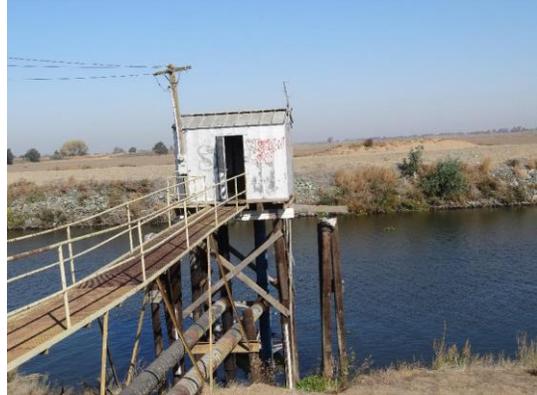
Photo 3 of 3 : UCIP_FA_2019_23142_39547.jpg

Comment Code					
Inspector Comment					
DS_ID:19203 FS_ID:23142 EP_NO: N/A Repair Type: Non-Urgent Crossing Status: Found UCIP Comments: - siphon breakers not protected.- flow meter and gage station on waterside.- pump house on wooden pile structure. Walkway to the pumphouse. FIELD_STRUCT_DESC: 1 of 2: 16-inch irrigation discharge pipe of an unknown material through the levee, 4 feet below the crown. Pump in a pump house on a pile structure in the stream. Walkway to the pump house. Siphon breaker on the landside (LS) slope. Concrete distribution box on the LS berm. [Additional Reference(s): DWR Levee Log, 2007. USACE San Joaquin O&M Manual 9, April 1964, (HLM 5.45)]. FS Date: 10/22/2013

WS view: pump house on wooden pipe structure in the stream. Two steel pipes under the walkway.

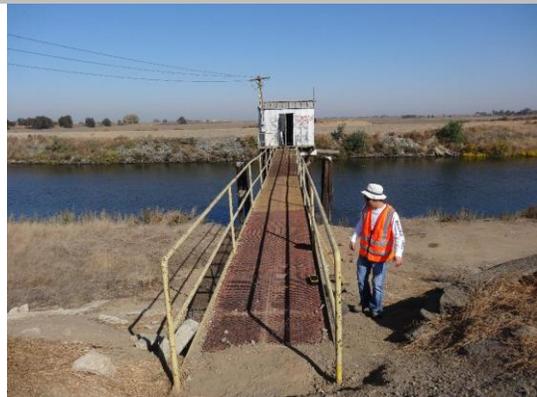
Photo 1 of 3 : UCIP_FA_2019_23140_39531.jpg

Comment Code					
Inspector Comment					
DS_ID:19206 FS_ID:23140 EP_NO: N/A Repair Type: Non-Urgent Crossing Status: Found UCIP Comments: - siphon breakers not protected.- flow meter and gage station on waterside.- pump house on wooden pile structure. Walkway to the pumphouse. FIELD_STRUCT_DESC: 2 of 2: 16-inch irrigation discharge pipe of an unknown material through the levee, 4 feet below the crown. Pump in a pump house on a pile structure in the stream. Walkway to the pump house. Siphon breaker on the landside (LS) slope. Concrete distribution box on the LS berm. [Additional Reference(s): DWR Levee Log, 2007. USACE San Joaquin O&M Manual 9, April 1964, (HLM 5.45)]. FS Date: 10/22/2013

WS view: steel walkway to pump house in the stream.

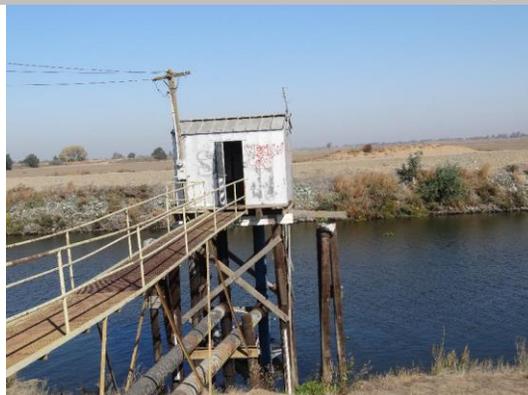
Photo 3 of 3 : UCIP_FA_2019_23140_39529.jpg

WS view: pump house on wooden pipe structure in the stream. Two steel pipes under the walkway.
