**Flood Control Project Maintenance
Levee Inspections**

Fall 2019 Levee Maintenance Deficiency Summary Report

San Joaquin River Basin

Reclamation District No. 2063 Crows Landing

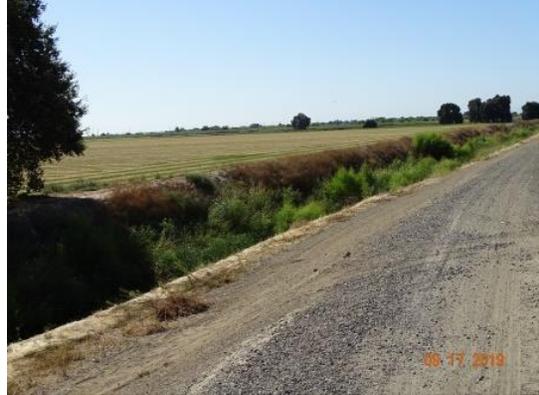
Photo 1 of 4 : FA_2019_RD2063_112_18_20190920_00119.jpg

LM Start	0.00	Rating **	M	Issue No.	18
LM End	1.30	Issue Type +	En	Location *	LS
Category	Earthen Levee		GPS Latitude/Longitude		
			Start	End	
Item	Encroachments		37.478705°	37.464660°	
			-121.044651°	-121.032946°	
DWR ID	DWR_RD2063_01_s_2012_18				
Comment Code					
DT : Ditch					
Inspector Comment					
Drainage ditch was part of the original levee construction. 10 ft of berm should exist between the levee toe and shoulder of the ditch.

Looking southeast at drainage ditch along landside toe. (Fall 2019)

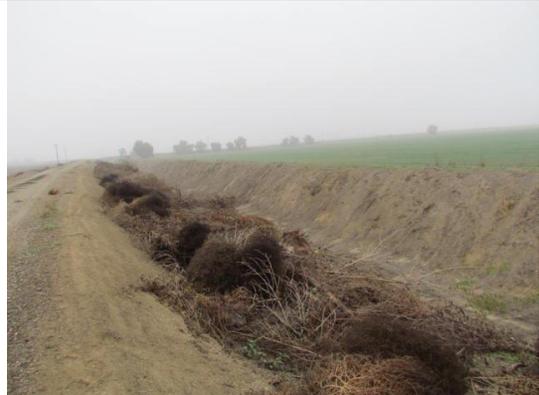
Photo 2 of 4 : FA_2019_RD2063_112_18_20190912_00001.jpg

Looking north at ditch on landside berm and toe.

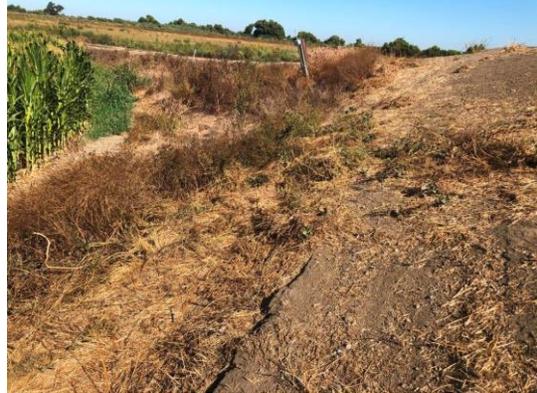
Photo 2 of 3 : SJR2019_DWR_RD2063_01_s _ 2017_59_4.JPG

LM Start	1.82	Rating **	M	Issue No.	38 (cont)
LM End	1.84	Issue Type +	Ma	Location *	
Category	Supplemental			GPS Latitude/Longitude	
				Start	End
Item	DWR Erosion Survey			37.457653°	37.457653°
				-121.033728°	-121.033728°
DWR ID	RD2063U01RM100.79				
Comment Code					
Inspector Comment					
Site ID: RD2063U01RM100.79 09/12/2019: Erosion has developed into the lower levee slope.

Close view of the erosion.

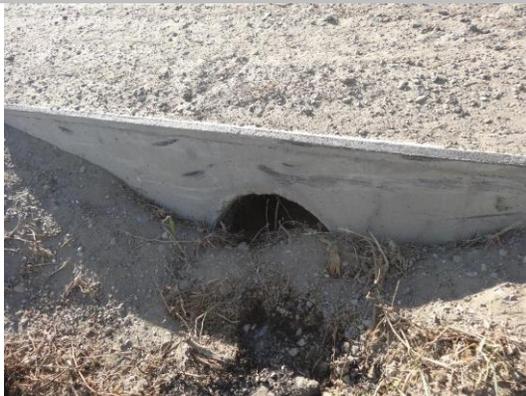
Photo 3 of 3 : UCIP_FA_2019_24443_43520.jpg

LM Start	2.93	Rating **	M	Issue No.	65 (cont)
LM End	2.93	Issue Type +	Ma	Location *	
Category	Supplemental			GPS Latitude/Longitude	
				Start	End
Item	DRAFT DWR UCIP LMA Responsibility			37.443871 °	37.443871 °
				-121.025775 °	-121.025775 °
DWR ID	22088				
Comment Code					
Inspector Comment					
DS_ID:22088 FS_ID:24443 EP_NO: N/A Repair Type: Non-Urgent Crossing Status: Found UCIP Comments: 11/05/2013 - clear and clean debris (P. Amatya - DWR UCIP) FIELD_STRUCT_DESC: *ABANDONED* 24-inch corrugated metal gravity drainage pipe through the levee, 9.5 feet below the crown. Flap gate on the waterside (WS) end. Pipe open on the landside (LS) end. Concrete headwall on each end. [Additional Reference(s): DWR Levee Log, 1992. USACE San Joaquin O&M Manual 6, September 1961, (HLM 2.97)]. FS Date: 11/5/2013

WS view: pipe, flap concrete headwall with soil debris blocking the inlet.

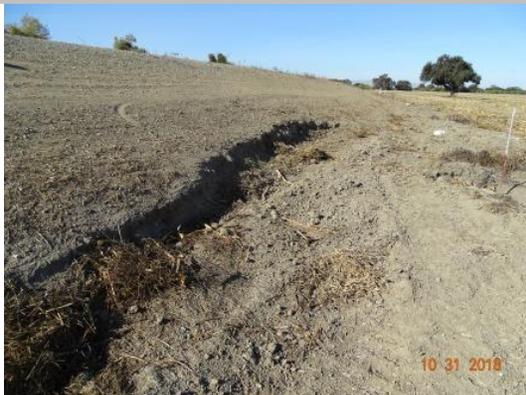
Photo 1 of 1 : FA_2019_RD2063_112_41_20190912_00008.jpg

LM Start	3.20	Rating **	M	Issue No.	41
LM End	3.22	Issue Type +	En	Location *	LS
Category	Earthen Levee			GPS Latitude/Longitude	
				Start	End
Item	Encroachments			37.442213 °	37.441981 °
				-121.022135 °	-121.021775 °
DWR ID	DWR_RD2063_01_f_2018_41				
Comment Code					
AT : Agricultural tilling					
Inspector Comment					
Farming equipment cutting into landside toe.

View of agricultural equipment cutting into the levee slope. (Fall 2018)

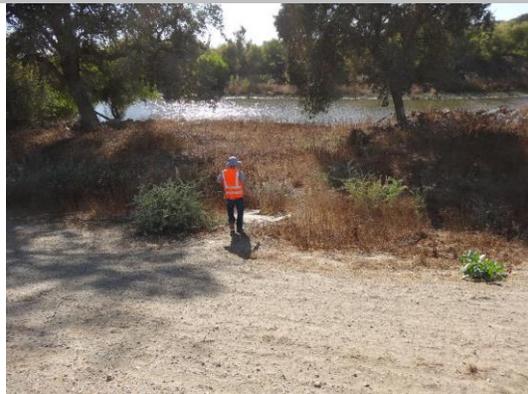
Photo 1 of 3 : UCIP_FA_2019_24469_43645.jpg

LM Start	3.29	Rating **	M	Issue No.	66
LM End	3.29	Issue Type +	Ma	Location *	
Category	Supplemental			GPS Latitude/Longitude	
				Start	End
Item	DRAFT DWR UCIP LMA Responsibility			37.441213°	37.441213°
				-121.021130°	-121.021130°
DWR ID	22089				
Comment Code					
Inspector Comment					
DS_ID:22089 FS_ID:24469 EP_NO: N/A Repair Type: Non-Urgent Crossing Status: Found UCIP Comments: 11/05/2013 - cleaning required in inlet pipe.- new flap gate (P. Amatya - DWR UCIP) FIELD_STRUCT_DESC: *ABANDONED* 24-inch corrugated metal gravity drainage pipe through the levee, 12.5 feet below the crown. Flap gate on the waterside (WS) end. Concrete headwall on each end. [Additional Reference(s): DWR Levee Log, 1992. USACE San Joaquin O&M Manual 6, September 1961, (HLM 3.33)]. FS Date: 11/5/2013

WS view: U typed concrete headwall on levee toe

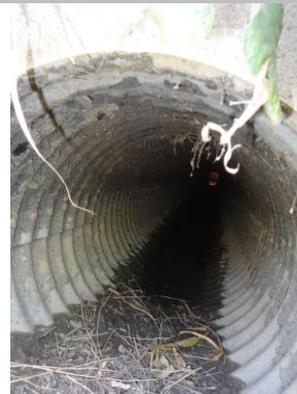
Photo 3 of 3 : UCIP_FA_2019_51821_43840.jpg

Comment Code					
Inspector Comment					
DS_ID:22096 FS_ID:51821 EP_NO: N/A Repair Type: No Action Needed Crossing Status: Found UCIP Comments: 05/11/2017 Review of photos indicate less than 1/4 of the inlet is silted in. Since the pipe is in good condition, it has been downgraded from Non-Urgent to No Action Needed. (K. Fazel - UCIP)11/05/2013:- new flap gate on waterside.- cleaning of outlet and inlet pipes required. (P. Amatya - DWR) FIELD_STRUCT_DESC: 24-inch corrugated metal gravity drainage pipe through the levee, 12 feet below the crown. Flap gate on the waterside (WS) end. Concrete headwall on each end. Installed by USACE in 1961. [Additional Reference(s): DWR Levee Log, 1992. USACE San Joaquin O&M Manual 6, September 1961, (HLM 4.08)]. FS Date: 11/5/2013

LS view: inside view of the CM pipe on levee toe.

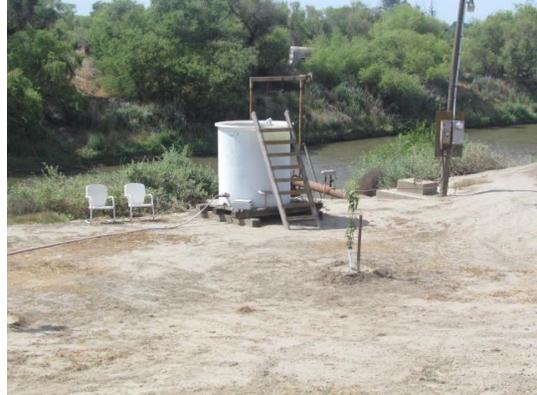
Photo 1 of 3 : FA_2019_RD2063_112_31_20190912_00004.jpg

LM Start	4.60	Rating **	M	Issue No.	31
LM End	4.60	Issue Type +	En	Location *	WS
Category	Earthen Levee		GPS Latitude/Longitude		
			Start	End	
Item	Encroachments		37.429638°	37.429638°	
			-121.005348°	-121.005348°	
DWR ID	DWR_RD2063_01_s_2012_31				
Comment Code					
CR : Crops					
Inspector Comment					
Landowner planted grape vines and fruit trees and water tank on waterside berm without a permit from the CVFPB.

Looking west at water tank on waterward berm.

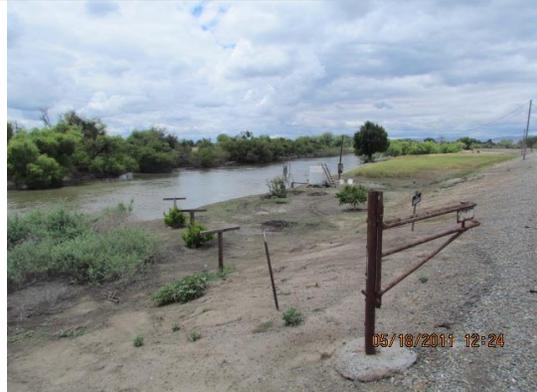
Photo 2 of 3 : FA_2019_RD2063_112_31_20190912_00005.jpg

Looking south at grapevines and fruit trees on waterside berm.

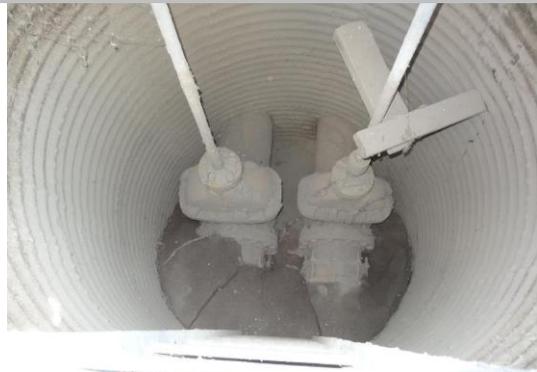
Photo 2 of 3 : UCIP_FA_2019_41670_43904.jpg

WS view: two gate valves inside CMP riser on levee slope.

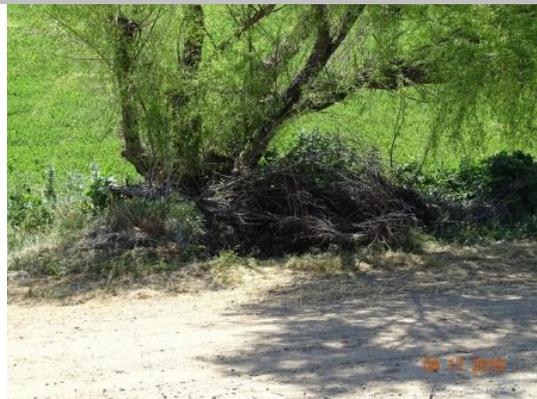
Photo 1 of 2 : FA_2019_RD2063_112_49_20190912_00011.jpg

LM Start	6.20	Rating **	M	Issue No.	49
LM End	6.20	Issue Type +	En	Location *	LS
Category	Earthen Levee			GPS Latitude/Longitude	
				Start	End
Item	Encroachments			37.414171 °	37.414171 °
				-121.001353 °	-121.001353 °
DWR ID	DWR_RD2063_01_s_2019_49				
Comment Code					
PR : Prunings					
Inspector Comment

View of prunings looking down landside slope. (Spring 2019)

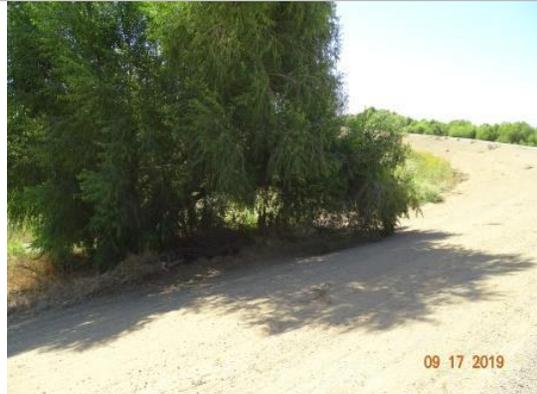
Photo 1 of 1 : FA_2019_RD2063_112_42_20190920_00111.jpg

Tree on landside toe should be trimmed. (2019)

LM Start	6.21	Rating **	M	Issue No.	42
LM End	6.21	Issue Type +	Ma	Location *	LS
Category	Earthen Levee			GPS Latitude/Longitude	
				Start	End
Item	Trim / Thin Trees			37.414133°	37.414133°
				-121.001380°	-121.001380°
DWR ID	DWR_RD2063_01_f_2019_42				
Comment Code					
T1 : Trim trees to at least five feet above ground level.					
Inspector Comment

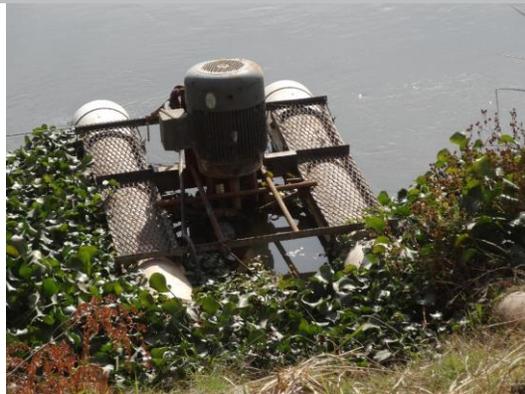
Photo 2 of 3 : UCIP_FA_2019_24628_43937.jpg

Comment Code					
Inspector Comment					
DS_ID:22108 FS_ID:24628 EP_NO: 4062 Repair Type: Non-Urgent Crossing Status: Found UCIP Comments: 11/06/2013 Abandoned pipe also found adjacent to this pipe. Needs proper abandonment. Soil erosion under pipe on waterside. No pipe visible on landside. Overhead powerline. (P. Amatya - DWR UCIP) FIELD_STRUCT_DESC: 12-inch polyvinyl chloride (PVC) irrigation discharge pipe through the levee, 3 feet below the crown. Floating pump in the river. Gate valve and air vent on the waterside (WS) berm. Service pole with overhead line on the WS shoulder. (pump with discharge pipe through the levee authorized under Permit No. 4062, 1962 - John W. Greer). [Additional Reference(s): DWR Levee Log, 1992]. FS Date: 11/6/2013

WS view: pump on floating structure in the stream.

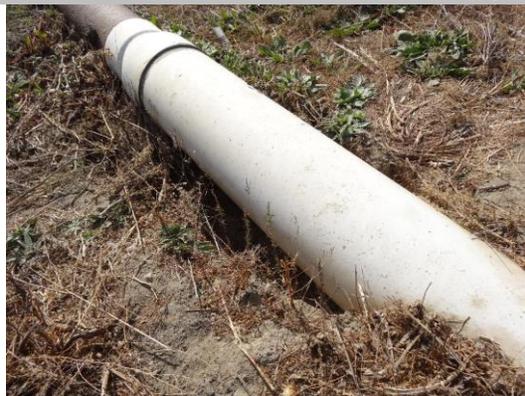
Photo 3 of 3 : UCIP_FA_2019_24628_43936.jpg

WS view: exposed pipe on levee slope. Erosion under the pipe.

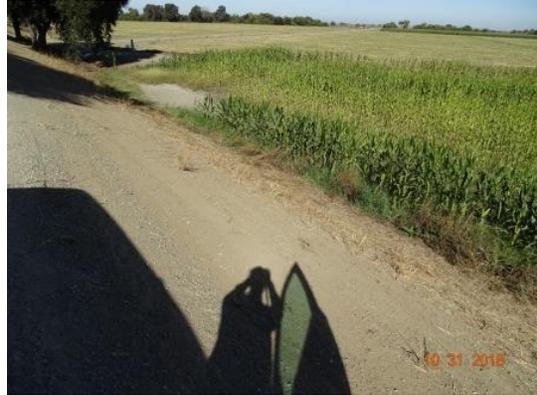
Photo 1 of 1 : FA_2019_RD2063_112_52_20190912_00014.jpg

LM Start	7.73	Rating **	U	Issue No.	52
LM End	8.15	Issue Type +	En	Location *	LS
Category	Earthen Levee		GPS Latitude/Longitude		
			Start	End	
Item	Encroachments		37.401878 °	37.400837 °	
			-120.983294 °	-120.976198 °	
DWR ID	DWR_RD2063_01_f_2018_52				
Comment Code					
CR : Crops					
Inspector Comment					
Landowner planted corn in levee toe up to the slope.

View of corn planted in levee toe right up to the landside slope. (Fall 2018)

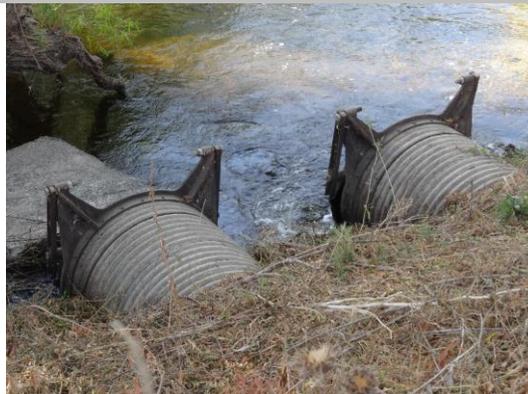
Photo 1 of 3 : UCIP_FA_2019_24650_44002.jpg

Comment Code					
Inspector Comment					
DS_ID:22113 FS_ID:24650 EP_NO: N/A Repair Type: No Action Needed Crossing Status: Found UCIP Comments: 10/27/2017 This structure is inspected annually under the Structure and Channel Summer Inspection (part of the Levee Inspection Program) conducted by the DWR Flood Project Integrity and Inspection Branch (FPIIB). (DWR UCIP - O. Magana) 11/06/2013 Working during field inspection. (P. Amatya - DWR UCIP) FIELD_STRUCT_DESC: [Reclamation District No. 2063 Pumping Plant] 1 of 2: 42-inch corrugated metal gravity drainage pipe through the levee, 18 feet below the crown. Slide gate in a corrugated metal pipe (CMP) riser on the waterside (WS) slope. Flap gate, concrete saddle, and apron on the WS end. Concrete headwall on the landside (LS) end. [Additional Reference(s): DWR Levee Log, 1992. USACE San Joaquin O&M Manual 6, September 1961, (HLM 8.60)]. FS Date: 11/6/2013

WS view: two flap gates on outfall pipe ends.

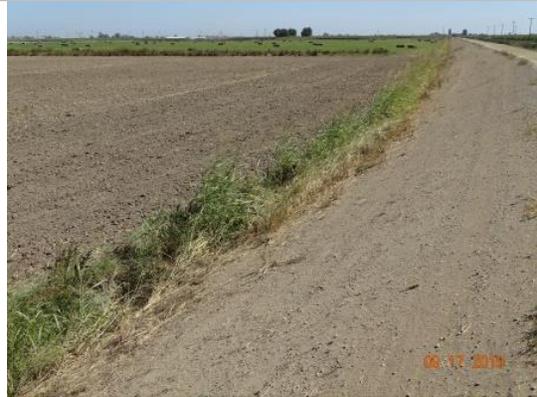
Photo 1 of 1 : FA_2019_RD2063_112_46_20190920_00117.jpg

LM Start	9.06	Rating **	M	Issue No.	46
LM End	9.11	Issue Type +	En	Location *	LS
Category	Earthen Levee		GPS Latitude/Longitude		
			Start	End	
Item	Encroachments		37.390852 °	37.390787 °	
			-120.966220 °	-120.965460 °	
DWR ID	DWR_RD2063_01_f_2019_46				
Comment Code					
DT : Ditch					
Inspector Comment					
Landowner has dug a small ditch along the landside toe.

Small ditch dug along landside toe. (Fall 2019)

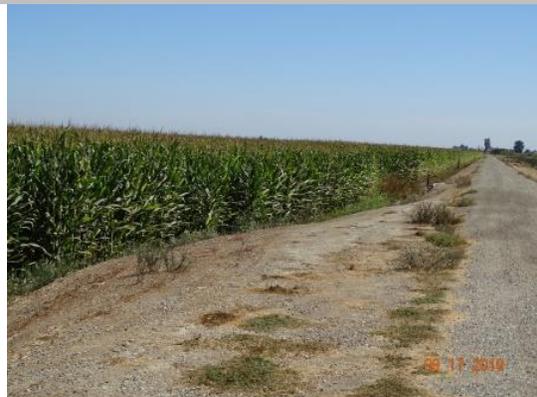
Photo 1 of 2 : FA_2019_RD2063_112_55_20190920_00118.jpg

LM Start	9.46	Rating **	U	Issue No.	55
LM End	10.41	Issue Type +	En	Location *	LS
Category	Earthen Levee		GPS Latitude/Longitude		
			Start	End	
Item	Encroachments		37.390683 °	37.390503 °	
			-120.959037 °	-120.941741 °	
DWR ID	DWR_RD2063_01_s_2019_55				
Comment Code					
CR : Crops					
Inspector Comment					
Crops planted on landside toe right up against the slope. Landowner claims levee was constructed 22 ft too far into his property according to his survey.

View of landside slope looking upstream. (Fall 2019)

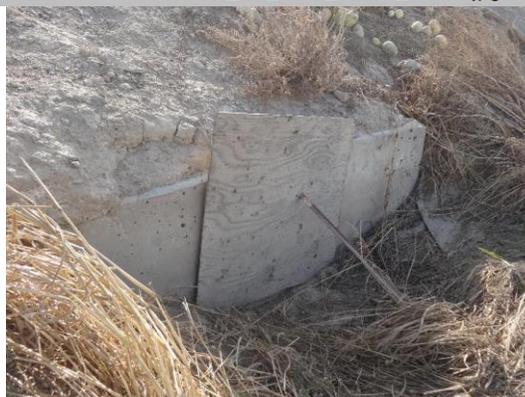
Photo 3 of 3 : UCIP_FA_2019_51825_43982.jpg

Comment Code					
Inspector Comment					
DS_ID:22115 FS_ID:51825 EP_NO: N/A Repair Type: No Action Needed Crossing Status: Found UCIP Comments: 04/11/2017 LS inlet has been cleared, as per DWR inspector Richard Willoughby. (K. Fazel - UCIP)11/06/2013 Landside inlet blocked by plywood. (P. Amatya - DWR) FIELD_STRUCT_DESC: 24-inch corrugated metal gravity drainage pipe through the levee, 5.6 feet below the crown. Flap gate and concrete U-shaped headwall on the waterside (WS) end. Concrete headwall on the landside (LS) end. Installed by USACE in 1961. [Additional Reference(s): DWR Levee Log, 1992. USACE San Joaquin O&M Manual 6, September 1961, (HLM 9.66)]. FS Date: 4/11/2017

LS view: concrete headwall on levee end. Pipe opening blocked by plywood.

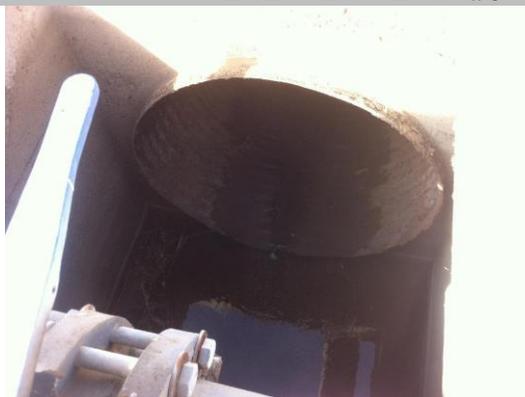
Photo 1 of 3 : UCIP_FA_2019_24644_43986.jpg

LM Start	9.94	Rating **	A/W	Issue No.	84
LM End	9.94	Issue Type +	Ma	Location *	
Category	Supplemental			GPS Latitude/Longitude	
				Start	End
Item	DRAFT DWR UCIP LMA Responsibility			37.390563°	37.390563°
				-120.950329°	-120.950329°
DWR ID	22116				
Comment Code					
Inspector Comment					
DS_ID:22116 FS_ID:24644 EP_NO: N/A Repair Type: No Action Needed Crossing Status: Found UCIP Comments: 11/06/2013 - not very old structure. (P. Amatya - DWR UCIP) FIELD_STRUCT_DESC: 48-inch corrugated metal gravity drainage pipe through the levee and across the drainage ditch on the waterside (WS), 6 feet below the crown. Slide gate and concrete box on the WS end. Concrete box on the landside (LS) end. Installed by USACE in 1961. [Additional Reference(s): DWR Levee Log, 1992. USACE San Joaquin O&M Manual 6, September 1961, (HLM 10.11)]. FS Date: 11/6/2013

WS view: CM pipe on outlet concrete box.

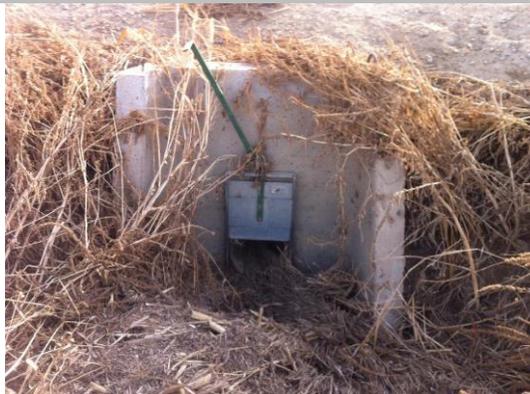
Photo 1 of 3 : UCIP_FA_2019_53096_43993.jpg

LS view: U type concrete headwall, slide gate, and pipe on levee toe.
