**Flood Control Project Maintenance
Levee Inspections**
LMA District Cover Sheet
Spring 2020 Levee Inspection Results

Reclamation District No. 2064 River Junction

Spring 2020 Levee Inspection Results

Waterway	Bank	Unit Miles
Unit No. 01 San Joaquin River	Right	5.56

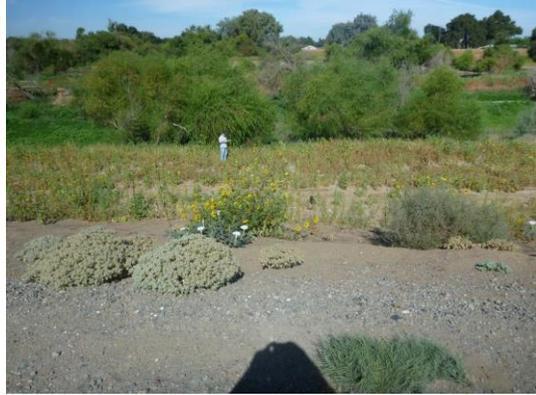
Photo 3 of 3 : SP_2020_RD2064_313_44_20200228_00014.jpg

LM Start	3.26	Rating **	A/W	Issue No.	44 (cont)
LM End	3.39	Issue Type +	Ma	Location *	WS
Category	Supplemental			GPS Latitude/Longitude	
				Start	End
Item	2017 Storm Damage			37.679100 °	37.677800 °
				-121.262600 °	-121.264400 °
DWR ID	LMA-488

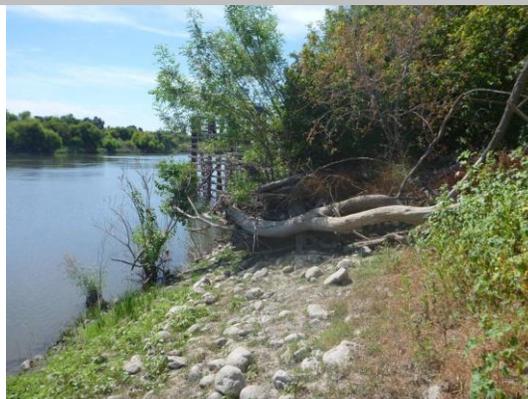
Photo 1 of 3 : SP_2020_RD2064_313_26_20200228_00005.jpg

LM Start	4.82	Rating **	A/W	Issue No.	26
LM End	4.85	Issue Type +	Ma	Location *	WS
Category	Supplemental			GPS Latitude/Longitude	
				Start	End
Item	2017 Storm Damage			37.671730 °	37.672140 °
				-121.246820 °	-121.246800 °
DWR ID	LMA-489

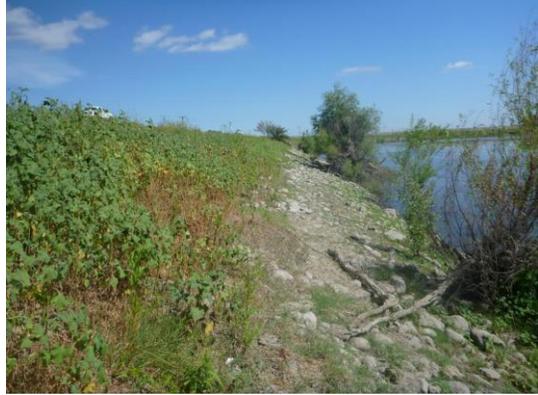
Photo 2 of 3 : SP_2020_RD2064_313_26_20200228_00006.jpg

LM Start	4.82	Rating **	A/W	Issue No.	26 (cont)
LM End	4.85	Issue Type +	Ma	Location *	WS
Category	Supplemental			GPS Latitude/Longitude	
				Start	End
Item	2017 Storm Damage			37.671730 °	37.672140 °
				-121.246820 °	-121.246800 °
DWR ID	LMA-489

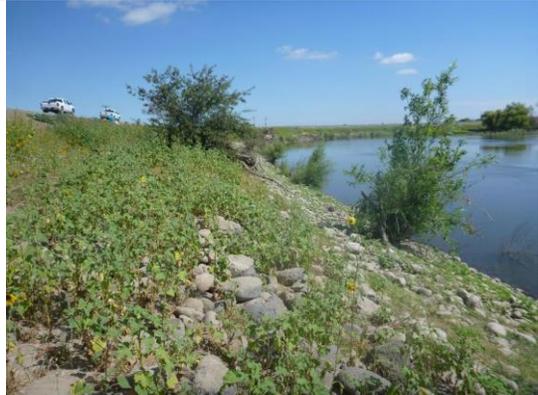
Photo 3 of 3 : SP_2020_RD2064_313_26_20200228_00007.jpg

LM Start	5.22	Rating **	A/W	Issue No.	26 (cont)
LM End	4.85	Issue Type +	Ma	Location *	WS
