**Flood Control Project Maintenance
Levee Inspections**
LMA District Cover Sheet
Spring 2020 Levee Inspection Results

Reclamation District No. 2092 Dos Rios

Waterway	Bank	Unit Miles
Unit No. 01 San Joaquin River	Right	3.71

Levee Inspection Report By Mile - Spring 2020

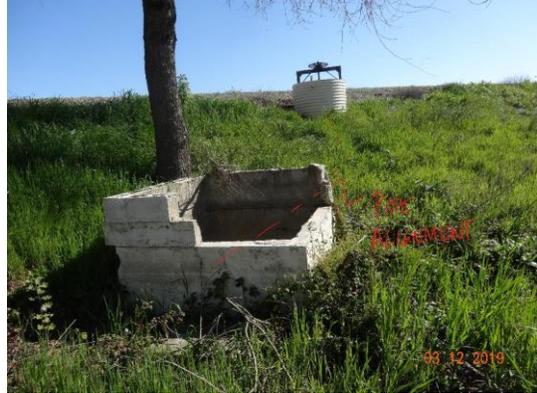
Photo 2 of 3 : UCIP_SP_2020_53820_79078.jpg

LM Start	1.30	Rating **	M	Issue No.	977 (cont)
LM End	1.30	Issue Type +	Ma	Location *	
Category	Supplemental			GPS Latitude/Longitude	
				Start	End
Item	DWR UCIP LMA Responsibility			37.590603 °	37.590603 °
				-121.164111 °	-121.164111 °
DWR ID	20562

WS view: approximate alignment on WS.

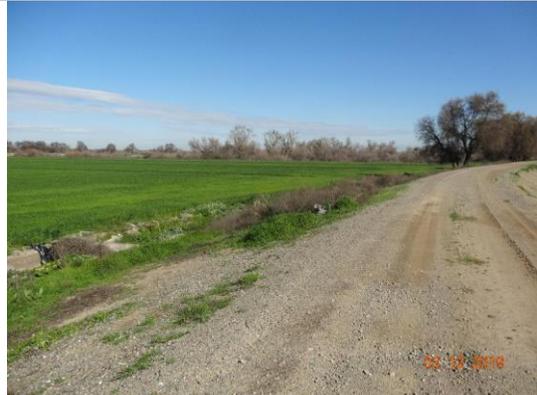
Photo 2 of 3 : UCIP_SP_2020_53817_79087.jpg

Comment Code					
Inspector Comment					
DS_ID:20563 FS_ID:53817 EP_NO: N/A Repair Type: Urgent Crossing Status: Found UCIP Comments: 03/12/2019 A thorough internal evaluation of this crossing is required, pipe shows evidence of pipe integrity (LS) issues (pipe wall sections missing on WS outlet). Internal inspection is recommended for this crossing to determine the extent of pipe damage through the levee. Maintenance issues identified at this crossing include: flap gate missing on WS, debris found inside concrete distribution box, and missing cover on riser. No permit has been identified for this crossing. Need to determine who maintains crossing; crossing appears functional. (O. Magana - DWR UCIP) FIELD_STRUCT_DESC: 24-inch corrugated metal drainage pipe through the levee, 14 feet below the crown. Slide gate in a corrugated metal pipe (CMP) riser on the waterside (WS) slope. Concrete U-shaped headwall at the landside (LS) toe. [Additional Reference(s): DWR Levee Log, 2005. USACE San Joaquin O&M Manual 5, August 1961, (HLM 1.71)]. FS Date: 3/12/2019 12:07:00 PM

LM Start	1.69	Rating **	U	Issue No.	978 (cont)
LM End	1.69	Issue Type +	Ma	Location *

WS view: overview of WS.

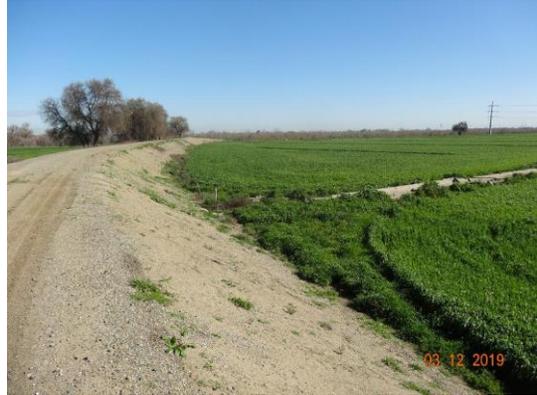
Photo 3 of 3 : UCIP_SP_2020_53817_79085.jpg

LM Start	1.69	Rating **	U	Issue No.	978 (cont)
LM End	1.69	Issue Type +	Ma	Location *	
Category	Supplemental			GPS Latitude/Longitude	
				Start	End
Item	DWR UCIP LMA Responsibility			37.585938 °	37.585938 °
				-121.163348 °	-121.163348 °
DWR ID	20563

LS view: overview of LS.

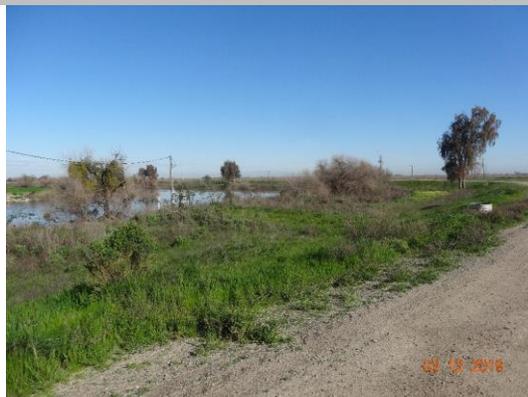
Photo 1 of 3 : UCIP_SP_2020_53805_79106.jpg

LM Start	2.34	Rating **	M	Issue No.	981
LM End	2.34	Issue Type +	En	Location *	
Category	Supplemental		GPS Latitude/Longitude		
			Start	End	
Item	DWR UCIP Field Study		37.581226 °	37.581226 °	
			-121.156175 °	-121.156175 °	
DWR ID	24680

WS view: overview of WS.

DS_ID:24680
 FS_ID:53805
 EP_NO: N/A
 Repair Type: Non-Urgent
 Crossing Status: Found
 UCIP Comments: 03/12/2019 No permit was found authorizing modifications to existing crossing. New crossing was added at this levee section using the old appurtenances associated with USACE O&M Legacy system Pipe (dsid 20566). The pipe associated with dsid 20566 has been grouted through (see dsid 20566 detail report). Irrigation pipe is functional and pipe is being maintained. Unable to confirm if riser located on WS is being used with this crossing. Need to coordinate with CVFPB to determine owner and if permit was issued for the modifications of this crossing. (O. Magana - DWR UCIP) 09/24/2013 No permit identified for this crossing. (W. Wylie - DWR UCIP)
 FIELD_STRUCT_DESC: 21-inch polyvinyl chloride (PVC) irrigation pipe through the levee, at an unknown depth. Pipe discharges into a concrete distribution box on the landside (LS) toe. Pump on pier off the waterside (WS) toe. [Additional Reference(s): DWR Levee Log, 2005].

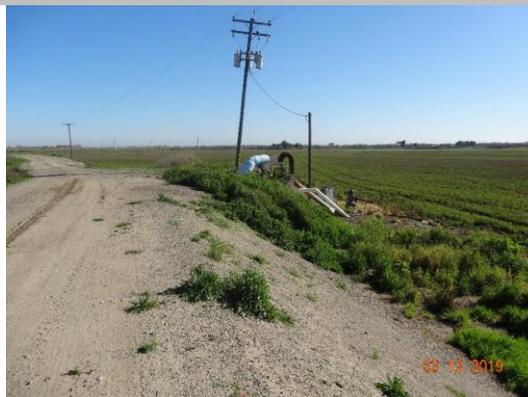
Photo 3 of 3 : UCIP_SP_2020_54051_79110.jpg

LM Start	2.34	Rating **	M	Issue No.	982 (cont)
LM End	2.34	Issue Type +	En	Location *	
Category	Supplemental			GPS Latitude/Longitude	
				Start	End
Item	DWR UCIP Field Study			37.581213 °	37.581213 °
				-121.156175 °	-121.156175 °
DWR ID	20566

LS view: overview of LS.

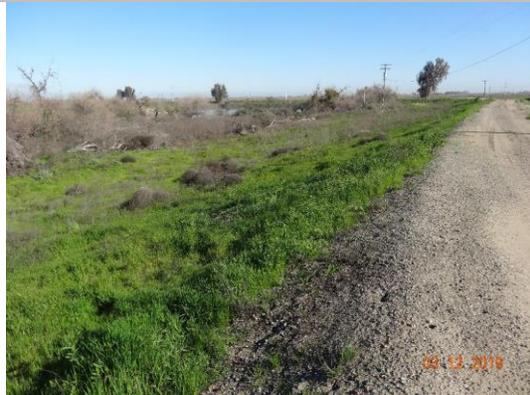
Photo 1 of 3 : UCIP_SP_2020_54052_79119.jpg

DS_ID:20567
 FS_ID:54052
 EP_NO: N/A
 Repair Type: Non-Urgent
 Crossing Status: Indicator Found
 UCIP Comments: 03/12/2019 Unable to locate concrete headwall on the WS due to high water. Unable to locate concrete headwall on LS due to dense vegetation. No permit was found authorizing crossing. If crossing is no longer in use recommend removing crossing and appurtenances from levee. Need to coordinate with CVFPB to determine pipe owner. (O. Magana - DWR UCIP)
 09/24/2013 Appears abandoned and if so should be done so properly. (W. Wylie - DWR UCIP)
 FIELD_STRUCT_DESC: *ABANDONED* 24-inch corrugated metal drainage pipe through the levee, 15 feet below the crown. Flap gate on the waterside (WS) end. Concrete U-shaped headwall on the WS end. Concrete headwall on the landside (LS) toe next to pump. [Additional Reference(s): DWR Levee Log, 2005. USACE San Joaquin O&M Manual 5, August 1961, (HLM 2.44)].

LM Start	2.40	Rating **	M	Issue No.	983 (cont)
LM End	2.40	Issue Type +	En	Location *

WS view: overview of WS.

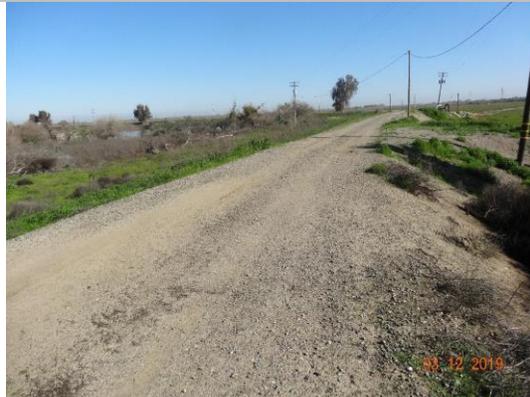
Photo 2 of 3 : UCIP_SP_2020_54052_79118.jpg

Overview of levee crown looking d/s towards crossing.

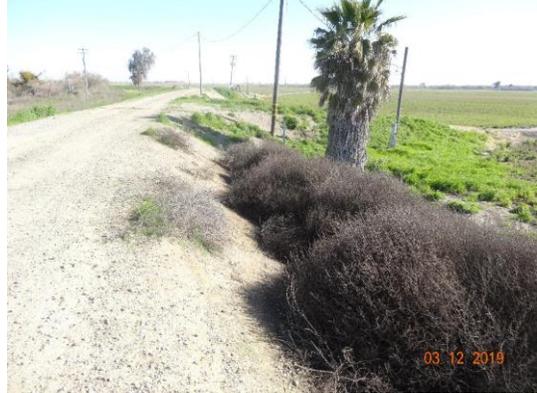
Photo 3 of 3 : UCIP_SP_2020_54052_79117.jpg

LM Start	2.40	Rating **	M	Issue No.	983 (cont)
LM End	2.40	Issue Type +	En	Location *	
Category	Supplemental		GPS Latitude/Longitude		
			Start	End	
Item	DWR UCIP Field Study		37.580426 °	37.580426 °	
			-121.156798 °	-121.156798 °	
DWR ID	20567

LS view: overview of LS.

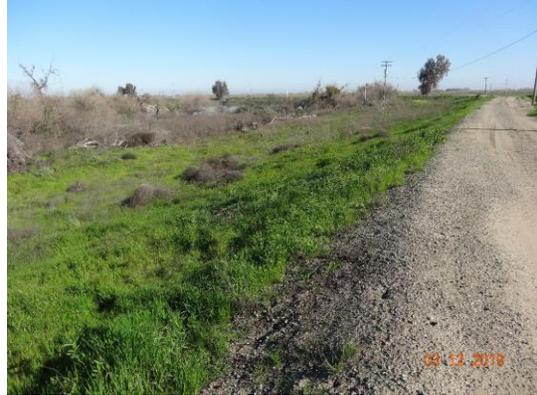
Photo 1 of 3 : UCIP_SP_2020_53808_79126.jpg

LM Start	2.41	Rating **	M	Issue No.	984
LM End	2.41	Issue Type +	En	Location *	
Category	Supplemental		GPS Latitude/Longitude		
			Start	End	
Item	DWR UCIP Field Study		37.580405 °	37.580405 °	
			-121.156825 °	-121.156825 °	
DWR ID	20568

WS view: overview of WS.

Comment Code					
Inspector Comment					
DS_ID:20568 FS_ID:53808 EP_NO: N/A Repair Type: Non-Urgent Crossing Status: Indicator Found UCIP Comments: 03/12/2019 No permit was found authorizing crossing. Crossing appears to be abandoned, if crossing is abandoned, owner will need to coordinate with CVFPB to comply with Title 23. (O. Magana - DWR UCIP) 09/24/2013 Pipe abandoned and should be verified as having been removed from the levee. (W. Wylie - DWR UCIP) FIELD_STRUCT_DESC: *ABANDONED* 4-inch drainage pipe of an unknown material through the levee, 1 foot below the crown. Pump on sump at the landside (LS) toe. Roadway extending to the LS pump. [Additional Reference(s): DWR Levee Log, 2005]. FS Date: 3/12/2019 12:10:00 PM

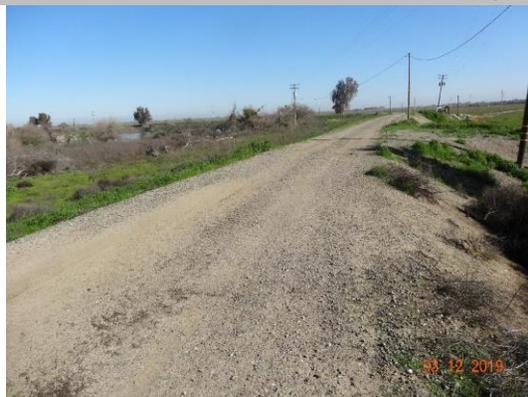
Photo 2 of 3 : UCIP_SP_2020_53808_79125.jpg

LM Start	2.41	Rating **	M	Issue No.	984 (cont)
LM End	2.41	Issue Type +	En	Location *	
Category	Supplemental			GPS Latitude/Longitude	
				Start	End
Item	DWR UCIP Field Study			37.580405 °	37.580405 °
				-121.156825 °	-121.156825 °
DWR ID	20568

Overview of levee crown.

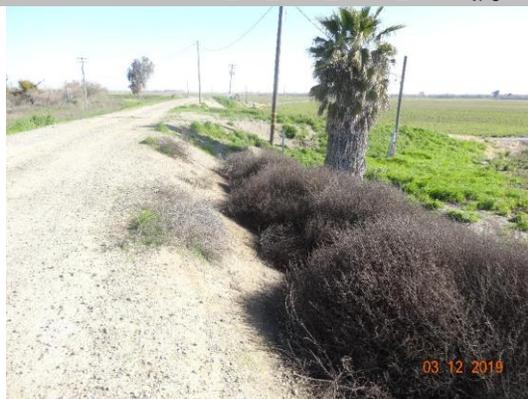
Photo 3 of 3 : UCIP_SP_2020_53808_79124.jpg

LM Start	2.41	Rating **	M	Issue No.	984 (cont)
LM End	2.41	Issue Type +	En	Location *

LS view: overview of LS.

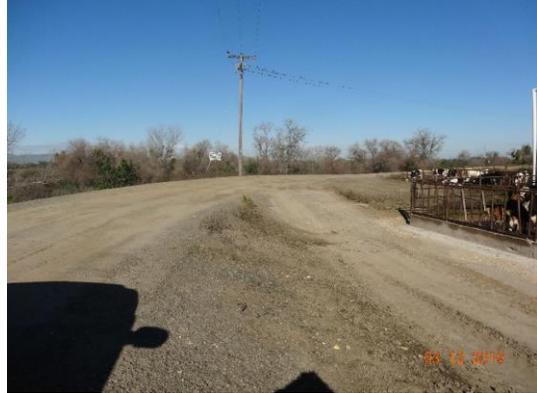
Photo 1 of 3 : UCIP_SP_2020_53813_79128.jpg

LM Start	2.79	Rating **	M	Issue No.	985
LM End	2.79	Issue Type +	En	Location *	
Category	Supplemental		GPS Latitude/Longitude		
			Start	End	
Item	DWR UCIP Field Study		37.575002 °	37.575002 °	
			-121.156753 °	-121.156753 °	
DWR ID	20569				
Comment Code					
Inspector Comment					
DS_ID:20569 FS_ID:53813 EP_NO: N/A Repair Type: Non-Urgent Crossing Status: Not Found UCIP Comments: 03/12/2019 Need to confirm status of crossing through levee section. (O. Magana - DWR UCIP) FIELD_STRUCT_DESC: 24-inch corrugated metal drainage pipe through the levee, 6 feet below the crown. Concrete U-shaped headwall and flap gate on the waterside (WS) end. [Additional Reference(s): DWR Levee Log, 2005. USACE San Joaquin O&M Manual 5, August 1961, (HLM 2.83)]. FS Date: 3/12/2019 12:10:00 PM

LS view: overview of LS.

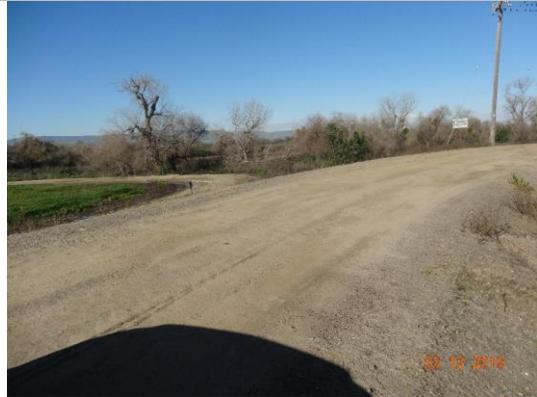
Photo 2 of 3 : UCIP_SP_2020_53813_79129.jpg

LM Start	2.79	Rating **	M	Issue No.	985 (cont)
LM End	2.79	Issue Type +	En	Location *

Overview of levee crown where crossing should be.

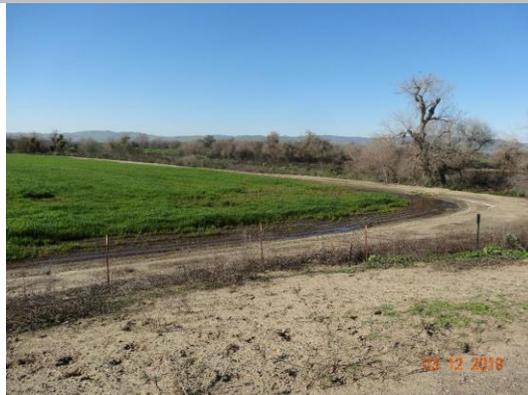
Photo 3 of 3 : UCIP_SP_2020_53813_79130.jpg

LM Start	2.79	Rating **	M	Issue No.	985 (cont)
LM End	2.79	Issue Type +	En	Location *	
Category	Supplemental			GPS Latitude/Longitude	
				Start	End
Item	DWR UCIP Field Study			37.575002 °	37.575002 °
				-121.156753 °	-121.156753 °
DWR ID	20569

WS view: overview of WS.

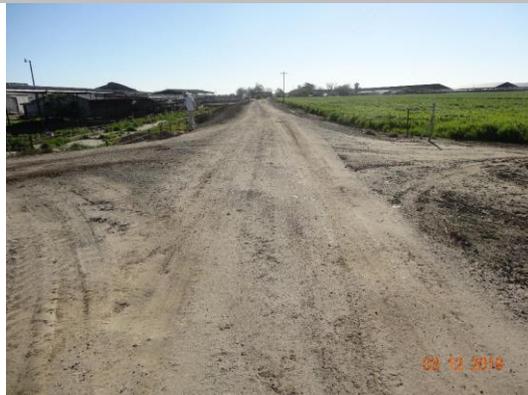
Photo 1 of 3 : UCIP_SP_2020_53810_79135.jpg

Comment Code					
Inspector Comment					
DS_ID:20570 FS_ID:53810 EP_NO: N/A Repair Type: Non-Urgent Crossing Status: Indicator Found UCIP Comments: 03/12/2019 Unable to locate concrete headwall on the WS. Concrete headwall is still visible on the LS however, this crossing appears to be abandoned. No permit was found authorizing crossing. If crossing is no longer in use recommend removing crossing and appurtenances from levee. (O. Magana - DWR UCIP) 09/24/2013 Appears abandoned and if so, should be done so properly. (W. Wylie - DWR UCIP) FIELD_STRUCT_DESC: *ABANDONED* 24-inch corrugated metal drainage pipe through the levee, 6.5 feet below the crown. Concrete U-shaped headwall and flap gate on the waterside (WS) end. Concrete headwall on the landside (LS) slope. [Additional Reference(s): DWR Levee Log, 2005. USACE San Joaquin O&M Manual 5, August 1961]. FS Date: 3/12/2019 12:11:00 PM

Overview of levee at crossing, photo taken d/s looking u/s towards crossing.

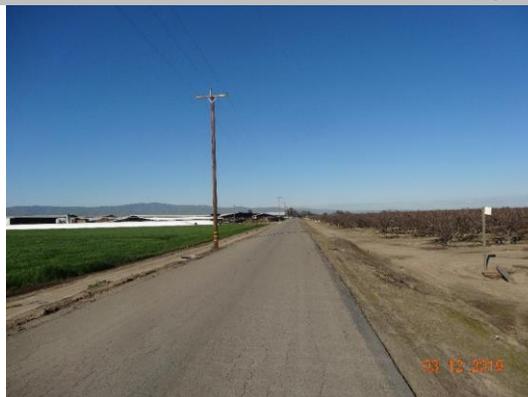
Photo 1 of 3 : UCIP_SP_2020_53786_79145.jpg

Comment Code					
Inspector Comment					
DS_ID:20572 FS_ID:53786 EP_NO: N/A Repair Type: Non-Urgent Crossing Status: Found UCIP Comments: 03/12/2019 No permit was found authorizing crossing. Unable to confirm if crossing is in use. Recommend adding cover to riser to address safety concern. No slide gate was found in CMP riser. If crossing is no longer in use, recommend proper abandonment or removal from levee. Owner will need to coordinate with CVFPB to be compliant with Title 23. (O. Magana - DWR UCIP) 09/24/2013 This pipe appears abandoned and if so, should be done so properly. (W. Wylie - DWR UCIP) FIELD_STRUCT_DESC: *ABANDONED* 36-inch corrugated metal drainage pipe through the levee, 11 feet below the crown. Slide gate in a corrugated metal pipe (CMP) riser on the waterside (WS) slope. Concrete headwalls on both ends. [Additional Reference(s): DWR Levee Log, 2005. USACE San Joaquin O&M Manual 5, August 1961, (HLM 3.52)]. FS Date: 3/12/2019 12:11:53 PM

Overview of levee crown looking d/s towards crossing.
