**Flood Control Project Maintenance
Levee Inspections**

Fall 2019 Levee Maintenance Deficiency Summary Report

Reclamation District No. 2103 Wheatland Vicinity

Waterway	Bank	Unit Miles
Unit No. 01 South Dry Creek	Left	4.64

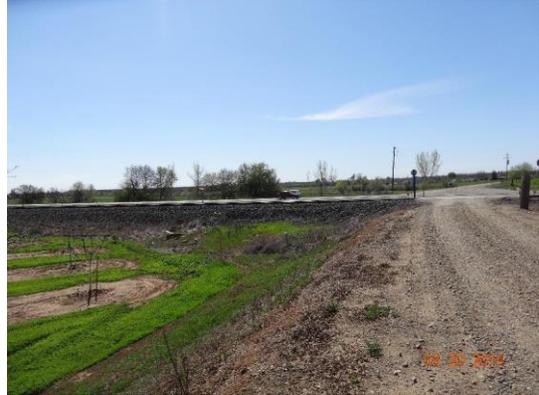
Photo 1 of 3 : UCIP_FA_2019_39987_71885.jpg

LM Start	0.56	Rating **	M	Issue No.	32
LM End	0.56	Issue Type +	En	Location *	
Category	Supplemental			GPS Latitude/Longitude	
				Start	End
Item	DRAFT DWR UCIP Field Study			39.022665 °	39.022665 °
				-121.444688 °	-121.444688 °
DWR ID	24879				
Comment Code					
Inspector Comment					
DS_ID:24879 FS_ID:39987 EP_NO: N/A Repair Type: Non-Urgent Crossing Status: Indicator Found UCIP Comments: 03/04/2014 Need to contact owner to obtain depth of line through levee. Also need permit authorizing conduit through levee. (O. Magana - DWR UCIP) FIELD_STRUCT_DESC: Conduit line through levee. Markers visible on both sides. FS Date: 3/4/2014

View of landward side.

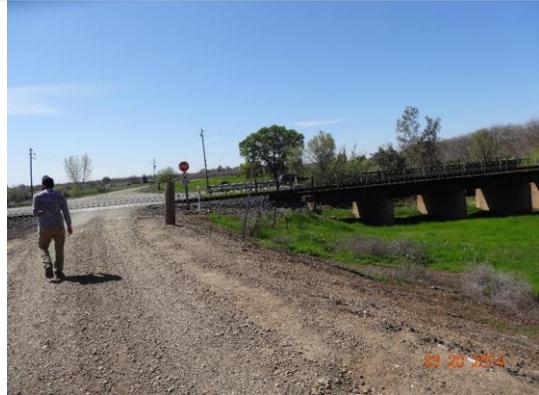
Photo 2 of 3 : UCIP_FA_2019_39987_71884.jpg

View of levee crown and waterward side.

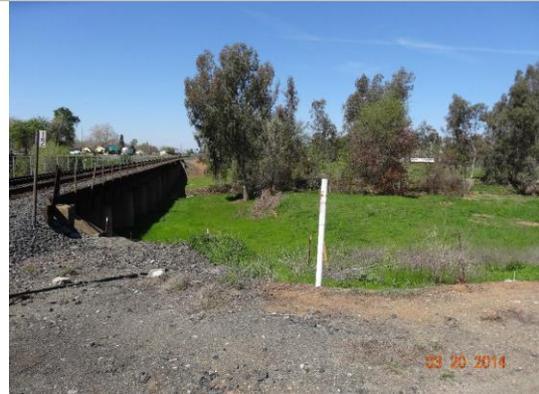
Photo 3 of 3 : UCIP_FA_2019_39987_71886.jpg

LM Start	0.56	Rating **	M	Issue No.	32 (cont)
LM End	0.56	Issue Type +	En	Location *	
Category	Supplemental			GPS Latitude/Longitude	
				Start	End
Item	DRAFT DWR UCIP Field Study			39.022665 °	39.022665 °
				-121.444688 °	-121.444688 °
DWR ID	24879				
Comment Code					
Inspector Comment					
DS_ID:24879 FS_ID:39987 EP_NO: N/A Repair Type: Non-Urgent Crossing Status: Indicator Found UCIP Comments: 03/04/2014 Need to contact owner to obtain depth of line through levee. Also need permit authorizing conduit through levee. (O. Magana - DWR UCIP) FIELD_STRUCT_DESC: Conduit line through levee. Markers visible on both sides. FS Date: 3/4/2014

View of waterward side.

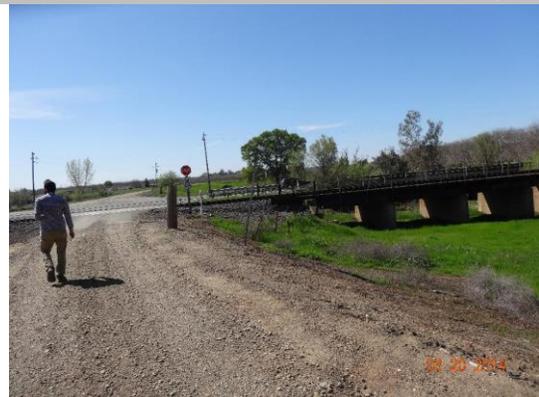
Photo 1 of 3 : UCIP_FA_2019_38323_69860.jpg

Comment Code					
Inspector Comment					
DS_ID:19469 FS_ID:38323 EP_NO: 2098 Repair Type: Non-Urgent Crossing Status: Indicator Found UCIP Comments: 03/20/2014 Need to contact owner to determine status of crossing. Need date of last inspection and confirmation that crossing is still in operable condition. (O. Magana - DWR UCIP) FIELD_STRUCT_DESC: 16-inch steel gas line through the levee, 3 feet below the crown. Marker on waterside (WS) slope. (16-inch line authorized under Permit No. 2098, 1955-Pacific Gas and Electric Company [PG&E]). [Additional Reference(s): DWR Levee Logs, 2005. USACE Sacramento O&M Manual Unit No. 146, November 1962, (HLM 0.56)] FS Date: 3/20/2014

View of levee crown at crossing.

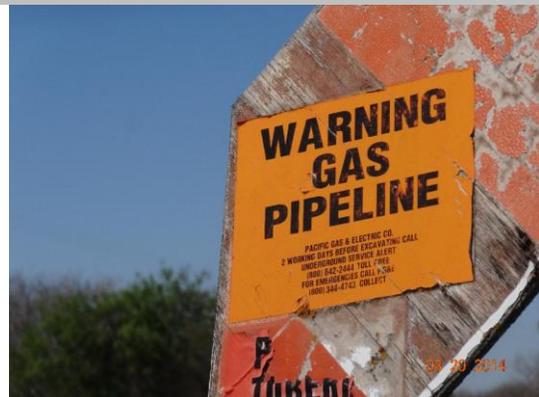
Photo 3 of 3 : UCIP_FA_2019_38323_69858.jpg

Comment Code					
Inspector Comment					
DS_ID:19469 FS_ID:38323 EP_NO: 2098 Repair Type: Non-Urgent Crossing Status: Indicator Found UCIP Comments: 03/20/2014 Need to contact owner to determine status of crossing. Need date of last inspection and confirmation that crossing is still in operable condition. (O. Magana - DWR UCIP) FIELD_STRUCT_DESC: 16-inch steel gas line through the levee, 3 feet below the crown. Marker on waterside (WS) slope. (16-inch line authorized under Permit No. 2098, 1955-Pacific Gas and Electric Company [PG&E]). [Additional Reference(s): DWR Levee Logs, 2005. USACE Sacramento O&M Manual Unit No. 146, November 1962, (HLM 0.56)] FS Date: 3/20/2014

Contact information of owner.

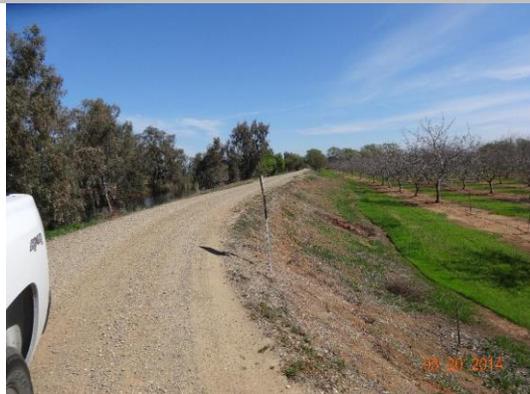
Photo 1 of 3 : UCIP_FA_2019_38324_69864.jpg

Comment Code					
Inspector Comment					
DS_ID:19470 FS_ID:38324 EP_NO: 789 Repair Type: Non-Urgent Crossing Status: Indicator Found UCIP Comments: 03/20/2014 Need to contact owner to determine status of crossing. Need date of last inspection and confirmation that crossing is still in operable condition. (O. Magana - DWR UCIP) FIELD_STRUCT_DESC: 16-inch steel gas line through levee, 3 feet below the crown. Concrete inspection chamber (24-inch by 18-inch box with 4-inch walls) on the waterside (WS) shoulder, covered with dirt. Gas line marker on landside (LS) slope. Extends underneath Dry Creek channel, covered with concrete slab approximately 18-inches wide. (8.625-inch gas line authorized under Permit No. 789, 1939-Pacific Gas and Electric Company [PG&E]). [Additional Reference(s): DWR Levee Logs, 2005, 16-inch gas line. USACE Sacramento O&M Manual Unit No. 146, November 1962, (HLM 0.63), 16-inch gas line] FS Date: 3/20/2014

View of levee crown looking upstream.

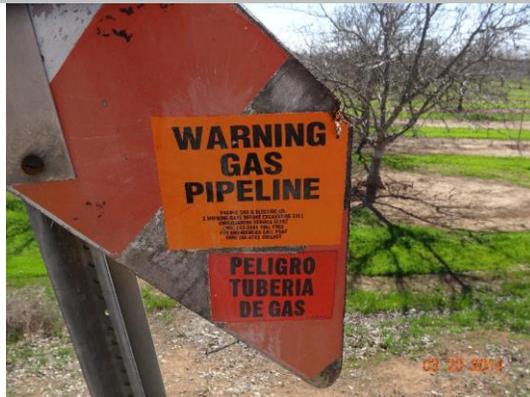
Photo 2 of 3 : UCIP_FA_2019_38324_69863.jpg

Contact information for gas pipeline.

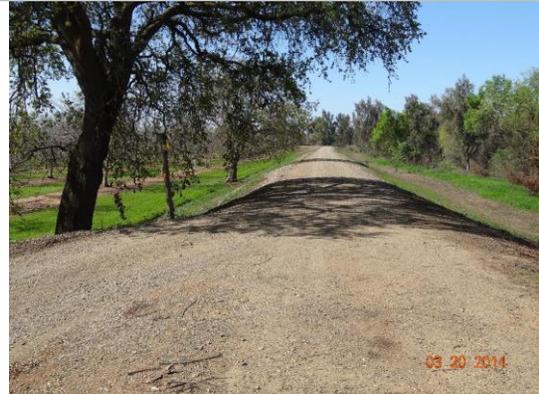
Photo 3 of 3 : UCIP_FA_2019_39988_71888.jpg

LM Start	0.81	Rating **	M	Issue No.	35 (cont)
LM End	0.81	Issue Type +	En	Location *	
Category	Supplemental			GPS Latitude/Longitude	
				Start	End
Item	DRAFT DWR UCIP Field Study			39.024725 °	39.024725 °
				-121.440978 °	-121.440978 °
DWR ID	24880				
Comment Code					
Inspector Comment					
DS_ID:24880 FS_ID:39988 EP_NO: N/A Repair Type: Non-Urgent Crossing Status: Indicator Found UCIP Comments: 03/04/2014 No marker found on waterward side-- need to confirm with owner if crossing goes through levee. If so, need depth of crossing through levee. Also need to obtain permit number used to authorize crossing. (O. Magana - DWR UCIP) FIELD_STRUCT_DESC: Conduit line through levee of unknown material or depth below the crown. Marker visible on landside (LS). FS Date: 3/4/2014

View of levee at crossing.

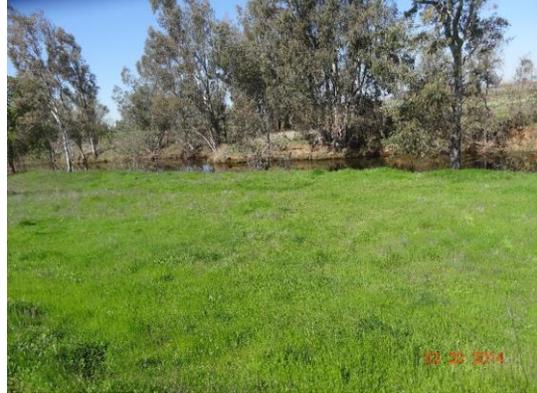
Photo 2 of 3 : UCIP_FA_2019_41183_69916.jpg

Comment Code					
Inspector Comment					
DS_ID:19473 FS_ID:41183 EP_NO: 1886 Repair Type: Non-Urgent Crossing Status: Indicator Found UCIP Comments: 03/20/2014 Need to coordinate with owner. Severely corroded section of steel pipe present on waterward side--no other evidense present at this location. Owner will need to coordinate with CVFPB and DWR-Inspector to determine proper action to abandon crossing. (O. Magana - DWR UCIP) FIELD_STRUCT_DESC: *ABANDONED* 12-inch steel irrigation pipe through the levee, 3.1 feet below the crown. Siphon breaker on the waterward slope. Concrete standpipe at the landward toe. Vertical pump on waterside (WS). Open on WS end. Permit includes gravel dam through channel of Dry Creek. Crossing is angled 45 degrees. (10-inch pipe authorized under Permit No. 1886, 1959-R. H. Blackford, Jr.) [Additional Reference(s): DWR Levee Logs, 2005. USACE Sacramento O&M Manual Unit No. 146, November 1962, (HLM 1.86)] FS Date: 3/20/2014

View of waterward side.

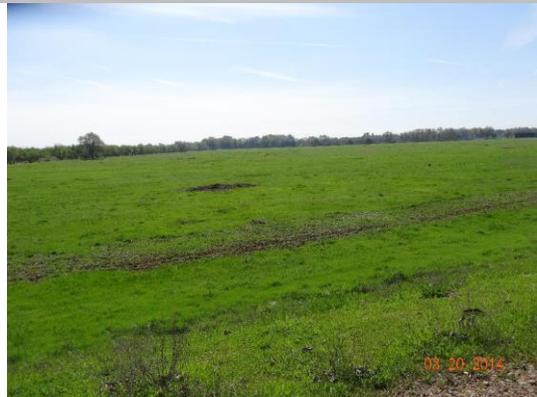
Photo 3 of 3 : UCIP_FA_2019_41183_69915.jpg

View of landward side.

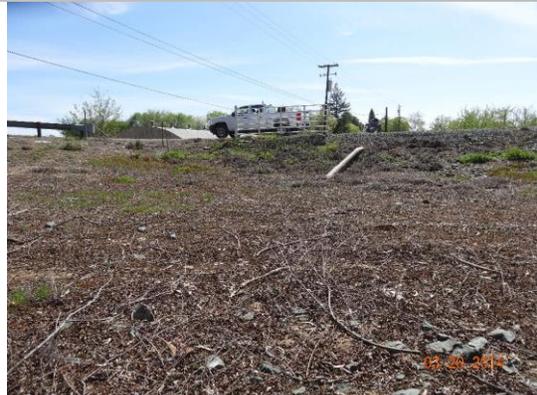
Photo 1 of 3 : UCIP_FA_2019_38331_69894.jpg

Comment Code					
Inspector Comment					
DS_ID:19477 FS_ID:38331 EP_NO: N/A Repair Type: Non-Urgent Crossing Status: Found UCIP Comments: 03/20/2014 Need to contact owner to determine status. (O. Magana - DWR UCIP) FIELD_STRUCT_DESC: 8-inch steel irrigation pipe through the levee, 3.1 feet below the crown. Siphon breaker on the waterward slope. Pump on the landward side. Pipe crosses creek to orchard on north side. (two 12-inch pipes authorized under Permit No. 1887, 1954-H. B. Waltz, HLM 2.41 and 2.68) [Additional Reference(s): DWR Levee Logs, 2005. USACE Sacramento O&M Manual Unit No. 146, November 1962, (HLM 2.68), 8-inch] FS Date: 3/20/2014

View of waterward side.

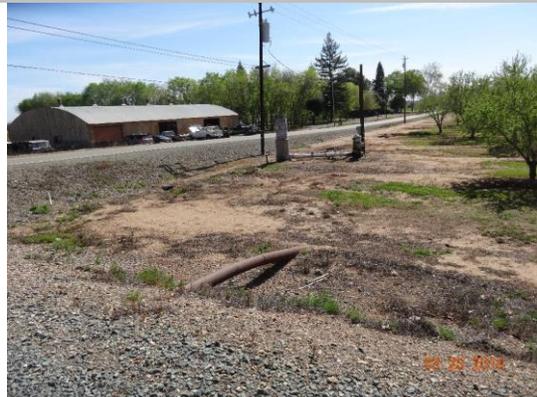
Photo 3 of 3 : UCIP_FA_2019_38331_69892.jpg

Comment Code					
Inspector Comment					
DS_ID:19477 FS_ID:38331 EP_NO: N/A Repair Type: Non-Urgent Crossing Status: Found UCIP Comments: 03/20/2014 Need to contact owner to determine status. (O. Magana - DWR UCIP) FIELD_STRUCT_DESC: 8-inch steel irrigation pipe through the levee, 3.1 feet below the crown. Siphon breaker on the waterward slope. Pump on the landward side. Pipe crosses creek to orchard on north side. (two 12-inch pipes authorized under Permit No. 1887, 1954-H. B. Waltz, HLM 2.41 and 2.68) [Additional Reference(s): DWR Levee Logs, 2005. USACE Sacramento O&M Manual Unit No. 146, November 1962, (HLM 2.68), 8-inch] FS Date: 3/20/2014

View of landward side.

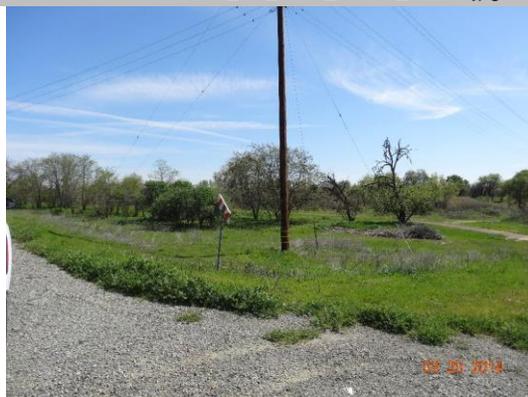
Photo 1 of 2 : UCIP_FA_2019_39993_69912.jpg

Comment Code					
Inspector Comment					
DS_ID:19486 FS_ID:39993 EP_NO: 5714 Repair Type: Non-Urgent Crossing Status: Indicator Found UCIP Comments: 03/20/2014 Need to contact owner to confirm crossing and determine status. (O. Magana - DWR UCIP) FIELD_STRUCT_DESC: 12-inch steel sewer pipes through the levee, 3.1 feet below the crown. Siphon breaker in 24-inch corrugated metal (CM) pipe riser on the landside (LS) shoulder. Standard CM cutoff wall around pipe at centerline of levee. Extends from wastewater treatment plant on landside (LS) to waste water lagoon on waterside (WS). Permit includes construction of lagoon with surrounding short levee, extending from/to project levee. (12-inch pipe authorized under Permit No. 5714, 1968-City of Wheatland). [Additional Reference(s): DWR Levee Logs, 2005] FS Date: 3/20/2014

View of waterward side.

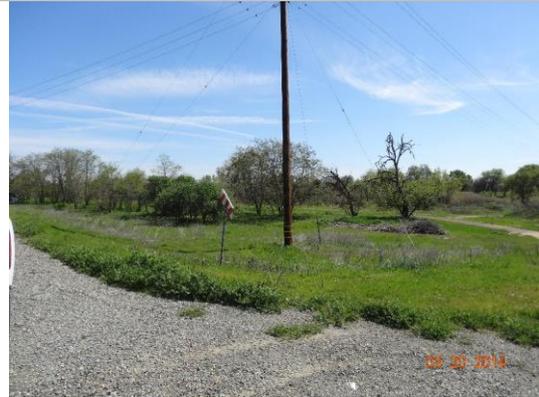
Photo 1 of 3 : UCIP_FA_2019_39994_69905.jpg

LM Start	1.29	Rating **	M	Issue No.	27
LM End	1.29	Issue Type +	En	Location *	
Category	Supplemental			GPS Latitude/Longitude	
				Start	End
Item	DRAFT DWR UCIP Field Study			38.998322°	38.998322°
				-121.414688°	-121.414688°
DWR ID	19509				
Comment Code					
Inspector Comment					
DS_ID:19509 FS_ID:39994 EP_NO: N/A Repair Type: Non-Urgent Crossing Status: Indicator Found UCIP Comments: Need to contact owner to determine details of the crossing through levee. FIELD_STRUCT_DESC: Wheatland Sewage Disposal Plant on waterward side, treatment plant on landward side. Service pole on waterward slope. FS Date: 3/20/2014

View of waterward side.

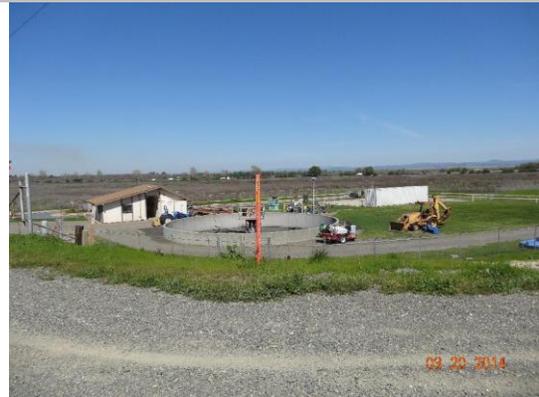
Photo 2 of 3 : UCIP_FA_2019_39994_69904.jpg

View of water treatment located on landward side, photo 1 of 3.

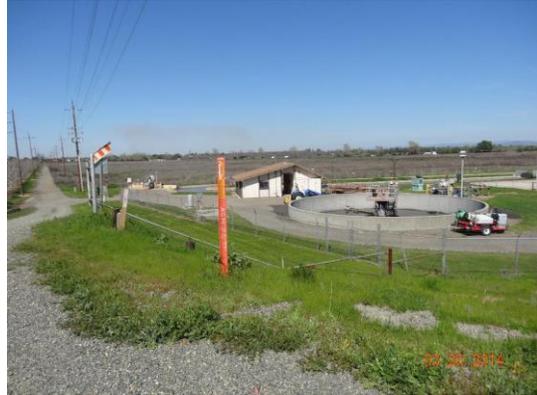
Photo 3 of 3 : UCIP_FA_2019_39994_69903.jpg

LM Start	1.29	Rating **	M	Issue No.	27 (cont)
LM End	1.29	Issue Type +	En	Location *	
Category	Supplemental			GPS Latitude/Longitude	
				Start	End
Item	DRAFT DWR UCIP Field Study			38.998322°	38.998322°
				-121.414688°	-121.414688°
DWR ID	19509				
Comment Code					
Inspector Comment					
DS_ID:19509 FS_ID:39994 EP_NO: N/A Repair Type: Non-Urgent Crossing Status: Indicator Found UCIP Comments: Need to contact owner to determine details of the crossing through levee. FIELD_STRUCT_DESC: Wheatland Sewage Disposal Plant on waterward side, treatment plant on landward side. Service pole on waterward slope. FS Date: 3/20/2014

View of water treatment located on landward side, photo 2 of 3.

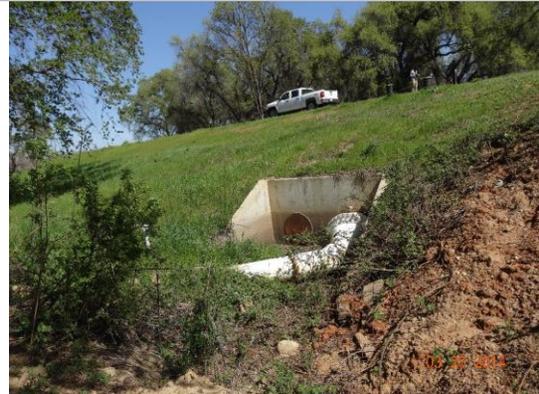
Photo 3 of 3 : UCIP_FA_2019_40045_71912.jpg

Comment Code					
Inspector Comment					
DS_ID:19488 FS_ID:40045 EP_NO: N/A Repair Type: Non-Urgent Crossing Status: Found UCIP Comments: 03/20/2014 Pipe has been plugged--visible on landward side. Need to contact owner to obtain additional information about abandoned crossing. (O. Magana - DWR UCIP) FIELD_STRUCT_DESC: 1 of 2: 30-inch corrugated metal irrigation pipe through levee, 13.8 feet below crown. Slide gates in 42-diameter riser on waterside (WS) slope. Concrete "U" headwall at both levee toes. Grouted spillway on landside (LS). [Additional Reference(s): DWR Levee Logs, 2005. USACE Sacramento O&M Manual Unit No. 146, November 1962, (HLM 2.67), two 30-inch] FS Date: 3/20/2014

View of waterward side.

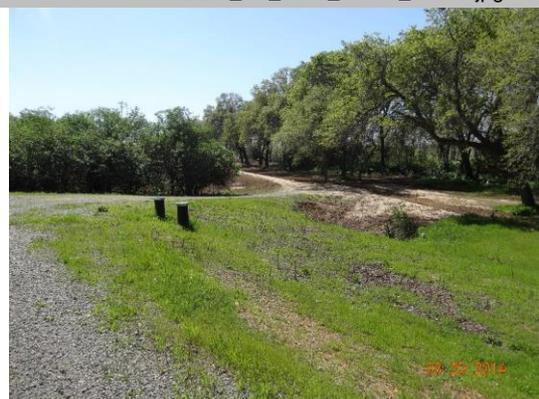
Photo 1 of 3 : UCIP_FA_2019_40046_71915.jpg

Comment Code					
Inspector Comment					
DS_ID:19504 FS_ID:40046 EP_NO: N/A Repair Type: Non-Urgent Crossing Status: Found UCIP Comments: 03/20/2014 Need to contact owner to determine status--crossing appears to be modified. Need to contact owner to obtain additional information about modified crossing. (O. Magana - DWR UCIP) FIELD_STRUCT_DESC: 2 of 2: 30-inch corrugated metal irrigation pipe through levee, 13.8 feet below crown. Slide gates in 42-diameter riser on waterside (WS) slope. Concrete "U" headwall at both levee toes. Grouted spillway on landside (LS). [Additional Reference(s): DWR Levee Logs, 2005. USACE Sacramento O&M Manual Unit No. 146, November 1962, (HLM 2.67), two 30-inch] FS Date: 3/20/2014

View of waterward side.

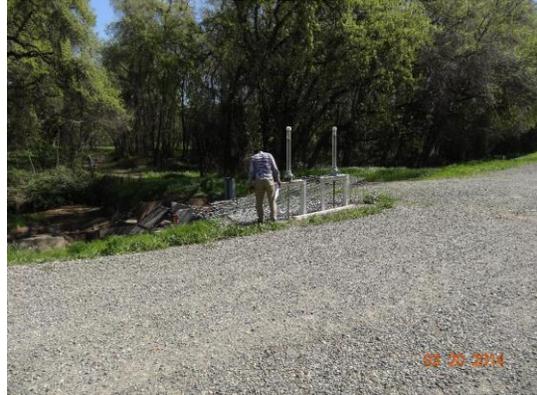
Photo 2 of 3 : UCIP_FA_2019_40046_71914.jpg

Comment Code					
Inspector Comment					
DS_ID:19504 FS_ID:40046 EP_NO: N/A Repair Type: Non-Urgent Crossing Status: Found UCIP Comments: 03/20/2014 Need to contact owner to determine status--crossing appears to be modified. Need to contact owner to obtain additional information about modified crossing. (O. Magana - DWR UCIP) FIELD_STRUCT_DESC: 2 of 2: 30-inch corrugated metal irrigation pipe through levee, 13.8 feet below crown. Slide gates in 42-diameter riser on waterside (WS) slope. Concrete "U" headwall at both levee toes. Grouted spillway on landside (LS). [Additional Reference(s): DWR Levee Logs, 2005. USACE Sacramento O&M Manual Unit No. 146, November 1962, (HLM 2.67), two 30-inch] FS Date: 3/20/2014

View of landward side.

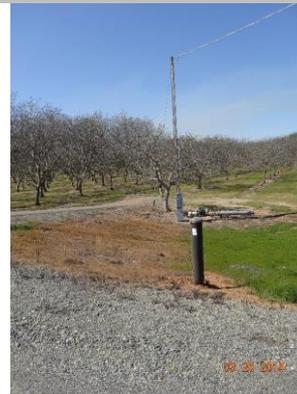
Photo 1 of 3 : UCIP_FA_2019_40048_71922.jpg

Comment Code					
Inspector Comment					
<p>DS_ID:19510 FS_ID:40048 EP_NO: N/A Repair Type: Non-Urgent Crossing Status: Found UCIP Comments: 01/03/2018 Crossing authorized under USACE O&M Manual was removed and replaced with new pipe authorized under Permit No. 18081 (2006). Need to contact owner to obtain as-builts for the current pipe. Current pipe is logged under dsid #####. (DWR UCIP - O. Magana) 03/20/2014 Crossing has been modified---need to contact owner to obtain permit used for modification. (DWR UCIP - O. Magana) FIELD_STRUCT_DESC: *REMOVED* 24-inch corrugated metal irrigation pipe through the levee, 8 feet below the crown. Slide gate in concrete square riser (not corrugated metal pipe riser as mentioned in desk study) located on the waterside (WS) slope. Concrete headwall and trash rack located at toe of WS slope. Breather pipe located on the landside (LS) slope. Pipe discharges in the irrigation ditch located on the landside (LS). Two CM cutoff walls. (no permit found for 24-inch pipe; 24-inch pipe removed and replaced with new 24-inch pipe under Permit No. 18081, 18081-Rev, 2006-Reclamation District No. 2103, four pipes were removed and replaced under this permit) [Additional Reference(s): DWR Levee Logs, 2005. USACE Sacramento O&M Manual Unit No. 146, November 1962, (HLM 4.05)] FS Date: 3/20/2014</p>

View of waterward side.

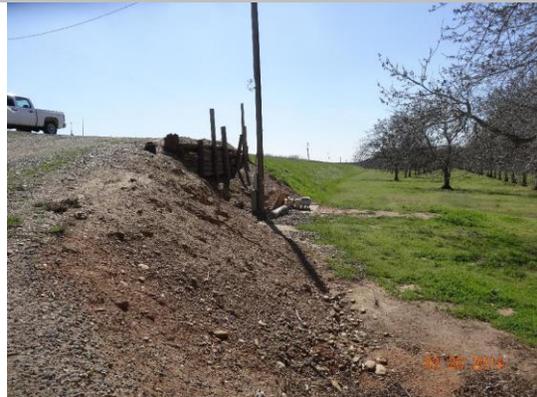
Photo 2 of 3 : UCIP_FA_2019_40049_71926.jpg

Comment Code					
Inspector Comment					
DS_ID:19493 FS_ID:40049 EP_NO: N/A Repair Type: Non-Urgent Crossing Status: Found UCIP Comments: 03/20/2014 Crossing has been modified---need to contact owner to obtain permit used for modification. (O. Magana - DWR UCIP) FIELD_STRUCT_DESC: 24-inch corrugated metal irrigation pipe through levee, 10.6 feet below the crown. Slide gate in concrete square riser (not 36-inch CM riser as mentioned in desk study) is located on the waterside (WS) slope. Concrete "U" headwall and trash rack on WS toe. 5-foot by 5-foot concrete distribution box and headwall located on the landside (LS) toe. [Additional Reference(s): DWR Levee Logs, 2005. USACE Sacramento O&M Manual Unit No. 146, November 1962, (HLM 4.87)] FS Date: 3/20/2014

Overview of waterward side.
