**Flood Control Project Maintenance
Levee Inspections**

Fall 2019 Levee Maintenance Deficiency Summary Report

Sacramento River Basin

Sutter Maintenance Yard East Levee Sutter Bypass

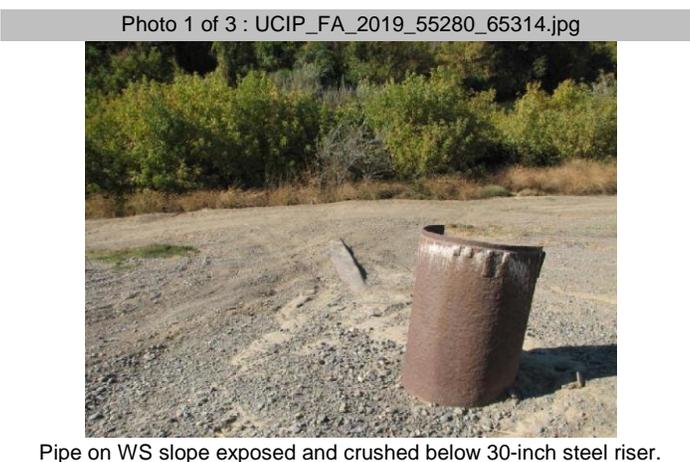
LM Start	14.71	Rating **	M	Issue No.	94
LM End	14.71	Issue Type +	En	Location *	
Category	Supplemental			GPS Latitude/Longitude	
				Start	End
Item	DRAFT DWR UCIP Field Study			38.979377 °	38.979377 °
				-121.691929 °	-121.691929 °
DWR ID	16875

Comment Code					
Inspector Comment					
DS_ID:16875 FS_ID:55280 EP_NO: N/A Repair Type: Non-Urgent Crossing Status: Found UCIP Comments: 05/01/2019 Record remains Non-Urgent, pipe is abandoned. Pipe needs to be abandoned properly according to Title 23 requirements. Internal inspection was completed by DWR DMP (see report). (O. Magana - DWR UCIP)04/11/2017 Abandoned. (DWR Sutter Yard- AFreitag)10/10/2016 Abandoned crossing.(DWR Sutter Yard - afreitag)04/18/2016 Abandoned crossing.05/07/2015 Abandoned crossing. Needs to be properly abandoned.11/12/2014 Same as last inspection.05/14/2014 Same as last inspection.10/30/2013 Same as last inspection.05/23/2013 Same as last inspection.10/09/2012 Pipe has not been abandoned properly. It should be removed from the levee section. FIELD_STRUCT_DESC: 16-inch steel irrigation pipe through the levee, 3.5 feet below the crown. Siphon breakers in 30-inch steel risers on both the waterside (WS) and the landside (LS) shoulders. Vertical pump on pile structure in stream (removed). [Additional Reference(s): DWR Levee Log, 2005. USACE Sacramento O&M Manual 315, May 1953 (Station 377+10)]. FS Date: 5/1/2019 3:16:00 PM
