**Flood Control Project Maintenance  
Levee Inspections**

**Fall 2019 Levee Maintenance Deficiency Summary Report**

**Sacramento Maintenance Yard Putah Creek**

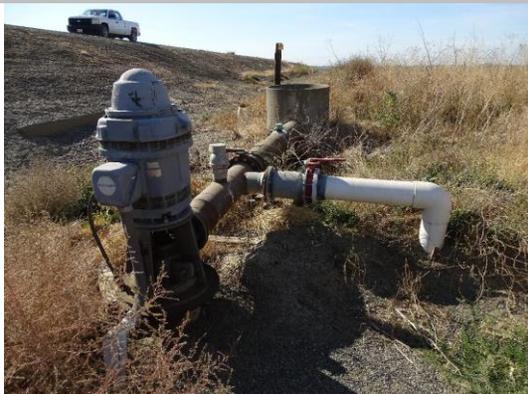
Photo 3 of 3 : UCIP\_FA\_2019\_55584\_82058.jpg

Item	DRAFT DWR UCIP LMA Responsibility			38.519660 °	38.519660 °
				-121.638820 °	-121.638820 °
DWR ID	488				
Comment Code					
Inspector Comment					
DS_ID:488 FS_ID:55584 EP_NO: 10261 Repair Type: Non-Urgent Crossing Status: Found UCIP Comments: 11/07/2019 Crossing type should be updated to Irrigation as it serves irrigation purposes. (O.Yakimov - DWR UCIP) FIELD_STRUCT_DESC: 24-inch drainage pipe of unknown material through the levee, 12.5 feet below the crown. Slide gate is located on the waterside (WS) end. Concrete standpipe and headwall are located on the WS. Water well is connected to the standpipe. (24-inch pipe [HLM 0.58] authorized under Automatic Board Order (ABO) issued as Permit No. 10261, 1974 - Tufts) [Additional Reference(s): DWR Levee Log, 1981 and 2005 (HLM 0.58). USACE Sacramento O&M Manual, Unit 119, December 1952, Revised 29 Dec 2016, (Station 31+00). USACE As-Built Drawing No. 50-04-2396, Revision 1, pdf page 19, Sheet 3, December 1947] FS Date: 11/7/2019 9:56:43 AM

Water well connected to standpipe at LS toe. Top of headwall is visible

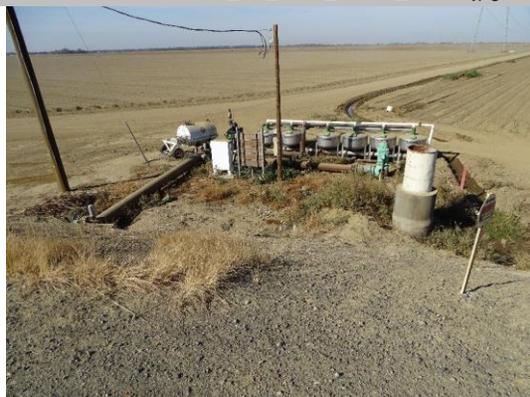
Photo 1 of 3 : UCIP\_FA\_2019\_55592\_82082.jpg

Item	DRAFT DWR UCIP Field Study		38.517110°	38.517110°	
			-121.648844°	-121.648844°	
DWR ID	489				
Comment Code					
Inspector Comment					
DS_ID:489 FS_ID:55592 EP_NO: 10262 Repair Type: Non-Urgent Crossing Status: Found UCIP Comments: 11/07/2019 No issues recorded during inspection (O.Yakimov - DWR UCIP)04/04/2012 Pump is disconnected from pipe and could cause backflow at highwater event. Can't see size of pipe sleeved through 24-inch pipe. (W. Wylie - DWR UCIP) FIELD_STRUCT_DESC: 18-inch steel irrigation pipe (field verified not 16-inch) sleeved through existing 24-inch drainage steel pipe through levee, 12.5 feet below the crown. Annular space sealed at both the waterside (WS) and landside (LS) ends. Concrete headwalls are located on both the WS and LS ends. PVC sleeved December of 2007 (unknown source). (16-inch pipe sleeved through 24-inch pipe authorized under Automatic Board Order (ABO) issued as Permit No. 10262, 1974 - Wells Fargo Bank, Trustee for S.H. Cowell Foundation) [Additional Reference(s): DWR Levee Log, March 2007 (HLM 1.17). USACE Sacramento O&M Manual 119, December 1952 - not sure if crossing is pipe referenced as Station G 198+85] FS Date: 11/7/2019 10:24:34 AM

View of LS looking from levee crown

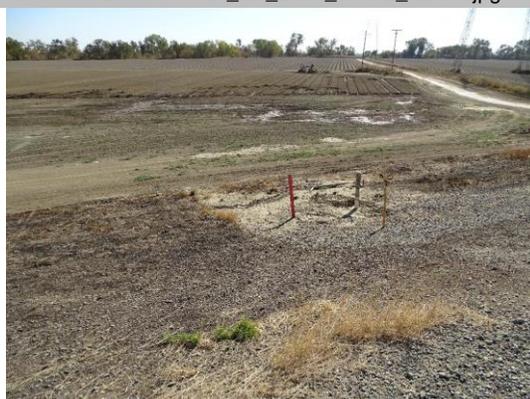
Photo 2 of 3 : UCIP\_FA\_2019\_55592\_82083.jpg

View of WS looking from levee crown. Air vent at levee toe

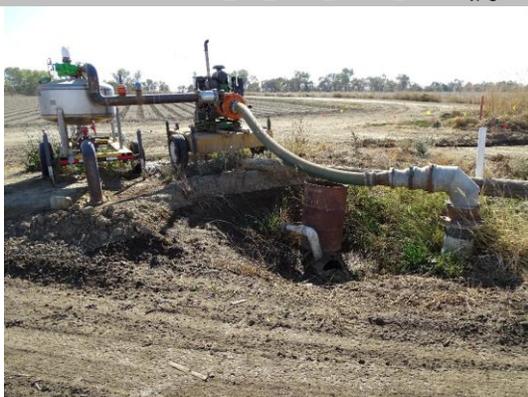
Photo 3 of 3 : UCIP\_FA\_2019\_55592\_82084.jpg

Item	DRAFT DWR UCIP Field Study			38.517110°	38.517110°
				-121.648844°	-121.648844°
DWR ID	489				
Comment Code					
Inspector Comment					
DS_ID:489 FS_ID:55592 EP_NO: 10262 Repair Type: Non-Urgent Crossing Status: Found UCIP Comments: 11/07/2019 No issues recorded during inspection (O.Yakimov - DWR UCIP)04/04/2012 Pump is disconnected from pipe and could cause backflow at highwater event. Can't see size of pipe sleeved through 24-inch pipe. (W. Wylie - DWR UCIP) FIELD_STRUCT_DESC: 18-inch steel irrigation pipe (field verified not 16-inch) sleeved through existing 24-inch drainage steel pipe through levee, 12.5 feet below the crown. Annular space sealed at both the waterside (WS) and landside (LS) ends. Concrete headwalls are located on both the WS and LS ends. PVC sleeved December of 2007 (unknown source). (16-inch pipe sleeved through 24-inch pipe authorized under Automatic Board Order (ABO) issued as Permit No. 10262, 1974 - Wells Fargo Bank, Trustee for S.H. Cowell Foundation) [Additional Reference(s): DWR Levee Log, March 2007 (HLM 1.17). USACE Sacramento O&M Manual 119, December 1952 - not sure if crossing is pipe referenced as Station G 198+85] FS Date: 11/7/2019 10:24:34 AM

Pump in the field on WS approximately 350 feet from levee

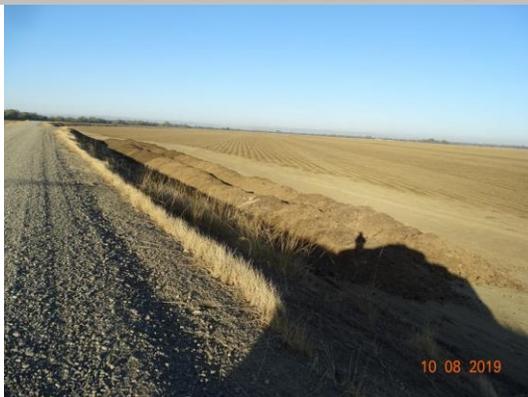
Photo 1 of 1 : FA\_2019\_ST0007\_282\_33\_20191008\_00070.jpg

LM Start	<b>1.17</b>	Rating **	U	Issue No.	<b>33</b>
LM End	<b>1.24</b>	Issue Type +	En	Location *	LS
Category	Earthen Levee			GPS Latitude/Longitude	
				Start	End
Item	Encroachments			38.516983°	38.516582°
				-121.649207°	-121.650248°
DWR ID	DWR_ST0007_01_f_2019_33				
Comment Code					
MA : Material					
Inspector Comment					
Dirt piles are at landside toe.

View of large dirt piles at the landside toe (Fall 2019).

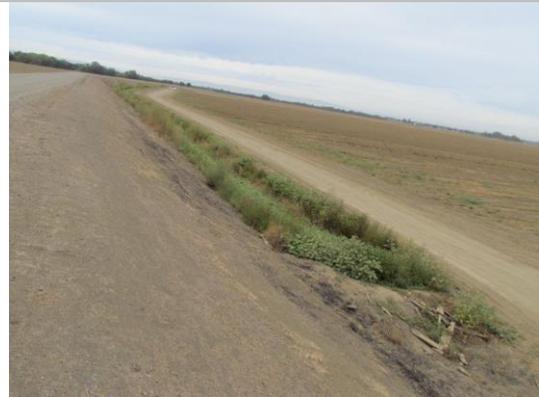
Photo 1 of 1 : FA\_2019\_ST0007\_282\_10\_20190826\_00004.jpg

LM Start	<b>1.52</b>	Rating **	M	Issue No.	<b>10</b>
LM End	<b>2.67</b>	Issue Type +	En	Location *	LS
Category	Earthen Levee		GPS Latitude/Longitude		
			Start	End	
Item	Encroachments		38.515258°	38.517376°	
			-121.655107°	-121.676054°	
DWR ID	DWR_ST0007_01_s_2012_10				
Comment Code					
DT : Ditch					
Inspector Comment					
This agriculture ditch is owned by Dos Rios Farms.

View of agriculture ditch within 10-foot of levee toe.

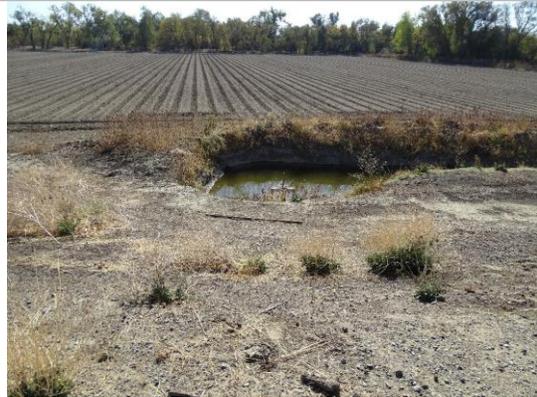
Photo 1 of 3 : UCIP\_FA\_2019\_55596\_82097.jpg

Item	DRAFT DWR UCIP Field Study			38.515739°	38.515739°
				-121.666432°	-121.666432°
DWR ID	491				
Comment Code					
Inspector Comment					
DS_ID:491 FS_ID:55596 EP_NO: 10262 Repair Type: Non-Urgent Crossing Status: Found UCIP Comments: 11/07/2019 At the time of inspection both LS and WS irrigation ditched are filled with water. Unable to see pipe. (O.Yakimov - DWR UCIP)09/21/2017 Pipe was permitted as an irrigation structure under ABO issued as Permit No. 10262. (DWR UCIP - O. Magana) 04/03/2012 Pipe has significant rust and exfoliation of metal showing at ends. Reccommend video inspection. (DWR UCIP - W. Wylie) FIELD_STRUCT_DESC: 24-inch irrigation pipe of unknown material through levee, 15.5 feet below crown. Slide gate is located on the waterside (WS) end. Concrete headwall is located on the landside (LS) end. (24-inch pipe [HLM 2.17] authorized under Automatic Board Order (ABO) issued as Permit No. 10262, 1974 - Wells Fargo Bank, Trustee for S.H. Cowell Foundation) [Additional Reference(s): DWR Levee Log, 1981 and 2005 (HLM 2.17). USACE Sacramento O&M Manual, Unit 119, December 1952, Revised 29 Dec 2016, (Station T 16+70). USACE As-Built Drawing No. 50-04-2396, Revision 1, pdf page 21, Sheet 5, December 1947] FS Date: 11/7/2019 10:40:42 AM

View of WS looking from levee crown

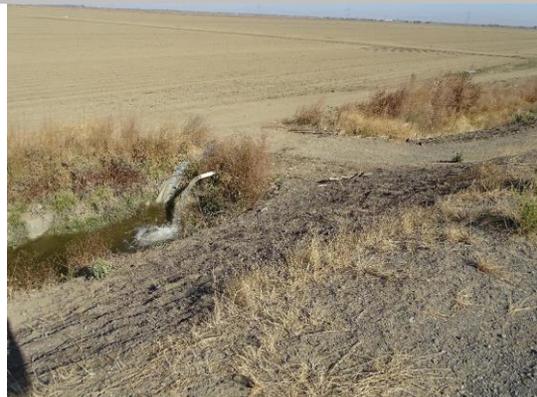
Photo 2 of 3 : UCIP\_FA\_2019\_55596\_82098.jpg

View of LS looking from levee crown

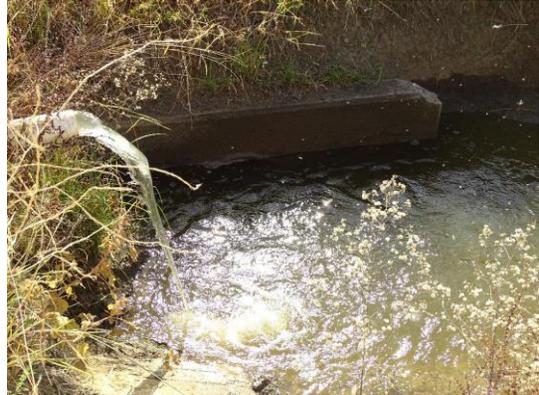
Photo 3 of 3 : UCIP\_FA\_2019\_55596\_82099.jpg

Item	DRAFT DWR UCIP Field Study			38.515739 °	38.515739 °
				-121.666432 °	-121.666432 °
DWR ID	491				
Comment Code					
Inspector Comment					
DS_ID:491 FS_ID:55596 EP_NO: 10262 Repair Type: Non-Urgent Crossing Status: Found UCIP Comments: 11/07/2019 At the time of inspection both LS and WS irrigation ditched are filled with water. Unable to see pipe. (O.Yakimov - DWR UCIP)09/21/2017 Pipe was permitted as an irrigation structure under ABO issued as Permit No. 10262. (DWR UCIP - O. Magana) 04/03/2012 Pipe has significant rust and exfoliation of metal showing at ends. Reccommend video inspection. (DWR UCIP - W. Wylie) FIELD_STRUCT_DESC: 24-inch irrigation pipe of unknown material through levee, 15.5 feet below crown. Slide gate is located on the waterside (WS) end. Concrete headwall is located on the landside (LS) end. (24-inch pipe [HLM 2.17] authorized under Automatic Board Order (ABO) issued as Permit No. 10262, 1974 - Wells Fargo Bank, Trustee for S.H. Cowell Foundation) [Additional Reference(s): DWR Levee Log, 1981 and 2005 (HLM 2.17). USACE Sacramento O&M Manual, Unit 119, December 1952, Revised 29 Dec 2016, (Station T 16+70). USACE As-Built Drawing No. 50-04-2396, Revision 1, pdf page 21, Sheet 5, December 1947] FS Date: 11/7/2019 10:40:42 AM

Concrete headwall in LS irrigation ditch

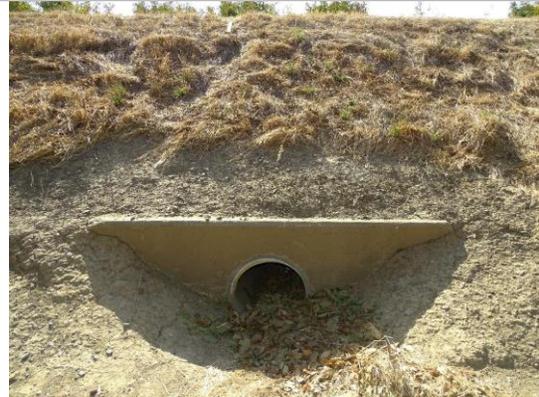
Photo 3 of 3 : UCIP\_FA\_2019\_55597\_82104.jpg

Item	DRAFT DWR UCIP LMA Responsibility			38.517580 °	38.517580 °
				-121.676820 °	-121.676820 °
DWR ID	492				
Comment Code					
Inspector Comment					
DS_ID:492 FS_ID:55597 EP_NO: 10262 Repair Type: Non-Urgent Crossing Status: Found UCIP Comments: 11/07/2019 No issues recorded during inspection (O.Yakimov - DWR UCIP) FIELD_STRUCT_DESC: 24-inch CIPP-lined drainage pipe of unknown material through levee, 13 feet below crown. Slide gate is located on the waterside (WS) end. Concrete headwalls are located on both the waterside (WS) and landside (LS). (24-inch pipe [HLM 2.77] authorized under Automatic Board Order (ABO) issued as Permit No. 10262, 1974 - Wells Fargo Bank, Trustee for S.H. Cowell Foundation) [Additional Reference(s): DWR Levee Log, 1981 and 2005 (HLM 2.77). USACE Sacramento O&M Manual, Unit 119, December 1952, Revised 29 Dec 2016, (Station P 213+00). USACE As-Built Drawing No. 50-04-2396, Revision 3, pdf page 22, Sheet 6, December 1947] FS Date: 11/7/2019 10:48:08 AM

LS levee slope, headwall, and pipe end

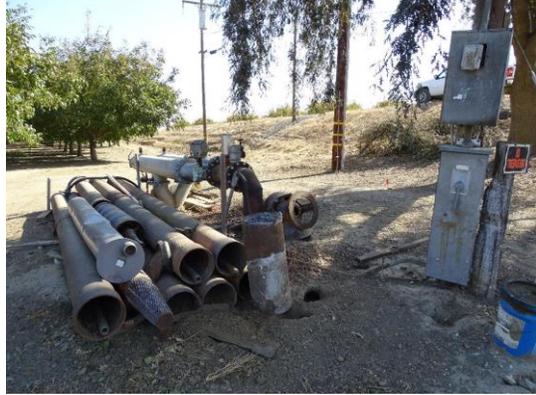
Photo 3 of 3 : UCIP\_FA\_2019\_55608\_82138.jpg

Item	DRAFT DWR UCIP Field Study			38.519731 °	38.519731 °	
				-121.685681 °	-121.685681 °	
DWR ID	16849					
Comment Code						
Inspector Comment						
DS_ID:16849 FS_ID:55608 EP_NO: N/A Repair Type: Non-Urgent Crossing Status: Found UCIP Comments: 11/07/2019 Missing permit for this crossing. (O.Yakimov - DWR UCIP)04/03/2012 Old pipe and concrete hauled to county dump. Evidence of the 14-inch pipe is no longer present at site. See new picture. (W. Wylie - DWR UCIP) FIELD_STRUCT_DESC: 10-inch steel irrigation pipe through the levee, 12 feet below the crown. Pipe terminates at standpipe located on the waterside (WS) approximately 500 feet south of levee. Mobile pumping plant is located in the floodway at edge of stream 740 feet south of levee. FS Date: 11/7/2019 1:05:17 PM

Filter plant and electrical boxes

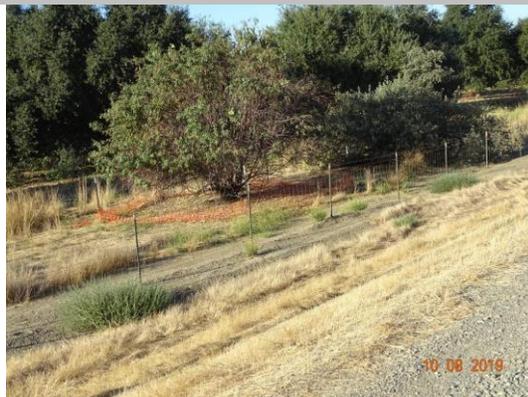
Photo 1 of 1 : FA\_2019\_ST0007\_282\_4\_20191008\_00072.jpg

LM Start	<b>3.25</b>	Rating **	M	Issue No.	<b>4</b>
LM End	<b>3.64</b>	Issue Type +	En	Location *	WS
Category	Earthen Levee			GPS Latitude/Longitude	
				Start	End
Item	Encroachments			38.519831 °	38.519848 °
				-121.686263 °	-121.693463 °
DWR ID	DWR_ST0007_01_s_ 2013_4				
Comment Code					
FE : Fence					
Inspector Comment					
No permit was found for this wire fence at the waterside levee toe.

View of barbed wire at the waterside toe (Fall 2019).

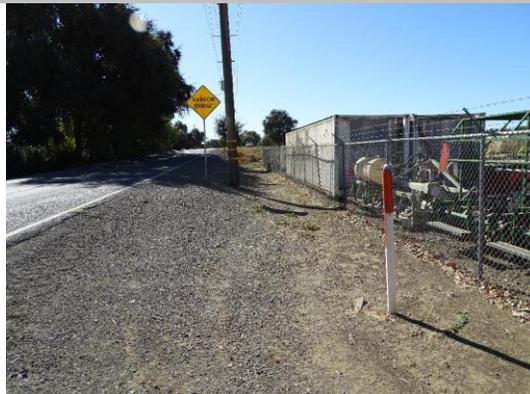
Photo 1 of 3 : UCIP\_FA\_2019\_55454\_81749.jpg

LM Start	<b>3.77</b>	Rating **	M	Issue No.	<b>66</b>
LM End	<b>3.77</b>	Issue Type +	En	Location *	
Category	Supplemental			GPS Latitude/Longitude	
				Start	End
Item	DRAFT DWR UCIP Field Study			38.520250°	38.520250°
				-121.695250°	-121.695250°
DWR ID	589				
Comment Code					
Inspector Comment					
DS_ID:589 FS_ID:55454 EP_NO: 17144 Repair Type: Non-Urgent Crossing Status: Indicator Found UCIP Comments: 10/22/2019 Fiber optic line marker bent and broken near bridge on west side on Macy Blvd. (O.Yakimov - DWR UCIP) FIELD_STRUCT_DESC: 5-inch steel conduit containing fiber optic cables across and under the levee at Mace Boulevard 50 feet below the crown. White and orange paddle marker is located 10 feet West of Mace Boulevard approximately 400 feet north of levee crossing. (5-inch pipe authorized under Permit No. 17144, 2000 - Williams Communications) FS Date: 10/22/2019 3:28:24 PM

White and orange marker 400 feet north of levee crossing at Mace Blvd

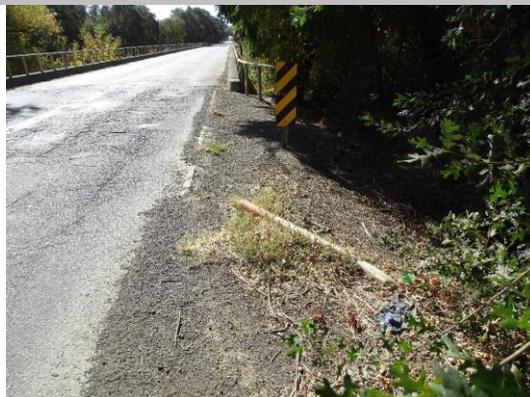
Photo 2 of 3 : UCIP\_FA\_2019\_55454\_81750.jpg

Bent to the ground line marker near Macy Blvd bridge

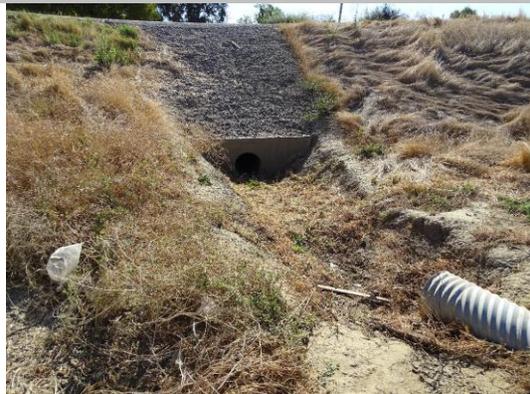
Photo 1 of 3 : UCIP\_FA\_2019\_55455\_81753.jpg

Item	DRAFT DWR UCIP LMA Responsibility		38.519790 °	38.519790 °	
			-121.695450 °	-121.695450 °	
DWR ID	496				
Comment Code					
Inspector Comment					
DS_ID:496 FS_ID:55455 EP_NO: 10251 Repair Type: Non-Urgent Crossing Status: Found UCIP Comments: 10/22/2019 Installed a new precast concrete box on the waterside. Pipe will be lined in November 2019 according to FMO staff. (O.Yakimov - DWR UCIP)4/10/2019 Major erosion through out pipe. Erosion on WS allows water to enter pipe and flood LS field. Erosion on farmers waterman valve. Field water drains into pipe and floods LS field. (J.McCabe - DWR Sacramento Yard) FIELD_STRUCT_DESC: 24-inch corrugated metal drainage pipe through levee, 15 feet below the crown. Two metal cutoff walls were installed through the levee. A T-post and T-handle are located on the landside (LS) toe. The outfall structure and flap gate are located on the west side of bridge, waterside (WS). (24-inch pipe [HLM 3.87] authorized under Automatic Board Order (ABO) issued as Permit No. 10251, 1974 - F.M.C. Corp.) [Additional Reference(s): DWR Levee Log, 1981 and 2005 (HLM 3.87). USACE Sacramento O&M Manual, Unit 119, December 1952, Revised 29 Dec 2016, (Station 1+50 PCT). USACE As-Built Drawing No. 50-04-2396, Revision 4, pdf page 23, Sheet 7, December 1947] FS Date: 10/22/2019 3:38:32 PM

LS levee slope, headwall, and pipe end

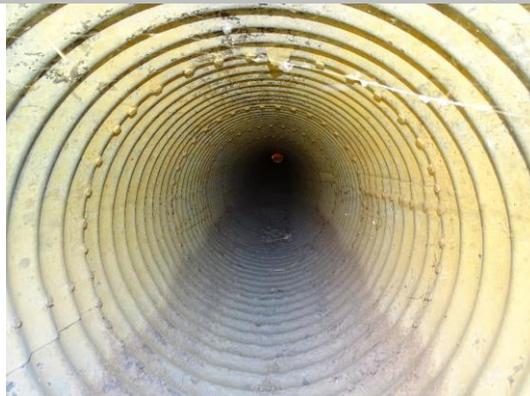
Photo 2 of 3 : UCIP\_FA\_2019\_55455\_81754.jpg

View inside of CMP drainage pipe

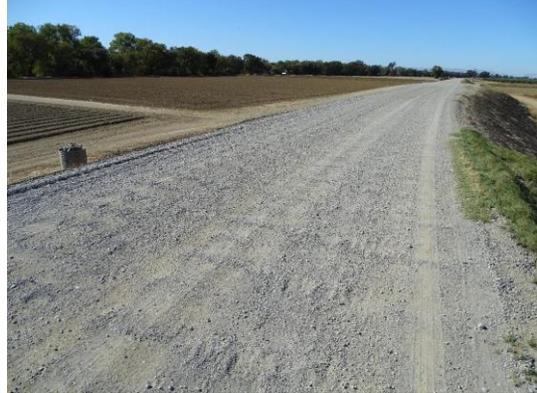
Photo 1 of 3 : UCIP\_FA\_2019\_55456\_81760.jpg

Item	DRAFT DWR UCIP LMA Responsibility		38.518685°	38.518685°	
			-121.699835°	-121.699835°	
DWR ID	497				
Comment Code					
Inspector Comment					
DS_ID:497 FS_ID:55456 EP_NO: 10251 Repair Type: Non-Urgent Crossing Status: Found UCIP Comments: 10/22/2019 Pipe inlet and headwall are not visible on LS. Slide gate in CMP riser is in closed position, crossing looks abandoned. Construction according to permit 10251-1 hasn't started yet. Field structure description is updated to match original pipe construction. (O.Yakimov - DWR UCIP) FIELD_STRUCT_DESC: 24-inch pipe through levee, 16 feet below the crown. 36-inch galvanized corrugated metal pipe (CMP) riser located on the waterside (WS) slope. (24-inch pipe [HLM 4.13] authorized under Automatic Board Order (ABO) issued as Permit No. 10251, 1974 - F.M.C. Corp.; assumed original 24-inch pipe was installed in 12/12/1952 per O&M manual) [Additional Reference(s): DWR Levee Log, 1981 and 2005 (HLM 4.13). USACE Sacramento O&M Manual, Unit 119, December 1952, Revised 29 Dec 2016, (Station 17+00 PCT). USACE As-Built Drawing No. 50-04-2396, Revision 4, pdf page 23, Sheet 7, December 1947] FS Date: 10/22/2019 11:37:56 AM

View of levee crown at the crossing

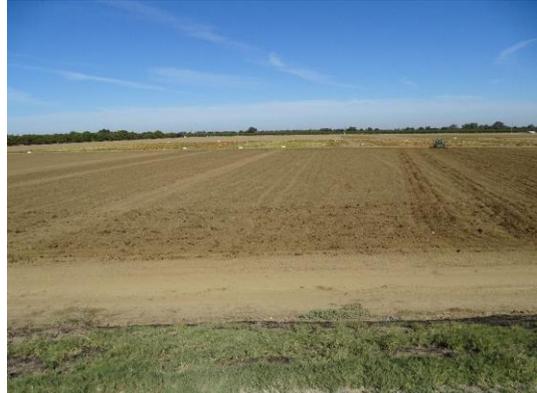
Photo 2 of 3 : UCIP\_FA\_2019\_55456\_81761.jpg

View of LS looking from levee crown

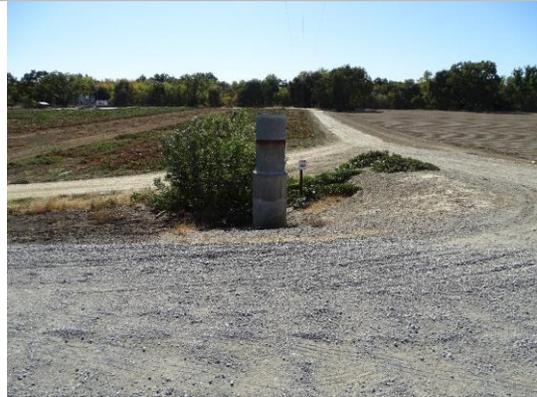
Photo 1 of 3 : UCIP\_FA\_2019\_55457\_81767.jpg

Item	DRAFT DWR UCIP Field Study		38.518270°	38.518270°	
			-121.704440°	-121.704440°	
DWR ID	498				
Comment Code					
Inspector Comment					
DS_ID:498 FS_ID:55457 EP_NO: 10250 Repair Type: Non-Urgent Crossing Status: Found UCIP Comments: 10/22/2019 Crossing is used to provide well water suply from WS to LS. Well and electric boxes located on WS about 500 ft south of the levee. PVC standpipe and fresno valve at dirt road shoulder on WS. (O.Yakimov - DWR UCIP) FIELD_STRUCT_DESC: 24-inch corrugated metal irrigation pipe through the levee, 11 feet below the crown. No control valves. Concrete standpipes on both sides of the levee. (24-inch pipe [HLM 4.39]authorizaed under Automatic Board Order (ABO) issued as Permit No. 10250, 1974 - Martha A. Faria). [Additional Reference(s): DWR Levee Log, 2005 (HLM 4.39). USACE Sacramento O&M Manual, Unit 119, December 1952, Revised 29 Dec 2016, (Station 31+50 PCT). USACE As-Built Drawing No. 50-04-2396, Revision 4, pdf page 23, Sheet 7, December 1947]. FS Date: 10/22/2019 2:09:24 PM

Raised concrete standpipe at WS levee toe

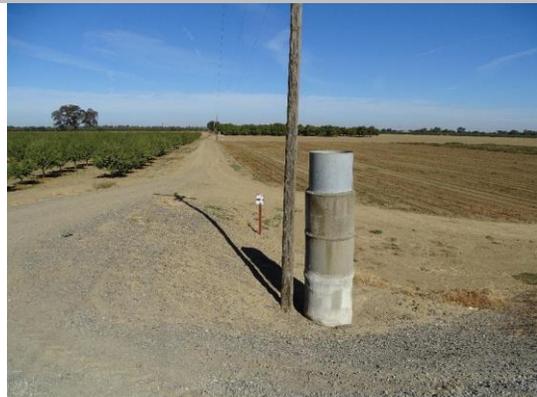
Photo 2 of 3 : UCIP\_FA\_2019\_55457\_81768.jpg

Raised concrete standpipe at LS levee toe

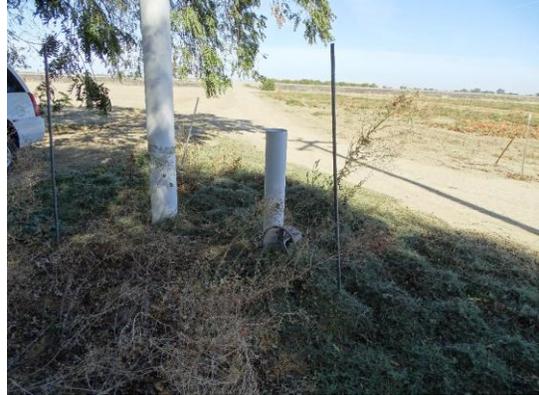
Photo 3 of 3 : UCIP\_FA\_2019\_55457\_81769.jpg

Item	DRAFT DWR UCIP Field Study			38.518270 °	38.518270 °
				-121.704440 °	-121.704440 °
DWR ID	498				
Comment Code					
Inspector Comment					
<p>DS_ID:498                  FS_ID:55457                  EP_NO: 10250                  Repair Type: Non-Urgent                  Crossing Status: Found                  UCIP Comments: 10/22/2019 Crossing is used to provide well water supply from WS to LS. Well and electric boxes located on WS about 500 ft south of the levee. PVC standpipe and fresno valve at dirt road shoulder on WS. (O.Yakimov - DWR UCIP)                  FIELD_STRUCT_DESC: 24-inch corrugated metal irrigation pipe through the levee, 11 feet below the crown. No control valves. Concrete standpipes on both sides of the levee. (24-inch pipe [HLM 4.39]authorized under Automatic Board Order (ABO) issued as Permit No. 10250, 1974 - Martha A. Faria). [Additional Reference(s): DWR Levee Log, 2005 (HLM 4.39). USACE Sacramento O&amp;M Manual, Unit 119, December 1952, Revised 29 Dec 2016, (Station 31+50 PCT). USACE As-Built Drawing No. 50-04-2396, Revision 4, pdf page 23, Sheet 7, December 1947].                  FS Date: 10/22/2019 2:09:24 PM</p>

PVC standpipe and closure device south of levee on WS

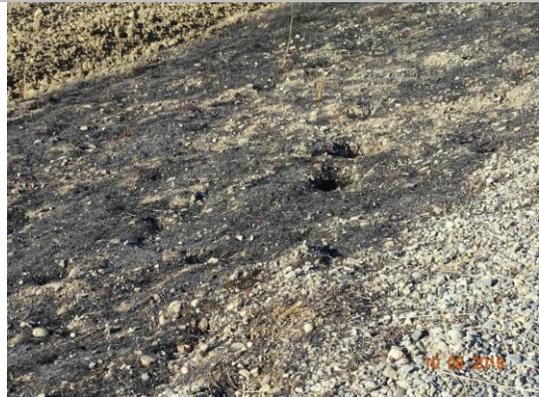
Photo 1 of 1 : FA\_2019\_ST0007\_282\_44\_20191008\_00074.jpg

LM Start	<b>4.57</b>	Rating **	M	Issue No.	<b>44</b>
LM End	<b>4.57</b>	Issue Type +	Ma	Location *	WS
Category	Earthen Levee		GPS Latitude/Longitude		
			Start	End	
Item	Animal Control		38.518175°	38.518175°	
			-121.709270°	-121.709270°	
DWR ID	DWR_ST0007_01_f_2019_44				
Comment Code					
A3 : No rodents visible, but rodent burrows visible; need to backfill and compact or grout burrows.					
Inspector Comment					
Multiple holes. Holes do not look deep.

View of animal holes on the waterside slope (Fall 2019).

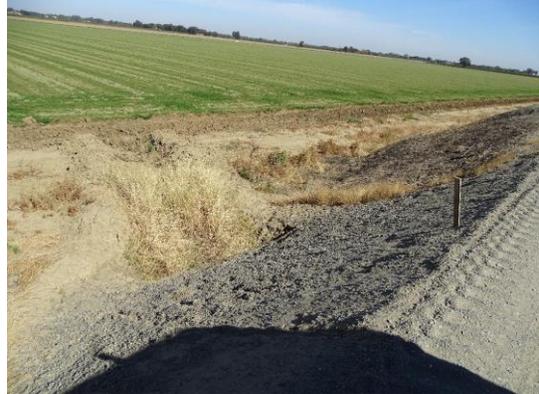
Photo 1 of 3 : UCIP\_FA\_2019\_55459\_81775.jpg

Item	DRAFT DWR UCIP LMA Responsibility			38.518022°	38.518022°
				-121.722521°	-121.722521°
DWR ID	500				
Comment Code					
Inspector Comment					
DS_ID:500 FS_ID:55459 EP_NO: 10256 Repair Type: Non-Urgent Crossing Status: Found UCIP Comments: 10/22/2019 No issues recorded during inspection (O.Yakimov - DWR UCIP)05/06/2013 Debris removed. See picture (C. Lund - DWR Sacramento Yard) 04/04/2012 Some debris in pipe invert LS (W. Wylie - DWR UCIP) FIELD_STRUCT_DESC: 24-inch CIPP-lined corrugated metal drainage pipe through the levee, 15 feet below the crown. Slide gate on the waterside (WS) end. Concrete headwall on the landside (LS) end. (24-inch pipe [HLM 5.39] authorized under Automatic Board Order (ABO) issued as Permit No. 10256, 1974 - Albert H. Lederer). [Additional Reference(s): DWR Levee Log, 2005 (HLM 5.39). USACE Sacramento O&M Manual, Unit 119, December 1952, Revised 29 Dec 2016, (Station 83+70 PCT). USACE As-Built Drawing No. 50-04-2396, Revision 4, pdf page 24, Sheet 8, December 1947]. FS Date: 10/22/2019 3:11:16 PM

View of LS looking from levee crown

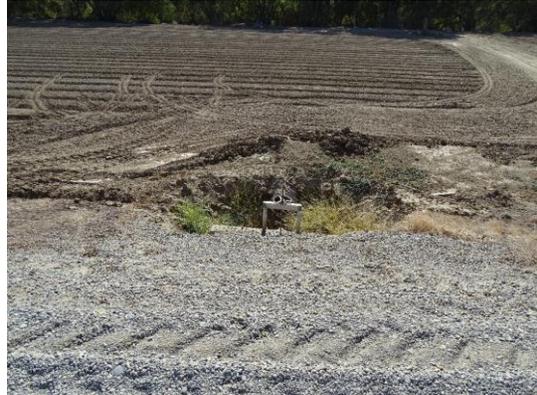
Photo 2 of 3 : UCIP\_FA\_2019\_55459\_81776.jpg

View of WS looking from levee crown

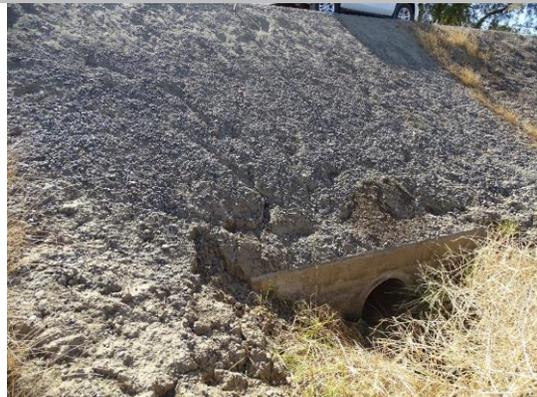
Photo 3 of 3 : UCIP\_FA\_2019\_55459\_81777.jpg

LS levee slope, headwall, and pipe end

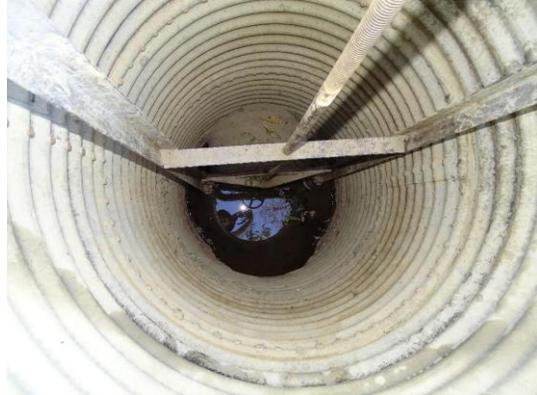
Photo 3 of 3 : UCIP\_FA\_2019\_55460\_81781.jpg

Item	DRAFT DWR UCIP LMA Responsibility			38.518032 °	38.518032 °
				-121.722778 °	-121.722778 °
DWR ID	501				
Comment Code					
Inspector Comment					
DS_ID:501 FS_ID:55460 EP_NO: 10256 Repair Type: Non-Urgent Crossing Status: Found UCIP Comments: 10/22/2019 Crossing has been modified to supply water from LS to WS. Should not be considered a storm drainage pipe. (O.Yakimov - DWR UCIP) FIELD_STRUCT_DESC: 24-inch corrugated metal drainage pipe through the levee, 12.5 feet below the crown. Slide gate on the waterside (WS) end in 36-inch standpipe. Concrete standpipe at LS toe with fill-in pipe. (24-inch pipe [HLM 5.40] authorized under Automatic Board Order (ABO) issued as Permit No. 10256, 1974 - Albert H. Lederer). [Additional Reference(s): DWR Levee Log, 2005 (HLM 5.40). USACE Sacramento O&M Manual, Unit 119, December 1952, Revised 29 Dec 2016, (Station 84+40 PCT). USACE As-Built Drawing No. 50-04-2396, Revision 4, pdf page 24, Sheet 8, December 1947]. FS Date: 10/22/2019 3:28:15 PM

View inside of CMP standpipe on WS

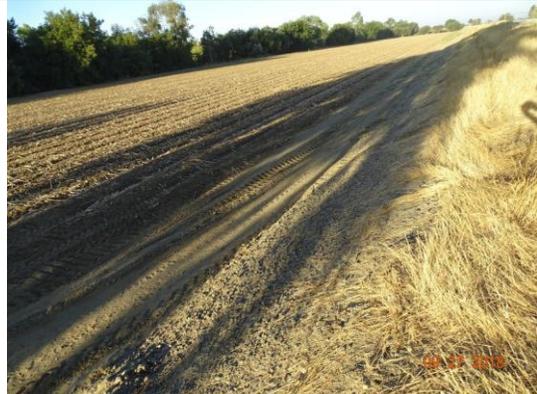
Photo 1 of 2 : FA\_2019\_ST0007\_282\_50\_20190826\_00013.jpg

LM Start	<b>5.31</b>	Rating **	A/W	Issue No.	<b>50</b>
LM End	<b>5.39</b>	Issue Type +	En	Location *	WS
Category	Earthen Levee			GPS Latitude/Longitude	
				Start	End
Item	Encroachments			38.518048 °	38.518132 °
				-121.723033 °	-121.724473 °
DWR ID	DWR_ST0007_01_f_2017_50				
Comment Code					
AT : Agricultural tilling					
Inspector Comment					
Access road now present where agricultural tilling was.

View looking upstream at the access road where the agricultural tilling was previously (September 2018).

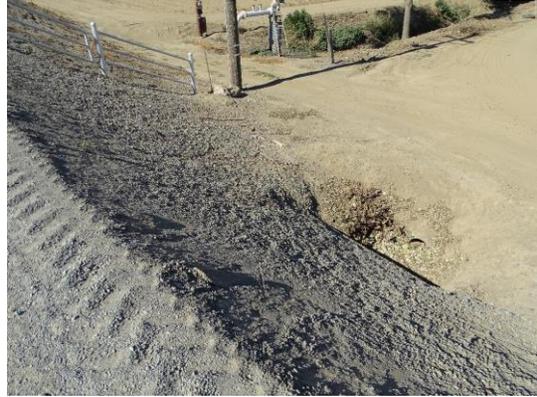
Photo 1 of 3 : UCIP\_FA\_2019\_55461\_81782.jpg

Item	DRAFT DWR UCIP LMA Responsibility		38.518249°	38.518249°	
			-121.727538°	-121.727538°	
DWR ID	502				
Comment Code					
Inspector Comment					
DS_ID:502 FS_ID:55461 EP_NO: 10255 Repair Type: Non-Urgent Crossing Status: Found UCIP Comments: 10/22/2019 No issues recorded during inspection (O.Yakimov - DWR UCIP) FIELD_STRUCT_DESC: 24-inch CIPP-lined corrugated metal drainage pipe through the levee, 11 feet below the crown. Slide gate on the waterside (WS) end. Concrete headwall on the landside (LS) end. (24-inch pipe [HLM 5.67] authorized under Automatic Board Order (ABO) issued as Permit No. 10255, 1974 - Owen W. and Ray W. Hamel). [Additional Reference(s): DWR Levee Log, 2005 (HLM 5.67). USACE Sacramento O&M Manual, Unit 119, December 1952, Revised 29 Dec 2016, (Station 97+00 PCT). USACE As-Built Drawing No. 50-04-2396, Revision 4, pdf page 24, Sheet 8, December 1947]. FS Date: 10/22/2019 4:03:27 PM

View of LS looking from levee crown

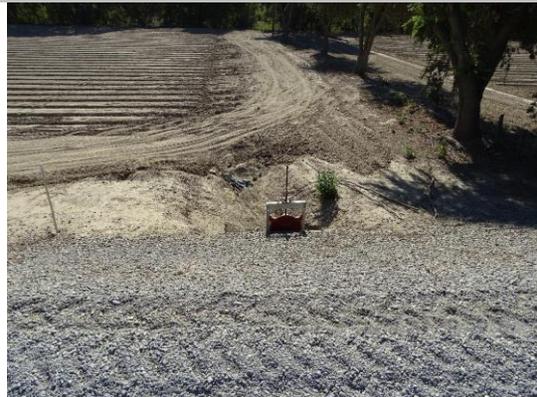
Photo 2 of 3 : UCIP\_FA\_2019\_55461\_81783.jpg

View of WS looking from levee crown

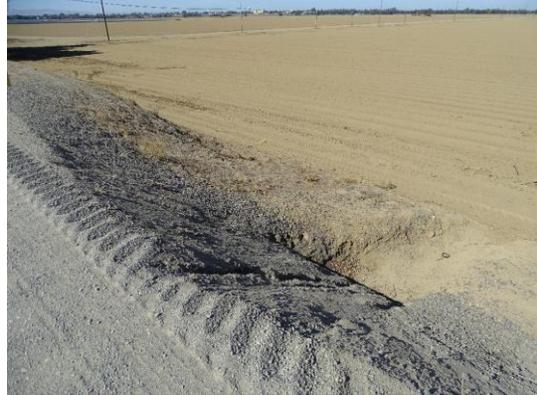
Photo 1 of 3 : UCIP\_FA\_2019\_55644\_82261.jpg

Item	DRAFT DWR UCIP LMA Responsibility		38.518368°	38.518368°	
			-121.730947°	-121.730947°	
DWR ID	503				
Comment Code					
Inspector Comment					
DS_ID:503 FS_ID:55644 EP_NO: 10252 Repair Type: Non-Urgent Crossing Status: Found UCIP Comments: 10/22/2019 No issues recorded during inspection (O.Yakimov - DWR UCIP)05/06/2013 owner of pipe needs to clean out obstruction in pipe. (C. Lund - DWR Sacramento Yard) 04/04/2012 Partially obstructed with sedimentation throughout crossing. (W. Wylie - DWR UCIP) FIELD_STRUCT_DESC: 24-inch CIPP-lined corrugated metal drainage pipe through the levee, 12 feet below the crown. Slide gate on the waterside (WS) end. Concrete headwall on the landside (LS) end. (24-inch pipe [HLM 5.86] authorized under Automatic Board Order (ABO) issued as Permit No. 10252, 1974 - John F. Hamel). [Additional Reference(s): DWR Levee Log, 2005 (HLM 5.86). USACE Sacramento O&M Manual, Unit 119, December 1952, Revised 29 Dec 2016, (Station 108+00 PCT). USACE As-Built Drawing No. 50-04-2396, Revision 4, pdf page 24, Sheet 8, December 1947]. FS Date: 10/22/2019 10:55:40 AM

View of LS looking from levee crown

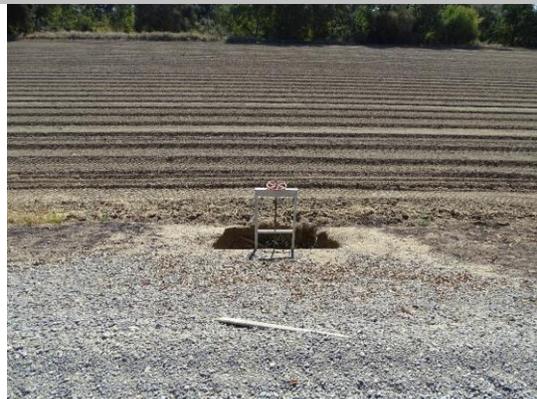
Photo 2 of 3 : UCIP\_FA\_2019\_55644\_82262.jpg

View of WS looking from levee crown

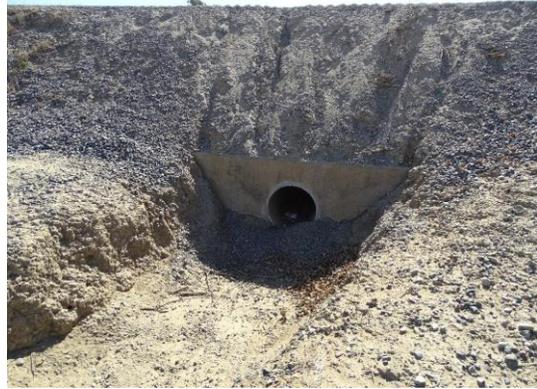
Photo 3 of 3 : UCIP\_FA\_2019\_55644\_82263.jpg

LS levee slope, headwall, and pipe end

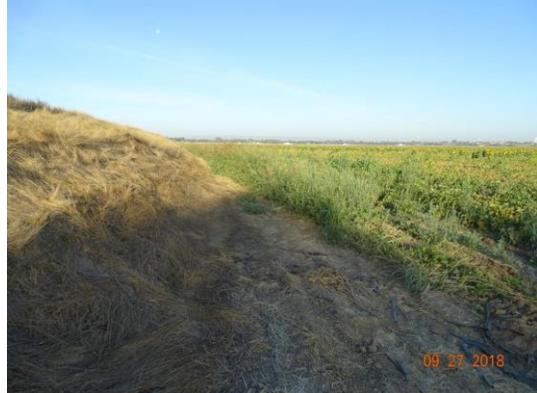
Photo 1 of 3 : FA\_2019\_ST0007\_282\_53\_20190826\_00015.jpg

LM Start	<b>5.84</b>	Rating **	A/W	Issue No.	<b>53</b>
LM End	<b>5.86</b>	Issue Type +	En	Location *	LS
Category	Earthen Levee			GPS Latitude/Longitude	
				Start	End
Item	Encroachments			38.518475 °	38.518478 °
				-121.732822 °	-121.733200 °
DWR ID	DWR_ST0007_01_f_ 2017_53				
Comment Code					
AT : Agricultural tilling					
Inspector Comment					
Adjacent ag field is currently planted, but not along encroached area. Condition should be monitored.

View looking upstream. Vegetation has encroached on the toe that is covering past evidence of agricultural tilling (September 2018).

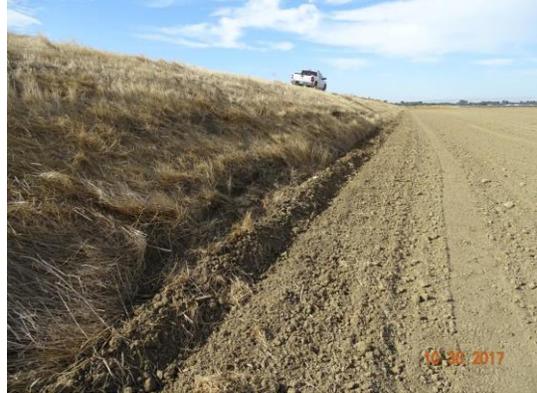
Photo 2 of 3 : FA\_2019\_ST0007\_282\_53\_20190826\_00016.jpg

Agricultural tilling has encroached into landside levee toe. Activity should cease and toe should be repaired.

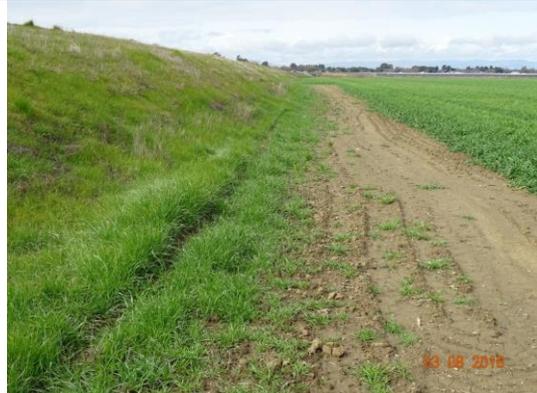
Photo 3 of 3 : FA\_2019\_ST0007\_282\_53\_20190826\_00017.jpg

Field not currently planted in area were tilling previously encroached on levee toe. Continue to monitor. Toe should be repaired.

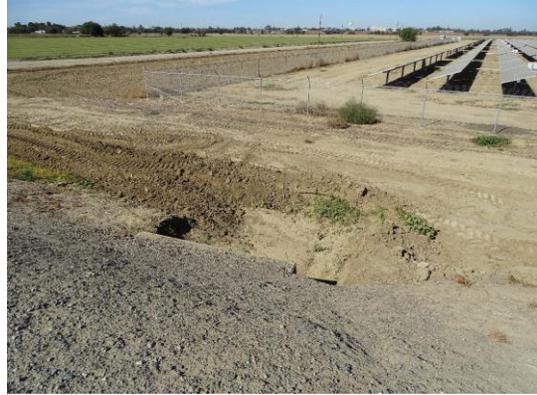
Photo 1 of 3 : UCIP\_FA\_2019\_55647\_82273.jpg

Item	DRAFT DWR UCIP LMA Responsibility			38.518208 °	38.518208 °
				-121.743990 °	-121.743990 °
DWR ID	505				
Comment Code					
Inspector Comment					
DS_ID:505 FS_ID:55647 EP_NO: 10253 Repair Type: Non-Urgent Crossing Status: Found UCIP Comments: 10/22/2019 Levee toe erosion on both sides of headwall on WS. (O.Yakimov - DWR UCIP) FIELD_STRUCT_DESC: 24-inch CIPP-lined corrugated metal drainage pipe through the levee, 10.4 feet below the crown. Slide gate on the waterside (WS), and concrete headwalls on both the WS and the landside (LS). (24-inch pipe [HLM 6.57] authorized under Automatic Board Order (ABO) issued as Permit No. 10253, 1974 - Lester J. Hamel). [Additional Reference(s): DWR Levee Log, 2005 (HLM 6.57. USACE Sacramento O&M Manual, Unit 119, December 1952, Revised 29 Dec 2016, (Station 145+50 PCT). USACE As-Built Drawing No. 50-04-2396, Revision 4, pdf page 24, Sheet 8, December 1947]. FS Date: 10/22/2019 11:07:35 AM

View of LS looking from levee crown

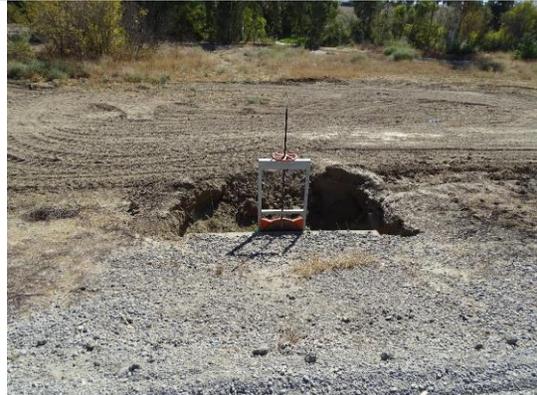
Photo 2 of 3 : UCIP\_FA\_2019\_55647\_82274.jpg

View of WS looking from levee crown

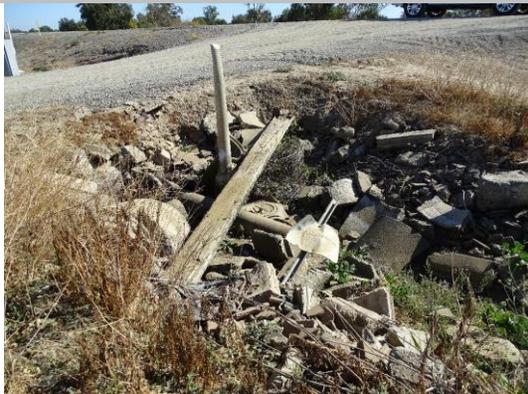
Photo 1 of 2 : UCIP\_FA\_2019\_55661\_82336.jpg

Item	DRAFT DWR UCIP Field Study		38.518120°	38.518120°	
			-121.744570°	-121.744570°	
DWR ID	506				
Comment Code					
Inspector Comment					
DS_ID:506 FS_ID:55661 EP_NO: 10820 Repair Type: Non-Urgent Crossing Status: Indicator Found UCIP Comments: 10/22/2019 Missing gas line marker on waterside. Landside marker needs a repair. (O.Yakimov - DWR UCIP)04/09/2012 Sign on LS bent over and broken. New signs need to be installed locating pipe that indicate a gas line crossing. The broken or missing signs do not indicate gasoline, only owner info. Owner is Calpine NRG Scott Vickers 707-249-9211. Supervisor will call phone number and ask for new signs to be installed. (W. Wylie - DWR UCIP) FIELD_STRUCT_DESC: 4-inch coated steel gas line through the levee, 2 feet below the crown. (4-inch pipe authorized under Permit No. 10820, 1975 - Dow Chemical). [Additional Reference(s): DWR Levee Log, 2005]. FS Date: 10/22/2019 12:30:14 PM

LS:sign post bent over in a ditch at toe

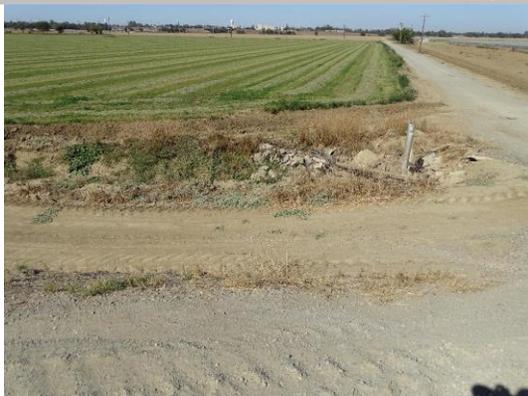
Photo 2 of 2 : UCIP\_FA\_2019\_55661\_82337.jpg

View of LS looking from levee crown

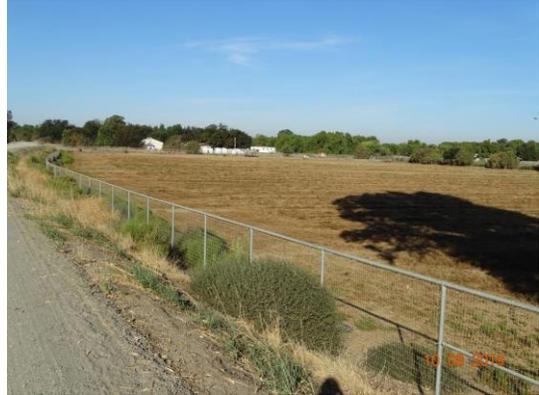
Photo 1 of 1 : FA\_2019\_ST0007\_282\_5\_20191008\_00078.jpg

LM Start	<b>6.63</b>	Rating **	M	Issue No.	<b>5</b>
LM End	<b>6.71</b>	Issue Type +	En	Location *	LS
Category	Earthen Levee		GPS Latitude/Longitude		
			Start	End	
Item	Encroachments		38.517746°	38.517647°	
			-121.747220°	-121.748679°	
DWR ID	DWR_ST0007_01_s_2012_5				
Comment Code					
FE : Fence					
Inspector Comment					
A chainlink fence is located at the landside toe.

View of fence at the landside toe (Fall 2019).

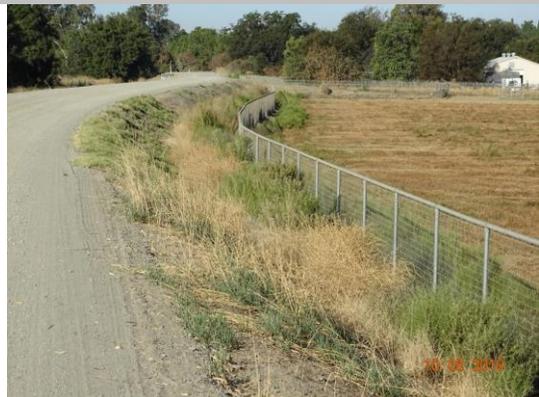
Photo 1 of 1 : FA\_2019\_ST0007\_282\_48\_20191008\_00079.jpg

LM Start	<b>6.63</b>	Rating **	U	Issue No.	<b>48</b>
LM End	<b>6.87</b>	Issue Type +	Ma	Location *	LS
Category	Earthen Levee		GPS Latitude/Longitude		
			Start	End	
Item	Vegetation		38.517718°	38.517628°	
			-121.747298°	-121.751802°	
DWR ID	DWR_ST0007_01_f_2019_48				
Comment Code					
V1 : Control annual grass and weeds on the levee slopes and easements.					
Inspector Comment					
Maintain annual vegetation.

View looking upstream of thick vegetation at the bottom of the landside slope (Fall 2019).

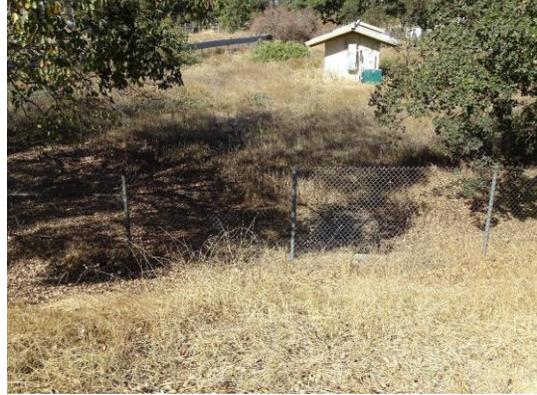
Photo 3 of 3 : UCIP\_FA\_2019\_55664\_82345.jpg

Item	DRAFT DWR UCIP LMA Responsibility			38.517679 °	38.517679 °
				-121.753146 °	-121.753146 °
DWR ID	508				
Comment Code					
Inspector Comment					
DS_ID:508 FS_ID:55664 EP_NO: 10247 Repair Type: Non-Urgent Crossing Status: Found UCIP Comments: 10/22/2019 No issues recorded during inspection (O.Yakimov - DWR UCIP) FIELD_STRUCT_DESC: 24-inch CIPP-lined drainage pipe of an unknown material through the levee, 11 feet below the crown. Flap gate on the waterside (WS) end. Concrete headwall on the landside (LS) end. Concrete Apron on the WS. (24-inch pipe [HLM 7.09] authorized under Automatic Board Order (ABO) issued as Permit No. 10247, 1974 - University of California, Office of the Regents). [Additional Reference(s): DWR Levee Log, 2005 (HLM 7.09). USACE Sacramento O&M Manual, Unit 119, December 1952, Revised 29 Dec 2016, (Station 172+00 PCT). USACE As-Built Drawing No. 50-04-2396, Revision 4, pdf page 25, Sheet 9, December 1947]. FS Date: 10/22/2019 1:55:30 PM

View of LS looking from levee crown

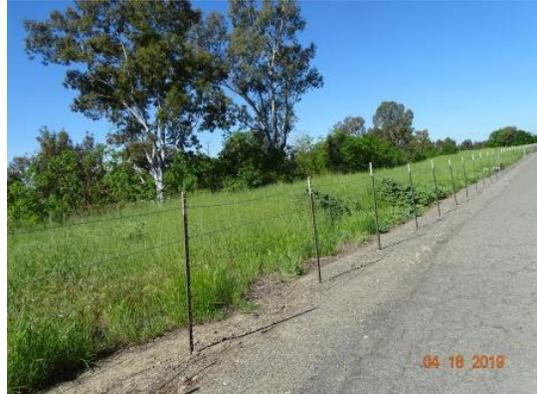
Photo 1 of 1 : FA\_2019\_ST0007\_282\_41\_20190826\_00011.jpg

LM Start	<b>6.95</b>	Rating **	M	Issue No.	<b>41</b>
LM End	<b>7.18</b>	Issue Type +	En	Location *	WS
Category	Earthen Levee			GPS Latitude/Longitude	
				Start	End
Item	Encroachments			38.517651 °	38.518178 °
				-121.753195 °	-121.757311 °
DWR ID	DWR_ST0007_01_s_2019_41				
Comment Code					
FE : Fence					
Inspector Comment					
There is a barbed wire fence on waterside shoulder.

View looking upstream at barbed wire fence on waterside shoulder (Spring 2019).

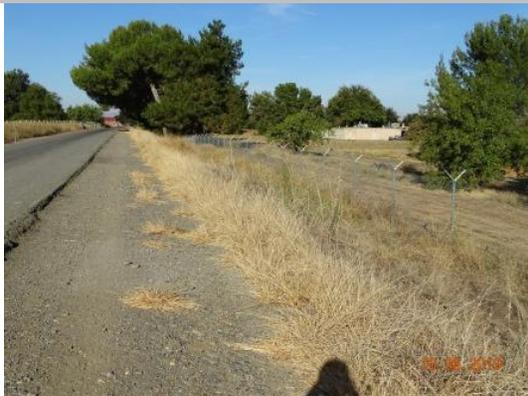
Photo 1 of 1 : FA\_2019\_ST0007\_282\_49\_20191008\_00080.jpg

LM Start	<b>7.04</b>	Rating **	M	Issue No.	<b>49</b>
LM End	<b>7.15</b>	Issue Type +	Ma	Location *	LS
Category	Earthen Levee			GPS Latitude/Longitude	
				Start	End
Item	Vegetation			38.517867°	38.518173°
				-121.754738°	-121.756818°
DWR ID	DWR_ST0007_01_f_2019_49				
Comment Code					
V1 : Control annual grass and weeds on the levee slopes and easements.					
Inspector Comment

View looking upstream at vegetation on the landside slope (Fall 2019).

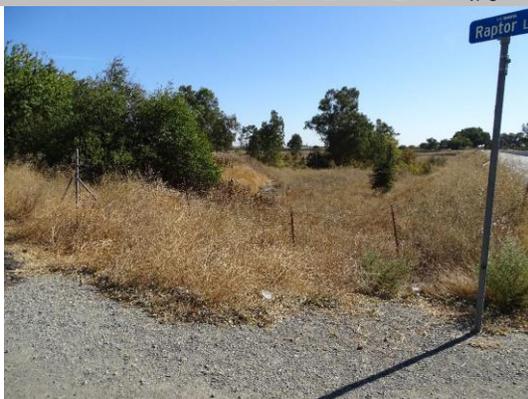
Photo 1 of 3 : UCIP\_FA\_2019\_55665\_82348.jpg

Item	DRAFT DWR UCIP Field Study			38.518166°	38.518166°
				-121.756850°	-121.756850°
DWR ID	509				
Comment Code					
Inspector Comment					
DS_ID:509 FS_ID:55665 EP_NO: 1603 Repair Type: Non-Urgent Crossing Status: Indicator Found UCIP Comments: 10/22/2019 No issues recorded during inspection (O.Yakimov - DWR UCIP) FIELD_STRUCT_DESC: 10-inch gas line of an unknown material through the levee, 5 feet below the crown. Standpipe and valve on the waterside (WS) slope. Gas line markers found on both sides of levee. (10-inch line authorized under Automatic Board Order (ABO) issued as Permit No. 10257, 1974 - Pacific Gas and Electric Company [PG&E]. Originally covered under Permit No. 1603, 1951 - PG&E). [Additional Reference(s): DWR Levee Log, 2005 (HLM 7.31), USACE Sacramento O&M Manual, Unit 119, December 1952, Revised 29 Dec 2016, (Station ~ 182+79 PCT). USACE As-Built Drawing No. 50-04-2396, Revision 4, pdf page 25, Sheet 9, December 1947]. FS Date: 10/22/2019 1:16:00 PM

View of WS looking from levee crown

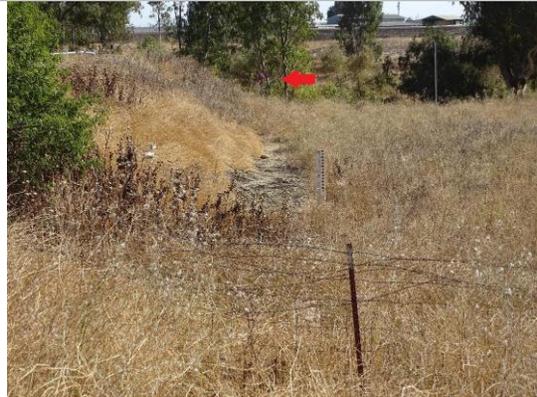
Photo 2 of 3 : UCIP\_FA\_2019\_55665\_82349.jpg

Comment Code					
Inspector Comment					
DS_ID:509 FS_ID:55665 EP_NO: 1603 Repair Type: Non-Urgent Crossing Status: Indicator Found UCIP Comments: 10/22/2019 No issues recorded during inspection (O.Yakimov - DWR UCIP) FIELD_STRUCT_DESC: 10-inch gas line of an unknown material through the levee, 5 feet below the crown. Standpipe and valve on the waterside (WS) slope. Gas line markers found on both sides of levee. (10-inch line authorized under Automatic Board Order (ABO) issued as Permit No. 10257, 1974 - Pacific Gas and Electric Company [PG&E]. Originally covered under Permit No. 1603, 1951 - PG&E). [Additional Reference(s): DWR Levee Log, 2005 (HLM 7.31). USACE Sacramento O&M Manual, Unit 119, December 1952, Revised 29 Dec 2016, (Station ~ 182+79 PCT). USACE As-Built Drawing No. 50-04-2396, Revision 4, pdf page 25, Sheet 9, December 1947]. FS Date: 10/22/2019 1:16:00 PM

Gas line marker on WS away from levee

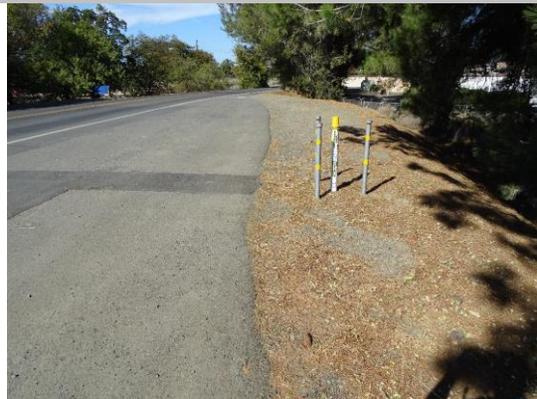
Photo 3 of 3 : UCIP\_FA\_2019\_55665\_82350.jpg

Gas line marker on east side of Old Davis Rd

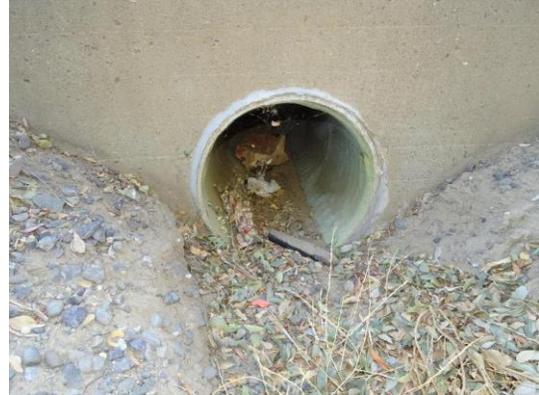
Photo 3 of 3 : UCIP\_FA\_2019\_55667\_82356.jpg

Item	DRAFT DWR UCIP LMA Responsibility			38.518181°	38.518181°	
				-121.757309°	-121.757309°	
DWR ID	512					
Comment Code						
Inspector Comment						
DS_ID:512 FS_ID:55667 EP_NO: 10247 Repair Type: Non-Urgent Crossing Status: Found UCIP Comments: 10/21/2019 No issues recorded during inspection (O.Yakimov - DWR UCIP)05/07/2013 Debris removed from outlet (C. Lund - DWR Sacramento Yard) 04/04/2012 Some debris blocking outlet. (W. Wylie - DWR UCIP) FIELD_STRUCT_DESC: 24-inch CIPP-lined drainage pipe of an unknown material through the levee, 12 feet below the crown. Flap gate on the waterside (WS) end. Concrete headwall on the landside (LS) end. (24-inch [HLM 7.36] authorized under Automatic Board Order (ABO) issued as Permit No. 10247, 1974 - University of California, Office of the Regents). [Additional Reference(s): DWR Levee Log, 2005 (HLM 7.36). USACE Sacramento O&M Manual, Unit 119, December 1952, Revised 29 Dec 2016, (Station 183+97 PCT). USACE As-Built Drawing No. 50-04-2396, Revision 4, pdf page 25, Sheet 9, December 1947]. FS Date: 10/21/2019 2:33:12 PM

LS levee slope, headwall, and pipe end

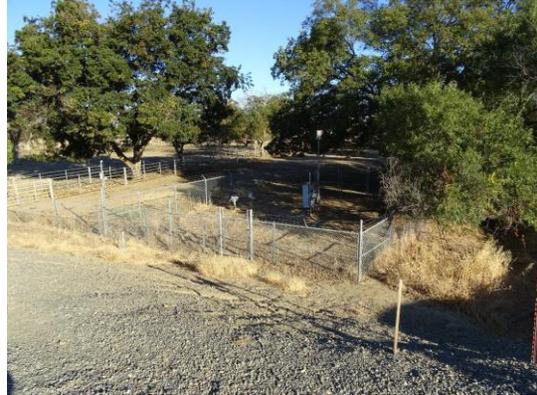
Photo 1 of 3 : UCIP\_FA\_2019\_55668\_82359.jpg

Item	DRAFT DWR UCIP Field Study			38.518200°	38.518200°
				-121.757402°	-121.757402°
DWR ID	511				
Comment Code					
Inspector Comment					
DS_ID:511 FS_ID:55668 EP_NO: 3289 Repair Type: Urgent Crossing Status: Found UCIP Comments: 10/21/2019 Flap gate isn't closing properly leaving a gap for backflow. Flap gate needs adjustment or replacement. (O.Yakimov - DWR UCIP) 04/04/2012 Installed 113 feet west of centerline of Old Davis Road. (W. Wylie - DWR UCIP) FIELD_STRUCT_DESC: 18-inch steel sewer pipe through the levee, 17.5 feet below the crown. Flap gate and grouted spillway on the waterside (WS) end. Fenced in area on the landside (LS) toe with appurtenances. (18-inch pipe authorized under Permit No. 3289, 1960 - The Regents of the University of California). [Additional Reference(s): DWR Levee Log, 2005]. FS Date: 10/21/2019 3:14:38 PM

LS view: control valves and electrical equipment

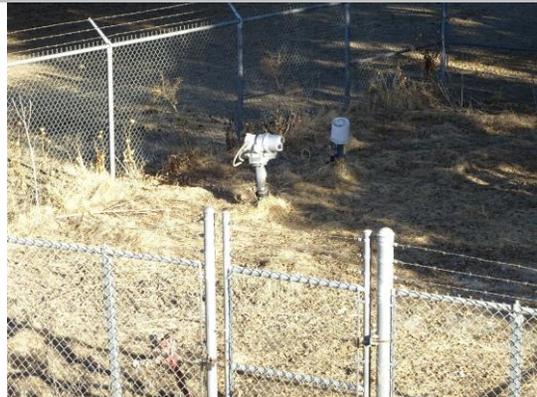
Photo 2 of 3 : UCIP\_FA\_2019\_55668\_82360.jpg

Powered control valve in fenced area near LS toe

Item	DRAFT DWR UCIP Field Study			38.518200°	38.518200°
				-121.757402°	-121.757402°
DWR ID	511				
Comment Code					
Inspector Comment					
DS_ID:511 FS_ID:55668 EP_NO: 3289 Repair Type: Urgent Crossing Status: Found UCIP Comments: 10/21/2019 Flap gate isn't closing properly leaving a gap for backflow. Flap gate needs adjustment or replacement. (O.Yakimov - DWR UCIP) 04/04/2012 Installed 113 feet west of centerline of Old Davis Road. (W. Wylie - DWR UCIP) FIELD_STRUCT_DESC: 18-inch steel sewer pipe through the levee, 17.5 feet below the crown. Flap gate and grouted spillway on the waterside (WS) end. Fenced in area on the landside (LS) toe with appurtenances. (18-inch pipe authorized under Permit No. 3289, 1960 - The Regents of the University of California). [Additional Reference(s): DWR Levee Log, 2005]. FS Date: 10/21/2019 3:14:38 PM

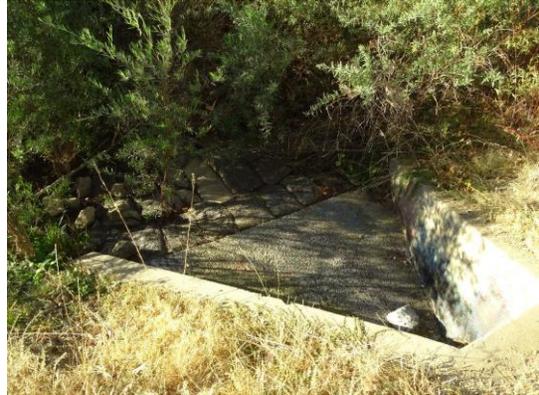
Photo 3 of 3 : UCIP\_FA\_2019\_55668\_82361.jpg

Outlet in riverbank approximately 400 feet south of levee

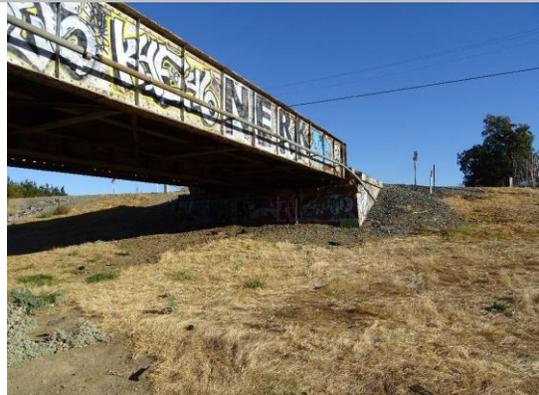
Photo 1 of 3 : UCIP\_FA\_2019\_55670\_82365.jpg

LM Start	<b>7.33</b>	Rating **	M	Issue No.	<b>82</b>
LM End	<b>7.33</b>	Issue Type +	En	Location *	
Category	Supplemental			GPS Latitude/Longitude	
				Start	End
Item	DRAFT DWR UCIP Field Study			38.518440°	38.518440°
				-121.760027°	-121.760027°
DWR ID	17762				
Comment Code					
Inspector Comment					
DS_ID:17762 FS_ID:55670 EP_NO: N/A Repair Type: Non-Urgent Crossing Status: Found UCIP Comments: 10/21/2019 Missing permit for this crossing. (O.Yakimov - DWR UCIP)04/04/2012 No Permit identified for crossing. (W. Wylie - DWR UCIP) FIELD_STRUCT_DESC: Fiber optics line markers on east side of railroad tracks. 5-inch OD steel conduit attached to east side of railroad bridge No permit identified. FS Date: 10/21/2019

5-inch-OD conduit on east side of RR bridge

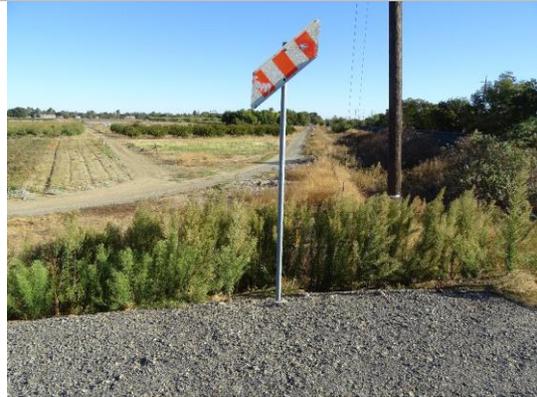
Photo 1 of 3 : UCIP\_FA\_2019\_55672\_82369.jpg

Item	DRAFT DWR UCIP Field Study			38.518496°	38.518496°
				-121.760411°	-121.760411°
DWR ID	515				
Comment Code					
Inspector Comment					
DS_ID:515 FS_ID:55672 EP_NO: 10257 Repair Type: Non-Urgent Crossing Status: Indicator Found UCIP Comments: 10/21/2019 ABO permit for this crossing. FIELD_STRUCT_DESC: 6-inch gas line of an unknown material through the levee, 5 feet below the crown and under the channel. Valve in 14-inch riser on the waterside (WS) toe. Markers on the landside (LS) shoulder and toe. (6-inch line authorized under Automatic Board Order (ABO) issued as Permit No. 10257, 1974 - Pacific Gas and Electric Company [PG&E]). [Additional Reference(s): DWR Levee Log, 2005 (HLM 7.52). USACE Sacramento O&M Manual, Unit 119, December 1952, Revised 29 Dec 2016, (Station ~ 193+00 PCT). USACE As-Built Drawing No. 50-04-2396, Revision 4, pdf page 25, Sheet 9, December 1947]. FS Date: 10/21/2019 3:53:27 PM

View of LS looking from levee crown

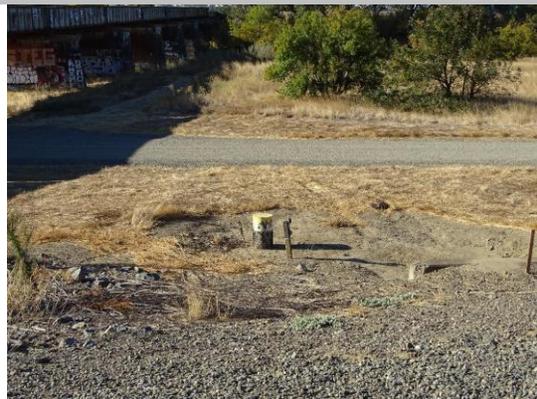
Photo 2 of 3 : UCIP\_FA\_2019\_55672\_82370.jpg

View of WS looking from levee crown

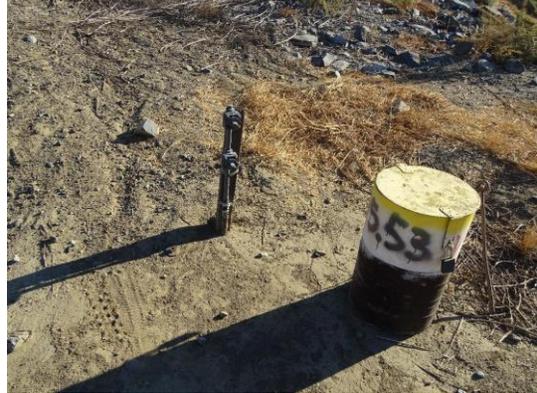
Photo 3 of 3 : UCIP\_FA\_2019\_55672\_82371.jpg

Item	DRAFT DWR UCIP Field Study			38.518496°	38.518496°
				-121.760411°	-121.760411°
DWR ID	515				
Comment Code					
Inspector Comment					
DS_ID:515 FS_ID:55672 EP_NO: 10257 Repair Type: Non-Urgent Crossing Status: Indicator Found UCIP Comments: 10/21/2019 ABO permit for this crossing. FIELD_STRUCT_DESC: 6-inch gas line of an unknown material through the levee, 5 feet below the crown and under the channel. Valve in 14-inch riser on the waterside (WS) toe. Markers on the landside (LS) shoulder and toe. (6-inch line authorized under Automatic Board Order (ABO) issued as Permit No. 10257, 1974 - Pacific Gas and Electric Company [PG&E]). [Additional Reference(s): DWR Levee Log, 2005 (HLM 7.52). USACE Sacramento O&M Manual, Unit 119, December 1952, Revised 29 Dec 2016, (Station ~ 193+00 PCT). USACE As-Built Drawing No. 50-04-2396, Revision 4, pdf page 25, Sheet 9, December 1947]. FS Date: 10/21/2019 3:53:27 PM

Valve on post and valve in 14-inch riser at WS levee toe
