**Flood Control Project Maintenance  
Levee Inspections**

**Fall 2019 Levee Maintenance Deficiency Summary Report**

**Sacramento Maintenance Yard Putah Creek**

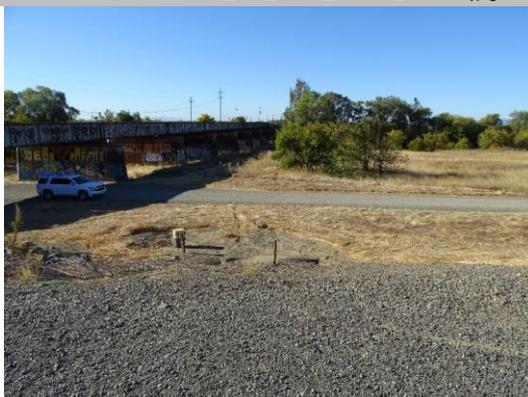
Photo 3 of 3 : UCIP\_FA\_2019\_55673\_82374.jpg

Item	DRAFT DWR UCIP LMA Responsibility		38.518510 °	38.518510 °	
			-121.760474 °	-121.760474 °	
DWR ID	516				
Comment Code					
Inspector Comment					
DS_ID:516 FS_ID:55673 EP_NO: 10260 Repair Type: Non-Urgent Crossing Status: Found UCIP Comments: 10/21/2019 No issues recorded during inspection (O.Yakimov - DWR UCIP)05/07/2013 Owner of pipe may have to clean sediment. (C. Lund - DWR Sacramento Yard) 04/05/2012 Pipe is partially obstructed with sedimentation. (W. Wylie - DWR UCIP) FIELD_STRUCT_DESC: 24-inch corrugated metal drainage pipe through the levee, 12 feet below the crown. Flap gate on the waterside (WS) end. (24-inch pipe [HLM 7.52] authorized under Automatic Board Order (ABO) issued as Permit No. 10260, 1974 - Southern Pacific Transportation Company). [Additional Reference(s): DWR Levee Log, 2005 (HLM 7.52). USACE Sacramento O&M Manual, Unit 119, December 1952, Revised 29 Dec 2016, (Station 193+20 PCT). USACE As-Built Drawing No. 50-04-2396, Revision 4, pdf page 25, Sheet 9, December 1947]. FS Date: 10/21/2019 4:00:06 PM

View of WS looking from levee crown

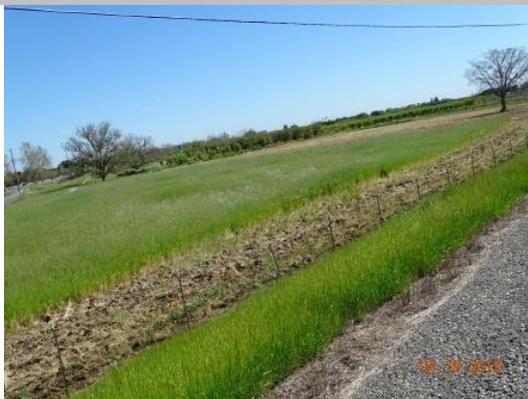
Photo 1 of 1 : FA\_2019\_ST0007\_282\_42\_20190826\_00012.jpg

LM Start	<b>7.39</b>	Rating **	M	Issue No.	<b>42</b>
LM End	<b>7.85</b>	Issue Type +	En	Location *	LS
Category	Earthen Levee		GPS Latitude/Longitude		
			Start	End	
Item	Encroachments		38.518659 °	38.518570 °	
			-121.761060 °	-121.769577 °	
DWR ID	DWR_ST0007_01_s_ 2019_42				
Comment Code					
FE : Fence					
Inspector Comment					
There is a barbed wire fence on the landside.

View looking downstream at barbed wire fence located within the landside easment (Spring 2019).

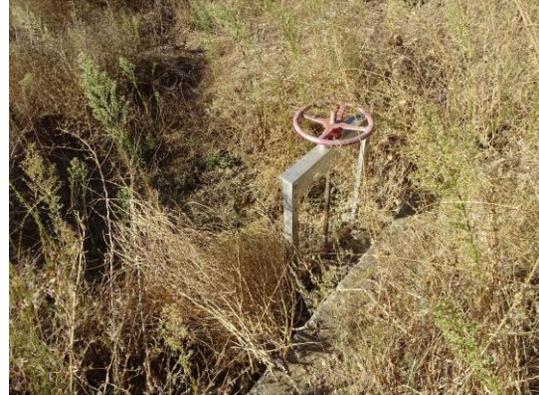
Photo 3 of 3 : UCIP\_FA\_2019\_55675\_82385.jpg

Item	DRAFT DWR UCIP LMA Responsibility			38.519002°	38.519002°	
				-121.764315°	-121.764315°	
DWR ID	518					
Comment Code						
Inspector Comment						
DS_ID:518 FS_ID:55675 EP_NO: 10247 Repair Type: Non-Urgent Crossing Status: Found UCIP Comments: 10/21/2019 Difficult access to pipe inlet on LS due to a fence. (O.Yakimov - DWR UCIP)05/07/2013 Fence blocking inlet. Owner of fence needs to move fence away from inlet. (C. Lund - DWR Sacramento Yard) 04/05/2012 Clear debris from pipe. (W. Wylie - DWR UCIP) FIELD_STRUCT_DESC: 24-inch CIPP-lined corrugated metal drainage pipe through the levee, 12 feet below the crown. Slide gate on the waterside (WS) slope, and headwalls on both sides. (24-inch pipe [HLM 7.75] authorized under Automatic Board Order (ABO) issued as Permit No. 10247, 1974 - University of California, Office of the Regents). [Additional Reference(s): DWR Levee Log, 2005 (HLM 7.75). USACE Sacramento O&M Manual, Unit 119, December 1952, Revised 29 Dec 2016, (Station 204+00 PCT). USACE As-Built Drawing No. 50-04-2396, Revision 4, pdf page 25, Sheet 9, December 1947]. FS Date: 10/21/2019 8:27:02 AM

WS: headwall and slide gate

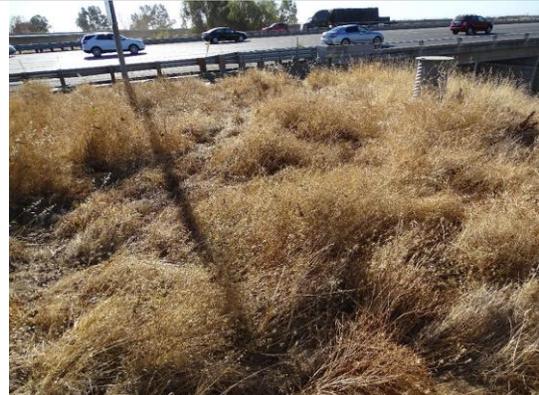
Photo 1 of 3 : UCIP\_FA\_2019\_55678\_82390.jpg

Item	DRAFT DWR UCIP Field Study		38.518920 °	38.518920 °	
			-121.771850 °	-121.771850 °	
DWR ID	519				
Comment Code					
Inspector Comment					
DS_ID:519 FS_ID:55678 EP_NO: 7279 Repair Type: Non-Urgent Crossing Status: Found UCIP Comments: 10/21/2019 Sediment buildup inside the pipe and its outlet. Remove sediment and debris. (O.Yakimov - DWR UCIP) FIELD_STRUCT_DESC: 36-inch steel pressure pipe through the levee, 3.5 feet below the crown. Air valve in 24-inch corrugated metal pipe (CMP) on the landside (LS), and a concrete spillway on the waterside (WS) end with concrete drop box at outlet. (Permit No. 7279, 1971 - State of California, Department of Public Works, Division of Highways and Bridges). [Additional Reference(s): DWR Levee Log, 2005, 42-inch pipe listed]. FS Date: 10/21/2019 8:52:38 AM

Standpipe and air vent at WS shoulder

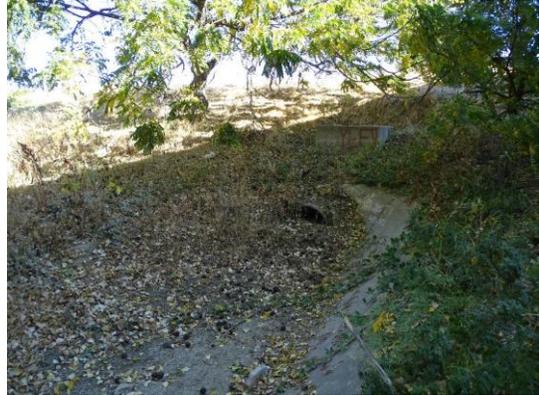
Photo 2 of 3 : UCIP\_FA\_2019\_55678\_82391.jpg

Item	DRAFT DWR UCIP Field Study		38.518920 °	38.518920 °	
			-121.771850 °	-121.771850 °	
DWR ID	519				
Comment Code					
Inspector Comment					
DS_ID:519 FS_ID:55678 EP_NO: 7279 Repair Type: Non-Urgent Crossing Status: Found UCIP Comments: 10/21/2019 Seediment buildup inside the pipe and its outlet. Remove sediment and debris. (O.Yakimov - DWR UCIP) FIELD_STRUCT_DESC: 36-inch steel pressure pipe through the levee, 3.5 feet below the crown. Air valve in 24-inch corrugated metal pipe (CMP) on the landside (LS), and a concrete spillway on the waterside (WS) end with concrete drop box at outlet. (Permit No. 7279, 1971 - State of California, Department of Public Works, Division of Highways and Bridges). [Additional Reference(s): DWR Levee Log, 2005, 42-inch pipe listed]. FS Date: 10/21/2019 8:52:38 AM

WS: pipe and spillway below drop box

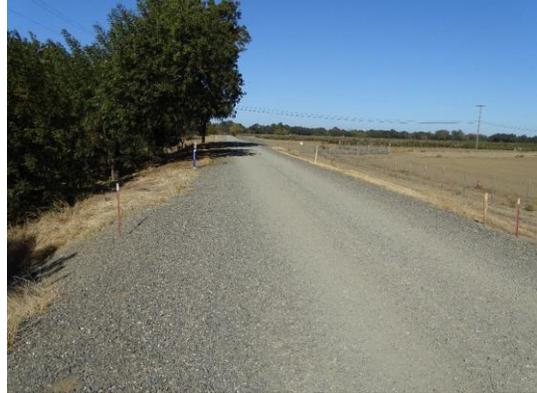
Photo 1 of 3 : UCIP\_FA\_2019\_55679\_82393.jpg

Item	DRAFT DWR UCIP LMA Responsibility		38.521246°	38.521246°	
			-121.776434°	-121.776434°	
DWR ID	520				
Comment Code					
Inspector Comment					
DS_ID:520 FS_ID:55679 EP_NO: 10247 Repair Type: Non-Urgent Crossing Status: Found UCIP Comments: 10/21/2019 No issues recorded during inspection (O.Yakimov - DWR UCIP)05/07/2012 Cleaned inlet and outlets. Owner of pipe may need to clean pipe. (C. Lund - DWR Sacramento Yard) 04/05/2012 Pipe is plugged with soil on LS. (W. Wylie - DWR UCIP) FIELD_STRUCT_DESC: 24-inch CIPP-lined corrugated metal drainage pipe through the levee, 8 feet below the crown. Slide gate on the waterside (WS) end. (24-inch pipe [HLM 8.45] authorized under Automatic Board Order (ABO) issued as Permit No. 10247, 1974 - University of California, Office of the Regents). [Additional Reference(s): DWR Levee Log, 2005 (HLM 8.45). USACE Sacramento O&M Manual, Unit 119, December 1952, Revised 29 Dec 2016, (Station 241+50 PCT). USACE As-Built Drawing No. 50-04-2396, Revision 2, pdf page 26, Sheet 10, December 1947]. FS Date: 10/21/2019 10:02:10 AM

View of levee crown at the crossing

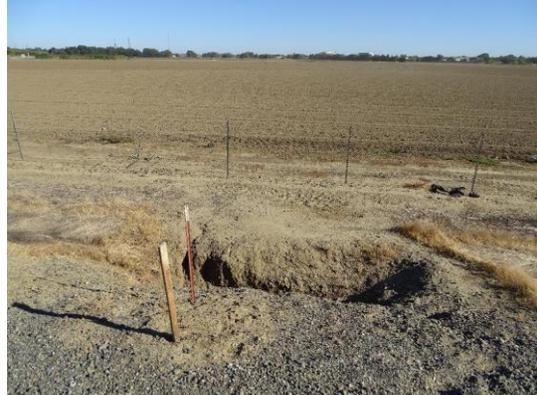
Photo 2 of 3 : UCIP\_FA\_2019\_55679\_82394.jpg

View of LS looking from levee crown

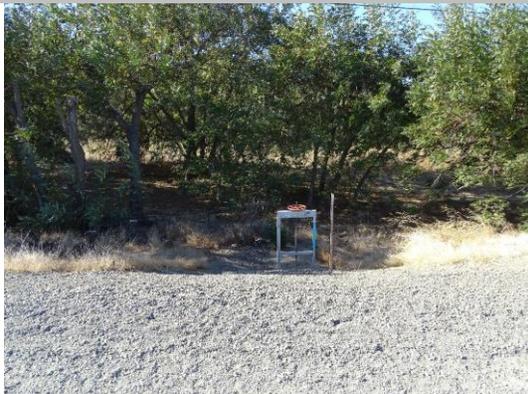
Photo 3 of 3 : UCIP\_FA\_2019\_55679\_82395.jpg

Item	DRAFT DWR UCIP LMA Responsibility		38.521246°	38.521246°	
			-121.776434°	-121.776434°	
DWR ID	520				
Comment Code					
Inspector Comment					
DS_ID:520 FS_ID:55679 EP_NO: 10247 Repair Type: Non-Urgent Crossing Status: Found UCIP Comments: 10/21/2019 No issues recorded during inspection (O.Yakimov - DWR UCIP)05/07/2012 Cleaned inlet and outlets. Owner of pipe may need to clean pipe. (C. Lund - DWR Sacramento Yard) 04/05/2012 Pipe is plugged with soil on LS. (W. Wylie - DWR UCIP) FIELD_STRUCT_DESC: 24-inch CIPP-lined corrugated metal drainage pipe through the levee, 8 feet below the crown. Slide gate on the waterside (WS) end. (24-inch pipe [HLM 8.45] authorized under Automatic Board Order (ABO) issued as Permit No. 10247, 1974 - University of California, Office of the Regents). [Additional Reference(s): DWR Levee Log, 2005 (HLM 8.45). USACE Sacramento O&M Manual, Unit 119, December 1952, Revised 29 Dec 2016, (Station 241+50 PCT). USACE As-Built Drawing No. 50-04-2396, Revision 2, pdf page 26, Sheet 10, December 1947]. FS Date: 10/21/2019 10:02:10 AM

View of WS looking from levee crown

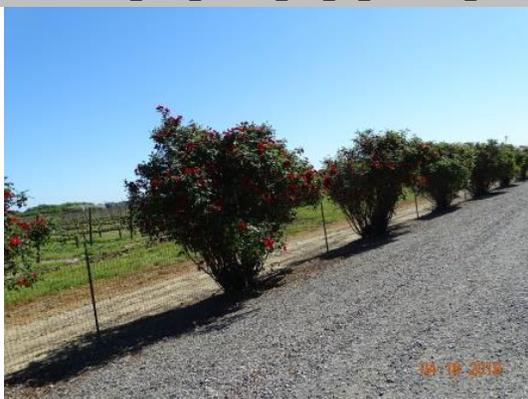
Photo 1 of 1 : FA\_2019\_ST0007\_282\_38\_20190826\_00008.jpg

LM Start	<b>8.32</b>	Rating **	M	Issue No.	<b>38</b>
LM End	<b>8.62</b>	Issue Type +	En	Location *	LS
Category	Earthen Levee		GPS Latitude/Longitude		
			Start	End	
Item	Encroachments		38.521613°	38.523854°	
			-121.777127°	-121.781915°	
DWR ID	DWR_ST0007_01_s_2019_38				
Comment Code					
FE : Fence					
Inspector Comment					
There is a barbed wire fence on the landside.

View looking downstream at barbed wire fence on the landside easment (Spring 2019).

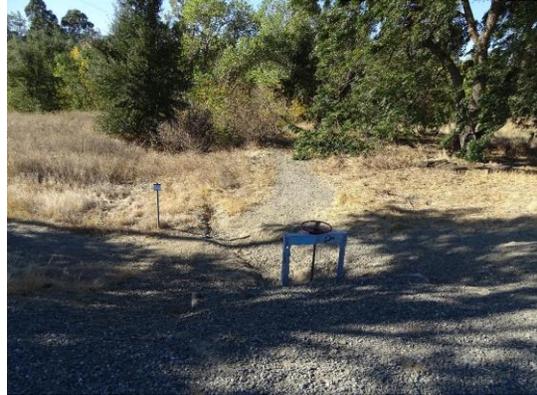
Photo 1 of 3 : UCIP\_FA\_2019\_55680\_82398.jpg

Item	DRAFT DWR UCIP LMA Responsibility		38.521660 °	38.521660 °	
			-121.777203 °	-121.777203 °	
DWR ID	521				
Comment Code					
Inspector Comment					
DS_ID:521 FS_ID:55680 EP_NO: 10247 Repair Type: Non-Urgent Crossing Status: Found UCIP Comments: 10/21/2019 No issues recorded during inspection (O.Yakimov - DWR UCIP)05/07/2013 Removed material at slidegate and inlet. (C. Lund - DWR Sacramento Yard) 04/05/2012 Pipe is partially blocked by sedimentation and slide gate will not open. (W. Wylie - DWR UCIP) FIELD_STRUCT_DESC: 24-inch CIPP-lined corrugated metal drainage pipe through the levee, 7 feet below the crown. Slide gate on the waterside (WS) end. Headwalls on both ends. (24-inch pipe [HLM 8.50] authorized under Automatic Board Order (ABO) issued as Permit No. 10247, 1974 - University of California, Office of the Regents. Also mentioned in Permit No. 5896, 1967 - The Regents of the University of California, Office of Architects and Engineers, University of California, Davis Campus). [Additional Reference(s): DWR Levee Log, 2005 (HLM 8.50). USACE Sacramento O&M Manual, Unit 119, December 1952, Revised 29 Dec 2016, (Station 244+20 PCT). USACE As-Built Drawing No. 50-04-2396, Revision 2, pdf page 26, Sheet 10, December 1947]. FS Date: 10/21/2019 11:46:58 AM

View of WS looking from levee crown

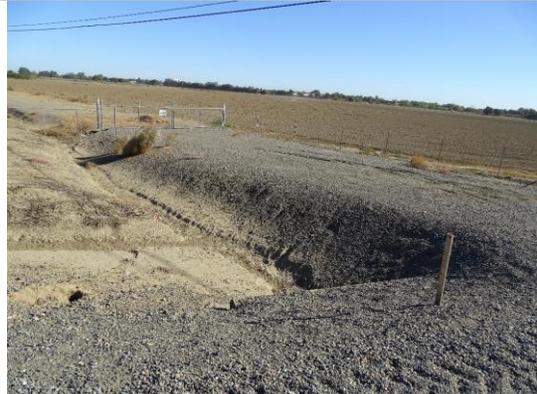
Photo 2 of 3 : UCIP\_FA\_2019\_55680\_82399.jpg

LM Start	<b>8.33</b>	Rating **	M	Issue No.	<b>91 (cont)</b>
LM End	<b>8.33</b>	Issue Type +	Ma	Location *

View of LS looking from levee crown

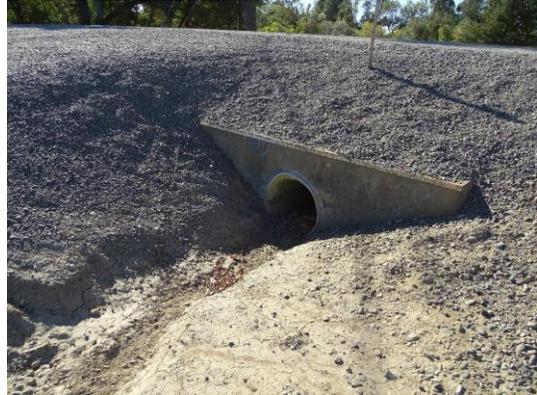
Photo 3 of 3 : UCIP\_FA\_2019\_55680\_82400.jpg

Item	DRAFT DWR UCIP LMA Responsibility			38.521660 °	38.521660 °
				-121.777203 °	-121.777203 °
DWR ID	521				
Comment Code					
Inspector Comment					
DS_ID:521 FS_ID:55680 EP_NO: 10247 Repair Type: Non-Urgent Crossing Status: Found UCIP Comments: 10/21/2019 No issues recorded during inspection (O.Yakimov - DWR UCIP)05/07/2013 Removed material at slidegate and inlet. (C. Lund - DWR Sacramento Yard) 04/05/2012 Pipe is partially blocked by sedimentation and slide gate will not open. (W. Wylie - DWR UCIP) FIELD_STRUCT_DESC: 24-inch CIPP-lined corrugated metal drainage pipe through the levee, 7 feet below the crown. Slide gate on the waterside (WS) end. Headwalls on both ends. (24-inch pipe [HLM 8.50] authorized under Automatic Board Order (ABO) issued as Permit No. 10247, 1974 - University of California, Office of the Regents. Also mentioned in Permit No. 5896, 1967 - The Regents of the University of California, Office of Architects and Engineers, University of California, Davis Campus). [Additional Reference(s): DWR Levee Log, 2005 (HLM 8.50). USACE Sacramento O&M Manual, Unit 119, December 1952, Revised 29 Dec 2016, (Station 244+20 PCT). USACE As-Built Drawing No. 50-04-2396, Revision 2, pdf page 26, Sheet 10, December 1947]. FS Date: 10/21/2019 11:46:58 AM

LS levee slope, headwall, and pipe end

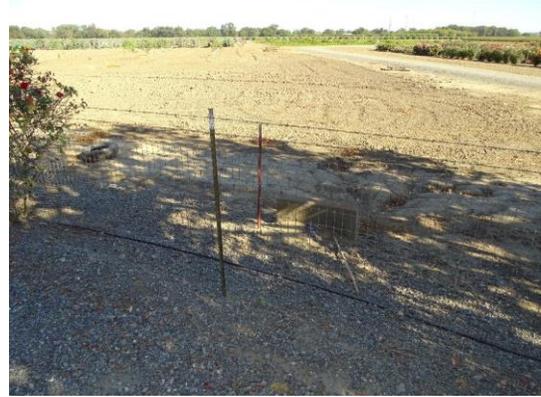
Photo 1 of 3 : UCIP\_FA\_2019\_55681\_82403.jpg

Item	DRAFT DWR UCIP Field Study		38.523210°	38.523210°	
			-121.780170°	-121.780170°	
DWR ID	522				
Comment Code					
Inspector Comment					
DS_ID:522 FS_ID:55681 EP_NO: 5896 Repair Type: Non-Urgent Crossing Status: Found UCIP Comments: 10/21/2019 Sediment buildup around pipe outlet prevents flap gate from opening. (O. Yakimov - DWR UCIP)05/07/2013 Inspected inlet of pipe from other side of fence. Outlet discharge under elderberry. Need permit to cut veg. (C. Lund - DWR Sacramento Yard) 04/05/2012 Fence prevents access to pipe. Pipe likely needs to be cleared of sedimentation. (W. Wylie - DWR UCIP) FIELD_STRUCT_DESC: 12-inch corrugated metal drainage pipe through the levee, 3.4 feet below the crown. Flap gate on the waterside (WS) end. Concrete headwall on the landside (LS) end. (Permit No. 5896, 1967 - The Regents of the University of California, Office of Architects and Engineers, University of California, Davis Campus). [Additional Reference(s): DWR Levee Log, 2005]. FS Date: 10/21/2019 12:48:47 PM

View of LS looking from levee crown

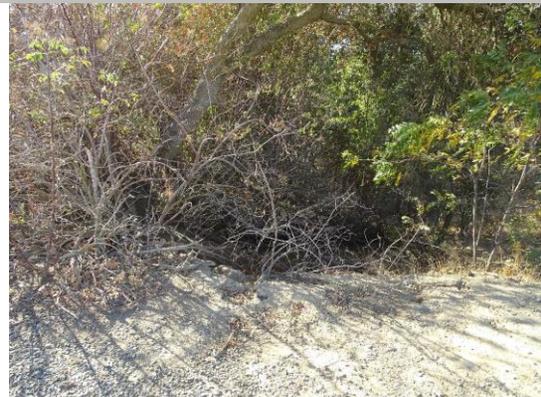
Photo 2 of 3 : UCIP\_FA\_2019\_55681\_82404.jpg

LM Start	<b>8.52</b>	Rating **	M	Issue No.	<b>92 (cont)</b>
LM End	<b>8.52</b>	Issue Type +	En	Location *

View of WS looking from levee crown

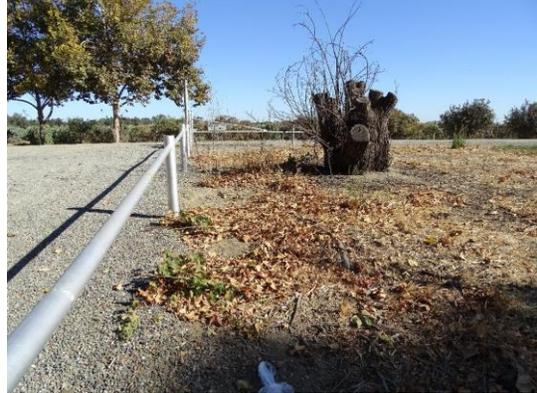
Photo 3 of 3 : UCIP\_FA\_2019\_55682\_82409.jpg

Item	DRAFT DWR UCIP Field Study			38.523630 °	38.523630 °	
				-121.781150 °	-121.781150 °	
DWR ID	616					
Comment Code						
Inspector Comment						
DS_ID:616 FS_ID:55682 EP_NO: N/A Repair Type: Non-Urgent Crossing Status: Not Found UCIP Comments: 10/21/2019 Crossing not found. Location of standpipe at the gate does not correspond to station number for this crossing found in as-built. This pipe is a candidate for electromagnetic survey. (O.Yakimov - DWR UCIP)04/05/2012 found 8-inch standpipe north of Levee gate at LAT: 38.52393499 Long: -121.78208740. Also found a T-post on the downhill slope below the 8-inch standpipe on WS. However, no pipe was found. The actual pipe location is likely between the gate and the location shown in the O+M manual and reported on this form. (W. Wylie - DWR UCIP) FIELD_STRUCT_DESC: 8-inch corrugated metal pipe of unknown purpose, referenced in the O&M manual, through the levee, at an unknown depth. Construction drawings show a 24-inch irrigation pipe at the site. [Additional Reference(s): USACE Sacramento O&M Manual, Unit 119, December 1952, Revised 29 Dec 2016, (Station 258+12 PCT), 8-inch pipe referenced. USACE As-Built Drawing No. 50-04-2396, Revision 2, pdf page 26, Sheet 10, 24-inch pipe referenced on levee alignment, December 1947]. FS Date: 10/21/2019 12:56:46 PM

View of WS berm looking towards the gate where 8-inch standpipe found

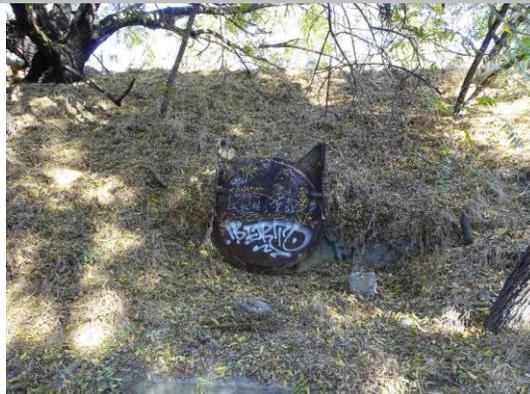
Photo 1 of 3 : UCIP\_FA\_2019\_55684\_82410.jpg

Item	DRAFT DWR UCIP LMA Responsibility		38.523999 °	38.523999 °	
			-121.783037 °	-121.783037 °	
DWR ID	523				
Comment Code					
Inspector Comment					
DS_ID:523 FS_ID:55684 EP_NO: 10247 Repair Type: Non-Urgent Crossing Status: Found UCIP Comments: 10/21/2019 Pipe inlet is closed with steel plate bolted to headwall in drainage canal on LS. (O.Yakimov - DWR UCIP) FIELD_STRUCT_DESC: *ABANDONED* 48-inch drainage pipe of an unknown material through the levee, 15 feet below the crown. Steel plate installed over inlet off the landside (LS) toe. Pipe not grouted. Flap gate on waterside (WS) end. Headwalls on both ends. (48-inch pipe [HLM 8.88] authorized under Automatic Board Order (ABO) issued as Permit No. 10247, 1974 - University of California, Office of the Regents). [Additional Reference(s): DWR Levee Log, 2005 (HLM 8.88). USACE Sacramento O&M Manual, Unit 119, December 1952, Revised 29 Dec 2016, (Station 262+30 PCT), 48-inch pipe referenced. USACE As-Built Drawing No. 50-04-2396, Revision 2, pdf page 26, Sheet 10, 24-inch pipe referenced on levee alignment, December 1947]. FS Date: 10/21/2019 1:46:45 PM

WS levee slope, headwall, and flap gate

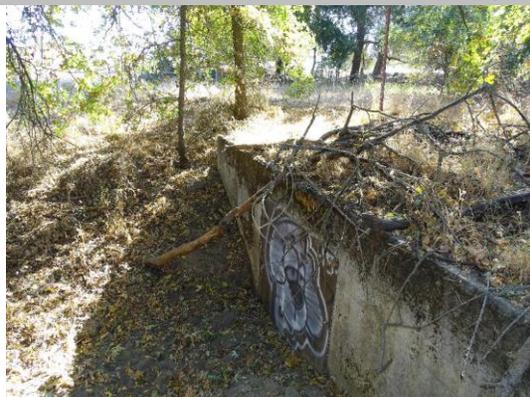
Photo 2 of 3 : UCIP\_FA\_2019\_55684\_82411.jpg

LM Start	<b>8.69</b>	Rating **	M	Issue No.	<b>94 (cont)</b>
LM End	<b>8.69</b>	Issue Type +	Ma	Location *

Steel plate installed over pipe off LS toe

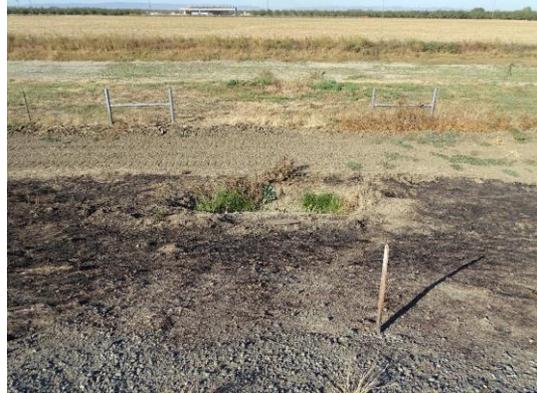
Photo 1 of 3 : UCIP\_FA\_2019\_55423\_81633.jpg

Item	DRAFT DWR UCIP Field Study		38.507320°	38.507320°	
			-121.662799°	-121.662799°	
DWR ID	16631				
Comment Code					
Inspector Comment					
DS_ID:16631 FS_ID:55423 EP_NO: 10275 Repair Type: Non-Urgent Crossing Status: Found UCIP Comments: 10/22/2019 No issues recorded during inspection (O.Yakimov - DWR UCIP)09/21/2017 Pipe was permitted as an irrigation structure under ABO issued as Permit No. 10275. (DWR UCIP - O. Magana) FIELD_STRUCT_DESC: 24-inch CIPP-lined corrugated metal irrigation pipe through the levee, crossing at angle, 11 feet below the crown. Slide gate on waterside (WS) end. (24-inch pipe [HLM 0.20] authorized under Automatic Board Order (ABO) issued as Permit No. 10275, 1974 - Mary Pereira). [Additional Reference(s): DWR Levee Log, 2005 (HLM 0.20). USACE Sacramento O&M Manual, Unit 119, December 1952, Revised 29 Dec 2016, (Station 12+65). USACE As-Built Drawing No. 50-04-2396, Revision 1, pdf page 20, Sheet 4, December 1947]. FS Date: 10/22/2019 8:50:15 AM

View of LS looking from levee crown

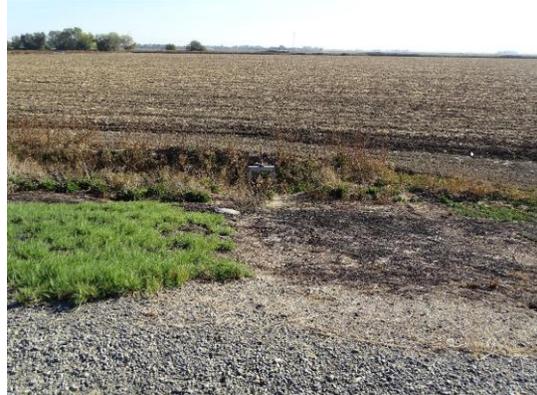
Photo 2 of 3 : UCIP\_FA\_2019\_55423\_81634.jpg

LM Start	<b>0.18</b>	Rating **	M	Issue No.	<b>49 (cont)</b>
LM End	<b>0.18</b>	Issue Type +	En	Location *

View of WS looking from levee crown

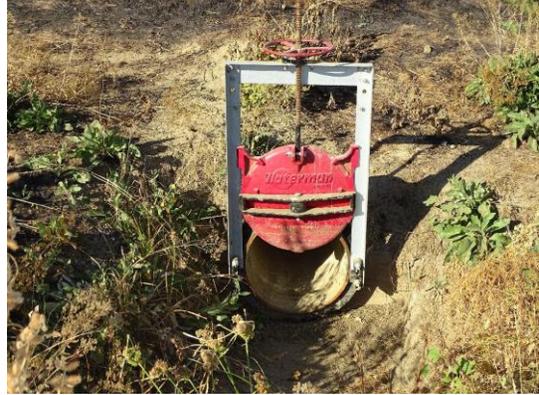
Photo 3 of 3 : UCIP\_FA\_2019\_55423\_81635.jpg

Item	DRAFT DWR UCIP Field Study			38.507320°	38.507320°
				-121.662799°	-121.662799°
DWR ID	16631				
Comment Code					
Inspector Comment					
DS_ID:16631 FS_ID:55423 EP_NO: 10275 Repair Type: Non-Urgent Crossing Status: Found UCIP Comments: 10/22/2019 No issues recorded during inspection (O.Yakimov - DWR UCIP)09/21/2017 Pipe was permitted as an irrigation structure under ABO issued as Permit No. 10275. (DWR UCIP - O. Magana) FIELD_STRUCT_DESC: 24-inch CIPP-lined corrugated metal irrigation pipe through the levee, crossing at angle, 11 feet below the crown. Slide gate on waterside (WS) end. (24-inch pipe [HLM 0.20] authorized under Automatic Board Order (ABO) issued as Permit No. 10275, 1974 - Mary Pereira). [Additional Reference(s): DWR Levee Log, 2005 (HLM 0.20). USACE Sacramento O&M Manual, Unit 119, December 1952, Revised 29 Dec 2016, (Station 12+65). USACE As-Built Drawing No. 50-04-2396, Revision 1, pdf page 20, Sheet 4, December 1947]. FS Date: 10/22/2019 8:50:15 AM

Headwall and slide gate at WS levee toe

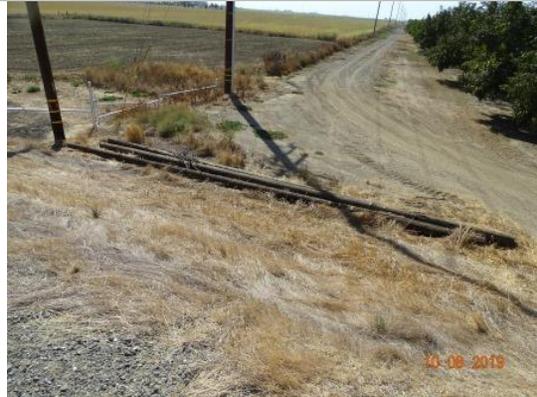
Photo 1 of 1 : FA\_2019\_ST0007\_283\_44\_20191008\_00067.jpg

LM Start	<b>0.56</b>	Rating **	U	Issue No.	<b>44</b>
LM End	<b>0.56</b>	Issue Type +	En	Location *	LS
Category	Earthen Levee		GPS Latitude/Longitude		
			Start	End	
Item	Encroachments		38.510277°	38.510277°	
			-121.667693°	-121.667693°	
DWR ID	DWR_ST0007_02_f_2019_44				
Comment Code					
MA : Material					
Inspector Comment					
Old telephone poles are on the landside toe.

View of telephone poles at the landside toe (Fall 2019).

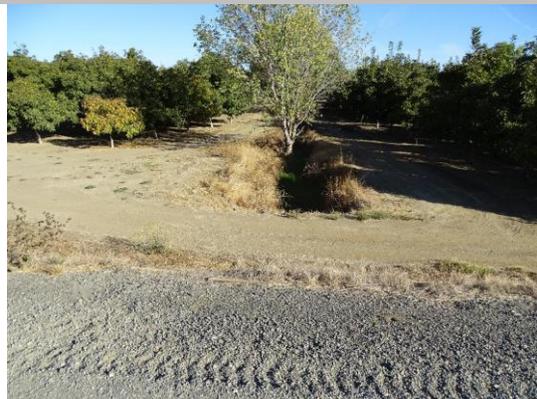
Photo 1 of 3 : UCIP\_FA\_2019\_55424\_81638.jpg

Item	DRAFT DWR UCIP LMA Responsibility		38.510700°	38.510700°	
			-121.672410°	-121.672410°	
DWR ID	16621				
Comment Code					
Inspector Comment					
DS_ID:16621 FS_ID:55424 EP_NO: 10270 Repair Type: Non-Urgent Crossing Status: Found UCIP Comments: 10/22/2019 Crossing visually is in good condition. 12-inch diameter through hole has developed due to soil instability on WS berm visible on the top of pipe outlet embankment. (O.Yakimov - DWR UCIP) FIELD_STRUCT_DESC: 36-inch corrugated metal drainage pipe through the levee, 14 feet below the crown. Flap gate on the waterside (WS) end. Concrete headwall on the landside (LS) end. (36-inch pipe [HLM 0.85] authorized under Automatic Board Order (ABO) issued as Permit No. 10270, 1974 - Hamel). [Additional Reference(s): DWR Levee Log, 2005 (HLM 0.85). USACE Sacramento O&M Manual, Unit 119, December 1952, Revised 29 Dec 2016, (Station T 1+45). USACE As-Built Drawing No. 50-04-2396, Revision 1, pdf page 21, Sheet 5, December 1947]. FS Date: 10/22/2019 9:59:31 AM

View of WS looking from levee crown

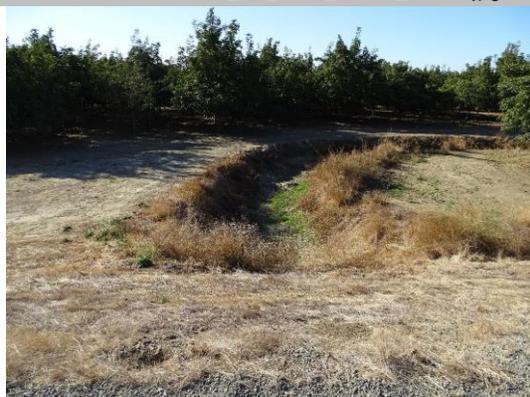
Photo 2 of 3 : UCIP\_FA\_2019\_55424\_81639.jpg

Item	DRAFT DWR UCIP LMA Responsibility			38.510700°	38.510700°
				-121.672410°	-121.672410°
DWR ID	16621				
Comment Code					
Inspector Comment					
DS_ID:16621 FS_ID:55424 EP_NO: 10270 Repair Type: Non-Urgent Crossing Status: Found UCIP Comments: 10/22/2019 Crossing visually is in good condition. 12-inch diameter through hole has developed due to soil instability on WS berm visible on the top of pipe outlet embankment. (O.Yakimov - DWR UCIP) FIELD_STRUCT_DESC: 36-inch corrugated metal drainage pipe through the levee, 14 feet below the crown. Flap gate on the waterside (WS) end. Concrete headwall on the landside (LS) end. (36-inch pipe [HLM 0.85] authorized under Automatic Board Order (ABO) issued as Permit No. 10270, 1974 - Hamel). [Additional Reference(s): DWR Levee Log, 2005 (HLM 0.85). USACE Sacramento O&M Manual, Unit 119, December 1952, Revised 29 Dec 2016, (Station T 1+45). USACE As-Built Drawing No. 50-04-2396, Revision 1, pdf page 21, Sheet 5, December 1947]. FS Date: 10/22/2019 9:59:31 AM

View of LS looking from levee crown

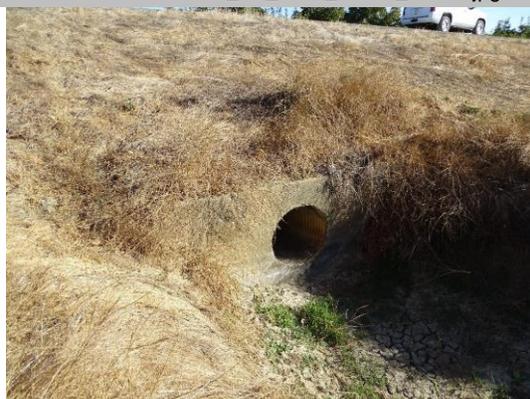
Photo 3 of 3 : UCIP\_FA\_2019\_55424\_81640.jpg

LM Start	<b>0.82</b>	Rating **	M	Issue No.	<b>50 (cont)</b>
LM End	<b>0.82</b>	Issue Type +	Ma	Location *

Headwall and pipe at LS toe

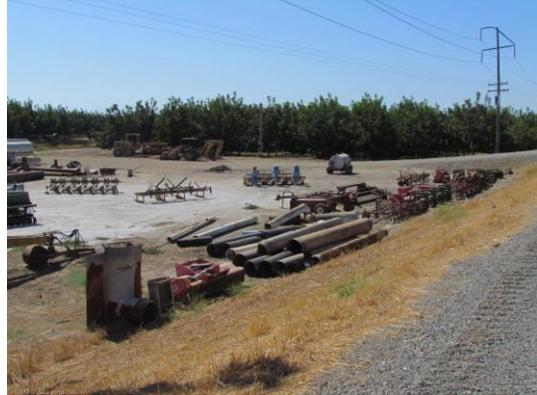
Photo 1 of 1 : FA\_2019\_ST0007\_283\_23\_20190826\_00003.jpg

LM Start	<b>1.01</b>	Rating **	M	Issue No.	<b>23</b>
LM End	<b>1.05</b>	Issue Type +	En	Location *	LS
Category	Earthen Levee		GPS Latitude/Longitude		
			Start	End	
Item	Encroachments		38.511402°	38.511598°	
			-121.675727°	-121.676413°	
DWR ID	DWR_ST0007_02_f_2016_23				
Comment Code					
EQ : Equipment					
Inspector Comment					
This ag equipment and materials should be moved at least 10 feet away from the LS levee toe.

Levee mile 1.01 landside toe looking upstream.

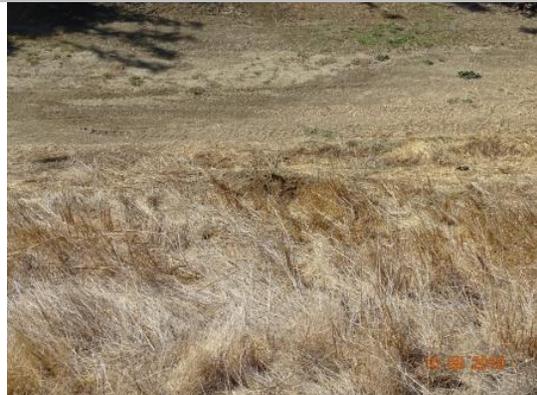
Photo 1 of 2 : FA\_2019\_ST0007\_283\_32\_20191008\_00066.jpg

LM Start	<b>1.15</b>	Rating **	U	Issue No.	<b>32</b>
LM End	<b>1.15</b>	Issue Type +	Ma	Location *	LS
Category	Earthen Levee		GPS Latitude/Longitude		
			Start	End	
Item	Animal Control		38.512052°	38.512052°	
			-121.678188°	-121.678188°	
DWR ID	DWR_ST0007_02_f_2018_32				
Comment Code					
A1 : Exterminate rodents and backfill and compact or grout burrows.					
Inspector Comment					
There were a couple new rodent holes with fresh dirt but less than Fall 2018.

View looking downslope at animal hole with fresh dirt (Fall 2019).

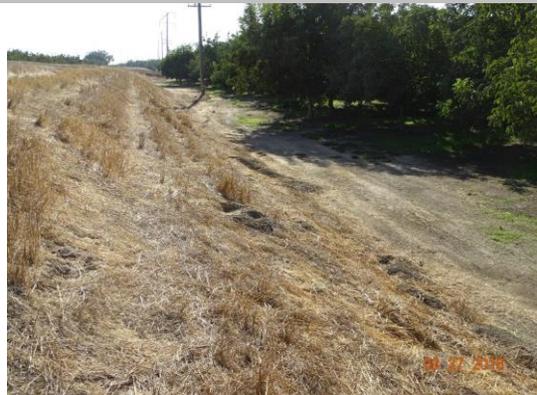
Photo 2 of 2 : FA\_2019\_ST0007\_283\_32\_20190826\_00010.jpg

LM Start	<b>1.15</b>	Rating **	U	Issue No.	<b>32 (cont)</b>
LM End	<b>1.15</b>	Issue Type +	Ma	Location *	LS

View looking downstream at multiple animal holes on the levee slope (September 2018).

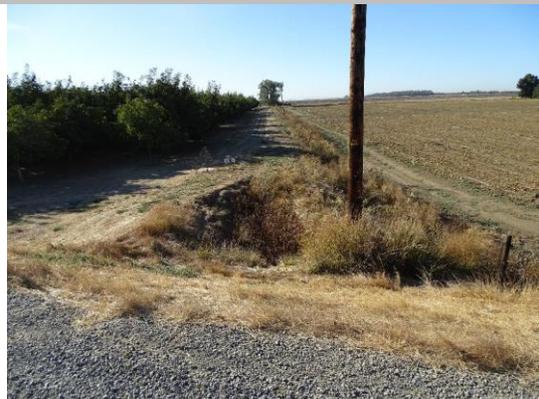
Photo 1 of 3 : UCIP\_FA\_2019\_55426\_81648.jpg

Item	DRAFT DWR UCIP Field Study		38.514220°	38.514220°	
			-121.685880°	-121.685880°	
DWR ID	16622				
Comment Code					
Inspector Comment					
DS_ID:16622 FS_ID:55426 EP_NO: 10270 Repair Type: Non-Urgent Crossing Status: Found UCIP Comments: 10/22/2019 Overgrown vegetation in LS drainage canal - unable to see pipe inlet at LS toe. (O.Yakimov - DWR UCIP)09/21/2017 Pipe was permitted as an irrigation structure under ABO issued as Permit No. 10270. (DWR UCIP - O. Magana) FIELD_STRUCT_DESC: 24-inch CIPP-lined corrugated metal irrigation pipe through the levee, 16 feet below the crown. Slide gate on the waterside (WS) slope. Concrete headwalls on both ends. (24-inch pipe [HLM 1.64] authorized under Automatic Board Order (ABO) issued as Permit No. 10270, 1974 - Hamel). [Additional Reference(s): DWR Levee Log, 2005 (HLM 1.64). USACE Sacramento O&M Manual, Unit 119, December 1952, Revised 29 Dec 2016, (Station P 233+00). USACE As-Built Drawing No. 50-04-2396, Revision 3, pdf page 22, Sheet 6, December 1947]. FS Date: 10/22/2019 10:33:28 AM

View of LS looking from levee crown

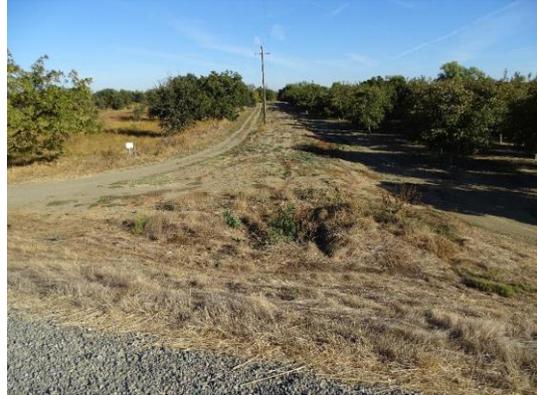
Photo 2 of 3 : UCIP\_FA\_2019\_55426\_81649.jpg

Item	DRAFT DWR UCIP Field Study		38.514220°	38.514220°	
			-121.685880°	-121.685880°	
DWR ID	16622				
Comment Code					
Inspector Comment					
DS_ID:16622 FS_ID:55426 EP_NO: 10270 Repair Type: Non-Urgent Crossing Status: Found UCIP Comments: 10/22/2019 Overgrown vegetation in LS drainage canal - unable to see pipe inlet at LS toe. (O.Yakimov - DWR UCIP)09/21/2017 Pipe was permitted as an irrigation structure under ABO issued as Permit No. 10270. (DWR UCIP - O. Magana) FIELD_STRUCT_DESC: 24-inch CIPP-lined corrugated metal irrigation pipe through the levee, 16 feet below the crown. Slide gate on the waterside (WS) slope. Concrete headwalls on both ends. (24-inch pipe [HLM 1.64] authorized under Automatic Board Order (ABO) issued as Permit No. 10270, 1974 - Hamel). [Additional Reference(s): DWR Levee Log, 2005 (HLM 1.64). USACE Sacramento O&M Manual, Unit 119, December 1952, Revised 29 Dec 2016, (Station P 233+00). USACE As-Built Drawing No. 50-04-2396, Revision 3, pdf page 22, Sheet 6, December 1947]. FS Date: 10/22/2019 10:33:28 AM

View of WS looking from levee crown

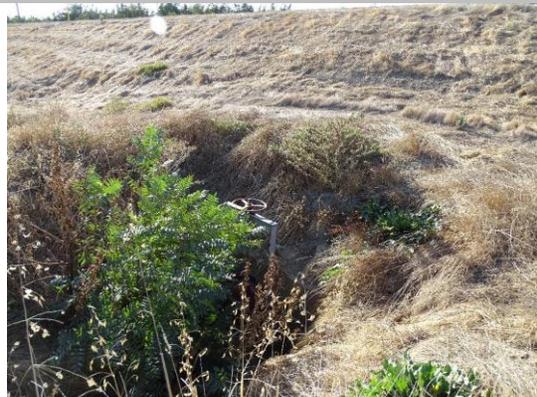
Photo 3 of 3 : UCIP\_FA\_2019\_55426\_81650.jpg

WS levee slope, headwall and slide gate

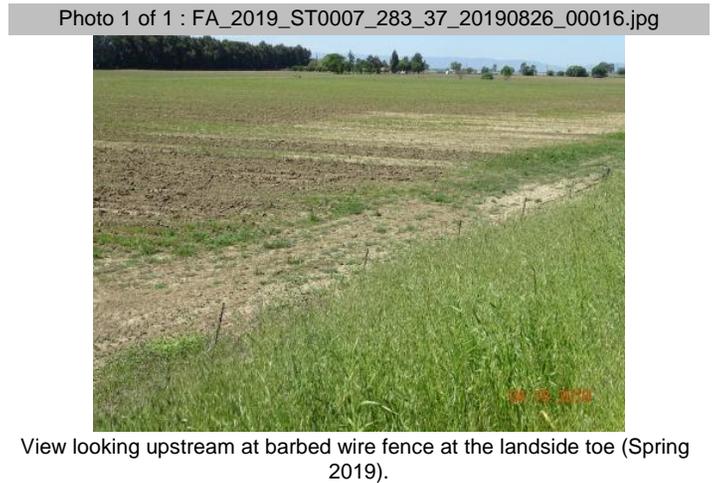
LM Start	<b>1.59</b>	Rating **	M	Issue No.	<b>37</b>
LM End	<b>2.09</b>	Issue Type +	En	Location *	LS
Category	Earthen Levee		GPS Latitude/Longitude		
			Start	End	
Item	Encroachments		38.514240°	38.515438°	
			-121.685957°	-121.694916°	
DWR ID	DWR_ST0007_02_s_2019_37				
Comment Code					
FE : Fence					
Inspector Comment					
There is a barbed wire fence on the landside toe.

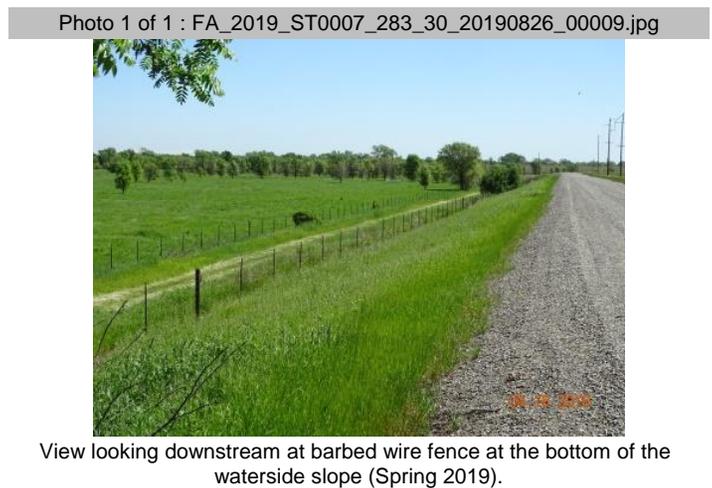
LM Start	<b>1.62</b>	Rating **	M	Issue No.	<b>30</b>
LM End	<b>2.09</b>	Issue Type +	En	Location *	WS
Category	Earthen Levee		GPS Latitude/Longitude		
			Start	End	
Item	Encroachments		38.514372°	38.515443°	
			-121.686399°	-121.694841°	
DWR ID	DWR_ST0007_02_s_2019_30				
Comment Code					
FE : Fence					
Inspector Comment					
There is a barbed wire fence on the waterside toe.

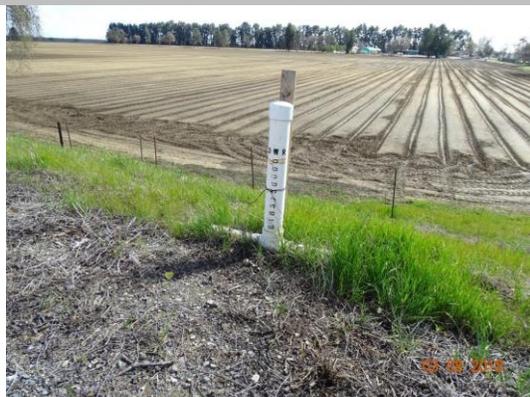
Photo 1 of 1 : FA\_2019\_ST0007\_283\_9\_20190826\_00001.jpg

LM Start	<b>2.00</b>	Rating **	A/W	Issue No.	<b>9</b>
LM End	<b>2.09</b>	Issue Type +	Ma	Location *	LS
Category	Earthen Levee			GPS Latitude/Longitude	
				Start	End
Item	Animal Control			38.515356 °	38.515456 °
				-121.693168 °	-121.694817 °
DWR ID	DWR_ST0007_02_s_2013_9				
Comment Code					
A1 : Exterminate rodents and backfill and compact or grout burrows.					
Inspector Comment					
There are no indications of recent rodent activity. Bait stations have been removed. Area should be monitored.

Rodent bait station at LM 2.09.

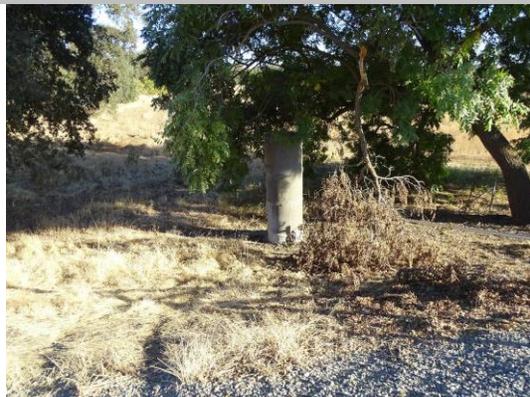
Photo 1 of 3 : UCIP\_FA\_2019\_55428\_81655.jpg

Item	DRAFT DWR UCIP Field Study			38.515440 °	38.515440 °
				-121.694920 °	-121.694920 °
DWR ID	16624				
Comment Code					
Inspector Comment					
DS_ID:16624 FS_ID:55428 EP_NO: 10268 Repair Type: Non-Urgent Crossing Status: Found UCIP Comments: 10/23/2019 Crossing looks abandoned. Headwall and pipe next to the headwall at LS toe is exposed. Pile of tree trimming put on LS along pipe alignment. Unable to locate 10-inch standpipe with gate valve on LS. (O.Yakimov - DWR UCIP)04/09/2012 It is apparent that there is an irrigation pipe sleeved through the 25-inch pipe, but size cannot be determined. (W. Wylie - DWR UCIP) FIELD_STRUCT_DESC: 24-inch corrugated metal irrigation pipe through the levee, 13 feet below the crown. Gate valve on the landside (LS) in 10-inch concrete standpipe. 36-inch standpipe on the waterside (WS) toe. Headwall on the LS toe. (24-inch pipe authorized under Automatic Board Order (ABO) issued as Permit No. 10268, 1974 - Dow Chemical Company). [Additional Reference(s): DWR Levee Log, 2005 (HLM 2.16). USACE Sacramento O&M Manual, Unit 119, December 1952, Revised 29 Dec 2016, (Station P 265+70). USACE As-Built Drawing No. 50-04-2396, Revision 3, pdf page 22, Sheet 6, December 1947]. FS Date: 10/23/2019 12:08:26 PM

View of WS looking from levee crown

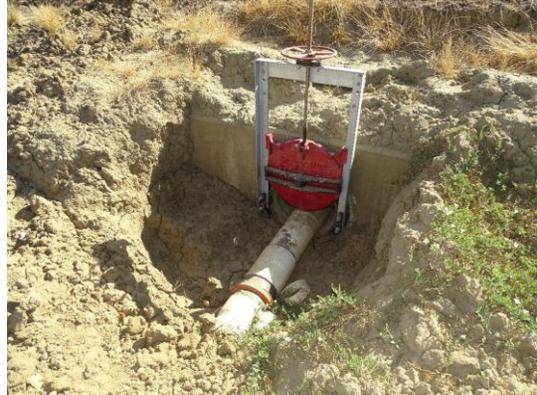
Photo 3 of 3 : UCIP\_FA\_2019\_55411\_81621.jpg

Item	DRAFT DWR UCIP LMA Responsibility			38.514865°	38.514865°
				-121.703839°	-121.703839°
DWR ID	16625				
Comment Code					
Inspector Comment					
DS_ID:16625 FS_ID:55411 EP_NO: 10277 Repair Type: Urgent Crossing Status: Found UCIP Comments: 10/21/2019 A PVC pipe runs through a drainage pipe from LS to WS levee toe. Slide gate cannot be closed properly to prevent flooding on LS. Remove PVC pipe. (O.Yakimov - DWR UCIP) FIELD_STRUCT_DESC: 24-inch CIPP-lined corrugated metal drainage pipe through the levee, 9 feet below the crown. Slide gate on the waterside (WS) slope. Concrete headwalls on both ends. (24-inch pipe [HLM 2.71] authorized under Automatic Board Order (ABO) issued as Permit No. 10277, 1974 - Naomi Schoeningh). [Additional Reference(s): DWR Levee Log, 2005 (HLM 2.71). USACE Sacramento O&M Manual, Unit 119, December 1952, Revised 29 Dec 2016, (Station 30+15 PCT). USACE As-Built Drawing No. 50-04-2396, Revision 4, pdf page 23, Sheet 7, December 1947]. FS Date: 10/21/2019 11:18:53 AM

Headwall and slidegate at WS toe with a PVC pipe running through

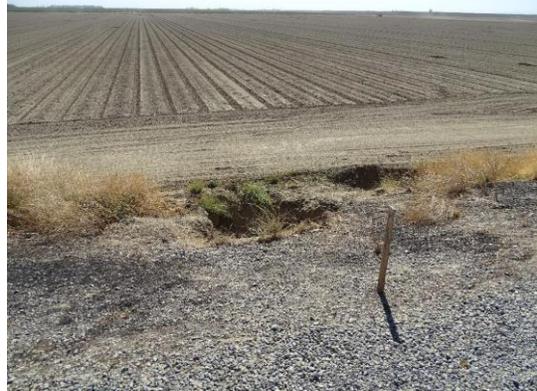
Photo 1 of 3 : UCIP\_FA\_2019\_55412\_81623.jpg

Item	DRAFT DWR UCIP LMA Responsibility		38.515080°	38.515080°	
			-121.711050°	-121.711050°	
DWR ID	16626				
Comment Code					
Inspector Comment					
DS_ID:16626 FS_ID:55412 EP_NO: 10277 Repair Type: Urgent Crossing Status: Found UCIP Comments: 10/21/2019 A PVC pipe runs through a drainage pipe from LS to WS levee toe. Slide gate cannot be closed properly to prevent flooding on LS. Remove PVC pipe. (O.Yakimov - DWR UCIP) FIELD_STRUCT_DESC: 24-inch CIPP-lined corrugated metal drainage pipe through the levee, 9 feet below the crown. Slide gate on the waterside (WS) slope, and headwalls on both sides. (24-inch pipe [HLM 3.11] authorized under Automatic Board Order (ABO) issued as Permit No. 10277, 1974 - Naomi Schoeningh). [Additional Reference(s): DWR Levee Log, 2005 (HLM 3.11). USACE Sacramento O&M Manual, Unit 119, December 1952, Revised 29 Dec 2016, (Station 50+72 PCT). USACE As-Built Drawing No. 50-04-2396, Revision 4, pdf page 23, Sheet 7, December 1947]. FS Date: 10/21/2019 1:30:39 PM

View of LS from levee crown

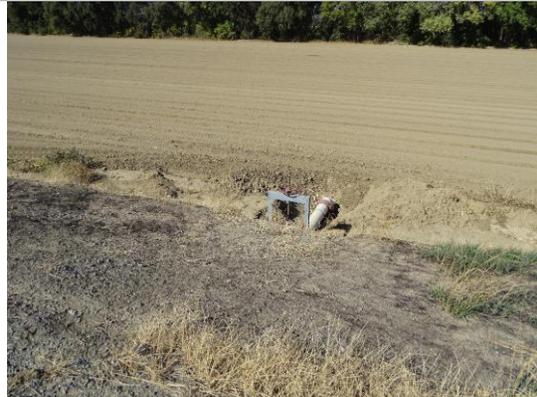
Photo 2 of 3 : UCIP\_FA\_2019\_55412\_81624.jpg

View of WS from levee crown

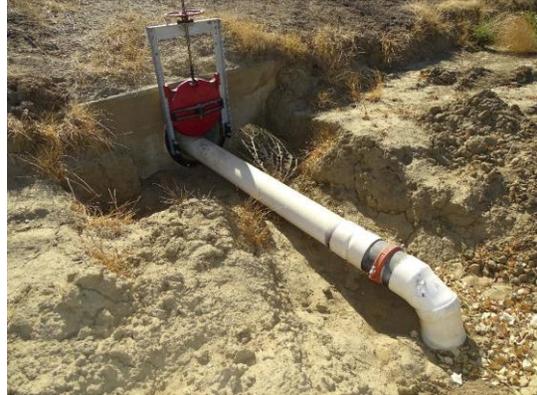
Photo 3 of 3 : UCIP\_FA\_2019\_55412\_81625.jpg

Item	DRAFT DWR UCIP LMA Responsibility			38.515080°	38.515080°	
				-121.711050°	-121.711050°	
DWR ID	16626					
Comment Code						
Inspector Comment						
DS_ID:16626 FS_ID:55412 EP_NO: 10277 Repair Type: Urgent Crossing Status: Found UCIP Comments: 10/21/2019 A PVC pipe runs through a drainage pipe from LS to WS levee toe. Slide gate cannot be closed properly to prevent flooding on LS. Remove PVC pipe. (O.Yakimov - DWR UCIP) FIELD_STRUCT_DESC: 24-inch CIPP-lined corrugated metal drainage pipe through the levee, 9 feet below the crown. Slide gate on the waterside (WS) slope, and headwalls on both sides. (24-inch pipe [HLM 3.11] authorized under Automatic Board Order (ABO) issued as Permit No. 10277, 1974 - Naomi Schoeningh). [Additional Reference(s): DWR Levee Log, 2005 (HLM 3.11). USACE Sacramento O&M Manual, Unit 119, December 1952, Revised 29 Dec 2016, (Station 50+72 PCT). USACE As-Built Drawing No. 50-04-2396, Revision 4, pdf page 23, Sheet 7, December 1947]. FS Date: 10/21/2019 1:30:39 PM

Headwall and slidegate at WS toe with a PVC pipe running through

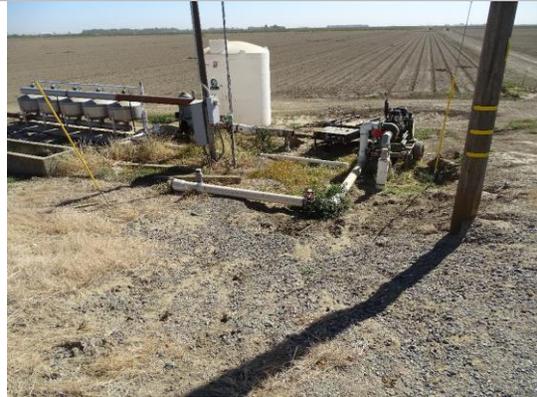
Photo 1 of 3 : UCIP\_FA\_2019\_55432\_81676.jpg

Item	DRAFT DWR UCIP Field Study			38.515162°	38.515162°
				-121.713653°	-121.713653°
DWR ID	16734				
Comment Code					
Inspector Comment					
DS_ID:16734 FS_ID:55432 EP_NO: 2273 Repair Type: Non-Urgent Crossing Status: Not Found UCIP Comments: 10/21/2019 10-inch steel irrigation pipe not found. Please refer to another crossing at this location dsid 16627. (O.Yakimov - DWR UCIP)04/06/2012 10-inch looks like it was removed from crown but evidence of connection remains on manifold from pump. No evidence remains on WS slope or toe. (W. Wylie - DWR UCIP) FIELD_STRUCT_DESC: 2 of 2: 10-inch steel irrigation pipe through the levee, 2 feet below the crown. Pump on well on the landside (LS). Manifold on LS toe with takeoff for 10-inch pipe. Siphon breaker on the waterside (WS) shoulder. (10-inch pipe authorized under Permit No. 2273, 1956 - P. W. Schoeningh). FS Date: 10/21/2019 10:01:29 AM

View of LS at the crossing looking from levee crown

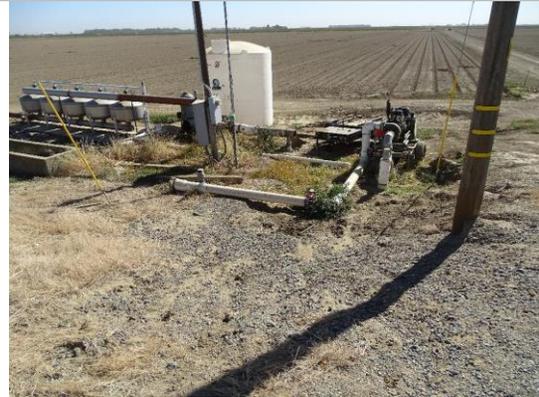
Photo 3 of 3 : UCIP\_FA\_2019\_55432\_81673.jpg

Item	DRAFT DWR UCIP Field Study			38.515162°	38.515162°
				-121.713653°	-121.713653°
DWR ID	16734				
Comment Code					
Inspector Comment					
DS_ID:16734 FS_ID:55432 EP_NO: 2273 Repair Type: Non-Urgent Crossing Status: Not Found UCIP Comments: 10/21/2019 10-inch steel irrigation pipe not found. Please refer to another crossing at this location dsid 16627. (O.Yakimov - DWR UCIP)04/06/2012 10-inch looks like it was removed from crown but evidence o fconnection remains on manifold from pump. No evidence remains on WS slope or toe. (W. Wylie - DWR UCIP) FIELD_STRUCT_DESC: 2 of 2: 10-inch steel irrigation pipe through the levee, 2 feet below the crown. Pump on well on the landside (LS). Manifold on LS toe with takeoff for 10-inch pipe. Siphon breaker on the waterside (WS) shoulder. (10-inch pipe authorized under Permit No. 2273, 1956 - P. W. Schoeningh). FS Date: 10/21/2019 10:01:29 AM

View of LS from levee crown

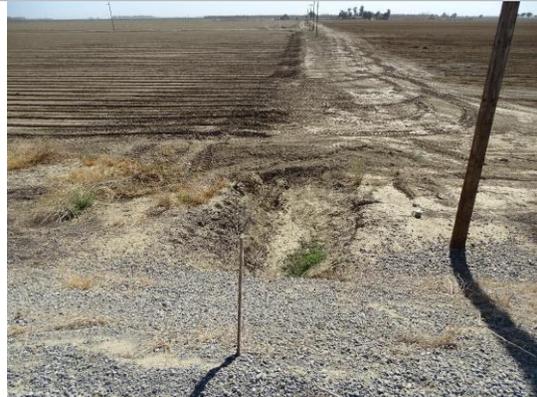
Photo 1 of 3 : UCIP\_FA\_2019\_55433\_81684.jpg

Item	DRAFT DWR UCIP Field Study		38.515620 °	38.515620 °	
			-121.727540 °	-121.727540 °	
DWR ID	16628				
Comment Code					
Inspector Comment					
DS_ID:16628 FS_ID:55433 EP_NO: 10269 Repair Type: Non-Urgent Crossing Status: Found UCIP Comments: 10/21/2019 No issues recorded during inspection (O.Yakimov - DWR UCIP) 09/21/2017 Pipe was permitted as an irrigation structure under ABO issued as Permit No. 10269. (DWR UCIP - O. Magana) FIELD_STRUCT_DESC: 24-inch CIPP-lined corrugated metal irrigation pipe through the levee, 12 feet below the crown. Slide gate on the waterside (WS) end. Concrete headwalls on both ends. (24-inch pipe [HLM 4.02] authorized under Automatic Board Order (ABO) issued as Permit No. 10269, 1974 - Joseph Fahn). [Additional Reference(s): DWR Levee Log, 2005 (HLM 4.02). USACE Sacramento O&M Manual, Unit 119, December 1952, Revised 29 Dec 2016, (Station 98+00 PCT). USACE As-Built Drawing No. 50-04-2396, Revision 4, pdf page 24, Sheet 8, December 1947]. FS Date: 10/21/2019 9:01:36 AM

View of LS looking from levee crown

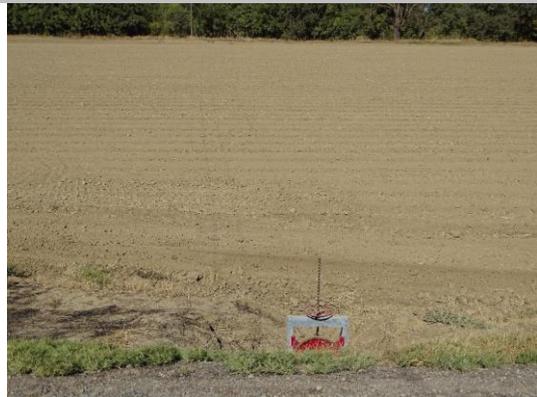
Photo 2 of 3 : UCIP\_FA\_2019\_55433\_81685.jpg

View of WS looking from levee crown

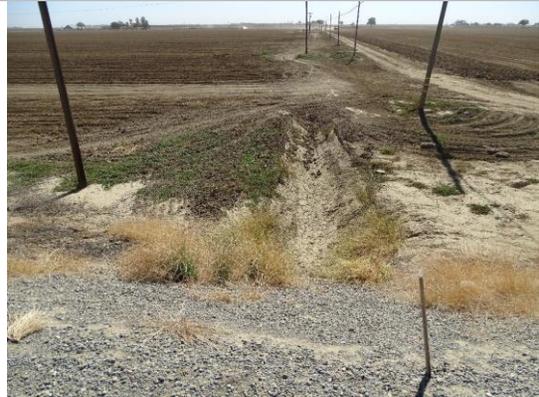
Photo 1 of 3 : UCIP\_FA\_2019\_55434\_81690.jpg

Item	DRAFT DWR UCIP LMA Responsibility			38.515770°	38.515770°
				-121.731840°	-121.731840°
DWR ID	16629				
Comment Code					
Inspector Comment					
DS_ID:16629 FS_ID:55434 EP_NO: 10269 Repair Type: Non-Urgent Crossing Status: Found UCIP Comments: 10/21/2019 Pipe is partially silted, cleanup pipe. (O.Yakimov - DWR UCIP) FIELD_STRUCT_DESC: 24-inch CIPP-lined corrugated metal drainage pipe through the levee, 12.5 feet below the crown. Slide gate on the waterside (WS) end. Concrete headwalls on both ends. (24-inch pipe [HLM 4.26] authorized under Automatic Board Order (ABO) issued as Permit No. 10269, 1974 - Joseph Fahn). [Additional Reference(s): DWR Levee Log, 2005 (HLM 4.26). USACE Sacramento O&M Manual, Unit 119, December 1952, Revised 29 Dec 2016, (Station 109+75 PCT). USACE As-Built Drawing No. 50-04-2396, Revision 4, pdf page 24, Sheet 8, December 1947]. FS Date: 10/21/2019 9:16:52 AM

View of LS looking from levee crown

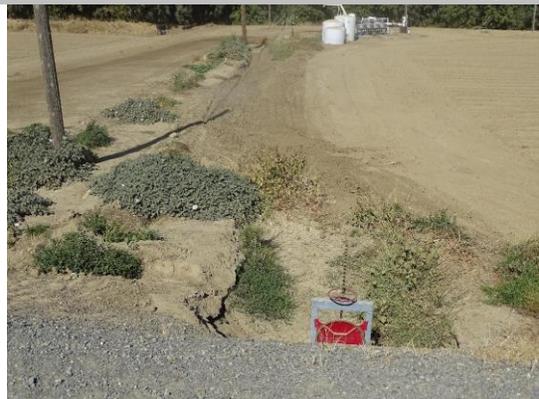
Photo 2 of 3 : UCIP\_FA\_2019\_55434\_81691.jpg

View of WS looking from levee crown

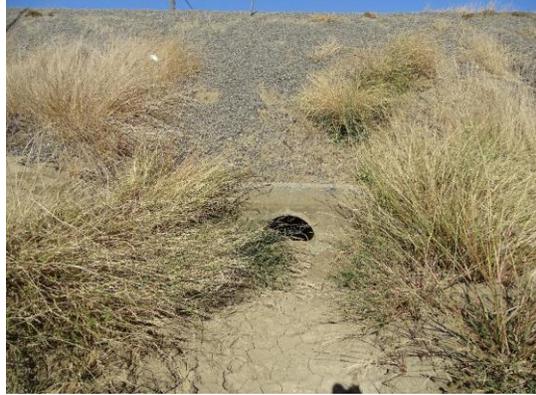
Photo 3 of 3 : UCIP\_FA\_2019\_55434\_81688.jpg

Item	DRAFT DWR UCIP LMA Responsibility			38.515770°	38.515770°	
				-121.731840°	-121.731840°	
DWR ID	16629					
Comment Code						
Inspector Comment						
DS_ID:16629 FS_ID:55434 EP_NO: 10269 Repair Type: Non-Urgent Crossing Status: Found UCIP Comments: 10/21/2019 Pipe is partially silted, cleanup pipe. (O.Yakimov - DWR UCIP) FIELD_STRUCT_DESC: 24-inch CIPP-lined corrugated metal drainage pipe through the levee, 12.5 feet below the crown. Slide gate on the waterside (WS) end. Concrete headwalls on both ends. (24-inch pipe [HLM 4.26] authorized under Automatic Board Order (ABO) issued as Permit No. 10269, 1974 - Joseph Fahn). [Additional Reference(s): DWR Levee Log, 2005 (HLM 4.26). USACE Sacramento O&M Manual, Unit 119, December 1952, Revised 29 Dec 2016, (Station 109+75 PCT). USACE As-Built Drawing No. 50-04-2396, Revision 4, pdf page 24, Sheet 8, December 1947]. FS Date: 10/21/2019 9:16:52 AM

LS slope, headwall and pipe at levee toe

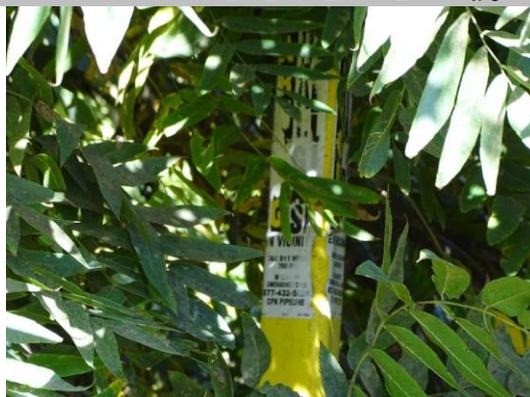
Photo 3 of 3 : UCIP\_FA\_2019\_55435\_81694.jpg

Item	DRAFT DWR UCIP Field Study			38.515780 °	38.515780 °
				-121.731950 °	-121.731950 °
DWR ID	16630				
Comment Code					
Inspector Comment					
DS_ID:16630 FS_ID:55435 EP_NO: 10820 Repair Type: Non-Urgent Crossing Status: Indicator Found UCIP Comments: 10/21/2019 Missing gas line marker on both sides of levee. (O.Yakimov - DWR UCIP)04/09/2012 Signs for pipeline need to be updated to state Gas line. Current markers are insufficient. (W. Wylie - DWR UCIP) FIELD_STRUCT_DESC: 4-inch coated steel natural gas pipeline across the channel and levees of Putah Creek, 2 feet below the crown. Approximately 0.5 mile downstream from Old Davis Road. (4-inch line authorized through levees and across channel under Permit No. 10820, 1975 - Dow Chemical). [Additional Reference(s): DWR Levee Log, 2005]. FS Date: 10/21/2019 9:25:13 AM

Closeup view of gas line marker

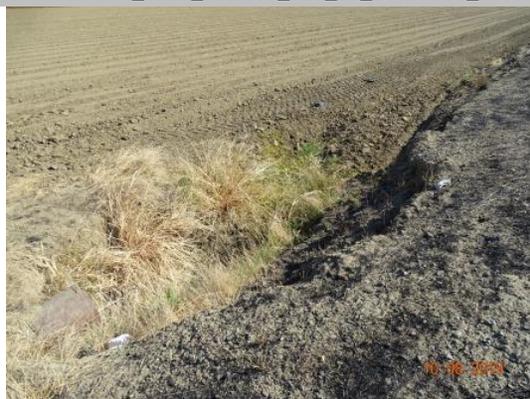
Photo 1 of 2 : FA\_2019\_ST0007\_283\_33\_20191008\_00065.jpg

LM Start	<b>4.66</b>	Rating **	M	Issue No.	<b>33</b>
LM End	<b>4.66</b>	Issue Type +	Ma	Location *	WS
Category	Earthen Levee			GPS Latitude/Longitude	
				Start	End
Item	Erosion / Bank Caving			38.515817 °	38.515817 °
				-121.740942 °	-121.740942 °
DWR ID	DWR_ST0007_02_f_2018_33				
Comment Code					
E2 : Schedule repair of erosion site prior to the next inspection.					
Inspector Comment					
Erosion has not significantly increased from Fall 2018.

View of erosion on the levee slope (Fall 2019).

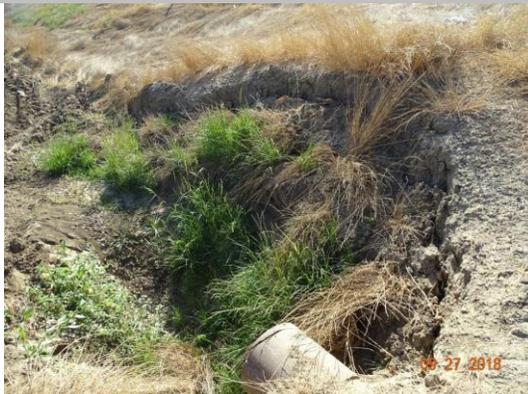
Photo 2 of 2 : FA\_2019\_ST0007\_283\_33\_20190826\_00013.jpg

LM Start	<b>4.66</b>	Rating **	M	Issue No.	<b>33 (cont)</b>
LM End	<b>4.66</b>	Issue Type +	Ma	Location *	WS
Category	Earthen Levee			GPS Latitude/Longitude	
				Start	End
Item	Erosion / Bank Caving			38.515817°	38.515817°
				-121.740942°	-121.740942°
DWR ID	DWR_ST0007_02_f_2018_33				
Comment Code					
E2 : Schedule repair of erosion site prior to the next inspection.					
Inspector Comment					
Erosion has not significantly increased from Fall 2018.

View of erosion on the levee slope appears to be due to water from the pipe and trench (September 2018).

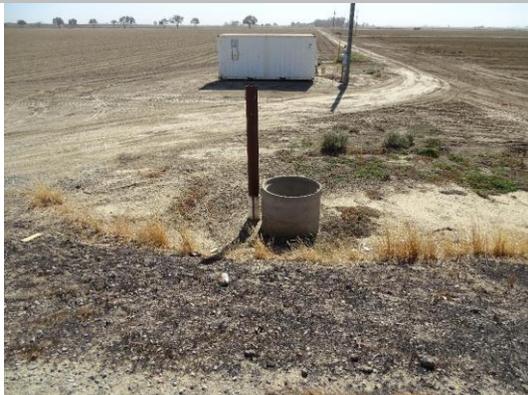
Photo 1 of 3 : UCIP\_FA\_2019\_55436\_81697.jpg

Item	DRAFT DWR UCIP LMA Responsibility			38.515814°	38.515814°
				-121.741030°	-121.741030°
DWR ID	16644				
Comment Code					
Inspector Comment					
DS_ID:16644 FS_ID:55436 EP_NO: 10271 Repair Type: Non-Urgent Crossing Status: Found UCIP Comments: 10/21/2019 No issues recorded during inspection (O.Yakimov - DWR UCIP) FIELD_STRUCT_DESC: 24-inch corrugated metal drainage pipe through the levee, 9.5 feet below the crown. Flap gate on the waterside (WS). 36-inch standpipe on the landside (LS). (24-inch pipe [HLM 4.77] authorized under Automatic Board Order (ABO) issued as Permit No. 10271, 1974 - Ray H. Hamel). [Additional Reference(s): DWR Levee Log, 2005 (HLM 4.77). USACE Sacramento O&M Manual, Unit 119, December 1952, Revised 29 Dec 2016, (Station 136+40 PCT). USACE As-Built Drawing No. 50-04-2396, Revision 4, pdf page 24, Sheet 8, December 1947]. FS Date: 10/21/2019 9:46:01 AM

View of LS looking from levee crown. 36-inch standpipe near levee toe

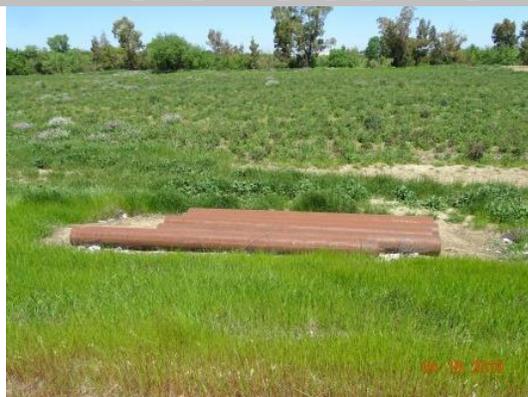
Photo 1 of 1 : FA\_2019\_ST0007\_283\_40\_20190826\_00019.jpg

LM Start	<b>5.06</b>	Rating **	M	Issue No.	<b>40</b>
LM End	<b>5.06</b>	Issue Type +	En	Location *	WS
Category	Earthen Levee			GPS Latitude/Longitude	
				Start	End
Item	Encroachments			38.515327 °	38.515327 °
				-121.748322 °	-121.748322 °
DWR ID	DWR_ST0007_02_s_2019_40				
Comment Code					
MA : Material					
Inspector Comment					
Several pipes need to be removed from slope.

View of pipes on the waterside slope (Spring 2019).
