**Flood Control Project Maintenance  
Levee Inspections**

**Fall 2019 Levee Maintenance Deficiency Summary Report**

**Sacramento Maintenance Yard Putah Creek**

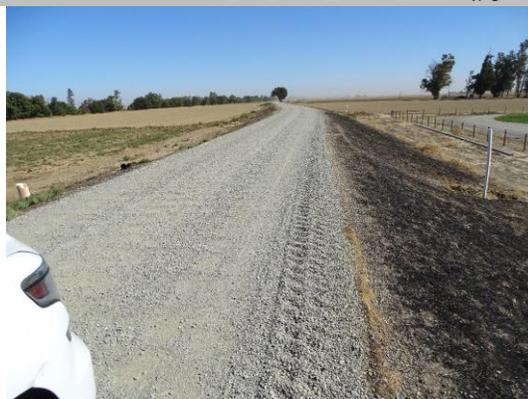
Photo 1 of 3 : UCIP\_FA\_2019\_55438\_81702.jpg

Item	DRAFT DWR UCIP Field Study			38.515332 °	38.515332 °
				-121.748533 °	-121.748533 °
DWR ID	16632				
Comment Code					
Inspector Comment					
<p>DS_ID:16632                  FS_ID:55438                  EP_NO: 10279                  Repair Type: Non-Urgent                  Crossing Status: Indicator Found                  UCIP Comments: 10/21/2019 PVC pipe is capped on LS levee slope at the standpipe. Damaged PVC standpipe on WS. (O.Yakimov-DWR UCIP) 04/06/2012 Pipe and headwalls are completely buried on both sides of levee. 15-inch pipe permitted to sleeve through the 24-inch CMP. Indication that 15-inch pipe is at crossing. (W. Wylie - DWR UCIP)                  FIELD_STRUCT_DESC: 15-inch polyvinyl chloride (PVC) irrigation pipe grouted within an existing 24-inch corrugated metal irrigation pipe through the levee, 10 feet below the crown. Slide gate on the waterside (WS) end. Concrete headwall on landside (LS) end. (15--inch pipe authorized under Permit No. 17552, 2003 - Albert Martinelli), (24-inch pipe [HLM 5.19] authorized under Automatic Board Order (ABO) issued as Permit No. 10279, 1974 - Carmelita Watkins). [Additional Reference(s): DWR Levee Log, 2005 (HLM 5.19). USACE Sacramento O&amp;M Manual, Unit 119, December 1952, Revised 29 Dec 2016, (Station 158+60 PCT). USACE As-Built Drawing No. 50-04-2396, Revision 4, pdf page 25, Sheet 9, December 1947].                  FS Date: 10/21/2019 10:19:59 AM</p>

Levee crown at crossing

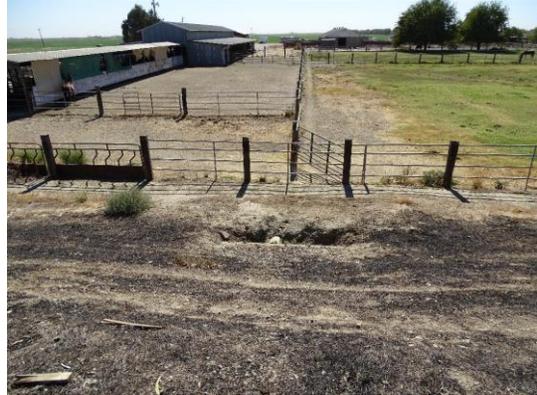
Photo 1 of 3 : UCIP\_FA\_2019\_55439\_81707.jpg

Item	DRAFT DWR UCIP LMA Responsibility			38.515369°	38.515369°
				-121.755247°	-121.755247°
DWR ID	16620				
Comment Code					
Inspector Comment					
DS_ID:16620 FS_ID:55439 EP_NO: 10267 Repair Type: Non-Urgent Crossing Status: Found UCIP Comments: 10/21/2019 No issues recorded during inspection (O.Yakimov - DWR UCIP)05/22/2013 Gate has been oiled and debris removed from outlet on land side. (C. Lund - DWR Sacramento Yard) 04/06/2012 Pipe is partially filled with sediment and slide gate is in need of maintenance as it will not move. (W. Wylie - DWR UCIP) FIELD_STRUCT_DESC: 24-inch CIPP-lined corrugated metal drainage pipe through the levee, 13 feet below the crown. Slide gate on the waterside (WS) slope. Concrete headwalls on both ends. (24-inch pipe [HLM 5.56] authorized under Automatic Board Order (ABO) issued as Permit No. 10267, 1974 - Davis Laboratories, Inc.). [Additional Reference(s): DWR Levee Log, 2005 (HLM 5.56). USACE Sacramento O&M Manual, Unit 119, December 1952, Revised 29 Dec 2016, (Station 177+60 PCT). USACE As-Built Drawing No. 50-04-2396, Revision 4, pdf page 25, Sheet 9, December 1947]. FS Date: 10/21/2019 11:46:42 AM

View of LS looking from levee crown

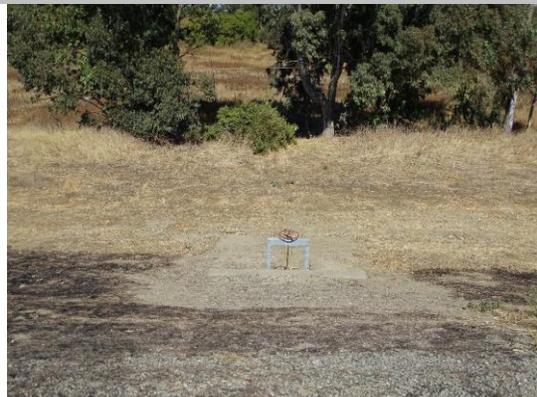
Photo 2 of 3 : UCIP\_FA\_2019\_55439\_81708.jpg

View of WS looking from levee crown

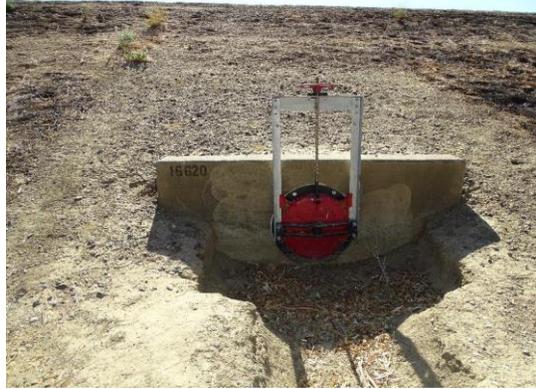
Photo 3 of 3 : UCIP\_FA\_2019\_55439\_81709.jpg

Item	DRAFT DWR UCIP LMA Responsibility			38.515369 °	38.515369 °	
				-121.755247 °	-121.755247 °	
DWR ID	16620					
Comment Code						
Inspector Comment						
DS_ID:16620 FS_ID:55439 EP_NO: 10267 Repair Type: Non-Urgent Crossing Status: Found UCIP Comments: 10/21/2019 No issues recorded during inspection (O.Yakimov - DWR UCIP)05/22/2013 Gate has been oiled and debris removed from outlet on land side. (C. Lund - DWR Sacramento Yard) 04/06/2012 Pipe is partially filled with sediment and slide gate is in need of maintenance as it will not move. (W. Wylie - DWR UCIP) FIELD_STRUCT_DESC: 24-inch CIPP-lined corrugated metal drainage pipe through the levee, 13 feet below the crown. Slide gate on the waterside (WS) slope. Concrete headwalls on both ends. (24-inch pipe [HLM 5.56] authorized under Automatic Board Order (ABO) issued as Permit No. 10267, 1974 - Davis Laboratories, Inc.). [Additional Reference(s): DWR Levee Log, 2005 (HLM 5.56). USACE Sacramento O&M Manual, Unit 119, December 1952, Revised 29 Dec 2016, (Station 177+60 PCT). USACE As-Built Drawing No. 50-04-2396, Revision 4, pdf page 25, Sheet 9, December 1947]. FS Date: 10/21/2019 11:46:42 AM

WS levee slope, headwall and slide gate

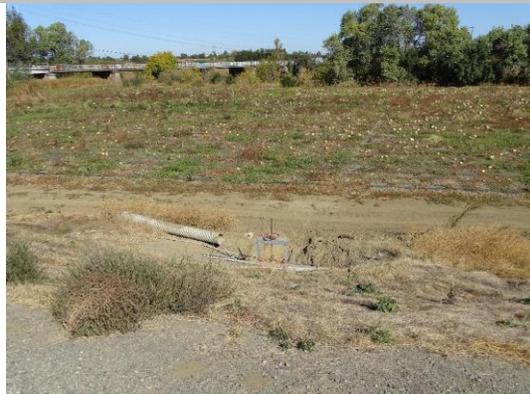
Photo 1 of 3 : UCIP\_FA\_2019\_55419\_81628.jpg

DS\_ID:16636  
 FS\_ID:55419  
 EP\_NO: 10279  
 Repair Type: Urgent  
 Crossing Status: Found  
 UCIP Comments: 10/21/2019 A 6-inch hose connected to a water well on LS runs through a drainage pipe from LS to WS. Slide gate cannot be closed properly to prevent flooding on LS. Remove hose. (O.Yakimov - DWR UCIP)05/22/2013 Pipe was cleaned by the owner and 6 in pipe is still being used. (C. Lund - DWR Sacramento Yard) 04/05/2012 Pipe needs to be cleared of sedimentation. (W. Wylie - DWR UCIP)  
 FIELD\_STRUCT\_DESC: 24-inch CIPP-lined corrugated metal drainage pipe through the levee, 14 feet below the crown. Slide gate on the waterside (WS) end. Concrete headwall on landside (LS) end. (name change for existing 24-inch drainpipe and slide gate on WS [HLM 5.89] issued under Permit No. 10279-1, 2012 - Elizabeth Dankworth and Michelle Christison; 24-inch pipe [HLM 5.89] authorized under Automatic Board Order (ABO) issued as Permit No. 10279, 1974 - Carmelita Watkins). [Additional Reference(s): DWR Levee Log, 2005 (HLM 5.89). USACE Sacramento O&M Manual, Unit 119, December 1952, Revised 29 Dec 2016, (Station 193+00 PCT). USACE As-Built Drawing No. 50-04-2396, Revision 4, pdf page 25, Sheet 9, December 1947].

View of WS from levee crown

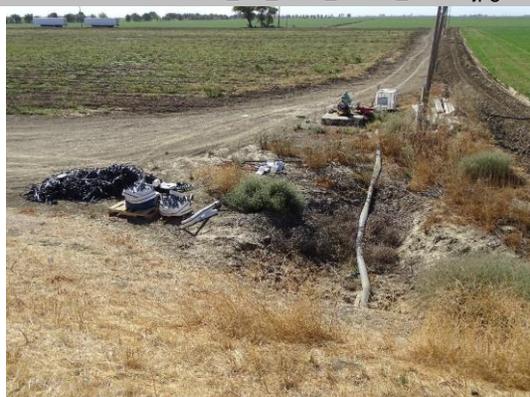
Photo 2 of 3 : UCIP\_FA\_2019\_55419\_81629.jpg

View of LS from levee crown

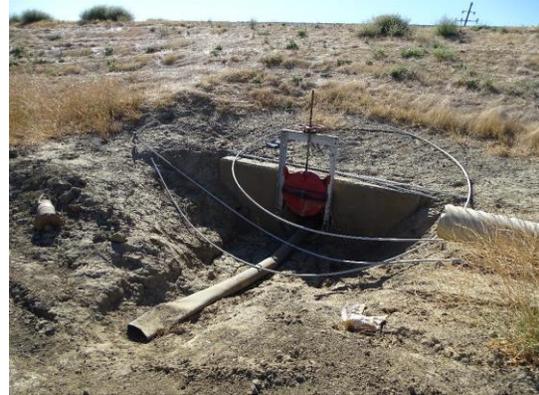
Photo 3 of 3 : UCIP\_FA\_2019\_55419\_81630.jpg

Item	DRAFT DWR UCIP LMA Responsibility			38.516000 °	38.516000 °	
				-121.760500 °	-121.760500 °	
DWR ID	16636					
Comment Code						
Inspector Comment						
<p>DS_ID:16636                  FS_ID:55419                  EP_NO: 10279                  Repair Type: Urgent                  Crossing Status: Found                  UCIP Comments: 10/21/2019 A 6-inch hose connected to a water well on LS runs through a drainage pipe from LS to WS. Slide gate cannot be closed properly to prevent flooding on LS. Remove hose. (O.Yakimov - DWR UCIP)05/22/2013 Pipe was cleaned by the owner and 6 in pipe is still being used. (C. Lund - DWR Sacramento Yard) 04/05/2012 Pipe needs to be cleared of sedimentation. (W. Wylie - DWR UCIP)                  FIELD_STRUCT_DESC: 24-inch CIPP-lined corrugated metal drainage pipe through the levee, 14 feet below the crown. Slide gate on the waterside (WS) end. Concrete headwall on landside (LS) end. (name change for existing 24-inch drainpipe and slide gate on WS [HLM 5.89] issued under Permit No. 10279-1, 2012 - Elizabeth Dankworth and Michelle Christison; 24-inch pipe [HLM 5.89] authorized under Automatic Board Order (ABO) issued as Permit No. 10279, 1974 - Carmelita Watkins). [Additional Reference(s): DWR Levee Log, 2005 (HLM 5.89). USACE Sacramento O&amp;M Manual, Unit 119, December 1952, Revised 29 Dec 2016, (Station 193+00 PCT). USACE As-Built Drawing No. 50-04-2396, Revision 4, pdf page 25, Sheet 9, December 1947].                  FS Date: 10/21/2019 1:39:07 PM</p>

WS slope with headwall and slide gate

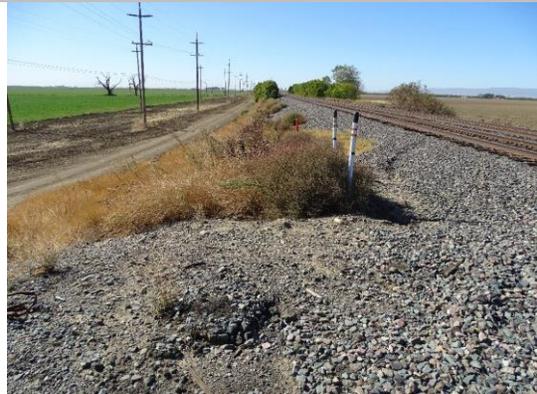
Photo 1 of 2 : UCIP\_FA\_2019\_55444\_81714.jpg

Item	DRAFT DWR UCIP Field Study			38.516171 °	38.516171 °
				-121.762037 °	-121.762037 °
DWR ID	17763				
Comment Code					
Inspector Comment					
<p>DS_ID:17763                  FS_ID:55444                  EP_NO: N/A                  Repair Type: Non-Urgent                  Crossing Status: Indicator Found                  UCIP Comments: 10/21/2019 Missing permit for this crossing. (O.Yakimov - DWR UCIP)04/04/2012 No permit identified for this crossing. (W. Wylie - DWR UCIP)                  FIELD_STRUCT_DESC: Fiber optics line markers on east side of railroad tracks. No permit identified for this crossing. It appears they may be routed under the west side of the railroad bridge inside a 6-inch steel conduit.                  FS Date: 10/21/2019 1:35:50 PM</p>

Fiber optics line markers on east side of railroad tracks

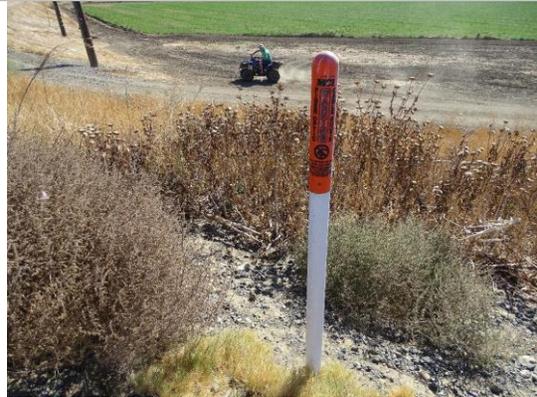
Photo 2 of 2 : UCIP\_FA\_2019\_55444\_81715.jpg

LM Start	<b>5.82</b>	Rating **	M	Issue No.	<b>67 (cont)</b>
LM End	<b>5.82</b>	Issue Type +	En	Location *	
Category	Supplemental			GPS Latitude/Longitude	
				Start	End
Item	DRAFT DWR UCIP Field Study			38.516171 °	38.516171 °
				-121.762037 °	-121.762037 °
DWR ID	17763				
Comment Code					
Inspector Comment					
DS_ID:17763 FS_ID:55444 EP_NO: N/A Repair Type: Non-Urgent Crossing Status: Indicator Found UCIP Comments: 10/21/2019 Missing permit for this crossing. (O.Yakimov - DWR UCIP)04/04/2012 No permit identified for this crossing. (W. Wylie - DWR UCIP) FIELD_STRUCT_DESC: Fiber optics line markers on east side of railroad tracks. No permit identified for this crossing. It appears they may be routed under the west side of the railroad bridge inside a 6-inch steel conduit. FS Date: 10/21/2019 1:35:50 PM

Line marker closeup view

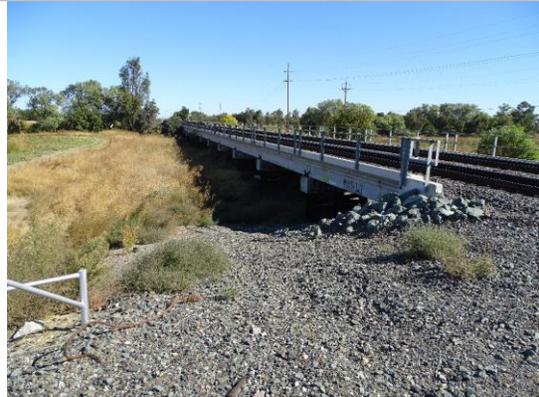
Photo 2 of 2 : UCIP\_FA\_2019\_55445\_81717.jpg

LM Start	<b>5.83</b>	Rating **	M	Issue No.	<b>68 (cont)</b>
LM End	<b>5.83</b>	Issue Type +	En	Location *	
Category	Supplemental			GPS Latitude/Longitude	
				Start	End
Item	DRAFT DWR UCIP Field Study			38.516256°	38.516256°
				-121.762204°	-121.762204°
DWR ID	17764				
Comment Code					
Inspector Comment					
DS_ID:17764 FS_ID:55445 EP_NO: N/A Repair Type: Non-Urgent Crossing Status: Found UCIP Comments: 10/21/2019 Detached fiber optic cable marker found on LS slope. Missing permit for this crossing and cable marker on waterside. (O.Yakimov - DWR UCIP)04/04/2012 No permit identified for crossing. (W. Wylie - DWR UCIP) FIELD_STRUCT_DESC: Fiber optics line markers on west side of railroad tracks. No permit identified for this crossing. FS Date: 10/21/2019 1:39:58 PM

View of waterside looking from levee crown

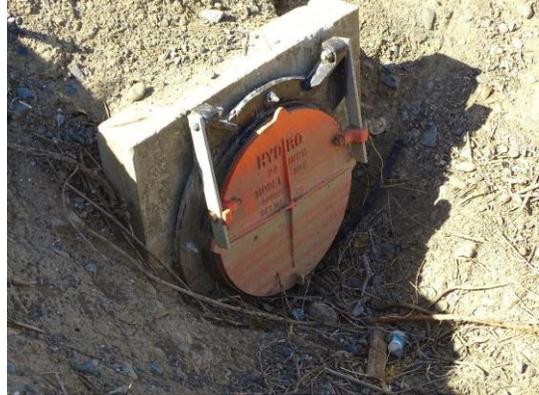
Photo 1 of 3 : UCIP\_FA\_2019\_55446\_81718.jpg

Item	DRAFT DWR UCIP LMA Responsibility		38.516290°	38.516290°	
			-121.762280°	-121.762280°	
DWR ID	16639				
Comment Code					
Inspector Comment					
DS_ID:16639 FS_ID:55446 EP_NO: 10278 Repair Type: Non-Urgent Crossing Status: Found UCIP Comments: 10/21/2019 No issues recorded during inspection (O. Yakimov - DWR UCIP)07/12/2019 After reviewing the USACE O&M manual as-builts there is no reference to this 24-inch pipe. Will need to coordinate with previous UCIP inspector to determine if additional information is available to tie pipe to USACE O&M manual. (O. Magana - DWR UCIP) 05/22/2013 All material was removed. (C. Lund - DWR Sacramento Yard) 04/05/2012 Flap gate blocked by minor amounts of sedimentation. (W. Wylie - DWR UCIP) FIELD_STRUCT_DESC: 24-inch CIPP-lined corrugated metal drainage pipe through the levee, 15 feet below the crown. Flap gate on waterside (WS) end. Headwall on the landside (LS). (24-inch pipe [HLM 5.99] authorized under Automatic Board Order (ABO) issued as Permit No. 10278, 1974 - Southern Pacific Transportation Company). [Additional Reference(s): DWR Levee Log, 2005. USACE Sacramento O&M Manual 119, December 1952]. FS Date: 10/21/2019 1:46:38 PM

Headwall and flap gate

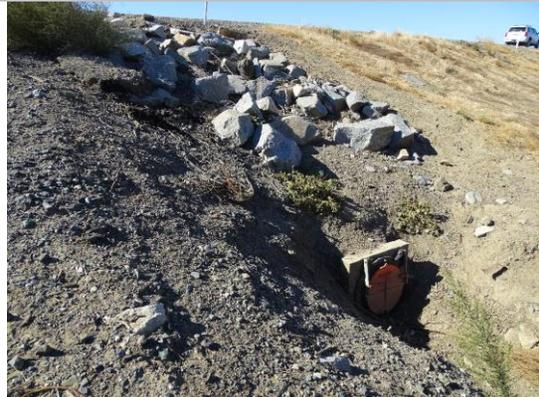
Photo 2 of 3 : UCIP\_FA\_2019\_55446\_81719.jpg

View of WS slope and flap gate at levee toe

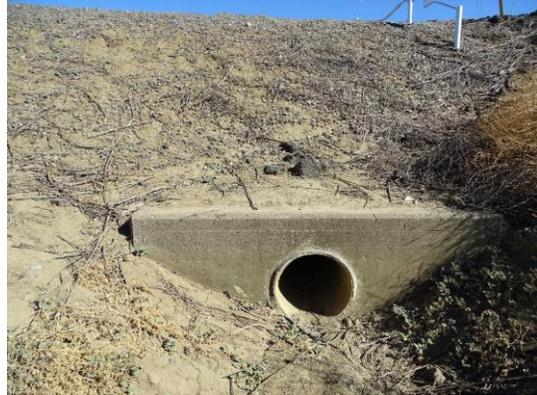
Photo 3 of 3 : UCIP\_FA\_2019\_55446\_81720.jpg

Item	DRAFT DWR UCIP LMA Responsibility			38.516290°	38.516290°	
				-121.762280°	-121.762280°	
DWR ID	16639					
Comment Code						
Inspector Comment						
<p>DS_ID:16639                  FS_ID:55446                  EP_NO: 10278                  Repair Type: Non-Urgent                  Crossing Status: Found                  UCIP Comments: 10/21/2019 No issues recorded during inspection (O.Yakimov - DWR UCIP)07/12/2019 After reviewing the USACE O&amp;M manual as-builts there is no reference to this 24-inch pipe. Will need to coordinate with previous UCIP inspector to determine if additional information is available to tie pipe to USACE O&amp;M manual. (O. Magana - DWR UCIP)                  05/22/2013 All material was removed. (C. Lund - DWR Sacramento Yard)                  04/05/2012 Flap gate blocked by minor amounts of sedimentation. (W. Wylie - DWR UCIP)                  FIELD_STRUCT_DESC: 24-inch CIPP-lined corrugated metal drainage pipe through the levee, 15 feet below the crown. Flap gate on waterside (WS) end. Headwall on the landside (LS). (24-inch pipe [HLM 5.99] authorized under Automatic Board Order (ABO) issued as Permit No. 10278, 1974 - Southern Pacific Transportation Company). [Additional Reference(s): DWR Levee Log, 2005. USACE Sacramento O&amp;M Manual 119, December 1952].                  FS Date: 10/21/2019 1:46:38 PM</p>

LS levee slope, headwall and pipe

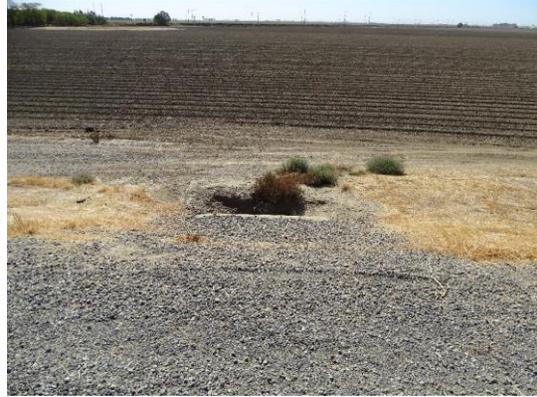
Photo 1 of 3 : UCIP\_FA\_2019\_55448\_81724.jpg

Item	DRAFT DWR UCIP LMA Responsibility		38.516658°	38.516658°	
			-121.765572°	-121.765572°	
DWR ID	16641				
Comment Code					
Inspector Comment					
DS_ID:16641 FS_ID:55448 EP_NO: 10265 Repair Type: Non-Urgent Crossing Status: Found UCIP Comments: 10/21/2019 No issues recorded during inspection (O.Yakimov - DWR UCIP)04/05/2012 Pipe has some sedimentation buildup internally. (W. Wylie - DWR UCIP) FIELD_STRUCT_DESC: 24-inch CIPP-lined corrugated metal drainage pipe through the levee, 11 feet below the crown. Slide gate on the waterside (WS) end. Concrete headwall on the landside (LS) end. (24-inch pipe [HLM 6.19] authorized under Automatic Board Order (ABO) issued as Permit No. 10265, 1974 - State of California, Division of Highways. Also included in Automatic Board Order (ABO) issued as Permit No. 11296, 1974 - Capitol National Bank of Sacramento and Crocker Citizens National Bank). [Additional Reference(s): DWR Levee Log, 2005 (HLM 6.19). USACE Sacramento O&M Manual, Unit 119, December 1952, Revised 29 Dec 2016, (Station 208+00 PCT). USACE As-Built Drawing No. 50-04-2396, Revision 4, pdf page 25, Sheet 9, December 1947]. FS Date: 10/21/2019 2:08:05 PM

View of LS looking from levee crown

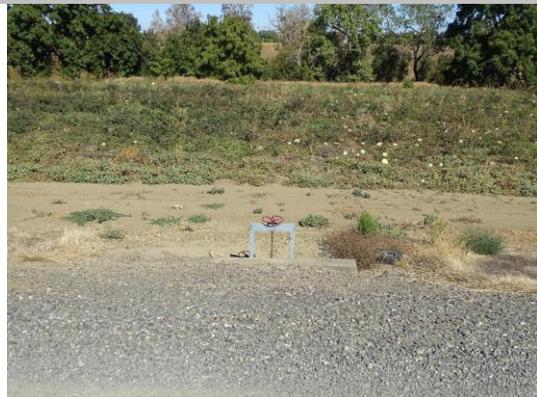
Photo 2 of 3 : UCIP\_FA\_2019\_55448\_81725.jpg

View of WS looking from levee crown

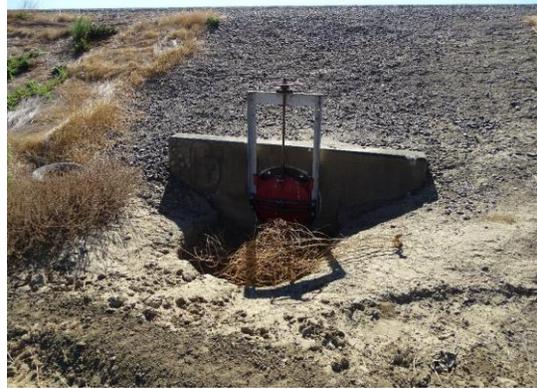
Photo 3 of 3 : UCIP\_FA\_2019\_55448\_81726.jpg

Item	DRAFT DWR UCIP LMA Responsibility			38.516658°	38.516658°
				-121.765572°	-121.765572°
DWR ID	16641				
Comment Code					
Inspector Comment					
DS_ID:16641 FS_ID:55448 EP_NO: 10265 Repair Type: Non-Urgent Crossing Status: Found UCIP Comments: 10/21/2019 No issues recorded during inspection (O.Yakimov - DWR UCIP)04/05/2012 Pipe has some sedimentation buildup internally. (W. Wylie - DWR UCIP) FIELD_STRUCT_DESC: 24-inch CIPP-lined corrugated metal drainage pipe through the levee, 11 feet below the crown. Slide gate on the waterside (WS) end. Concrete headwall on the landside (LS) end. (24-inch pipe [HLM 6.19] authorized under Automatic Board Order (ABO) issued as Permit No. 10265, 1974 - State of California, Division of Highways. Also included in Automatic Board Order (ABO) issued as Permit No. 11296, 1974 - Capitol National Bank of Sacramento and Crocker Citizens National Bank). [Additional Reference(s): DWR Levee Log, 2005 (HLM 6.19). USACE Sacramento O&M Manual, Unit 119, December 1952, Revised 29 Dec 2016, (Station 208+00 PCT). USACE As-Built Drawing No. 50-04-2396, Revision 4, pdf page 25, Sheet 9, December 1947]. FS Date: 10/21/2019 2:08:05 PM

WS levee slope, headwall, and slide gate

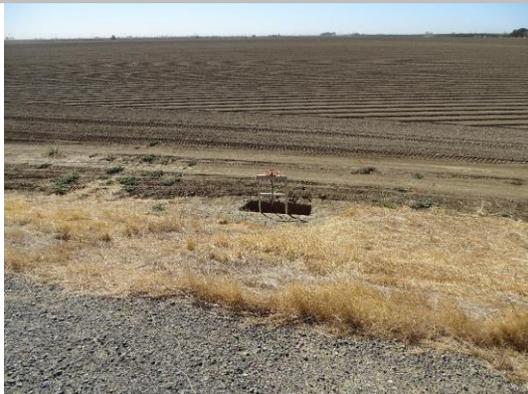
Photo 1 of 3 : UCIP\_FA\_2019\_55450\_81729.jpg

Item	DRAFT DWR UCIP LMA Responsibility		38.517199°	38.517199°	
			-121.771262°	-121.771262°	
DWR ID	16642				
Comment Code					
Inspector Comment					
DS_ID:16642 FS_ID:55450 EP_NO: 10265 Repair Type: Non-Urgent Crossing Status: Found UCIP Comments: 10/21/2019 No issues recorded during inspection (O.Yakimov - DWR UCIP)07/12/2019 After reviewing the USACE O&M manual as-builts there is no reference to this 30-inch pipe. Will need to coordinate with previous UCIP inspector to determine if additional information is available to tie pipe to USACE O&M manual. (O. Magana - DWR UCIP) 04/10/2019 There is no more debris around pipe. And is now sprayed and maintained. (J. McCabe - DWR Sacramento yard) 04/01/2019 Debris buildup at WS outlet. FIELD_STRUCT_DESC: 30-inch CIPP-lined drainage pipe of an unknown material through the levee, 17 feet below the crown. Headwall and slide gate on the landside (LS) end. Flap gate on the waterside (WS) end, 120 feet to the north of the crossing. (36-inch pipe [HLM 6.50] authorized under Automatic Board Order (ABO) issued as Permit No. 10265, 1974 - State of California, Division of Highways. Also included in Automatic Board Order (ABO) issued as Permit No. 11296, 1974 - Capitol National Bank of Sacramento and Crocker Citizens National Bank). [Additional Reference(s): DWR Levee Log, 2005, 36-inch pipe listed. USACE Sacramento O&M Manual 119, December 1952]. FS Date: 10/21/2019 2:11:00 PM

View of LS looking from levee crown

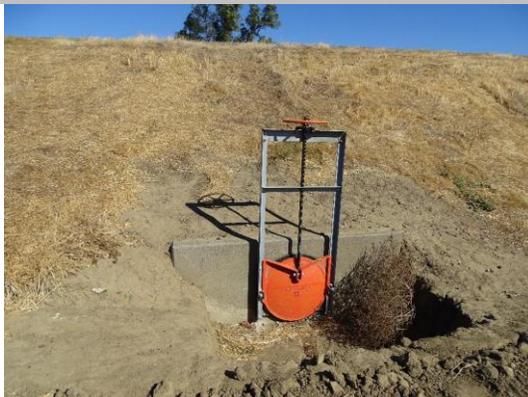
Photo 2 of 3 : UCIP\_FA\_2019\_55450\_81730.jpg

LS slope, headwall, and slide gate

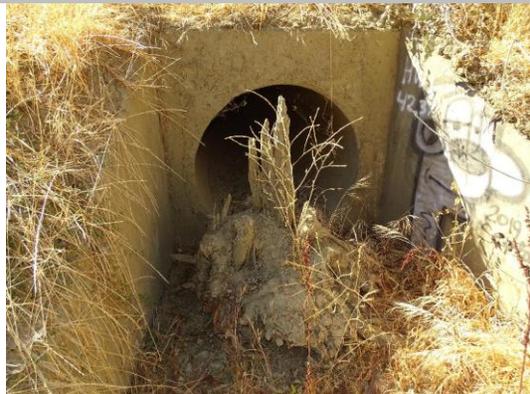
Photo 1 of 3 : UCIP\_FA\_2019\_55451\_81734.jpg

Item	DRAFT DWR UCIP Field Study			38.517828 °	38.517828 °
				-121.773010 °	-121.773010 °
DWR ID	16643				
Comment Code					
Inspector Comment					
DS_ID:16643 FS_ID:55451 EP_NO: 7279 Repair Type: Non-Urgent Crossing Status: Found UCIP Comments: 10/21/2019 Large rootball blocking the outlet on WS. (O.Yakimov - DWR UCIP)04/05/2012 There is no handle on the slide gate operation mechanism and there is a large rootball blocking the outlet on WS. (W. Wylie - DWR UCIP) FIELD_STRUCT_DESC: 48-inch reinforced concrete drainage pipe through the levee, 26 feet below the crown. Slide gate in concrete box on the waterside (WS) slope of the levee. Two drop inlets and weir inlet at the landside (LS) toe. Concrete headwall at outlet. Flap gate on the WS end is off. (Permit No. 7279, 1971 - State of California, Department of Public Works, Division of Highways and Bridges). [Additional Reference(s): DWR Levee Log, 2005]. FS Date: 10/21/2019 2:17:58 PM

WS headwall and outfall showing rootball blocking pipe

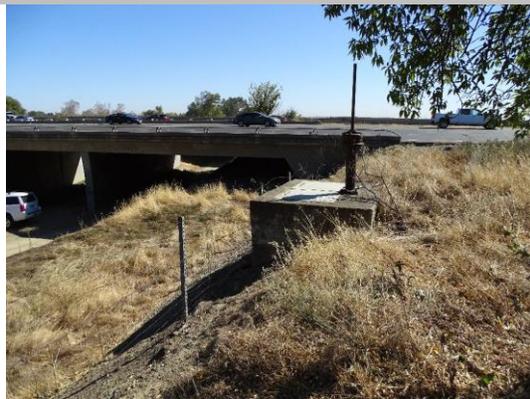
Photo 2 of 3 : UCIP\_FA\_2019\_55451\_81735.jpg

Concrete box with slide gate mechanism on WS shoulder

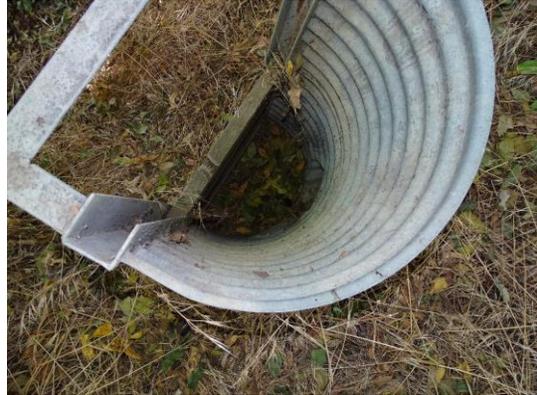
Photo 3 of 3 : UCIP\_FA\_2019\_55451\_81736.jpg

Weir inlet in a ditch on LS

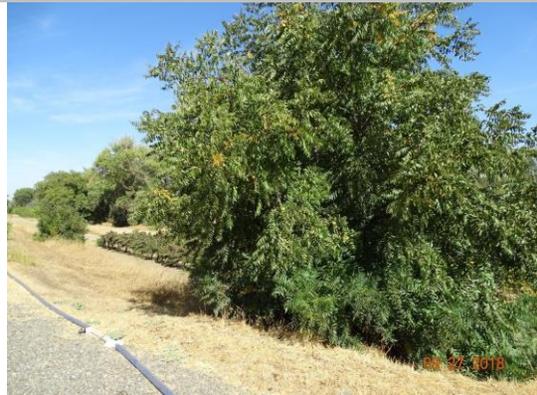
Photo 1 of 1 : FA\_2019\_ST0007\_283\_39\_20190826\_00018.jpg

LM Start	<b>6.49</b>	Rating **	U	Issue No.	<b>39</b>
LM End	<b>6.49</b>	Issue Type +	En	Location *	WS
Category	Earthen Levee			GPS Latitude/Longitude	
				Start	End
Item	Encroachments			38.518247 °	38.518247 °
				-121.773805 °	-121.773805 °
DWR ID	DWR_ST0007_02_f_2016_39				
Comment Code					
TR : Tree or limb					
Inspector Comment					
Three small walnut trees on the waterside shoulder should be removed.

View looking upstream of walnut trees on the waterside slope (September 2018).

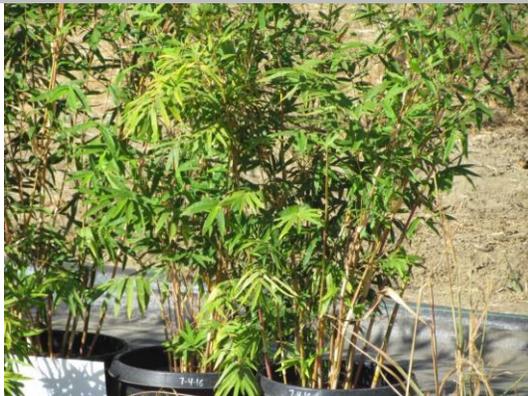
Photo 1 of 2 : FA\_2019\_ST0007\_283\_41\_20190826\_00020.jpg

LM Start	<b>6.53</b>	Rating **	U	Issue No.	<b>41</b>
LM End	<b>6.71</b>	Issue Type +	En	Location *	WS
Category	Earthen Levee			GPS Latitude/Longitude	
				Start	End
Item	Encroachments			38.518497°	38.519953°
				-121.774398°	-121.777080°
DWR ID	DWR_ST0007_02_s_2017_41				
Comment Code					
TR : Tree or limb					
Inspector Comment					
Bamboo being introduced by landowner on the waterside berm. This is unauthorized.

Bamboo being grown in pots by landowner on the waterside berm.

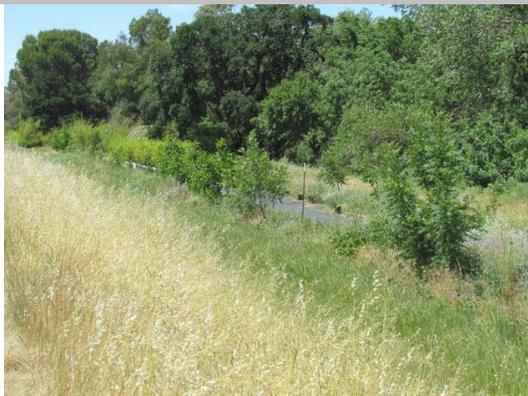
Photo 2 of 2 : FA\_2019\_ST0007\_283\_41\_20190826\_00021.jpg

Waterward berm landowner has several hundred bamboo plants and other crops on waterside.

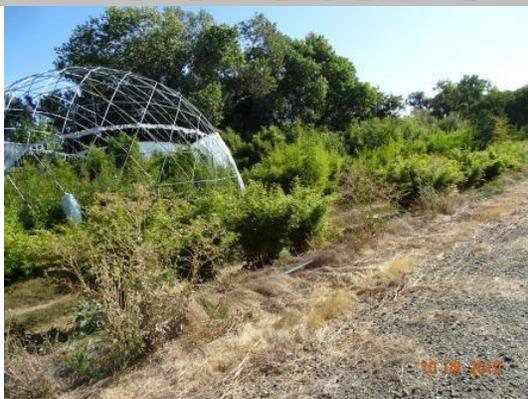
Photo 1 of 1 : FA\_2019\_ST0007\_283\_27\_20191008\_00063.jpg

LM Start	<b>6.54</b>	Rating **	M	Issue No.	<b>27</b>
LM End	<b>6.70</b>	Issue Type +	En	Location *	WS
Category	Earthen Levee			GPS Latitude/Longitude	
				Start	End
Item	Vegetation			38.518590°	38.519875°
				-121.774528°	-121.776912°
DWR ID	DWR_ST0007_02_f_2017_27				
Comment Code					
V6 : Landscaping					
Inspector Comment					
Trees are still present and should be removed.

View of bamboo at the waterside toe (Fall 2019).

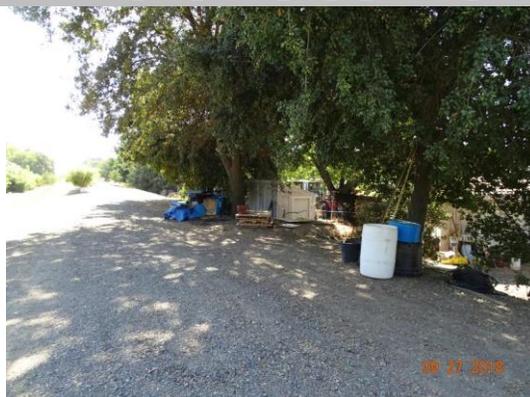
Photo 1 of 1 : FA\_2019\_ST0007\_283\_11\_20190826\_00002.jpg

LM Start	<b>6.56</b>	Rating **	M	Issue No.	<b>11</b>
LM End	<b>6.70</b>	Issue Type +	En	Location *	LS
Category	Earthen Levee		GPS Latitude/Longitude		
			Start	End	
Item	Encroachments		38.518760 °	38.519938 °	
			-121.774927 °	-121.776952 °	
DWR ID	DWR_ST0007_02_s_2012_11				
Comment Code					
MA : Material					
Inspector Comment					
Shipping containers, storage units and other items/debris on the landside easement need to be moved.

View looking downstream at some of the debris on the landside slope almost up to the crown (September 2018).

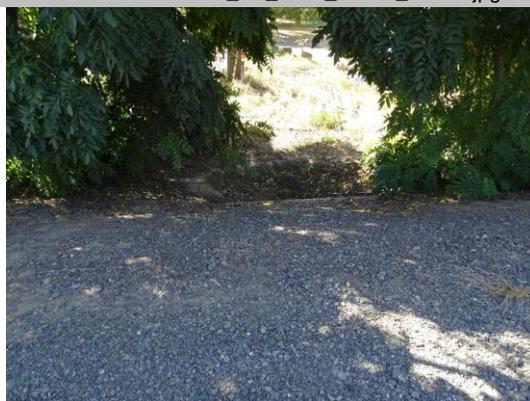
Photo 1 of 3 : UCIP\_FA\_2019\_55452\_81739.jpg

Item	DRAFT DWR UCIP LMA Responsibility		38.519470 °	38.519470 °	
			-121.776150 °	-121.776150 °	
DWR ID	16633				
Comment Code					
Inspector Comment					
DS_ID:16633 FS_ID:55452 EP_NO: 10276 Repair Type: Non-Urgent Crossing Status: Found UCIP Comments: 10/21/2019 Minor sediment builtup at slide gate. (O.Yakimov - DWR UCIP)05/22/2013 Will contact owner of pipe and ask to clean for inspection. (C. Lund - DWR Sacramento Yard) 04/05/2012 Pipe heavily clogged with soil. (W. Wylie - DWR UCIP) FIELD_STRUCT_DESC: 24-inch CIPP-lined drainage pipe of an unknown material through the levee, 6 feet below the crown. Slide gate on the waterside (WS) end, and headwalls on both ends. (24-inch pipe [HLM 6.83] authorized under Automatic Board Order (ABO) issued as Permit No. 10276, 1974 - Patricia Schlabes). [Additional Reference(s): DWR Levee Log, 2005 (HLM 6.83). USACE Sacramento O&M Manual, Unit 119, December 1952, Revised 29 Dec 2016, (Station 237+50 PCT). USACE As-Built Drawing No. 50-04-2396, Revision 2, pdf page 26, Sheet 10, December 1947]. FS Date: 10/21/2019 2:32:50 PM

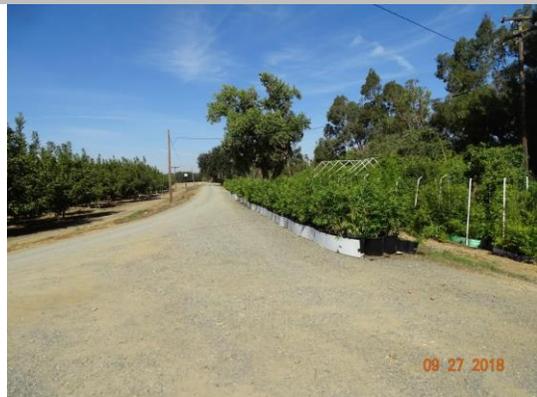
Photo 1 of 1 : FA\_2019\_ST0007\_283\_35\_20190826\_00015.jpg

LM Start	<b>6.71</b>	Rating **	U	Issue No.	<b>35</b>
LM End	<b>6.74</b>	Issue Type +	En	Location *	CR
Category	Earthen Levee			GPS Latitude/Longitude	
				Start	End
Item	Encroachments			38.519980°	38.520198°
				-121.777138°	-121.777535°
DWR ID	DWR_ST0007_02_f_2018_35				
Comment Code					
TR : Tree or limb					
Inspector Comment					
Remove bamboo pots from waterside crown.

View of bamboo in pots on the crown (September 2018).

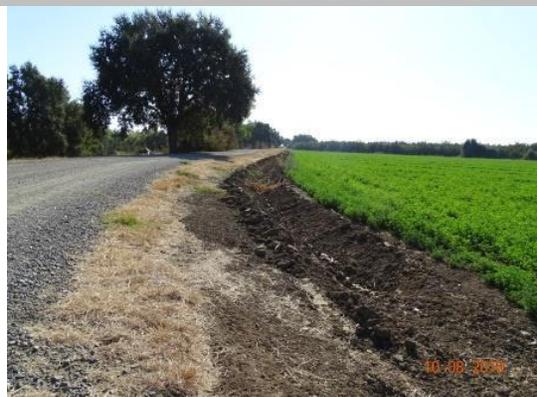
Photo 1 of 1 : FA\_2019\_ST0007\_283\_24\_20191008\_00061.jpg

LM Start	<b>6.82</b>	Rating **	M	Issue No.	<b>24</b>
LM End	<b>7.05</b>	Issue Type +	En	Location *	LS
Category	Earthen Levee			GPS Latitude/Longitude	
				Start	End
Item	Encroachments			38.520863°	38.522675°
				-121.778703°	-121.782318°
DWR ID	DWR_ST0007_02_f_2019_24				
Comment Code					
DT : Ditch					
Inspector Comment					
There is a newly excavated v-ditch at landside toe.

View looking downstream at v-ditch at the landside toe (Fall 2019).

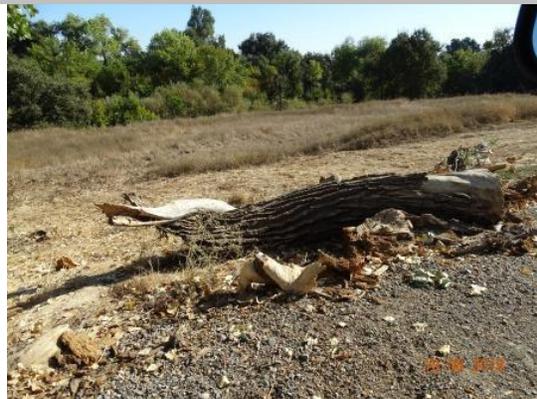
Photo 1 of 1 : FA\_2019\_ST0007\_283\_25\_20191008\_00062.jpg

LM Start	<b>6.96</b>	Rating **	M	Issue No.	<b>25</b>
LM End	<b>6.96</b>	Issue Type +	En	Location *	WS
Category	Earthen Levee		GPS Latitude/Longitude		
			Start	End	
Item	Encroachments		38.522043°	38.522043°	
			-121.780993°	-121.780993°	
DWR ID	DWR_ST0007_02_f_2019_25				
Comment Code					
TR : Tree or limb					
Inspector Comment					
Remove fallen cottonwood limb.

View of large cottonwood limb on the waterside shoulder (Fall 2019).
