**Flood Control Project Maintenance  
Levee Inspections**  
**LMA District Cover Sheet**  
**Spring 2020 Levee Inspection Results**

**Sacramento Maintenance Yard Putah Creek**

**Spring 2020 Levee Inspection Results**

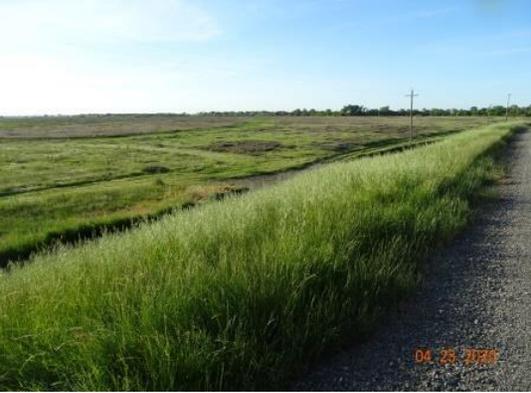
Photo 1 of 1 : SP\_2020\_ST0007\_282\_70\_20200423\_00125.jpg

LM Start	<b>0.03</b>	Rating **	<b>U</b>	Issue No.	<b>70</b>
LM End	<b>6.96</b>	Issue Type +	<b>Ma</b>	Location *	<b>WS</b>
Category	Earthen Levee		GPS Latitude/Longitude		
			Start	End	
Item	Vegetation		38.523271 °	38.517691 °	
			-121.631470 °	-121.753362 °	
DWR ID	DWR_ST0007_01_s_2020_70				
Comment Code					
V1 : Control annual grass and weeds on the levee slopes and easements.					
Inspector Comment

View looking upstream at annual vegetation on the waterside slope (Spring 2020).

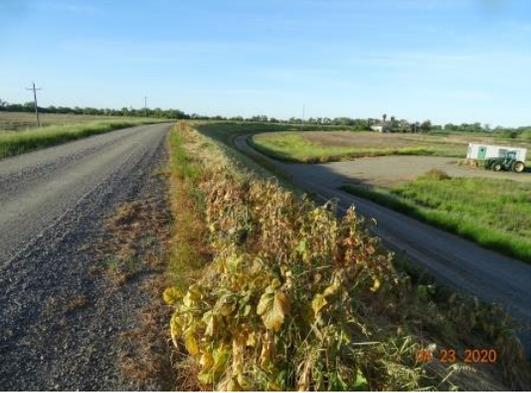
Photo 1 of 1 : SP\_2020\_ST0007\_282\_32\_20200423\_00124.jpg

LM Start	<b>0.03</b>	Rating **	<b>U</b>	Issue No.	<b>32</b>
LM End	<b>8.31</b>	Issue Type +	<b>Ma</b>	Location *	<b>LS</b>
Category	Earthen Levee		GPS Latitude/Longitude		
			Start	End	
Item	Vegetation		38.523271 °	38.521546 °	
			-121.631470 °	-121.776987 °	
DWR ID	DWR_ST0007_01_f_2019_32				
Comment Code					
V1 : Control annual grass and weeds on the levee slopes and easements.					
Inspector Comment

View looking upstream at annual vegetation on the landside slope (Spring 2020).

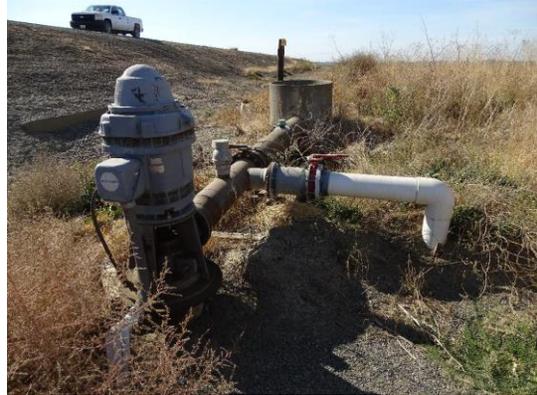
Photo 3 of 3 : UCIP\_SP\_2020\_55584\_82058.jpg

Water well connected to standpipe at LS toe. Top of headwall is visible

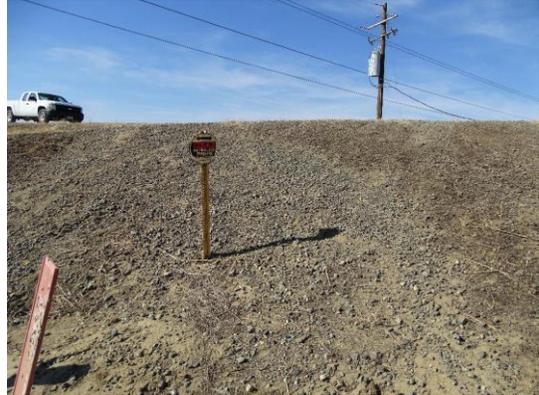
Photo 1 of 3 : UCIP\_SP\_2020\_55590\_82065.jpg

DS\_ID:637  
 FS\_ID:55590  
 EP\_NO: 17717-Rev.  
 Repair Type: Non-Urgent  
 Crossing Status: Indicator Found  
 UCIP Comments: 11/07/2019 In addition to paddle markers on both sides of levee, pipe alignment and mitigation line are marked with flags on WS approximately 320 feet from levee toe. Record updated from No Action Needed to Non-Urgent. No inspection records were available to determine status of line through the levee. (O.Yakimov - DWR UCIP)  
 FIELD\_STRUCT\_DESC: 20-inch petroleum pipeline across the levee, 40 feet below the levee crown. Pipe is bored through Putah Creek at an unknown depth. Paddle markers are located on the landside (LS) and waterside (WS) shoulders. (name change and 20-inch line authorized under Permit No. 17717-Rev., 2004 - SFPP, L.P., Delaware Limited Partnership c/o Paragon Partners Ltd; 20-inch line was authorized under Permit No. 17717, 2004 - Paragon Partners Ltd)

WS levee slope and pipeline marker

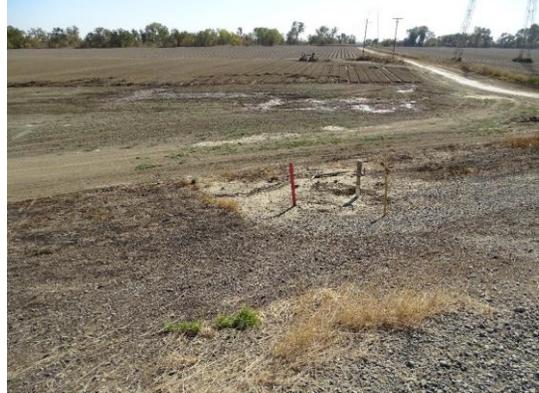
Photo 2 of 3 : UCIP\_SP\_2020\_55592\_82083.jpg

View of WS looking from levee crown. Air vent at levee toe

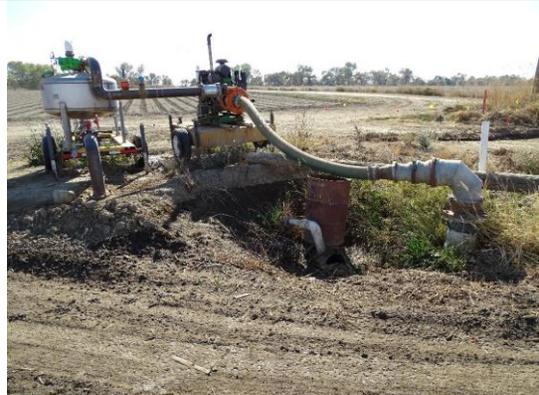
Photo 3 of 3 : UCIP\_SP\_2020\_55592\_82084.jpg

Pump in the field on WS approximately 350 feet from levee

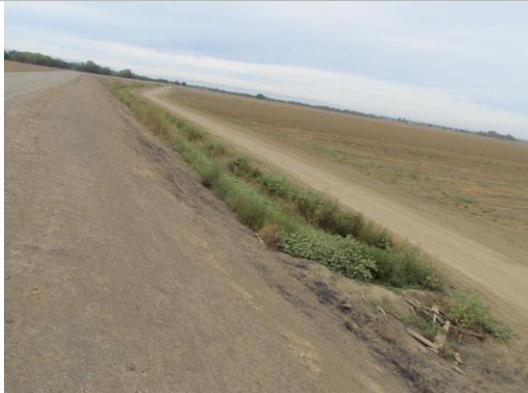
Photo 1 of 1 : SP\_2020\_ST0007\_282\_10\_20200304\_00003.jpg

LM Start	<b>1.52</b>	Rating **	M	Issue No.	<b>10</b>
LM End	<b>2.67</b>	Issue Type +	En	Location *	LS
Category	Earthen Levee		GPS Latitude/Longitude		
			Start	End	
Item	Encroachments		38.515258 °	38.517376 °	
			-121.655107 °	-121.676054 °	
DWR ID	DWR_ST0007_01_s_2012_10				
Comment Code					
DT : Ditch					
Inspector Comment					
This agriculture ditch is owned by Dos Rios Farms.

View of agriculture ditch within 10-foot of levee toe.

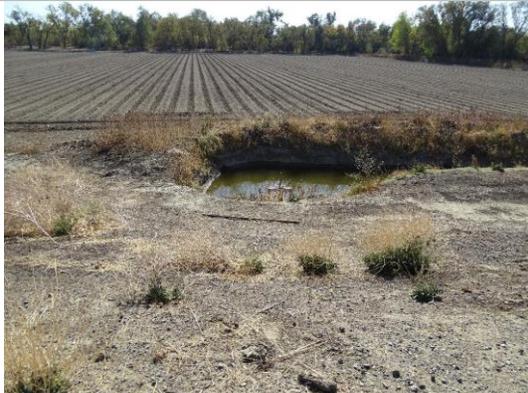
Photo 1 of 3 : UCIP\_SP\_2020\_55596\_82097.jpg

Item	DWR UCIP Field Study		38.515739 °	38.515739 °	
			-121.666432 °	-121.666432 °	
DWR ID	491				
Comment Code					
Inspector Comment					
DS_ID:491 FS_ID:55596 EP_NO: 10262 Repair Type: Non-Urgent Crossing Status: Found UCIP Comments: 11/07/2019 Record remains Non-Urgent. At the time of inspection both LS and WS irrigation ditched were filled with water. Unable to see pipe. Need to have CVFPB review ABO and determine current owner. (O.Yakimov - DWR UCIP)09/21/2017 Pipe was permitted as an irrigation structure under ABO issued as Permit No. 10262. (DWR UCIP - O. Magana) 04/03/2012 Pipe has significant rust and exfoliation of metal showing at ends. Reccomend video inspection. (DWR UCIP - W. Wylie) FIELD_STRUCT_DESC: 24-inch irrigation pipe of unknown material through levee, 15.5 feet below crown. Slide gate is located on the waterside (WS) end. Concrete headwall is located on the landside (LS) end. (24-inch pipe [HLM 2.17] authorized under Automatic Board Order (ABO) issued as Permit No. 10262, 1974 - Wells Fargo Bank, Trustee for S.H. Cowell Foundation) [Additional Reference(s): DWR Levee Log, 1981 and 2005 (HLM 2.17). USACE Sacramento O&M Manual, Unit 119, December 1952, Revised 29 Dec 2016, (Station T 16+70), listed as 24-inch pipe. USACE As-Built Drawing No. 50-04-2396, Revision 1, pdf page 21, Sheet 5, December 1947] FS Date: 11/7/2019 10:40:42 AM

View of WS looking from levee crown

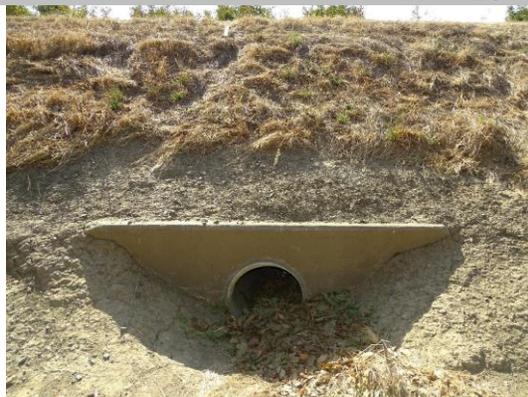
Photo 3 of 3 : UCIP\_SP\_2020\_55597\_82104.jpg

LS levee slope, headwall, and pipe end

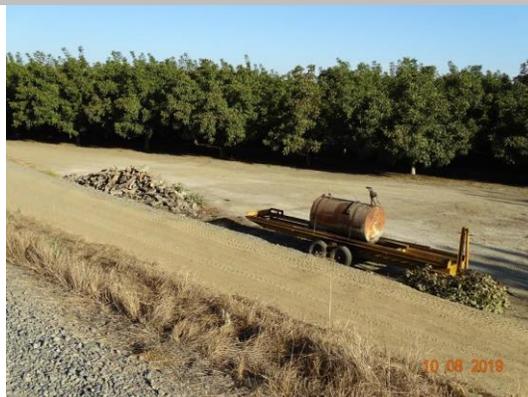
Photo 1 of 1 : SP\_2020\_ST0007\_282\_35\_20200304\_00007.jpg

LM Start	<b>3.05</b>	Rating **	M	Issue No.	<b>35</b>
LM End	<b>3.05</b>	Issue Type +	En	Location *	LS
Category	Earthen Levee		GPS Latitude/Longitude		
			Start	End	
Item	Encroachments		38.519205 °	38.519205 °	
			-121.682618 °	-121.682618 °	
DWR ID	DWR_ST0007_01_s_2018_35				
Comment Code					
EQ : Equipment					
Inspector Comment					
Ag equipment and cut wood pile should be removed from LS toe to allow inspection and access.

View of equipment and large wood pile at the landside toe (Fall 2019).

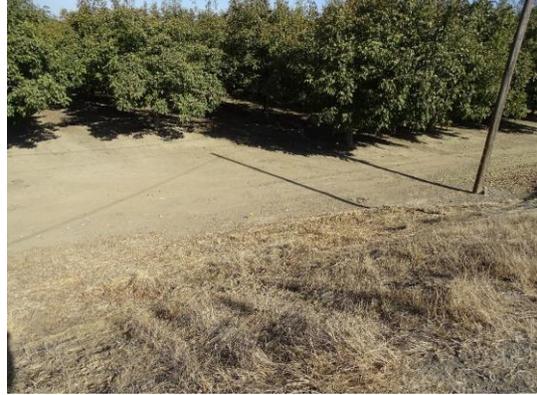
Photo 3 of 3 : UCIP\_SP\_2020\_55598\_82109.jpg

View of LS looking from levee crown

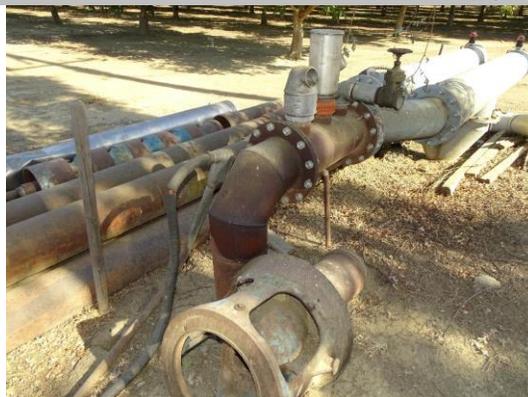
Photo 2 of 3 : UCIP\_SP\_2020\_55608\_82137.jpg

Comment Code					
Inspector Comment					
DS_ID:16849 FS_ID:55608 EP_NO: N/A Repair Type: Non-Urgent Crossing Status: Found UCIP Comments: 11/07/2019 Record remains Non-Urgent. Missing permit for this crossing. (O.Yakimov - DWR UCIP)04/03/2012 Old pipe and concrete hauled to county dump. Evidence of the 14-inch pipe is no longer present at site. See new picture. (W. Wylie - DWR UCIP) FIELD_STRUCT_DESC: 10-inch steel irrigation pipe through the levee, 12 feet below the crown. Pipe terminates at standpipe located on the waterside (WS) approximately 500 feet south of levee. Mobile pumping plant is located in the floodway at edge of stream 740 feet south of levee. FS Date: 11/7/2019 1:05:17 PM

View of pipe at LS toe

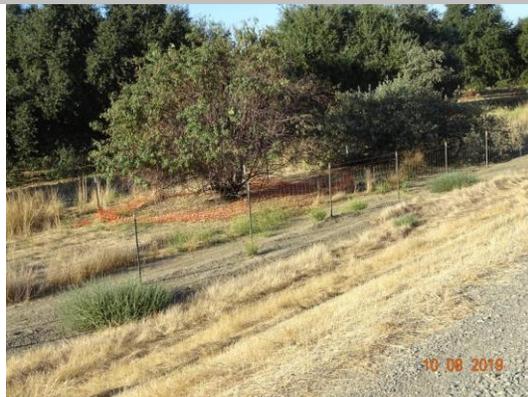
Photo 1 of 1 : SP\_2020\_ST0007\_282\_4\_20200304\_00001.jpg

LM Start	<b>3.25</b>	Rating **	M	Issue No.	<b>4</b>
LM End	<b>3.64</b>	Issue Type +	En	Location *	WS
Category	Earthen Levee			GPS Latitude/Longitude	
				Start	End
Item	Encroachments			38.519831 °	38.519848 °
				-121.686263 °	-121.693463 °
DWR ID	DWR_ST0007_01_s_2013_4				
Comment Code					
FE : Fence					
Inspector Comment					
No permit was found for this wire fence at the waterside levee toe.

View of barbed wire at the waterside toe (Fall 2019).

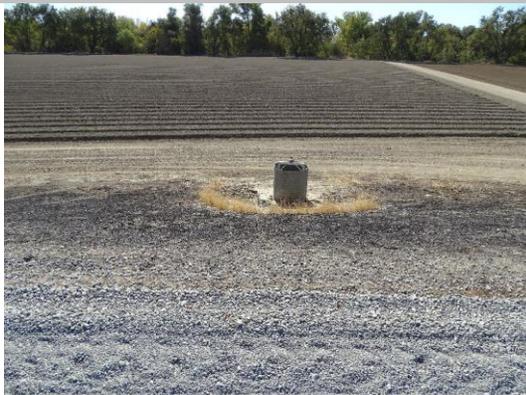
Photo 3 of 3 : UCIP\_SP\_2020\_55456\_81762.jpg

View of WS looking from levee crown

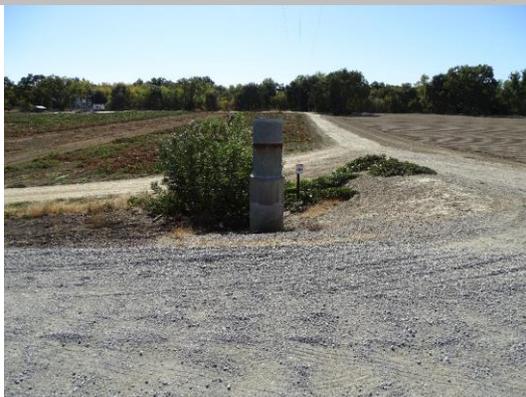
Photo 1 of 3 : UCIP\_SP\_2020\_55457\_81767.jpg

Raised concrete standpipe at WS levee toe

<b>Comment Code</b>					
<b>Inspector Comment</b>					
DS_ID:498 FS_ID:55457 EP_NO: 10250 Repair Type: Non-Urgent Crossing Status: Found UCIP Comments: 10/22/2019 Record updated from No Action Needed to Non-Urgent. Need to have CVFPB review ABO and determine current owner. Crossing is used to provide well water supply from WS to LS. Well and electric boxes located on WS about 500 ft south of the levee. PVC standpipe and fresno valve at dirt road shoulder on WS. (O.Yakimov - DWR UCIP) FIELD_STRUCT_DESC: 24-inch corrugated metal irrigation pipe through the levee, 11 feet below the crown. No control valves. Concrete standpipes on both sides of the levee. (24-inch pipe [HLM 4.39]authorized under Automatic Board Order (ABO) issued as Permit No. 10250, 1974 - Martha A. Faria). [Additional Reference(s): DWR Levee Log, 2005 (HLM 4.39). USACE Sacramento O&M Manual, Unit 119, December 1952, Revised 29 Dec 2016, (Station 31+50 PCT), listed as 24-inch pipe. USACE As-Built Drawing No. 50-04-2396, Revision 4, pdf page 23, Sheet 7, December 1947]. FS Date: 10/22/2019 2:09:24 PM

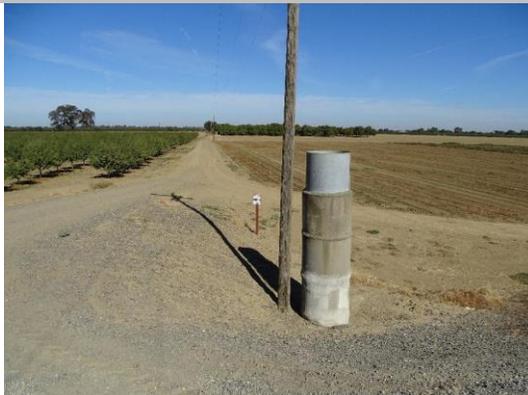
Photo 2 of 3 : UCIP\_SP\_2020\_55457\_81768.jpg

Raised concrete standpipe at LS levee toe

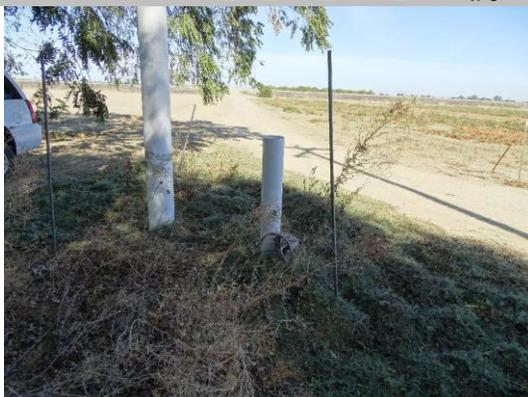
Photo 3 of 3 : UCIP\_SP\_2020\_55457\_81769.jpg

PVC standpipe and closure devise south of levee on WS

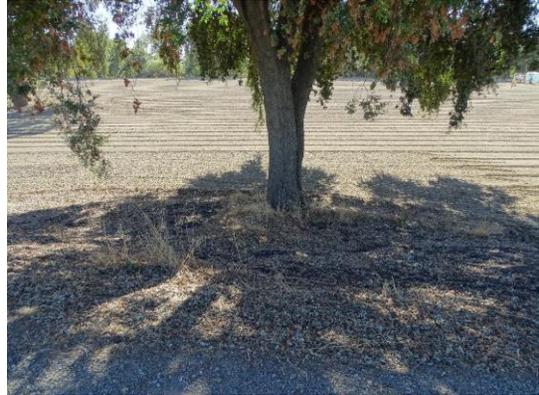
Photo 2 of 3 : UCIP\_SP\_2020\_55458\_81772.jpg

View of WS looking from levee crown

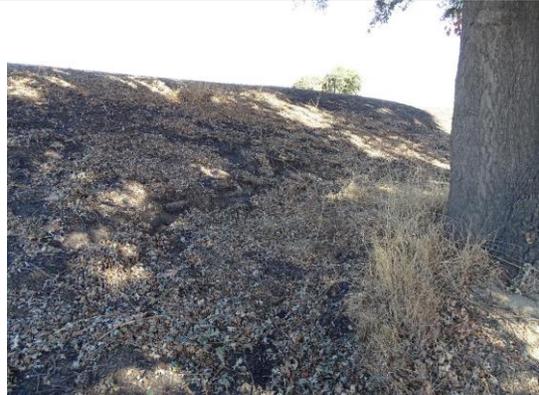
Photo 3 of 3 : UCIP\_SP\_2020\_55458\_81773.jpg

Top part of headwall on WS levee slope under the tree

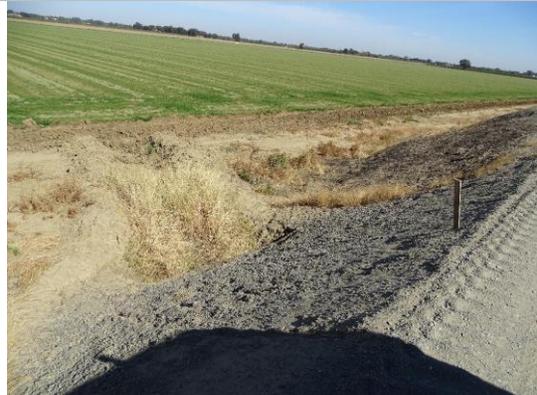
Photo 1 of 3 : UCIP\_SP\_2020\_55459\_81775.jpg

Item	DWR UCIP LMA Responsibility		38.518022 °	38.518022 °	
			-121.722521 °	-121.722521 °	
DWR ID	500				
Comment Code					
Inspector Comment					
DS_ID:500 FS_ID:55459 EP_NO: 10256 Repair Type: Non-Urgent Crossing Status: Found UCIP Comments: 10/22/2019 Record updated from No Action Needed to Non-Urgent. Need to have CVFPB review ABO and determine current owner. (O.Yakimov - DWR UCIP) 05/06/2013 Debris removed. See picture (C. Lund - DWR Sacramento Yard) 04/04/2012 Some debris in pipe invert LS (W. Wylie - DWR UCIP) FIELD_STRUCT_DESC: 24-inch CIPP-lined corrugated metal drainage pipe through the levee, 15 feet below the crown. Slide gate on the waterside (WS) end. Concrete headwall on the landside (LS) end. (24-inch pipe [HLM 5.39] authorized under Automatic Board Order (ABO) issued as Permit No. 10256, 1974 - Albert H. Lederer). [Additional Reference(s): DWR Levee Log, 2005 (HLM 5.39). USACE Sacramento O&M Manual, Unit 119, December 1952, Revised 29 Dec 2016, (Station 83+70 PCT), listed as 24-inch pipe. USACE As-Built Drawing No. 50-04-2396, Revision 4, pdf page 24, Sheet 8, December 1947]. FS Date: 10/22/2019 3:11:16 PM

View of LS looking from levee crown

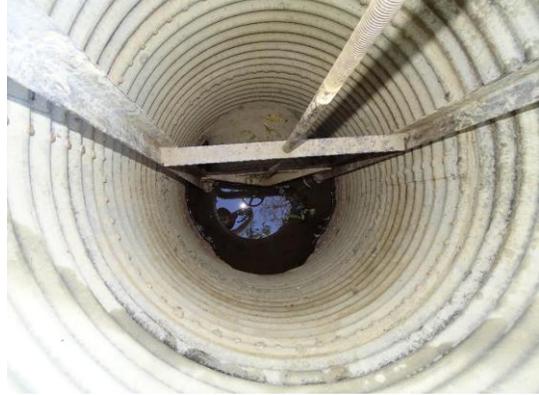
Photo 3 of 3 : UCIP\_SP\_2020\_55460\_81781.jpg

View inside of CMP standpipe on WS

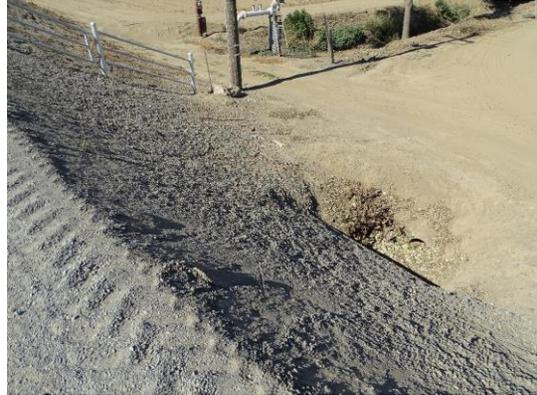
Photo 1 of 3 : UCIP\_SP\_2020\_55461\_81782.jpg

Item	DWR UCIP LMA Responsibility		38.518249 °	38.518249 °	
			-121.727538 °	-121.727538 °	
DWR ID	502				
Comment Code					
Inspector Comment					
DS_ID:502 FS_ID:55461 EP_NO: 10255 Repair Type: Non-Urgent Crossing Status: Found UCIP Comments: 10/22/2019 Record updated from No Action Needed to Non-Urgent. Need to have CVFPB review ABO and determine current owner. (O.Yakimov - DWR UCIP) FIELD_STRUCT_DESC: 24-inch CIPP-lined corrugated metal drainage pipe through the levee, 11 feet below the crown. Slide gate on the waterside (WS) end. Concrete headwall on the landside (LS) end. (24-inch pipe [HLM 5.67] authorized under Automatic Board Order (ABO) issued as Permit No. 10255, 1974 - Owen W. and Ray W. Hamel). [Additional Reference(s): DWR Levee Log, 2005 (HLM 5.67). USACE Sacramento O&M Manual, Unit 119, December 1952, Revised 29 Dec 2016, (Station 97+00 PCT), listed as 24-inch pipe. USACE As-Built Drawing No. 50-04-2396, Revision 4, pdf page 24, Sheet 8, December 1947]. FS Date: 10/22/2019 4:03:27 PM

View of LS looking from levee crown

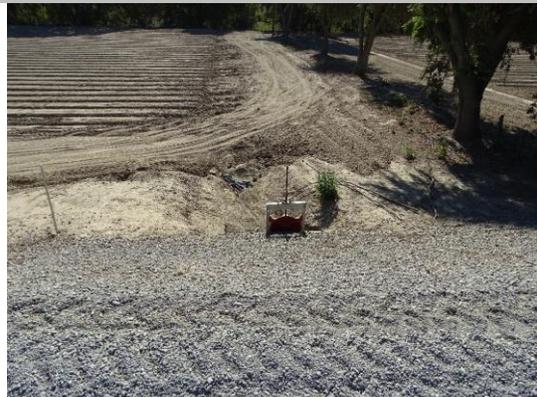
Photo 2 of 3 : UCIP\_SP\_2020\_55461\_81783.jpg

View of WS looking from levee crown

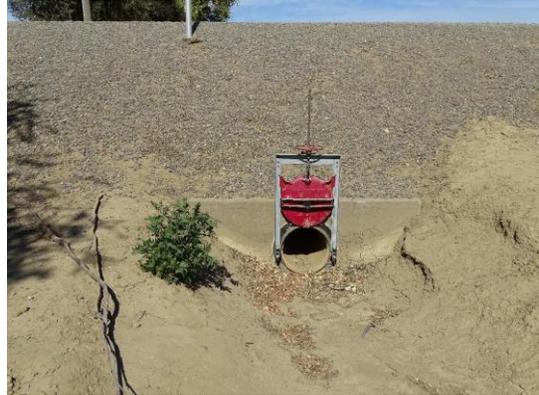
Photo 3 of 3 : UCIP\_SP\_2020\_55461\_81784.jpg

WS levee slope, headwall, and slide gate

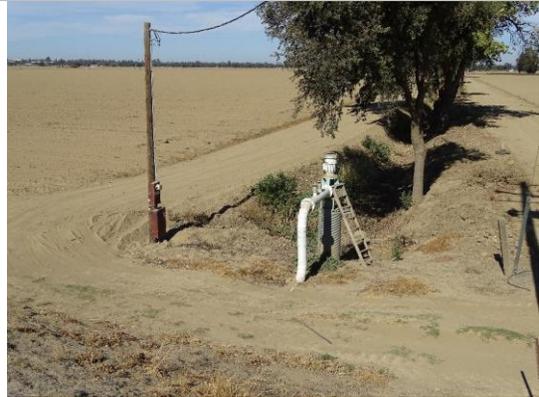
Photo 1 of 3 : UCIP\_SP\_2020\_55462\_81786.jpg

View of LS looking from levee crown

Comment Code					
Inspector Comment					
DS_ID:590 FS_ID:55462 EP_NO: 14140 Repair Type: Non-Urgent Crossing Status: Found UCIP Comments: 10/22/2019 Record remains Non-Urgent. Broken air vent on WS shoulder, closure devices not present. (O.Yakimov - DWR UCIP)04/04/2012 Air vent broken off on water side shoulder. Also, no flap gate or other positive closure device on either side of levee. No requirement in permit for applicant to install positive closure device, but it may be necessary if maintenance or upgrade is performed on pipe. (W. Wylie - DWR UCIP) FIELD_STRUCT_DESC: 6-inch polyvinyl chloride (PVC) drainage pipe through the levee, 16 feet below the crown. 24-inch standpipe with pump on the landside (LS). Pipe outfall at creek with riprap. (8-inch pipe relocation authorized under Permit No. 14140, 1985 - Clyde Rust Jr. and John F. Hamel et.al) FS Date: 10/22/2019 4:12:16 PM

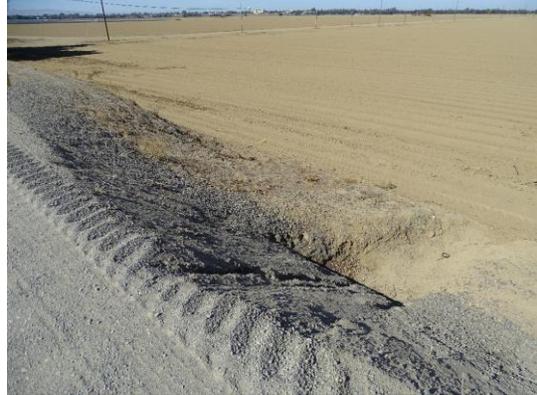
Photo 1 of 3 : UCIP\_SP\_2020\_55644\_82261.jpg

Item	DWR UCIP LMA Responsibility		38.518368 °	38.518368 °	
			-121.730947 °	-121.730947 °	
DWR ID	503				
Comment Code					
Inspector Comment					
DS_ID:503 FS_ID:55644 EP_NO: 10252 Repair Type: Non-Urgent Crossing Status: Found UCIP Comments: 10/22/2019 Record updated from No Action Needed to Non-Urgent. Need to have CVFPB review ABO and determine current owner. (O.Yakimov - DWR UCIP) 05/06/2013 owner of pipe needs to clean out obstruction in pipe. (C. Lund - DWR Sacramento Yard) 04/04/2012 Partially obstructed with sedimentation throughout crossing. (W. Wylie - DWR UCIP) FIELD_STRUCT_DESC: 24-inch CIPP-lined corrugated metal drainage pipe through the levee, 12 feet below the crown. Slide gate on the waterside (WS) end. Concrete headwall on the landside (LS) end. (24-inch pipe [HLM 5.86] authorized under Automatic Board Order (ABO) issued as Permit No. 10252, 1974 - John F. Hamel). [Additional Reference(s): DWR Levee Log, 2005 (HLM 5.86). USACE Sacramento O&M Manual, Unit 119, December 1952, Revised 29 Dec 2016, (Station 108+00 PCT), listed as 24-inch pipe. USACE As-Built Drawing No. 50-04-2396, Revision 4, pdf page 24, Sheet 8, December 1947]. FS Date: 10/22/2019 10:55:40 AM

View of LS looking from levee crown

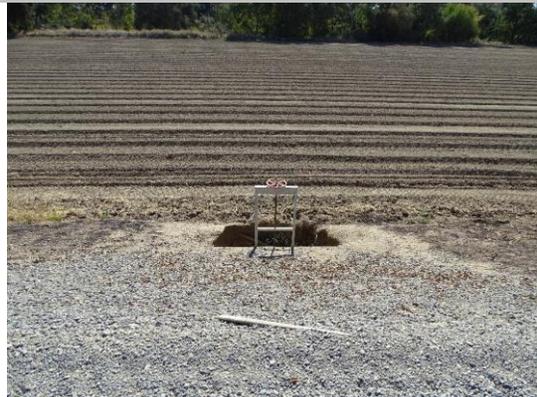
Photo 2 of 3 : UCIP\_SP\_2020\_55644\_82262.jpg

View of WS looking from levee crown

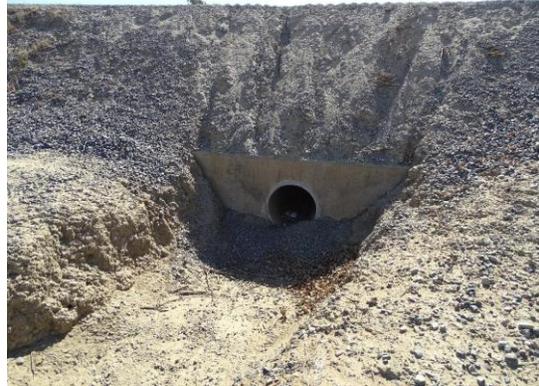
Photo 3 of 3 : UCIP\_SP\_2020\_55644\_82263.jpg

LS levee slope, headwall, and pipe end

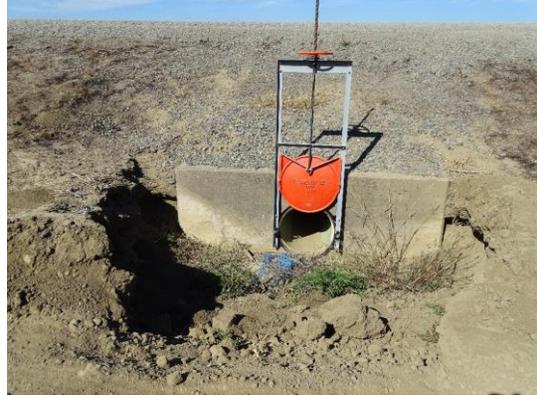
Photo 3 of 3 : UCIP\_SP\_2020\_55647\_82275.jpg

WS levee slope, headwall, and slide gate

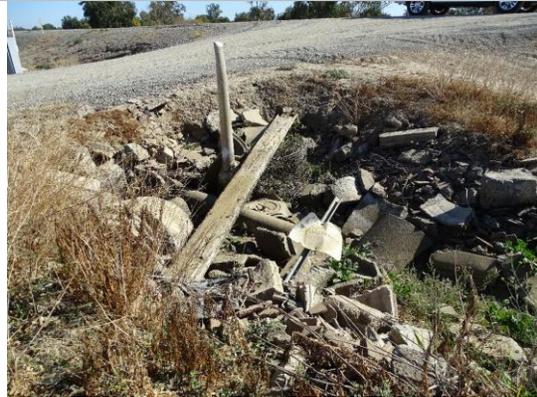
Photo 1 of 2 : UCIP\_SP\_2020\_55661\_82336.jpg

LS:sign post bent over in a ditch at toe

DS\_ID:506  
 FS\_ID:55661  
 EP\_NO: 10820  
 Repair Type: Non-Urgent  
 Crossing Status: Indicator Found  
 UCIP Comments: 10/22/2019 Record remains Non-Urgent. No inspection records were available to determine status of line through the levee. Missing gas line marker on waterside. Landside marker needs a repair. (O.Yakimov - DWR UCIP)04/09/2012 Sign on LS bent over and broken. New signs need to be installed locating pipe that indicate a gas line crossing. The broken or missing signs do not indicate gasoline, only owner info. Owner is Calpine NRG Scott Vickers 707-249-9211. Supervisor will call phone number and ask for new signs to be installed. (W. Wylie - DWR UCIP)  
 FIELD\_STRUCT\_DESC: 4-inch coated steel gas line through the levee, 2 feet below the crown. (4-inch pipe authorized under Permit No. 10820, 1975 - Dow Chemical). [Additional Reference(s): DWR Levee Log, 2005, (HLM 6.62)].  
 FS Date: 10/22/2019 12:30:14 PM

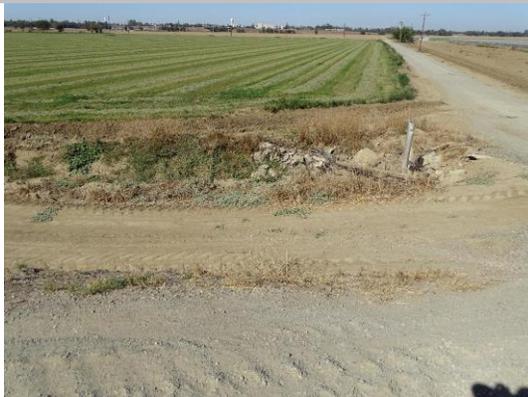
Photo 2 of 2 : UCIP\_SP\_2020\_55661\_82337.jpg

View of LS looking from levee crown

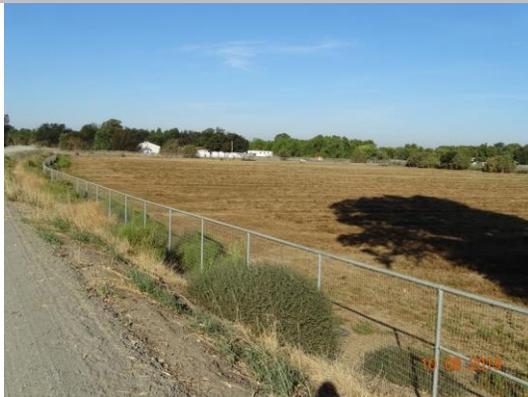
Photo 1 of 1 : SP\_2020\_ST0007\_282\_5\_20200304\_00002.jpg

LM Start	<b>6.63</b>	Rating **	M	Issue No.	<b>5</b>
LM End	<b>6.71</b>	Issue Type +	En	Location *	LS
Category	Earthen Levee			GPS Latitude/Longitude	
				Start	End
Item	Encroachments			38.517746 °	38.517647 °
				-121.747220 °	-121.748679 °
DWR ID	DWR_ST0007_01_s_2012_5				
Comment Code					
FE : Fence					
Inspector Comment					
A chainlink fence is located at the landside toe.

View of fence at the landside toe (Fall 2019).

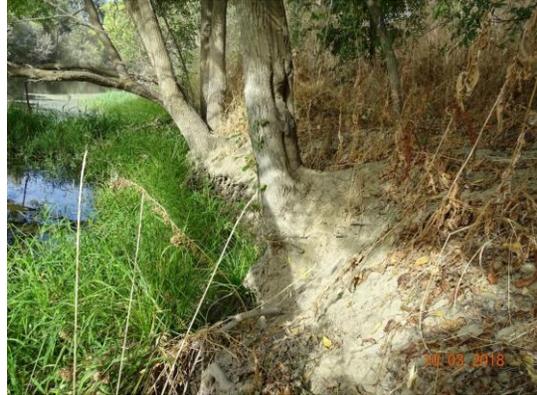
Photo 1 of 1 : SP\_2020\_ST0007\_282\_34\_20200304\_00006.jpg

LM Start	<b>6.88</b>	Rating **	M	Issue No.	<b>34</b>
LM End	<b>6.93</b>	Issue Type +	Ma	Location *	WS
Category	Supplemental		GPS Latitude/Longitude		
			Start	End	
Item	2017 USACE Erosion Survey		38.517362 °	38.517355 °	
			-121.751778 °	-121.752824 °	
DWR ID	DWR_ST0007_01_f_2018_34				
Comment Code					
Inspector Comment					
2017 Site ID: PUC 7.2 L Status: Eroding 2017 Field Notes: New erosion along lower bank. Site History: 2011 - The toe to mid-bank is slumping. Large tree pop-outs have furthered the erosion. Slope is slightly steeper than 1:1.

View looking upstream at erosion at the waterside toe. Tree roots are exposed (September 2018).

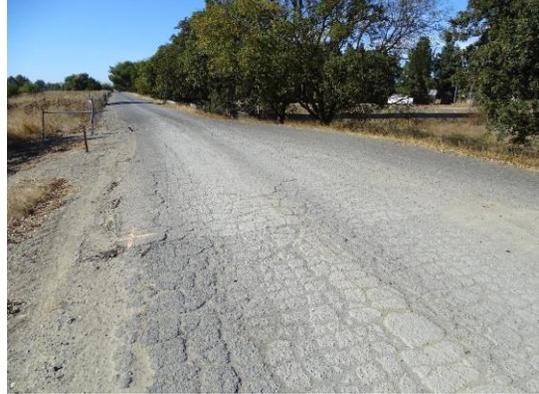
Photo 1 of 3 : UCIP\_SP\_2020\_55664\_82343.jpg

Item	DWR UCIP LMA Responsibility			38.517679 °	38.517679 °
				-121.753146 °	-121.753146 °
DWR ID	508				
Comment Code					
Inspector Comment					
DS_ID:508 FS_ID:55664 EP_NO: 10247 Repair Type: Non-Urgent Crossing Status: Found UCIP Comments: 10/22/2019 Record updated from No Action Needed to Non-Urgent. Need to have CVFPB review ABO and determine current owner. (O.Yakimov - DWR UCIP) FIELD_STRUCT_DESC: 24-inch CIPP-lined corrugated metal drainage pipe through the levee, 11.0 feet below the crown. Flap gate on the waterside (WS) end. Concrete headwall on the landside (LS) end. Concrete Apron on the WS. (24-inch pipe [HLM 7.09] authorized under Automatic Board Order (ABO) issued as Permit No. 10247, 1974 - University of California, Office of the Regents). [Additional Reference(s): DWR Levee Log, 2005 (HLM 7.09). USACE Sacramento O&M Manual, Unit 119, December 1952, Revised 29 Dec 2016, (Station 172+00 PCT), listed as 24-inch pipe. USACE As-Built Drawing No. 50-04-2396, Revision 4, pdf page 25, Sheet 9, December 1947]. FS Date: 10/22/2019 1:55:30 PM

View of levee crown at the crossing

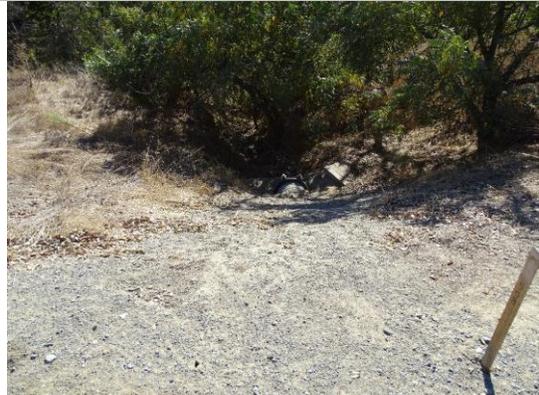
Photo 2 of 3 : UCIP\_SP\_2020\_55664\_82344.jpg

View of WS looking from levee crown

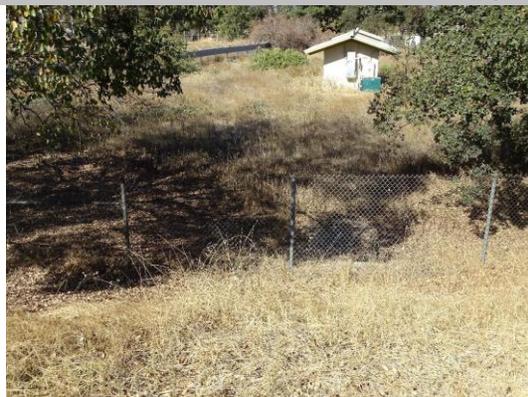
Photo 3 of 3 : UCIP\_SP\_2020\_55664\_82345.jpg

View of LS looking from levee crown

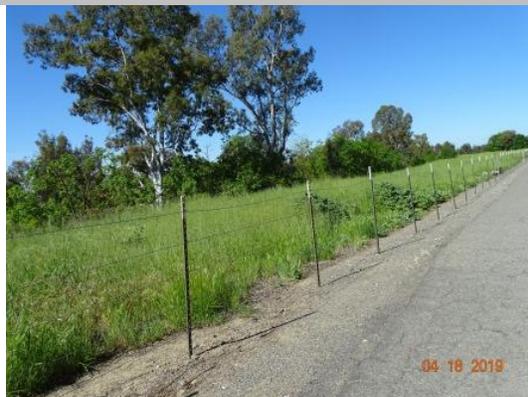
Photo 1 of 1 : SP\_2020\_ST0007\_282\_41\_20200304\_00010.jpg

LM Start	<b>6.95</b>	Rating **	M	Issue No.	<b>41</b>
LM End	<b>7.18</b>	Issue Type +	En	Location *	WS
Category	Earthen Levee			GPS Latitude/Longitude	
				Start	End
Item	Encroachments			38.517651 °	38.518178 °
				-121.753195 °	-121.753111 °
DWR ID	DWR_ST0007_01_s_2019_41				
Comment Code					
FE : Fence					
Inspector Comment					
There is a barbed wire fence on waterside shoulder.

View looking upstream at barbed wire fence on waterside shoulder (Spring 2019).

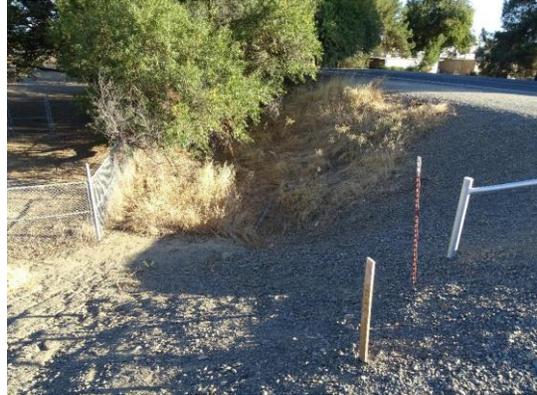
Photo 2 of 3 : UCIP\_SP\_2020\_55667\_82355.jpg

View of LS looking from levee crown

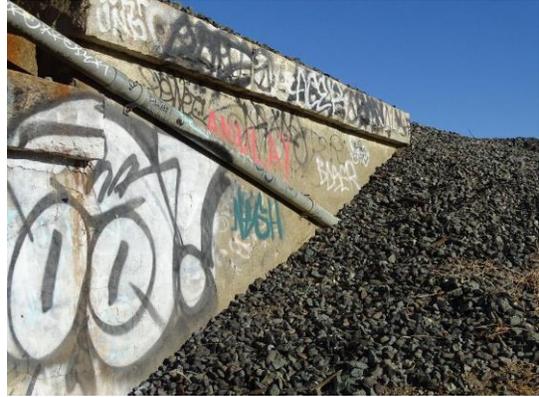
Photo 3 of 3 : UCIP\_SP\_2020\_55670\_82367.jpg

Conduit coming out from levee on WS

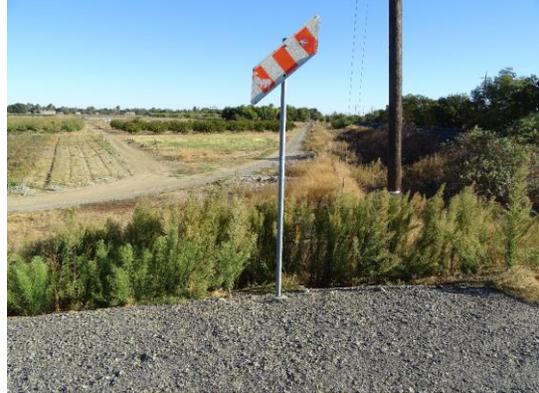
Photo 1 of 3 : UCIP\_SP\_2020\_55672\_82369.jpg

Item	DWR UCIP Field Study		38.518496 °	38.518496 °	
			-121.760411 °	-121.760411 °	
DWR ID	515				
Comment Code					
Inspector Comment					
DS_ID:515 FS_ID:55672 EP_NO: 10257 Repair Type: Non-Urgent Crossing Status: Indicator Found UCIP Comments: 10/21/2019 Record updated from No Action Needed to Non-Urgent. Need to have CVFPB review ABO and determine current owner. (O.Yakimov - DWR UCIP) FIELD_STRUCT_DESC: 6-inch gas line of an unknown material through the levee, 5 feet below the crown and under the channel. Valve in 14-inch riser on the waterside (WS) toe. Markers on the landside (LS) shoulder and toe. (6-inch line authorized under Automatic Board Order (ABO) issued as Permit No. 10257, 1974 - Pacific Gas and Electric Company [PG&E]). [Additional Reference(s): DWR Levee Log, 2005 (HLM 7.52). USACE Sacramento O&M Manual, Unit 119, December 1952, Revised 29 Dec 2016, (Station ~ 193+00 PCT). USACE As-Built Drawing No. 50-04-2396, Revision 4, pdf page 25, Sheet 9, December 1947]. FS Date: 10/21/2019 3:53:27 PM

View of LS looking from levee crown

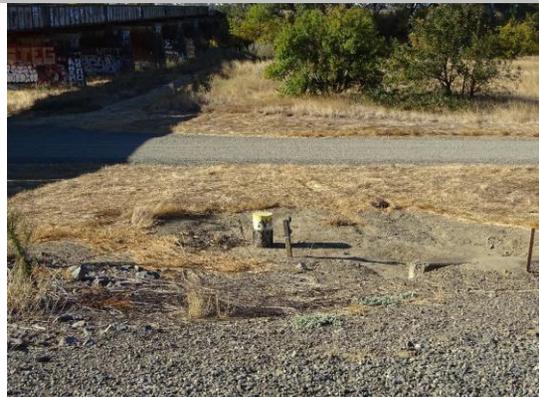
Photo 2 of 3 : UCIP\_SP\_2020\_55672\_82370.jpg

View of WS looking from levee crown

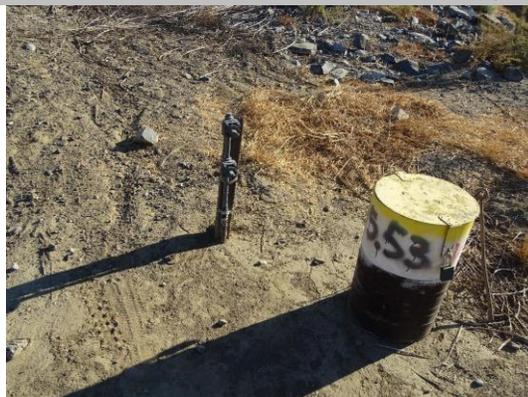
Photo 3 of 3 : UCIP\_SP\_2020\_55672\_82371.jpg

Valve on post and valve in 14-inch riser at WS levee toe

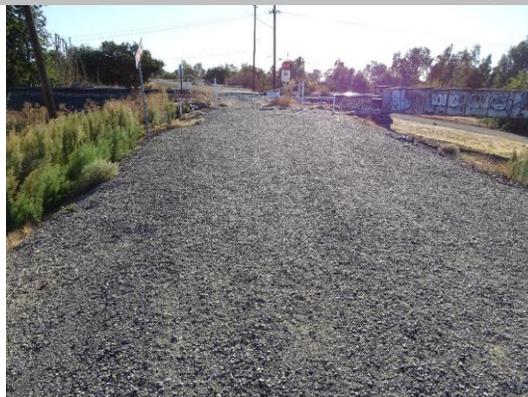
Photo 1 of 3 : UCIP\_SP\_2020\_55673\_82372.jpg

View of levee crown at the crossing

Comment Code					
Inspector Comment					
DS_ID:516 FS_ID:55673 EP_NO: 10260 Repair Type: Non-Urgent Crossing Status: Found UCIP Comments: 10/21/2019 Record remains Non-Urgent. Need to have CVFPB review ABO and determine current owner. (O. Yakimov - DWR UCIP) 05/07/2013 Owner of pipe may have to clean sediment. (C. Lund - DWR Sacramento Yard) 04/05/2012 Pipe is partially obstructed with sedimentation. (W. Wylie - DWR UCIP) FIELD_STRUCT_DESC: 24-inch corrugated metal drainage pipe through the levee, 12 feet below the crown. Flap gate on the waterside (WS) end. (24-inch pipe [HLM 7.52] authorized under Automatic Board Order (ABO) issued as Permit No. 10260, 1974 - Southern Pacific Transportation Company). [Additional Reference(s): DWR Levee Log, 2005 (HLM 7.52). USACE Sacramento O&M Manual, Unit 119, December 1952, Revised 29 Dec 2016, (Station 193+20 PCT), listed as 24-inch pipe. USACE As-Built Drawing No. 50-04-2396, Revision 4, pdf page 25, Sheet 9, December 1947]. FS Date: 10/21/2019 4:00:06 PM

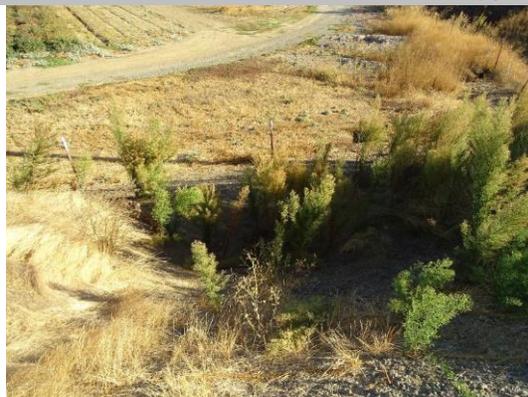
Photo 2 of 3 : UCIP\_SP\_2020\_55673\_82373.jpg

View of LS looking from levee crown

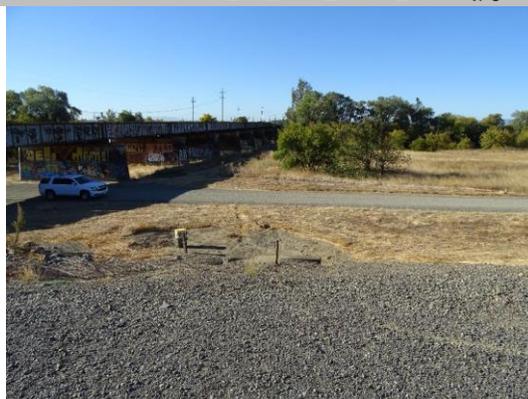
Photo 3 of 3 : UCIP\_SP\_2020\_55673\_82374.jpg

View of WS looking from levee crown

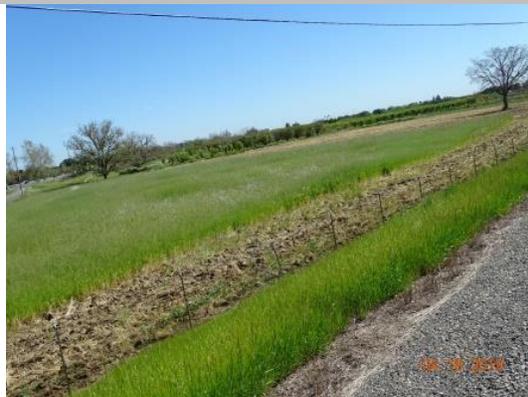
Photo 1 of 1 : SP\_2020\_ST0007\_282\_42\_20200304\_00011.jpg

LM Start	<b>7.39</b>	Rating **	M	Issue No.	<b>42</b>
LM End	<b>7.85</b>	Issue Type +	En	Location *	LS
Category	Earthen Levee			GPS Latitude/Longitude	
				Start	End
Item	Encroachments			38.518659 °	38.518570 °
				-121.761060 °	-121.769577 °
DWR ID	DWR_ST0007_01_s_2019_42				
Comment Code					
FE : Fence					
Inspector Comment					
There is a barbed wire fence on the landside.

View looking downstream at barbed wire fence located within the landside easment (Spring 2019).

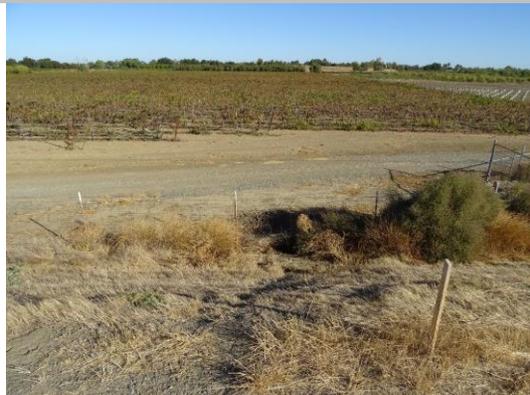
Photo 1 of 3 : UCIP\_SP\_2020\_55675\_82382.jpg

Item	DWR UCIP LMA Responsibility		38.519002 °	38.519002 °	
			-121.764315 °	-121.764315 °	
DWR ID	518				
Comment Code					
Inspector Comment					
<p>DS_ID:518                  FS_ID:55675                  EP_NO: 10247                  Repair Type: Non-Urgent                  Crossing Status: Found                  UCIP Comments: 10/21/2019 Difficult access to pipe inlet on LS due to a fence. (O.Yakimov - DWR UCIP)05/07/2013 Fence blocking inlet. Owner of fence needs to move fence away from inlet. (C. Lund - DWR Sacramento Yard)                  04/05/2012 Clear debris from pipe. (W. Wylie - DWR UCIP)                  FIELD_STRUCT_DESC: 24-inch CIPP-lined corrugated metal drainage pipe through the levee, 12 feet below the crown. Slide gate on the waterside (WS) slope, and headwalls on both sides. (24-inch pipe [HLM 7.75] authorized under Automatic Board Order (ABO) issued as Permit No. 10247, 1974 - University of California, Office of the Regents).                  [Additional Reference(s): DWR Levee Log, 2005 (HLM 7.75). USACE Sacramento O&amp;M Manual, Unit 119, December 1952, Revised 29 Dec 2016, (Station 204+00 PCT), listed as 24-inch pipe. USACE As-Built Drawing No. 50-04-2396, Revision 4, pdf page 25, Sheet 9, December 1947].                  FS Date: 10/21/2019 8:27:02 AM</p>

View of LS looking from levee crown

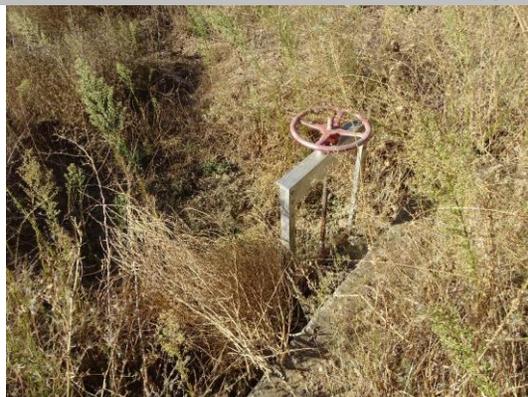
Photo 3 of 3 : UCIP\_SP\_2020\_55675\_82385.jpg

WS: headwall and slide gate

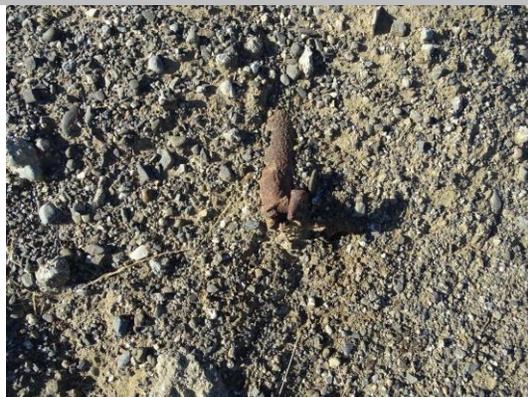
Photo 1 of 2 : UCIP\_SP\_2020\_55676\_82388.jpg

Cutoff pipe on LS levee shoulder

Comment Code					
Inspector Comment					
DS_ID:592 FS_ID:55676 EP_NO: 6705 Repair Type: Non-Urgent Crossing Status: Not Found UCIP Comments: 10/21/2019 Record remains Non-Urgent. Possible pipe that penetrates levee found at LS shoulder. (O.Yakimov - DWR UCIP)04/05/2012 Found a 4-inch pipe near toe of ramp at LM 7.805 but it could not be determined if this pipe crossed through the levee. No additional info is available for pipe location. Lat and long for this pipe: Lat: 38.51898120 Long: -121.765378980. Attempt to determine if this pipe crosses through levee. (W. Wylie - DWR UCIP) FIELD_STRUCT_DESC: 4-inch steel irrigation pipe through the levee, 1.5 feet below the crown. Located approximately 110 feet east of the ramp at Levee Mile 7.81. (4-inch pipe authorized under Permit No. 6705, 1969 - University of California, Davis Campus. Also mentioned as a 3-inch steel pipe in Permit No. 5896, 1967 - The Regents of the University of California, Office of Architects and Engineers, University of California, Davis Campus). FS Date: 10/21/2019 8:44:19 AM

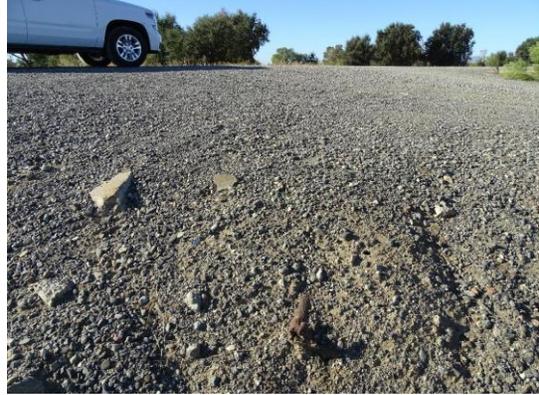
Photo 2 of 2 : UCIP\_SP\_2020\_55676\_82389.jpg

LS levee slope with cutoff pipe sticking out

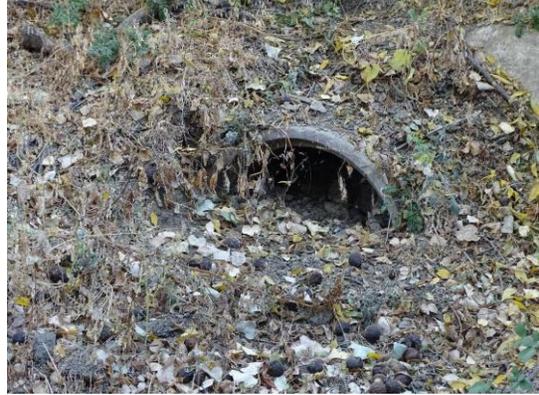
Photo 3 of 3 : UCIP\_SP\_2020\_55678\_82392.jpg

Sediment buildup inside the pipe and in the spillway

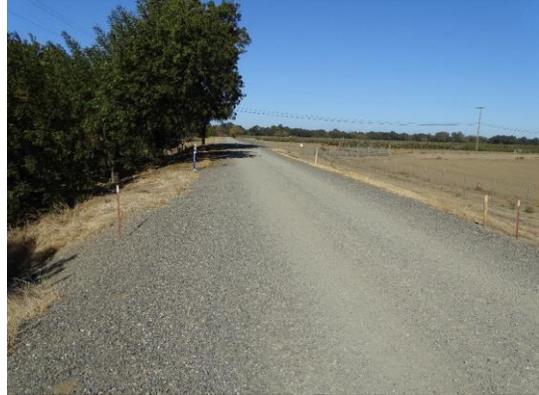
Photo 1 of 3 : UCIP\_SP\_2020\_55679\_82393.jpg

View of levee crown at the crossing

<b>Comment Code</b>					
<b>Inspector Comment</b>					
DS_ID:520 FS_ID:55679 EP_NO: 10247 Repair Type: Non-Urgent Crossing Status: Found UCIP Comments: 10/21/2019 Record updated from No Action Needed to Non-Urgent. Need to have CVFPB review ABO and determine current owner. (O.Yakimov - DWR UCIP) 05/07/2012 Cleaned inlet and outlets. Owner of pipe may need to clean pipe. (C. Lund - DWR Sacramento Yard) 04/05/2012 Pipe is plugged with soil on LS. (W. Wylie - DWR UCIP) FIELD_STRUCT_DESC: 24-inch CIPP-lined corrugated metal drainage pipe through the levee, 8 feet below the crown. Slide gate on the waterside (WS) end. (24-inch pipe [HLM 8.45] authorized under Automatic Board Order (ABO) issued as Permit No. 10247, 1974 - University of California, Office of the Regents). [Additional Reference(s): DWR Levee Log, 2005 (HLM 8.45). USACE Sacramento O&M Manual, Unit 119, December 1952, Revised 29 Dec 2016, (Station 241+50 PCT). USACE As-Built Drawing No. 50-04-2396, Revision 2, pdf page 26, Sheet 10, December 1947]. FS Date: 10/21/2019 10:02:10 AM

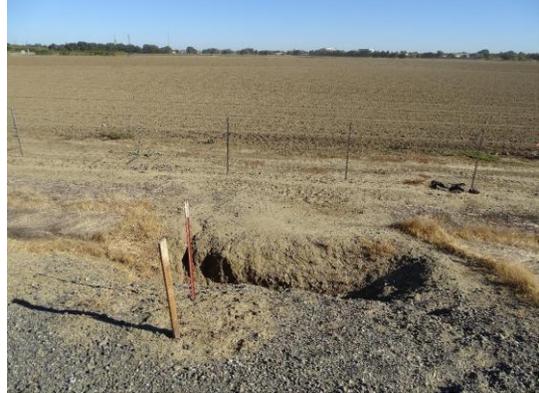
Photo 2 of 3 : UCIP\_SP\_2020\_55679\_82394.jpg

View of LS looking from levee crown

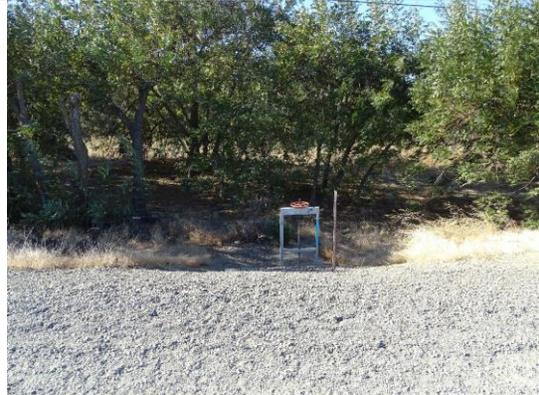
Photo 3 of 3 : UCIP\_SP\_2020\_55679\_82395.jpg

View of WS looking from levee crown

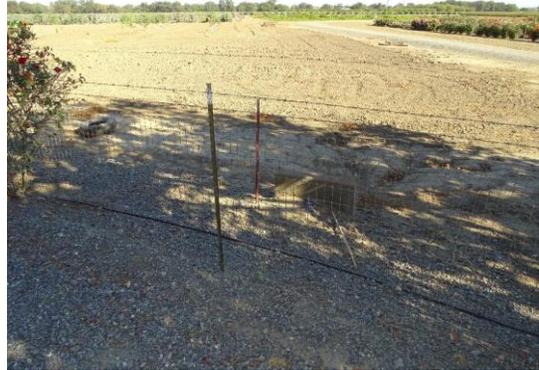
Photo 1 of 3 : UCIP\_SP\_2020\_55681\_82403.jpg

Item	DWR UCIP Field Study		38.523210 °	38.523210 °	
			-121.780170 °	-121.780170 °	
DWR ID	522				
Comment Code					
Inspector Comment					
<p>DS_ID:522                  FS_ID:55681                  EP_NO: 5896                  Repair Type: Non-Urgent                  Crossing Status: Found                  UCIP Comments: 10/21/2019 Record updated from No Action Needed to Non-Urgent. Sediment buildup around pipe outlet prevents flap gate from opening. (O.Yakimov - DWR UCIP)05/07/2013 Inspected inlet of pipe from other side of fence. Outlet discharge under elderberry. Need permit to cut veg. (C. Lund - DWR Sacramento Yard)                  04/05/2012 Fence prevents access to pipe. Pipe likely needs to be cleared of sedimentation. (W. Wylie - DWR UCIP)                  FIELD_STRUCT_DESC: 12-inch corrugated metal drainage pipe through the levee, 3.4 feet below the crown. Flap gate on the waterside (WS) end. Concrete headwall on the landside (LS) end. (12-inch pipe authorized under Permit No. 5896, 1967 - The Regents of the University of California, Office of Architects and Engineers, University of California, Davis Campus). [Additional Reference(s): DWR Levee Log, 2005, (HLM 8.70)].                  FS Date: 10/21/2019 12:48:47 PM</p>

View of LS looking from levee crown

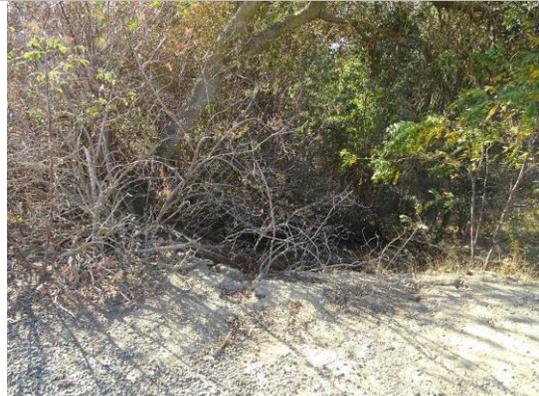
Photo 2 of 3 : UCIP\_SP\_2020\_55681\_82404.jpg

View of WS looking from levee crown

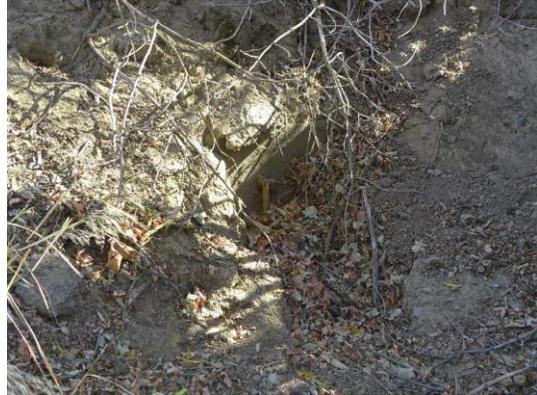
Photo 3 of 3 : UCIP\_SP\_2020\_55681\_82405.jpg

Sediment and debris buildup around flap gate

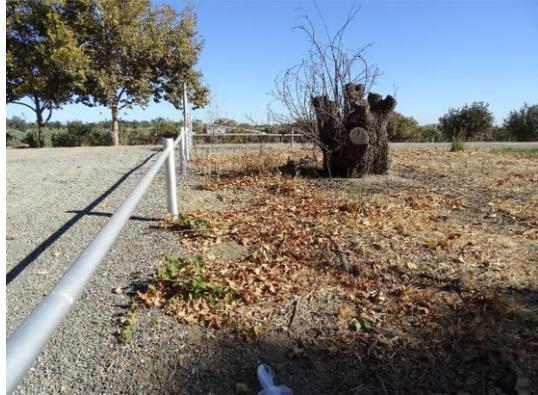
Photo 3 of 3 : UCIP\_SP\_2020\_55682\_82409.jpg

View of WS berm looking towards the gate where 8-inch standpipe found

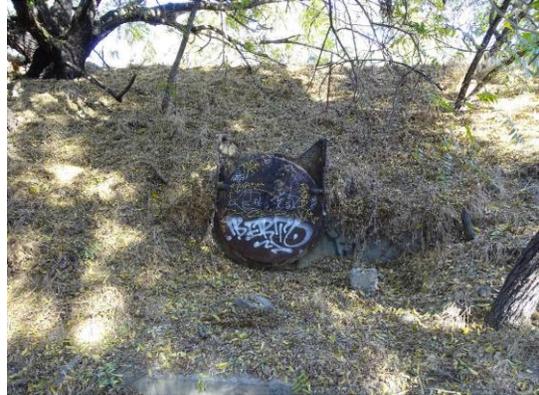
Photo 1 of 3 : UCIP\_SP\_2020\_55684\_82410.jpg

DS\_ID:523  
 FS\_ID:55684  
 EP\_NO: 10247  
 Repair Type: Non-Urgent  
 Crossing Status: Found  
 UCIP Comments: 10/21/2019 Record remains Non-Urgent. Pipe inlet is closed with steel plate bolted to headwall in drainage canal on LS. (O.Yakimov - DWR UCIP)  
 FIELD\_STRUCT\_DESC: \*ABANDONED\* 48-inch corrugated metal drainage pipe through the levee, 15.0 feet below the crown. Steel plate installed over inlet off the landside (LS) toe. Pipe not grouted. Flap gate on waterside (WS) end. Headwalls on both ends. (48-inch pipe [HLM 8.88] authorized under Automatic Board Order (ABO) issued as Permit No. 10247, 1974 - University of California, Office of the Regents). [Additional Reference(s): DWR Levee Log, 2005 (HLM 8.88). USACE Sacramento O&M Manual, Unit 119, December 1952, Revised 29 Dec 2016, (Station 262+30 PCT), 48-inch pipe referenced. USACE As-Built Drawing No. 50-04-2396, Revision 2, pdf page 26, Sheet 10, 24-inch pipe referenced on levee alignment, December 1947].

WS levee slope, headwall, and flap gate

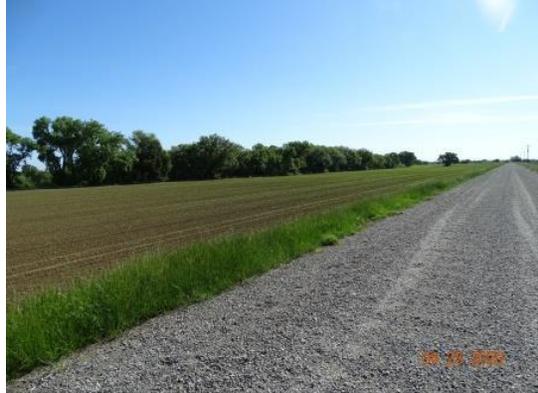
Photo 1 of 1 : SP\_2020\_ST0007\_283\_31\_20200518\_00098.jpg

LM Start	<b>0.02</b>	Rating **	<b>U</b>	Issue No.	<b>31</b>
LM End	<b>2.94</b>	Issue Type +	<b>Ma</b>	Location *	<b>WS</b>
Category	Earthen Levee		GPS Latitude/Longitude		
			Start	End	
Item	Vegetation		38.504950 °	38.515013 °	
			-121.663154 °	-121.709273 °	
DWR ID	DWR_ST0007_02_s_2020_31				
Comment Code					
V1 : Control annual grass and weeds on the levee slopes and easements.					
Inspector Comment

View looking downstream at annual vegetation on the waterside slope (Spring 2020).

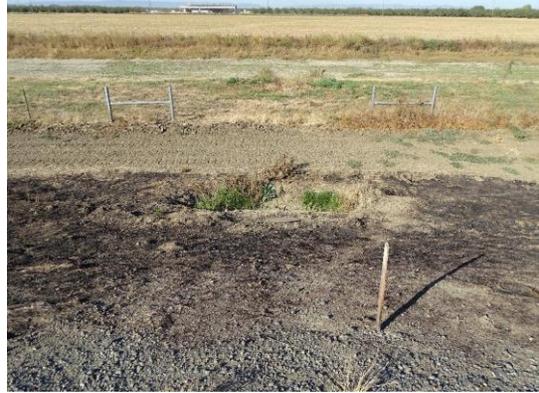
Photo 1 of 3 : UCIP\_SP\_2020\_55423\_81633.jpg

Item	DWR UCIP Field Study		38.507320 °	38.507320 °	
			-121.662799 °	-121.662799 °	
DWR ID	16631				
Comment Code					
Inspector Comment					
<p>DS_ID:16631                      FS_ID:55423                      EP_NO: 10275                      Repair Type: Non-Urgent                      Crossing Status: Found                      UCIP Comments: 10/22/2019 Record updated from No Action Needed to Non-Urgent. Need to have CVFPB review ABO and determine current owner. (O.Yakimov - DWR UCIP)09/21/2017 Pipe was permitted as an irrigation structure under ABO issued as Permit No. 10275. (DWR UCIP - O. Magana)                      FIELD_STRUCT_DESC: 24-inch CIPP-lined corrugated metal drainage pipe through the levee, crossing at angle, 11 feet below the crown. Slide gate on waterside (WS) end. (24-inch pipe [HLM 0.20] authorized under Automatic Board Order (ABO) issued as Permit No. 10275, 1974 - Mary Pereira). [Additional Reference(s): DWR Levee Log, 2005 (HLM 0.20). USACE Sacramento O&amp;M Manual, Unit 119, December 1952, Revised 29 Dec 2016, (Station 12+65), listed as 24-inch pipe. USACE As-Built Drawing No. 50-04-2396, Revision 1, pdf page 20, Sheet 4, December 1947].                      FS Date: 10/22/2019 8:50:15 AM</p>

View of LS looking from levee crown

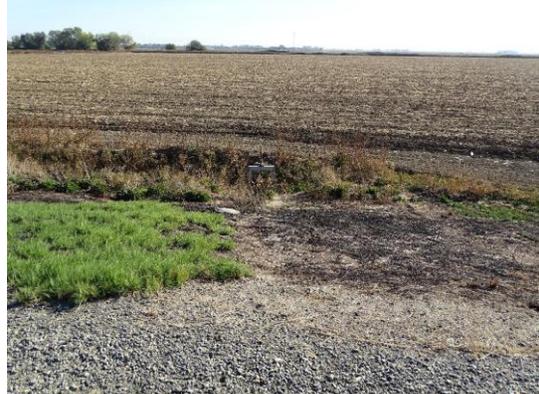
Photo 2 of 3 : UCIP\_SP\_2020\_55423\_81634.jpg

View of WS looking from levee crown

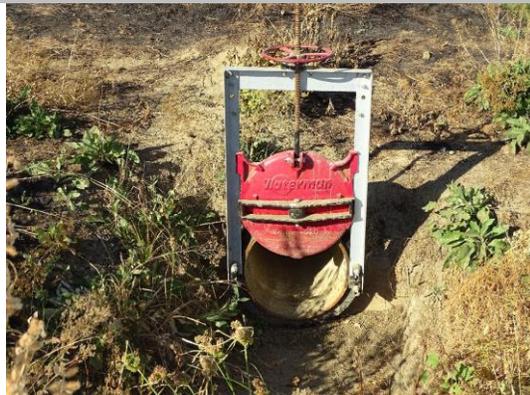
Photo 3 of 3 : UCIP\_SP\_2020\_55423\_81635.jpg

Headwall and slide gate at WS levee toe

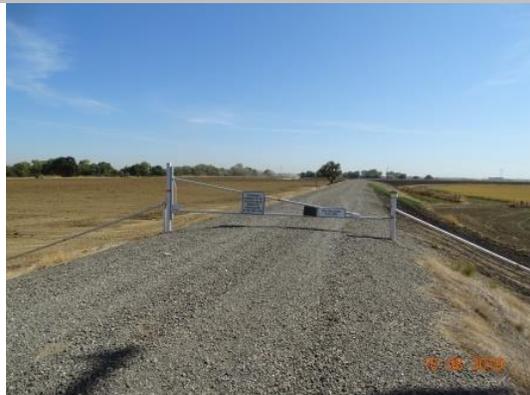
Photo 1 of 1 : SP\_2020\_ST0007\_283\_29\_20200304\_00008.jpg

LM Start	<b>0.55</b>	Rating **	M	Issue No.	<b>29</b>
LM End	<b>0.55</b>	Issue Type +	En	Location *	LS
Category	Earthen Levee			GPS Latitude/Longitude	
				Start	End
Item	Encroachments			38.510249 °	38.510249 °
				-121.667551 °	-121.667551 °
DWR ID	DWR_ST0007_02_s_2013_29				
Comment Code					
FE : Fence					
Inspector Comment					
There is no CVFPB Permit for this gate. DWR - Sac Maintenance Yard installed this gate a few years ago.

View looking downstream at gate on the crown (Fall 2019).

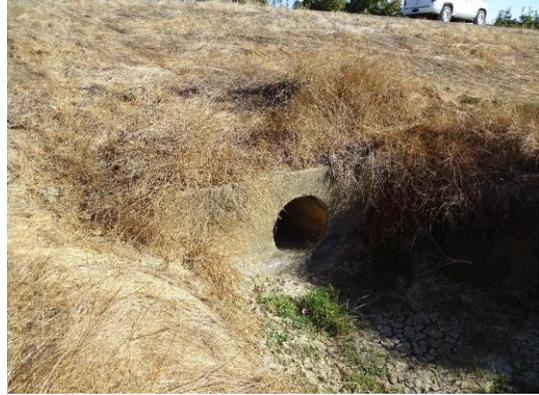
Photo 3 of 3 : UCIP\_SP\_2020\_55424\_81640.jpg

Headwall and pipe at LS toe
