**Flood Control Project Maintenance  
Levee Inspections**  
**LMA District Cover Sheet**  
**Spring 2020 Levee Inspection Results**

**Sacramento Maintenance Yard Putah Creek**

**Spring 2020 Levee Inspection Results**

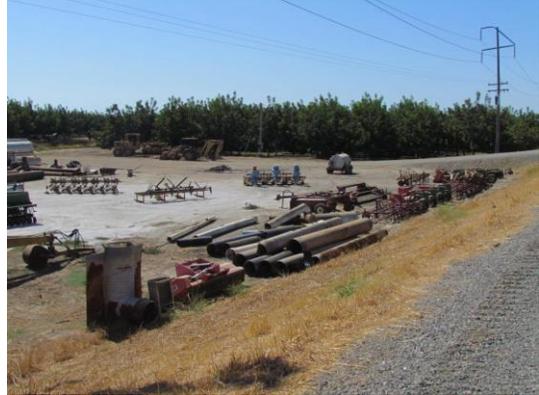
Photo 1 of 1 : SP\_2020\_ST0007\_283\_23\_20200304\_00003.jpg

LM Start	<b>1.01</b>	Rating **	U	Issue No.	<b>23</b>
LM End	<b>1.05</b>	Issue Type +	En	Location *	LS
Category	Earthen Levee			GPS Latitude/Longitude	
				Start	End
Item	Encroachments			38.511402 °	38.511598 °
				-121.675727 °	-121.676413 °
DWR ID	DWR_ST0007_02_f_2016_23				
Comment Code					
EQ : Equipment					
Inspector Comment					
This ag equipment and materials should be moved at least 10 feet away from the LS levee toe.

Levee mile 1.01 landside toe looking upstream.

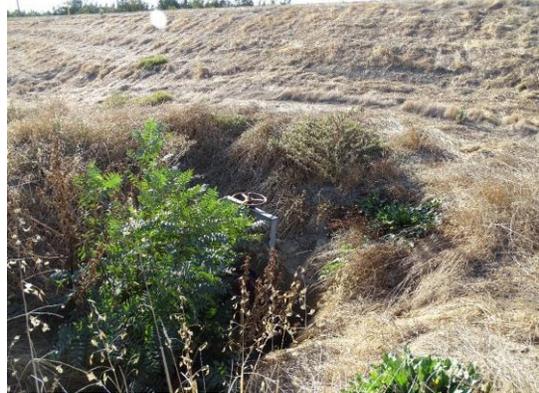
Photo 3 of 3 : UCIP\_SP\_2020\_55426\_81650.jpg

WS levee slope, headwall and slide gate

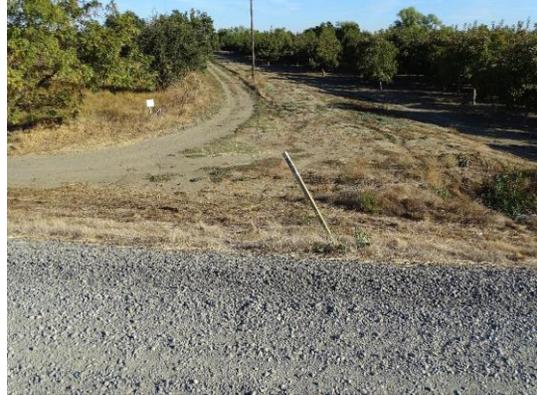
Photo 3 of 3 : UCIP\_SP\_2020\_55427\_81654.jpg

View of WS looking from levee crown

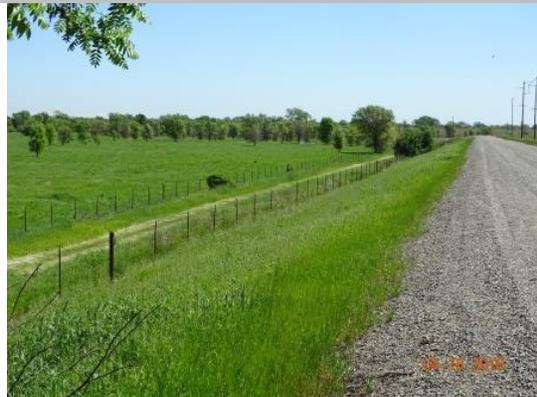
Photo 1 of 1 : SP\_2020\_ST0007\_283\_30\_20200304\_00009.jpg

LM Start	<b>1.62</b>	Rating **	M	Issue No.	<b>30</b>
LM End	<b>2.09</b>	Issue Type +	En	Location *	WS
Category	Earthen Levee			GPS Latitude/Longitude	
				Start	End
Item	Encroachments			38.514372 °	38.515443 °
				-121.686399 °	-121.694841 °
DWR ID	DWR_ST0007_02_s_2019_30				
Comment Code					
FE : Fence					
Inspector Comment					
There is a barbed wire fence on the waterside toe.

View looking downstream at barbed wire fence at the bottom of the waterside slope (Spring 2019).

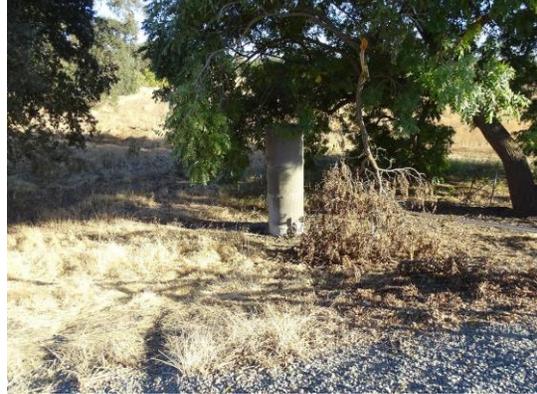
Photo 1 of 3 : UCIP\_SP\_2020\_55428\_81655.jpg

Item	DWR UCIP Field Study		38.515440 °	38.515440 °	
			-121.694920 °	-121.694920 °	
DWR ID	16624				
Comment Code					
Inspector Comment					
DS_ID:16624 FS_ID:55428 EP_NO: 10268 Repair Type: Non-Urgent Crossing Status: Found UCIP Comments: 10/23/2019 Record remains Non-Urgent. Crossing looks abandoned. Headwall and pipe next to the headwall at LS toe is exposed. Pile of tree trimming put on LS along pipe alignment. Unable to locate 10-inch standpipe with gate valve on LS. (O.Yakimov - DWR UCIP)04/09/2012 It is apparent that there is an irrigation pipe sleeved through the 25-inch pipe, but size cannot be determined. (W. Wylie - DWR UCIP) FIELD_STRUCT_DESC: 24-inch corrugated metal irrigation pipe through the levee, 13 feet below the crown. Gate valve on the landside (LS) in 10-inch concrete standpipe. 36-inch standpipe on the waterside (WS) toe. Headwall on the LS toe. (24-inch pipe authorized under Automatic Board Order (ABO) issued as Permit No. 10268, 1974 - Dow Chemical Company). [Additional Reference(s): DWR Levee Log, 2005 (HLM 2.16). USACE Sacramento O&M Manual, Unit 119, December 1952, Revised 29 Dec 2016, (Station P 265+70), listed as 24-inch pipe. USACE As-Built Drawing No. 50-04-2396, Revision 3, pdf page 22, Sheet 6, December 1947]. FS Date: 10/23/2019 12:08:26 PM

View of WS looking from levee crown

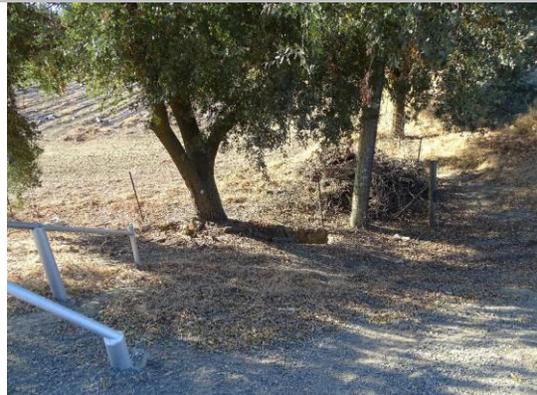
Photo 2 of 3 : UCIP\_SP\_2020\_55428\_81656.jpg

View of LS looking from levee crown

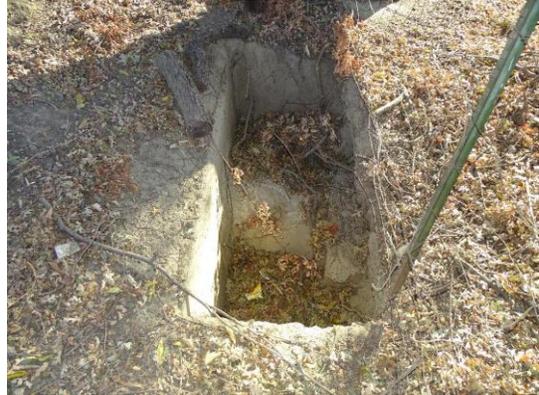
Photo 3 of 3 : UCIP\_SP\_2020\_55428\_81657.jpg

Headwall and pipe exposed at LS toe

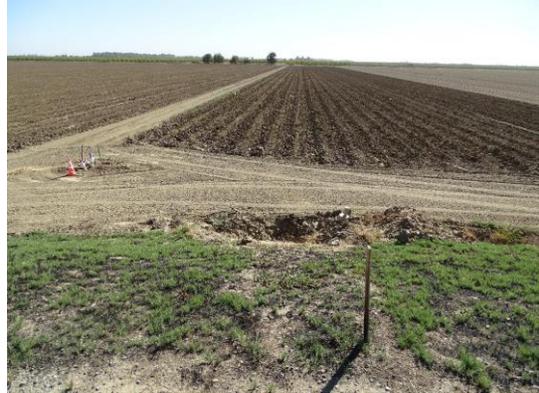
Photo 1 of 3 : UCIP\_SP\_2020\_55411\_81619.jpg

Item	DWR UCIP LMA Responsibility		38.514865 °	38.514865 °	
			-121.703839 °	-121.703839 °	
DWR ID	16625				
Comment Code					
Inspector Comment					
DS_ID:16625 FS_ID:55411 EP_NO: 10277 Repair Type: Urgent Crossing Status: Found UCIP Comments: 10/21/2019 Record updated from No Action Needed to Urgent. A PVC pipe runs through a drainage pipe from LS to WS levee toe. Slide gate cannot be closed properly to prevent flooding on LS. Remove PVC pipe. Need to have CVFPB review ABO and determine current owner. (O.Yakimov - DWR UCIP) FIELD_STRUCT_DESC: 24-inch CIPP-lined corrugated metal drainage pipe through the levee, 9 feet below the crown. Slide gate on the waterside (WS) slope. Concrete headwalls on both ends. (24-inch pipe [HLM 2.71] authorized under Automatic Board Order (ABO) issued as Permit No. 10277, 1974 - Naomi Schoeningh). [Additional Reference(s): DWR Levee Log, 2005 (HLM 2.71). USACE Sacramento O&M Manual, Unit 119, December 1952, Revised 29 Dec 2016, (Station 30+15 PCT), listed as 24-inch pipe. USACE As-Built Drawing No. 50-04-2396, Revision 4, pdf page 23, Sheet 7, December 1947]. FS Date: 10/21/2019 11:18:53 AM

View of LS from levee crown

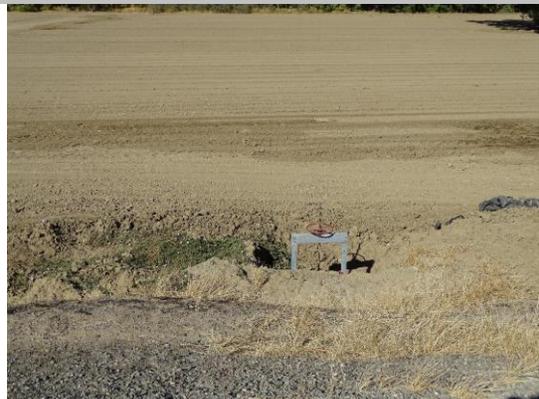
Photo 2 of 3 : UCIP\_SP\_2020\_55411\_81620.jpg

View of WS from levee crown

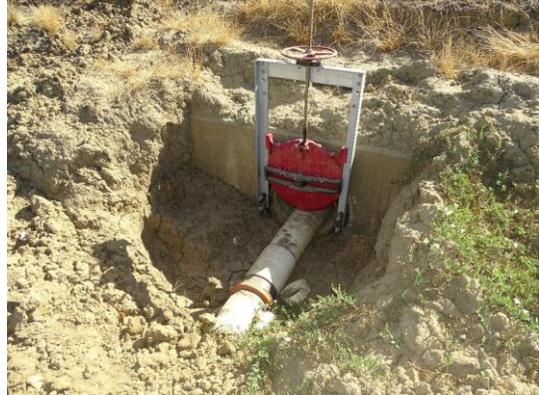
Photo 3 of 3 : UCIP\_SP\_2020\_55411\_81621.jpg

Headwall and slidegate at WS toe with a PVC pipe running through

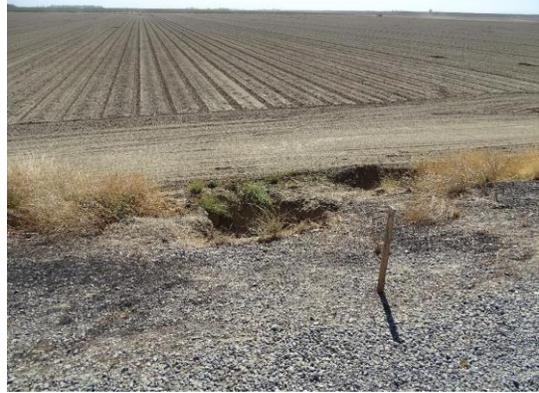
Photo 1 of 3 : UCIP\_SP\_2020\_55412\_81623.jpg

Item	DWR UCIP LMA Responsibility		38.515080 °	38.515080 °	
			-121.711050 °	-121.711050 °	
DWR ID	16626				
Comment Code					
Inspector Comment					
<p>DS_ID:16626                  FS_ID:55412                  EP_NO: 10277                  Repair Type: Urgent                  Crossing Status: Found                  UCIP Comments: 10/21/2019 Record updated from No Action Needed to Urgent. A PVC pipe runs through a drainage pipe from LS to WS levee toe. Slide gate cannot be closed properly to prevent flooding on LS. Remove PVC pipe. Need to have CVFPB review ABO and determine current owner. (O.Yakimov - DWR UCIP)                  FIELD_STRUCT_DESC: 24-inch CIPP-lined corrugated metal drainage pipe through the levee, 9 feet below the crown. Slide gate on the waterside (WS) slope, and headwalls on both sides. (24-inch pipe [HLM 3.11] authorized under Automatic Board Order (ABO) issued as Permit No. 10277, 1974 - Naomi Schoeningh). [Additional Reference(s): DWR Levee Log, 2005 (HLM 3.11). USACE Sacramento O&amp;M Manual, Unit 119, December 1952, Revised 29 Dec 2016, (Station 50+72 PCT), listed as 24-inch pipe. USACE As-Built Drawing No. 50-04-2396, Revision 4, pdf page 23, Sheet 7, December 1947].                  FS Date: 10/21/2019 1:30:39 PM</p>

View of LS from levee crown

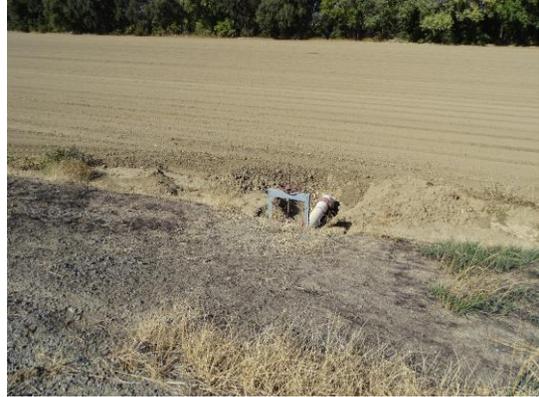
Photo 2 of 3 : UCIP\_SP\_2020\_55412\_81624.jpg

View of WS from levee crown

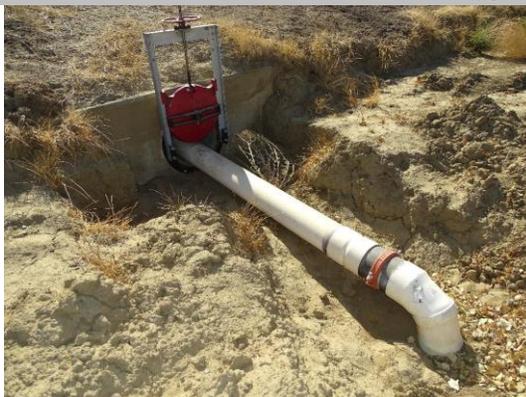
Photo 3 of 3 : UCIP\_SP\_2020\_55412\_81625.jpg

Headwall and slidegate at WS toe with a PVC pipe running through

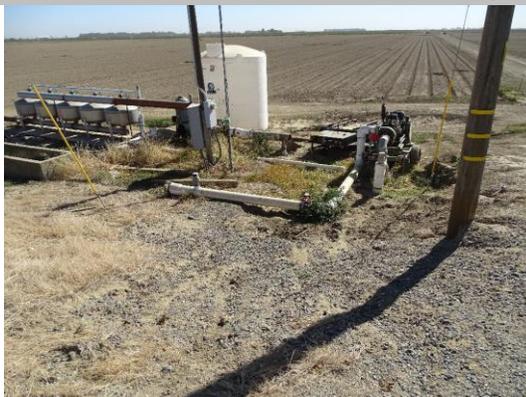
Photo 1 of 3 : UCIP\_SP\_2020\_55431\_81665.jpg

View of LS from levee crown. Water well is disconnected from crossing

Comment Code					
Inspector Comment					
DS_ID:16627 FS_ID:55431 EP_NO: 2273A Repair Type: Non-Urgent Crossing Status: Found UCIP Comments: 10/21/2019 8-inch PVC pipe through the levee or sleeved through an existing 18-inch coated steel irrigation pipe. Unable to verify crossing details through the levee. Water well is disconnected from crossing. See Field Structure Description for more details. (O.Yakimov - DWR UCIP)04/06/2012 WS shoulder air vent looks broken and needs marker. (W. Wylie - DWR UCIP) FIELD_STRUCT_DESC: 8-inch PVC irrigation pipe sleeved through 18-inch coated steel pipe through the levee, 2-feet below the crown. Mobile water pump on the landside (LS). Junction pole, electric box, 8-inch PVC standpipe, and air vent on the waterside off the levee near riverbank. Broken pumping platform in river channel, disconnected steel pipe coming from pumping platform toward PVC standpipe on WS. Air vent on PVC riser at LS toe, air vent on the WS shoulder, and air vent on PVC riser at WS toe. (No permit authorizing modifications found. Original 18-inch pipe authorized under Permit No. 2273-A, 1980 - William B. Schoeningh). [Additional Reference(s): DWR Levee Log, 2005, (HLM 3.26)]. FS Date: 10/21/2019 8:50:12 AM

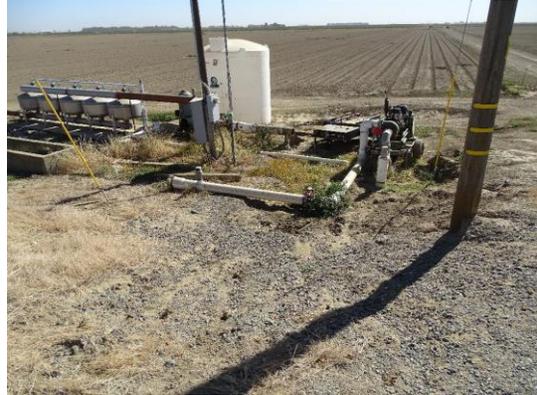
Photo 1 of 3 : UCIP\_SP\_2020\_55432\_81676.jpg

Item	DWR UCIP Field Study		38.515162 °	38.515162 °	
			-121.713653 °	-121.713653 °	
DWR ID	16734				
Comment Code					
Inspector Comment					
DS_ID:16734 FS_ID:55432 EP_NO: 2273 Repair Type: Non-Urgent Crossing Status: Not Found UCIP Comments: 10/21/2019 Record updated from No Action Needed to Non-Urgent. 10-inch steel irrigation pipe not found. Please refer to another crossing at this location dsid 16627. (O.Yakimov - DWR UCIP) 04/06/2012 10-inch looks like it was removed from crown but evidence of connection remains on manifold from pump. No evidence remains on WS slope or toe. (W. Wylie - DWR UCIP) FIELD_STRUCT_DESC: 10-inch steel irrigation pipe through the levee, 2 feet below the crown. Pump on well on the landside (LS). Manifold on LS toe with takeoff for 10-inch pipe. Siphon breaker on the waterside (WS) shoulder. (10-inch pipe authorized under Permit No. 2273, 1956 - P. W. Schoeningh). FS Date: 10/21/2019 10:01:29 AM

View of LS at the crossing looking from levee crown

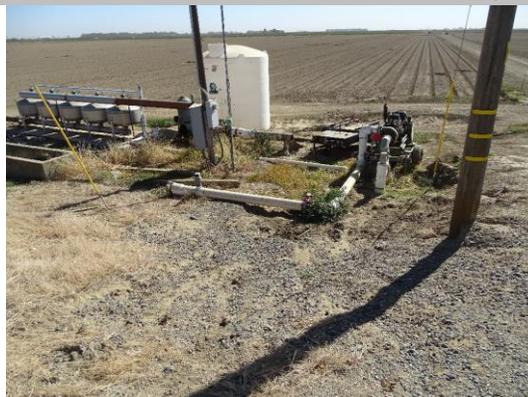
Photo 3 of 3 : UCIP\_SP\_2020\_55432\_81673.jpg

View of LS from levee crown

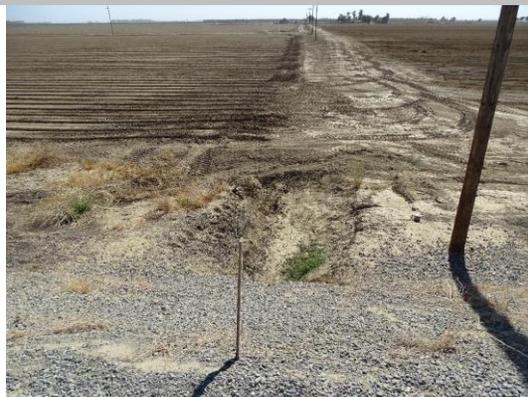
Photo 1 of 3 : UCIP\_SP\_2020\_55433\_81684.jpg

View of LS looking from levee crown

<b>Comment Code</b>					
<b>Inspector Comment</b>					
DS_ID:16628 FS_ID:55433 EP_NO: 10269 Repair Type: Non-Urgent Crossing Status: Found UCIP Comments: 10/21/2019 Record updated from No Action Needed to Non-Urgent. Need to have CVFPB review ABO and determine current owner. (O.Yakimov - DWR UCIP) 09/21/2017 Pipe was permitted as an irrigation structure under ABO issued as Permit No. 10269. (DWR UCIP - O. Magana) FIELD_STRUCT_DESC: 24-inch CIPP-lined corrugated metal irrigation pipe through the levee, 12 feet below the crown. Slide gate on the waterside (WS) end. Concrete headwalls on both ends. (24-inch pipe [HLM 4.02] authorized under Automatic Board Order (ABO) issued as Permit No. 10269, 1974 - Joseph Fahn). [Additional Reference(s): DWR Levee Log, 2005 (HLM 4.02). USACE Sacramento O&M Manual, Unit 119, December 1952, Revised 29 Dec 2016, (Station 98+00 PCT), listed as 24-inch pipe. USACE As-Built Drawing No. 50-04-2396, Revision 4, pdf page 24, Sheet 8, December 1947]. FS Date: 10/21/2019 9:01:36 AM

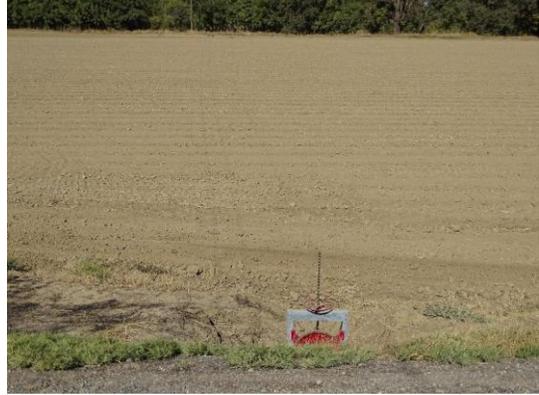
Photo 2 of 3 : UCIP\_SP\_2020\_55433\_81685.jpg

View of WS looking from levee crown

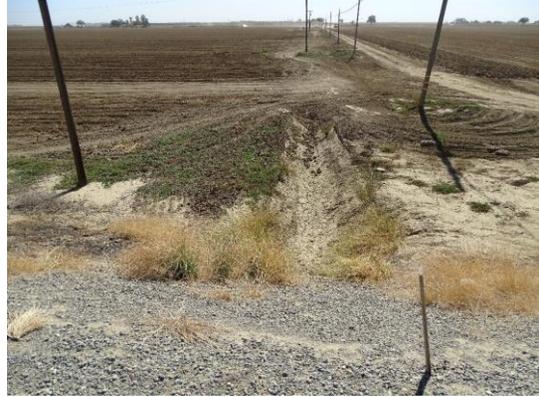
Photo 1 of 3 : UCIP\_SP\_2020\_55434\_81690.jpg

Item	DWR UCIP LMA Responsibility		38.515770 °	38.515770 °	
			-121.731840 °	-121.731840 °	
DWR ID	16629				
Comment Code					
Inspector Comment					
DS_ID:16629 FS_ID:55434 EP_NO: 10269 Repair Type: Non-Urgent Crossing Status: Found UCIP Comments: 10/21/2019 Pipe is partially silted, cleanup pipe. Record updated from No Action Needed to Non-Urgent. Need to have CVFPB review ABO and determine current owner. (O.Yakimov - DWR UCIP) FIELD_STRUCT_DESC: 24-inch CIPP-lined corrugated metal drainage pipe through the levee, 12.5 feet below the crown. Slide gate on the waterside (WS) end. Concrete headwalls on both ends. (24-inch pipe [HLM 4.26] authorized under Automatic Board Order (ABO) issued as Permit No. 10269, 1974 - Joseph Fahn). [Additional Reference(s): DWR Levee Log, 2005 (HLM 4.26). USACE Sacramento O&M Manual, Unit 119, December 1952, Revised 29 Dec 2016, (Station 109+75 PCT), listed as 24-inch pipe. USACE As-Built Drawing No. 50-04-2396, Revision 4, pdf page 24, Sheet 8, December 1947]. FS Date: 10/21/2019 9:16:52 AM

View of LS looking from levee crown

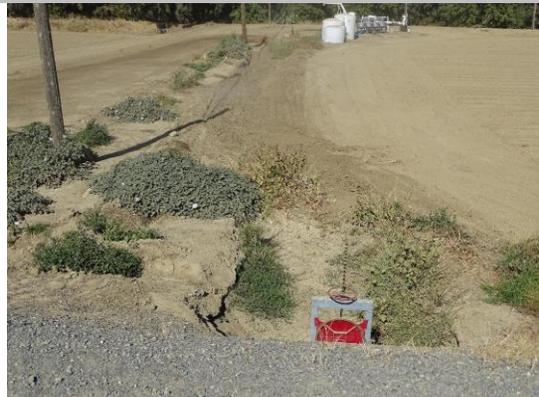
Photo 2 of 3 : UCIP\_SP\_2020\_55434\_81691.jpg

View of WS looking from levee crown

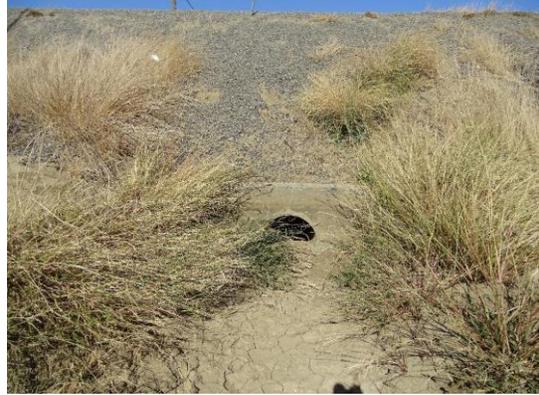
Photo 3 of 3 : UCIP\_SP\_2020\_55434\_81688.jpg

LS slope, headwall and pipe at levee toe

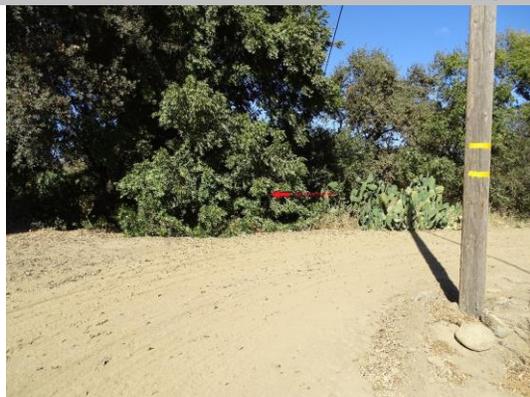
Photo 2 of 3 : UCIP\_SP\_2020\_55435\_81695.jpg

Comment Code					
Inspector Comment					
DS_ID:16630 FS_ID:55435 EP_NO: 10820 Repair Type: Non-Urgent Crossing Status: Indicator Found UCIP Comments: 10/21/2019 Record remains Non-Urgent. No records are available to determine status of line through the levee. Missing gas line marker on both sides of levee. (O.Yakimov - DWR UCIP)04/09/2012 Signs for pipeline need to be updated to state Gas line. Current markers are insufficient. (W. Wylie - DWR UCIP) FIELD_STRUCT_DESC: 4-inch coated steel natural gas pipeline across the channel and levees of Putah Creek, 2 feet below the crown. Approximately 0.5 mile downstream from Old Davis Road. (4-inch line authorized through levees and across channel under Permit No. 10820, 1975 - Dow Chemical). [Additional Reference(s): DWR Levee Log, 2005, (HLM 4.27)]. FS Date: 10/21/2019 9:25:13 AM

Gas line marker under telephone line on riverbank

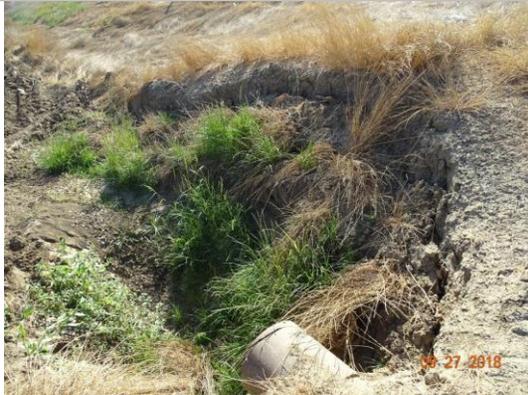
Photo 2 of 2 : SP\_2020\_ST0007\_283\_33\_20200304\_00013.jpg

LM Start	<b>4.66</b>	Rating **	M	Issue No.	<b>33</b>
LM End	<b>4.66</b>	Issue Type +	Ma	Location *	WS
Category	Earthen Levee			GPS Latitude/Longitude	
				Start	End
Item	Erosion / Bank Caving			38.515817 °	38.515817 °
				-121.740942 °	-121.740942 °
DWR ID	DWR_ST0007_02_f_2018_33				
Comment Code					
E2 : Schedule repair of erosion site prior to the next inspection.					
Inspector Comment					
Erosion has not significantly increased from Fall 2019.

View of erosion on the levee slope appears to be due to water from the pipe and trench (September 2018).

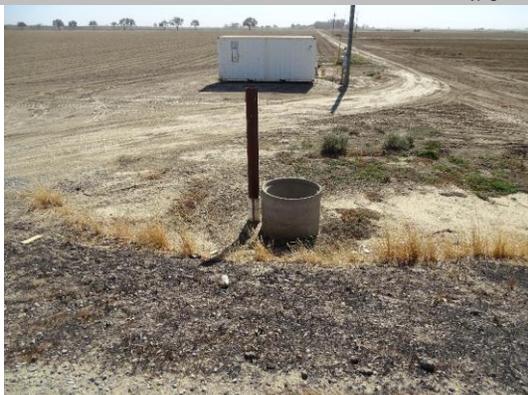
Photo 1 of 3 : UCIP\_SP\_2020\_55436\_81697.jpg

View of LS looking from levee crown. 36-inch standpipe near levee toe

DS\_ID:16644  
 FS\_ID:55436  
 EP\_NO: 10271  
 Repair Type: Non-Urgent  
 Crossing Status: Found  
 UCIP Comments: 10/21/2019 Record updated from No Action Needed to Non-Urgent. Need to have CVFPB review ABO and determine current owner. (O.Yakimov - DWR UCIP)  
 FIELD\_STRUCT\_DESC: 24-inch corrugated metal drainage pipe through the levee, 9.5 feet below the crown. Flap gate on the waterside (WS). 36-inch standpipe on the landside (LS). (24-inch pipe [HLM 4.77] authorized under Automatic Board Order (ABO) issued as Permit No. 10271, 1974 - Ray H. Hamel). [Additional Reference(s): DWR Levee Log, 2005 (HLM 4.77). USACE Sacramento O&M Manual, Unit 119, December 1952, Revised 29 Dec 2016, (Station 136+40 PCT), listed as 24-inch pipe. USACE As-Built Drawing No. 50-04-2396, Revision 4, pdf page 24, Sheet 8, December 1947].  
 FS Date: 10/21/2019 9:46:01 AM

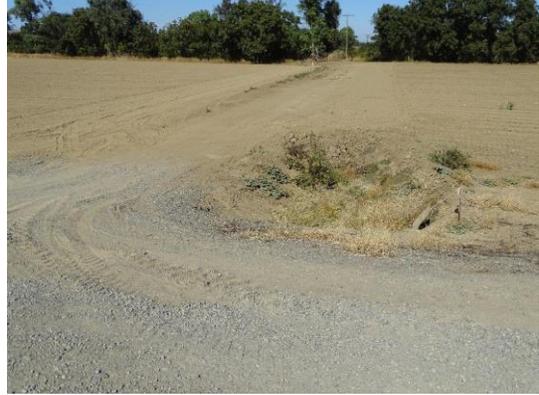
Photo 2 of 3 : UCIP\_SP\_2020\_55436\_81698.jpg

View of WS looking from levee crown

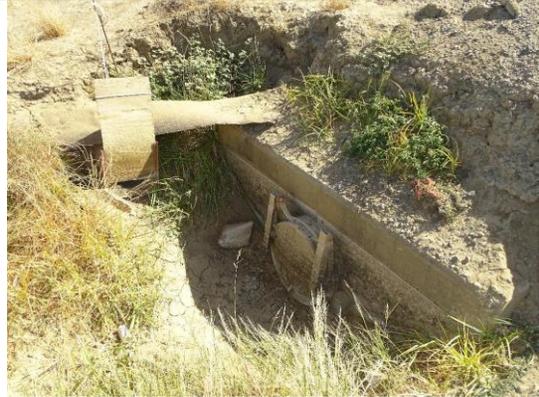
Photo 3 of 3 : UCIP\_SP\_2020\_55436\_81699.jpg

Headwall and flap gate at WS levee toe

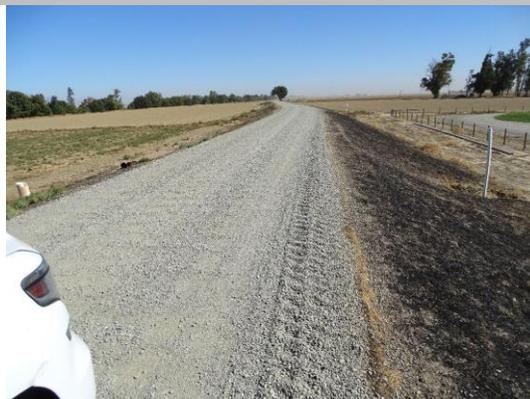
Photo 1 of 3 : UCIP\_SP\_2020\_55438\_81702.jpg

Item	DWR UCIP Field Study		38.515332 °	38.515332 °	
			-121.748533 °	-121.748533 °	
DWR ID	16632				
Comment Code					
Inspector Comment					
DS_ID:16632 FS_ID:55438 EP_NO: 10279 Repair Type: Non-Urgent Crossing Status: Indicator Found UCIP Comments: 10/21/2019 Record remains Non-Urgent. PVC pipe is capped on LS levee slope at the standpipe. Damaged PVC standpipe on WS. (O.Yakimov-DWR UCIP) 04/06/2012 Pipe and headwalls are completely buried on both sides of levee. 15-inch pipe permitted to sleeve through the 24-inch CMP. Indication that 15-inch pipe is at crossing. (W. Wylie - DWR UCIP) FIELD_STRUCT_DESC: 15-inch polyvinyl chloride (PVC) irrigation pipe grouted within an existing 24-inch corrugated metal irrigation pipe through the levee, 10 feet below the crown. Slide gate on the waterside (WS) end. Concrete headwall on landside (LS) end. (15-inch pipe authorized under Permit No. 17552, 2003 - Albert Martinelli), (24-inch pipe [HLM 5.19] authorized under Automatic Board Order (ABO) issued as Permit No. 10279, 1974 - Carmelita Watkins). [Additional Reference(s): DWR Levee Log, 2005 (HLM 5.19). USACE Sacramento O&M Manual, Unit 119, December 1952, Revised 29 Dec 2016, (Station 158+60 PCT), listed as 24-inch pipe. USACE As-Built Drawing No. 50-04-2396, Revision 4, pdf page 25, Sheet 9, December 1947]. FS Date: 10/21/2019 10:19:59 AM

Levee crown at crossing

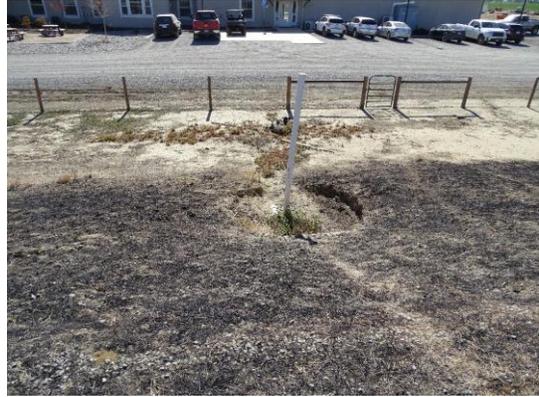
Photo 2 of 3 : UCIP\_SP\_2020\_55438\_81703.jpg

View of LS looking from levee crown

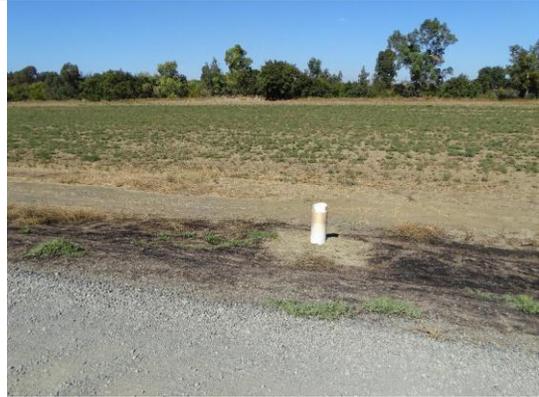
Photo 3 of 3 : UCIP\_SP\_2020\_55438\_81704.jpg

LM Start	<b>5.07</b>	Rating **	M	Issue No.	<b>70 (cont)</b>
LM End	<b>5.07</b>	Issue Type +	En	Location *

View of WS looking from levee crown

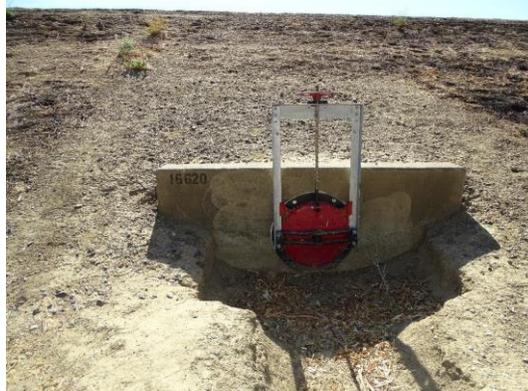
Photo 3 of 3 : UCIP\_SP\_2020\_55439\_81709.jpg

LM Start	<b>5.44</b>	Rating **	M	Issue No.	<b>71 (cont)</b>
LM End	<b>5.44</b>	Issue Type +	Ma	Location *	
Category	Supplemental			GPS Latitude/Longitude	
				Start	End
Item	DWR UCIP LMA Responsibility			38.515369 °	38.515369 °
				-121.755247 °	-121.755247 °
DWR ID	16620

WS levee slope, headwall and slide gate

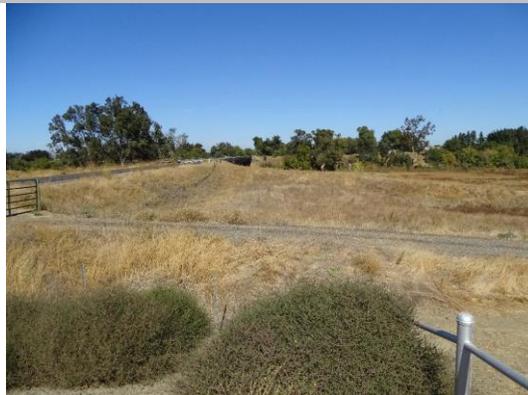
Photo 1 of 2 : UCIP\_SP\_2020\_55441\_81712.jpg

LM Start	<b>5.53</b>	Rating **	M	Issue No.	<b>72</b>
LM End	<b>5.53</b>	Issue Type +	En	Location *	
Category	Supplemental			GPS Latitude/Longitude	
				Start	End
Item	DWR UCIP Field Study			38.515536 °	38.515536 °
				-121.756984 °	-121.756984 °
DWR ID	16634

View of WS looking from levee crown at potential crossing

Comment Code					
Inspector Comment					
DS_ID:16634 FS_ID:55441 EP_NO: 1603 Repair Type: Non-Urgent Crossing Status: Indicator Found UCIP Comments: 10/21/2019 Record updated from No Action Needed to Non-Urgent. No records are available to determine status of line through the levee. Gas line markers visible near riverbank. Need to install markers on both sides of levee. (O.Yakimov - DWR UCIP) FIELD_STRUCT_DESC: 10-inch high pressure gas line of an unknown material through the levee, 5 feet below the crown. (Permit No. 1603, 1951 - Pacific Gas and Electric Company [PG&E]). [Additional Reference(s): DWR Levee Log, 2005, (HLM 5.67)]. FS Date: 10/21/2019 1:26:07 PM

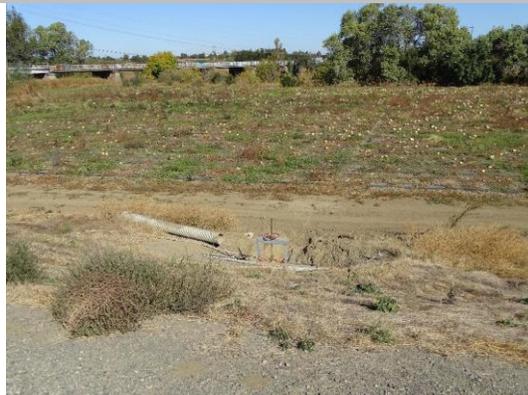
Photo 1 of 3 : UCIP\_SP\_2020\_55419\_81628.jpg

LM Start	<b>5.74</b>	Rating **	U	Issue No.	<b>73</b>
LM End	<b>5.74</b>	Issue Type +	Ma	Location *	
Category	Supplemental			GPS Latitude/Longitude	
				Start	End
Item	DWR UCIP LMA Responsibility			38.516000 °	38.516000 °
				-121.760500 °	-121.760500 °
DWR ID	16636

View of WS from levee crown

Comment Code					
Inspector Comment					
<p>DS_ID:16636                      FS_ID:55419                      EP_NO: 10279                      Repair Type: Urgent                      Crossing Status: Found                      UCIP Comments: 10/21/2019 Rating updated from No Action Needed to Urgent. A 6-inch hose connected to a water well on LS runs through a drainage pipe from LS to WS. Slide gate cannot be closed properly to prevent flooding on LS. Remove hose. (O. Yakimov - DWR UCIP)05/22/2013 Pipe was cleaned by the owner and 6 in pipe is still being used. (C. Lund - DWR Sacramento Yard)                      04/05/2012 Pipe needs to be cleared of sedimentation. (W. Wylie - DWR UCIP)                      FIELD_STRUCT_DESC: 24-inch CIPP-lined corrugated metal drainage pipe through the levee, 14 feet below the crown. Slide gate on the waterside (WS) end. Concrete headwall on landside (LS) end. (name change for existing 24-inch drainpipe and slide gate on WS [HLM 5.89] issued under Permit No. 10279-1, 2012 - Elizabeth Dankworth and Michelle Christison; 24-inch pipe [HLM 5.89] authorized under Automatic Board Order (ABO) issued as Permit No. 10279, 1974 - Carmelita Watkins). [Additional Reference(s): DWR Levee Log, 2005 (HLM 5.89). USACE Sacramento O&amp;M Manual, Unit 119, December 1952, Revised 29 Dec 2016, (Station 193+00 PCT), listed as 24-inch pipe. USACE As-Built Drawing No. 50-04-2396, Revision 4, pdf page 25, Sheet 9, December 1947].                      FS Date: 10/21/2019 1:39:07 PM</p>

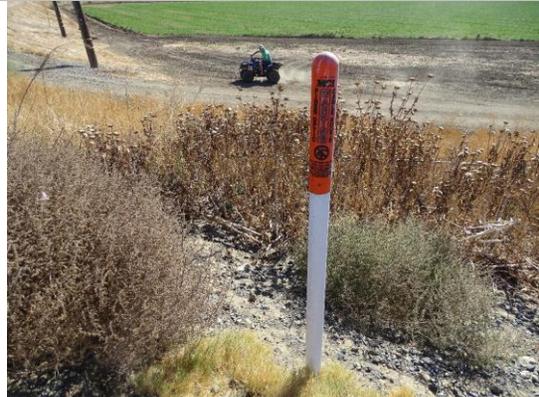
Photo 2 of 2 : UCIP\_SP\_2020\_55444\_81715.jpg

LM Start	<b>5.82</b>	Rating **	M	Issue No.	<b>76</b>
LM End	<b>5.82</b>	Issue Type +	En	Location *	
Category	Supplemental		GPS Latitude/Longitude		
			Start	End	
Item	DWR UCIP Field Study		38.516171 °	38.516171 °	
			-121.762037 °	-121.762037 °	
DWR ID	17763				
Comment Code					
Inspector Comment					
DS_ID:17763 FS_ID:55444 EP_NO: N/A Repair Type: Non-Urgent Crossing Status: Indicator Found UCIP Comments: 10/21/2019 Record updated to Non-Urgent. Missing permit for this crossing. (O.Yakimov - DWR UCIP)04/04/2012 No permit identified for this crossing. (W. Wylie - DWR UCIP) FIELD_STRUCT_DESC: Fiber optics line markers on east side of railroad tracks. No permit identified for this crossing. It appears they may be routed under the west side of the railroad bridge inside a 6-inch steel conduit. FS Date: 10/21/2019 1:35:50 PM

LM Start	<b>5.82</b>	Rating **	M	Issue No.	<b>76 (cont)</b>
LM End	<b>5.82</b>	Issue Type +	En	Location *

Line marker closeup view

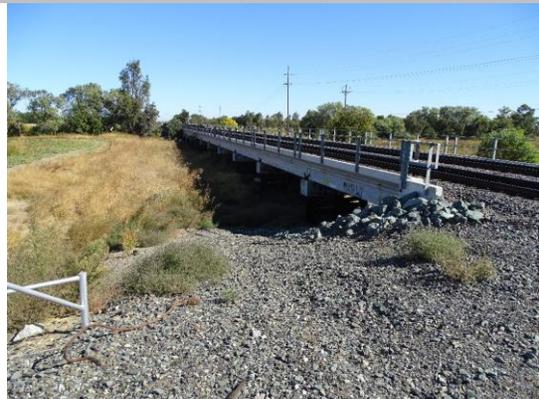
Photo 2 of 2 : UCIP\_SP\_2020\_55445\_81717.jpg

LM Start	<b>5.83</b>	Rating **	M	Issue No.	<b>77</b>
LM End	<b>5.83</b>	Issue Type +	En	Location *	
Category	Supplemental		GPS Latitude/Longitude		
			Start	End	
Item	DWR UCIP Field Study		38.516256 °	38.516256 °	
			-121.762204 °	-121.762204 °	
DWR ID	17764				
Comment Code					
Inspector Comment					
DS_ID:17764 FS_ID:55445 EP_NO: N/A Repair Type: Non-Urgent Crossing Status: Found UCIP Comments: 10/21/2019 Detached fiber optic cable marker found on LS slope. Missing permit for this crossing and cable marker on waterside. (O.Yakimov - DWR UCIP)04/04/2012 No permit identified for crossing. (W. Wylie - DWR UCIP) FIELD_STRUCT_DESC: Fiber optics line markers on west side of railroad tracks. No permit identified for this crossing. FS Date: 10/21/2019 1:39:58 PM

LM Start	<b>5.83</b>	Rating **	M	Issue No.	<b>77 (cont)</b>
LM End	<b>5.83</b>	Issue Type +	En	Location *

View of waterside looking from levee crown

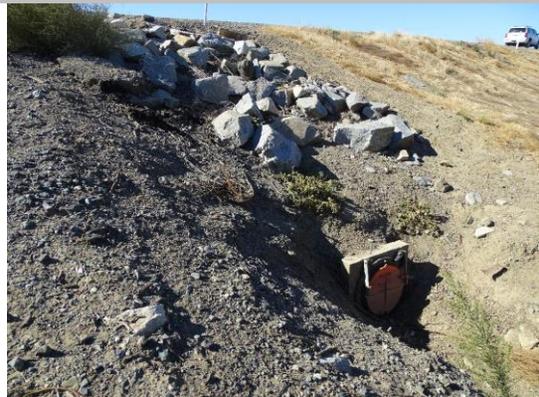
Photo 2 of 3 : UCIP\_SP\_2020\_55446\_81719.jpg

Item	DWR UCIP LMA Responsibility		38.516290 °	38.516290 °	
			-121.762280 °	-121.762280 °	
DWR ID	16639				
Comment Code					
Inspector Comment					
<p>DS_ID:16639                      FS_ID:55446                      EP_NO: 10278                      Repair Type: Non-Urgent                      Crossing Status: Found                      UCIP Comments: 10/21/2019 Record updated from No Action Needed to Non-Urgent. Need to have CVFPB review ABO and determine current owner. (O. Yakimov - DWR UCIP)07/12/2019 After reviewing the USACE O&amp;M manual as-builts there is no reference to this 24-inch pipe. Will need to coordinate with previous UCIP inspector to determine if additional information is available to tie pipe to USACE O&amp;M manual. (O. Magana - DWR UCIP)                      05/22/2013 All material was removed. (C. Lund - DWR Sacramento Yard)                      04/05/2012 Flap gate blocked by minor amounts of sedimentation. (W. Wylie - DWR UCIP)                      FIELD_STRUCT_DESC: 24-inch CIPP-lined corrugated metal drainage pipe through the levee, 15 feet below the crown. Flap gate on waterside (WS) end. Headwall on the landside (LS). (24-inch pipe [HLM 5.99] authorized under Automatic Board Order (ABO) issued as Permit No. 10278, 1974 - Southern Pacific Transportation Company). [Additional Reference(s): DWR Levee Log, 2005, (HLM 5.99). USACE Sacramento O&amp;M Manual 119, December 1952].                      FS Date: 10/21/2019 1:46:38 PM</p>

LM Start	<b>5.84</b>	Rating **	M	Issue No.	<b>78 (cont)</b>
LM End	<b>5.84</b>	Issue Type +	Ma	Location *

View of WS slope and flap gate at levee toe

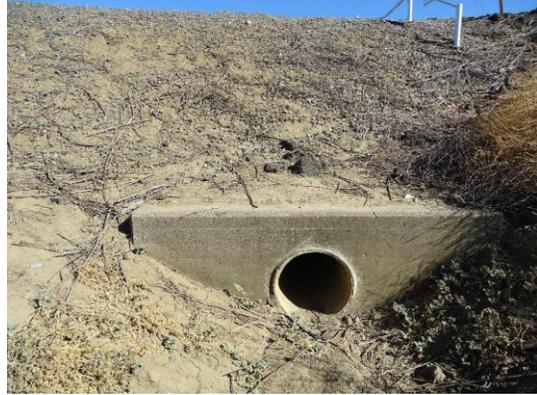
Photo 3 of 3 : UCIP\_SP\_2020\_55446\_81720.jpg

LM Start	<b>5.84</b>	Rating **	M	Issue No.	<b>78 (cont)</b>
LM End	<b>5.84</b>	Issue Type +	Ma	Location *	
Category	Supplemental			GPS Latitude/Longitude	
				Start	End
Item	DWR UCIP LMA Responsibility			38.516290 °	38.516290 °
				-121.762280 °	-121.762280 °
DWR ID	16639

LS levee slope, headwall and pipe

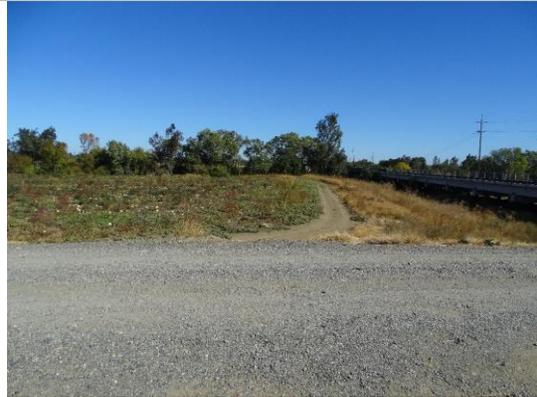
Photo 1 of 3 : UCIP\_SP\_2020\_55447\_81721.jpg

LM Start	<b>5.85</b>	Rating **	M	Issue No.	<b>79</b>
LM End	<b>5.85</b>	Issue Type +	En	Location *	
Category	Supplemental			GPS Latitude/Longitude	
				Start	End
Item	DWR UCIP Field Study			38.516351 °	38.516351 °
				-121.762373 °	-121.762373 °
DWR ID	16638

View of WS looking from levee crown

Comment Code					
Inspector Comment					
DS_ID:16638 FS_ID:55447 EP_NO: 1603 Repair Type: Non-Urgent Crossing Status: Indicator Found UCIP Comments: 10/21/2019 Record updated from No Action Needed to Non-Urgent. No records were available to determine status of line through the levee. Update line markers and install closer to levee toes. (O.Yakimov - DWR UCIP) FIELD_STRUCT_DESC: 6-inch gas line of an unknown material through the levee, 5 feet below the crown. Carsonite marker at toe of landside (LS) ramp. Gas line marker at waterside (WS) creek edge, 380 feet to the north. (Line was authorized under Permit No. 1603, 1951 - Pacific Gas and Electric Company [PG&E]). [Additional Reference(s): DWR Levee Log, 2005, HLM 5.49]. FS Date: 10/21/2019 1:56:54 PM

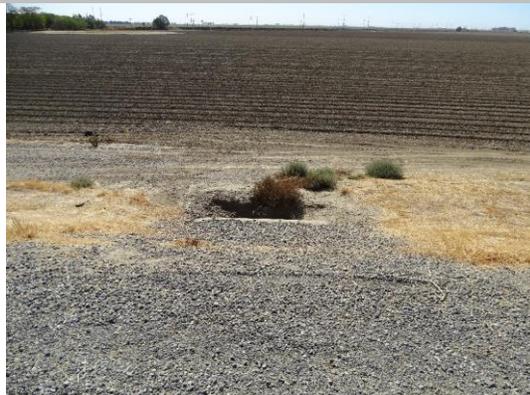
Photo 1 of 3 : UCIP\_SP\_2020\_55448\_81724.jpg

Item	DWR UCIP LMA Responsibility		38.516658 °	38.516658 °	
			-121.765572 °	-121.765572 °	
DWR ID	16641				
Comment Code					
Inspector Comment					
DS_ID:16641 FS_ID:55448 EP_NO: 10265 Repair Type: Non-Urgent Crossing Status: Found UCIP Comments: 10/21/2019 Record updated from No Action Needed to Non-Urgent. Need to have CVFPB review ABO and determine current owner. (O.Yakimov - DWR UCIP)04/05/2012 Pipe has some sedimentation buildup internally. (W. Wylie - DWR UCIP) FIELD_STRUCT_DESC: 24-inch CIPP-lined corrugated metal drainage pipe through the levee, 11 feet below the crown. Slide gate on the waterside (WS) end. Concrete headwall on the landside (LS) end. (24-inch pipe [HLM 6.19] authorized under Automatic Board Order (ABO) issued as Permit No. 10265, 1974 - State of California, Division of Highways. Also included in Automatic Board Order (ABO) issued as Permit No. 11296, 1974 - Capitol National Bank of Sacramento and Crocker Citizens National Bank). [Additional Reference(s): DWR Levee Log, 2005 (HLM 6.19). USACE Sacramento O&M Manual, Unit 119, December 1952, Revised 29 Dec 2016, (Station 208+00 PCT), listed as 24-inch pipe. USACE As-Built Drawing No. 50-04-2396, Revision 4, pdf page 25, Sheet 9, December 1947]. FS Date: 10/21/2019 2:08:05 PM

View of LS looking from levee crown

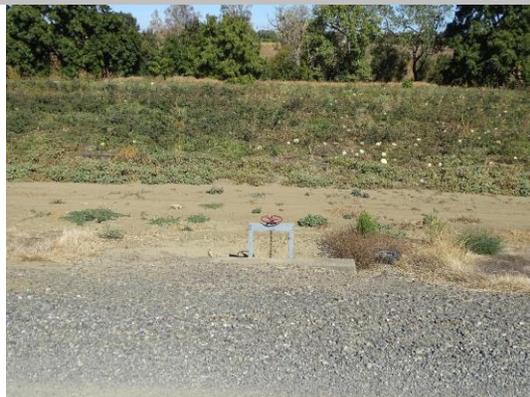
Photo 2 of 3 : UCIP\_SP\_2020\_55448\_81725.jpg

LM Start	<b>6.02</b>	Rating **	M	Issue No.	<b>80 (cont)</b>
LM End	<b>6.02</b>	Issue Type +	Ma	Location *

View of WS looking from levee crown

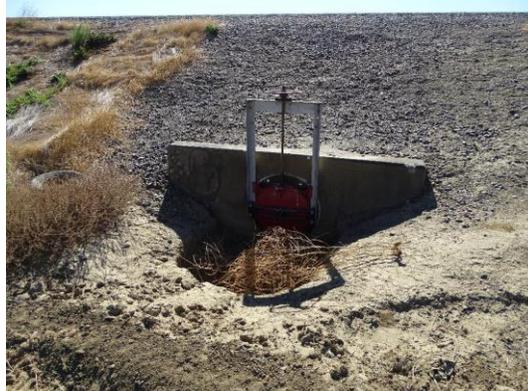
Photo 3 of 3 : UCIP\_SP\_2020\_55448\_81726.jpg

LM Start	<b>6.02</b>	Rating **	M	Issue No.	<b>80 (cont)</b>
LM End	<b>6.02</b>	Issue Type +	Ma	Location *	
Category	Supplemental			GPS Latitude/Longitude	
				Start	End
Item	DWR UCIP LMA Responsibility			38.516658 °	38.516658 °
				-121.765572 °	-121.765572 °
DWR ID	16641

WS levee slope, headwall, and slide gate

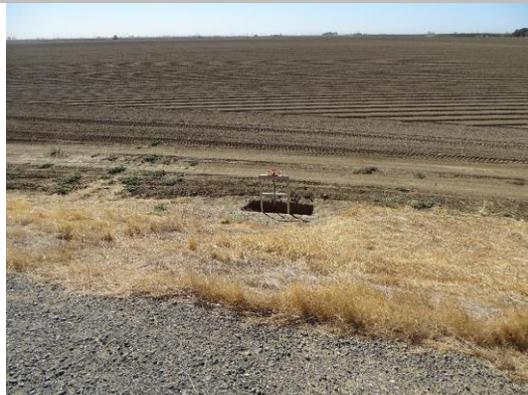
Photo 1 of 3 : UCIP\_SP\_2020\_55450\_81729.jpg

LM Start	<b>6.34</b>	Rating **	M	Issue No.	<b>81</b>
LM End	<b>6.34</b>	Issue Type +	Ma	Location *	
Category	Supplemental			GPS Latitude/Longitude	
				Start	End
Item	DWR UCIP LMA Responsibility			38.517199 °	38.517199 °
				-121.771262 °	-121.771262 °
DWR ID	16642

View of LS looking from levee crown

DS\_ID:16642  
 FS\_ID:55450  
 EP\_NO: 10265  
 Repair Type: Non-Urgent  
 Crossing Status: Found  
 UCIP Comments: 10/21/2019 Record remains Non-Urgent. Need to have CVFPB review ABO and determine current owner. (O. Yakimov - DWR UCIP)07/12/2019 After reviewing the USACE O&M manual as-builts there is no reference to this 30-inch pipe. Will need to coordinate with previous UCIP inspector to determine if additional information is available to tie pipe to USACE O&M manual. (O. Magana - DWR UCIP) 04/10/2019 There is no more debris around pipe. And is now sprayed and maintained. (J. McCabe - DWR Sacramento yard) 04/01/2019 Debris buildup at WS outlet.  
 FIELD\_STRUCT\_DESC: 30-inch CIPP-lined drainage pipe of an unknown material through the levee, 17 feet below the crown. Headwall and slide gate on the landside (LS) end. Flap gate on the waterside (WS) end, 120 feet to the north of the crossing. (36-inch pipe [HLM 6.50] authorized under Automatic Board Order (ABO) issued as Permit No. 10265, 1974 - State of California, Division of Highways. Also included in Automatic Board Order (ABO) issued as Permit No. 11296, 1974 - Capitol National Bank of Sacramento and Crocker Citizens National Bank). [Additional Reference(s): DWR Levee Log, 2005, (HLM 6.50), 36-inch pipe listed. USACE Sacramento O&M Manual 119, December 1952].

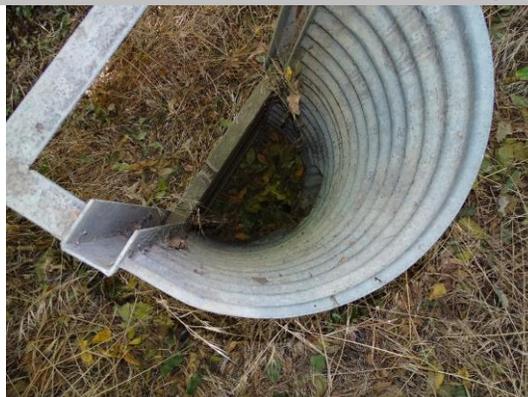
Photo 3 of 3 : UCIP\_SP\_2020\_55451\_81736.jpg

Item	DWR UCIP Field Study		38.517828 °	38.517828 °	
			-121.773010 °	-121.773010 °	
DWR ID	16643				
Comment Code					
Inspector Comment					
DS_ID:16643 FS_ID:55451 EP_NO: 7279 Repair Type: Non-Urgent Crossing Status: Found UCIP Comments: 10/21/2019 Record remains Non-Urgent. Large rootball blocking the outlet on WS. (O.Yakimov - DWR UCIP)04/05/2012 There is no handle on the slide gate operation mechanism and there is a large rootball blocking the outlet on WS. (W. Wylie - DWR UCIP) FIELD_STRUCT_DESC: 48-inch reinforced concrete drainage pipe through the levee, 26 feet below the crown. Slide gate in concrete box on the waterside (WS) slope of the levee. Two drop inlets and weir inlet at the landside (LS) toe. Concrete headwall at outlet. Flap gate on the WS end is off. (Gravity drain was authorized under Permit No. 7279, 1971 - State of California, Department of Public Works, Division of Highways and Bridges). [Additional Reference(s): DWR Levee Log, 2005, (HLM 6.60)]. FS Date: 10/21/2019 2:17:58 PM

LM Start	<b>6.44</b>	Rating **	M	Issue No.	<b>82 (cont)</b>
LM End	<b>6.44</b>	Issue Type +	En	Location *	
Category	Supplemental			GPS Latitude/Longitude	
				Start	End
Item	DWR UCIP Field Study			38.517828 °	38.517828 °
				-121.773010 °	-121.773010 °
DWR ID	16643

Weir inlet in a ditch on LS

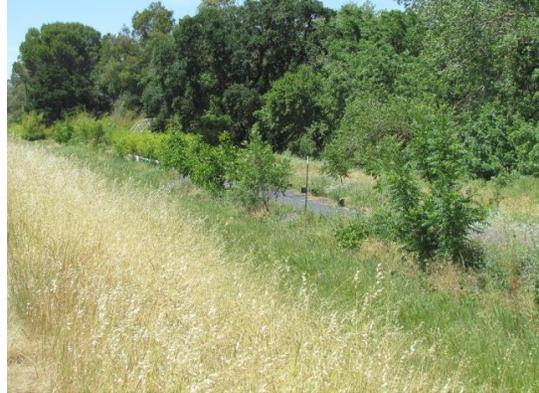
Photo 2 of 2 : SP\_2020\_ST0007\_283\_41\_20200304\_00020.jpg

LM Start	<b>6.53</b>	Rating **	<b>U</b>	Issue No.	<b>41 (cont)</b>
LM End	<b>6.71</b>	Issue Type +	<b>En</b>	Location *	<b>WS</b>
Category	Earthen Levee		GPS Latitude/Longitude		
			Start	End	
Item	Encroachments		38.518497 °	38.519953 °	
			-121.774398 °	-121.777080 °	
DWR ID	DWR_ST0007_02_s_2017_41

Waterward berm landowner has several hundred bamboo plants and other crops on waterside.

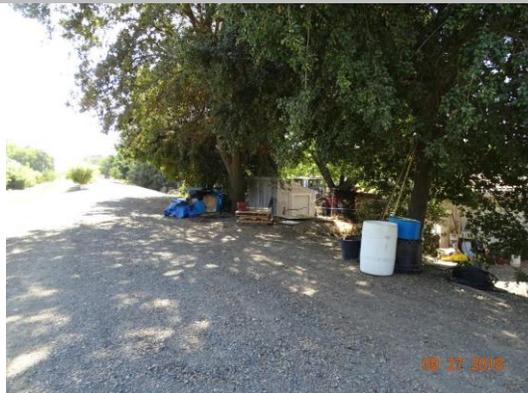
Photo 1 of 1 : SP\_2020\_ST0007\_283\_11\_20200304\_00002.jpg

LM Start	<b>6.64</b>	Rating **	U	Issue No.	<b>11</b>
LM End	<b>6.70</b>	Issue Type +	En	Location *	LS
Category	Earthen Levee		GPS Latitude/Longitude		
			Start	End	
Item	Encroachments		38.519406 °	38.519938 °	
			-121.776052 °	-121.776952 °	
DWR ID	DWR_ST0007_02_s_2012_11				
Comment Code					
MA : Material					
Inspector Comment					
Shipping containers, storage units and other items/debris on the landside easement need to be moved.

View looking downstream at some of the debris on the landside slope almost up to the crown (September 2018).

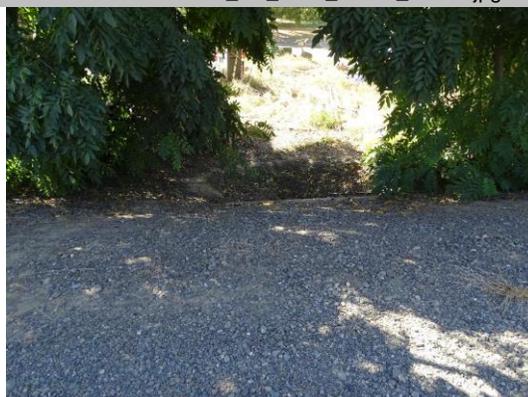
Photo 1 of 3 : UCIP\_SP\_2020\_55452\_81739.jpg

Item	DWR UCIP LMA Responsibility		38.519470 °	38.519470 °	
			-121.776150 °	-121.776150 °	
DWR ID	16633				
Comment Code					
Inspector Comment					
DS_ID:16633 FS_ID:55452 EP_NO: 10276 Repair Type: Non-Urgent Crossing Status: Found UCIP Comments: 10/21/2019 Record remains Non-Urgent. Minor sediment builtup at slide gate. Need to have CVFPB review ABO and determine current owner. (O.Yakimov - DWR UCIP)05/22/2013 Will contact owner of pipe and ask to clean for inspection. (C. Lund - DWR Sacramento Yard) 04/05/2012 Pipe heavily clogged with soil. (W. Wylie - DWR UCIP) FIELD_STRUCT_DESC: 24-inch CIPP-lined drainage pipe of an unknown material through the levee, 6 feet below the crown. Slide gate on the waterside (WS) end, and headwalls on both ends. (24-inch pipe [HLM 6.83] authorized under Automatic Board Order (ABO) issued as Permit No. 10276, 1974 - Patricia Schlages). [Additional Reference(s): DWR Levee Log, 2005 (HLM 6.83). USACE Sacramento O&M Manual, Unit 119, December 1952, Revised 29 Dec 2016, (Station 237+50 PCT), listed as 24-inch pipe. USACE As-Built Drawing No. 50-04-2396, Revision 2, pdf page 26, Sheet 10, December 1947]. FS Date: 10/21/2019 2:32:50 PM

View of LS looking from levee crown

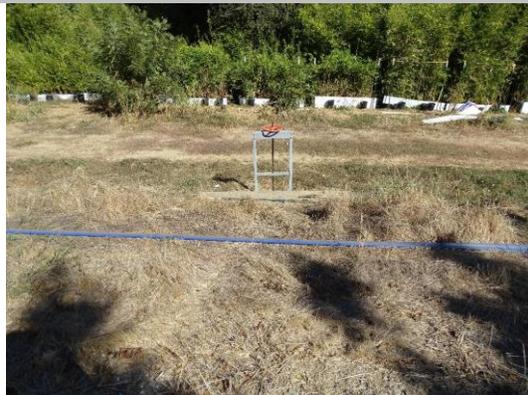
Photo 2 of 3 : UCIP\_SP\_2020\_55452\_81740.jpg

LM Start	<b>6.65</b>	Rating **	M	Issue No.	<b>83 (cont)</b>
LM End	<b>6.65</b>	Issue Type +	Ma	Location *	
Category	Supplemental			GPS Latitude/Longitude	
				Start	End
Item	DWR UCIP LMA Responsibility			38.519470 °	38.519470 °
				-121.776150 °	-121.776150 °
DWR ID	16633

View of WS looking from levee crown

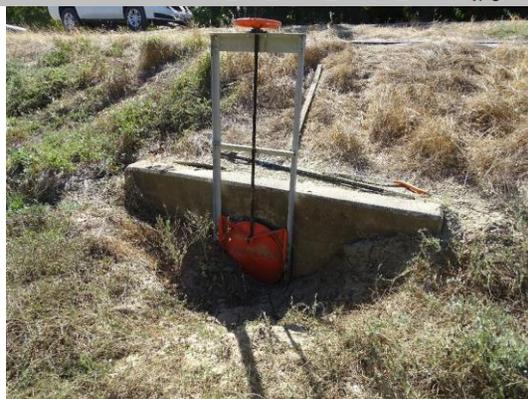
Photo 3 of 3 : UCIP\_SP\_2020\_55452\_81741.jpg

LM Start	<b>6.65</b>	Rating **	M	Issue No.	<b>83 (cont)</b>
LM End	<b>6.65</b>	Issue Type +	Ma	Location *

WS levee slope, headwall, and slide gate

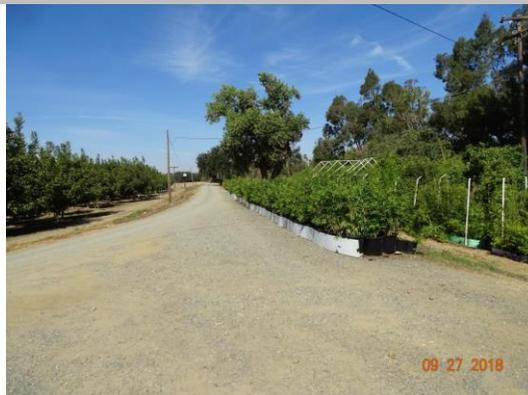
Photo 1 of 1 : SP\_2020\_ST0007\_283\_35\_20200304\_00015.jpg

LM Start	<b>6.71</b>	Rating **	U	Issue No.	<b>35</b>
LM End	<b>6.74</b>	Issue Type +	En	Location *	CR
Category	Earthen Levee			GPS Latitude/Longitude	
				Start	End
Item	Encroachments			38.519980 °	38.520198 °
				-121.777138 °	-121.777535 °
DWR ID	DWR_ST0007_02_f_2018_35				
Comment Code					
TR : Tree or limb					
Inspector Comment					
Remove bamboo pots from waterside crown.

View of bamboo in pots on the crown (September 2018).

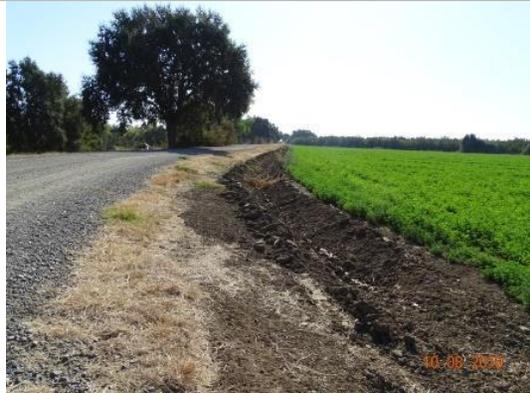
Photo 1 of 1 : SP\_2020\_ST0007\_283\_24\_20200304\_00004.jpg

LM Start	<b>6.82</b>	Rating **	M	Issue No.	<b>24</b>
LM End	<b>7.05</b>	Issue Type +	En	Location *	LS
Category	Earthen Levee		GPS Latitude/Longitude		
			Start	End	
Item	Encroachments		38.520863 °	38.522675 °	
			-121.778703 °	-121.782318 °	
DWR ID	DWR_ST0007_02_f_2019_24				
Comment Code					
DT : Ditch					
Inspector Comment					
Ditch at the landside toe.

View looking downstream at v-ditch at the landside toe (Fall 2019).
