# **Rim Fire: Interactions with BAER Teams**

California Cooperative Snow Survey Meeting  
November 3, 2015

Chris B Graham, PhD  
Water Operations Analyst/Hydrologist  
Hetch Hetchy Water and Power  
Water Enterprise

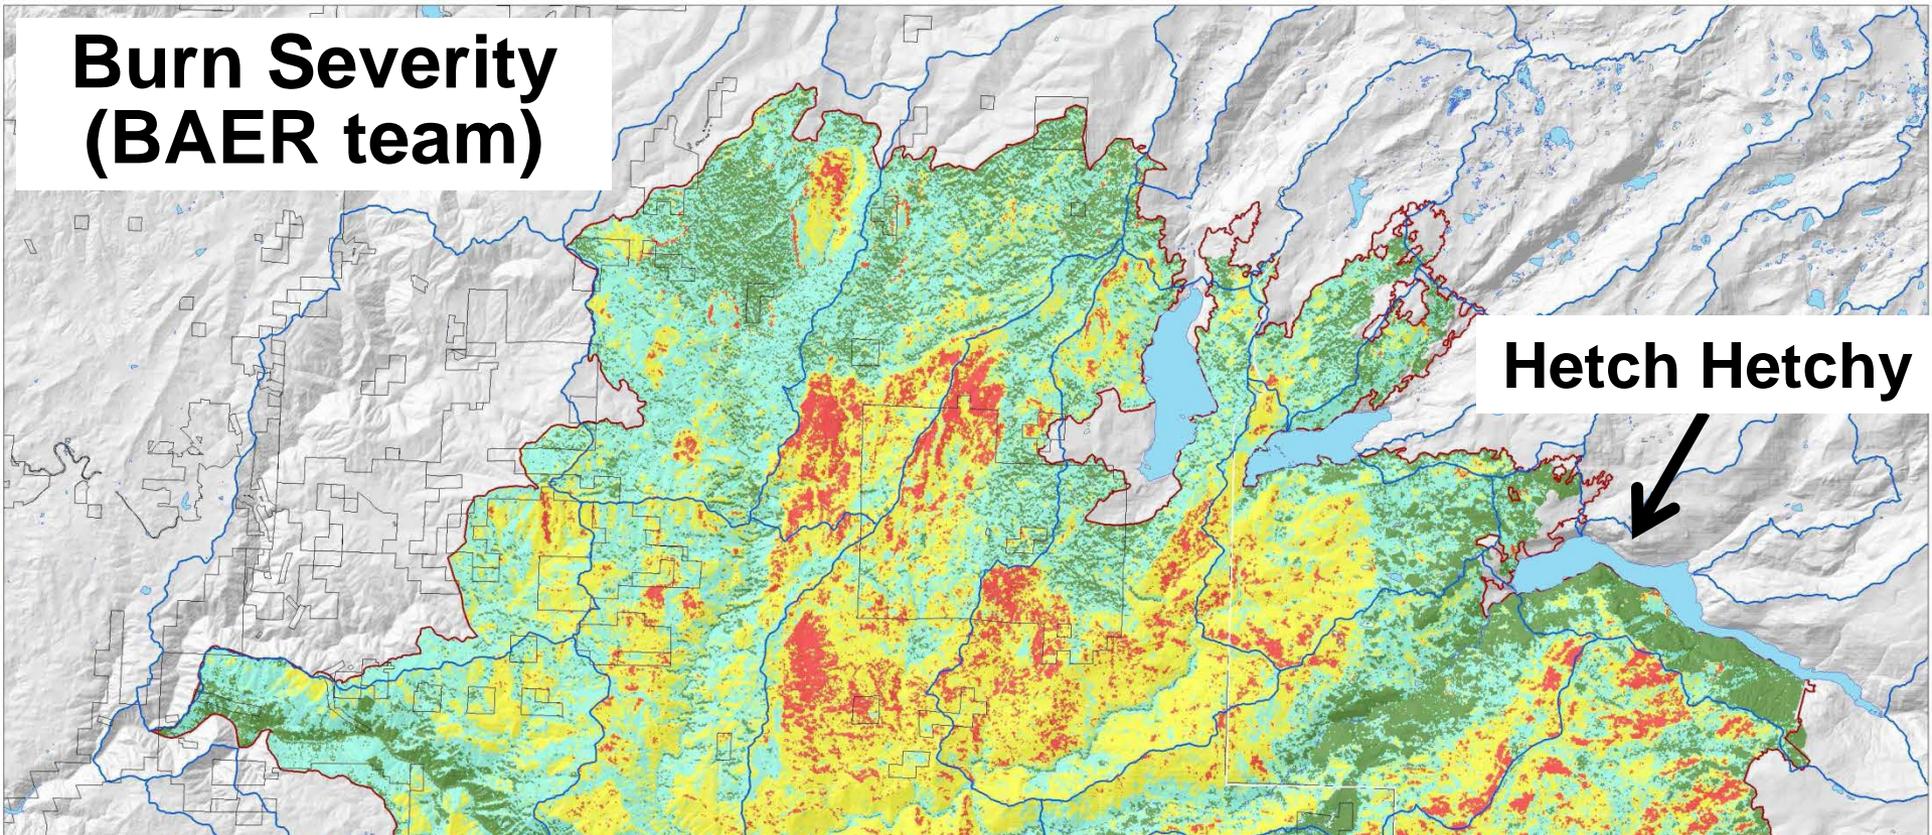
# Burn Severity (BAER team)

**Table 2. Acres burned by Soil Burn Severity**

Soil Burn Severity	Acres
High	16,796
Moderate	94,940
Low	143,225
Unburned	1,934
<b>Total</b>	<b>256,895</b>

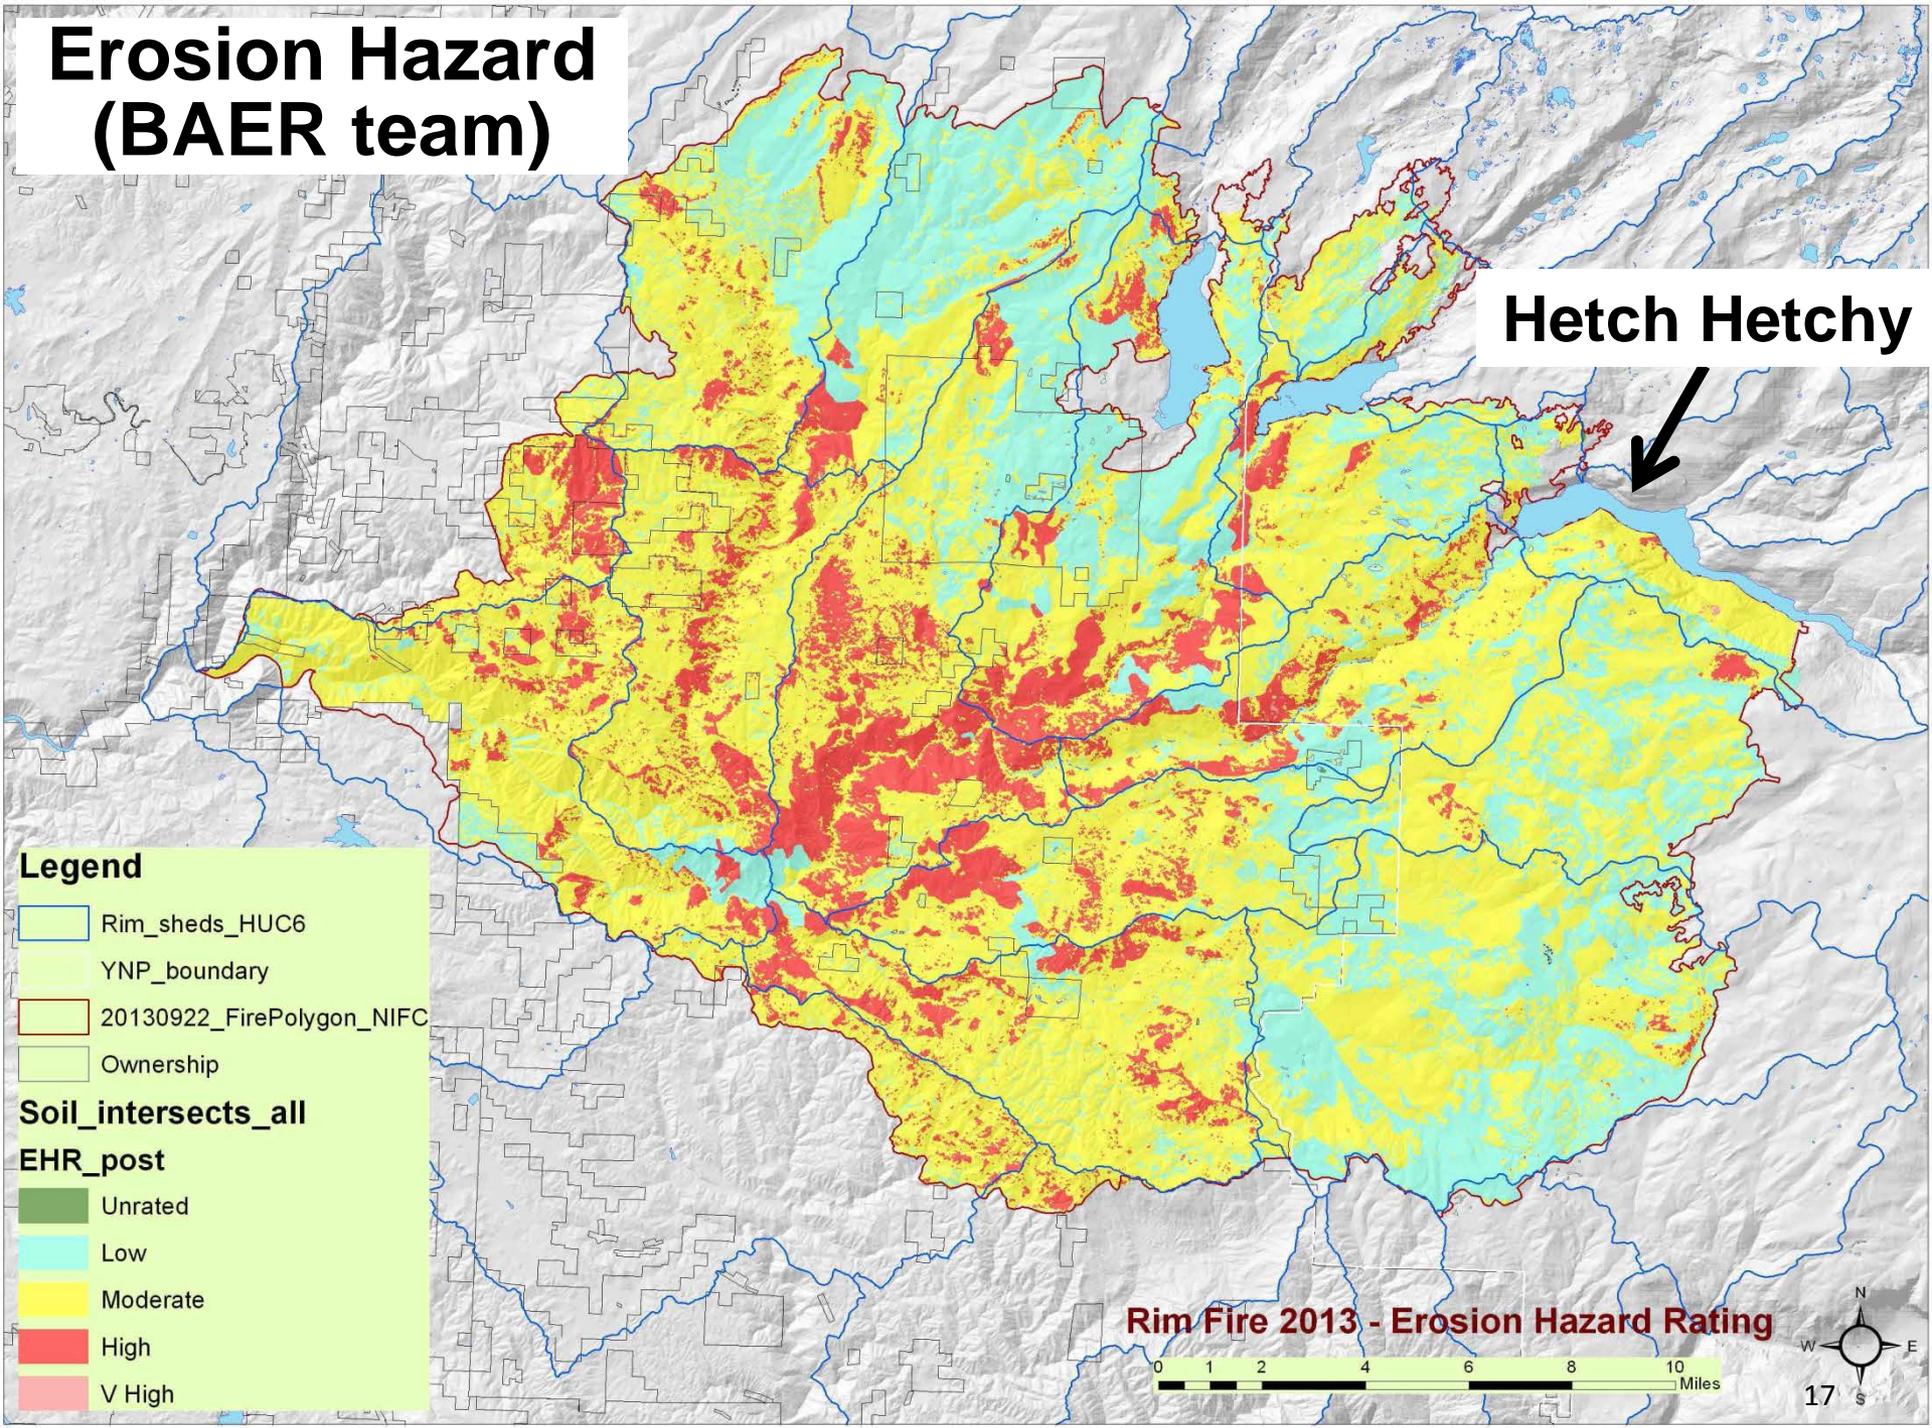
# Erosion Hazard (BAER team)

Rim Fire 2013 - Erosion Hazard Rating

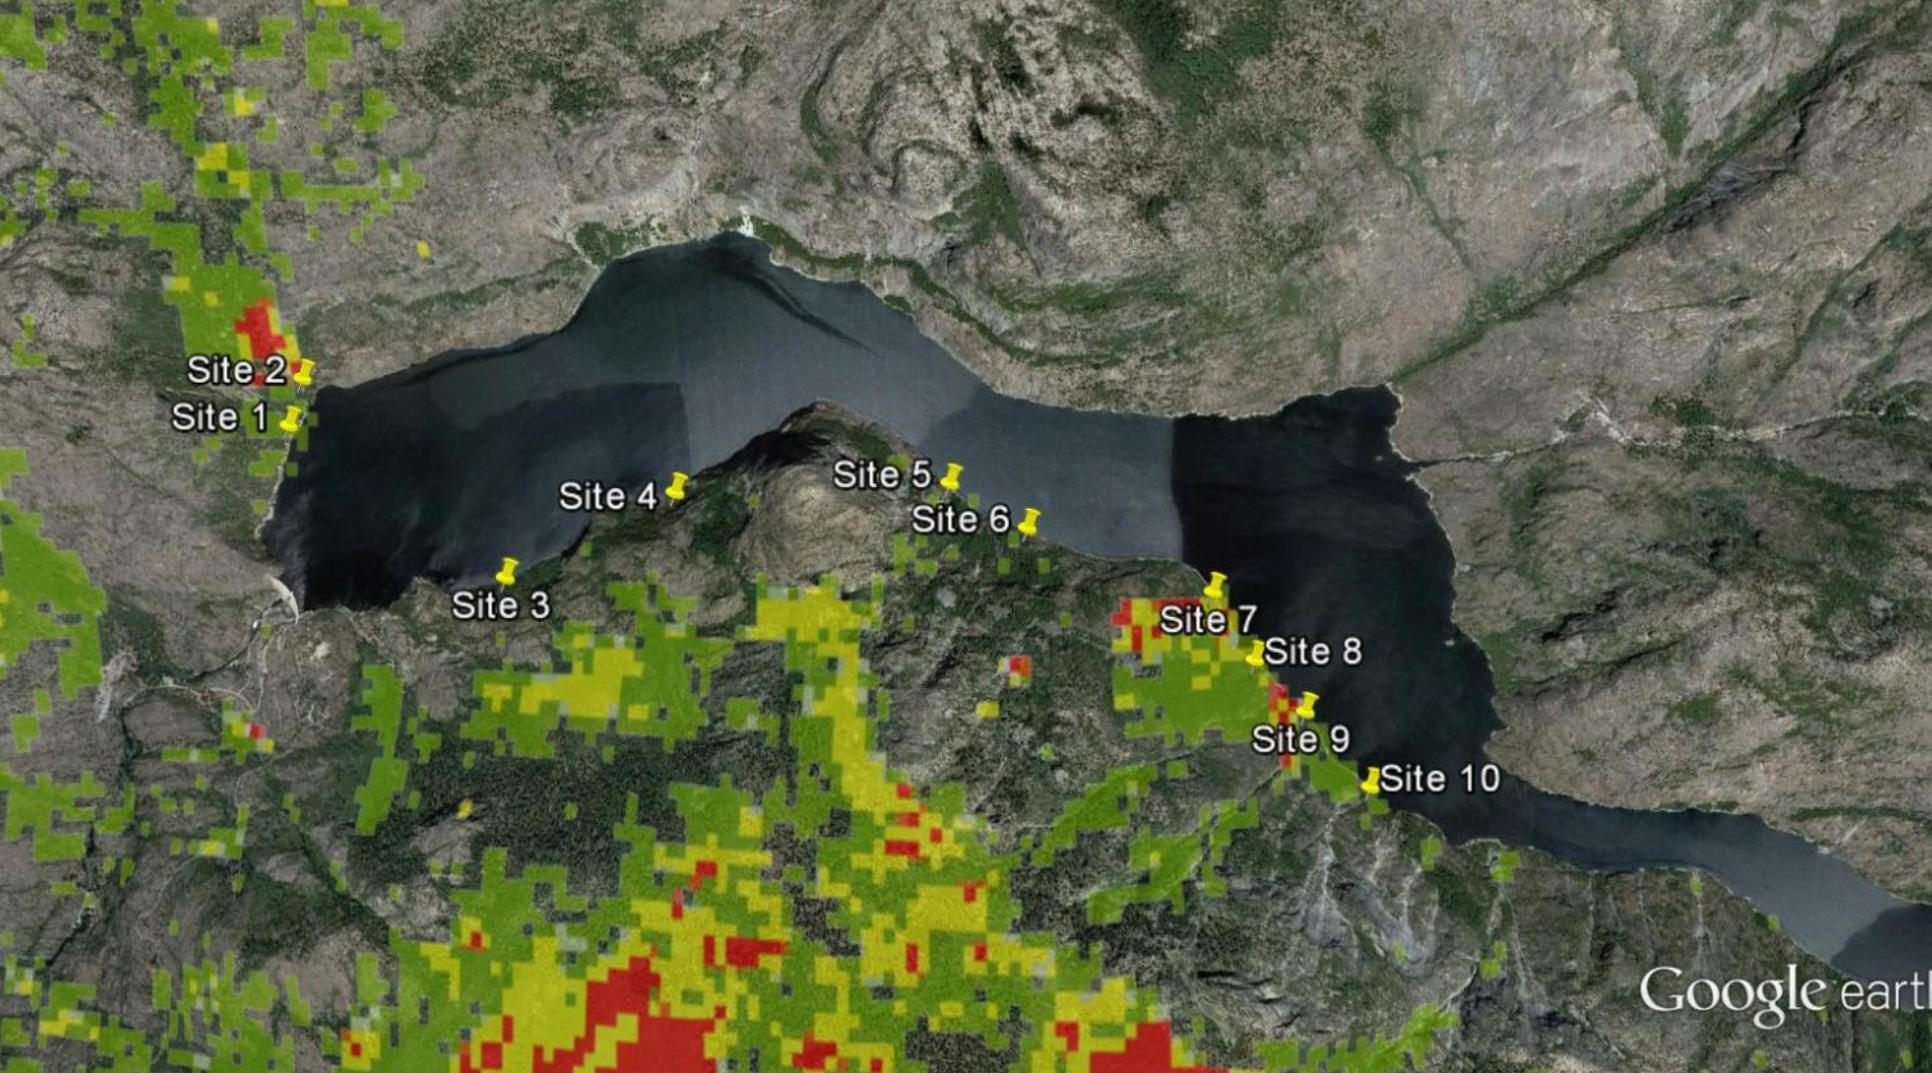
Potential Sediment Increase @ affected locations  
2-3 times for low burn severity sites  
3-4 times for moderate severity sites

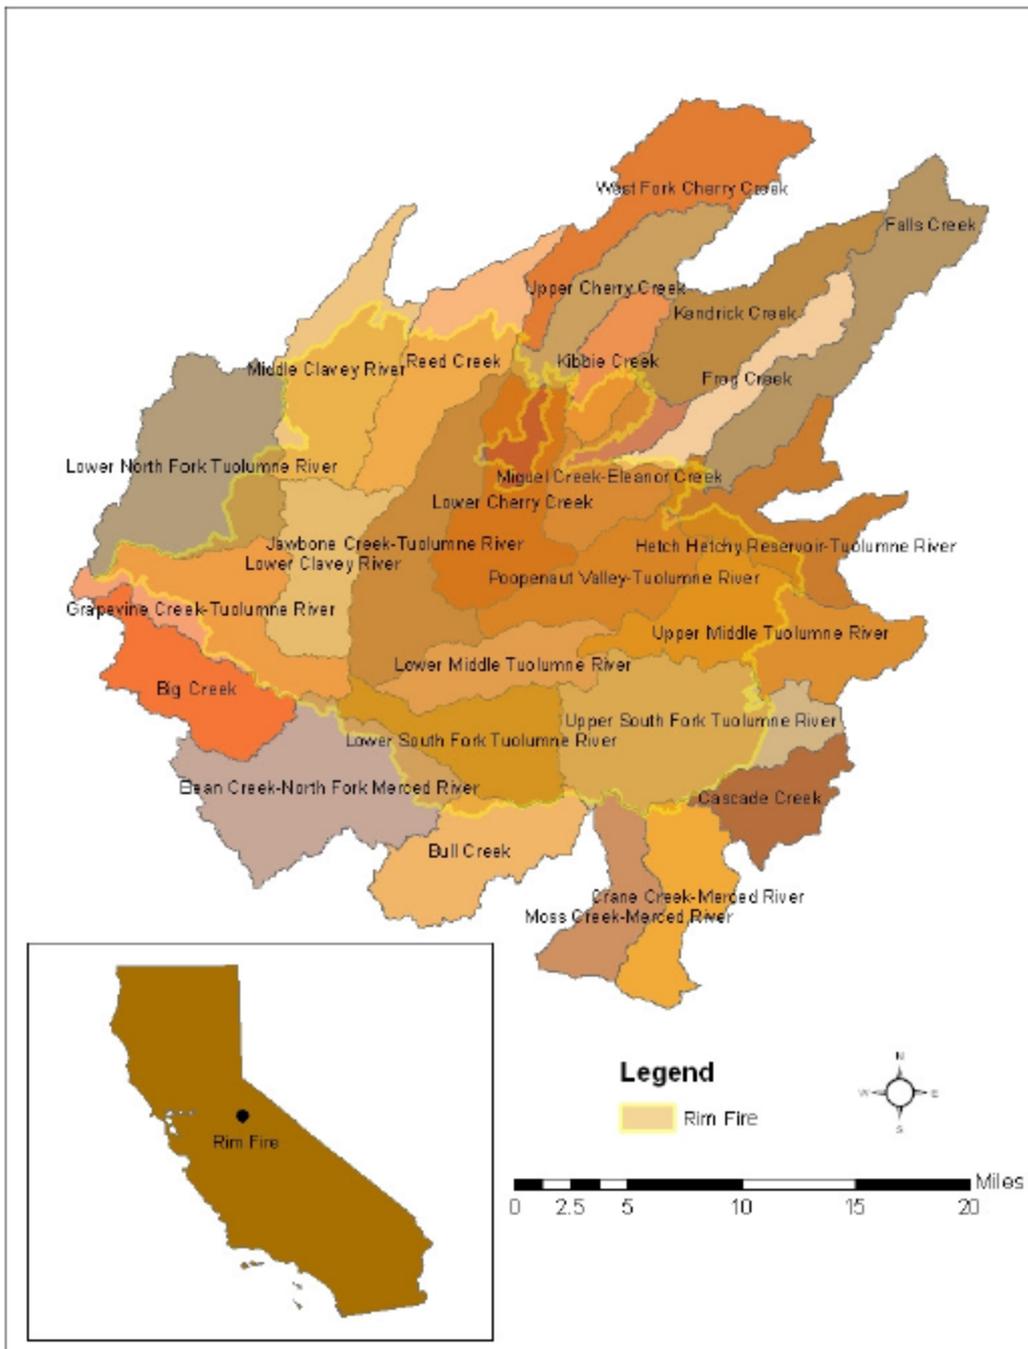
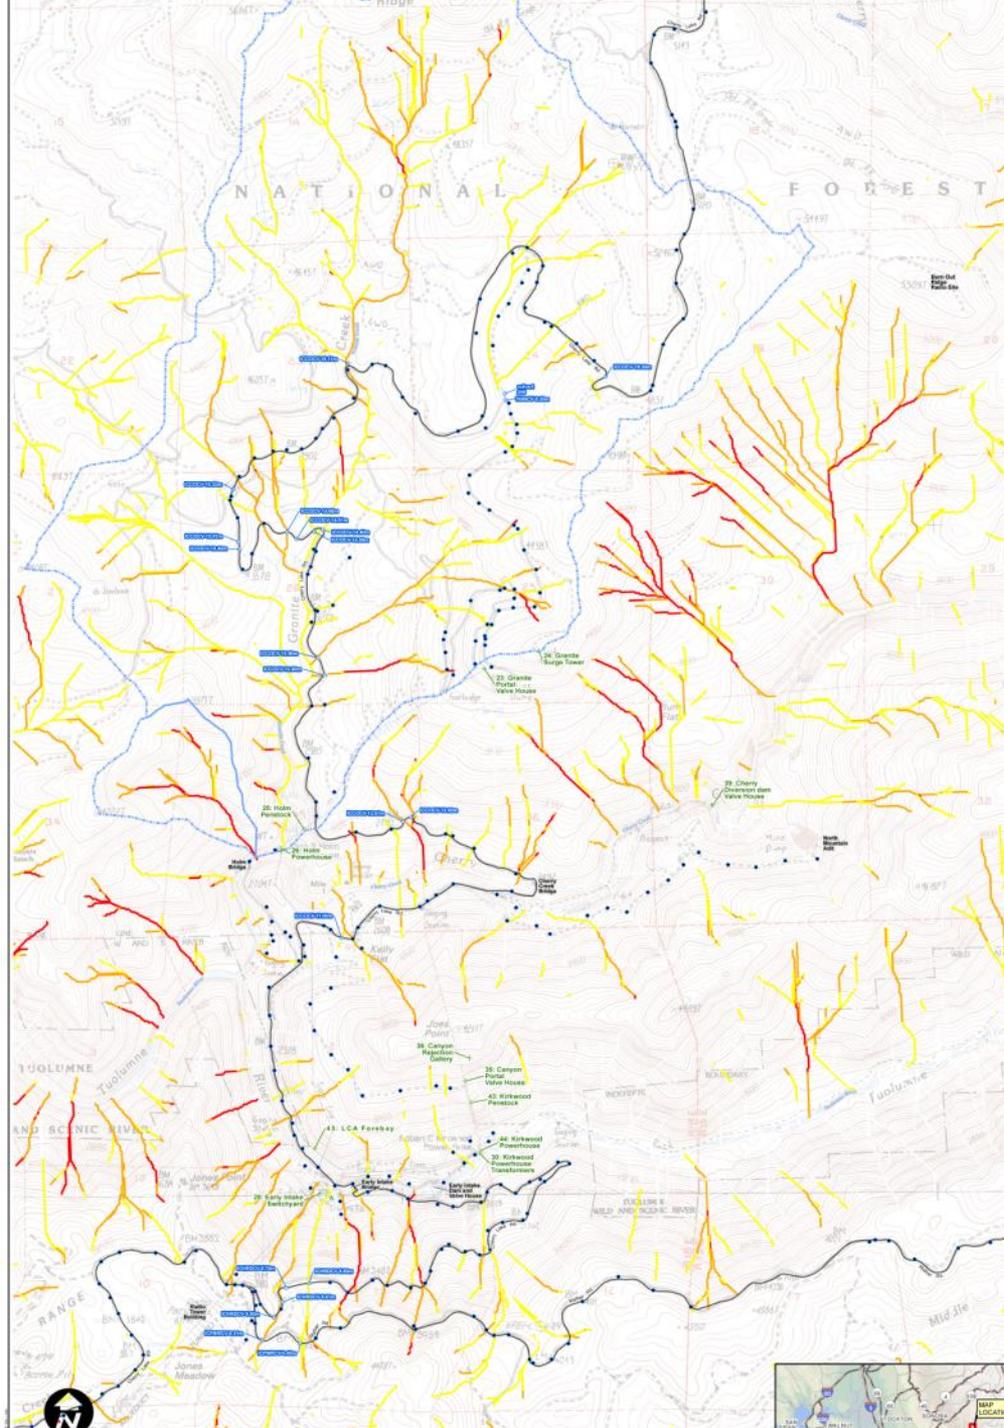
Watershed	Watershed acres	Pre Fire Discharge	Post Fire Discharge	Times Increase
21. Lake Eleanor Dam	49,510	710	796	1.12
22. Hillslope Above open ditch	0.32	0.02	0.05	2.88

23. Hillslope Between Powerhouse and Bridge	169	4	18	4.11
24. Cherry Creek at Dion Holm Power House	148,077	1887	3016	1.60
25. Granite Creek at Dion Holm Power House	4,045	76	374	4.93

26. Cherry RD Lower Granite Culvert (ID:ICCOCD14.4)	2,509	50	245	4.94
27. Culvert Cherry Lake Road	122	3	15	4.38
28. Stream Crossing 1N96 (ID: 01N96CD.30)	902	20	86	4.30

29. Cherry RD Upper Granite Culvert (ID: ICCOCD16.11)	1,043	23	117	5.17
30. Cherry Lake Road Crossing (ID: ICCOCD18.30)	32	1	4	4.04
31. Cherry Lake Dam	73,875	1015	1124	1.11
