**Flood Control Project Maintenance
Levee Inspections**

**Fall 2015 Levee Maintenance Deficiency Summary Report
Overall LMA & Unit Ratings, including USACE Erosion Survey**

**Flood Control Project Maintenance
Levee Inspections**
LMA District Cover Sheet
Fall 2015 Levee Inspection Results

Levee District No. 0001 (Sutter County)

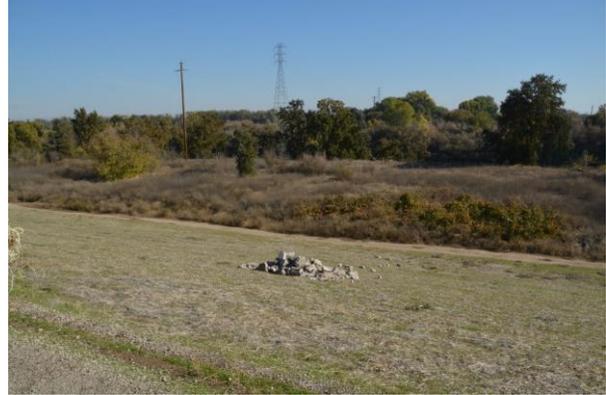
Photo 1 of 1 : FA_2015_LD0001S_433_22_20151117_00021.jpg

LM Start	8.87	Rating **	M	Issue No.	22
LM End	8.87	Issue Type +	Ma	Location *	WS
Category	Earthen Levee		GPS Latitude/Longitude		
			Start	End	
Item	Encroachments		39.072503 °	39.072503 °	
			-121.606710 °	-121.606710 °	
DWR ID	DWR_LD0001S_01_f_2015_22				
Action/Comments					
Debris Inspector Comments: Concrete debris piled up on waterside slope.

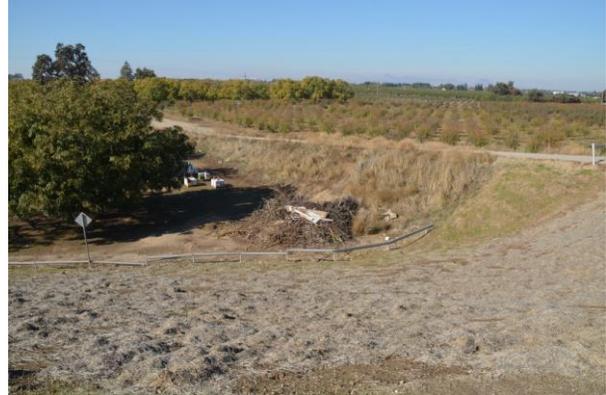
Photo 1 of 1 : FA_2015_LD0001S_433_23_20151117_00022.jpg

LM Start	9.35	Rating **	M	Issue No.	23
LM End	9.35	Issue Type +	En	Location *	LS
Category	Earthen Levee		GPS Latitude/Longitude		
			Start	End	
Item	Vegetation		39.079026 °	39.079026 °	
			-121.604386 °	-121.604386 °	
DWR ID	DWR_LD0001S_01_f_2015_23				
Action/Comments					
Landscaping Inspector Comments: Tree trimmings at landside toe need removal.

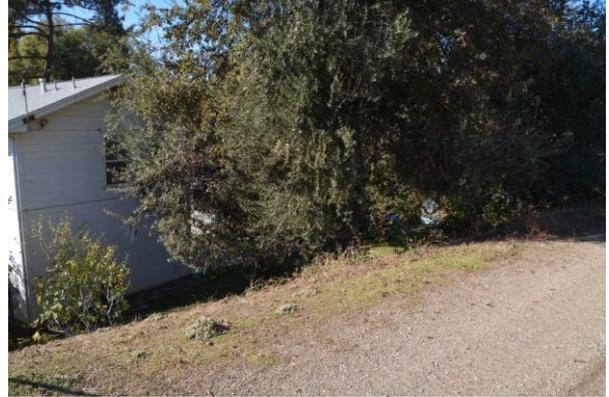
Photo 1 of 2 : FA_2015_LD0001S_433_18_20151117_00015.jpg

LM Start	13.34	Rating **	U	Issue No.	18
LM End	13.34	Issue Type +	Ma	Location *	LS
Category	Earthen Levee		GPS Latitude/Longitude		
			Start	End	
Item	Vegetation		39.133050 °	39.133050 °	
			-121.603813 °	-121.603813 °	
DWR ID	DWR_LD0001S_01_f_2015_18				
Action/Comments					
Trees / Woody Vegetation Inspector Comments: Overgrown olive trees (6), buckeye (1) and oak trees (2) on slope of levee, branches touching and obscuring levee. Ivy obscuring slope.

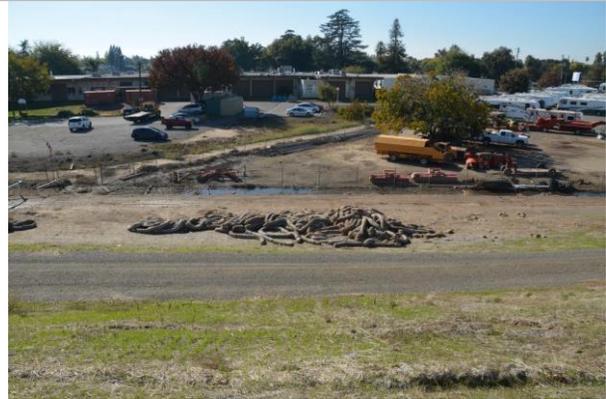
Photo 1 of 1 : FA_2015_LD0001S_433_28_20151117_00025.jpg

LM Start	15.18	Rating **	M	Issue No.	28
LM End	15.18	Issue Type +	En	Location *	LS
Category	Earthen Levee			GPS Latitude/Longitude	
				Start	End
Item	Encroachments			39.156619 °	39.156619 °
				-121.617647 °	-121.617647 °
DWR ID	DWR_LD0001S_01_f_2015_28				
Action/Comments					
Debris Inspector Comments: Piles of straw waddles.
