**Flood Control Project Maintenance
Levee Inspections**
LMA District Cover Sheet
Spring 2016 Levee Inspection Results

Levee District No. 0001 (Sutter County)

Spring 2016 Levee Inspection Results

Waterway		Bank	Unit Miles
Unit No. 01 Feather River		Right	16.11

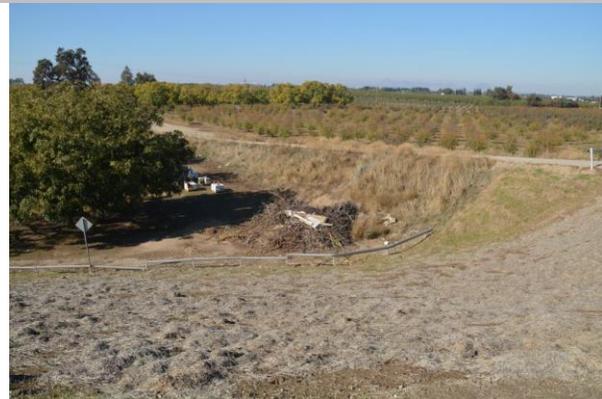
Photo 1 of 1 : SP_2016_LD0001S_433_23_20160307_00012.jpg

LM Start	9.35	Rating **	M	Issue No.	23
LM End	9.35	Issue Type +	En	Location *	LS
Category	Earthen Levee			GPS Latitude/Longitude	
				Start	End
Item	Vegetation			39.079026 °	39.079026 °
				-121.604386 °	-121.604386 °
DWR ID	DWR_LD0001S_01_f_2015_23				
Comment Code					
V6 : Landscaping					
Inspector Comment					
Tree trimmings at landside toe need removal.
