**Flood Control Project Maintenance
Levee Inspections**
LMA District Cover Sheet
Spring 2016 Levee Inspection Results

Sutter Maintenance Yard Maintenance Area 0007

Spring 2016 Levee Inspection Results

Waterway		Bank	Unit Miles
Unit No. 01 Feather River		Right	11.90

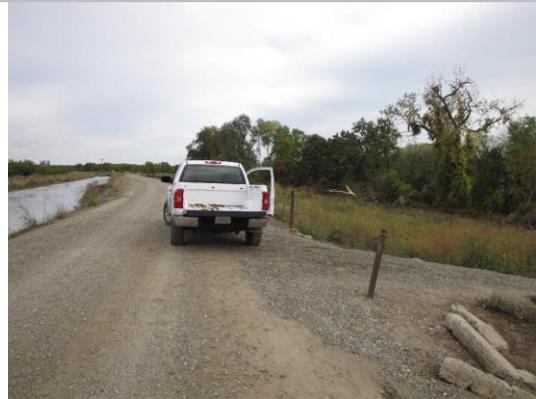
Photo 1 of 2 : UCIP_SP_2016_47833_65802.jpg

Overview of levee crown looking upstream.

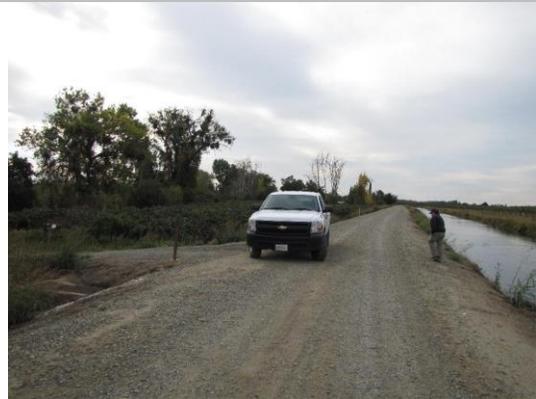
Photo 2 of 2 : UCIP_SP_2016_47833_65801.jpg

View of levee crown looking downstream.

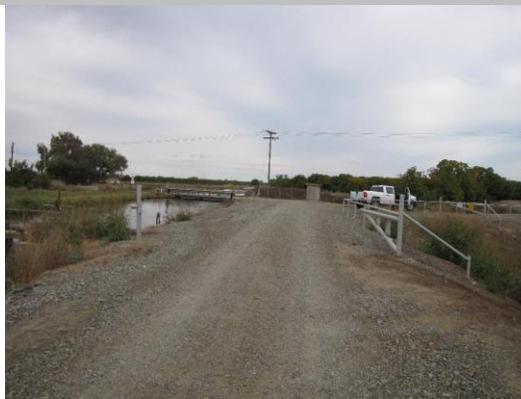
Photo 1 of 2 : UCIP_SP_2016_47834_65806.jpg

Comment Code					
Inspector Comment					
FS_ID:47834 DS_ID:20816 EP_NO: N/A Repair Type: Non-Urgent Crossing Status: Found UCIP Comments: 5/16/2016 Feather River West Levee Improvement Project--Levee currently under construction.6/10/2015 Crossing has been modified since last inspection. 3' black plastic pipe is now running through the metal pipe and the difference was capped and welded. 12/29/2014 Same as last inspection.5/19/2014 Same as last inspection.11/6/2013 Same as last inspection.5/13/2013 SBFCA project recommends removal. Permit number and owner in detailed report book.5/7/2013 Same as last inspection. Recommend finding owner.10/30/2012 Crossing was installed about 1 foot deep--need permit authorizing work FIELD_STRUCT_DESC: 12-inch irrigation pipe through the levee 1 foot below the crown. Crossing on landside (LS) is attached to weir above ground. Siphon breaker on waterside (WS). No opening on WS. FS Date: 5/16/2016 10:21:55 AM

Overview of levee crown looking upstream at crossing.

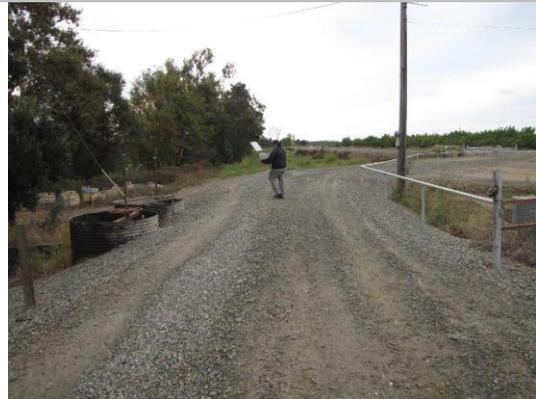
Photo 1 of 2 : UCIP_SP_2016_47836_65814.jpg

Comment Code					
Inspector Comment					
FS_ID:47836 DS_ID:16926 EP_NO: N/A Repair Type: Non-Urgent Crossing Status: Found UCIP Comments: 5/16/2016 Feather River West Levee Improvement Project--Levee currently under construction.6/10/2015 Debris still present in risers and pipes were not replaced with the SBFCA project.12/29/2014 Same as last inspection.5/19/2014 Same as last inspection.11/6/2013 Same as last inspection.5/13/2013 SBFCA project recommends replacing in accordance with title 23.5/7/2013 Same debris issue as last inspection. Recommend repairing top cover to prevent falls. Wheel to open gate chained and locked so could not verify gate operation.10/31/2012 Debris inside riser could prevent slide gate from closing. This crossing was listed in the USACE Periodic Inspections as ID# USACE_CESPK_MA07_2010_a_0060 however, no issues noted. FIELD_STRUCT_DESC: 1 of 2: 60-inch drain pipe through the levee, 12.5 feet below the crown. Slide gates in 78-inch corrugated metal pipe (CMP) wells on the waterside (WS) slope. Concrete bulkhead on both ends. Reinforced concrete spillway an the WS end. This entry matches the Drainage or Irrigation Structure referenced in O&M manual (Historic Station 1+90). (USACE O&M Manual, 1957) FS Date: 5/16/2016 10:22:42 AM

View of levee crown looking downstream.

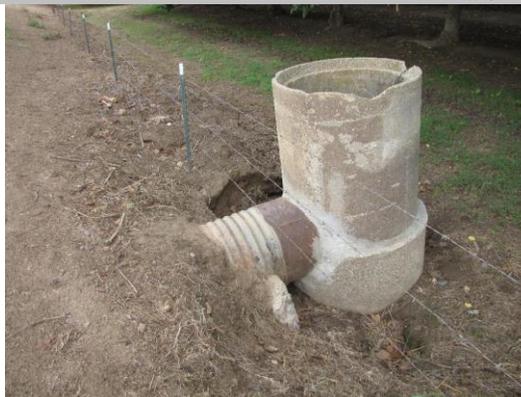
Photo 2 of 2 : UCIP_SP_2016_47998_65836.jpg

Comment Code					
Inspector Comment					
<p>FS_ID:47998 DS_ID:16923 EP_NO: 18710 Repair Type: Non-Urgent Crossing Status: Found UCIP Comments: 5/16/2016 Feather River West Levee Improvement Project--Levee currently under construction. Crossing, referenced as 1792+96, will be removed and replaced with a 36-inch pipe as indicated in the project Plans for Construction of Feather River West Levee Project, Project Area A, Feather River West Levee Improvement Plans, Sta 1765+00 to 2368+26, Volume 3 of 5.6/10/2015 Small erosion still present around concrete standpipe. Think its just caused by rain runoff. 12/29/2014 Same as last inspection.5/19/2014 Same as last inspection.11/6/2013 Same as last inspection.5/13/2013 SBFCA project recommends removal.5/7/2013 Same as last inspection. Need to investigate source of WS erosion.10/31/2012 Erosion on WS around concrete standpipe--might be leaking. Burrow activity present on WS slope, unable to determine if structure is still being used. This crossing was listed in the USACE Periodic Inspections as ID# USACE_CESPK_MA07_2010_a_0075 however, no issues noted. FIELD_STRUCT_DESC: 24-inch corrugated metal pipe (CMP) irrigation line through the levee 12.7 feet below the crown. Flap gate on the waterside (WS) end. Concrete distribution box at the WS toe. Second concrete distribution box connected to deep well pump located 400-500 feet from landside (LS) toe. This entry matches the Drainage or Irrigation Structure referenced in O&M manual (Historic Station 28+00). (USACE O&M Manual, 1957) Permit No. 18710 was issued in 2011 for continued use of existing 24-inch irrigation pipe. (Permit No. 18710-2011, Sandra Waller) FS Date: 5/16/2016 10:24:00 AM</p>

View of crossing and standpipe located on WS end.

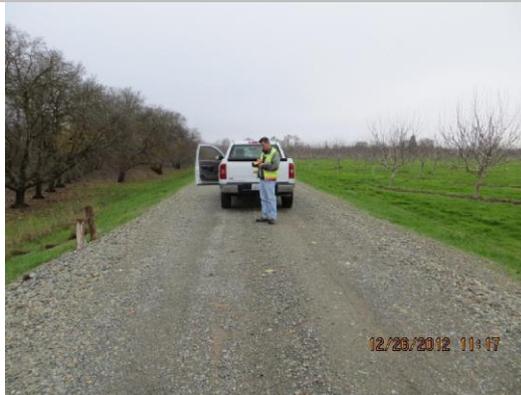
Photo 1 of 2 : UCIP_SP_2016_47933_65844.jpg

FS_ID:47933
 DS_ID:20817
 EP_NO: N/A
 Repair Type: Non-Urgent
 Crossing Status: Found
 UCIP Comments: 5/16/2016 Feather River West Levee Improvement Project--Levee currently under construction. New gate valve, referenced as STA 1799+44, will be installed as indicated in the project Plans for Construction of Feather River West Levee Project, Project Area A, Feather River West Levee Improvement Plans, Sta 1765+00 to 2368+26, Volume 3 of 5.6/10/2015 Air vac is still bent over.12/29/2014 Same as last inspection.5/19/2014 Same as last inspection.11/6/2013 Air vac bent over and both metal posts are laying at toe of levee.5/13/2013 Permit number and owner in detailed report book.5/7/2013 Need to find owner of structure.10/30/2012 Need permit authorizing work.
 FIELD_STRUCT_DESC: Air vac on waterside (WS) shoulder protected by two metal posts. No other signs of encroachment are present.
 FS Date: 5/16/2016 10:24:00 AM

Overview of levee crown looking downstream at crossing.

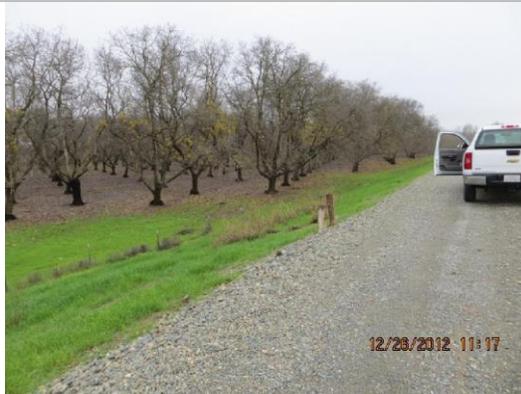
Photo 2 of 2 : UCIP_SP_2016_47933_65843.jpg

View of WS at crossing.

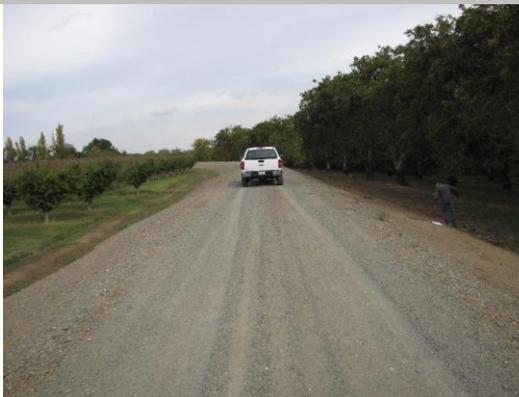
Photo 1 of 2 : UCIP_SP_2016_48000_65849.jpg

FS_ID:48000
 DS_ID:16910
 EP_NO: N/A
 Repair Type: Non-Urgent
 Crossing Status: Found
 UCIP Comments: 5/16/2016 Feather River West Levee Improvement Project--Levee currently under construction. Crossing, referenced as STA 1809+65, will be removed and replaced as indicated in the project Plans for Construction of Feather River West Levee Project, Project Area A, Feather River West Levee Improvement Plans, Sta 1765+00 to 2368+26, Volume 3 of 5.6/10/2015 Pipe appears in good condition. No noticeable issues to report.12/29/2014 Same as last inspection.5/19/2014 Same as last inspection.11/6/2013 Same as last inspection.5/13/2013 SBFCA project recommends replacing in accordance with title 23.5/7/2013 WS sediment blocking gate has been cleared so gate can operate normally. Recommend clearing sediment buildup at mouth of pipe on LS.10/31/2012 WS headwall may be present not visible due to soil cover. Sediment build up on LS headwall--clear. This crossing was listed in the USACE Periodic Inspections as ID# USACE_CESPK_MA07_2010_a_0083 for inoperable gate.

View of levee crown looking upstream.

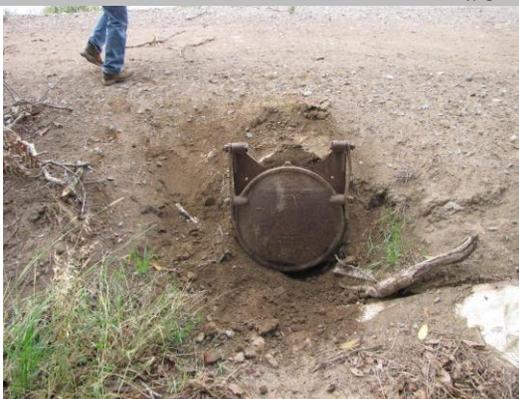
Photo 2 of 2 : UCIP_SP_2016_48000_65852.jpg

View of flap gate located on WS.

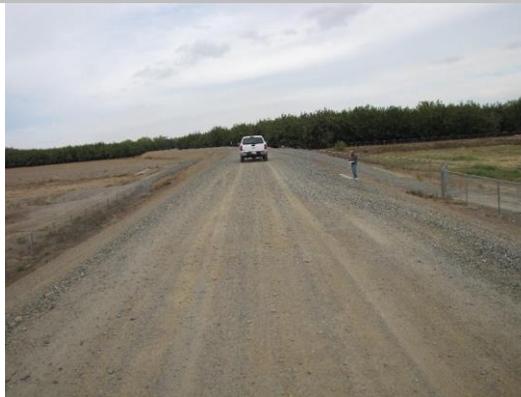
Photo 1 of 2 : UCIP_SP_2016_48001_65855.jpg

FS_ID:48001
 DS_ID:16921
 EP_NO: N/A
 Repair Type: Urgent
 Crossing Status: Found
 UCIP Comments: 5/16/2016 Feather River West Levee Improvement Project--Levee currently under construction. Crossing, referenced as STA 1818+72, will be removed and replaced with a 36-inch pipe as indicated in the project Plans for Construction of Feather River West Levee Project, Project Area A, Feather River West Levee Improvement Plans, Sta 1765+00 to 2368+26, Volume 3 of 5.6/10/2015 Riser is still damaged and cant locate signs of pipe on LS.12/29/2014 Same as last inspection.5/19/2014 Same as last inspection.11/6/2013 Same as last inspection.5/13/2013 SBFCA project recommends relacing in accordance with title 23.5/7/2013 Same as last inspection, rodent activity near crossing, need to repair rodent hole on WS.10/31/2012 CMP riser damage-repair needed. Unable to locate pipe on LS. This crossing was listed in the USACE Periodic Inspections as ID# USACE_CESPK_MA07_2010_a_0090 however, no issues noted.

Overview of levee crown looking upstream.

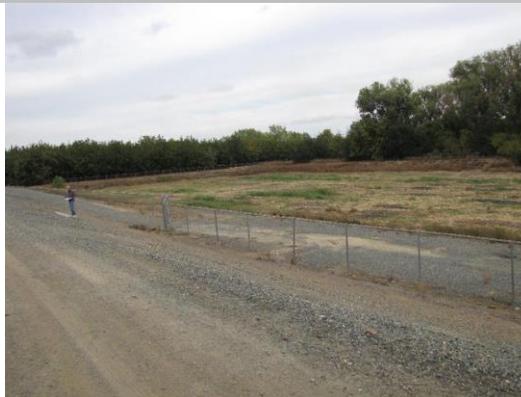
Photo 2 of 2 : UCIP_SP_2016_48001_65854.jpg

View of WS slope looking upstream. Matt is standing near CMP riser.

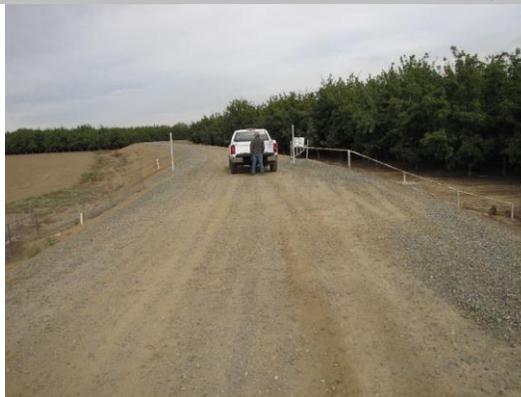
Photo 1 of 2 : UCIP_SP_2016_47937_65864.jpg

Comment Code					
Inspector Comment					
<p>FS_ID:47937 DS_ID:16919 EP_NO: 5722 Repair Type: Non-Urgent Crossing Status: Indicator Found UCIP Comments: 5/16/2016 Feather River West Levee Improvement Project--Levee currently under construction. Both 12-inch and 24-inch, referenced as STA 1823+01, will be removed as indicated in the project Plans for Construction of Feather River West Levee Project, Project Area A, Feather River West Levee Improvement Plans, Sta 1765+00 to 2368+26, Volume 3 of 5.6/10/2015 Same as last inspection.12/29/2014 Same as last inspection.5/19/2014 Same as last inspection.11/6/2013 Same as last inspection.5/13/2013 SBFCA project recommends relacing in accordance with title 23.5/7/2013 Same as last inspection. WS sediment drop above concrete stand pipe. Coordinate with owner and levee inspector to address issue.10/31/2012 dense burrow activity on crown and slopes. FIELD_STRUCT_DESC: 12-inch cement coated and lined steel sewer pipe sleeved through the existing 24-inch corrugated metal pipe (CMP). Annular space pressure grouted. A 36 inch diameter reinforced concrete pipe riser is located on the waterside (WS). (Permit No. 5722-1968, City of Gridley) The existing 24-inch CMP matches the Drainage or Irrigation structure referenced in the O&M manual (historic station 56+90, USACE O&M Manual, 1957) Per O&M manual the 24-inch CMP goes through levee at a depth of 21.4 feet below the crown. Slide gate in 36-inch reinforced concrete pipe riser located on the WS slope. FS Date: 5/16/2016 10:25:00 AM</p>

Overview of levee crown looking upstream.

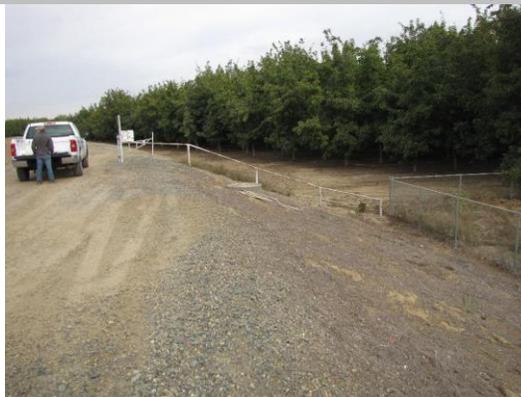
Photo 2 of 2 : UCIP_SP_2016_47937_65863.jpg

View of WS slope looking at crossing.

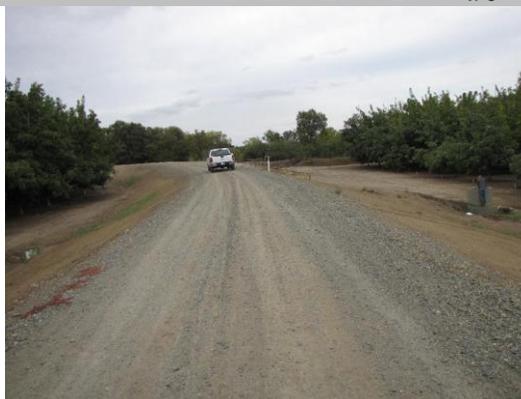
Photo 1 of 2 : UCIP_SP_2016_47981_65872.jpg

Comment Code					
Inspector Comment					
FS_ID:47981 DS_ID:16918 EP_NO: N/A Repair Type: Non-Urgent Crossing Status: Found UCIP Comments: 5/16/2016 Feather River West Levee Improvement Project--Levee currently under construction. 12-inch and 24-inch crossings, referenced as STA 1834+42, will be removed and replaced with a 36-inch pipe as indicated in the project Plans for Construction of Feather River West Levee Project, Project Area A, Feather River West Levee Improvement Plans, Sta 1765+00 to 2368+26, Volume 3 of 5.6/10/2015 Same as last inspection.12/29/2014 Same as last inspection.5/19/2014 Same as last inspection.11/6/2013 Same as last inspection.5/13/2013 SBFCA project recommends relacing in accordance with title 23.5/7/2013 Structure does appear to be altered. Contact Levee Inspector to pursue NOV.10/31/2012 Unable to determine if this crossing has been altered, will need to coordinate with levee inspector. This crossing was listed in the USACE Periodic Inspection as ID# USACE_CESPK_MA07_2010_a_0104 however, no issues reported. FIELD_STRUCT_DESC: Flap gate inside riser on the WS end. 12-inch pipe sleeved through existing 24-inch pipe. 24-inch corrugated metal (CM) drainpipe through the levee, 15.3 feet below the crown. A reinforced concrete pipe riser located on the waterside (WS). (USACE O&M Manual, 1957) FS Date: 5/16/2016 10:26:00 AM

View of levee crown looking upstream at crossing.

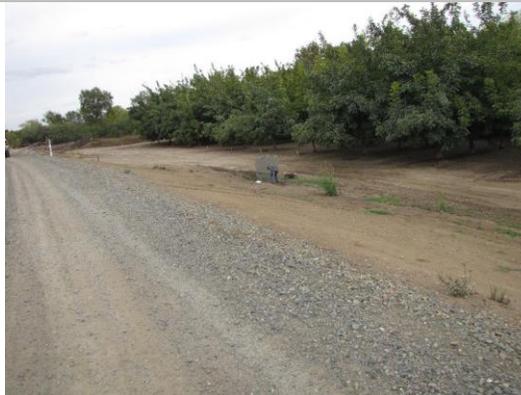
Photo 2 of 2 : UCIP_SP_2016_47981_65871.jpg

View of WS looking at crossing.

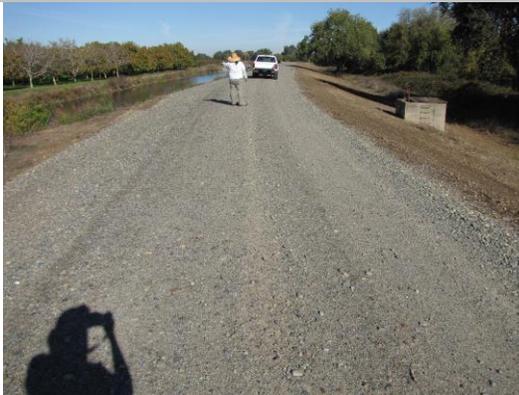
Photo 1 of 2 : UCIP_SP_2016_48003_65891.jpg

FS_ID:48003
 DS_ID:16943
 EP_NO: N/A
 Repair Type: Non-Urgent
 Crossing Status: Found
 UCIP Comments: 5/16/2016 Feather River West Levee Improvement Project--Levee currently under construction. Crossing, referenced as STA 1934+54, will be removed and replaced with a 12-inch pipe as indicated in the project Plans for Construction of Feather River West Levee Project, Project Area A, Feather River West Levee Improvement Plans, Sta 1765+00 to 2368+26, Volume 3 of 5.6/10/2015 Pipe has been removed during the SBFCA project. It was originally listed to be replaced so it may be added back in on a later date.12/29/2014 Same as last inspection.5/19/2014 Same as last inspection.11/7/2013 Same as last inspection.5/13/2013 SBFCA project recommends relacing in accordance with title 23.5/10/2013 Barrel down inside standpipe. Slide gate difficult to operate.11/5/2012 burrow activity on WS slope. This crossing was listed in the USACE Periodic Inspection as ID# USACE_CESPK_MA07_2010_a_0160 no issues reported.

Overview of levee crown and slopes at crossing looking upstream.

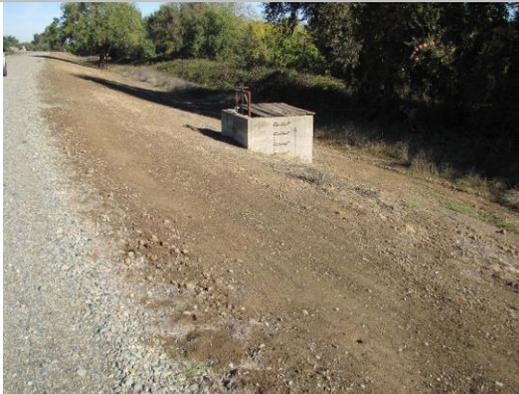
Photo 2 of 2 : UCIP_SP_2016_48003_65890.jpg

View of concrete distribution box with slide gate inside.

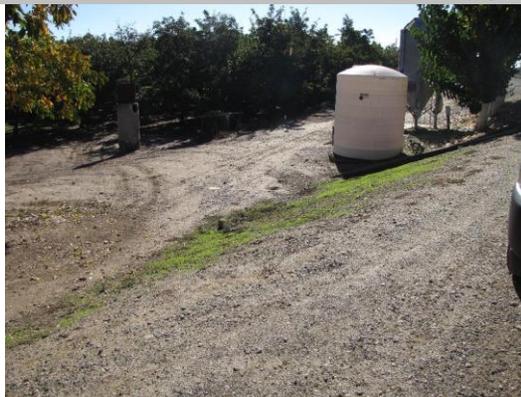
Photo 1 of 2 : UCIP_SP_2016_48004_65903.jpg

Comment Code					
Inspector Comment					
<p>FS_ID:48004 DS_ID:16920 EP_NO: N/A Repair Type: Non-Urgent Crossing Status: Found UCIP Comments: 5/16/2016 Feather River West Levee Improvement Project--Levee currently under construction. Crossing, referenced as STA 1956+20, will be removed and replaced with a 36-inch pipe as indicated in the project Plans for Construction of Feather River West Levee Project, Project Area A, Feather River West Levee Improvement Plans, Sta 1765+00 to 2368+26, Volume 3 of 5.6/10/2015 Unable to locate any signs of this crossing during this inspection. Looks to have been removed for the SBFCA project.12/29/2014 Same as last inspection.5/19/2014 Same as last inspection.11/7/2013 Same as last inspection.5/13/2013 SBFCA project recommends relacing in accordance with title 23.5/10/2013 Same as last inspection.11/5/2012 No access to LS--residential property; unable to determine the type of abandonment for this crossing; need to determine if there is a positive closure device on WS. This crossing was listed in the USACE Periodic Inspection as ID# USACE_CESPK_MA07_2010_a_0173 unknown. FIELD_STRUCT_DESC: *ABANDONED* 24-inch corrugated metal (CM) irrigation pipe through the levee, 14.0 feet below the crown. Slide gate on the landside (LS). Slide gate in concrete pipe riser on the waterside (WS) berm. This entry matches the Drainage or Irrigation Structure referenced in O&M manual (Historic Station 191+13). (USACE O&M Manual, 1957) FS Date: 5/16/2016 10:29:00 AM</p>

View of WS.

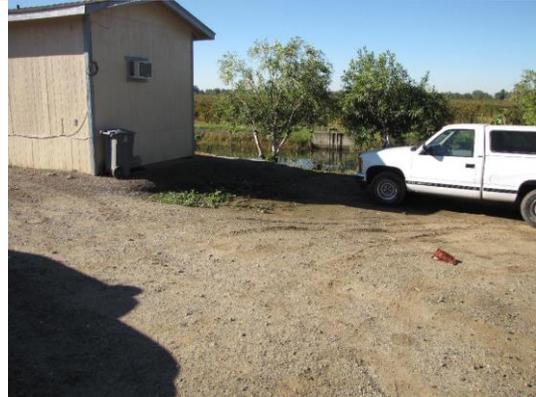
Photo 2 of 2 : UCIP_SP_2016_48004_65902.jpg

View of LS--no access.

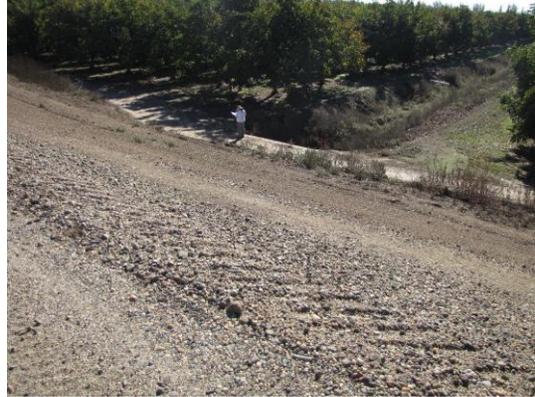
Photo 1 of 2 : UCIP_SP_2016_48005_65904.jpg

Comment Code					
Inspector Comment					
<p>FS_ID:48005 DS_ID:16922 EP_NO: N/A Repair Type: Non-Urgent Crossing Status: Found UCIP Comments: 5/16/2016 Feather River West Levee Improvement Project--Levee currently under construction. Crossing, referenced as STA 1961+03, will be removed as indicated in the project Plans for Construction of Feather River West Levee Project, Project Area A, Feather River West Levee Improvement Plans, Sta 1765+00 to 2368+26, Volume 3 of 5. The 2-60 inch pipes will be replaced with a single 36-inch pipe.6/10/2015 Sediment still blocking the flap gates on WS. LS inlet ebng overgrown by vegetation in the ditch.12/29/2014 Same as last inspection.5/19/2014 Same as last inspection.11/7/2013 Same as last inspection.5/13/2013 SBFCA project recommends relacing in accordance with title 23.5/10/2013 Same as last inspection.11/5/2012 Sediment blocking flap gates on WS--need to clear sediment. This crossing was listed in the USACE Periodic Inspection as ID# USACE_CESPK_MA07_2010_a_0180 no issues reported. FIELD_STRUCT_DESC: 1 of 2: 60 inch pipe (downstream pipe), through the levee, 23.4 feet below the crown. Flap gate on the waterside (WS) end. Concrete headwalls on both ends. Ditch at WS outlet. This entry matches the Drainage or Irrigation Structure referenced in O&M manual (Historic Station 195+80). (USACE O&M Manual, 1957) FS Date: 5/16/2016 10:29:00 AM</p>

View of WS. Concrete headwall located at levee toe.

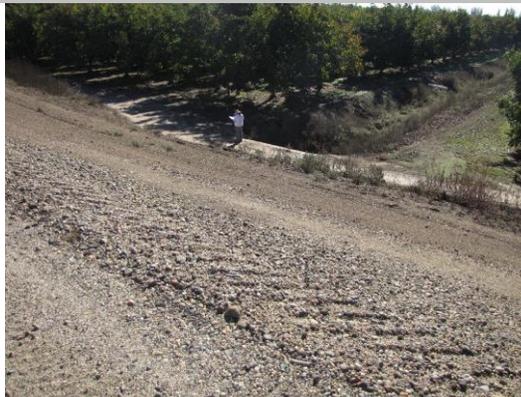
Photo 1 of 2 : UCIP_SP_2016_48006_65911.jpg

FS_ID:48006
DS_ID:17013
EP_NO: N/A
Repair Type: Non-Urgent
Crossing Status: Found
UCIP Comments: 5/16/2016 Feather River West Levee Improvement Project--Levee currently under construction. Crossing, referenced as STA 1961+10, will be removed as indicated in the project Plans for Construction of Feather River West Levee Project, Project Area A, Feather River West Levee Improvement Plans, Sta 1765+00 to 2368+26, Volume 3 of 5. The 2-60 inch pipes will be replaced with a single 36-inch pipe.6/10/2015 Sediment still blocking the flap gates on WS. LS inlet being overgrown by vegetation in the ditch.12/29/2014 Same as last inspection.5/19/2014 Same as last inspection.11/7/2013 Same as last inspection.5/13/2013 SBFCA project recommends relacing in accordance with title 23.5/10/2013 Same as last inspection.11/5/2012 Sediment blocking flap gate--need to remove sediment to make flap gates operational.
FIELD_STRUCT_DESC: 2 of 2: 60 inch pipe (upstream pipe), through the levee, 23.4 feet below the crown. Flap gate on the waterside (WS) end. Concrete headwalls on both ends. Ditch located at WS outlet. This entry matches the Drainage or Irrigation Structure referenced in O&M manual (Historic Station 195+80). (USACE O&M Manual, 1957)

View of WS with clear slope.

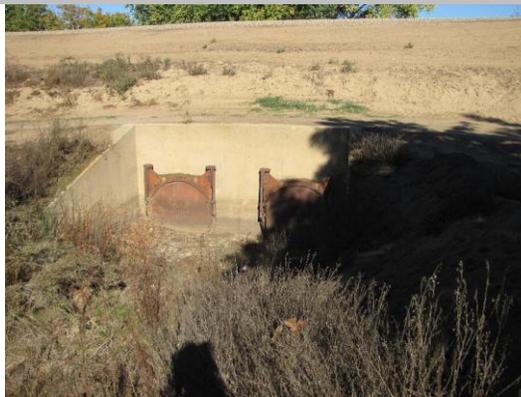
Photo 2 of 2 : UCIP_SP_2016_48006_65910.jpg

View of headwall and flap gates located on WS.

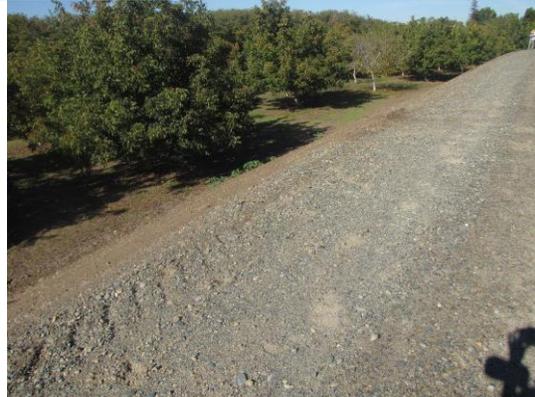
Photo 1 of 2 : UCIP_SP_2016_48007_65923.jpg

Comment Code					
Inspector Comment					
FS_ID:48007 DS_ID:16960 EP_NO: 17895 Repair Type: Non-Urgent Crossing Status: Indicator Found UCIP Comments: 5/16/2016 Feather River West Levee Improvement Project--Levee currently under construction. Crossing, referenced as STA 2084+03, will be removed and replaced as indicated in the project Plans for Construction of Feather River West Levee Project, Project Area A, Feather River West Levee Improvement Plans, Sta 1765+00 to 2368+26, Volume 3 of 5.6/10/2015 Minor erodin still present near air vent.12/30/2014 Same as last inspection.5/19/2014 Same as last inspection.11/7/2013 Same as last inspection.11/5/2012 localized erosion at air vent located on WS shoulder; this crossing appears to have leaking at the air vent--will need to determine reason for erosion at air vent (vehicles going over vent?); also recommend installing utility marker. FIELD_STRUCT_DESC: 5-inch diameter steel irrigation pipe through the right (west) bank levee and connect to existing pipe within the overflow area of the Feather River. (Permit No. 17895-2005, John Kucek) FS Date: 5/16/2016 10:30:00 AM

View of LS and levee crown looking upstream towards crossing.

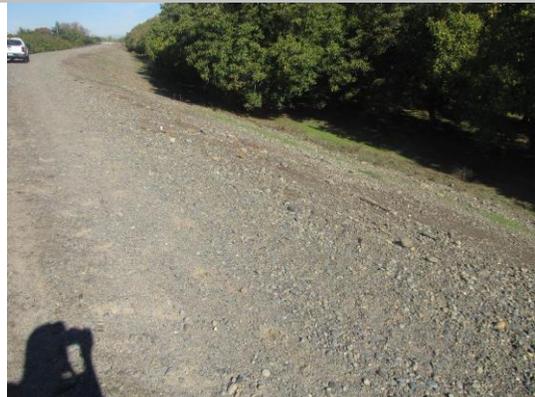
Photo 2 of 2 : UCIP_SP_2016_48007_65922.jpg

View of WS and levee crown looking upstream towards crossing.

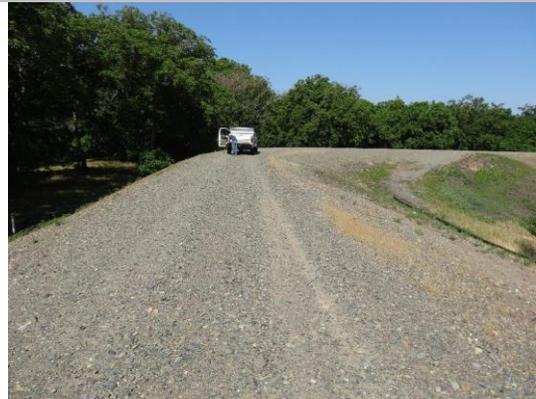
Photo 1 of 2 : UCIP_SP_2016_47872_65926.jpg

Comment Code					
Inspector Comment					
FS_ID:47872 DS_ID:23096 EP_NO: N/A Repair Type: Urgent Crossing Status: Indicator Found UCIP Comments: 5/16/2016 Feather River West Levee Improvement Project--Levee currently under construction.6/10/2015 Same as last inspection.12/30/2014 Same as last inspection.5/19/2014 Same as last inspection.11/7/2013 Same as last inspection.5/9/2013 Depression along WS slope that could indicate a leak or poor compaction. Unknown permit number need to coordinate with landowner to find out more info. FIELD_STRUCT_DESC: Irrigation crossing through levee depth unknown. Steel stand pipe located on landside (LS) toe. Also present is 4.5 inch PVC pipe near stand pipe located on LS toe. FS Date: 5/16/2016 10:31:33 AM

Overview from crown looking U/S

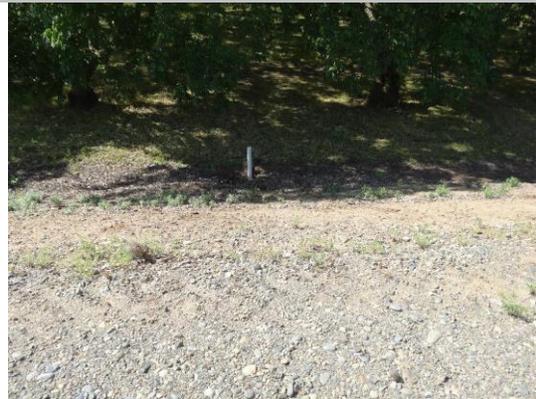
Photo 2 of 2 : UCIP_SP_2016_47872_65925.jpg

LM Start	8.45	Rating **	U	Issue No.	72 (cont)
LM End	8.45	Issue Type +	En	Location *	LS

LS slope

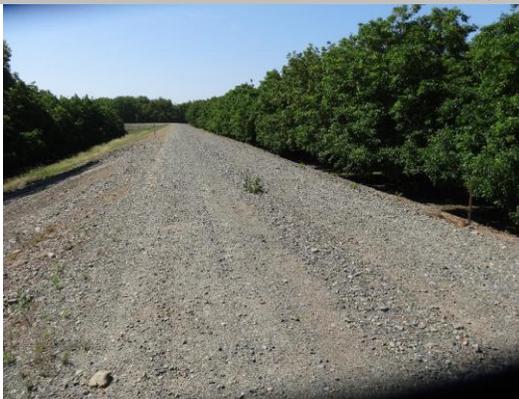
Photo 1 of 2 : UCIP_SP_2016_47873_65930.jpg

LM Start	8.61	Rating **	M	Issue No.	73
LM End	8.61	Issue Type +	En	Location *	LS
Category	Supplemental			GPS Latitude/Longitude	
				Start	End
Item	DWR UCIP Field Study			39.406614 °	39.406614 °
				-121.637384 °	-121.637384 °
DWR ID					
Comment Code					
Inspector Comment					
FS_ID:47873 DS_ID:23094 EP_NO: N/A Repair Type: Non-Urgent Crossing Status: Indicator Found UCIP Comments: 5/16/2016 Feather River West Levee Improvement Project--Levee currently under construction.6/10/2015 same as last inspection.12/30/2014 Same as last inspection.5/19/2014 Same as last inspection.11/7/2013 Same as last inspection.5/9/2013 Unkown permit coordinate with landowner to find out more information. FIELD_STRUCT_DESC: Unknown irrigation pipe size at unknown depth. Pipe capped with valve inside of 6 inch steel standpipe on landside (LS) shoulder. FS Date: 5/16/2016 10:31:49 AM

Overview looking D/S

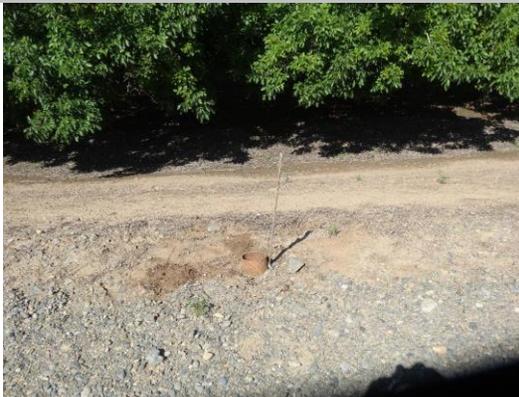
Photo 2 of 2 : UCIP_SP_2016_47873_65929.jpg

LM Start	8.61	Rating **	M	Issue No.	73 (cont)
LM End	8.61	Issue Type +	En	Location *	LS

LS slope with steel standpipe

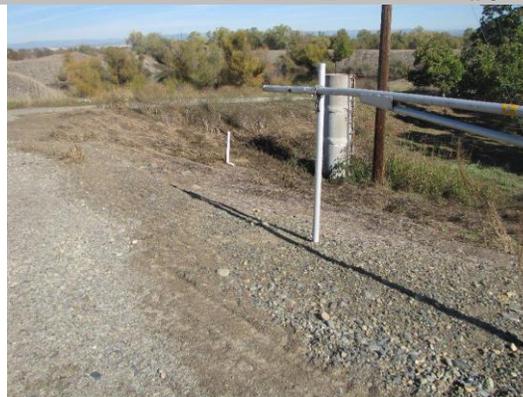
Photo 2 of 2 : UCIP_SP_2016_47989_65940.jpg

Comment Code					
Inspector Comment					
FS_ID:47989 DS_ID:16948 EP_NO: N/A Repair Type: Non-Urgent Crossing Status: Found UCIP Comments: 5/16/2016 Feather River West Levee Improvement Project--Levee currently under construction.6/11/2015 WS standpipe was overgrown with blackberries and unable to be inspected.12/30/2014 Same as last inspection.5/20/2014 Same as last inspection.11/7/2013 Same as last inspection.5/13/2013 SBFCA project recommends relacing in accordance with title 23.5/10/2013 Same as last inspection. Cleared back some of the black berries but live birds nest on ladder prevented me from inspecting inside of standpipe. Recommend spraying the black berries to clear path to ladder.11/5/2012 unable to determine the condition of the slide gate inside WS concrete standpipe blackberry shrubs overgrown against access latter. FIELD_STRUCT_DESC: 12-inch steel irrigation pipe through the levee, 14.0 feet below the crown. Slide gate in 36-inch concrete standpipe at the waterside (WS)toe. Concrete distribution box at the landside (LS) toe. FS Date: 5/16/2016 10:32:00 AM

LM Start	9.53	Rating **	M	Issue No.	80 (cont)
LM End	9.53	Issue Type +	En	Location *	CR

View of WS and levee shoulder looking upstream at crossing. Crossing appurtenances include concrete riser and power pole.

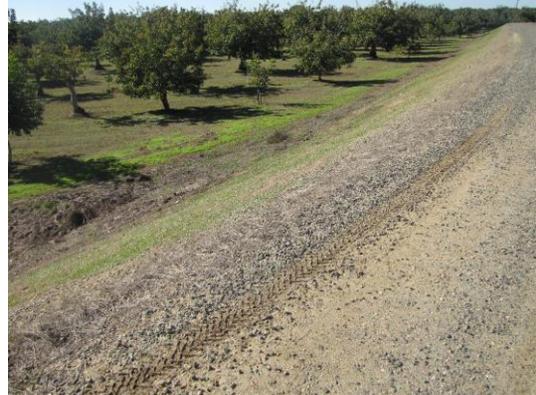
Photo 1 of 2 : UCIP_SP_2016_47990_65946.jpg

Comment Code					
Inspector Comment					
FS_ID:47990 DS_ID:16947 EP_NO: N/A Repair Type: Non-Urgent Crossing Status: Indicator Found UCIP Comments: 5/16/2016 Feather River West Levee Improvement Project--Levee currently under construction. Crossing, referenced as STA 2201+87, will be removed and replaced as indicated in the project Plans for Construction of Feather River West Levee Project, Project Area A, Feather River West Levee Improvement Plans, Sta 1765+00 to 2368+26, Volume 3 of 5.6/11/2015 Abandoned crossing. SBFCa project recommends removal.12/30/2014 Same as last inspection.5/20/2014 Same as last inspection.11/7/2013 Same as last inspection.5/13/2013 SBFCa project recommends removal.5/10/2013 Same as last inspection.11/5/2012 Crossing appears to be abandoned; slide gate located inside concrete standpipe is buried with trash; no other features were visible during inspection. This crossing needs to be properly abandoned. FIELD_STRUCT_DESC: *ABANDONED* 10-inch reinforced concrete encased steel irrigation pipe through the levee, 14.5 feet below the crown. Slide gate in 24-inch concrete standpipe at the waterside (WS) toe. This entry matches the Drainage or Irrigation Structure referenced in O&M manual (Historic Station 437+30). (USACE O&M Manual, 1957) FS Date: 5/16/2016 10:32:00 AM

View of LS and levee crown looking upstream at crossing.

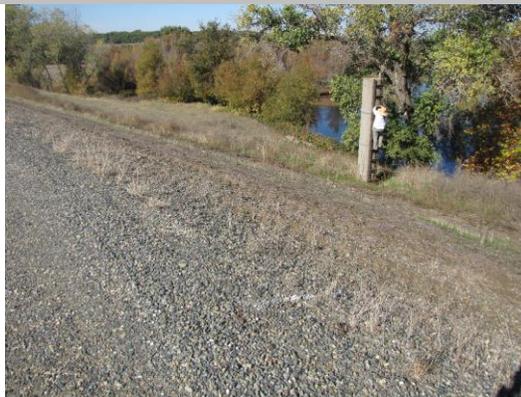
Photo 2 of 2 : UCIP_SP_2016_47990_65945.jpg

Comment Code					
Inspector Comment					
FS_ID:47990 DS_ID:16947 EP_NO: N/A Repair Type: Non-Urgent Crossing Status: Indicator Found UCIP Comments: 5/16/2016 Feather River West Levee Improvement Project--Levee currently under construction. Crossing, referenced as STA 2201+87, will be removed and replaced as indicated in the project Plans for Construction of Feather River West Levee Project, Project Area A, Feather River West Levee Improvement Plans, Sta 1765+00 to 2368+26, Volume 3 of 5.6/11/2015 Abandoned crossing. SBFCA project recommends removal.12/30/2014 Same as last inspection.5/20/2014 Same as last inspection.11/7/2013 Same as last inspection.5/13/2013 SBFCA project recommends removal.5/10/2013 Same as last inspection.11/5/2012 Crossing appears to be abandoned; slide gate located inside concrete standpipe is buried with trash; no other features were visible during inspection. This crossing needs to be properly abandoned. FIELD_STRUCT_DESC: *ABANDONED* 10-inch reinforced concrete encased steel irrigation pipe through the levee, 14.5 feet below the crown. Slide gate in 24-inch concrete standpipe at the waterside (WS) toe. This entry matches the Drainage or Irrigation Structure referenced in O&M manual (Historic Station 437+30). (USACE O&M Manual, 1957) FS Date: 5/16/2016 10:32:00 AM

View of WS shoulder and slope looking upstream at crossing.

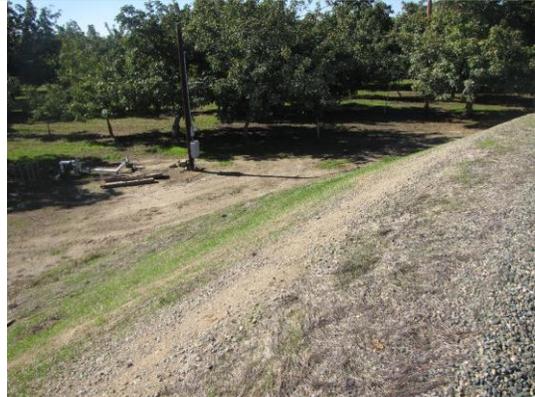
Photo 1 of 2 : UCIP_SP_2016_47878_65947.jpg

Comment Code					
Inspector Comment					
FS_ID:47878 DS_ID:16946 EP_NO: N/A Repair Type: Non-Urgent Crossing Status: Indicator Found UCIP Comments: 5/16/2016 Feather River West Levee Improvement Project--Levee currently under construction.6/11/2015 Same as last inspection.12/30/2014 Same as last inspection.5/20/2014 Same as last inspection.11/7/2013 Same as last inspection.5/13/2013 SBFCA project recommends removal.5/10/2013 Same as last inspection.11/5/2012 unable to determine if this crossing still is in use, signs of depression on waterward shoulder, pump located on LS (GW?) valve on waterward toe. No slide gate or concrete standpipe present; structure appears to have been modified--need permit issued for modifications. FIELD_STRUCT_DESC: 10-inch steel irrigation pipe through the levee, 14.5 feet below the crown. Slide gate in concrete standpipe and pump on the landside (LS). FS Date: 5/16/2016 10:32:59 AM

View of LS and levee slope. Pump located on LS toe--GW pump or part of structure.

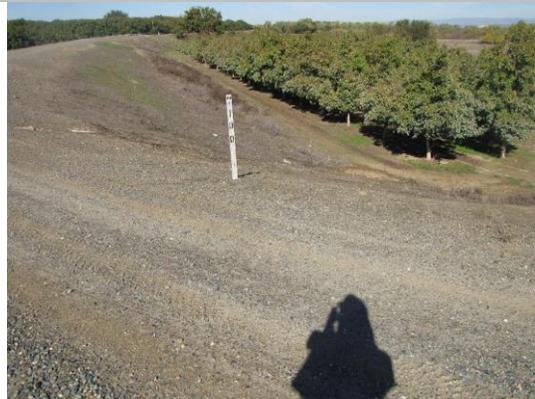
Photo 2 of 2 : UCIP_SP_2016_47878_65952.jpg

LM Start	10.10	Rating **	M	Issue No.	75 (cont)
LM End	10.10	Issue Type +	En	Location *	LS

View of WS and levee crown looking upstream at crossing.

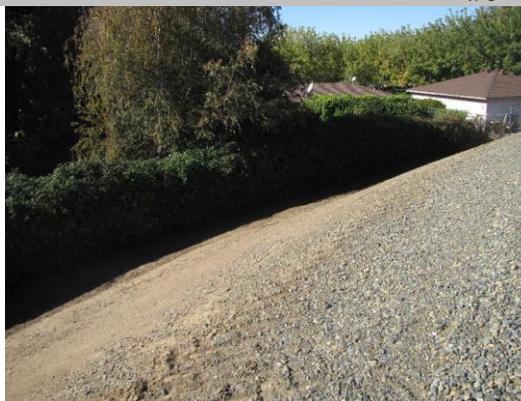
Photo 1 of 2 : UCIP_SP_2016_47991_65953.jpg

Comment Code					
Inspector Comment					
FS_ID:47991 DS_ID:16933 EP_NO: N/A Repair Type: Non-Urgent Crossing Status: Found UCIP Comments: 5/16/2016 Feather River West Levee Improvement Project--Levee currently under construction. Crossing, referenced as STA 2239+66, will be removed as indicared in the project Plans for Construction of Feather River West Levee Project, Project Area A, Feather River West Levee Improvement Plans, Sta 1765+00 to 2368+26, Volume 3 of 5.6/11/2015 Still unable to find anything on the LS. SBFCA project recommends removal.12/30/2014 Same as last inspection.5/20/2014 Same as last inspection.11/7/2013 Same as last inspection.5/13/2013 SBFCA project recommends removal.5/10/2013 Same as last inspection.11/5/2012 nothing found on LS-residential; no headwall found on LS--has it been buried? Need to investigate if crossing is here. This crossing was listed in the USACE Periodic Inspection as ID# USACE_CESPK_MA07_2010_a_0314 no issues reported. FIELD_STRUCT_DESC: 24-inch corrugated metal (CM) drainpipe through the levee, 14.5 feet below the crown. Concrete headwall at both toes. Flap gate in 36-inch concrete standpipe on the berm. This entry matches the Drainage or Irrigation Structure referenced in O&M manual (Historic Station 471+26). (USACE O&M Manual, 1957) FS Date: 5/16/2016 10:33:00 AM

View of LS--no signs of crossing or appurtances are present.

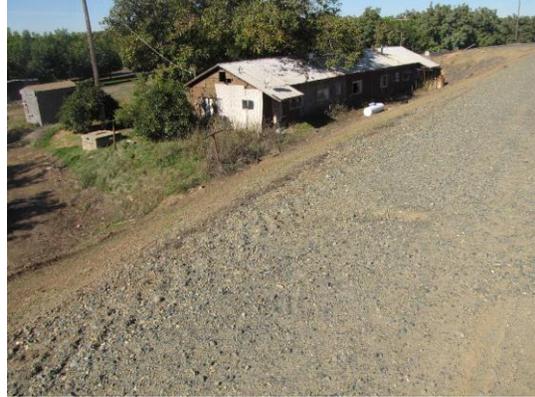
Photo 1 of 2 : UCIP_SP_2016_47958_65974.jpg

Comment Code					
Inspector Comment					
<p>FS_ID:47958 DS_ID:16939 EP_NO: N/A Repair Type: Non-Urgent Crossing Status: Found UCIP Comments: 5/16/2016 Feather River West Levee Improvement Project--Levee currently under construction. Crossing, referenced as STA 2260+55, will be removed as indicated in the project Plans for Construction of Feather River West Levee Project, Project Area A, Feather River West Levee Improvement Plans, Sta 1765+00 to 2368+26, Volume 3 of 5.6/11/2015 Both pipe ends are beeing overgrown by vegetation and are getting hard to inspect. Vegetation needs to be cleared away.12/30/2014 Same as last inspection.5/20/2014 Same as last inspection.11/7/2013 Same as last inspection.5/13/2013 SBFCA project recommends relacing in accordance with title 23.5/10/2013 Same as last inspection. Talking with farmer he said the pipe may be getting removed.11/5/2012 flash boards missing on LS. This crossing was listed in the USACE Periodic Inspection as ID# USACE_CESPK_MA07_2010_a_0332 no issues reported. FIELD_STRUCT_DESC: 24-inch corrugated metal (CM) drainpipe through the levee. 18.9 feet below the crown. Flap gate on the waterside (WS) end. This entry matches the Drainage or Irrigation Structure referenced in O&M manual (Historic Station 494+50). (USACE O&M Manual, 1957) FS Date: 5/16/2016 10:34:00 AM</p>

View of LS looking upstream at crossing.

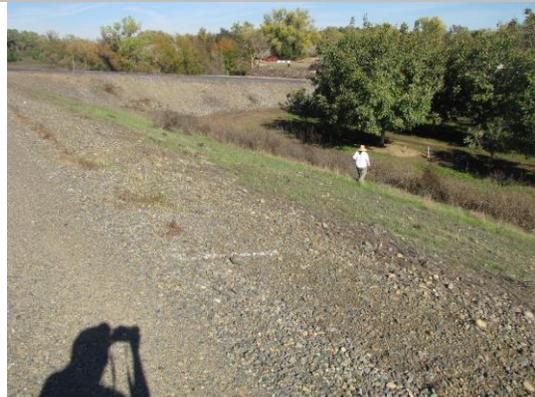
Photo 2 of 2 : UCIP_SP_2016_47958_65973.jpg

LM Start	11.08	Rating **	M	Issue No.	86 (cont)
LM End	11.08	Issue Type +	En	Location *	CR

View of WS looking upstream at crossing.

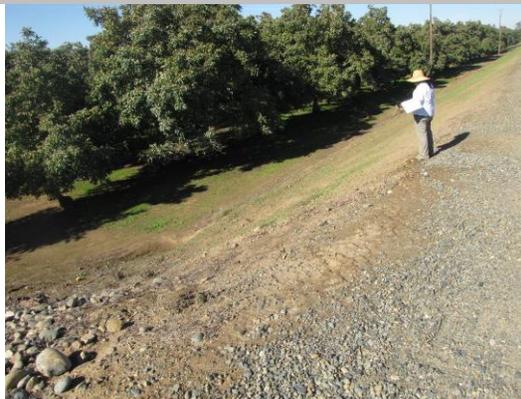
Photo 1 of 2 : UCIP_SP_2016_47994_65979.jpg

Comment Code					
Inspector Comment					
FS_ID:47994 DS_ID:16938 EP_NO: N/A Repair Type: Non-Urgent Crossing Status: Found UCIP Comments: 5/16/2016 Feather River West Levee Improvement Project--Levee currently under construction. Crossing, referenced as STA 2262+69, will be removed and replaced with a new 36-inch pipe as indicated in the project Plans for Construction of Feather River West Levee Project, Project Area A, Feather River West Levee Improvement Plans, Sta 1765+00 to 2368+26, Volume 3 of 5.6/11/2015 Scour still present near the WS apron. 12/30/2014 Same as last inspection.5/20/2014 Same as last inspection.11/7/2013 Same as last inspection.5/10/2013 Same as last inspection.5/13/2013 SBFCA project recommends relacing in accordance with title 23.11/5/2012 burrow activity near headwall on LS; scour near concrete apron and below apron; This crossing was listed in the USACE Periodic Inspection as ID# USACE_CESPK_MA07_2010_a_0336 no issues reported. FIELD_STRUCT_DESC: 24-inch corrugated metal (CM) drainpipe through the levee, 15.8 feet below the crown. Concrete headwall at both toes. Flap gate on the waterside (WS) end. This entry matches the Drainage or Irrigation Structure referenced in O&M manual (Historic Station 496+20). (USACE O&M Manual, 1957) FS Date: 5/16/2016 10:35:00 AM

View of LS looking upstream at crossing.

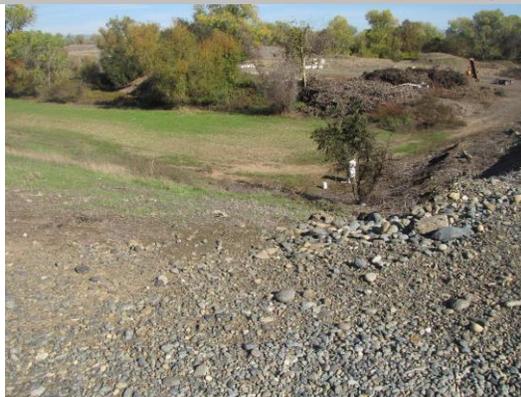
Photo 2 of 2 : UCIP_SP_2016_47994_65978.jpg

Comment Code					
Inspector Comment					
<p>FS_ID:47994 DS_ID:16938 EP_NO: N/A Repair Type: Non-Urgent Crossing Status: Found UCIP Comments: 5/16/2016 Feather River West Levee Improvement Project--Levee currently under construction. Crossing, referenced as STA 2262+69, will be removed and replaced with a new 36-inch pipe as indicated in the project Plans for Construction of Feather River West Levee Project, Project Area A, Feather River West Levee Improvement Plans, Sta 1765+00 to 2368+26, Volume 3 of 5.6/11/2015 Scour still present near the WS apron. 12/30/2014 Same as last inspection.5/20/2014 Same as last inspection.11/7/2013 Same as last inspection.5/10/2013 Same as last inspection.5/13/2013 SBFCA project recommends relacing in accordance with title 23.11/5/2012 burrow activity near headwall on LS; scour near concrete apron and below apron; This crossing was listed in the USACE Periodic Inspection as ID# USACE_CESPK_MA07_2010_a_0336 no issues reported. FIELD_STRUCT_DESC: 24-inch corrugated metal (CM) drainpipe through the levee, 15.8 feet below the crown. Concrete headwall at both toes. Flap gate on the waterside (WS) end. This entry matches the Drainage or Irrigation Structure referenced in O&M manual (Historic Station 496+20). (USACE O&M Manual, 1957) FS Date: 5/16/2016 10:35:00 AM</p>

View of WS looking upstream at crossing.

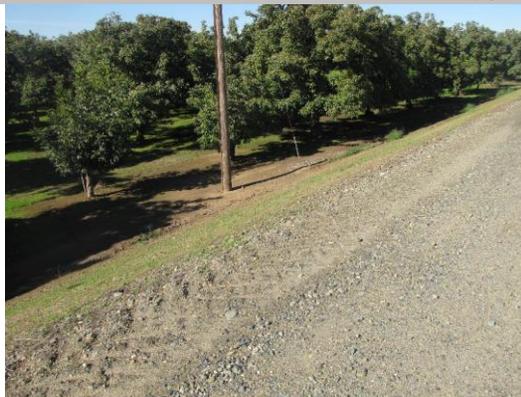
Photo 1 of 2 : UCIP_SP_2016_47960_65987.jpg

FS_ID:47960
 DS_ID:16937
 EP_NO: N/A
 Repair Type: Non-Urgent
 Crossing Status: Found
 UCIP Comments: 5/16/2016 Feather River West Levee Improvement Project--Levee currently under construction. Crossing, referenced as STA 2268+27, will be removed as indicated in the project Plans for Construction of Feather River West Levee Project, Project Area A, Feather River West Levee Improvement Plans, Sta 1765+00 to 2368+26, Volume 3 of 5.6/11/2015 Abandoned crossing. SBFCA project recommends removal.12/30/2014 Same as last inspection.5/20/2014 Same as last inspection.11/7/2013 Same as last inspection.5/13/2013 SBFCA project recommends removal.5/10/2013 Same as last inspection.11/5/2012 Abandoned pipe-need to properly abandon structure; CMP riser cover missing on WS; WS pipe filled with concrete; LS crossing not visible.
 FIELD_STRUCT_DESC: *ABANDONED* 24-inch reinforced concrete encased corrugated metal (CM) irrigation pipe through the levee, 19.5 feet below the crown. Concrete headwall at the landside (LS) toe. Slide gate in 36-inch CM riser on the waterside (WS) slope. This entry matches the Drainage or Irrigation Structure referenced in O&M manual (Historic Station 502+20). (USACE O&M Manual, 1957)

LM Start	11.23	Rating **	M	Issue No.	87 (cont)
LM End	11.23	Issue Type +	En	Location *	CR

View of LS looking upstream at crossing.

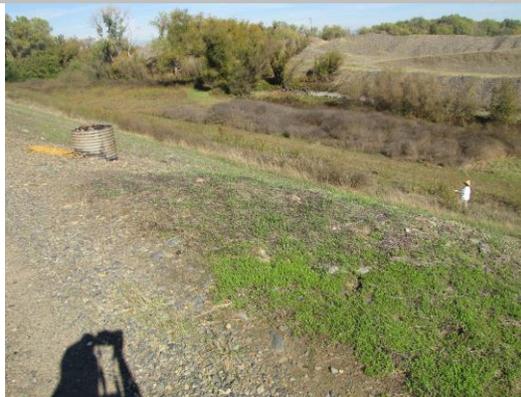
Photo 2 of 2 : UCIP_SP_2016_47960_65985.jpg

View of WS looking upstream at crossing.

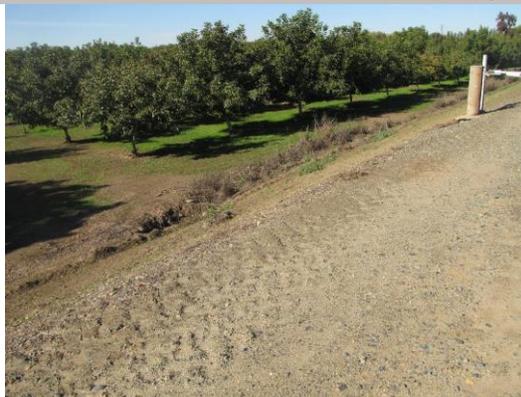
Photo 1 of 2 : UCIP_SP_2016_48009_65990.jpg

FS_ID:48009
 DS_ID:16936
 EP_NO: N/A
 Repair Type: Non-Urgent
 Crossing Status: Found
 UCIP Comments: 5/16/2016 Feather River West Levee Improvement Project--Levee currently under construction. Crossing, referenced as STA 2274+86, will be removed as indicated in the project Plans for Construction of Feather River West Levee Project, Project Area A, Feather River West Levee Improvement Plans, Sta 1765+00 to 2368+26, Volume 3 of 5.6/11/2015 LS inlet is still mostly buried with soil. SBFCA project recommends removal.12/30/2014 Same as last inspection.5/20/2014 Same as last inspection.5/13/2013 SBFCA project recommends removal.5/10/2013 Same as last inspection. LS inlet excavated but more than 50% still covered by soil.11/7/2013 Same as last inspection.11/5/2012 Non-fuctional crossing LS inlet buried; WS-debris in CMP riser, riser missing lid; This crossing was listed in the USACE Periodic Inspection as ID# USACE_CESPK_MA07_2010_a_0344 for pipes filled > 50 % with soil. FIELD_STRUCT_DESC: 24-inch corrugated metal (CM) drainpipe through the levee, 16.2 feet below the crown. Concrete headwall at both waterside (WS) and landside (LS) toes. Flap gate on the WS end. This entry matches the Drainage or Irrigation Structure referenced in O&M manual (Historic Station 508+40). (USACE O&M Manual, 1957)

LM Start	11.35	Rating **	M	Issue No.	97 (cont)
LM End	11.35	Issue Type +	En	Location *	CR

View of LS looking upstream at crossing.

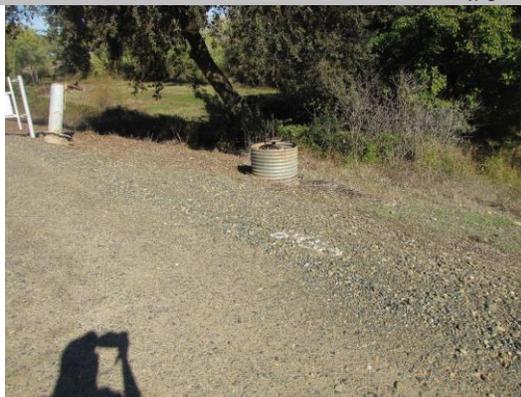
Photo 2 of 2 : UCIP_SP_2016_48009_65994.jpg

View of WS looking upstream at crossing.

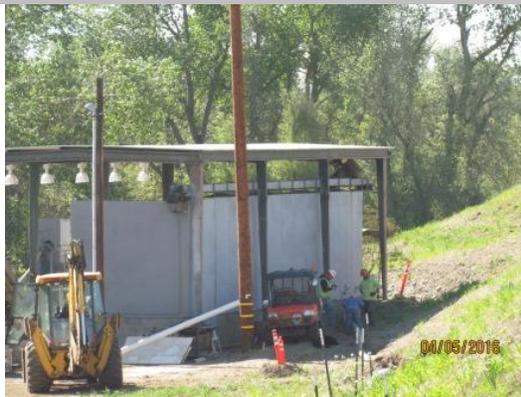
Photo 1 of 1 : SP_2016_MA0007_200_40_20160418_00104.jpg

LM Start	11.49	Rating **	M	Issue No.	40
LM End	11.49	Issue Type +	En	Location *	WS
Category	Earthen Levee		GPS Latitude/Longitude		
			Start	End	
Item	Encroachments		39.437454 °	39.437454 °	
			-121.646024 °	-121.646024 °	
DWR ID	DWR_MA0007_01_s_2016_40				
Comment Code					
BU : Building					
Inspector Comment

View showing structure, waterside, looking downstream.

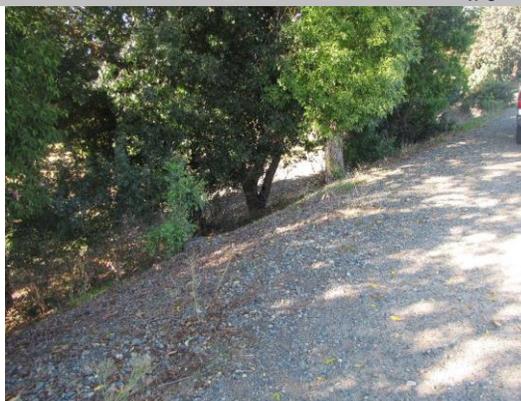
Photo 1 of 2 : UCIP_SP_2016_47997_65996.jpg

LM Start	11.51	Rating **	M	Issue No.	88
LM End	11.51	Issue Type +	En	Location *	WS
Category	Supplemental		GPS Latitude/Longitude		
			Start	End	
Item	DWR UCIP Field Study		39.437766 °	39.437766 °	
			-121.646196 °	-121.646196 °	
DWR ID

Comment Code					
Inspector Comment					
<p>FS_ID:47997 DS_ID:16934 EP_NO: N/A Repair Type: Non-Urgent Crossing Status: Found UCIP Comments: 5/16/2016 Feather River West Levee Improvement Project--Levee currently under construction. Crossing, referenced as STA 2283+95, will be removed and replaced as indicated in the project Plans for Construction of Feather River West Levee Project, Project Area A, Feather River West Levee Improvement Plans, Sta 1765+00 to 2368+26, Volume 3 of 5.6/11/2015 same as last inspection.12/30/2014 Same as last inspection.11/7/2013 Same as last inspection. Metal cone structure on WS was removed and a flapgate was under it.5/20/2014 Same as last inspection.5/13/2013 SBFCA project recommends relacing in accordance with title 23.5/10/2013 Same as last inspection. Burrow activity above WS riser.11/5/2012 unable to determine the condition of the slide gate inside riser--need to determine condition. This crossing was listed in the USACE Periodic Inspection as ID# USACE_CESPK_MA07_2010_a_0355 no issues reported. FIELD_STRUCT_DESC: 24-inch reinforced concrete encased corrugated metal (CM) irrigation pipe through the levee, 18.8 feet below the crown. Slide gate in 36-inch CM riser on the waterside (WS) slope. This entry matches the Drainage or Irrigation Structure referenced in O&M manual (Historic Station 517+40). (USACE O&M Manual, 1957) FS Date: 5/16/2016 3:33:31 PM</p>

View of LS looking upstream at crossing.
