**Flood Control Project Maintenance  
Levee Inspections**

**Fall 2015 Levee Maintenance Deficiency Summary Report**

**Sacramento River Basin**

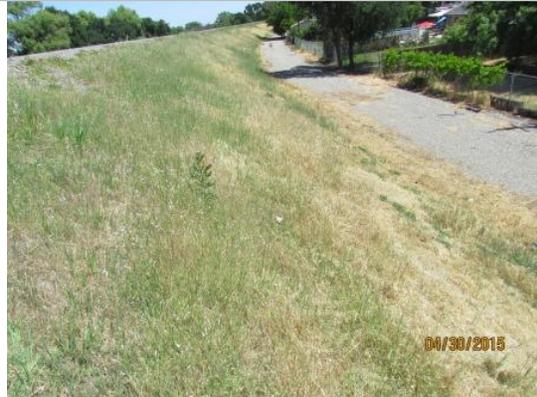
Photo 1 of 2 : FA\_2015\_NA0001\_51\_164\_20150910\_00034.jpg

LM Start	<b>0.48</b>	Rating **	A/W	Issue No.	<b>164</b>
LM End	<b>0.48</b>	Issue Type +	Ma	Location *	LS
Category	Earthen Levee		GPS Latitude/Longitude		
			Start	End	
Item	Erosion / Bank Caving		38.623227 °	38.623227 °	
			-121.460399 °	-121.460399 °	
DWR ID	DWR_NA0001_01_s_2012_164				
Action/Comments					
Note and monitor erosion site. Inspector Comments: 4'-5' diameter by 1' deep hole mid-slope on the landside.

Another view of the depression on the landside levee slope.

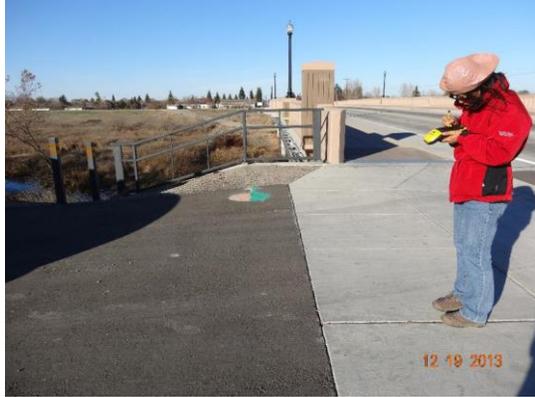
Photo 1 of 1 : UCIP\_FA\_2015\_4476.jpg

LM Start	<b>0.66</b>	Rating **	M	Issue No.	<b>185</b>
LM End	<b>0.66</b>	Issue Type +	En	Location *	LS
Category	Supplemental			GPS Latitude/Longitude	
				Start	End
Item	DWR UCIP Field Study			38.623668 °	38.623668 °
				-121.457156 °	-121.457156 °
DWR ID					
Action/Comments					
Inspector Comments: FS_ID:31169 DS_ID:24800 EP_NO: N/A FS_HLM: 0.66 Repair Type: Non-Urgent Crossing Status: Found

Indicator of crossing found on waterward side edge. Symbol is a Flood Control Structure (green/orange circle).

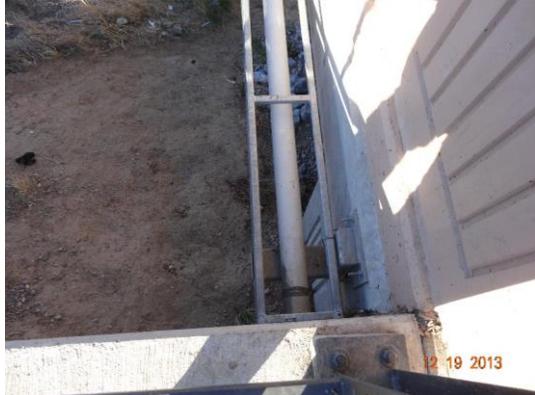
Photo 1 of 3 : UCIP\_FA\_2015\_3311.jpg

LM Start	<b>0.66</b>	Rating **	U	Issue No.	<b>186</b>
LM End	<b>0.66</b>	Issue Type +	En	Location *	LS
Category	Supplemental			GPS Latitude/Longitude	
				Start	End
Item	DWR UCIP Field Study			38.623667 °	38.623667 °
				-121.457134 °	-121.457134 °
DWR ID					
Action/Comments					
Inspector Comments: FS_ID:31167 DS_ID:24266 EP_NO: 3417 FS_HLM: 0.662 Repair Type: Urgent Crossing Status: Found UCIP Comments: no markers visible on waterward or landward side indicating this is a gas line--need to contact owner to determine if this crossing is gas line. FIELD_STRUCT_DESC: 4-inch steel gas line through the levee, 1.5 feet below the crown. CM cutoff wall around pipe at center of levee. Pump hung on bridge for channel crossing. (Permit No. 3417-1961) FS Date: 12/19/2013

View of pipe suspended over waterway.

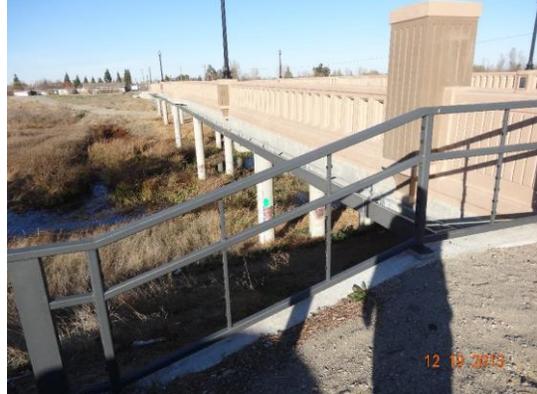
Photo 3 of 3 : UCIP\_FA\_2015\_4475.jpg

LM Start	<b>0.66</b>	Rating **	U	Issue No.	<b>186 (cont)</b>
LM End	<b>0.66</b>	Issue Type +	En	Location *	LS

View of waterward side--pipe suspended along downstream face of bridge.

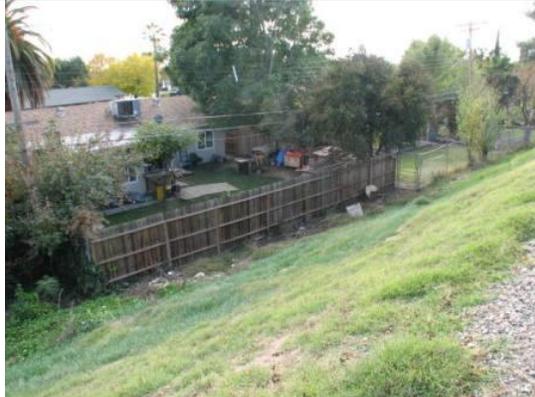
Photo 1 of 1 : FA\_2015\_NA0001\_51\_183\_20150910\_00045.jpg

LM Start	<b>0.77</b>	Rating **	U	Issue No.	<b>183</b>
LM End	<b>0.77</b>	Issue Type +	En	Location *	LS
Category	Earthen Levee		GPS Latitude/Longitude		
			Start	End	
Item	Encroachments		38.624016 °	38.624016 °	
			-121.455193 °	-121.455193 °	
DWR ID	DWR_NA0001_01_s_2012_183				
Action/Comments					
Fence Inspector Comments: Dog-eared fence built within 10' of the toe

11/17/2011 Wooden privacy fence.

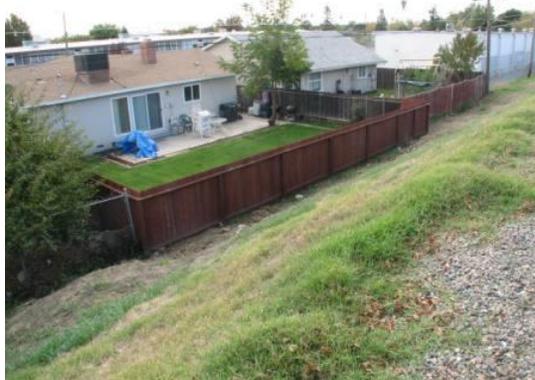
Photo 1 of 1 : FA\_2015\_NA0001\_51\_182\_20150910\_00044.jpg

LM Start	<b>0.95</b>	Rating **	U	Issue No.	<b>182</b>
LM End	<b>0.95</b>	Issue Type +	En	Location *	LS
Category	Earthen Levee		GPS Latitude/Longitude		
			Start	End	
Item	Encroachments		38.625072 °	38.625072 °	
			-121.452225 °	-121.452225 °	
DWR ID	DWR_NA0001_01_s_2012_182				
Action/Comments					
Fence Inspector Comments: Dog-eared wooden fence built within 10' of the toe.

11/17/2011 Wooden privacy fence built at the levee toe.

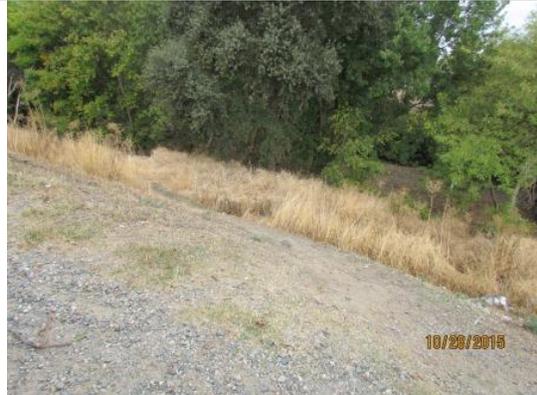
Photo 1 of 1 : FA\_2015\_NA0001\_51\_76\_20151112\_00062.jpg

View of the waterside levee slope damaged by foot traffic.

LM Start	<b>1.05</b>	Rating **	M	Issue No.	<b>76</b>
LM End	<b>1.05</b>	Issue Type +	Ma	Location *	WS
Category	Earthen Levee		GPS Latitude/Longitude		
			Start	End	
Item	Slope Stability		38.625069 °	38.625069 °	
			-121.450360 °	-121.450360 °	
DWR ID	DWR_NA0001_01_f_2015_76				
Action/Comments					
Repair the levee slope damaged by foot traffic and prevent access where possible.

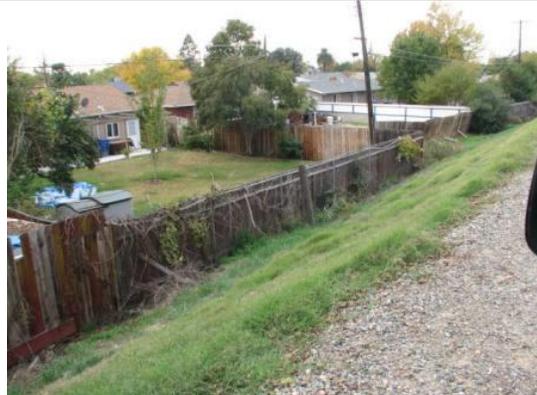
Photo 1 of 1 : FA\_2015\_NA0001\_51\_23\_20150910\_00020.jpg

LM Start	<b>1.14</b>	Rating **	U	Issue No.	<b>23</b>
LM End	<b>1.14</b>	Issue Type +	En	Location *	LS
Category	Earthen Levee		GPS Latitude/Longitude		
			Start	End	
Item	Encroachments		38.624869 °	38.624869 °	
			-121.448662 °	-121.448662 °	
DWR ID	DWR_NA0001_01_s_2012_23				
Action/Comments					
Fence Inspector Comments: Dog-eared wooden fence and chain link fence is built against the levee slope.

11/17/2011 Fence built on the levee slope.

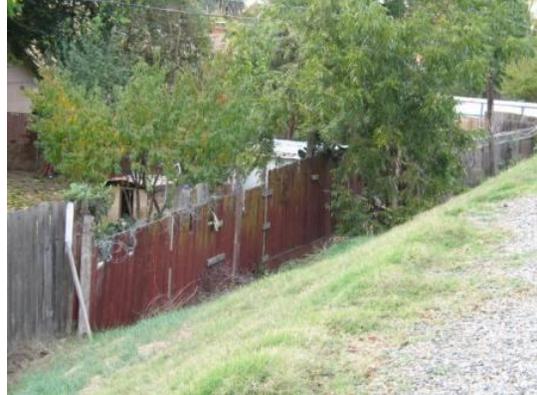
Photo 1 of 1 : FA\_2015\_NA0001\_51\_22\_20150910\_00019.jpg

LM Start	<b>1.15</b>	Rating **	U	Issue No.	<b>22</b>
LM End	<b>1.15</b>	Issue Type +	En	Location *	LS
Category	Earthen Levee		GPS Latitude/Longitude		
			Start	End	
Item	Encroachments		38.624879 °	38.624879 °	
			-121.448486 °	-121.448486 °	
DWR ID	DWR_NA0001_01_s_2012_22				
Action/Comments					
Fence Inspector Comments: Dog-eared wooden fence is built against the levee slope.

11/17/2011 Wooden privacy fence built at the levee toe.

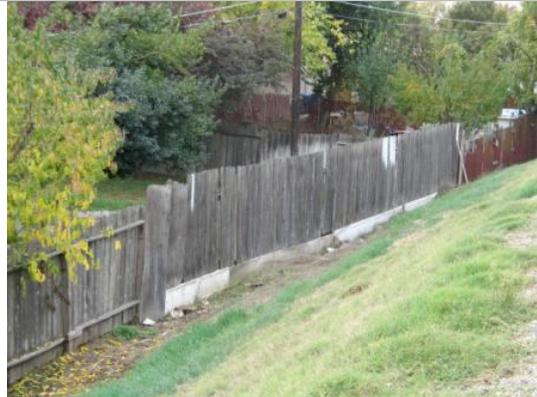
Photo 1 of 1 : FA\_2015\_NA0001\_51\_21\_20150910\_00018.jpg

LM Start	<b>1.17</b>	Rating **	U	Issue No.	<b>21</b>
LM End	<b>1.17</b>	Issue Type +	En	Location *	LS
Category	Earthen Levee		GPS Latitude/Longitude		
			Start	End	
Item	Encroachments		38.624906 °	38.624906 °	
			-121.448259 °	-121.448259 °	
DWR ID	DWR_NA0001_01_s_2012_21				
Action/Comments					
Fence Inspector Comments: Dog-eared wooden fence is built against the levee slope.

11/17/2011 Wooden privacy fence built at the levee toe.

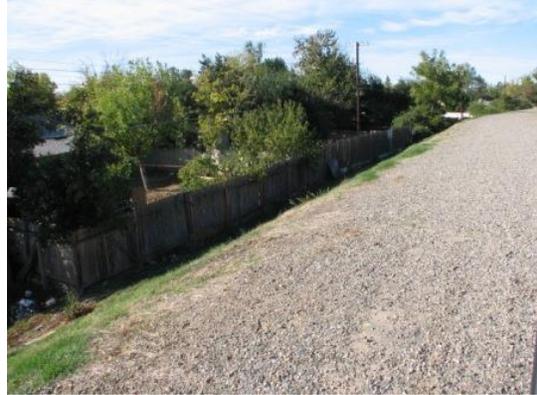
Photo 1 of 1 : FA\_2015\_NA0001\_51\_20\_20150910\_00017.jpg

LM Start	<b>1.18</b>	Rating **	U	Issue No.	<b>20</b>
LM End	<b>1.18</b>	Issue Type +	En	Location *	LS
Category	Earthen Levee			GPS Latitude/Longitude	
				Start	End
Item	Encroachments			38.624900 °	38.624900 °
				-121.448037 °	-121.448037 °
DWR ID	DWR_NA0001_01_s_2012_20				
Action/Comments					
Fence Inspector Comments: Dog-eared wooden fence is built against the levee slope.

Photo of solid fences built against the levee slope.

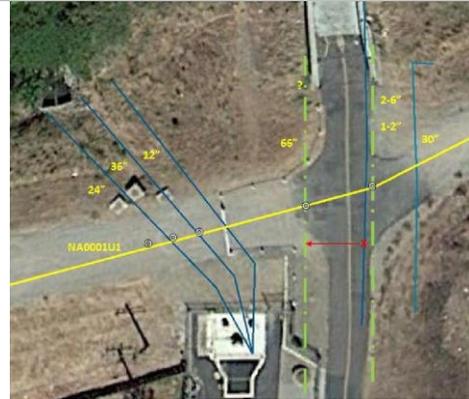
Photo 1 of 1 : UCIP\_FA\_2015\_4624.jpg

LM Start	<b>1.22</b>	Rating **	M	Issue No.	<b>187</b>
LM End	<b>1.22</b>	Issue Type +	En	Location *	LS
Category	Supplemental			GPS Latitude/Longitude	
				Start	End

Item	DWR UCIP Field Study			38.625117 °	38.625117 °
				-121.447318 °	-121.447318 °
DWR ID					
Action/Comments					
Inspector Comments: FS_ID:31178 DS_ID:24248 EP_NO: 14575 FS_HLM: 1.22 Repair Type: Non-Urgent Crossing Status: Not Found UCIP Comments: Crossing is present in the layer provided by the City of Sacramento, however this crossing was not found in the field. Need to determine status of crossing. If crossing is no longer used, owner will need to coordinate with Central Valley Flood Protection Board to comply with Title 23. FIELD_STRUCT_DESC: 30-inch concrete encased steel water main through the levee, 4.5 feet below the crown. Steel cutoff wall around pipe at center of levee. (Permit No. 14575-1988) FS Date: 12/19/2013

Alignment indicated in blue is approximate locations for pipes that cross levee. Alignment information was obtained from the City of Sacramento.

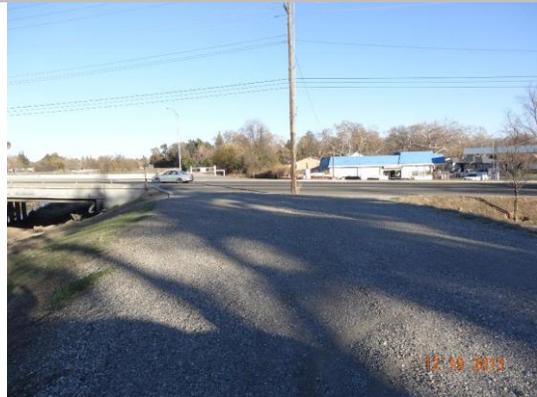
Photo 2 of 3 : UCIP\_FA\_2015\_3022.jpg

LM Start	<b>1.28</b>	Rating **	M	Issue No.	<b>188 (cont)</b>
LM End	<b>1.28</b>	Issue Type +	En	Location *	LS

Overview of levee crown.

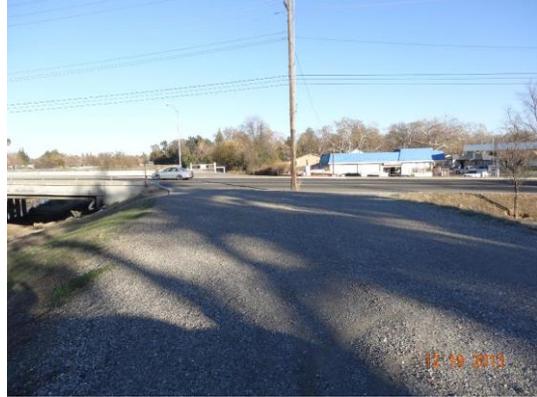
Photo 2 of 3 : UCIP\_FA\_2015\_4591.jpg

LM Start	<b>1.28</b>	Rating **	M	Issue No.	<b>189 (cont)</b>
LM End	<b>1.28</b>	Issue Type +	En	Location *	LS
Category	Supplemental			GPS Latitude/Longitude	
				Start	End
Item	DWR UCIP Field Study			38.625500 °	38.625500 °
				-121.446390 °	-121.446390 °
DWR ID					
Action/Comments					
Inspector Comments: FS_ID:30085 DS_ID:24576 EP_NO: N/A FS_HLM: 1.271 Repair Type: Non-Urgent Crossing Status: Indicator Found UCIP Comments: Unable to confirm location--will need to coordinate with owner to determine if crossing is still active and determine location. FIELD_STRUCT_DESC: 1 of 3: 16-inch pipe through the levee, 8.0 feet below the crown. Floodgates within the levee across the channel, installed under Permit No. 14480 (1986). FS Date: 12/19/2013

Overview of levee crown at crossing.

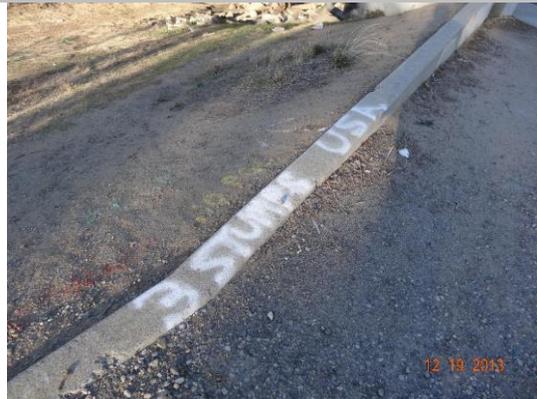
Photo 3 of 3 : UCIP\_FA\_2015\_4592.jpg

Concrete floodwall along waterward shoulder.

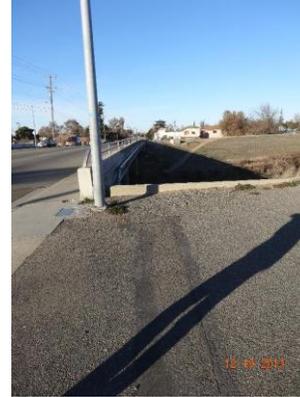
Photo 3 of 3 : UCIP\_FA\_2015\_3026.jpg

LM Start	<b>1.30</b>	Rating **	U	Issue No.	<b>190 (cont)</b>
LM End	<b>1.30</b>	Issue Type +	En	Location *	LS
Category	Supplemental			GPS Latitude/Longitude	
				Start	End
Item	DWR UCIP Field Study			38.625603 °	38.625603 °
				-121.446035 °	-121.446035 °
DWR ID					
Action/Comments					
Inspector Comments: FS_ID:29734 DS_ID:24252 EP_NO: 15152 FS_HLM: 1.297 Repair Type: Urgent Crossing Status: Indicator Found

View of levee crown with repair signs at crossing.

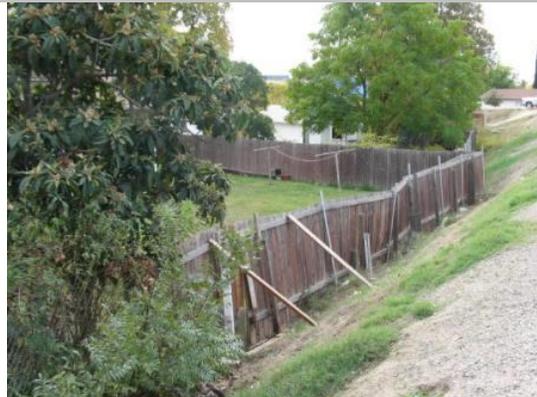
Photo 1 of 1 : FA\_2015\_NA0001\_51\_17\_20150910\_00015.jpg

LM Start	<b>1.33</b>	Rating **	U	Issue No.	<b>17</b>
LM End	<b>1.33</b>	Issue Type +	En	Location *	LS
Category	Earthen Levee			GPS Latitude/Longitude	
				Start	End
Item	Encroachments			38.625885 °	38.625885 °
				-121.445424 °	-121.445424 °
DWR ID	DWR_NA0001_01_s_2012_17				
Action/Comments					
Fence Inspector Comments: Wooden privacy fence

11/17/2011 Wooden privacy fence built at the levee toe. Levee slope is being used to support the fence.

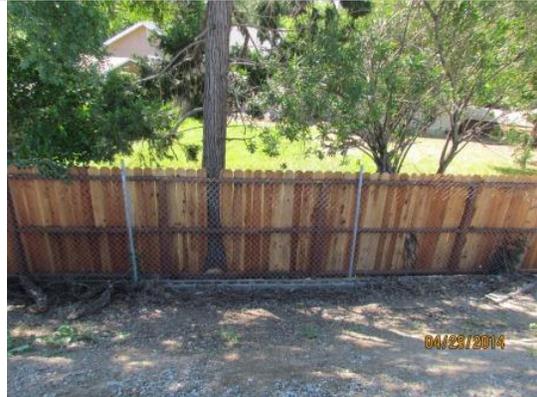
Photo 1 of 1 : FA\_2015\_NA0001\_51\_50\_20150910\_00030.jpg

LM Start	<b>1.35</b>	Rating **	U	Issue No.	<b>50</b>
LM End	<b>1.35</b>	Issue Type +	En	Location *	LS
Category	Earthen Levee			GPS Latitude/Longitude	
				Start	End
Item	Encroachments			38.625982 °	38.625982 °
				-121.445231 °	-121.445231 °
DWR ID	DWR_NA0001_01_s_2014_50				
Action/Comments					
Fence

View of the fence at the landside levee toe obstructing visibility and access.

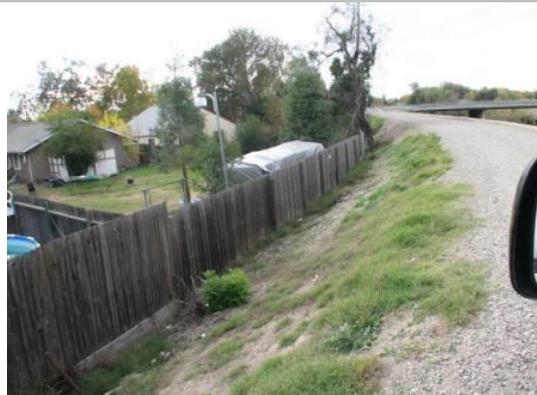
Photo 1 of 1 : FA\_2015\_NA0001\_51\_16\_20150910\_00014.jpg

LM Start	<b>1.36</b>	Rating **	U	Issue No.	<b>16</b>
LM End	<b>1.36</b>	Issue Type +	En	Location *	LS
Category	Earthen Levee			GPS Latitude/Longitude	
				Start	End
Item	Encroachments			38.626000 °	38.626000 °
				-121.444978 °	-121.444978 °
DWR ID	DWR_NA0001_01_s_2012_16				
Action/Comments					
Fence Inspector Comments: Wooden privacy fence

11/17/2011 Wooden privacy fence built at the levee toe.

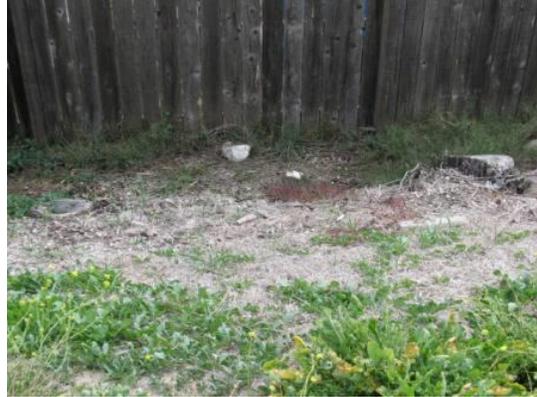
Photo 1 of 1 : FA\_2015\_NA0001\_51\_178\_20150910\_00043.jpg

LM Start	<b>1.36</b>	Rating **	N	Issue No.	<b>178</b>
LM End	<b>1.36</b>	Issue Type +	Ma	Location *	LS
Category	Earthen Levee		GPS Latitude/Longitude		
			Start	End	
Item	Trim / Thin Trees		38.626063 °	38.626063 °	
			-121.444988 °	-121.444988 °	
DWR ID	DWR_NA0001_01_s_2012_178				
Action/Comments					
Tree stumps. Inspector Comments: Two stumps at landside toe.

11/17/2011 Two stumps at levee toe.

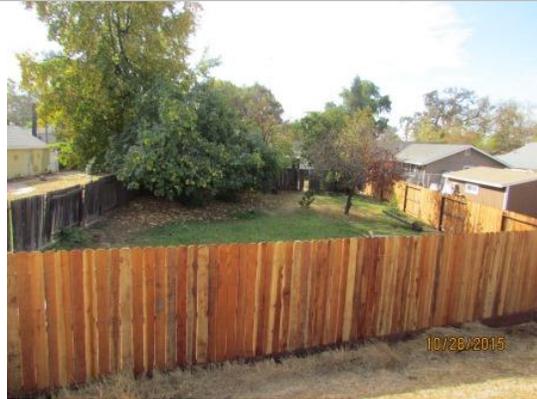
Photo 1 of 1 : FA\_2015\_NA0001\_51\_15\_20151112\_00061.jpg

LM Start	<b>1.37</b>	Rating **	U	Issue No.	<b>15</b>
LM End	<b>1.37</b>	Issue Type +	En	Location *	LS
Category	Earthen Levee		GPS Latitude/Longitude		
			Start	End	
Item	Encroachments		38.626048 °	38.626048 °	
			-121.444785 °	-121.444785 °	
DWR ID	DWR_NA0001_01_s_2012_15				
Action/Comments					
Fence Inspector Comments: Wooden privacy fence LS toe.

View of the fence at the landside levee toe.

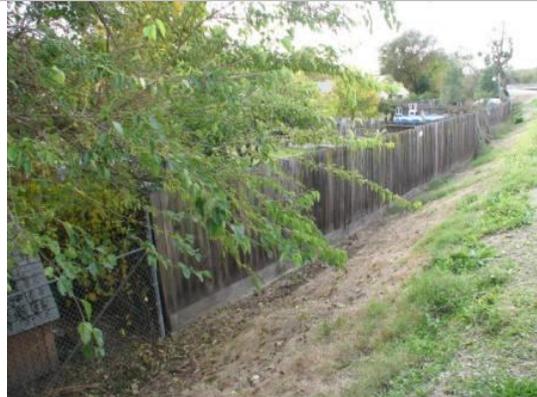
Photo 1 of 1 : FA\_2015\_NA0001\_51\_14\_20150910\_00012.jpg

LM Start	<b>1.38</b>	Rating **	U	Issue No.	<b>14</b>
LM End	<b>1.38</b>	Issue Type +	En	Location *	LS
Category	Earthen Levee		GPS Latitude/Longitude		
			Start	End	
Item	Encroachments		38.626085 °	38.626085 °	
			-121.444580 °	-121.444580 °	
DWR ID	DWR_NA0001_01_s_2012_14				
Action/Comments					
Fence Inspector Comments: Wooden privacy fence

11/17/2011 Wooden privacy fence built at the levee toe.

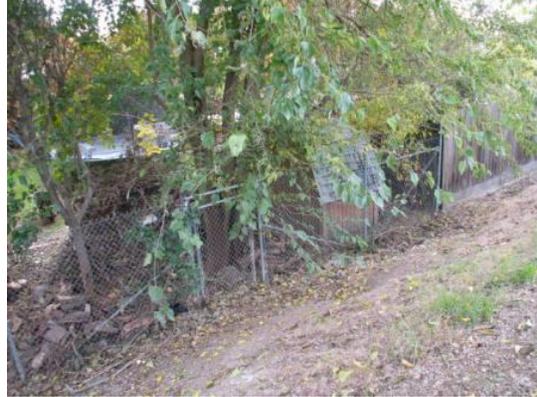
Photo 1 of 1 : FA\_2015\_NA0001\_51\_38\_20150910\_00028.jpg

LM Start	<b>1.40</b>	Rating **	M	Issue No.	<b>38</b>
LM End	<b>1.40</b>	Issue Type +	En	Location *	LS
Category	Earthen Levee		GPS Latitude/Longitude		
			Start	End	
Item	Encroachments		38.626210 °	38.626210 °	
			-121.444320 °	-121.444320 °	
DWR ID	DWR_NA0001_01_s_2012_38				
Action/Comments					
Building Inspector Comments: Small wooden storage shed and firewood are placed along chain link fence within 10-ft of levee toe.

11/17/2011 Shed and firewood can be seen through the chainlink fence.

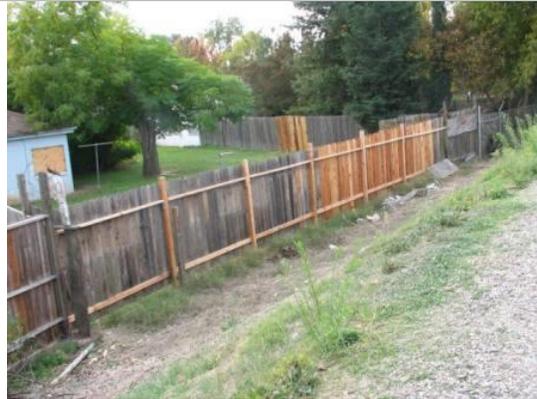
Photo 1 of 1 : FA\_2015\_NA0001\_51\_13\_20150910\_00011.jpg

LM Start	<b>1.40</b>	Rating **	U	Issue No.	<b>13</b>
LM End	<b>1.40</b>	Issue Type +	En	Location *	LS
Category	Earthen Levee		GPS Latitude/Longitude		
			Start	End	
Item	Encroachments		38.626155 °	38.626155 °	
			-121.444250 °	-121.444250 °	
DWR ID	DWR_NA0001_01_s_2012_13				
Action/Comments					
Fence Inspector Comments: Wooden fence with barbed wire is built within 10-ft of levee toe. 04/13/2011 Fence has blown over and now partially rests on the levee. Fall insp 2011 fence has been rebuilt in same location, within 10' of levee toe.

11/17/2011 New wooden privacy fence built within 15' of the levee toe.

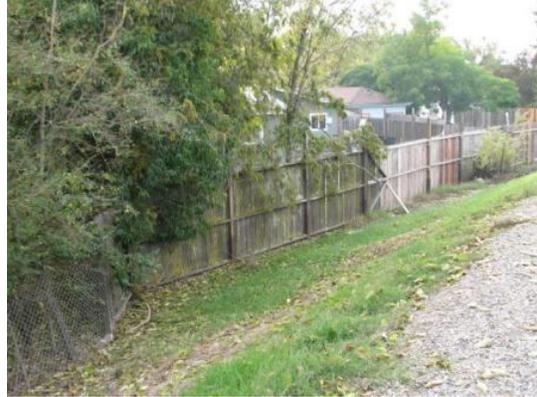
Photo 1 of 1 : FA\_2015\_NA0001\_51\_12\_20150910\_00010.jpg

LM Start	<b>1.41</b>	Rating **	U	Issue No.	<b>12</b>
LM End	<b>1.41</b>	Issue Type +	En	Location *	LS
Category	Earthen Levee		GPS Latitude/Longitude		
			Start	End	
Item	Encroachments		38.626212 °	38.626212 °	
			-121.444082 °	-121.444082 °	
DWR ID	DWR_NA0001_01_s_2012_12				
Action/Comments					
Fence Inspector Comments: Dog-eared wooden fence is built near the levee slope.

11/17/2011 Wooden privacy fence built within 15' of the levee toe.

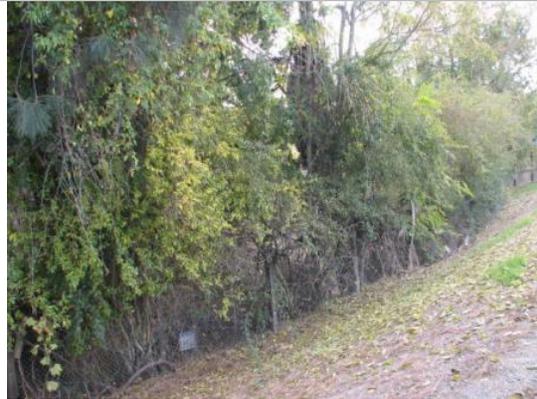
Photo 1 of 1 : FA\_2015\_NA0001\_51\_177\_20150910\_00042.jpg

LM Start	<b>1.42</b>	Rating **	U	Issue No.	<b>177</b>
LM End	<b>1.42</b>	Issue Type +	En	Location *	LS
Category	Earthen Levee		GPS Latitude/Longitude		
			Start	End	
Item	Vegetation		38.626388 °	38.626388 °	
			-121.443910 °	-121.443910 °	
DWR ID	DWR_NA0001_01_s_2012_177				
Action/Comments					
Landscaping Inspector Comments: Thick vegetation at the toe.

11/17/2011 Thick vegetation at the levee toe.

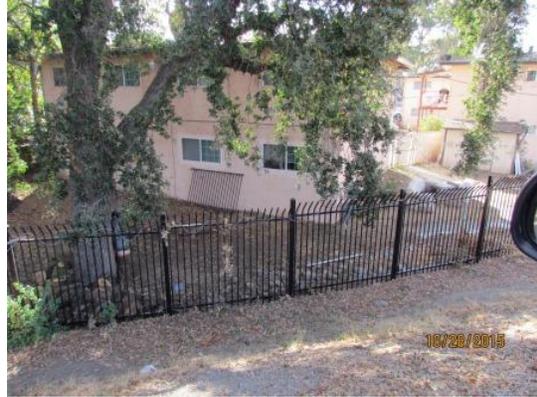
Photo 1 of 1 : FA\_2015\_NA0001\_51\_70\_20151112\_00060.jpg

LM Start	<b>1.44</b>	Rating **	U	Issue No.	<b>70</b>
LM End	<b>1.44</b>	Issue Type +	En	Location *	LS
Category	Earthen Levee		GPS Latitude/Longitude		
			Start	End	
Item	Encroachments		38.626589 °	38.626589 °	
			-121.443640 °	-121.443640 °	
DWR ID	DWR_NA0001_01_f_2015_70				
Action/Comments					
Fence Inspector Comments: Rought iron fence at LS toe blocks access.

View of the fence at the landside levee toe.

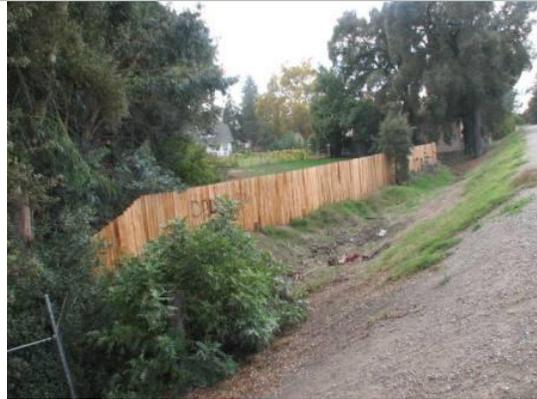
Photo 1 of 1 : FA\_2015\_NA0001\_51\_176\_20150910\_00041.jpg

LM Start	<b>1.47</b>	Rating **	A/W	Issue No.	<b>176</b>
LM End	<b>1.47</b>	Issue Type +	En	Location *	LS
Category	Earthen Levee		GPS Latitude/Longitude		
			Start	End	
Item	Encroachments		38.626881 °	38.626881 °	
			-121.443253 °	-121.443253 °	
DWR ID	DWR_NA0001_01_s_2012_176				
Action/Comments					
Fence Inspector Comments: Wooden privacy fence within 10' of the levee toe.

11/17/2011 Wooden privacy fence built within 15' of the levee toe.

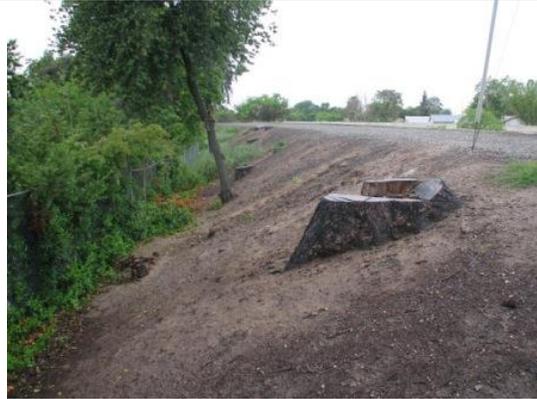
Photo 1 of 1 : FA\_2015\_NA0001\_51\_56\_20150910\_00032.jpg

LM Start	<b>1.52</b>	Rating **	N	Issue No.	<b>56</b>
LM End	<b>1.52</b>	Issue Type +	Ma	Location *	LS
Category	Earthen Levee		GPS Latitude/Longitude		
			Start	End	
Item	Trim / Thin Trees		38.627224 °	38.627224 °	
			-121.442515 °	-121.442515 °	
DWR ID	DWR_NA0001_01_s_2012_56				
Action/Comments					
Tree stumps. Inspector Comments: 5 stumps 14 to 30 Inches in diameter.

Several large stumps on levee slope.

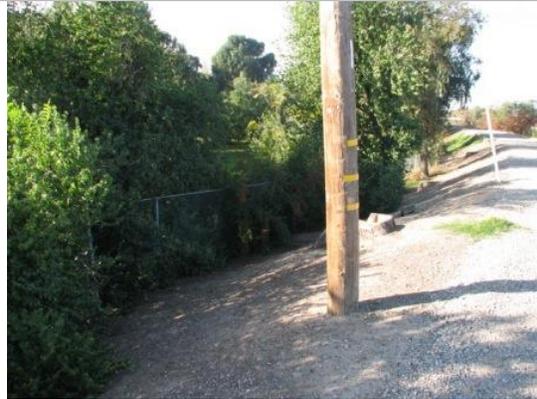
Photo 1 of 1 : FA\_2015\_NA0001\_51\_35\_20150910\_00027.jpg

LM Start	<b>1.53</b>	Rating **	M	Issue No.	<b>35</b>
LM End	<b>1.53</b>	Issue Type +	En	Location *	LS
Category	Earthen Levee		GPS Latitude/Longitude		
			Start	End	
Item	Vegetation		38.627255 °	38.627255 °	
			-121.442402 °	-121.442402 °	
DWR ID	DWR_NA0001_01_s_2012_35				
Action/Comments					
Landscaping Inspector Comments: Bushes and trees along chain link fence block access and visibility.

Fall 2009 photo:Vegetation obstructing visibility near levee slope.

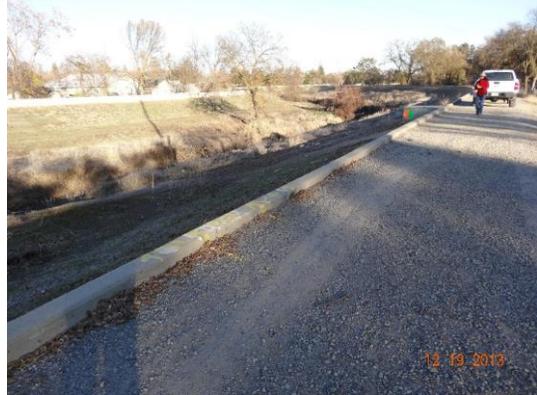
Photo 1 of 3 : UCIP\_FA\_2015\_4625.jpg

LM Start	<b>1.57</b>	Rating **	M	Issue No.	<b>184</b>
LM End	<b>1.57</b>	Issue Type +	En	Location *	LS
Category	Supplemental			GPS Latitude/Longitude	
				Start	End
Item	DWR UCIP Field Study			38.627277 °	38.627277 °
				-121.441650 °	-121.441650 °
DWR ID	DWR_NA0001_01_f_2015_184				
Action/Comments					
Inspector Comments: FS_ID:46793 DS_ID:24573 EP_NO: N/A FS_HLM: 1.571 Repair Type: Non-Urgent Crossing Status: Indicator Found UCIP Comments: 11/12/15 Markers have been installed on both levees--confirmed during DWR Fall Inspection. Need to coordinate with PG&E to determine permit for this crossing.12/19/13 No markers visible indicating crossing through levee. PG&E line. Need to coordinate with owner. Permit? FIELD_STRUCT_DESC: 2 of 2: 6-inch pipe through the levee, below ground elevation and under the channel. FS Date: 11/12/2015

View of waterward side.

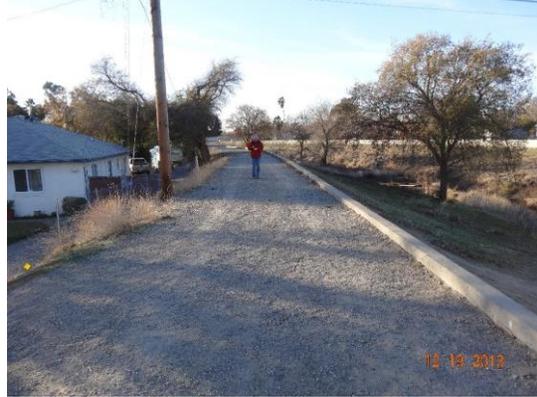
Photo 2 of 3 : UCIP\_FA\_2015\_4626.jpg

LM Start	<b>1.57</b>	Rating **	M	Issue No.	<b>184 (cont)</b>
LM End	<b>1.57</b>	Issue Type +	En	Location *	LS
Category	Supplemental			GPS Latitude/Longitude	
				Start	End
Item	DWR UCIP Field Study			38.627277 °	38.627277 °
				-121.441650 °	-121.441650 °
DWR ID	DWR_NA0001_01_f_2015_184				
Action/Comments					
Inspector Comments: FS_ID:46793 DS_ID:24573 EP_NO: N/A FS_HLM: 1.571 Repair Type: Non-Urgent Crossing Status: Indicator Found UCIP Comments: 11/12/15 Markers have been installed on both levees--confirmed during DWR Fall Inspection. Need to coordinate with PG&E to determine permit for this crossing.12/19/13 No markers visible indicating crossing through levee. PG&E line. Need to coordinate with owner. Permit? FIELD_STRUCT_DESC: 2 of 2: 6-inch pipe through the levee, below ground elevation and under the channel. FS Date: 11/12/2015

Overview of area near crossing. Inspector is standing where crossing goes through levee.

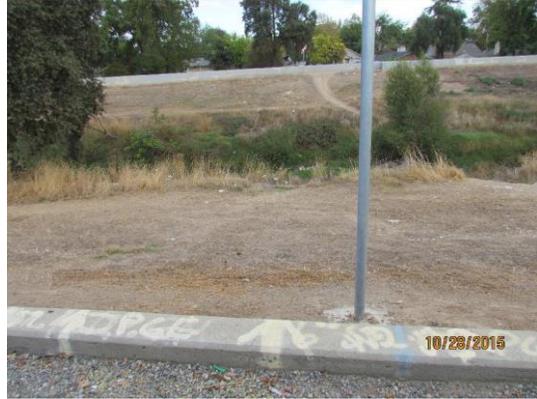
Photo 3 of 3 : UCIP\_FA\_2015\_5876.jpg

Markers installed on both levees in 2015.

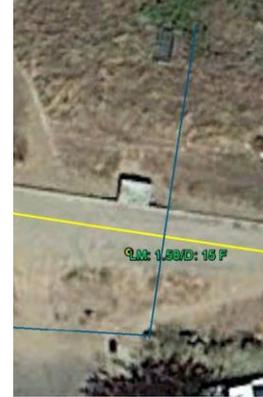
Photo 1 of 3 : UCIP\_FA\_2015\_4627.jpg

LM Start	<b>1.58</b>	Rating **	M	Issue No.	<b>191</b>
LM End	<b>1.58</b>	Issue Type +	En	Location *	LS
Category	Supplemental			GPS Latitude/Longitude	
				Start	End
Item	DWR UCIP Field Study			38.627241 °	38.627241 °
				-121.441465 °	-121.441465 °
DWR ID					
Action/Comments					
Inspector Comments: FS_ID:31182 DS_ID:24255 EP_NO: N/A FS_HLM: 1.58 Repair Type: Non-Urgent Crossing Status: Found

Alignment in blue is an estimate of pipe alignment provided by the City of Sacramento. The symbol at LM 1.58 is field confirmed location.

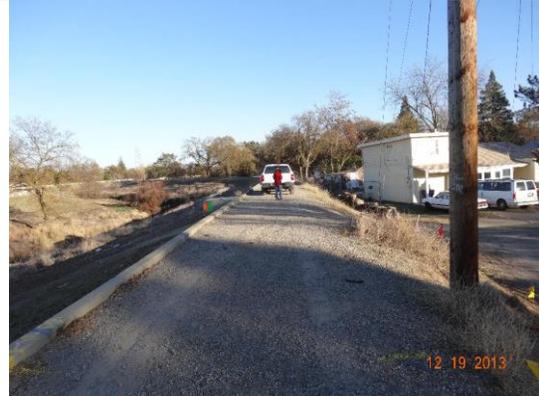
Photo 2 of 3 : UCIP\_FA\_2015\_4628.jpg

Overview of levee at crossing.

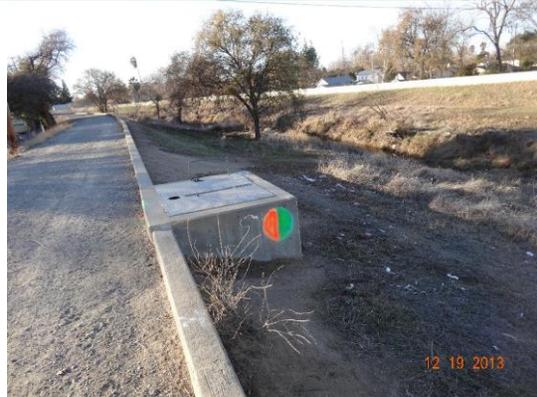
Photo 3 of 3 : UCIP\_FA\_2015\_4629.jpg

LM Start	<b>1.58</b>	Rating **	M	Issue No.	<b>191 (cont)</b>
LM End	<b>1.58</b>	Issue Type +	En	Location *	LS
Category	Supplemental			GPS Latitude/Longitude	
				Start	End
Item	DWR UCIP Field Study			38.627241 °	38.627241 °
				-121.441465 °	-121.441465 °
DWR ID					
Action/Comments					
Inspector Comments: FS_ID:31182 DS_ID:24255 EP_NO: N/A FS_HLM: 1.58 Repair Type: Non-Urgent Crossing Status: Found

View of concrete vault located on waterward apex.

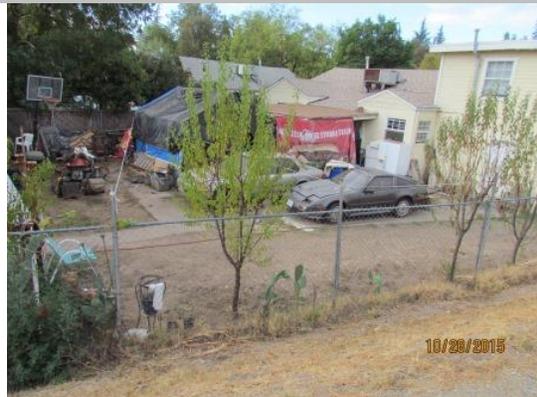
Photo 1 of 1 : FA\_2015\_NA0001\_51\_67\_20151112\_00059.jpg

LM Start	<b>1.60</b>	Rating **	M	Issue No.	<b>67</b>
LM End	<b>1.60</b>	Issue Type +	En	Location *	LS
Category	Earthen Levee			GPS Latitude/Longitude	
				Start	End
Item	Encroachments			38.627207 °	38.627207 °
				-121.441104 °	-121.441104 °
DWR ID	DWR_NA0001_01_f_2015_67				
Action/Comments					
Fence Inspector Comments: Fence at landside levee toe. 6 fruit trees and various cactus plants at LS toe.

View of the fence and landscaping at the landside levee toe.

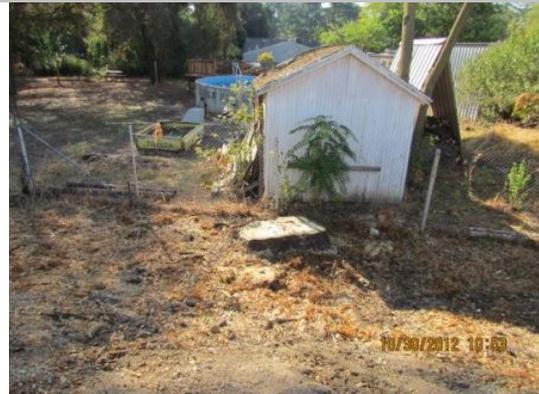
Photo 1 of 1 : FA\_2015\_NA0001\_51\_31\_20150910\_00025.jpg

LM Start	<b>1.61</b>	Rating **	N	Issue No.	<b>31</b>
LM End	<b>1.61</b>	Issue Type +	Ma	Location *	LS
Category	Earthen Levee		GPS Latitude/Longitude		
			Start	End	
Item	Trim / Thin Trees		38.627191 °	38.627191 °	
			-121.440861 °	-121.440861 °	
DWR ID	DWR_NA0001_01_f_2012_31				
Action/Comments					
Tree stumps.

View of large tree stump at levee toe.

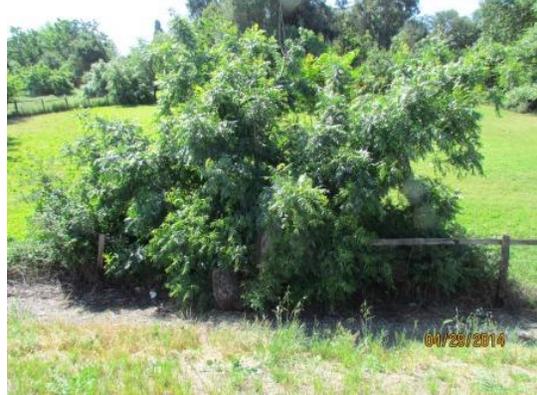
Photo 1 of 1 : FA\_2015\_NA0001\_51\_48\_20150910\_00029.jpg

LM Start	<b>1.69</b>	Rating **	A/W	Issue No.	<b>48</b>
LM End	<b>1.69</b>	Issue Type +	Ma	Location *	LS
Category	Earthen Levee		GPS Latitude/Longitude		
			Start	End	
Item	Vegetation		38.627594 °	38.627594 °	
			-121.439540 °	-121.439540 °	
DWR ID	DWR_NA0001_01_s_2014_48				
Action/Comments					
Trees / Woody Vegetation Inspector Comments: Tree obstructing visibility and access.

View of the overgrown tree at the landside levee toe.

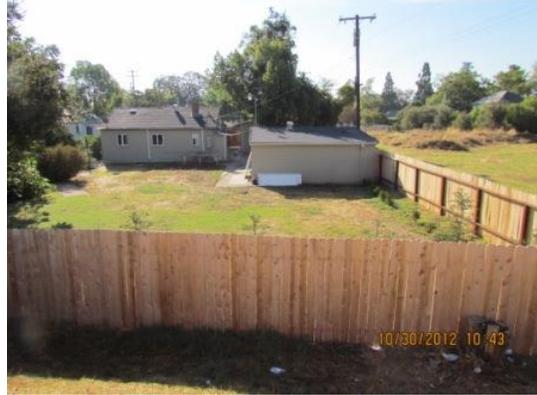
Photo 1 of 1 : FA\_2015\_NA0001\_51\_10\_20150910\_00009.jpg

LM Start	<b>1.79</b>	Rating **	U	Issue No.	<b>10</b>
LM End	<b>1.79</b>	Issue Type +	En	Location *	LS
Category	Earthen Levee		GPS Latitude/Longitude		
			Start	End	
Item	Encroachments		38.627948 °	38.627948 °	
			-121.437682 °	-121.437682 °	
DWR ID	DWR_NA0001_01_f_2012_10				
Action/Comments					
Fence Inspector Comments: Wooden fence constructed at LS levee toe.

View of new fence constructed at levee toe and 7 redwood trees planted behind fence within easement.

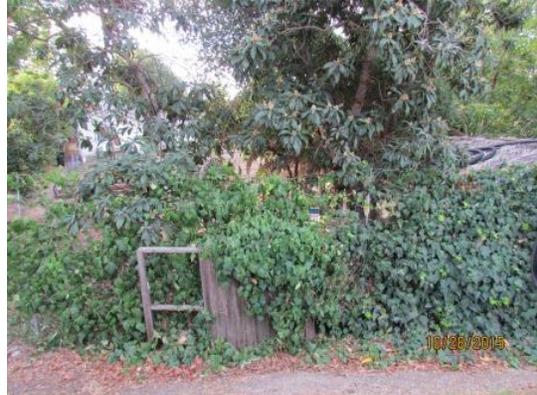
Photo 1 of 1 : FA\_2015\_NA0001\_51\_170\_20151112\_00057.jpg

LM Start	<b>1.81</b>	Rating **	U	Issue No.	<b>170</b>
LM End	<b>1.81</b>	Issue Type +	En	Location *	LS
Category	Earthen Levee		GPS Latitude/Longitude		
			Start	End	
Item	Vegetation		38.627934 °	38.627934 °	
			-121.437423 °	-121.437423 °	
DWR ID	DWR_NA0001_01_s_2012_170				
Action/Comments					
Landscaping Inspector Comments: Growth on old wooden fence, which has since been replaced by a chainlink fence is obstructive.

View of the landscaping at the landside levee toe.

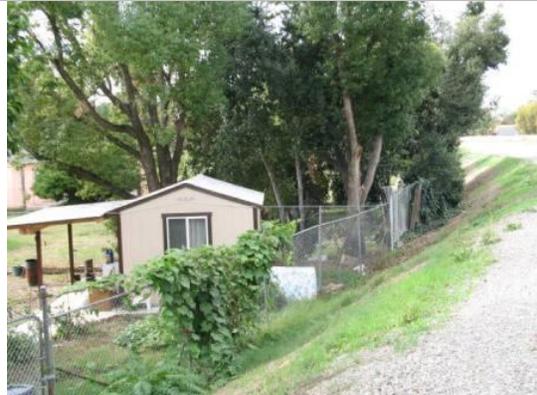
Photo 1 of 1 : FA\_2015\_NA0001\_51\_169\_20150910\_00038.jpg

LM Start	<b>1.82</b>	Rating **	U	Issue No.	<b>169</b>
LM End	<b>1.82</b>	Issue Type +	En	Location *	LS
Category	Earthen Levee		GPS Latitude/Longitude		
			Start	End	
Item	Encroachments		38.627922 °	38.627922 °	
			-121.437296 °	-121.437296 °	
DWR ID	DWR_NA0001_01_s_2012_169				
Action/Comments					
Building Inspector Comments: Shed on concrete pad within 10' of the levee toe.

11/17/2011 Wooden shed on concrete pad built within 15' of levee toe.

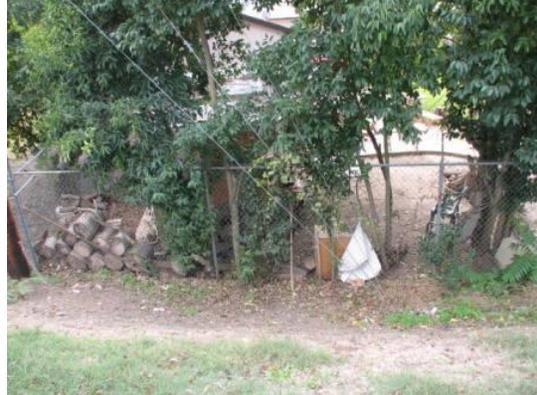
Photo 1 of 1 : FA\_2015\_NA0001\_51\_33\_20150910\_00026.jpg

LM Start	<b>1.83</b>	Rating **	U	Issue No.	<b>33</b>
LM End	<b>1.83</b>	Issue Type +	En	Location *	LS
Category	Earthen Levee		GPS Latitude/Longitude		
			Start	End	
Item	Encroachments		38.627897 °	38.627897 °	
			-121.437073 °	-121.437073 °	
DWR ID	DWR_NA0001_01_s_2012_33				
Action/Comments					
Building Inspector Comments: Wooden animal pen is built against levee slope.

11/17/2011 Wooden structure is built within 15' of the levee toe.

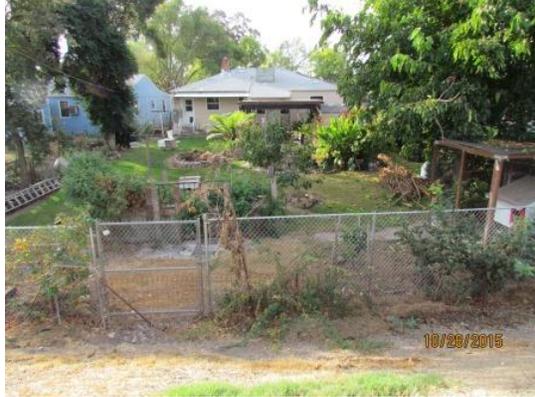
Photo 1 of 1 : FA\_2015\_NA0001\_51\_9\_20151112\_00058.jpg

LM Start	<b>1.85</b>	Rating **	M	Issue No.	<b>9</b>
LM End	<b>1.85</b>	Issue Type +	En	Location *	LS
Category	Earthen Levee		GPS Latitude/Longitude		
			Start	End	
Item	Encroachments		38.627884 °	38.627884 °	
			-121.436682 °	-121.436682 °	
DWR ID	DWR_NA0001_01_s_2012_9				
Action/Comments					
Fence

View of the fence at the landside levee toe.

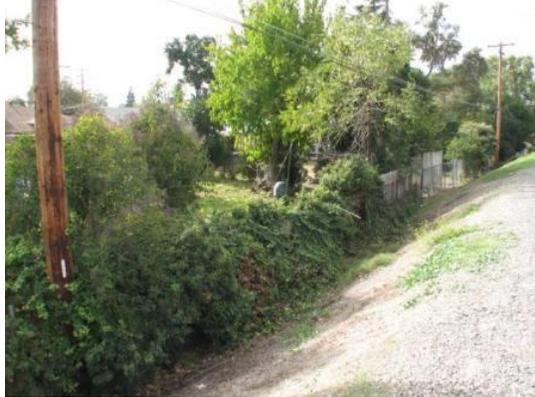
Photo 1 of 1 : FA\_2015\_NA0001\_51\_8\_20150910\_00007.jpg

LM Start	<b>1.85</b>	Rating **	M	Issue No.	<b>8</b>
LM End	<b>1.85</b>	Issue Type +	En	Location *	LS
Category	Earthen Levee		GPS Latitude/Longitude		
			Start	End	
Item	Vegetation		38.627889 °	38.627889 °	
			-121.436638 °	-121.436638 °	
DWR ID	DWR_NA0001_01_s_2012_8				
Action/Comments					
Landscaping Inspector Comments: Ivy, trees and other landscaping growing on a wooden privacy fence are obstructing visibility.

11/17/2011 Landscaping vegetation growth on the fence is obstructive.

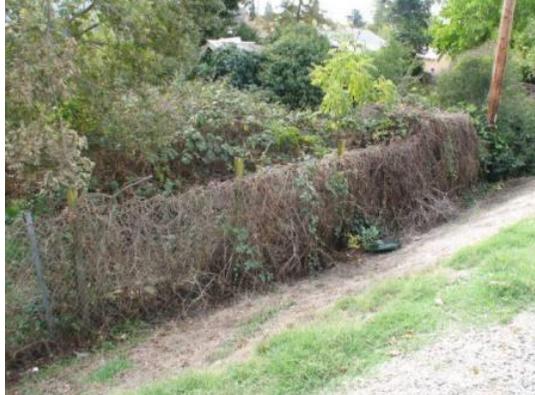
Photo 1 of 1 : FA\_2015\_NA0001\_51\_7\_20150910\_00006.jpg

LM Start	<b>1.86</b>	Rating **	U	Issue No.	<b>7</b>
LM End	<b>1.86</b>	Issue Type +	En	Location *	LS
Category	Earthen Levee		GPS Latitude/Longitude		
			Start	End	
Item	Vegetation		38.627889 °	38.627889 °	
			-121.436454 °	-121.436454 °	
DWR ID	DWR_NA0001_01_s_2012_7				
Action/Comments					
Landscaping Inspector Comments: Metal sided shelter, blackberries and cherry trees are obstructive.

11/17/2011 Blackberries growing on fence are obstructive.

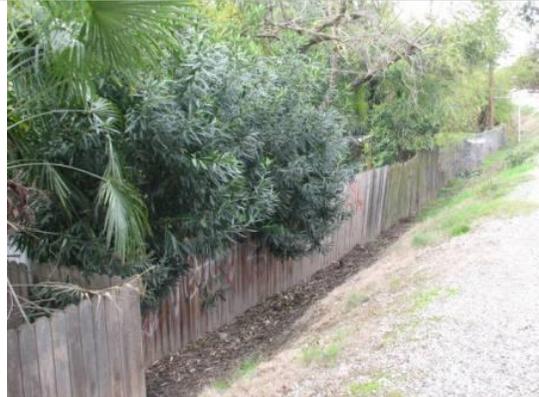
Photo 1 of 1 : FA\_2015\_NA0001\_51\_6\_20150910\_00005.jpg

LM Start	<b>1.90</b>	Rating **	U	Issue No.	<b>6</b>
LM End	<b>1.90</b>	Issue Type +	En	Location *	LS
Category	Earthen Levee		GPS Latitude/Longitude		
			Start	End	
Item	Encroachments		38.627725 °	38.627725 °	
			-121.435715 °	-121.435715 °	
DWR ID	DWR_NA0001_01_s_2012_6				
Action/Comments					
Fence Inspector Comments: Dog-eared wooden fence is built within 10-ft of the levee slope.

11/17/2011 Wooden privacy fence built at the levee toe.

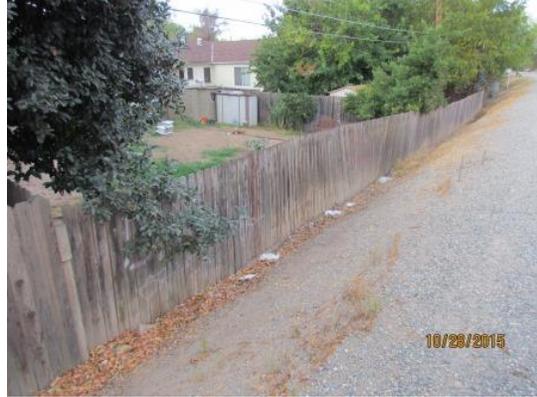
Photo 1 of 1 : FA\_2015\_NA0001\_51\_4\_20151112\_00056.jpg

LM Start	<b>1.92</b>	Rating **	U	Issue No.	<b>4</b>
LM End	<b>1.92</b>	Issue Type +	En	Location *	LS
Category	Earthen Levee		GPS Latitude/Longitude		
			Start	End	
Item	Encroachments		38.627715 °	38.627715 °	
			-121.435452 °	-121.435452 °	
DWR ID	DWR_NA0001_01_s_2012_4				
Action/Comments					
Fence Inspector Comments: Wooden fence and landscaping completely block visibility.

View of the wooden fence at the landside levee toe.

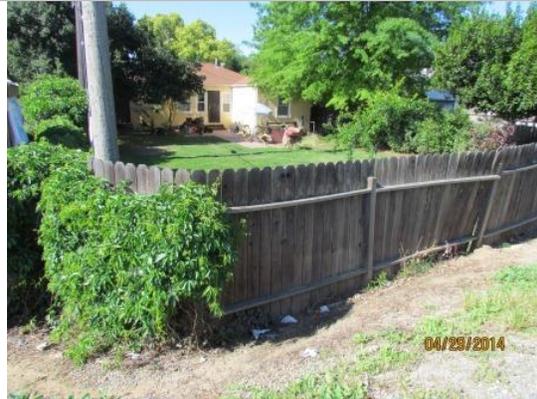
Photo 1 of 1 : FA\_2015\_NA0001\_51\_3\_20150910\_00002.jpg

LM Start	<b>1.93</b>	Rating **	U	Issue No.	<b>3</b>
LM End	<b>1.93</b>	Issue Type +	En	Location *	LS
Category	Earthen Levee		GPS Latitude/Longitude		
			Start	End	
Item	Encroachments		38.627658 °	38.627658 °	
			-121.435192 °	-121.435192 °	
DWR ID	DWR_NA0001_01_s_2012_3				
Action/Comments					
Fence Inspector Comments: Dog-eared wooden fence is built against the levee slope.

View of the fence at the landside levee toe.

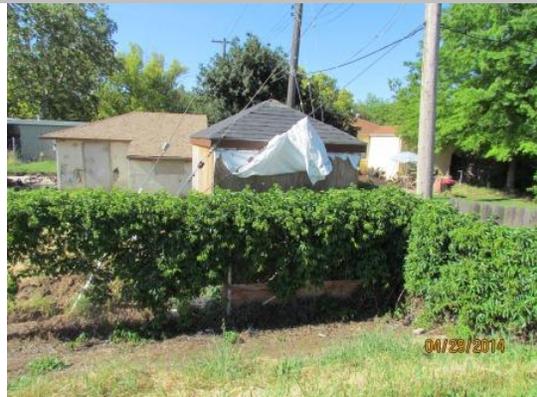
Photo 1 of 1 : FA\_2015\_NA0001\_51\_30\_20150910\_00024.jpg

LM Start	<b>1.93</b>	Rating **	U	Issue No.	<b>30</b>
LM End	<b>1.93</b>	Issue Type +	En	Location *	LS
Category	Earthen Levee		GPS Latitude/Longitude		
			Start	End	
Item	Encroachments		38.627646 °	38.627646 °	
			-121.435151 °	-121.435151 °	
DWR ID	DWR_NA0001_01_s_2012_30				
Action/Comments					
Building Inspector Comments: Concrete pad and wooden frame structure is being built within 15-ft of levee toe.

Building on concrete pad within 15 feet of the landside levee toe.

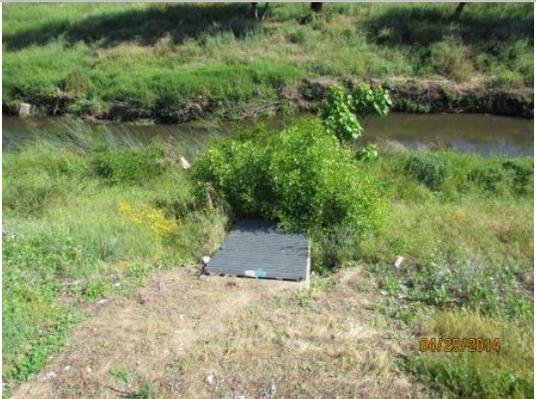
Photo 1 of 2 : FA\_2015\_NA0001\_51\_168\_20150910\_00037.jpg

LM Start	<b>1.95</b>	Rating **	M	Issue No.	<b>168</b>
LM End	<b>1.95</b>	Issue Type +	En	Location *	WS
Category	Earthen Levee		GPS Latitude/Longitude		
			Start	End	
Item	Encroachments		38.627565 °	38.627565 °	
			-121.434818 °	-121.434818 °	
DWR ID	DWR_NA0001_01_s_2012_168				
Action/Comments					
Pipe Inspector Comments: Flap gate is blocked by debris in the outfall structure. Gate is blocked in the open position.

View of the vegetation obstructing the outfall.

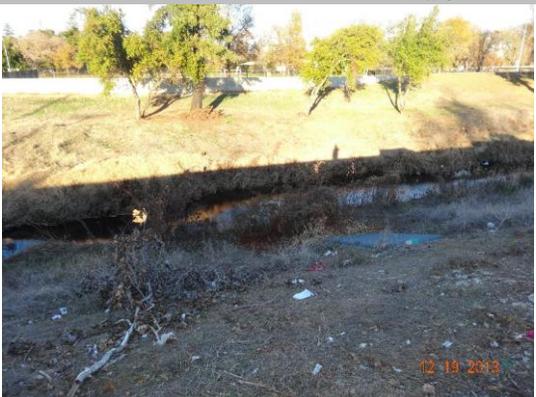
Photo 1 of 3 : UCIP\_FA\_2015\_4630.jpg

LM Start	<b>1.95</b>	Rating **	M	Issue No.	<b>192</b>
LM End	<b>1.95</b>	Issue Type +	En	Location *	WS
Category	Supplemental		GPS Latitude/Longitude		
			Start	End	
Item	DWR UCIP Field Study		38.627568 °	38.627568 °	
			-121.434815 °	-121.434815 °	
DWR ID					
Action/Comments					
Inspector Comments: FS_ID:41549 DS_ID:24259 EP_NO: N/A FS_HLM: 1.95 Repair Type: Non-Urgent Crossing Status: Found

Debris screen visible on waterward slope.

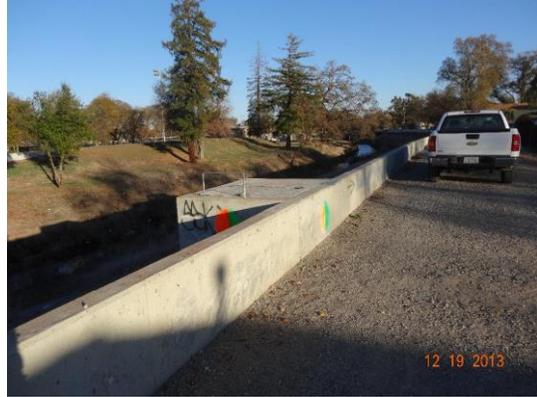
Photo 2 of 3 : UCIP\_FA\_2015\_4631.jpg

LM Start	1.95	Rating **	M	Issue No.	192 (cont)
LM End	1.95	Issue Type +	En	Location *	WS
Category	Supplemental			GPS Latitude/Longitude	
				Start	End
Item	DWR UCIP Field Study			38.627568 °	38.627568 °
				-121.434815 °	-121.434815 °
DWR ID					
Action/Comments					
Inspector Comments: FS_ID:41549 DS_ID:24259 EP_NO: N/A FS_HLM: 1.95 Repair Type: Non-Urgent Crossing Status: Found UCIP Comments: 1/29/14 approximate alignment of crossings was provided by the City of Sacramento for known crossings through levee. Unable to confirm last inspection. Also City records indicate 10-inch not 15-inch--need to clarify with owner. Crossing is operational. FIELD_STRUCT_DESC: 15-inch pipe through the levee, 8.5 feet below the crown. Flap gate on the waterward end. FS Date: 12/19/2013

View of floodwall along waterward side.

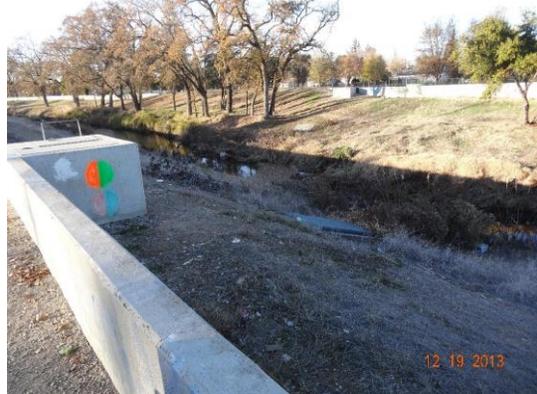
Photo 3 of 3 : UCIP\_FA\_2015\_4632.jpg

View of waterward side--concrete vault and u-shape concrete headwall with debris screen.

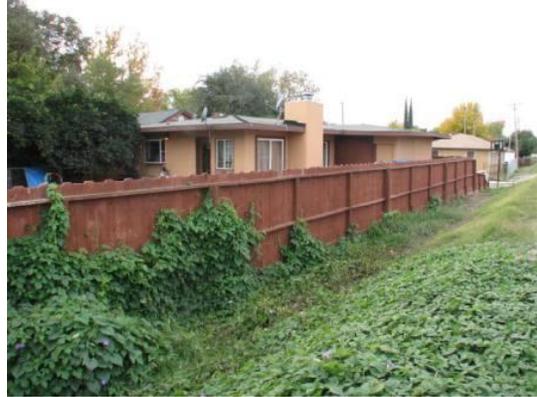
Photo 1 of 1 : FA\_2015\_NA0001\_51\_167\_20150910\_00036.jpg

LM Start	<b>1.98</b>	Rating **	U	Issue No.	<b>167</b>
LM End	<b>1.98</b>	Issue Type +	En	Location *	LS
Category	Earthen Levee		GPS Latitude/Longitude		
			Start	End	
Item	Encroachments		38.627433 °	38.627433 °	
			-121.434341 °	-121.434341 °	
DWR ID	DWR_NA0001_01_s_2012_167				
Action/Comments					
Fence Inspector Comments: Wooden privacy fence within 10' of the levee toe.

11/17/2011 Wooden privacy fence built at the levee toe.

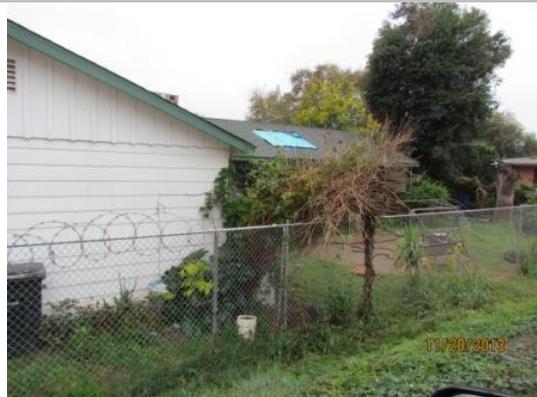
Photo 1 of 1 : FA\_2015\_NA0001\_51\_1\_20150910\_00001.jpg

LM Start	<b>1.99</b>	Rating **	M	Issue No.	<b>1</b>
LM End	<b>1.99</b>	Issue Type +	En	Location *	LS
Category	Earthen Levee		GPS Latitude/Longitude		
			Start	End	
Item	Vegetation		38.627318 °	38.627318 °	
			-121.434208 °	-121.434208 °	
DWR ID	DWR_NA0001_01_s_2012_1				
Action/Comments					
Landscaping Inspector Comments: Vine growing on fence and slope blocks visibility.

View of the fence and landscaping at the landside levee toe.

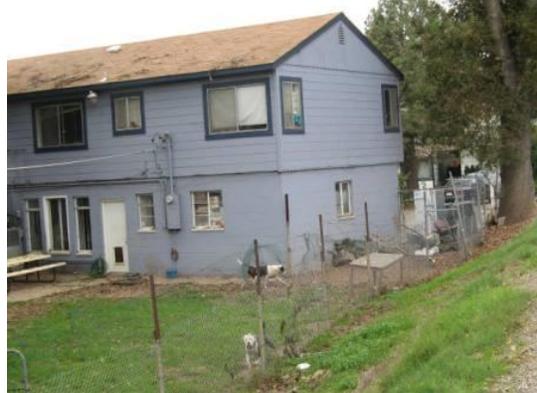
Photo 1 of 1 : FA\_2015\_NA0001\_51\_29\_20150910\_00023.jpg

LM Start	<b>2.02</b>	Rating **	U	Issue No.	<b>29</b>
LM End	<b>2.02</b>	Issue Type +	En	Location *	LS
Category	Earthen Levee		GPS Latitude/Longitude		
			Start	End	
Item	Encroachments		38.627292 °	38.627292 °	
			-121.433709 °	-121.433709 °	
DWR ID	DWR_NA0001_01_s_2012_29				
Action/Comments					
Building Inspector Comments: Two-story home foundation is within 10-ft of levee toe. Chain link fence is built on levee toe.

11/17/2011 Building foundation is within 15' of the levee toe.

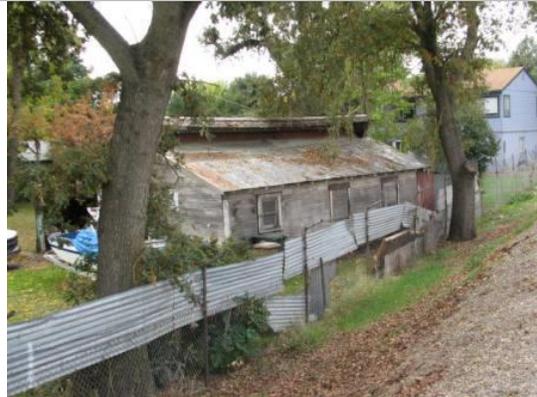
Photo 1 of 1 : FA\_2015\_NA0001\_51\_28\_20150910\_00022.jpg

LM Start	<b>2.04</b>	Rating **	U	Issue No.	<b>28</b>
LM End	<b>2.04</b>	Issue Type +	En	Location *	LS
Category	Earthen Levee		GPS Latitude/Longitude		
			Start	End	
Item	Encroachments		38.627257 °	38.627257 °	
			-121.433327 °	-121.433327 °	
DWR ID	DWR_NA0001_01_s_2012_28				
Action/Comments					
Building Inspector Comments: Large wooden building behind corrugated metal covered fence is within 10-ft of levee toe.

11/17/2011 Wooden structure is within 15' of the levee toe.

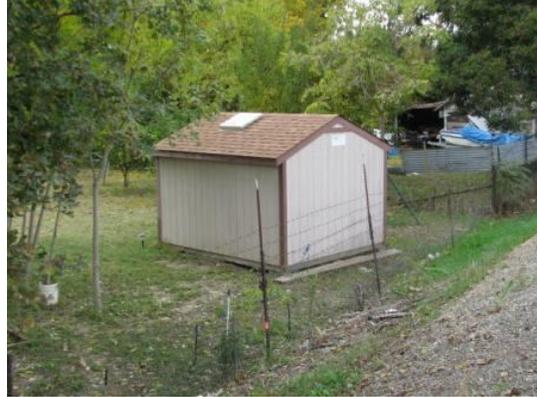
Photo 1 of 1 : FA\_2015\_NA0001\_51\_27\_20150910\_00021.jpg

LM Start	<b>2.05</b>	Rating **	M	Issue No.	<b>27</b>
LM End	<b>2.05</b>	Issue Type +	En	Location *	LS
Category	Earthen Levee		GPS Latitude/Longitude		
			Start	End	
Item	Encroachments		38.627230 °	38.627230 °	
			-121.433039 °	-121.433039 °	
DWR ID	DWR_NA0001_01_s_2012_27				
Action/Comments					
Building Inspector Comments: Pre-fab storage shed is within 10-ft of landside toe.

11/17/2011 Wooden structure is within 15' of the levee toe.

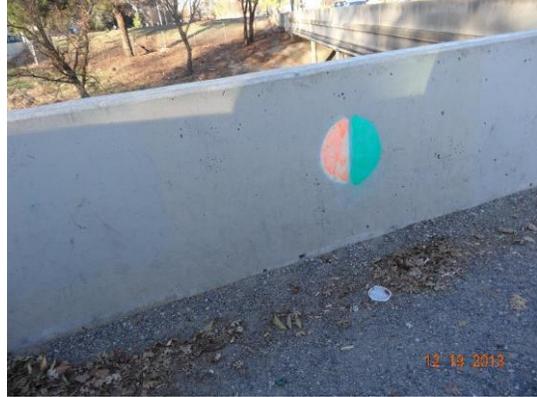
Photo 1 of 3 : UCIP\_FA\_2015\_2970.jpg

Inspector Comments: FS\_ID:31185  
 DS\_ID:24420  
 EP\_NO: 13044  
 FS\_HLM: 2.08  
 Repair Type: Non-Urgent  
 Crossing Status: Indicator Found  
 UCIP Comments: Orange/Green symbol for flood structure found on floodwall. No crossing found. Need to determine if crossing is in use. This crossing is not shown in the City of Sacramento's sewer drain mains or water mains. Need to contact owner to determine if crossing is still in use.  
 FIELD\_STRUCT\_DESC: 12-inch steel water main through the levee, 4.0 feet below the crown. (Permit No. 13044-1981)  
 FS Date: 12/19/2013

Marker of crossing on floodwall indicating crossing through levee.

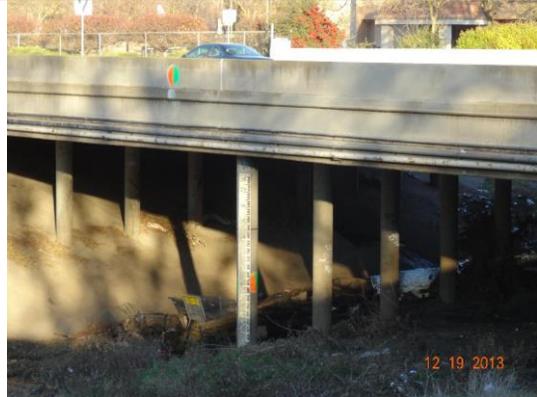
Photo 2 of 3 : UCIP\_FA\_2015\_2971.jpg

Markers visible of crossing on bridge.

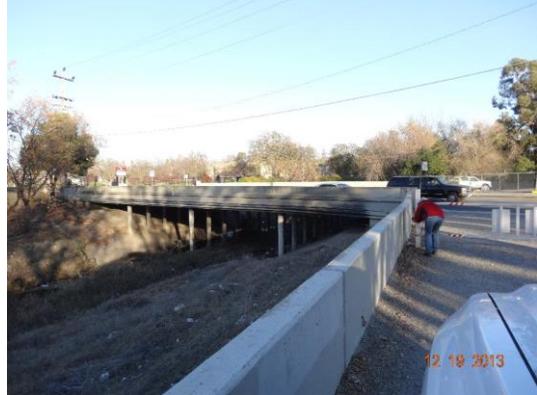
Photo 3 of 3 : UCIP\_FA\_2015\_2972.jpg

LM Start	<b>2.08</b>	Rating **	M	Issue No.	<b>193 (cont)</b>
LM End	<b>2.08</b>	Issue Type +	En	Location *	LS
Category	Supplemental			GPS Latitude/Longitude	
				Start	End
Item	DWR UCIP Field Study			38.627239 °	38.627239 °
				-121.432501 °	-121.432501 °
DWR ID					
Action/Comments					
Inspector Comments: FS_ID:31185 DS_ID:24420 EP_NO: 13044 FS_HLM: 2.08 Repair Type: Non-Urgent Crossing Status: Indicator Found

Overview markers located on bridge and floodwall indicating crossing through levee.

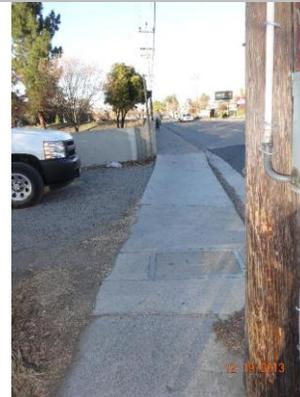
Photo 1 of 2 : UCIP\_FA\_2015\_4571.jpg

LM Start	<b>2.08</b>	Rating **	M	Issue No.	<b>194</b>
LM End	<b>2.08</b>	Issue Type +	En	Location *	LS
Category	Supplemental			GPS Latitude/Longitude	
				Start	End
Item	DWR UCIP Field Study			38.627242 °	38.627242 °
				-121.432469 °	-121.432469 °
DWR ID					
Action/Comments					
Inspector Comments: FS_ID:31424 DS_ID:24797 EP_NO: N/A FS_HLM: 2.085 Repair Type: Non-Urgent Crossing Status: Found UCIP Comments: no permit--need to determine additional information and owner of crossings. FIELD_STRUCT_DESC: 1-4 inch conduit and 1-2 inch communication cable through levee. Conduits are suspended through waterway and attached to downstream face of bridge. FS Date: 12/19/2013

Service box located on sidewalk unable to determine if box belongs to conduits.
