**Flood Control Project Maintenance  
Levee Inspections**

**Fall 2015 Levee Maintenance Deficiency Summary Report**

**Sacramento River Basin**

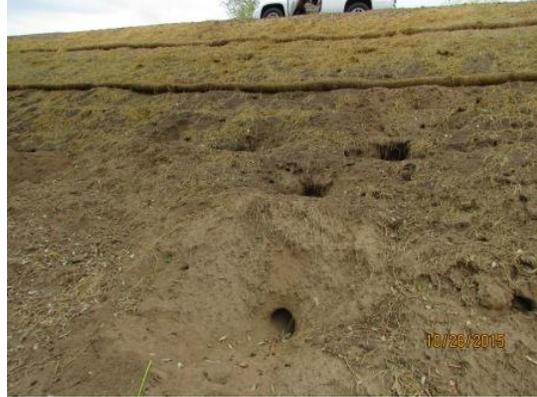
Photo 1 of 1 : FA\_2015\_NA0001\_52\_28\_20151112\_00018.jpg

LM Start	<b>0.09</b>	Rating **	A/W	Issue No.	<b>28</b>
LM End	<b>0.10</b>	Issue Type +	Ma	Location *	LS
Category	Earthen Levee		GPS Latitude/Longitude		
			Start	End	
Item	Animal Control		38.603765 °	38.603878 °	
			-121.471642 °	-121.471448 °	
DWR ID	DWR_NA0001_02_f_2015_28				
Action/Comments					
Inspector Comments: The holes were backfilled by the LMA.

View of the rodent holes on the landside levee slope.

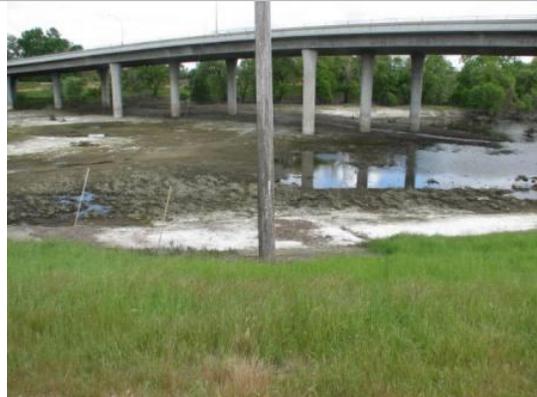
Photo 1 of 1 : FA\_2015\_NA0001\_52\_2\_20150910\_00001.jpg

LM Start	<b>0.33</b>	Rating **	M	Issue No.	<b>2</b>
LM End	<b>0.33</b>	Issue Type +	En	Location *	WS
Category	Earthen Levee		GPS Latitude/Longitude		
			Start	End	
Item	Encroachments		38.605822 °	38.605822 °	
			-121.468078 °	-121.468078 °	
DWR ID	DWR_NA0001_02_s_2012_2				
Action/Comments					
Pole Inspector Comments: Power pole in levee

04/13/2011 Power pole is in the levee on the water side.

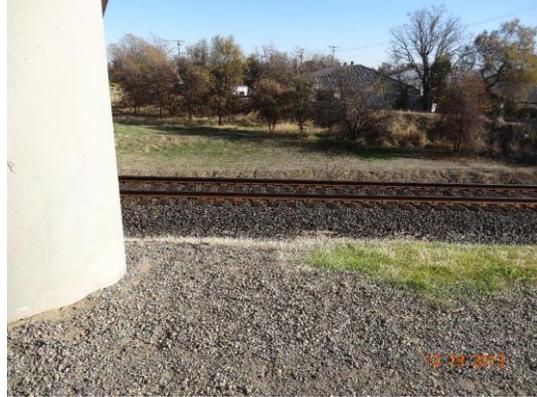
Photo 1 of 3 : UCIP\_FA\_2015\_4573.jpg

LM Start	<b>0.36</b>	Rating **	M	Issue No.	<b>151</b>
LM End	<b>0.36</b>	Issue Type +	En	Location *	WS
Category	Supplemental			GPS Latitude/Longitude	
				Start	End
Item	DWR UCIP Field Study			38.606204 °	38.606204 °
				-121.467817 °	-121.467817 °
DWR ID					
<b>Action/Comments</b>					
Inspector Comments: FS_ID:31443 DS_ID:24798 EP_NO: N/A FS_HLM: 0.32 Repair Type: Non-Urgent Crossing Status: Indicator Found UCIP Comments: no permit (unauthorize crossing)--need to determine additional information about crossing. Unable to determine if pipe crosses levee. FIELD_STRUCT_DESC: 4-inch HDPE pipe through levee at unknown depth. FS Date: 12/06/2013

View of landward side.

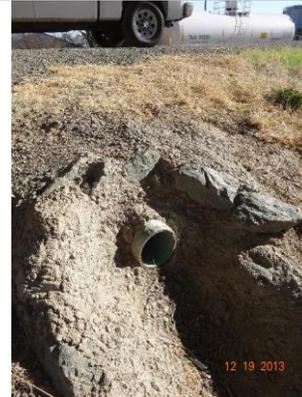
Photo 2 of 3 : UCIP\_FA\_2015\_4574.jpg

View of pipe through levee.

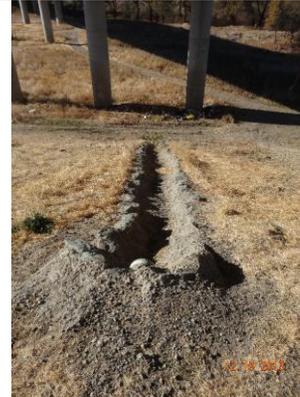
Photo 3 of 3 : UCIP\_FA\_2015\_4575.jpg

View of waterward slope.

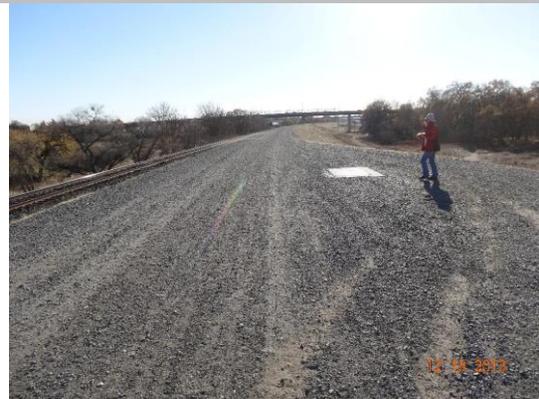
Photo 1 of 3 : UCIP\_FA\_2015\_3034.jpg

Item	DWR UCIP Field Study			38.608858 °	38.608858 °
				-121.466861 °	-121.466861 °
DWR ID					
Action/Comments					
Inspector Comments: FS_ID:28585 DS_ID:24273 EP_NO: N/A FS_HLM: 0.51 Repair Type: Non-Urgent Crossing Status: Indicator Found UCIP Comments: Multiple pumps visible on landward side however unable to confirm additional crossing only 1 crossing was confirmed at this location. Need to contact owner to determine status of crossing. FIELD_STRUCT_DESC: 24-inch pipe sleeved through 30-inch CM pipe through the levee, 2.8 feet below the crown. Annular gap grouted. Flap gate on waterward end. Slide gate in concrete pipe riser at waterward toe. Pump on structure over concrete sump on landward side. (USACE-1959). This entry matches the Drainage or Irrigation Structure referenced in O&M manual (Station 216+00). FS Date: 12/19/2013

View of levee crown--vault visible on crown.

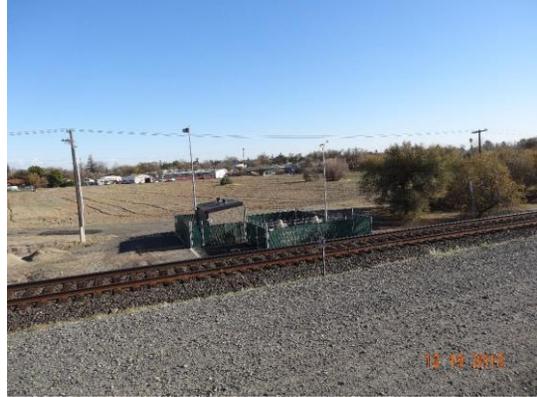
Photo 2 of 3 : UCIP\_FA\_2015\_3071.jpg

Overview of landward side.

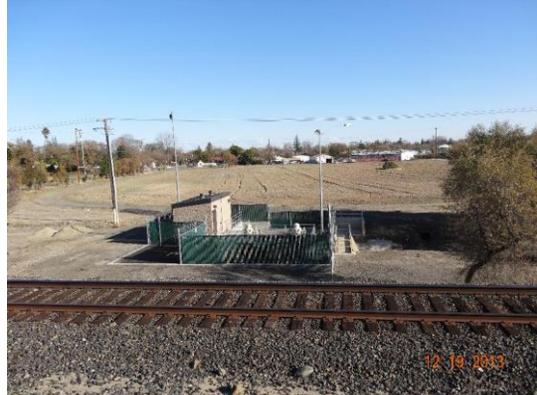
Photo 3 of 3 : UCIP\_FA\_2015\_3072.jpg

Overview of pumps located on landward side.

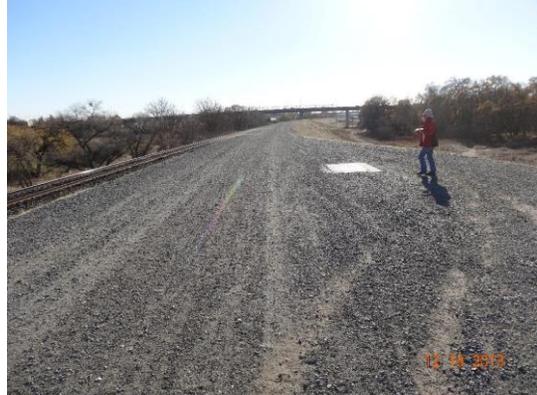
Photo 1 of 3 : UCIP\_FA\_2015\_2997.jpg

LM Start	<b>0.55</b>	Rating **	M	Issue No.	<b>153</b>
LM End	<b>0.55</b>	Issue Type +	En	Location *	WS
Category	Supplemental			GPS Latitude/Longitude	
				Start	End
Item	DWR UCIP Field Study			38.608870 °	38.608870 °
				-121.466856 °	-121.466856 °
DWR ID					
Action/Comments					
Inspector Comments: FS_ID:28584 DS_ID:24612 EP_NO: N/A FS_HLM: 0.512 Repair Type: Non-Urgent Crossing Status: Indicator Found

Vault locate on levee crow.

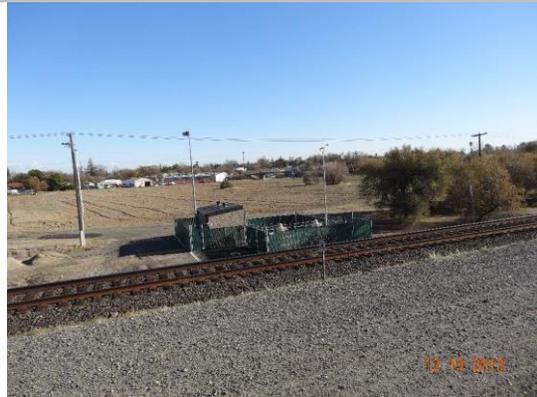
Photo 2 of 3 : UCIP\_FA\_2015\_2998.jpg

Overview of landward side.

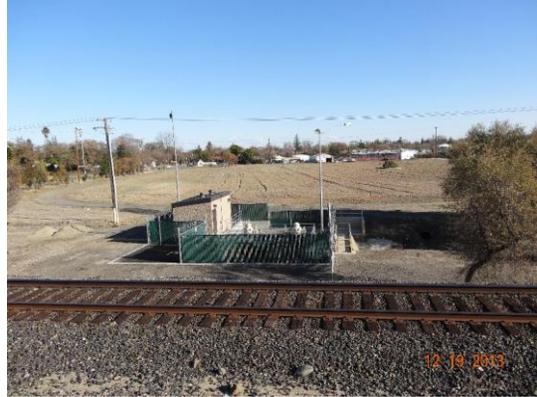
Photo 3 of 3 : UCIP\_FA\_2015\_3030.jpg

Multiple pumps located on landward side.

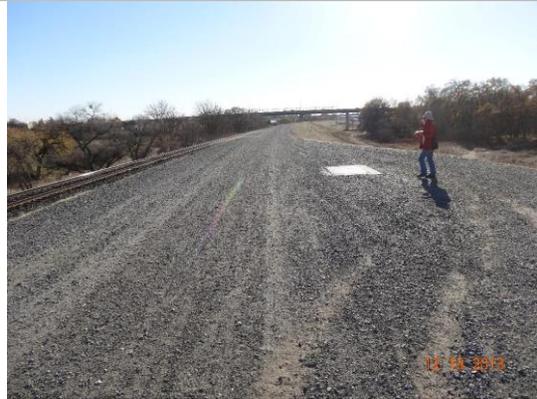
Photo 1 of 3 : UCIP\_FA\_2015\_3181.jpg

Item	DWR UCIP Field Study			38.608870 °	38.608870 °
				-121.466856 °	-121.466856 °
DWR ID					
Action/Comments					
Inspector Comments: FS_ID:29763 DS_ID:24274 EP_NO: 6064 FS_HLM: 0.511 Repair Type: Non-Urgent Crossing Status: Found UCIP Comments: Need to determine the status of crossing. Unable to confirm if crossing found in field corresponds to this entry. FIELD_STRUCT_DESC: [Pump Station No. 153] 36-inch steel drainpipe through the levee, 5.2 feet below the crown. CM cutoff wall around pipe between center and waterward shoulder. Siphon breaker in concrete box on waterward slope. Second siphon breaker in concrete box on the landward side. Portion of pipe exposed on waterward slope. Concrete "U" headwall and flap gate on the water ward end. Rock revetment on waterward slope. (Permit No. 6064-1968) FS Date: 12/19/2013

Vault located on levee crown.

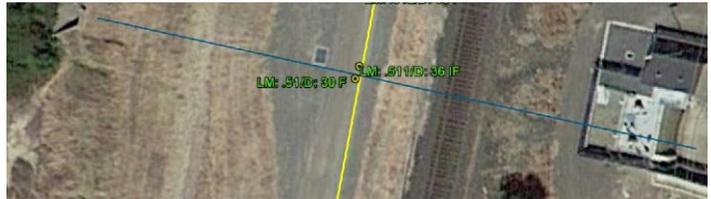
Photo 3 of 3 : UCIP\_FA\_2015\_3183.jpg

Approximate alignment provided by City of Sacramento indicates a 36-inch storm drain at this location.

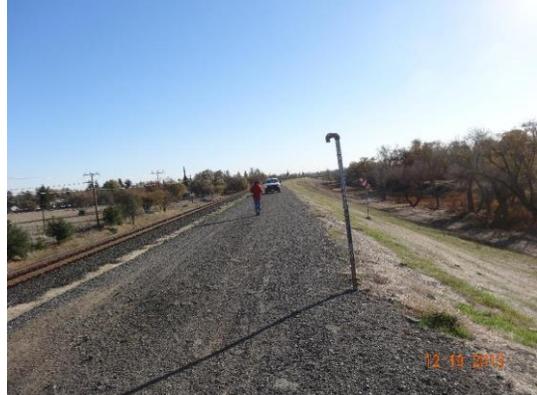
Photo 1 of 3 : UCIP\_FA\_2015\_4584.jpg

LM Start	<b>1.02</b>	Rating **	M	Issue No.	<b>155</b>
LM End	<b>1.02</b>	Issue Type +	En	Location *	WS
Category	Supplemental			GPS Latitude/Longitude	
				Start	End
Item	DWR UCIP Field Study			38.615697 °	38.615697 °
				-121.466952 °	-121.466952 °
DWR ID					
Action/Comments					
Inspector Comments: FS_ID:42132 DS_ID:24613 EP_NO: 2347 FS_HLM: 0.99 Repair Type: Non-Urgent Crossing Status: Indicator Found

Overview of levee crown with utility gas markers on waterward side.

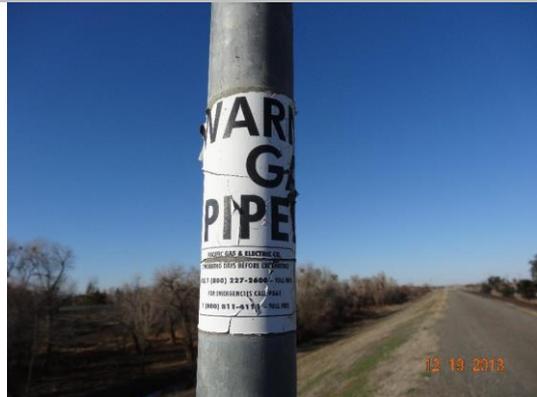
Photo 2 of 3 : UCIP\_FA\_2015\_4585.jpg

Multiple markers visible on waterward side--post with contact information.

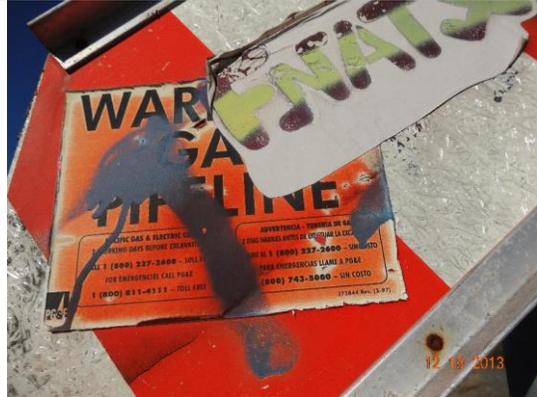
Photo 3 of 3 : UCIP\_FA\_2015\_4586.jpg

Contact information for owner--sign visible on waterward side slope.

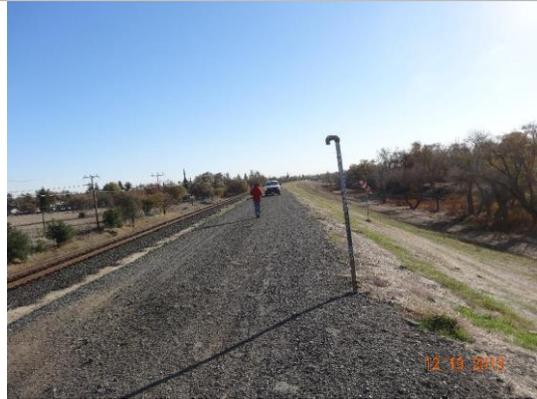
Photo 1 of 3 : UCIP\_FA\_2015\_3358.jpg

Item	DWR UCIP Field Study			38.615760 °	38.615760 °
				-121.466950 °	-121.466950 °
DWR ID					
Action/Comments					
Inspector Comments: FS_ID:42130 DS_ID:24277 EP_NO: 2333 FS_HLM: 0.991 Repair Type: Non-Urgent Crossing Status: Indicator Found UCIP Comments: 11/3/2014 (DWR-Olivia) Need to contact owner to determine status of crossing. Priority under Part IX has been changed from Urgent to Non-Urgent as a measure to normalize the data. Markers present however unable to confirm pipe size. Recommend LMA to contact owner to determine additional information details--confirm pipe size, alignment, and last inspection completed confirming integrity of crossing. Need to contact owner to determine status of crossing. Unable to confirm if indicators visible on levee crown and landward side correspond to this crossing. FIELD_STRUCT_DESC: 12-inch gas line through the levee, 3.0 feet below the crown. For emergencies contact PG&E at 1-800-811-4111. (Permit No. 2333-1957) FS Date: 12/19/2013

Overview of levee crown at crossings.

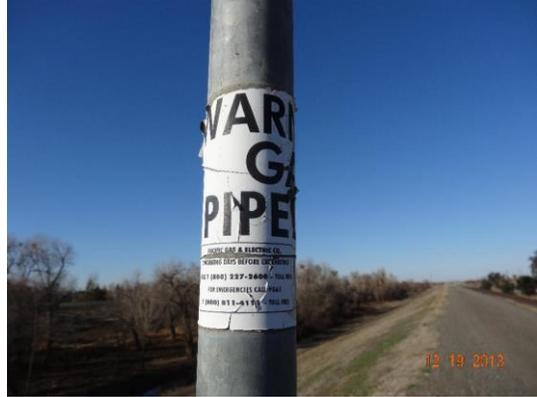
Photo 2 of 3 : UCIP\_FA\_2015\_3359.jpg

Marker located on the waterward side.

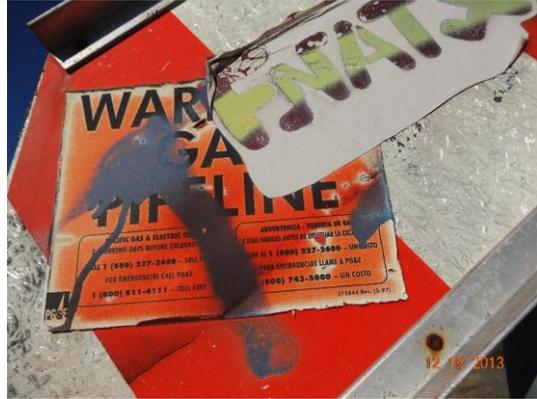
Photo 3 of 3 : UCIP\_FA\_2015\_3360.jpg

LM Start	1.03	Rating **	M	Issue No.	156 (cont)
LM End	1.03	Issue Type +	En	Location *	WS
Category	Supplemental			GPS Latitude/Longitude	
	Start		End		
Item	DWR UCIP Field Study			38.615760 °	38.615760 °
				-121.466950 °	-121.466950 °
DWR ID					
Action/Comments					
Inspector Comments: FS_ID:42130 DS_ID:24277 EP_NO: 2333 FS_HLM: 0.991 Repair Type: Non-Urgent Crossing Status: Indicator Found UCIP Comments: 11/3/2014 (DWR-Olivia) Need to contact owner to determine status of crossing. Priority under Part IX has been changed from Urgent to Non-Urgent as a measure to normalize the data. Markers present however unable to confirm pipe size. Recommend LMA to contact owner to determine additional information details--confirm pipe size, alignment, and last inspection completed confirming integrity of crossing. Need to contact owner to determine status of crossing. Unable to confirm if indicators visible on levee crown and landward side correspond to this crossing. FIELD_STRUCT_DESC: 12-inch gas line through the levee, 3.0 feet below the crown. For emergencies contact PG&E at 1-800-811-4111. (Permit No. 2333-1957) FS Date: 12/19/2013

Marker with emergency contact information located on waterward slope.

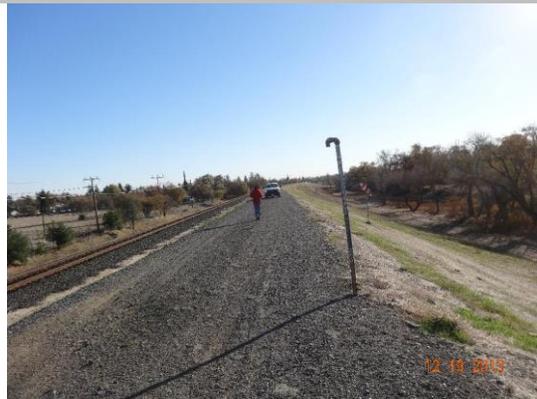
Photo 1 of 3 : UCIP\_FA\_2015\_3404.jpg

LM Start	1.03	Rating **	M	Issue No.	157
LM End	1.03	Issue Type +	En	Location *	WS
Category	Supplemental			GPS Latitude/Longitude	
	Start		End		
Item	DWR UCIP Field Study			38.615772 °	38.615772 °
				-121.466971 °	-121.466971 °
DWR ID					
Action/Comments					
Inspector Comments: FS_ID:28666 DS_ID:24614 EP_NO: 1949 FS_HLM: 0.991 Repair Type: Non-Urgent Crossing Status: Indicator Found UCIP Comments: Need to contact owner to determine if pipe was left inside levee as part of abandonment process. FIELD_STRUCT_DESC: Abandoned 12-inch steel gas line through the levee, 3.0 feet below the crown. Pipe grout filled. Concrete cutoff wall around pipe under center of levee. (Permit No. 1450-1949) This entry matches the Drainage or Irrigation Structure referenced in O&M manual (Station 243+31). Pipe abandoned under Permit No. 17468 (2004). FS Date: 12/19/2013

Overview of levee crown at crossings.

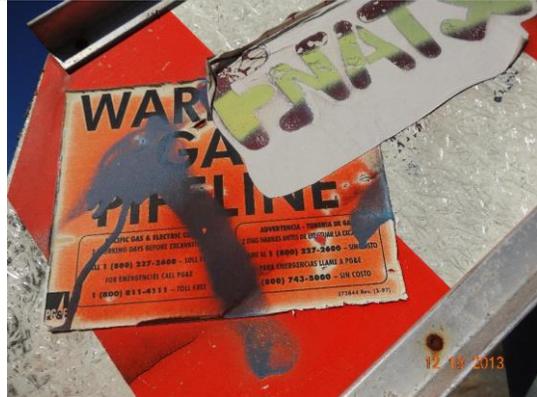
Photo 3 of 3 : UCIP\_FA\_2015\_3406.jpg

Marker with emergency contact information located on waterward slope.

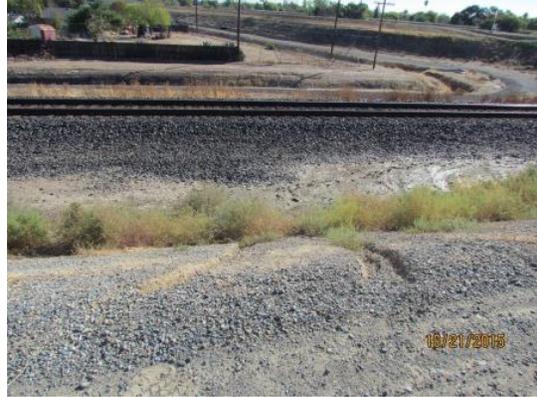
Photo 1 of 1 : FA\_2015\_NA0001\_52\_26\_20151112\_00015.jpg

View of the damaged landside levee slope.

LM Start	<b>1.40</b>	Rating **	M	Issue No.	<b>26</b>
LM End	<b>1.40</b>	Issue Type +	Ma	Location *	LS
Category	Earthen Levee			GPS Latitude/Longitude	
				Start	End
Item	Slope Stability			38.621054 °	38.621054 °
				-121.468008 °	-121.468008 °
DWR ID	DWR_NA0001_02_f_2015_26				
Action/Comments					
Repair the levee slope damaged by vehicle traffic and prevent access where possible.

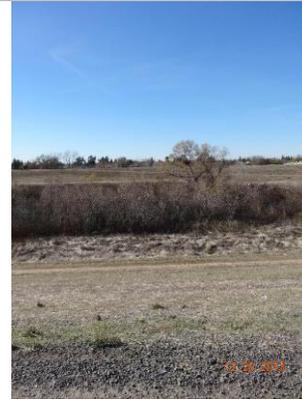
Photo 1 of 3 : UCIP\_FA\_2015\_3407.jpg

LM Start	<b>1.96</b>	Rating **	M	Issue No.	<b>159</b>
LM End	<b>1.96</b>	Issue Type +	En	Location *	LS
Category	Supplemental			GPS Latitude/Longitude	
				Start	End
Item	DWR UCIP Field Study			38.629129 °	38.629129 °
				-121.469556 °	-121.469556 °
DWR ID					
Action/Comments					
Inspector Comments: FS_ID:28667 DS_ID:24481 EP_NO: N/A FS_HLM: 1.95 Repair Type: Non-Urgent Crossing Status: Indicator Found UCIP Comments: Only found concrete box located on landward side toe. Need to contact owner to determine if crossing goes through levee and to notify that concrete box is filled with debris. FIELD_STRUCT_DESC: 12-inch CM railroad drainpipe through the levee. (USACE-1959). This entry matches the Drainage or Irrigation Structure referenced in O&M manual (Station 302+00). FS Date: 12/20/2013

View of waterward side.

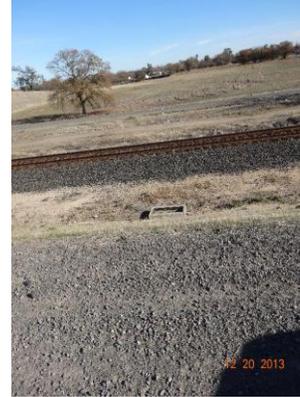
Photo 2 of 3 : UCIP\_FA\_2015\_3408.jpg

LM Start	1.96	Rating **	M	Issue No.	159 (cont)
LM End	1.96	Issue Type +	En	Location *	LS
Category	Supplemental			GPS Latitude/Longitude	
				Start	End
Item	DWR UCIP Field Study			38.629129 °	38.629129 °
				-121.469556 °	-121.469556 °
DWR ID					
<b>Action/Comments</b>					
Inspector Comments: FS_ID:28667 DS_ID:24481 EP_NO: N/A FS_HLM: 1.95 Repair Type: Non-Urgent Crossing Status: Indicator Found UCIP Comments: Only found concrete box located on landward side toe. Need to contact owner to determine if crossing goes through levee and to notify that concrete box is filled with debris. FIELD_STRUCT_DESC: 12-inch CM railroad drainpipe through the levee. (USACE-1959). This entry matches the Drainage or Irrigation Structure referenced in O&M manual (Station 302+00). FS Date: 12/20/2013

View of landward side. Depression visible at levee toe around concrete box.

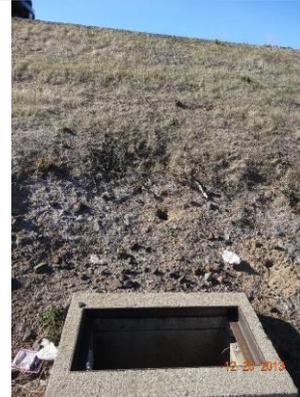
Photo 3 of 3 : UCIP\_FA\_2015\_3409.jpg

View of landward side some--erosion or subsidence present just above concrete box.

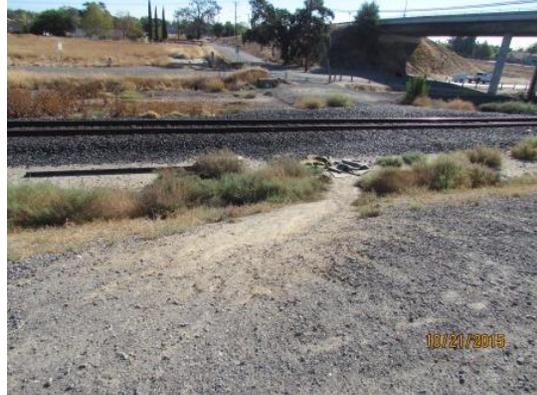
Photo 1 of 1 : FA\_2015\_NA0001\_52\_25\_20151112\_00014.jpg

View of the landside levee slope damaged by foot traffic.

LM Start	<b>2.05</b>	Rating **	M	Issue No.	<b>25</b>
LM End	<b>2.05</b>	Issue Type +	Ma	Location *	LS
Category	Earthen Levee			GPS Latitude/Longitude	
				Start	End
Item	Slope Stability			38.630425 °	38.630425 °
				-121.469807 °	-121.469807 °
DWR ID	DWR_NA0001_02_f_2015_25				
Action/Comments					
Repair the levee slope damaged by foot traffic and prevent access where possible.

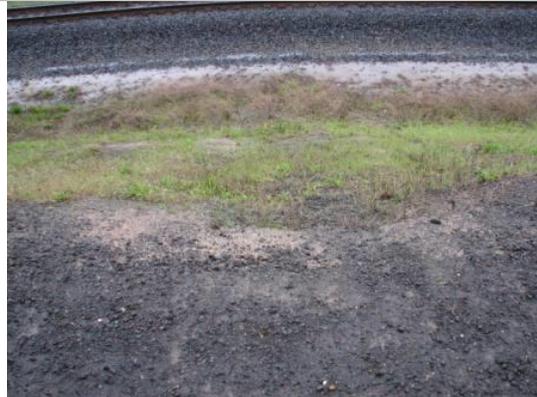
Photo 1 of 2 : FA\_2015\_NA0001\_52\_150\_20150910\_00006.jpg

03/14/2012 Photo shows depression, the issue has not gotten any worse since the fall 2011 inspection.

LM Start	<b>2.33</b>	Rating **	A/W	Issue No.	<b>150</b>
LM End	<b>2.33</b>	Issue Type +	Ob	Location *	LS
Category	Earthen Levee			GPS Latitude/Longitude	
				Start	End
Item	Erosion / Bank Caving			38.634446 °	38.634446 °
				-121.470573 °	-121.470573 °
DWR ID	DWR_NA0001_02_s_2012_150				
Action/Comments					
Note and monitor erosion site. Inspector Comments: Monitor erosion at this location. Also noted in USACE PI.

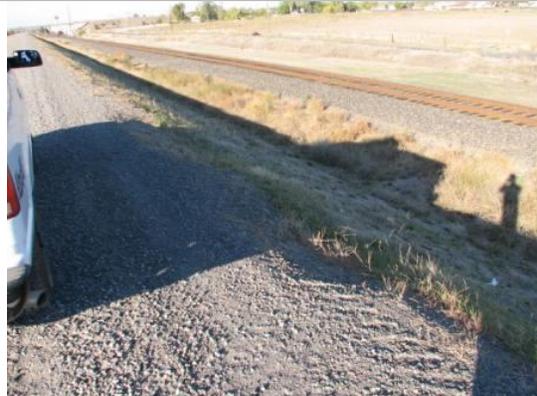
Photo 2 of 2 : FA\_2015\_NA0001\_52\_150\_20150910\_00007.jpg

11/16/2011 Depressions present on levee slope.

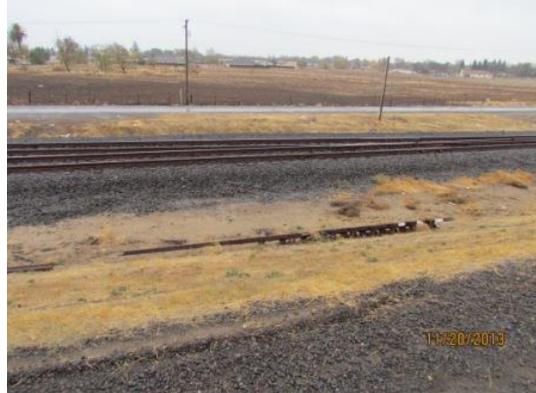
Photo 1 of 1 : FA\_2015\_NA0001\_52\_11\_20150910\_00005.jpg

LM Start	<b>2.52</b>	Rating **	M	Issue No.	<b>11</b>
LM End	<b>2.52</b>	Issue Type +	En	Location *	LS
Category	Earthen Levee		GPS Latitude/Longitude		
			Start	End	
Item	Encroachments		38.637177 °	38.637177 °	
			-121.471076 °	-121.471076 °	
DWR ID	DWR_NA0001_02_f_2013_11				
Action/Comments					
Material Inspector Comments: Railroad rails on landside levee slope.

View of the rails at the landside levee toe.

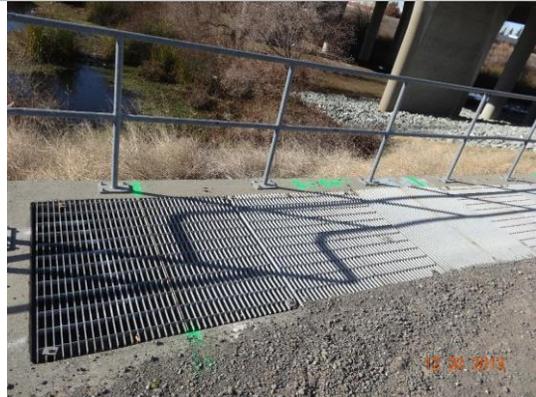
Photo 1 of 3 : UCIP\_FA\_2015\_3218.jpg

Item	DWR UCIP Field Study		38.640988 °	38.640988 °	
			-121.471797 °	-121.471797 °	
DWR ID					
Action/Comments					
Inspector Comments: FS_ID:28724 DS_ID:24608 EP_NO: 9596 FS_HLM: 2.791 Repair Type: Non-Urgent Crossing Status: Indicator Found UCIP Comments: Dense vegetation on waterward side limits inspector's inspection. Recommend removing vegetation. FIELD_STRUCT_DESC: [Magpie Creek Diversion Plant] 1 of 3: 54-inch steel drainpipe through the levee, 3.0 feet below the crown. Steel cutoff wall around pipe under center of levee. Siphon breaker in protective housing on waterward shoulder. Concrete headwall and flap gate on waterward end. Trench on waterward side. Pumping plant on landward side. (Permit No. 9596-1975) FS Date: 12/20/2013

Concrete box contains 3-54 inch crossings.

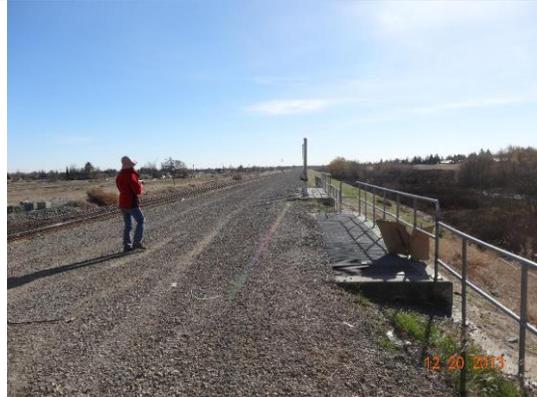
Photo 2 of 3 : UCIP\_FA\_2015\_3219.jpg

Overview of levee crown.

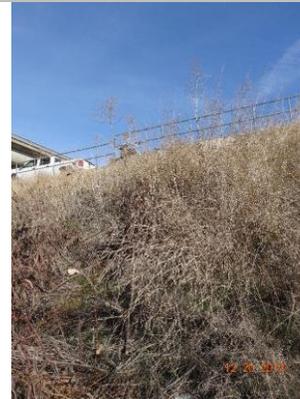
Photo 3 of 3 : UCIP\_FA\_2015\_3220.jpg

Dense vegetation located on waterward slope.

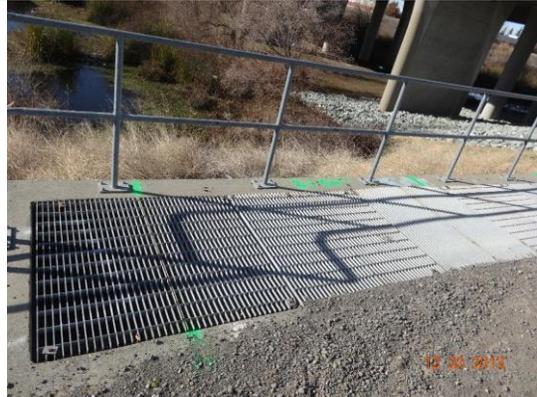
Photo 1 of 3 : UCIP\_FA\_2015\_2940.jpg

LM Start	<b>2.79</b>	Rating **	M	Issue No.	<b>161</b>
LM End	<b>2.79</b>	Issue Type +	En	Location *	LS
Category	Supplemental			GPS Latitude/Longitude	
				Start	End
Item	DWR UCIP Field Study			38.641016 °	38.641016 °
				-121.471805 °	-121.471805 °
DWR ID					
Action/Comments					
Inspector Comments: FS_ID:28725 DS_ID:24609 EP_NO: 9596 FS_HLM: 2.792 Repair Type: Non-Urgent Crossing Status: Indicator Found

Concrete box contains 3-54 inch crossings.

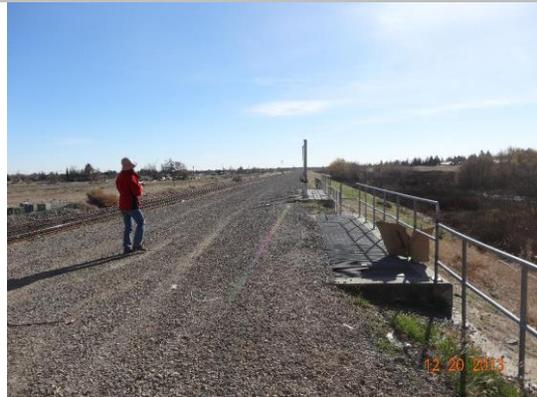
Photo 2 of 3 : UCIP\_FA\_2015\_2941.jpg

Overview of levee crown with two concrete boxes with multiple crossings inside.

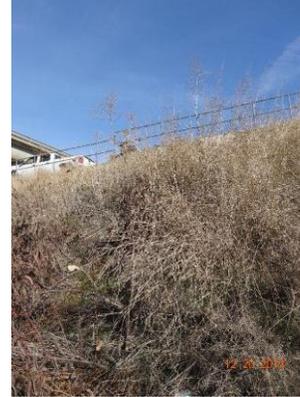
Photo 3 of 3 : UCIP\_FA\_2015\_2956.jpg

Dense vegetation located on waterward slope.

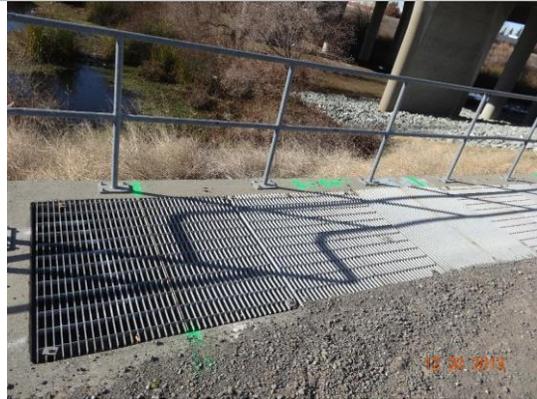
Photo 1 of 2 : UCIP\_FA\_2015\_2957.jpg

Item	DWR UCIP Field Study			38.641041 °	38.641041 °
				-121.471809 °	-121.471809 °
DWR ID					
Action/Comments					
Inspector Comments: FS_ID:28726 DS_ID:24610 EP_NO: 9596 FS_HLM: 2.793 Repair Type: Urgent Crossing Status: Indicator Found UCIP Comments: Signs of pipe removal are visible on waterward and landward side--gate missing on WS and pump missing on LS. Need to contact owner to determine status of crossing. FIELD_STRUCT_DESC: [Magpie Creek Diversion Plant] 3 of 3: 54-inch steel drainpipe through the levee, 3.0 feet below the crown. Steel cutoff wall around pipe under center of levee. Siphon breaker in protective housing on waterward shoulder. Concrete headwall and flap gate on waterward end. Trench on waterward side. Pumping plant on landward side. (Permit No. 9596-1975) FS Date: 12/20/2013

Concrete box contains 3-54 inch crossings.

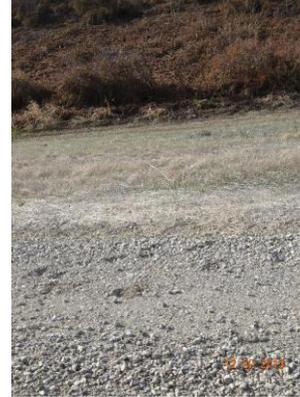
Photo 2 of 3 : UCIP\_FA\_2015\_4588.jpg

LM Start	<b>2.87</b>	Rating **	U	Issue No.	<b>163 (cont)</b>
LM End	<b>2.87</b>	Issue Type +	En	Location *	LS
Category	Supplemental			GPS Latitude/Longitude	
				Start	End
Item	DWR UCIP Field Study			38.642162 °	38.642162 °
				-121.472041 °	-121.472041 °
DWR ID					
Action/Comments					
Inspector Comments: FS_ID:43049 DS_ID:24484 EP_NO: N/A FS_HLM: 2.87 Repair Type: Urgent Crossing Status: Indicator Found UCIP Comments: Hole visible just above the concrete box located on landward side--unable to determine if hole is associated with pipe failure or burrow activity. Need to contact owner to determine status and details of crossing's alignment. FIELD_STRUCT_DESC: 12-inch CM railroad drainpipe through the levee. (USACE-1959). This entry matches the Drainage or Irrigation Structure referenced in O&M manual (Station 340+00). FS Date: 12/20/2013

View of waterward side.

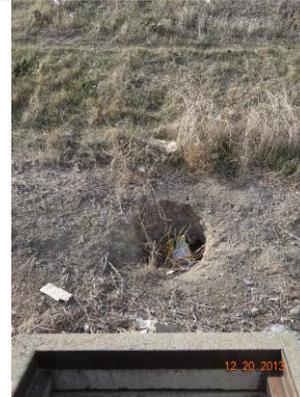
Photo 3 of 3 : UCIP\_FA\_2015\_4589.jpg

Large hole on landward side just immediately above concrete box.

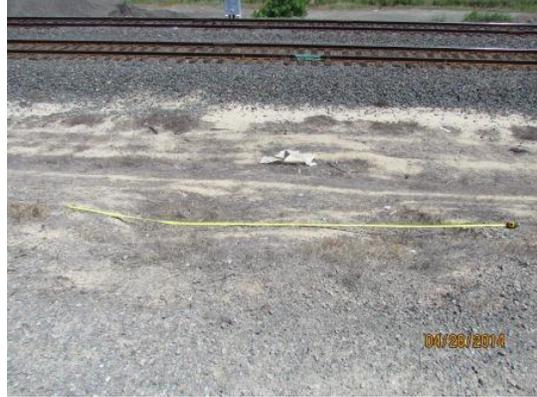
Photo 1 of 1 : FA\_2015\_NA0001\_52\_6\_20150910\_00002.jpg

View of landside slope instability.

LM Start	<b>2.92</b>	Rating **	A/W	Issue No.	<b>6</b>
LM End	<b>2.92</b>	Issue Type +	Ob	Location *	LS
Category	Earthen Levee		GPS Latitude/Longitude		
			Start	End	
Item	Slope Stability		38.642950 °	38.642950 °	
			-121.472166 °	-121.472166 °	
DWR ID	DWR_NA0001_02_f_2012_6				
Action/Comments					
Repair slope instability. Inspector Comments: Monitor this location.

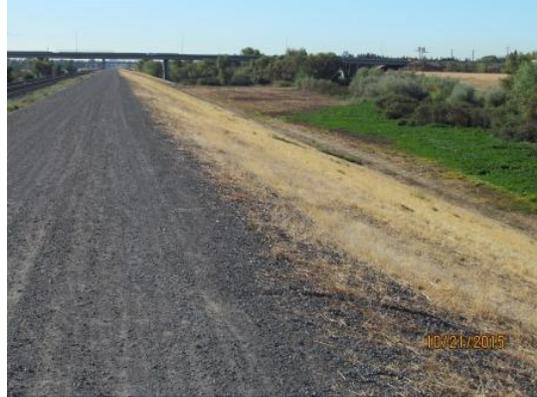
Photo 1 of 1 : FA\_2015\_NA0001\_52\_24\_20151112\_00013.jpg

View of the acceptable vegetation control on the waterside levee slope.

LM Start	<b>3.19</b>	Rating **	A	Issue No.	<b>24</b>
LM End	<b>3.19</b>	Issue Type +	Ma	Location *	WS
Category	Earthen Levee		GPS Latitude/Longitude		
			Start	End	
Item	Vegetation		38.646814 °	38.646814 °	
			-121.472937 °	-121.472937 °	
DWR ID	DWR_NA0001_02_f_2015_24				
Action/Comments					
Control annual grass and weeds on the levee slopes and easements.

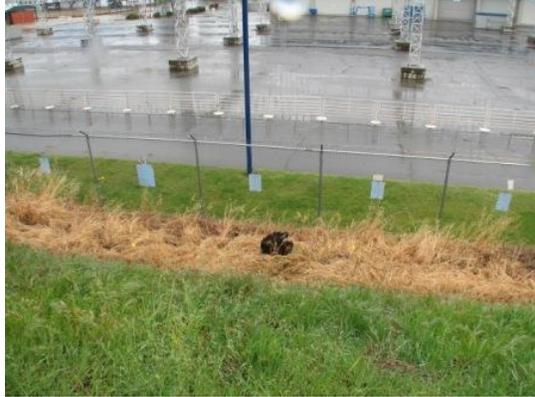
Photo 1 of 1 : FA\_2015\_NA0001\_490\_11\_20150910\_00003.jpg

LM Start	<b>0.75</b>	Rating **	N	Issue No.	<b>11</b>
LM End	<b>0.75</b>	Issue Type +	Ma	Location *	LS
Category	Earthen Levee			GPS Latitude/Longitude	
				Start	End
Item	Trim / Thin Trees			38.589359 °	38.589359 °
				-121.430990 °	-121.430990 °
DWR ID	DWR_NA0001_03_s_2012_11				
Action/Comments					
Tree stumps. Inspector Comments: Tree stump >2" Dia.

Tree stump on levee slope greater than 2" Dia.

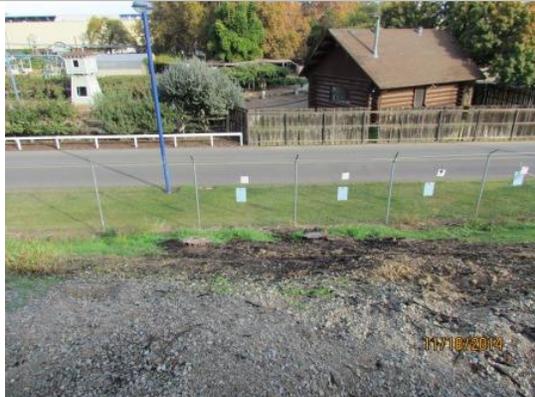
Photo 1 of 1 : FA\_2015\_NA0001\_490\_23\_20150910\_00004.jpg

LM Start	<b>0.85</b>	Rating **	N	Issue No.	<b>23</b>
LM End	<b>0.85</b>	Issue Type +	Ma	Location *	LS
Category	Earthen Levee			GPS Latitude/Longitude	
				Start	End
Item	Trim / Thin Trees			38.589624 °	38.589624 °
				-121.432935 °	-121.432935 °
DWR ID	DWR_NA0001_03_f_2014_23				
Action/Comments					
Tree stumps.

View of the tree stump on the landside levee slope.

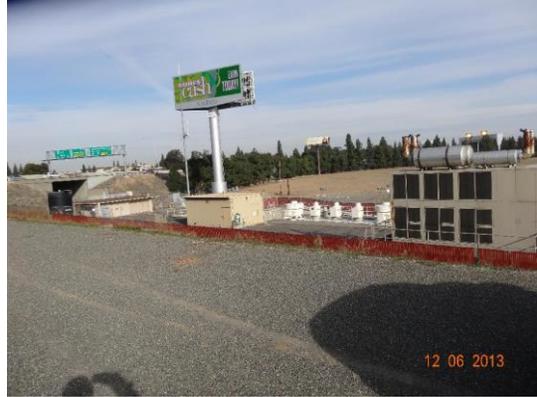
Photo 1 of 3 : UCIP\_FA\_2015\_3043.jpg

Item	DWR UCIP Field Study			38.593054 °	38.593054 °
				-121.444155 °	-121.444155 °
DWR ID					
Action/Comments					
Inspector Comments: FS_ID:42845 DS_ID:24292 EP_NO: 5776 FS_HLM: 1.525 Repair Type: Urgent Crossing Status: Found UCIP Comments: Hole present next to concrete vault on levee crown (waterward side). Hole could be sink hole or burrow activity unable to determine. Need to contact owner to determine status of crossing and to investigate hole. FIELD_STRUCT_DESC: [Drainage Plant No. 2] 5 of 8: 18-inch steel drainpipe through the levee. Metal cutoff wall around pipe under landward shoulder. Siphon breakers in concrete box on the waterward shoulder. Pumping plant at landward toe. Access ramp to pumping plant. Concrete discharge box on the waterward side. Flap gate on the waterward end. Outfall channel on waterward side. (Permit No. 5776-1972) FS Date: 12/03/2013

View of landward side.

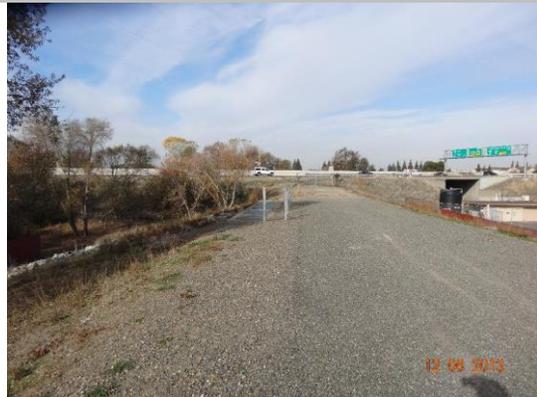
Photo 2 of 3 : UCIP\_FA\_2015\_3044.jpg

View of levee crown--concrete vault located on waterward shoulder.

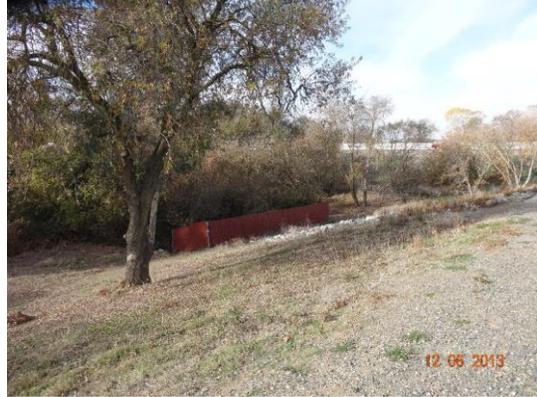
Photo 3 of 3 : UCIP\_FA\_2015\_3045.jpg

View of waterward side.

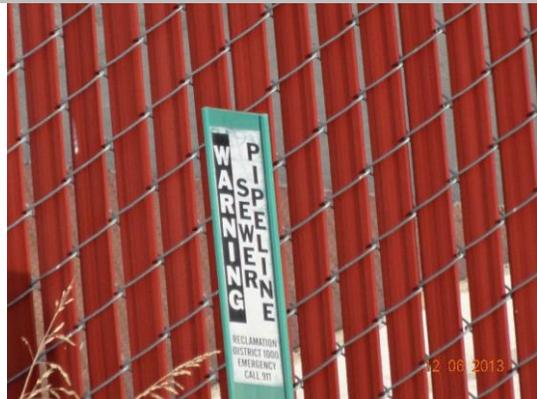
Photo 1 of 3 : UCIP\_FA\_2015\_2979.jpg

LM Start	<b>1.54</b>	Rating **	M	Issue No.	<b>33</b>
LM End	<b>1.54</b>	Issue Type +	En	Location *	WS
Category	Supplemental			GPS Latitude/Longitude	
				Start	End
Item	DWR UCIP Field Study			38.593290 °	38.593290 °
				-121.443980 °	-121.443980 °
DWR ID					
Action/Comments					
Inspector Comments: FS_ID:31225 DS_ID:24645 EP_NO: 2805 FS_HLM: 1.533 Repair Type: Non-Urgent Crossing Status: Indicator Found UCIP Comments: Unable to confirm what crossings are going through levee. Will need to coordinate with owner to determine active crossings. FIELD_STRUCT_DESC: [Arden Treatment Plant] 4 of 4: 34-inch concrete encased sewer pipe through the levee, 6.2 feet below the crown. Concrete cutoff wall around pipe under center of levee. Siphon breaker in housing at waterward shoulder. Treatment plant on landward side. FS Date: 12/03/2013

Sewer marker visible on landward toe.

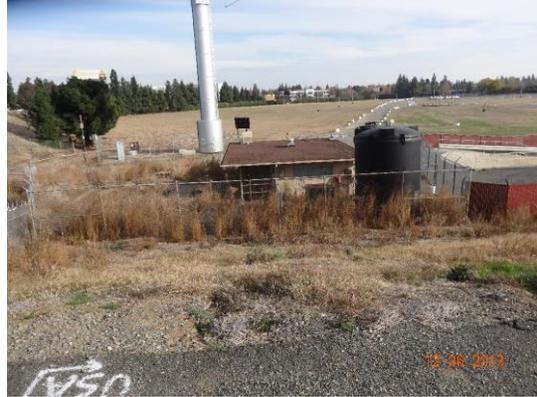
Photo 2 of 3 : UCIP\_FA\_2015\_2980.jpg

View of landward side.

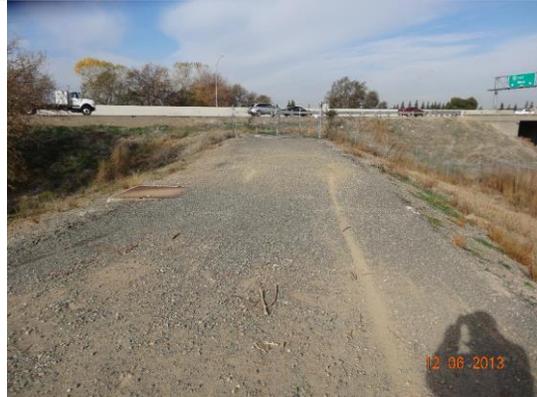
Photo 3 of 3 : UCIP\_FA\_2015\_2981.jpg

View of levee crown and concrete box located on waterward shoulder.

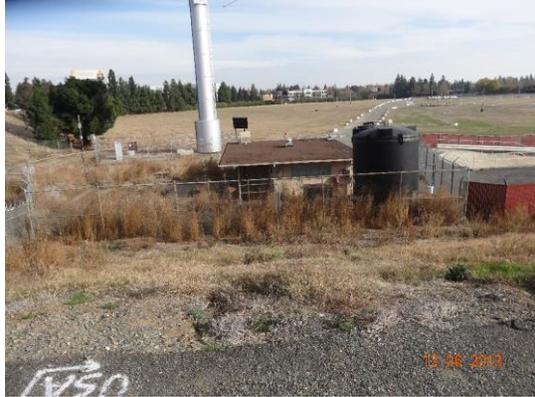
Photo 1 of 3 : UCIP\_FA\_2015\_2976.jpg

LM Start	<b>1.54</b>	Rating **	M	Issue No.	<b>34</b>
LM End	<b>1.54</b>	Issue Type +	En	Location *	WS
Category	Supplemental			GPS Latitude/Longitude	
				Start	End
Item	DWR UCIP Field Study			38.593290 °	38.593290 °
				-121.443980 °	-121.443980 °
DWR ID					
Action/Comments					
Inspector Comments: FS_ID:31224 DS_ID:24644 EP_NO: 2805 FS_HLM: 1.532 Repair Type: Non-Urgent Crossing Status: Indicator Found

View of landward side.

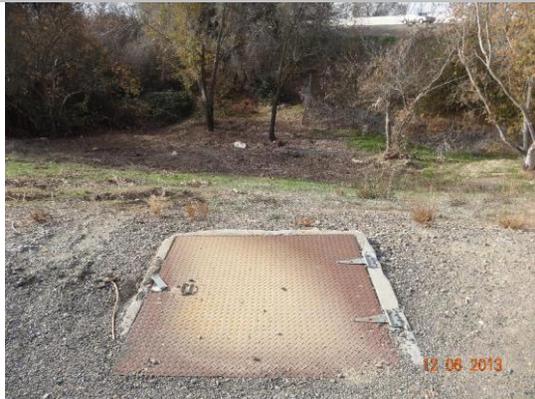
Photo 2 of 3 : UCIP\_FA\_2015\_2977.jpg

Concrete box located on waterward shoulder.

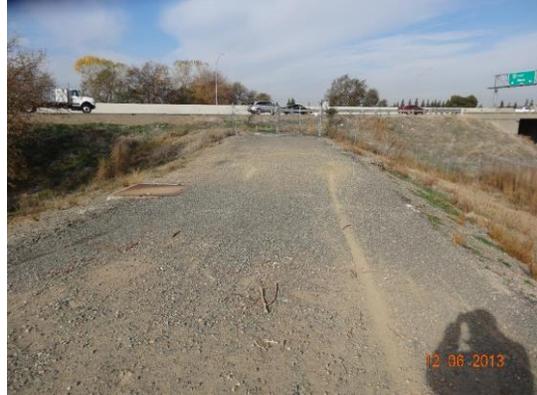
Photo 3 of 3 : UCIP\_FA\_2015\_2978.jpg

View of levee crown and concrete box located on waterward shoulder.

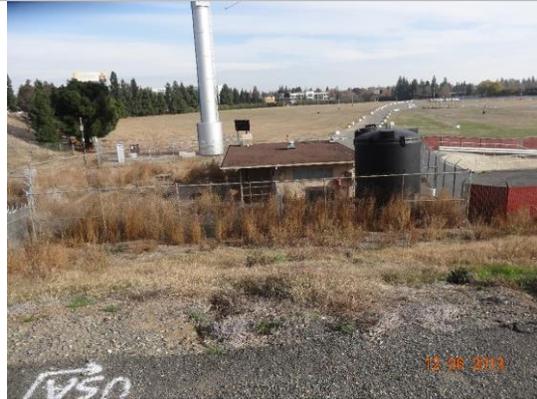
Photo 1 of 3 : UCIP\_FA\_2015\_2982.jpg

LM Start	<b>1.54</b>	Rating **	M	Issue No.	<b>35</b>
LM End	<b>1.54</b>	Issue Type +	En	Location *	WS
Category	Supplemental			GPS Latitude/Longitude	
				Start	End
Item	DWR UCIP Field Study			38.593224 °	38.593224 °
				-121.444299 °	-121.444299 °
DWR ID					
Action/Comments					
Inspector Comments: FS_ID:31227 DS_ID:24293 EP_NO: 2805 FS_HLM: 1.53 Repair Type: Non-Urgent Crossing Status: Indicator Found UCIP Comments: Unable to confirm what crossings are going through levee. Will need to coordinate with owner to determine active crossings. FIELD_STRUCT_DESC: [Arden Treatment Plant] 1 of 4: 18-inch concrete sewer main through the levee. Concrete cutoff wall around pipe under center of levee. Siphon breaker in housing on waterward shoulder. Treatment plant on landward side. (Permit No. 2805-1961) FS Date: 12/03/2013

View of landward side.

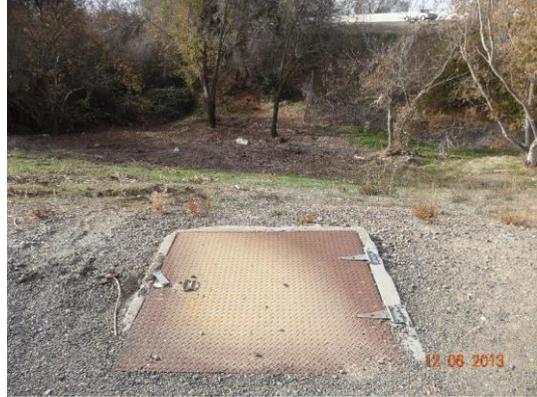
Photo 2 of 3 : UCIP\_FA\_2015\_2983.jpg

Concrete box located on waterward shoulder.

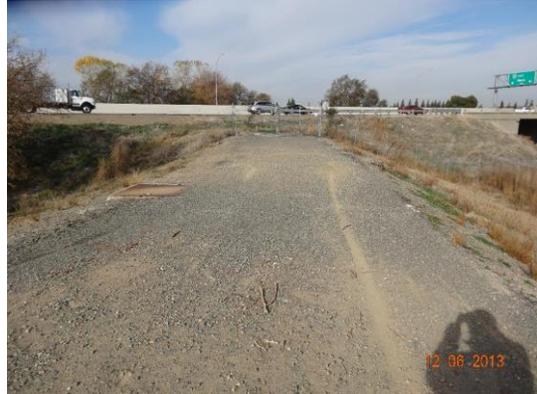
Photo 3 of 3 : UCIP\_FA\_2015\_2984.jpg

View of levee crown and concrete box located on waterward shoulder.

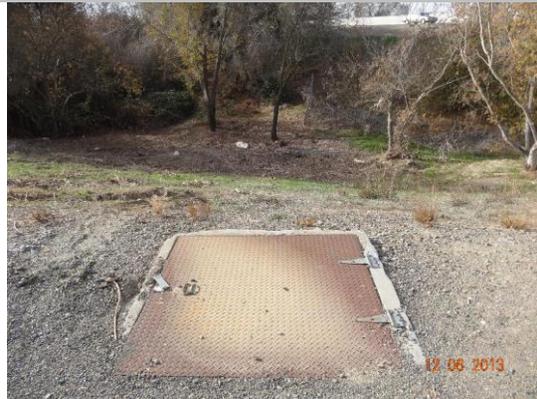
Photo 2 of 3 : UCIP\_FA\_2015\_2974.jpg

Concrete box located on waterward shoulder.

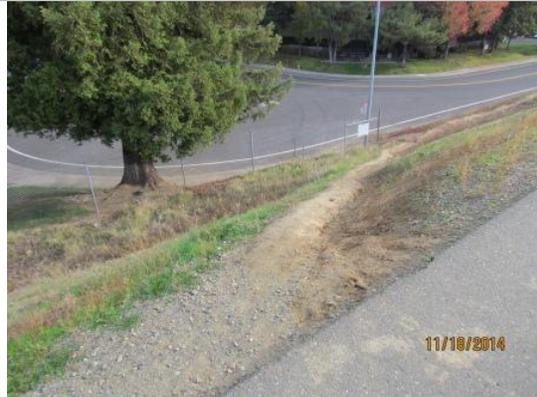
Photo 1 of 1 : FA\_2015\_NA0001\_490\_9\_20150910\_00002.jpg

LM Start	<b>1.82</b>	Rating **	A/W	Issue No.	<b>9</b>
LM End	<b>1.82</b>	Issue Type +	Ma	Location *	LS
Category	Earthen Levee			GPS Latitude/Longitude	
				Start	End
Item	Slope Stability			38.595700 °	38.595700 °
				-121.448198 °	-121.448198 °
DWR ID	DWR_NA0001_03_s_2012_9				
Action/Comments					
Repair the levee slope damaged by foot traffic and prevent access where possible. Inspector Comments: Slope repaired. Monitor for possible future erosion.

View of the erosion on landside levee slope due to pedestrian traffic.

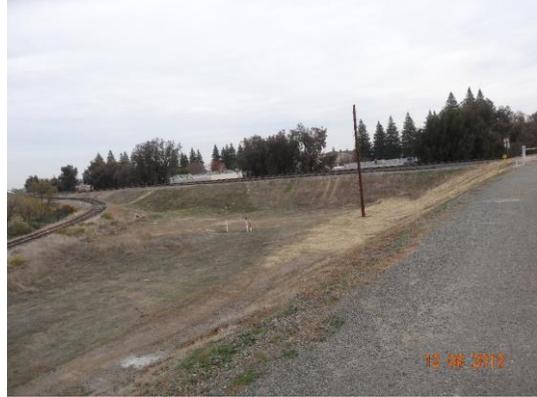
Photo 1 of 3 : UCIP\_FA\_2015\_2985.jpg

LM Start	<b>1.91</b>	Rating **	M	Issue No.	<b>37</b>
LM End	<b>1.91</b>	Issue Type +	En	Location *	LS
Category	Supplemental			GPS Latitude/Longitude	
				Start	End
Item	DWR UCIP Field Study			38.596096 °	38.596096 °
				-121.449815 °	-121.449815 °
DWR ID					
Action/Comments					
Inspector Comments: FS_ID:31230 DS_ID:24801 EP_NO: N/A FS_HLM: 1.9 Repair Type: Non-Urgent Crossing Status: Found UCIP Comments: No permit found--need to contact owner to determine status of crossing. FIELD_STRUCT_DESC: Gas line through levee at unknown depth. Markers visible on waterward and landward side. Kinder Morgan line contact infor 916-363-1666. FS Date: 12/06/2013

View of landward side.

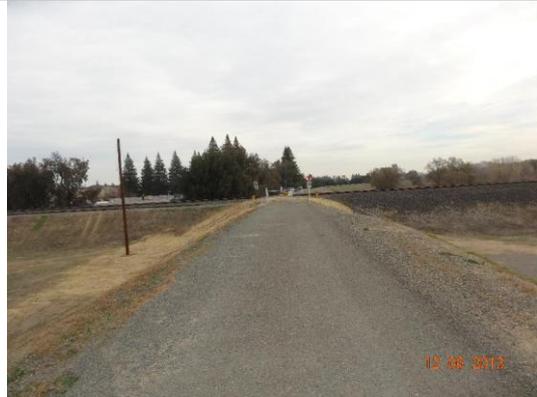
Photo 2 of 3 : UCIP\_FA\_2015\_2999.jpg

Overview of levee crown at crossing.

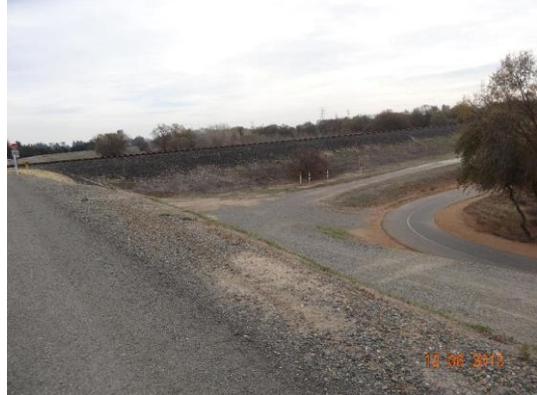
Photo 3 of 3 : UCIP\_FA\_2015\_3000.jpg

View of waterward side.

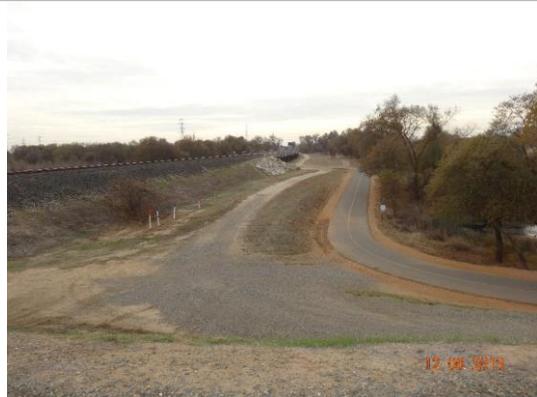
Photo 1 of 3 : UCIP\_FA\_2015\_4121.jpg

LM Start	<b>1.91</b>	Rating **	M	Issue No.	<b>38</b>
LM End	<b>1.91</b>	Issue Type +	En	Location *	LS
Category	Supplemental			GPS Latitude/Longitude	
				Start	End
Item	DWR UCIP Field Study			38.596108 °	38.596108 °
				-121.449887 °	-121.449887 °
DWR ID					
Action/Comments					
Inspector Comments: FS_ID:29827 DS_ID:24296 EP_NO: N/A FS_HLM: 1.903 Repair Type: Non-Urgent Crossing Status: Indicator Found UCIP Comments: Unable to confirm the diameter size or which owner is responsible for crossing. Owner could be Quest Communication or MCI--Need to contact owner to confirm crossing and obtain encroachment permit for work. FIELD_STRUCT_DESC: 3-inch cable through the levee, 2.5 feet below the crown. Two overhead telephone lines across the levee at location. FS Date: 12/06/2013

Conduit markers visible on waterward side.

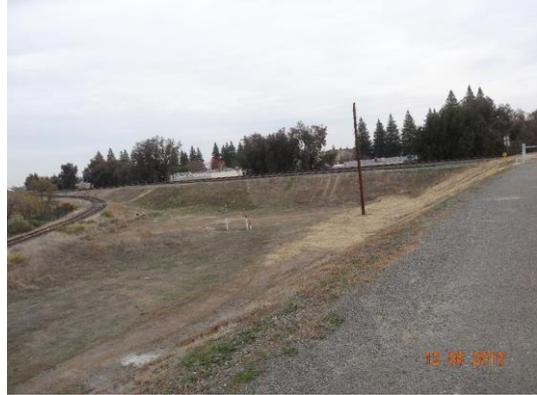
Photo 2 of 3 : UCIP\_FA\_2015\_4122.jpg

Conduit markers visible on landward side.

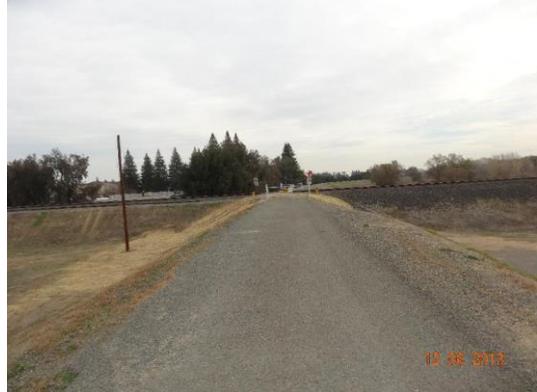
Photo 3 of 3 : UCIP\_FA\_2015\_4123.jpg

Overview of levee crown looking upstream at crossing.

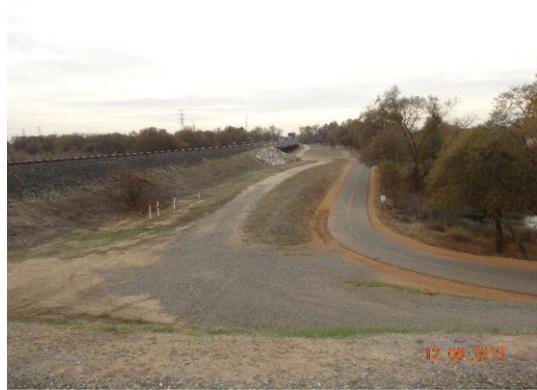
Photo 1 of 3 : UCIP\_FA\_2015\_1244.jpg

LM Start	<b>1.91</b>	Rating **	M	Issue No.	<b>39</b>
LM End	<b>1.91</b>	Issue Type +	En	Location *	LS
Category	Supplemental			GPS Latitude/Longitude	
				Start	End
Item	DWR UCIP Field Study			38.596108 °	38.596108 °
				-121.449887 °	-121.449887 °
DWR ID					
Action/Comments					
Inspector Comments: FS_ID:29826 DS_ID:24294 EP_NO: N/A FS_HLM: 1.902 Repair Type: Non-Urgent Crossing Status: Indicator Found

View of waterward side--markers visible.

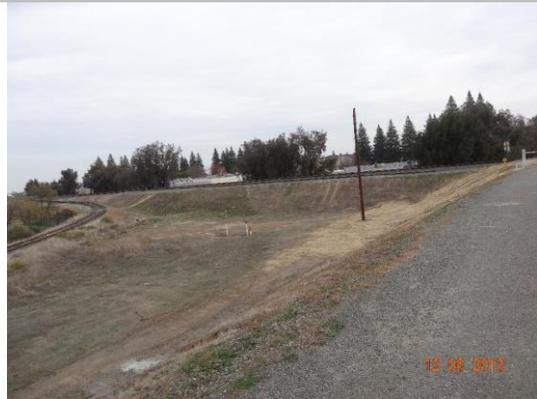
Photo 2 of 3 : UCIP\_FA\_2015\_1245.jpg

View of landward side--conduit markers visible.

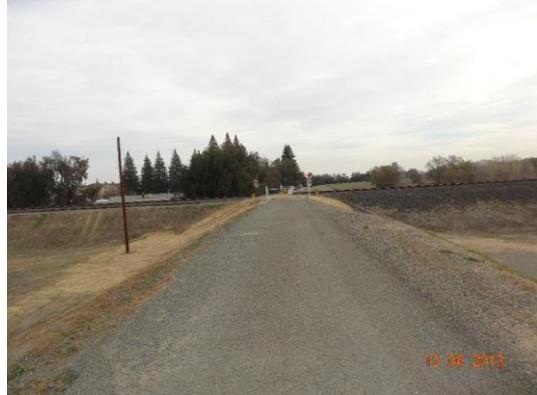
Photo 3 of 3 : UCIP\_FA\_2015\_4120.jpg

LM Start	<b>1.91</b>	Rating **	M	Issue No.	<b>39 (cont)</b>
LM End	<b>1.91</b>	Issue Type +	En	Location *	LS
Category	Supplemental			GPS Latitude/Longitude	
				Start	End
Item	DWR UCIP Field Study			38.596108 °	38.596108 °
				-121.449887 °	-121.449887 °
DWR ID					
Action/Comments					
Inspector Comments: FS_ID:29826 DS_ID:24294 EP_NO: N/A FS_HLM: 1.902 Repair Type: Non-Urgent Crossing Status: Indicator Found

Overview of levee crown looking upstram at crossing.

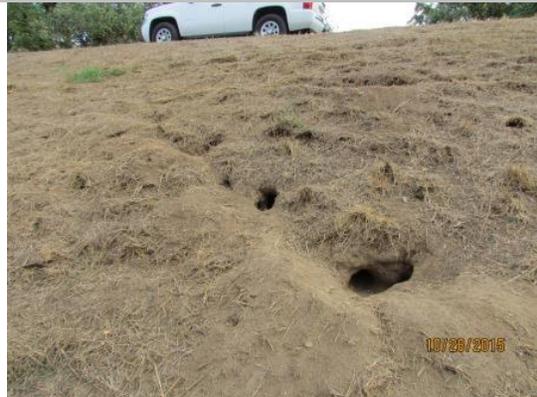
Photo 1 of 1 : FA\_2015\_NA0001\_490\_25\_20151112\_00011.jpg

LM Start	<b>2.40</b>	Rating **	A/W	Issue No.	<b>25</b>
LM End	<b>2.40</b>	Issue Type +	Ma	Location *	LS
Category	Earthen Levee			GPS Latitude/Longitude	
				Start	End
Item	Animal Control			38.595549 °	38.595549 °
				-121.458714 °	-121.458714 °
DWR ID	DWR_NA0001_03_f_2015_25				
Action/Comments					
Exterminate rodents and backfill and compact or grout burrows. Inspector Comments: The holes were backfilled by the LMA.

View of the rodent holes on the landside levee slope.

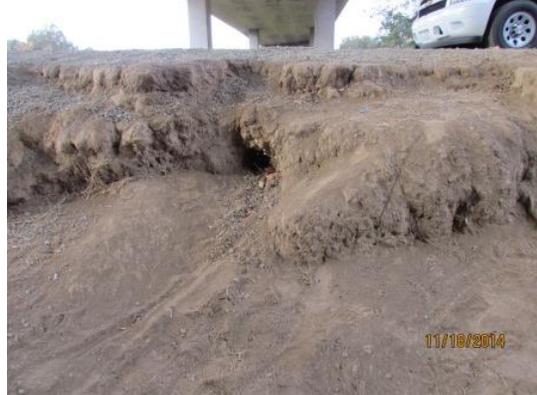
Photo 1 of 1 : FA\_2015\_NA0001\_490\_1\_20150910\_00001.jpg

LM Start	<b>3.17</b>	Rating **	A/W	Issue No.	<b>1</b>
LM End	<b>3.17</b>	Issue Type +	Ma	Location *	LS
Category	Earthen Levee			GPS Latitude/Longitude	
				Start	End
Item	Animal Control			38.599141 °	38.599141 °
				-121.470227 °	-121.470227 °
DWR ID	DWR_NA0001_03_f_2013_1				
Action/Comments					
No rodents visible, but rodent burrows visible; need to backfill and compact or grout burrows.

View of the rodent holes on the landside levee slope.

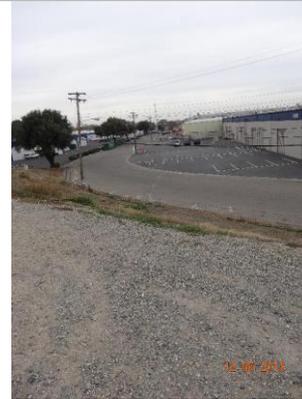
Photo 1 of 3 : UCIP\_FA\_2015\_3096.jpg

LM Start	<b>3.29</b>	Rating **	U	Issue No.	<b>40</b>
LM End	<b>3.29</b>	Issue Type +	En	Location *	LS
Category	Supplemental			GPS Latitude/Longitude	
				Start	End
Item	DWR UCIP Field Study			38.600718 °	38.600718 °
				-121.471491 °	-121.471491 °
DWR ID					
Action/Comments					
Inspector Comments: FS_ID:43284 DS_ID:24648 EP_NO: 911 FS_HLM: 3.25 Repair Type: Urgent Crossing Status: Found UCIP Comments: 2/6/2015 Permit information was entered and crossing description updated. (UCIP-Olivia)12/3/13 Need to contact owner to determine status of crossing. Markers missing. (UCIP-Olivia) FIELD_STRUCT_DESC: 12-3/4-inch gas line through the levee. FS Date: 12/03/2013

View of landward side with undergroundservice alert (USA) paint with approximate alignment of multiple crossing in general area.

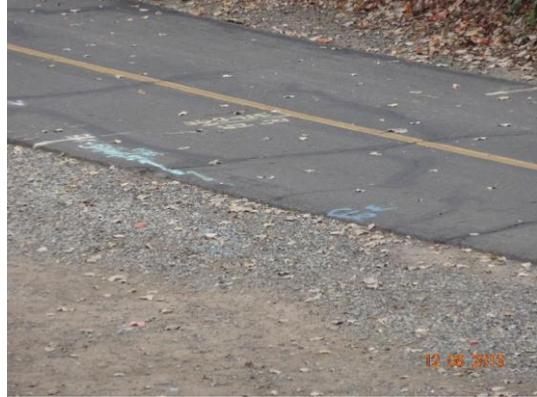
Photo 2 of 3 : UCIP\_FA\_2015\_3097.jpg

Underground service alert (USA) marked approximate alignment for 12-inch gas line through levee.

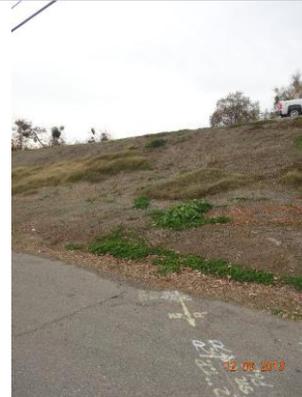
Photo 3 of 3 : UCIP\_FA\_2015\_3098.jpg

View of waterward side slope and USA paint markings indicating alignment.

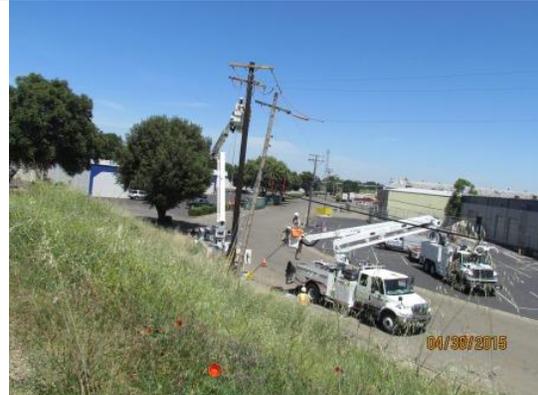
Photo 1 of 1 : FA\_2015\_NA0001\_490\_24\_20150910\_00005.jpg

LM Start	<b>3.31</b>	Rating **	M	Issue No.	<b>24</b>
LM End	<b>3.31</b>	Issue Type +	En	Location *	LS
Category	Earthen Levee		GPS Latitude/Longitude		
			Start	End	
Item	Encroachments		38.600958 °	38.600958 °	
			-121.471618 °	-121.471618 °	
DWR ID	DWR_NA0001_03_s_2015_24				
Action/Comments					
Pole Inspector Comments: SMUD replacing old pole at the landside toe of the levee. May or may not be permitted.

View of a new pole installed at the landside levee toe.

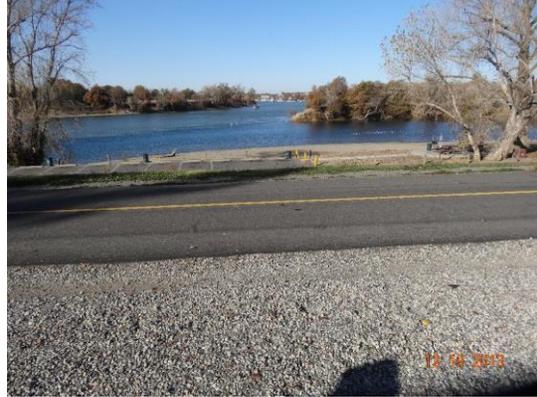
Photo 1 of 3 : UCIP\_FA\_2015\_3099.jpg

LM Start	<b>0.05</b>	Rating **	M	Issue No.	<b>746</b>
LM End	<b>0.05</b>	Issue Type +	En	Location *	LS
Category	Supplemental			GPS Latitude/Longitude	
				Start	End
Item	DWR UCIP Field Study			38.597198 °	38.597198 °
				-121.506532 °	-121.506532 °
DWR ID					
Action/Comments					
Inspector Comments: FS_ID:29003 DS_ID:24344 EP_NO: N/A FS_HLM: 0.06 Repair Type: Non-Urgent Crossing Status: Indicator Found UCIP Comments: Metal boxes located on landward side could be associated with utility -- unable to confirm. Will need to contact owner. FIELD_STRUCT_DESC: Electrical conduit through the levee. FS Date: 12/19/2013

View of waterward side.
