**Flood Control Project Maintenance  
Levee Inspections**

**Fall 2015 Levee Maintenance Deficiency Summary Report**

**Sacramento River Basin**

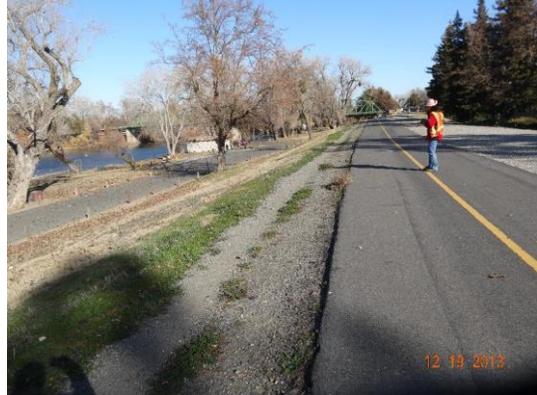
Photo 2 of 3 : UCIP\_FA\_2015\_3100.jpg

Overview of levee crown and waterward side.

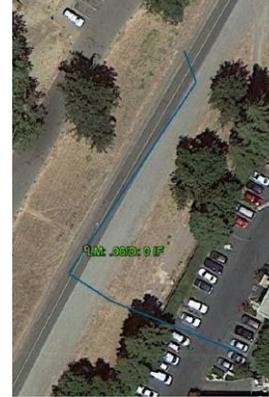
Photo 3 of 3 : UCIP\_FA\_2015\_3101.jpg

LM Start	0.05	Rating **	M	Issue No.	746 (cont)
LM End	0.05	Issue Type +	En	Location *	LS
Category	Supplemental			GPS Latitude/Longitude	
	Start		End		
Item	DWR UCIP Field Study			38.597198 °	38.597198 °
				-121.506532 °	-121.506532 °
DWR ID					
Action/Comments					
Inspector Comments: FS_ID:29003 DS_ID:24344 EP_NO: N/A FS_HLM: 0.06 Repair Type: Non-Urgent Crossing Status: Indicator Found

Approximate alignment provided by the City of Sacramento for 2 inch line. Point labelled in green is field verified location where signs of crossing exist.

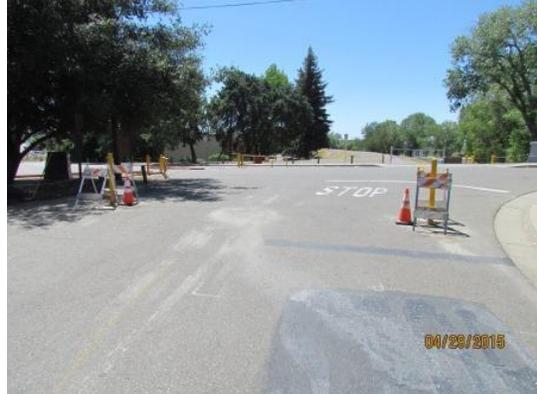
Photo 1 of 1 : FA\_2015\_NA0001\_55\_242\_20150910\_00187.jpg

LM Start	0.20	Rating **	M	Issue No.	242
LM End	0.20	Issue Type +	En	Location *	CR
Category	Earthen Levee			GPS Latitude/Longitude	
	Start		End		
Item	Encroachments			38.598832 °	38.598832 °
				-121.504984 °	-121.504984 °
DWR ID	DWR_NA0001_04_s_2015_242				
Action/Comments					
Fence Inspector Comments: Unpermitted gate being installed by Sacramento County Parks.

View of the gate installation in progress on the levee crown.

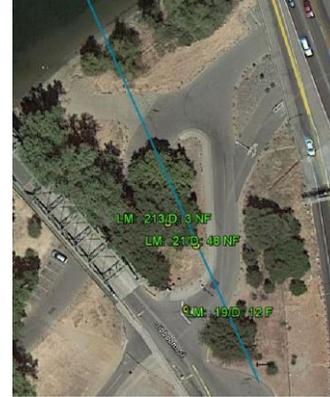
Photo 1 of 1 : UCIP\_FA\_2015\_3215.jpg

LM Start	<b>0.21</b>	Rating **	M	Issue No.	<b>747</b>
LM End	<b>0.21</b>	Issue Type +	En	Location *	CR
Category	Supplemental			GPS Latitude/Longitude	
				Start	End
Item	DWR UCIP Field Study			38.598982 °	38.598982 °
				-121.505045 °	-121.505045 °
DWR ID					
Action/Comments					
Inspector Comments: FS_ID:29006 DS_ID:24435 EP_NO: 17171 FS_HLM: 0.21 Repair Type: Non-Urgent Crossing Status: Not Found UCIP Comments: Unable to find any indications that crossing is still active. Will need to contact owner to determine status of crossing. FIELD_STRUCT_DESC: 48-inch steel water line through the levee, approximately 32.0 feet below the crown. Siphon and blowoff valves in concrete riser on the landward side. (Permit No. 17171-2001) FS Date: 12/19/2013

Approximate alignment provided by the City of Sacramento--crossing not found during field visit.

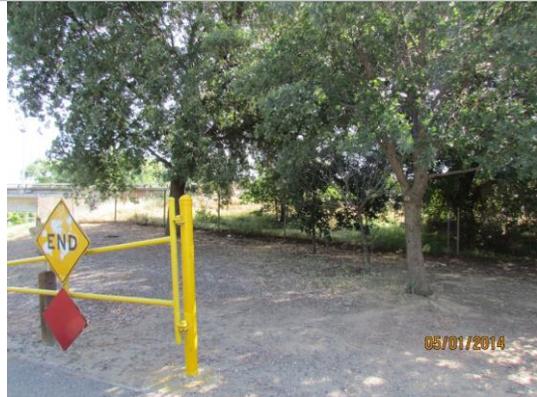
Photo 1 of 1 : FA\_2015\_NA0001\_55\_177\_20150910\_00153.jpg

LM Start	<b>0.21</b>	Rating **	M	Issue No.	<b>177</b>
LM End	<b>0.21</b>	Issue Type +	En	Location *	CR
Category	Earthen Levee			GPS Latitude/Longitude	
				Start	End
Item	Vegetation			38.598980 °	38.598980 °
				-121.504773 °	-121.504773 °
DWR ID	DWR_NA0001_04_s_2012_177				
Action/Comments					
Landscaping Inspector Comments: Landscaping on levee crown at overpass.

View of the landscaping on the levee crown.

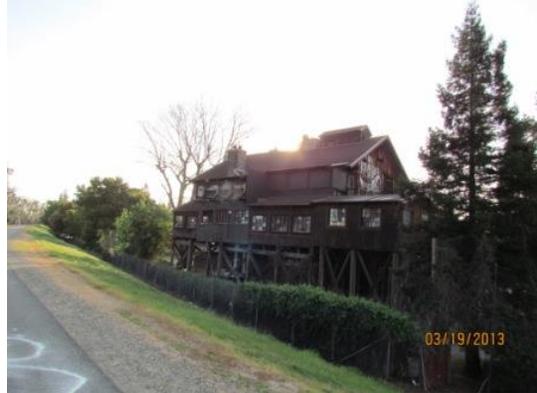
Photo 1 of 1 : FA\_2015\_NA0001\_55\_1\_20150910\_00001.jpg

LM Start	<b>0.31</b>	Rating **	M	Issue No.	<b>1</b>
LM End	<b>0.45</b>	Issue Type +	En	Location *	LS
Category	Earthen Levee		GPS Latitude/Longitude		
			Start	End	
Item	Vegetation		38.599835 °	38.600769 °	
			-121.503448 °	-121.501133 °	
DWR ID	DWR_NA0001_04_s_2012_1				
Action/Comments					
Landscaping Inspector Comments: Vines and privacy fence within 10-ft of the landside toe or on the levee slope obstruct visibility and access.

View of the vines obstructing visibility.

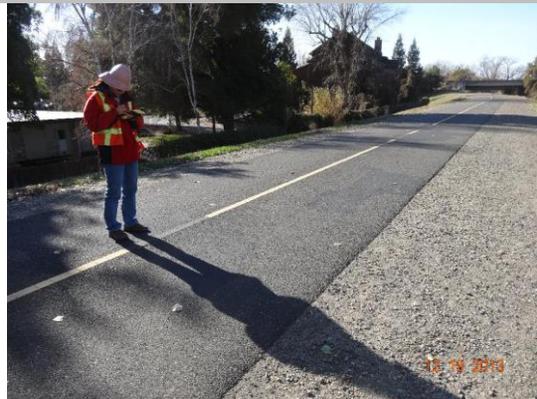
Photo 1 of 3 : UCIP\_FA\_2015\_3243.jpg

LM Start	<b>0.40</b>	Rating **	M	Issue No.	<b>748</b>
LM End	<b>0.40</b>	Issue Type +	En	Location *	LS
Category	Supplemental		GPS Latitude/Longitude		
			Start	End	
Item	DWR UCIP Field Study		38.600436 °	38.600436 °	
			-121.502058 °	-121.502058 °	
DWR ID					
Action/Comments					
Inspector Comments: FS_ID:31249 DS_ID:24303 EP_NO: N/A FS_HLM: 0.41 Repair Type: Non-Urgent Crossing Status: Found UCIP Comments: Non-functional crossing--need additional information about how crossing was abandoned. FIELD_STRUCT_DESC: Abandoned 42-inch CM pipe through the levee, 16.5 feet below the crown. Gravel filled with both ends welded shut. Flap gate on the waterward end. Slide gate in CM riser and splash board drain structure on the landward side. (USACE-1955). This entry matches the Drainage or Irrigation Structure referenced in O&M manual (Station 10+00). FS Date: 12/19/2013

View of levee crown at this location.

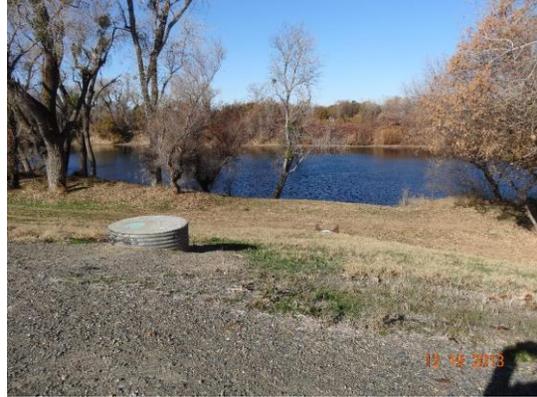
Photo 2 of 3 : UCIP\_FA\_2015\_3244.jpg

LM Start	0.40	Rating **	M	Issue No.	748 (cont)
LM End	0.40	Issue Type +	En	Location *	LS
Category	Supplemental			GPS Latitude/Longitude	
				Start	End
Item	DWR UCIP Field Study			38.600436 °	38.600436 °
				-121.502058 °	-121.502058 °
DWR ID					
Action/Comments					
Inspector Comments: FS_ID:31249 DS_ID:24303 EP_NO: N/A FS_HLM: 0.41 Repair Type: Non-Urgent Crossing Status: Found UCIP Comments: Non-functional crossing--need additional information about how crossing was abandoned. FIELD_STRUCT_DESC: Abandoned 42-inch CM pipe through the levee, 16.5 feet below the crown. Gravel filled with both ends welded shut. Flap gate on the waterward end. Slide gate in CM riser and splash board drain structure on the landward side. (USACE-1955). This entry matches the Drainage or Irrigation Structure referenced in O&M manual (Station 10+00). FS Date: 12/19/2013

View of waterward side--standpipe located on waterward slope. Standpipe filled with concrete.

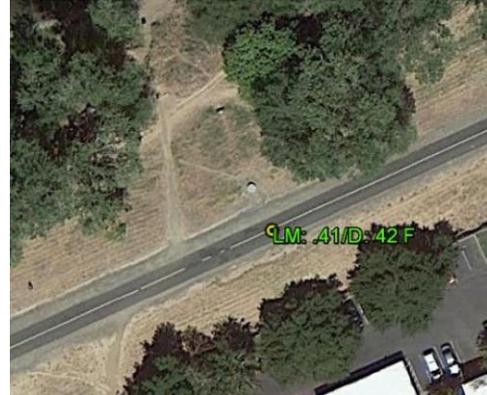
Photo 3 of 3 : UCIP\_FA\_2015\_3245.jpg

Overview of crossing location.

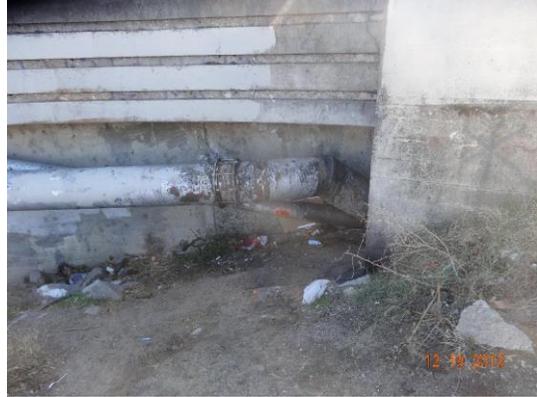
Photo 1 of 2 : UCIP\_FA\_2015\_2921.jpg

LM Start	<b>1.88</b>	Rating **	U	Issue No.	<b>749</b>
LM End	<b>1.88</b>	Issue Type +	En	Location *	WS
Category	Supplemental			GPS Latitude/Longitude	
				Start	End
Item	DWR UCIP Field Study			38.595911 °	38.595911 °
				-121.477485 °	-121.477485 °
DWR ID					
Action/Comments					
Inspector Comments: FS_ID:29027 DS_ID:24307 EP_NO: N/A FS_HLM: 1.911 Repair Type: Urgent Crossing Status: Found UCIP Comments: No markers or labels visible to indicate line is gas line--unable to confirm. FIELD_STRUCT_DESC: 1 of 2: 20-inch gas main through the levee, 5.0 feet below the crown. FS Date: 12/19/2013

Two crossings visible at bridge.

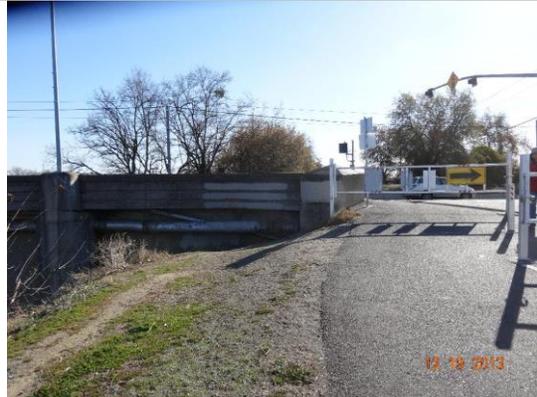
Photo 2 of 2 : UCIP\_FA\_2015\_2922.jpg

View of line exposed at the bridge.

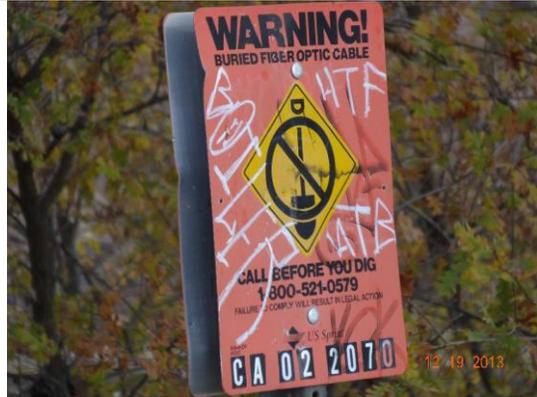
Photo 1 of 3 : UCIP\_FA\_2015\_4302.jpg

LM Start	<b>2.25</b>	Rating **	M	Issue No.	<b>750</b>
LM End	<b>2.25</b>	Issue Type +	En	Location *	LS
Category	Supplemental			GPS Latitude/Longitude	
				Start	End
Item	DWR UCIP Field Study			38.591923 °	38.591923 °
				-121.473744 °	-121.473744 °
DWR ID					
Action/Comments					
Inspector Comments: FS_ID:29927 DS_ID:24310 EP_NO: 14150 FS_HLM: 2.268 Repair Type: Non-Urgent Crossing Status: Indicator Found UCIP Comments: unable to confirm if crossing is 4-inch steel conduit--will need to coordinate with owner. FIELD_STRUCT_DESC: 4-inch steel pipe conduit containing fiber optic cables through the levee, 3.5 feet below the crown. Markers on the levee shoulder. Rock revetment on the waterward slope. (Permit No. 14150-1986) FS Date: 12/19/2013

Contact information for US Sprint--not MCI as records indicate.

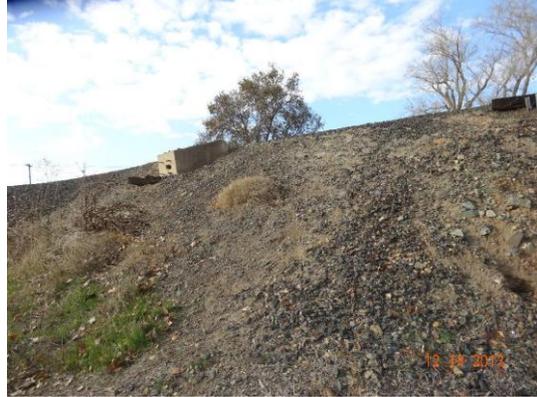
Photo 2 of 3 : UCIP\_FA\_2015\_4303.jpg

LM Start	2.25	Rating **	M	Issue No.	750 (cont)
LM End	2.25	Issue Type +	En	Location *	LS
Category	Supplemental			GPS Latitude/Longitude	
				Start	End
Item	DWR UCIP Field Study			38.591923 °	38.591923 °
				-121.473744 °	-121.473744 °
DWR ID					
Action/Comments					
Inspector Comments: FS_ID:29927 DS_ID:24310 EP_NO: 14150 FS_HLM: 2.268 Repair Type: Non-Urgent Crossing Status: Indicator Found UCIP Comments: unable to confirm if crossing is 4-inch steel conduit--will need to coordinate with owner. FIELD_STRUCT_DESC: 4-inch steel pipe conduit containing fiber optic cables through the levee, 3.5 feet below the crown. Markers on the levee shoulder. Rock revetment on the waterward slope. (Permit No. 14150-1986) FS Date: 12/19/2013

View of waterward slope--concrete box could be associated with conduit?

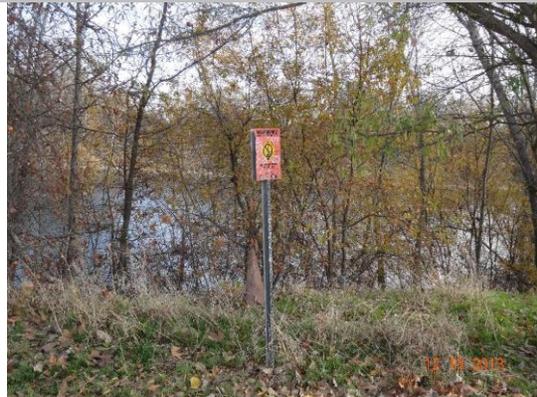
Photo 3 of 3 : UCIP\_FA\_2015\_4304.jpg

Marker for buried fiber optic cable on waterward side.

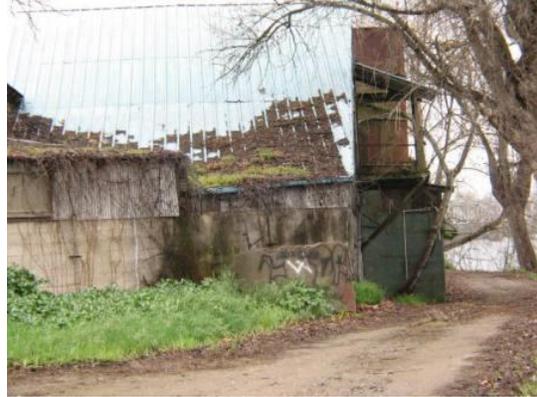
Photo 1 of 1 : FA\_2015\_NA0001\_55\_2\_20150910\_00002.jpg

LM Start	<b>2.68</b>	Rating **	U	Issue No.	<b>2</b>
LM End	<b>2.68</b>	Issue Type +	En	Location *	LS
Category	Earthen Levee		GPS Latitude/Longitude		
			Start	End	
Item	Encroachments		38.588913 °	38.588913 °	
			-121.467210 °	-121.467210 °	
DWR ID	DWR_NA0001_04_s_2012_2				
Action/Comments					
Building Inspector Comments: Bell Marine

03/16/2012 Structure on Bell Marine property.

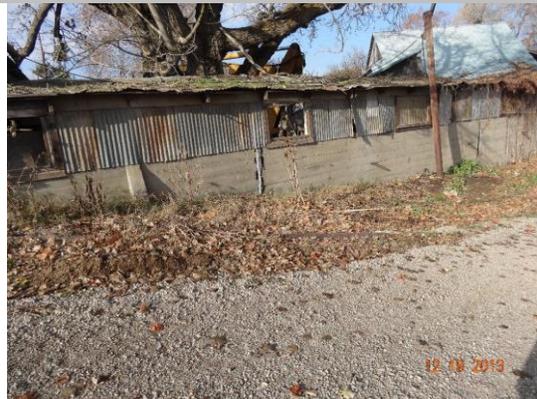
Photo 1 of 2 : UCIP\_FA\_2015\_4305.jpg

Item	DWR UCIP Field Study		38.587906 °	38.587906 °	
			-121.466689 °	-121.466689 °	
DWR ID					
Action/Comments					
Inspector Comments: FS_ID:29944 DS_ID:24327 EP_NO: 3362 FS_HLM: 2.73 Repair Type: Non-Urgent Crossing Status: Found UCIP Comments: Pipe sections abandoned on levee crown--need to contact owner to determine status of crossing. FIELD_STRUCT_DESC: 12-inch steel pipe through the levee. Pipe extends from a settling pond, on the left bank berm, to an existing borrow pit located in the overflow area adjacent to the right bank. The pipeline is buried through the top of the riverbanks and buried in the left bank with aggregate revetment placed on the bank. The remainder of the pipeline is exposed across the bottom of the channel and the right bank. The line is used to divert wash water return from the gravel plant to the opposite side of the river. (Permit 8146-1974) FS Date: 12/19/2013

View of structure located on levee crown.

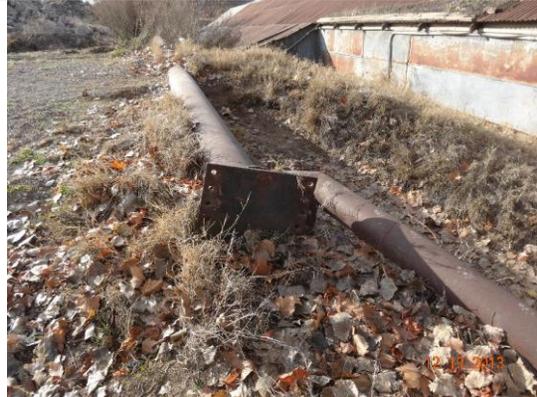
Photo 2 of 2 : UCIP\_FA\_2015\_4427.jpg

Remnants of old crossing located on levee crown.

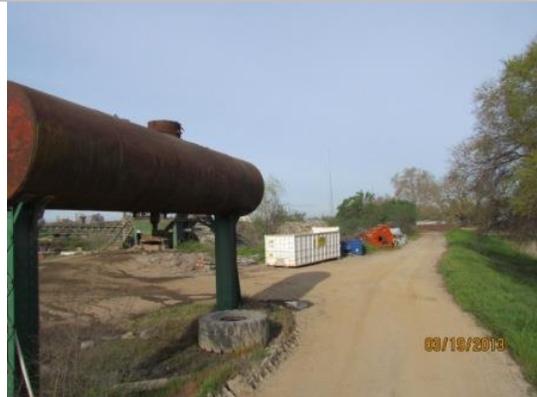
Photo 1 of 1 : FA\_2015\_NA0001\_55\_3\_20150910\_00003.jpg

LM Start	2.72	Rating **	M	Issue No.	3
LM End	2.86	Issue Type +	En	Location *	LS
Category	Earthen Levee			GPS Latitude/Longitude	
				Start	End
Item	Encroachments			38.587939 °	38.587299 °
				-121.466635 °	-121.464320 °
DWR ID	DWR_NA0001_04_s_2012_3				
Action/Comments					
Equipment Inspector Comments: Bell Marine, LMA sent a letter to property owner for the violation.

View of the debris obstructing visibility and access.

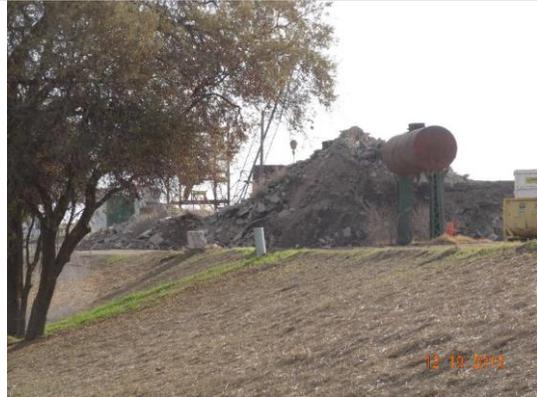
Photo 1 of 2 : UCIP\_FA\_2015\_4595.jpg

LM Start	<b>2.77</b>	Rating **	M	Issue No.	<b>752</b>
LM End	<b>2.77</b>	Issue Type +	En	Location *	CR
Category	Supplemental			GPS Latitude/Longitude	
				Start	End
Item	DWR UCIP Field Study			38.587629 °	38.587629 °
				-121.465905 °	-121.465905 °
DWR ID					
Action/Comments					
Inspector Comments: FS_ID:31444 DS_ID:24805 EP_NO: N/A FS_HLM: 2.78 Repair Type: Non-Urgent Crossing Status: Indicator Found UCIP Comments: No permit (unauthorized crossing)--need additional information about crossing. FIELD_STRUCT_DESC: Standpipe located on waterward shoulder. Unable to confirm pipe alignment. No permit found. FS Date: 12/19/2013

Standpipe located on waterward shoulder.

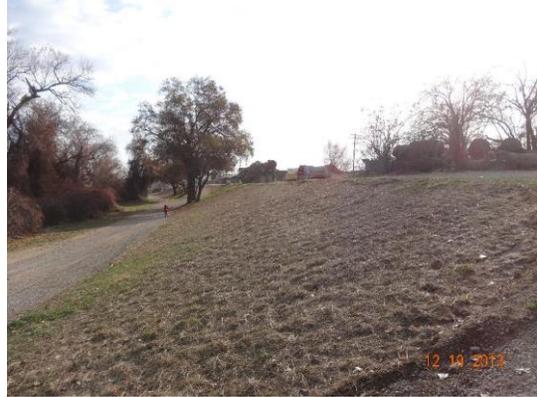
Photo 2 of 2 : UCIP\_FA\_2015\_4596.jpg

View of waterward slope.

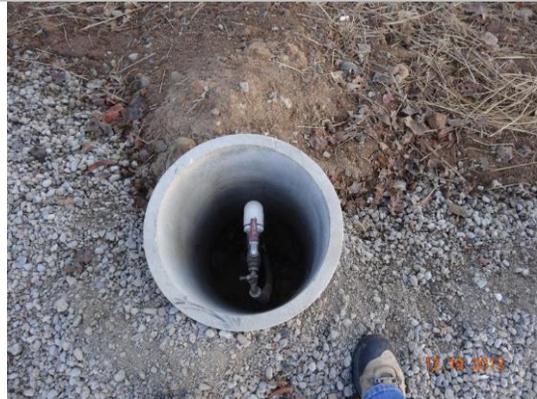
Photo 1 of 1 : UCIP\_FA\_2015\_4597.jpg

LM Start	2.82	Rating **	M	Issue No.	753
LM End	2.82	Issue Type +	En	Location *	CR
Category	Supplemental			GPS Latitude/Longitude	
			Start	End	
Item	DWR UCIP Field Study			38.587438 °	38.587438 °
				-121.464989 °	-121.464989 °
DWR ID					
Action/Comments					
Inspector Comments: FS_ID:31445 DS_ID:24806 EP_NO: N/A FS_HLM: 2.83 Repair Type: Non-Urgent Crossing Status: Found UCIP Comments: No permit found (unauthorized?)--need additional information about crossing. FIELD_STRUCT_DESC: Standpipe located on waterward shoulder. Pipe crosses levee crown and landward side. Pipe used for irrigation. No Permit found. FS Date: 12/13/2013

Spigot located inside riser located on waterward shoulder.

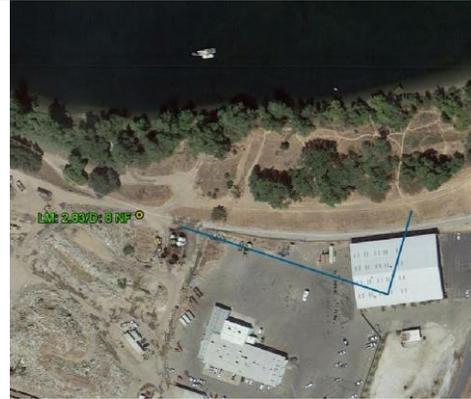
Photo 1 of 1 : UCIP\_FA\_2015\_3246.jpg

Item	DWR UCIP Field Study			38.587383 °	38.587383 °
				-121.464951 °	-121.464951 °
DWR ID					
Action/Comments					
Inspector Comments: FS_ID:31253 DS_ID:24328 EP_NO: 5890 FS_HLM: 2.831 Repair Type: Non-Urgent Crossing Status: Not Found UCIP Comments: Need to contact owner to determine status of crossing--approximate alignment indicates pipe does not cross levee however records shows drain pipe crosses levee. FIELD_STRUCT_DESC: 8-inch CM drainpipe through the levee, 2.1 feet below the crown. Concrete drop inlet structure at waterward shoulder. Maintenance facilities and yard on the landward side. Rock revetment on waterward slope. (Pemit No. 5890-1968) This entry matches the Drainage or Irrigation Structure referenced in O&M manual (Station 156+75). FS Date: 12/19/2013

Approximate alignment indicated in blue and approximate location indicated by DWR-UCIP in green label.

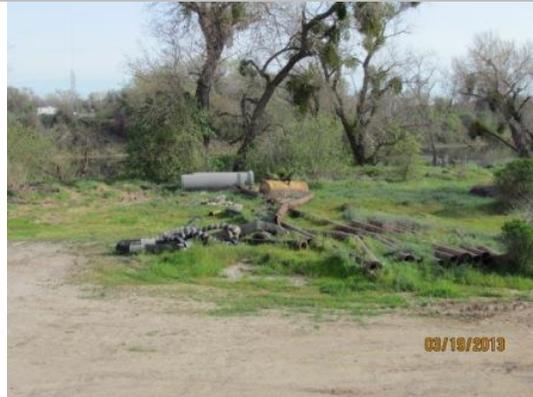
Photo 1 of 2 : FA\_2015\_NA0001\_55\_4\_20150910\_00004.jpg

LM Start	<b>2.83</b>	Rating **	M	Issue No.	<b>4</b>
LM End	<b>2.83</b>	Issue Type +	En	Location *	WS
Category	Earthen Levee			GPS Latitude/Longitude	
				Start	End
Item	Encroachments			38.587272 °	38.587272 °
				-121.464768 °	-121.464768 °
DWR ID	DWR_NA0001_04_s_2012_4				
Action/Comments					
Debris Inspector Comments: Bell Marine, LMA sent a letter to the property owner for this violation.

View of the debris stored in floodway.

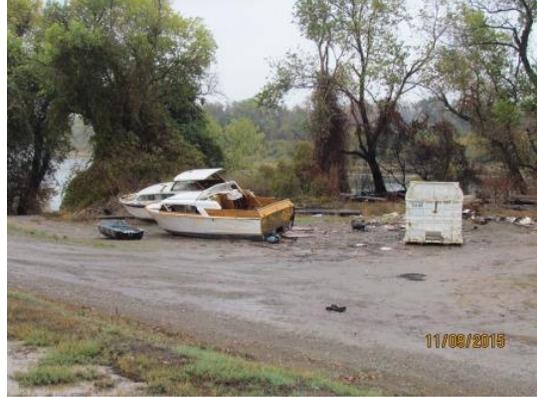
Photo 2 of 2 : FA\_2015\_NA0001\_55\_4\_20151112\_00214.jpg

Another view of the debris in the floodway.

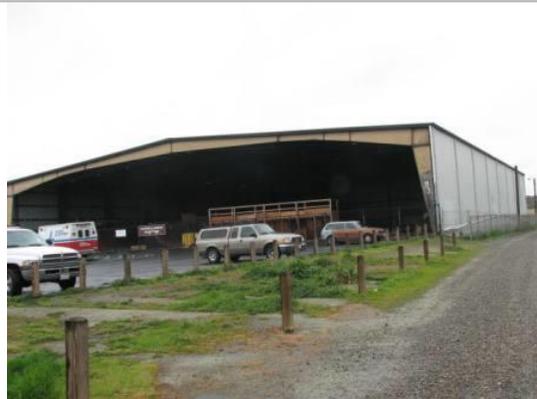
Photo 1 of 1 : FA\_2015\_NA0001\_55\_5\_20150910\_00005.jpg

LM Start	<b>2.92</b>	Rating **	U	Issue No.	<b>5</b>
LM End	<b>2.96</b>	Issue Type +	En	Location *	LS
Category	Earthen Levee			GPS Latitude/Longitude	
				Start	End
Item	Encroachments			38.587251 °	38.587318 °
				-121.463237 °	-121.462513 °
DWR ID	DWR_NA0001_04_s_2012_5				
Action/Comments					
Building Inspector Comments: City of Sacramento building. Building is now Sutter's Landing Skate Park.

03/16/2012 Sutter's Landing Skate Park.

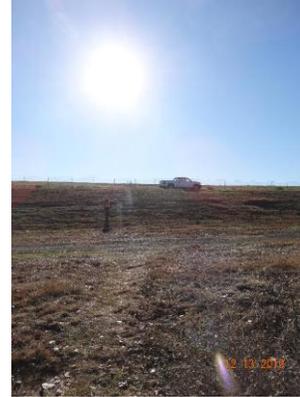
Photo 1 of 3 : UCIP\_FA\_2015\_3247.jpg

Item	DWR UCIP Field Study			38.588601 °	38.588601 °
				-121.458503 °	-121.458503 °
DWR ID					
Action/Comments					
Inspector Comments: FS_ID:31254 DS_ID:24330 EP_NO: 15041 FS_HLM: 3.19 Repair Type: Non-Urgent Crossing Status: Indicator Found UCIP Comments: Hole present on riser located on landward side--contact owner. Additional pipe found in waterward berm. Unable to confirm if this pipe section is part of crossing--size does not match. Unable to find CM standpipe on waterward side. FIELD_STRUCT_DESC: 16-inch CM drainpipe through the levee. Steel cutoff wall around pipe at center of levee. Storm drain gate on landward shoulder. Drainage ditch on landward side. CM standpipe on waterward side. Rock-filled ditch on waterward side. (Permit No. 15041-1993) FS Date: 12/13/2013

Overview of waterward side.

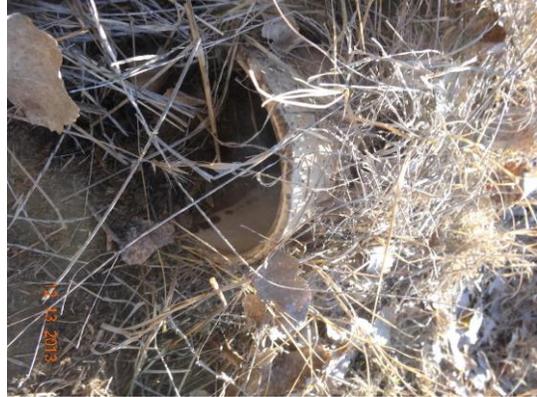
Photo 3 of 3 : UCIP\_FA\_2015\_3249.jpg

Pipe buried through vegetation.

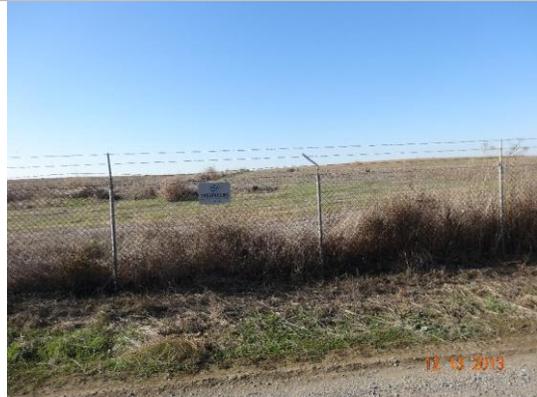
Photo 1 of 3 : UCIP\_FA\_2015\_4254.jpg

Item	DWR UCIP Field Study			38.589033 °	38.589033 °
				-121.451145 °	-121.451145 °
DWR ID					
Action/Comments					
Inspector Comments: FS_ID:42128 DS_ID:24807 EP_NO: N/A FS_HLM: 3.61 Repair Type: Non-Urgent Crossing Status: Indicator Found UCIP Comments: 11/3/2014 (DWR-Olivia) Need to contact owner to determine status of crossing. Priority under Part IX has been changed from Urgent to Non-Urgent as a measure to normalize the data. Per Title 23 markers are necessary for pressure line--markers present. Recommend LMA to contact owner to determine additional information details--CVFPB permit, depth of pipe through levee, alignment, and last inspection completed confirming integrity of crossing.No permit found. Will need to contact owner to determine the status of crossing. FIELD_STRUCT_DESC: Petroleum pipeline through the levee, unknow depth. Markers visible on waterward side. Unable to confirm alignment. Owner contact information for Kinder Morgan is 916-363-1666. FS Date: 12/13/2013

View of landward side.

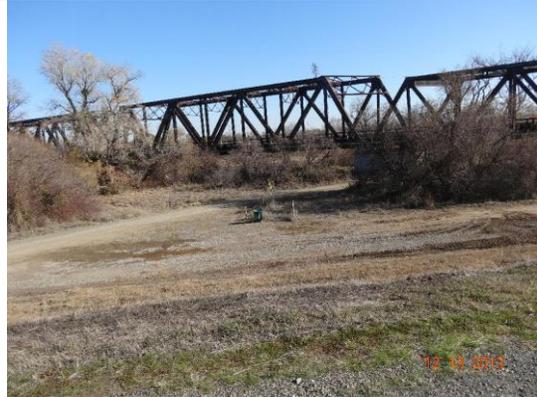
Photo 2 of 3 : UCIP\_FA\_2015\_4255.jpg

View of waterward side.

Inspector Comments: FS\_ID:42128  
 DS\_ID:24807  
 EP\_NO: N/A  
 FS\_HLM: 3.61  
 Repair Type: Non-Urgent  
 Crossing Status: Indicator Found  
 UCIP Comments: 11/3/2014 (DWR-Olivia) Need to contact owner to determine status of crossing. Priority under Part IX has been changed from Urgent to Non-Urgent as a measure to normalize the data. Per Title 23 markers are necessary for pressure line--markers present. Recommend LMA to contact owner to determine additional information details--CVFPB permit, depth of pipe through levee, alignment, and last inspection completed confirming integrity of crossing.No permit found. Will need to contact owner to determine the status of crossing.  
 FIELD\_STRUCT\_DESC: Petroleum pipeline through the levee, unknow depth. Markers visible on waterward side. Unable to confirm alignment. Owner contact information for Kinder Morgan is 916-363-1666.  
 FS Date: 12/13/2013

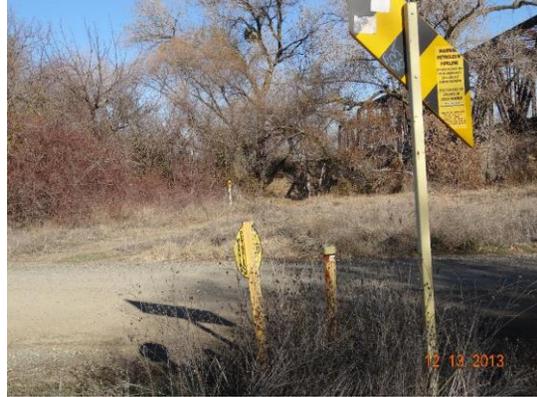
Photo 3 of 3 : UCIP\_FA\_2015\_4272.jpg

View of markers visible on landward side.

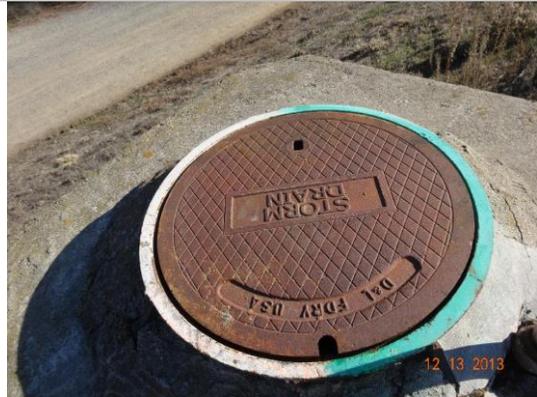
Photo 1 of 3 : UCIP\_FA\_2015\_3250.jpg

LM Start	3.75	Rating **	M	Issue No.	757	
LM End	3.75	Issue Type +	En	Location *	LS	
Category	Supplemental			GPS Latitude/Longitude		
			Start	End		
Item	DWR UCIP Field Study			38.587724 °	38.587724 °	
				-121.449554 °	-121.449554 °	
DWR ID						
Action/Comments						
Inspector Comments: FS_ID:31255 DS_ID:24335 EP_NO: N/A FS_HLM: 3.73 Repair Type: Non-Urgent Crossing Status: Found UCIP Comments: Control box is non-functional parts have been removed. Unable to confirm diameter size and status--City of Sacramento indicates a 24 inch sewer main not 18 inch. Need to contact owner to confirm size. FIELD_STRUCT_DESC: 18-inch sewer main through the levee. Concrete manhole on the waterward slope. FS Date: 12/13/2013

Manhole located on waterward slope.

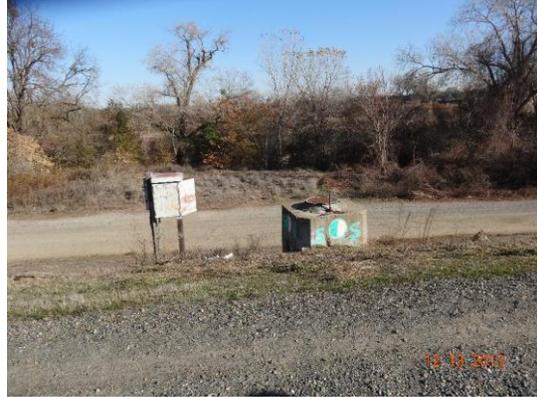
Photo 2 of 3 : UCIP\_FA\_2015\_3251.jpg

View of waterward side.

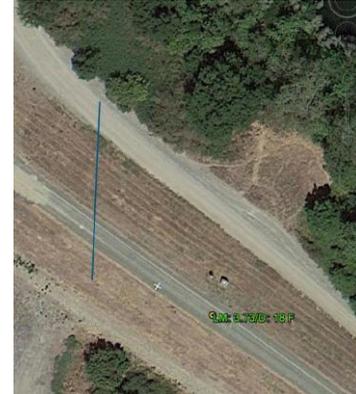
Photo 3 of 3 : UCIP\_FA\_2015\_3252.jpg

LM Start	3.75	Rating **	M	Issue No.	757 (cont)
LM End	3.75	Issue Type +	En	Location *	LS
Category	Supplemental			GPS Latitude/Longitude	
				Start	End
Item	DWR UCIP Field Study			38.587724 °	38.587724 °
				-121.449554 °	-121.449554 °
DWR ID					
Action/Comments					
Inspector Comments: FS_ID:31255 DS_ID:24335 EP_NO: N/A FS_HLM: 3.73 Repair Type: Non-Urgent Crossing Status: Found UCIP Comments: Control box is non-functional parts have been removed. Unable to confirm diameter size and status--City of Sacramento indicates a 24 inch sewer main not 18 inch. Need to contact owner to confirm size. FIELD_STRUCT_DESC: 18-inch sewer main through the levee. Concrete manhole on the waterward slope. FS Date: 12/13/2013

Approximate alignment provided by City of Sacramento and DWR-UCIP confirmed location of sewer line is indicated by green label.

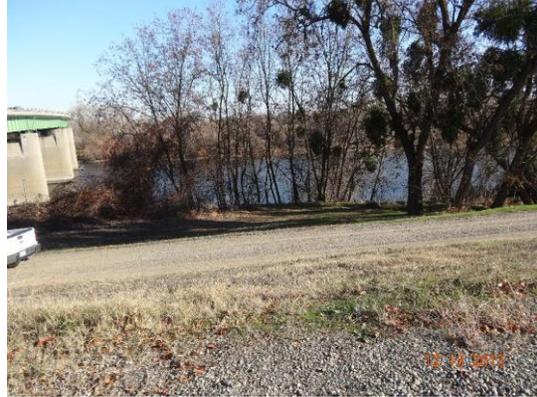
Photo 1 of 3 : UCIP\_FA\_2015\_4499.jpg

LM Start	<b>3.88</b>	Rating **	U	Issue No.	<b>758</b>
LM End	<b>3.88</b>	Issue Type +	En	Location *	LS
Category	Supplemental			GPS Latitude/Longitude	
				Start	End
Item	DWR UCIP Field Study			38.586496 °	38.586496 °
				-121.447631 °	-121.447631 °
DWR ID					
Action/Comments					
Inspector Comments: FS_ID:29954 DS_ID:24311 EP_NO: 2805 FS_HLM: 3.86 Repair Type: Urgent Crossing Status: Indicator Found

View of waterward side.

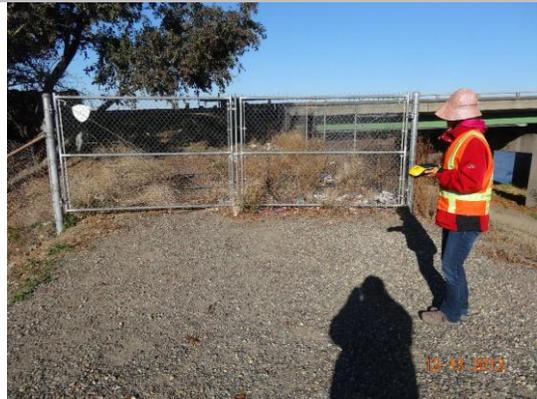
Photo 2 of 3 : UCIP\_FA\_2015\_4500.jpg

View of levee crown section near highway.

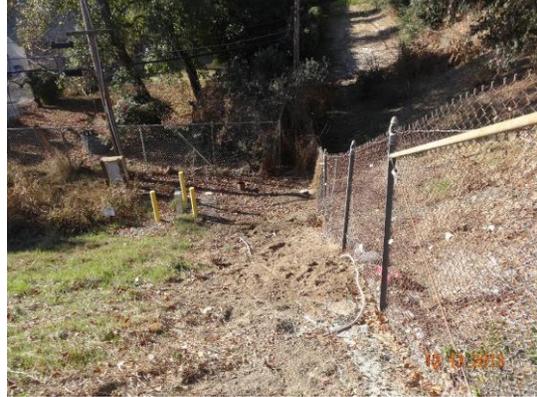
Photo 3 of 3 : UCIP\_FA\_2015\_4501.jpg

Sewer line along fence line on landward side--riser near back fence.

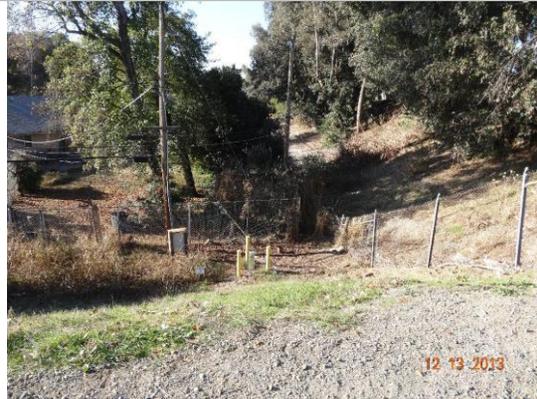
Photo 1 of 3 : UCIP\_FA\_2015\_1207.jpg

LM Start	<b>3.89</b>	Rating **	M	Issue No.	<b>759</b>
LM End	<b>3.89</b>	Issue Type +	En	Location *	LS
Category	Supplemental			GPS Latitude/Longitude	
				Start	End
Item	DWR UCIP Field Study			38.586479 °	38.586479 °
				-121.447574 °	-121.447574 °
DWR ID					
Action/Comments					
Inspector Comments: FS_ID:29054 DS_ID:24337 EP_NO: N/A FS_HLM: 3.865 Repair Type: Non-Urgent Crossing Status: Found UCIP Comments: Unknown owner--Need to coordinate with DWR Inspector and CVFPB. FIELD_STRUCT_DESC: 3-inch PVC conduit through levee, 2.0 feet below the crown. FS Date: 12/13/2013

View of landward side.

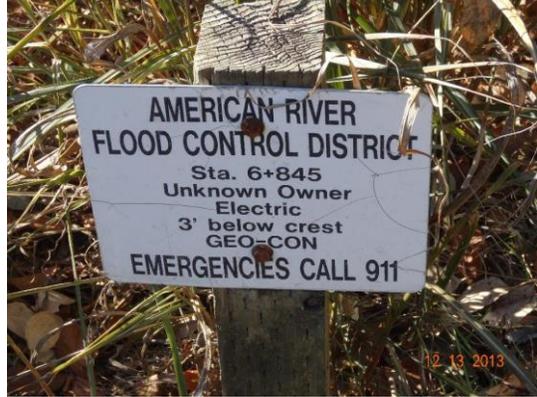
Photo 2 of 3 : UCIP\_FA\_2015\_1208.jpg

Electrical conduit marker located on landward toe.

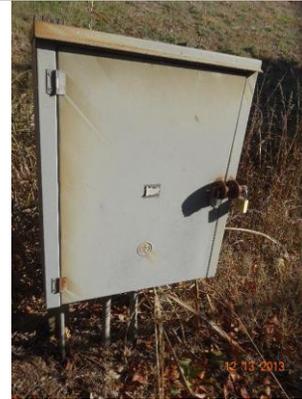
Photo 3 of 3 : UCIP\_FA\_2015\_3106.jpg

Control box located on landward toe.

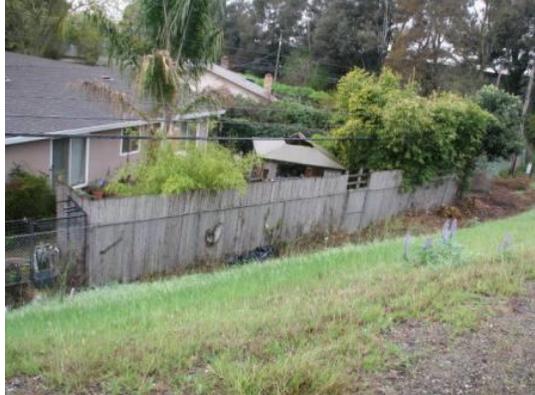
Photo 1 of 2 : FA\_2015\_NA0001\_55\_8\_20150910\_00008.jpg

LM Start	<b>3.90</b>	Rating **	U	Issue No.	<b>8</b>
LM End	<b>3.90</b>	Issue Type +	En	Location *	LS
Category	Earthen Levee		GPS Latitude/Longitude		
			Start	End	
Item	Encroachments		38.586327 °	38.586327 °	
			-121.447373 °	-121.447373 °	
DWR ID	DWR_NA0001_04_s_2012_8				
Action/Comments					
Fence Inspector Comments: Bamboo privacy fence within 10-ft of the landside toe obstructs visibility.

03/16/2012 Wood privacy fence completely obstructs access and visibility.

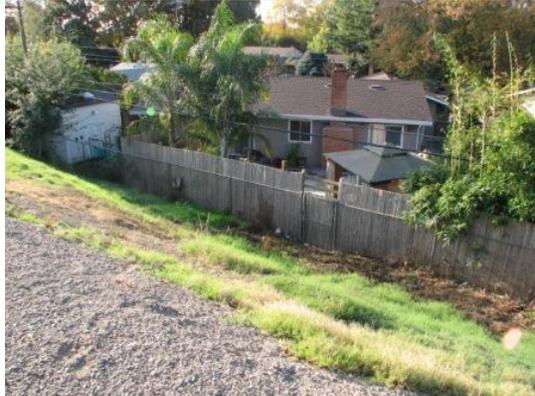
Photo 2 of 2 : FA\_2015\_NA0001\_55\_8\_20150910\_00009.jpg

Fall 2009 photo: Fence and landscaping within 10-ft of levee toe obstructs access and visibility.

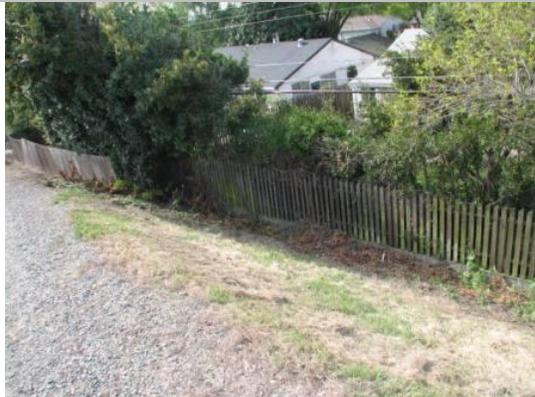
Photo 1 of 1 : FA\_2015\_NA0001\_55\_6\_20150910\_00006.jpg

LM Start	<b>3.92</b>	Rating **	U	Issue No.	<b>6</b>
LM End	<b>3.92</b>	Issue Type +	En	Location *	LS
Category	Earthen Levee		GPS Latitude/Longitude		
			Start	End	
Item	Encroachments		38.586154 °	38.586154 °	
			-121.447115 °	-121.447115 °	
DWR ID	DWR_NA0001_04_s_2012_6				
Action/Comments					
Fence Inspector Comments: Privacy fence within 10-ft of the landside toe obstructs visibility. 04/14/2011 Landscaping has been removed.

04/14/2011 Landscaping, which was a Fall inspection issue has been removed, however wooden fence is still obstructing access and visibility.

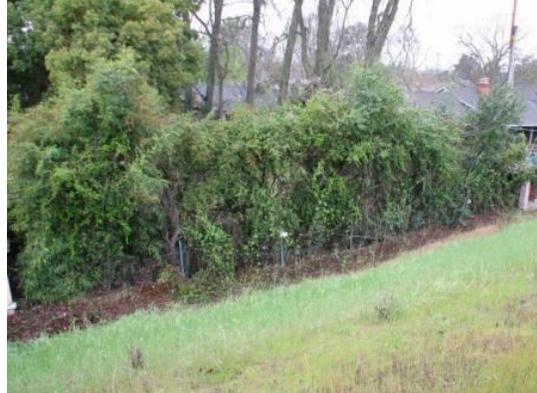
Photo 1 of 1 : FA\_2015\_NA0001\_55\_112\_20150910\_00095.jpg

LM Start	<b>3.99</b>	Rating **	U	Issue No.	<b>112</b>
LM End	<b>3.99</b>	Issue Type +	En	Location *	LS
Category	Earthen Levee		GPS Latitude/Longitude		
			Start	End	
Item	Vegetation		38.585385 °	38.585385 °	
			-121.446168 °	-121.446168 °	
DWR ID	DWR_NA0001_04_s_2012_112				
Action/Comments					
Landscaping Inspector Comments: Landscaping completely blocks visibility.

03/16/2012 Landscape obstructs visibility and access.

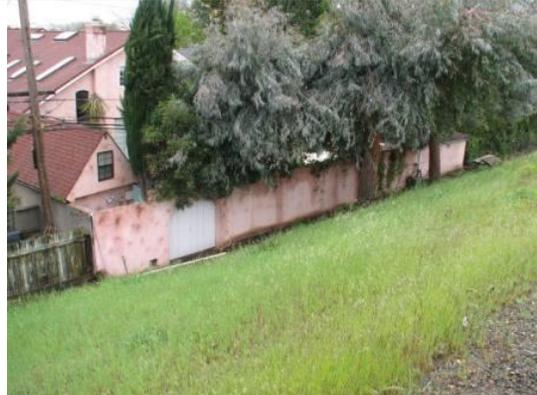
Photo 1 of 1 : FA\_2015\_NA0001\_55\_13\_20150910\_00013.jpg

LM Start	<b>4.00</b>	Rating **	U	Issue No.	<b>13</b>
LM End	<b>4.00</b>	Issue Type +	En	Location *	LS
Category	Earthen Levee		GPS Latitude/Longitude		
			Start	End	
Item	Encroachments		38.585325 °	38.585325 °	
			-121.446059 °	-121.446059 °	
DWR ID	DWR_NA0001_04_s_2012_13				
Action/Comments					
Fence Inspector Comments: Pink cement block fence obstructs access and visibility.

03/16/2012 Concrete wall obstructs access and visibility.

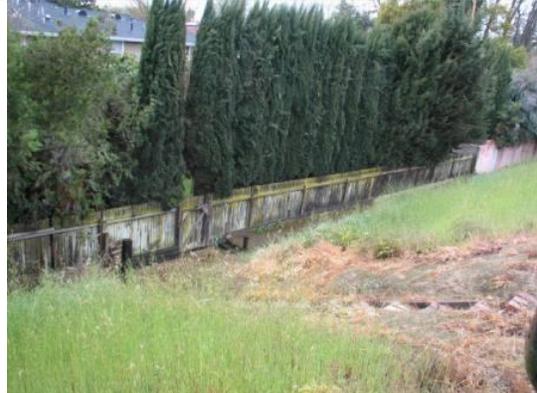
Photo 1 of 1 : FA\_2015\_NA0001\_55\_14\_20150910\_00014.jpg

LM Start	<b>4.02</b>	Rating **	U	Issue No.	<b>14</b>
LM End	<b>4.02</b>	Issue Type +	En	Location *	LS
Category	Earthen Levee		GPS Latitude/Longitude		
			Start	End	
Item	Encroachments		38.585175 °	38.585175 °	
			-121.445883 °	-121.445883 °	
DWR ID	DWR_NA0001_04_s_2012_14				
Action/Comments					
Fence Inspector Comments: Privacy fence and helix pencil shrubs planted within 10-ft of the levee toe obstruct access and visibility.

03/16/2012 Wood privacy fence completely obstructs access and visibility.

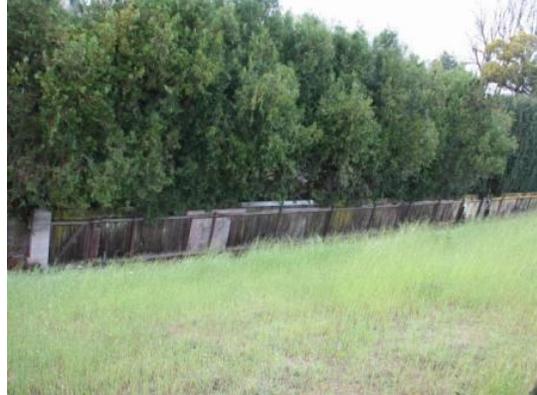
Photo 1 of 1 : FA\_2015\_NA0001\_55\_15\_20150910\_00015.jpg

LM Start	<b>4.03</b>	Rating **	U	Issue No.	<b>15</b>
LM End	<b>4.03</b>	Issue Type +	En	Location *	LS
Category	Earthen Levee		GPS Latitude/Longitude		
			Start	End	
Item	Encroachments		38.585021 °	38.585021 °	
			-121.445678 °	-121.445678 °	
DWR ID	DWR_NA0001_04_s_2012_15				
Action/Comments					
Fence Inspector Comments: Privacy fence and evergreen shrub landscaping within 10-ft of the levee toe obstruct access and visibility.

03/16/2012 Wood privacy fence completely obstructs access and visibility.

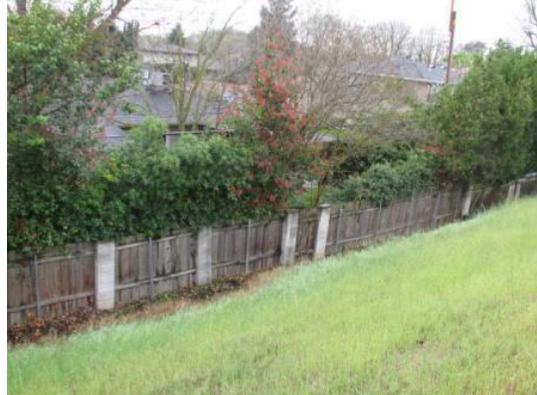
Photo 1 of 1 : FA\_2015\_NA0001\_55\_16\_20150910\_00016.jpg

LM Start	<b>4.04</b>	Rating **	U	Issue No.	<b>16</b>
LM End	<b>4.04</b>	Issue Type +	En	Location *	LS
Category	Earthen Levee		GPS Latitude/Longitude		
			Start	End	
Item	Encroachments		38.584885 °	38.584885 °	
			-121.445520 °	-121.445520 °	
DWR ID	DWR_NA0001_04_s_2012_16				
Action/Comments					
Fence Inspector Comments: Privacy fence and landscaping within 10-ft of the levee toe obstruct access and visibility.

03/16/2012 Wood privacy fence completely obstructs access and visibility.

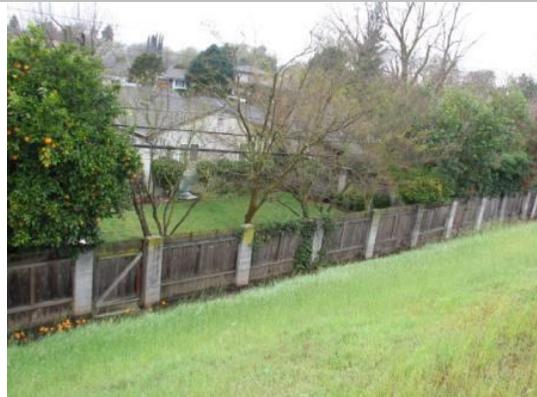
Photo 1 of 1 : FA\_2015\_NA0001\_55\_17\_20150910\_00017.jpg

LM Start	<b>4.05</b>	Rating **	U	Issue No.	<b>17</b>
LM End	<b>4.05</b>	Issue Type +	En	Location *	LS
Category	Earthen Levee		GPS Latitude/Longitude		
			Start	End	
Item	Encroachments		38.584810 °	38.584810 °	
			-121.445403 °	-121.445403 °	
DWR ID	DWR_NA0001_04_s_2012_17				
Action/Comments					
Fence Inspector Comments: Privacy fence and maple tree landscaping within 10-ft of the levee toe obstruct access and visibility.

03/16/2012 Wood privacy fence completely obstructs access and visibility.

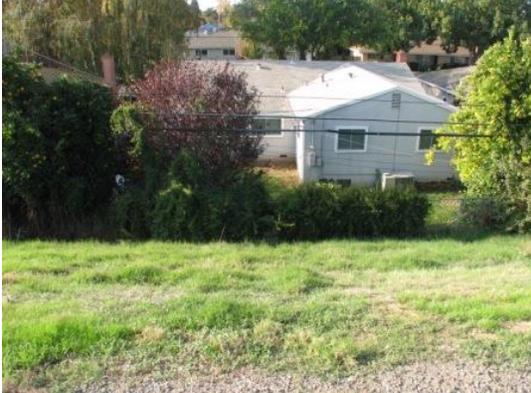
Photo 1 of 1 : FA\_2015\_NA0001\_55\_186\_20150910\_00159.jpg

LM Start	<b>4.10</b>	Rating **	M	Issue No.	<b>186</b>
LM End	<b>4.10</b>	Issue Type +	En	Location *	LS
Category	Earthen Levee		GPS Latitude/Longitude		
			Start	End	
Item	Vegetation		38.584354 °	38.584354 °	
			-121.444792 °	-121.444792 °	
DWR ID	DWR_NA0001_04_s_2012_186				
Action/Comments					
Landscaping Inspector Comments: Landscaping on cyclone fence within 10-ft of levee toe obstructs access and visibility.

Fall 2009 photo: Landscaping within 10-ft of levee toe obstructs access and visibility.

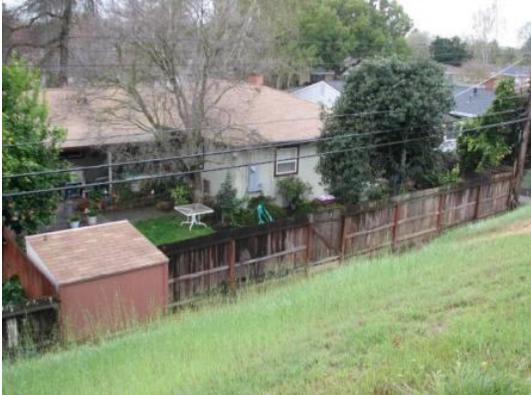
Photo 1 of 1 : FA\_2015\_NA0001\_55\_20\_20150910\_00020.jpg

LM Start	<b>4.11</b>	Rating **	U	Issue No.	<b>20</b>
LM End	<b>4.11</b>	Issue Type +	En	Location *	LS
Category	Earthen Levee		GPS Latitude/Longitude		
			Start	End	
Item	Encroachments		38.584243 °	38.584243 °	
			-121.444647 °	-121.444647 °	
DWR ID	DWR_NA0001_04_s_2012_20				
Action/Comments					
Fence Inspector Comments: Privacy fence and shed within 10-ft of the levee toe obstruct access and visibility.

03/16/2012 Wood privacy fence completely obstructs access and visibility.

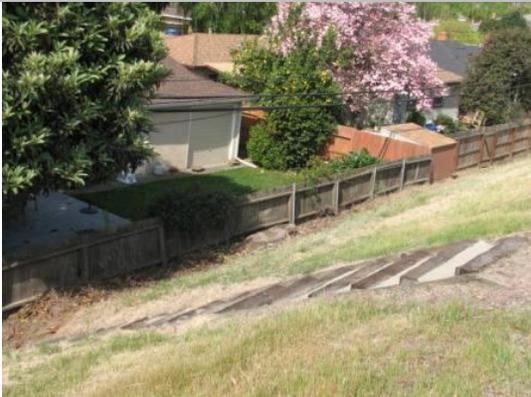
Photo 1 of 1 : FA\_2015\_NA0001\_55\_21\_20150910\_00021.jpg

LM Start	<b>4.12</b>	Rating **	U	Issue No.	<b>21</b>
LM End	<b>4.12</b>	Issue Type +	En	Location *	LS
Category	Earthen Levee		GPS Latitude/Longitude		
			Start	End	
Item	Vegetation		38.584129 °	38.584129 °	
			-121.444485 °	-121.444485 °	
DWR ID	DWR_NA0001_04_s_2012_21				
Action/Comments					
Landscaping Inspector Comments: Palms and other landscaping on levee slope, as well as the wooden privacy fence within 10-ft of the levee toe obstruct access and visibility. 04/14/2011 Palms have been removed.

04/14/2011 Palms have been removed.

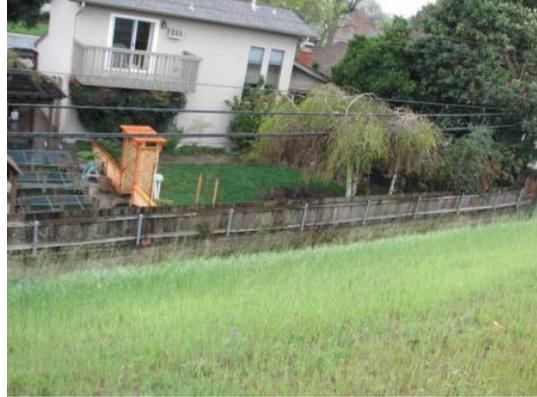
Photo 1 of 1 : FA\_2015\_NA0001\_55\_22\_20150910\_00022.jpg

LM Start	<b>4.13</b>	Rating **	U	Issue No.	<b>22</b>
LM End	<b>4.13</b>	Issue Type +	En	Location *	LS
Category	Earthen Levee		GPS Latitude/Longitude		
			Start	End	
Item	Encroachments		38.584034 °	38.584034 °	
			-121.444322 °	-121.444322 °	
DWR ID	DWR_NA0001_04_s_2012_22				
Action/Comments					
Fence Inspector Comments: Cement block and wooden fence as well as the landscape planting are within 10-ft of the levee slope and obstruct access and visibility.

03/16/2012 Wood privacy fence completely obstructs access and visibility.

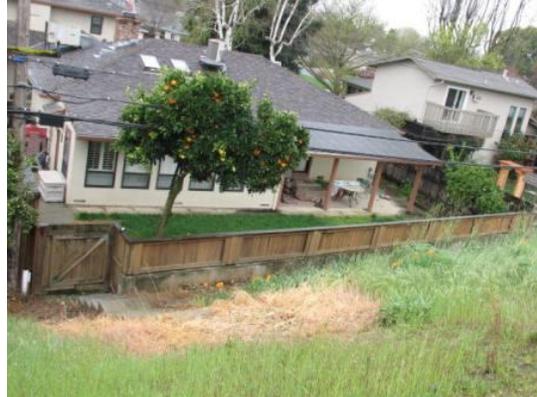
Photo 1 of 1 : FA\_2015\_NA0001\_55\_23\_20150910\_00023.jpg

LM Start	<b>4.14</b>	Rating **	U	Issue No.	<b>23</b>
LM End	<b>4.14</b>	Issue Type +	En	Location *	LS
Category	Earthen Levee		GPS Latitude/Longitude		
			Start	End	
Item	Encroachments		38.583935 °	38.583935 °	
			-121.444150 °	-121.444150 °	
DWR ID	DWR_NA0001_04_s_2012_23				
Action/Comments					
Fence Inspector Comments: Cement block and wooden fence obstruct visibility.

03/16/2012 Wooden fence on cement wall obstructs access and visibility.

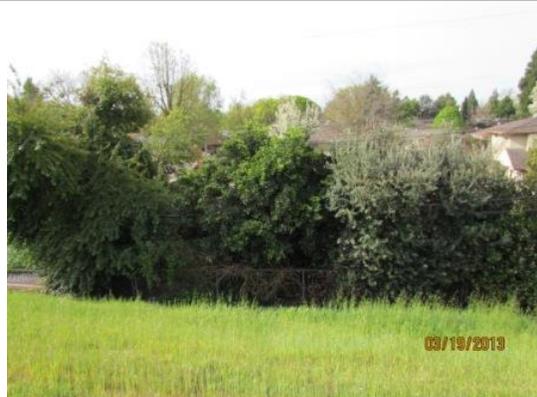
Photo 1 of 1 : FA\_2015\_NA0001\_55\_187\_20150910\_00160.jpg

LM Start	<b>4.15</b>	Rating **	M	Issue No.	<b>187</b>
LM End	<b>4.15</b>	Issue Type +	En	Location *	LS
Category	Earthen Levee		GPS Latitude/Longitude		
			Start	End	
Item	Vegetation		38.583858 °	38.583858 °	
			-121.443981 °	-121.443981 °	
DWR ID	DWR_NA0001_04_s_2012_187				
Action/Comments					
Landscaping Inspector Comments: Orange, guava and other trees and landscaping obstruct access and visibility.

View of the obstructing vegetation at levee toe.

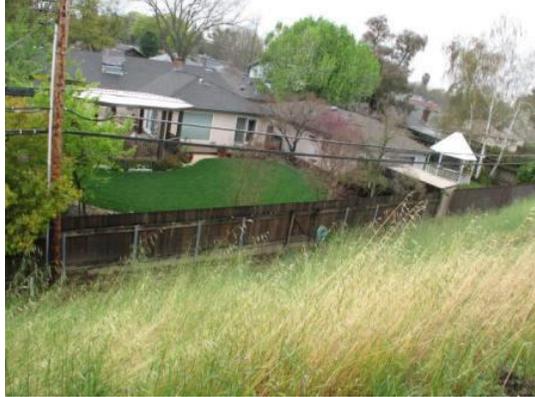
Photo 1 of 1 : FA\_2015\_NA0001\_55\_191\_20150910\_00162.jpg

LM Start	<b>4.21</b>	Rating **	U	Issue No.	<b>191</b>
LM End	<b>4.21</b>	Issue Type +	En	Location *	LS
Category	Earthen Levee		GPS Latitude/Longitude		
			Start	End	
Item	Encroachments		38.583355 °	38.583355 °	
			-121.443123 °	-121.443123 °	
DWR ID	DWR_NA0001_04_s_2012_191				
Action/Comments					
Fence Inspector Comments: Wooden privacy fence within 10-ft of the levee toe obstruct access and visibility.

03/16/2012 Wood privacy fence completely obstructs access and visibility.

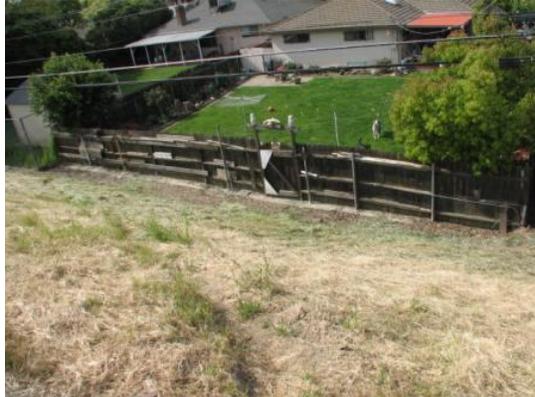
Photo 1 of 1 : FA\_2015\_NA0001\_55\_24\_20150910\_00024.jpg

LM Start	<b>4.22</b>	Rating **	U	Issue No.	<b>24</b>
LM End	<b>4.22</b>	Issue Type +	En	Location *	LS
Category	Earthen Levee		GPS Latitude/Longitude		
			Start	End	
Item	Encroachments		38.583265 °	38.583265 °	
			-121.442965 °	-121.442965 °	
DWR ID	DWR_NA0001_04_s_2012_24				
Action/Comments					
Fence Inspector Comments: Wooden privacy fence obstructs visibility. Retaining wall built into levee toe. 04/14/2011 retaining wall removed.

04/14/2011 Retaining wall has been removed. Wooden fence remains and is obstructing access and visibility.

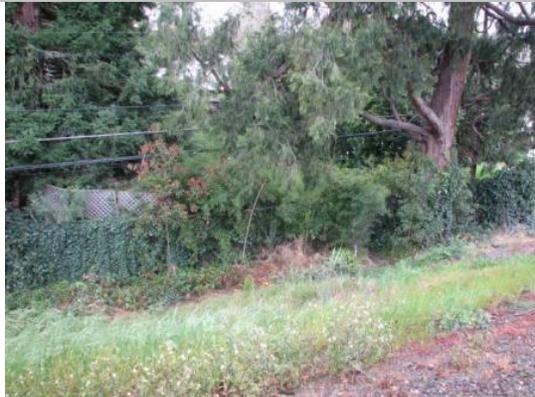
Photo 1 of 1 : FA\_2015\_NA0001\_55\_192\_20150910\_00163.jpg

LM Start	<b>4.25</b>	Rating **	U	Issue No.	<b>192</b>
LM End	<b>4.25</b>	Issue Type +	En	Location *	LS
Category	Earthen Levee		GPS Latitude/Longitude		
			Start	End	
Item	Vegetation		38.583031 °	38.583031 °	
			-121.442620 °	-121.442620 °	
DWR ID	DWR_NA0001_04_s_2012_192				
Action/Comments					
Landscaping Inspector Comments: Ivy and vine growth on cyclone fence obstruct visibility. Steps and landscaping built up levee slope.

03/16/2012 Landscaping on fence obstructs visibility and access.

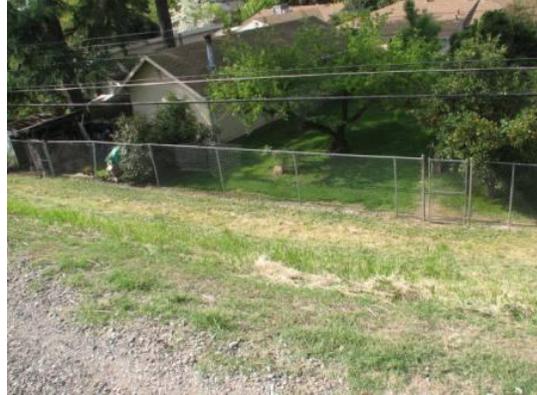
Photo 1 of 1 : FA\_2015\_NA0001\_55\_194\_20150910\_00164.jpg

LM Start	<b>4.28</b>	Rating **	M	Issue No.	<b>194</b>
LM End	<b>4.28</b>	Issue Type +	En	Location *	LS
Category	Earthen Levee			GPS Latitude/Longitude	
				Start	End
Item	Encroachments			38.582716 °	38.582716 °
				-121.442128 °	-121.442128 °
DWR ID	DWR_NA0001_04_s_2012_194				
Action/Comments					
Fence Inspector Comments: Planting boxes built into levee slope. 04/14/2011 Planter boxes removed. Chainlink fence partially obstructs access.

04/14/2011 Planter boxes have been removed. Chainlink fence partially blocks access.

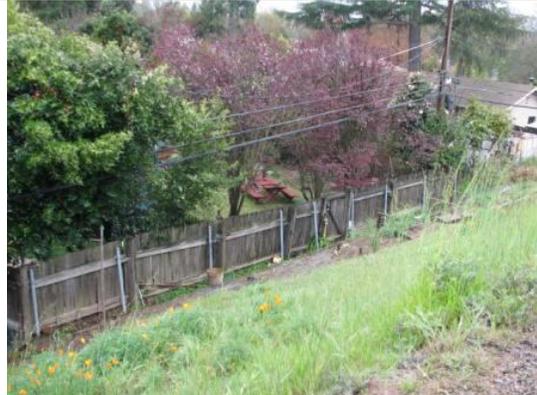
Photo 1 of 1 : FA\_2015\_NA0001\_55\_26\_20150910\_00025.jpg

LM Start	<b>4.31</b>	Rating **	U	Issue No.	<b>26</b>
LM End	<b>4.31</b>	Issue Type +	En	Location *	LS
Category	Earthen Levee			GPS Latitude/Longitude	
				Start	End
Item	Encroachments			38.582479 °	38.582479 °
				-121.441768 °	-121.441768 °
DWR ID	DWR_NA0001_04_s_2012_26				
Action/Comments					
Fence Inspector Comments: Wooden fence within 10-ft of the levee toe. Garden and ramp built on levee slope.

03/16/2012 Wood privacy fence completely obstructs access and visibility.

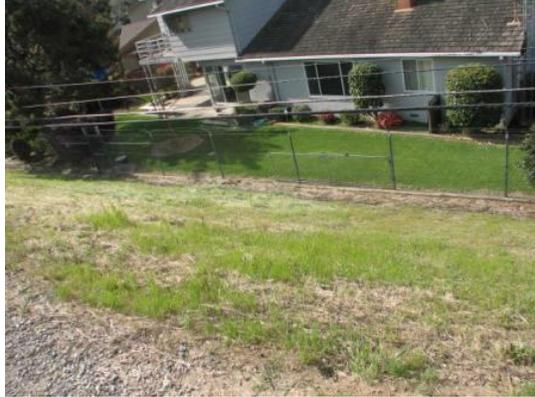
Photo 1 of 1 : FA\_2015\_NA0001\_55\_195\_20150910\_00165.jpg

LM Start	<b>4.32</b>	Rating **	M	Issue No.	<b>195</b>
LM End	<b>4.32</b>	Issue Type +	En	Location *	LS
Category	Earthen Levee		GPS Latitude/Longitude		
			Start	End	
Item	Encroachments		38.582333 °	38.582333 °	
			-121.441506 °	-121.441506 °	
DWR ID	DWR_NA0001_04_s_2012_195				
Action/Comments					
Fence Inspector Comments: Landscaping planted on levee slope. 04/14/2011 Landscaping removed, chainlink fence remains.

04/14/2011 Landscape removed, chainlink fence remains.

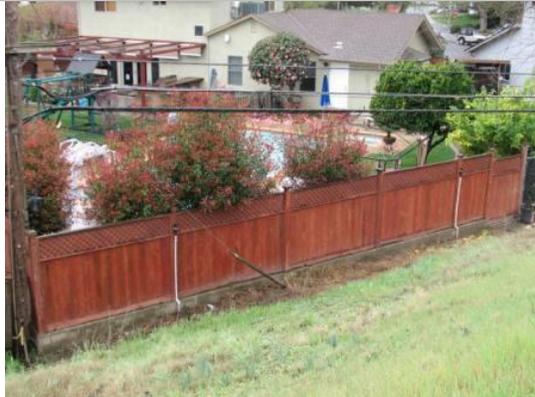
Photo 1 of 1 : FA\_2015\_NA0001\_55\_27\_20150910\_00026.jpg

LM Start	<b>4.34</b>	Rating **	U	Issue No.	<b>27</b>
LM End	<b>4.34</b>	Issue Type +	En	Location *	LS
Category	Earthen Levee		GPS Latitude/Longitude		
			Start	End	
Item	Encroachments		38.582223 °	38.582223 °	
			-121.441264 °	-121.441264 °	
DWR ID	DWR_NA0001_04_s_2012_27				
Action/Comments					
Fence Inspector Comments: Wooden privacy fence obstructs visibility.

03/16/2012 Wood privacy fence completely obstructs access and visibility.

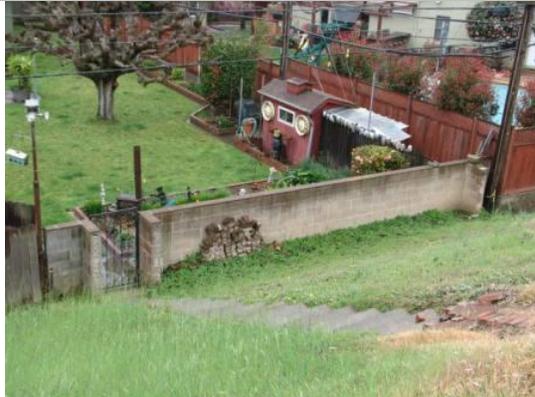
Photo 1 of 1 : FA\_2015\_NA0001\_55\_28\_20150910\_00027.jpg

LM Start	<b>4.35</b>	Rating **	U	Issue No.	<b>28</b>
LM End	<b>4.35</b>	Issue Type +	En	Location *	LS
Category	Earthen Levee		GPS Latitude/Longitude		
			Start	End	
Item	Encroachments		38.582186 °	38.582186 °	
			-121.441160 °	-121.441160 °	
DWR ID	DWR_NA0001_04_s_2012_28				
Action/Comments					
Fence Inspector Comments: Cement block fence obstructs access and visibility.

03/16/2012 Cinder block wall obstructs visibility and access.

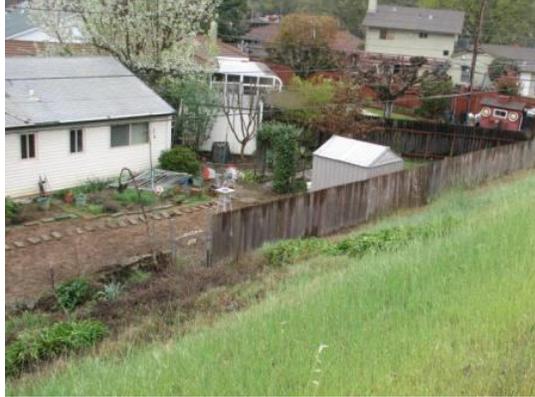
Photo 1 of 1 : FA\_2015\_NA0001\_55\_29\_20150910\_00028.jpg

LM Start	<b>4.36</b>	Rating **	M	Issue No.	<b>29</b>
LM End	<b>4.36</b>	Issue Type +	En	Location *	LS
Category	Earthen Levee		GPS Latitude/Longitude		
			Start	End	
Item	Encroachments		38.582083 °	38.582083 °	
			-121.440875 °	-121.440875 °	
DWR ID	DWR_NA0001_04_s_2012_29				
Action/Comments					
Fence Inspector Comments: Large flowering bush on levee slope - removed by ARFCD 2012. Retaining wall removed by ARFCD 2012. Wooden fence located at the levee toe obstructs access and visibility. 04/14/2011

03/16/2012 Flowering bush is dormant, landscaping on levee slope and wooden privacy fence.

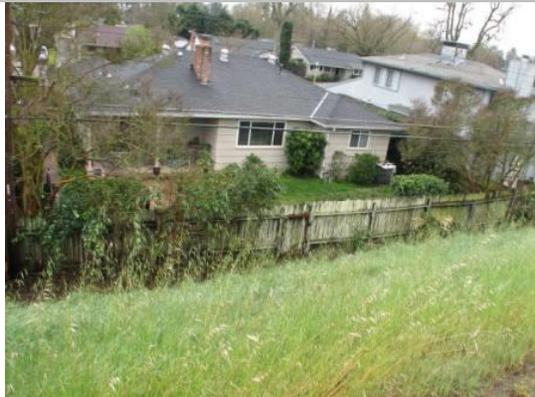
Photo 1 of 1 : FA\_2015\_NA0001\_55\_198\_20150910\_00167.jpg

LM Start	<b>4.41</b>	Rating **	U	Issue No.	<b>198</b>
LM End	<b>4.41</b>	Issue Type +	En	Location *	LS
Category	Earthen Levee		GPS Latitude/Longitude		
			Start	End	
Item	Encroachments		38.581788 °	38.581788 °	
			-121.440086 °	-121.440086 °	
DWR ID	DWR_NA0001_04_s_2012_198				
Action/Comments					
Fence Inspector Comments: Privacy fence and landscaping within 10-ft of the levee toe obstruct access and visibility.

03/16/2012 Wood privacy fence completely obstructs access and visibility.
