**Flood Control Project Maintenance  
Levee Inspections**

**Fall 2015 Levee Maintenance Deficiency Summary Report**

**Sacramento River Basin**

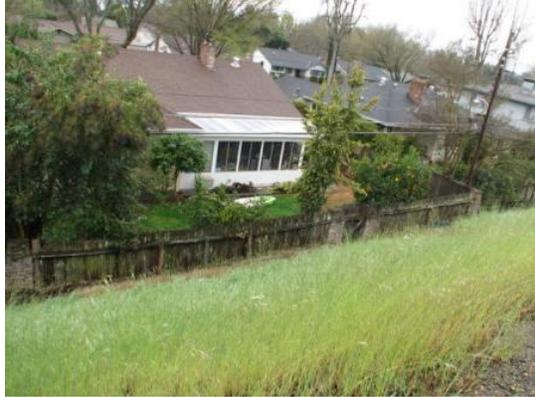
Photo 1 of 1 : FA\_2015\_NA0001\_55\_30\_20150910\_00029.jpg

LM Start	<b>4.42</b>	Rating **	U	Issue No.	<b>30</b>
LM End	<b>4.42</b>	Issue Type +	En	Location *	LS
Category	Earthen Levee		GPS Latitude/Longitude		
			Start	End	
Item	Encroachments		38.581724 °	38.581724 °	
			-121.439891 °	-121.439891 °	
DWR ID	DWR_NA0001_04_s_2012_30				
Action/Comments					
Fence Inspector Comments: Privacy fence and landscaping within 10-ft of the levee toe obstruct access and visibility.

03/16/2012 Wood privacy fence completely obstructs access and visibility.

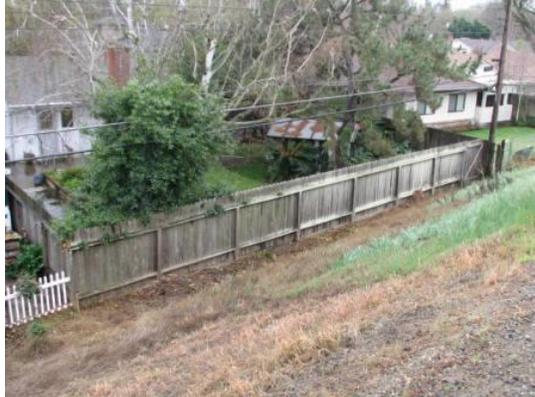
Photo 1 of 1 : FA\_2015\_NA0001\_55\_31\_20150910\_00030.jpg

LM Start	<b>4.47</b>	Rating **	U	Issue No.	<b>31</b>
LM End	<b>4.47</b>	Issue Type +	En	Location *	LS
Category	Earthen Levee		GPS Latitude/Longitude		
			Start	End	
Item	Encroachments		38.581495 °	38.581495 °	
			-121.439129 °	-121.439129 °	
DWR ID	DWR_NA0001_04_s_2012_31				
Action/Comments					
Fence Inspector Comments: Privacy fence within 10-ft of the levee toe obstructs access and visibility.

03/16/2012 Wood privacy fence completely obstructs access and visibility.

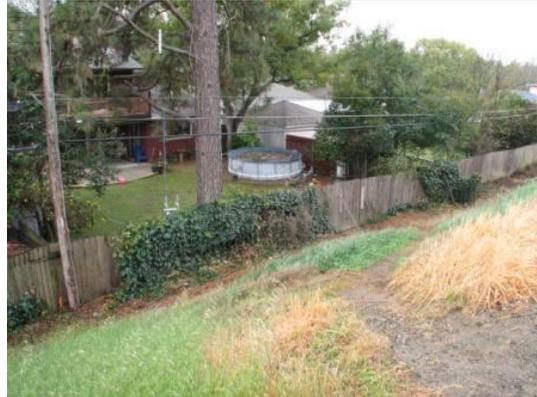
Photo 1 of 1 : FA\_2015\_NA0001\_55\_199\_20150910\_00168.jpg

LM Start	<b>4.54</b>	Rating **	U	Issue No.	<b>199</b>
LM End	<b>4.54</b>	Issue Type +	En	Location *	LS
Category	Earthen Levee		GPS Latitude/Longitude		
			Start	End	
Item	Encroachments		38.581205 °	38.581205 °	
			-121.437830 °	-121.437830 °	
DWR ID	DWR_NA0001_04_s_2012_199				
Action/Comments					
Fence Inspector Comments: Wooden fence is within 10-ft of the levee toe.

03/16/2012 Wood privacy fence completely obstructs access and visibility.

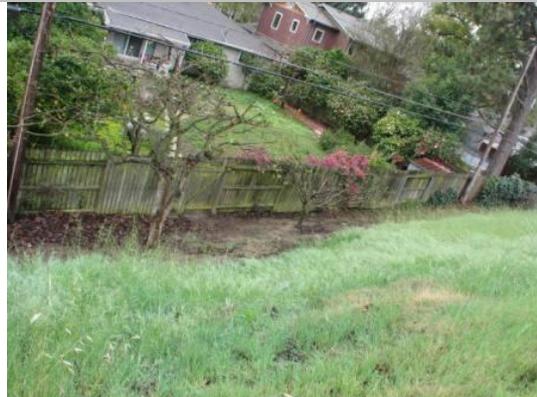
Photo 1 of 1 : FA\_2015\_NA0001\_55\_200\_20150910\_00169.jpg

LM Start	<b>4.55</b>	Rating **	U	Issue No.	<b>200</b>
LM End	<b>4.55</b>	Issue Type +	En	Location *	LS
Category	Earthen Levee		GPS Latitude/Longitude		
			Start	End	
Item	Encroachments		38.581178 °	38.581178 °	
			-121.437584 °	-121.437584 °	
DWR ID	DWR_NA0001_04_s_2012_200				
Action/Comments					
Fence Inspector Comments: Privacy fence, persimmon tree and landscaping within 10-ft of the levee toe obstruct access and visibility.

03/16/2012 Wood privacy fence completely obstructs access and visibility.

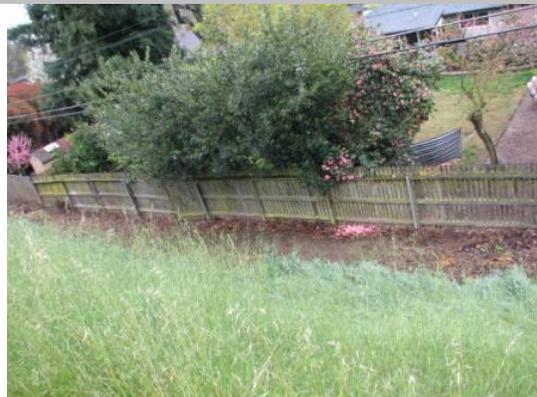
Photo 1 of 1 : FA\_2015\_NA0001\_55\_201\_20150910\_00170.jpg

LM Start	<b>4.57</b>	Rating **	U	Issue No.	<b>201</b>
LM End	<b>4.57</b>	Issue Type +	En	Location *	LS
Category	Earthen Levee		GPS Latitude/Longitude		
			Start	End	
Item	Encroachments		38.581155 °	38.581155 °	
			-121.437320 °	-121.437320 °	
DWR ID	DWR_NA0001_04_s_2012_201				
Action/Comments					
Fence Inspector Comments: Privacy fence within 10-ft of the levee toe obstruct access and visibility.

03/16/2012 Wood privacy fence completely obstructs access and visibility.

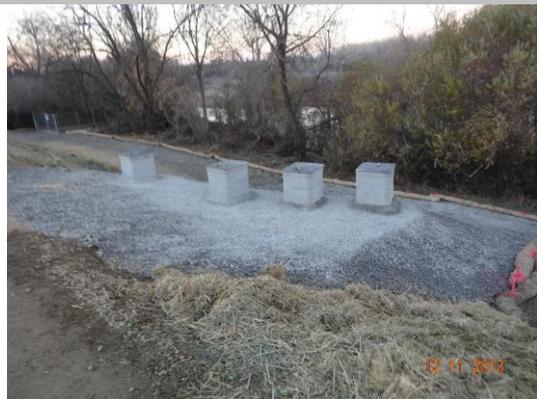
Photo 1 of 3 : UCIP\_FA\_2015\_4598.jpg

LM Start	<b>4.61</b>	Rating **	M	Issue No.	<b>760</b>
LM End	<b>4.61</b>	Issue Type +	En	Location *	LS
Category	Supplemental		GPS Latitude/Longitude		
			Start	End	
Item	DWR UCIP Field Study		38.581101 °	38.581101 °	
			-121.436502 °	-121.436502 °	
DWR ID					
Action/Comments					
Inspector Comments: FS_ID:31446 DS_ID:24808 EP_NO: N/A FS_HLM: 4.611 Repair Type: Non-Urgent Crossing Status: Indicator Found UCIP Comments: New construction--need permit and details on crossing. FIELD_STRUCT_DESC: 1 of 4: Concrete service box located on waterward shoulder. Landward side has been regraded. No permit was found for the work. Unable to verify if crossing crosses levee. FS Date: 12/13/2013

Service boxes located on waterward shoulder.

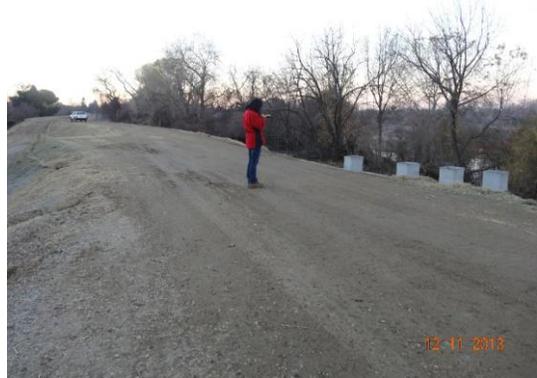
Photo 2 of 3 : UCIP\_FA\_2015\_4599.jpg

**Action/Comments**  
 Inspector Comments: FS\_ID:31446  
 DS\_ID:24808  
 EP\_NO: N/A  
 FS\_HLM: 4.611  
 Repair Type: Non-Urgent  
 Crossing Status: Indicator Found  
 UCIP Comments: New construction--need permit and details on crossing.  
 FIELD\_STRUCT\_DESC: 1 of 4: Concrete service box located on waterward shoulder. Landward side has been regraded. No permit was found for the work. Unable to verify if crossing crosses levee.  
 FS Date: 12/13/2013

View of regraded levee crown with service boxes on waterward slope.

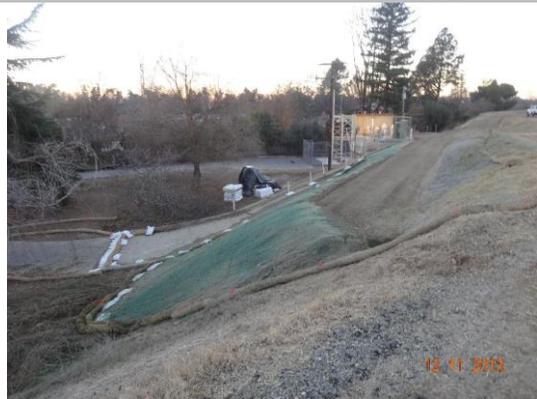
Photo 3 of 3 : UCIP\_FA\_2015\_4600.jpg

View of landward side.

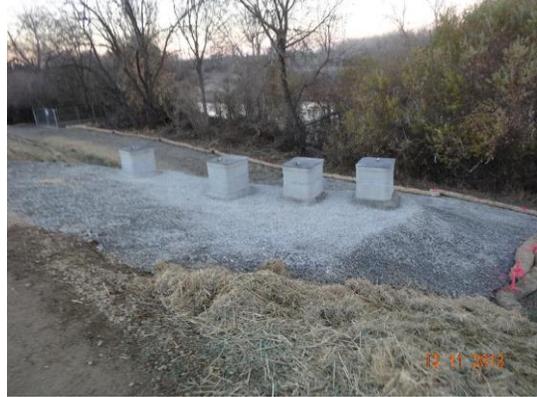
Photo 1 of 3 : UCIP\_FA\_2015\_4126.jpg

LM Start	<b>4.61</b>	Rating **	M	Issue No.	<b>761</b>
LM End	<b>4.61</b>	Issue Type +	En	Location *	LS
Category	Supplemental			GPS Latitude/Longitude	
				Start	End
Item	DWR UCIP Field Study			38.581092 °	38.581092 °
				-121.436466 °	-121.436466 °
DWR ID					
Action/Comments					
Inspector Comments: FS_ID:31447 DS_ID:24809 EP_NO: N/A FS_HLM: 4.612 Repair Type: Non-Urgent Crossing Status: Indicator Found

View of waterward side.

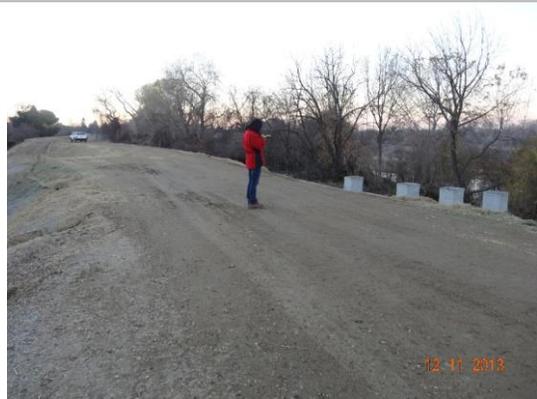
Photo 2 of 3 : UCIP\_FA\_2015\_4127.jpg

View of levee crown at crossings.

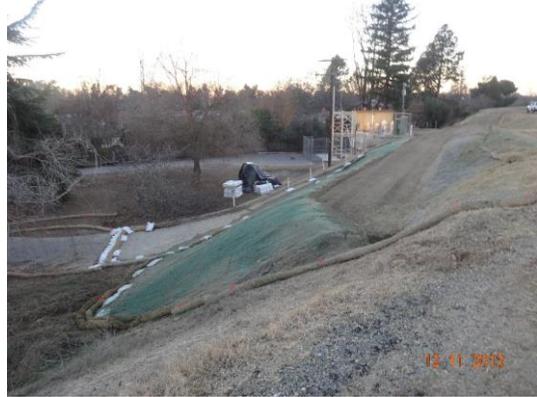
Photo 3 of 3 : UCIP\_FA\_2015\_4128.jpg

LM Start	<b>4.61</b>	Rating **	M	Issue No.	<b>761 (cont)</b>
LM End	<b>4.61</b>	Issue Type +	En	Location *	LS
Category	Supplemental			GPS Latitude/Longitude	
				Start	End
Item	DWR UCIP Field Study			38.581092 °	38.581092 °
				-121.436466 °	-121.436466 °
DWR ID					
Action/Comments					
Inspector Comments: FS_ID:31447 DS_ID:24809 EP_NO: N/A FS_HLM: 4.612 Repair Type: Non-Urgent Crossing Status: Indicator Found

View of landward side.

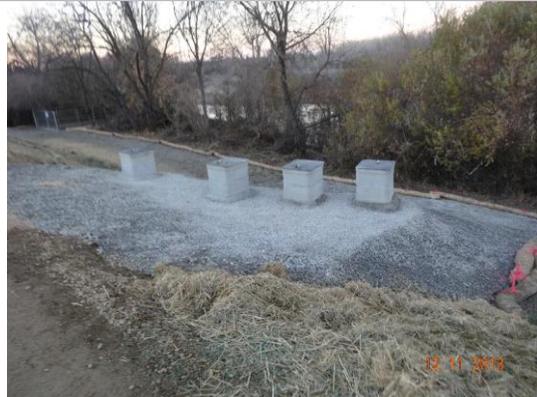
Photo 1 of 3 : UCIP\_FA\_2015\_4129.jpg

LM Start	<b>4.61</b>	Rating **	M	Issue No.	<b>762</b>
LM End	<b>4.61</b>	Issue Type +	En	Location *	LS
Category	Supplemental			GPS Latitude/Longitude	
				Start	End
Item	DWR UCIP Field Study			38.581087 °	38.581087 °
				-121.436449 °	-121.436449 °
DWR ID					
Action/Comments					
Inspector Comments: FS_ID:31448 DS_ID:24810 EP_NO: N/A FS_HLM: 4.613 Repair Type: Non-Urgent Crossing Status: Indicator Found UCIP Comments: New construction; no permit found; Need additional information about crossings to determine whether crossings penetrate levee. FIELD_STRUCT_DESC: 3 of 4: Concrete service box located on waterward shoulder. Landward side has been regraded. No permit was found for the work. Unable to verify if crossing crosses levee. FS Date: 12/13/2013

View of waterward side.

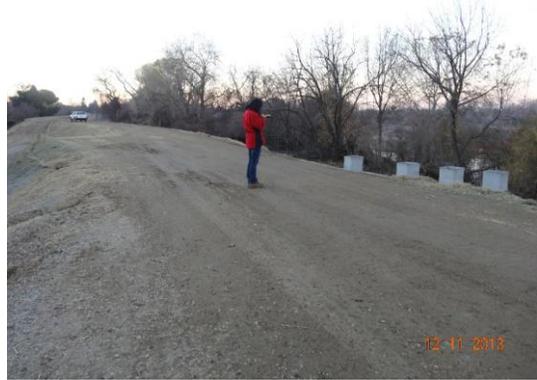
Photo 2 of 3 : UCIP\_FA\_2015\_4130.jpg

LM Start	4.61	Rating **	M	Issue No.	762 (cont)
LM End	4.61	Issue Type +	En	Location *	LS
Category	Supplemental			GPS Latitude/Longitude	
				Start	End
Item	DWR UCIP Field Study			38.581087 °	38.581087 °
				-121.436449 °	-121.436449 °
DWR ID					
Action/Comments					
Inspector Comments: FS_ID:31448 DS_ID:24810 EP_NO: N/A FS_HLM: 4.613 Repair Type: Non-Urgent Crossing Status: Indicator Found UCIP Comments: New construction; no permit found; Need additional information about crossings to determine whether crossings penetrate levee. FIELD_STRUCT_DESC: 3 of 4: Concrete service box located on waterward shoulder. Landward side has been regraded. No permit was found for the work. Unable to verify if crossing crosses levee. FS Date: 12/13/2013

View of levee crown.

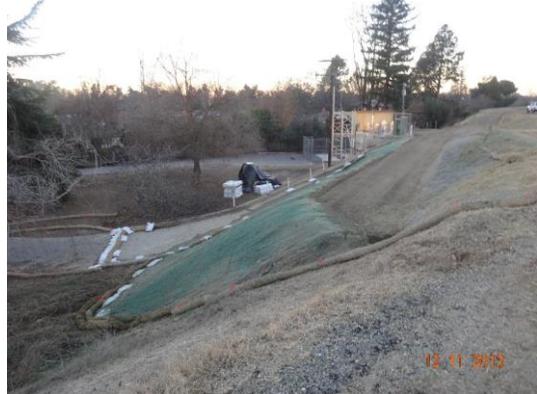
Photo 3 of 3 : UCIP\_FA\_2015\_4131.jpg

View of landward side.

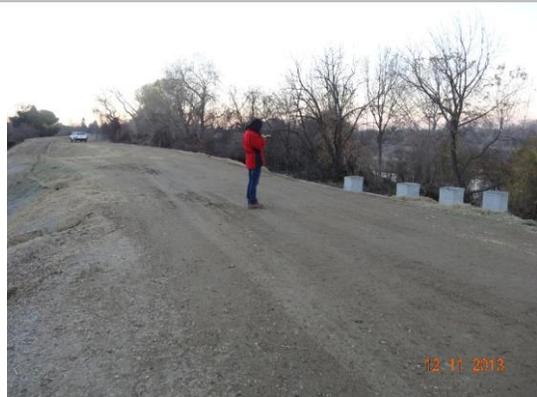
Photo 2 of 3 : UCIP\_FA\_2015\_4133.jpg

LM Start	<b>4.61</b>	Rating **	M	Issue No.	<b>763</b>
LM End	<b>4.61</b>	Issue Type +	En	Location *	LS
Category	Supplemental			GPS Latitude/Longitude	
				Start	End
Item	DWR UCIP Field Study			38.581082 °	38.581082 °
				-121.436431 °	-121.436431 °
DWR ID					
Action/Comments					
Inspector Comments: FS_ID:31449 DS_ID:24811 EP_NO: N/A FS_HLM: 4.614 Repair Type: Non-Urgent Crossing Status: Indicator Found

View of levee crown.

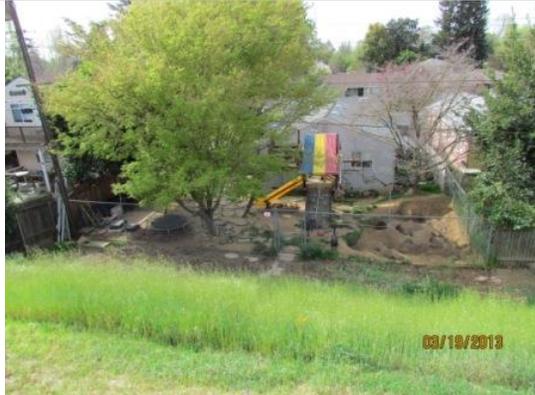
Photo 1 of 2 : FA\_2015\_NA0001\_55\_739\_20150910\_00192.jpg

LM Start	<b>4.72</b>	Rating **	M	Issue No.	<b>739</b>
LM End	<b>4.72</b>	Issue Type +	En	Location *	LS
Category	Earthen Levee			GPS Latitude/Longitude	
				Start	End
Item	Encroachments			38.580778 °	38.580778 °
				-121.434467 °	-121.434467 °
DWR ID	DWR_NA0001_04_s_2012_739				
Action/Comments					
Debris Inspector Comments: PVC pipe and debris, also noted in USACE PI.

View of the previously noted debris stored in the upstream corner of the property. Note extensive burrowing in the backyard on the downstream (right) corner of the property.

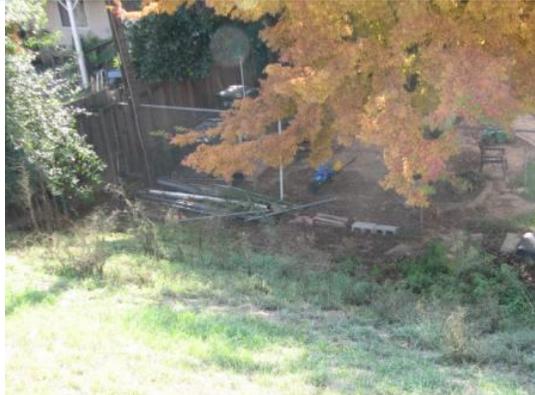
Photo 2 of 2 : FA\_2015\_NA0001\_55\_739\_20150910\_00193.jpg

11/15/2011 Debris on levee side of fence. This item was noted in the USACE PI.

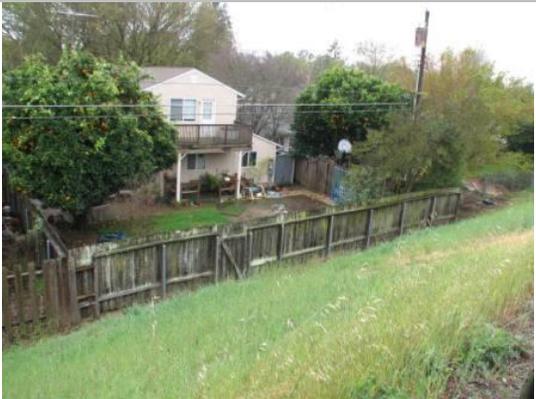
Photo 1 of 1 : FA\_2015\_NA0001\_55\_40\_20150910\_00032.jpg

LM Start	<b>4.73</b>	Rating **	U	Issue No.	<b>40</b>
LM End	<b>4.73</b>	Issue Type +	En	Location *	LS
Category	Earthen Levee		GPS Latitude/Longitude		
			Start	End	
Item	Encroachments		38.580759 °	38.580759 °	
			-121.434294 °	-121.434294 °	
DWR ID	DWR_NA0001_04_s_2012_40				
Action/Comments					
Fence Inspector Comments: Privacy fence within 10-ft of the levee toe obstruct access and visibility.

03/16/2012 Wood privacy fence completely obstructs access and visibility.

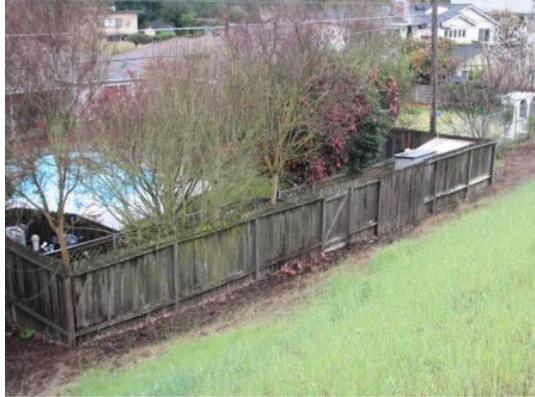
Photo 1 of 1 : FA\_2015\_NA0001\_55\_43\_20150910\_00034.jpg

LM Start	<b>4.78</b>	Rating **	U	Issue No.	<b>43</b>
LM End	<b>4.78</b>	Issue Type +	En	Location *	LS
Category	Earthen Levee		GPS Latitude/Longitude		
			Start	End	
Item	Encroachments		38.580731 °	38.580731 °	
			-121.433490 °	-121.433490 °	
DWR ID	DWR_NA0001_04_s_2012_43				
Action/Comments					
Fence Inspector Comments: Privacy fence and storage sheds within 10-ft of the levee toe obstruct access and visibility.

03/16/2012 Wood privacy fence completely obstructs access and visibility.

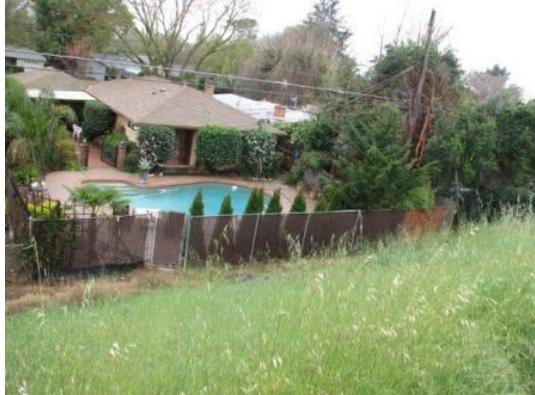
Photo 1 of 1 : FA\_2015\_NA0001\_55\_205\_20150910\_00172.jpg

LM Start	<b>4.83</b>	Rating **	U	Issue No.	<b>205</b>
LM End	<b>4.83</b>	Issue Type +	En	Location *	LS
Category	Earthen Levee		GPS Latitude/Longitude		
			Start	End	
Item	Encroachments		38.580723 °	38.580723 °	
			-121.432577 °	-121.432577 °	
DWR ID	DWR_NA0001_04_s_2012_205				
Action/Comments					
Fence Inspector Comments: Privacy fence and landscape prunings on levee slope and toe. prunings removed. Fence obstructs access and visibility.

03/16/2012 Chainlink fence with privacy slats obstructs visibility and access.

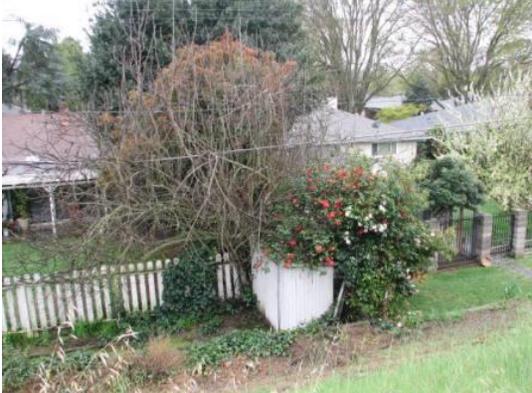
Photo 1 of 1 : FA\_2015\_NA0001\_55\_206\_20150910\_00173.jpg

LM Start	<b>4.87</b>	Rating **	U	Issue No.	<b>206</b>
LM End	<b>4.87</b>	Issue Type +	En	Location *	LS
Category	Earthen Levee		GPS Latitude/Longitude		
			Start	End	
Item	Vegetation		38.580778 °	38.580778 °	
			-121.431704 °	-121.431704 °	
DWR ID	DWR_NA0001_04_s_2012_206				
Action/Comments					
Landscaping Inspector Comments: Fig tree obstructs visibility and access.

03/16/2012 Landscaping obstructs visibility and access.

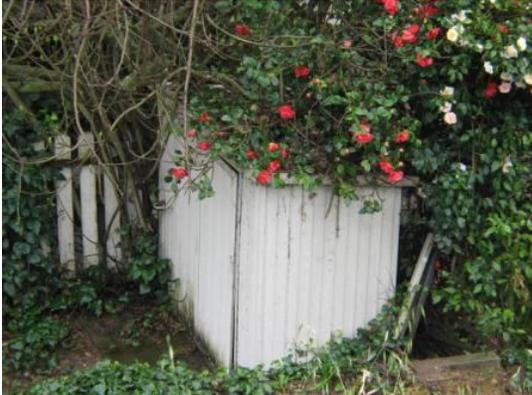
Photo 1 of 1 : FA\_2015\_NA0001\_55\_96\_20150910\_00079.jpg

LM Start	<b>4.87</b>	Rating **	U	Issue No.	<b>96</b>
LM End	<b>4.87</b>	Issue Type +	En	Location *	LS
Category	Earthen Levee		GPS Latitude/Longitude		
			Start	End	
Item	Encroachments		38.580767 °	38.580767 °	
			-121.431684 °	-121.431684 °	
DWR ID	DWR_NA0001_04_s_2012_96				
Action/Comments					
Building Inspector Comments: Wooden shed is located beneath the fig tree.

3/16/2012 Structure is within 15' of levee toe.

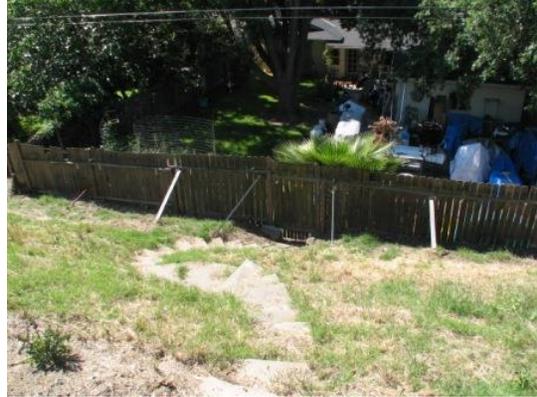
Photo 1 of 1 : FA\_2015\_NA0001\_55\_45\_20150910\_00035.jpg

LM Start	<b>4.93</b>	Rating **	U	Issue No.	<b>45</b>
LM End	<b>4.93</b>	Issue Type +	En	Location *	LS
Category	Earthen Levee		GPS Latitude/Longitude		
			Start	End	
Item	Encroachments		38.580846 °	38.580846 °	
			-121.430699 °	-121.430699 °	
DWR ID	DWR_NA0001_04_s_2012_45				
Action/Comments					
Fence Inspector Comments: Wooden fence with bracing obstructs access and visibility.

Wooden fence and braces obstruct access and visibility.

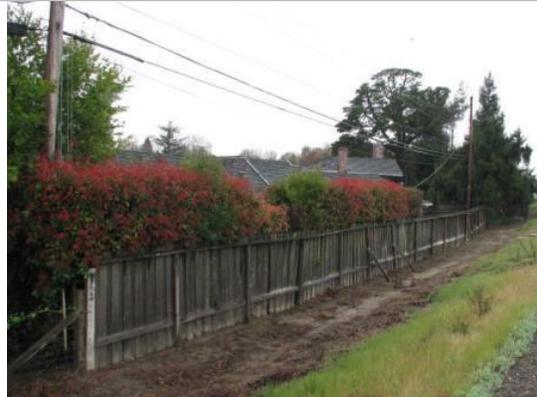
Photo 1 of 1 : FA\_2015\_NA0001\_55\_46\_20150910\_00036.jpg

LM Start	<b>5.08</b>	Rating **	U	Issue No.	<b>46</b>
LM End	<b>5.08</b>	Issue Type +	En	Location *	LS
Category	Earthen Levee		GPS Latitude/Longitude		
			Start	End	
Item	Encroachments		38.581001 °	38.581001 °	
			-121.427854 °	-121.427854 °	
DWR ID	DWR_NA0001_04_s_2012_46				
Action/Comments					
Fence Inspector Comments: Privacy fence and landscaping within 10-ft of the levee toe obstruct access and visibility.

03/16/2012 Wood privacy fence completely obstructs access and visibility.

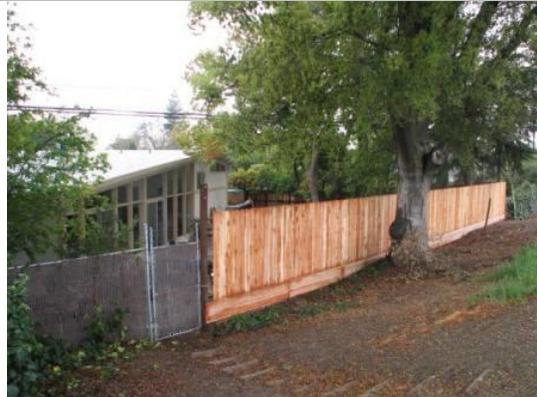
Photo 1 of 1 : FA\_2015\_NA0001\_55\_208\_20150910\_00174.jpg

LM Start	<b>5.12</b>	Rating **	U	Issue No.	<b>208</b>
LM End	<b>5.12</b>	Issue Type +	En	Location *	LS
Category	Earthen Levee		GPS Latitude/Longitude		
			Start	End	
Item	Encroachments		38.580913 °	38.580913 °	
			-121.427119 °	-121.427119 °	
DWR ID	DWR_NA0001_04_s_2012_208				
Action/Comments					
Fence Inspector Comments: Privacy fence and landscaping within 10-ft of the levee toe obstruct access and visibility.

03/16/2012 Wood privacy fence completely obstructs access and visibility.

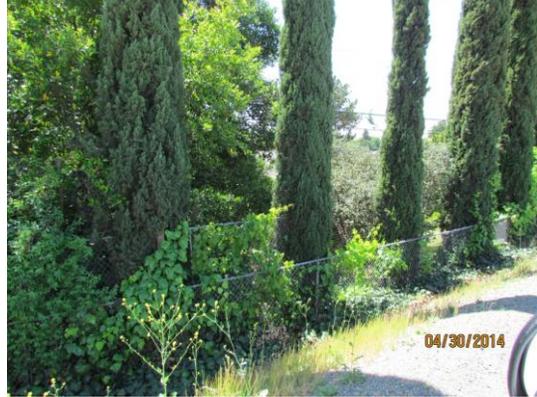
Photo 1 of 1 : FA\_2015\_NA0001\_55\_47\_20150910\_00037.jpg

LM Start	<b>5.15</b>	Rating **	M	Issue No.	<b>47</b>
LM End	<b>5.15</b>	Issue Type +	En	Location *	LS
Category	Earthen Levee		GPS Latitude/Longitude		
			Start	End	
Item	Encroachments		38.580773 °	38.580773 °	
			-121.426691 °	-121.426691 °	
DWR ID	DWR_NA0001_04_s_2012_47				
Action/Comments					
Fence Inspector Comments: Chain link fence, helix sky pencil, and landscaping within 10-ft of the levee toe obstruct access and visibility.

View of the fence and vegetation at the landside levee toe.

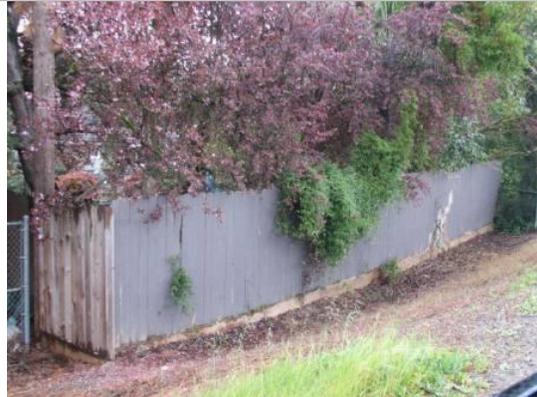
Photo 1 of 1 : FA\_2015\_NA0001\_55\_48\_20150910\_00038.jpg

LM Start	<b>5.17</b>	Rating **	U	Issue No.	<b>48</b>
LM End	<b>5.17</b>	Issue Type +	En	Location *	LS
Category	Earthen Levee		GPS Latitude/Longitude		
			Start	End	
Item	Encroachments		38.580622 °	38.580622 °	
			-121.426372 °	-121.426372 °	
DWR ID	DWR_NA0001_04_s_2012_48				
Action/Comments					
Fence Inspector Comments: Wood privacy fence and landscaping within 10-ft of the levee toe obstruct access and visibility.

03/16/2012 Wood privacy fence completely obstructs access and visibility.

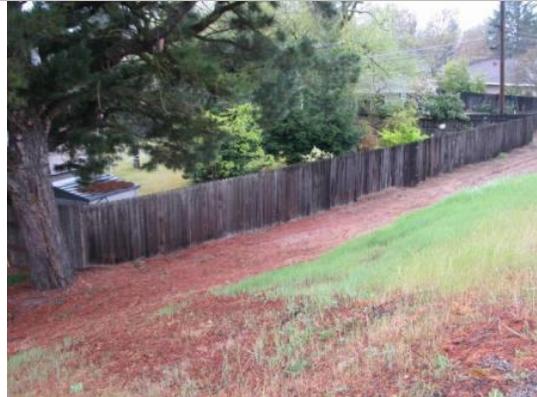
Photo 1 of 1 : FA\_2015\_NA0001\_55\_49\_20150910\_00039.jpg

LM Start	<b>5.44</b>	Rating **	U	Issue No.	<b>49</b>
LM End	<b>5.44</b>	Issue Type +	En	Location *	LS
Category	Earthen Levee		GPS Latitude/Longitude		
			Start	End	
Item	Encroachments		38.577589 °	38.577589 °	
			-121.423350 °	-121.423350 °	
DWR ID	DWR_NA0001_04_s_2012_49				
Action/Comments					
Fence Inspector Comments: Wood privacy fence within 10-ft of the levee toe obstruct access and visibility.

03/16/2012 Wood privacy fence completely obstructs access and visibility.

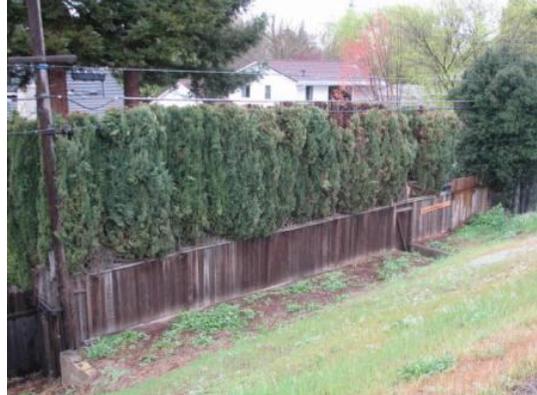
Photo 1 of 1 : FA\_2015\_NA0001\_55\_53\_20150910\_00042.jpg

LM Start	<b>5.61</b>	Rating **	U	Issue No.	<b>53</b>
LM End	<b>5.61</b>	Issue Type +	En	Location *	LS
Category	Earthen Levee			GPS Latitude/Longitude	
				Start	End
Item	Vegetation			38.575250 °	38.575250 °
				-121.423240 °	-121.423240 °
DWR ID	DWR_NA0001_04_s_2012_53				
Action/Comments					
Landscaping Inspector Comments: Wood privacy fence, helix sky pencil, vines and landscaping within 10-ft of the levee toe obstruct access and visibility. Cement stairs up levee slope.

03/16/2012 Landscaping and fence obstruct visibility and access.

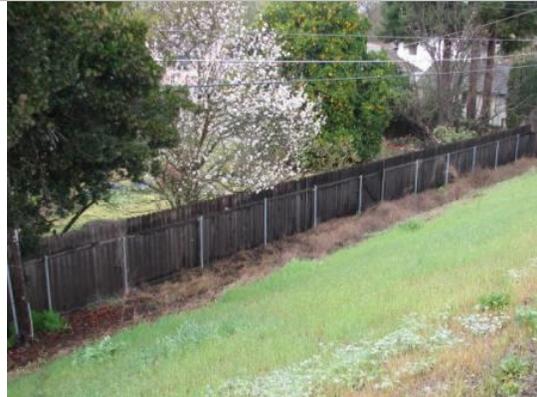
Photo 1 of 1 : FA\_2015\_NA0001\_55\_54\_20150910\_00043.jpg

LM Start	<b>5.62</b>	Rating **	U	Issue No.	<b>54</b>
LM End	<b>5.62</b>	Issue Type +	En	Location *	LS
Category	Earthen Levee			GPS Latitude/Longitude	
				Start	End
Item	Encroachments			38.575093 °	38.575093 °
				-121.423263 °	-121.423263 °
DWR ID	DWR_NA0001_04_s_2012_54				
Action/Comments					
Fence Inspector Comments: Wood privacy fence and landscaping within 10-ft of the levee toe obstruct access and visibility.

03/16/2012 Wood privacy fence completely obstructs access and visibility.

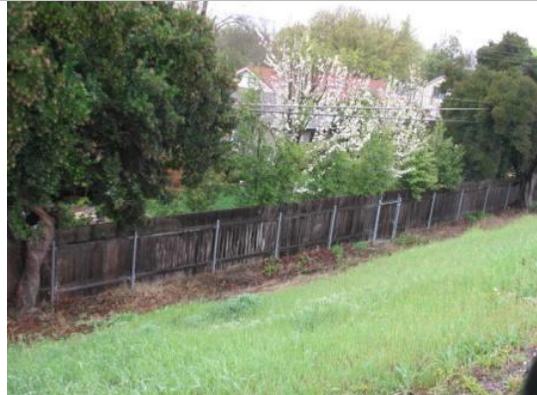
Photo 1 of 1 : FA\_2015\_NA0001\_55\_55\_20150910\_00044.jpg

LM Start	<b>5.63</b>	Rating **	U	Issue No.	<b>55</b>
LM End	<b>5.63</b>	Issue Type +	En	Location *	LS
Category	Earthen Levee			GPS Latitude/Longitude	
				Start	End
Item	Encroachments			38.574837 °	38.574837 °
				-121.423297 °	-121.423297 °
DWR ID	DWR_NA0001_04_s_2012_55				
Action/Comments					
Fence Inspector Comments: Wood privacy fence within 10-ft of the levee toe obstructs visibility.

03/16/2012 Wood privacy fence completely obstructs access and visibility.

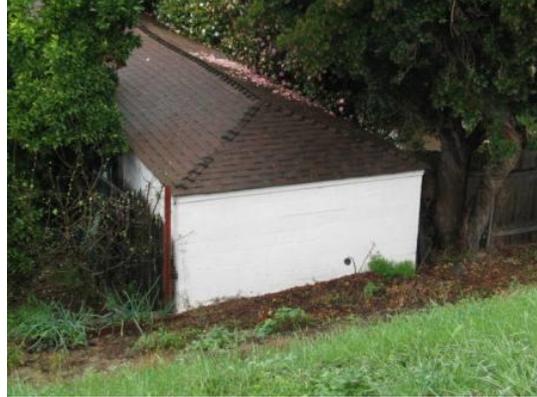
Photo 1 of 1 : FA\_2015\_NA0001\_55\_56\_20150910\_00045.jpg

LM Start	<b>5.65</b>	Rating **	U	Issue No.	<b>56</b>
LM End	<b>5.65</b>	Issue Type +	En	Location *	LS
Category	Earthen Levee		GPS Latitude/Longitude		
			Start	End	
Item	Encroachments		38.574648 °	38.574648 °	
			-121.423348 °	-121.423348 °	
DWR ID	DWR_NA0001_04_s_2012_56				
Action/Comments					
Building Inspector Comments: Cement block building on levee slope obstructs access.

03/16/2012 Structure within 15' of levee toe.

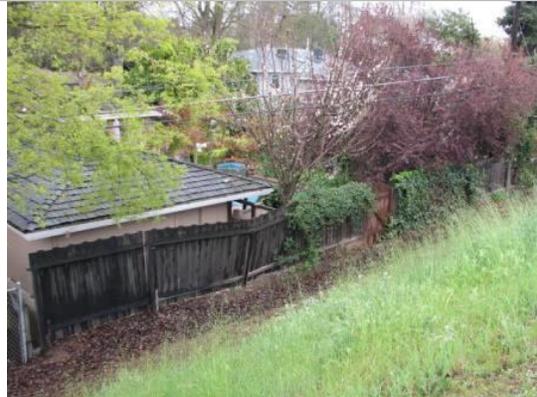
Photo 1 of 1 : FA\_2015\_NA0001\_55\_57\_20150910\_00046.jpg

LM Start	<b>5.70</b>	Rating **	U	Issue No.	<b>57</b>
LM End	<b>5.70</b>	Issue Type +	En	Location *	LS
Category	Earthen Levee		GPS Latitude/Longitude		
			Start	End	
Item	Encroachments		38.573927 °	38.573927 °	
			-121.423480 °	-121.423480 °	
DWR ID	DWR_NA0001_04_s_2012_57				
Action/Comments					
Fence Inspector Comments: Wood privacy fence with ivy obstructs visibility.

03/16/2012 Wood privacy fence completely obstructs access and visibility.

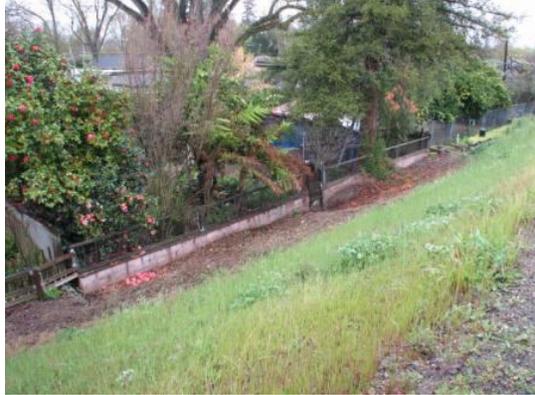
Photo 1 of 1 : FA\_2015\_NA0001\_55\_59\_20150910\_00047.jpg

LM Start	<b>5.73</b>	Rating **	U	Issue No.	<b>59</b>
LM End	<b>5.73</b>	Issue Type +	En	Location *	LS
Category	Earthen Levee		GPS Latitude/Longitude		
			Start	End	
Item	Encroachments		38.573403 °	38.573403 °	
			-121.423642 °	-121.423642 °	
DWR ID	DWR_NA0001_04_s_2012_59				
Action/Comments					
Fence Inspector Comments: Brick fence and landscaping within 10-ft of the levee toe obstructs access and visibility.

03/16/2012 Fence and landscaping obstruct visibility and access.

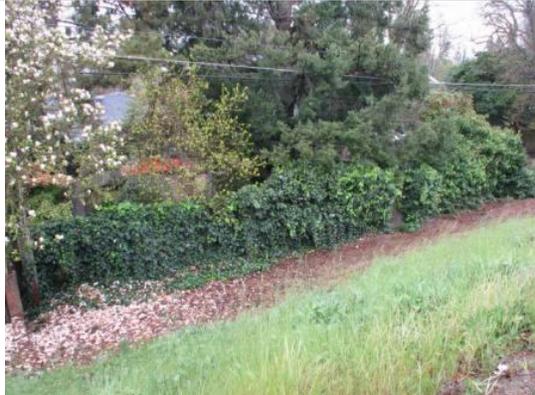
Photo 1 of 1 : FA\_2015\_NA0001\_55\_61\_20150910\_00048.jpg

LM Start	<b>5.77</b>	Rating **	U	Issue No.	<b>61</b>
LM End	<b>5.77</b>	Issue Type +	En	Location *	LS
Category	Earthen Levee		GPS Latitude/Longitude		
			Start	End	
Item	Vegetation		38.572918 °	38.572918 °	
			-121.423760 °	-121.423760 °	
DWR ID	DWR_NA0001_04_s_2012_61				
Action/Comments					
Landscaping Inspector Comments: Dense ivy and shrubs are within 10-ft of the levee toe.

03/16/2012 Landscaping obstructs access and visibility.

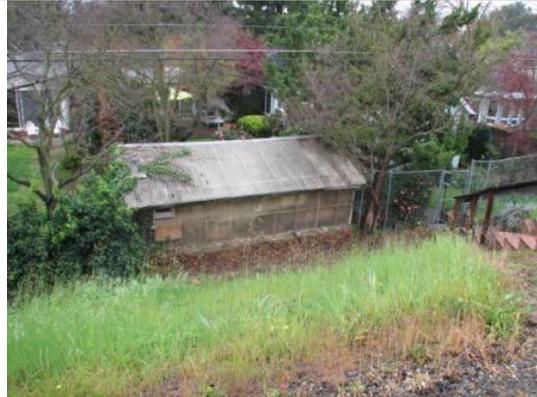
Photo 1 of 1 : FA\_2015\_NA0001\_55\_63\_20150910\_00049.jpg

LM Start	<b>5.81</b>	Rating **	U	Issue No.	<b>63</b>
LM End	<b>5.81</b>	Issue Type +	En	Location *	LS
Category	Earthen Levee		GPS Latitude/Longitude		
			Start	End	
Item	Encroachments		38.572325 °	38.572325 °	
			-121.423913 °	-121.423913 °	
DWR ID	DWR_NA0001_04_s_2012_63				
Action/Comments					
Building Inspector Comments: Wood and fiberglass structure within 10-ft of the levee toe.

03/16/2012 Wood and fiberglass structure is within 15' of levee toe.

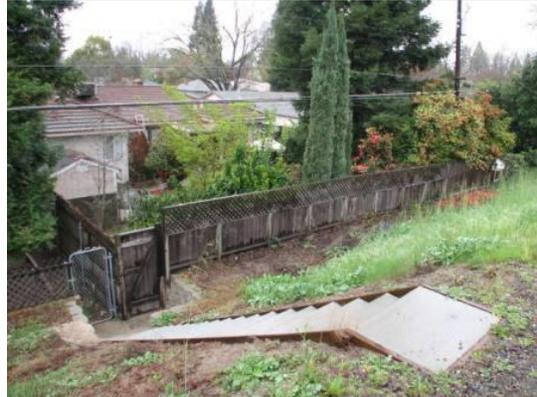
Photo 1 of 1 : FA\_2015\_NA0001\_55\_65\_20150910\_00050.jpg

LM Start	<b>5.83</b>	Rating **	U	Issue No.	<b>65</b>
LM End	<b>5.83</b>	Issue Type +	En	Location *	LS
Category	Earthen Levee		GPS Latitude/Longitude		
			Start	End	
Item	Encroachments		38.572067 °	38.572067 °	
			-121.423970 °	-121.423970 °	
DWR ID	DWR_NA0001_04_s_2012_65				
Action/Comments					
Fence Inspector Comments: Extended privacy fence and retaining wall within 10-ft of levee toe.

03/16/2012 Wood privacy fence completely obstructs access and visibility.

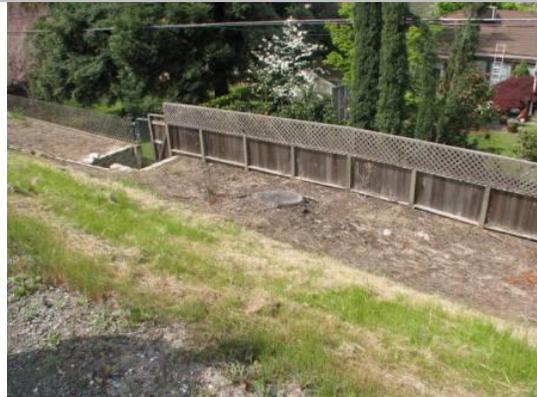
Photo 1 of 1 : FA\_2015\_NA0001\_55\_181\_20150910\_00157.jpg

LM Start	<b>5.83</b>	Rating **	N	Issue No.	<b>181</b>
LM End	<b>5.83</b>	Issue Type +	Ma	Location *	LS
Category	Earthen Levee		GPS Latitude/Longitude		
			Start	End	
Item	Trim / Thin Trees		38.572032 °	38.572032 °	
			-121.423981 °	-121.423981 °	
DWR ID	DWR_NA0001_04_s_2012_181				
Action/Comments					
Tree stumps. Inspector Comments: 04/14/2011 Large stump at toe of levee.

04/14/2011 Large stump at toe of levee.

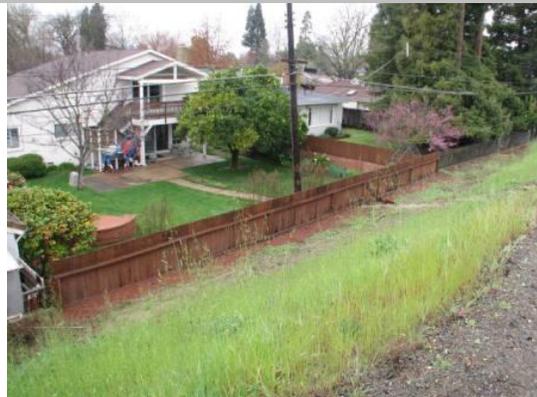
Photo 1 of 1 : FA\_2015\_NA0001\_55\_210\_20150910\_00175.jpg

LM Start	<b>5.85</b>	Rating **	U	Issue No.	<b>210</b>
LM End	<b>5.85</b>	Issue Type +	En	Location *	LS
Category	Earthen Levee		GPS Latitude/Longitude		
			Start	End	
Item	Encroachments		38.571733 °	38.571733 °	
			-121.424055 °	-121.424055 °	
DWR ID	DWR_NA0001_04_s_2012_210				
Action/Comments					
Fence Inspector Comments: Privacy fence and retaining wall are within 10-ft of levee toe.

03/16/2012 Wood privacy fence completely obstructs access and visibility.

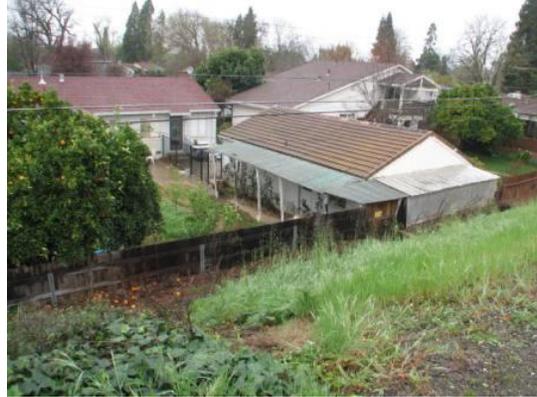
Photo 1 of 1 : FA\_2015\_NA0001\_55\_66\_20150910\_00051.jpg

LM Start	<b>5.86</b>	Rating **	U	Issue No.	<b>66</b>
LM End	<b>5.86</b>	Issue Type +	En	Location *	LS
Category	Earthen Levee			GPS Latitude/Longitude	
				Start	End
Item	Encroachments			38.571586 °	38.571586 °
				-121.424097 °	-121.424097 °
DWR ID	DWR_NA0001_04_s_2012_66				
Action/Comments					
Building

03/16/2012 Structure is within 15' of levee toe.

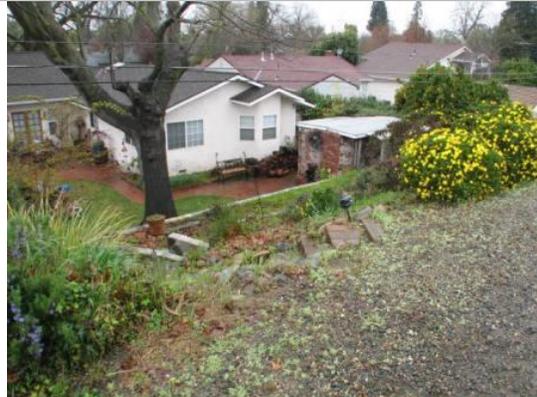
Photo 1 of 1 : FA\_2015\_NA0001\_55\_68\_20150910\_00053.jpg

LM Start	<b>5.87</b>	Rating **	U	Issue No.	<b>68</b>
LM End	<b>5.87</b>	Issue Type +	En	Location *	LS
Category	Earthen Levee			GPS Latitude/Longitude	
				Start	End
Item	Vegetation			38.571525 °	38.571525 °
				-121.424152 °	-121.424152 °
DWR ID	DWR_NA0001_04_f_2013_68				
Action/Comments					
Landscaping Inspector Comments: Levee slope has been landscaped. This obstructs visibility.

03/16/2012 Levee slope is heavily landscaped, retaining wall has been constructed at the levee toe.

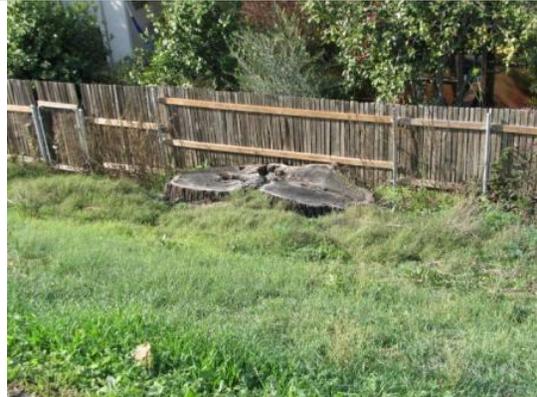
Photo 1 of 1 : FA\_2015\_NA0001\_55\_740\_20150910\_00194.jpg

LM Start	<b>5.91</b>	Rating **	N	Issue No.	<b>740</b>
LM End	<b>5.91</b>	Issue Type +	Ma	Location *	LS
Category	Earthen Levee			GPS Latitude/Longitude	
				Start	End
Item	Trim / Thin Trees			38.570940 °	38.570940 °
				-121.424173 °	-121.424173 °
DWR ID	DWR_NA0001_04_s_2012_740				
Action/Comments					
Tree stumps. Inspector Comments: Large stump

11/15/2011 Large stump at levee toe.

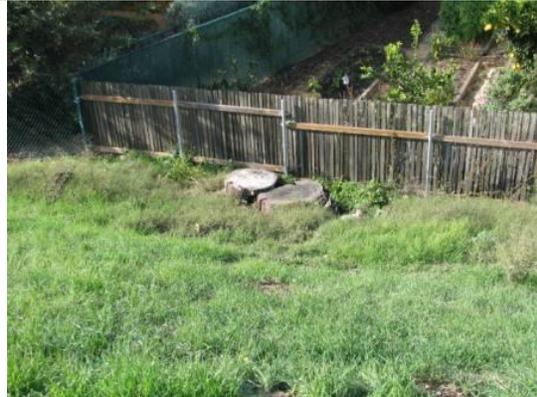
Photo 1 of 1 : FA\_2015\_NA0001\_55\_741\_20150910\_00195.jpg

LM Start	<b>5.92</b>	Rating **	N	Issue No.	<b>741</b>
LM End	<b>5.92</b>	Issue Type +	Ma	Location *	LS
Category	Earthen Levee			GPS Latitude/Longitude	
				Start	End
Item	Trim / Thin Trees			38.570800 °	38.570800 °
				-121.424184 °	-121.424184 °
DWR ID	DWR_NA0001_04_s_2012_741				
Action/Comments					
Tree stumps. Inspector Comments: Stump.

11/15/2011 Stump at levee toe.

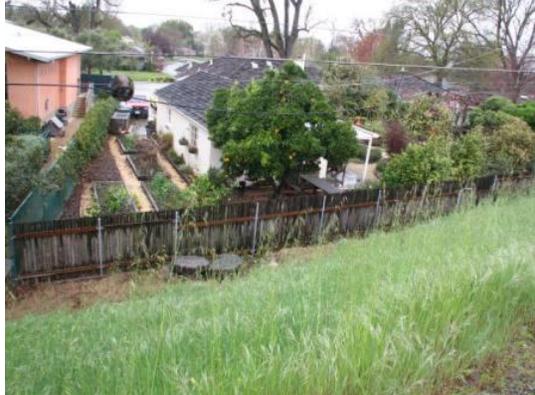
Photo 1 of 1 : FA\_2015\_NA0001\_55\_88\_20150910\_00071.jpg

LM Start	<b>5.92</b>	Rating **	U	Issue No.	<b>88</b>
LM End	<b>5.92</b>	Issue Type +	En	Location *	LS
Category	Earthen Levee		GPS Latitude/Longitude		
			Start	End	
Item	Encroachments		38.570752 °	38.570752 °	
			-121.424219 °	-121.424219 °	
DWR ID	DWR_NA0001_04_f_2012_88				
Action/Comments					
Fence Inspector Comments: Wooden privacy fence.

03/16/2012 Wood privacy fence completely obstructs access and visibility.

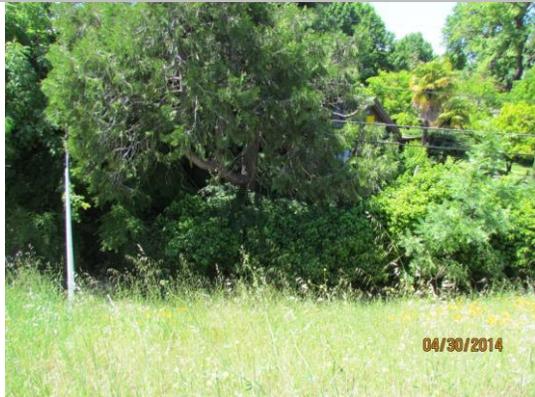
Photo 1 of 1 : FA\_2015\_NA0001\_55\_71\_20150910\_00054.jpg

LM Start	<b>5.94</b>	Rating **	M	Issue No.	<b>71</b>
LM End	<b>5.94</b>	Issue Type +	En	Location *	LS
Category	Earthen Levee		GPS Latitude/Longitude		
			Start	End	
Item	Vegetation		38.570450 °	38.570450 °	
			-121.424237 °	-121.424237 °	
DWR ID	DWR_NA0001_04_s_2012_71				
Action/Comments					
Landscaping Inspector Comments: Landscaping and garden within 10-ft of the levee toe.

View of the landscaping at the landside levee toe.

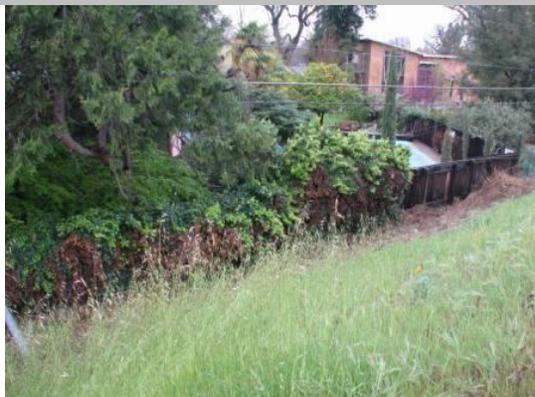
Photo 1 of 1 : FA\_2015\_NA0001\_55\_72\_20150910\_00055.jpg

LM Start	<b>5.94</b>	Rating **	U	Issue No.	<b>72</b>
LM End	<b>5.94</b>	Issue Type +	En	Location *	LS
Category	Earthen Levee		GPS Latitude/Longitude		
			Start	End	
Item	Encroachments		38.570391 °	38.570391 °	
			-121.424227 °	-121.424227 °	
DWR ID	DWR_NA0001_04_s_2012_72				
Action/Comments					
Fence Inspector Comments: Wood fence and landscaping within 10-ft of the levee toe obstructs visibility.

03/16/2012 Wood privacy fence completely obstructs access and visibility.

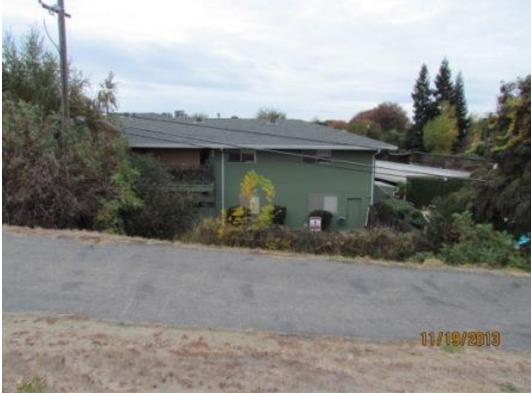
Photo 1 of 1 : FA\_2015\_NA0001\_55\_211\_20150910\_00176.jpg

LM Start	<b>5.98</b>	Rating **	M	Issue No.	<b>211</b>
LM End	<b>5.98</b>	Issue Type +	En	Location *	LS
Category	Earthen Levee		GPS Latitude/Longitude		
			Start	End	
Item	Encroachments		38.569893 °	38.569893 °	
			-121.424310 °	-121.424310 °	
DWR ID	DWR_NA0001_04_s_2012_211				
Action/Comments					
Fence Inspector Comments: Apartment complex privacy fence and shrubs within 10-ft of the slope obstruct visibility.

View of the fence at the landside levee toe.

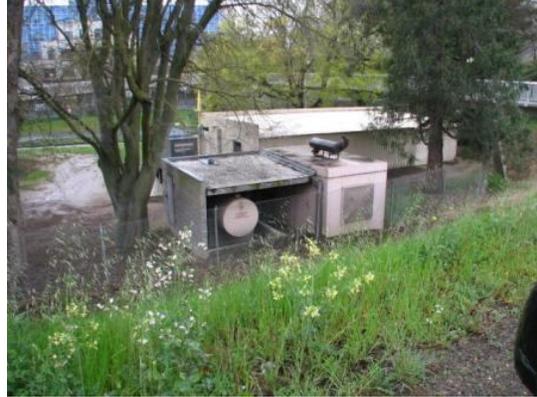
Photo 1 of 1 : FA\_2015\_NA0001\_55\_73\_20150910\_00056.jpg

LM Start	<b>6.58</b>	Rating **	U	Issue No.	<b>73</b>
LM End	<b>6.58</b>	Issue Type +	En	Location *	LS
Category	Earthen Levee		GPS Latitude/Longitude		
			Start	End	
Item	Encroachments		38.561643 °	38.561643 °	
			-121.421262 °	-121.421262 °	
DWR ID	DWR_NA0001_04_s_2012_73				
Action/Comments					
Building Inspector Comments: Generator and sheds within 10-ft of levee slope.

03/16/2012 Structure for generator is within 5' of levee toe.

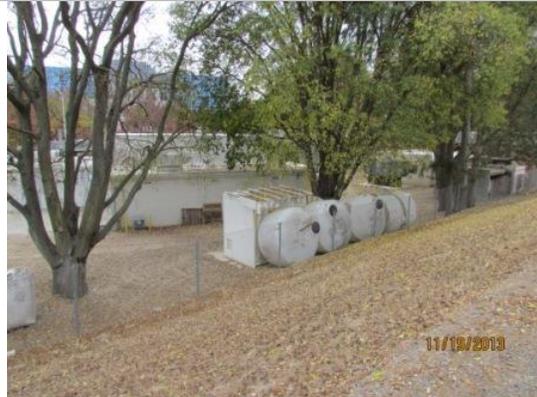
Photo 1 of 1 : FA\_2015\_NA0001\_55\_185\_20150910\_00158.jpg

LM Start	<b>6.60</b>	Rating **	M	Issue No.	<b>185</b>
LM End	<b>6.60</b>	Issue Type +	En	Location *	LS
Category	Earthen Levee		GPS Latitude/Longitude		
			Start	End	
Item	Encroachments		38.561448 °	38.561448 °	
			-121.421071 °	-121.421071 °	
DWR ID	DWR_NA0001_04_f_2013_185				
Action/Comments					
Tank Inspector Comments: 5 water tanks and storage shed within 10 feet of landside levee toe.

View of the water tanks stored at the landside levee toe.

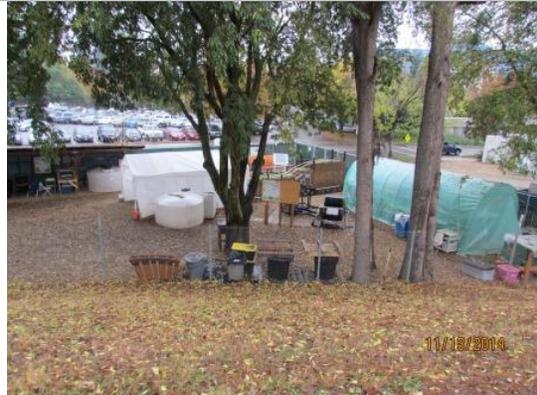
Photo 1 of 1 : FA\_2015\_NA0001\_55\_51\_20150910\_00040.jpg

LM Start	<b>6.62</b>	Rating **	M	Issue No.	<b>51</b>
LM End	<b>6.62</b>	Issue Type +	En	Location *	LS
Category	Earthen Levee		GPS Latitude/Longitude		
			Start	End	
Item	Encroachments		38.561117 °	38.561117 °	
			-121.420749 °	-121.420749 °	
DWR ID	DWR_NA0001_04_f_2013_51				
Action/Comments					
Material Inspector Comments: Pipe and other material stored within 10 feet of landside levee toe.

View of the material stored at the landside levee toe.

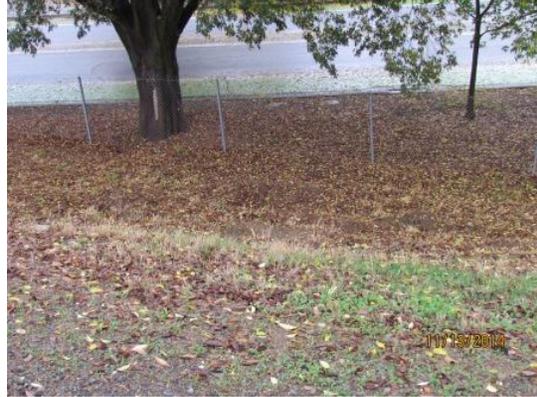
Photo 1 of 1 : FA\_2015\_NA0001\_55\_240\_20150910\_00185.jpg

LM Start	<b>6.65</b>	Rating **	M	Issue No.	<b>240</b>
LM End	<b>6.65</b>	Issue Type +	Ma	Location *	LS
Category	Earthen Levee			GPS Latitude/Longitude	
				Start	End
Item	Animal Control			38.560883 °	38.560883 °
				-121.420514 °	-121.420514 °
DWR ID	DWR_NA0001_04_f_2014_240				
Action/Comments					
Exterminate rodents and backfill and compact or grout burrows.

View of a rodent burrow at the landside levee toe.

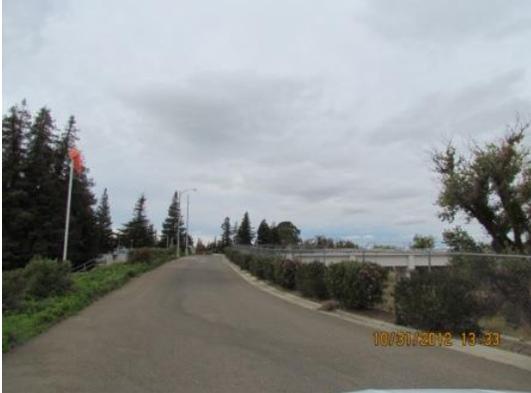
Photo 1 of 1 : FA\_2015\_NA0001\_55\_140\_20150910\_00118.jpg

LM Start	<b>6.82</b>	Rating **	M	Issue No.	<b>140</b>
LM End	<b>6.94</b>	Issue Type +	En	Location *	WS
Category	Earthen Levee		GPS Latitude/Longitude		
			Start	End	
Item	Vegetation		38.559152 °	38.558115 °	
			-121.418108 °	-121.416328 °	
DWR ID	DWR_NA0001_04_f_2012_140				
Action/Comments					
Landscaping Inspector Comments: Bushes at waterside hinge obstruct visibility of waterside slope from levee crown.

View of landscaping at waterside hinge obstructing visibility.

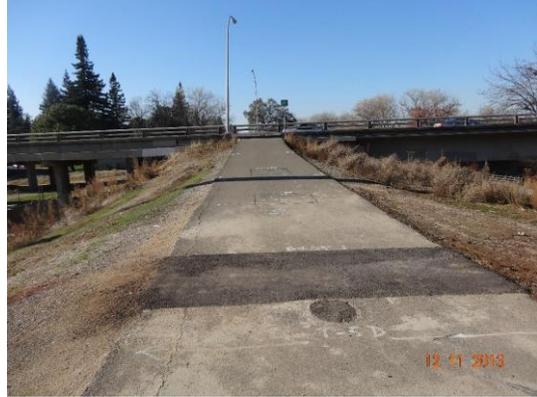
Photo 1 of 3 : UCIP\_FA\_2015\_3184.jpg

LM Start	<b>7.34</b>	Rating **	M	Issue No.	<b>771</b>
LM End	<b>7.34</b>	Issue Type +	En	Location *	WS
Category	Supplemental			GPS Latitude/Longitude	
				Start	End
Item	DWR UCIP Field Study			38.558197 °	38.558197 °
				-121.409106 °	-121.409106 °
DWR ID

Inspector Comments: FS\_ID:30023  
 DS\_ID:24319  
 EP\_NO: 3596  
 FS\_HLM: 7.384  
 Repair Type: Non-Urgent  
 Crossing Status: Indicator Found  
 UCIP Comments: Need to contact owners to determine how crossing was abandoned.  
 FIELD\_STRUCT\_DESC: [Power Inn Road Plant] 4 of 4: Abandoned 48-inch CM drainpipe through the levee, 20.0 feet below the crown. Two CM cutoff walls around pipe under each shoulder. Slide gate with control pedestal in CM pipe riser on waterward slope. Slide gate with control pedestal in collection sump on landward side. Pumping plant at landward toe. Reinforced concrete discharge box at the toe of the water ward slope. Flap gate on waterward end. (Permit No. 3596-1962) 60-inch discharge pipe from box across the berm to the riverbank installed under Permit No. 5894 (1970). Pipe abandoned and CM pipe riser cut 2.0 feet below ground surface under Permit No. 3596A (1998).

Signs of crossing repair patch section visible on levee crown.

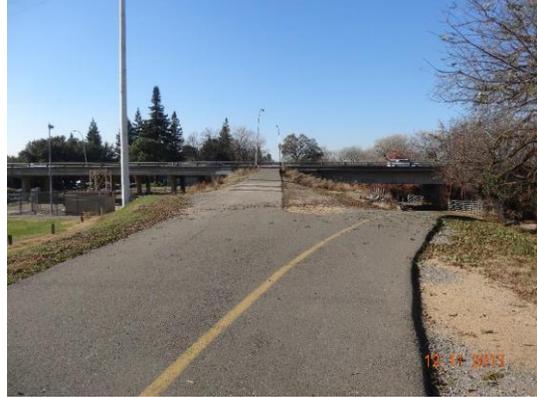
Photo 2 of 3 : UCIP\_FA\_2015\_4456.jpg

LM Start	7.34	Rating **	M	Issue No.	771 (cont)
LM End	7.34	Issue Type +	En	Location *	WS
Category	Supplemental			GPS Latitude/Longitude	
				Start	End
Item	DWR UCIP Field Study			38.558197 °	38.558197 °
DWR ID				-121.409106 °	-121.409106 °
Action/Comments					
Inspector Comments: FS_ID:30023 DS_ID:24319 EP_NO: 3596 FS_HLM: 7.384 Repair Type: Non-Urgent Crossing Status: Indicator Found UCIP Comments: Need to contact owners to determine how crossing was abandoned. FIELD_STRUCT_DESC: [Power Inn Road Plant] 4 of 4: Abandoned 48-inch CM drainpipe through the levee, 20.0 feet below the crown. Two CM cutoff walls around pipe under each shoulder. Slide gate with control pedestal in CM pipe riser on waterward slope. Slide gate with control pedestal in collection sump on landward side. Pumping plant at landward toe. Reinforced concrete discharge box at the toe of the water ward slope. Flap gate on waterward end. (Permit No. 3596-1962) 60-inch discharge pipe from box across the berm to the riverbank installed under Permit No. 5894 (1970). Pipe abandoned and CM pipe riser cut 2.0 feet below ground surface under Permit No. 3596A (1998). FS Date: 12/11/2013

Overview of levee crown at crossings.

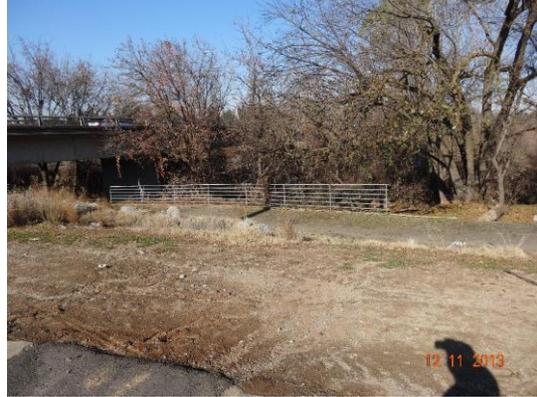
Photo 3 of 3 : UCIP\_FA\_2015\_4583.jpg

LM Start	7.34	Rating **	M	Issue No.	771 (cont)
LM End	7.34	Issue Type +	En	Location *	WS
Category	Supplemental			GPS Latitude/Longitude	
				Start	End
Item	DWR UCIP Field Study			38.558197 °	38.558197 °
DWR ID				-121.409106 °	-121.409106 °
Action/Comments					
Inspector Comments: FS_ID:30023 DS_ID:24319 EP_NO: 3596 FS_HLM: 7.384 Repair Type: Non-Urgent Crossing Status: Indicator Found UCIP Comments: Need to contact owners to determine how crossing was abandoned. FIELD_STRUCT_DESC: [Power Inn Road Plant] 4 of 4: Abandoned 48-inch CM drainpipe through the levee, 20.0 feet below the crown. Two CM cutoff walls around pipe under each shoulder. Slide gate with control pedestal in CM pipe riser on waterward slope. Slide gate with control pedestal in collection sump on landward side. Pumping plant at landward toe. Reinforced concrete discharge box at the toe of the water ward slope. Flap gate on waterward end. (Permit No. 3596-1962) 60-inch discharge pipe from box across the berm to the riverbank installed under Permit No. 5894 (1970). Pipe abandoned and CM pipe riser cut 2.0 feet below ground surface under Permit No. 3596A (1998). FS Date: 12/11/2013

View of waterward side.

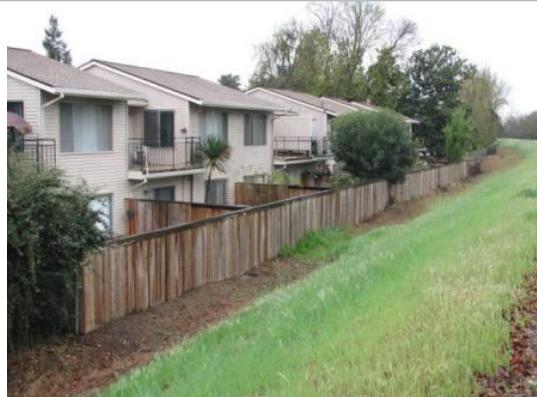
Photo 1 of 1 : FA\_2015\_NA0001\_55\_74\_20150910\_00057.jpg

LM Start	7.65	Rating **	U	Issue No.	74
LM End	7.68	Issue Type +	En	Location *	LS
Category	Earthen Levee			GPS Latitude/Longitude	
				Start	End
Item	Encroachments			38.559177 °	38.559218 °
DWR ID	DWR_NA0001_04_s_2012_74			-121.403541 °	-121.402967 °
Action/Comments					
Fence Inspector Comments: Wooden privacy fence for seven apartment units is within 10-ft of levee toe and obstructs access and visibility.

03/16/2012 Wood privacy fence completely obstructs access and visibility.

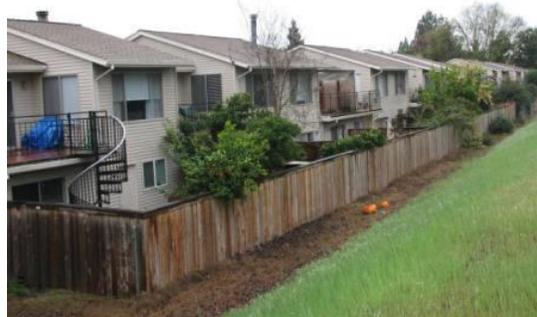
Photo 1 of 1 : FA\_2015\_NA0001\_55\_75\_20150910\_00058.jpg

LM Start	<b>7.69</b>	Rating **	U	Issue No.	<b>75</b>
LM End	<b>7.72</b>	Issue Type +	En	Location *	LS
Category	Earthen Levee		GPS Latitude/Longitude		
			Start	End	
Item	Encroachments		38.559230 °	38.559261 °	
			-121.402708 °	-121.402219 °	
DWR ID	DWR_NA0001_04_s_2012_75				
Action/Comments					
Fence Inspector Comments: Wooden privacy fence for seven apartment units is within 10-ft of levee toe and obstructs access and visibility.

03/16/2012 Wood privacy fence completely obstructs access and visibility.

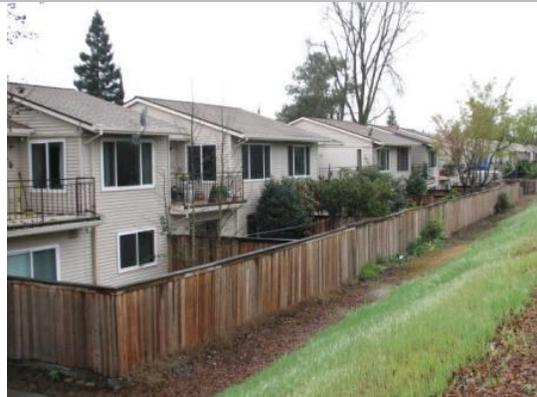
Photo 1 of 1 : FA\_2015\_NA0001\_55\_76\_20150910\_00059.jpg

LM Start	<b>7.75</b>	Rating **	U	Issue No.	<b>76</b>
LM End	<b>7.76</b>	Issue Type +	En	Location *	LS
Category	Earthen Levee		GPS Latitude/Longitude		
			Start	End	
Item	Encroachments		38.559308 °	38.559309 °	
			-121.401717 °	-121.401388 °	
DWR ID	DWR_NA0001_04_s_2012_76				
Action/Comments					
Fence Inspector Comments: Wooden privacy fence for seven apartment units is within 10-ft of levee toe and obstructs access and visibility.

03/16/2012 Wood privacy fence completely obstructs access and visibility.

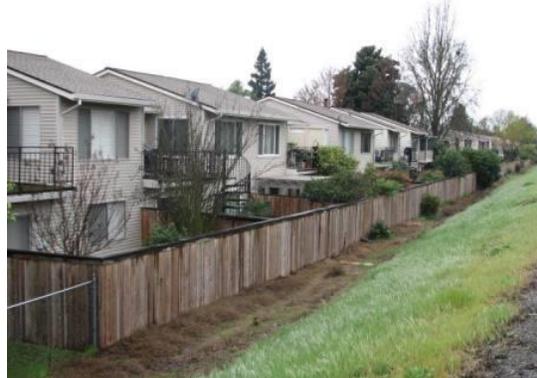
Photo 1 of 1 : FA\_2015\_NA0001\_55\_77\_20150910\_00060.jpg

LM Start	<b>7.78</b>	Rating **	U	Issue No.	<b>77</b>
LM End	<b>7.80</b>	Issue Type +	En	Location *	LS
Category	Earthen Levee		GPS Latitude/Longitude		
			Start	End	
Item	Encroachments		38.559330 °	38.559366 °	
			-121.401162 °	-121.400683 °	
DWR ID	DWR_NA0001_04_s_2012_77				
Action/Comments					
Fence Inspector Comments: Wooden privacy fence for seven apartment units is within 10-ft of levee toe and obstructs access and visibility.

03/16/2012 Wood privacy fence completely obstructs access and visibility.

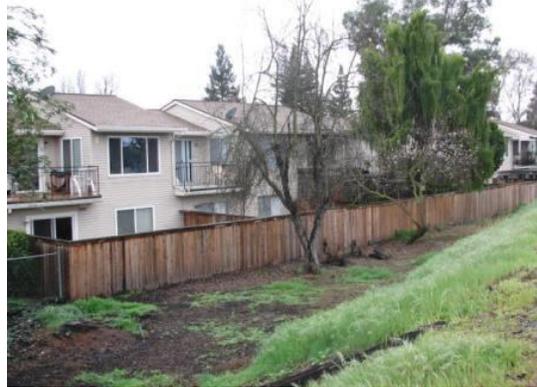
Photo 1 of 1 : FA\_2015\_NA0001\_55\_78\_20150910\_00061.jpg

LM Start	<b>7.82</b>	Rating **	U	Issue No.	<b>78</b>
LM End	<b>7.84</b>	Issue Type +	En	Location *	LS
Category	Earthen Levee		GPS Latitude/Longitude		
			Start	End	
Item	Encroachments		38.559379 °	38.559435 °	
			-121.400354 °	-121.399944 °	
DWR ID	DWR_NA0001_04_s_2012_78				
Action/Comments					
Fence Inspector Comments: Wooden privacy fence for seven apartment units is within 10-ft of levee toe and obstructs access and visibility.

03/16/2012 Wood privacy fence completely obstructs access and visibility.

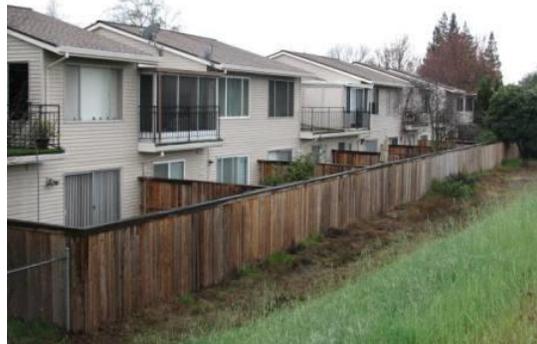
Photo 1 of 1 : FA\_2015\_NA0001\_55\_79\_20150910\_00062.jpg

LM Start	<b>7.86</b>	Rating **	U	Issue No.	<b>79</b>
LM End	<b>7.88</b>	Issue Type +	En	Location *	LS
Category	Earthen Levee		GPS Latitude/Longitude		
			Start	End	
Item	Encroachments		38.559514 °	38.559643 °	
			-121.399700 °	-121.399248 °	
DWR ID	DWR_NA0001_04_s_2012_79				
Action/Comments					
Fence Inspector Comments: Wooden privacy fence for seven apartment units is within 10-ft of levee toe and obstructs access and visibility.

03/16/2012 Wood privacy fence completely obstructs access and visibility.
