**Flood Control Project Maintenance  
Levee Inspections**

**Fall 2015 Levee Maintenance Deficiency Summary Report**

**Sacramento River Basin**

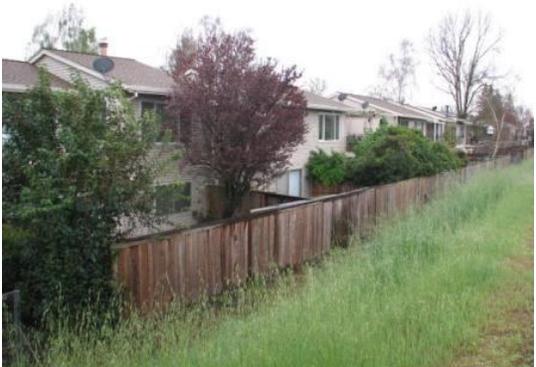
Photo 1 of 1 : FA\_2015\_NA0001\_55\_80\_20150910\_00063.jpg

LM Start	<b>7.90</b>	Rating **	U	Issue No.	<b>80</b>
LM End	<b>7.93</b>	Issue Type +	En	Location *	LS
Category	Earthen Levee		GPS Latitude/Longitude		
			Start	End	
Item	Encroachments		38.559753 °	38.559911 °	
			-121.398982 °	-121.398506 °	
DWR ID	DWR_NA0001_04_s_2012_80				
Action/Comments					
Fence Inspector Comments: Wooden privacy fence for seven apartment units is within 10-ft of levee toe and obstructs access and visibility.

03/16/2012 Wood privacy fence completely obstructs access and visibility.

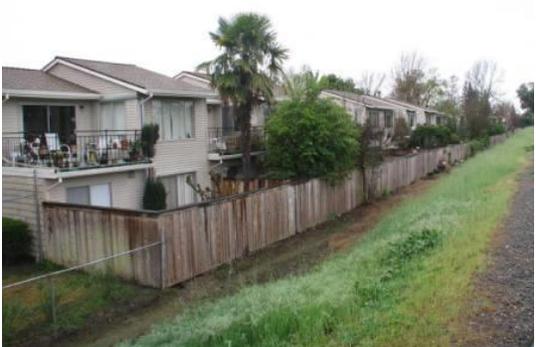
Photo 1 of 1 : FA\_2015\_NA0001\_55\_224\_20150910\_00177.jpg

LM Start	<b>7.94</b>	Rating **	U	Issue No.	<b>224</b>
LM End	<b>7.97</b>	Issue Type +	En	Location *	LS
Category	Earthen Levee		GPS Latitude/Longitude		
			Start	End	
Item	Encroachments		38.559994 °	38.560185 °	
			-121.398318 °	-121.397845 °	
DWR ID	DWR_NA0001_04_s_2012_224				
Action/Comments					
Fence Inspector Comments: Wooden privacy fence for seven apartment units is within 10-ft of levee toe and obstructs access and visibility.

03/16/2012 Wood privacy fence completely obstructs access and visibility.

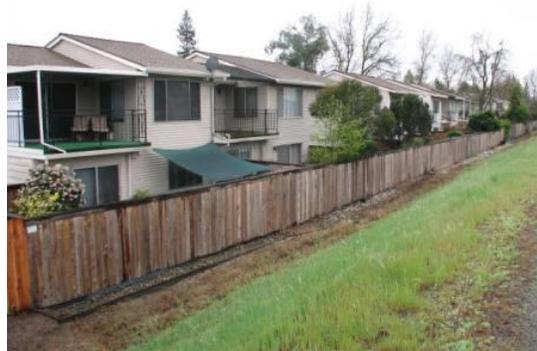
Photo 1 of 1 : FA\_2015\_NA0001\_55\_81\_20150910\_00064.jpg

LM Start	<b>7.98</b>	Rating **	U	Issue No.	<b>81</b>
LM End	<b>8.00</b>	Issue Type +	En	Location *	LS
Category	Earthen Levee		GPS Latitude/Longitude		
			Start	End	
Item	Encroachments		38.560281 °	38.560435 °	
			-121.397604 °	-121.397239 °	
DWR ID	DWR_NA0001_04_s_2012_81				
Action/Comments					
Fence Inspector Comments: Wooden privacy fence for seven apartment units is within 10-ft of levee toe and obstructs access and visibility.

03/16/2012 Wood privacy fence completely obstructs access and visibility.

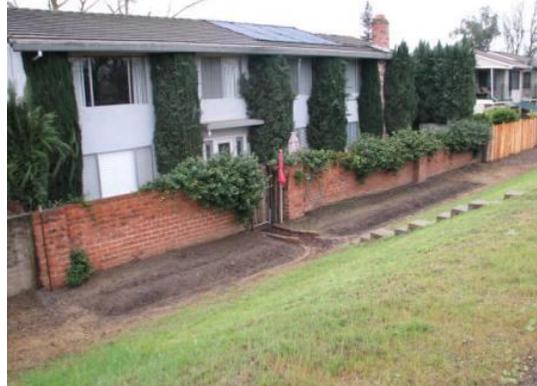
Photo 1 of 1 : FA\_2015\_NA0001\_55\_82\_20150910\_00065.jpg

LM Start	<b>8.02</b>	Rating **	U	Issue No.	<b>82</b>
LM End	<b>8.02</b>	Issue Type +	En	Location *	LS
Category	Earthen Levee		GPS Latitude/Longitude		
			Start	End	
Item	Encroachments		38.560537 °	38.560537 °	
			-121.396912 °	-121.396912 °	
DWR ID	DWR_NA0001_04_s_2012_82				
Action/Comments					
Fence Inspector Comments: Brick fence is within 10-ft of levee toe, obstructing access and visibility.

03/16/2012 Brick wall completely obstructs access and visibility.

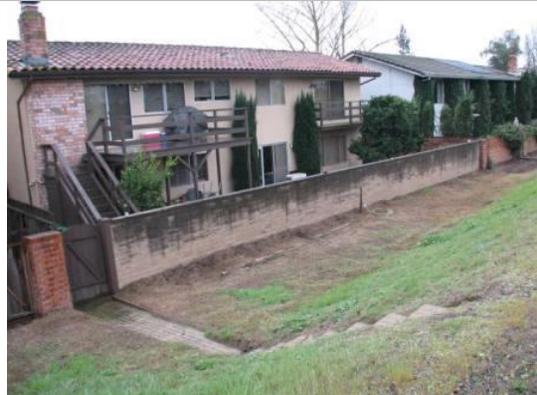
Photo 1 of 1 : FA\_2015\_NA0001\_55\_83\_20150910\_00066.jpg

LM Start	<b>8.04</b>	Rating **	U	Issue No.	<b>83</b>
LM End	<b>8.04</b>	Issue Type +	En	Location *	LS
Category	Earthen Levee		GPS Latitude/Longitude		
			Start	End	
Item	Encroachments		38.560647 °	38.560647 °	
			-121.396660 °	-121.396660 °	
DWR ID	DWR_NA0001_04_s_2012_83				
Action/Comments					
Fence Inspector Comments: Brick fence is within 10-ft of levee toe and obstructs access and visibility.

03/16/2012 Brick wall completely obstructs access and visibility.

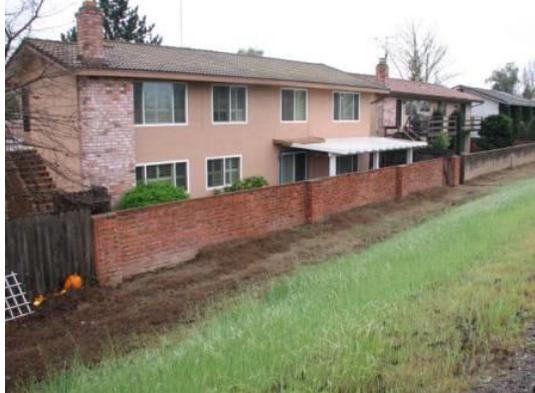
Photo 1 of 1 : FA\_2015\_NA0001\_55\_84\_20150910\_00067.jpg

LM Start	<b>8.05</b>	Rating **	U	Issue No.	<b>84</b>
LM End	<b>8.05</b>	Issue Type +	En	Location *	LS
Category	Earthen Levee		GPS Latitude/Longitude		
			Start	End	
Item	Encroachments		38.560728 °	38.560728 °	
			-121.396471 °	-121.396471 °	
DWR ID	DWR_NA0001_04_s_2012_84				
Action/Comments					
Fence Inspector Comments: Brick fence is within 10-ft of levee toe and obstructs access and visibility.

03/16/2012 Brick wall completely obstructs access and visibility.

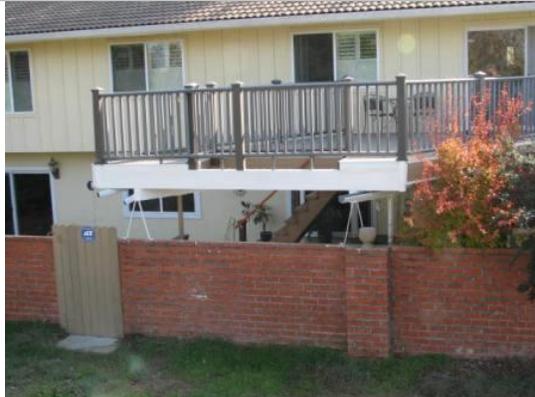
Photo 1 of 1 : FA\_2015\_NA0001\_55\_745\_20150910\_00196.jpg

LM Start	<b>8.06</b>	Rating **	A/W	Issue No.	<b>745</b>
LM End	<b>8.06</b>	Issue Type +	En	Location *	LS
Category	Earthen Levee		GPS Latitude/Longitude		
			Start	End	
Item	Encroachments		38.560830 °	38.560830 °	
			-121.396232 °	-121.396232 °	
DWR ID	DWR_NA0001_04_s_2012_745				
Action/Comments					
Urban Inspector Comments: Drains direct gutter flow onto levee toe.

11/15/2011 Gutter drains that are suspended from the balcony direct flow onto the levee toe.

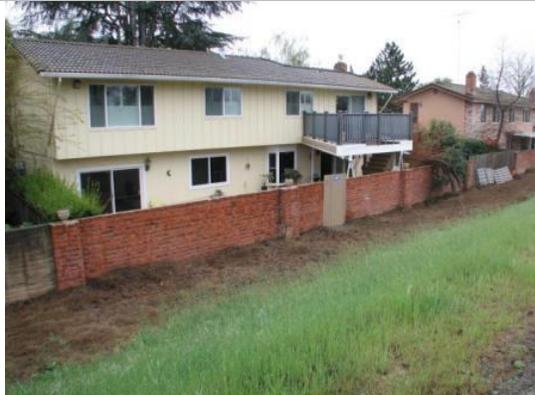
Photo 1 of 1 : FA\_2015\_NA0001\_55\_85\_20150910\_00068.jpg

LM Start	<b>8.07</b>	Rating **	U	Issue No.	<b>85</b>
LM End	<b>8.07</b>	Issue Type +	En	Location *	LS
Category	Earthen Levee		GPS Latitude/Longitude		
			Start	End	
Item	Encroachments		38.560845 °	38.560845 °	
			-121.396189 °	-121.396189 °	
DWR ID	DWR_NA0001_04_s_2012_85				
Action/Comments					
Fence Inspector Comments: Brick fence is within 10-ft of levee toe and obstructs access and visibility.

03/16/2012 Brick wall completely obstructs access and visibility.

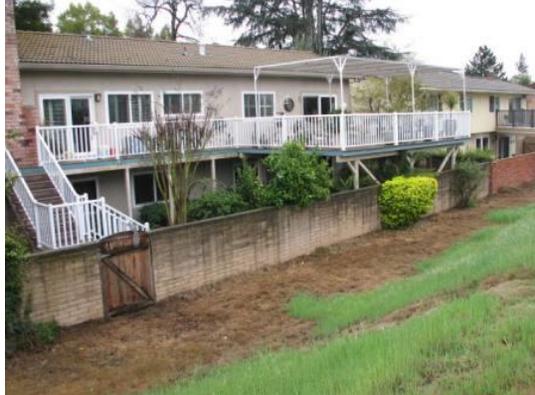
Photo 1 of 1 : FA\_2015\_NA0001\_55\_86\_20150910\_00069.jpg

LM Start	<b>8.08</b>	Rating **	U	Issue No.	<b>86</b>
LM End	<b>8.08</b>	Issue Type +	En	Location *	LS
Category	Earthen Levee		GPS Latitude/Longitude		
			Start	End	
Item	Encroachments		38.560907 °	38.560907 °	
			-121.396043 °	-121.396043 °	
DWR ID	DWR_NA0001_04_s_2012_86				
Action/Comments					
Fence Inspector Comments: Brick fence is within 10-ft of levee toe and obstructs access and visibility.

03/16/2012 Brick wall completely obstructs access and visibility.

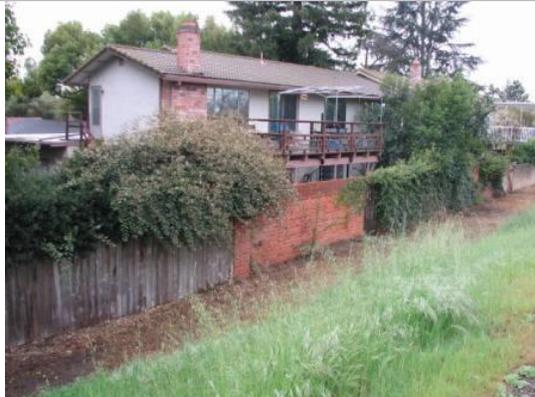
Photo 1 of 1 : FA\_2015\_NA0001\_55\_87\_20150910\_00070.jpg

LM Start	<b>8.09</b>	Rating **	U	Issue No.	<b>87</b>
LM End	<b>8.09</b>	Issue Type +	En	Location *	LS
Category	Earthen Levee		GPS Latitude/Longitude		
			Start	End	
Item	Encroachments		38.561008 °	38.561008 °	
			-121.395817 °	-121.395817 °	
DWR ID	DWR_NA0001_04_s_2012_87				
Action/Comments					
Fence Inspector Comments: Brick fence is within 10-ft of levee toe and obstructs access and visibility.

03/16/2012 Brick wall completely obstructs access and visibility.

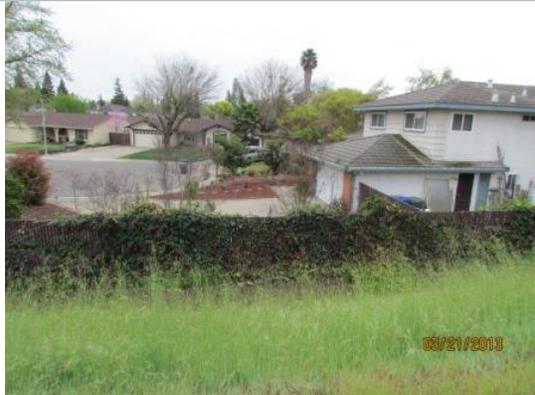
Photo 1 of 1 : FA\_2015\_NA0001\_55\_225\_20150910\_00178.jpg

LM Start	<b>8.13</b>	Rating **	M	Issue No.	<b>225</b>
LM End	<b>8.13</b>	Issue Type +	En	Location *	LS
Category	Earthen Levee		GPS Latitude/Longitude		
			Start	End	
Item	Vegetation		38.561248 °	38.561248 °	
			-121.395169 °	-121.395169 °	
DWR ID	DWR_NA0001_04_s_2012_225				
Action/Comments					
Landscaping Inspector Comments: Landscaping along chain link fence within 10-ft of levee toe obstructs access and visibility.

View of the landscaping at the levee toe.

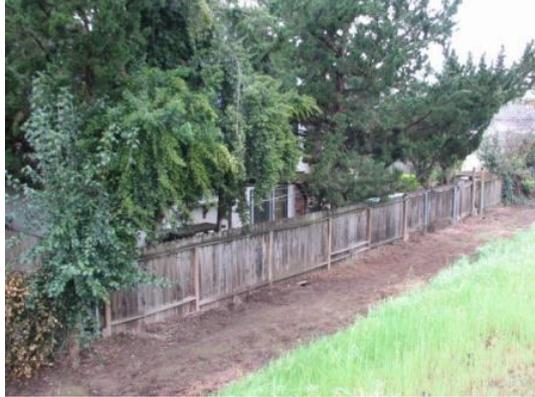
Photo 1 of 1 : FA\_2015\_NA0001\_55\_89\_20150910\_00072.jpg

LM Start	<b>8.16</b>	Rating **	U	Issue No.	<b>89</b>
LM End	<b>8.16</b>	Issue Type +	En	Location *	LS
Category	Earthen Levee		GPS Latitude/Longitude		
			Start	End	
Item	Encroachments		38.561467 °	38.561467 °	
			-121.394728 °	-121.394728 °	
DWR ID	DWR_NA0001_04_s_2012_89				
Action/Comments					
Fence Inspector Comments: Fence and landscaping arbor within 10-ft of levee toe obstructs access and visibility.

03/16/2012 Wood privacy fence completely obstructs access and visibility.

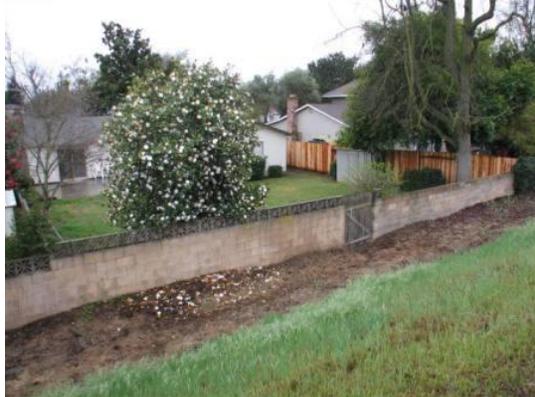
Photo 1 of 1 : FA\_2015\_NA0001\_55\_90\_20150910\_00073.jpg

LM Start	<b>8.17</b>	Rating **	U	Issue No.	<b>90</b>
LM End	<b>8.17</b>	Issue Type +	En	Location *	LS
Category	Earthen Levee		GPS Latitude/Longitude		
			Start	End	
Item	Encroachments		38.561544 °	38.561544 °	
			-121.394494 °	-121.394494 °	
DWR ID	DWR_NA0001_04_s_2012_90				
Action/Comments					
Fence Inspector Comments: Cement block fence within 10-ft of the levee toe.

03/16/2012 Cinder block wall completely obstructs access and visibility.

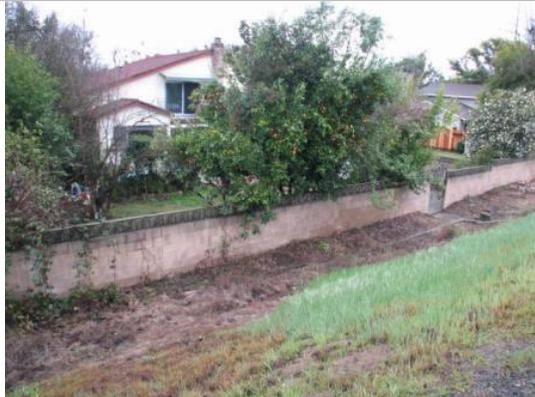
Photo 1 of 1 : FA\_2015\_NA0001\_55\_91\_20150910\_00074.jpg

LM Start	<b>8.18</b>	Rating **	U	Issue No.	<b>91</b>
LM End	<b>8.18</b>	Issue Type +	En	Location *	LS
Category	Earthen Levee		GPS Latitude/Longitude		
			Start	End	
Item	Encroachments		38.561593 °	38.561593 °	
			-121.394315 °	-121.394315 °	
DWR ID	DWR_NA0001_04_s_2012_91				
Action/Comments					
Fence Inspector Comments: Concrete block fence and landscaping within 10-ft of levee toe obstructs access and visibility.

03/16/2012 Cinder block wall completely obstructs access and visibility.

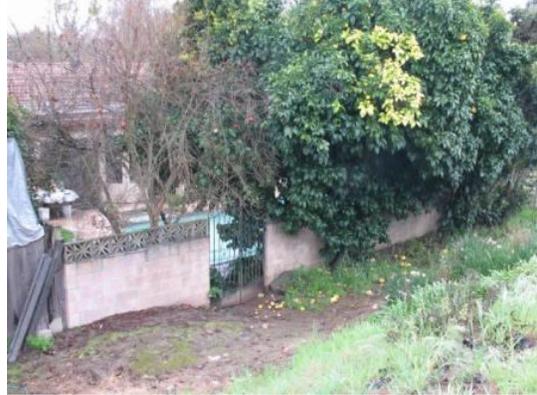
Photo 1 of 1 : FA\_2015\_NA0001\_55\_92\_20150910\_00075.jpg

LM Start	<b>8.19</b>	Rating **	U	Issue No.	<b>92</b>
LM End	<b>8.19</b>	Issue Type +	En	Location *	LS
Category	Earthen Levee		GPS Latitude/Longitude		
			Start	End	
Item	Encroachments		38.561658 °	38.561658 °	
			-121.394157 °	-121.394157 °	
DWR ID	DWR_NA0001_04_s_2012_92				
Action/Comments					
Fence Inspector Comments: Cement block fence and landscaping within 10-ft of levee toe obstructs access and visibility.

03/16/2012 Cinder block fence completely obstructs access and visibility.

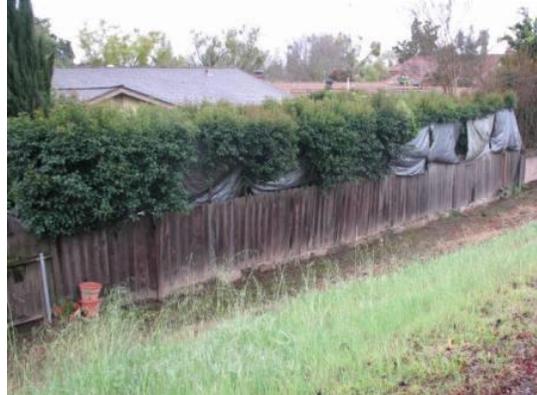
Photo 1 of 1 : FA\_2015\_NA0001\_55\_93\_20150910\_00076.jpg

LM Start	<b>8.21</b>	Rating **	U	Issue No.	<b>93</b>
LM End	<b>8.21</b>	Issue Type +	En	Location *	LS
Category	Earthen Levee		GPS Latitude/Longitude		
			Start	End	
Item	Encroachments		38.561750 °	38.561750 °	
			-121.393917 °	-121.393917 °	
DWR ID	DWR_NA0001_04_s_2012_93				
Action/Comments					
Fence Inspector Comments: Wooden fence, strung tarps, and landscaping within 10-ft of levee toe obstructs access and visibility.

03/16/2012 Wood privacy fence completely obstructs access and visibility.

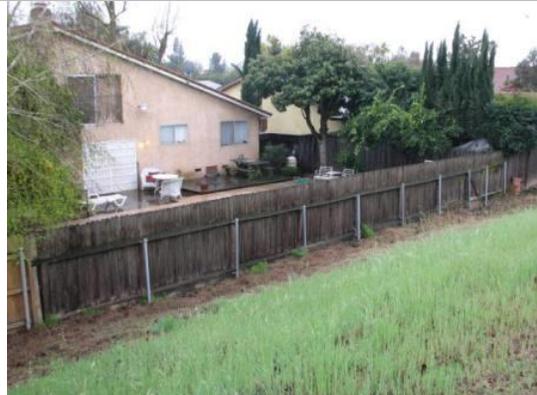
Photo 1 of 1 : FA\_2015\_NA0001\_55\_94\_20150910\_00077.jpg

LM Start	<b>8.21</b>	Rating **	U	Issue No.	<b>94</b>
LM End	<b>8.21</b>	Issue Type +	En	Location *	LS
Category	Earthen Levee		GPS Latitude/Longitude		
			Start	End	
Item	Encroachments		38.561799 °	38.561799 °	
			-121.393758 °	-121.393758 °	
DWR ID	DWR_NA0001_04_s_2012_94				
Action/Comments					
Fence Inspector Comments: Wood privacy fence and pool within 10-ft of levee toe obstructs access and visibility.

03/16/2012 Wood privacy fence completely obstructs access and visibility.

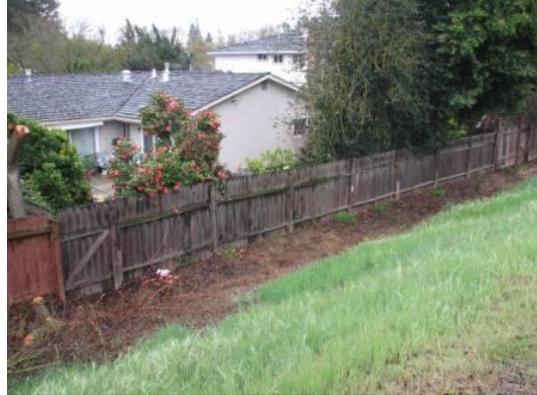
Photo 1 of 1 : FA\_2015\_NA0001\_55\_99\_20150910\_00082.jpg

LM Start	<b>8.26</b>	Rating **	U	Issue No.	<b>99</b>
LM End	<b>8.26</b>	Issue Type +	En	Location *	LS
Category	Earthen Levee		GPS Latitude/Longitude		
			Start	End	
Item	Encroachments		38.562120 °	38.562120 °	
			-121.392983 °	-121.392983 °	
DWR ID	DWR_NA0001_04_s_2012_99				
Action/Comments					
Fence Inspector Comments: Wood privacy fence within 10-ft of levee toe obstructs access and visibility.

03/16/2012 Wood privacy fence completely obstructs access and visibility.

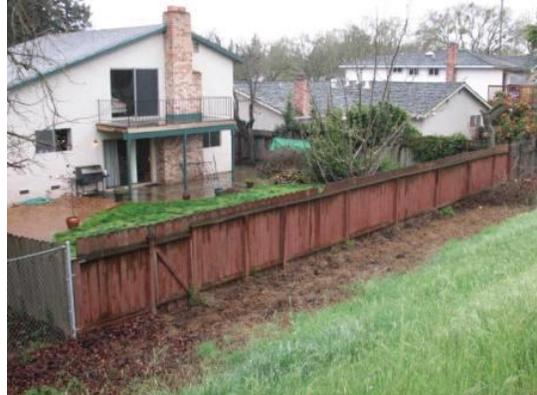
Photo 1 of 1 : FA\_2015\_NA0001\_55\_100\_20150910\_00083.jpg

LM Start	<b>8.27</b>	Rating **	U	Issue No.	<b>100</b>
LM End	<b>8.27</b>	Issue Type +	En	Location *	LS
Category	Earthen Levee		GPS Latitude/Longitude		
			Start	End	
Item	Encroachments		38.562182 °	38.562182 °	
			-121.392778 °	-121.392778 °	
DWR ID	DWR_NA0001_04_s_2012_100				
Action/Comments					
Fence Inspector Comments: Wood privacy fence within 10-ft of levee toe obstructs access and visibility.

03/16/2012 Wood privacy fence completely obstructs access and visibility.

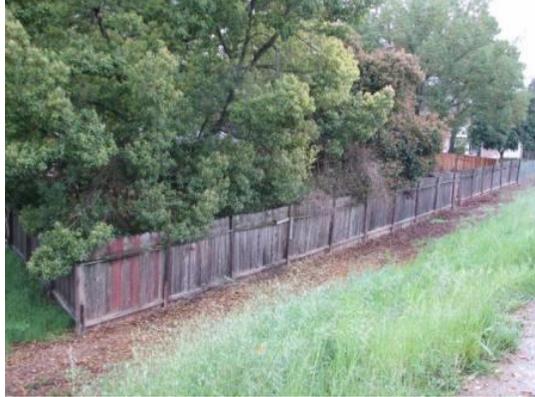
Photo 1 of 1 : FA\_2015\_NA0001\_55\_101\_20150910\_00084.jpg

LM Start	<b>8.32</b>	Rating **	U	Issue No.	<b>101</b>
LM End	<b>8.32</b>	Issue Type +	En	Location *	LS
Category	Earthen Levee		GPS Latitude/Longitude		
			Start	End	
Item	Encroachments		38.562508 °	38.562508 °	
			-121.392037 °	-121.392037 °	
DWR ID	DWR_NA0001_04_s_2012_101				
Action/Comments					
Fence Inspector Comments: Wood privacy fence within 10-ft of levee toe obstructs access and visibility.

03/16/2012 Wood privacy fence completely obstructs access and visibility.

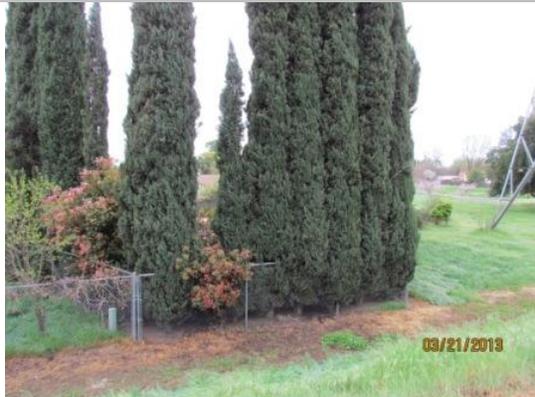
Photo 1 of 1 : FA\_2015\_NA0001\_55\_102\_20150910\_00085.jpg

LM Start	<b>8.38</b>	Rating **	M	Issue No.	<b>102</b>
LM End	<b>8.38</b>	Issue Type +	En	Location *	LS
Category	Earthen Levee		GPS Latitude/Longitude		
			Start	End	
Item	Vegetation		38.562889 °	38.562889 °	
			-121.391042 °	-121.391042 °	
DWR ID	DWR_NA0001_04_s_2012_102				
Action/Comments					
Landscaping Inspector Comments: Helix sky pencil along chain link fence is within 10-ft of the levee toe.

View of the landscaping at the levee toe.

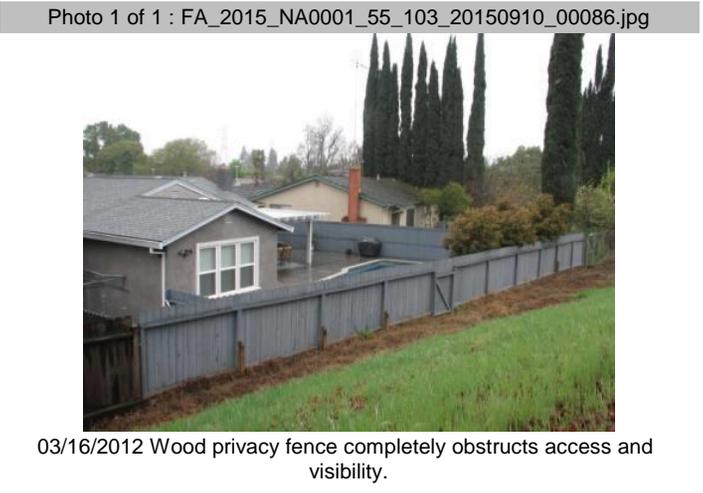
LM Start	<b>8.40</b>	Rating **	U	Issue No.	<b>103</b>
LM End	<b>8.40</b>	Issue Type +	En	Location *	LS
Category	Earthen Levee		GPS Latitude/Longitude		
			Start	End	
Item	Encroachments		38.563042 °	38.563042 °	
			-121.390692 °	-121.390692 °	
DWR ID	DWR_NA0001_04_s_2012_103				
Action/Comments					
Fence Inspector Comments: Wood privacy fence within 10-ft of levee toe obstructs access and visibility.

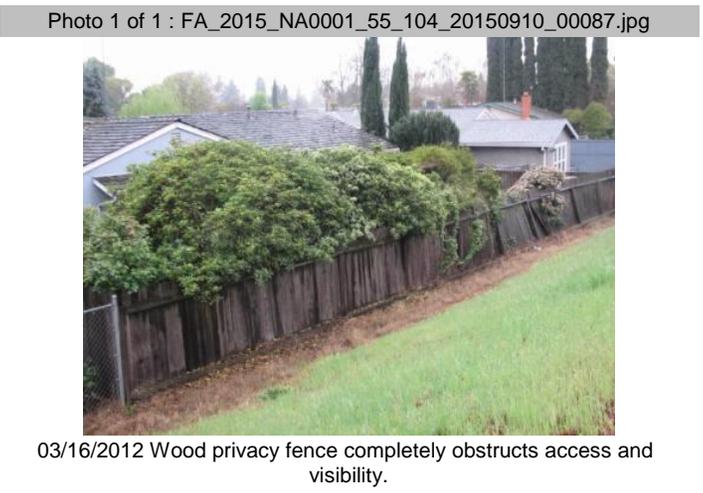
LM Start	<b>8.41</b>	Rating **	U	Issue No.	<b>104</b>
LM End	<b>8.41</b>	Issue Type +	En	Location *	LS
Category	Earthen Levee		GPS Latitude/Longitude		
			Start	End	
Item	Encroachments		38.563108 °	38.563108 °	
			-121.390452 °	-121.390452 °	
DWR ID	DWR_NA0001_04_s_2012_104				
Action/Comments					
Fence Inspector Comments: Wood privacy fence within 10-ft of levee toe obstructs access and visibility.

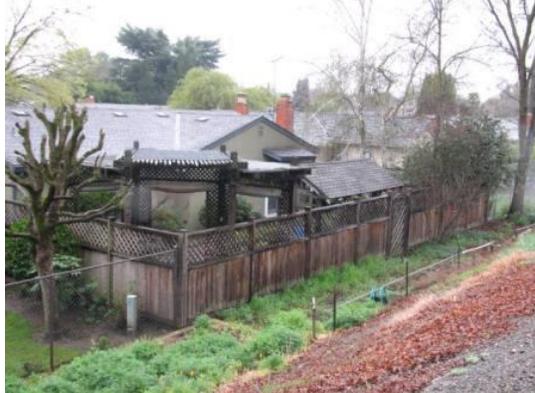
Photo 1 of 1 : FA\_2015\_NA0001\_55\_106\_20150910\_00089.jpg

LM Start	<b>8.45</b>	Rating **	U	Issue No.	<b>106</b>
LM End	<b>8.45</b>	Issue Type +	En	Location *	LS
Category	Earthen Levee		GPS Latitude/Longitude		
			Start	End	
Item	Encroachments		38.563308 °	38.563308 °	
			-121.389885 °	-121.389885 °	
DWR ID	DWR_NA0001_04_s_2012_106				
Action/Comments					
Fence Inspector Comments: Wood privacy fence within 10-ft of levee toe obstructs access and visibility. Block wall built into the levee.

03/16/2012 Wood privacy fence completely obstructs access and visibility.

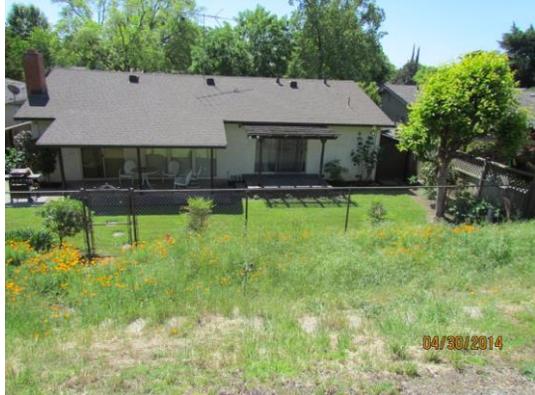
Photo 1 of 1 : FA\_2015\_NA0001\_55\_246\_20150910\_00190.jpg

LM Start	<b>8.46</b>	Rating **	M	Issue No.	<b>246</b>
LM End	<b>8.46</b>	Issue Type +	En	Location *	LS
Category	Earthen Levee		GPS Latitude/Longitude		
			Start	End	
Item	Encroachments		38.563434 °	38.563434 °	
			-121.389675 °	-121.389675 °	
DWR ID	DWR_NA0001_04_s_2014_246				
Action/Comments					
Retaining Wall Inspector Comments: Retaining wall and irrigation at landside levee toe.

View of the irrigation and retaining wall at the landside levee toe.

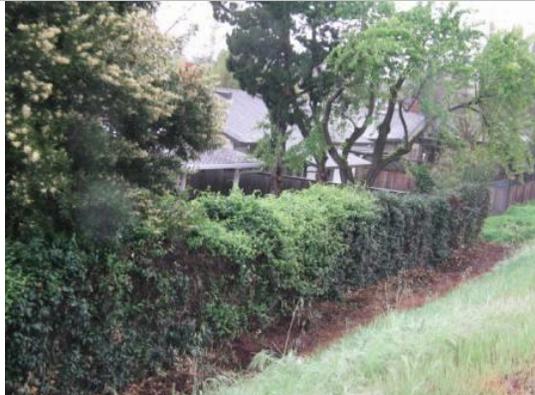
Photo 1 of 1 : FA\_2015\_NA0001\_55\_107\_20150910\_00090.jpg

LM Start	<b>8.47</b>	Rating **	U	Issue No.	<b>107</b>
LM End	<b>8.47</b>	Issue Type +	En	Location *	LS
Category	Earthen Levee		GPS Latitude/Longitude		
			Start	End	
Item	Vegetation		38.563511 °	38.563511 °	
			-121.389509 °	-121.389509 °	
DWR ID	DWR_NA0001_04_s_2012_107				
Action/Comments					
Landscaping

03/16/2012 Landscaping obstructs visibility and access.

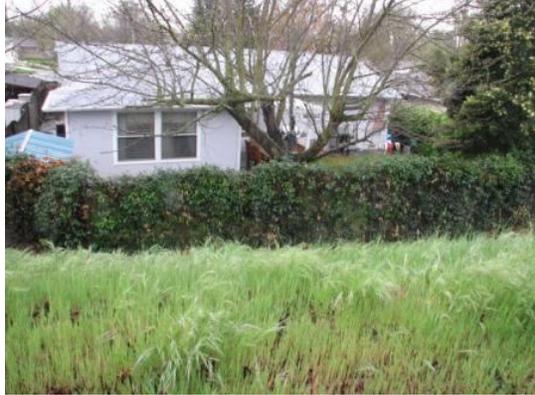
Photo 1 of 1 : FA\_2015\_NA0001\_55\_108\_20150910\_00091.jpg

LM Start	<b>8.48</b>	Rating **	U	Issue No.	<b>108</b>
LM End	<b>8.48</b>	Issue Type +	En	Location *	LS
Category	Earthen Levee		GPS Latitude/Longitude		
			Start	End	
Item	Vegetation		38.563587 °	38.563587 °	
			-121.389313 °	-121.389313 °	
DWR ID	DWR_NA0001_04_s_2012_108				
Action/Comments					
Landscaping

03/16/2012 Landscaping obstructs visibility and access.

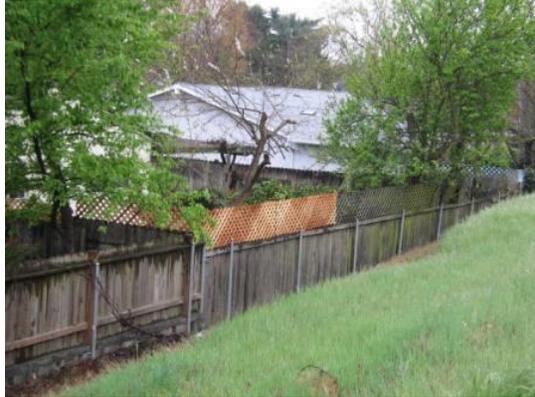
Photo 1 of 1 : FA\_2015\_NA0001\_55\_109\_20150910\_00092.jpg

LM Start	<b>8.49</b>	Rating **	U	Issue No.	<b>109</b>
LM End	<b>8.49</b>	Issue Type +	En	Location *	LS
Category	Earthen Levee		GPS Latitude/Longitude		
			Start	End	
Item	Encroachments		38.563580 °	38.563580 °	
			-121.389140 °	-121.389140 °	
DWR ID	DWR_NA0001_04_s_2012_109				
Action/Comments					
Fence Inspector Comments: Wood privacy fence within 10-ft of levee toe obstructs access and visibility.

03/16/2012 Wood privacy fence completely obstructs access and visibility.

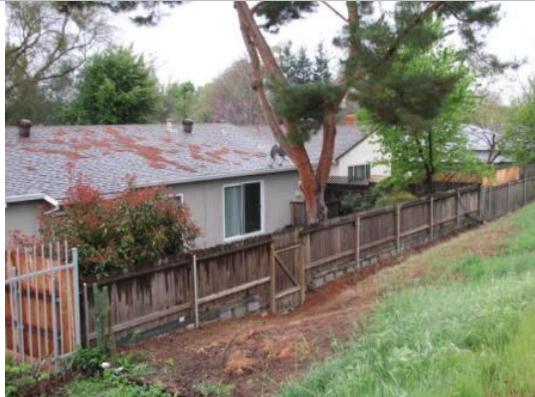
Photo 1 of 1 : FA\_2015\_NA0001\_55\_110\_20150910\_00093.jpg

LM Start	<b>8.51</b>	Rating **	U	Issue No.	<b>110</b>
LM End	<b>8.51</b>	Issue Type +	En	Location *	LS
Category	Earthen Levee		GPS Latitude/Longitude		
			Start	End	
Item	Encroachments		38.563732 °	38.563732 °	
			-121.388930 °	-121.388930 °	
DWR ID	DWR_NA0001_04_s_2012_110				
Action/Comments					
Fence Inspector Comments: Wood privacy fence within 10-ft of levee toe obstructs access and visibility.

03/16/2012 Wood privacy fence completely obstructs access and visibility.

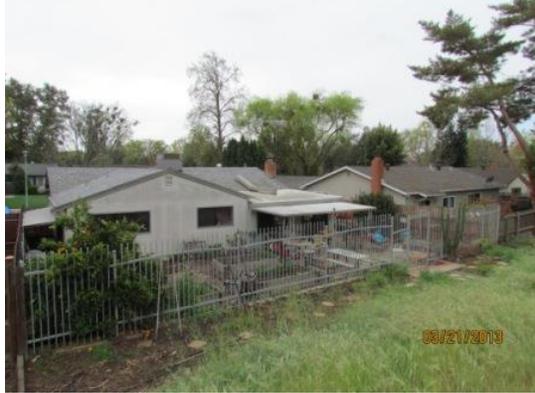
Photo 1 of 1 : FA\_2015\_NA0001\_55\_226\_20150910\_00179.jpg

LM Start	<b>8.52</b>	Rating **	M	Issue No.	<b>226</b>
LM End	<b>8.52</b>	Issue Type +	En	Location *	LS
Category	Earthen Levee		GPS Latitude/Longitude		
			Start	End	
Item	Vegetation		38.563793 °	38.563793 °	
			-121.388758 °	-121.388758 °	
DWR ID	DWR_NA0001_04_s_2012_226				
Action/Comments					
Landscaping Inspector Comments: Garden, trees and cactus planted against the levee toe.

View of landscaping at the levee toe.

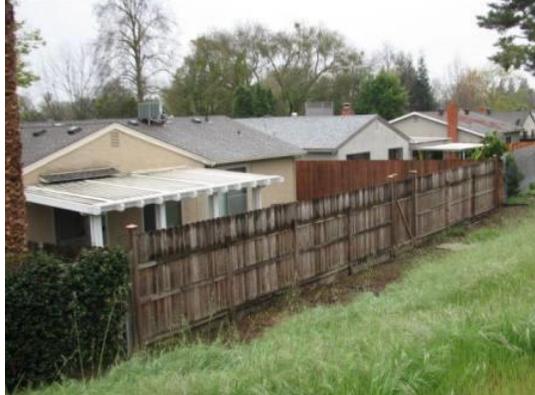
Photo 1 of 1 : FA\_2015\_NA0001\_55\_111\_20150910\_00094.jpg

LM Start	<b>8.53</b>	Rating **	U	Issue No.	<b>111</b>
LM End	<b>8.53</b>	Issue Type +	En	Location *	LS
Category	Earthen Levee		GPS Latitude/Longitude		
			Start	End	
Item	Encroachments		38.563820 °	38.563820 °	
			-121.388518 °	-121.388518 °	
DWR ID	DWR_NA0001_04_s_2012_111				
Action/Comments					
Fence Inspector Comments: Wood privacy fence within 10-ft of levee toe obstructs access and visibility.

03/16/2012 Wood privacy fence completely obstructs access and visibility.

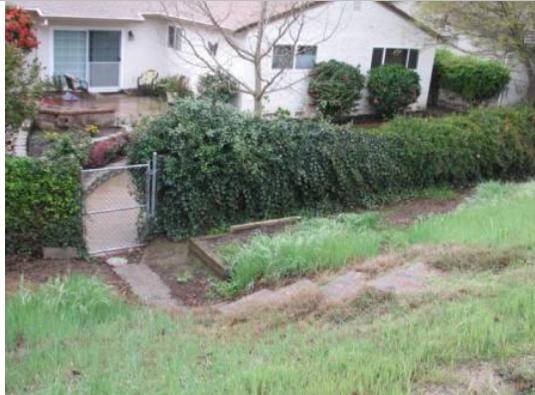
Photo 1 of 1 : FA\_2015\_NA0001\_55\_113\_20150910\_00096.jpg

LM Start	<b>8.55</b>	Rating **	U	Issue No.	<b>113</b>
LM End	<b>8.55</b>	Issue Type +	En	Location *	LS
Category	Earthen Levee		GPS Latitude/Longitude		
			Start	End	
Item	Vegetation		38.563963 °	38.563963 °	
			-121.388135 °	-121.388135 °	
DWR ID	DWR_NA0001_04_s_2012_113				
Action/Comments					
Landscaping

03/16/2012 Landscaping on chainlink fence blocks visibility and access.

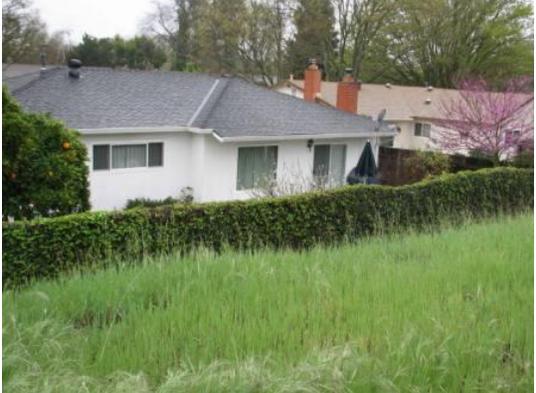
Photo 1 of 1 : FA\_2015\_NA0001\_55\_114\_20150910\_00097.jpg

LM Start	<b>8.57</b>	Rating **	U	Issue No.	<b>114</b>
LM End	<b>8.57</b>	Issue Type +	En	Location *	LS
Category	Earthen Levee		GPS Latitude/Longitude		
			Start	End	
Item	Vegetation		38.564020 °	38.564020 °	
			-121.387887 °	-121.387887 °	
DWR ID	DWR_NA0001_04_s_2012_114				
Action/Comments					
Landscaping Inspector Comments: Ivy and orange tree obstruct visibility.

03/16/2012 Ivy on chainlink fence completely obstructs visibility and access.

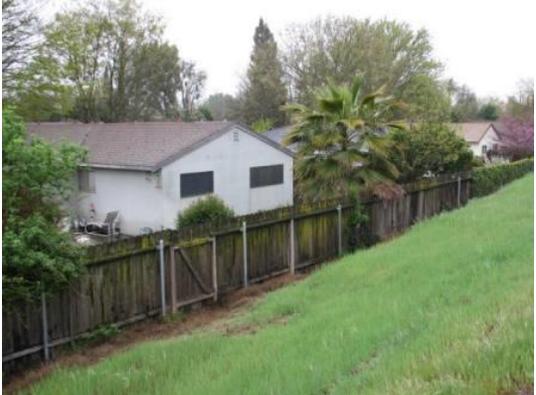
Photo 1 of 1 : FA\_2015\_NA0001\_55\_115\_20150910\_00098.jpg

LM Start	<b>8.58</b>	Rating **	U	Issue No.	<b>115</b>
LM End	<b>8.58</b>	Issue Type +	En	Location *	LS
Category	Earthen Levee		GPS Latitude/Longitude		
			Start	End	
Item	Encroachments		38.564047 °	38.564047 °	
			-121.387743 °	-121.387743 °	
DWR ID	DWR_NA0001_04_s_2012_115				
Action/Comments					
Fence Inspector Comments: Wood privacy fence within 10-ft of levee toe obstructs access and visibility.

03/16/2012 Wood privacy fence completely obstructs access and visibility.

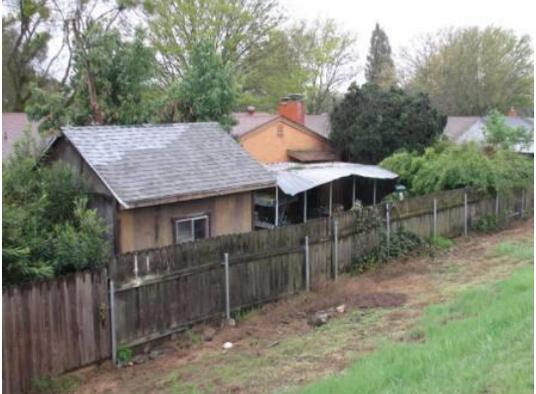
Photo 1 of 1 : FA\_2015\_NA0001\_55\_117\_20150910\_00100.jpg

LM Start	<b>8.59</b>	Rating **	U	Issue No.	<b>117</b>
LM End	<b>8.59</b>	Issue Type +	En	Location *	LS
Category	Earthen Levee		GPS Latitude/Longitude		
			Start	End	
Item	Encroachments		38.564094 °	38.564094 °	
			-121.387498 °	-121.387498 °	
DWR ID	DWR_NA0001_04_s_2012_117				
Action/Comments					
Fence Inspector Comments: Wood privacy fence and wood out building within 10-ft of levee toe obstructs access and visibility.

03/16/2012 Wood privacy fence completely obstructs access and visibility.

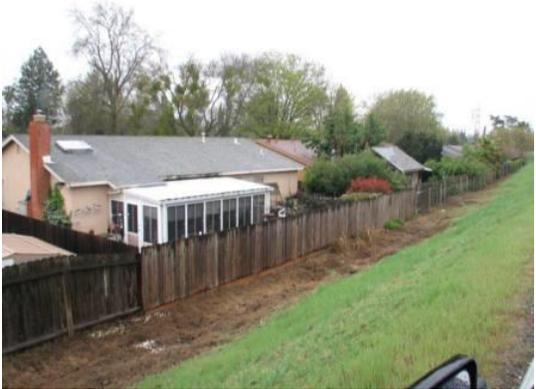
Photo 1 of 1 : FA\_2015\_NA0001\_55\_116\_20150910\_00099.jpg

LM Start	<b>8.60</b>	Rating **	U	Issue No.	<b>116</b>
LM End	<b>8.60</b>	Issue Type +	En	Location *	LS
Category	Earthen Levee			GPS Latitude/Longitude	
				Start	End
Item	Encroachments			38.564133 °	38.564133 °
				-121.387318 °	-121.387318 °
DWR ID	DWR_NA0001_04_s_2012_116				
Action/Comments					
Fence Inspector Comments: Wood privacy fence within 10-ft of levee toe obstructs access and visibility.

03/16/2012 Wood privacy fence completely obstructs access and visibility.

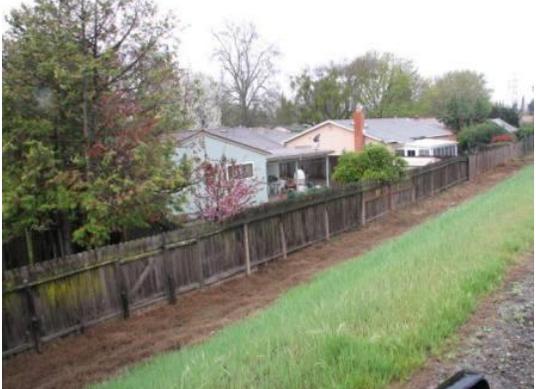
Photo 1 of 1 : FA\_2015\_NA0001\_55\_118\_20150910\_00101.jpg

LM Start	<b>8.61</b>	Rating **	U	Issue No.	<b>118</b>
LM End	<b>8.61</b>	Issue Type +	En	Location *	LS
Category	Earthen Levee			GPS Latitude/Longitude	
				Start	End
Item	Encroachments			38.564133 °	38.564133 °
				-121.387092 °	-121.387092 °
DWR ID	DWR_NA0001_04_s_2012_118				
Action/Comments					
Fence Inspector Comments: Wood privacy fence within 10-ft of levee toe obstructs access and visibility.

03/16/2012 Wood privacy fence completely obstructs access and visibility.

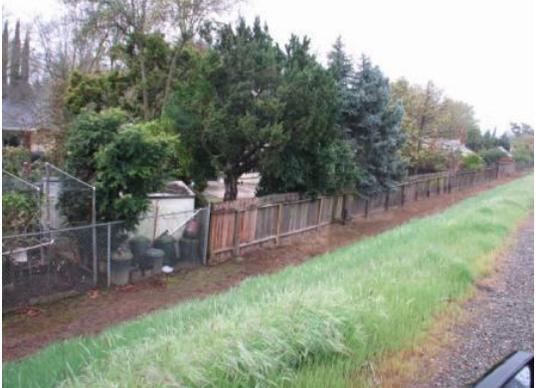
Photo 1 of 1 : FA\_2015\_NA0001\_55\_119\_20150910\_00102.jpg

LM Start	<b>8.63</b>	Rating **	U	Issue No.	<b>119</b>
LM End	<b>8.63</b>	Issue Type +	En	Location *	LS
Category	Earthen Levee		GPS Latitude/Longitude		
			Start	End	
Item	Encroachments		38.564217 °	38.564217 °	
			-121.386846 °	-121.386846 °	
DWR ID	DWR_NA0001_04_s_2012_119				
Action/Comments					
Fence Inspector Comments: Wood privacy fence within 10-ft of levee toe obstructs access and visibility.

03/16/2012 Wood privacy fence completely obstructs access and visibility.

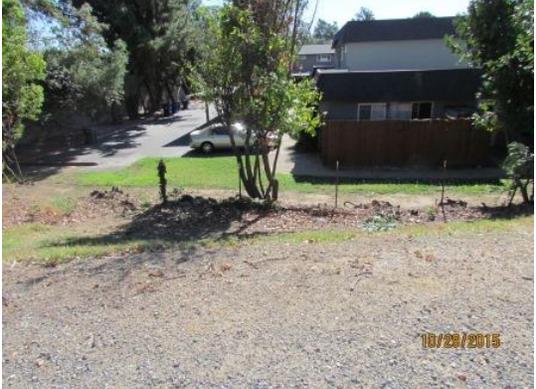
Photo 1 of 1 : FA\_2015\_NA0001\_55\_230\_20151112\_00213.jpg

LM Start	<b>8.83</b>	Rating **	N	Issue No.	<b>230</b>
LM End	<b>8.83</b>	Issue Type +	Ma	Location *	LS
Category	Earthen Levee		GPS Latitude/Longitude		
			Start	End	
Item	Trim / Thin Trees		38.564929 °	38.564929 °	
			-121.383248 °	-121.383248 °	
DWR ID	DWR_NA0001_04_f_2015_230				
Action/Comments					
Tree stumps. Inspector Comments: 5 shrub stumps with multiple branches.

View of the multiple tree stumps at the landside levee toe.

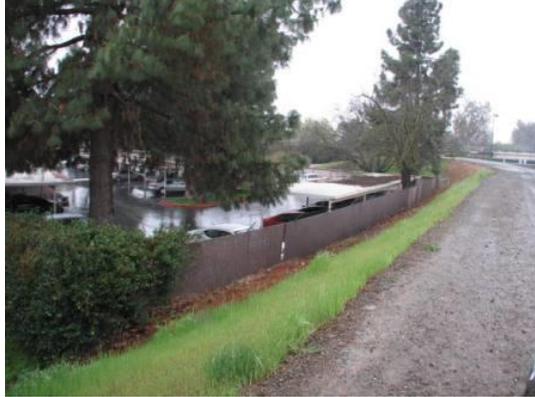
Photo 1 of 1 : FA\_2015\_NA0001\_55\_235\_20150910\_00181.jpg

LM Start	<b>8.90</b>	Rating **	U	Issue No.	<b>235</b>
LM End	<b>8.90</b>	Issue Type +	En	Location *	LS
Category	Earthen Levee		GPS Latitude/Longitude		
			Start	End	
Item	Encroachments		38.565352 °	38.565352 °	
			-121.382044 °	-121.382044 °	
DWR ID	DWR_NA0001_04_s_2012_235				
Action/Comments					
Fence Inspector Comments: Chain link fence with privacy slats and barbed wire within 10-ft of levee toe obstructs access and visibility.

03/16/2012 Chainlink fence with privacy slats and barbed wire obstruct visibility and access.

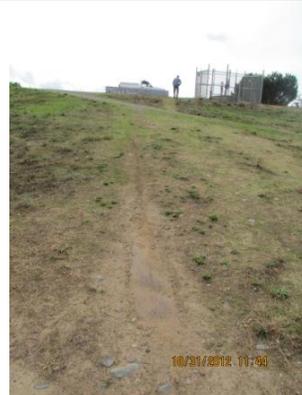
Photo 1 of 2 : FA\_2015\_NA0001\_55\_175\_20150910\_00150.jpg

LM Start	<b>9.41</b>	Rating **	A/W	Issue No.	<b>175</b>
LM End	<b>9.41</b>	Issue Type +	En	Location *	WS
Category	Earthen Levee		GPS Latitude/Longitude		
			Start	End	
Item	Encroachments		38.566700 °	38.566700 °	
			-121.372961 °	-121.372961 °	
DWR ID	DWR_NA0001_04_s_2012_175				
Action/Comments					
Pipe Inspector Comments: Flap gates in good condition. Pipe is exposed at waterside toe.

View of exposed pipe at waterside toe.

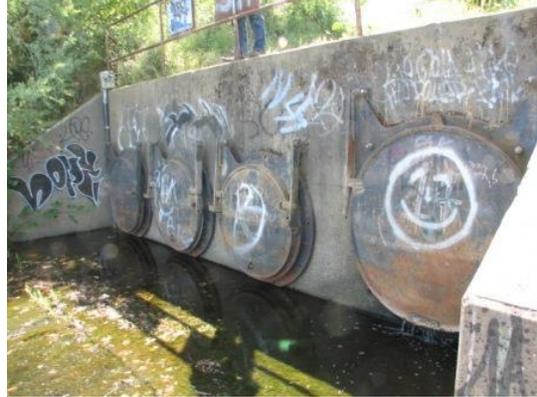
Photo 2 of 2 : FA\_2015\_NA0001\_55\_175\_20150910\_00151.jpg

LM Start	<b>9.41</b>	Rating **	A/W	Issue No.	<b>175 (cont)</b>
LM End	<b>9.41</b>	Issue Type +	En	Location *	WS
Category	Earthen Levee			GPS Latitude/Longitude	
				Start	End
Item	Encroachments			38.566700 °	38.566700 °
				-121.372961 °	-121.372961 °
DWR ID	DWR_NA0001_04_s_2012_175				
Action/Comments					
Pipe Inspector Comments: Flap gates in good condition. Pipe is exposed at waterside toe.

Drainage outfall to American River.

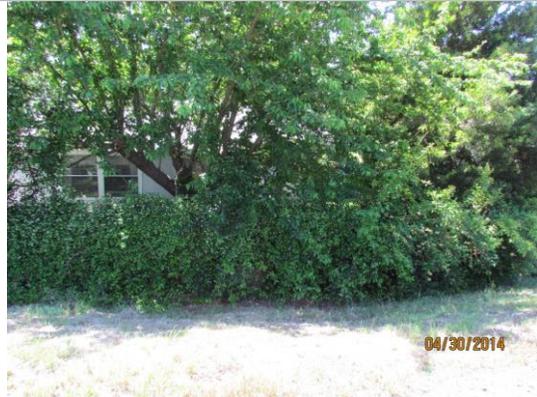
Photo 1 of 1 : FA\_2015\_NA0001\_55\_236\_20150910\_00182.jpg

LM Start	<b>9.48</b>	Rating **	M	Issue No.	<b>236</b>
LM End	<b>9.48</b>	Issue Type +	En	Location *	LS
Category	Earthen Levee			GPS Latitude/Longitude	
				Start	End
Item	Vegetation			38.566948 °	38.566948 °
				-121.371562 °	-121.371562 °
DWR ID	DWR_NA0001_04_s_2012_236				
Action/Comments					
Landscaping Inspector Comments: Landscaping within 10-ft of levee toe.

View of the landscaping at the landside levee to obstructing visibility and access.

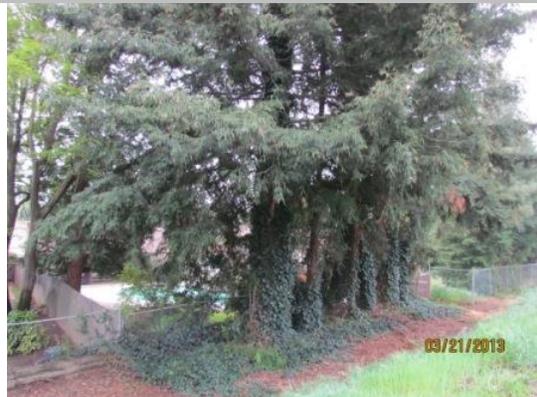
Photo 1 of 1 : FA\_2015\_NA0001\_55\_237\_20150910\_00183.jpg

LM Start	<b>9.48</b>	Rating **	M	Issue No.	<b>237</b>
LM End	<b>9.48</b>	Issue Type +	En	Location *	LS
Category	Earthen Levee			GPS Latitude/Longitude	
				Start	End
Item	Vegetation			38.566938 °	38.566938 °
				-121.371550 °	-121.371550 °
DWR ID	DWR_NA0001_04_s_2012_237				
Action/Comments					
Landscaping Inspector Comments: Redwoods and ivy along fence within 10-ft of levee toe.

View of landscaping at levee toe.

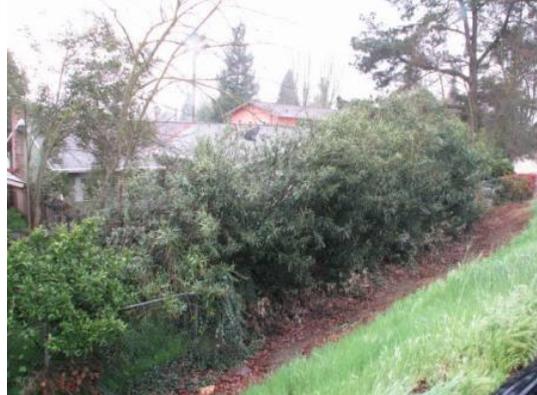
Photo 1 of 1 : FA\_2015\_NA0001\_55\_121\_20150910\_00103.jpg

LM Start	<b>9.52</b>	Rating **	U	Issue No.	<b>121</b>
LM End	<b>9.52</b>	Issue Type +	En	Location *	LS
Category	Earthen Levee		GPS Latitude/Longitude		
			Start	End	
Item	Vegetation		38.567058 °	38.567058 °	
			-121.370954 °	-121.370954 °	
DWR ID	DWR_NA0001_04_s_2012_121				
Action/Comments					
Landscaping Inspector Comments: Oleander bushes and shrubs within 10-ft of landside toe.

03/16/2012 Landscaping obstructs visibility and access.

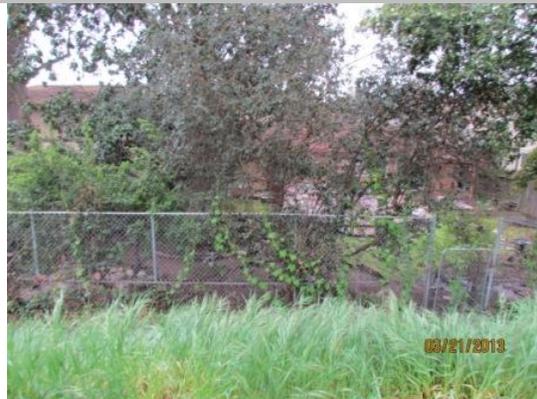
Photo 1 of 1 : FA\_2015\_NA0001\_55\_122\_20150910\_00104.jpg

LM Start	<b>9.55</b>	Rating **	M	Issue No.	<b>122</b>
LM End	<b>9.55</b>	Issue Type +	En	Location *	LS
Category	Earthen Levee		GPS Latitude/Longitude		
			Start	End	
Item	Vegetation		38.567181 °	38.567181 °	
			-121.370366 °	-121.370366 °	
DWR ID	DWR_NA0001_04_s_2012_122				
Action/Comments					
Landscaping Inspector Comments: Trees and ground cover within 10-ft of levee toe.

View of landscaping at levee toe.

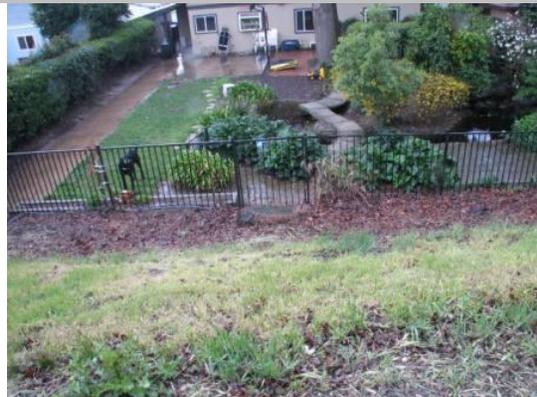
Photo 1 of 1 : FA\_2015\_NA0001\_55\_123\_20150910\_00105.jpg

LM Start	<b>9.57</b>	Rating **	N	Issue No.	<b>123</b>
LM End	<b>9.57</b>	Issue Type +	Ma	Location *	LS
Category	Earthen Levee		GPS Latitude/Longitude		
			Start	End	
Item	Trim / Thin Trees		38.567285 °	38.567285 °	
			-121.369964 °	-121.369964 °	
DWR ID	DWR_NA0001_04_s_2012_123				
Action/Comments					
Tree stumps. Inspector Comments: Trees, bushes and ground cover within 10-ft of levee toe.

03/16/2012 Large tree stump at levee toe.

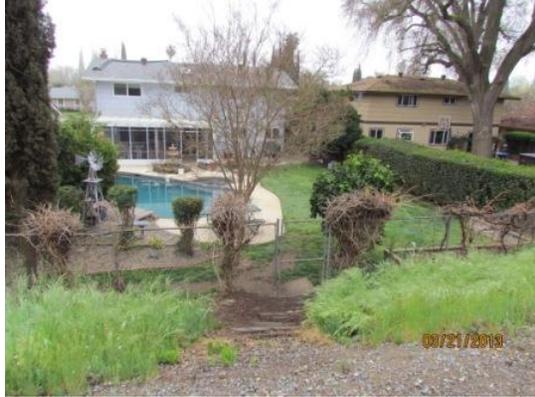
Photo 1 of 1 : FA\_2015\_NA0001\_55\_124\_20150910\_00106.jpg

LM Start	<b>9.58</b>	Rating **	M	Issue No.	<b>124</b>
LM End	<b>9.58</b>	Issue Type +	En	Location *	LS
Category	Earthen Levee		GPS Latitude/Longitude		
			Start	End	
Item	Vegetation		38.567242 °	38.567242 °	
			-121.369858 °	-121.369858 °	
DWR ID	DWR_NA0001_04_s_2012_124				
Action/Comments					
Landscaping Inspector Comments: Ivy and vines on chain link fence within 10-ft of levee toe.

View of landscaping at levee toe.

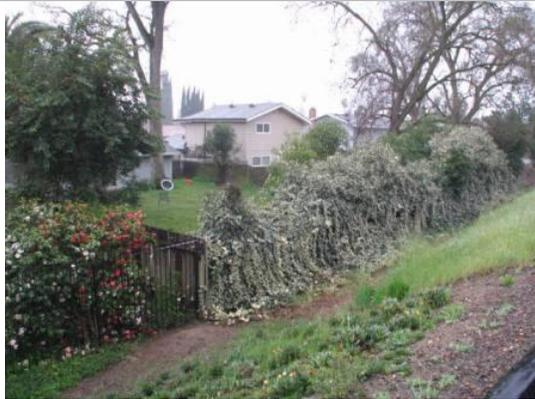
Photo 1 of 1 : FA\_2015\_NA0001\_55\_125\_20150910\_00107.jpg

LM Start	<b>9.60</b>	Rating **	U	Issue No.	<b>125</b>
LM End	<b>9.60</b>	Issue Type +	En	Location *	LS
Category	Earthen Levee		GPS Latitude/Longitude		
			Start	End	
Item	Vegetation		38.567360 °	38.567360 °	
			-121.369555 °	-121.369555 °	
DWR ID	DWR_NA0001_04_s_2012_125				
Action/Comments					
Landscaping Inspector Comments: Dense golden ivy on C/L fence obstructs access and visibility.

03/16/2012 Landscaping obstructs visibility and access.

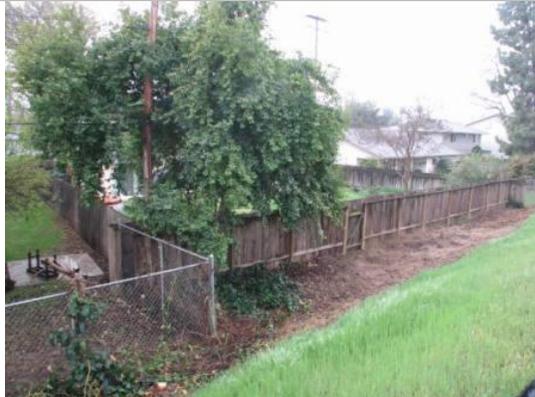
Photo 1 of 1 : FA\_2015\_NA0001\_55\_128\_20150910\_00108.jpg

LM Start	<b>9.65</b>	Rating **	U	Issue No.	<b>128</b>
LM End	<b>9.65</b>	Issue Type +	En	Location *	LS
Category	Earthen Levee		GPS Latitude/Longitude		
			Start	End	
Item	Encroachments		38.567493 °	38.567493 °	
			-121.368633 °	-121.368633 °	
DWR ID	DWR_NA0001_04_s_2012_128				
Action/Comments					
Fence Inspector Comments: Wooden privacy fence within 10-ft of levee toe.

03/16/2012 Wood privacy fence completely obstructs access and visibility.

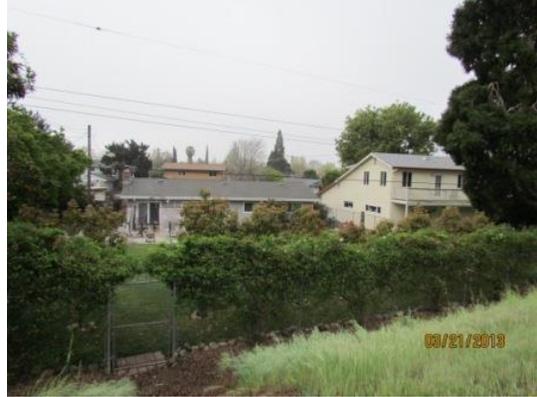
Photo 1 of 1 : FA\_2015\_NA0001\_55\_129\_20150910\_00109.jpg

LM Start	<b>9.67</b>	Rating **	M	Issue No.	<b>129</b>
LM End	<b>9.67</b>	Issue Type +	En	Location *	LS
Category	Earthen Levee		GPS Latitude/Longitude		
			Start	End	
Item	Vegetation		38.567594 °	38.567594 °	
			-121.368195 °	-121.368195 °	
DWR ID	DWR_NA0001_04_s_2012_129				
Action/Comments					
Landscaping Inspector Comments: Trees and vines along C/L fence within 10-ft of levee toe.

View of landscaping at levee toe.

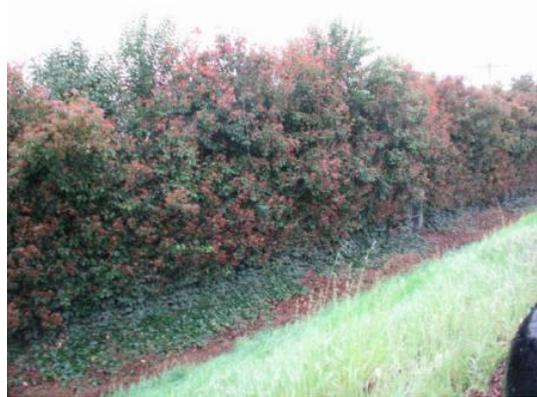
Photo 1 of 1 : FA\_2015\_NA0001\_55\_130\_20150910\_00110.jpg

LM Start	<b>9.69</b>	Rating **	U	Issue No.	<b>130</b>
LM End	<b>9.69</b>	Issue Type +	En	Location *	LS
Category	Earthen Levee		GPS Latitude/Longitude		
			Start	End	
Item	Vegetation		38.567626 °	38.567626 °	
			-121.367921 °	-121.367921 °	
DWR ID	DWR_NA0001_04_s_2012_130				
Action/Comments					
Landscaping Inspector Comments: Tall hedge obstructs access and visibility.

03/16/2012 Tall hedge obstructs visibility and access.

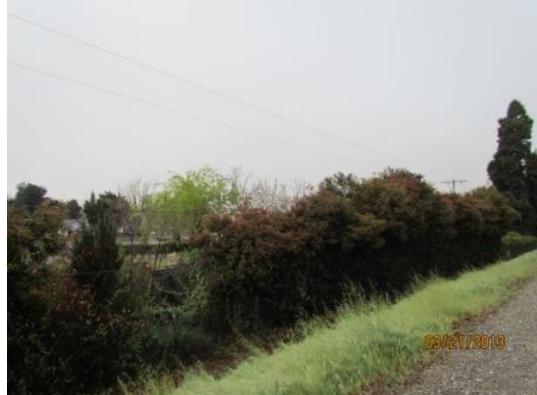
Photo 1 of 1 : FA\_2015\_NA0001\_55\_131\_20150910\_00111.jpg

LM Start	<b>9.70</b>	Rating **	M	Issue No.	<b>131</b>
LM End	<b>9.70</b>	Issue Type +	En	Location *	LS
Category	Earthen Levee		GPS Latitude/Longitude		
			Start	End	
Item	Vegetation		38.567680 °	38.567680 °	
			-121.367674 °	-121.367674 °	
DWR ID	DWR_NA0001_04_s_2012_131				
Action/Comments					
Landscaping Inspector Comments: Tall hedge obstructs access and visibility.

View of landscaping at levee toe.

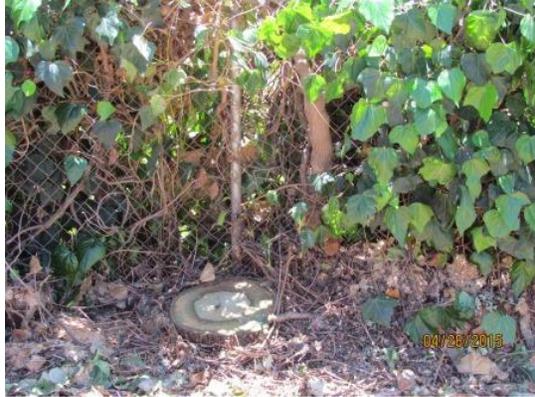
Photo 1 of 1 : FA\_2015\_NA0001\_55\_234\_20150910\_00180.jpg

LM Start	<b>9.72</b>	Rating **	N	Issue No.	<b>234</b>
LM End	<b>9.72</b>	Issue Type +	Ma	Location *	LS
Category	Earthen Levee		GPS Latitude/Longitude		
			Start	End	
Item	Trim / Thin Trees		38.567761 °	38.567761 °	
			-121.367363 °	-121.367363 °	
DWR ID	DWR_NA0001_04_s_2015_234				
Action/Comments					
Tree stumps.

View of the tree stump at the landside levee toe.

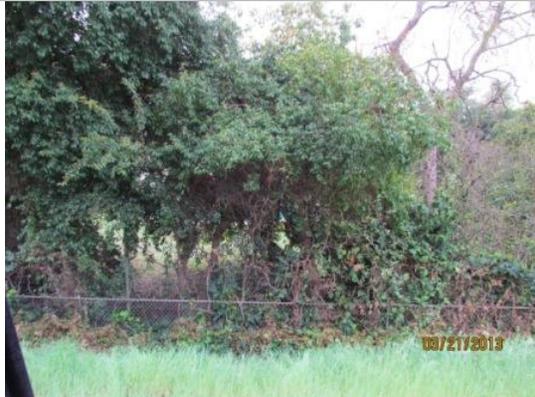
Photo 1 of 1 : FA\_2015\_NA0001\_55\_132\_20150910\_00112.jpg

LM Start	<b>9.72</b>	Rating **	M	Issue No.	<b>132</b>
LM End	<b>9.72</b>	Issue Type +	En	Location *	LS
Category	Earthen Levee		GPS Latitude/Longitude		
			Start	End	
Item	Vegetation		38.567772 °	38.567772 °	
			-121.367227 °	-121.367227 °	
DWR ID	DWR_NA0001_04_s_2012_132				
Action/Comments					
Landscaping Inspector Comments: Trees and ivy on levee slope obstruct access and visibility.

View of obstructive landscaping.

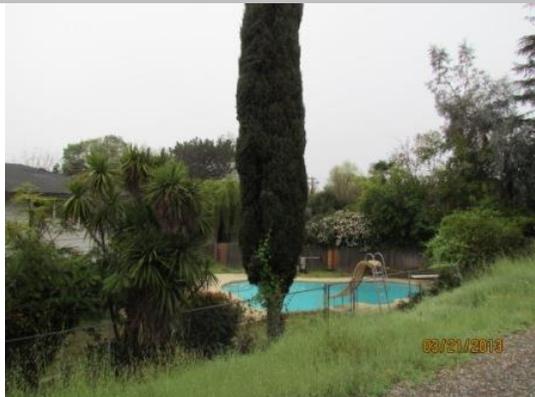
Photo 1 of 1 : FA\_2015\_NA0001\_55\_133\_20150910\_00113.jpg

LM Start	<b>9.74</b>	Rating **	M	Issue No.	<b>133</b>
LM End	<b>9.74</b>	Issue Type +	En	Location *	LS
Category	Earthen Levee		GPS Latitude/Longitude		
			Start	End	
Item	Vegetation		38.567856 °	38.567856 °	
			-121.366892 °	-121.366892 °	
DWR ID	DWR_NA0001_04_s_2012_133				
Action/Comments					
Landscaping Inspector Comments: Lemon tree, palm, sky pencil and ivy planted within 10-ft of levee toe obstructs access and visibility.

View of landscaping at levee toe.

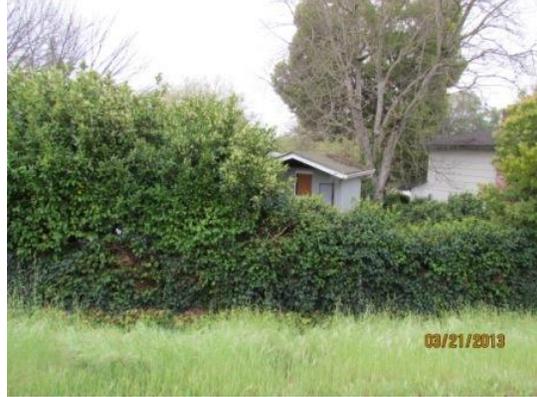
Photo 1 of 1 : FA\_2015\_NA0001\_55\_134\_20150910\_00114.jpg

LM Start	<b>9.77</b>	Rating **	U	Issue No.	<b>134</b>
LM End	<b>9.77</b>	Issue Type +	En	Location *	LS
Category	Earthen Levee		GPS Latitude/Longitude		
			Start	End	
Item	Vegetation		38.567873 °	38.567873 °	
			-121.366410 °	-121.366410 °	
DWR ID	DWR_NA0001_04_s_2012_134				
Action/Comments					
Landscaping Inspector Comments: Ivy, hedge and play house is within 10-ft of levee toe.

View of landscaping and playhouse.

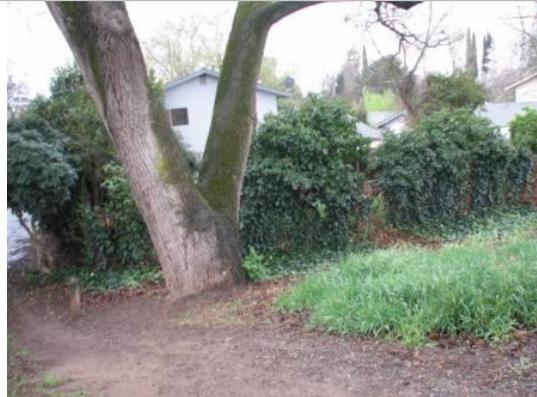
Photo 1 of 1 : FA\_2015\_NA0001\_55\_135\_20150910\_00115.jpg

LM Start	<b>9.89</b>	Rating **	U	Issue No.	<b>135</b>
LM End	<b>9.89</b>	Issue Type +	En	Location *	LS
Category	Earthen Levee		GPS Latitude/Longitude		
			Start	End	
Item	Vegetation		38.568446 °	38.568446 °	
			-121.364385 °	-121.364385 °	
DWR ID	DWR_NA0001_04_s_2012_135				
Action/Comments					
Landscaping Inspector Comments: Tall hedge and ivy within 10-ft of landside levee toe.

03/16/2012 Landscaping is obstructing visibility.

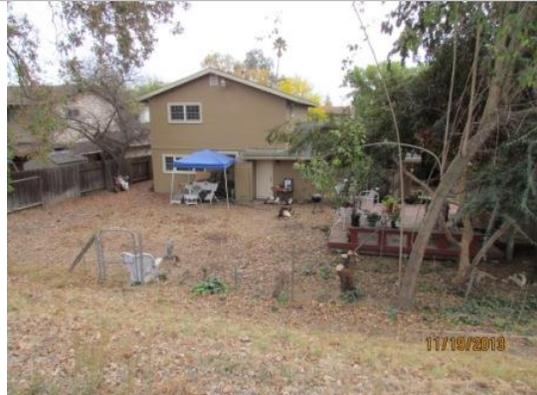
Photo 1 of 1 : FA\_2015\_NA0001\_55\_136\_20150910\_00116.jpg

LM Start	<b>9.95</b>	Rating **	M	Issue No.	<b>136</b>
LM End	<b>9.95</b>	Issue Type +	En	Location *	LS
Category	Earthen Levee		GPS Latitude/Longitude		
			Start	End	
Item	Encroachments		38.568714 °	38.568714 °	
			-121.363257 °	-121.363257 °	
DWR ID	DWR_NA0001_04_s_2012_136				
Action/Comments					
Fence Inspector Comments: Wire fence within 10-ft of landside levee toe.

View of the fence and tree stump at the landside levee toe.

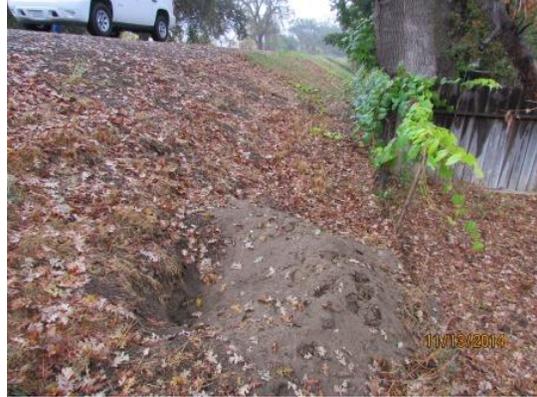
Photo 1 of 1 : FA\_2015\_NA0001\_55\_239\_20150910\_00184.jpg

LM Start	<b>9.96</b>	Rating **	M	Issue No.	<b>239</b>
LM End	<b>9.96</b>	Issue Type +	Ma	Location *	LS
Category	Earthen Levee		GPS Latitude/Longitude		
			Start	End	
Item	Animal Control		38.568773 °	38.568773 °	
			-121.363057 °	-121.363057 °	
DWR ID	DWR_NA0001_04_f_2014_239				
Action/Comments					
Exterminate rodents and backfill and compact or grout burrows.

View of several large rodent burrows.

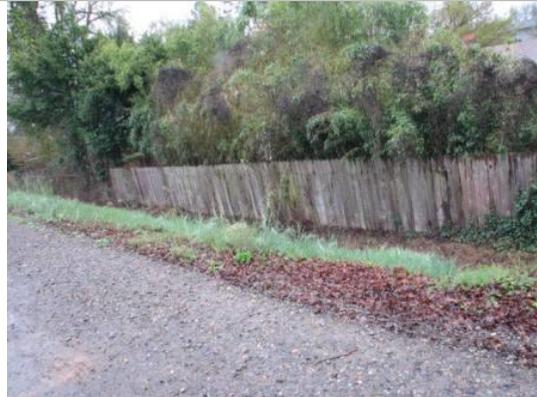
Photo 1 of 1 : FA\_2015\_NA0001\_55\_138\_20150910\_00117.jpg

LM Start	<b>10.00</b>	Rating **	U	Issue No.	<b>138</b>
LM End	<b>10.00</b>	Issue Type +	En	Location *	LS
Category	Earthen Levee		GPS Latitude/Longitude		
			Start	End	
Item	Encroachments		38.568953 °	38.568953 °	
			-121.362396 °	-121.362396 °	
DWR ID	DWR_NA0001_04_s_2012_138				
Action/Comments					
Fence Inspector Comments: 03/16/2012 Wood privacy fence completely obstructs visibility and access.

03/16/2012 Wood privacy fence completely obstructs access and visibility.

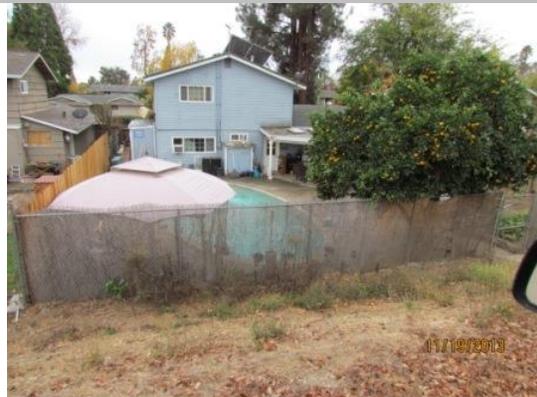
Photo 1 of 1 : FA\_2015\_NA0001\_55\_202\_20150910\_00171.jpg

LM Start	<b>10.03</b>	Rating **	A	Issue No.	<b>202</b>
LM End	<b>10.03</b>	Issue Type +	En	Location *	LS
Category	Earthen Levee		GPS Latitude/Longitude		
			Start	End	
Item	Encroachments		38.569111 °	38.569111 °	
			-121.361921 °	-121.361921 °	
DWR ID	DWR_NA0001_04_s_2013_202				
Action/Comments					
Pool Inspector Comments: Pool filled with water.

View of the pool filled with water.
