**Flood Control Project Maintenance  
Levee Inspections**

**Fall 2015 Levee Maintenance Deficiency Summary Report**

**Sacramento River Basin**

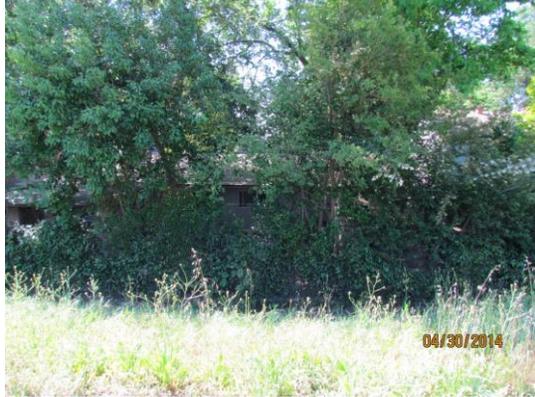
Photo 1 of 1 : FA\_2015\_NA0001\_55\_245\_20150910\_00189.jpg

LM Start	<b>10.06</b>	Rating **	U	Issue No.	<b>245</b>
LM End	<b>10.06</b>	Issue Type +	En	Location *	LS
Category	Earthen Levee			GPS Latitude/Longitude	
				Start	End
Item	Encroachments			38.569247 °	38.569247 °
				-121.361315 °	-121.361315 °
DWR ID	DWR_NA0001_04_s_2014_245				
Action/Comments					
Fence Inspector Comments: Rod fence covered with vegetation within 10ft of levee toe.

View of the fence at the landside levee toe.

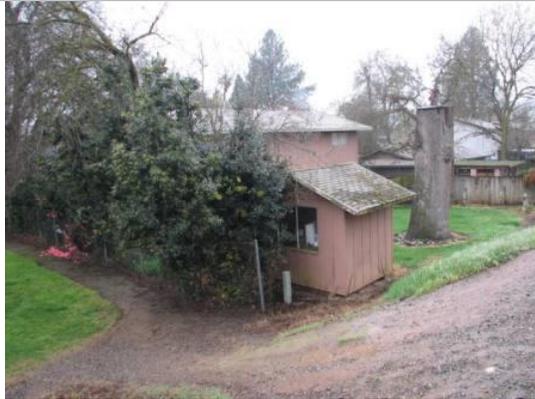
Photo 1 of 1 : FA\_2015\_NA0001\_55\_176\_20150910\_00152.jpg

LM Start	<b>10.08</b>	Rating **	U	Issue No.	<b>176</b>
LM End	<b>10.08</b>	Issue Type +	En	Location *	LS
Category	Earthen Levee			GPS Latitude/Longitude	
				Start	End
Item	Encroachments			38.569293 °	38.569293 °
				-121.361002 °	-121.361002 °
DWR ID	DWR_NA0001_04_s_2012_176				
Action/Comments					
Building

03/16/2012 Wood structure within 15' of levee toe.

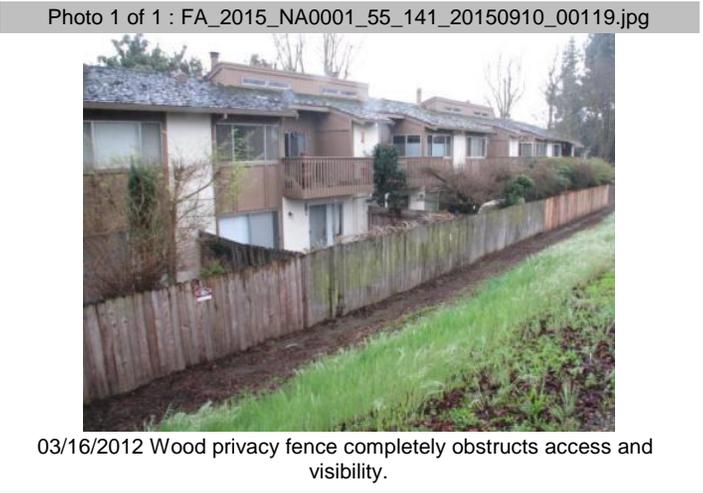
LM Start	<b>10.24</b>	Rating **	U	Issue No.	<b>141</b>
LM End	<b>10.27</b>	Issue Type +	En	Location *	LS
Category	Earthen Levee		GPS Latitude/Longitude		
			Start	End	
Item	Encroachments		38.569982 °	38.570118 °	
			-121.358134 °	-121.357604 °	
DWR ID	DWR_NA0001_04_s_2012_141				
Action/Comments					
Fence Inspector Comments: Wooden fence behind six apartment units is within 10-ft of levee slope.

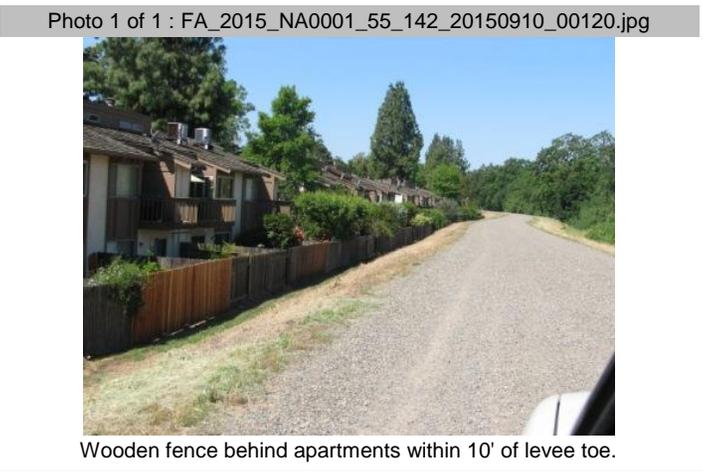
LM Start	<b>10.28</b>	Rating **	U	Issue No.	<b>142</b>
LM End	<b>10.30</b>	Issue Type +	En	Location *	LS
Category	Earthen Levee		GPS Latitude/Longitude		
			Start	End	
Item	Encroachments		38.570175 °	38.570229 °	
			-121.357390 °	-121.357041 °	
DWR ID	DWR_NA0001_04_s_2012_142				
Action/Comments					
Fence Inspector Comments: Wooden fence behind six apartment units is within 10-ft of levee slope.

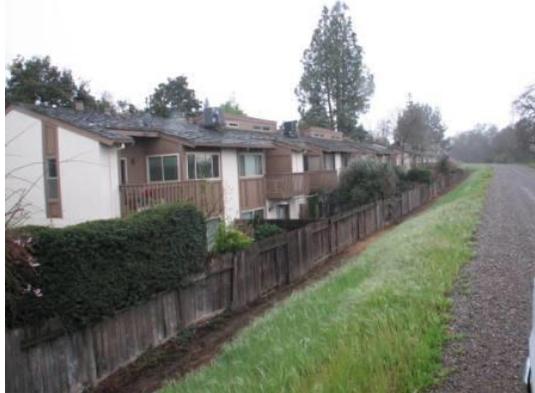
Photo 1 of 1 : FA\_2015\_NA0001\_55\_143\_20150910\_00121.jpg

LM Start	<b>10.32</b>	Rating **	U	Issue No.	<b>143</b>
LM End	<b>10.34</b>	Issue Type +	En	Location *	LS
Category	Earthen Levee		GPS Latitude/Longitude		
			Start	End	
Item	Encroachments		38.570257 °	38.570297 °	
			-121.356783 °	-121.356403 °	
DWR ID	DWR_NA0001_04_s_2012_143				
Action/Comments					
Fence Inspector Comments: Wooden fence behind six apartment units is within 10-ft of levee slope.

03/16/2012 Wood privacy fence completely obstructs access and visibility.

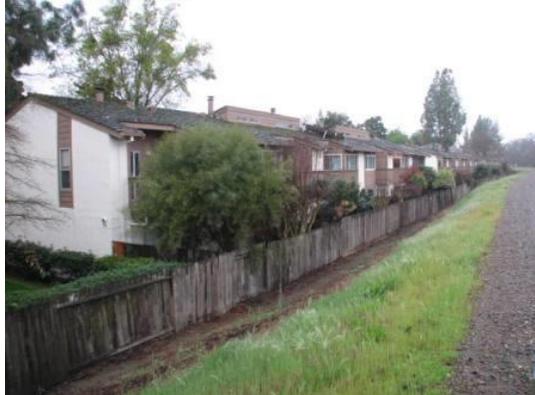
Photo 1 of 1 : FA\_2015\_NA0001\_55\_144\_20150910\_00122.jpg

LM Start	<b>10.35</b>	Rating **	U	Issue No.	<b>144</b>
LM End	<b>10.37</b>	Issue Type +	En	Location *	LS
Category	Earthen Levee		GPS Latitude/Longitude		
			Start	End	
Item	Encroachments		38.570325 °	38.570397 °	
			-121.356185 °	-121.355757 °	
DWR ID	DWR_NA0001_04_s_2012_144				
Action/Comments					
Fence Inspector Comments: Wooden fence behind six apartment units is within 10-ft of levee slope.

03/16/2012 Wood privacy fence completely obstructs access and visibility.

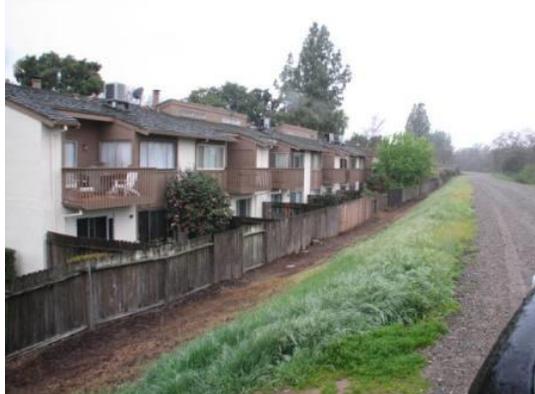
Photo 1 of 1 : FA\_2015\_NA0001\_55\_145\_20150910\_00123.jpg

LM Start	<b>10.38</b>	Rating **	U	Issue No.	<b>145</b>
LM End	<b>10.41</b>	Issue Type +	En	Location *	LS
Category	Earthen Levee		GPS Latitude/Longitude		
			Start	End	
Item	Encroachments		38.570417 °	38.570500 °	
			-121.355625 °	-121.355151 °	
DWR ID	DWR_NA0001_04_s_2012_145				
Action/Comments					
Fence Inspector Comments: Wooden fence behind six apartment units is within 10-ft of levee slope.

03/16/2012 Wood privacy fence completely obstructs access and visibility.

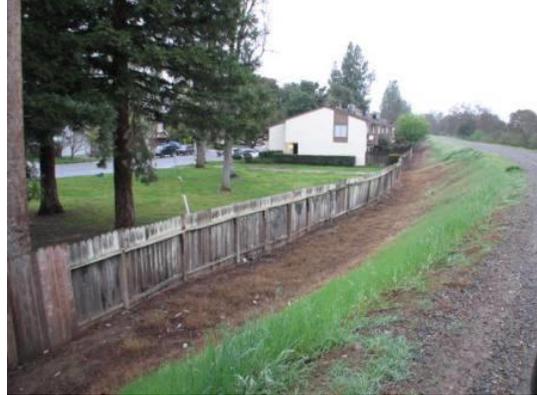
Photo 1 of 1 : FA\_2015\_NA0001\_55\_147\_20150910\_00125.jpg

LM Start	<b>10.43</b>	Rating **	U	Issue No.	<b>147</b>
LM End	<b>10.43</b>	Issue Type +	En	Location *	LS
Category	Earthen Levee		GPS Latitude/Longitude		
			Start	End	
Item	Encroachments		38.570542 °	38.570542 °	
			-121.354772 °	-121.354772 °	
DWR ID	DWR_NA0001_04_s_2012_147				
Action/Comments					
Fence Inspector Comments: Wooden privacy fence.

03/16/2012 Wood privacy fence completely obstructs access and visibility.

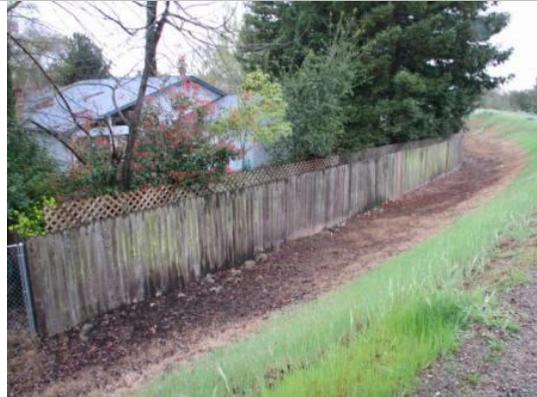
Photo 1 of 1 : FA\_2015\_NA0001\_55\_148\_20150910\_00126.jpg

LM Start	<b>10.45</b>	Rating **	U	Issue No.	<b>148</b>
LM End	<b>10.45</b>	Issue Type +	En	Location *	LS
Category	Earthen Levee		GPS Latitude/Longitude		
			Start	End	
Item	Encroachments		38.570524 °	38.570524 °	
			-121.354359 °	-121.354359 °	
DWR ID	DWR_NA0001_04_s_2012_148				
Action/Comments					
Fence Inspector Comments: Wooden privacy fence obstructs visibility and access.

03/16/2012 Wood privacy fence completely obstructs access and visibility.

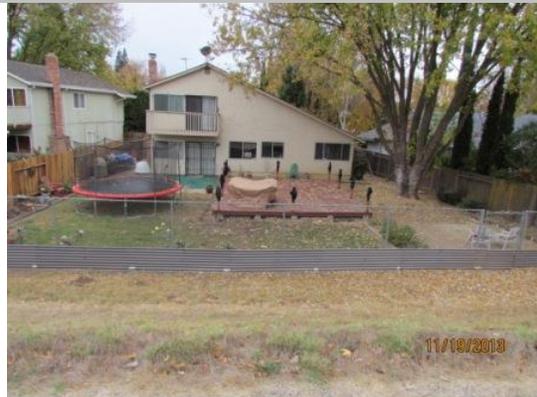
Photo 1 of 1 : FA\_2015\_NA0001\_55\_180\_20150910\_00156.jpg

LM Start	<b>10.47</b>	Rating **	M	Issue No.	<b>180</b>
LM End	<b>10.47</b>	Issue Type +	En	Location *	LS
Category	Earthen Levee		GPS Latitude/Longitude		
			Start	End	
Item	Encroachments		38.570397 °	38.570397 °	
			-121.354084 °	-121.354084 °	
DWR ID	DWR_NA0001_04_s_2012_180				
Action/Comments					
Fence Inspector Comments: Chainlink fence partially obstructs, currently visibility is unobstructed.

Chainlink fence is partially obstructing visibility and access.

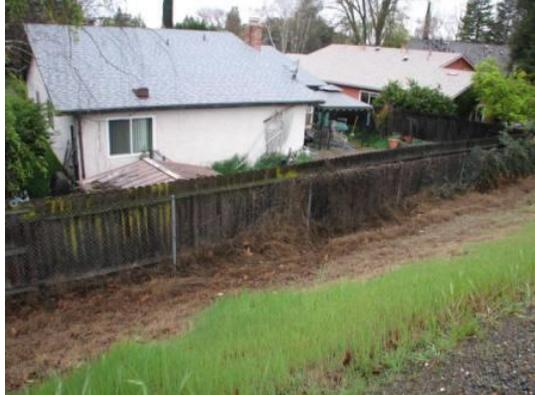
Photo 1 of 1 : FA\_2015\_NA0001\_55\_151\_20150910\_00129.jpg

LM Start	<b>10.51</b>	Rating **	U	Issue No.	<b>151</b>
LM End	<b>10.51</b>	Issue Type +	En	Location *	LS
Category	Earthen Levee		GPS Latitude/Longitude		
			Start	End	
Item	Encroachments		38.569921 °	38.569921 °	
			-121.353643 °	-121.353643 °	
DWR ID	DWR_NA0001_04_s_2012_151				
Action/Comments					
Fence Inspector Comments: Wooden privacy fence within 10-ft of levee toe.

03/16/2012 Wood privacy fence completely obstructs access and visibility.

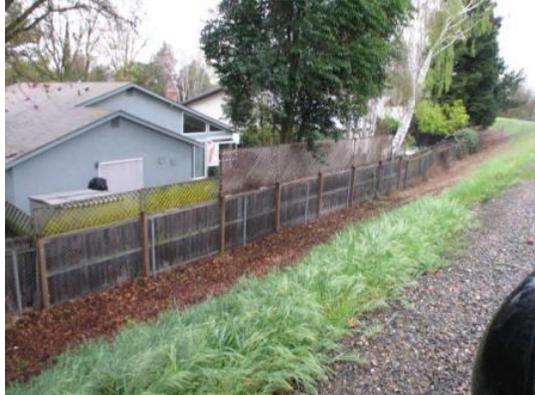
Photo 1 of 1 : FA\_2015\_NA0001\_55\_152\_20150910\_00130.jpg

LM Start	<b>10.52</b>	Rating **	U	Issue No.	<b>152</b>
LM End	<b>10.52</b>	Issue Type +	En	Location *	LS
Category	Earthen Levee		GPS Latitude/Longitude		
			Start	End	
Item	Encroachments		38.569758 °	38.569758 °	
			-121.353535 °	-121.353535 °	
DWR ID	DWR_NA0001_04_s_2012_152				
Action/Comments					
Fence Inspector Comments: Wooden privacy fence within 10-ft of levee toe.

03/16/2012 Wood privacy fence completely obstructs access and visibility.

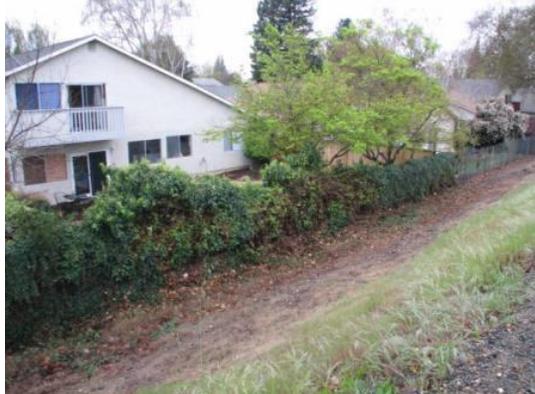
Photo 1 of 1 : FA\_2015\_NA0001\_55\_153\_20150910\_00131.jpg

LM Start	<b>10.57</b>	Rating **	U	Issue No.	<b>153</b>
LM End	<b>10.57</b>	Issue Type +	En	Location *	LS
Category	Earthen Levee		GPS Latitude/Longitude		
			Start	End	
Item	Encroachments		38.569166 °	38.569166 °	
			-121.353272 °	-121.353272 °	
DWR ID	DWR_NA0001_04_s_2012_153				
Action/Comments					
Fence Inspector Comments: Wooden privacy fence and ivy within 10-ft of levee toe.

03/16/2012 Wood privacy fence completely obstructs access and visibility.

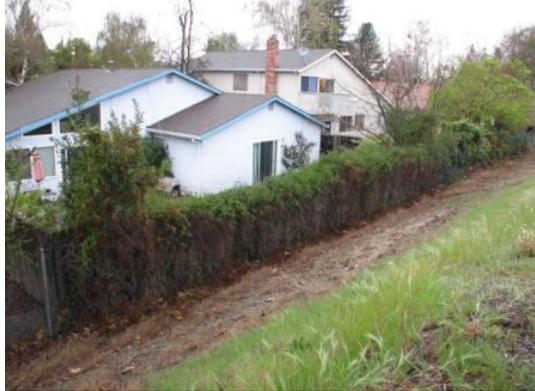
Photo 1 of 1 : FA\_2015\_NA0001\_55\_154\_20150910\_00132.jpg

LM Start	<b>10.57</b>	Rating **	U	Issue No.	<b>154</b>
LM End	<b>10.57</b>	Issue Type +	En	Location *	LS
Category	Earthen Levee			GPS Latitude/Longitude	
				Start	End
Item	Encroachments			38.569020 °	38.569020 °
				-121.353313 °	-121.353313 °
DWR ID	DWR_NA0001_04_s_2012_154				
Action/Comments					
Fence Inspector Comments: Wooden privacy fence within 10-ft of levee toe.

03/16/2012 Wood privacy fence completely obstructs access and visibility.

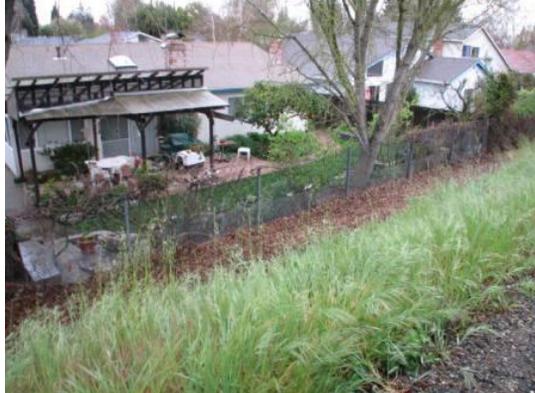
Photo 1 of 1 : FA\_2015\_NA0001\_55\_155\_20150910\_00133.jpg

LM Start	<b>10.59</b>	Rating **	M	Issue No.	<b>155</b>
LM End	<b>10.59</b>	Issue Type +	En	Location *	LS
Category	Earthen Levee			GPS Latitude/Longitude	
				Start	End
Item	Vegetation			38.568892 °	38.568892 °
				-121.353162 °	-121.353162 °
DWR ID	DWR_NA0001_04_s_2012_155				
Action/Comments					
Landscaping Inspector Comments: Trees and bushes are within 10-ft of the levee toe.

03/16/2012 Trees and bushes within 10' of levee toe.

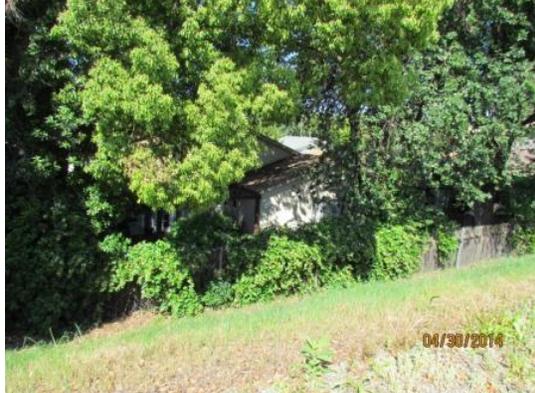
Photo 1 of 1 : FA\_2015\_NA0001\_55\_156\_20150910\_00134.jpg

LM Start	<b>10.60</b>	Rating **	U	Issue No.	<b>156</b>
LM End	<b>10.60</b>	Issue Type +	En	Location *	LS
Category	Earthen Levee			GPS Latitude/Longitude	
				Start	End
Item	Encroachments			38.568713 °	38.568713 °
				-121.353150 °	-121.353150 °
DWR ID	DWR_NA0001_04_s_2012_156				
Action/Comments					
Fence Inspector Comments: Wooden privacy fence and landscaping within 10-ft of levee toe.

View of the fence at the landside levee toe obstructing visibility and access.

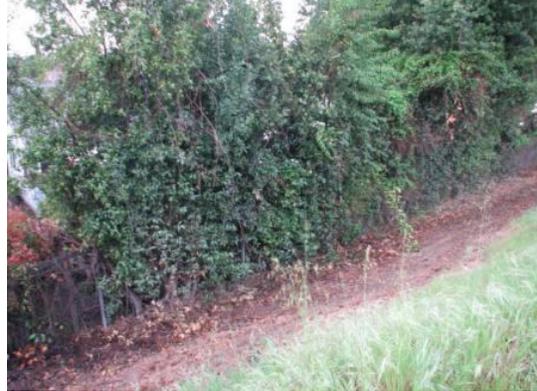
Photo 1 of 1 : FA\_2015\_NA0001\_55\_157\_20150910\_00135.jpg

LM Start	<b>10.61</b>	Rating **	M	Issue No.	<b>157</b>
LM End	<b>10.61</b>	Issue Type +	En	Location *	LS
Category	Earthen Levee		GPS Latitude/Longitude		
			Start	End	
Item	Vegetation		38.568608 °	38.568608 °	
			-121.353054 °	-121.353054 °	
DWR ID	DWR_NA0001_04_s_2012_157				
Action/Comments					
Landscaping Inspector Comments: Tall hedge and vine on levee toe.

03/16/2012 Landscaping obstructs visibility

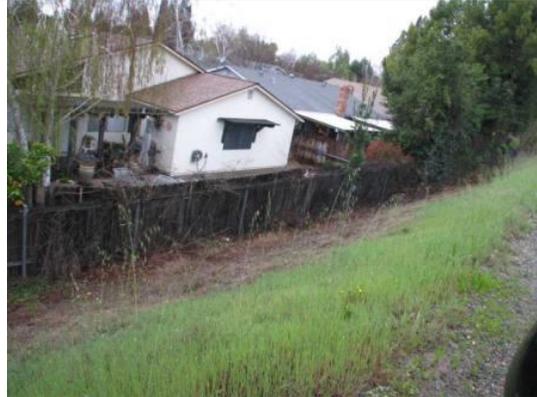
Photo 1 of 1 : FA\_2015\_NA0001\_55\_158\_20150910\_00136.jpg

LM Start	<b>10.62</b>	Rating **	U	Issue No.	<b>158</b>
LM End	<b>10.62</b>	Issue Type +	En	Location *	LS
Category	Earthen Levee		GPS Latitude/Longitude		
			Start	End	
Item	Encroachments		38.568355 °	38.568355 °	
			-121.353033 °	-121.353033 °	
DWR ID	DWR_NA0001_04_s_2012_158				
Action/Comments					
Fence Inspector Comments: Wooden privacy fence within 10-ft of levee toe.

03/16/2012 Wood privacy fence completely obstructs access and visibility.

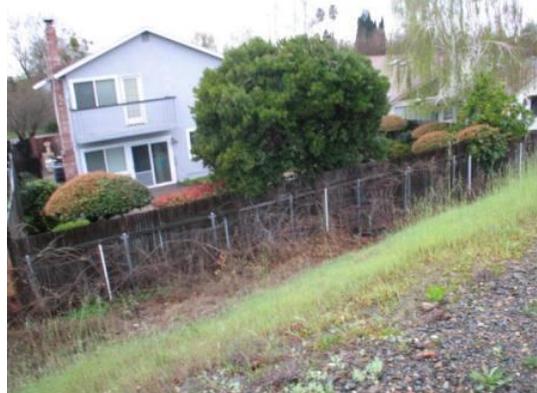
Photo 1 of 1 : FA\_2015\_NA0001\_55\_159\_20150910\_00137.jpg

LM Start	<b>10.63</b>	Rating **	U	Issue No.	<b>159</b>
LM End	<b>10.63</b>	Issue Type +	En	Location *	LS
Category	Earthen Levee		GPS Latitude/Longitude		
			Start	End	
Item	Encroachments		38.568313 °	38.568313 °	
			-121.352941 °	-121.352941 °	
DWR ID	DWR_NA0001_04_s_2012_159				
Action/Comments					
Fence Inspector Comments: Wooden privacy fence within 10-ft of levee toe.

03/16/2012 Wood privacy fence completely obstructs access and visibility.

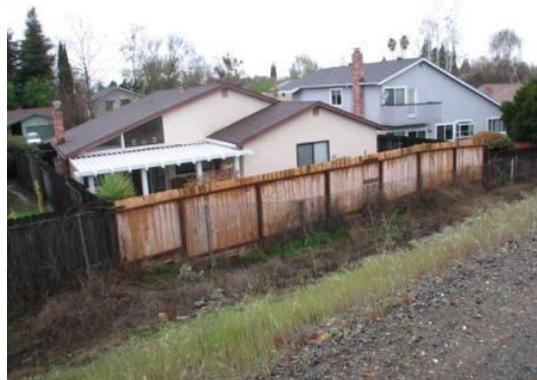
Photo 1 of 1 : FA\_2015\_NA0001\_55\_160\_20150910\_00138.jpg

LM Start	<b>10.64</b>	Rating **	U	Issue No.	<b>160</b>
LM End	<b>10.64</b>	Issue Type +	En	Location *	LS
Category	Earthen Levee		GPS Latitude/Longitude		
			Start	End	
Item	Encroachments		38.568188 °	38.568188 °	
			-121.352864 °	-121.352864 °	
DWR ID	DWR_NA0001_04_f_2012_160				
Action/Comments					
Fence Inspector Comments: Tall wooden privacy fence within 10-ft of levee toe.

03/16/2012 Wood privacy fence completely obstructs access and visibility.

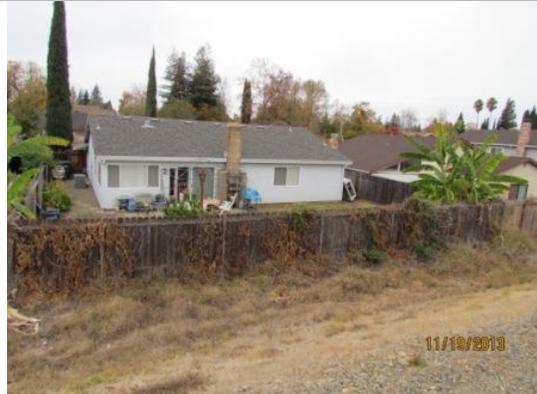
Photo 1 of 1 : FA\_2015\_NA0001\_55\_161\_20150910\_00139.jpg

LM Start	<b>10.65</b>	Rating **	U	Issue No.	<b>161</b>
LM End	<b>10.65</b>	Issue Type +	En	Location *	LS
Category	Earthen Levee		GPS Latitude/Longitude		
			Start	End	
Item	Encroachments		38.568058 °	38.568058 °	
			-121.352785 °	-121.352785 °	
DWR ID	DWR_NA0001_04_s_2012_161				
Action/Comments					
Fence Inspector Comments: Wooden privacy fence and vine within 10-ft of levee toe.

View of wood privacy fence completely obstructing access and visibility.

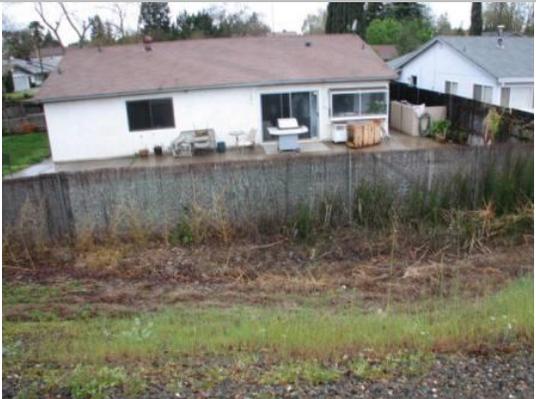
Photo 1 of 1 : FA\_2015\_NA0001\_55\_179\_20150910\_00155.jpg

LM Start	<b>10.66</b>	Rating **	U	Issue No.	<b>179</b>
LM End	<b>10.66</b>	Issue Type +	En	Location *	LS
Category	Earthen Levee		GPS Latitude/Longitude		
			Start	End	
Item	Encroachments		38.567917 °	38.567917 °	
			-121.352698 °	-121.352698 °	
DWR ID	DWR_NA0001_04_s_2012_179				
Action/Comments					
Fence Inspector Comments: Chainlink fence with bamboo mats prevent visibility.

03/16/2012 Bamboo panels on chainlink fence completely obstruct visibility.

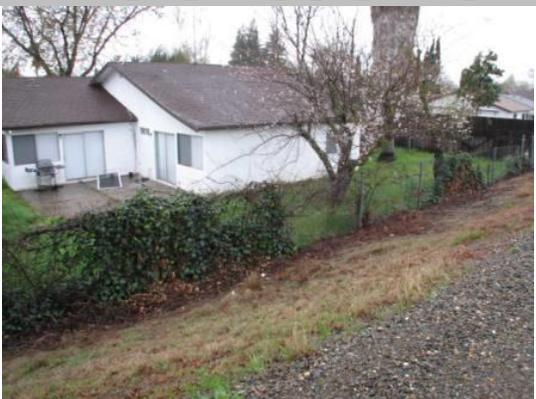
Photo 1 of 1 : FA\_2015\_NA0001\_55\_178\_20150910\_00154.jpg

LM Start	<b>10.68</b>	Rating **	M	Issue No.	<b>178</b>
LM End	<b>10.68</b>	Issue Type +	En	Location *	LS
Category	Earthen Levee		GPS Latitude/Longitude		
			Start	End	
Item	Encroachments		38.567552 °	38.567552 °	
			-121.352500 °	-121.352500 °	
DWR ID	DWR_NA0001_04_s_2012_178				
Action/Comments					
Fence Inspector Comments: Chainlink fence

03/16/2012 Chainlink fence partially blocks visibility.

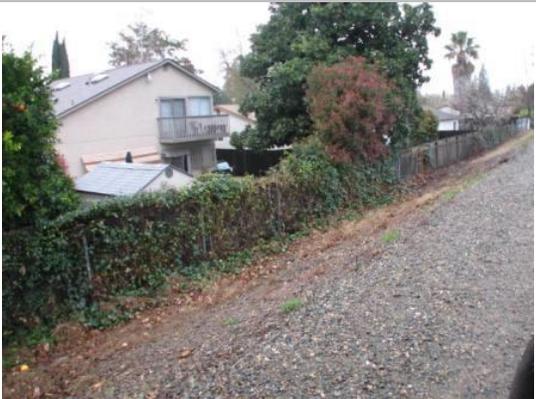
Photo 1 of 1 : FA\_2015\_NA0001\_55\_163\_20150910\_00141.jpg

LM Start	<b>10.71</b>	Rating **	U	Issue No.	<b>163</b>
LM End	<b>10.71</b>	Issue Type +	En	Location *	LS
Category	Earthen Levee		GPS Latitude/Longitude		
			Start	End	
Item	Encroachments		38.567250 °	38.567250 °	
			-121.352341 °	-121.352341 °	
DWR ID	DWR_NA0001_04_s_2012_163				
Action/Comments					
Fence Inspector Comments: Wooden privacy fence and landscaping within 10-ft of levee toe.

03/16/2012 Wood privacy fence completely obstructs access and visibility.

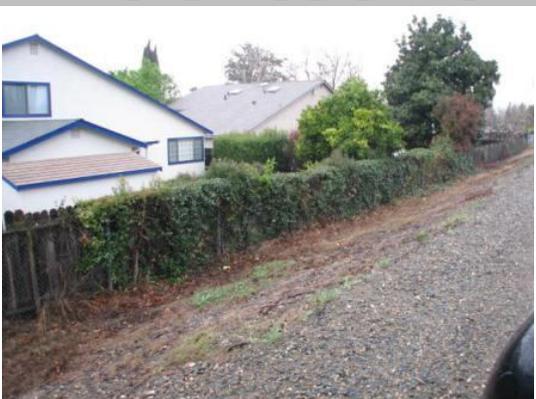
Photo 1 of 1 : FA\_2015\_NA0001\_55\_172\_20150910\_00149.jpg

LM Start	<b>10.72</b>	Rating **	U	Issue No.	<b>172</b>
LM End	<b>10.72</b>	Issue Type +	En	Location *	LS
Category	Earthen Levee		GPS Latitude/Longitude		
			Start	End	
Item	Encroachments		38.567008 °	38.567008 °	
			-121.352226 °	-121.352226 °	
DWR ID	DWR_NA0001_04_s_2012_172				
Action/Comments					
Fence Inspector Comments: Wooden privacy fence.

03/16/2012 Wood privacy fence completely obstructs access and visibility.

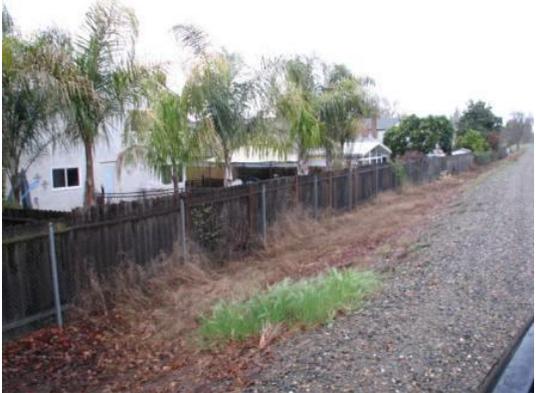
Photo 1 of 1 : FA\_2015\_NA0001\_55\_166\_20150910\_00143.jpg

LM Start	<b>10.75</b>	Rating **	U	Issue No.	<b>166</b>
LM End	<b>10.75</b>	Issue Type +	En	Location *	LS
Category	Earthen Levee		GPS Latitude/Longitude		
			Start	End	
Item	Encroachments		38.566705 °	38.566705 °	
			-121.352063 °	-121.352063 °	
DWR ID	DWR_NA0001_04_s_2012_166				
Action/Comments					
Fence Inspector Comments: Wooden privacy fence within 10-ft of levee toe.

03/16/2012 Wood privacy fence completely obstructs access and visibility.

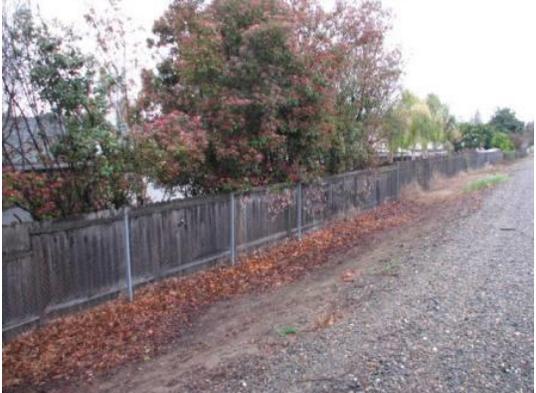
Photo 1 of 1 : FA\_2015\_NA0001\_55\_171\_20150910\_00148.jpg

LM Start	<b>10.76</b>	Rating **	U	Issue No.	<b>171</b>
LM End	<b>10.76</b>	Issue Type +	En	Location *	LS
Category	Earthen Levee		GPS Latitude/Longitude		
			Start	End	
Item	Encroachments		38.566499 °	38.566499 °	
			-121.351952 °	-121.351952 °	
DWR ID	DWR_NA0001_04_s_2012_171				
Action/Comments					
Fence Inspector Comments: Wooden privacy fence and tall hedge within 10-ft of levee toe.

03/16/2012 Wood privacy fence completely obstructs access and visibility.

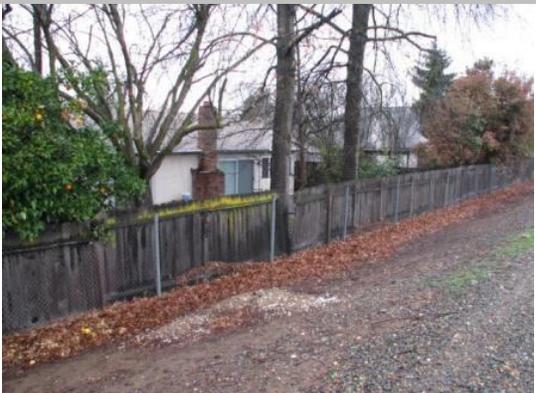
Photo 1 of 1 : FA\_2015\_NA0001\_55\_169\_20150910\_00146.jpg

LM Start	<b>10.77</b>	Rating **	U	Issue No.	<b>169</b>
LM End	<b>10.77</b>	Issue Type +	En	Location *	LS
Category	Earthen Levee		GPS Latitude/Longitude		
			Start	End	
Item	Encroachments		38.566399 °	38.566399 °	
			-121.351931 °	-121.351931 °	
DWR ID	DWR_NA0001_04_s_2012_169				
Action/Comments					
Fence Inspector Comments: Wooden privacy fence within 10-ft of levee toe.

03/16/2012 Wood privacy fence completely obstructs access and visibility.

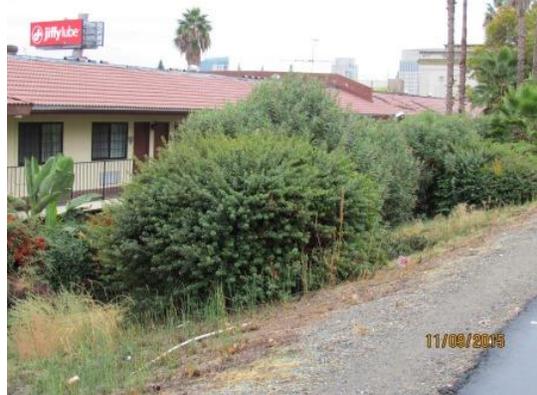
Photo 1 of 1 : FA\_2015\_NA0001\_56\_2\_20151112\_00003.jpg

LM Start	<b>0.10</b>	Rating **	U	Issue No.	<b>2</b>
LM End	<b>0.17</b>	Issue Type +	En	Location *	LS
Category	Earthen Levee		GPS Latitude/Longitude		
			Start	End	
Item	Vegetation		38.595044 °	38.594117 °	
			-121.506497 °	-121.506377 °	
DWR ID	DWR_NA0001_05_s_2012_2				
Action/Comments					
Landscaping Inspector Comments: Landscaping behind Best Western.

View of the landscaping on the landside levee slope obstructing visibility and access.

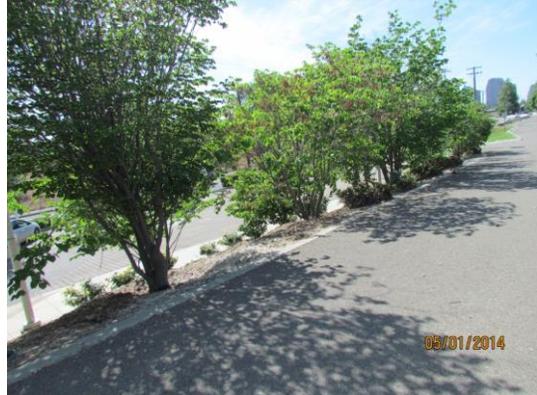
Photo 1 of 1 : FA\_2015\_NA0001\_56\_5\_20150910\_00002.jpg

LM Start	<b>0.27</b>	Rating **	M	Issue No.	<b>5</b>
LM End	<b>0.35</b>	Issue Type +	En	Location *	LS
Category	Earthen Levee		GPS Latitude/Longitude		
			Start	End	
Item	Vegetation		38.592630 °	38.591517 °	
			-121.505850 °	-121.505447 °	
DWR ID	DWR_NA0001_05_s_2012_5				
Action/Comments					
Landscaping Inspector Comments: Landscaping at City intake facility.

View of the landscaping on the landside levee slope at the City intake facility.

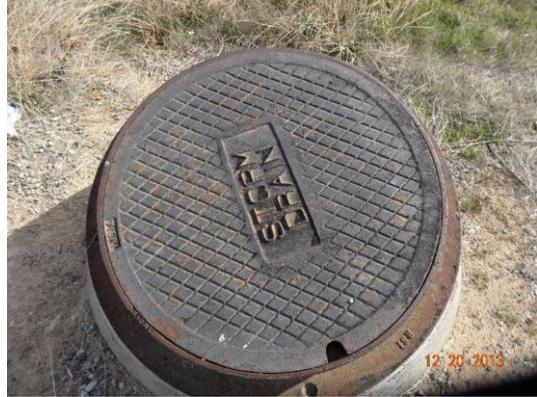
Photo 1 of 3 : UCIP\_FA\_2015\_4202.jpg

LM Start	<b>0.75</b>	Rating **	M	Issue No.	<b>10</b>
LM End	<b>0.75</b>	Issue Type +	En	Location *	LS
Category	Supplemental			GPS Latitude/Longitude	
				Start	End
Item	DWR UCIP Field Study			38.660518 °	38.660518 °
				-121.461826 °	-121.461826 °
DWR ID					
Action/Comments					
Inspector Comments: FS_ID:30706 DS_ID:24812 EP_NO: N/A FS_HLM: 0.749 Repair Type: Non-Urgent Crossing Status: Indicator Found UCIP Comments: Unable to confirm if line goes through levee or along landward slope. No permit found. FIELD_STRUCT_DESC: Storm drain manhole located on landward side. FS Date: 12/20/2013

Manhole located on landward side identified as storm drain. Unable to determine if drain crosses levee.

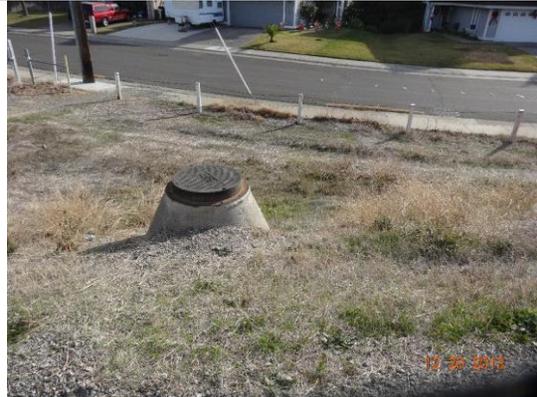
Photo 2 of 3 : UCIP\_FA\_2015\_4203.jpg

Manhole located on landward slope.

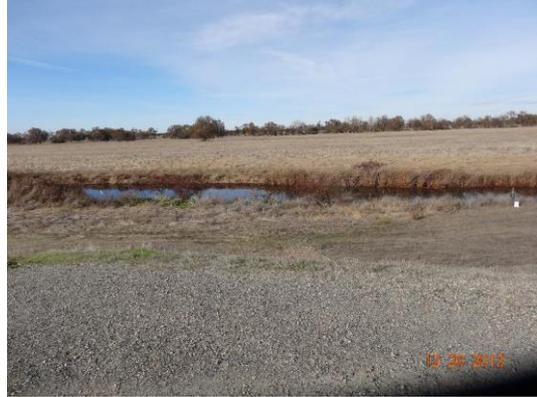
Photo 3 of 3 : UCIP\_FA\_2015\_4204.jpg

LM Start	<b>0.75</b>	Rating **	M	Issue No.	<b>10 (cont)</b>
LM End	<b>0.75</b>	Issue Type +	En	Location *	LS
Category	Supplemental			GPS Latitude/Longitude	
				Start	End
Item	DWR UCIP Field Study			38.660518 °	38.660518 °
				-121.461826 °	-121.461826 °
DWR ID					
Action/Comments					
Inspector Comments: FS_ID:30706 DS_ID:24812 EP_NO: N/A FS_HLM: 0.749 Repair Type: Non-Urgent Crossing Status: Indicator Found

View of waterward side.

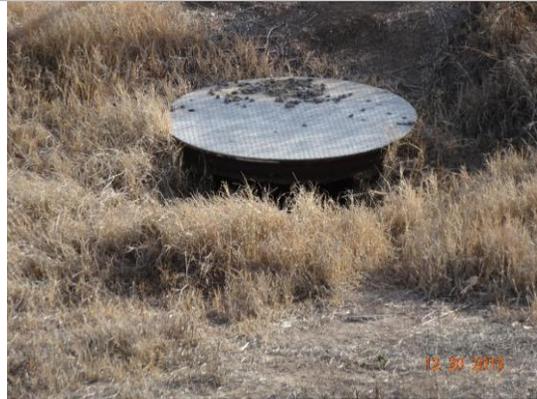
Photo 1 of 3 : UCIP\_FA\_2015\_3485.jpg

Item	DWR UCIP Field Study			38.661156 °	38.661156 °
				-121.460475 °	-121.460475 °
DWR ID					
Action/Comments					
Inspector Comments: FS_ID:29223 DS_ID:24354 EP_NO: N/A FS_HLM: 0.83 Repair Type: Non-Urgent Crossing Status: Indicator Found UCIP Comments: Unable to find CM riser and flap gate on waterward end--need to contact owner to determine status of crossing. Manhole found on landward side however unable to determine if manhole is part of this crossing. FIELD_STRUCT_DESC: 24-inch pipe through the levee, 12.5 feet below the crown. Two CM cutoff walls around pipe. Slide gate in CM riser and flap gate at waterward end. Concrete headwalls on both ends. (USACE-1959). This entry matches the Drainage or Irrigation Structure referenced in O&M manual (Station 440+50). FS Date: 12/20/2013

Manhole visible on landward toe.

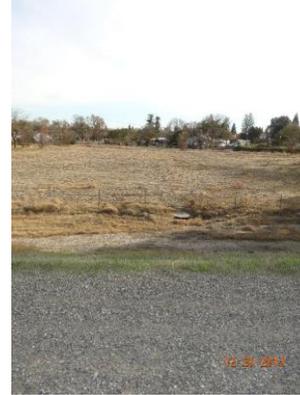
Photo 2 of 3 : UCIP\_FA\_2015\_3486.jpg

LM Start	0.84	Rating **	M	Issue No.	11 (cont)
LM End	0.84	Issue Type +	En	Location *	LS
Category	Supplemental			GPS Latitude/Longitude	
				Start	End
Item	DWR UCIP Field Study			38.661156 °	38.661156 °
				-121.460475 °	-121.460475 °
DWR ID					
Action/Comments					
Inspector Comments: FS_ID:29223 DS_ID:24354 EP_NO: N/A FS_HLM: 0.83 Repair Type: Non-Urgent Crossing Status: Indicator Found UCIP Comments: Unable to find CM riser and flap gate on waterward end--need to contact owner to determine status of crossing. Manhole found on landward side however unable to determine if manhole is part of this crossing. FIELD_STRUCT_DESC: 24-inch pipe through the levee, 12.5 feet below the crown. Two CM cutoff walls around pipe. Slide gate in CM riser and flap gate at waterward end. Concrete headwalls on both ends. (USACE-1959). This entry matches the Drainage or Irrigation Structure referenced in O&M manual (Station 440+50). FS Date: 12/20/2013

View of landward side--manhole on landward toe.

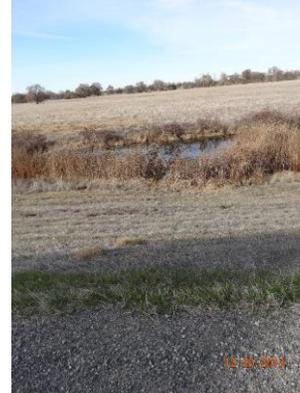
Photo 3 of 3 : UCIP\_FA\_2015\_3487.jpg

View of waterward side--no evidence of crossing.

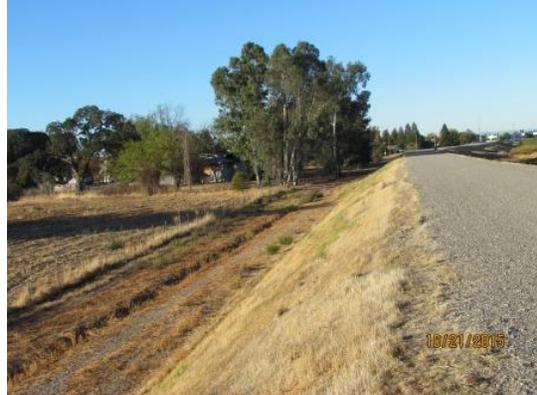
Photo 1 of 1 : FA\_2015\_NA0001\_57\_9\_20151112\_00005.jpg

View of the acceptable vegetation control.

LM Start	<b>0.89</b>	Rating **	A	Issue No.	<b>9</b>
LM End	<b>0.89</b>	Issue Type +	Ma	Location *	LS
Category	Earthen Levee		GPS Latitude/Longitude		
			Start	End	
Item	Vegetation		38.661620 °	38.661620 °	
			-121.459562 °	-121.459562 °	
DWR ID	DWR_NA0001_06_f_2015_9				
Action/Comments					
Control annual grass and weeds on the levee slopes and easements.

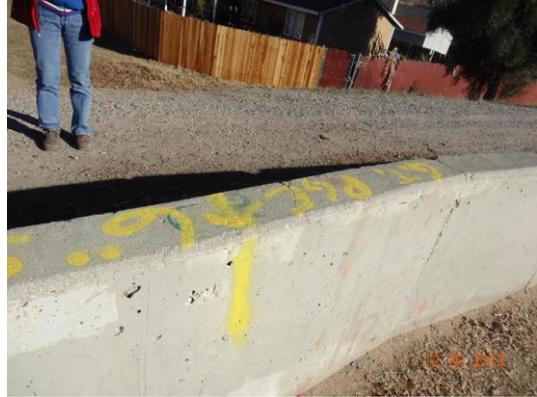
Photo 1 of 3 : UCIP\_FA\_2015\_4137.jpg

LM Start	Rating **	M	Issue No.	44
LM End	Issue Type +	En	Location *	LS
Category	Supplemental	GPS Latitude/Longitude		
		Start	End	
Item	DWR UCIP Field Study	38.627760 °	38.627760 °	
		-121.441593 °	-121.441593 °	
DWR ID				
Action/Comments				
Inspector Comments: FS_ID:46795 DS_ID:24835 EP_NO: N/A FS_HLM: 1.582 Repair Type: Non-Urgent Crossing Status: Indicator Found UCIP Comments: 11/12/15 Markers have been installed on both levees--confirmed during 2015 DWR Fall Inspection. Need to coordinate with PG&E to determine permit for this crossing.12/19/13 Gas line - no markers visible. No permit available. FIELD_STRUCT_DESC: 2 of 2: 6-inch pipe through the levee and under the channel at an unknown depth. FS Date: 12/20/2013

6-inch gas line through levee at an unknown depth.

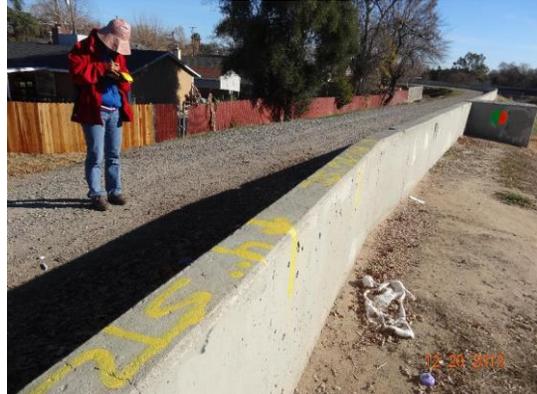
Photo 2 of 3 : UCIP\_FA\_2015\_4138.jpg

Underground service alert (USA) markings visible on floodwall.

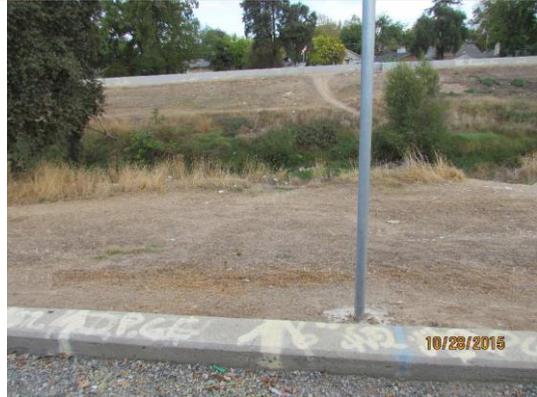
Photo 3 of 3 : UCIP\_FA\_2015\_5877.jpg

LM Start		Rating **	M	Issue No.	<b>44 (cont)</b>
LM End		Issue Type +	En	Location *	LS
Category	Supplemental			GPS Latitude/Longitude	
				Start	End
Item	DWR UCIP Field Study			38.627760 °	38.627760 °
				-121.441593 °	-121.441593 °
DWR ID					
Action/Comments					
Inspector Comments: FS_ID:46795 DS_ID:24835 EP_NO: N/A FS_HLM: 1.582 Repair Type: Non-Urgent Crossing Status: Indicator Found

Markers installed through both levees in 2015.

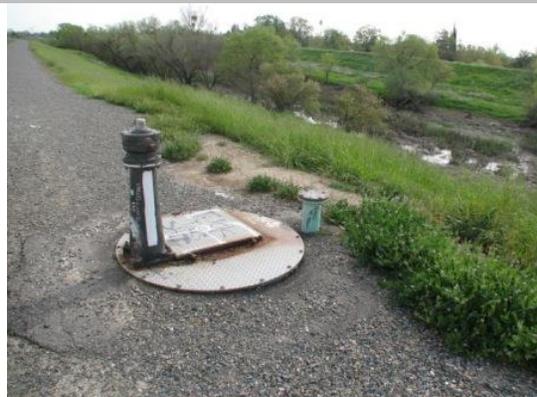
Photo 1 of 1 : FA\_2015\_NA0001\_58\_17\_20150910\_00016.jpg

LM Start	<b>0.37</b>	Rating **	A/W	Issue No.	<b>17</b>
LM End	<b>0.37</b>	Issue Type +	En	Location *	CR
Category	Earthen Levee			GPS Latitude/Longitude	
				Start	End
Item	Encroachments			38.623325 °	38.623325 °
				-121.462217 °	-121.462217 °
DWR ID	DWR_NA0001_07_s_2012_17				
Action/Comments					
Pipe Inspector Comments: Closure device for sewer line located on levee crown.

Closure device for SS beneath channel.

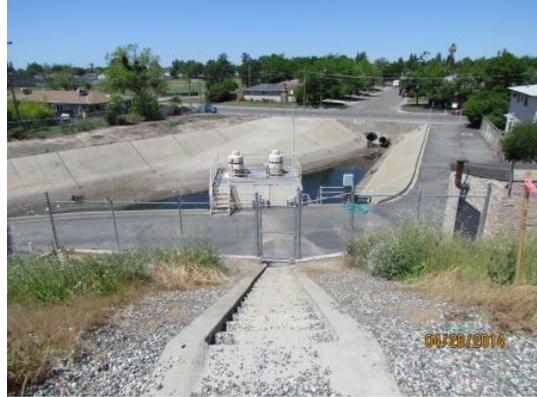
Photo 1 of 1 : FA\_2015\_NA0001\_58\_42\_20150910\_00028.jpg

LM Start	<b>0.60</b>	Rating **	A/W	Issue No.	<b>42</b>
LM End	<b>0.60</b>	Issue Type +	En	Location *	CR
Category	Earthen Levee		GPS Latitude/Longitude		
			Start	End	
Item	Encroachments		38.625311 °	38.625311 °	
			-121.458994 °	-121.458994 °	
DWR ID	DWR_NA0001_07_s_2014_42				
Action/Comments					
Pipe Inspector Comments: Two pipes crossing the levee.

View of the pump station on the landside levee toe.

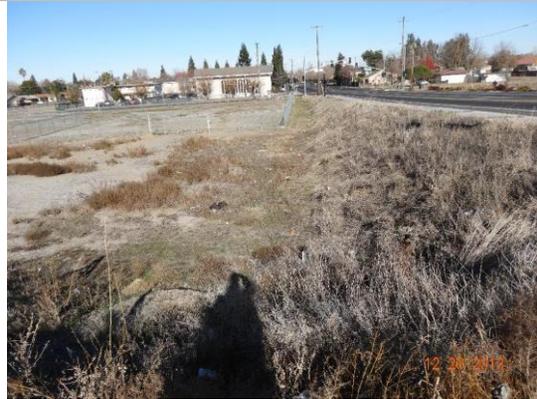
Photo 1 of 3 : UCIP\_FA\_2015\_1215.jpg

LM Start	<b>0.71</b>	Rating **	U	Issue No.	<b>45</b>
LM End	<b>0.71</b>	Issue Type +	En	Location *	CR
Category	Supplemental		GPS Latitude/Longitude		
			Start	End	
Item	DWR UCIP Field Study		38.624843 °	38.624843 °	
			-121.457097 °	-121.457097 °	
DWR ID					
Action/Comments					
Inspector Comments: FS_ID:29237 DS_ID:24363 EP_NO: 3417 FS_HLM: 0.7 Repair Type: Urgent Crossing Status: Found UCIP Comments: Missing gas line markers -- need to contact owner to determine status. FIELD_STRUCT_DESC: 4-inch steel gas line through the levee, 2.0 feet below the crown. CM cutoff wall around pipe at center of levee. (Permit No. 3417-1961) Landscaping and staircase on landward slope added under Permit No. 3510 (1978), but was removed in 1994. FS Date: 12/20/2013

View of landward side.

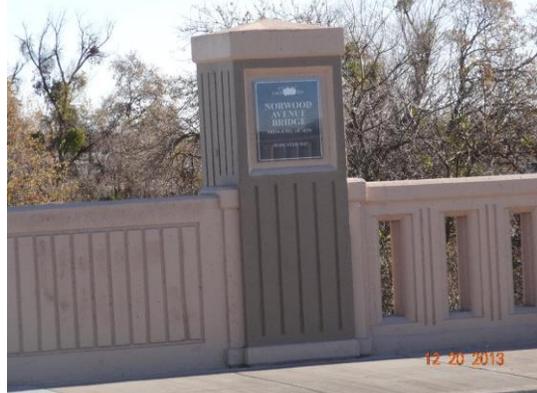
Photo 2 of 3 : UCIP\_FA\_2015\_1216.jpg

Inspector Comments: FS\_ID:29237  
 DS\_ID:24363  
 EP\_NO: 3417  
 FS\_HLM: 0.7  
 Repair Type: Urgent  
 Crossing Status: Found  
 UCIP Comments: Missing gas line markers -- need to contact owner to determine status.  
 FIELD\_STRUCT\_DESC: 4-inch steel gas line through the levee, 2.0 feet below the crown. CM cutoff wall around pipe at center of levee. (Permit No. 3417-1961) Landscaping and staircase on landward slope added under Permit No. 3510 (1978), but was removed in 1994.  
 FS Date: 12/20/2013

Norwood Avenue Bridge

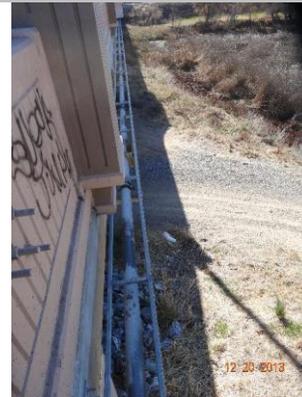
Photo 3 of 3 : UCIP\_FA\_2015\_1217.jpg

View of pipe attached to bridge.

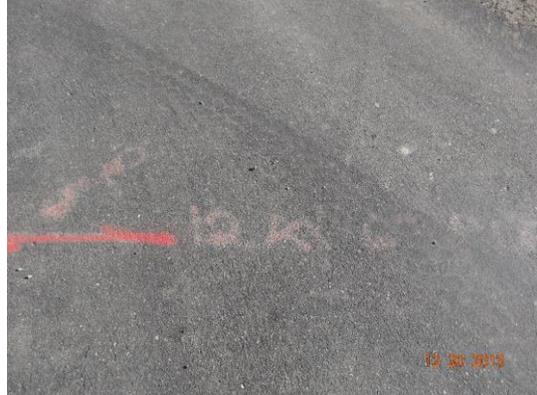
Photo 1 of 3 : UCIP\_FA\_2015\_3436.jpg

LM Start	<b>1.24</b>	Rating **	M	Issue No.	<b>46</b>
LM End	<b>1.24</b>	Issue Type +	En	Location *	CR
Category	Supplemental			GPS Latitude/Longitude	
				Start	End
Item	DWR UCIP Field Study			38.625785 °	38.625785 °
				-121.447464 °	-121.447464 °
DWR ID					
<b>Action/Comments</b>					
Inspector Comments: FS_ID:40803 DS_ID:24447 EP_NO: 16466 FS_HLM: 1.23 Repair Type: Non-Urgent Crossing Status: Found

Underground Service Alert (USA) faint utility markers visible on levee crown.

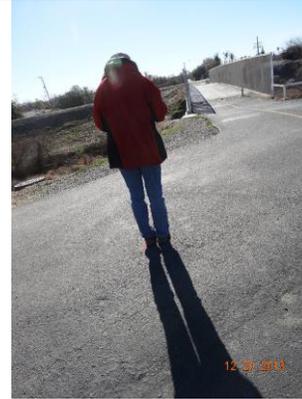
Photo 2 of 3 : UCIP\_FA\_2015\_3437.jpg

View of levee crown and estimate where crossings cross levee.

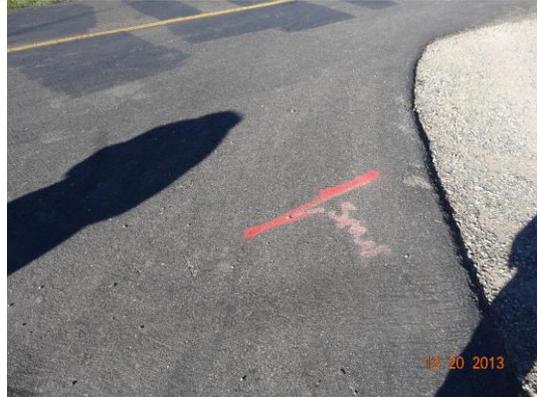
Photo 3 of 3 : UCIP\_FA\_2015\_3438.jpg

LM Start	<b>1.24</b>	Rating **	M	Issue No.	<b>46 (cont)</b>
LM End	<b>1.24</b>	Issue Type +	En	Location *	CR
Category	Supplemental			GPS Latitude/Longitude	
				Start	End
Item	DWR UCIP Field Study			38.625785 °	38.625785 °
				-121.447464 °	-121.447464 °
DWR ID					
Action/Comments					
Inspector Comments: FS_ID:40803 DS_ID:24447 EP_NO: 16466 FS_HLM: 1.23 Repair Type: Non-Urgent Crossing Status: Found

Underground Service Alert (USA) marking present on pavement however, unable to verify crossings.

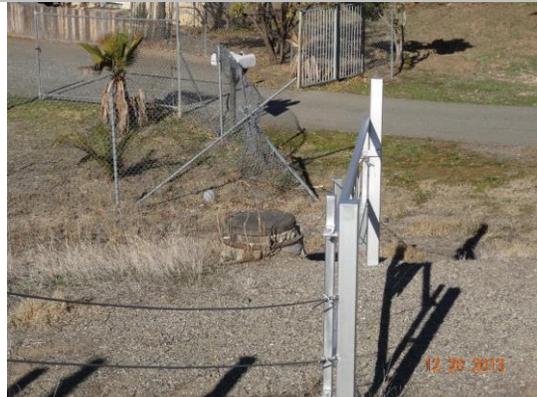
Photo 1 of 1 : UCIP\_FA\_2015\_3382.jpg

LM Start	<b>1.31</b>	Rating **	M	Issue No.	<b>47</b>
LM End	<b>1.31</b>	Issue Type +	En	Location *	CR
Category	Supplemental			GPS Latitude/Longitude	
				Start	End
Item	DWR UCIP Field Study			38.626198 °	38.626198 °
				-121.446321 °	-121.446321 °
DWR ID					
Action/Comments					
Inspector Comments: FS_ID:29275 DS_ID:24553 EP_NO: N/A FS_HLM: 1.3 Repair Type: Non-Urgent Crossing Status: Found UCIP Comments: Only manhole present--need to coordinate with owner to determine if crossing is still present and whether manhole corresponds to this crossing. FIELD_STRUCT_DESC: 8-inch (not 10-inch as indicated in desk study) sewer pipe through the levee, 7.5 feet below the crown. Floodgates within the levee across the channel, installed under Permit No. 14480 (1986). FS Date: 12/20/2013

Manhole visible on landward side.

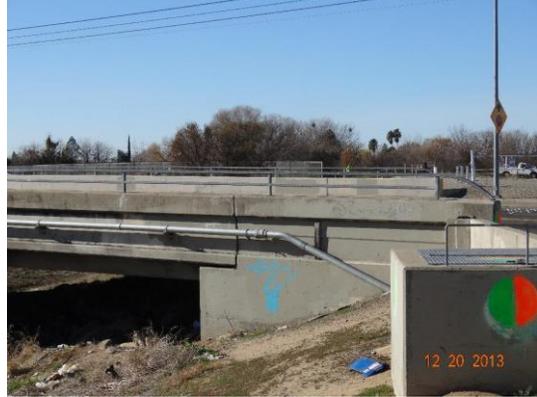
Photo 1 of 2 : UCIP\_FA\_2015\_3312.jpg

LM Start	<b>1.33</b>	Rating **	U	Issue No.	<b>48</b>
LM End	<b>1.33</b>	Issue Type +	En	Location *	CR
Category	Supplemental			GPS Latitude/Longitude	
				Start	End
Item	DWR UCIP Field Study			38.626296 °	38.626296 °
				-121.446038 °	-121.446038 °
DWR ID					
<b>Action/Comments</b>					
Inspector Comments: FS_ID:31273 DS_ID:24443 EP_NO: 15152 FS_HLM: 1.304 Repair Type: Urgent Crossing Status: Indicator Found UCIP Comments: Unable to confirm if crossing is the same one authorized through permit. FIELD_STRUCT_DESC: 4-inch steel gas main through the levee, 2.5 feet below the crown. Vent on the waterward shoulder. (Permit No. 15152-1989) FS Date: 12/20/2013

Close up view of crossing through levee.

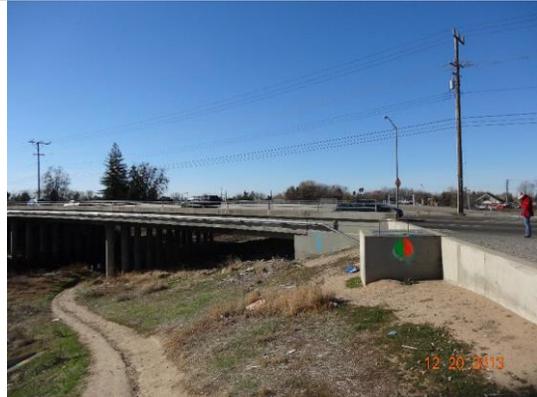
Photo 2 of 2 : UCIP\_FA\_2015\_3313.jpg

Crossing attached to upstream face of bridge.

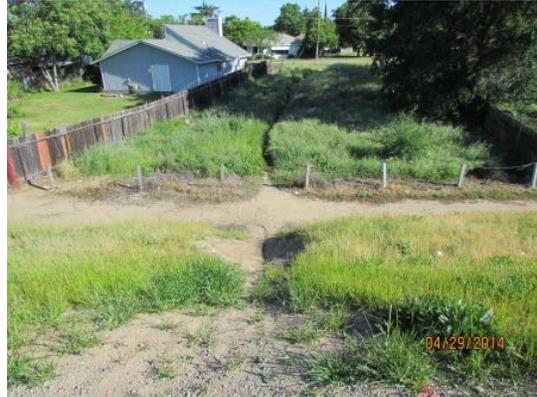
Photo 1 of 1 : FA\_2015\_NA0001\_58\_34\_20150910\_00027.jpg

LM Start	<b>1.39</b>	Rating **	A/W	Issue No.	<b>34</b>
LM End	<b>1.39</b>	Issue Type +	Ma	Location *	LS
Category	Earthen Levee		GPS Latitude/Longitude		
			Start	End	
Item	Slope Stability		38.626601 °	38.626601 °	
			-121.445016 °	-121.445016 °	
DWR ID	DWR_NA0001_07_s_2012_34				
Action/Comments					
Repair the levee slope damaged by foot traffic and prevent access where possible. Inspector Comments: Damage caused by foot traffic.

View of the landside levee slope damaged by foot traffic.

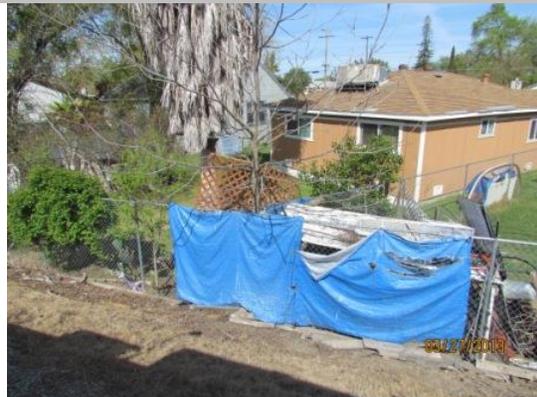
Photo 1 of 1 : FA\_2015\_NA0001\_58\_8\_20150910\_00006.jpg

LM Start	<b>1.50</b>	Rating **	M	Issue No.	<b>8</b>
LM End	<b>1.50</b>	Issue Type +	En	Location *	LS
Category	Earthen Levee		GPS Latitude/Longitude		
			Start	End	
Item	Encroachments		38.627526 °	38.627526 °	
			-121.443310 °	-121.443310 °	
DWR ID	DWR_NA0001_07_s_2013_8				
Action/Comments					
Fence

View of the fence obstruction visibility and access at the landside levee toe.

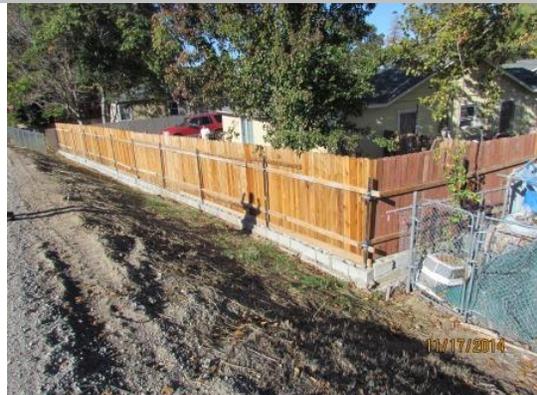
Photo 1 of 1 : FA\_2015\_NA0001\_58\_43\_20150910\_00029.jpg

LM Start	<b>1.53</b>	Rating **	U	Issue No.	<b>43</b>
LM End	<b>1.54</b>	Issue Type +	En	Location *	LS
Category	Earthen Levee		GPS Latitude/Longitude		
			Start	End	
Item	Encroachments		38.627675 °	38.627718 °	
			-121.442874 °	-121.442631 °	
DWR ID	DWR_NA0001_07_s_2014_43				
Action/Comments					
Fence Inspector Comments: New fence constructed on the property line with 18 inch CMU block base.

View of a fence at the landside levee toe obstructing visibility and access.

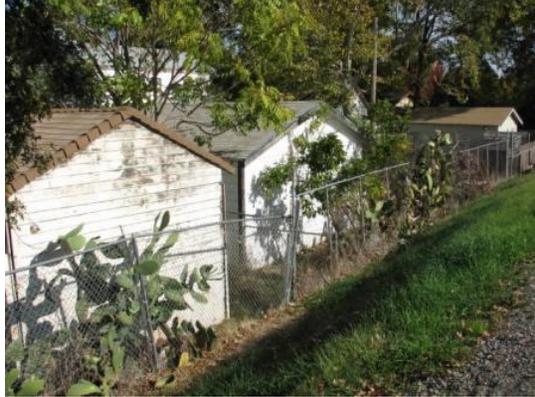
Photo 1 of 1 : FA\_2015\_NA0001\_58\_30\_20150910\_00026.jpg

LM Start	<b>1.56</b>	Rating **	U	Issue No.	<b>30</b>
LM End	<b>1.56</b>	Issue Type +	En	Location *	LS
Category	Earthen Levee		GPS Latitude/Longitude		
			Start	End	
Item	Encroachments		38.627744 °	38.627744 °	
			-121.442367 °	-121.442367 °	
DWR ID	DWR_NA0001_07_s_2012_30				
Action/Comments					
Building Inspector Comments: Large side building is within 10-ft of the levee toe.

11/17/2011 Building obstructs visibility and access.

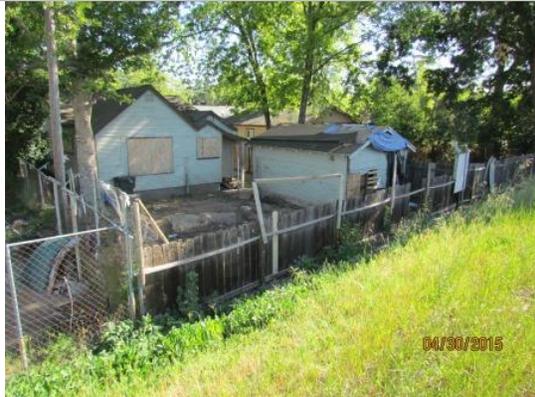
Photo 1 of 1 : FA\_2015\_NA0001\_58\_3\_20150910\_00002.jpg

LM Start	<b>1.57</b>	Rating **	U	Issue No.	<b>3</b>
LM End	<b>1.57</b>	Issue Type +	En	Location *	LS
Category	Earthen Levee		GPS Latitude/Longitude		
			Start	End	
Item	Encroachments		38.627682 °	38.627682 °	
			-121.442113 °	-121.442113 °	
DWR ID	DWR_NA0001_07_s_2012_3				
Action/Comments					
Fence Inspector Comments: Wooden privacy fence is within 10-ft of the levee toe.

Wooden privacy fence is constructed at the landside levee toe.

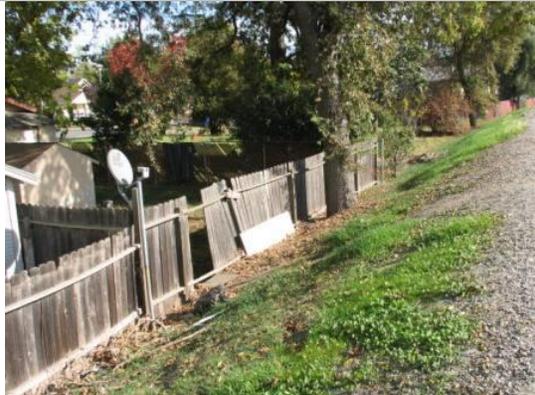
Photo 1 of 1 : FA\_2015\_NA0001\_58\_4\_20150910\_00003.jpg

LM Start	<b>1.58</b>	Rating **	U	Issue No.	<b>4</b>
LM End	<b>1.58</b>	Issue Type +	En	Location *	LS
Category	Earthen Levee		GPS Latitude/Longitude		
			Start	End	
Item	Encroachments		38.627707 °	38.627707 °	
			-121.441965 °	-121.441965 °	
DWR ID	DWR_NA0001_07_s_2012_4				
Action/Comments					
Fence Inspector Comments: Wooden privacy fence is within 10-ft of the levee toe.

11/17/2011 Wooden privacy fence is constructed at the toe.

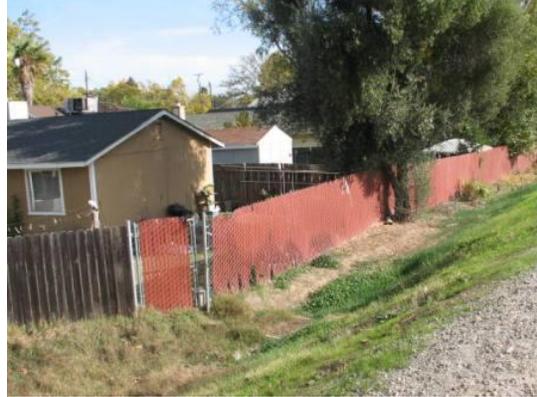
Photo 1 of 1 : FA\_2015\_NA0001\_58\_29\_20150910\_00025.jpg

LM Start	<b>1.61</b>	Rating **	M	Issue No.	<b>29</b>
LM End	<b>1.61</b>	Issue Type +	En	Location *	LS
Category	Earthen Levee		GPS Latitude/Longitude		
			Start	End	
Item	Encroachments		38.627733 °	38.627733 °	
			-121.441415 °	-121.441415 °	
DWR ID	DWR_NA0001_07_s_2012_29				
Action/Comments					
Fence Inspector Comments: Privacy fence is within 10-ft of the levee toe.

11/17/2011 Privacy fence is constructed at the toe.

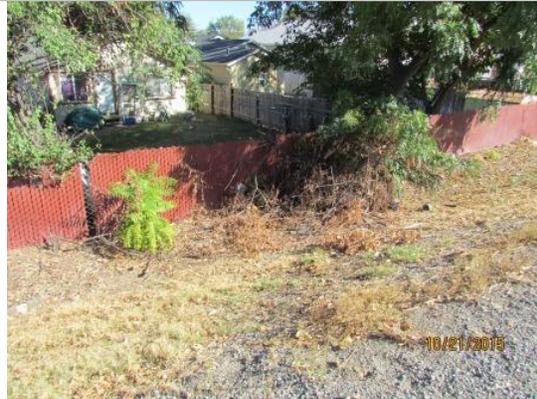
Photo 1 of 1 : FA\_2015\_NA0001\_58\_39\_20151112\_00035.jpg

LM Start	<b>1.62</b>	Rating **	M	Issue No.	<b>39</b>
LM End	<b>1.62</b>	Issue Type +	Ma	Location *	LS
Category	Earthen Levee		GPS Latitude/Longitude		
			Start	End	
Item	Encroachments		38.627711 °	38.627711 °	
			-121.441210 °	-121.441210 °	
DWR ID	DWR_NA0001_07_f_2015_39				
Action/Comments					
Prunings

View of the prunings at the landside levee toe.

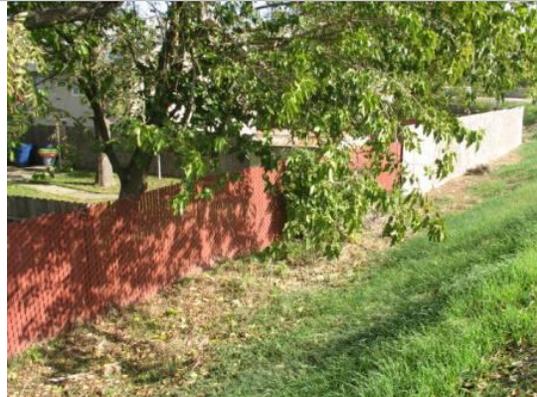
Photo 1 of 1 : FA\_2015\_NA0001\_58\_27\_20150910\_00023.jpg

LM Start	<b>1.63</b>	Rating **	U	Issue No.	<b>27</b>
LM End	<b>1.63</b>	Issue Type +	En	Location *	LS
Category	Earthen Levee		GPS Latitude/Longitude		
			Start	End	
Item	Encroachments		38.627681 °	38.627681 °	
			-121.441021 °	-121.441021 °	
DWR ID	DWR_NA0001_07_s_2012_27				
Action/Comments					
Fence Inspector Comments: Privacy fence and overgrown trees are within 10-ft of the levee toe.

11/17/2011 Privacy fence is constructed at the toe.

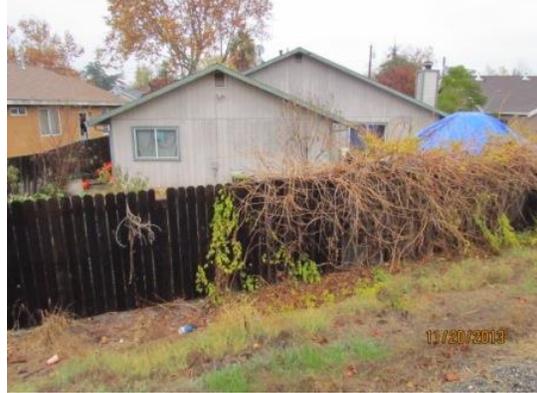
Photo 1 of 1 : FA\_2015\_NA0001\_58\_6\_20150910\_00004.jpg

LM Start	<b>1.69</b>	Rating **	U	Issue No.	<b>6</b>
LM End	<b>1.69</b>	Issue Type +	En	Location *	LS
Category	Earthen Levee		GPS Latitude/Longitude		
			Start	End	
Item	Encroachments		38.627948 °	38.627948 °	
			-121.439958 °	-121.439958 °	
DWR ID	DWR_NA0001_07_s_2012_6				
Action/Comments					
Fence Inspector Comments: Wooden privacy fence with vines are within 10-ft of the levee toe.

View of the wooden fence at the landside levee toe.

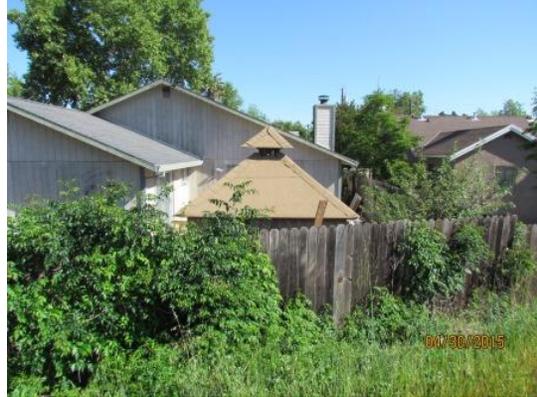
Photo 1 of 1 : FA\_2015\_NA0001\_58\_1\_20150910\_00001.jpg

LM Start	<b>1.69</b>	Rating **	U	Issue No.	<b>1</b>
LM End	<b>1.69</b>	Issue Type +	En	Location *	LS
Category	Earthen Levee		GPS Latitude/Longitude		
			Start	End	
Item	Encroachments		38.628004 °	38.628004 °	
			-121.439927 °	-121.439927 °	
DWR ID	DWR_NA0001_07_s_2012_1				
Action/Comments					
Building Inspector Comments: Construction of new structure is within 15' of levee.

View of the shed at the landside levee toe.

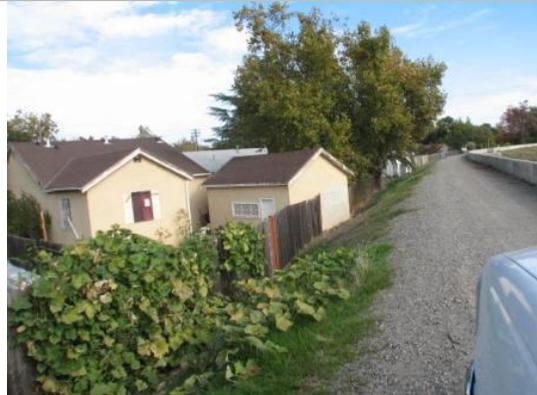
Photo 1 of 1 : FA\_2015\_NA0001\_58\_7\_20150910\_00005.jpg

LM Start	<b>1.70</b>	Rating **	U	Issue No.	<b>7</b>
LM End	<b>1.70</b>	Issue Type +	En	Location *	LS
Category	Earthen Levee		GPS Latitude/Longitude		
			Start	End	
Item	Encroachments		38.627935 °	38.627935 °	
			-121.439758 °	-121.439758 °	
DWR ID	DWR_NA0001_07_s_2012_7				
Action/Comments					
Building Inspector Comments: Corner of building protrudes into levee slope. Wooden fence is built on the levee slope.

11/17/2011 Building is constructed at the toe.

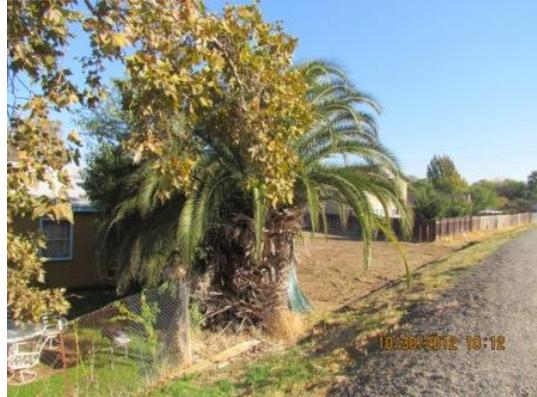
Photo 1 of 1 : FA\_2015\_NA0001\_58\_24\_20150910\_00020.jpg

LM Start	<b>1.72</b>	Rating **	<b>M</b>	Issue No.	<b>24</b>
LM End	<b>1.72</b>	Issue Type +	<b>En</b>	Location *	<b>LS</b>
Category	Earthen Levee		GPS Latitude/Longitude		
			Start	End	
Item	Vegetation		38.628086 °	38.628086 °	
			-121.439544 °	-121.439544 °	
DWR ID	DWR_NA0001_07_s_2012_24				
Action/Comments					
Landscaping Inspector Comments: Palm tree was trimmed up.

View of palm tree within 10-ft of the levee toe trimmed up from previous inspection.
