**Flood Control Project Maintenance  
Levee Inspections**

**Fall 2015 Levee Maintenance Deficiency Summary Report**

**Sacramento River Basin**

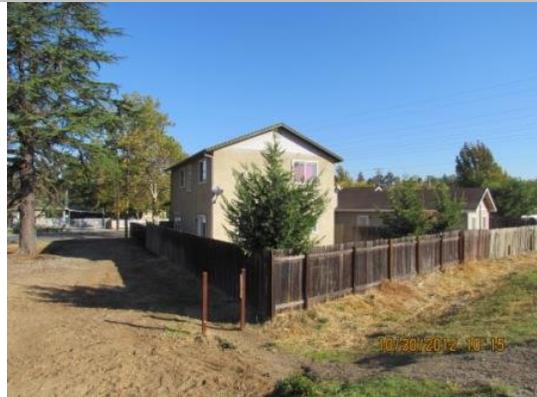
Photo 1 of 1 : FA\_2015\_NA0001\_58\_23\_20150910\_00019.jpg

LM Start	<b>1.74</b>	Rating **	<b>U</b>	Issue No.	<b>23</b>
LM End	<b>1.74</b>	Issue Type +	<b>En</b>	Location *	<b>LS</b>
Category	Earthen Levee		GPS Latitude/Longitude		
			Start	End	
Item	Encroachments		38.628208 °	38.628208 °	
			-121.439142 °	-121.439142 °	
DWR ID	DWR_NA0001_07_s_2012_23				
Action/Comments					
Fence Inspector Comments: Wooden fence and cedar trees are within 10-ft of levee toe.

View of wooden privacy fence constructed at the toe.

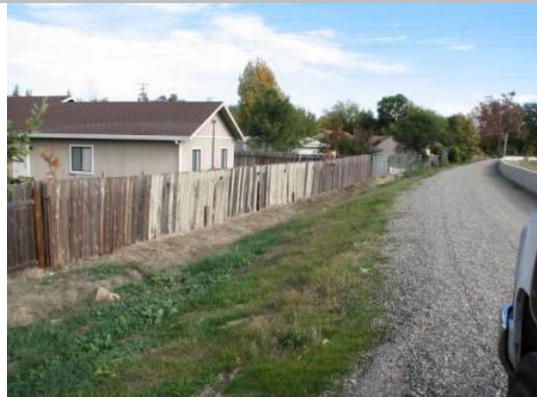
Photo 1 of 1 : FA\_2015\_NA0001\_58\_9\_20150910\_00007.jpg

LM Start	<b>1.75</b>	Rating **	<b>U</b>	Issue No.	<b>9</b>
LM End	<b>1.75</b>	Issue Type +	<b>En</b>	Location *	<b>LS</b>
Category	Earthen Levee		GPS Latitude/Longitude		
			Start	End	
Item	Encroachments		38.628197 °	38.628197 °	
			-121.438863 °	-121.438863 °	
DWR ID	DWR_NA0001_07_s_2012_9				
Action/Comments					
Fence Inspector Comments: Wooden privacy fence is within 10-ft of the levee toe.

11/17/2011 Wooden privacy fence is constructed at the toe.

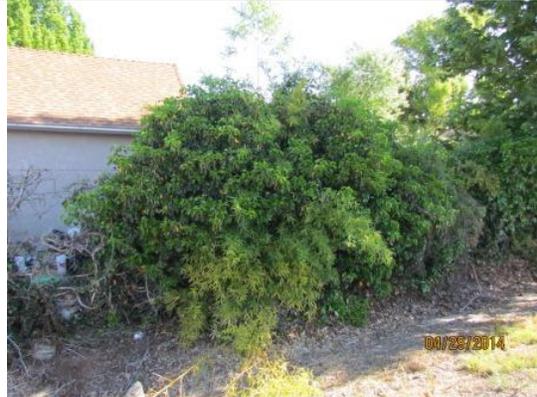
Photo 1 of 1 : FA\_2015\_NA0001\_58\_10\_20150910\_00008.jpg

LM Start	<b>1.79</b>	Rating **	U	Issue No.	<b>10</b>
LM End	<b>1.79</b>	Issue Type +	En	Location *	LS
Category	Earthen Levee		GPS Latitude/Longitude		
			Start	End	
Item	Vegetation		38.628273 °	38.628273 °	
			-121.438255 °	-121.438255 °	
DWR ID	DWR_NA0001_07_s_2012_10				
Action/Comments					
Landscaping Inspector Comments: Ivy and other landscape plantings have grown up chain link fence on the levee toe. Building is within 10-ft of the levee toe. Prunings are on the levee slope.

Landscaping has grown over the fence and obstructs visibility and access.

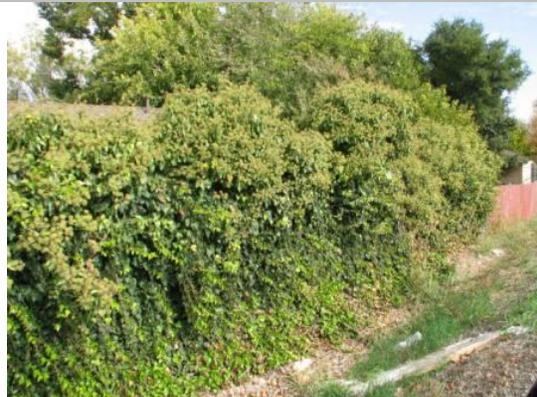
Photo 1 of 1 : FA\_2015\_NA0001\_58\_11\_20150910\_00009.jpg

LM Start	<b>1.80</b>	Rating **	U	Issue No.	<b>11</b>
LM End	<b>1.80</b>	Issue Type +	En	Location *	LS
Category	Earthen Levee		GPS Latitude/Longitude		
			Start	End	
Item	Vegetation		38.628297 °	38.628297 °	
			-121.437995 °	-121.437995 °	
DWR ID	DWR_NA0001_07_f_2012_11				
Action/Comments					
Landscaping Inspector Comments: Dense ivy and landscaping planted on chain link fence on levee toe. Porch and awning are within 10-ft of the levee toe.

11/17/2011 Overgrown vegetation obstructs visibility and access.

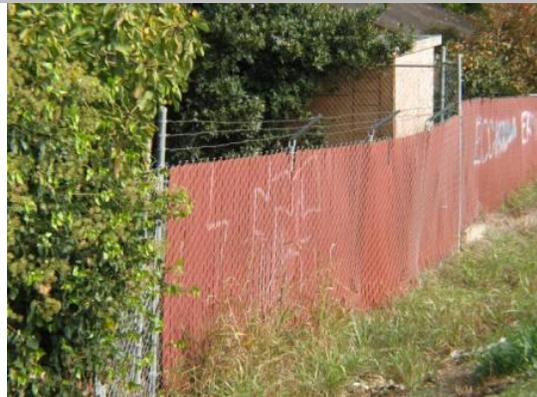
Photo 1 of 1 : FA\_2015\_NA0001\_58\_12\_20150910\_00010.jpg

LM Start	<b>1.81</b>	Rating **	U	Issue No.	<b>12</b>
LM End	<b>1.81</b>	Issue Type +	En	Location *	LS
Category	Earthen Levee		GPS Latitude/Longitude		
			Start	End	
Item	Encroachments		38.628307 °	38.628307 °	
			-121.437842 °	-121.437842 °	
DWR ID	DWR_NA0001_07_s_2012_12				
Action/Comments					
Fence Inspector Comments: Chain link privacy fence with barbed wire is within 10-ft of levee toe.

11/17/2011 Barbed wire topped privacy fence is located at the toe.

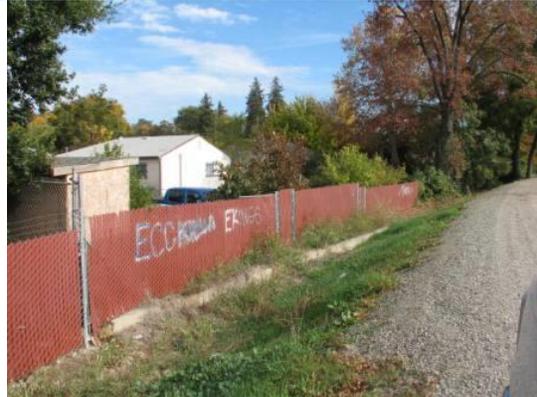
Photo 1 of 1 : FA\_2015\_NA0001\_58\_13\_20150910\_00011.jpg

LM Start	<b>1.82</b>	Rating **	U	Issue No.	<b>13</b>
LM End	<b>1.82</b>	Issue Type +	En	Location *	LS
Category	Earthen Levee		GPS Latitude/Longitude		
			Start	End	
Item	Encroachments		38.628303 °	38.628303 °	
			-121.437693 °	-121.437693 °	
DWR ID	DWR_NA0001_07_s_2012_13				
Action/Comments					
Fence Inspector Comments: Chain link privacy fence is within 10-ft of levee toe.

11/17/2011 Privacy fence is located at the toe.

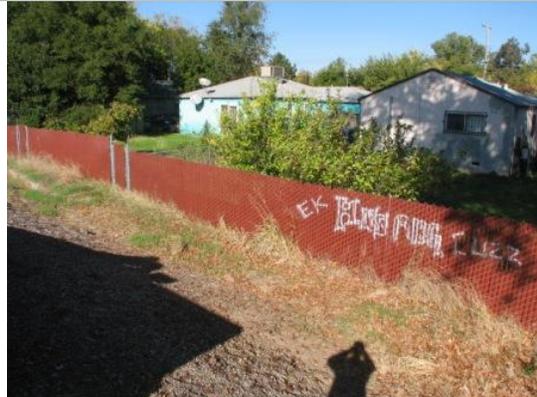
Photo 1 of 1 : FA\_2015\_NA0001\_58\_14\_20150910\_00012.jpg

LM Start	<b>1.83</b>	Rating **	U	Issue No.	<b>14</b>
LM End	<b>1.83</b>	Issue Type +	En	Location *	LS
Category	Earthen Levee		GPS Latitude/Longitude		
			Start	End	
Item	Encroachments		38.628303 °	38.628303 °	
			-121.437530 °	-121.437530 °	
DWR ID	DWR_NA0001_07_s_2012_14				
Action/Comments					
Fence Inspector Comments: Chain link privacy fence is within 10-ft of levee toe.

Fall 2009 photo of privacy fence within 10-ft of the levee toe obstructs visibility and access.

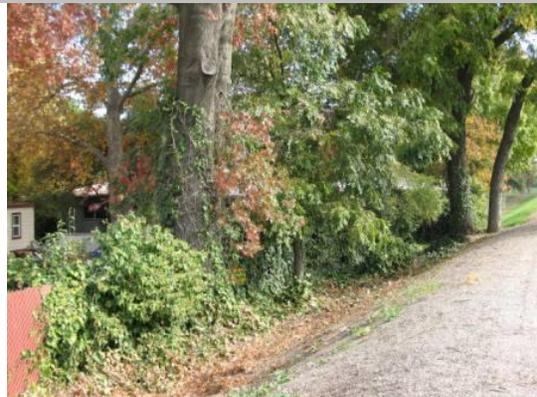
Photo 1 of 2 : FA\_2015\_NA0001\_58\_15\_20150910\_00013.jpg

LM Start	<b>1.84</b>	Rating **	U	Issue No.	<b>15</b>
LM End	<b>1.84</b>	Issue Type +	En	Location *	LS
Category	Earthen Levee		GPS Latitude/Longitude		
			Start	End	
Item	Vegetation		38.628295 °	38.628295 °	
			-121.437282 °	-121.437282 °	
DWR ID	DWR_NA0001_07_s_2012_15				
Action/Comments					
Landscaping Inspector Comments: Dense ivy growing on chain link fence within 10-ft of levee toe.

11/17/2011 Dense vegetation at the toe.

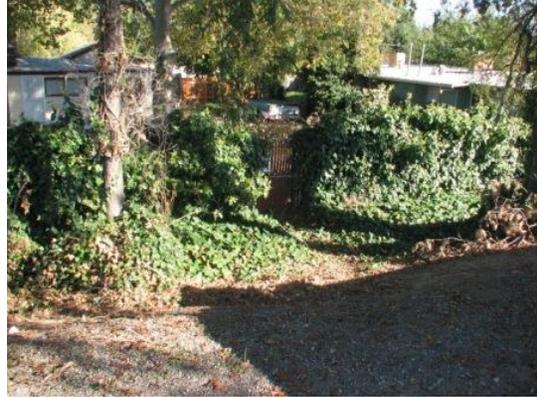
Photo 2 of 2 : FA\_2015\_NA0001\_58\_15\_20150910\_00014.jpg

LM Start	<b>1.84</b>	Rating **	U	Issue No.	<b>15 (cont)</b>
LM End	<b>1.84</b>	Issue Type +	En	Location *	LS
Category	Earthen Levee		GPS Latitude/Longitude		
			Start	End	
Item	Vegetation		38.628295 °	38.628295 °	
			-121.437282 °	-121.437282 °	
DWR ID	DWR_NA0001_07_s_2012_15				
Action/Comments					
Landscaping Inspector Comments: Dense ivy growing on chain link fence within 10-ft of levee toe.

Fall 2009 photo of dense ivy and fence obstruct visibility and access.

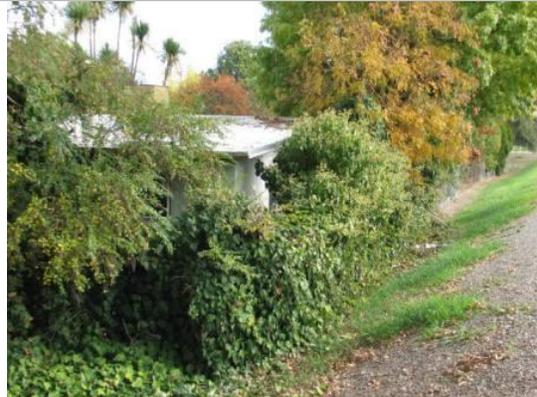
Photo 1 of 1 : FA\_2015\_NA0001\_58\_16\_20150910\_00015.jpg

LM Start	<b>1.86</b>	Rating **	U	Issue No.	<b>16</b>
LM End	<b>1.86</b>	Issue Type +	En	Location *	LS
Category	Earthen Levee		GPS Latitude/Longitude		
			Start	End	
Item	Vegetation		38.628262 °	38.628262 °	
			-121.436985 °	-121.436985 °	
DWR ID	DWR_NA0001_07_s_2012_16				
Action/Comments					
Landscaping Inspector Comments: Dense ivy and trees along chain link fence on levee toe. Large building is within 10-ft of levee toe.

11/17/2011 Vegetation and building obstruct visibility and access to the levee toe.

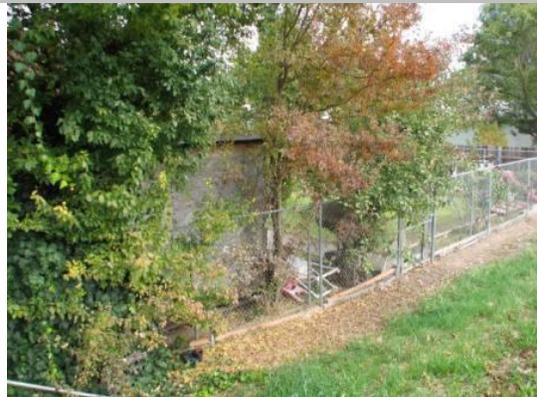
Photo 1 of 1 : FA\_2015\_NA0001\_58\_22\_20150910\_00018.jpg

LM Start	<b>1.87</b>	Rating **	U	Issue No.	<b>22</b>
LM End	<b>1.87</b>	Issue Type +	En	Location *	LS
Category	Earthen Levee		GPS Latitude/Longitude		
			Start	End	
Item	Encroachments		38.628318 °	38.628318 °	
			-121.436794 °	-121.436794 °	
DWR ID	DWR_NA0001_07_s_2012_22				
Action/Comments					
Building Inspector Comments: Wooden shed and landscaping along chain link fence within 10-ft of levee toe.

11/17/2011 Building is too close to the levee toe and obstructs visibility and access.

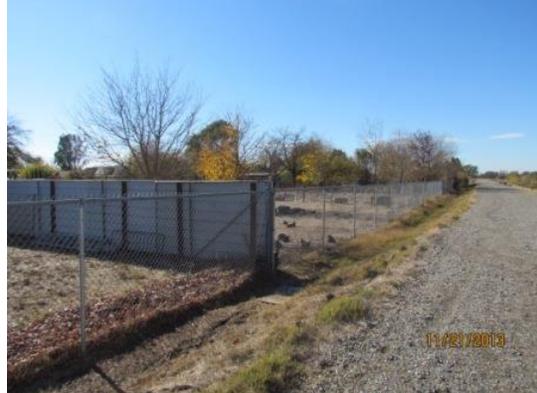
Photo 1 of 1 : FA\_2015\_NA0001\_59\_4\_20150910\_00004.jpg

LM Start	<b>0.30</b>	Rating **	M	Issue No.	<b>4</b>
LM End	<b>0.49</b>	Issue Type +	En	Location *	LS
Category	Earthen Levee		GPS Latitude/Longitude		
			Start	End	
Item	Encroachments		38.668191 °	38.668118 °	
			-121.442059 °	-121.438659 °	
DWR ID	DWR_NA0001_08_s_2012_4				
Action/Comments					
Fence Inspector Comments: Chain link fence near levee toe limits access.

View of the chainlink fence at landside levee toe facing downstream.

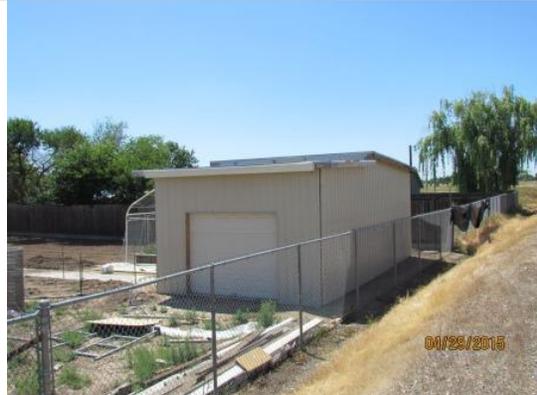
Photo 1 of 1 : FA\_2015\_NA0001\_59\_15\_20150910\_00009.jpg

LM Start	<b>0.33</b>	Rating **	U	Issue No.	<b>15</b>
LM End	<b>0.33</b>	Issue Type +	En	Location *	LS
Category	Earthen Levee		GPS Latitude/Longitude		
			Start	End	
Item	Encroachments		38.668135 °	38.668135 °	
			-121.441563 °	-121.441563 °	
DWR ID	DWR_NA0001_08_f_2013_15				
Action/Comments					
Building Inspector Comments: Building within 10 feet of landside levee toe.

View of the building within 10 feet of landside levee toe, facing downstream.

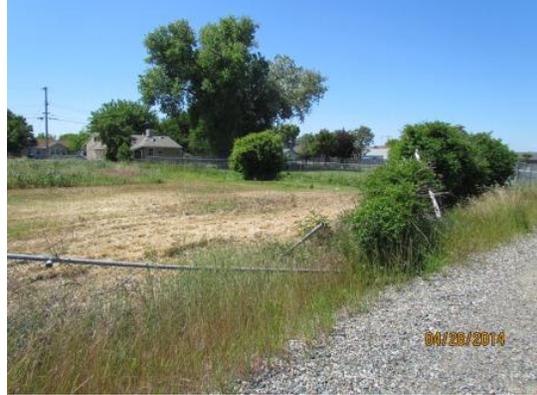
Photo 1 of 1 : FA\_2015\_NA0001\_59\_22\_20150910\_00012.jpg

LM Start	<b>0.39</b>	Rating **	M	Issue No.	<b>22</b>
LM End	<b>0.39</b>	Issue Type +	En	Location *	LS
Category	Earthen Levee		GPS Latitude/Longitude		
			Start	End	
Item	Encroachments		38.668155 °	38.668155 °	
			-121.440484 °	-121.440484 °	
DWR ID	DWR_NA0001_08_s_2014_22				
Action/Comments					
Fence Inspector Comments: Remove fence from landside levee slope.

View of the broken fence on landside levee toe.

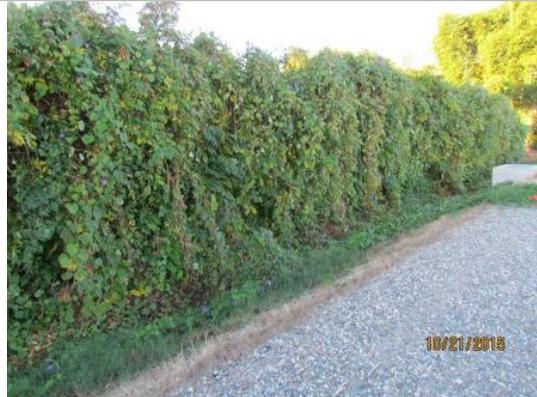
Photo 1 of 1 : FA\_2015\_NA0001\_59\_6\_20151112\_00015.jpg

LM Start	<b>0.40</b>	Rating **	U	Issue No.	<b>6</b>
LM End	<b>0.43</b>	Issue Type +	En	Location *	LS
Category	Earthen Levee		GPS Latitude/Longitude		
			Start	End	
Item	Vegetation		38.668147 °	38.668141 °	
			-121.440248 °	-121.439755 °	
DWR ID	DWR_NA0001_08_s_2012_6				
Action/Comments					
Landscaping Inspector Comments: Vines on fence limit visibility.

View of the vines on fence obstructing visibility of landside toe.

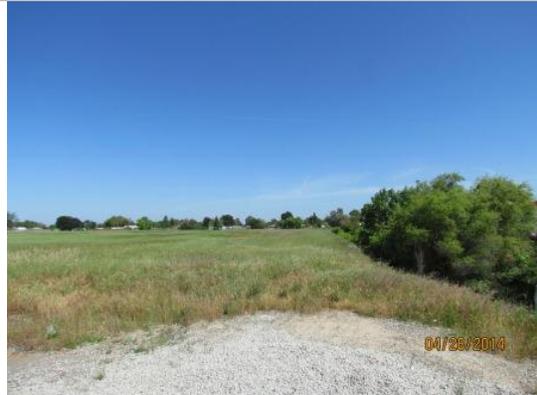
Photo 1 of 1 : FA\_2015\_NA0001\_59\_1\_20150910\_00001.jpg

LM Start	<b>0.51</b>	Rating **	U	Issue No.	<b>1</b>
LM End	<b>1.03</b>	Issue Type +	En	Location *	WS
Category	Earthen Levee		GPS Latitude/Longitude		
			Start	End	
Item	Encroachments		38.668132 °	38.665528 °	
			-121.438229 °	-121.431688 °	
DWR ID	DWR_NA0001_08_s_2012_1				
Action/Comments					
Material Inspector Comments: This portion of the levee is inaccessible for maintenance.

View from downstream end of inaccessible portion of Magpie Creek due to landowner restrictions. There is no levee for ARFCD to maintain at this location. However, the channel maintenance is the responsibility of Sacramento Yard.

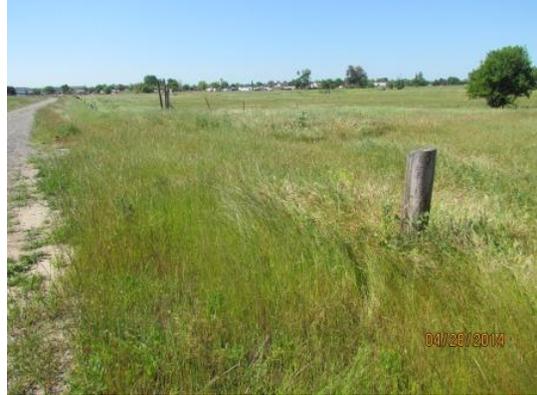
Photo 1 of 1 : FA\_2015\_NA0001\_59\_20\_20150910\_00010.jpg

LM Start	<b>1.21</b>	Rating **	M	Issue No.	<b>20</b>
LM End	<b>1.21</b>	Issue Type +	En	Location *	LS
Category	Earthen Levee			GPS Latitude/Longitude	
				Start	End
Item	Encroachments			38.662860 °	38.662860 °
				-121.431671 °	-121.431671 °
DWR ID	DWR_NA0001_08_s_2014_20				
Action/Comments					
Pole

View of the pole on landside levee toe.

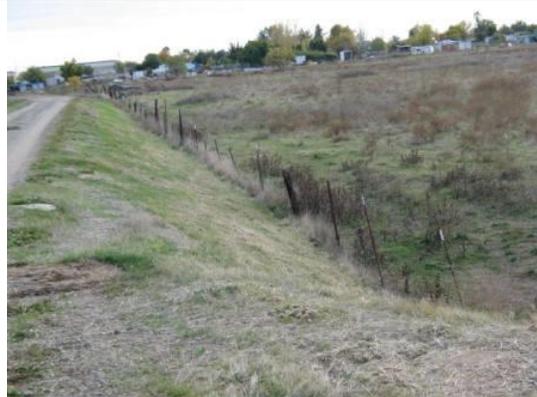
Photo 1 of 1 : FA\_2015\_NA0001\_59\_2\_20150910\_00002.jpg

LM Start	<b>1.22</b>	Rating **	M	Issue No.	<b>2</b>
LM End	<b>1.31</b>	Issue Type +	En	Location *	LS
Category	Earthen Levee			GPS Latitude/Longitude	
				Start	End
Item	Encroachments			38.662715 °	38.661584 °
				-121.431666 °	-121.431402 °
DWR ID	DWR_NA0001_08_s_2012_2				
Action/Comments					
Fence Inspector Comments: Barbed wire fence runs along the levee toe.

11/17/2011 Barbed wire fence at levee toe.

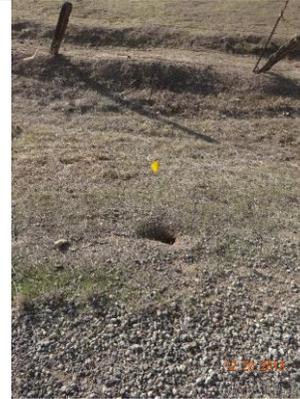
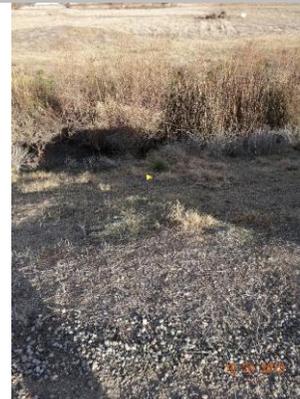
LM Start	<b>1.28</b>	Rating **	M	Issue No.	<b>23</b>
LM End	<b>1.28</b>	Issue Type +	En	Location *	LS
Category	Supplemental			GPS Latitude/Longitude	
				Start	End
Item	DWR UCIP Field Study			38.661843 °	38.661843 °
				-121.431675 °	-121.431675 °
DWR ID					
<b>Action/Comments</b>					
Inspector Comments: FS_ID:30689 DS_ID:24815 EP_NO: N/A FS_HLM: 1.32 Repair Type: Non-Urgent Crossing Status: Indicator Found UCIP Comments: unable to confirm if conduit or gas line cross levee or flag identifying problem areas. Need additional information. FIELD_STRUCT_DESC: Underground service alert (USA) markers found on waterward and landward side during field inspection. FS Date: 12/20/2013

View of landward side.

View of waterward side.

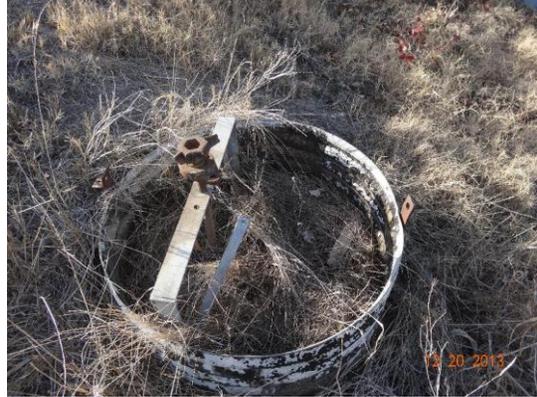
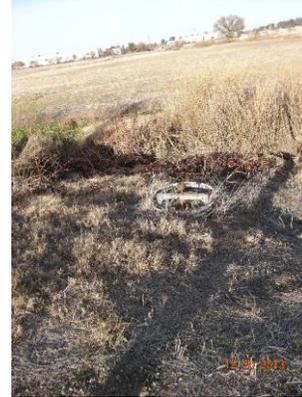
Item	DWR UCIP Field Study			38.660913 °	38.660913 °
				-121.429900 °	-121.429900 °
DWR ID					
Action/Comments					
Inspector Comments: FS_ID:29329 DS_ID:24384 EP_NO: N/A FS_HLM: 1.44 Repair Type: Non-Urgent Crossing Status: Indicator Found UCIP Comments: Non-functional crossing--need to coordinate with owner, DWR-Inspector, and CVFPB to determine how to properly abandon crossing. FIELD_STRUCT_DESC: Abandoned 24-inch pipe through the levee, 8.0 feet below the crown. Two CM cutoff walls around pipe. Slide gate in 30-inch CM riser and flap gate at waterward end. Concrete "U" headwall and splash apron on waterward end. Landward end cutoff and plugged, riser filled with dirt. (USACE-1959). This entry matches the Drainage or Irrigation Structure referenced in O&M manual (Station 72+10). FS Date: 12/20/2013

Slide gate non-functional--riser filled with soil.

View of riser with slide gate located on waterward side.

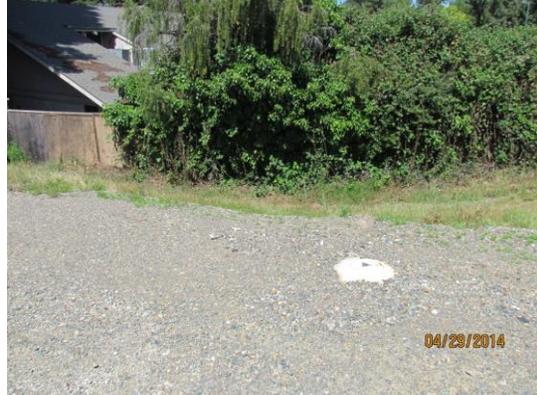
Photo 1 of 1 : FA\_2015\_NA0001\_60\_13\_20150910\_00005.jpg

LM Start	<b>0.02</b>	Rating **	A/W	Issue No.	<b>13</b>
LM End	<b>0.02</b>	Issue Type +	En	Location *	LS
Category	Earthen Levee		GPS Latitude/Longitude		
			Start	End	
Item	Encroachments		38.567955 °	38.567955 °	
			-121.383623 °	-121.383623 °	
DWR ID	DWR_NA0001_09_f_2013_13				
Action/Comments					
Monitoring Well Inspector Comments: Monitoring well at landside levee hinge.

View of the monitoring well cap at the landside levee hinge.

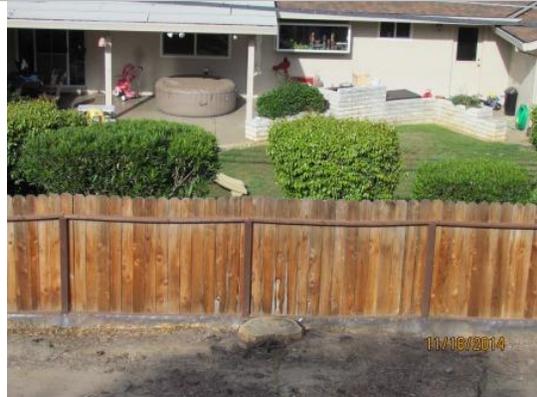
Photo 1 of 1 : FA\_2015\_NA0001\_60\_12\_20150910\_00004.jpg

LM Start	<b>0.40</b>	Rating **	N	Issue No.	<b>12</b>
LM End	<b>0.40</b>	Issue Type +	Ma	Location *	LS
Category	Earthen Levee		GPS Latitude/Longitude		
			Start	End	
Item	Trim / Thin Trees		38.566725 °	38.566725 °	
			-121.389935 °	-121.389935 °	
DWR ID	DWR_NA0001_09_f_2013_12				
Action/Comments					
Tree stumps.

View of the tree stump at the landside levee toe.

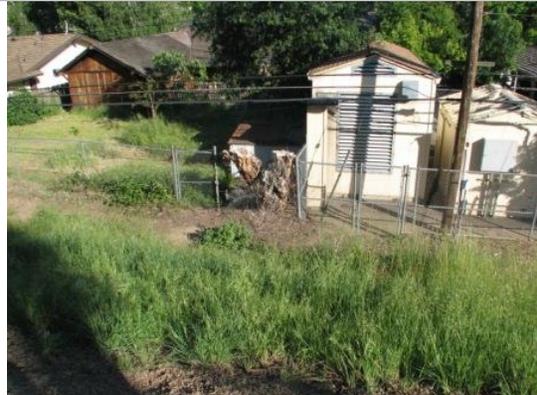
Photo 1 of 1 : FA\_2015\_NA0001\_60\_14\_20150910\_00006.jpg

LM Start	<b>0.45</b>	Rating **	N	Issue No.	<b>14</b>
LM End	<b>0.45</b>	Issue Type +	Ma	Location *	LS
Category	Earthen Levee		GPS Latitude/Longitude		
			Start	End	
Item	Trim / Thin Trees		38.566298 °	38.566298 °	
			-121.390680 °	-121.390680 °	
DWR ID	DWR_NA0001_09_s_2012_14				
Action/Comments					
Tree stumps. Inspector Comments: Tree trunk at fence line.

Tree trunk at fence line.

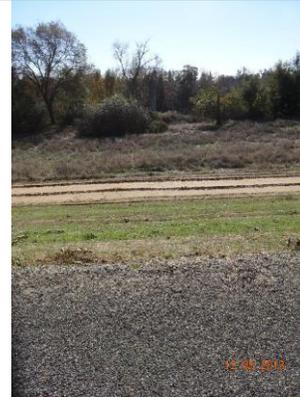
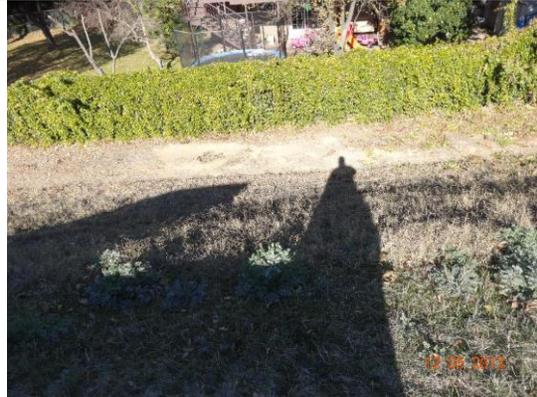
LM Start	<b>1.29</b>	Rating **	M	Issue No.	<b>30</b>
LM End	<b>1.29</b>	Issue Type +	En	Location *	LS
Category	Supplemental			GPS Latitude/Longitude	
				Start	End
Item	DWR UCIP Field Study			38.562285 °	38.562285 °
				-121.405265 °	-121.405265 °
DWR ID					
Action/Comments					
Inspector Comments: FS_ID:29347 DS_ID:24394 EP_NO: N/A FS_HLM: 1.31 Repair Type: Non-Urgent Crossing Status: Indicator Found UCIP Comments: Need to contact owner to determine status of crossing. FIELD_STRUCT_DESC: Abandoned 12-inch steel pipe through the levee, 14.0 feet below the crown. Riser unit on waterward side. (USACE-1959). This entry matches the Drainage or Irrigation Structure referenced in O&M manual (Station 296+85). Pipe abandonment was referenced in Permit No. 4622 (1964). FS Date: 12/05/2013

View of waterward side--tall riser located approximately 200 feet away.

View of landward side.

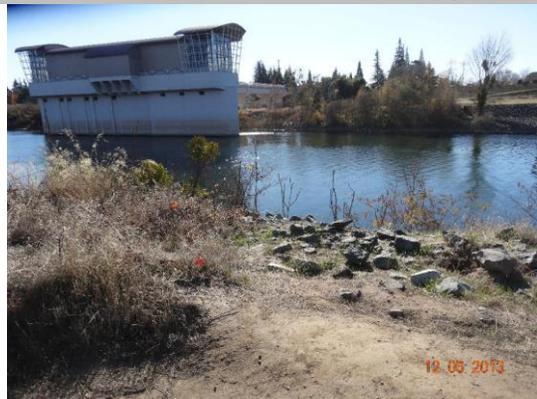
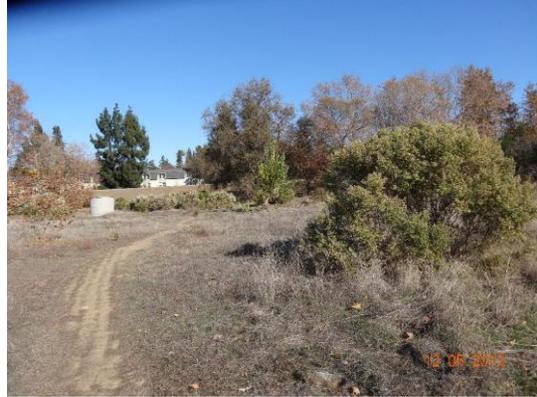
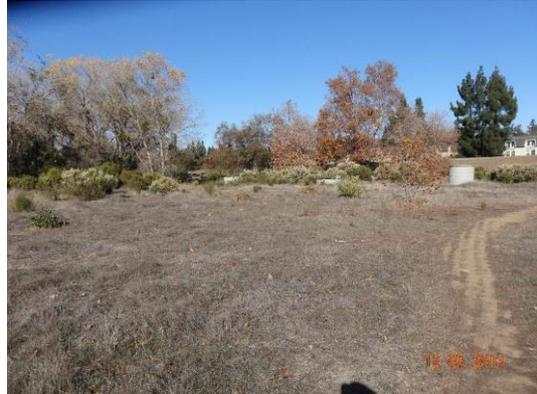
LM Start	1.88	Rating **	M	Issue No.	29
LM End	1.88	Issue Type +	En	Location *	LS
Category	Supplemental			GPS Latitude/Longitude	
			Start	End	
Item	DWR UCIP Field Study			38.561155 °	38.561155 °
				-121.415839 °	-121.415839 °
DWR ID	DWR_NA0001_09_f_2015_29				
Action/Comments					
Inspector Comments: FS_ID:29351 DS_ID:24597 EP_NO: 17587 FS_HLM: 1.97 Repair Type: Non-Urgent Crossing Status: Indicator Found UCIP Comments: Unable to confirm if riser belongs to this crossing--need to coordinate with owner to determine specifics. Description needs to be updated. FIELD_STRUCT_DESC: 54-inch water main through the levee. (Permit No. 17587-2003) FS Date: 12/05/2013

View of waterward edge--rip rap armor along toe.

View of waterward berm looking toward levee crown from waterward berm edge.

Three risers located on waterward berm.

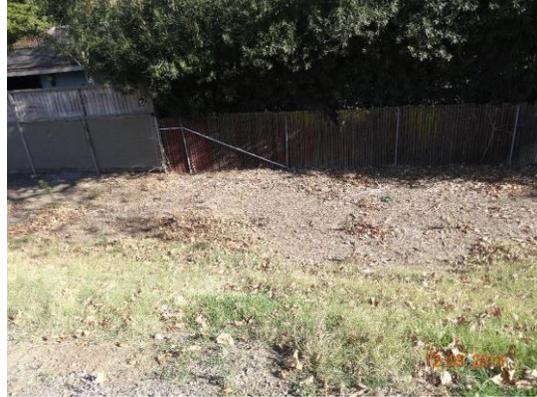
Photo 1 of 3 : UCIP\_FA\_2015\_3008.jpg

LM Start	<b>2.51</b>	Rating **	M	Issue No.	<b>31</b>
LM End	<b>2.51</b>	Issue Type +	En	Location *	LS
Category	Supplemental			GPS Latitude/Longitude	
				Start	End
Item	DWR UCIP Field Study			38.568767 °	38.568767 °
				-121.421178 °	-121.421178 °
DWR ID					
<b>Action/Comments</b>					
Inspector Comments: FS_ID:31309 DS_ID:24515 EP_NO: N/A FS_HLM: 2.56 Repair Type: Non-Urgent Crossing Status: Indicator Found

Landward side toe cleared.

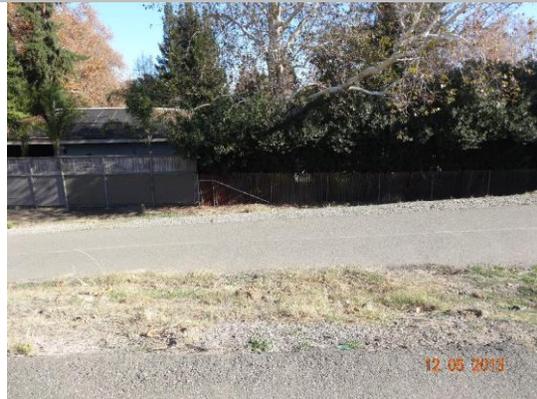
Photo 2 of 3 : UCIP\_FA\_2015\_3009.jpg

View of landward side.

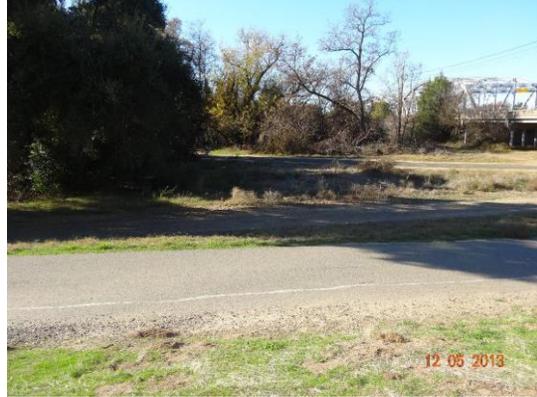
Photo 3 of 3 : UCIP\_FA\_2015\_3010.jpg

View of waterward side.

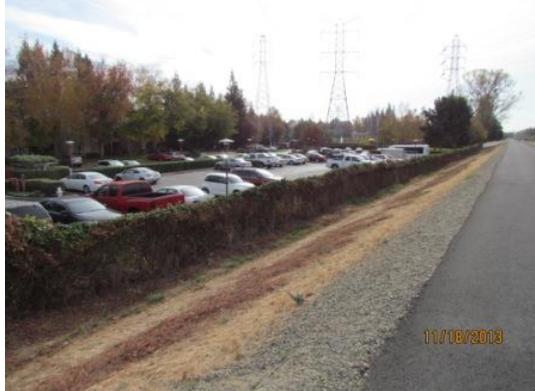
Photo 1 of 1 : FA\_2015\_NA0001\_60\_2\_20150910\_00002.jpg

LM Start	<b>3.06</b>	Rating **	U	Issue No.	<b>2</b>
LM End	<b>3.19</b>	Issue Type +	En	Location *	LS
Category	Earthen Levee		GPS Latitude/Longitude		
			Start	End	
Item	Encroachments		38.576423 °	38.578248 °	
			-121.419117 °	-121.418475 °	
DWR ID	DWR_NA0001_09_s_2012_2				
Action/Comments					
Fence

View of the trimmed vegetation on the chain linked fence still obstructing visibility.

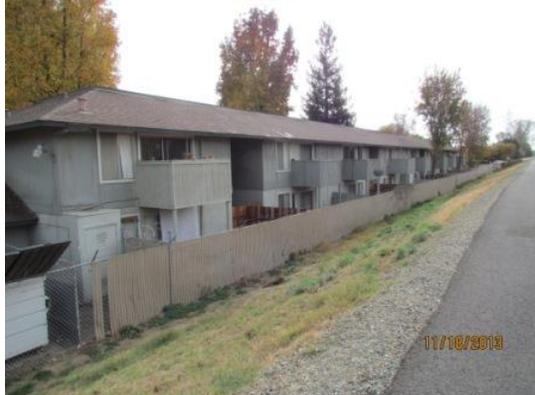
Photo 1 of 1 : FA\_2015\_NA0001\_60\_1\_20150910\_00001.jpg

LM Start	<b>3.19</b>	Rating **	U	Issue No.	<b>1</b>
LM End	<b>3.27</b>	Issue Type +	En	Location *	LS
Category	Earthen Levee		GPS Latitude/Longitude		
			Start	End	
Item	Encroachments		38.578258 °	38.579363 °	
			-121.418475 °	-121.418100 °	
DWR ID	DWR_NA0001_09_s_2012_1				
Action/Comments					
Fence

View of the fence at the landside levee toe.

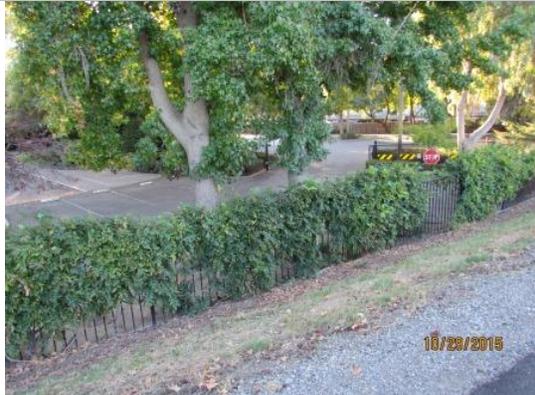
Photo 1 of 1 : FA\_2015\_NA0001\_60\_24\_20151112\_00014.jpg

LM Start	<b>3.30</b>	Rating **	M	Issue No.	<b>24</b>
LM End	<b>3.30</b>	Issue Type +	En	Location *	LS
Category	Earthen Levee		GPS Latitude/Longitude		
			Start	End	
Item	Vegetation		38.579851 °	38.579851 °	
			-121.417896 °	-121.417896 °	
DWR ID	DWR_NA0001_09_f_2015_24				
Action/Comments					
Landscaping Inspector Comments: Vine on the LS fence blocking visibility.

View of the vines on the fence at the landside levee toe.

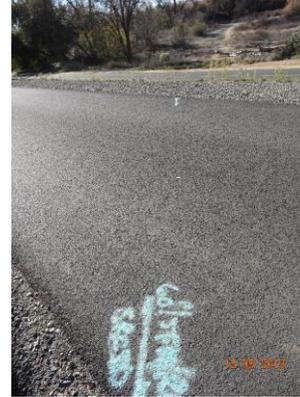
Photo 1 of 3 : UCIP\_FA\_2015\_4165.jpg

LM Start	<b>3.32</b>	Rating **	M	Issue No.	<b>32</b>
LM End	<b>3.32</b>	Issue Type +	En	Location *	LS
Category	Supplemental			GPS Latitude/Longitude	
				Start	End
Item	DWR UCIP Field Study			38.580094 °	38.580094 °
				-121.417821 °	-121.417821 °
DWR ID					
Action/Comments					
Inspector Comments: FS_ID:30125 DS_ID:24412 EP_NO: 17671 FS_HLM: 3.38 Repair Type: Non-Urgent Crossing Status: Indicator Found UCIP Comments: unable to confirm if manhole is part of this crossing-- need to contact owner to determine status of crossing. FIELD_STRUCT_DESC: 1 of 2: 60-inch sewer main under the levee. Connects to 60-inch main on landward side. (Permit No. 17671-2003) FS Date: 12/05/2013

View of waterward side.

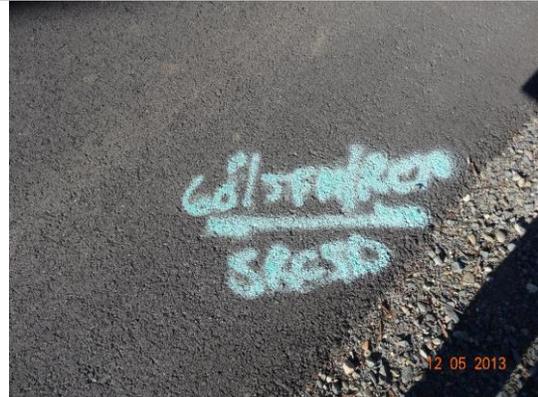
Photo 2 of 3 : UCIP\_FA\_2015\_4166.jpg

Underground service alert (USA) paint found on bike path on waterward side.

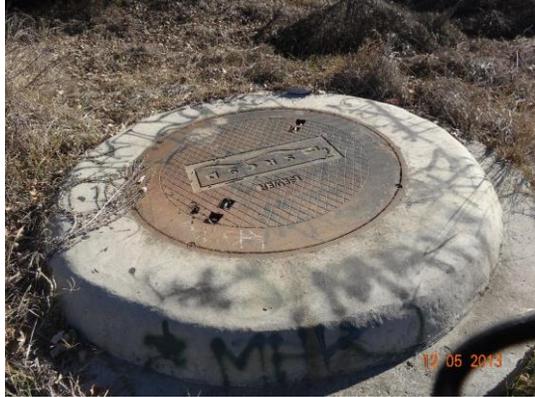
Photo 3 of 3 : UCIP\_FA\_2015\_4167.jpg

Manhole visible on waterward toe.

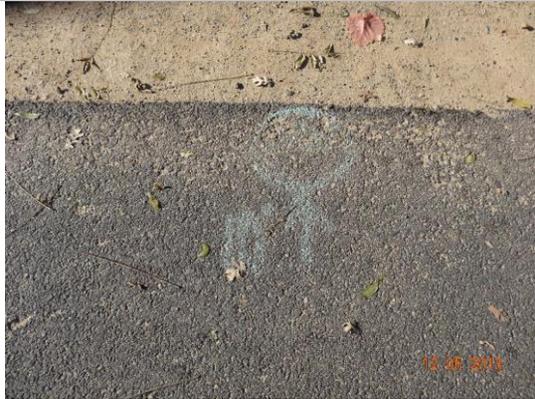
Photo 1 of 3 : UCIP\_FA\_2015\_3171.jpg

LM Start	<b>3.34</b>	Rating **	M	Issue No.	<b>33</b>
LM End	<b>3.34</b>	Issue Type +	En	Location *	LS
Category	Supplemental			GPS Latitude/Longitude	
				Start	End
Item	DWR UCIP Field Study			38.580347 °	38.580347 °
				-121.417734 °	-121.417734 °
DWR ID					
Action/Comments					
Inspector Comments: FS_ID:29633 DS_ID:24404 EP_NO: 12188 FS_HLM: 3.4 Repair Type: Non-Urgent Crossing Status: Indicator Found UCIP Comments: unable to confirm if crossing is still active--need to contact owner to determine status of crossing. FIELD_STRUCT_DESC: 60-inch concrete encased steel sewer line through the levee, 17.0 feet below the crown. Cutoff wall around pipe at the center of the levee. Rock revetment on waterward slope. Three pressure manholes in overflow area along pipe path. (Permit No. 12188-1979) FS Date: 12/05/2013

Faded paint markings located on levee crown.

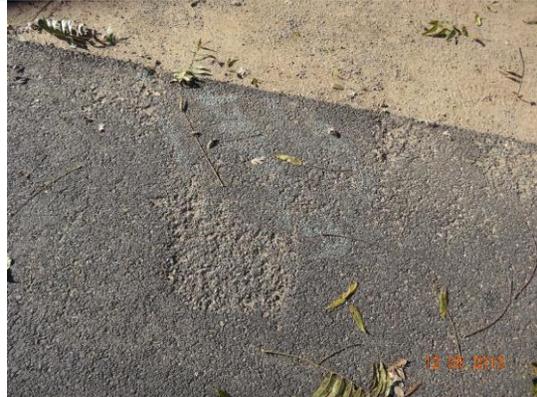
Photo 2 of 3 : UCIP\_FA\_2015\_3172.jpg

Inspector Comments: FS\_ID:29633  
 DS\_ID:24404  
 EP\_NO: 12188  
 FS\_HLM: 3.4  
 Repair Type: Non-Urgent  
 Crossing Status: Indicator Found  
 UCIP Comments: unable to confirm if crossing is still active--need to contact owner to determine status of crossing.  
 FIELD\_STRUCT\_DESC: 60-inch concrete encased steel sewer line through the levee, 17.0 feet below the crown. Cutoff wall around pipe at the center of the levee. Rock revetment on waterward slope. Three pressure manholes in overflow area along pipe path. (Permit No. 12188-1979)  
 FS Date: 12/05/2013

Underground service alert (USA) markings still present on levee crown.

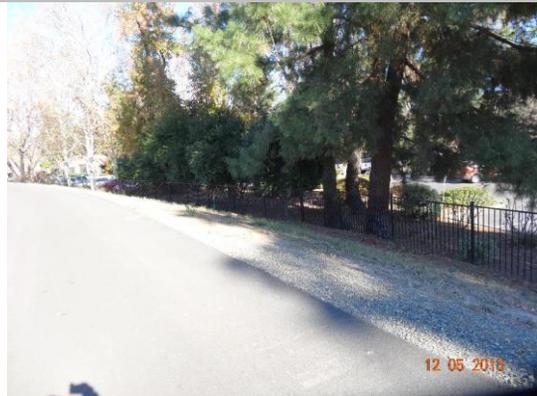
Photo 3 of 3 : UCIP\_FA\_2015\_3173.jpg

View of landward side.

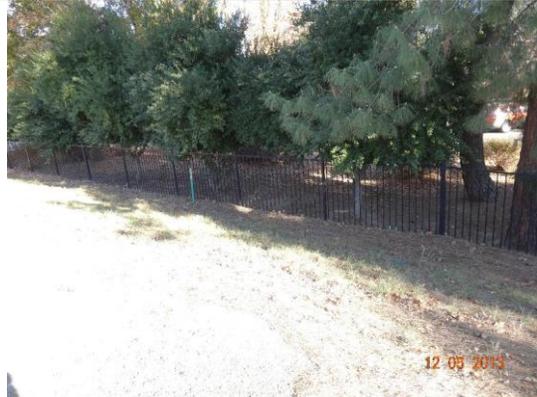
Photo 1 of 3 : UCIP\_FA\_2015\_4168.jpg

LM Start	<b>3.34</b>	Rating **	M	Issue No.	<b>34</b>
LM End	<b>3.34</b>	Issue Type +	En	Location *	LS
Category	Supplemental			GPS Latitude/Longitude	
				Start	End
Item	DWR UCIP Field Study			38.580435 °	38.580435 °
				-121.417711 °	-121.417711 °
DWR ID					
Action/Comments					
Inspector Comments: FS_ID:41437 DS_ID:24566 EP_NO: 17671 FS_HLM: 3.401 Repair Type: Non-Urgent Crossing Status: Indicator Found

Marker visible on landward.

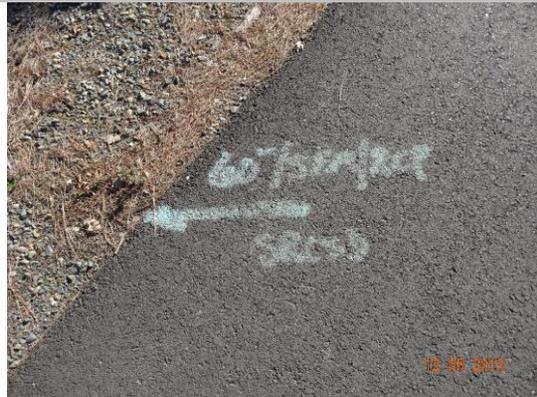
Photo 2 of 3 : UCIP\_FA\_2015\_4169.jpg

Underground service alert (USA) markings found on levee crown for 60-inch pipe.

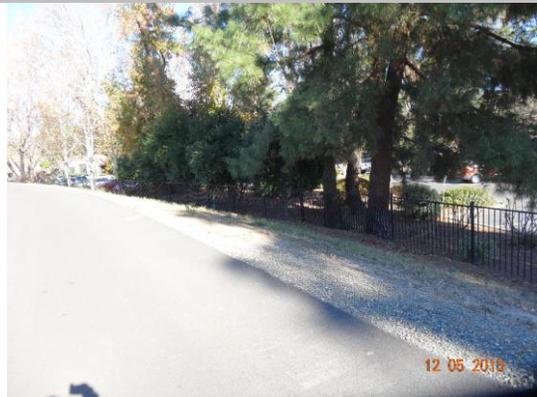
Photo 3 of 3 : UCIP\_FA\_2015\_4170.jpg

Overview of landward side.

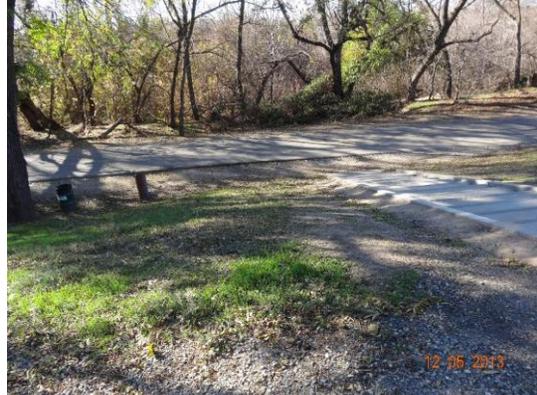
Photo 1 of 2 : UCIP\_FA\_2015\_3058.jpg

LM Start	<b>3.42</b>	Rating **	M	Issue No.	<b>35</b>
LM End	<b>3.42</b>	Issue Type +	En	Location *	LS
Category	Supplemental			GPS Latitude/Longitude	
				Start	End
Item	DWR UCIP Field Study			38.581572 °	38.581572 °
				-121.417819 °	-121.417819 °
DWR ID					
Action/Comments					
Inspector Comments: FS_ID:30684 DS_ID:24816 EP_NO: N/A FS_HLM: 3.48 Repair Type: Non-Urgent Crossing Status: Indicator Found

View of waterward side.

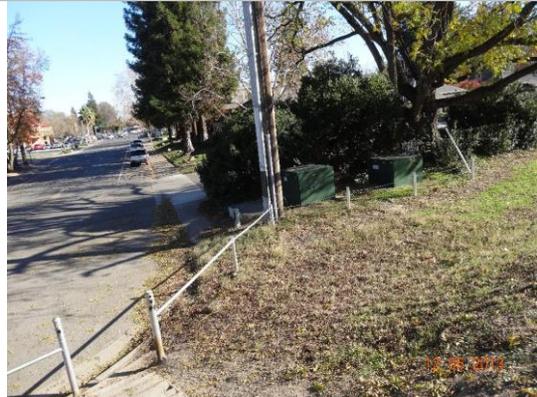
Photo 2 of 2 : UCIP\_FA\_2015\_3059.jpg

View of landward side.

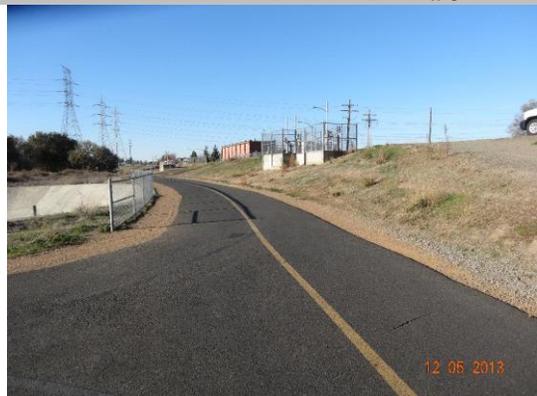
Photo 1 of 3 : UCIP\_FA\_2015\_2923.jpg

LM Start	<b>3.68</b>	Rating **	M	Issue No.	<b>36</b>
LM End	<b>3.68</b>	Issue Type +	En	Location *	LS
Category	Supplemental			GPS Latitude/Longitude	
				Start	End
Item	DWR UCIP Field Study			38.584344 °	38.584344 °
				-121.420968 °	-121.420968 °
DWR ID					
Action/Comments					
Inspector Comments: FS_ID:31304 DS_ID:24817 EP_NO: N/A FS_HLM: 3.752 Repair Type: Non-Urgent Crossing Status: Found

Bike path located on waterward side.

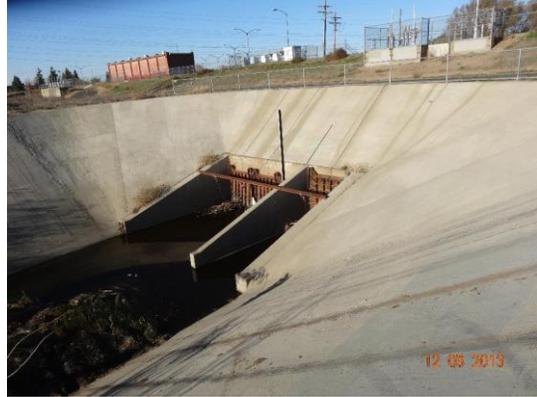
Photo 2 of 3 : UCIP\_FA\_2015\_3001.jpg

Inspector Comments: FS\_ID:31304  
 DS\_ID:24817  
 EP\_NO: N/A  
 FS\_HLM: 3.752  
 Repair Type: Non-Urgent  
 Crossing Status: Found  
 UCIP Comments: Need to confirm crossing size--need additional information about crossing.  
 FIELD\_STRUCT\_DESC: 1 of 2: Crossing through levee at unknown depth. Concrete structure (7x15-foot) located on waterward shoulder with slide gate inside manhole. Square flap gate located on waterward end. Concrete wings and apron at waterward end of outlet channel. Concrete box located on the waterward shoulder fenced off.  
 FS Date: 12/05/2013

Concrete wall and wing walls located on waterward side.

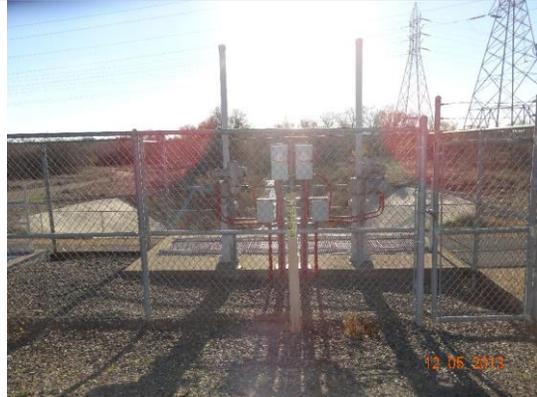
Photo 3 of 3 : UCIP\_FA\_2015\_3002.jpg

Concrete box and electrical box located on waterward shoulder.

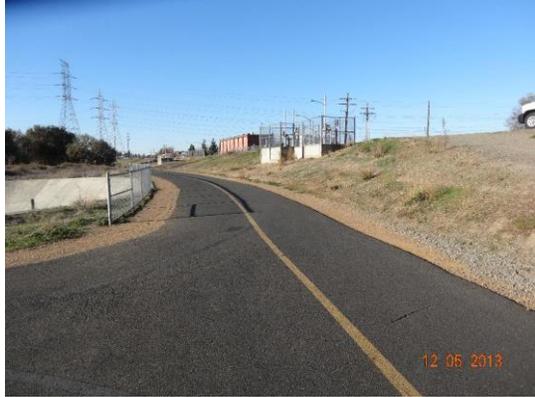
Photo 1 of 3 : UCIP\_FA\_2015\_3003.jpg

LM Start	<b>3.68</b>	Rating **	M	Issue No.	<b>37</b>
LM End	<b>3.68</b>	Issue Type +	En	Location *	LS
Category	Supplemental			GPS Latitude/Longitude	
				Start	End
Item	DWR UCIP Field Study			38.584355 °	38.584355 °
				-121.420989 °	-121.420989 °
DWR ID					
Action/Comments					
Inspector Comments: FS_ID:31306 DS_ID:24818 EP_NO: N/A FS_HLM: 3.754 Repair Type: Non-Urgent Crossing Status: Found

Bike path located on waterward side.

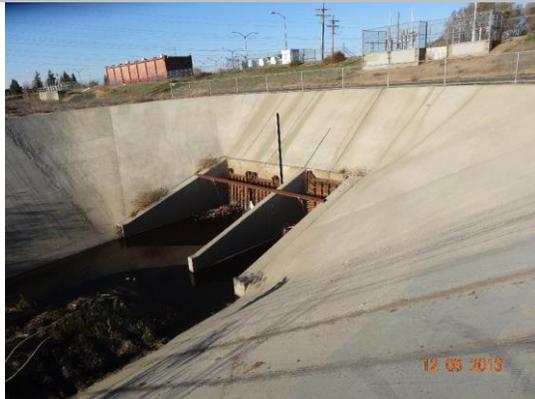
Photo 2 of 3 : UCIP\_FA\_2015\_3004.jpg

Concrete headwall located on waterward toe.

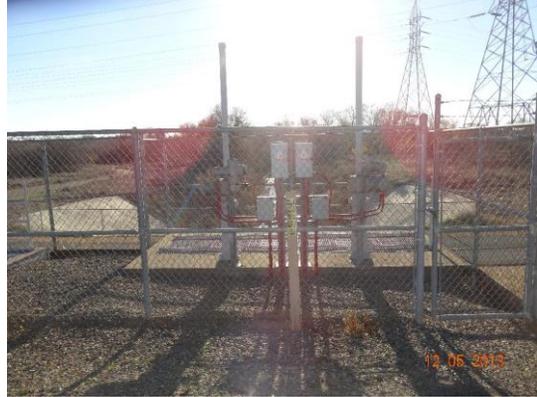
Photo 3 of 3 : UCIP\_FA\_2015\_3005.jpg

Concrete box and electrical boxes located on waterward shoulder.

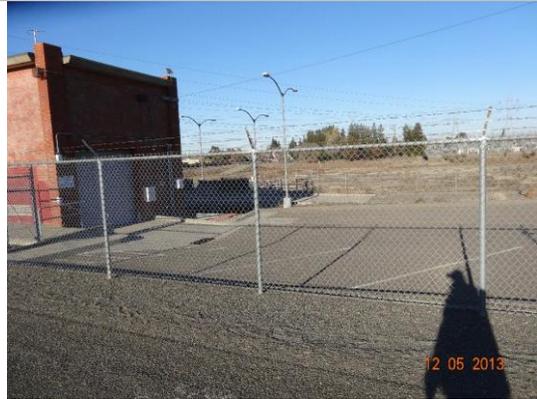
Photo 1 of 2 : UCIP\_FA\_2015\_3006.jpg

LM Start	<b>3.72</b>	Rating **	M	Issue No.	<b>38</b>
LM End	<b>3.72</b>	Issue Type +	En	Location *	LS
Category	Supplemental			GPS Latitude/Longitude	
				Start	End
Item	DWR UCIP Field Study			38.584710 °	38.584710 °
				-121.421496 °	-121.421496 °
DWR ID					
Action/Comments					
Inspector Comments: FS_ID:31307 DS_ID:24819 EP_NO: N/A FS_HLM: 3.79 Repair Type: Non-Urgent Crossing Status: Found UCIP Comments: Unable to confirm is pipe crosses levee--no permit available. FIELD_STRUCT_DESC: Service box located on waterward side and landward side. Unable to confirm crossing exists through levee. No permit found for this potential crossing. FS Date: 12/05/2013

Concrete box located inside fenced area located on landward side.

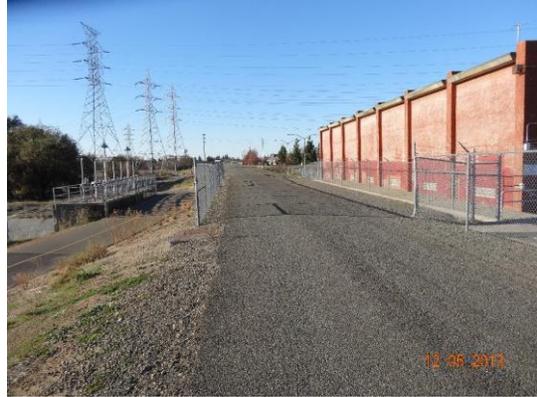
Photo 2 of 2 : UCIP\_FA\_2015\_3007.jpg

LM Start	<b>3.72</b>	Rating **	M	Issue No.	<b>38 (cont)</b>
LM End	<b>3.72</b>	Issue Type +	En	Location *	LS
Category	Supplemental			GPS Latitude/Longitude	
				Start	End
Item	DWR UCIP Field Study			38.584710 °	38.584710 °
				-121.421496 °	-121.421496 °
DWR ID					
Action/Comments					
Inspector Comments: FS_ID:31307 DS_ID:24819 EP_NO: N/A FS_HLM: 3.79 Repair Type: Non-Urgent Crossing Status: Found UCIP Comments: Unable to confirm is pipe crosses levee--no permit available. FIELD_STRUCT_DESC: Service box located on waterward side and landward side. Unable to confirm crossing exists through levee. No permit found for this potential crossing. FS Date: 12/05/2013

View of concrete service box located on waterward shoulder.

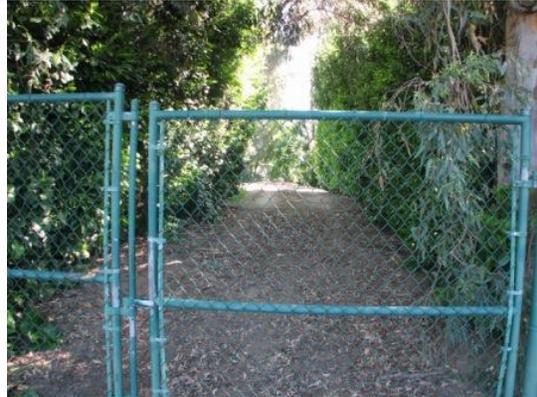
Photo 1 of 1 : FA\_2015\_NA0001\_61\_16\_20150910\_00005.jpg

LM Start	<b>0.00</b>	Rating **	U	Issue No.	<b>16</b>
LM End	<b>0.62</b>	Issue Type +	En	Location *	CR
Category	Earthen Levee			GPS Latitude/Longitude	
				Start	End
Item	Encroachments			38.600917 °	38.592184 °
				-121.332100 °	-121.334347 °
DWR ID	DWR_NA0001_10_s_2012_16				
Action/Comments					
Urban

Levee encroached on by property owners north of Arden Way. This section is not reasonably accessible.

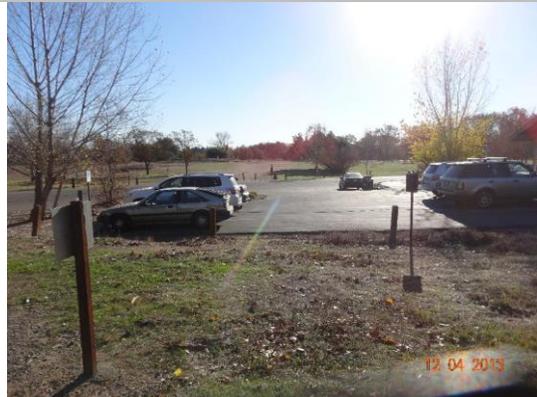
Photo 1 of 2 : UCIP\_FA\_2015\_4135.jpg

LM Start	<b>0.62</b>	Rating **	M	Issue No.	<b>118</b>
LM End	<b>0.62</b>	Issue Type +	En	Location *	CR
Category	Supplemental			GPS Latitude/Longitude	
				Start	End
Item	DWR UCIP Field Study			38.592105 °	38.592105 °
				-121.334423 °	-121.334423 °
DWR ID					
Action/Comments					
Inspector Comments: FS_ID:31450 DS_ID:24820 EP_NO: N/A FS_HLM: 0.7 Repair Type: Non-Urgent Crossing Status: Indicator Found UCIP Comments: Unable to determine alignment of crossing, does it cross levee? Permit? FIELD_STRUCT_DESC: Protective posts located on landward side for what appears to be for gas/petroleum line. Unable to confirm if line goes through levee or if line runs parallel. No permit found. FS Date: 12/04/2013

No signs of crossing on waterward side.

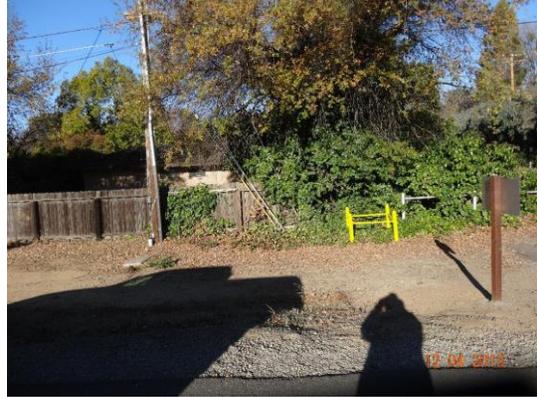
Photo 2 of 2 : UCIP\_FA\_2015\_4136.jpg

LM Start	0.62	Rating **	M	Issue No.	118 (cont)
LM End	0.62	Issue Type +	En	Location *	CR
Category	Supplemental			GPS Latitude/Longitude	
				Start	End
Item	DWR UCIP Field Study			38.592105 °	38.592105 °
				-121.334423 °	-121.334423 °
DWR ID					
Action/Comments					
Inspector Comments: FS_ID:31450 DS_ID:24820 EP_NO: N/A FS_HLM: 0.7 Repair Type: Non-Urgent Crossing Status: Indicator Found UCIP Comments: Unable to determine alignment of crossing, does it cross levee? Permit? FIELD_STRUCT_DESC: Protective posts located on landward side for what appears to be for gas/petroleum line. Unable to confirm if line goes through levee or if line runs parallel. No permit found. FS Date: 12/04/2013

View of protective posts located on landward side.

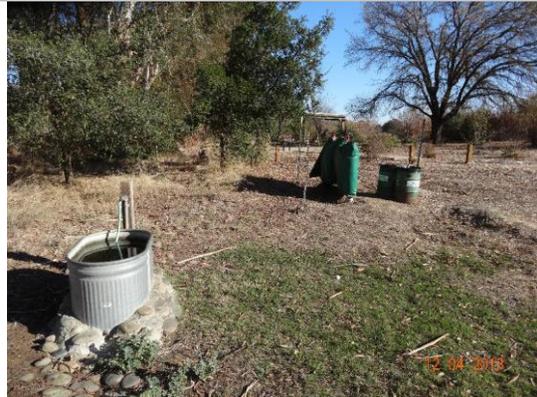
Photo 1 of 3 : UCIP\_FA\_2015\_2770.jpg

LM Start	0.72	Rating **	M	Issue No.	119
LM End	0.72	Issue Type +	En	Location *	CR
Category	Supplemental			GPS Latitude/Longitude	
				Start	End
Item	DWR UCIP Field Study			38.591003 °	38.591003 °
				-121.335459 °	-121.335459 °
DWR ID					
Action/Comments					
Inspector Comments: FS_ID:26281 DS_ID:24464 EP_NO: 12725 FS_HLM: 0.8 Repair Type: Non-Urgent Crossing Status: Indicator Found UCIP Comments: Unable to confirm if this crossing is the same under permit 12725. Drinking fountain and water flow prevention located on waterward side. Need to coordinate with American River Flood Control District. FIELD_STRUCT_DESC: 6-inch steel water pipe through the levee, 2.5 feet below the crown. Arcade Water District well at landward toe. (Permit No. 12725-1980) FS Date: 12/04/2013

View of waterward side--faucet and water flow prevention system.

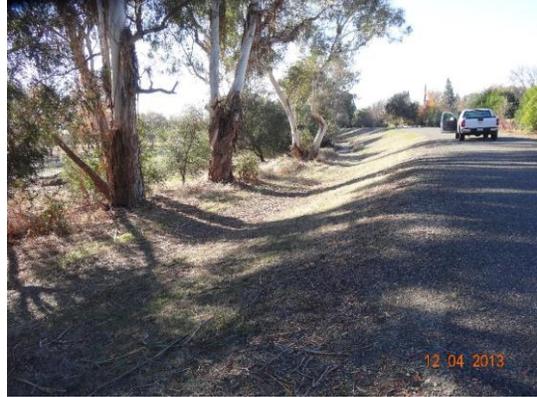
Photo 2 of 3 : UCIP\_FA\_2015\_2771.jpg

LM Start	0.72	Rating **	M	Issue No.	119 (cont)
LM End	0.72	Issue Type +	En	Location *	CR
Category	Supplemental			GPS Latitude/Longitude	
				Start	End
Item	DWR UCIP Field Study			38.591003 °	38.591003 °
				-121.335459 °	-121.335459 °
DWR ID					
Action/Comments					
Inspector Comments: FS_ID:26281 DS_ID:24464 EP_NO: 12725 FS_HLM: 0.8 Repair Type: Non-Urgent Crossing Status: Indicator Found UCIP Comments: Unable to confirm if this crossing is the same under permit 12725. Drinking fountain and water flow prevention located on waterward side. Need to coordinate with American River Flood Control District. FIELD_STRUCT_DESC: 6-inch steel water pipe through the levee, 2.5 feet below the crown. Arcade Water District well at landward toe. (Permit No. 12725-1980) FS Date: 12/04/2013

View of waterward slope.

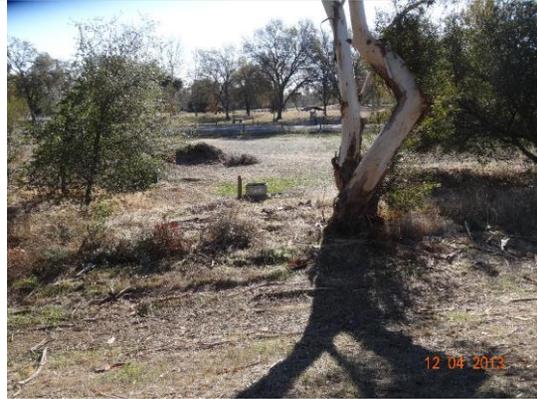
Photo 3 of 3 : UCIP\_FA\_2015\_2772.jpg

View of faucet located on waterward side.

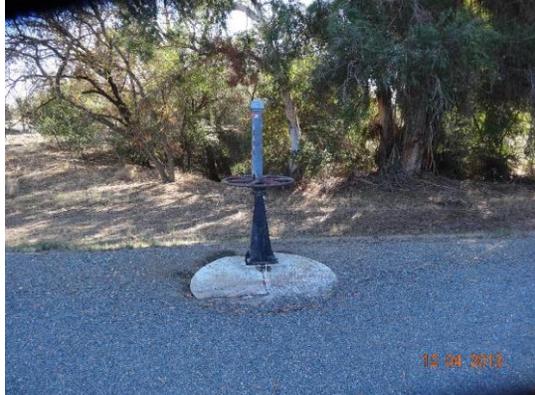
Photo 1 of 3 : UCIP\_FA\_2015\_2773.jpg

LM Start	<b>0.94</b>	Rating **	M	Issue No.	<b>120</b>
LM End	<b>0.94</b>	Issue Type +	En	Location *	CR
Category	Supplemental			GPS Latitude/Longitude	
				Start	End
Item	DWR UCIP Field Study			38.587989 °	38.587989 °
				-121.336773 °	-121.336773 °
DWR ID					
<b>Action/Comments</b>					
Inspector Comments: FS_ID:41550 DS_ID:24413 EP_NO: 2806 FS_HLM: 1.02 Repair Type: Non-Urgent Crossing Status: Found

View of gate stem located on waterward shoulder.

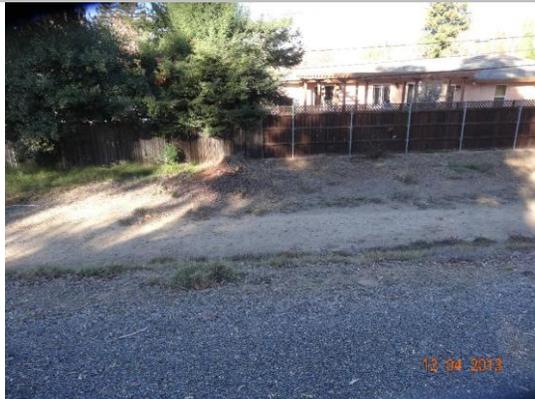
Photo 2 of 3 : UCIP\_FA\_2015\_2774.jpg

View of landward side.

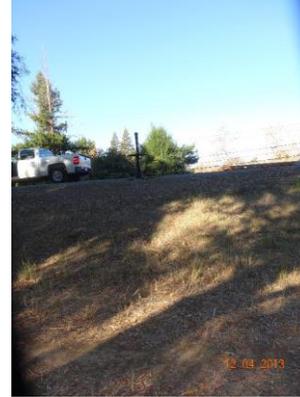
Photo 3 of 3 : UCIP\_FA\_2015\_2775.jpg

LM Start	<b>0.94</b>	Rating **	M	Issue No.	<b>120 (cont)</b>
LM End	<b>0.94</b>	Issue Type +	En	Location *	CR
Category	Supplemental			GPS Latitude/Longitude	
				Start	End
Item	DWR UCIP Field Study			38.587989 °	38.587989 °
				-121.336773 °	-121.336773 °
DWR ID					
Action/Comments					
Inspector Comments: FS_ID:41550 DS_ID:24413 EP_NO: 2806 FS_HLM: 1.02 Repair Type: Non-Urgent Crossing Status: Found

View of waterward slope.

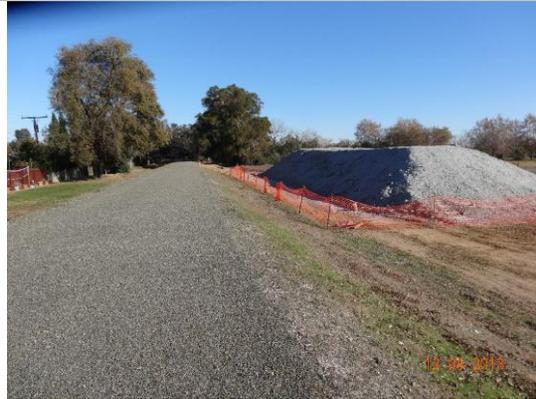
Photo 1 of 3 : UCIP\_FA\_2015\_3317.jpg

LM Start	<b>1.04</b>	Rating **	M	Issue No.	<b>121</b>
LM End	<b>1.04</b>	Issue Type +	En	Location *	CR
Category	Supplemental			GPS Latitude/Longitude	
				Start	End
Item	DWR UCIP Field Study			38.586813 °	38.586813 °
				-121.337643 °	-121.337643 °
DWR ID					
Action/Comments					
Inspector Comments: FS_ID:31284 DS_ID:24821 EP_NO: N/A FS_HLM: 1.12 Repair Type: Non-Urgent Crossing Status: Found UCIP Comments: Unable to determine reason for box and whether there is a utility that crosses levee. No permit found. FIELD_STRUCT_DESC: Service box located on waterward side. No permit found. FS Date: 12/04/2013

Overview of levee crown at crossing.

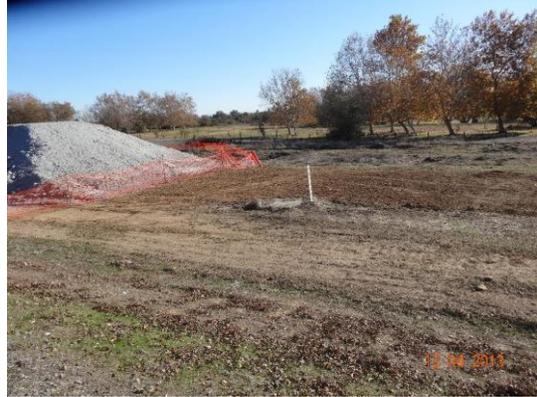
Photo 2 of 3 : UCIP\_FA\_2015\_3318.jpg

LM Start	1.04	Rating **	M	Issue No.	121 (cont)
LM End	1.04	Issue Type +	En	Location *	CR
Category	Supplemental			GPS Latitude/Longitude	
				Start	End
Item	DWR UCIP Field Study			38.586813 °	38.586813 °
				-121.337643 °	-121.337643 °
DWR ID					
Action/Comments					
Inspector Comments: FS_ID:31284 DS_ID:24821 EP_NO: N/A FS_HLM: 1.12 Repair Type: Non-Urgent Crossing Status: Found UCIP Comments: Unable to determine reason for box and whether there is a utility that crosses levee. No permit found. FIELD_STRUCT_DESC: Service box located on waterward side. No permit found. FS Date: 12/04/2013

Concrete vault located on waterward side.

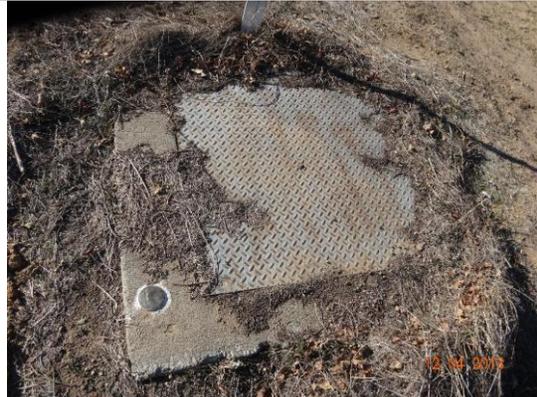
Photo 3 of 3 : UCIP\_FA\_2015\_3319.jpg

Close up of concrete box located on waterward side.

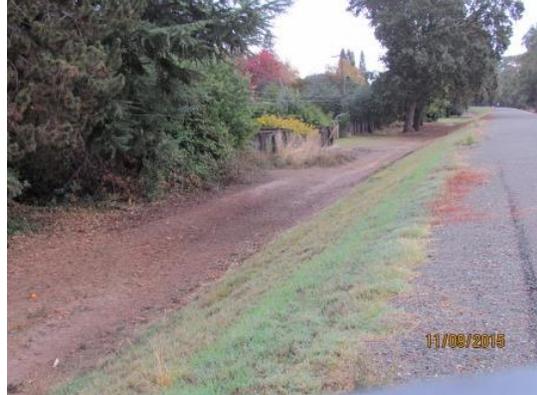
Photo 1 of 1 : FA\_2015\_NA0001\_61\_11\_20151112\_00014.jpg

LM Start	<b>1.10</b>	Rating **	A	Issue No.	<b>11</b>
LM End	<b>1.10</b>	Issue Type +	Ma	Location *	LS
Category	Earthen Levee			GPS Latitude/Longitude	
				Start	End
Item	Vegetation			38.585987 °	38.585987 °
				-121.338334 °	-121.338334 °
DWR ID	DWR_NA0001_10_f_2015_11				
Action/Comments					
Control annual grass and weeds on the levee slopes and easements.

View of the acceptable vegetation control on the landside levee slope.
