**Flood Control Project Maintenance  
Levee Inspections**

**Fall 2015 Levee Maintenance Deficiency Summary Report**

**Sacramento River Basin**

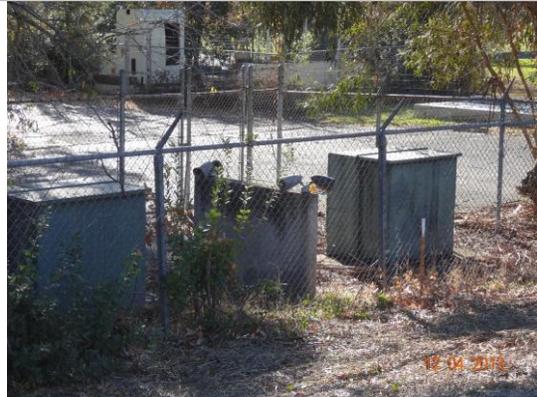
Photo 1 of 3 : UCIP\_FA\_2015\_1203.jpg

LM Start	<b>1.28</b>	Rating **	M	Issue No.	<b>122</b>
LM End	<b>1.28</b>	Issue Type +	En	Location *	LS
Category	Supplemental			GPS Latitude/Longitude	
				Start	End
Item	DWR UCIP Field Study			38.583873 °	38.583873 °
				-121.340037 °	-121.340037 °
DWR ID					
Action/Comments					
Inspector Comments: FS_ID:41536 DS_ID:24097 EP_NO: 12276 FS_HLM: 1.36 Repair Type: Non-Urgent Crossing Status: Indicator Found UCIP Comments: Unable to find markers indicating crossing through levee. FIELD_STRUCT_DESC: Two 3-inch PVC electrical conduits through the levee, 3.0 feet below the crown. Northeast Sewage Treatment Plant on waterward side. Conduits extend from treatment plant to transformers located on waterward side. (Permit No. 12276-1980) FS Date: 12/04/2013

View of transformers located on waterward side.

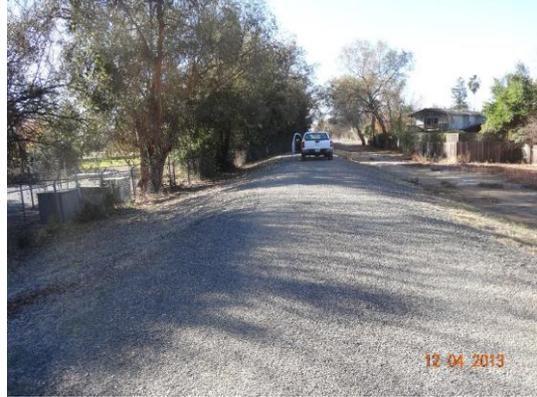
Photo 2 of 3 : UCIP\_FA\_2015\_2572.jpg

LM Start	<b>1.28</b>	Rating **	M	Issue No.	<b>122 (cont)</b>
LM End	<b>1.28</b>	Issue Type +	En	Location *	LS
Category	Supplemental			GPS Latitude/Longitude	
				Start	End
Item	DWR UCIP Field Study			38.583873 °	38.583873 °
				-121.340037 °	-121.340037 °
DWR ID					
Action/Comments					
Inspector Comments: FS_ID:41536 DS_ID:24097 EP_NO: 12276 FS_HLM: 1.36 Repair Type: Non-Urgent Crossing Status: Indicator Found UCIP Comments: Unable to find markers indicating crossing through levee. FIELD_STRUCT_DESC: Two 3-inch PVC electrical conduits through the levee, 3.0 feet below the crown. Northeast Sewage Treatment Plant on waterward side. Conduits extend from treatment plant to transformers located on waterward side. (Permit No. 12276-1980) FS Date: 12/04/2013

Overview of levee looking downstream.

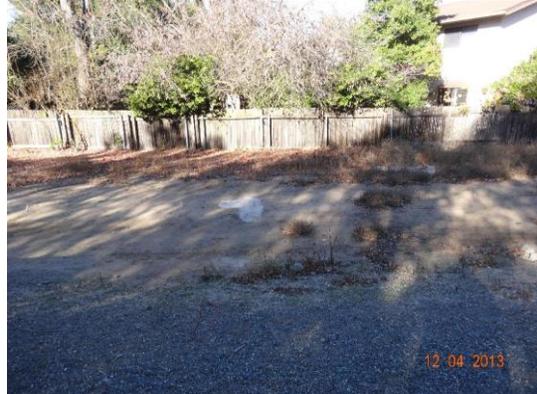
Photo 3 of 3 : UCIP\_FA\_2015\_2573.jpg

View of landward side.

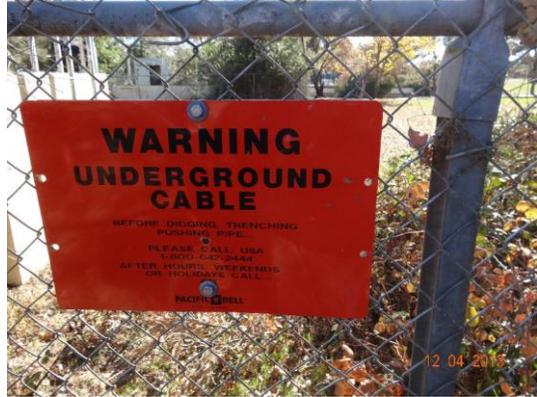
Photo 1 of 3 : UCIP\_FA\_2015\_2585.jpg

LM Start	<b>1.28</b>	Rating **	M	Issue No.	<b>123</b>
LM End	<b>1.28</b>	Issue Type +	En	Location *	LS
Category	Supplemental			GPS Latitude/Longitude	
				Start	End
Item	DWR UCIP Field Study			38.583873 °	38.583873 °
				-121.340037 °	-121.340037 °
DWR ID					
Action/Comments					
Inspector Comments: FS_ID:26299 DS_ID:24477 EP_NO: 7993 FS_HLM: 1.365 Repair Type: Non-Urgent Crossing Status: Found

Sign for unground cable with contact information.

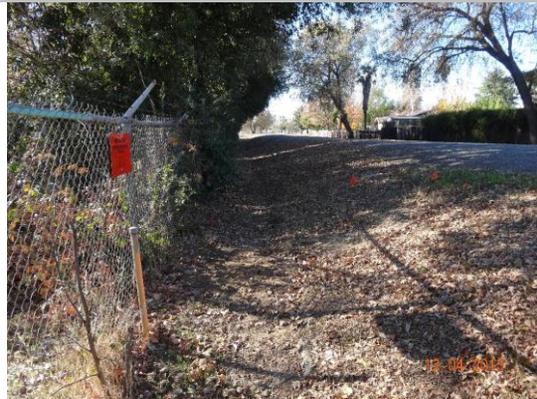
Photo 2 of 3 : UCIP\_FA\_2015\_2586.jpg

View of waterward side--Underground Alert System markers showing alignment.

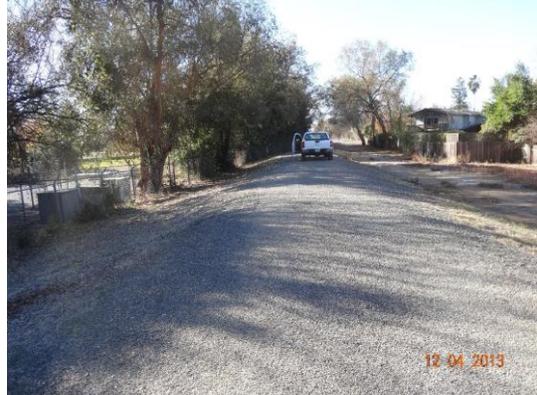
Photo 3 of 3 : UCIP\_FA\_2015\_2587.jpg

LM Start	<b>1.28</b>	Rating **	M	Issue No.	<b>123 (cont)</b>
LM End	<b>1.28</b>	Issue Type +	En	Location *	LS
Category	Supplemental			GPS Latitude/Longitude	
				Start	End
Item	DWR UCIP Field Study			38.583873 °	38.583873 °
				-121.340037 °	-121.340037 °
DWR ID					
Action/Comments					
Inspector Comments: FS_ID:26299 DS_ID:24477 EP_NO: 7993 FS_HLM: 1.365 Repair Type: Non-Urgent Crossing Status: Found

Overview of levee crown looking downstream.

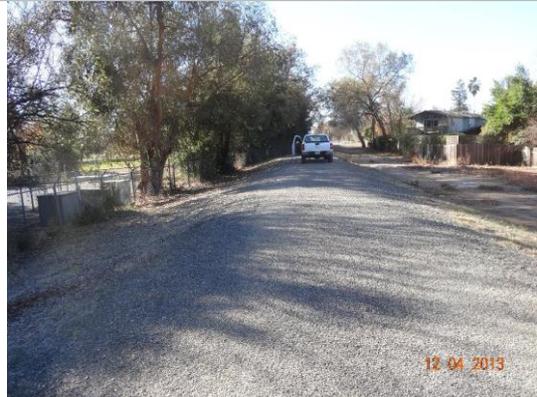
Photo 1 of 2 : UCIP\_FA\_2015\_2580.jpg

LM Start	<b>1.28</b>	Rating **	M	Issue No.	<b>124</b>
LM End	<b>1.28</b>	Issue Type +	En	Location *	LS
Category	Supplemental			GPS Latitude/Longitude	
				Start	End

Item	DWR UCIP Field Study			38.583780 °	38.583780 °
				-121.340126 °	-121.340126 °
DWR ID					
Action/Comments					
Inspector Comments: FS_ID:26296 DS_ID:24568 EP_NO: 3599B FS_HLM: 1.37 Repair Type: Non-Urgent Crossing Status: Indicator Found UCIP Comments: Need to determine status of structure-unable to determine if crossing is being used. Only indicator visible during inspection was the underground alert service markers and spray paint visible on the levee crown. FIELD_STRUCT_DESC: 1 of 3: 12-inch concrete encased pipe through the levee, 15.3 feet below the crown. Two cutoff walls around pipe in line with each shoulder. Slide gate in concrete gate structure at landward toe-not found 2013. Sewage treatment plant on waterward side. Control valve in concrete box on the waterward side. (Permit No. 3599B-1964) FS Date: 12/04/2013

Overview of levee crown looking downstream.

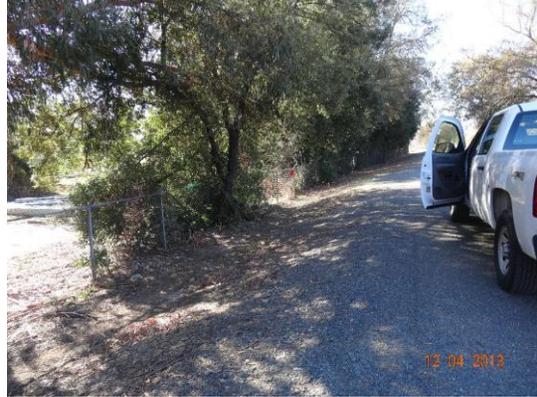
Photo 2 of 2 : UCIP\_FA\_2015\_2581.jpg

Item	DWR UCIP Field Study			38.583780 °	38.583780 °	
				-121.340126 °	-121.340126 °	
DWR ID						
Action/Comments						
Inspector Comments: FS_ID:26296 DS_ID:24568 EP_NO: 3599B FS_HLM: 1.37 Repair Type: Non-Urgent Crossing Status: Indicator Found UCIP Comments: Need to determine status of structure-unable to determine if crossing is being used. Only indicator visible during inspection was the underground alert service markers and spray paint visible on the levee crown. FIELD_STRUCT_DESC: 1 of 3: 12-inch concrete encased pipe through the levee, 15.3 feet below the crown. Two cutoff walls around pipe in line with each shoulder. Slide gate in concrete gate structure at landward toe-not found 2013. Sewage treatment plant on waterward side. Control valve in concrete box on the waterward side. (Permit No. 3599B-1964) FS Date: 12/04/2013

View of waterward side.

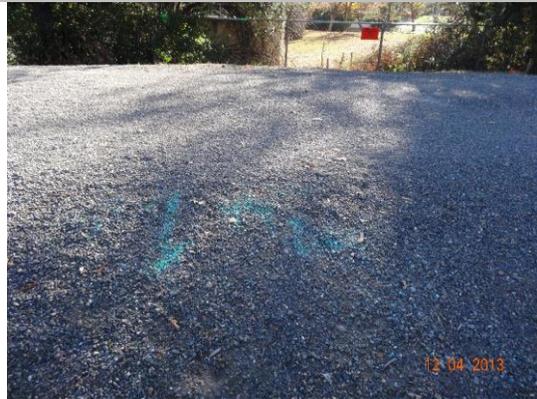
Photo 3 of 3 : UCIP\_FA\_2015\_2584.jpg

USA markers indicate alignment through levee crown.

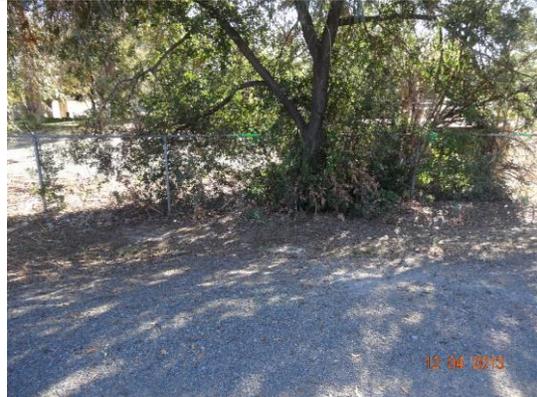
Photo 1 of 3 : UCIP\_FA\_2015\_0602.jpg

LM Start	<b>1.29</b>	Rating **	M	Issue No.	<b>126</b>
LM End	<b>1.29</b>	Issue Type +	En	Location *	LS
Category	Supplemental			GPS Latitude/Longitude	
				Start	End
Item	DWR UCIP Field Study			38.583738 °	38.583738 °
				-121.340161 °	-121.340161 °
DWR ID					
Action/Comments					
Inspector Comments: FS_ID:26426 DS_ID:24098 EP_NO: 3599 FS_HLM: 1.38 Repair Type: Non-Urgent Crossing Status: Indicator Found

View of Underground Service Alert (USA) markers and flags confirming buried sewer lines.

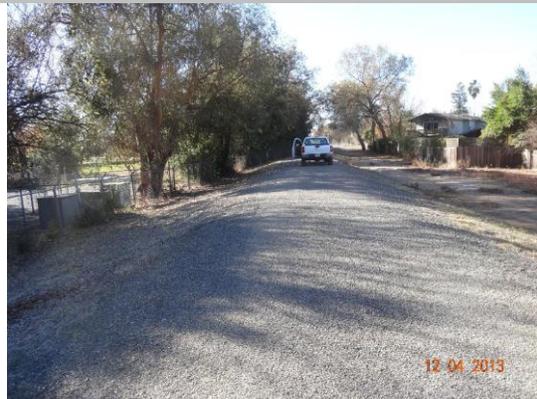
Photo 2 of 3 : UCIP\_FA\_2015\_0603.jpg

Overview of levee crown looking downstream.

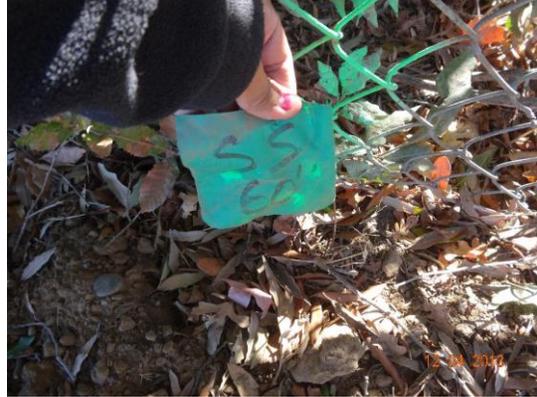
Photo 3 of 3 : UCIP\_FA\_2015\_0604.jpg

USA marker indicates 60 inch line through levee.

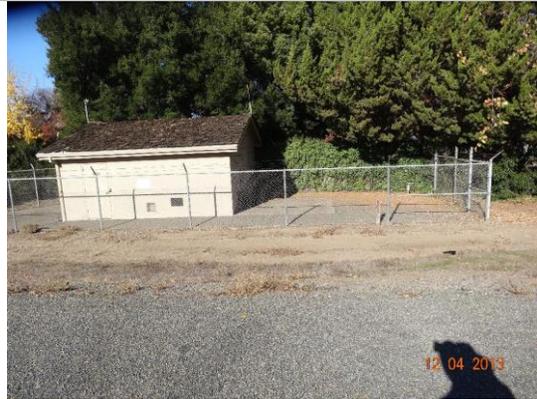
Photo 1 of 3 : UCIP\_FA\_2015\_4622.jpg

LM Start	<b>1.53</b>	Rating **	M	Issue No.	<b>127</b>
LM End	<b>1.53</b>	Issue Type +	En	Location *	LS
Category	Supplemental			GPS Latitude/Longitude	
				Start	End
Item	DWR UCIP Field Study			38.581594 °	38.581594 °
				-121.343622 °	-121.343622 °
DWR ID					
Action/Comments					
Inspector Comments: FS_ID:41548 DS_ID:24419 EP_NO: N/A FS_HLM: 1.62 Repair Type: Non-Urgent Crossing Status: Found UCIP Comments: Need to find out the status of crossing--unable to determine if crossing is being used. FIELD_STRUCT_DESC: 24-inch pipe through the levee, 7.0 feet below the crown. Concrete inspection box at waterward toe. FS Date: 12/04/2013

Structure located on landward side.

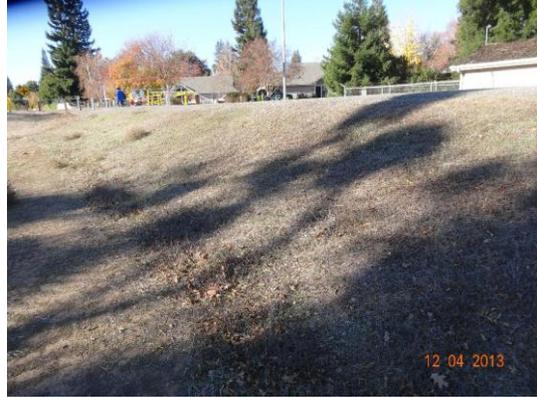
Photo 2 of 3 : UCIP\_FA\_2015\_4623.jpg

View of waterward side.

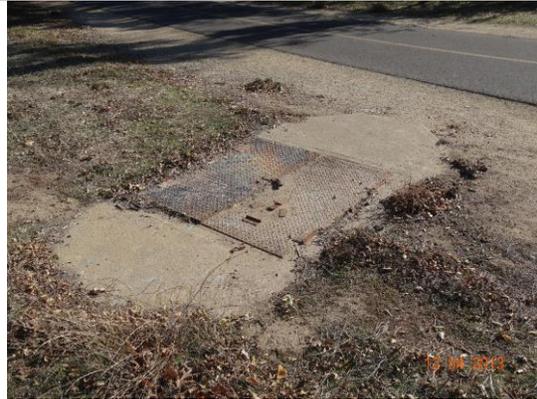
Photo 3 of 3 : UCIP\_FA\_2015\_4652.jpg

Concrete box located on waterward side near paved trail.

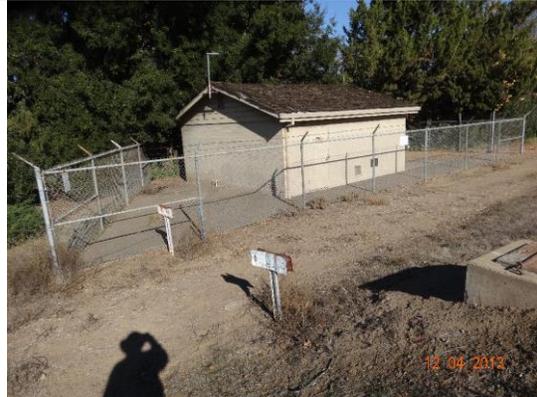
Photo 1 of 3 : UCIP\_FA\_2015\_3320.jpg

LM Start	<b>1.53</b>	Rating **	M	Issue No.	<b>128</b>
LM End	<b>1.53</b>	Issue Type +	En	Location *	LS
Category	Supplemental			GPS Latitude/Longitude	
				Start	End
Item	DWR UCIP Field Study			38.581588 °	38.581588 °
				-121.343631 °	-121.343631 °
DWR ID					
Action/Comments					
Inspector Comments: FS_ID:41546 DS_ID:24101 EP_NO: N/A FS_HLM: 1.621 Repair Type: Non-Urgent Crossing Status: Found

View of landward side--chlorine line adjacent to 8-inch pipe.

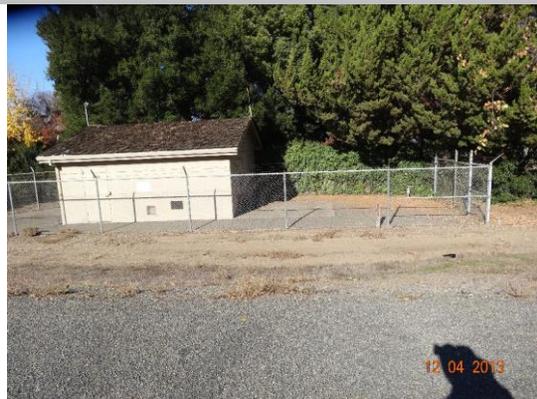
Photo 2 of 3 : UCIP\_FA\_2015\_3321.jpg

Structure located on waterward side.

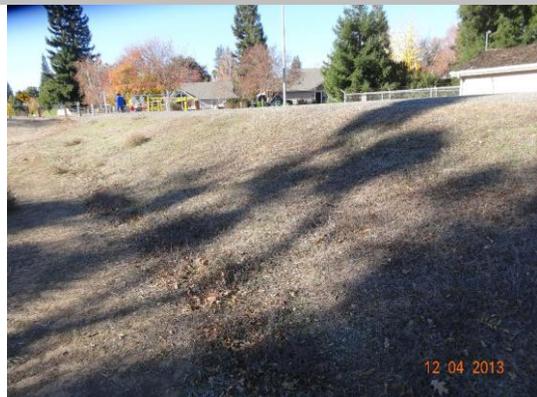
Photo 3 of 3 : UCIP\_FA\_2015\_3322.jpg

View of waterward side.

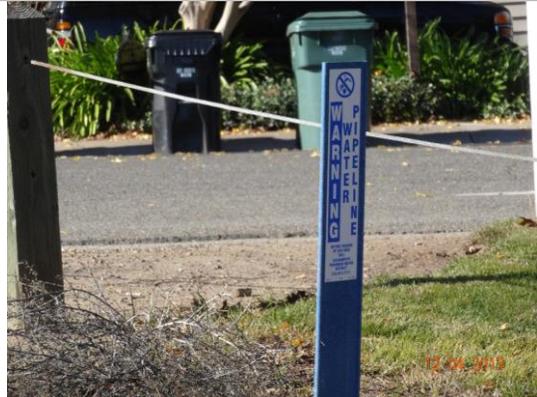
Photo 2 of 2 : UCIP\_FA\_2015\_1219.jpg

Waterline marker at levee mile 1.63.

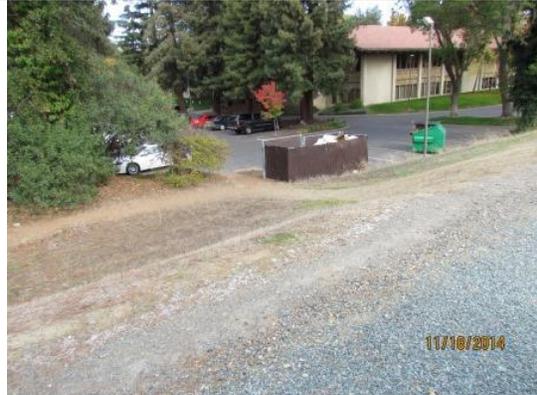
Photo 1 of 1 : FA\_2015\_NA0001\_61\_116\_20150910\_00007.jpg

LM Start	<b>3.74</b>	Rating **	A/W	Issue No.	<b>116</b>
LM End	<b>3.74</b>	Issue Type +	Ma	Location *	LS
Category	Earthen Levee		GPS Latitude/Longitude		
			Start	End	
Item	Slope Stability		38.568526 °	38.568526 °	
			-121.380331 °	-121.380331 °	
DWR ID	DWR_NA0001_10_s_2012_116				
Action/Comments					
Repair the levee slope damaged by foot traffic and prevent access where possible. Inspector Comments: Foot traffic is eroding the landside slope.

View of the erosion on the landside levee slope caused by pedestrian foot traffic.

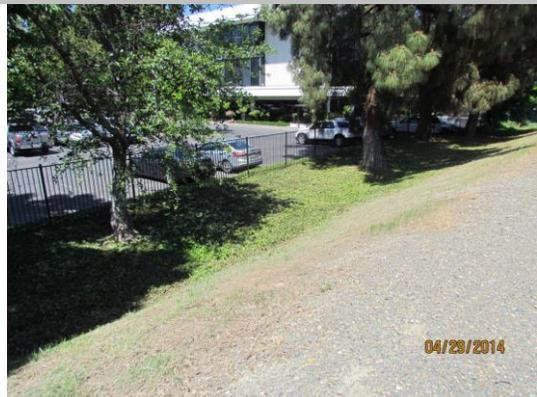
Photo 1 of 1 : FA\_2015\_NA0001\_61\_4\_20150910\_00001.jpg

LM Start	<b>3.75</b>	Rating **	M	Issue No.	<b>4</b>
LM End	<b>3.84</b>	Issue Type +	En	Location *	LS
Category	Earthen Levee		GPS Latitude/Longitude		
			Start	End	
Item	Vegetation		38.568492 °	38.568076 °	
			-121.380477 °	-121.382001 °	
DWR ID	DWR_NA0001_10_s_2012_4				
Action/Comments					
Landscaping Inspector Comments: Ivy and trees.

View of the landscaping at the landside levee toe and slope.

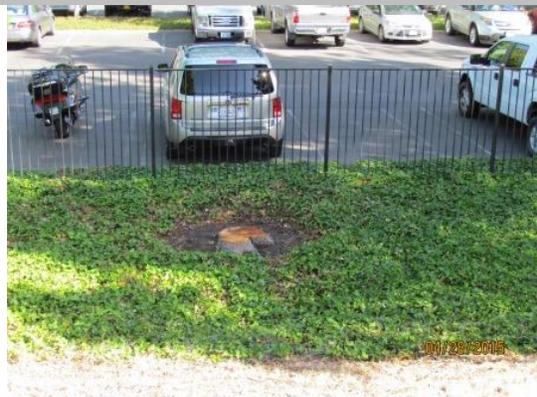
Photo 1 of 1 : FA\_2015\_NA0001\_61\_23\_20150910\_00006.jpg

LM Start	<b>3.83</b>	Rating **	N	Issue No.	<b>23</b>
LM End	<b>3.83</b>	Issue Type +	Ma	Location *	LS
Category	Earthen Levee		GPS Latitude/Longitude		
			Start	End	
Item	Trim / Thin Trees		38.568111 °	38.568111 °	
			-121.381896 °	-121.381896 °	
DWR ID	DWR_NA0001_10_s_2015_23				
Action/Comments					
Tree stumps.

View of the tree stump at the landside levee toe.

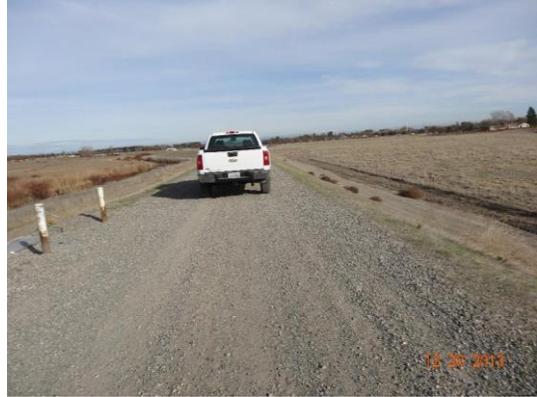
Photo 1 of 3 : UCIP\_FA\_2015\_3011.jpg

LM Start	<b>0.08</b>	Rating **	M	Issue No.	<b>7</b>
LM End	<b>0.08</b>	Issue Type +	En	Location *	LS
Category	Supplemental			GPS Latitude/Longitude	
				Start	End
Item	DWR UCIP Field Study			38.662976 °	38.662976 °
				-121.456464 °	-121.456464 °
DWR ID					
Action/Comments					
Inspector Comments: FS_ID:31310 DS_ID:24823 EP_NO: N/A FS_HLM: 0.08 Repair Type: Non-Urgent Crossing Status: Found UCIP Comments: no permit found--owner? (unauthorized?) FIELD_STRUCT_DESC: 24-inch pipe through the levee at unknown depth. Concrete box located on waterward shoulder. Concrete wall located on waterward and landward side. Siphon breaker inside concrete service box located on waterward shoulder. No permit found. FS Date: 12/20/2013

View of levee crown at crossing.

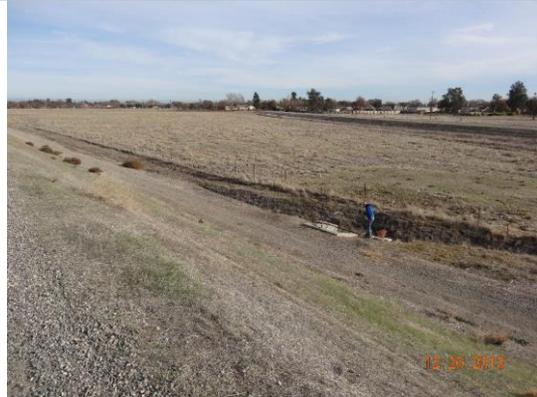
Photo 2 of 3 : UCIP\_FA\_2015\_3012.jpg

View of landward side.

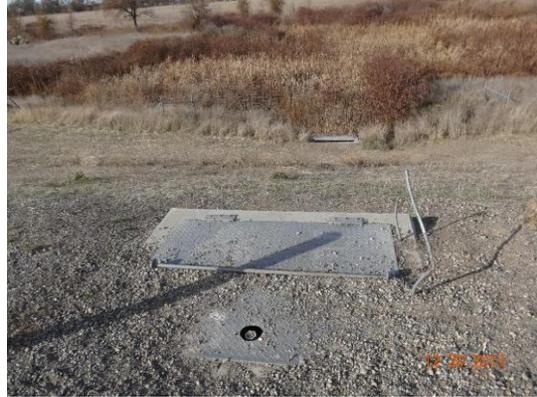
Photo 3 of 3 : UCIP\_FA\_2015\_3013.jpg

View of waterward side.

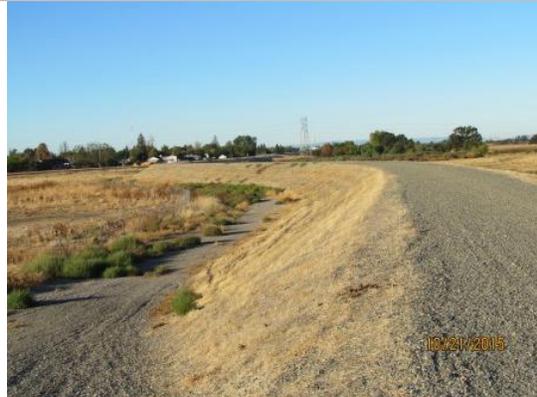
Photo 1 of 1 : FA\_2015\_NA0001\_436\_6\_20151112\_00007.jpg

LM Start	<b>0.31</b>	Rating **	A	Issue No.	<b>6</b>
LM End	<b>0.31</b>	Issue Type +	Ma	Location *	LS
Category	Earthen Levee			GPS Latitude/Longitude	
				Start	End
Item	Vegetation			38.664805 °	38.664805 °
				-121.453014 °	-121.453014 °
DWR ID	DWR_NA0001_11_f_2015_6				
Action/Comments					
Control annual grass and weeds on the levee slopes and easements.

View of the acceptable vegetation control on the landside levee slope.

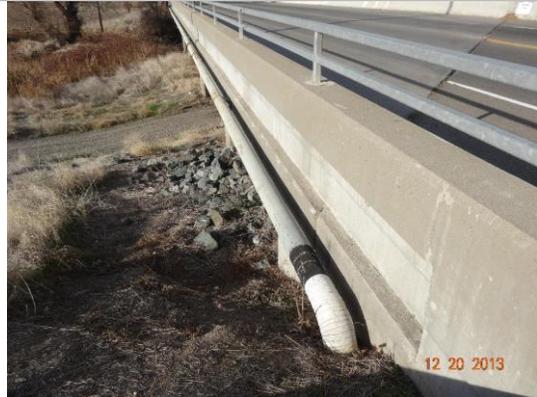
Photo 1 of 1 : UCIP\_FA\_2015\_3014.jpg

LM Start	<b>0.48</b>	Rating **	M	Issue No.	<b>8</b>
LM End	<b>0.48</b>	Issue Type +	En	Location *	LS
Category	Supplemental			GPS Latitude/Longitude	
				Start	End
Item	DWR UCIP Field Study			38.666585 °	38.666585 °
				-121.451009 °	-121.451009 °
DWR ID					
Action/Comments					
Inspector Comments: FS_ID:31311 DS_ID:24824 EP_NO: N/A FS_HLM: 0.491 Repair Type: Non-Urgent Crossing Status: Found UCIP Comments: owner? permit? (unauthorized?) FIELD_STRUCT_DESC: 6 inch conduit through levee at unknown depth. Conduit extends across the channel, attached to bridge. FS Date: 12/20/2013

Crossing visible on waterward side.

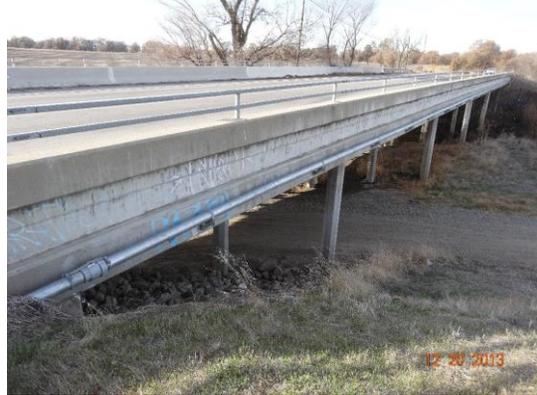
Photo 1 of 1 : UCIP\_FA\_2015\_3015.jpg

LM Start	<b>0.49</b>	Rating **	M	Issue No.	<b>9</b>
LM End	<b>0.49</b>	Issue Type +	En	Location *	LS
Category	Supplemental			GPS Latitude/Longitude	
				Start	End
Item	DWR UCIP Field Study			38.666745 °	38.666745 °
				-121.450918 °	-121.450918 °
DWR ID					
Action/Comments					
Inspector Comments: FS_ID:31312 DS_ID:24825 EP_NO: N/A FS_HLM: 0.501 Repair Type: Non-Urgent Crossing Status: Found UCIP Comments: owner? permit? (unauthorized?) FIELD_STRUCT_DESC: 4 inch conduit through levee at unknown depth. Conduit extends across the channel, attached to bridge. FS Date: 12/20/2013

Conduit attached to the upstream face of Rio Linda Blvd Bridge.

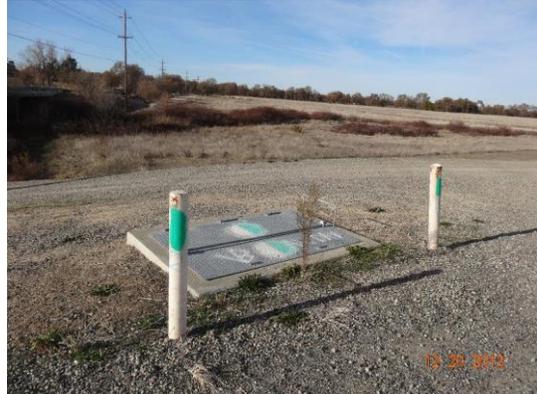
Photo 1 of 3 : UCIP\_FA\_2015\_3016.jpg

LM Start	<b>0.52</b>	Rating **	M	Issue No.	<b>10</b>
LM End	<b>0.52</b>	Issue Type +	En	Location *	LS
Category	Supplemental			GPS Latitude/Longitude	
				Start	End
Item	DWR UCIP Field Study			38.667108 °	38.667108 °
				-121.450827 °	-121.450827 °
DWR ID					
Action/Comments					
Inspector Comments: FS_ID:31313 DS_ID:24826 EP_NO: N/A FS_HLM: 0.52 Repair Type: Non-Urgent Crossing Status: Found UCIP Comments: owner? permit? (unauthorized?) FIELD_STRUCT_DESC: 24-inch (estimate only field verify) storm drain pipe through levee at an unknown depth. Concrete headwalls with debris screens located on waterward and landward side. Concrete box with protective posts located on waterward shoulder. No permit found. FS Date: 12/20/2013

Concrete vault with protective posts located on waterward shoulder.

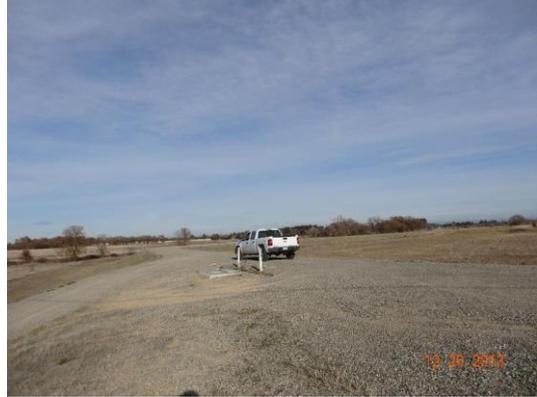
Photo 2 of 3 : UCIP\_FA\_2015\_3017.jpg

View of levee crown at crossing.

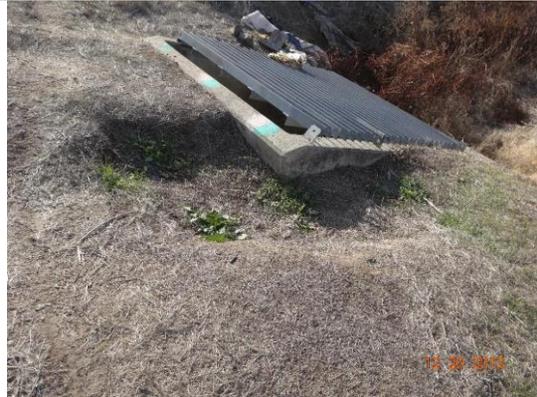
Photo 3 of 3 : UCIP\_FA\_2015\_3018.jpg

Concrete headwall located on waterward side--depression found on wall edge.

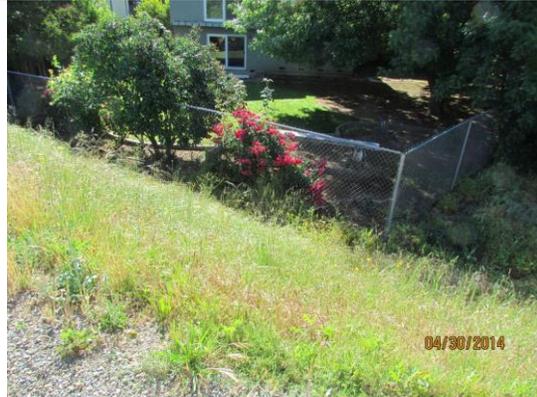
Photo 1 of 1 : FA\_2015\_NA0001\_438\_2\_20150910\_00002.jpg

LM Start	<b>0.08</b>	Rating **	M	Issue No.	<b>2</b>
LM End	<b>0.08</b>	Issue Type +	En	Location *	LS
Category	Earthen Levee		GPS Latitude/Longitude		
			Start	End	
Item	Vegetation		38.571036 °	38.571036 °	
			-121.353441 °	-121.353441 °	
DWR ID	DWR_NA0001_12_s_2014_2				
Action/Comments					
Landscaping

View of the landscaping at the landside levee toe.

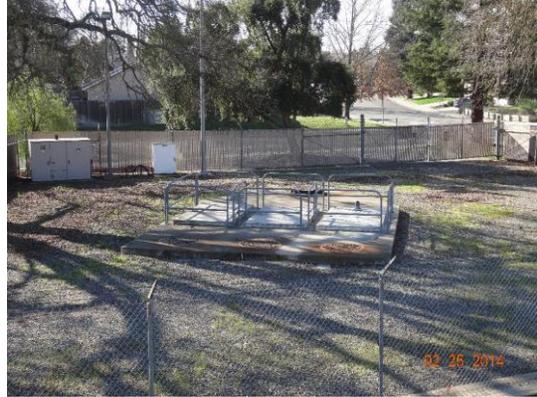
Photo 1 of 3 : UCIP\_FA\_2015\_4610.jpg

LM Start	<b>0.72</b>	Rating **	M	Issue No.	<b>5</b>
LM End	<b>0.72</b>	Issue Type +	En	Location *	LS
Category	Supplemental			GPS Latitude/Longitude	
				Start	End
Item	DWR UCIP Field Study			38.576589 °	38.576589 °
				-121.344058 °	-121.344058 °
DWR ID					
Action/Comments					
Inspector Comments: FS_ID:30541 DS_ID:24830 EP_NO: N/A FS_HLM: 0.723 Repair Type: Non-Urgent Crossing Status: Indicator Found UCIP Comments: Unable to confirm pipe size--need to contact owner to obtain additional information on crossing. FIELD_STRUCT_DESC: 3 of 3: Drainpipe unknown size through the levee at unknown depth. Pipe crosses levee at an angle. SRCSD Facility N16 NE Siphon Outlet located on landward side. Facility is fenced off. Inside facility are 3 concrete boxes with 3 manholes. No permit found. FS Date: 02/25/2014

Manholes located on landward side.

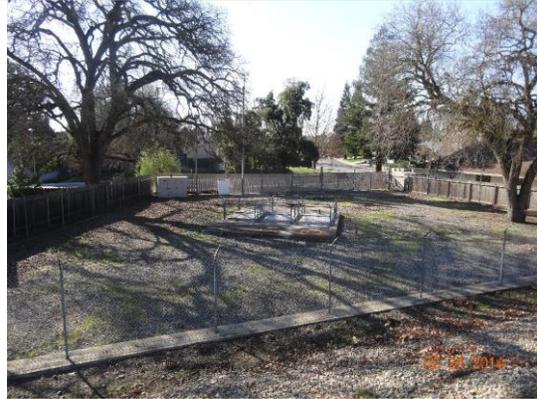
Photo 2 of 3 : UCIP\_FA\_2015\_4611.jpg

Concrete vault located on landward side.

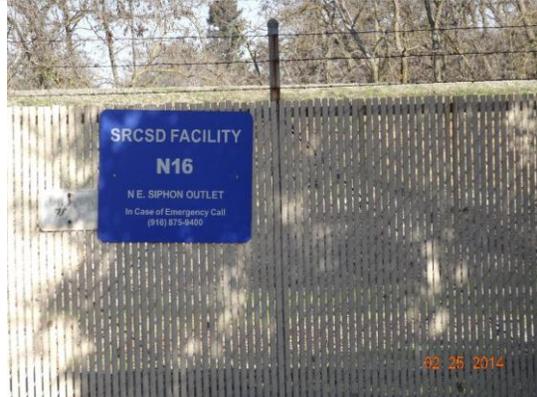
Photo 3 of 3 : UCIP\_FA\_2015\_4612.jpg

LM Start	<b>0.72</b>	Rating **	M	Issue No.	<b>5 (cont)</b>
LM End	<b>0.72</b>	Issue Type +	En	Location *	LS
Category	Supplemental			GPS Latitude/Longitude	
				Start	End
Item	DWR UCIP Field Study			38.576589 °	38.576589 °
				-121.344058 °	-121.344058 °
DWR ID					
Action/Comments					
Inspector Comments: FS_ID:30541 DS_ID:24830 EP_NO: N/A FS_HLM: 0.723 Repair Type: Non-Urgent Crossing Status: Indicator Found

SRCSD Facility N16, NE Siphon Outlet, sign visible from Mira Del Rio Drive.

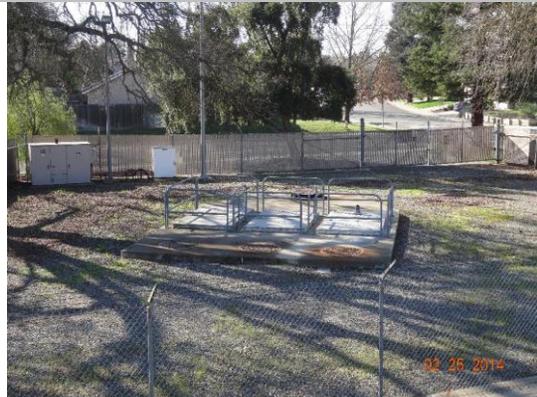
Photo 1 of 2 : UCIP\_FA\_2015\_4452.jpg

LM Start	<b>0.72</b>	Rating **	M	Issue No.	<b>6</b>
LM End	<b>0.72</b>	Issue Type +	En	Location *	LS
Category	Supplemental			GPS Latitude/Longitude	
				Start	End
Item	DWR UCIP Field Study			38.576596 °	38.576596 °
				-121.344029 °	-121.344029 °
DWR ID					
Action/Comments					
Inspector Comments: FS_ID:30540 DS_ID:24829 EP_NO: N/A FS_HLM: 0.722 Repair Type: Non-Urgent Crossing Status: Indicator Found UCIP Comments: Unable to confirm pipe size--need to contact owner to obtain additional information on crossing. FIELD_STRUCT_DESC: 2 of 3: Drainpipe unknown size through the levee at unknown depth. Pipe crosses levee at an angle. SRCSD Facility N16 NE Siphon Outlet located on landward side. Facility is fenced off. Inside facility are 3 concrete boxes with 3 manholes. No permit found. FS Date: 02/25/2014

Manholes visible on landward side.

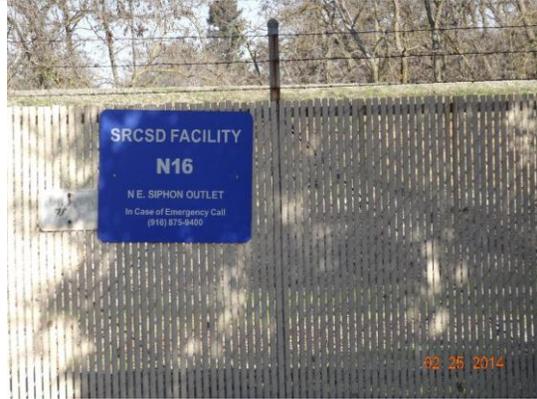
Photo 2 of 2 : UCIP\_FA\_2015\_4453.jpg

LM Start	0.72	Rating **	M	Issue No.	6 (cont)	
LM End	0.72	Issue Type +	En	Location *	LS	
Category	Supplemental			GPS Latitude/Longitude		
			Start	End		
Item	DWR UCIP Field Study			38.576596 °	38.576596 °	
				-121.344029 °	-121.344029 °	
DWR ID						
Action/Comments						
Inspector Comments: FS_ID:30540 DS_ID:24829 EP_NO: N/A FS_HLM: 0.722 Repair Type: Non-Urgent Crossing Status: Indicator Found UCIP Comments: Unable to confirm pipe size--need to contact owner to obtain additional information on crossing. FIELD_STRUCT_DESC: 2 of 3: Drainpipe unknown size through the levee at unknown depth. Pipe crosses levee at an angle. SRCSD Facility N16 NE Siphon Outlet located on landward side. Facility is fenced off. Inside facility are 3 concrete boxes with 3 manholes. No permit found. FS Date: 02/25/2014

SRCSD Facility N16, NE Siphon Outlet, sign visible from Mira Del Rio Drive.

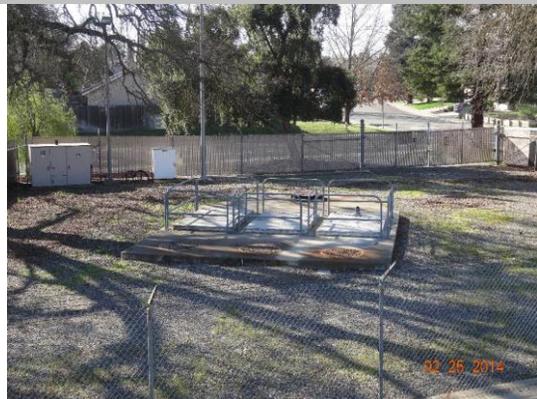
Photo 1 of 3 : UCIP\_FA\_2015\_4449.jpg

LM Start	0.72	Rating **	M	Issue No.	7	
LM End	0.72	Issue Type +	En	Location *	LS	
Category	Supplemental			GPS Latitude/Longitude		
			Start	End		
Item	DWR UCIP Field Study			38.576600 °	38.576600 °	
				-121.344008 °	-121.344008 °	
DWR ID						
Action/Comments						
Inspector Comments: FS_ID:30539 DS_ID:24828 EP_NO: N/A FS_HLM: 0.721 Repair Type: Non-Urgent Crossing Status: Indicator Found UCIP Comments: Unable to confirm pipe size--need to contact owner to obtain additional information on crossing. FIELD_STRUCT_DESC: 1 of 3: Drainpipe unknown size through the levee at unknown depth. Pipe crosses levee at an angle. SRCSD Facility N16 NE Siphon Outlet located on landward side. Facility is fenced off. Inside facility are 3 concrete boxes with 3 manholes. No permit found. FS Date: 02/25/2014

Concrete vault with manholes located on landward side.

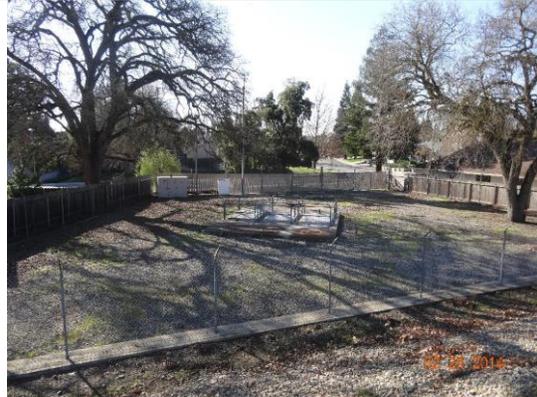
Photo 2 of 3 : UCIP\_FA\_2015\_4450.jpg

LM Start	<b>0.72</b>	Rating **	M	Issue No.	<b>7 (cont)</b>
LM End	<b>0.72</b>	Issue Type +	En	Location *	LS
Category	Supplemental			GPS Latitude/Longitude	
				Start	End
Item	DWR UCIP Field Study			38.576600 °	38.576600 °
				-121.344008 °	-121.344008 °
DWR ID					
Action/Comments					
Inspector Comments: FS_ID:30539 DS_ID:24828 EP_NO: N/A FS_HLM: 0.721 Repair Type: Non-Urgent Crossing Status: Indicator Found UCIP Comments: Unable to confirm pipe size--need to contact owner to obtain additional information on crossing. FIELD_STRUCT_DESC: 1 of 3: Drainpipe unknown size through the levee at unknown depth. Pipe crosses levee at an angle. SRCSD Facility N16 NE Siphon Outlet located on landward side. Facility is fenced off. Inside facility are 3 concrete boxes with 3 manholes. No permit found. FS Date: 02/25/2014

Concrete vault for 3 crossings located on landward side.

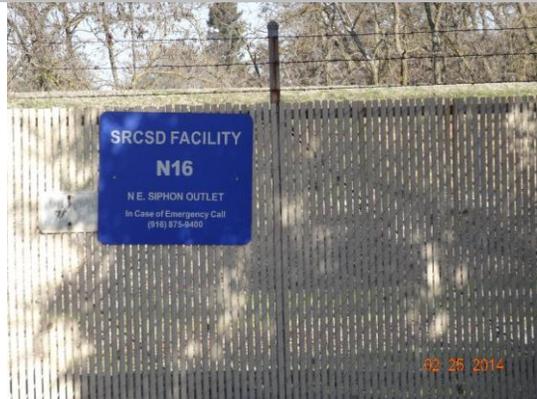
Photo 3 of 3 : UCIP\_FA\_2015\_4451.jpg

SRCDS Facility N16, NE Siphon Outlet, sign visible from Mira Del Rio Drive.
