**Flood Control Project Maintenance
Levee Inspections**
LMA District Cover Sheet
Spring 2016 Levee Inspection Results

Lake County Watershed Protection District

Spring 2016 Levee Inspection Results

Waterway		Bank	Unit Miles
Unit No. 01 Middle Creek		Left	3.35

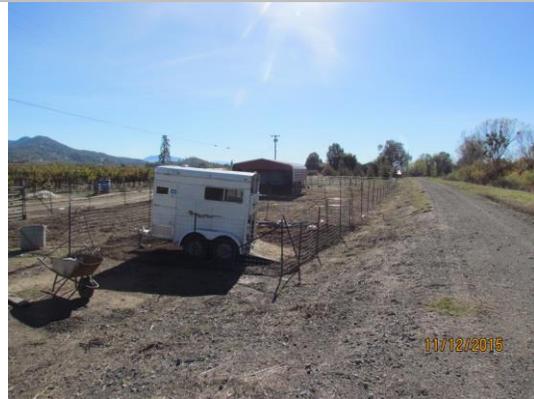
Photo 1 of 1 : SP_2016_NA0009_3_24_20160321_00015.jpg

LM Start	0.14	Rating **	M	Issue No.	24
LM End	0.22	Issue Type +	En	Location *	LS
Category	Earthen Levee			GPS Latitude/Longitude	
				Start	End
Item	Encroachments			39.188465 °	39.187392 °
				-122.907687 °	-122.907885 °
DWR ID	DWR_NA0009_01_f_2015_24				
Comment Code					
FE : Fence					
Inspector Comment					
Remove the fence from the landside toe.

View of the fence along the landside toe.

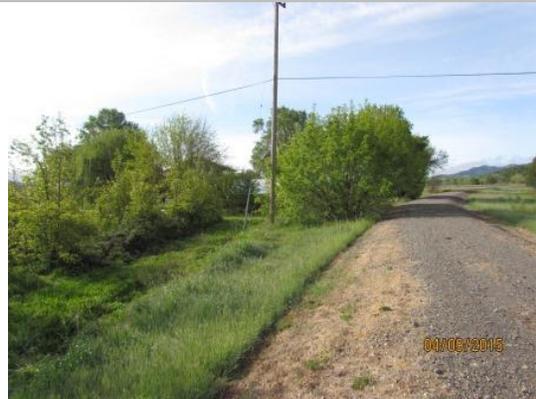
Photo 1 of 2 : SP_2016_NA0009_3_11_20160321_00005.jpg

LM Start	0.26	Rating **	M	Issue No.	11
LM End	0.26	Issue Type +	Ma	Location *	LS
Category	Earthen Levee			GPS Latitude/Longitude	
				Start	End
Item	Trim / Thin Trees			39.186777 °	39.186777 °
				-122.908102 °	-122.908102 °
DWR ID	DWR_NA0009_01_s_2013_11				
Comment Code					
T3 : Trim and thin trees to allow visibility of the ground and room to flood fight.					
Inspector Comment					
Remove the trees from the landside slope.

Remove the trees from the landside slope.

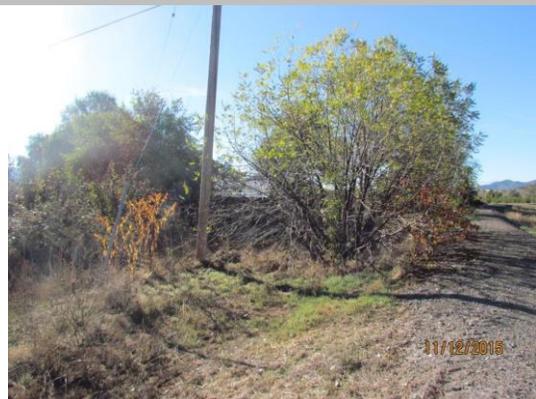
Photo 2 of 2 : SP_2016_NA0009_3_11_20160321_00006.jpg

LM Start	0.26	Rating **	M	Issue No.	11 (cont)
LM End	0.26	Issue Type +	Ma	Location *	LS

Remove the trees from the landside slope.

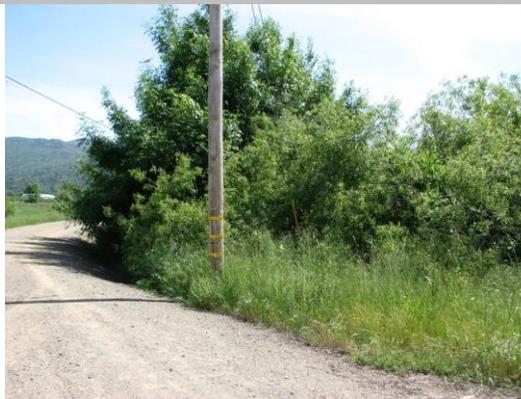
Photo 1 of 1 : SP_2016_NA0009_3_28_20160509_00031.jpg

LM Start	1.13	Rating **	U	Issue No.	28
LM End	1.13	Issue Type +	Ma	Location *	LS
Category	Earthen Levee		GPS Latitude/Longitude		
			Start	End	
Item	Trim / Thin Trees		39.175718 °	39.175718 °	
			-122.911618 °	-122.911618 °	
DWR ID	DWR_NA0009_01_s_2016_28				
Comment Code					
T2 : Thin trees to allow visibility of the ground and room to flood fight.					
Inspector Comment

5/2/2016: Trim trees and clear vegetation on L/S slope.

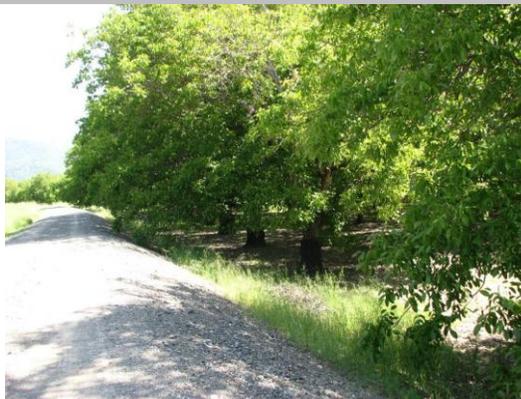
Photo 1 of 1 : SP_2016_NA0009_3_27_20160509_00030.jpg

LM Start	1.15	Rating **	M	Issue No.	27
LM End	1.41	Issue Type +	Ma	Location *	LS
Category	Earthen Levee		GPS Latitude/Longitude		
			Start	End	
Item	Trim / Thin Trees		39.175465 °	39.172077 °	
			-122.912012 °	-122.914226 °	
DWR ID	DWR_NA0009_01_s_2016_27				
Comment Code					
T1 : Trim trees to at least five feet above ground level.					
Inspector Comment					
Orchard trees should be trimmed to 5' above LS slope.

5/2/2016: Trip trees on L/S slope.

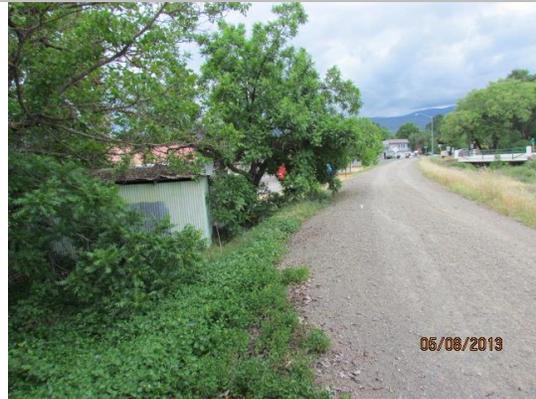
Photo 1 of 1 : SP_2016_NA0009_3_15_20160321_00010.jpg

LM Start	2.38	Rating **	M	Issue No.	15
LM End	2.41	Issue Type +	Ma	Location *	LS
Category	Earthen Levee		GPS Latitude/Longitude		
			Start	End	
Item	Trim / Thin Trees		39.161381 °	39.161708 °	
			-122.912551 °	-122.912168 °	
DWR ID	DWR_NA0009_01_s_2013_15				
Comment Code					
T1 : Trim trees to at least five feet above ground level.					
Inspector Comment

Trim the trees up 5 feet to allow visibility.

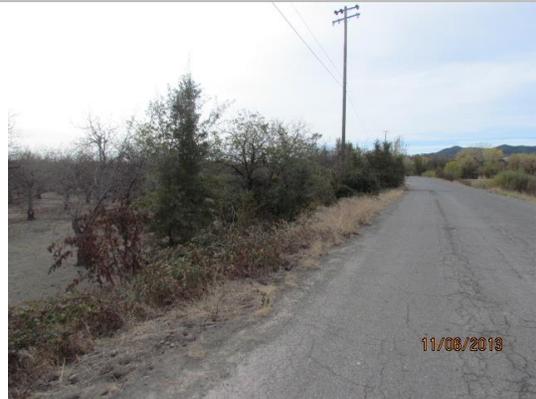
Photo 1 of 1 : SP_2016_NA0009_3_3_20160321_00001.jpg

LM Start	2.48	Rating **	U	Issue No.	3
LM End	2.55	Issue Type +	Ma	Location *	LS
Category	Earthen Levee		GPS Latitude/Longitude		
			Start	End	
Item	Vegetation		39.161615 °	39.160804 °	
			-122.911733 °	-122.912536 °	
DWR ID	DWR_NA0009_01_s_2012_3				
Comment Code					
V2 : Remove the wild growth other than native grasses from the levee slopes.					
Inspector Comment

View of the vegetation along the landside slope.

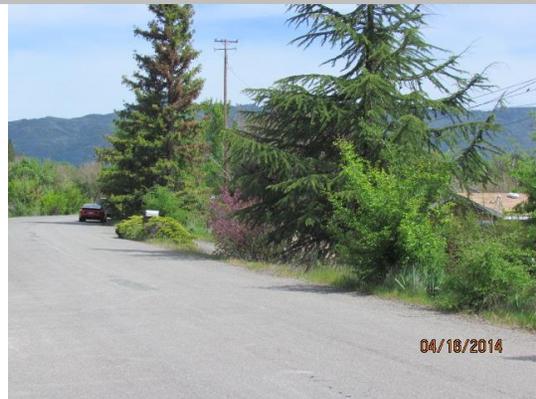
Photo 1 of 1 : SP_2016_NA0009_3_5_20160321_00003.jpg

LM Start	2.58	Rating **	M	Issue No.	5
LM End	2.66	Issue Type +	En	Location *	LS
Category	Earthen Levee		GPS Latitude/Longitude		
			Start	End	
Item	Vegetation		39.160443 °	39.159308 °	
			-122.912845 °	-122.913417 °	
DWR ID	DWR_NA0009_01_s_2012_5				
Comment Code					
V6 : Landscaping					
Inspector Comment

View of the landscape along the landside slope.

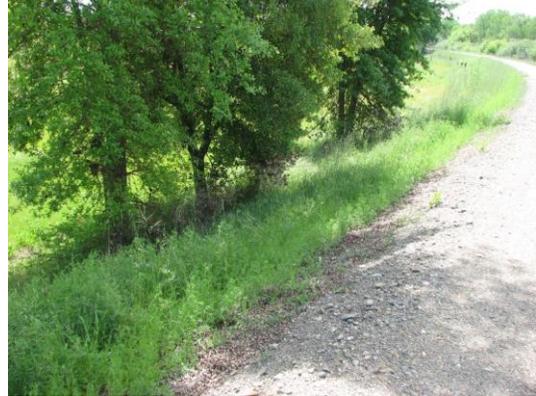
Photo 1 of 1 : SP_2016_NA0009_3_25_20160420_00028.jpg

LM Start	2.95	Rating **	M	Issue No.	25
LM End	2.98	Issue Type +	Ma	Location *	LS
Category	Earthen Levee		GPS Latitude/Longitude		
			Start	End	
Item	Trim / Thin Trees		39.155301 °	39.154790 °	
			-122.914633 °	-122.914740 °	
DWR ID	DWR_NA0009_01_s_2016_25				
Comment Code					
T1 : Trim trees to at least five feet above ground level.					
Inspector Comment

Trim trees to 5' above levee slope (LS). 4/19/2016

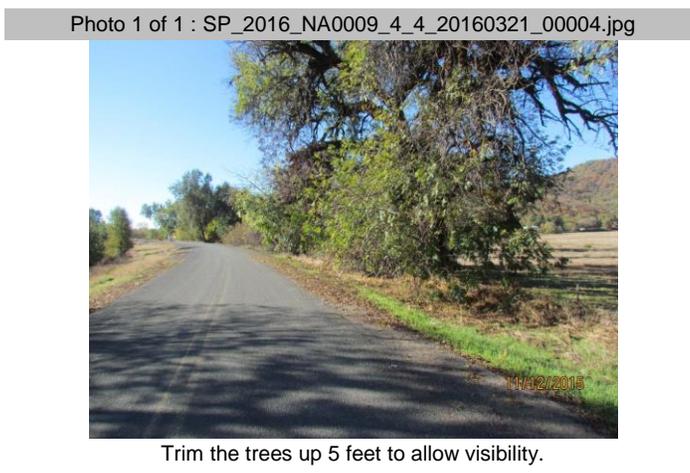
LM Start	0.02	Rating **	M	Issue No.	4
LM End	0.14	Issue Type +	Ma	Location *	LS
Category	Earthen Levee		GPS Latitude/Longitude		
			Start	End	
Item	Trim / Thin Trees		39.189540 °	39.187900 °	
			-122.908065 °	-122.908655 °	
DWR ID	DWR_NA0009_02_s_2013_4				
Comment Code					
T1 : Trim trees to at least five feet above ground level.					
Inspector Comment					
Trim the trees up 5 feet to allow visibility.

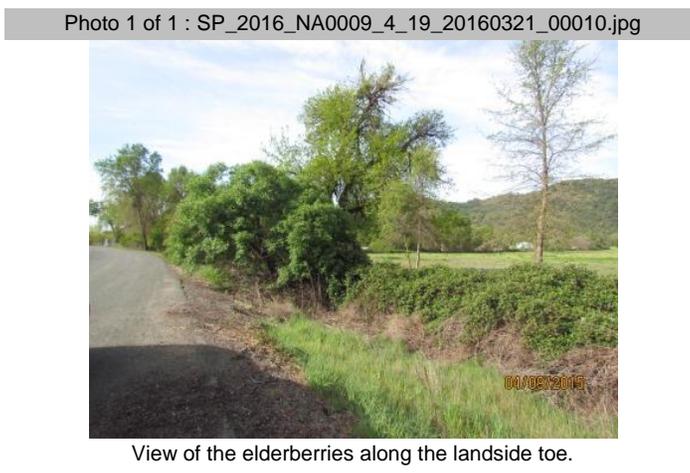
LM Start	0.08	Rating **	M	Issue No.	19
LM End	0.08	Issue Type +	Ma	Location *	LS
Category	Earthen Levee		GPS Latitude/Longitude		
			Start	End	
Item	Vegetation		39.188772 °	39.188772 °	
			-122.908465 °	-122.908465 °	
DWR ID	DWR_NA0009_02_s_2014_19				
Comment Code					
V4 : Elderberries are blocking visibility and flood fight capability.					
Inspector Comment

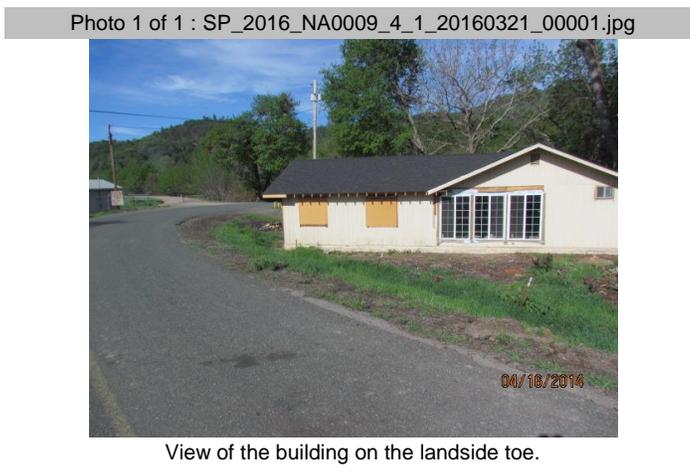
LM Start	0.20	Rating **	U	Issue No.	1
LM End	0.20	Issue Type +	En	Location *	LS
Category	Earthen Levee		GPS Latitude/Longitude		
			Start	End	
Item	Encroachments		39.187039 °	39.187039 °	
			-122.908880 °	-122.908880 °	
DWR ID	DWR_NA0009_02_s_2016_1				
Comment Code					
BU : Building					
Inspector Comment

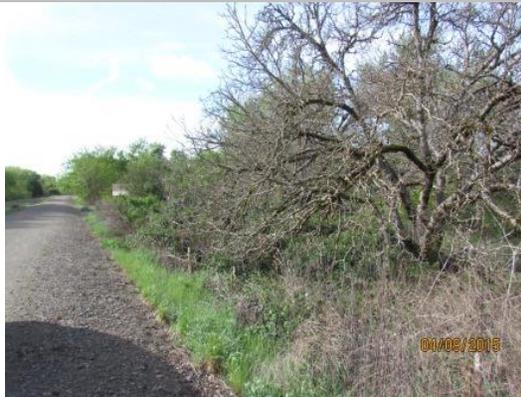
Photo 1 of 2 : SP_2016_NA0009_4_7_20160321_00006.jpg

LM Start	0.97	Rating **	M	Issue No.	7
LM End	0.98	Issue Type +	Ma	Location *	LS
Category	Earthen Levee			GPS Latitude/Longitude	
				Start	End
Item	Vegetation			39.177218 °	39.176992 °
				-122.913673 °	-122.913642 °
DWR ID	DWR_NA0009_02_s_2012_7				
Comment Code					
V2 : Remove the wild growth other than native grasses from the levee slopes.					
Inspector Comment					
Remove the vegetation from the landside toe.

Remove the vegetation from the landside toe.

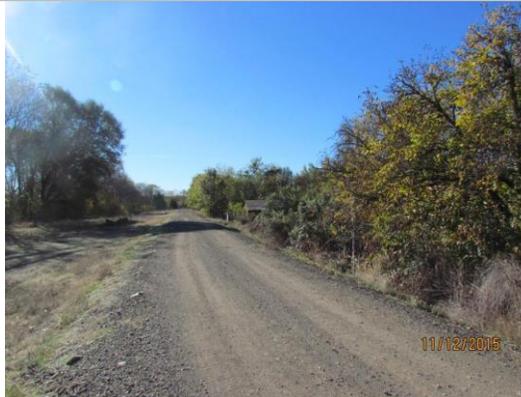
Photo 2 of 2 : SP_2016_NA0009_4_7_20160321_00007.jpg

LM Start	0.97	Rating **	M	Issue No.	7 (cont)
LM End	0.98	Issue Type +	Ma	Location *	LS

Remove the vegetation from the landside toe.

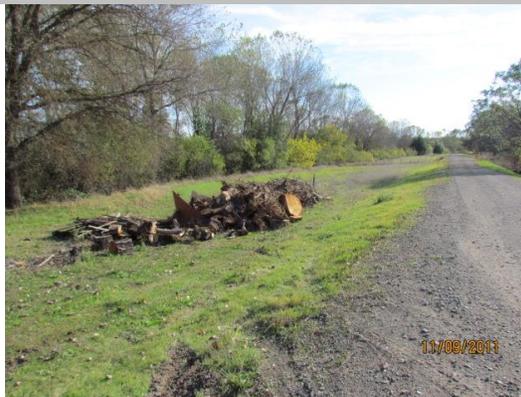
Photo 1 of 1 : SP_2016_NA0009_4_3_20160321_00003.jpg

LM Start	0.99	Rating **	M	Issue No.	3
LM End	0.99	Issue Type +	Ma	Location *	WS
Category	Earthen Levee		GPS Latitude/Longitude		
			Start	End	
Item	Encroachments		39.176835 °	39.176835 °	
			-122.913558 °	-122.913558 °	
DWR ID	DWR_NA0009_02_s_2012_3				
Comment Code					
TR : Tree or limb					
Inspector Comment

View of the tree prunings on the W/S toe.

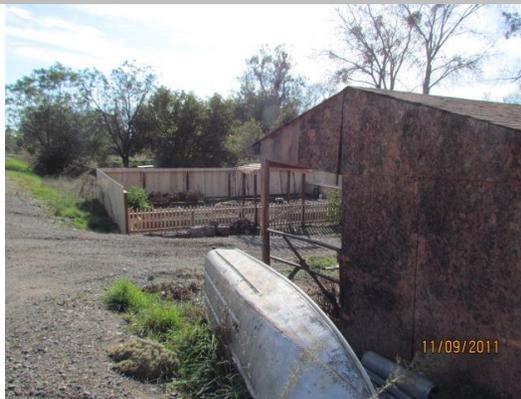
Photo 1 of 1 : SP_2016_NA0009_4_2_20160321_00002.jpg

LM Start	0.99	Rating **	U	Issue No.	2
LM End	0.99	Issue Type +	En	Location *	LS
Category	Earthen Levee		GPS Latitude/Longitude		
			Start	End	
Item	Encroachments		39.176815 °	39.176815 °	
			-122.913540 °	-122.913540 °	
DWR ID	DWR_NA0009_02_s_2012_2				
Comment Code					
FE : Fence					
Inspector Comment					
Unpermitted fence and building.

View of the building & fence along the Landside toe.

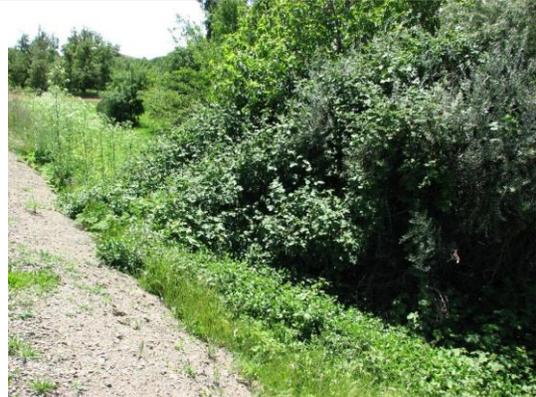
Photo 1 of 1 : SP_2016_NA0009_4_21_20160509_00035.jpg

LM Start	2.69	Rating **	M	Issue No.	21
LM End	2.69	Issue Type +	Ma	Location *	LS
Category	Earthen Levee			GPS Latitude/Longitude	
				Start	End
Item	Vegetation			39.153399 °	39.153399 °
				-122.915741 °	-122.915741 °
DWR ID	DWR_NA0009_02_s_2016_21				
Comment Code					
V2 : Remove the wild growth other than native grasses from the levee slopes.					
Inspector Comment					
Remove thick brambles and trim trees to restore visibility and access to LS slope and toe.

5/2/2016: Trim landscaping on L/S toe and slope to allow visibility and access.

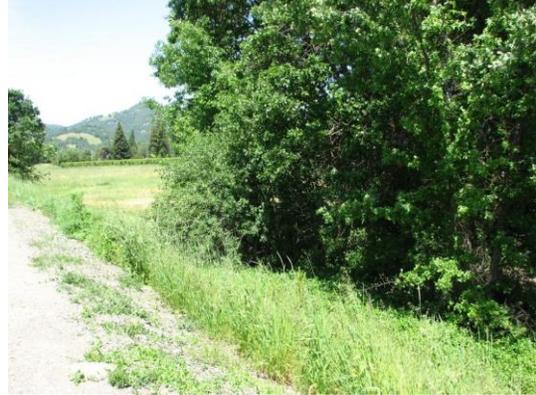
Photo 1 of 1 : SP_2016_NA0009_5_9_20160509_00023.jpg

LM Start	0.49	Rating **	M	Issue No.	9
LM End	0.49	Issue Type +	Ma	Location *	LS
Category	Earthen Levee		GPS Latitude/Longitude		
			Start	End	
Item	Vegetation		39.154195 °	39.154195 °	
			-122.918134 °	-122.918134 °	
DWR ID	DWR_NA0009_03_s_2016_9				
Comment Code					
V2 : Remove the wild growth other than native grasses from the levee slopes.					
Inspector Comment					
Tree should be trimmed and surrounding brush and weeds should be cleared to allow visibility and access.

5/2/2016: Trim trees and vegetation to allow visibility and access to L/S slope and toe.

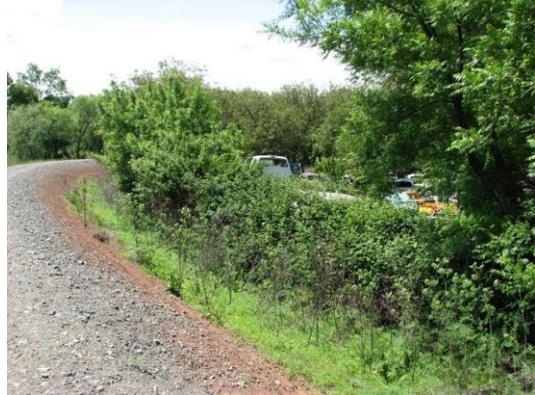
Photo 1 of 1 : SP_2016_NA0009_5_13_20160513_00026.jpg

LM Start	1.07	Rating **	U	Issue No.	13
LM End	1.13	Issue Type +	En	Location *	LS
Category	Earthen Levee		GPS Latitude/Longitude		
			Start	End	
Item	Encroachments		39.159789 °	39.159613 °	
			-122.923515 °	-122.924643 °	
DWR ID	DWR_NA0009_03_s_2016_13				
Comment Code					
AV : Abandoned vehicles					
Inspector Comment					
Junk yard full of abandoned vehicles, some stacked at levee toe obstructing visibility and access to levee toe.

5/2/2016: Vehicle junk yard behind fence covered in dense growth of bushes and vines.

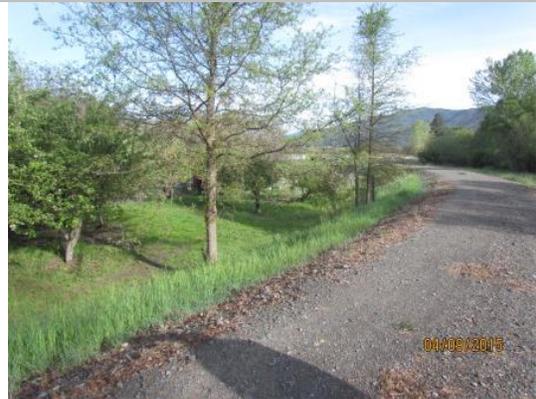
Photo 1 of 2 : SP_2016_NA0009_6_2_20160321_00001.jpg

LM Start	1.05	Rating **	M	Issue No.	2
LM End	1.18	Issue Type +	Ma	Location *	LS
Category	Earthen Levee		GPS Latitude/Longitude		
			Start	End	
Item	Trim / Thin Trees		39.180479 °	39.181947 °	
			-122.896567 °	-122.895112 °	
DWR ID	DWR_NA0009_04_s_2012_2				
Comment Code					
T1 : Trim trees to at least five feet above ground level.					
Inspector Comment					
Trim the trees up 5 feet for better visibility.

Trim the trees for better visibility.

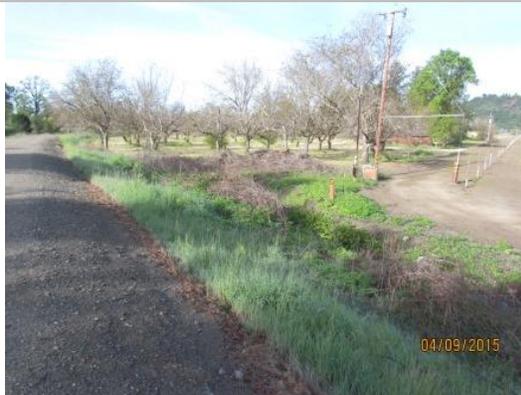
Photo 1 of 2 : SP_2016_NA0009_6_9_20160321_00004.jpg

LM Start	1.19	Rating **	M	Issue No.	9
LM End	1.26	Issue Type +	Ma	Location *	LS
Category	Earthen Levee			GPS Latitude/Longitude	
				Start	End
Item	Vegetation			39.182154 °	39.182951 °
				-122.895005 °	-122.894409 °
DWR ID	DWR_NA0009_04_s_2012_9				
Comment Code					
V2 : Remove the wild growth other than native grasses from the levee slopes.					
Inspector Comment					
Remove the vegetation from the landside toe.

View of the vegetation growing at the toe.

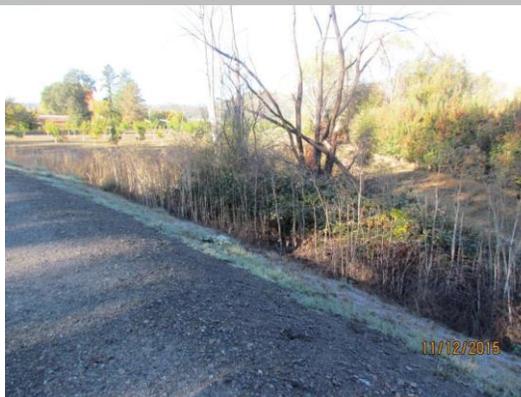
Photo 2 of 2 : SP_2016_NA0009_6_9_20160321_00005.jpg

LM Start	1.19	Rating **	M	Issue No.	9 (cont)
LM End	1.26	Issue Type +	Ma	Location *	LS

View of the vegetation at the landside toe.
