**Flood Control Project Maintenance
Levee Inspections**

Fall 2015 Levee Maintenance Deficiency Summary Report

Sacramento River Basin

Sacramento River West Side Levee District

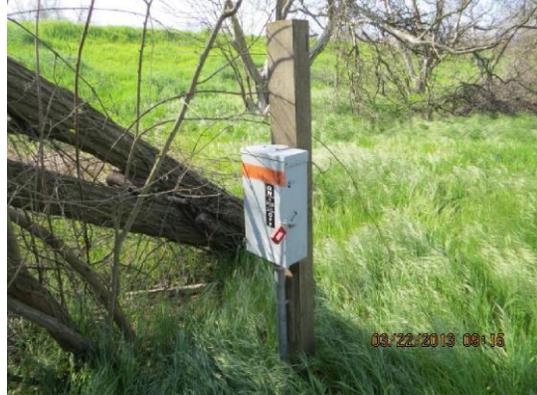
Photo 1 of 3 : UCIP_FA_2015_0202.jpg

LM Start	Rating **	M	Issue No.	1555
LM End	Issue Type +	En	Location *	N/A
Category	Supplemental		GPS Latitude/Longitude	
			Start	End
Item	DWR UCIP Field Study		39.187497 °	39.187497 °
DWR ID			-121.962074 °	-121.962074 °
Action/Comments				
Inspector Comments: FS_ID:46812 DS_ID:20314 EP_NO: 15763 FS_HLM: 46.553 Repair Type: Non-Urgent Crossing Status: Found UCIP Comments: Fresno valve on WS shoulder is broken. Pipe appears to be abandoned. Need to abandon properly if necessary. site visit on 10/09/2015 indicates water is present somewhere along the waterside levee slope. Possibly siphon breaker or fresno valve sprays and drains down levee slope from WS shoulder. internal inspection of pipe recommended to determine source of leak. Pipe is active, but can be removed and capped when not in use. FIELD_STRUCT_DESC: 4-inch galvanized steel irrigation pipe through levee 2.0 feet below crown. Irrigation valve approx. 50 feet landward of the landward levee toe. Fresno valve on WS shoulder with connection for pump at WS berm. (Permit No. 15763, 1992). FS Date: 03/22/2013

Electrical box at WS berm for portable pump.

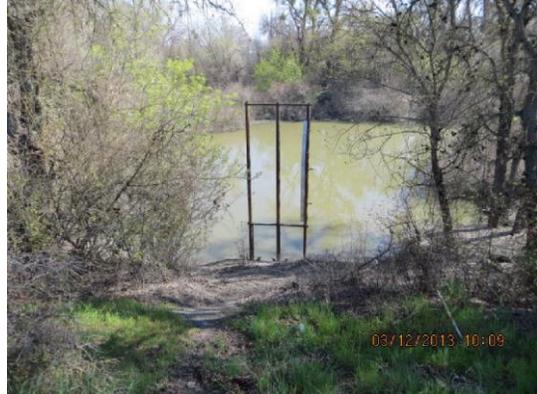
Photo 2 of 3 : UCIP_FA_2015_0338.jpg

Air vents at outlet on WS toe.

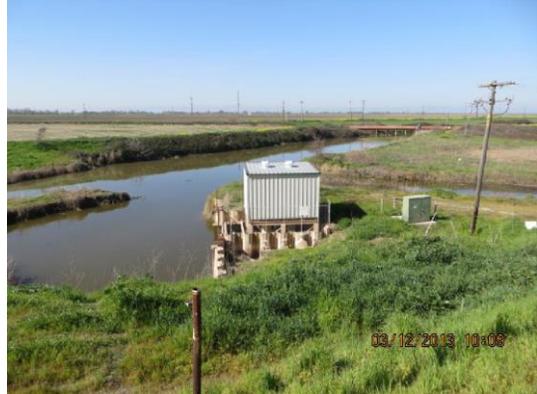
Photo 3 of 3 : UCIP_FA_2015_0309.jpg

Pump house on LS toe.

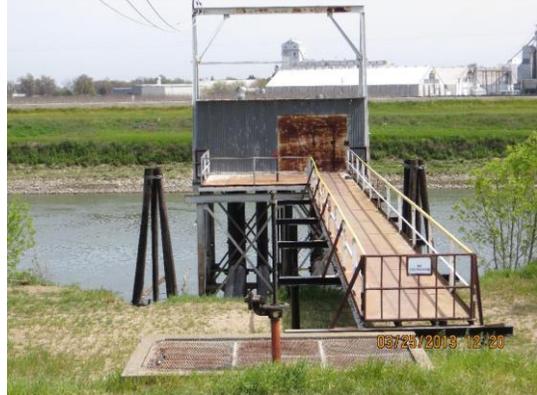
Photo 2 of 3 : UCIP_FA_2015_0391.jpg

Pumping plant with concrete surge box and slide gate in foreground-off WS toe.

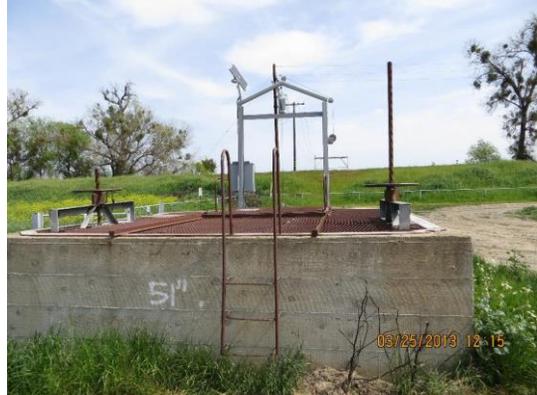
Photo 3 of 3 : UCIP_FA_2015_0392.jpg

Concrete distribution box on 150-feet off landside toe.

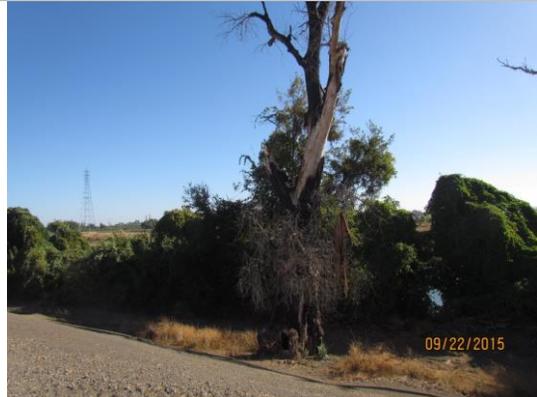
Photo 1 of 1 : FA_2015_NA0016_435_82_20151001_00094.jpg

LM Start	1.28	Rating **	A/W	Issue No.	82
LM End	1.28	Issue Type +	Ma	Location *	WS
Category	Earthen Levee			GPS Latitude/Longitude	
				Start	End
Item	Vegetation			38.817036 °	38.817036 °
				-121.725410 °	-121.725410 °
DWR ID	DWR_NA0016_01_s_2014_82				
Action/Comments					
Trees / Woody Vegetation

View of the dying tree on the waterward side of the levee. Monitor trees that could pose a threat to the integrity of the levee. Fall 2015.

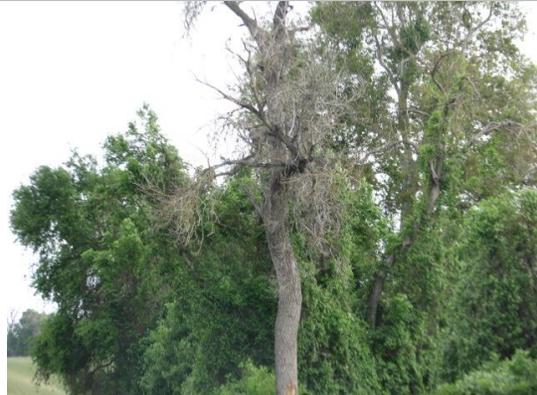
Photo 1 of 1 : FA_2015_NA0016_435_83_20150914_00036.jpg

LM Start	1.33	Rating **	A/W	Issue No.	83
LM End	1.33	Issue Type +	Ma	Location *	WS
Category	Earthen Levee			GPS Latitude/Longitude	
				Start	End
Item	Vegetation			38.817781 °	38.817781 °
				-121.725466 °	-121.725466 °
DWR ID	DWR_NA0016_01_s_2014_83				
Action/Comments					
Trees / Woody Vegetation

Monitor trees that pose a future threat to the integrity of the levee. Spring 2014

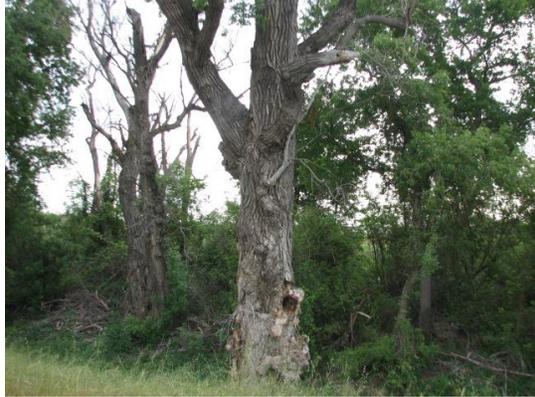
Photo 1 of 1 : FA_2015_NA0016_435_84_20150914_00037.jpg

LM Start	1.87	Rating **	A/W	Issue No.	84
LM End	1.87	Issue Type +	Ma	Location *	WS
Category	Earthen Levee		GPS Latitude/Longitude		
			Start	End	
Item	Vegetation		38.825534 °	38.825534 °	
			-121.724749 °	-121.724749 °	
DWR ID	DWR_NA0016_01_s_2014_84				
Action/Comments					
Trees / Woody Vegetation

Monitor trees that pose a future threat to the integrity of the levee. Spring 2014

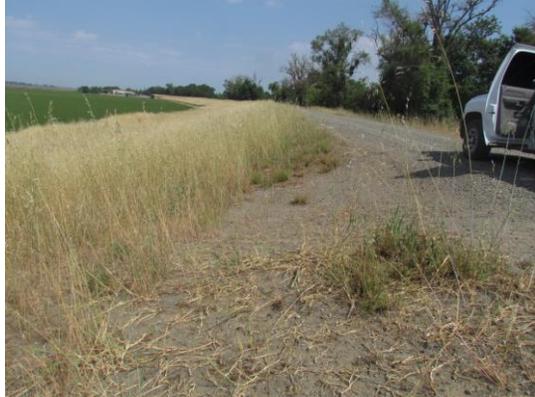
Photo 1 of 1 : FA_2015_NA0016_435_85_20150914_00038.jpg

View of the sloughing on the landward side of the levee looking upstream. Spring 2015.

LM Start	1.94	Rating **	A/W	Issue No.	85
LM End	1.94	Issue Type +	Ma	Location *	LS
Category	Earthen Levee		GPS Latitude/Longitude		
			Start	End	
Item	Slope Stability		38.826567 °	38.826567 °	
			-121.725060 °	-121.725060 °	
DWR ID	DWR_NA0016_01_s_2015_85				
Action/Comments					
Repair slope instability.

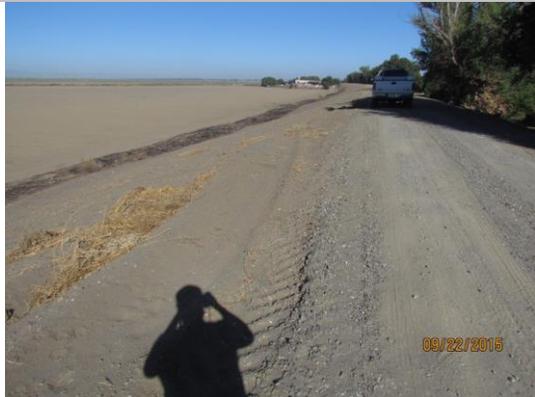
Photo 1 of 1 : FA_2015_NA0016_435_87_20151001_00095.jpg

View of the landward slope that was damaged by vehicles looking upstream. Fall 2015.

LM Start	2.15	Rating **	M	Issue No.	87
LM End	2.15	Issue Type +	Ma	Location *	LS
Category	Earthen Levee		GPS Latitude/Longitude		
			Start	End	
Item	Slope Stability		38.829330 °	38.829330 °	
			-121.726607 °	-121.726607 °	
DWR ID	DWR_NA0016_01_f_2015_87				
Action/Comments					
Repair the levee slope damaged by vehicle traffic and prevent access where possible.

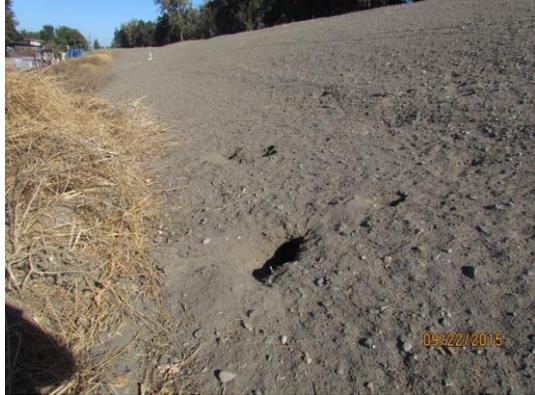
Photo 1 of 1 : FA_2015_NA0016_435_88_20151001_00096.jpg

View of the animal hole on the landward side of the levee looking upstream. Fall 2015.

LM Start	2.37	Rating **	M	Issue No.	88
LM End	2.37	Issue Type +	Ma	Location *	LS
Category	Earthen Levee			GPS Latitude/Longitude	
				Start	End
Item	Animal Control			38.831965 °	38.831965 °
				-121.729048 °	-121.729048 °
DWR ID	DWR_NA0016_01_f_2015_88				
Action/Comments					
No rodents visible, but rodent burrows visible; need to backfill and compact or grout burrows.

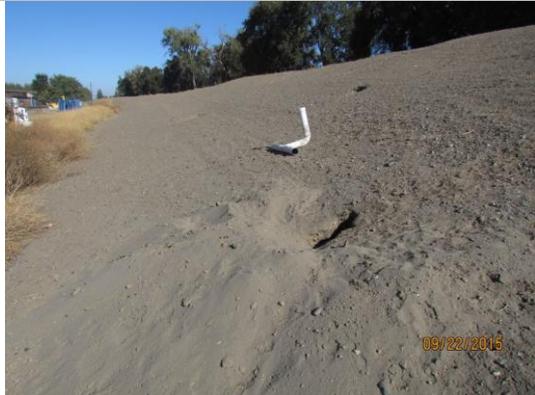
Photo 1 of 1 : FA_2015_NA0016_435_89_20151001_00098.jpg

View of the animal hole on the landward side of the levee looking upstream. Fall 2015.

LM Start	2.39	Rating **	U	Issue No.	89
LM End	2.39	Issue Type +	Ma	Location *	LS
Category	Earthen Levee			GPS Latitude/Longitude	
				Start	End
Item	Animal Control			38.832187 °	38.832187 °
				-121.729256 °	-121.729256 °
DWR ID	DWR_NA0016_01_f_2015_89				
Action/Comments					
No rodents visible, but rodent burrows visible; need to backfill and compact or grout burrows.

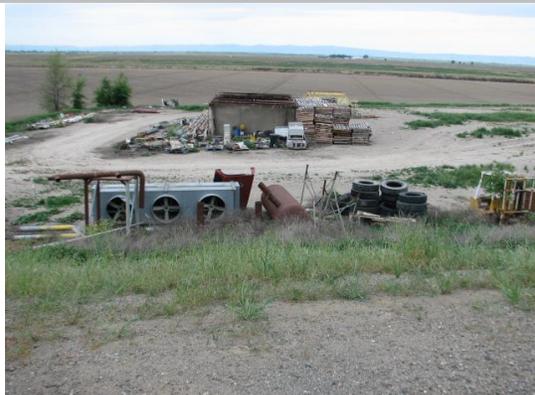
Photo 1 of 2 : FA_2015_NA0016_435_1550_20150914_00054.jpg

LM Start	2.39	Rating **	M	Issue No.	1550
LM End	2.39	Issue Type +	En	Location *	LS
Category	Earthen Levee			GPS Latitude/Longitude	
				Start	End
Item	Encroachments			38.832203 °	38.832203 °
				-121.729278 °	-121.729278 °
DWR ID	DWR_NA0016_01_f_2013_1550				
Action/Comments					
Debris Inspector Comments: Equipment are at the levee toe.

Pieces of machinery and debris at the levee toe. Spring 2014

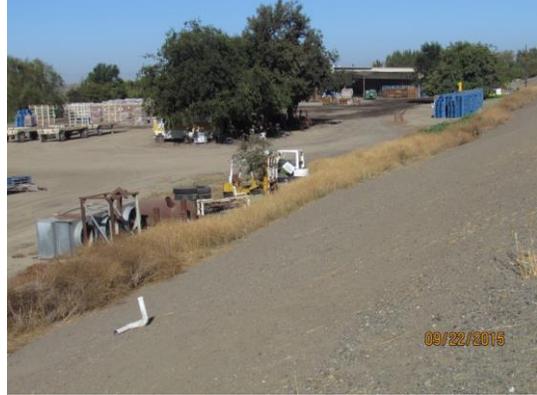
Photo 2 of 2 : FA_2015_NA0016_435_1550_20151001_00097.jpg

View of the machinery along the landward levee toe looking upstream. Fall 2015.

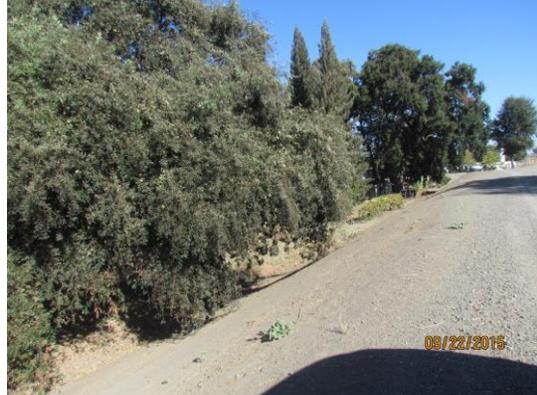
Photo 1 of 1 : FA_2015_NA0016_435_98_20151001_00099.jpg

View of the trees on the landward side of the levee that needs to be trimmed looking upstream. Fall 2015.

LM Start	2.74	Rating **	M	Issue No.	98
LM End	2.74	Issue Type +	Ma	Location *	LS
Category	Earthen Levee		GPS Latitude/Longitude		
			Start	End	
Item	Trim / Thin Trees		38.836454 °	38.836454 °	
			-121.732037 °	-121.732037 °	
DWR ID	DWR_NA0016_01_f_2015_98				
Action/Comments					
Trim trees to at least five feet above ground level.

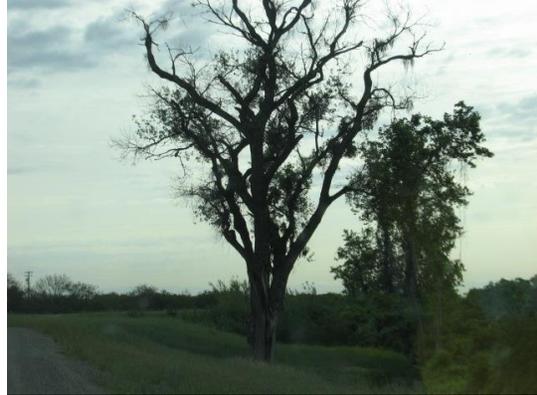
Photo 1 of 1 : FA_2015_NA0016_435_86_20150914_00039.jpg

LM Start	3.14	Rating **	A/W	Issue No.	86
LM End	3.14	Issue Type +	Ma	Location *	WS
Category	Earthen Levee		GPS Latitude/Longitude		
			Start	End	
Item	Vegetation		38.841283 °	38.841283 °	
			-121.728827 °	-121.728827 °	
DWR ID	DWR_NA0016_01_s_2014_86				
Action/Comments					
Trees / Woody Vegetation

Monitor trees that pose a future threat to the integrity of the levee. Spring 2014

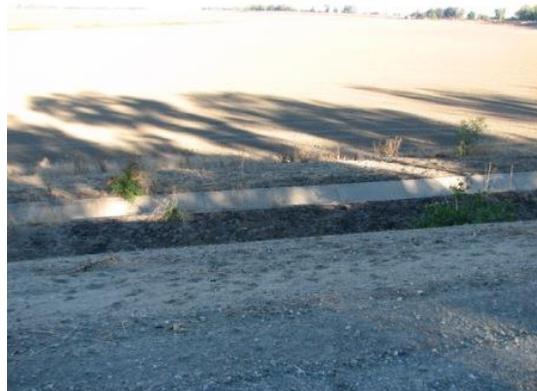
Photo 1 of 1 : FA_2015_NA0016_435_8_20150914_00006.jpg

LM Start	3.56	Rating **	A/W	Issue No.	8
LM End	3.94	Issue Type +	Ma	Location *	LS
Category	Earthen Levee		GPS Latitude/Longitude		
			Start	End	
Item	Encroachments		38.846767 °	38.850758 °	
			-121.729943 °	-121.725263 °	
DWR ID	DWR_NA0016_01_s_2012_8				
Action/Comments					
Ditch Inspector Comments: concrete lined

A concrete lined ditch runs along the toe of the levee. Fall 2013

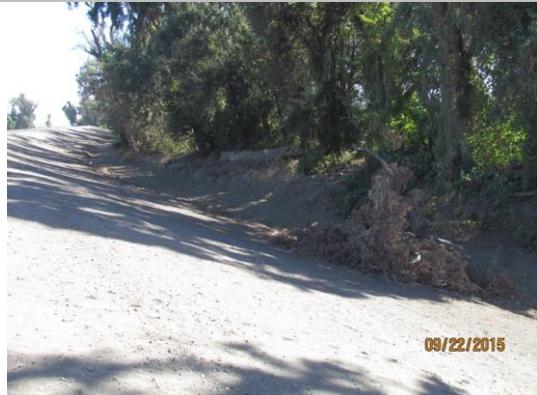
Photo 1 of 1 : FA_2015_NA0016_435_106_20151001_00101.jpg

LM Start	3.76	Rating **	M	Issue No.	106
LM End	3.76	Issue Type +	Ma	Location *	WS
Category	Earthen Levee		GPS Latitude/Longitude		
			Start	End	
Item	Encroachments		38.849210 °	38.849210 °	
			-121.728054 °	-121.728054 °	
DWR ID	DWR_NA0016_01_f_2015_106				
Action/Comments					
Tree or limb

View of the tree branch on the waterward side of the levee looking upstream. Fall 2015.

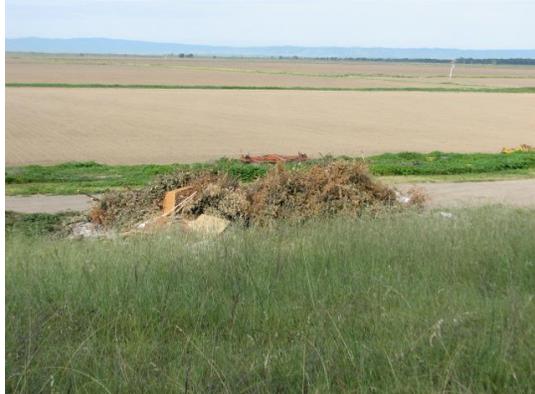
Photo 1 of 2 : FA_2015_NA0016_435_1551_20150914_00057.jpg

LM Start	4.59	Rating **	M	Issue No.	1551
LM End	4.59	Issue Type +	En	Location *	LS
Category	Earthen Levee		GPS Latitude/Longitude		
			Start	End	
Item	Encroachments		38.856995 °	38.856995 °	
			-121.730938 °	-121.730938 °	
DWR ID	DWR_NA0016_01_f_2013_1551				
Action/Comments					
Debris

On going debris pile at the landside toe of the levee. Spring 2014

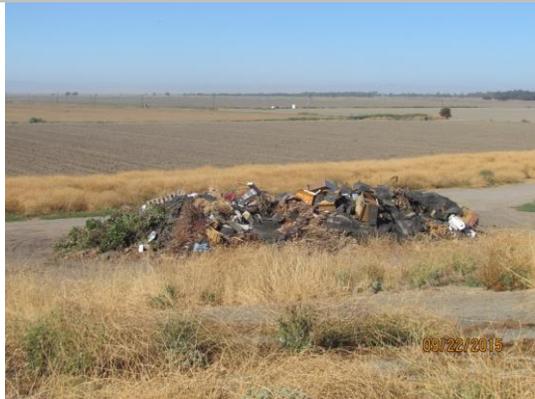
Photo 2 of 2 : FA_2015_NA0016_435_1551_20151001_00102.jpg

View of the ongoing debris pile at the landward levee toe. Fall 2015.

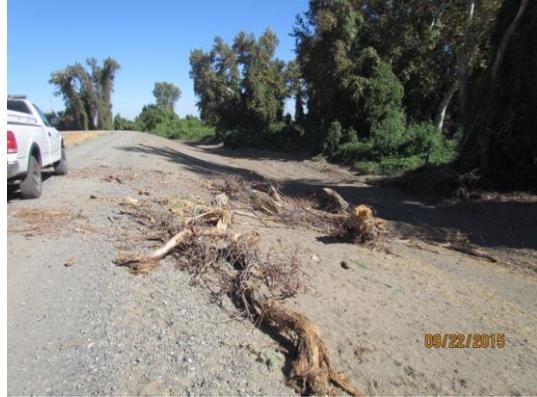
Photo 1 of 1 : FA_2015_NA0016_435_112_20151001_00103.jpg

LM Start	4.67	Rating **	M	Issue No.	112
LM End	4.67	Issue Type +	Ma	Location *	WS
Category	Earthen Levee		GPS Latitude/Longitude		
			Start	End	
Item	Encroachments		38.858156 °	38.858156 °	
			-121.731422 °	-121.731422 °	
DWR ID	DWR_NA0016_01_f_2015_112				
Action/Comments					
Tree or limb

View of the tree branches on the waterward side of the levee looking upstream. Fall 2015.

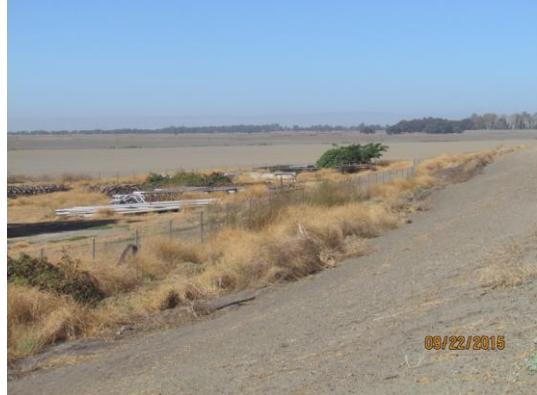
Photo 1 of 1 : FA_2015_NA0016_435_9_20151001_00104.jpg

LM Start	4.80	Rating **	A/W	Issue No.	9
LM End	4.80	Issue Type +	Ma	Location *	LS
Category	Earthen Levee		GPS Latitude/Longitude		
			Start	End	
Item	Encroachments		38.859419 °	38.859419 °	
			-121.732708 °	-121.732708 °	
DWR ID	DWR_NA0016_01_s_2012_9				
Action/Comments					
Fence Inspector Comments: chain link fence runs along levee

View of the chain link fence along the landward levee toe looking upstream. The fence does not obstruct the view. Fall 2015.

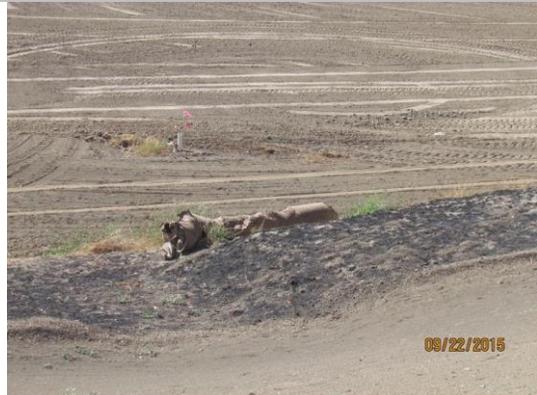
Photo 1 of 2 : FA_2015_NA0016_435_113_20151001_00105.jpg

LM Start	6.50	Rating **	M	Issue No.	113
LM End	6.50	Issue Type +	En	Location *	LS
Category	Earthen Levee		GPS Latitude/Longitude		
			Start	End	
Item	Encroachments		38.868129 °	38.868129 °	
			-121.756462 °	-121.756462 °	
DWR ID	DWR_NA0016_01_f_2015_113				
Action/Comments					
Pipe

View of the abandoned pipe at the landward levee toe. Fall 2015.

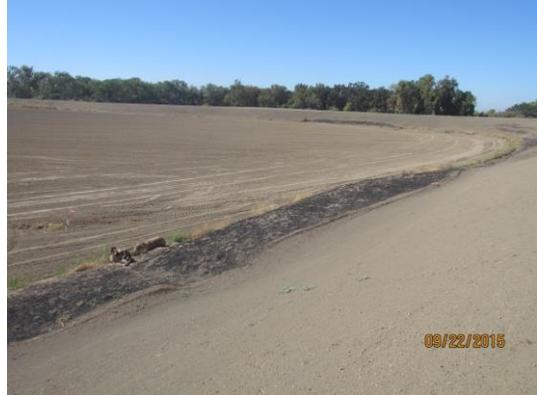
Photo 2 of 2 : FA_2015_NA0016_435_113_20151001_00106.jpg

Perspective view of the abandoned pipe looking upstream. Fall 2015.

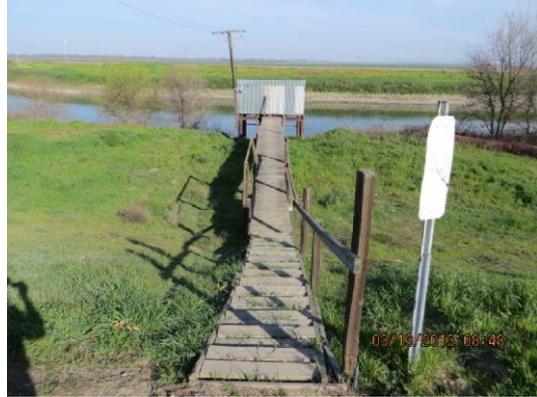
Photo 2 of 3 : UCIP_FA_2015_0420.jpg

Stairs and pump on WS.

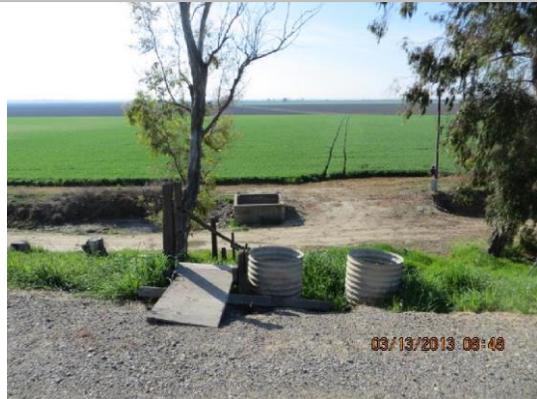
Photo 3 of 3 : UCIP_FA_2015_0421.jpg

LM Start	7.86	Rating **	M	Issue No.	1561 (cont)
LM End	7.86	Issue Type +	En	Location *	LS
Category	Supplemental			GPS Latitude/Longitude	
				Start	End
Item	DWR UCIP Field Study			38.861018 °	38.861018 °
				-121.769651 °	-121.769651 °
DWR ID					
Action/Comments					
Inspector Comments: FS_ID:10144 DS_ID:20428 EP_NO: 18206 FS_HLM: 7.942 Repair Type: Non-Urgent Crossing Status: Found UCIP Comments: Flap gates rusted through at concrete distribution box on LS toe. FIELD_STRUCT_DESC: 1 of 2: 20-inch steel pipe through levee 4.7 feet below crown (Permit No. 18206, 2007). Two slant pumps in pump house on the waterward berm. Siphon breakers in corrugated metal riser units on the shoulder. Flap gate on both pipes in concrete distribution box on the landward side. Wooden steps on both slopes. Replaced 20-inch pipe installed under Permit No. 9377. FS Date: 03/13/2013

Stairs, distribution box, and air vent in CMP riser on LS.

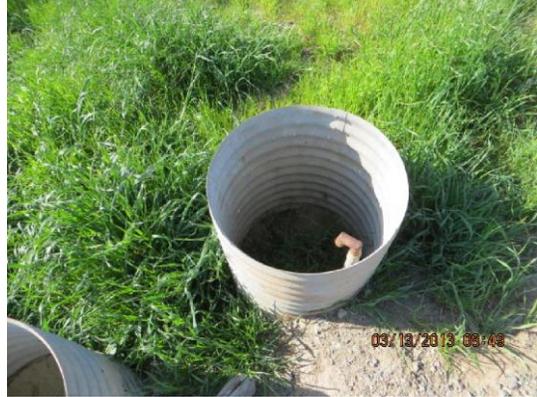
Photo 1 of 3 : UCIP_FA_2015_0416.jpg

LM Start	7.86	Rating **	M	Issue No.	1562
LM End	7.86	Issue Type +	En	Location *	LS
Category	Supplemental			GPS Latitude/Longitude	
				Start	End
Item	DWR UCIP Field Study			38.861017 °	38.861017 °
				-121.769658 °	-121.769658 °
DWR ID					
Action/Comments					
Inspector Comments: FS_ID:10143 DS_ID:20427 EP_NO: 18206 FS_HLM: 7.942 Repair Type: Non-Urgent Crossing Status: Found

Vent in riser on LS shoulder.

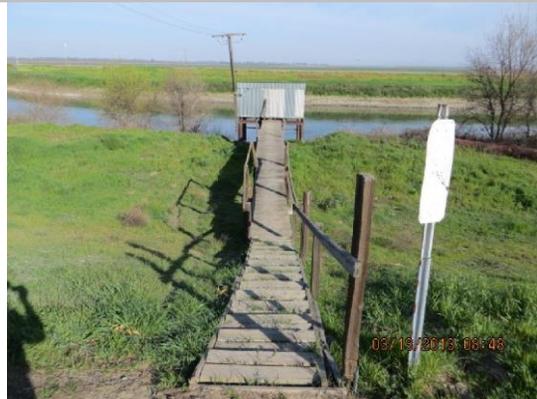
Photo 2 of 3 : UCIP_FA_2015_0417.jpg

Stairs, pump platform on WS.

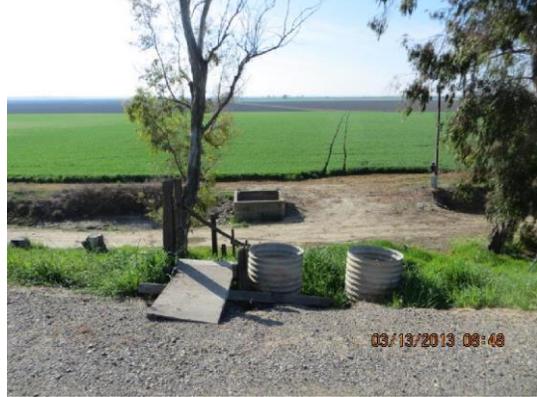
Photo 3 of 3 : UCIP_FA_2015_0418.jpg

LM Start	7.86	Rating **	M	Issue No.	1562 (cont)
LM End	7.86	Issue Type +	En	Location *	LS
Category	Supplemental			GPS Latitude/Longitude	
				Start	End
Item	DWR UCIP Field Study			38.861017 °	38.861017 °
				-121.769658 °	-121.769658 °
DWR ID					
Action/Comments					
Inspector Comments: FS_ID:10143 DS_ID:20427 EP_NO: 18206 FS_HLM: 7.942 Repair Type: Non-Urgent Crossing Status: Found

Steps, air vent in riser, and distribution box on LS.

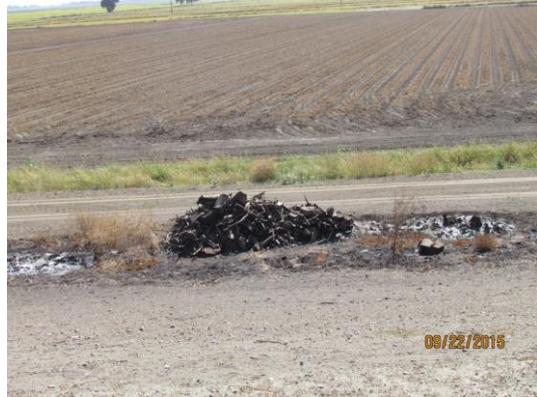
Photo 1 of 1 : FA_2015_NA0016_435_118_20151001_00110.jpg

LM Start	8.45	Rating **	M	Issue No.	118
LM End	8.45	Issue Type +	En	Location *	LS
Category	Earthen Levee			GPS Latitude/Longitude	
				Start	End
Item	Encroachments			38.858559 °	38.858559 °
				-121.779689 °	-121.779689 °
DWR ID	DWR_NA0016_01_f_2015_118				
Action/Comments					
Firewood

View of the wood pile on the landward side of the levee. Fall 2015.

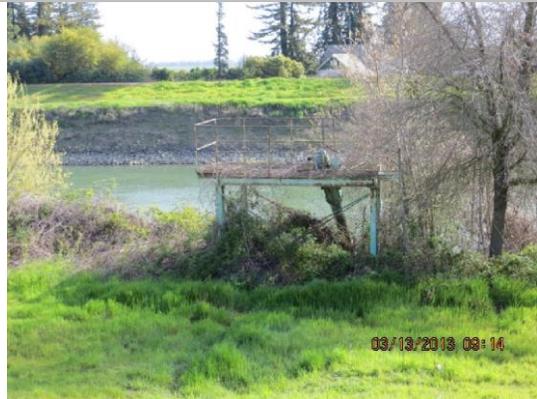
Photo 2 of 3 : UCIP_FA_2015_0498.jpg

Pump platform on WS.

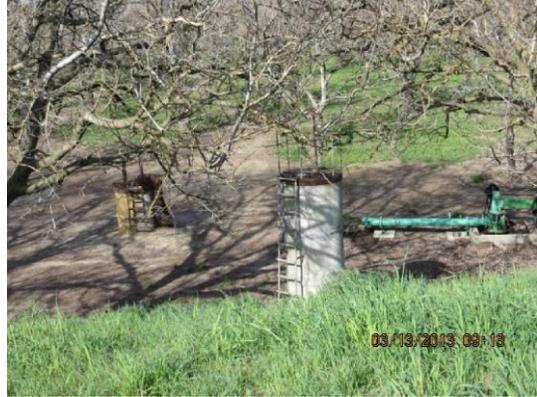
Photo 3 of 3 : UCIP_FA_2015_0499.jpg

LM Start	9.21	Rating **	U	Issue No.	1563 (cont)
LM End	9.21	Issue Type +	En	Location *	LS
Category	Supplemental			GPS Latitude/Longitude	
				Start	End
Item	DWR UCIP Field Study			38.860993 °	38.860993 °
				-121.784840 °	-121.784840 °
DWR ID					
Action/Comments					
Inspector Comments: FS_ID:10150 DS_ID:20231 EP_NO: 1641 FS_HLM: 9.308 Repair Type: Urgent Crossing Status: Found

Concrete riser on LS toe.

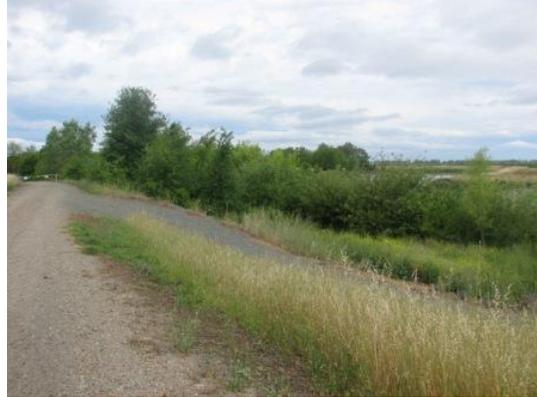
Photo 1 of 2 : FA_2015_NA0016_435_29_20150914_00022.jpg

LM Start	9.68	Rating **	A/W	Issue No.	29
LM End	9.79	Issue Type +	Ma	Location *	WS
Category	Earthen Levee			GPS Latitude/Longitude	
				Start	End
Item	Vegetation			38.862320 °	38.862848 °
				-121.791243 °	-121.793267 °
DWR ID	DWR_NA0016_01_s_2012_29				
Action/Comments					
Environmental Requirements.

The revegetation site along the berm.

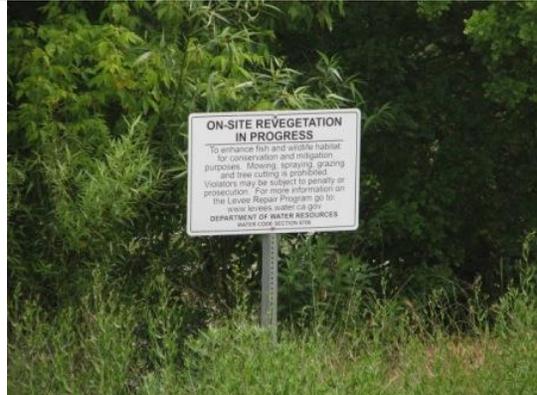
Photo 2 of 2 : FA_2015_NA0016_435_29_20150914_00023.jpg

Revegetation site. Photo taken spring 2012.

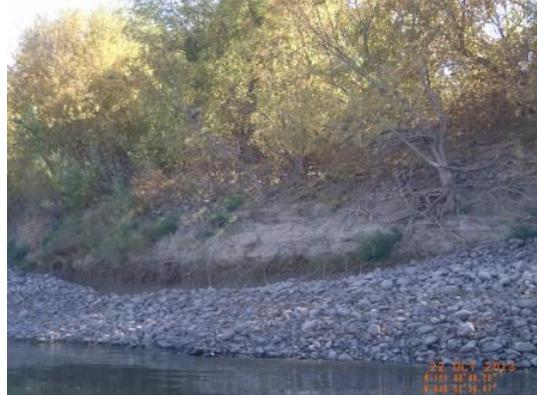
Photo 1 of 1 : USACE2013A_SAC_101-3_R_3.jpg

LM Start	11.50	Rating **	M	Issue No.	7
LM End	11.53	Issue Type +	Ma	Location *	WS
Category	Supplemental			GPS Latitude/Longitude	
				Start	End
Item	2015 USACE Erosion Survey, DRAFT			38.874854 °	38.875109 °
				-121.813018 °	-121.813592 °
DWR ID					
Action/Comments					
Inspector Comments: 1997 - Toe damage and loss of cobble revetment and small patch of local damage to the cobble revetment. 2000 - Cohesive vertical toe; revegetation site. 2015: No observed changes. [2015 Site ID: SAC_101-3_R]

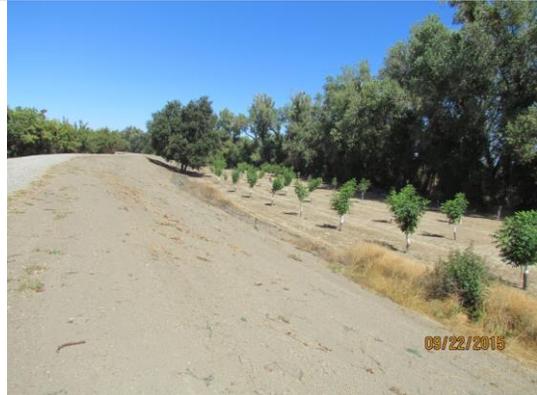
Photo 1 of 1 : FA_2015_NA0016_435_966_20151001_00111.jpg

LM Start	11.71	Rating **	U	Issue No.	966
LM End	11.71	Issue Type +	En	Location *	WS
Category	Earthen Levee			GPS Latitude/Longitude	
				Start	End
Item	Encroachments			38.876807 °	38.876807 °
				-121.816028 °	-121.816028 °
DWR ID	DWR_NA0016_01_s_2012_966				
Action/Comments					
Crops Inspector Comments: New walnut orchard between toe and river with approximately 80-90 trees.

View of the walnut orchard planted on the waterward side of the levee looking upstream. Fall 2015.

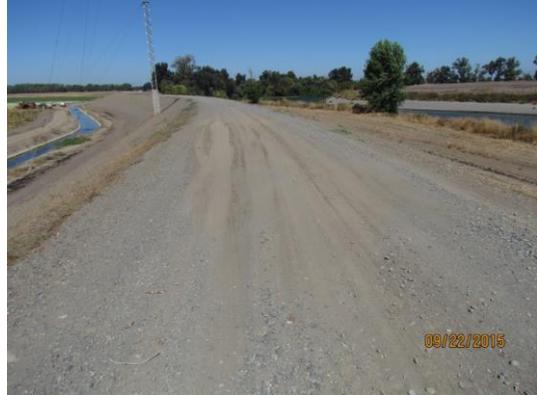
Photo 1 of 1 : FA_2015_NA0016_435_123_20151001_00113.jpg

View of the depression on the crown of the levee looking upstream. Fall 2015.

LM Start	13.53	Rating **	M	Issue No.	123
LM End	13.53	Issue Type +	Ma	Location *	CR
Category	Earthen Levee			GPS Latitude/Longitude	
				Start	End
Item	Crown Surface / Depressions / Rutting			38.898709 °	38.898709 °
				-121.803780 °	-121.803780 °
DWR ID	DWR_NA0016_01_f_2015_123				
Action/Comments					
Add appropriate material and re-grade the levee to bring the crown above the design elevation.

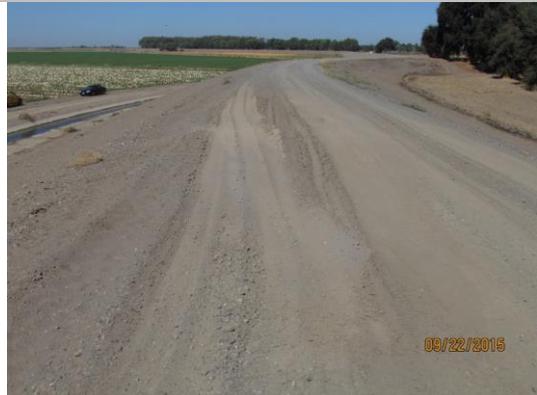
Photo 1 of 1 : FA_2015_NA0016_435_124_20151001_00114.jpg

View of the depression on the crown of the levee looking upstream. Fall 2015.

LM Start	13.64	Rating **	M	Issue No.	124
LM End	13.64	Issue Type +	Ma	Location *	CR
Category	Earthen Levee			GPS Latitude/Longitude	
				Start	End
Item	Crown Surface / Depressions / Rutting			38.900238 °	38.900238 °
				-121.804446 °	-121.804446 °
DWR ID	DWR_NA0016_01_f_2015_124				
Action/Comments					
Add appropriate material and re-grade the levee to bring the crown above the design elevation.

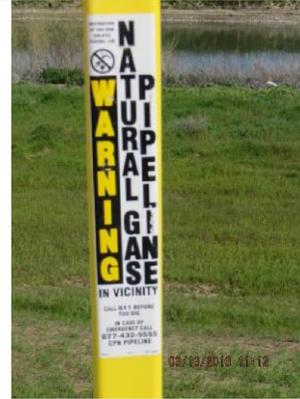
Photo 1 of 2 : UCIP_FA_2015_0452.jpg

LM Start	16.22	Rating **	M	Issue No.	1564
LM End	16.22	Issue Type +	En	Location *	CR
Category	Supplemental			GPS Latitude/Longitude	
				Start	End
Item	DWR UCIP Field Study			38.923407 °	38.923407 °
				-121.834588 °	-121.834588 °
DWR ID					
Action/Comments					
Inspector Comments: FS_ID:10203 DS_ID:20432 EP_NO: N/A FS_HLM: 16.394 Repair Type: Non-Urgent Crossing Status: Found UCIP Comments: Need to determine if this is a permitted crossing as it was not previously noted. Need to determine size and depth below the crown. FIELD_STRUCT_DESC: Gas line through levee at unknown depth below the crown. Marker on WS shoulder. FS Date: 03/13/2013

Gasline marker on WS shoulder.

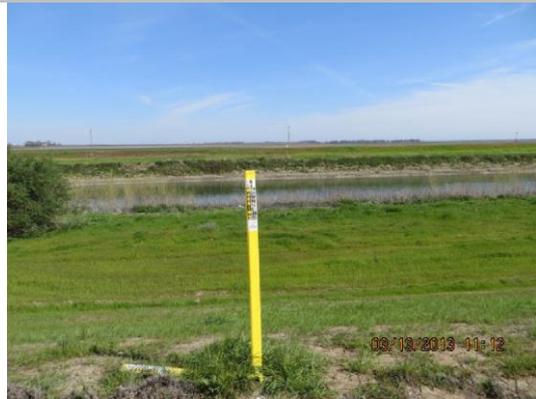
Photo 2 of 2 : UCIP_FA_2015_0453.jpg

Gasline marker on WS shoulder.

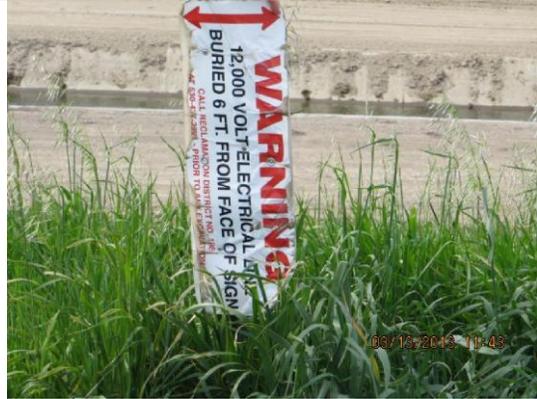
Photo 1 of 1 : UCIP_FA_2015_0220.jpg

LM Start	17.94	Rating **	M	Issue No.	1565
LM End	17.94	Issue Type +	En	Location *	WS
Category	Supplemental			GPS Latitude/Longitude	
				Start	End
Item	DWR UCIP Field Study			38.942979 °	38.942979 °
				-121.837030 °	-121.837030 °
DWR ID					
Action/Comments					
Inspector Comments: FS_ID:11323 DS_ID:22957 EP_NO: 18026 FS_HLM: 18.101 Repair Type: Non-Urgent Crossing Status: Found UCIP Comments: Conduit needs to be located and signs installed where it crosses the levee crown. FIELD_STRUCT_DESC: Electric Conduit through the levee at unknown depth. Signage on LS shoulder. (Permit No. 18026, 2007) FS Date: 03/13/2013

Sign on LS shoulder.

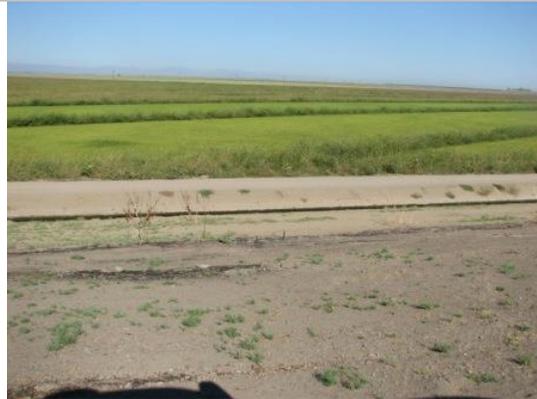
Photo 1 of 1 : FA_2015_NA0016_435_15_20150914_00013.jpg

LM Start	18.21	Rating **	A/W	Issue No.	15
LM End	18.45	Issue Type +	Ma	Location *	LS
Category	Earthen Levee			GPS Latitude/Longitude	
				Start	End
Item	Encroachments			38.946742 °	38.950180 °
				-121.837557 °	-121.837760 °
DWR ID	DWR_NA0016_01_s_2012_15				
Action/Comments					
Ditch Inspector Comments: concrete lined

A concrete lined ditch. Fall 2012

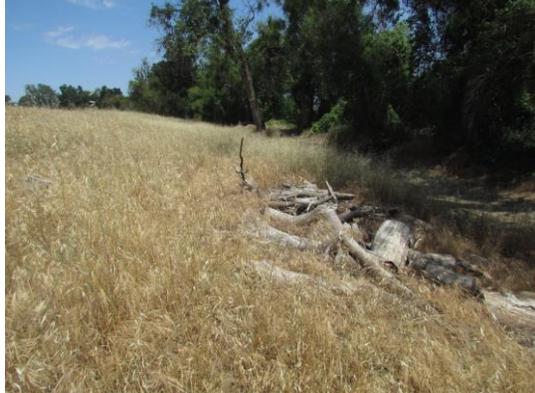
Photo 1 of 1 : FA_2015_NA0016_435_94_20150914_00042.jpg

LM Start	18.25	Rating **	M	Issue No.	94
LM End	18.25	Issue Type +	En	Location *	WS
Category	Earthen Levee		GPS Latitude/Longitude		
			Start	End	
Item	Encroachments		38.947323 °	38.947323 °	
			-121.837406 °	-121.837406 °	
DWR ID	DWR_NA0016_01_s_2015_94				
Action/Comments					
Firewood

View of the firewood on the waterward side of the levee looking upstream. Spring 2015.

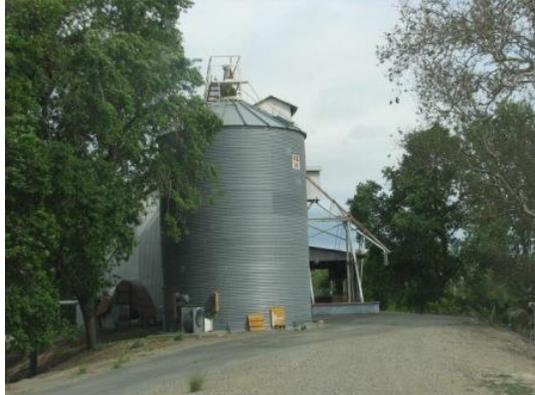
Photo 1 of 1 : FA_2015_NA0016_435_16_20150914_00014.jpg

LM Start	18.54	Rating **	A/W	Issue No.	16
LM End	18.54	Issue Type +	Ma	Location *	CR
Category	Earthen Levee		GPS Latitude/Longitude		
			Start	End	
Item	Encroachments		38.951400 °	38.951400 °	
			-121.838255 °	-121.838255 °	
DWR ID	DWR_NA0016_01_s_2012_16				
Action/Comments					
Building

Another rice mill on the crown. Photo taken spring 2012.

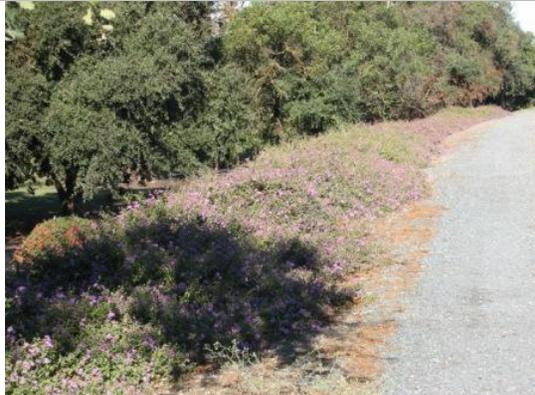
Photo 1 of 1 : FA_2015_NA0016_435_18_20150914_00016.jpg

LM Start	18.68	Rating **	M	Issue No.	18
LM End	18.68	Issue Type +	En	Location *	LS
Category	Earthen Levee		GPS Latitude/Longitude		
			Start	End	
Item	Vegetation		38.952925 °	38.952925 °	
			-121.840010 °	-121.840010 °	
DWR ID	DWR_NA0016_01_s_2012_18				
Action/Comments					
Landscaping

Groundcover and trees with irrigation are planted on the levee slope. Fall 2011.

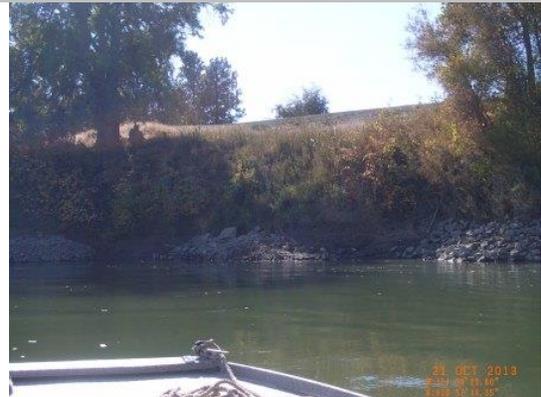
Photo 1 of 1 : USACE2013A_SAC_111-0_R_1.jpg

LM Start	18.76	Rating **	M	Issue No.	10
LM End	18.78	Issue Type +	Ma	Location *	WS
Category	Supplemental		GPS Latitude/Longitude		
			Start	End	
Item	2015 USACE Erosion Survey, DRAFT		38.954060 °	38.954312 °	
			-121.840560 °	-121.840774 °	
DWR ID					
Action/Comments					
Inspector Comments: 2009 - Minor erosion, should be repaired under maintenance. 2011 - Some new minor erosion at the toe. 2015: No observed changes. [2015 Site ID: SAC_111-0_R]

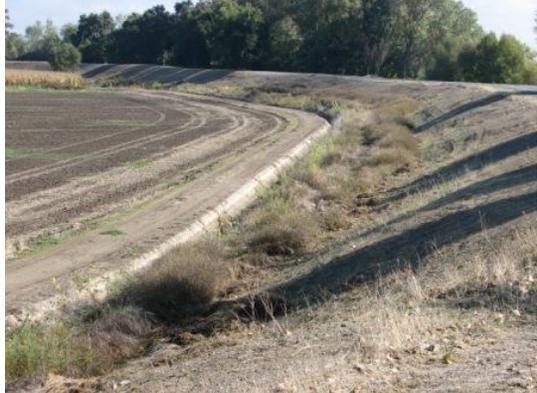
Photo 1 of 1 : FA_2015_NA0016_435_31_20150914_00026.jpg

LM Start	19.14	Rating **	A/W	Issue No.	31
LM End	19.91	Issue Type +	Ma	Location *	LS
Category	Earthen Levee		GPS Latitude/Longitude		
			Start	End	
Item	Encroachments		38.957332 °	38.966719 °	
			-121.837043 °	-121.835880 °	
DWR ID	DWR_NA0016_01_s_2012_31				
Action/Comments					
Ditch

The concrete lined agricultural ditch runs along the toe. Fall 2011.

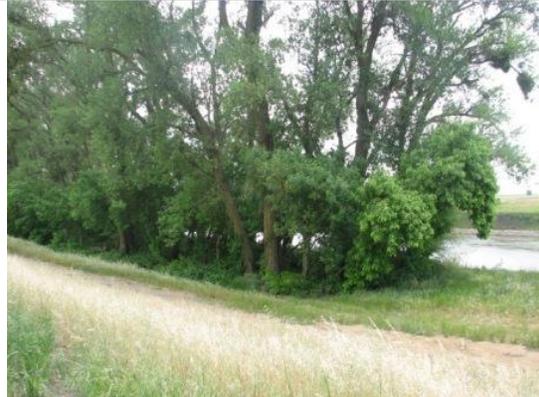
Photo 1 of 2 : FA_2015_NA0016_435_30_20150914_00024.jpg

LM Start	22.11	Rating **	A/W	Issue No.	30
LM End	22.42	Issue Type +	Ma	Location *	WS
Category	Earthen Levee		GPS Latitude/Longitude		
			Start	End	
Item	Vegetation		38.989493 °	38.989712 °	
			-121.816257 °	-121.810410 °	
DWR ID	DWR_NA0016_01_s_2012_30				
Action/Comments					
Environmental Requirements.

The revegetation site on the berm.

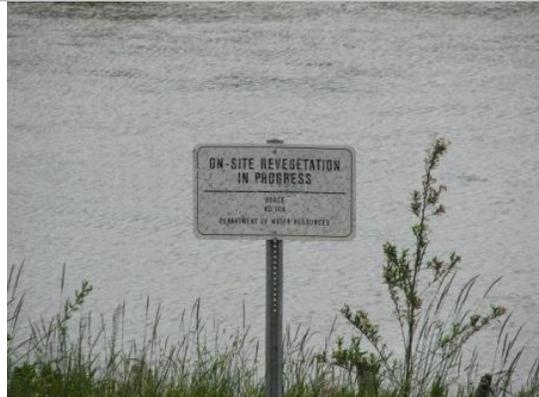
Photo 2 of 2 : FA_2015_NA0016_435_30_20150914_00025.jpg

Revegetation site. Photo taken spring 2012.

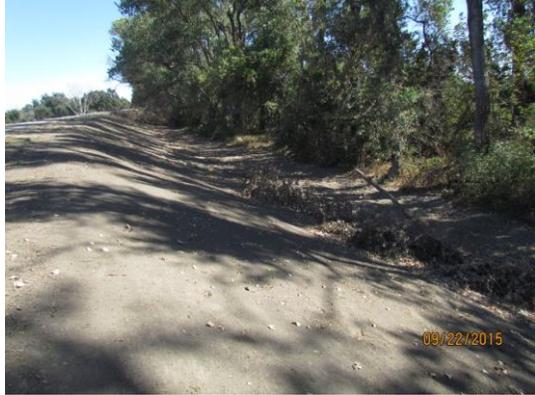
Photo 1 of 1 : FA_2015_NA0016_435_129_20151001_00117.jpg

LM Start	22.55	Rating **	M	Issue No.	129
LM End	22.55	Issue Type +	En	Location *	WS
Category	Earthen Levee		GPS Latitude/Longitude		
			Start	End	
Item	Encroachments		38.990101 °	38.990101 °	
			-121.808116 °	-121.808116 °	
DWR ID	DWR_NA0016_01_f_2015_129				
Action/Comments					
Tree or limb

View of the tree branches on the waterward side of the levee looking upstream. Fall 2015.

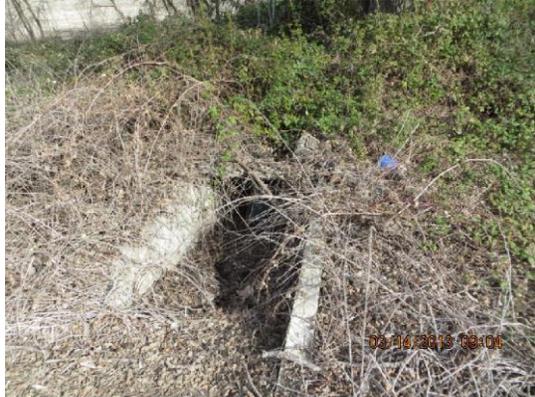
Photo 1 of 2 : UCIP_FA_2015_0262.jpg

LM Start	22.70	Rating **	M	Issue No.	1567
LM End	22.70	Issue Type +	En	Location *	WS
Category	Supplemental		GPS Latitude/Longitude		
			Start	End	
Item	DWR UCIP Field Study		38.989862 °	38.989862 °	
			-121.805243 °	-121.805243 °	
DWR ID					
Action/Comments					
Inspector Comments: FS_ID:10266 DS_ID:20248 EP_NO: N/A FS_HLM: 22.969 Repair Type: Non-Urgent Crossing Status: Found UCIP Comments: Pipe needs to be verified as having been properly abandoned. FIELD_STRUCT_DESC: 24-inch pipe through levee 19.5 feet below crown. Abandoned concrete pumphouse on waterward toe. Originally included in the 1960 O&M manual. FS Date: 03/14/2013

Concrete box on LS toe.

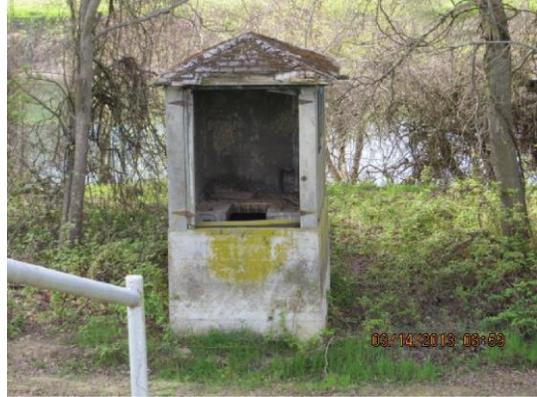
Photo 2 of 2 : UCIP_FA_2015_0263.jpg

LM Start	22.70	Rating **	M	Issue No.	1567 (cont)
LM End	22.70	Issue Type +	En	Location *	WS
Category	Supplemental			GPS Latitude/Longitude	
				Start	End
Item	DWR UCIP Field Study			38.989862 °	38.989862 °
				-121.805243 °	-121.805243 °
DWR ID					
Action/Comments					
Inspector Comments: FS_ID:10266 DS_ID:20248 EP_NO: N/A FS_HLM: 22.969 Repair Type: Non-Urgent Crossing Status: Found UCIP Comments: Pipe needs to be verified as having been properly abandoned. FIELD_STRUCT_DESC: 24-inch pipe through levee 19.5 feet below crown. Abandoned concrete pumphouse on waterward toe. Originally included in the 1960 O&M manual. FS Date: 03/14/2013

Concrete pumphouse on WS berm.

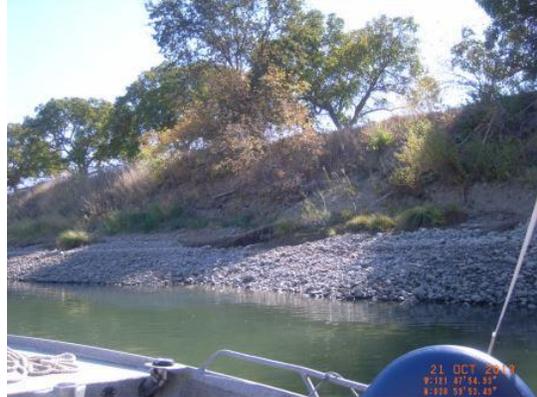
Photo 1 of 1 : USACE2013A_SAC_115-9_R_5.jpg

LM Start	23.55	Rating **	M	Issue No.	11
LM End	23.65	Issue Type +	Ma	Location *	WS
Category	Supplemental		GPS Latitude/Longitude		
			Start	End	
Item	2015 USACE Erosion Survey, DRAFT		38.997696 °	38.998336 °	
			-121.797584 °	-121.799298 °	
DWR ID					
Action/Comments					
Inspector Comments: 2008 - Slippage of cobbles off hard underlying toe material. 2011 - Minor slumping site. 2012 - Failing cobble site, site extended upstream. 2015: No observed changes. [2015 Site ID: SAC_115-9_R]

USACE 2013 Photo #1

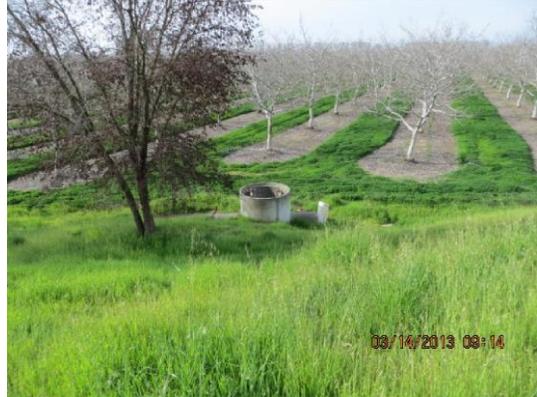
Photo 2 of 3 : UCIP_FA_2015_0258.jpg

Concrete distribution riser on LS toe.

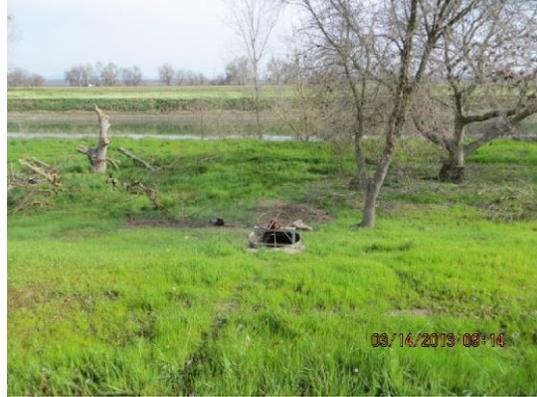
Photo 3 of 3 : UCIP_FA_2015_0259.jpg

LM Start	23.70	Rating **	M	Issue No.	1568 (cont)
LM End	23.70	Issue Type +	En	Location *	WS
Category	Supplemental			GPS Latitude/Longitude	
				Start	End
Item	DWR UCIP Field Study			38.998247 °	38.998247 °
				-121.800236 °	-121.800236 °
DWR ID					
Action/Comments					
Inspector Comments: FS_ID:10261 DS_ID:20249 EP_NO: 9374 FS_HLM: 23.976 Repair Type: Non-Urgent Crossing Status: Found

36-inch cmp riser on WS slope with slide gate.

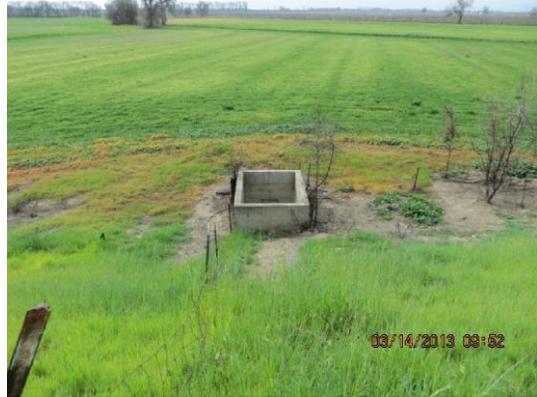
Photo 1 of 2 : UCIP_FA_2015_0260.jpg

LM Start	24.73	Rating **	M	Issue No.	1569
LM End	24.73	Issue Type +	En	Location *	WS
Category	Supplemental			GPS Latitude/Longitude	
				Start	End
Item	DWR UCIP Field Study			39.005097 °	39.005097 °
				-121.816116 °	-121.816116 °
DWR ID					
Action/Comments					
Inspector Comments: FS_ID:10265 DS_ID:20251 EP_NO: 9328 FS_HLM: 25.018 Repair Type: Non-Urgent Crossing Status: Found UCIP Comments: Appears abandoned. Needs to be abandoned properly. FIELD_STRUCT_DESC: 24-inch corrugated metal pipe through levee 20.0 feet below crown. Slide gate in 36-inch corrugated metal riser unit on the waterward slope. 7'X9' Distribution box at toe of the landward slope (ABO. No. 9328, 1960) FS Date: 03/14/2013

7-foot by 9-foot distribution box at LS toe.

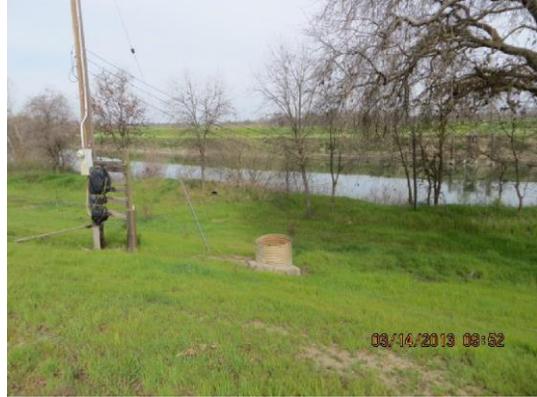
Photo 2 of 2 : UCIP_FA_2015_0261.jpg

LM Start	24.73	Rating **	M	Issue No.	1569 (cont)
LM End	24.73	Issue Type +	En	Location *	WS
Category	Supplemental			GPS Latitude/Longitude	
				Start	End
Item	DWR UCIP Field Study			39.005097 °	39.005097 °
				-121.816116 °	-121.816116 °
DWR ID					
Action/Comments					
Inspector Comments: FS_ID:10265 DS_ID:20251 EP_NO: 9328 FS_HLM: 25.018 Repair Type: Non-Urgent Crossing Status: Found UCIP Comments: Appears abandoned. Needs to be abandoned properly. FIELD_STRUCT_DESC: 24-inch corrugated metal pipe through levee 20.0 feet below crown. Slide gate in 36-inch corrugated metal riser unit on the waterward slope. 7'X9' Distribution box at toe of the landward slope (ABO. No. 9328, 1960) FS Date: 03/14/2013

Slide gate in 36-inch CMP riser on WS slope.

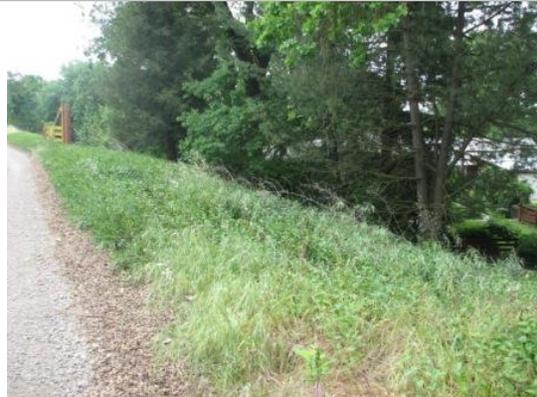
Photo 1 of 1 : FA_2015_NA0016_435_34_20150914_00029.jpg

LM Start	24.84	Rating **	M	Issue No.	34
LM End	24.84	Issue Type +	En	Location *	LS
Category	Earthen Levee			GPS Latitude/Longitude	
				Start	End
Item	Vegetation			39.005240 °	39.005240 °
				-121.818123 °	-121.818123 °
DWR ID	DWR_NA0016_01_s_2012_34				
Action/Comments					
Landscaping

The tall grasses blend with the groundcover on the leve slope. Photo taken spring 2012.

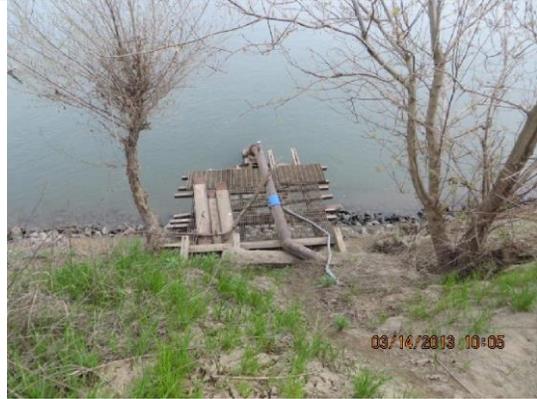
Photo 1 of 3 : UCIP_FA_2015_0264.jpg

Action/Comments
 Inspector Comments: FS_ID:42860
 DS_ID:20339
 EP_NO: 9330
 FS_HLM: 25.312
 Repair Type: Urgent
 Crossing Status: Found
 UCIP Comments: Possible sink hole over pipe alignment on WS berm at rivers edge. general condition of pipe and appurtances in disrepair.
 FIELD_STRUCT_DESC: 10-inch pipe through levee 12.3 feet below crown. 6-inch pipe discharges into 10-inch pipe on waterward end, portable pump and gate valve on waterward side. Power pole and anchor on waterward shoulder and toe (ABO No. 9330, 1960). Originally included in the 1960 O&M manual.
 FS Date: 03/14/2013

Pump platform on WS slope..

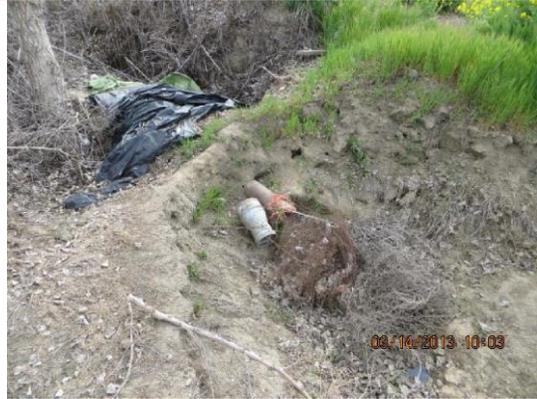
Photo 2 of 3 : UCIP_FA_2015_0265.jpg

6-inch pipe at LS toe.

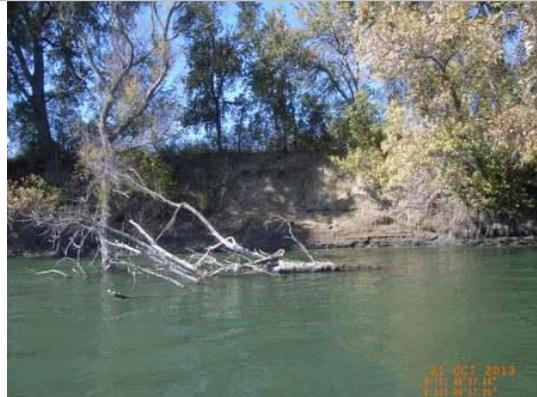
Photo 1 of 1 : USACE2013A_SAC_118-0_R_2.jpg

LM Start	25.75	Rating **	M	Issue No.	12
LM End	25.91	Issue Type +	Ma	Location *	WS
Category	Supplemental			GPS Latitude/Longitude	
				Start	End
Item	2015 USACE Erosion Survey, DRAFT			39.014499 °	39.016401 °
				-121.825880 °	-121.824230 °
DWR ID					
Action/Comments					
Inspector Comments: 2008 - Whole bank is eroding, nearly vertical slope with cohesive toe. Bed is very deep along the toe (greater than 30 ft deep at 20 ft from the shore). 2011 - Some new minor erosion. 2015: No observed changes. [2015 Site ID: SAC_118-0_R]

USACE 2013 Photo #1

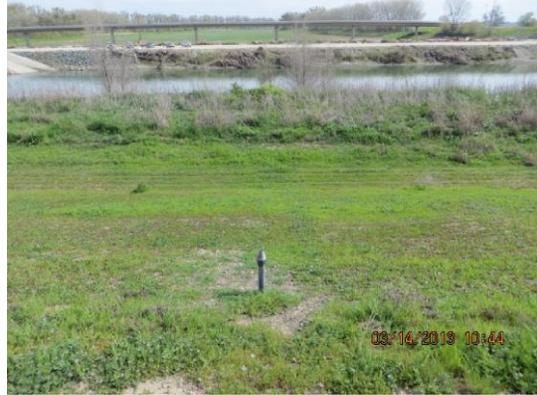
Photo 1 of 2 : UCIP_FA_2015_0340.jpg

LM Start	26.46	Rating **	M	Issue No.	1571
LM End	26.46	Issue Type +	En	Location *	WS
Category	Supplemental			GPS Latitude/Longitude	
				Start	End
Item	DWR UCIP Field Study			39.023842 °	39.023842 °
				-121.823077 °	-121.823077 °
DWR ID					
Action/Comments					
Inspector Comments: FS_ID:10285 DS_ID:20253 EP_NO: 9136 FS_HLM: 26.771 Repair Type: Non-Urgent Crossing Status: Found UCIP Comments: Pipe appears to be abandoned. Pipe needs to be abandoned properly. FIELD_STRUCT_DESC: 18-inch steel pipe through levee 3.0 feet below crown. Steel cutoff wall at centerline. Air release valve on the waterward shoulder (Permit No. 9136, 1974). Slide gate in 72-inch diameter CMP riser on LS toe. FS Date: 03/14/2013

Air release valve on WS shoulder.

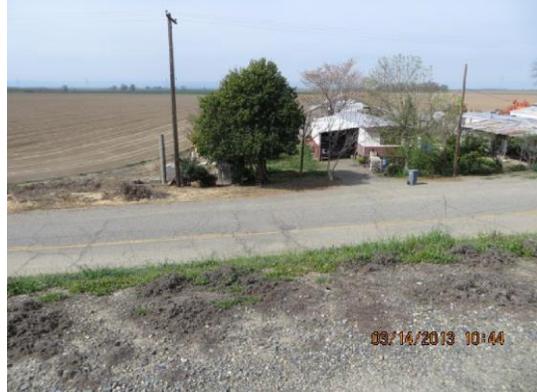
Photo 2 of 2 : UCIP_FA_2015_0341.jpg

72-inch CMP riser on LS toe under JP next to tree.

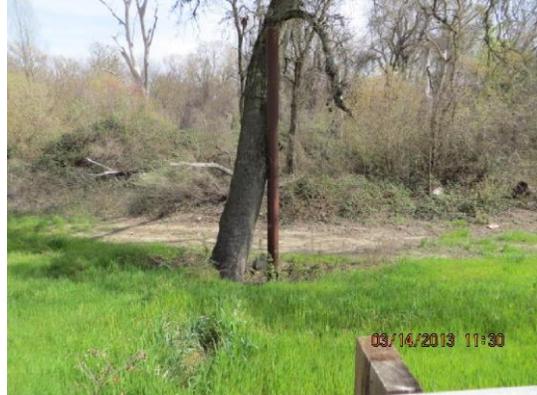
Photo 1 of 2 : UCIP_FA_2015_0361.jpg

LM Start	27.46	Rating **	M	Issue No.	1572
LM End	27.46	Issue Type +	En	Location *	WS
Category	Supplemental			GPS Latitude/Longitude	
				Start	End
Item	DWR UCIP Field Study			39.033767 °	39.033767 °
				-121.833110 °	-121.833110 °
DWR ID					
Action/Comments					
Inspector Comments: FS_ID:10289 DS_ID:20256 EP_NO: 9368 FS_HLM: 27.784 Repair Type: Non-Urgent Crossing Status: Found

steel standpipe on WS toe.

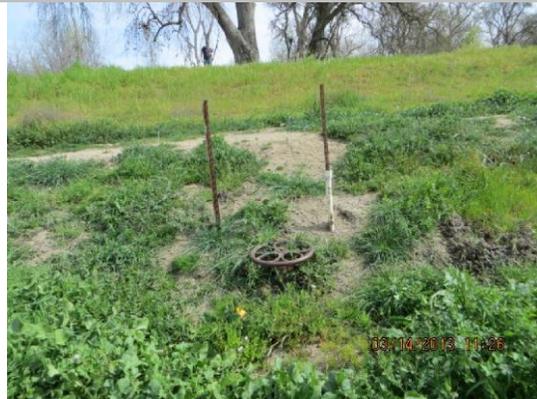
Photo 2 of 2 : UCIP_FA_2015_0362.jpg

gate valve off landside toe.

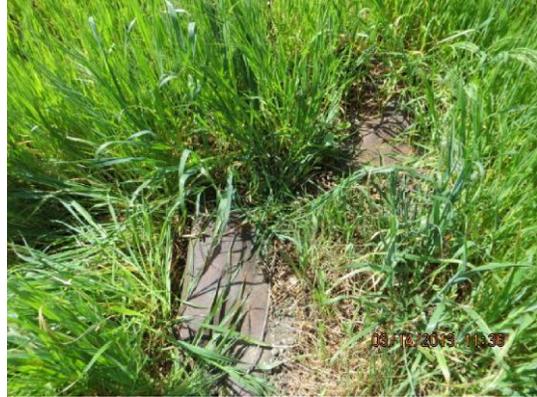
Photo 1 of 2 : UCIP_FA_2015_0363.jpg

LM Start	27.46	Rating **	M	Issue No.	1573
LM End	27.46	Issue Type +	En	Location *	WS
Category	Supplemental			GPS Latitude/Longitude	
				Start	End
Item	DWR UCIP Field Study			39.033814 °	39.033814 °
				-121.833158 °	-121.833158 °
DWR ID					
Action/Comments					
Inspector Comments: FS_ID:10290 DS_ID:20416 EP_NO: N/A FS_HLM: 27.789 Repair Type: Non-Urgent Crossing Status: Indicator Found

Pipe debris on WS slope.

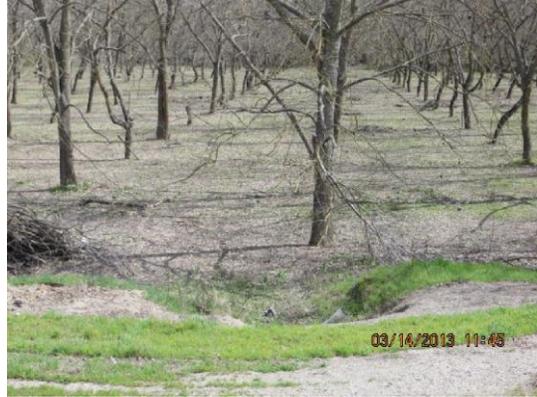
Photo 1 of 3 : UCIP_FA_2015_0365.jpg

LM Start	27.54	Rating **	M	Issue No.	1574
LM End	27.54	Issue Type +	En	Location *	WS
Category	Supplemental			GPS Latitude/Longitude	
				Start	End
Item	DWR UCIP Field Study			39.034870 °	39.034870 °
				-121.833501 °	-121.833501 °
DWR ID					
Action/Comments					
Inspector Comments: FS_ID:10291 DS_ID:20257 EP_NO: 9355 FS_HLM: 27.865 Repair Type: Non-Urgent Crossing Status: Found

Excavation at WS toe where pipe should be.

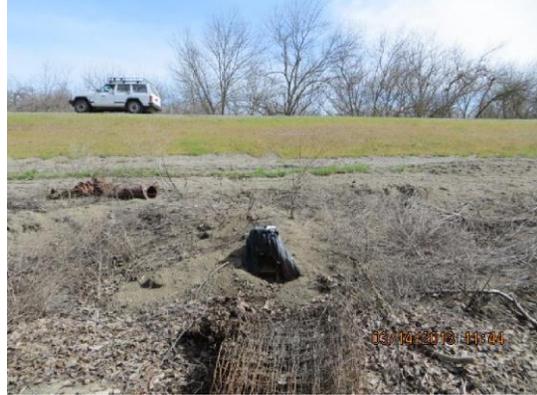
Photo 3 of 3 : UCIP_FA_2015_0367.jpg

LM Start	27.54	Rating **	M	Issue No.	1574 (cont)
LM End	27.54	Issue Type +	En	Location *	WS
Category	Supplemental			GPS Latitude/Longitude	
				Start	End
Item	DWR UCIP Field Study			39.034870 °	39.034870 °
				-121.833501 °	-121.833501 °
DWR ID					
Action/Comments					
Inspector Comments: FS_ID:10291 DS_ID:20257 EP_NO: 9355 FS_HLM: 27.865 Repair Type: Non-Urgent Crossing Status: Found

Gate valve buried on LS toe.
