**Flood Control Project Maintenance
Levee Inspections**

Fall 2015 Levee Maintenance Deficiency Summary Report

Sacramento River Basin

Sacramento River West Side Levee District

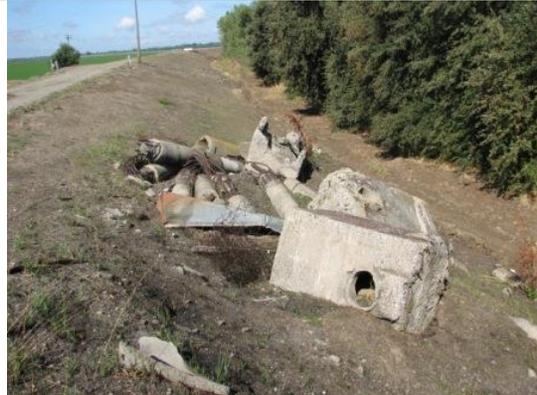
Photo 1 of 2 : FA_2015_NA0016_435_59_20150914_00032.jpg

LM Start	28.02	Rating **	M	Issue No.	59
LM End	28.02	Issue Type +	En	Location *	WS
Category	Earthen Levee			GPS Latitude/Longitude	
				Start	End
Item	Encroachments			39.040750 °	39.040750 °
				-121.835299 °	-121.835299 °
DWR ID	DWR_NA0016_01_s_2012_59				
Action/Comments					
Debris Inspector Comments: piles of concrete

Concrete debris is on the waterside levee slope. Fall 2011.

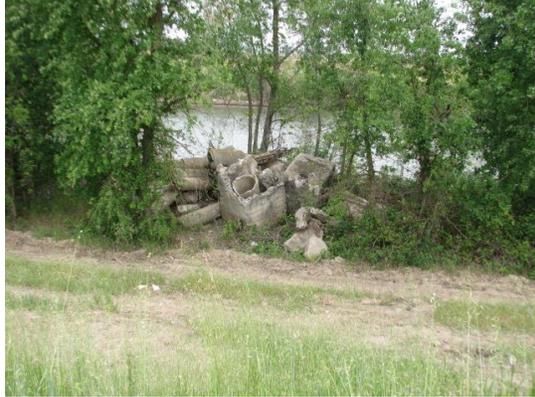
Photo 2 of 2 : FA_2015_NA0016_435_59_20150914_00033.jpg

LM Start	28.02	Rating **	M	Issue No.	59 (cont)
LM End	28.02	Issue Type +	En	Location *	WS
Category	Earthen Levee			GPS Latitude/Longitude	
				Start	End
Item	Encroachments			39.040750 °	39.040750 °
				-121.835299 °	-121.835299 °
DWR ID	DWR_NA0016_01_s_2012_59				
Action/Comments					
Debris Inspector Comments: piles of concrete

Concrete debris that was on the levee slope is now on the berm area. Spring 2014

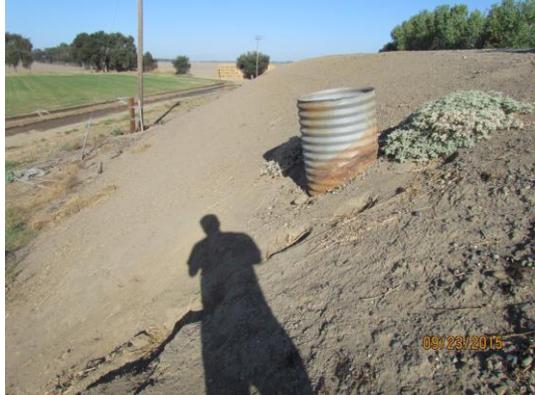
Photo 1 of 1 : FA_2015_NA0016_435_132_20151001_00118.jpg

View of the slope stability damaged by foot traffic on the landward side of the levee looking upstream. Fall 2015.

LM Start	28.05	Rating **	M	Issue No.	132
LM End	28.05	Issue Type +	Ma	Location *	LS
Category	Earthen Levee			GPS Latitude/Longitude	
				Start	End
Item	Slope Stability			39.041013 °	39.041013 °
				-121.835747 °	-121.835747 °
DWR ID	DWR_NA0016_01_f_2015_132				
Action/Comments					
Repair the levee slope damaged by foot traffic and prevent access where possible.

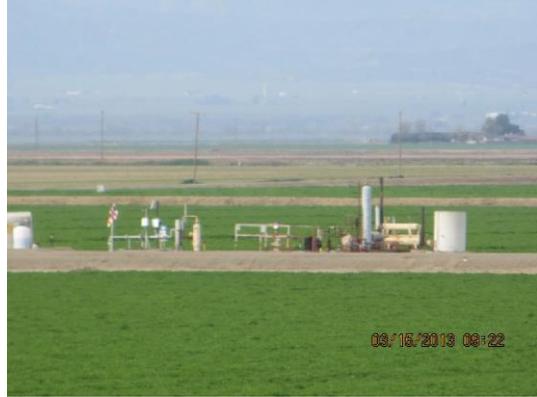
Photo 1 of 1 : UCIP_FA_2015_0383.jpg

LM Start	28.61	Rating **	U	Issue No.	1575
LM End	28.61	Issue Type +	En	Location *	LS
Category	Supplemental			GPS Latitude/Longitude	
				Start	End
Item	DWR UCIP Field Study			39.047758 °	39.047758 °
				-121.840914 °	-121.840914 °
DWR ID					
Action/Comments					
Inspector Comments: FS_ID:41839 DS_ID:20319 EP_NO: 16632 FS_HLM: 28.95 Repair Type: Urgent Crossing Status: Indicator Found UCIP Comments: No gasoline markers on either side of levee. FIELD_STRUCT_DESC: 4-inch natural gas pipeline through levee 62.0 feet below crown. Crosses channel (Permit No. 16632, 1999). Gas well visible 1500-feet west of levee. FS Date: 03/15/2013

gas well 1500-feet west of this location.

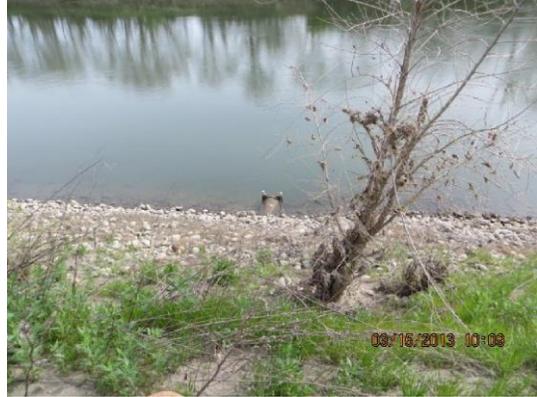
Photo 2 of 3 : UCIP_FA_2015_0385.jpg

Action/Comments
 Inspector Comments: FS_ID:10324
 DS_ID:20311
 EP_NO: 12609
 FS_HLM: 29.123
 Repair Type: Urgent
 Crossing Status: Found
 UCIP Comments: Flap gate missing from waterward end of pipe.
 FIELD_STRUCT_DESC: 24-inch steel outfall pipe through levee 4.1 feet below crown. Siphon breaker in 18-inch concrete riser on WS shoulder. Flap gate on discharge end of pipe 130 feet waterward of the centerline of the levee at elevation 41.5 feet, USED Datum, and the riverbank has rock protection at this location (Permit No. 12609, 1979).
 FS Date: 03/15/2013

Pipe and flap gate at rivers edge

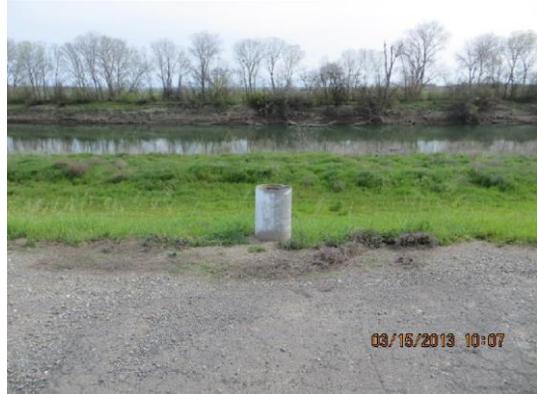
Photo 3 of 3 : UCIP_FA_2015_0386.jpg

18-inch concrete riser on WS shoulder.

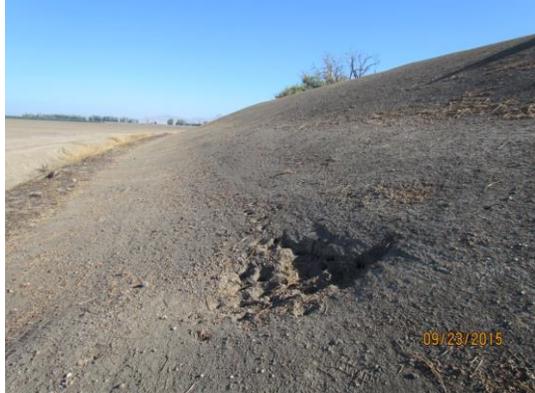
Photo 1 of 1 : FA_2015_NA0016_435_133_20151001_00119.jpg

View of the depression caused by animal activity on the landward side of the levee looking upstream. Fall 2015.

LM Start	28.87	Rating **	M	Issue No.	133
LM End	28.87	Issue Type +	Ma	Location *	LS
Category	Earthen Levee		GPS Latitude/Longitude		
			Start	End	
Item	Animal Control		39.051571 °	39.051571 °	
			-121.841871 °	-121.841871 °	
DWR ID	DWR_NA0016_01_f_2015_133				
Action/Comments					
Repair the levee slope damaged by livestock and prevent large animal access.

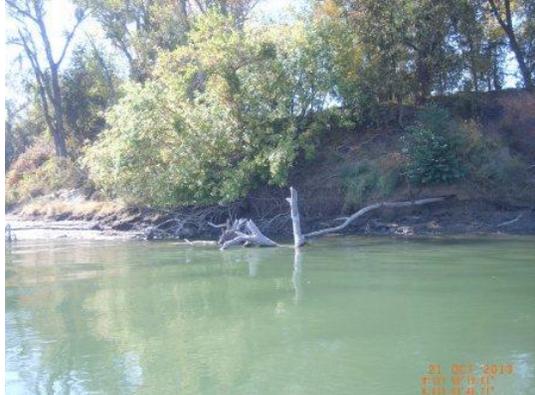
Photo 1 of 1 : USACE2013A_SAC_122-0_R_5.jpg

LM Start	29.69	Rating **	M	Issue No.	2
LM End	29.73	Issue Type +	Ma	Location *	WS
Category	Supplemental		GPS Latitude/Longitude		
			Start	End	
Item	2015 USACE Erosion Survey, DRAFT		39.063209 °	39.063997 °	
			-121.838927 °	-121.839335 °	
DWR ID					
Action/Comments					
Inspector Comments: 1997 - Mass failure of the lower cohesive bank and toe. 2000 - Still eroding, steeply dipping foresets in the toe are falling off. 2010 - Some new erosion and some new deposition. Eddy current off the upstream rock. 2011 - Still plenty of berm left. 2015: No observed changes. [2015 Site ID: SAC_122-0_R]

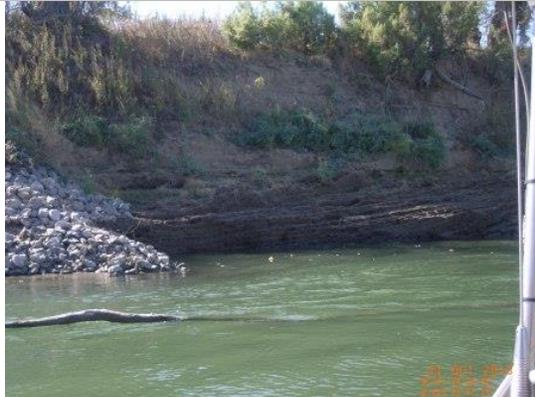
Photo 1 of 1 : USACE2013A_SAC_122-3_R_6.jpg

LM Start	29.96	Rating **	M	Issue No.	13
LM End	30.00	Issue Type +	Ma	Location *	WS
Category	Supplemental		GPS Latitude/Longitude		
			Start	End	
Item	2015 USACE Erosion Survey, DRAFT		39.065886 °	39.066287 °	
			-121.842950 °	-121.843602 °	
DWR ID					
Action/Comments					
Inspector Comments: 2002 - Upstream end has recent slope failure and exposure of tree roots. 2003 - Some new minor slope erosion with new snags on the bank. 2004 - Appears a little worse. 2005 - Scallop in bank at the upstream end looks worse. 2009 - Minimal new erosion, Berm width is still large, but one large event or one fallen tree and it could go fast. 2010 - New erosion, bank is nearly all vertical from slumping. Site looks bad. 2011 - Site continues to look bad. 2012 - Minor new erosion. 2015: Undermining of toe rock. [2015 Site ID: SAC_122-3_R]

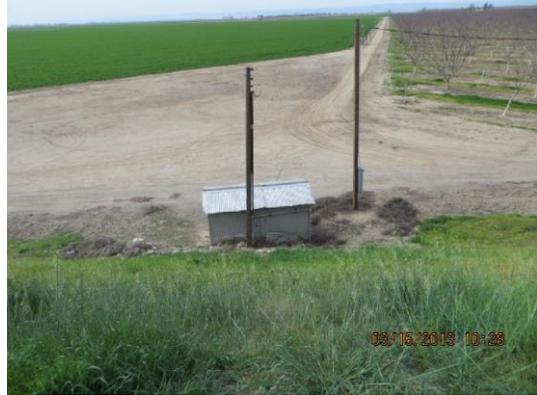
Photo 1 of 3 : UCIP_FA_2015_0387.jpg

Pumphouse at LS toe.

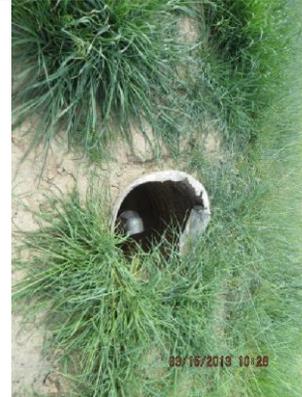
Photo 2 of 3 : UCIP_FA_2015_0388.jpg

Siphon breaker in 24-inch cmp on LS shoulder.

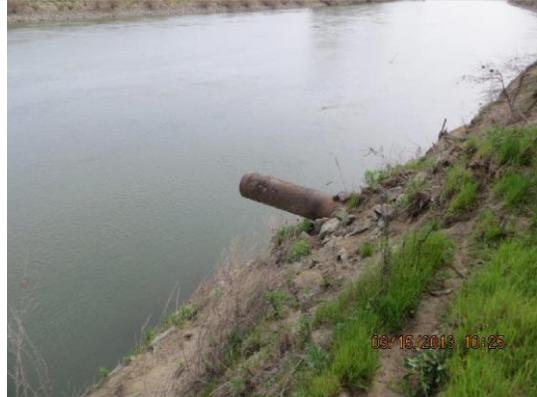
Photo 3 of 3 : UCIP_FA_2015_0389.jpg

24-inch pipe at rivers edge

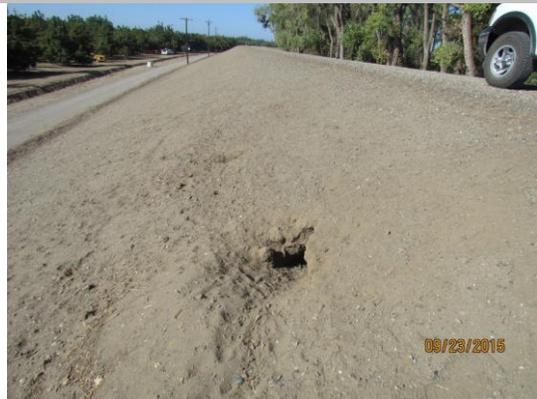
Photo 1 of 1 : FA_2015_NA0016_435_135_20151001_00120.jpg

View of the rodent hole on the landward side of the levee looking upstream. Fall 2015.

LM Start	30.86	Rating **	M	Issue No.	135
LM End	30.86	Issue Type +	Ma	Location *	LS
Category	Earthen Levee			GPS Latitude/Longitude	
				Start	End
Item	Animal Control			39.068482 °	39.068482 °
				-121.856639 °	-121.856639 °
DWR ID	DWR_NA0016_01_f_2015_135				
Action/Comments					
No rodents visible, but rodent burrows visible; need to backfill and compact or grout burrows.

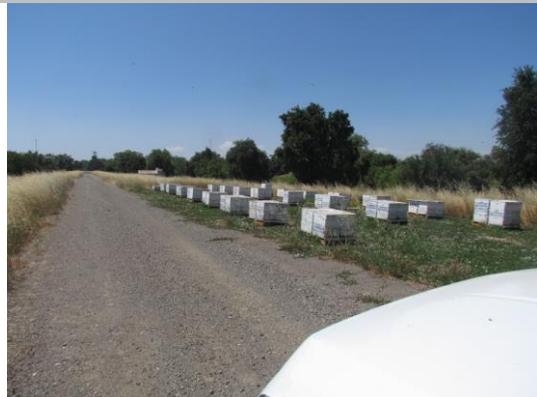
Photo 1 of 1 : FA_2015_NA0016_435_99_20150914_00046.jpg

LM Start	31.28	Rating **	M	Issue No.	99
LM End	31.28	Issue Type +	En	Location *	WS
Category	Earthen Levee			GPS Latitude/Longitude	
				Start	End
Item	Encroachments			39.066921 °	39.066921 °
				-121.864077 °	-121.864077 °
DWR ID	DWR_NA0016_01_s_2015_99				
Action/Comments					
Building

View of the beehives on the shoulder of the waterward side of the levee looking upstream. Spring 2015.

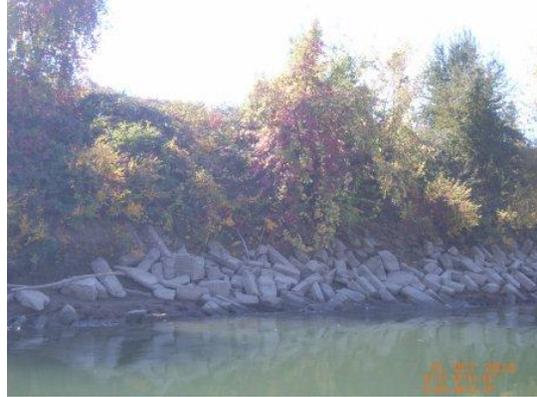
Photo 1 of 1 : USACE2013A_SAC_123-7_R_3.jpg

LM Start	31.43	Rating **	M	Issue No.	17
LM End	31.45	Issue Type +	Ma	Location *	WS
Category	Supplemental			GPS Latitude/Longitude	
				Start	End
Item	2015 USACE Erosion Survey, DRAFT			39.067004 °	39.066901 °
				-121.866913 °	-121.867322 °
DWR ID					
Action/Comments					
Inspector Comments: 1997 - Erosion into the levee section; old concrete rubble loss at toe; transition between the rock upstream and the cobble downstream. 2000 - Cohesive bench with concrete slabs on top; 25 ft deep scour hole on the downstream end. 2015: No observed changes. [2015 Site ID: SAC_123-7_R]

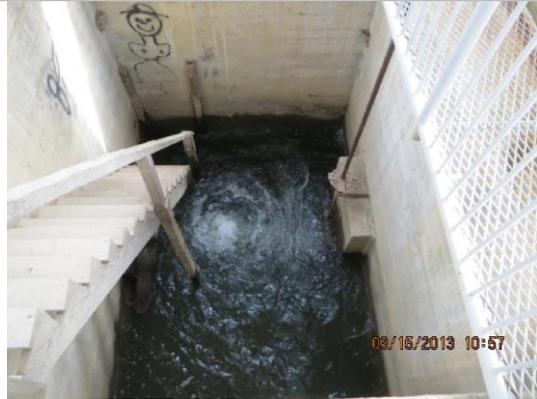
Photo 1 of 3 : UCIP_FA_2015_0192.jpg

Slide gate inside concrete block house.

Item	DWR UCIP Field Study			39.066163 °	39.066163 °	
				-121.870198 °	-121.870198 °	
DWR ID						
Action/Comments						
Inspector Comments: FS_ID:11543 DS_ID:20262 EP_NO: 9338 FS_HLM: 31.999 Repair Type: Non-Urgent Crossing Status: Found UCIP Comments: Pipe leaking at intake pipe on rivers edge below pump FIELD_STRUCT_DESC: 24-inch steel pipe through levee 24.0 feet below crown (ABO No. 9338, 1960). Slide gate in abandoned concrete pump house on the waterward slope. Three slant pumps mounted on pile structure on the waterward bank. 30-inch concrete pipe under the highway on the landside. 48-inch steel riser on the landside of highway. Overhead high tower power line crosses the levee. Power line has been run underground to service box on waterward shoulder at L.M. 32.01. Ramps on both slopes. Originally included in the 1960 O&M manual. FS Date: 03/15/2013

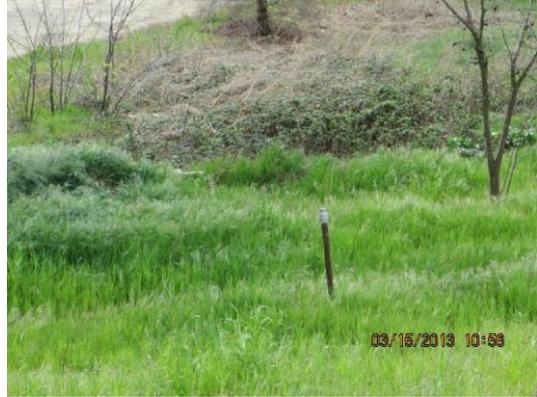
Photo 2 of 3 : UCIP_FA_2015_0193.jpg

Siphon breaker on LS toe.

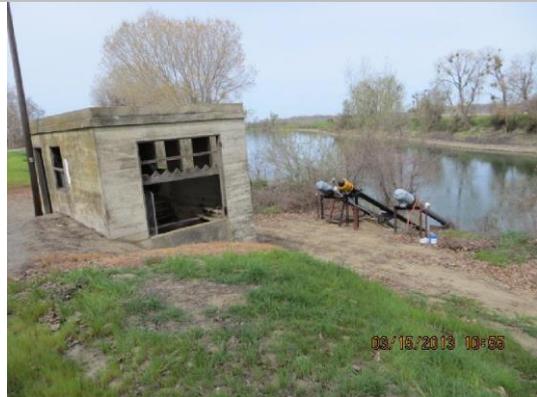
Photo 3 of 3 : UCIP_FA_2015_0194.jpg

Concrete block houe with slide gate inside.

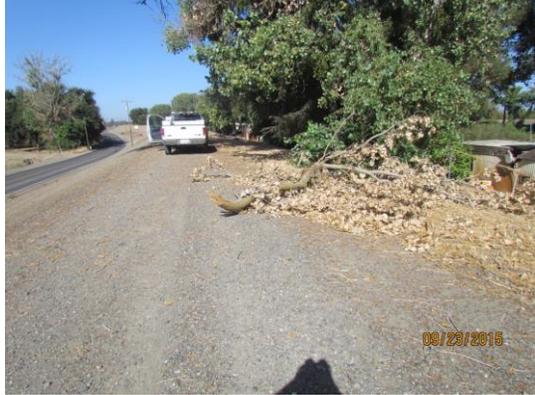
Photo 1 of 1 : FA_2015_NA0016_435_136_20151001_00121.jpg

LM Start	32.07	Rating **	M	Issue No.	136
LM End	32.07	Issue Type +	Ma	Location *	CR
Category	Earthen Levee			GPS Latitude/Longitude	
				Start	End
Item	Encroachments			39.069416 °	39.069416 °
				-121.877380 °	-121.877380 °
DWR ID	DWR_NA0016_01_f_2015_136				
Action/Comments					
Tree or limb

View of a fallen tree branch on the crown of the levee looking upstream. Fall 2015.

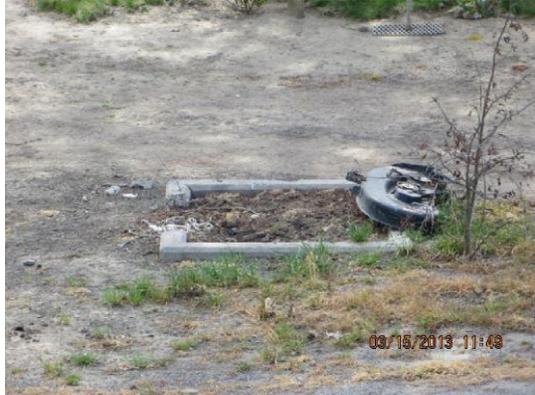
Photo 1 of 2 : UCIP_FA_2015_0176.jpg

4X4 concrete box off LS toe.

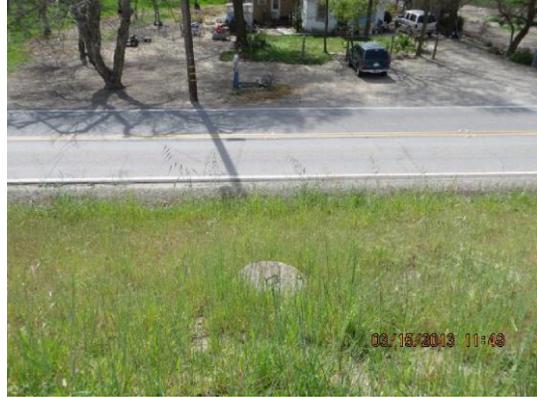
Photo 2 of 2 : UCIP_FA_2015_0177.jpg

Siphon Breaker in 25-inch CMP riser on LS slope with 4X4 concrete box off LS toe.

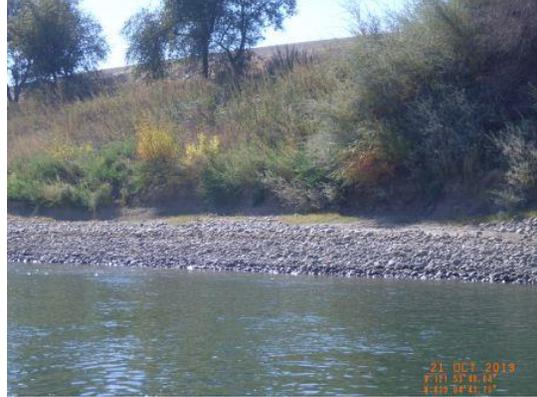
Photo 1 of 1 : USACE2013A_SAC_125-6_R_5.jpg

LM Start	33.29	Rating **	M	Issue No.	5
LM End	33.37	Issue Type +	Ma	Location *	WS
Category	Supplemental			GPS Latitude/Longitude	
				Start	End
Item	2015 USACE Erosion Survey, DRAFT			39.078340 °	39.079351 °
				-121.894656 °	-121.895317 °
DWR ID					
Action/Comments					
Inspector Comments: 2008 - Slow erosion of the hard toe. 2010 - Cobble rubble is failing, erosion is into the toe of the levee, with vertical slumping. 2012 - Site appears to be relatively stable. 2013 - New animal holes. 2015: No observed changes. [2015 Site ID: SAC_125-6_R]

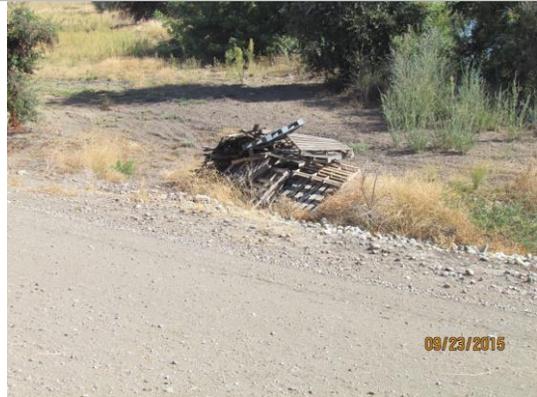
Photo 1 of 2 : FA_2015_NA0016_435_137_20151001_00124.jpg

LM Start	33.37	Rating **	M	Issue No.	137
LM End	33.37	Issue Type +	En	Location *	WS
Category	Earthen Levee			GPS Latitude/Longitude	
				Start	End
Item	Encroachments			39.079366 °	39.079366 °
				-121.895677 °	-121.895677 °
DWR ID	DWR_NA0016_01_f_2015_137				
Action/Comments					
Debris

View of debris on the waterward side of the levee. Fall 2015.

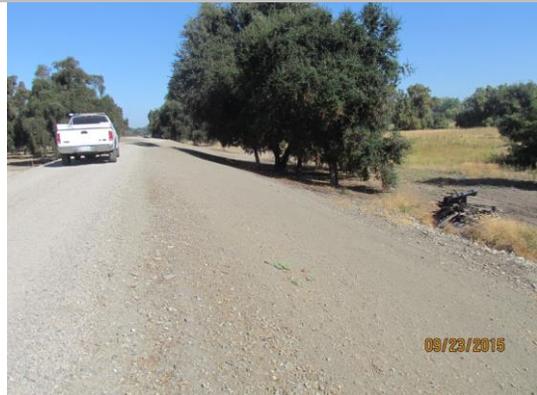
Photo 2 of 2 : FA_2015_NA0016_435_137_20151001_00122.jpg

Perspective view of the debris on the waterward side of the levee looking upstream. Fall 2015.

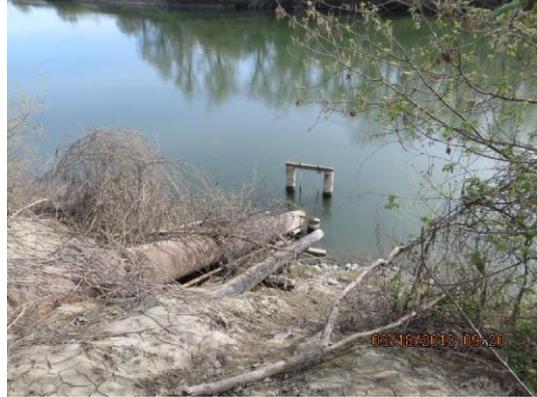
Photo 1 of 3 : UCIP_FA_2015_0184.jpg

Pipe at waters edge.

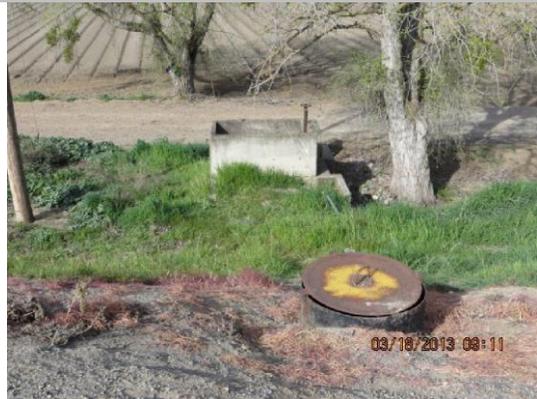
Photo 2 of 3 : UCIP_FA_2015_0185.jpg

siphon breaker in 36-inch steel riser on LS slope with concrete distribution box on LS toe.

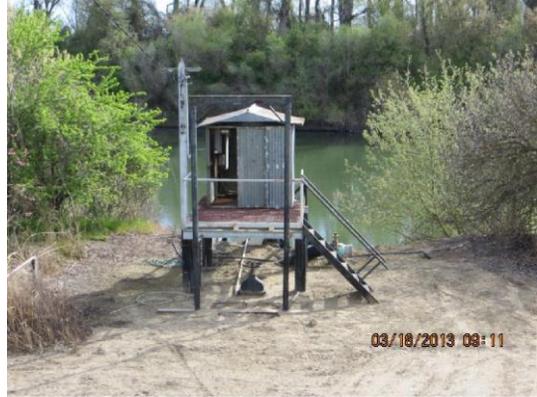
Photo 3 of 3 : UCIP_FA_2015_0186.jpg

Pump at WS berm.

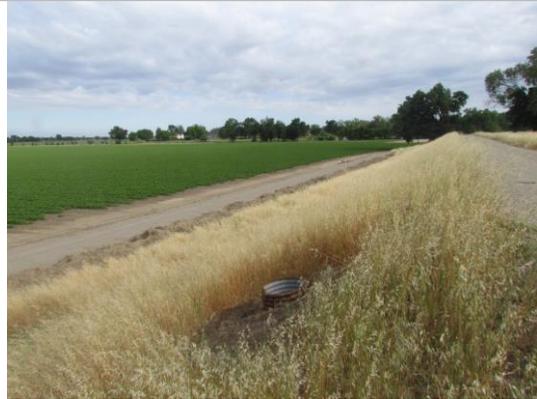
Photo 1 of 1 : FA_2015_NA0016_435_100_20150914_00047.jpg

LM Start	34.01	Rating **	M	Issue No.	100
LM End	34.07	Issue Type +	En	Location *	LS
Category	Earthen Levee			GPS Latitude/Longitude	
				Start	End
Item	Encroachments			39.087176 °	39.088099 °
				-121.896480 °	-121.896498 °
DWR ID	DWR_NA0016_01_s_2015_100				
Action/Comments					
Ditch

View of the ditch at the landward side of the levee looking upstream. Spring 2015.

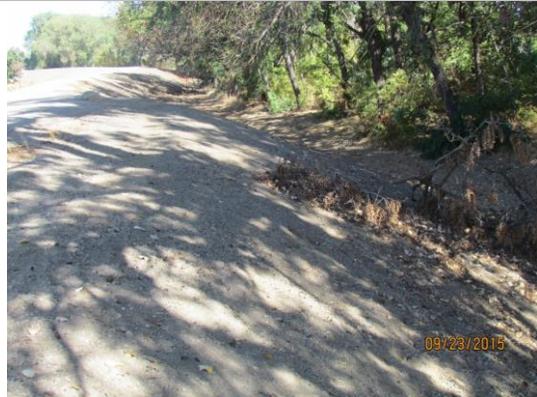
Photo 1 of 1 : FA_2015_NA0016_435_138_20151001_00125.jpg

LM Start	35.22	Rating **	M	Issue No.	138
LM End	35.22	Issue Type +	Ma	Location *	WS
Category	Earthen Levee			GPS Latitude/Longitude	
				Start	End
Item	Encroachments			39.099225 °	39.099225 °
				-121.904326 °	-121.904326 °
DWR ID	DWR_NA0016_01_f_2015_138				
Action/Comments					
Tree or limb

View of the fall tree branch on the waterward side of the levee looking upstream. Fall 2015.

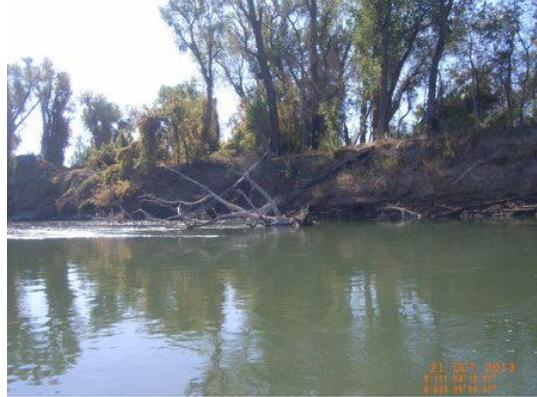
Photo 1 of 1 : USACE2013A_SAC_127-9_R_5.jpg

LM Start	35.23	Rating **	M	Issue No.	1
LM End	35.33	Issue Type +	Ma	Location *	WS
Category	Supplemental			GPS Latitude/Longitude	
				Start	End
Item	2015 USACE Erosion Survey, DRAFT			39.099482 °	39.100836 °
				-121.903430 °	-121.904320 °
DWR ID					
Action/Comments					
Inspector Comments: 1997 - Major scour off the downstream end of existing rock, creating a scour pocket where the levee starts diverging from the bankline. 2000 - Some minor erosion, 20 ft deep hole at downstream end. 2004 - Small amount of new erosion. 2010 - Bad transition off downstream end of rock revetment, some new erosion. 2012 - Site extended downstream, minor new erosion. 2013- Minor new erosion. 2015: No observed changes. [2015 Site ID: SAC_127-9_R]

USACE 2013 Photo #1

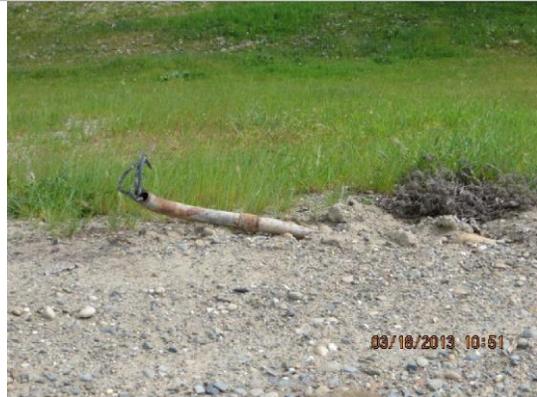
Photo 1 of 2 : UCIP_FA_2015_0188.jpg

LM Start	35.56	Rating **	M	Issue No.	1581
LM End	35.56	Issue Type +	En	Location *	WS
Category	Supplemental			GPS Latitude/Longitude	
				Start	End
Item	DWR UCIP Field Study			39.103533 °	39.103533 °
				-121.906814 °	-121.906814 °
DWR ID					
Action/Comments					
Inspector Comments: FS_ID:10425 DS_ID:20398 EP_NO: 9364 FS_HLM: 35.996 Repair Type: Non-Urgent Crossing Status: Found UCIP Comments: Remove abandoned pipe from levee. FIELD_STRUCT_DESC: 4 of 4: *Abandoned* 1.25-inch conduit through levee 3.0 feet below crown (ABO No. 9364A). FS Date: 03/18/2013

Electrical conduit on WS shoulder.

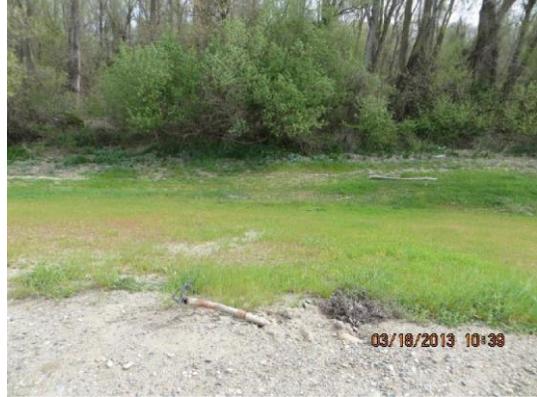
Photo 2 of 2 : UCIP_FA_2015_0333.jpg

LM Start	35.56	Rating **	M	Issue No.	1581 (cont)
LM End	35.56	Issue Type +	En	Location *	WS
Category	Supplemental			GPS Latitude/Longitude	
	Start		End		
Item	DWR UCIP Field Study			39.103533 °	39.103533 °
				-121.906814 °	-121.906814 °
DWR ID					
Action/Comments					
Inspector Comments: FS_ID:10425 DS_ID:20398 EP_NO: 9364 FS_HLM: 35.996 Repair Type: Non-Urgent Crossing Status: Found UCIP Comments: Remove abandoned pipe from levee. FIELD_STRUCT_DESC: 4 of 4: *Abandoned* 1.25-inch conduit through levee 3.0 feet below crown (ABO No. 9364A). FS Date: 03/18/2013

Electrical conduit on WS shoulder.

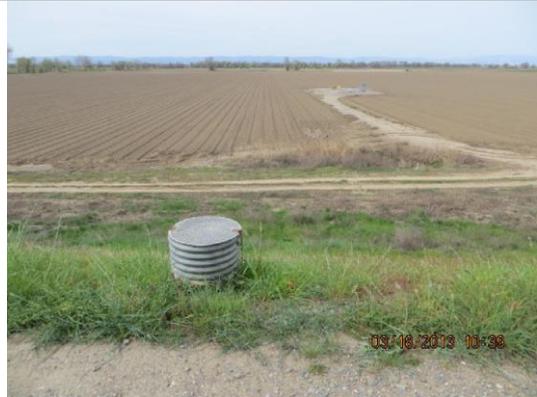
Photo 1 of 1 : UCIP_FA_2015_0187.jpg

LM Start	35.56	Rating **	M	Issue No.	1582
LM End	35.56	Issue Type +	En	Location *	WS
Category	Supplemental			GPS Latitude/Longitude	
	Start		End		
Item	DWR UCIP Field Study			39.103533 °	39.103533 °
				-121.906814 °	-121.906814 °
DWR ID					
Action/Comments					
Inspector Comments: FS_ID:10424 DS_ID:20273 EP_NO: 9364A FS_HLM: 35.996 Repair Type: Non-Urgent Crossing Status: Found UCIP Comments: Need to verify type of abandonment. FIELD_STRUCT_DESC: 3 of 4: 18-inch steel pipe through levee 16.0 feet below crown. Metal cutoff wall. Gate valve on the waterward bank. Siphon breaker in 24-inch corrugated metal riser unit on the landward shoulder. (ABO No. 9364A, 1960). Originally included in the 1960 O&M manual. FS Date: 03/18/2013

Siphon breaker in 24-inch CMP riser on LS shoulder.

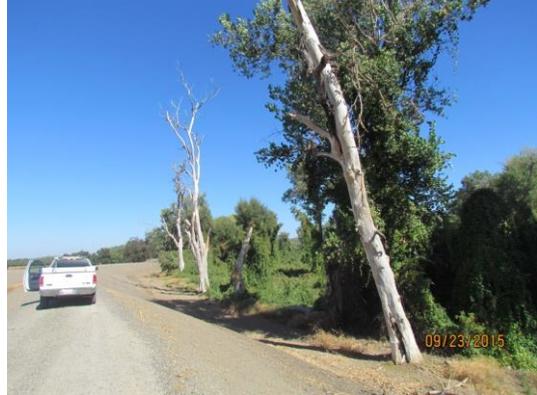
Photo 1 of 1 : FA_2015_NA0016_435_139_20151001_00126.jpg

LM Start	35.69	Rating **	A/W	Issue No.	139
LM End	35.69	Issue Type +	Ma	Location *	WS
Category	Earthen Levee		GPS Latitude/Longitude		
			Start	End	
Item	Vegetation		39.105381 °	39.105381 °	
			-121.907770 °	-121.907770 °	
DWR ID	DWR_NA0016_01_f_2015_139				
Action/Comments					
Trees / Woody Vegetation

View of the dying tree on the waterward side of the levee looking upstream. Fall 2015.

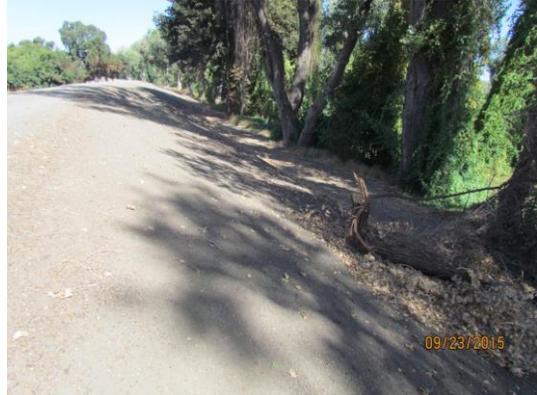
Photo 1 of 1 : FA_2015_NA0016_435_140_20151001_00127.jpg

LM Start	35.86	Rating **	M	Issue No.	140
LM End	35.86	Issue Type +	En	Location *	WS
Category	Earthen Levee		GPS Latitude/Longitude		
			Start	End	
Item	Encroachments		39.107611 °	39.107611 °	
			-121.908817 °	-121.908817 °	
DWR ID	DWR_NA0016_01_f_2015_140				
Action/Comments					
Tree or limb

View of the fallen tree branch on the waterward side of the levee looking upstream. Fall 2015.

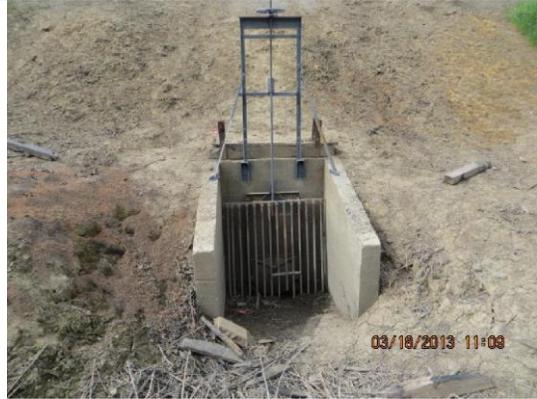
Photo 1 of 3 : UCIP_FA_2015_0334.jpg

Inspector Comments: FS_ID:10426
 DS_ID:20345
 EP_NO: 9374
 FS_HLM: 36.597
 Repair Type: Non-Urgent
 Crossing Status: Found
 UCIP Comments: Verify if pipe is abandoned with landowner and remove or abandon properly if necessary.
 FIELD_STRUCT_DESC: 3 of 3: *Abandoned* 24-inch concrete encased steel drain pipe through levee 17.0 feet below crown. Slide gate on concrete headwalls in waterward end, walkway to control gate and gate valve on landward end (ABO No. 9374, 1960). Originally included in the 1960 O&M manual.
 FS Date: 03/18/2013

Outlet/inlet on WS toe.

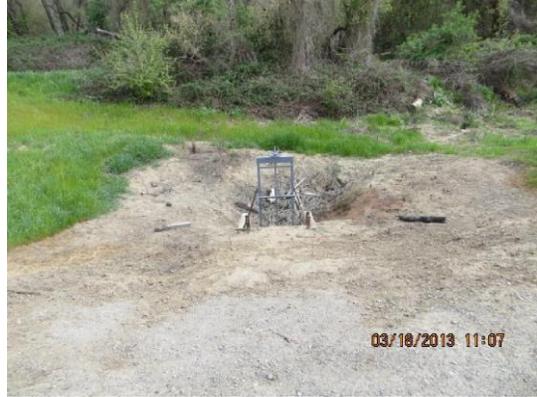
Photo 3 of 3 : UCIP_FA_2015_0336.jpg

LM Start	36.15	Rating **	M	Issue No.	1583 (cont)
LM End	36.15	Issue Type +	En	Location *	WS
Category	Supplemental			GPS Latitude/Longitude	
				Start	End
Item	DWR UCIP Field Study			39.111233 °	39.111233 °
				-121.911450 °	-121.911450 °
DWR ID					
Action/Comments					
Inspector Comments: FS_ID:10426 DS_ID:20345 EP_NO: 9374 FS_HLM: 36.597 Repair Type: Non-Urgent Crossing Status: Found

Slide gate on WS toe.

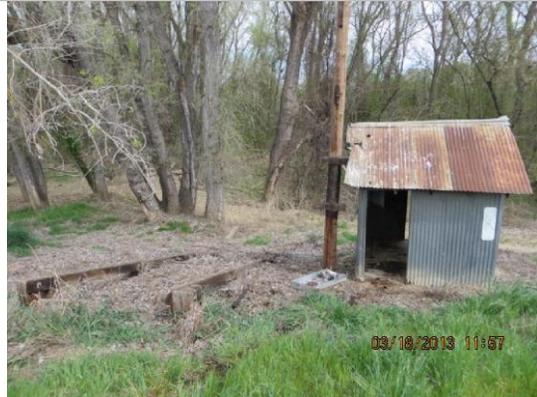
Photo 1 of 3 : UCIP_FA_2015_0462.jpg

LM Start	36.24	Rating **	M	Issue No.	1584
LM End	36.24	Issue Type +	En	Location *	WS
Category	Supplemental			GPS Latitude/Longitude	
				Start	End
Item	DWR UCIP Field Study			39.112377 °	39.112377 °
				-121.912286 °	-121.912286 °
DWR ID					
Action/Comments					
Inspector Comments: FS_ID:10444 DS_ID:20274 EP_NO: 9374 FS_HLM: 36.69 Repair Type: Non-Urgent Crossing Status: Found UCIP Comments: Pipe should be abandoned properly. FIELD_STRUCT_DESC: 4 of 4: 24-inch corrugated metal pipe through levee 15.5 feet below crown (ABO No. 9374, 1974). Two corrugated metal cutoff walls. Slide gate in 36-inch corrugated metal riser unit on the waterward slope. Pump house with no connection on waterward bank. 12-inch steel pipe with steel plate over end at WS toe (likely pump connection point). 6-foot diameter concrete riser on LS toe. Skid rails mounted on wood piling on the waterward slope. Department of Water Resources B.M. SR 47 on top of concrete anchor post on the waterward shoulder. Power pole and meter box on the waterward shoulder. Switch panel in metal house on the waterward slope. Concrete standpipe on the landward side. Overhead power line crosses the levee to service pole. FS Date: 03/18/2013

Pump house, JP, and wooden ramp on WS slope.

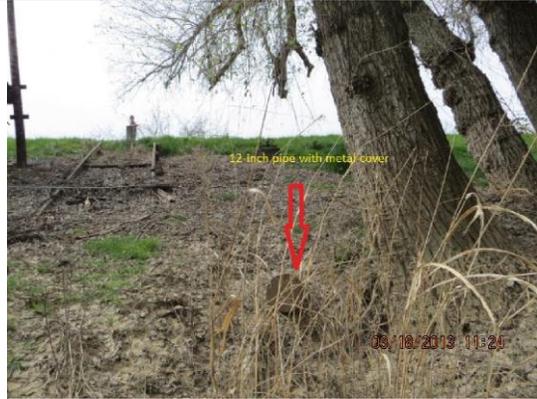
Photo 2 of 3 : UCIP_FA_2015_0463.jpg

Inspector Comments: FS_ID:10444
 DS_ID:20274
 EP_NO: 9374
 FS_HLM: 36.69
 Repair Type: Non-Urgent
 Crossing Status: Found
 UCIP Comments: Pipe should be abandoned properly.
 FIELD_STRUCT_DESC: 4 of 4: 24-inch corrugated metal pipe through levee 15.5 feet below crown (ABO No. 9374, 1974). Two corrugated metal cutoff walls. Slide gate in 36-inch corrugated metal riser unit on the waterward slope. Pump house with no connection on waterward bank. 12-inch steel pipe with steel plate over end at WS toe (likely pump connection point). 6-foot diameter concrete riser on LS toe. Skid rails mounted on wood piling on the waterward slope. Department of Water Resources B.M. SR 47 on top of concrete anchor post on the waterward shoulder. Power pole and meter box on the waterward shoulder. Switch panel in metal house on the waterward slope. Concrete standpipe on the landward side. Overhead power line crosses the levee to service pole.

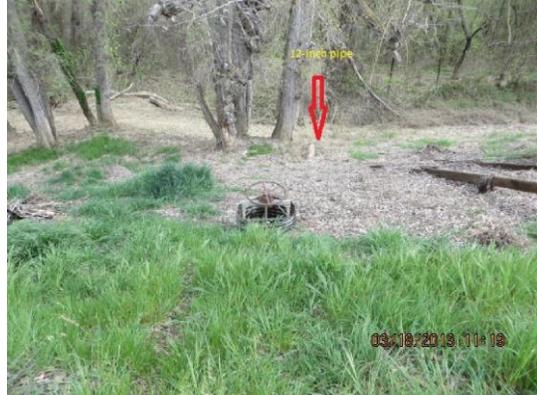
Photo 3 of 3 : UCIP_FA_2015_0464.jpg

Item	DWR UCIP Field Study			39.112377 °	39.112377 °	
				-121.912286 °	-121.912286 °	
DWR ID						
Action/Comments						
Inspector Comments: FS_ID:10444 DS_ID:20274 EP_NO: 9374 FS_HLM: 36.69 Repair Type: Non-Urgent Crossing Status: Found UCIP Comments: Pipe should be abandoned properly. FIELD_STRUCT_DESC: 4 of 4: 24-inch corrugated metal pipe through levee 15.5 feet below crown (ABO No. 9374, 1974). Two corrugated metal cutoff walls. Slide gate in 36-inch corrugated metal riser unit on the waterward slope. Pump house with no connection on waterward bank. 12-inch steel pipe with steel plate over end at WS toe (likely pump connection point). 6-foot diameter concrete riser on LS toe. Skid rails mounted on wood piling on the waterward slope. Department of Water Resources B.M. SR 47 on top of concrete anchor post on the waterward shoulder. Power pole and meter box on the waterward shoulder. Switch panel in metal house on the waterward slope. Concrete standpipe on the landward side. Overhead power line crosses the levee to service pole. FS Date: 03/18/2013

36-inch CMP riser with slide gate on WS slope with 12-inch pipe at Toe.

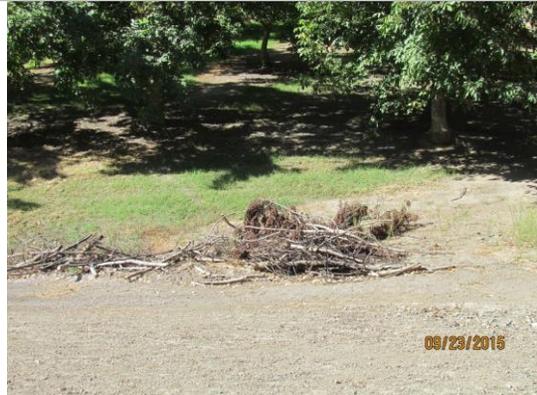
Photo 1 of 1 : FA_2015_NA0016_435_141_20151001_00128.jpg

LM Start	36.32	Rating **	M	Issue No.	141	
LM End	36.32	Issue Type +	En	Location *	LS	
Category	Earthen Levee			GPS Latitude/Longitude		
			Start	End		
Item	Encroachments			39.113305 °	39.113305 °	
				-121.913224 °	-121.913224 °	
DWR ID	DWR_NA0016_01_f_2015_141					
Action/Comments						
Prunings

View of the pile of prunings on the landward side of the levee. Fall 2015.

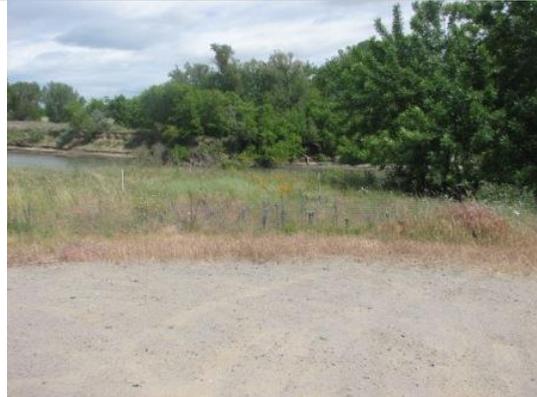
Photo 1 of 2 : FA_2015_NA0016_435_33_20150914_00027.jpg

LM Start	37.07	Rating **	A/W	Issue No.	33
LM End	37.15	Issue Type +	Ma	Location *	WS
Category	Earthen Levee		GPS Latitude/Longitude		
			Start	End	
Item	Vegetation		39.120977 °	39.121543 °	
			-121.919843 °	-121.921245 °	
DWR ID	DWR_NA0016_01_s_2012_33				
Action/Comments					
Environmental Requirements.

The revegetation on the berm with the fence and stakes.

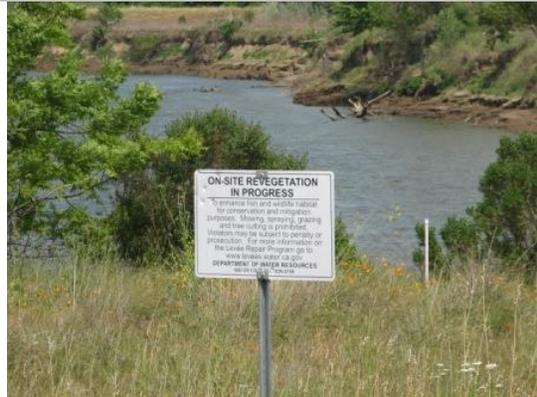
Photo 2 of 2 : FA_2015_NA0016_435_33_20150914_00028.jpg

Revegetation site. Photo taken spring 2012.

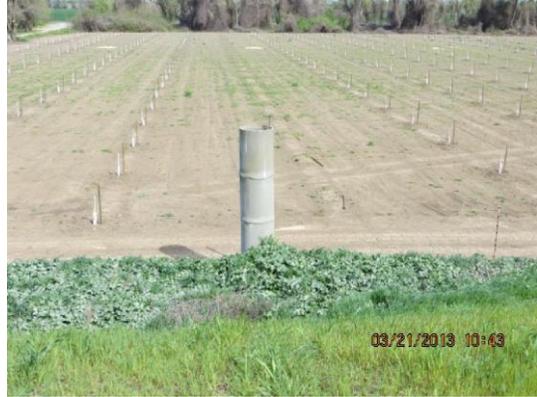
Photo 1 of 3 : UCIP_FA_2015_0299.jpg

Inspector Comments: FS_ID:10528
 DS_ID:20282
 EP_NO: 9352
 FS_HLM: 40.431
 Repair Type: Non-Urgent
 Crossing Status: Found
 UCIP Comments: Pipe appears to have been removed from levee section. Need to verify pipe abandonment.
 FIELD_STRUCT_DESC: 12-inch steel pipe through levee 5.0 feet below crown. Switch house on waterward shoulder, pump and gate valve on waterward bank. Concrete discharge standpipe on landward side. Permit was for a 14-inch (Permit No. 635, 1935). Included in the 1960 O&M manual and ABO No. 9351.
 FS Date: 03/21/2013

Concrete standpipe at LS toe.

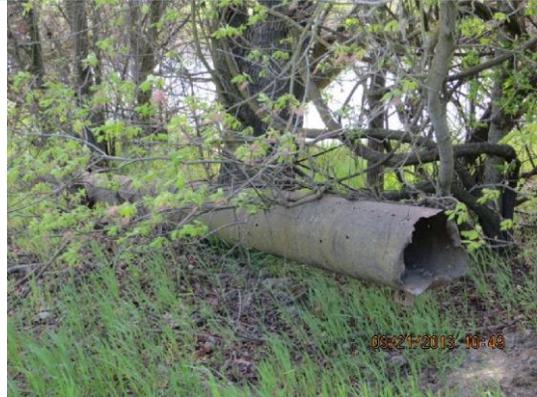
Photo 2 of 3 : UCIP_FA_2015_0460.jpg

12-inch pipe debris on WS berm.

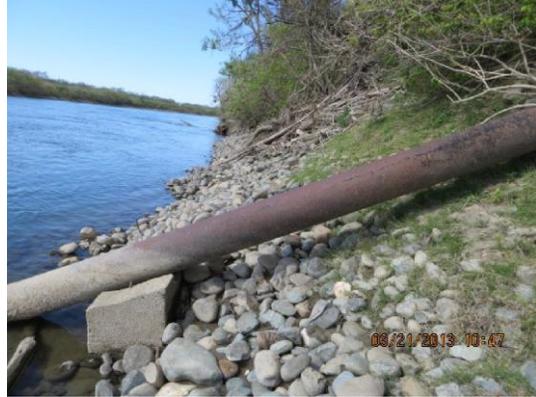
Photo 3 of 3 : UCIP_FA_2015_0461.jpg

LM Start	39.93	Rating **	M	Issue No.	1585 (cont)
LM End	39.93	Issue Type +	En	Location *	WS
Category	Supplemental			GPS Latitude/Longitude	
				Start	End
Item	DWR UCIP Field Study			39.143387 °	39.143387 °
				-121.927196 °	-121.927196 °
DWR ID					
Action/Comments					
Inspector Comments: FS_ID:10528 DS_ID:20282 EP_NO: 9352 FS_HLM: 40.431 Repair Type: Non-Urgent Crossing Status: Found

Pipe visible at WS toe.

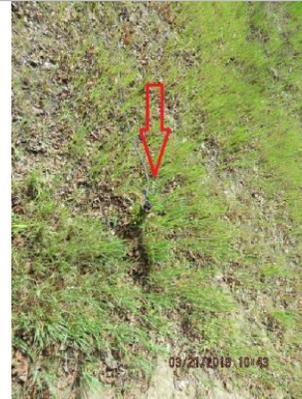
Photo 1 of 2 : UCIP_FA_2015_0221.jpg

LM Start	39.93	Rating **	M	Issue No.	1586
LM End	39.93	Issue Type +	En	Location *	WS
Category	Supplemental			GPS Latitude/Longitude	
				Start	End
Item	DWR UCIP Field Study			39.143387 °	39.143387 °
				-121.927196 °	-121.927196 °
DWR ID					
Action/Comments					
Inspector Comments: FS_ID:11343 DS_ID:22966 EP_NO: 9352 FS_HLM: 40.431 Repair Type: Non-Urgent Crossing Status: Found UCIP Comments: Pipe should be removed. FIELD_STRUCT_DESC: 1.5-inch galvanized iron electrical conduit through the levee at unknown depth. Visible on WS slope (Permit No. 635, 1935). FS Date: 03/21/2013

1.5-inch electrical conduit on WS slope.

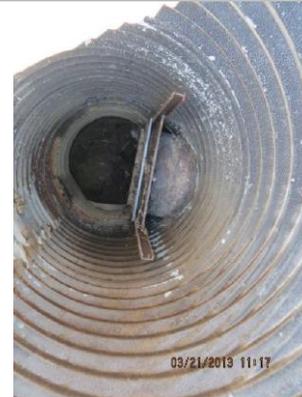
Photo 1 of 3 : UCIP_FA_2015_0411.jpg

LM Start	40.44	Rating **	M	Issue No.	1587
LM End	40.44	Issue Type +	En	Location *	WS
Category	Supplemental			GPS Latitude/Longitude	
				Start	End
Item	DWR UCIP Field Study			39.143838 °	39.143838 °
				-121.919338 °	-121.919338 °
DWR ID					
Action/Comments					
Inspector Comments: FS_ID:10527 DS_ID:20285 EP_NO: 12799 FS_HLM: 40.94 Repair Type: Non-Urgent Crossing Status: Found UCIP Comments: Pipe appears abandoned. Need to verify type of abandonment FIELD_STRUCT_DESC: 18-inch steel pipe through levee 6.5 feet below crown. 30-inch CMP standpipe on LS toe. Pump on the waterward toe. Vent in 12-inch CMP riser on the WS shoulder. (Permit No. 12799, 1979). FS Date: 03/21/2013

Slide gate in CMP riser on LS toe.

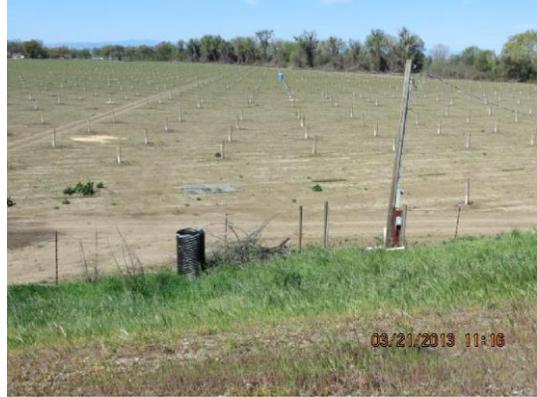
Photo 2 of 3 : UCIP_FA_2015_0412.jpg

Inspector Comments: FS_ID:10527
 DS_ID:20285
 EP_NO: 12799
 FS_HLM: 40.94
 Repair Type: Non-Urgent
 Crossing Status: Found
 UCIP Comments: Pipe appears abandoned. Need to verify type of abandonment
 FIELD_STRUCT_DESC: 18-inch steel pipe through levee 6.5 feet below crown. 30-inch CMP standpipe on LS toe. Pump on the waterward toe. Vent in 12-inch CMP riser on the WS shoulder.
 (Permit No. 12799, 1979).
 FS Date: 03/21/2013

30-inch CMP riser with slide gate at LS toe.

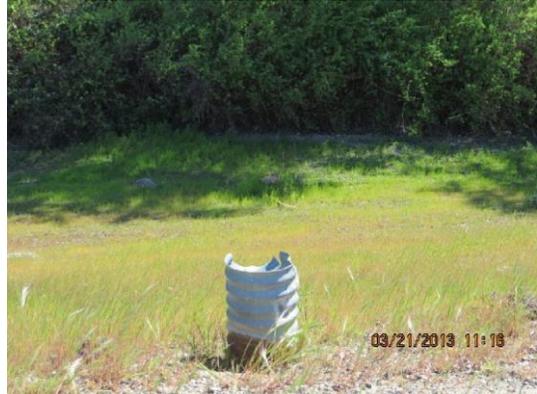
Photo 3 of 3 : UCIP_FA_2015_0442.jpg

Vent in 12-inch CMP riser on WS shoulder.

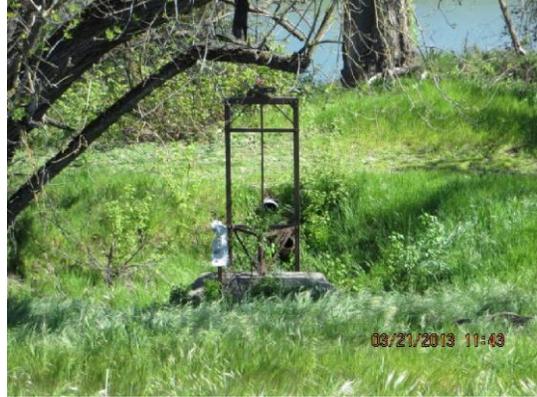
Photo 2 of 3 : UCIP_FA_2015_0301.jpg

LM Start	40.89	Rating **	M	Issue No.	1588 (cont)
LM End	40.89	Issue Type +	En	Location *	LS
Category	Supplemental			GPS Latitude/Longitude	
				Start	End
Item	DWR UCIP Field Study			39.150054 °	39.150054 °
				-121.918717 °	-121.918717 °
DWR ID					
Action/Comments					
Inspector Comments: FS_ID:10533 DS_ID:20287 EP_NO: 9351 FS_HLM: 41.397 Repair Type: Non-Urgent Crossing Status: Found UCIP Comments: Appears abandoned. Should be abandoned properly. FIELD_STRUCT_DESC: 30-inch corrugated metal pipe through levee 17.5 feet below crown. Slide gate on the waterward end. Discharges into concrete box at the landward toe (ABO No. 9351, 1960). Small pump discharges into sump area in front of slide gate at WS toe. FS Date: 03/21/2013

Slide gate at WS toe.

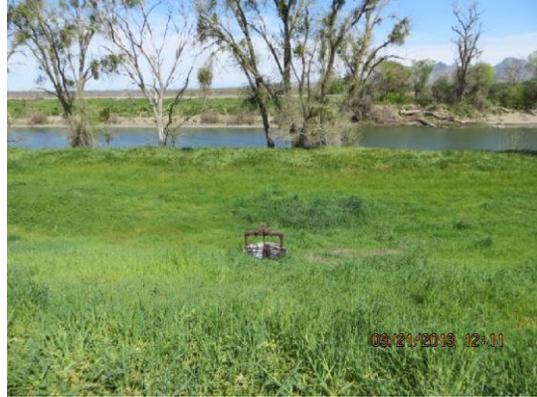
Photo 1 of 3 : UCIP_FA_2015_0303.jpg

LM Start	41.86	Rating **	M	Issue No.	1589
LM End	41.86	Issue Type +	En	Location *	LS
Category	Supplemental			GPS Latitude/Longitude	
				Start	End
Item	DWR UCIP Field Study			39.158648 °	39.158648 °
				-121.932429 °	-121.932429 °
DWR ID					
Action/Comments					
Inspector Comments: FS_ID:10536 DS_ID:20289 EP_NO: 9341 FS_HLM: 42.373 Repair Type: Non-Urgent Crossing Status: Found

Slide gate in CMP riser on WS toe.

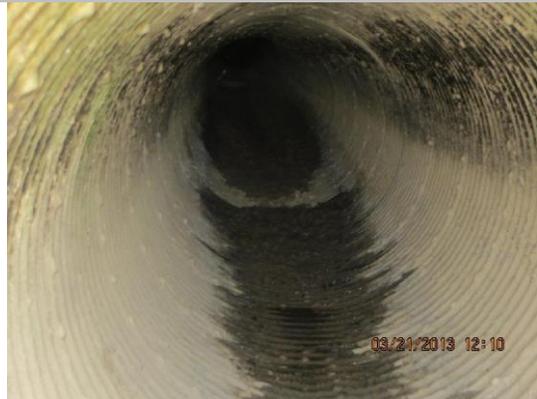
Photo 2 of 3 : UCIP_FA_2015_0304.jpg

View from LS toe of CMP pipe.

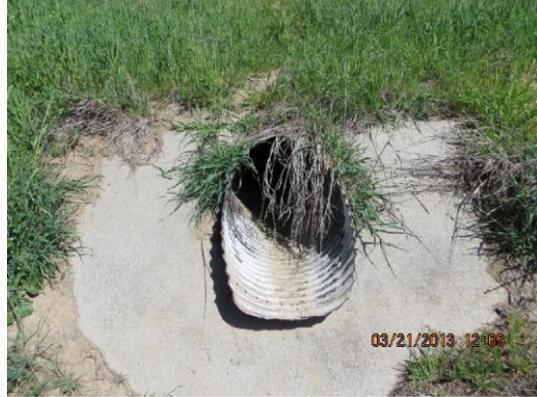
Photo 3 of 3 : UCIP_FA_2015_0305.jpg

LM Start	41.86	Rating **	M	Issue No.	1589 (cont)
LM End	41.86	Issue Type +	En	Location *	LS
Category	Supplemental			GPS Latitude/Longitude	
				Start	End
Item	DWR UCIP Field Study			39.158648 °	39.158648 °
				-121.932429 °	-121.932429 °
DWR ID					
Action/Comments					
Inspector Comments: FS_ID:10536 DS_ID:20289 EP_NO: 9341 FS_HLM: 42.373 Repair Type: Non-Urgent Crossing Status: Found

30-inch CMP at outlet on LS toe.

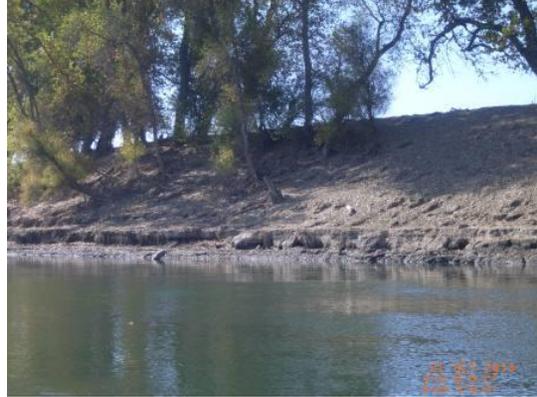
Photo 1 of 1 : USACE2013A_SAC_136-6_R_5.jpg

LM Start	42.90	Rating **	M	Issue No.	4
LM End	43.09	Issue Type +	Ma	Location *	WS
Category	Supplemental			GPS Latitude/Longitude	
				Start	End
Item	2015 USACE Erosion Survey, DRAFT			39.172501 °	39.174949 °
				-121.939053 °	-121.940737 °
DWR ID					
Action/Comments					
Inspector Comments: 2010 - Lower portion of 136.7 that did not extend far enough. Abrupt transition from upstream site. 2012 - Site extended upstream, minor new erosion. 2013 - Minor new erosion at the toe. New tree popout. Downstream limit extended. 2015: No observed changes. [2015 Site ID: SAC_136-6_R]

USACE 2013 Photo #1

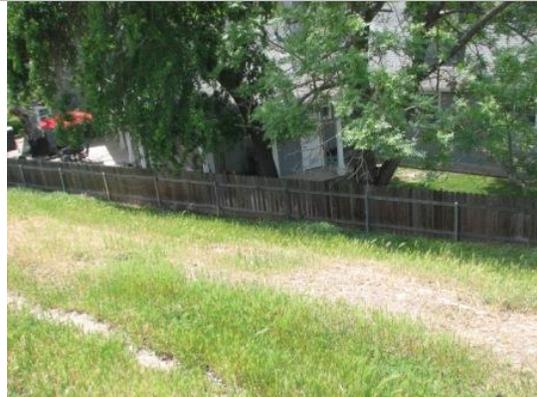
Photo 1 of 1 : FA_2015_NA0016_435_46_20150914_00030.jpg

LM Start	43.24	Rating **	M	Issue No.	46
LM End	43.24	Issue Type +	En	Location *	LS
Category	Earthen Levee			GPS Latitude/Longitude	
				Start	End
Item	Encroachments			39.176429 °	39.176429 °
				-121.942889 °	-121.942889 °
DWR ID	DWR_NA0016_01_s_2012_46				
Action/Comments					
Fence

A solid fence along the toe of the levee. Photo taken spring 2012.

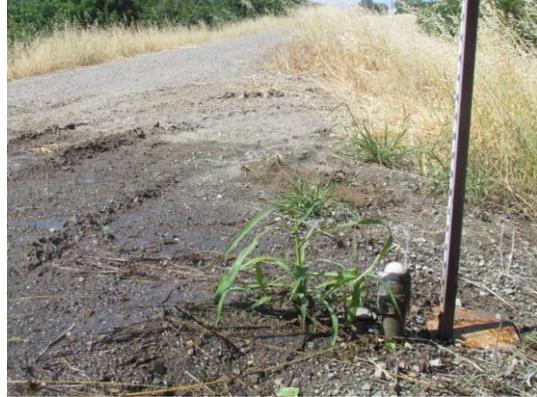
Photo 1 of 3 : FA_2015_NA0016_435_109_20150914_00051.jpg

LM Start	46.01	Rating **	A/W	Issue No.	109
LM End	46.01	Issue Type +	En	Location *	WS
Category	Earthen Levee			GPS Latitude/Longitude	
				Start	End
Item	Encroachments			39.187479 °	39.187479 °
				-121.962081 °	-121.962081 °
DWR ID	DWR_NA0016_01_s_2015_109				
Action/Comments					
Pipe Inspector Comments: The siphon filter is fixed. There is no external leak on the levee from the pipe, however there are vegetation growing in line with the pipe.

View of the siphon breaker on the shoulder of the waterward side of the levee looking upstream. Spring 2015.

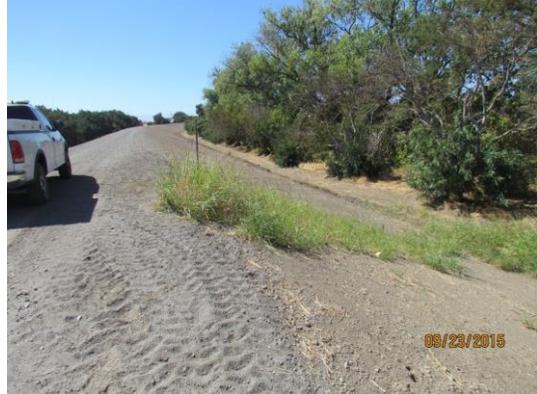
Photo 2 of 3 : FA_2015_NA0016_435_109_20151001_00131.jpg

Perspective view of the vegetation where the pipe runs through the levee on the waterward side of the levee looking upstream. Fall 2015.

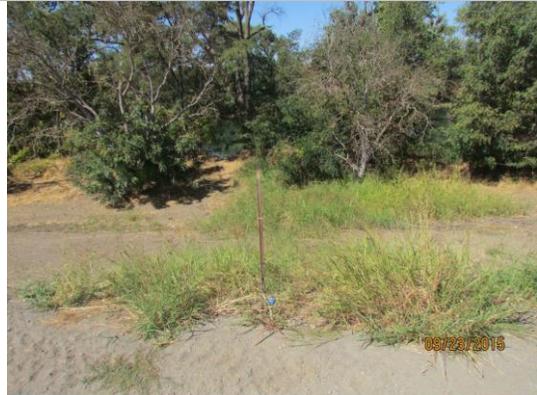
Photo 3 of 3 : FA_2015_NA0016_435_109_20151001_00133.jpg

Vegetation is aligned where the pipe is on the waterward side of the levee. Fall 2015.

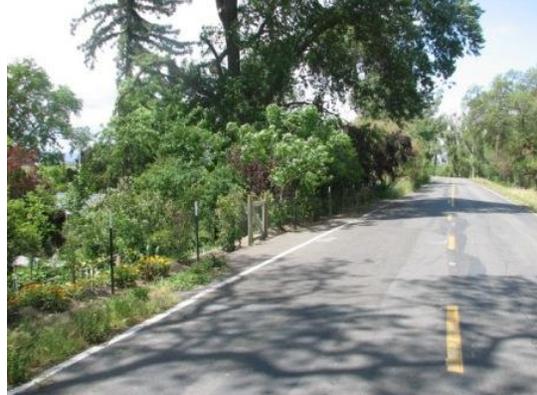
Photo 1 of 1 : FA_2015_NA0016_435_54_20150914_00031.jpg

LM Start	47.01	Rating **	M	Issue No.	54
LM End	47.01	Issue Type +	En	Location *	LS
Category	Earthen Levee		GPS Latitude/Longitude		
			Start	End	
Item	Vegetation		39.188577 °	39.188577 °	
			-121.979388 °	-121.979388 °	
DWR ID	DWR_NA0016_01_s_2012_54				
Action/Comments					
Landscaping Inspector Comments: Cactus on slope and toe of levee, landscape continues along roadway with fence and stairs.

The front yard along the road and on the levee slope. Photo taken spring 2012.

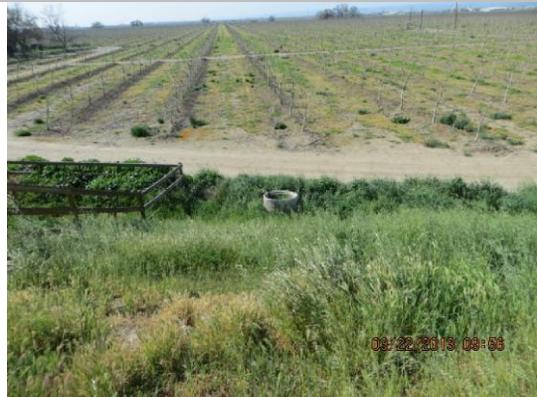
Photo 1 of 1 : UCIP_FA_2015_0231.jpg

LM Start	47.16	Rating **	M	Issue No.	1590
LM End	47.16	Issue Type +	En	Location *	LS
Category	Supplemental		GPS Latitude/Longitude		
			Start	End	
Item	DWR UCIP Field Study		39.189783 °	39.189783 °	
			-121.981548 °	-121.981548 °	
DWR ID					
Action/Comments					
Inspector Comments: FS_ID:10553 DS_ID:20298 EP_NO: 9347 FS_HLM: 47.71 Repair Type: Non-Urgent Crossing Status: Indicator Found UCIP Comments: Need to verify type of abandonment. FIELD_STRUCT_DESC: 1 of 2: 24-inch pipe through levee 25.5 feet below crown. 14-inch pipe sleeved through this pipe. Annular space grouted. Pump in pump house on the landward side. Gate valve in pump house (ABO No. 9347, 1960). Originally included in the 1960 O&M manual. FS Date: 03/22/2013

Possible location for pipe crossing.

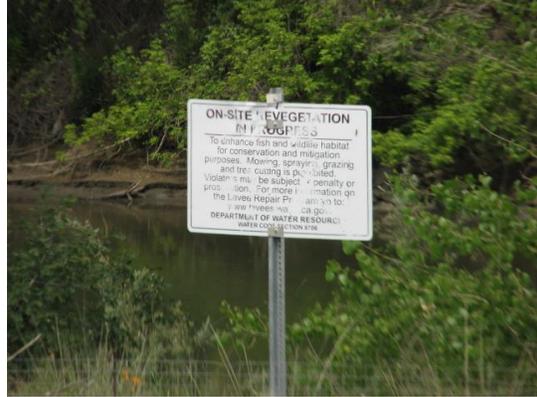
Photo 1 of 1 : FA_2015_NA0016_435_90_20150914_00040.jpg

LM Start	47.19	Rating **	A/W	Issue No.	90
LM End	47.62	Issue Type +	Ob	Location *	WS
Category	Earthen Levee		GPS Latitude/Longitude		
			Start	End	
Item	Vegetation		39.189930 °	39.193491 °	
			-121.982143 °	-121.988184 °	
DWR ID	DWR_NA0016_01_s_2014_90				
Action/Comments					
Environmental Requirements.

A revegetation site along the waterside berm. Spring 2014

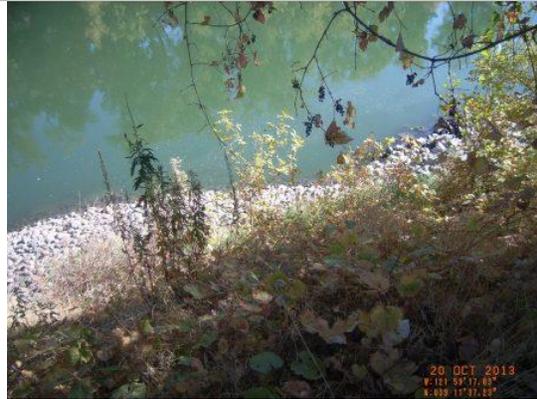
Photo 1 of 1 : USACE2013A_SAC_141-5_R_6.jpg

LM Start	47.62	Rating **	M	Issue No.	3
LM End	47.77	Issue Type +	Ma	Location *	WS
Category	Supplemental		GPS Latitude/Longitude		
			Start	End	
Item	2015 USACE Erosion Survey, DRAFT		39.193769 °	39.195595 °	
			-121.987901 °	-121.988621 °	
DWR ID					
Action/Comments					
Inspector Comments: 2010 - Old cobble site starting to unravel at toe. 2011 - Cobbles continue to unravel. 2013 - Site extended downstream to revetment. 2015: No observed changes. [2015 Site ID: SAC_141-5_R]

USACE 2013 Photo #1

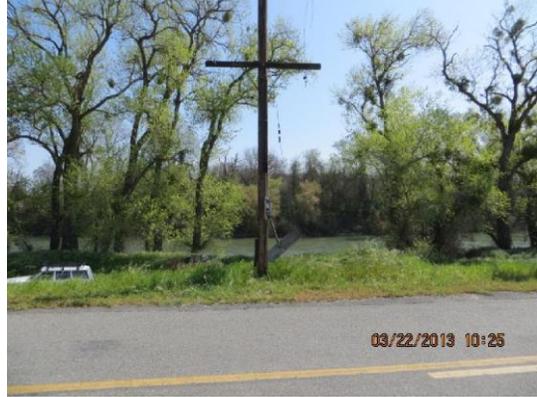
Photo 1 of 2 : UCIP_FA_2015_0232.jpg

Action/Comments
 Inspector Comments: FS_ID:10563
 DS_ID:20309
 EP_NO: 9347
 FS_HLM: 48.269
 Repair Type: Non-Urgent
 Crossing Status: Indicator Found
 UCIP Comments: Need to determine type of abandonment.
 FIELD_STRUCT_DESC: 2 of 2: *Removed*16-inch steel pipe through levee 17.3 feet below crown. Gate valve on the waterward end. Pump on the waterward bank. Switch box on the waterward shoulder. (ABO No. 9347,1960). Originally included in the 1960 O&M manual.
 FS Date: 03/22/2013

JP on WS shoulder for removed pump switch house.

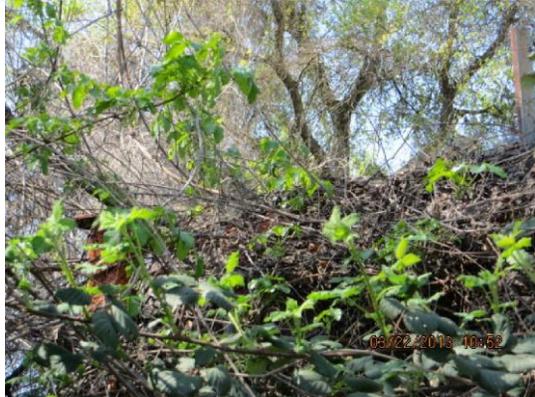
Photo 1 of 3 : UCIP_FA_2015_0234.jpg

LM Start	48.38	Rating **	M	Issue No.	1592
LM End	48.38	Issue Type +	En	Location *	WS
Category	Supplemental			GPS Latitude/Longitude	
				Start	End
Item	DWR UCIP Field Study			39.203761 °	39.203761 °
				-121.985220 °	-121.985220 °
DWR ID					
Action/Comments					
Inspector Comments: FS_ID:10566 DS_ID:20300 EP_NO: 9343 FS_HLM: 48.939 Repair Type: Non-Urgent Crossing Status: Found

Pump on structure covered in brush on WS berm.

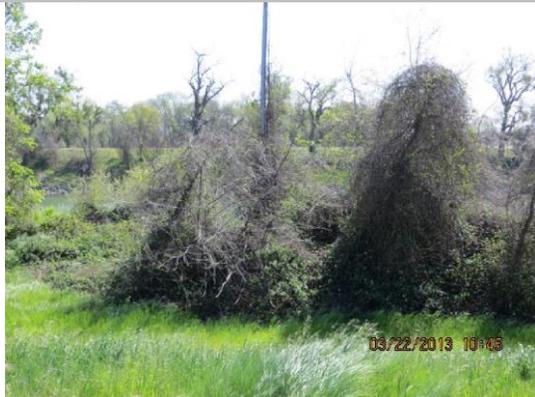
Photo 2 of 3 : UCIP_FA_2015_0235.jpg

Pump covered in brush on WS berm.
