**Flood Control Project Maintenance
Levee Inspections**

Fall 2015 Levee Maintenance Deficiency Summary Report

Sacramento River Basin

Sacramento River West Side Levee District

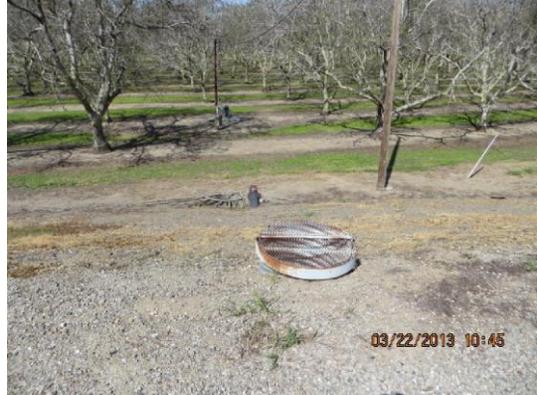
Photo 3 of 3 : UCIP_FA_2015_0236.jpg

LM Start	48.38	Rating **	M	Issue No.	1592 (cont)
LM End	48.38	Issue Type +	En	Location *	WS
Category	Supplemental			GPS Latitude/Longitude	
				Start	End
Item	DWR UCIP Field Study			39.203761 °	39.203761 °
				-121.985220 °	-121.985220 °
DWR ID					
Action/Comments					
Inspector Comments: FS_ID:10566 DS_ID:20300 EP_NO: 9343 FS_HLM: 48.939 Repair Type: Non-Urgent Crossing Status: Found

Siphon Breaker in 30-inch CMP riser on LS shoulder and butterfly valve at LS toe.

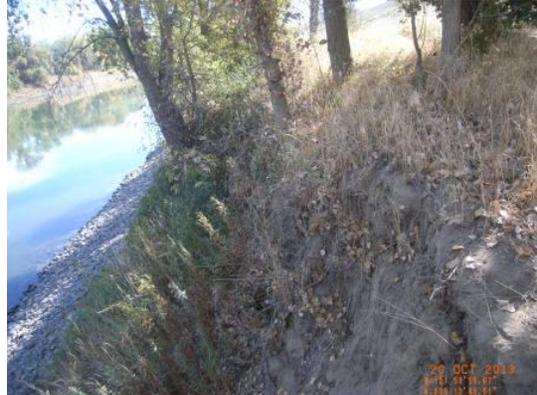
Photo 1 of 1 : USACE2013A_SAC_143-5_R_8.jpg

LM Start	49.46	Rating **	M	Issue No.	19
LM End	49.57	Issue Type +	Ma	Location *	WS
Category	Supplemental			GPS Latitude/Longitude	
				Start	End
Item	2015 USACE Erosion Survey, DRAFT			39.213608 °	39.213869 °
				-121.997543 °	-121.999641 °
DWR ID					
Action/Comments					
Inspector Comments: 2011 - Multiple scallops, one tree pop out. Old cobble site starting to unravel at midbank. 2012 - Mid bank slumping continues to worsen but cobble at the toe appears stable. 2015: No observed changes. [2015 Site ID: SAC_143-5_R]

USACE 2013 Photo #1
