**Flood Control Project Maintenance  
Levee Inspections**

**Fall 2015 Levee Maintenance Deficiency Summary Report  
Overall LMA & Unit Ratings, including USACE Erosion Survey**

**Yolo County Service Area 6**

Waterway		Bank	Unit Miles	
Unit No. 01 Right Bank of Sacramento River at Knights Landing		Right	5.87	
	Spring (March - May)	Summer (June - August)	(September - November) Fall	Winter (December - February)
Unit Maintenance Rating (Fall Only)			U	
Date of Inspection	05/26/2015 - 05/26/2015		10/02/2015 - 10/02/2015	
DWR Inspector	Jai Lor		Jai Lor	
Accompanied By	Chris Starke Yolo County

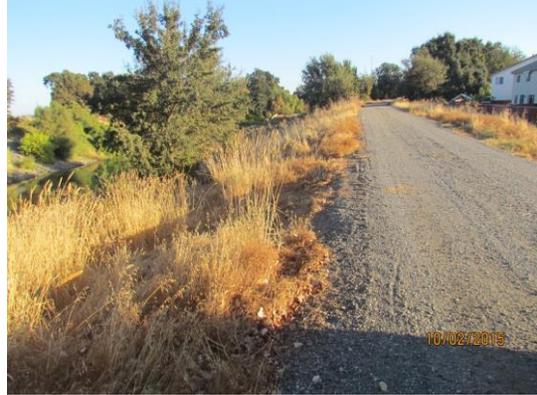
Photo 1 of 1 : FA\_2015\_NA0022\_350\_68\_20151005\_00063.jpg

LM Start	<b>0.04</b>	Rating **	M	Issue No.	<b>68</b>
LM End	<b>0.11</b>	Issue Type +	Ma	Location *	WS
Category	Earthen Levee		GPS Latitude/Longitude		
			Start	End	
Item	Vegetation		38.799548 °	38.800526 °	
			-121.724064 °	-121.723410 °	
DWR ID	DWR_NA0022_01_f_2015_68				
Action/Comments					
Control annual grass and weeds on the levee slopes and easements.

View of the vegetation on the waterward side of the levee looking downstream. Fall 2015.

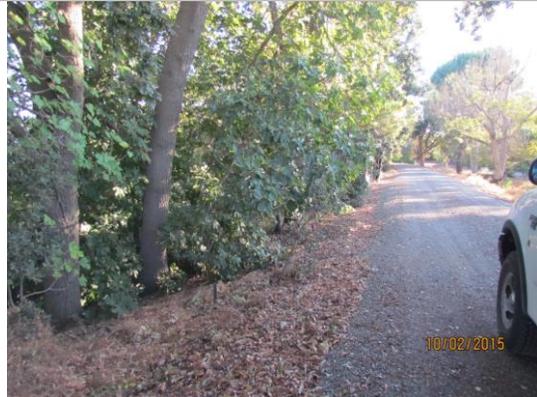
Photo 1 of 1 : FA\_2015\_NA0022\_350\_6\_20151005\_00065.jpg

LM Start	<b>0.13</b>	Rating **	U	Issue No.	<b>6</b>
LM End	<b>0.21</b>	Issue Type +	Ma	Location *	WS
Category	Earthen Levee			GPS Latitude/Longitude	
				Start	End
Item	Vegetation			38.800645 °	38.801368 °
				-121.723172 °	-121.722054 °
DWR ID	DWR_NA0022_01_s_2012_6				
Action/Comments					
Remove the wild growth other than native grasses from the levee slopes. Inspector Comments: Tall trees block visibility.

View of the vegetation and trees on the waterward side of the levee looking downstream. Fall 2015.

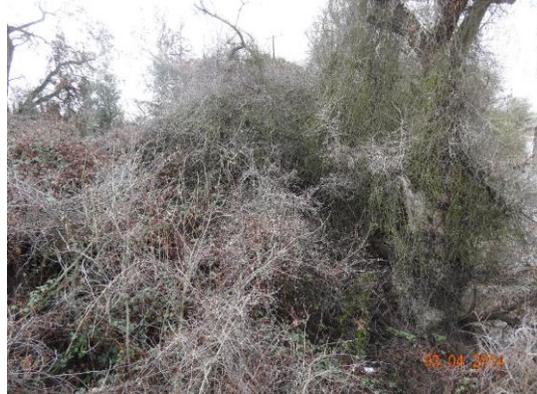
Photo 2 of 3 : UCIP\_FA\_2015\_3825.jpg

View of waterward toe photo taken from bridge.

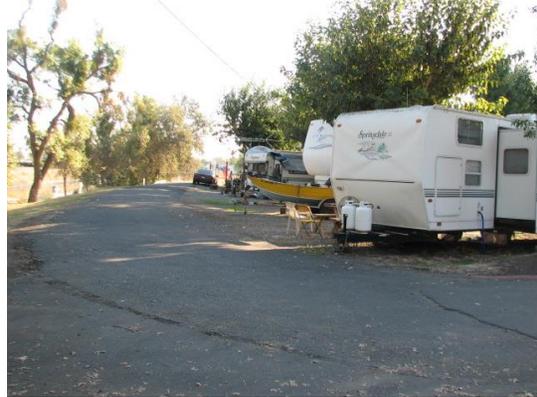
Photo 1 of 2 : FA\_2015\_NA0022\_350\_28\_20150914\_00027.jpg

LM Start	<b>0.22</b>	Rating **	M	Issue No.	<b>28</b>
LM End	<b>0.25</b>	Issue Type +	En	Location *	LS
Category	Earthen Levee			GPS Latitude/Longitude	
				Start	End
Item	Encroachments			38.801500 °	38.801613 °
				-121.721878 °	-121.721328 °
DWR ID	DWR_NA0022_01_s_2012_28				
Action/Comments					
Building Inspector Comments: RV park runs on and along levee to bridge

The RV park is encroached into the levee crown. Fall 2013

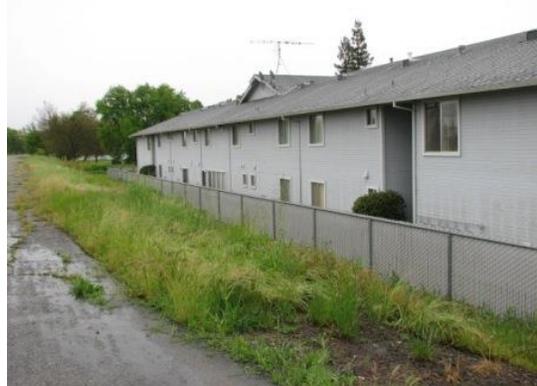
Photo 1 of 1 : FA\_2015\_NA0022\_350\_26\_20150914\_00025.jpg

LM Start	<b>0.34</b>	Rating **	A/W	Issue No.	<b>26</b>
LM End	<b>0.38</b>	Issue Type +	En	Location *	LS
Category	Earthen Levee		GPS Latitude/Longitude		
			Start	End	
Item	Encroachments		38.801967 °	38.802105 °	
			-121.719727 °	-121.718963 °	
DWR ID	DWR_NA0022_01_s_2012_26				
Action/Comments					
Building Inspector Comments: Apartments with chainlink fence with lathe woven into it.

The apartments and fence along the toe of the levee. Fall 2013

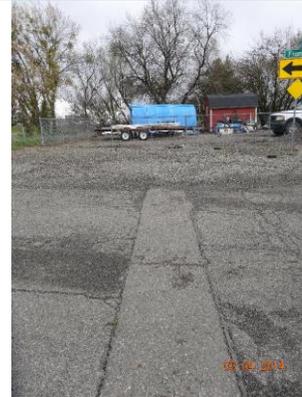
Photo 2 of 3 : UCIP\_FA\_2015\_2951.jpg

View of waterward side. Alignment is visible on paved road.

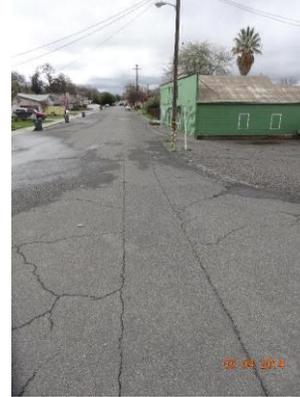
Photo 3 of 3 : UCIP\_FA\_2015\_2952.jpg

LM Start	<b>0.51</b>	Rating **	M	Issue No.	<b>406 (cont)</b>
LM End	<b>0.51</b>	Issue Type +	En	Location *	WS
Category	Supplemental			GPS Latitude/Longitude	
				Start	End
Item	DWR UCIP Field Study			38.802062 °	38.802062 °
				-121.716740 °	-121.716740 °
DWR ID					
Action/Comments					
Inspector Comments: FS_ID:31627 DS_ID:19544 EP_NO: N/A FS_HLM: 0.51 Repair Type: Non-Urgent Crossing Status: Indicator Found

View of landward side. Alignment is visible on paved road.

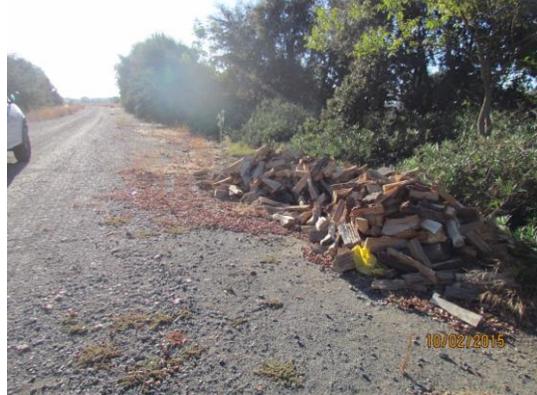
Photo 1 of 1 : FA\_2015\_NA0022\_350\_70\_20151005\_00069.jpg

LM Start	<b>0.65</b>	Rating **	M	Issue No.	<b>70</b>
LM End	<b>0.65</b>	Issue Type +	En	Location *	LS
Category	Earthen Levee		GPS Latitude/Longitude		
			Start	End	
Item	Encroachments		38.801372 °	38.801372 °	
			-121.714247 °	-121.714247 °	
DWR ID	DWR_NA0022_01_f_2015_70				
Action/Comments					
Firewood

View of the firewood on the landward side of the levee looking downstream. Fall 2015.

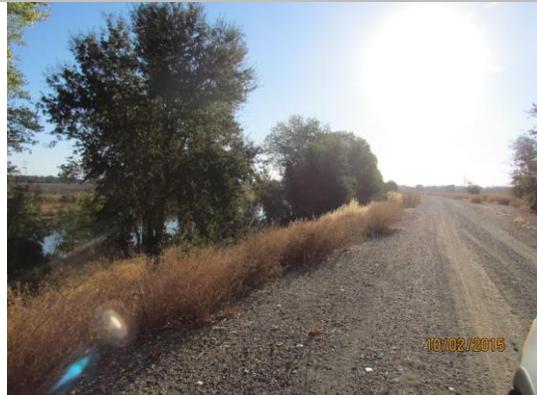
Photo 1 of 1 : FA\_2015\_NA0022\_350\_71\_20151005\_00070.jpg

LM Start	<b>0.68</b>	Rating **	M	Issue No.	<b>71</b>
LM End	<b>0.95</b>	Issue Type +	Ma	Location *	WS
Category	Earthen Levee		GPS Latitude/Longitude		
			Start	End	
Item	Vegetation		38.801181 °	38.800237 °	
			-121.713724 °	-121.708977 °	
DWR ID	DWR_NA0022_01_f_2015_71				
Action/Comments					
Control annual grass and weeds on the levee slopes and easements.

View of the vegetation on the waterward side of the levee looking downstream. Fall 2015.

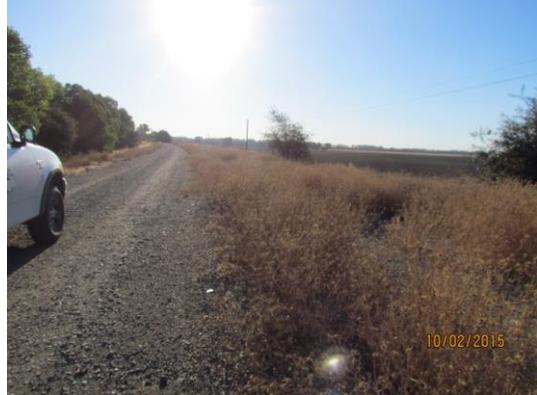
Photo 1 of 1 : FA\_2015\_NA0022\_350\_72\_20151005\_00071.jpg

LM Start	<b>0.73</b>	Rating **	M	Issue No.	<b>72</b>
LM End	<b>0.95</b>	Issue Type +	Ma	Location *	LS
Category	Earthen Levee		GPS Latitude/Longitude		
			Start	End	
Item	Vegetation		38.800949 °	38.800230 °	
			-121.712939 °	-121.709004 °	
DWR ID	DWR_NA0022_01_f_2015_72				
Action/Comments					
Control annual grass and weeds on the levee slopes and easements.

View of the vegetation on the landward side of the levee looking downstream. Fall 2015.

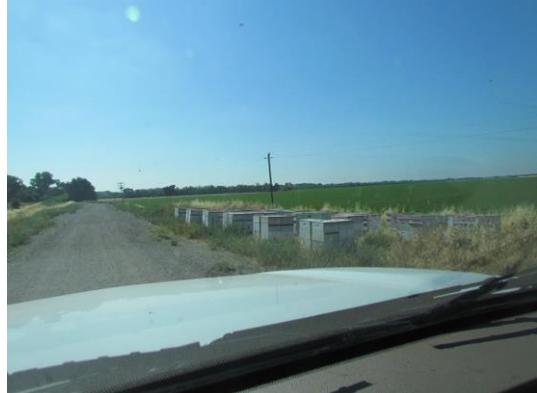
Photo 1 of 1 : FA\_2015\_NA0022\_350\_73\_20150914\_00049.jpg

LM Start	<b>0.84</b>	Rating **	M	Issue No.	<b>73</b>
LM End	<b>1.67</b>	Issue Type +	En	Location *	LS
Category	Earthen Levee		GPS Latitude/Longitude		
			Start	End	
Item	Encroachments		38.800500 °	38.799074 °	
			-121.710990 °	-121.698341 °	
DWR ID	DWR_NA0022_01_s_2015_73				
Action/Comments					
Building Inspector Comments: There are beehives on the landward side of the levee.

View of the beehives on the landward side of the levee looking downstream. Spring 2015.

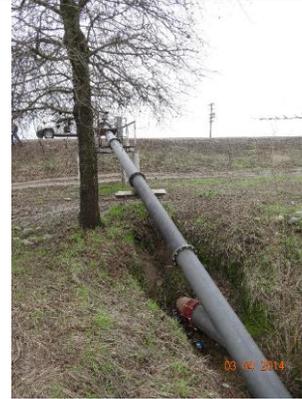
Photo 2 of 3 : UCIP\_FA\_2015\_4163.jpg

Pipe located on waterward side.

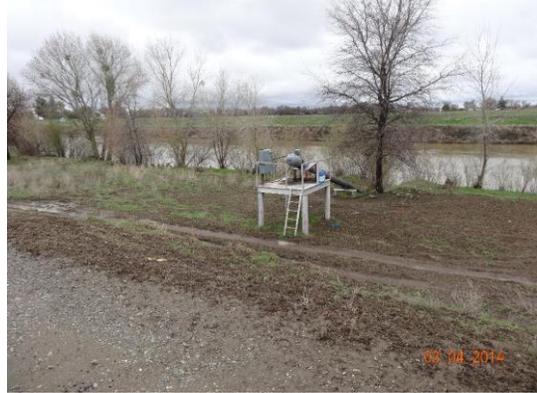
Photo 3 of 3 : UCIP\_FA\_2015\_4164.jpg

LM Start	<b>0.93</b>	Rating **	M	Issue No.	<b>409 (cont)</b>
LM End	<b>0.93</b>	Issue Type +	En	Location *	LS
Category	Supplemental			GPS Latitude/Longitude	
				Start	End
Item	DWR UCIP Field Study			38.800200 °	38.800200 °
				-121.709258 °	-121.709258 °
DWR ID					
Action/Comments					
Inspector Comments: FS_ID:31969 DS_ID:19540 EP_NO: N/A FS_HLM: 0.95 Repair Type: Non-Urgent Crossing Status: Found

View of waterward side.

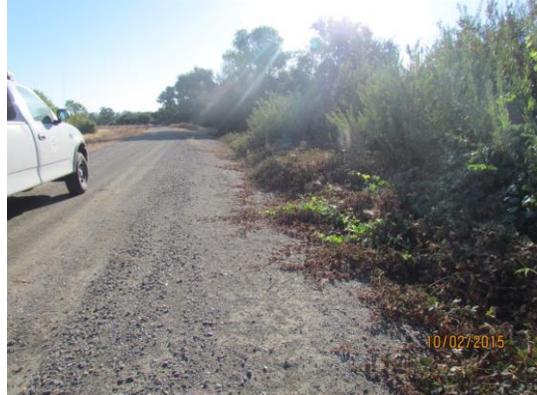
Photo 1 of 1 : FA\_2015\_NA0022\_350\_21\_20151005\_00072.jpg

LM Start	<b>0.95</b>	Rating **	U	Issue No.	<b>21</b>
LM End	<b>1.12</b>	Issue Type +	Ma	Location *	LS
Category	Earthen Levee			GPS Latitude/Longitude	
				Start	End
Item	Vegetation			38.800188 °	38.800577 °
				-121.708918 °	-121.705830 °
DWR ID	DWR_NA0022_01_s_2012_21				
Action/Comments					
Remove the wild growth other than native grasses from the levee slopes. Inspector Comments: Vegetation completely blocks visibility on the landward slope.

View of the vegetation on the landward side of the levee looking downstream. Fall 2015.

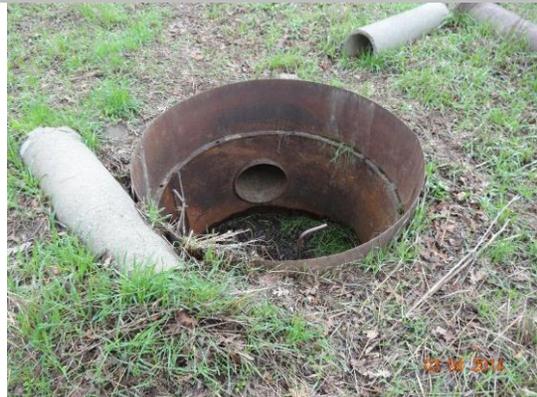
Photo 2 of 3 : UCIP\_FA\_2015\_3854.jpg

Riser on landward toe.

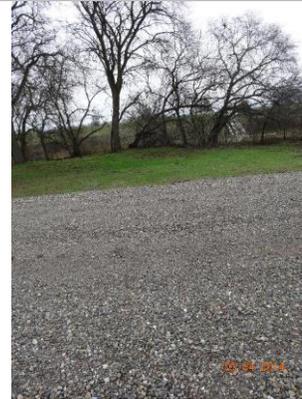
Photo 1 of 3 : UCIP\_FA\_2015\_4844.jpg

LM Start	<b>1.75</b>	Rating **	M	Issue No.	<b>411</b>
LM End	<b>1.75</b>	Issue Type +	En	Location *	LS
Category	Supplemental			GPS Latitude/Longitude	
				Start	End
Item	DWR UCIP Field Study			38.797928 °	38.797928 °
				-121.697992 °	-121.697992 °
DWR ID					
Action/Comments					
Inspector Comments: FS_ID:38190 DS_ID:19539 EP_NO: N/A FS_HLM: 1.78 Repair Type: Non-Urgent Crossing Status: Indicator Found UCIP Comments: Need to contact owner to determine status of crossing. FIELD_STRUCTURE_DESC: Abandoned 12-inch (not 18-inch as mentioned in USACE O&M manual) CM drain pipe through the levee. Gate valve in pumphouse on waterward side. (USACE-1953). This entry matches the Drainage or Irrigation Structure referenced in O&M manual (Station 224+3.5). Drain pipe was abandoned prior to 1968. FS Date: 03/04/2014

View of waterward side.

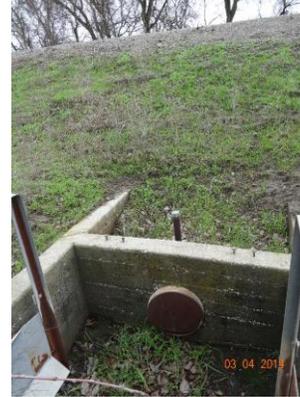
Photo 2 of 3 : UCIP\_FA\_2015\_4845.jpg

LM Start	1.75	Rating **	M	Issue No.	411 (cont)
LM End	1.75	Issue Type +	En	Location *	LS
Category	Supplemental			GPS Latitude/Longitude	
				Start	End
Item	DWR UCIP Field Study			38.797928 °	38.797928 °
				-121.697992 °	-121.697992 °
DWR ID					
Action/Comments					
Inspector Comments: FS_ID:38190 DS_ID:19539 EP_NO: N/A FS_HLM: 1.78 Repair Type: Non-Urgent Crossing Status: Indicator Found UCIP Comments: Need to contact owner to determine status of crossing. FIELD_STRUCT_DESC: Abandoned 12-inch (not 18-inch as mentioned in USACE O&M manual) CM drain pipe through the levee. Gate valve in pumphouse on waterward side. (USACE-1953). This entry matches the Drainage or Irrigation Structure referenced in O&M manual (Station 224+3.5). Drain pipe was abandoned prior to 1968. FS Date: 03/04/2014

Concrete box located on landward toe.

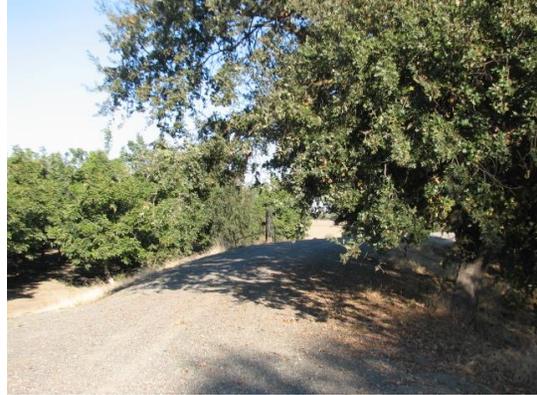
Photo 1 of 1 : FA\_2015\_NA0022\_350\_9\_20150914\_00011.jpg

LM Start	<b>1.80</b>	Rating **	M	Issue No.	<b>9</b>
LM End	<b>1.80</b>	Issue Type +	Ma	Location *	CR
Category	Earthen Levee		GPS Latitude/Longitude		
			Start	End	
Item	Trim / Thin Trees		38.797228 °	38.797228 °	
			-121.697577 °	-121.697577 °	
DWR ID	DWR_NA0022_01_f_2013_9				
Action/Comments					
Trim trees over roadway to at least 12 feet above ground level.

Trees need to be trimmed up to 12 feet above the crown. Fall 2013

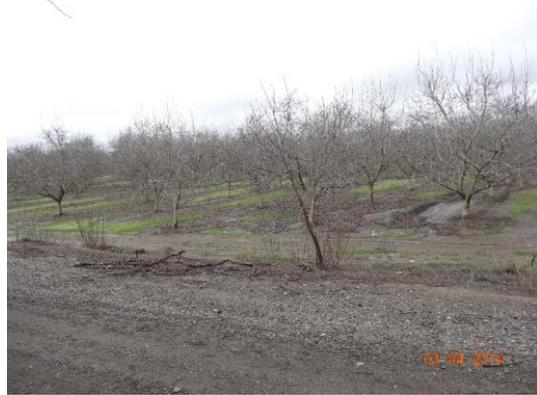
Photo 3 of 3 : UCIP\_FA\_2015\_3958.jpg

View of landward side.

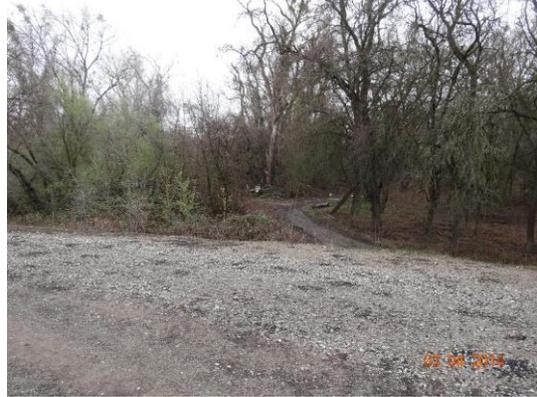
Photo 2 of 3 : UCIP\_FA\_2015\_3036.jpg

View of waterward side.

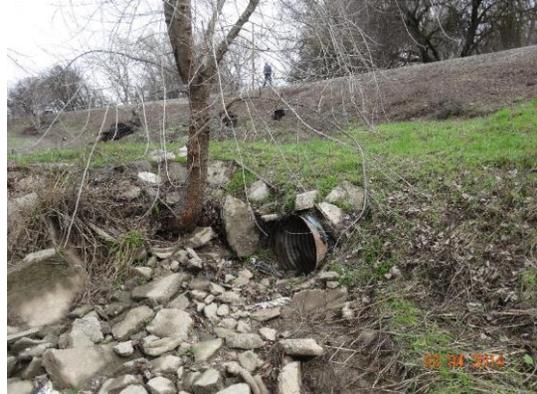
Photo 3 of 3 : UCIP\_FA\_2015\_3037.jpg

Outlet located on landward toe.

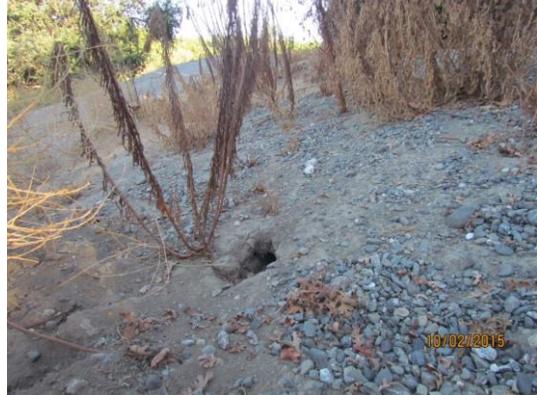
Photo 1 of 1 : FA\_2015\_NA0022\_350\_8\_20151005\_00074.jpg

LM Start	<b>2.14</b>	Rating **	M	Issue No.	<b>8</b>
LM End	<b>2.14</b>	Issue Type +	Ma	Location *	LS
Category	Earthen Levee		GPS Latitude/Longitude		
			Start	End	
Item	Animal Control		38.792956 °	38.792956 °	
			-121.696025 °	-121.696025 °	
DWR ID	DWR_NA0022_01_s_2012_8				
Action/Comments					
No rodents visible, but rodent burrows visible; need to backfill and compact or grout burrows.

View of the rodent hole on the landward side of the levee looking downstream. Fall 2015.

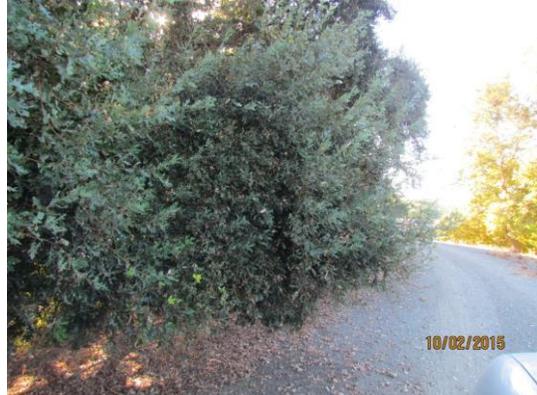
Photo 1 of 1 : FA\_2015\_NA0022\_350\_91\_20151005\_00075.jpg

LM Start	<b>2.14</b>	Rating **	M	Issue No.	<b>91</b>
LM End	<b>2.16</b>	Issue Type +	Ma	Location *	WS
Category	Earthen Levee		GPS Latitude/Longitude		
			Start	End	
Item	Trim / Thin Trees		38.792942 °	38.792670 °	
			-121.696033 °	-121.695798 °	
DWR ID	DWR_NA0022_01_f_2015_91				
Action/Comments					
Trim trees to at least five feet above ground level.

View of the trees on the waterward side of the levee looking downstream. Fall 2015.

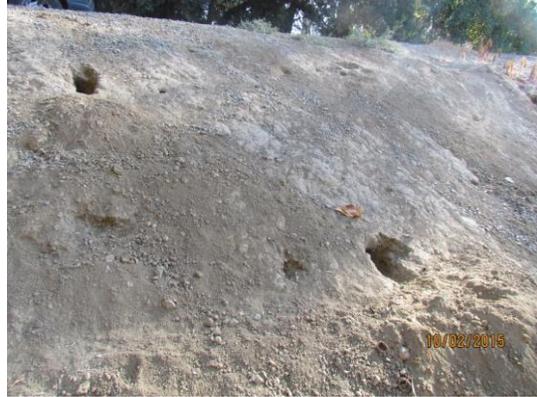
Photo 2 of 2 : FA\_2015\_NA0022\_350\_92\_20151005\_00079.jpg

LM Start	<b>2.16</b>	Rating **	U	Issue No.	<b>92 (cont)</b>
LM End	<b>2.16</b>	Issue Type +	Ma	Location *	LS
Category	Earthen Levee		GPS Latitude/Longitude		
			Start	End	
Item	Animal Control		38.792692 °	38.792692 °	
			-121.695833 °	-121.695833 °	
DWR ID	DWR_NA0022_01_f_2015_92				
Action/Comments					
No rodents visible, but rodent burrows visible; need to backfill and compact or grout burrows.

View of multiple rodent burrows on the landward side of the levee. Fall 2015.

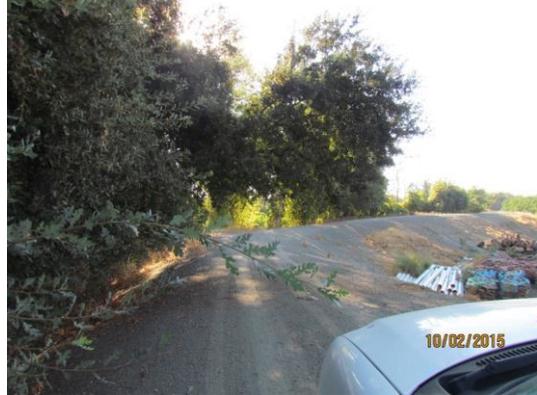
Photo 1 of 1 : FA\_2015\_NA0022\_350\_25\_20151005\_00076.jpg

LM Start	<b>2.17</b>	Rating **	M	Issue No.	<b>25</b>
LM End	<b>2.17</b>	Issue Type +	Ma	Location *	CR
Category	Earthen Levee		GPS Latitude/Longitude		
			Start	End	
Item	Trim / Thin Trees		38.792652 °	38.792652 °	
			-121.695742 °	-121.695742 °	
DWR ID	DWR_NA0022_01_s_2014_25				
Action/Comments					
Trim trees to at least five feet above ground level.

View of the tree branch above the crown of the levee looking downstream. Fall 2015.

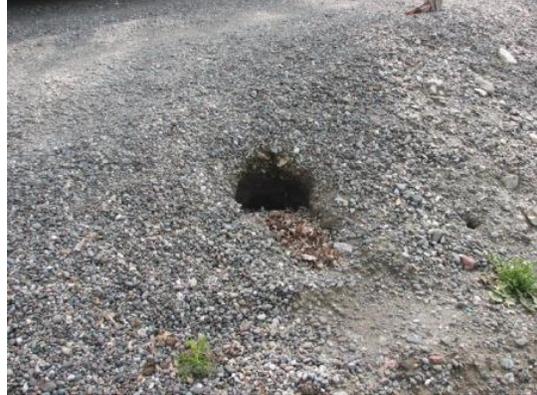
Photo 1 of 1 : FA\_2015\_NA0022\_350\_35\_20150914\_00033.jpg

LM Start	<b>2.19</b>	Rating **	M	Issue No.	<b>35</b>
LM End	<b>2.19</b>	Issue Type +	Ma	Location *	LS
Category	Earthen Levee			GPS Latitude/Longitude	
				Start	End
Item	Animal Control			38.792428 °	38.792428 °
				-121.695495 °	-121.695495 °
DWR ID	DWR_NA0022_01_s_2012_35				
Action/Comments					
No rodents visible, but rodent burrows visible; need to backfill and compact or grout burrows.

A rodent hole needs to be backfilled and compacted.

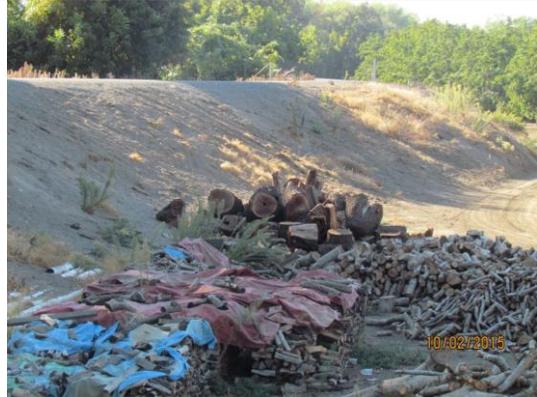
Photo 1 of 1 : FA\_2015\_NA0022\_350\_39\_20151005\_00081.jpg

LM Start	<b>2.20</b>	Rating **	M	Issue No.	<b>39</b>
LM End	<b>2.20</b>	Issue Type +	Ma	Location *	LS
Category	Earthen Levee			GPS Latitude/Longitude	
				Start	End
Item	Encroachments			38.792283 °	38.792283 °
				-121.695447 °	-121.695447 °
DWR ID	DWR_NA0022_01_s_2012_39				
Action/Comments					
Firewood Inspector Comments: Firewood are placed at the levee toe.

View of the growing firewood at the toe of the landward side of the levee looking downstream. Fall 2015.

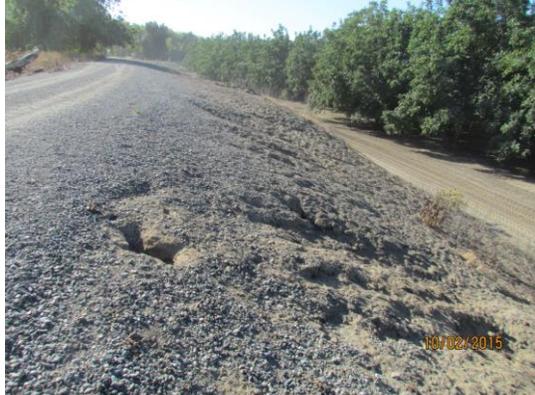
Photo 1 of 2 : FA\_2015\_NA0022\_350\_94\_20151005\_00083.jpg

LM Start	<b>2.25</b>	Rating **	M	Issue No.	<b>94</b>
LM End	<b>2.25</b>	Issue Type +	Ma	Location *	LS
Category	Earthen Levee		GPS Latitude/Longitude		
			Start	End	
Item	Erosion / Bank Caving		38.791556 °	38.791556 °	
			-121.695361 °	-121.695361 °	
DWR ID	DWR_NA0022_01_f_2015_94				
Action/Comments					
Schedule repair of erosion site prior to the next inspection.

View of the erosion on the landward side of the levee looking downstream. Fall 2015.

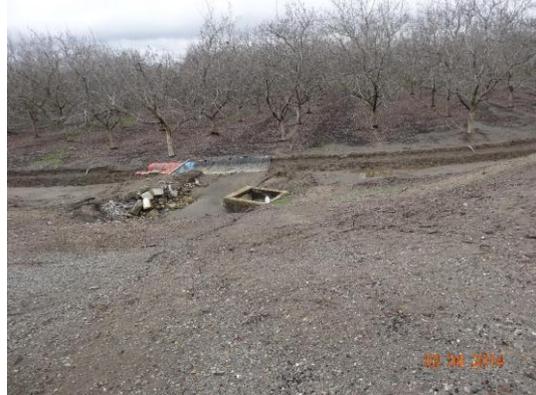
Photo 3 of 3 : UCIP\_FA\_2015\_3040.jpg

Item	DWR UCIP Field Study			38.790260 °	38.790260 °	
				-121.694510 °	-121.694510 °	
DWR ID						
Action/Comments						
Inspector Comments: FS_ID:31634 DS_ID:19525 EP_NO: N/A FS_HLM: 2.38 Repair Type: Urgent Crossing Status: Indicator Found UCIP Comments: Surface erosion near concrete box on landward side. Unable to determine if crossing is leaking or if pump is pulling sand from waterward side. Need to contact owner to determine status of crossing and to check integrity of crossing. FIELD_STRUCT_DESC: 16-inch steel drain pipe through the levee, 4-feet below the crown. Concrete well and pumphouse on waterward side. Screw gate in pumphouse. Slant pump mounted on steel structure on the waterward bank, installed under Permit No. 5951 (1967). Concrete discharge box (4x4-foot) at toe of landward slope. Overhead powerline and anchor crosses levee. Pole on both shoulders. (USACE-1953). This entry matches the Drainage or Irrigation Structure referenced in O&M manual (Station 192+60). FS Date: 03/04/2014

View of landward toe.

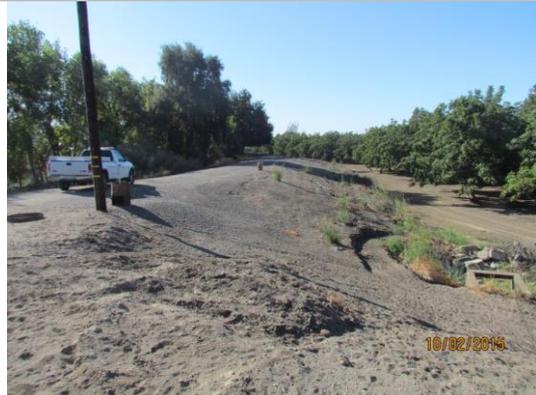
Photo 1 of 3 : FA\_2015\_NA0022\_350\_96\_20151005\_00089.jpg

LM Start	2.35	Rating **	U	Issue No.	96	
LM End	2.35	Issue Type +	En	Location *	LS	
Category	Earthen Levee			GPS Latitude/Longitude		
			Start	End		
Item	Encroachments			38.790206 °	38.790206 °	
				-121.694534 °	-121.694534 °	
DWR ID	DWR_NA0022_01_f_2015_96					
Action/Comments						
Pipe Inspector Comments: There seems to be an erosion around the concrete box encasing the pipe.

Perspective view of the erosion around the pipe on the landward side of the levee looking downstream. Fall 2015.

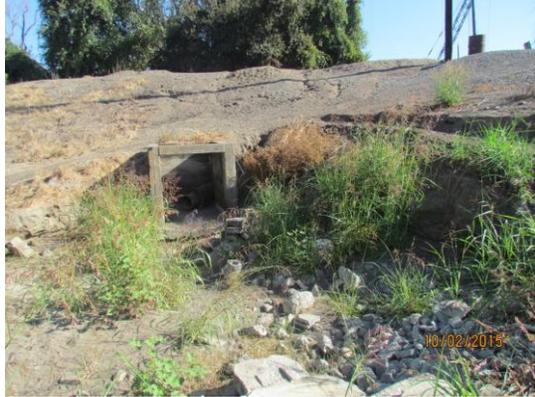
Photo 2 of 3 : FA\_2015\_NA0022\_350\_96\_20151005\_00091.jpg

LM Start	<b>2.35</b>	Rating **	U	Issue No.	<b>96 (cont)</b>
LM End	<b>2.35</b>	Issue Type +	En	Location *	LS
Category	Earthen Levee		GPS Latitude/Longitude		
			Start	End	
Item	Encroachments		38.790206 °	38.790206 °	
			-121.694534 °	-121.694534 °	
DWR ID	DWR_NA0022_01_f_2015_96				
Action/Comments					
Pipe Inspector Comments: There seems to be an erosion around the concrete box encasing the pipe.

The erosion is within the levee prism. Fall 2015.

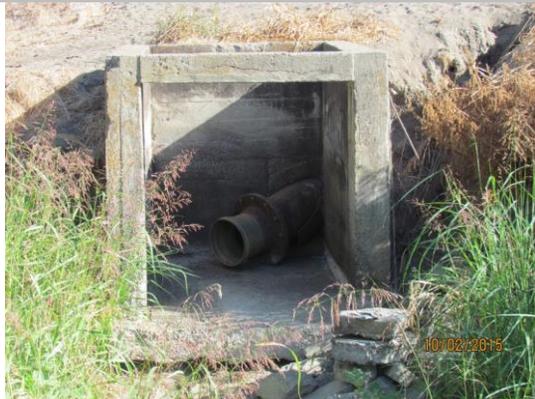
Photo 3 of 3 : FA\_2015\_NA0022\_350\_96\_20151005\_00092.jpg

LM Start	<b>2.35</b>	Rating **	U	Issue No.	<b>96 (cont)</b>
LM End	<b>2.35</b>	Issue Type +	En	Location *	LS

View of the pipe in the concrete box. Fall 2015.

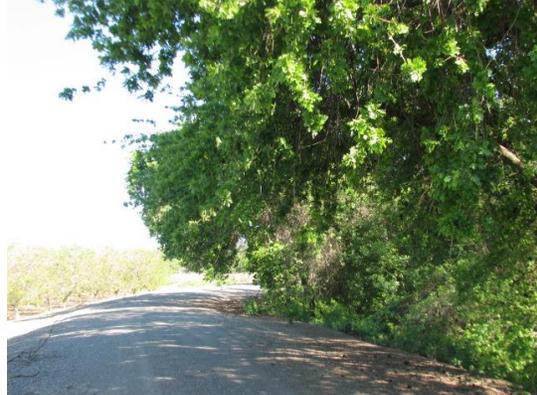
Photo 1 of 1 : FA\_2015\_NA0022\_350\_32\_20150914\_00032.jpg

LM Start	<b>2.43</b>	Rating **	M	Issue No.	<b>32</b>
LM End	<b>2.43</b>	Issue Type +	Ma	Location *	CR
Category	Earthen Levee		GPS Latitude/Longitude		
			Start	End	
Item	Trim / Thin Trees		38.789111 °	38.789111 °	
			-121.694462 °	-121.694462 °	
DWR ID	DWR_NA0022_01_s_2014_32				
Action/Comments					
Trim trees over roadway to at least 12 feet above ground level.

Trees need to be trimmed up to at least 12 feet above the crown. Spring 2014

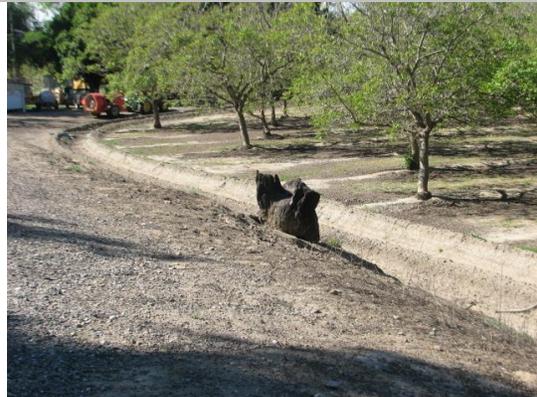
Photo 1 of 1 : FA\_2015\_NA0022\_350\_37\_20150914\_00037.jpg

LM Start	<b>2.50</b>	Rating **	U	Issue No.	<b>37</b>
LM End	<b>2.50</b>	Issue Type +	Ma	Location *	LS
Category	Earthen Levee		GPS Latitude/Longitude		
			Start	End	
Item	Trim / Thin Trees		38.788062 °	38.788062 °	
			-121.694244 °	-121.694244 °	
DWR ID	DWR_NA0022_01_s_2014_37				
Action/Comments					
Tree stumps.

Tree stump decomposing and may pose a risk to the levee. Spring 2014

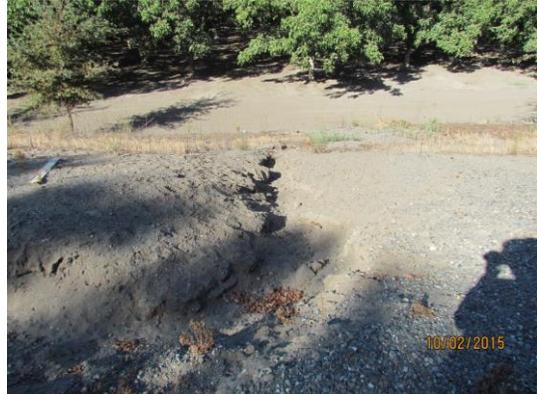
Photo 2 of 2 : FA\_2015\_NA0022\_350\_87\_20151005\_00095.jpg

LM Start	<b>2.67</b>	Rating **	M	Issue No.	<b>87</b>
LM End	<b>2.67</b>	Issue Type +	Ma	Location *	LS
Category	Earthen Levee			GPS Latitude/Longitude	
				Start	End
Item	Erosion / Bank Caving			38.785613 °	38.785613 °
				-121.694266 °	-121.694266 °
DWR ID	DWR_NA0022_01_s_2012_87				
Action/Comments					
Schedule repair of erosion site prior to the next inspection.

LM Start	<b>2.67</b>	Rating **	M	Issue No.	<b>87 (cont)</b>
LM End	<b>2.67</b>	Issue Type +	Ma	Location *	LS

The erosion runs down to the landward side toe. Fall 2015.

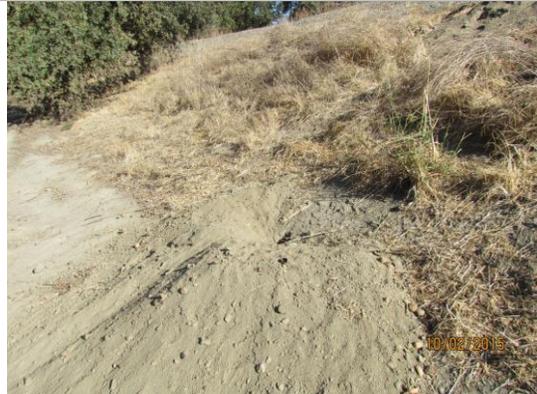
Photo 1 of 2 : FA\_2015\_NA0022\_350\_52\_20151005\_00096.jpg

LM Start	<b>2.87</b>	Rating **	U	Issue No.	<b>52</b>
LM End	<b>2.87</b>	Issue Type +	Ma	Location *	LS
Category	Earthen Levee			GPS Latitude/Longitude	
				Start	End
Item	Animal Control			38.783571 °	38.783571 °
				-121.692110 °	-121.692110 °
DWR ID	DWR_NA0022_01_f_2013_52				
Action/Comments					
Exterminate rodents and backfill and compact or grout burrows.

View of the rodent hole and material on the landward side of the levee. Fall 2015.

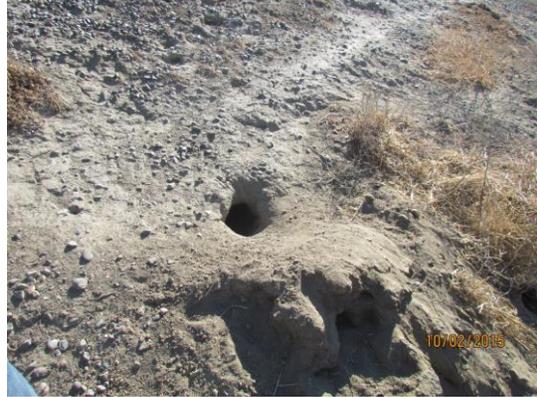
Photo 2 of 2 : FA\_2015\_NA0022\_350\_52\_20151005\_00098.jpg

LM Start	<b>2.87</b>	Rating **	U	Issue No.	<b>52 (cont)</b>
LM End	<b>2.87</b>	Issue Type +	Ma	Location *	LS
Category	Earthen Levee			GPS Latitude/Longitude	
				Start	End
Item	Animal Control			38.783571 °	38.783571 °
				-121.692110 °	-121.692110 °
DWR ID	DWR_NA0022_01_f_2013_52				
Action/Comments					
Exterminate rodents and backfill and compact or grout burrows.

There are multiple rodent holes in this area. Fall 2015.

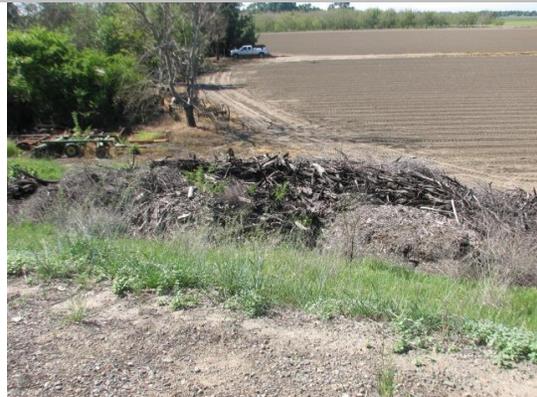
Photo 1 of 1 : FA\_2015\_NA0022\_350\_42\_20150914\_00042.jpg

LM Start	<b>3.02</b>	Rating **	M	Issue No.	<b>42</b>
LM End	<b>3.02</b>	Issue Type +	En	Location *	LS
Category	Earthen Levee			GPS Latitude/Longitude	
				Start	End
Item	Encroachments			38.782239 °	38.782239 °
				-121.690037 °	-121.690037 °
DWR ID	DWR_NA0022_01_s_2014_42				
Action/Comments					
Prunings

A large pruning pile near the toe of the levee. Spring 2014

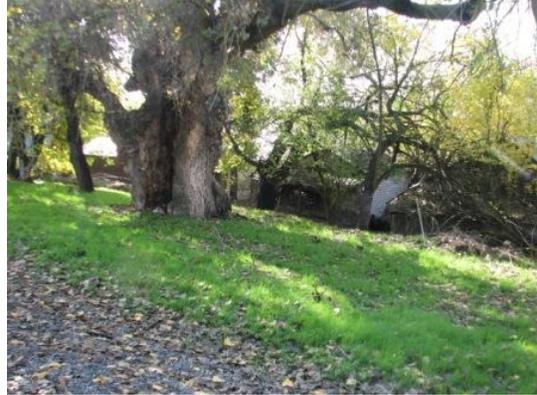
Photo 1 of 2 : FA\_2015\_NA0022\_350\_12\_20150914\_00013.jpg

LM Start	<b>3.06</b>	Rating **	A/W	Issue No.	<b>12</b>
LM End	<b>3.14</b>	Issue Type +	En	Location *	LS
Category	Earthen Levee		GPS Latitude/Longitude		
			Start	End	
Item	Encroachments		38.781828 °	38.780852 °	
			-121.689415 °	-121.688887 °	
DWR ID	DWR_NA0022_01_s_2012_12				
Action/Comments					
Building

Buildings are located at the toe of the levee. Fall 2012

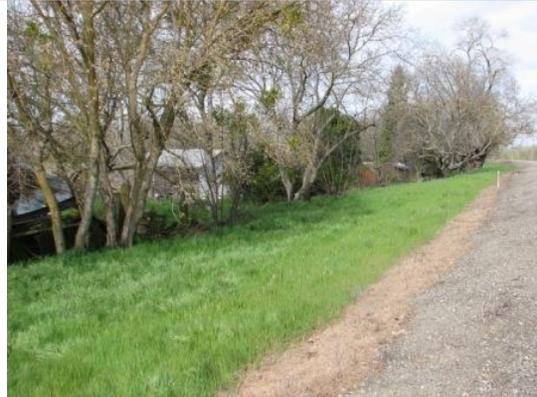
Photo 2 of 2 : FA\_2015\_NA0022\_350\_12\_20150914\_00014.jpg

LM Start	<b>3.06</b>	Rating **	A/W	Issue No.	<b>12 (cont)</b>
LM End	<b>3.14</b>	Issue Type +	En	Location *	LS

The buildings are encroaching into the levee slope.

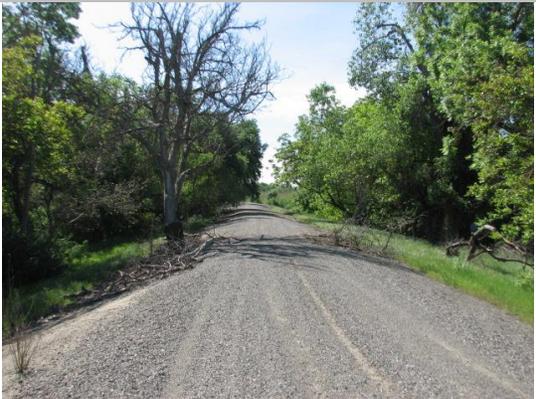
Photo 1 of 1 : FA\_2015\_NA0022\_350\_43\_20150914\_00043.jpg

LM Start	<b>3.07</b>	Rating **	A/W	Issue No.	<b>43</b>
LM End	<b>3.07</b>	Issue Type +	Ma	Location *	WS
Category	Earthen Levee		GPS Latitude/Longitude		
			Start	End	
Item	Vegetation		38.781701 °	38.781701 °	
			-121.689357 °	-121.689357 °	
DWR ID	DWR_NA0022_01_s_2014_43				
Action/Comments					
Trees / Woody Vegetation

A tree is dying and needs to be monitored as it may pose a threat to the levee. Spring 2014

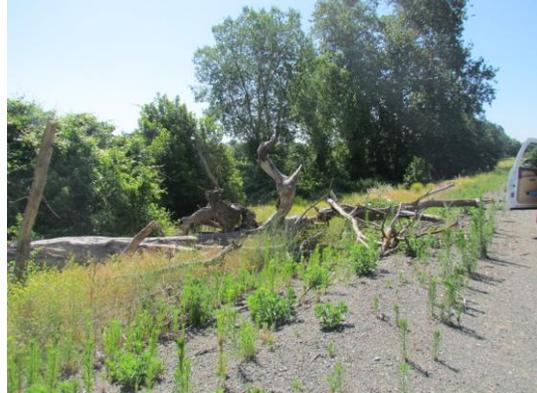
Photo 1 of 2 : FA\_2015\_NA0022\_350\_47\_20150914\_00047.jpg

LM Start	<b>3.14</b>	Rating **	M	Issue No.	<b>47</b>
LM End	<b>3.14</b>	Issue Type +	En	Location *	WS
Category	Earthen Levee		GPS Latitude/Longitude		
			Start	End	
Item	Encroachments		38.780857 °	38.780857 °	
			-121.688921 °	-121.688921 °	
DWR ID	DWR_NA0022_01_s_2015_47				
Action/Comments					
Tree or limb Inspector Comments: The tree has fallen over from Spring 2014.

View of the fallen tree on the waterward side of the levee looking downstream. Spring 2015.

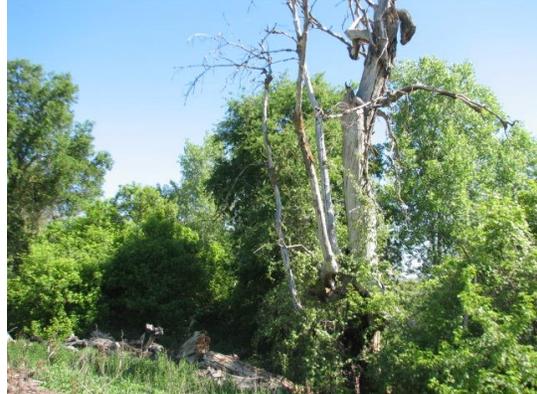
Photo 2 of 2 : FA\_2015\_NA0022\_350\_47\_20150914\_00048.jpg

LM Start	<b>3.14</b>	Rating **	M	Issue No.	<b>47 (cont)</b>
LM End	<b>3.14</b>	Issue Type +	En	Location *	WS

Some trees have fallen and others are dying and need to be monitored. The trees may pose a threat to the levee. Spring 2014

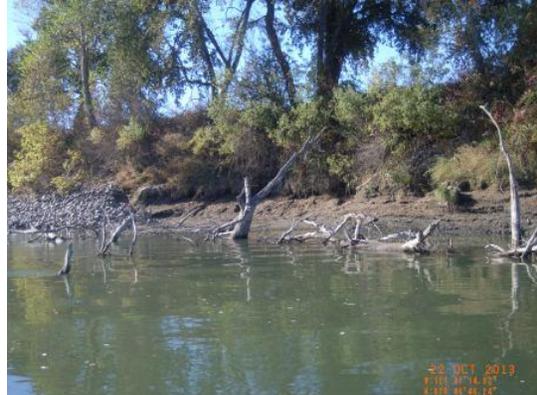
Photo 1 of 1 : USACE2013A\_SAC\_86-9\_R\_5.jpg

LM Start	<b>3.18</b>	Rating **	M	Issue No.	<b>5</b>
LM End	<b>3.28</b>	Issue Type +	Ma	Location *	WS
Category	Supplemental		GPS Latitude/Longitude		
			Start	End	
Item	2015 USACE Erosion Survey, DRAFT		38.780407 °	38.779137 °	
			-121.688238 °	-121.687432 °	
DWR ID					
Action/Comments					
Inspector Comments: 2006 - Short section is into the levee toe, rest is near the levee toe. Mass failure and fluvial erosion of depositional material. Rock at the upstream and downstream ends. 2011 - Minor new erosion. 2012 - Slope continues to steepen, tree roots have become exposed, and new eddy formed. 2015: No observed changes. [2015 Site ID: SAC_86-9_R]

USACE 2013 Photo #1

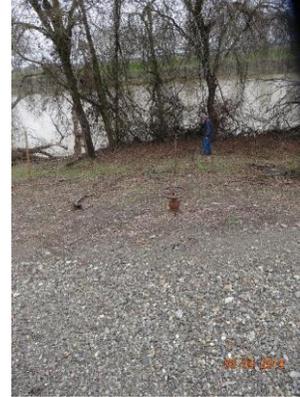
Photo 2 of 3 : UCIP\_FA\_2015\_6529.jpg

LM Start	<b>3.23</b>	Rating **	M	Issue No.	<b>416 (cont)</b>
LM End	<b>3.23</b>	Issue Type +	En	Location *	WS
Category	Supplemental			GPS Latitude/Longitude	
				Start	End
Item	DWR UCIP Field Study			38.779625 °	38.779625 °
				-121.688090 °	-121.688090 °
DWR ID					
Action/Comments					
Inspector Comments: FS_ID:39858 DS_ID:19526 EP_NO: 3205 FS_HLM: 3.289 Repair Type: Non-Urgent Crossing Status: Found UCIP Comments: Need to contact owner to determine status of crossing. If crossing is no longer used need to coordinate with CVFPB for proper abandonment. FIELD_STRUCT_DESC: 12-inch pipe through the levee, 4-feet below the crown. Pump on the waterward band. Gate valve on the waterward slope. Siphon breaker in 18-inch concrete pipe riser on the landward slope. 36-inch concrete standpipe at toe of landward slope. Metal cutoff wall installed. (Permit No. 3205-1959) FS Date: 03/04/2014

View of waterward side.

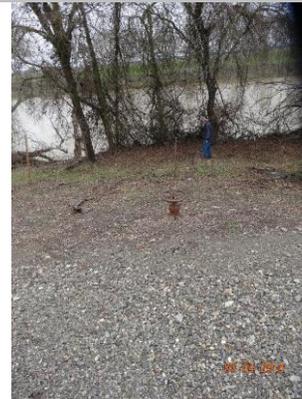
Photo 2 of 3 : UCIP\_FA\_2015\_3987.jpg

LM Start	<b>3.24</b>	Rating **	M	Issue No.	<b>417</b>
LM End	<b>3.24</b>	Issue Type +	En	Location *	WS
Category	Supplemental			GPS Latitude/Longitude	
				Start	End
Item	DWR UCIP Field Study			38.779543 °	38.779543 °
				-121.688170 °	-121.688170 °
DWR ID					
Action/Comments					
Inspector Comments: FS_ID:31916 DS_ID:19545 EP_NO: N/A FS_HLM: 3.29 Repair Type: Non-Urgent Crossing Status: Indicator Found

View of waterward side.

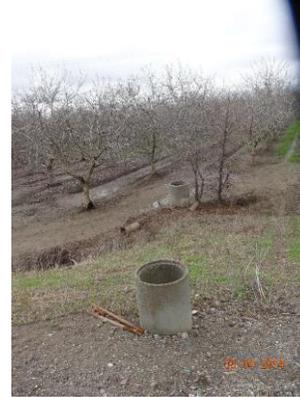
Photo 3 of 3 : UCIP\_FA\_2015\_3988.jpg

LM Start	<b>3.24</b>	Rating **	M	Issue No.	<b>417 (cont)</b>
LM End	<b>3.24</b>	Issue Type +	En	Location *	WS
Category	Supplemental			GPS Latitude/Longitude	
				Start	End
Item	DWR UCIP Field Study			38.779543 °	38.779543 °
				-121.688170 °	-121.688170 °
DWR ID					
Action/Comments					
Inspector Comments: FS_ID:31916 DS_ID:19545 EP_NO: N/A FS_HLM: 3.29 Repair Type: Non-Urgent Crossing Status: Indicator Found

View of landward side.

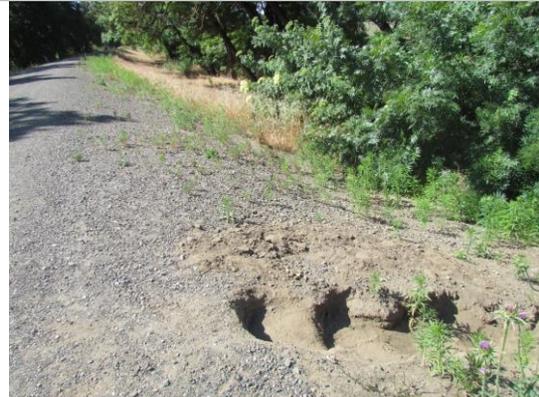
Photo 1 of 1 : FA\_2015\_NA0022\_350\_79\_20150914\_00052.jpg

LM Start	<b>3.41</b>	Rating **	M	Issue No.	<b>79</b>
LM End	<b>3.41</b>	Issue Type +	En	Location *	LS
Category	Earthen Levee			GPS Latitude/Longitude	
				Start	End
Item	Encroachments			38.777204 °	38.777204 °
				-121.687045 °	-121.687045 °
DWR ID	DWR_NA0022_01_s_2015_79				
Action/Comments					
Stairway

View of the stairs on the landward side of the levee looking downstream. Spring 2015.

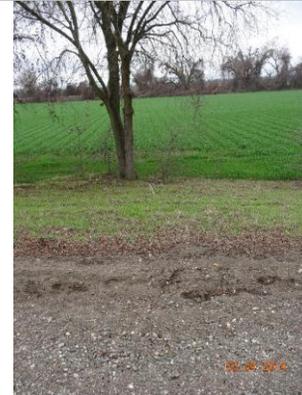
Photo 3 of 3 : UCIP\_FA\_2015\_4849.jpg

Item	DWR UCIP Field Study			38.775208 °	38.775208 °
				-121.687070 °	-121.687070 °
DWR ID					
Action/Comments					
Inspector Comments: FS_ID:38996 DS_ID:19528 EP_NO: 3722 FS_HLM: 3.59 Repair Type: Non-Urgent Crossing Status: Found UCIP Comments: Pipe visible only on waterward side--Pipe needs to be properly abandoned per Title 23. Need to contact owner to determine status of crossing. FIELD_STRUCT_DESC: Abandoned 10-inch steel drain pipe through the levee, 3.0 feet below the crown. 1-1/2 inch conduit 1 foot below the crown. Pump and gate valve on the waterward bank. Metal cutoff walls at centerline of levee. Siphon breaker on the landward shoulder in 12-inch concrete riser. Pipe connects to existing 24-inch concrete standpipe at landward toe. (Permit No. 3722-1961). No standpipe found on landward toe. FS Date: 03/04/2014

View of landward side.

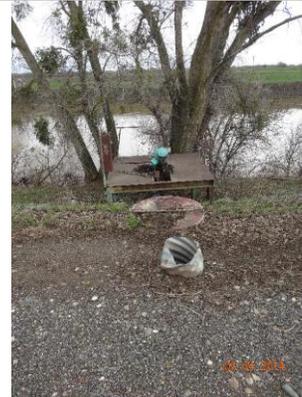
Photo 2 of 3 : UCIP\_FA\_2015\_3210.jpg

Item	DWR UCIP Field Study			38.770295 °	38.770295 °
				-121.692580 °	-121.692580 °
DWR ID					
<b>Action/Comments</b>					
Inspector Comments: FS_ID:38999 DS_ID:19529 EP_NO: 4570 FS_HLM: 4.08 Repair Type: Non-Urgent Crossing Status: Found UCIP Comments: Need to contact owner to determine status of crossing. CMP riser damage on waterward slope. FIELD_STRUCT_DESC: 16-inch drain pipe through the levee, 5.0 feet below the crown. Metal plate welded on the waterward end. Pump, 1-1/2-inch conduit, and gate valve in concrete U-headwall on waterward bank, installed under Permit 7618A (1971). Pipe extends from pump to concrete standpipe on the landward side, pipe exposed on the landward slope. Water meter in 36-inch CM pipe riser on the waterward slope. Siphon breaker on the landward shoulder, in 7-inch metal riser. 30-inch concrete riser at toe of landward slope. Metal cutoff wall installed. (Permit No. 4570-1964). FS Date: 03/04/2014

View of waterward side.

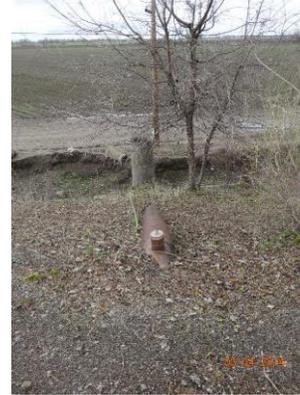
Photo 3 of 3 : UCIP\_FA\_2015\_3211.jpg

LM Start	<b>4.01</b>	Rating **	M	Issue No.	<b>420 (cont)</b>
LM End	<b>4.01</b>	Issue Type +	En	Location *	CR
Category	Supplemental			GPS Latitude/Longitude	
				Start	End
Item	DWR UCIP Field Study			38.770295 °	38.770295 °
				-121.692580 °	-121.692580 °
DWR ID					
Action/Comments					
Inspector Comments: FS_ID:38999 DS_ID:19529 EP_NO: 4570 FS_HLM: 4.08 Repair Type: Non-Urgent Crossing Status: Found

View of landward side.

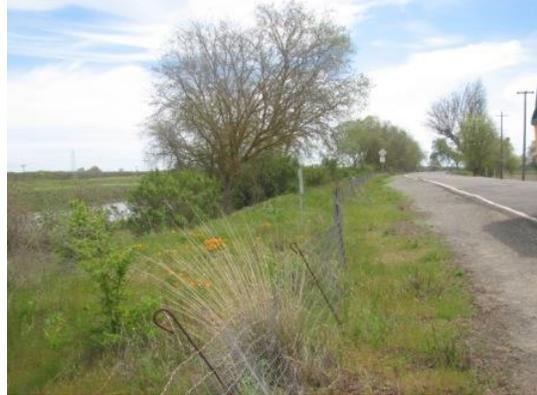
Photo 1 of 2 : FA\_2015\_NA0022\_350\_36\_20150914\_00035.jpg

LM Start	<b>4.25</b>	Rating **	A/W	Issue No.	<b>36</b>
LM End	<b>4.49</b>	Issue Type +	Ma	Location *	WS
Category	Earthen Levee			GPS Latitude/Longitude	
				Start	End
Item	Vegetation			38.767125 °	38.764582 °
				-121.693267 °	-121.690285 °
DWR ID	DWR_NA0022_01_s_2012_36				
Action/Comments					
Environmental Requirements.

Another view of the site.

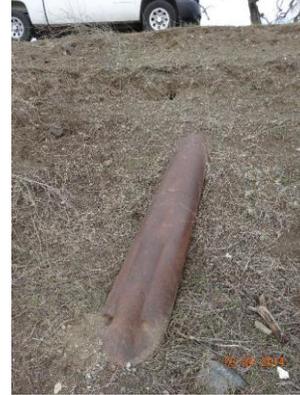
Photo 1 of 3 : UCIP\_FA\_2015\_4192.jpg

LM Start	<b>4.44</b>	Rating **	M	Issue No.	<b>421</b>
LM End	<b>4.44</b>	Issue Type +	En	Location *	WS
Category	Supplemental			GPS Latitude/Longitude	
				Start	End
Item	DWR UCIP Field Study			38.765142 °	38.765142 °
				-121.690963 °	-121.690963 °
DWR ID					
Action/Comments					
Inspector Comments: FS_ID:31986 DS_ID:19530 EP_NO: 9409 FS_HLM: 4.51 Repair Type: Non-Urgent Crossing Status: Found

Pipe through levee punctured visible on landward slope.

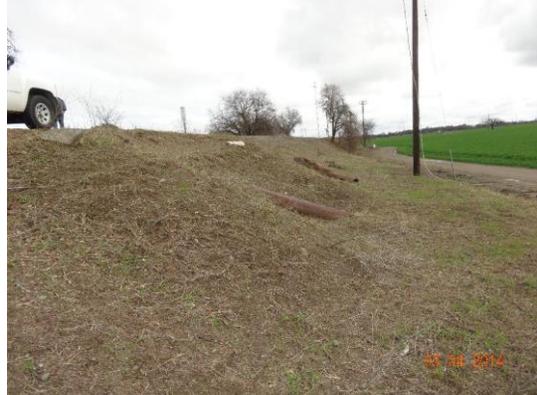
Photo 3 of 3 : UCIP\_FA\_2015\_4194.jpg

LM Start	<b>4.44</b>	Rating **	M	Issue No.	<b>421 (cont)</b>
LM End	<b>4.44</b>	Issue Type +	En	Location *	WS
Category	Supplemental			GPS Latitude/Longitude	
				Start	End
Item	DWR UCIP Field Study			38.765142 °	38.765142 °
				-121.690963 °	-121.690963 °
DWR ID					
Action/Comments					
Inspector Comments: FS_ID:31986 DS_ID:19530 EP_NO: 9409 FS_HLM: 4.51 Repair Type: Non-Urgent Crossing Status: Found

View of landward side.

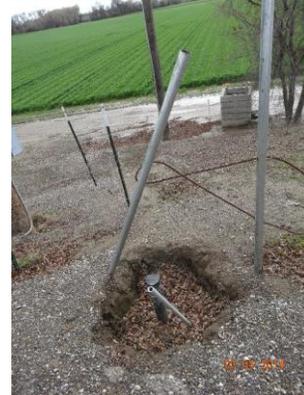
Photo 2 of 2 : UCIP\_FA\_2015\_4851.jpg

Item	DWR UCIP Field Study			38.764248 °	38.764248 °
				-121.689918 °	-121.689918 °
DWR ID					
Action/Comments					
Inspector Comments: FS_ID:42864 DS_ID:19537 EP_NO: 18298 FS_HLM: 4.6 Repair Type: Urgent Crossing Status: Found UCIP Comments: Subsidence visible where siphon breaker is located on landward side. Unable to determine if subsidence is due to poor compaction or leak at siphon breaker. Need to contact owner to address issue. FIELD_STRUCT_DESC: 14-inch steel water pipe through the levee, 2-feet below the levee crown. Supported by 6 pilings on waterside slope, extending into channel. Pump platform supported by steel structure on waterward side. Siphon breaker and air release valve on the landward shoulder. Concrete distribution box at landward toe. Rock riprap on the waterward slope. (Permit No. 18298-2007) FS Date: 03/04/2014

View of landward side--subsidence near levee crown.

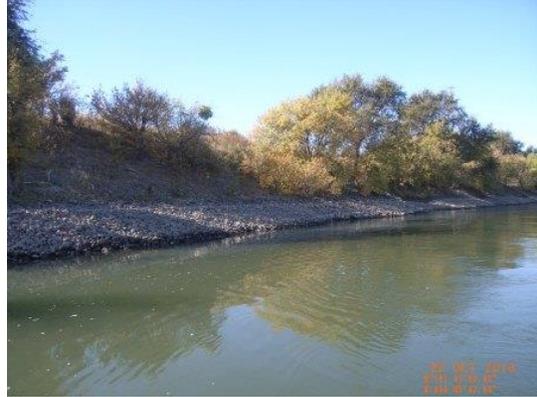
Photo 1 of 1 : USACE2013A\_SAC\_85-4\_R\_5.jpg

LM Start	<b>4.66</b>	Rating **	M	Issue No.	<b>3</b>
LM End	<b>4.86</b>	Issue Type +	Ma	Location *	WS
Category	Supplemental			GPS Latitude/Longitude	
				Start	End
Item	2015 USACE Erosion Survey, DRAFT			38.763486 °	38.763313 °
				-121.687567 °	-121.684038 °
DWR ID					
<b>Action/Comments</b>					
Inspector Comments: 2009 - Erosion into the levee toe. Some cobbles have been dumped into the erosion pockets. 2010 - Old cobble site starting to unravel. 2012 - Slope continues to steepen and new animal holes. 2013 - Downstream cobble is unraveling. 2015: No observed changes. [2015 Site ID: SAC_85-4_R]

USACE 2013 Photo #1

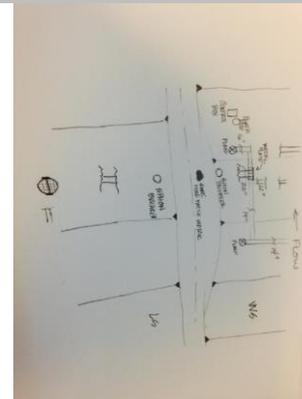
Photo 1 of 3 : UCIP\_FA\_2015\_4195.jpg

LM Start	<b>4.69</b>	Rating **	U	Issue No.	<b>423</b>
LM End	<b>4.69</b>	Issue Type +	En	Location *	WS
Category	Supplemental			GPS Latitude/Longitude	
				Start	End
Item	DWR UCIP Field Study			38.763087 °	38.763087 °
				-121.687125 °	-121.687125 °
DWR ID					
<b>Action/Comments</b>					
Inspector Comments: FS_ID:42865 DS_ID:19531 EP_NO: N/A FS_HLM: 4.77 Repair Type: Urgent Crossing Status: Found UCIP Comments: Signs of sink hole repair on levee crown. Owner will need to contact CVFPB to address sink hole repair. FIELD_STRUCT_DESC: 20-inch steel pipe through the levee, 4.7 feet below the crown. Two slant pumps on the waterward slope. No control valves. Ramp on landward slope. (ABO Permit No. 9408-1974). FS Date: 03/04/2014

Plan view of crossing and appurtenances at levee mile 4.77.

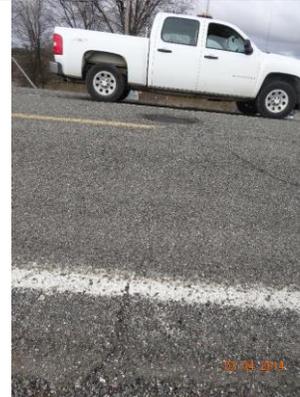
Photo 2 of 3 : UCIP\_FA\_2015\_4196.jpg

LM Start	<b>4.69</b>	Rating **	U	Issue No.	<b>423 (cont)</b>
LM End	<b>4.69</b>	Issue Type +	En	Location *	WS
Category	Supplemental			GPS Latitude/Longitude	
				Start	End
Item	DWR UCIP Field Study			38.763087 °	38.763087 °
				-121.687125 °	-121.687125 °
DWR ID					
Action/Comments					
Inspector Comments: FS_ID:42865 DS_ID:19531 EP_NO: N/A FS_HLM: 4.77 Repair Type: Urgent Crossing Status: Found UCIP Comments: Signs of sink hole repair on levee crown. Owner will need to contact CVFPB to address sink hole repair. FIELD_STRUCT_DESC: 20-inch steel pipe through the levee, 4.7 feet below the crown. Two slant pumps on the waterward slope. No control valves. Ramp on landward slope. (ABO Permit No. 9408-1974). FS Date: 03/04/2014

View of levee crown. Signs of sink hole repair along pipe alignment.

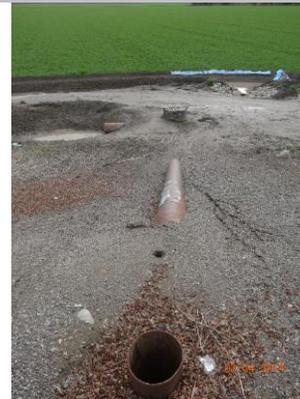
Photo 3 of 3 : UCIP\_FA\_2015\_4197.jpg

View of landward side.

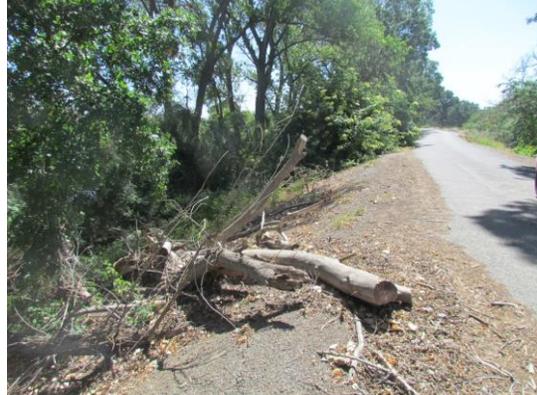
Photo 1 of 1 : FA\_2015\_NA0022\_350\_82\_20150914\_00054.jpg

LM Start	<b>5.50</b>	Rating **	M	Issue No.	<b>82</b>
LM End	<b>5.50</b>	Issue Type +	En	Location *	WS
Category	Earthen Levee		GPS Latitude/Longitude		
			Start	End	
Item	Encroachments		38.759594 °	38.759594 °	
			-121.673860 °	-121.673860 °	
DWR ID	DWR_NA0022_01_s_2015_82				
Action/Comments					
Tree or limb Inspector Comments: A tree fell over on the waterward side of the levee.

View of the fallen tree on the waterward side of the levee looking downstream. Spring 2015.

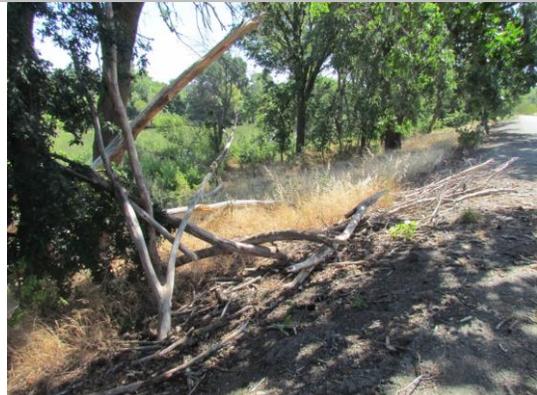
Photo 1 of 1 : FA\_2015\_NA0022\_350\_83\_20150914\_00055.jpg

LM Start	<b>5.56</b>	Rating **	M	Issue No.	<b>83</b>
LM End	<b>5.56</b>	Issue Type +	En	Location *	WS
Category	Earthen Levee		GPS Latitude/Longitude		
			Start	End	
Item	Encroachments		38.759339 °	38.759339 °	
			-121.672863 °	-121.672863 °	
DWR ID	DWR_NA0022_01_s_2015_83				
Action/Comments					
Tree or limb Inspector Comments: Prunings and fallen tree are on the waterward side of the levee.

View of the tree and tree limbs on the waterward side of the levee looking downstream. Spring 2015.

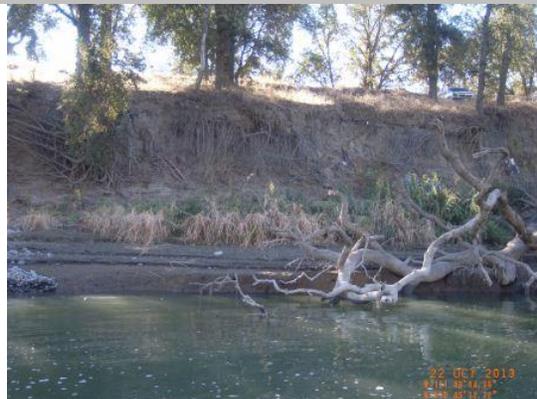
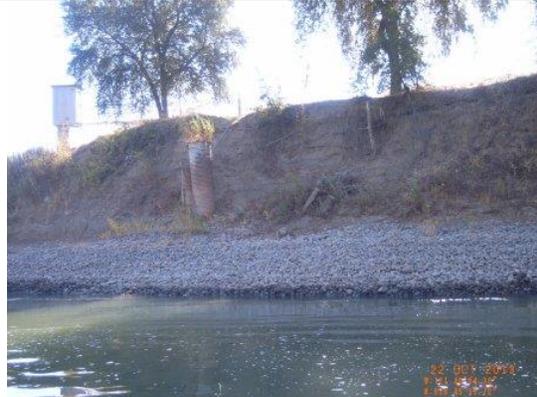
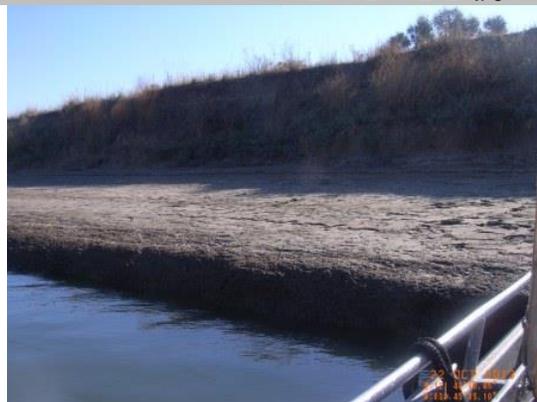
LM Start	<b>5.67</b>	Rating **	M	Issue No.	<b>4</b>
LM End	<b>5.85</b>	Issue Type +	Ma	Location *	WS
Category	Supplemental		GPS Latitude/Longitude		
			Start	End	
Item	2015 USACE Erosion Survey, DRAFT		38.759000 °	38.759390 °	
			-121.670759 °	-121.667500 °	
DWR ID					
Action/Comments					
Inspector Comments: 2006 - Approximately 18 to 20 ft of bank near levee at the corner of the levee and the Freemont Weir. Vertical bank with undercutting/mass failure. 2007 - Staked at top of bank for monitoring. 2011 - Site has become significantly worse with more of the toe and lower bank eroded. Many trees have fallen since last year. 2012 - Site looks worse with more erosion around trees. 2013 - Additional erosion into the toe. 2015: Site extended upstream about 500 ft to account for eroding bank. [2015 Site ID: SAC_83-9_R]

LM Start	5.67	Rating **	M	Issue No.	4 (cont)
LM End	5.85	Issue Type +	Ma	Location *	WS
Category	Supplemental		GPS Latitude/Longitude		
			Start	End	
Item	2015 USACE Erosion Survey, DRAFT		38.759000 °	38.759390 °	
DWR ID			-121.670759 °	-121.667500 °	
Action/Comments					
Inspector Comments: 2006 - Approximately 18 to 20 ft of bank near levee at the corner of the levee and the Freemont Weir. Vertical bank with undercutting/mass failure. 2007 - Staked at top of bank for monitoring. 2011 - Site has become significantly worse with more of the toe and lower bank eroded. Many trees have fallen since last year. 2012 - Site looks worse with more erosion around trees. 2013 - Additional erosion into the toe. 2015: Site extended upstream about 500 ft to account for eroding bank. [2015 Site ID: SAC_83-9_R]
