**Flood Control Project Maintenance
Levee Inspections**
LMA District Cover Sheet
Spring 2016 Levee Inspection Results

Reclamation District No. 0341 Sherman Island

Spring 2016 Levee Inspection Results

Waterway	Bank	Unit Miles
Unit No. 01 Threemile Slough	Right	3.36

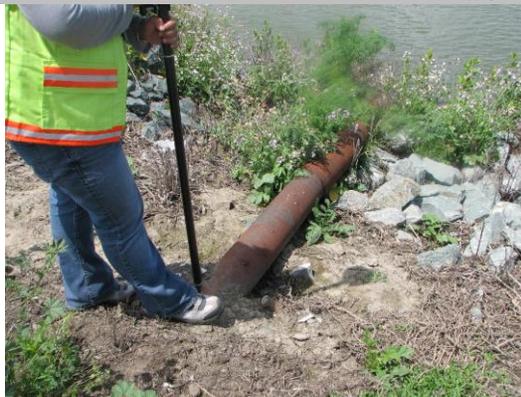
Photo 1 of 2 : UCIP_SP_2016_22116_37758.jpg

View of pipe and rip rap located on waterward side.

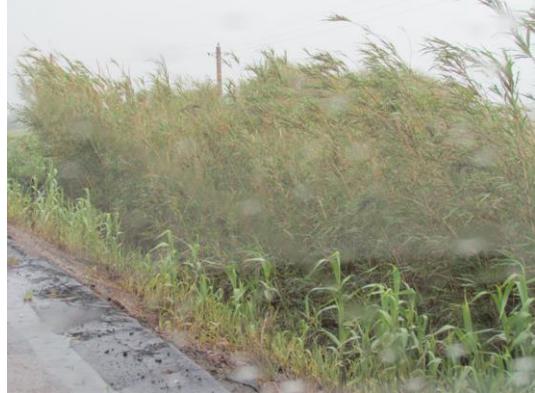
Photo 1 of 1 : SP_2016_RD0341_168_46_20160316_00081.jpg

LM Start	3.97	Rating **	U	Issue No.	46
LM End	6.15	Issue Type +	Ma	Location *	LS
Category	Earthen Levee			GPS Latitude/Longitude	
				Start	End
Item	Vegetation			38.097763 °	38.080323 °
				-121.706287 °	-121.730453 °
DWR ID	DWR_RD0341_02_f_2015_46				
Comment Code					
V1 : Control annual grass and weeds on the levee slopes and easements.					
Inspector Comment					
Remove the wild vegetation from the landside slope and shoulder.

This picture was taken from downstream levee mile 6.15 looking upstream of the landside levee slope and shoulder towards levee mile 3.97.

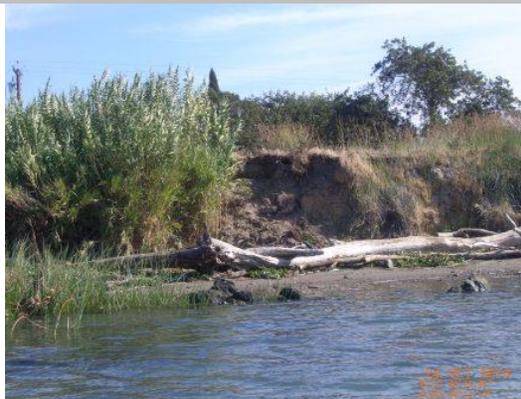
Photo 1 of 1 : SP_2016_RD0341_168_3_20160223_00003.jpg

LM Start	4.47	Rating **	U	Issue No.	3
LM End	4.62	Issue Type +	Ma	Location *	WS
Category	Supplemental			GPS Latitude/Longitude	
				Start	End
Item	2015 USACE Erosion Survey, DRAFT			38.090620 °	38.088572 °
				-121.706684 °	-121.707127 °
DWR ID	DWR_RD0341_02_s_2016_3				
Comment Code					
Inspector Comment					
1999 - New small slump in eroded bank. 2005 - Reach extended because of vertical bank along the roadway upstream. 2011 - More slumping since last year. 2012 - Site upgraded to critical. Very steep slope which may be effecting the highway on top of the levee. 2015: New erosion towards downstream end of site. [2015 Site ID: SAC_8-0_L]

USACE 2013 Photo #1

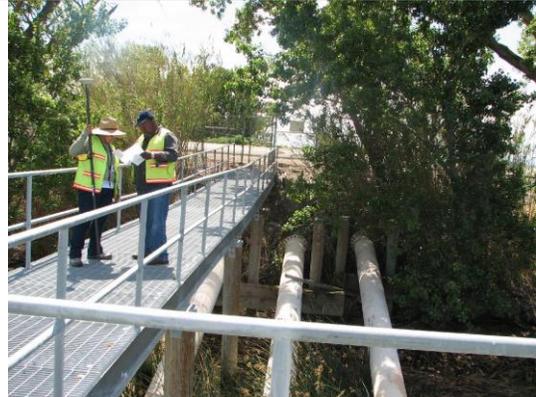
Photo 1 of 2 : UCIP_SP_2016_22253_37885.jpg

Comment Code					
Inspector Comment					
FS_ID:22253 DS_ID:24195 EP_NO: 15175 Repair Type: Non-Urgent Crossing Status: Found UCIP Comments: Dense vegetation limits the inspector's visibility to identify signs of pipe failure (leaks) along the slope. Recommend removing vegetation along pipe alignment to conduct proper inspection of structure and appurtenances. FIELD_STRUCT_DESC: 1 of 4: 24-inch steel irrigaiton pipe in 30-inch steel casings through the levee, 6.6 feet below the crown. Annular gap grouted. Siphon breakers at waterward shoulder, with concrete risers on both ends. Screened inlet manifold (36-inch) with backwash system on pile structure in stream. Surrounded by fence with entry gate. Irrigation pond at landward toe. (Permit No. 15175-1993). Structure in stream installed under Permit No. 16737 (2000). FS Date: 5/6/2009

Pipes, walkway, fence, and support piles located on waterward side.

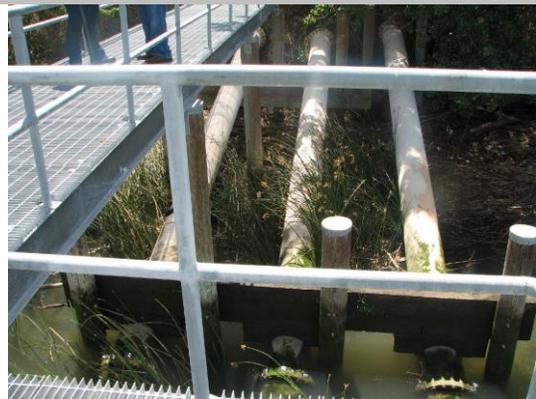
Photo 2 of 2 : UCIP_SP_2016_22253_37882.jpg

View of waterward side - 3-20 inch pipes.

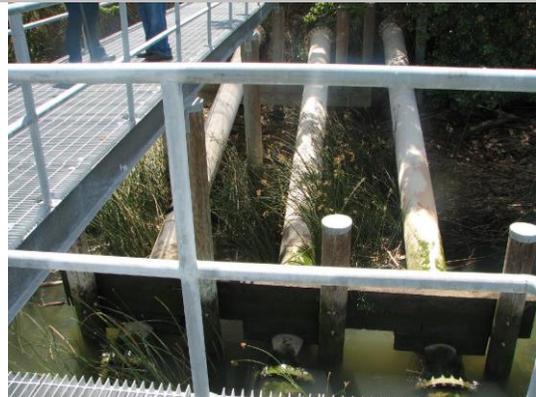
Photo 2 of 2 : UCIP_SP_2016_22254_37898.jpg

Comment Code					
Inspector Comment					
FS_ID:22254 DS_ID:24239 EP_NO: 15175 Repair Type: Non-Urgent Crossing Status: Found UCIP Comments: Dense vegetation limits the inspector's visibility to identify signs of pipe failure (leaks) along the slope. Recommend removing vegetation along pipe alignment to conduct proper inspection of structure and appurtenances. FIELD_STRUCT_DESC: 2 of 4: 24-inch steel irrigaiton pipe in 30-inch steel casings through the levee, 6.6 feet below the crown. Annular gap grouted. Siphon breakers at waterward shoulder, with concrete risers on both ends. Screened inlet manifold (36-inch) with backwash system on pile structure in stream. Surrounded by fence with entry gate. Irrigation pond at landward toe. (Permit No. 15175-1993). Structure in stream installed under Permit No. 16737 (2000). FS Date: 5/6/2009

View of waterward side - 3-20 inch pipes.

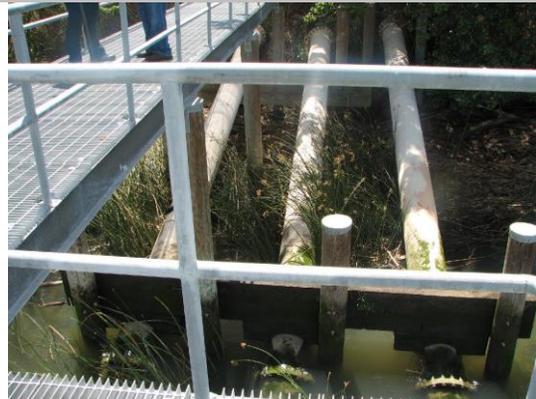
Photo 2 of 2 : UCIP_SP_2016_22255_37909.jpg

Comment Code					
Inspector Comment					
FS_ID:22255 DS_ID:24240 EP_NO: 15175 Repair Type: Non-Urgent Crossing Status: Found UCIP Comments: Dense vegetation limits the inspector's visibility to identify signs of pipe failure (leaks) along the slope. Recommend removing vegetation along pipe alignment to conduct proper inspection of structure and appurtenances. FIELD_STRUCT_DESC: 3 of 4: 24-inch steel irrigaiton pipe in 30-inch steel casings through the levee, 6.6 feet below the crown. Annular gap grouted. Siphon breakers at waterward shoulder, with concrete risers on both ends. Screened inlet manifold (36-inch) with backwash system on pile structure in stream. Surrounded by fence with entry gate. Irrigation pond at landward toe. (Permit No. 15175-1993). Structure in stream installed under Permit No. 16737 (2000). FS Date: 5/6/2009

View of waterward side - 3-20 inch pipes.

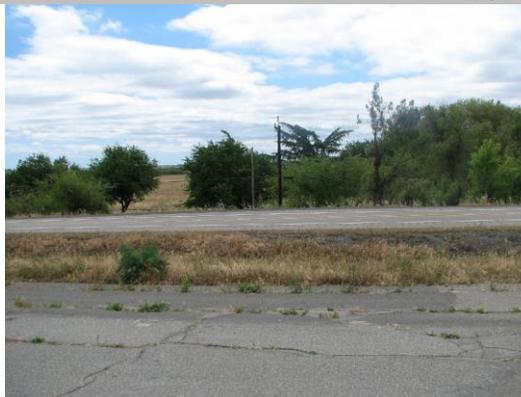
Photo 1 of 2 : UCIP_SP_2016_22256_37915.jpg

Inspector Comment					
FS_ID:22256 DS_ID:24127 EP_NO: 11116 Repair Type: Non-Urgent Crossing Status: Found UCIP Comments: Need to coordinate with owner to determine status of crossing. If crossing is no longer in use owner will need to contact the CVFPB to comply with Title 23. Dense vegetation limits the inspector's visibility to identify signs of pipe failure (leaks) along the slope. Recommend removing vegetation along pipe alignment to conduct proper inspection of structure and appurtenances. FIELD_STRUCT_DESC: 16-inch pipe sleeved through 18-inch pipe through the levee, 2.5 feet below the crown. Annular gap grouted. Air vent on waterward side. (USACE-1962). This entry matches the Drainage or Irrigation Structure referenced in O&M manual (HLM 5.40). This pipe was retained under ABO No. 11116 (1975). Annular gap grouted and pipe lengthened under Permit No. 15372 (1993). FS Date: 5/6/2009

Overview of levee crown at crossing.

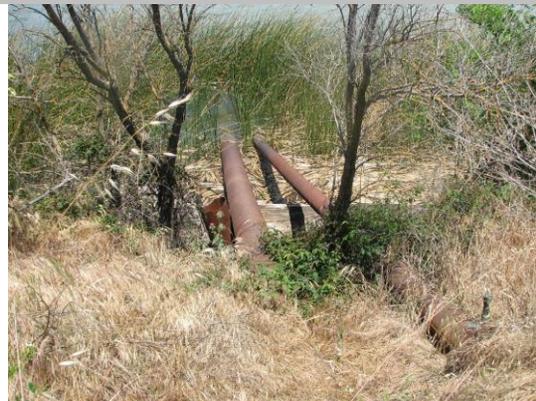
Photo 1 of 2 : UCIP_SP_2016_22258_37932.jpg

Comment Code					
Inspector Comment					
FS_ID:22258 DS_ID:24074 EP_NO: 11116 Repair Type: Non-Urgent Crossing Status: Found UCIP Comments: Dense vegetation limits the inspector's visibility to identify signs of pipe failure (leaks) along the slope. Recommend removing vegetation along pipe alignment to conduct proper inspection of structure and appurtenances. FIELD_STRUCT_DESC: 1 of 2: 8-inch pipe sleeved through 10-inch pipe through levee, 2.5 feet below the crown. Annular gap grouted. Concrete distribution box with slide gate at landward toe. Air vent on waterward side. (USACE-1962). This entry matches the Drainage or Irrigation Structure referenced in O&M manual (HLM 5.81). This pipe was retained under ABO No. 11116 (1975). Distributon box installed and pipe along landward slope removed and replaced with longer 10-inch steel pipe under Permit No. 15372 (1993). FS Date: 5/6/2009

8-inch pipe and 14-inch pipe on waterward side.

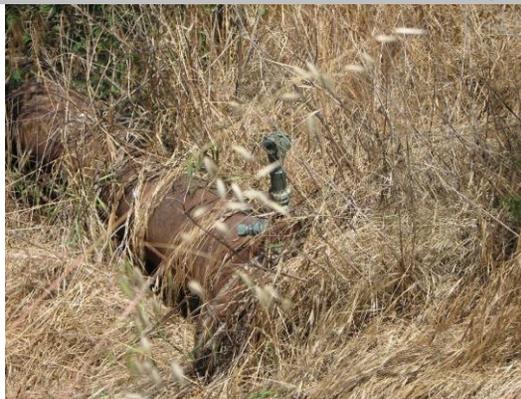
Photo 2 of 2 : UCIP_SP_2016_22258_37930.jpg

Comment Code					
Inspector Comment					
<p>FS_ID:22258 DS_ID:24074 EP_NO: 11116 Repair Type: Non-Urgent Crossing Status: Found UCIP Comments: Dense vegetation limits the inspector's visibility to identify signs of pipe failure (leaks) along the slope. Recommend removing vegetation along pipe alignment to conduct proper inspection of structure and appurtenances. FIELD_STRUCT_DESC: 1 of 2: 8-inch pipe sleeved through 10-inch pipe through levee, 2.5 feet below the crown. Annular gap grouted. Concrete distribution box with slide gate at landward toe. Air vent on waterward side. (USACE-1962). This entry matches the Drainage or Irrigation Structure referenced in O&M manual (HLM 5.81). This pipe was retained under ABO No. 11116 (1975). Distributon box installed and pipe along landward slope removed and replaced with longer 10-inch steel pipe under Permit No. 15372 (1993). FS Date: 5/6/2009</p>

Air vent located on waterward side.

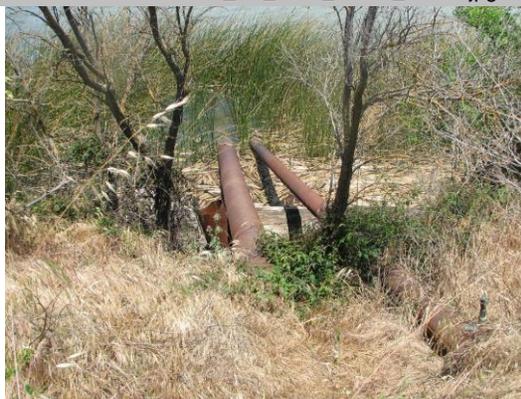
Photo 1 of 2 : UCIP_SP_2016_22259_37935.jpg

Comment Code					
Inspector Comment					
FS_ID:22259 DS_ID:24075 EP_NO: 1806 Repair Type: Non-Urgent Crossing Status: Found UCIP Comments: Dense vegetation limits the inspector's visibility to identify signs of pipe failure (leaks) along the slope. Recommend removing vegetation along pipe alignment to conduct proper inspection of structure and appurtenances. FIELD_STRUCT_DESC: 2 of 2: 14-inch steel irrigation pipe through the levee, 3.0 feet below the crown. Concrete distribution box with gate valve at landward toe. Air vent on waterward side. (Permit No. 1806-1959) This entry matches the Drainage or Irrigation Structure referenced in O&M manual (HLM 5.81). Distributon box installed and pipe along landward slope removed and replaced with longer 16-inch steel pipe under Permit No. 15372 (1993). FS Date: 5/6/2009

View of pipes on waterward side.

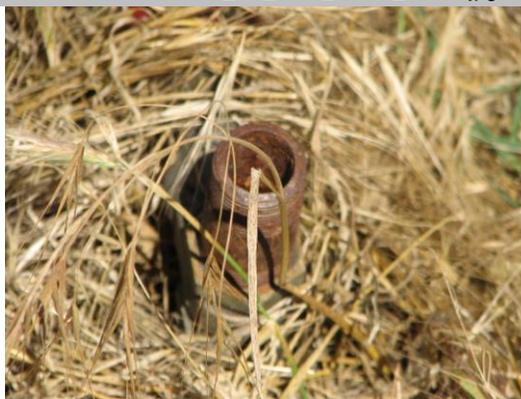
Photo 2 of 2 : UCIP_SP_2016_22259_37936.jpg

Air vent located on waterward side.

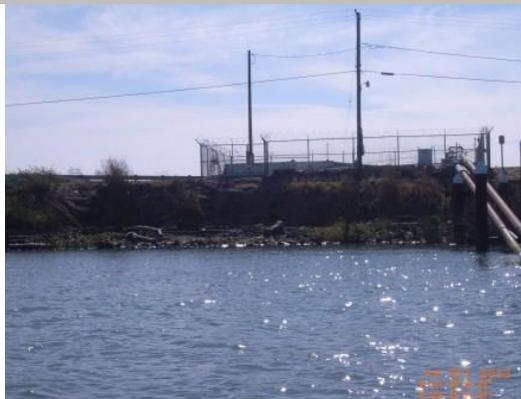
Photo 1 of 1 : SP_2016_RD0341_168_1_20160223_00001.jpg

LM Start	6.03	Rating **	U	Issue No.	1
LM End	6.16	Issue Type +	Ma	Location *	WS
Category	Supplemental			GPS Latitude/Longitude	
				Start	End
Item	2015 USACE Erosion Survey, DRAFT			38.080370 °	38.080526 °
				-121.728341 °	-121.730483 °
DWR ID	DWR_RD0341_02_s_2016_1				
Comment Code					
Inspector Comment					
2011 - Large slump at downstream end. Gully formed from surface runoff from the road. Shallow slumping throughout site. 2012 - The gully at upstream end has increased in size and site continues to worsen. 2015: No observed changes. [2015 Site ID: SAC_7-3_L]

USACE 2013 Photo #1

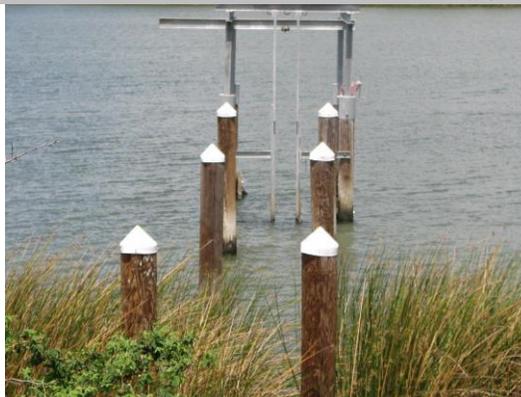
Photo 1 of 2 : UCIP_SP_2016_39861_71853.jpg

Comment Code					
Inspector Comment					
FS_ID:39861 DS_ID:24076 EP_NO: 11116 Repair Type: Non-Urgent Crossing Status: Found UCIP Comments: Need to contact owner to determine status of crossing. If crossing is no longer used will need to meet Title 23 requirements. Hole present in pipe section. Debris on waterward side-- 10-inch pipe section abandoned on slope. Dense vegetation limits the inspector's visibility to identify signs of pipe failure (leaks) along the slope. Recommend removing vegetation along pipe alignment to conduct proper inspection of structure and appurtenances. FIELD_STRUCT_DESC: 12-inch pipe sleeved through 14-inch pipe through levee, 4.0 feet below crown. Annular gap grouted. Slide gate in distribution box on landward side. (USACE-1962). This entry matches the Drainage or Irrigation Structure referenced in O&M manual (HLM 6.12). This pipe was retained under ABO No. 11116 (1975). Distributon box installed and pipe along landward slope removed and replaced with longer 16-inch steel pipe under Permit No. 15372 (1993). FS Date: 5/6/2009

View of structure located on waterward side.

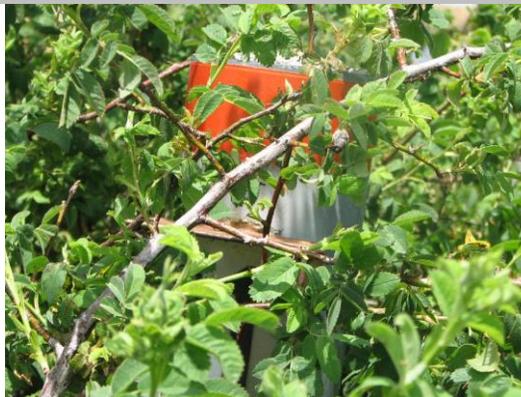
Photo 2 of 2 : UCIP_SP_2016_39861_71852.jpg

Marker visible on waterward side associated with crossing.

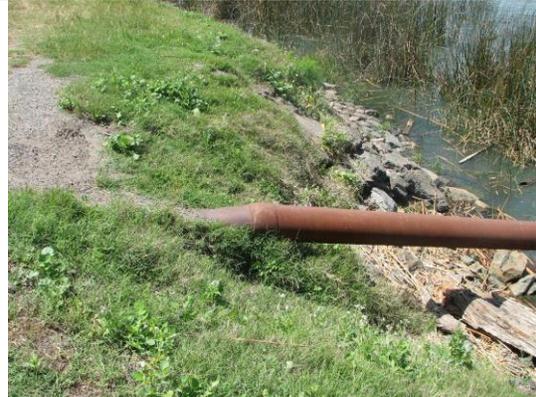
Photo 1 of 2 : UCIP_SP_2016_22261_37949.jpg

Comment Code					
Inspector Comment					
FS_ID:22261 DS_ID:24078 EP_NO: 11116 Repair Type: Non-Urgent Crossing Status: Found UCIP Comments: Dense vegetation limits the inspector's visibility to identify signs of pipe failure (leaks) along the slope. Recommend removing vegetation along pipe alignment to conduct proper inspection of structure and appurtenances. FIELD_STRUCT_DESC: 12-inch pipe through the levee, 2.0 feet below the crown. Siphon breaker on landward slope. Rock revetment on waterward slope. (USACE-1962). This entry matches the Drainage or Irrigation Structure referenced in O&M manual (HLM 6.31). This pipe was retained under ABO No. 11116 (1975). FS Date: 5/6/2009

Side view of pipe on waterward side.

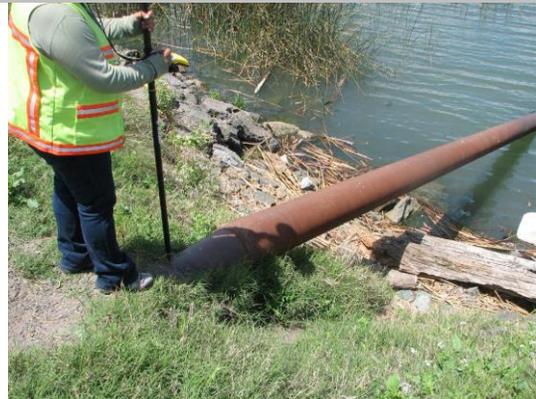
Photo 2 of 2 : UCIP_SP_2016_22261_37947.jpg

View of pipe and rip rap on waterward side.

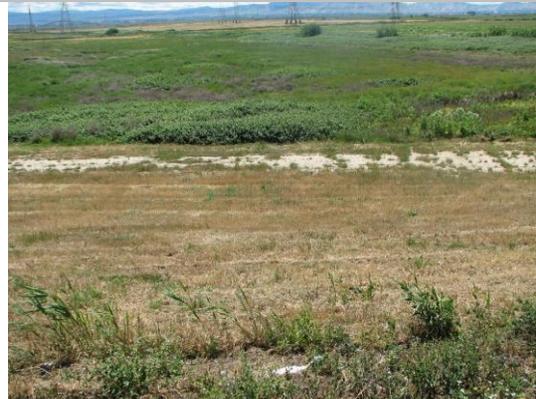
Photo 1 of 2 : UCIP_SP_2016_22262_37953.jpg

LM Start	6.63	Rating **	M	Issue No.	51
LM End	6.63	Issue Type +	En	Location *	WS
Category	Supplemental			GPS Latitude/Longitude	
				Start	End
Item	DWR UCIP Field Study			38.083549°	38.083549°
				-121.738161°	-121.738161°
DWR ID					
Comment Code					
Inspector Comment					
FS_ID:22262 DS_ID:24079 EP_NO: 11107 Repair Type: Non-Urgent Crossing Status: Indicator Found UCIP Comments: Need to contact owner to determine status of crossing. If crossing is no longer in used owner will need to comply with Title 23. Dense vegetation limits the inspector's visibility to identify signs of pipe failure (leaks) along the slope. Recommend removing vegetation along pipe alignment to conduct proper inspection of structure and appurtenances. FIELD_STRUCT_DESC: 4-inch pipe through the levee, 4.0 feet below the crown. This pipe was retained under ABO No. 11107 (1975). FS Date: 5/6/2009

View of landward side no evidence of crossing.

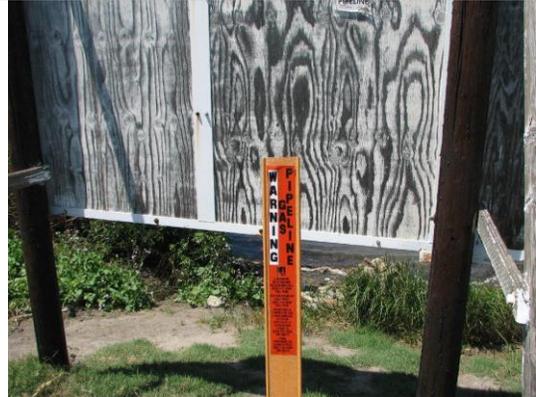
Photo 2 of 2 : UCIP_SP_2016_22268_37979.jpg

Comment Code					
Inspector Comment					
FS_ID:22268 DS_ID:24218 EP_NO: N/A Repair Type: Non-Urgent Crossing Status: Indicator Found UCIP Comments: Need to contact owner to determine status of crossing. Need date of last inspection and confirmation that crossing is still in operable condition. Multiple crossings in general area need to clarify which pipes are in this levee section. FIELD_STRUCT_DESC: Gas line crossing through the levee. (USACE-1962). This entry matches the Drainage or Irrigation Structure referenced in O&M manual (HLM 7.08). Utility marker contact information includes Contact prior to Excavation call 1-800-227-2600 or Emergency Contact 1-800-743-5000. FS Date: 5/6/2009

Utility marker located on waterward side.

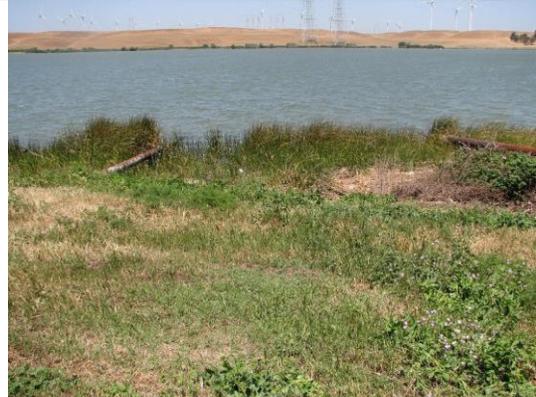
Photo 1 of 2 : UCIP_SP_2016_22293_38041.jpg

Comment Code					
Inspector Comment					
FS_ID:22293 DS_ID:24128 EP_NO: 1915 Repair Type: Non-Urgent Crossing Status: Found UCIP Comments: Will need to contact owner. Need to obtain maintenance records and clarify modifications made at to crossing (size). Also important to note that DWR DOE was out in the field during our pipe inspection they were conducting pipe evaluation for pipe replacement. Need to contact DWR DOE to determine location of pipe replacement. FIELD_STRUCT_DESC: 18-inch (not 12-inch as noted in historical records) steel irrigation pipe through the levee, 3.0 feet below the crown. Concrete pipe riser on landward side. (Permit No. 1352-1948) Siphon breaker on landward side installed under Permit No. 1915 (1954). Pipe removed and replaced by 12-inch steel pipe under Permit No. 10799 (1977). FS Date: 5/6/2009

Overview of waterward side-18-inch pipe located on right side and 12-inch pipe located on left side.

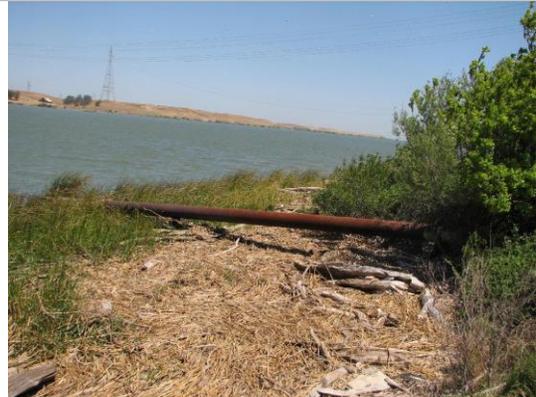
Photo 2 of 2 : UCIP_SP_2016_22293_38040.jpg

View of crossing located on waterward side.

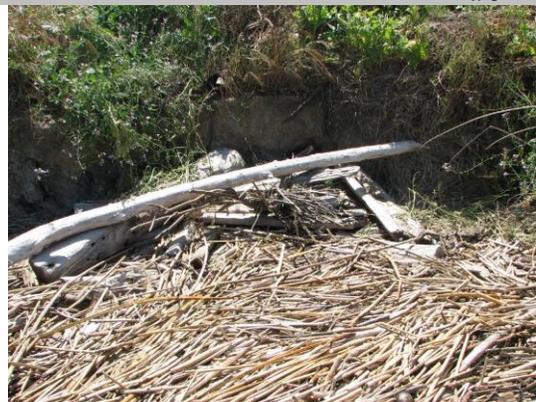
Photo 2 of 2 : UCIP_SP_2016_22294_38050.jpg

Concrete headwall located on waterward side.

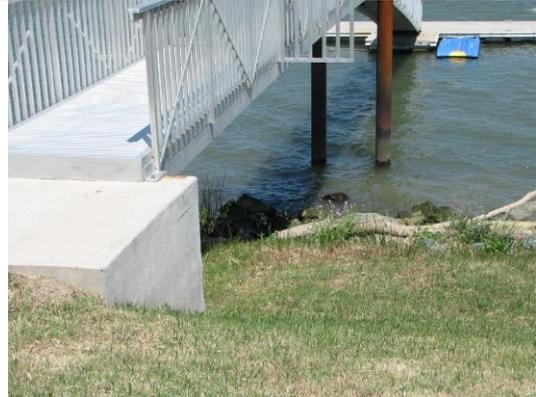
Photo 1 of 2 : UCIP_SP_2016_22303_38062.jpg

LM Start	8.01	Rating **	M	Issue No.	65
LM End	8.01	Issue Type +	En	Location *	WS
Category	Supplemental			GPS Latitude/Longitude	
				Start	End
Item	DWR UCIP Field Study			38.073340 °	38.073340 °
				-121.759340 °	-121.759340 °
DWR ID					
Comment Code					
Inspector Comment					
FS_ID:22303 DS_ID:24246 EP_NO: N/A Repair Type: Non-Urgent Crossing Status: Found UCIP Comments: Need to determine the status of conduit--has construction been completed? FIELD_STRUCT_DESC: Four 2.5-inch conduits sleeved through 12-inch steel pipe through the levee. Boat launching dock and ramp on the waterward side. Provide a field description of this crossing. FS Date: 5/6/2009

View of waterward side. Conduit goes through concrete structure connecting walkway.

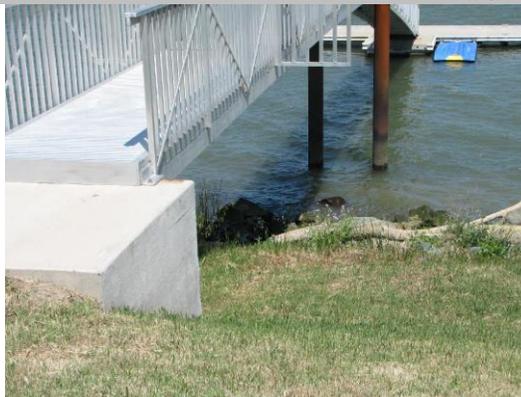
Photo 1 of 1 : UCIP_SP_2016_22305_38064.jpg

Comment Code					
Inspector Comment					
FS_ID:22305 DS_ID:24221 EP_NO: 17728 Repair Type: Non-Urgent Crossing Status: Not Found UCIP Comments: Need to clarify if three 2-inch steel conduits were installed. This permit appears to be associated with the dock installed at levee mile 7.91. See inspection sheet for LM 7.91. FIELD_STRUCT_DESC: Three 2-inch steel electric conduits encased in a single 6-inch steel conduit through the levee, 2.0 feet below the crown. Gaps filled with grout. Boat dock (60x8 feet) and landing on steel pilings in the channel. Metal bridge, concrete landing on pilings and foot paths on the waterward slope. Rock revetment on waterward slope. (Permit No. 17728-2004) FS Date: 5/6/2009

Dock installed at levee mile 7.91.

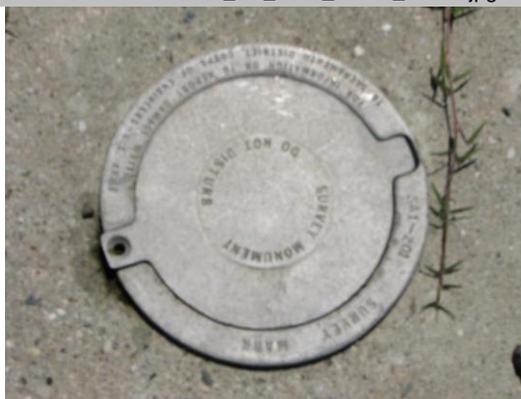
Photo 1 of 2 : UCIP_SP_2016_22306_38067.jpg

LM Start	8.43	Rating **	M	Issue No.	67
LM End	8.43	Issue Type +	En	Location *	WS
Category	Supplemental		GPS Latitude/Longitude		
			Start	End	
Item	DWR UCIP Field Study		38.070678 °	38.070678 °	
			-121.766206 °	-121.766206 °	
DWR ID					
Comment Code					
Inspector Comment					
FS_ID:22306 DS_ID:24130 EP_NO: 3494 Repair Type: Non-Urgent Crossing Status: Indicator Found UCIP Comments: Need to contact owner to determine status of crossing. Need date of last inspection and confirmation that crossing is still in operable condition. FIELD_STRUCT_DESC: 1 of 2: 26-inch concrete encased steel gas line through the levee, 5.1 feet below the crown. Concrete cutoff wall around pipe at center of levee. Location sign on waterward shoulder. Rock revetment on waterward slope. (Permit No. 3494-1961) Contact number listed on marker out in the field 1-800-811-4111. FS Date: 5/6/2009

Survey marker found at this location.

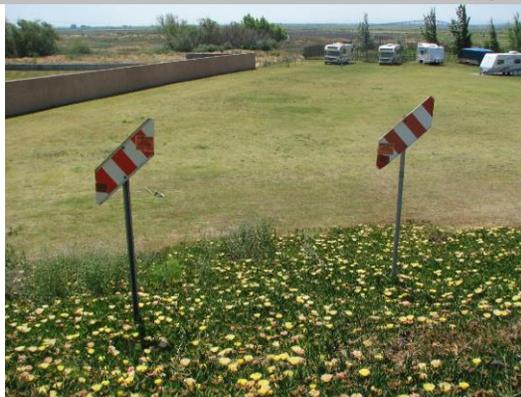
Photo 2 of 2 : UCIP_SP_2016_22307_38069.jpg

LM Start	8.43	Rating **	M	Issue No.	68 (cont)
LM End	8.43	Issue Type +	En	Location *	WS
Category	Supplemental			GPS Latitude/Longitude	
				Start	End
Item	DWR UCIP Field Study			38.070678 °	38.070678 °
				-121.766206 °	-121.766206 °
DWR ID					
Comment Code					
Inspector Comment					
FS_ID:22307 DS_ID:24233 EP_NO: 3494 Repair Type: Non-Urgent Crossing Status: Indicator Found UCIP Comments: Need to contact owner to determine status of crossing. Need date of last inspection and confirmation that crossing is still in operable condition. FIELD_STRUCT_DESC: 2 of 2: 26-inch concrete encased steel gas line through the levee, 5.1 feet below the crown. Concrete cutoff wall around pipe at center of levee. Location sign on waterward shoulder. Rock revetment on waterward slope. (Permit No. 3494-1961) Contact number provided on marker out in the field 1-800-811-4111. FS Date: 5/6/2009

Gas line markers located on landward side.

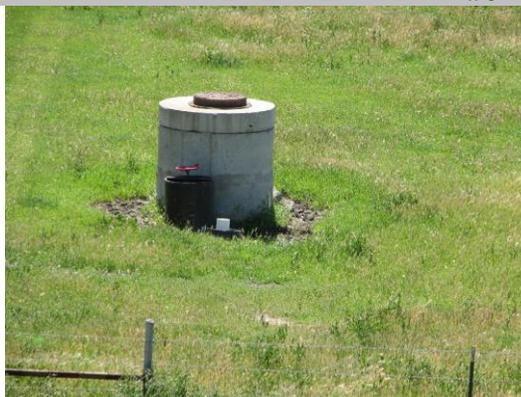
Photo 1 of 2 : UCIP_SP_2016_22309_38075.jpg

LM Start	8.52	Rating **	M	Issue No.	69
LM End	8.52	Issue Type +	En	Location *	WS
Category	Supplemental			GPS Latitude/Longitude	
				Start	End
Item	DWR UCIP Field Study			38.069690 °	38.069690 °
				-121.767313 °	-121.767313 °
DWR ID					
Comment Code					
Inspector Comment					
FS_ID:22309 DS_ID:24247 EP_NO: N/A Repair Type: Non-Urgent Crossing Status: Found UCIP Comments: New record found in the field. Unable to find any information for crossing during DWR desk study. Will need to find the owner and obtain records for crossing. Need to coordinate with CVFPB. FIELD_STRUCT_DESC: 10-inch steel pipe through the levee, at a shallow depth below the crown. Air vent on the waterward side. Distribution box with slide gate and observation well on the landward side. Pumping station on the landward side. Rip rap located on waterward side. FS Date: 5/6/2009

Concrete stand pipe and gate valve located on landward side.

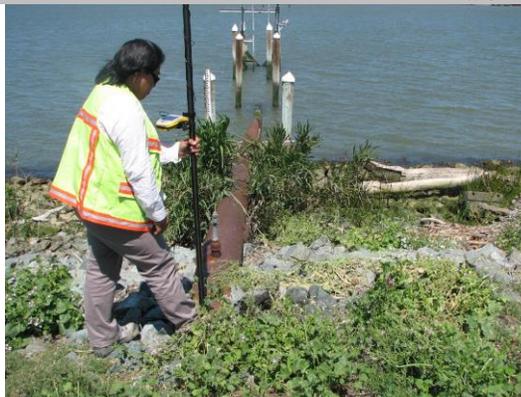
Photo 2 of 2 : UCIP_SP_2016_22309_38076.jpg

LM Start	8.52	Rating **	M	Issue No.	69 (cont)
LM End	8.52	Issue Type +	En	Location *	WS
Category	Supplemental			GPS Latitude/Longitude	
				Start	End
Item	DWR UCIP Field Study			38.069690 °	38.069690 °
				-121.767313 °	-121.767313 °
DWR ID					
Comment Code					
Inspector Comment					
FS_ID:22309 DS_ID:24247 EP_NO: N/A Repair Type: Non-Urgent Crossing Status: Found UCIP Comments: New record found in the field. Unable to find any information for crossing during DWR desk study. Will need to find the owner and obtain records for crossing. Need to coordinate with CVFPB. FIELD_STRUCT_DESC: 10-inch steel pipe through the levee, at a shallow depth below the crown. Air vent on the waterward side. Distribution box with slide gate and observation well on the landward side. Pumping station on the landward side. Rip rap located on waterward side. FS Date: 5/6/2009

Overview of crossing on waterward side.

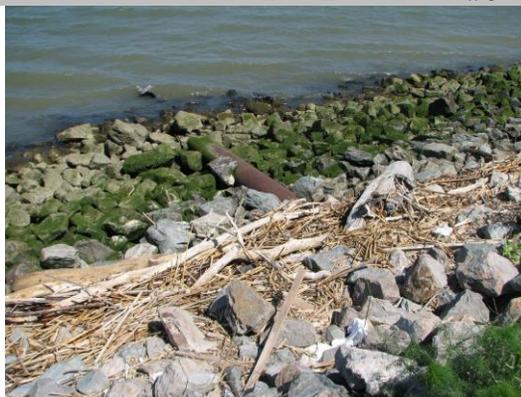
Photo 1 of 2 : UCIP_SP_2016_22323_38092.jpg

LM Start	8.69	Rating **	U	Issue No.	70
LM End	8.69	Issue Type +	En	Location *	WS
Category	Supplemental			GPS Latitude/Longitude	
				Start	End
Item	DWR UCIP Field Study			38.068019 °	38.068019 °
				-121.769367 °	-121.769367 °
DWR ID

Comment Code					
Inspector Comment					
FS_ID:22323 DS_ID:24131 EP_NO: 11108 Repair Type: Urgent Crossing Status: Found UCIP Comments: Depression signs along pipe. Dense vegetation limits the inspector's visibility to identify signs of pipe failure (leaks) along the slope. Recommend removing vegetation along pipe alignment to conduct proper inspection of structure and appurtenances. FIELD_STRUCT_DESC: 12-inch (not 10-inch mentioned in historical records) concrete encased pipe through the levee, 5.5 feet below the crown. Siphon breaker in pipe riser on landward slope. Gate valve on landward side. (USACE-1962). This entry matches the Drainage or Irrigation Structure referenced in O&M manual (HLM 8.59). This pipe was retained under ABO No. 11108 (1975). FS Date: 5/6/2009

Overview of waterward side. Slope protection along bank.

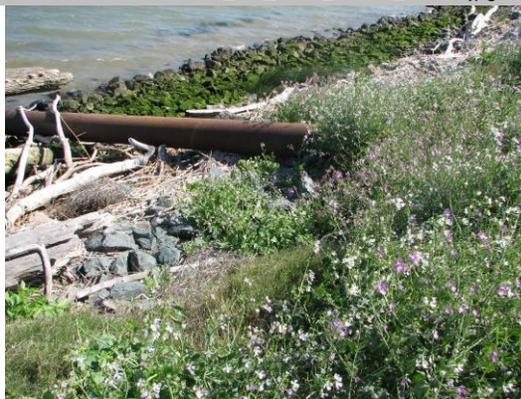
Photo 1 of 2 : UCIP_SP_2016_22324_38096.jpg

LM Start	9.12	Rating **	M	Issue No.	71
LM End	9.12	Issue Type +	En	Location *	WS
Category	Supplemental			GPS Latitude/Longitude	
				Start	End
Item	DWR UCIP Field Study			38.064563 °	38.064563 °
				-121.776153 °	-121.776153 °
DWR ID					
Comment Code					
Inspector Comment					
FS_ID:22324 DS_ID:24133 EP_NO: 11114 Repair Type: Non-Urgent Crossing Status: Found UCIP Comments: Dense vegetation limits the inspector's visibility to identify signs of pipe failure (leaks) along the slope. Recommend removing vegetation along pipe alignment to conduct proper inspection of structure and appurtenances. FIELD_STRUCT_DESC: 14-inch pipe through the levee, 4.0 feet below the crown. Concrete standpipe with slide gate on landward side. Rock revetment on waterward slope. This pipe was retained under ABO No. 11114 (1975). FS Date: 5/6/2009

Overview of waterward side.
