**Flood Control Project Maintenance  
Levee Inspections**

**Maintenance Issue Types Only, Levee Inspection Report By Mile - Spring 2016**

**Reclamation District No. 0524 Middle Roberts Island**

Waterway	Bank	Unit Miles	Inspection Start/End	Inspector
Unit No. 01 San Joaquin River	Left	6.20	04/12/2016 04/13/2016	Richard Willoughby

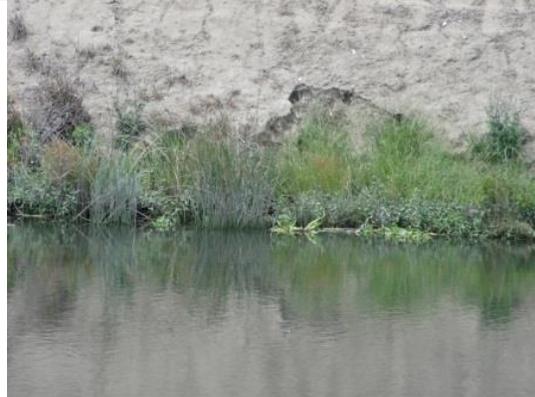
Photo 2 of 2 : SP\_2016\_RD0524\_107\_129\_20160404\_00170.jpg

LM Start	<b>0.19</b>	Rating **	U	Issue No.	<b>129 (cont)</b>
LM End	<b>0.19</b>	Issue Type +	Ma	Location *	WS
Category	Supplemental			GPS Latitude/Longitude	
				Start	End
Item	DWR Erosion Survey			37.939085 °	37.939085 °
				-121.343917 °	-121.343917 °
DWR ID	DWR_RD0524_01_s_2016_129				
Comment Code					
Inspector Comment					
06/24/2015: No significant change observed. 6/19/2014: No significant change observed. 08/13/2013: The erosion was discovered during 2013 spring levee inspection. Inspector comment: Erosion is located along the lower level of water-ward slope. [2015 Site ID:RD0524U01RM40.85]

Close view of the erosion.

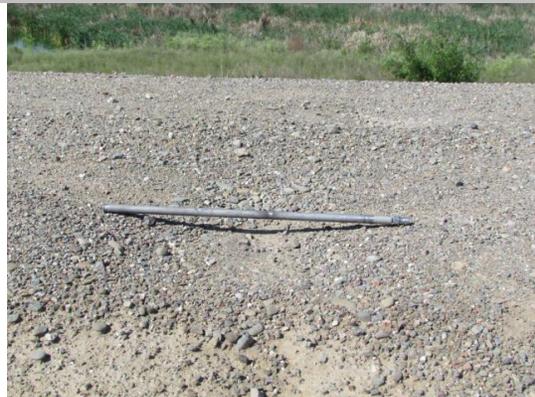
Photo 1 of 3 : SP\_2016\_RD0524\_107\_3\_20160404\_00006.jpg

LM Start	<b>0.21</b>	Rating **	M	Issue No.	<b>3</b>
LM End	<b>0.21</b>	Issue Type +	Ma	Location *	CR
Category	Earthen Levee			GPS Latitude/Longitude	
				Start	End
Item	Crown Surface / Depressions / Rutting			37.938890 °	37.938890 °
				-121.343657 °	-121.343657 °
DWR ID	DWR_RD0524_01_s_2016_3				
Comment Code					
C2 : Repair depressions or ruts in the crown or slope.					
Inspector Comment					
No change in status.

Looking west at 3" depression on levee crown. (Spring 2012)

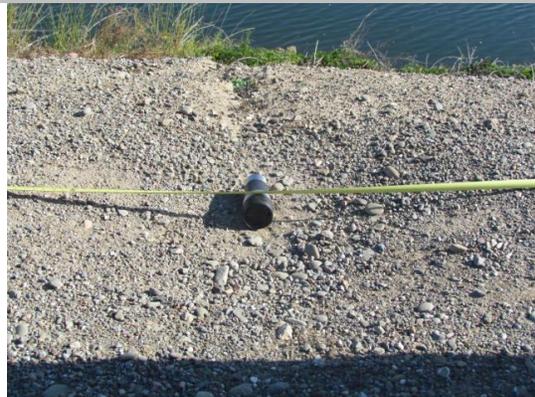
Photo 2 of 3 : SP\_2016\_RD0524\_107\_3\_20160404\_00007.jpg

Looking west at depression on levee crown near waterward shoulder.

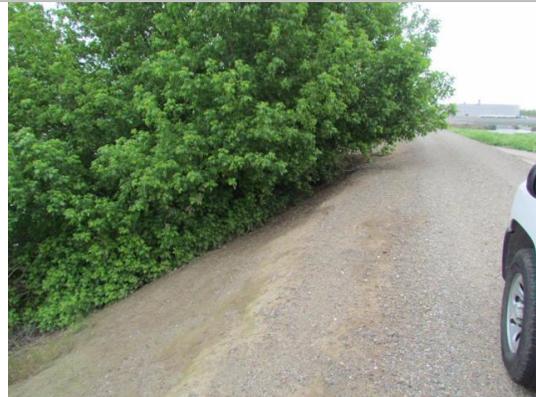
Photo 1 of 3 : SP\_2016\_RD0524\_107\_179\_20160414\_00340.jpg

LM Start	<b>0.27</b>	Rating **	U	Issue No.	<b>179</b>
LM End	<b>0.27</b>	Issue Type +	Ma	Location *	WS
Category	Earthen Levee		GPS Latitude/Longitude		
			Start	End	
Item	Trim / Thin Trees		37.938438 °	37.938438 °	
			-121.342883 °	-121.342883 °	
DWR ID	DWR_RD0524_01_s_2014_179				
Comment Code					
T2 : Thin trees to allow visibility of the ground and room to flood fight.					
Inspector Comment					
Tree blocking view of waterward slope.

Looking south at untrimmed tree on waterward slope (Spring 2016)

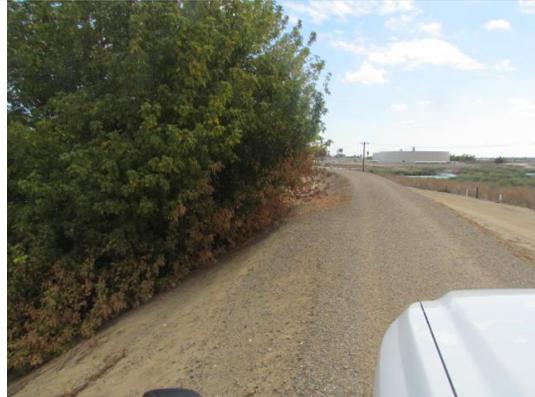
Photo 3 of 3 : SP\_2016\_RD0524\_107\_179\_20160404\_00202.jpg

LM Start	<b>0.27</b>	Rating **	U	Issue No.	<b>179 (cont)</b>
LM End	<b>0.27</b>	Issue Type +	Ma	Location *	WS
Category	Earthen Levee			GPS Latitude/Longitude	
				Start	End
Item	Trim / Thin Trees			37.938438 °	37.938438 °
				-121.342883 °	-121.342883 °
DWR ID	DWR_RD0524_01_s_2014_179				
Comment Code					
T2 : Thin trees to allow visibility of the ground and room to flood fight.					
Inspector Comment					
Tree blocking view of waterward slope.

Looking south at untrimmed tree on waterward slope. (Fall 2014)

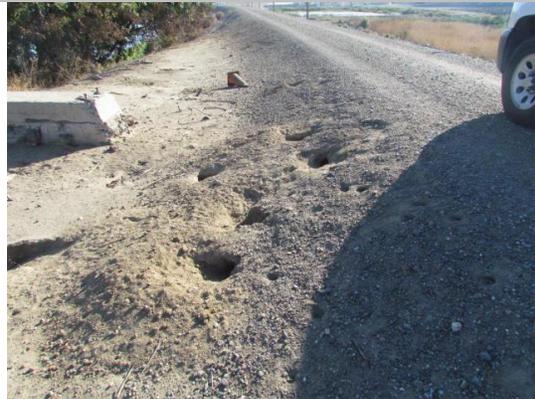
Photo 1 of 3 : SP\_2016\_RD0524\_107\_174\_20160404\_00194.jpg

LM Start	<b>0.30</b>	Rating **	U	Issue No.	<b>174</b>
LM End	<b>0.30</b>	Issue Type +	Ma	Location *	WS
Category	Earthen Levee			GPS Latitude/Longitude	
				Start	End
Item	Animal Control			37.938382 °	37.938382 °
				-121.342352 °	-121.342352 °
DWR ID	DWR_RD0524_01_f_2014_174				
Comment Code					
A3 : No rodents visible, but rodent burrows visible; need to backfill and compact or grout burrows.					
Inspector Comment					
Several rodent holes present at this site. No change at site during spring 2016 inspection.

Looking southeast at several rodent holes on waterward slope Fall 2015.

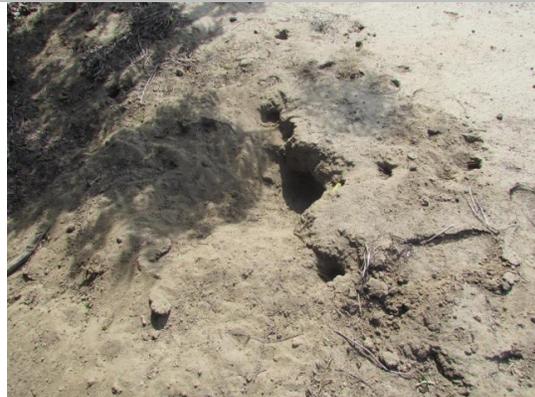
Photo 2 of 3 : SP\_2016\_RD0524\_107\_174\_20160404\_00195.jpg

Looking west at several rodent holes on waterward shoulder. (Spring 2015)

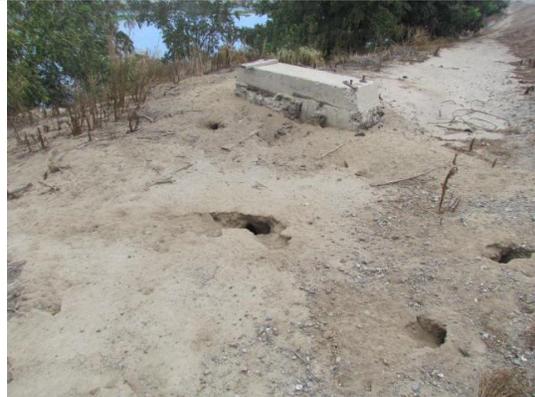
Photo 3 of 3 : SP\_2016\_RD0524\_107\_174\_20160404\_00196.jpg

LM Start	<b>0.30</b>	Rating **	U	Issue No.	<b>174 (cont)</b>
LM End	<b>0.30</b>	Issue Type +	Ma	Location *	WS
Category	Earthen Levee			GPS Latitude/Longitude	
				Start	End
Item	Animal Control			37.938382 °	37.938382 °
				-121.342352 °	-121.342352 °
DWR ID	DWR_RD0524_01_f_2014_174				
Comment Code					
A3 : No rodents visible, but rodent burrows visible; need to backfill and compact or grout burrows.					
Inspector Comment					
Several rodent holes present at this site. No change at site during spring 2016 inspection.

Looking southeast at several rodent holes on waterward slope.

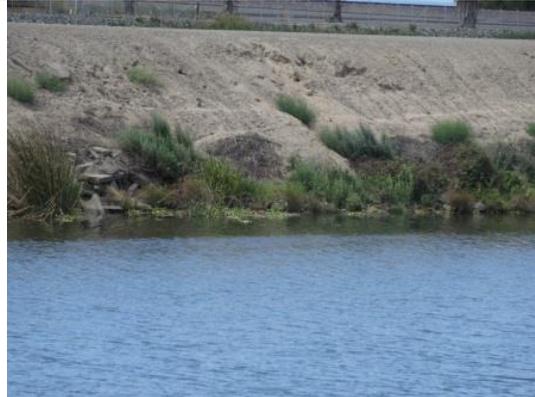
Photo 1 of 2 : SP\_2016\_RD0524\_107\_131\_20160404\_00171.jpg

LM Start	<b>0.40</b>	Rating **	U	Issue No.	<b>131</b>
LM End	<b>0.40</b>	Issue Type +	Ma	Location *	WS
Category	Supplemental			GPS Latitude/Longitude	
				Start	End
Item	DWR Erosion Survey			37.938870 °	37.938870 °
				-121.340460 °	-121.340460 °
DWR ID	DWR_RD0524_01_s_2016_131				
Comment Code					
Inspector Comment					
06/24/2015: No significant change observed. 6/19/2014: No significant change observed. 08/13/2013: No significant change at this site. 8/7/2012: The erosion is at the upper levee slope, and likely caused by slope slip. The lower levee slope is covered with dense vegetation. [2015 Site ID:RD0524U01RM40.99]

Front view of the erosion site. Note the vegetation at the levee toe and on the lower slope.

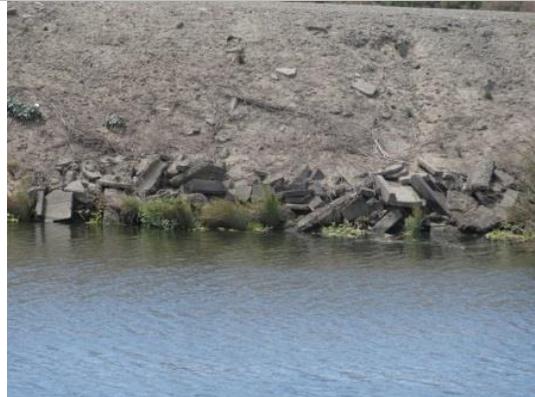
Photo 2 of 2 : SP\_2016\_RD0524\_107\_131\_20160404\_00172.jpg

Close view of the erosion.

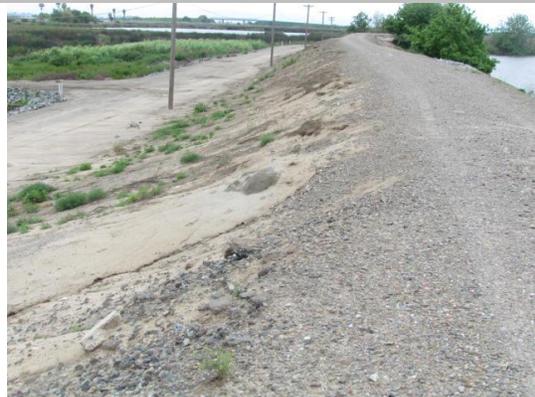
Photo 1 of 2 : SP\_2016\_RD0524\_107\_205\_20160414\_00342.jpg

LM Start	<b>0.40</b>	Rating **	U	Issue No.	<b>205</b>
LM End	<b>0.46</b>	Issue Type +	Ma	Location *	LS
Category	Earthen Levee			GPS Latitude/Longitude	
				Start	End
Item	Slope Stability			37.938625 °	37.938695 °
				-121.340479 °	-121.339420 °
DWR ID	DWR_RD0524_01_s_2016_205				
Comment Code					
S1 : Repair slope instability.					
Inspector Comment					
Several damage site within this reach.

Looking north at slope damage on landward slope.

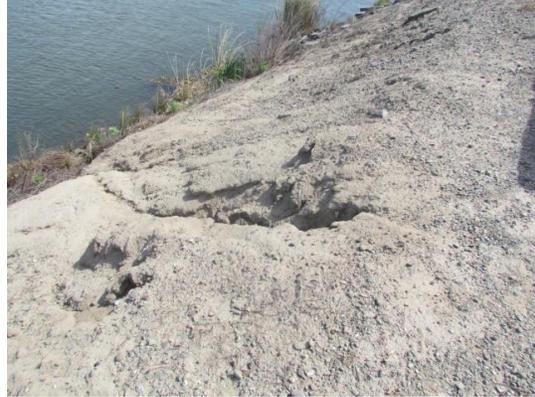
Photo 3 of 3 : SP\_2016\_RD0524\_107\_170\_20160404\_00189.jpg

LM Start	<b>0.41</b>	Rating **	U	Issue No.	<b>170 (cont)</b>
LM End	<b>0.45</b>	Issue Type +	Ma	Location *	WS
Category	Earthen Levee			GPS Latitude/Longitude	
				Start	End
Item	Slope Stability			37.938628 °	37.938688 °
				-121.340385 °	-121.339627 °
DWR ID	DWR_RD0524_01_s_2015_170				
Comment Code					
S1 : Repair slope instability.					
Inspector Comment					
Several slope instabilities within this reach.

Looking east at waterward slope erosion.

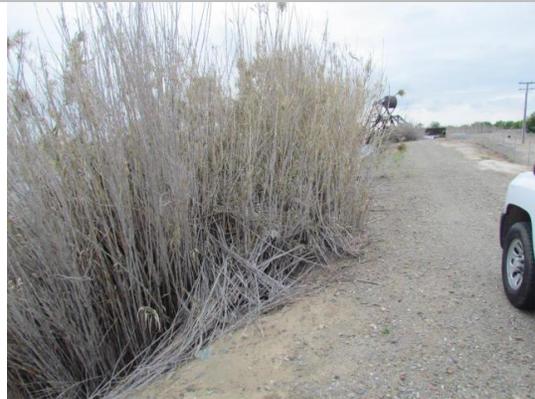
Photo 1 of 5 : SP\_2016\_RD0524\_107\_11\_20160414\_00345.jpg

LM Start	<b>0.62</b>	Rating **	U	Issue No.	<b>11</b>
LM End	<b>0.63</b>	Issue Type +	Ma	Location *	WS
Category	Earthen Levee			GPS Latitude/Longitude	
				Start	End
Item	Vegetation			37.938278 °	37.938247 °
				-121.336524 °	-121.336503 °
DWR ID	DWR_RD0524_01_s_2012_11				
Comment Code					
V2 : Remove the wild growth other than native grasses from the levee slopes.					
Inspector Comment					
Bamboo on waterward slope. Bamboo has been killed but still blocking view of waterward slope.

Looking southeast at bamboo on waterward slope. (Spring 2016)

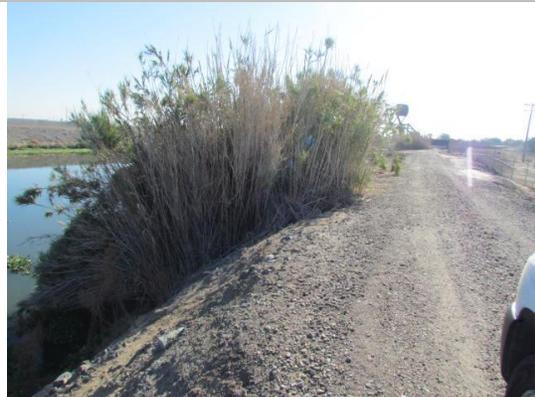
Photo 2 of 5 : SP\_2016\_RD0524\_107\_11\_20160404\_00014.jpg

Looking south at bamboo on waterside slope. (Fall 2015)

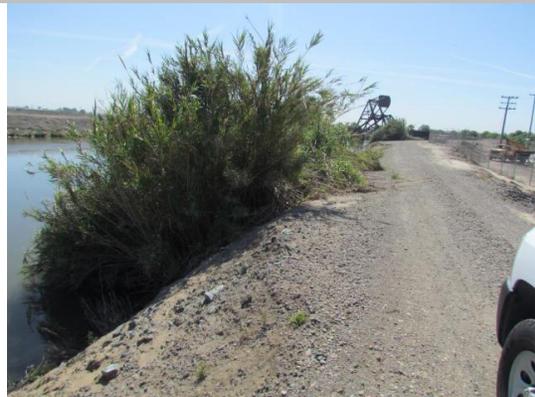
Photo 4 of 5 : SP\_2016\_RD0524\_107\_11\_20160404\_00016.jpg

Looking southeast at bamboo on waterside slope. (Spring 2012)

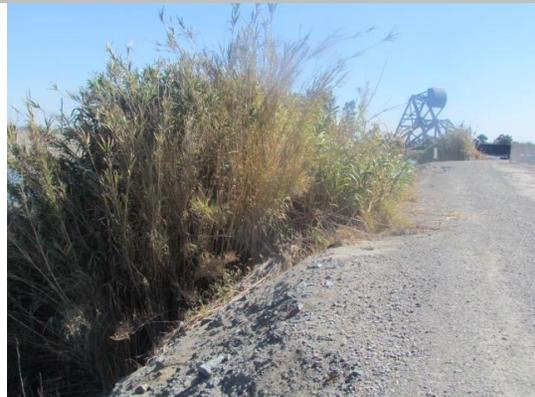
Photo 5 of 5 : SP\_2016\_RD0524\_107\_11\_20160404\_00017.jpg

Looking south at bamboo on waterside slope. (Fall Inspection 2012)

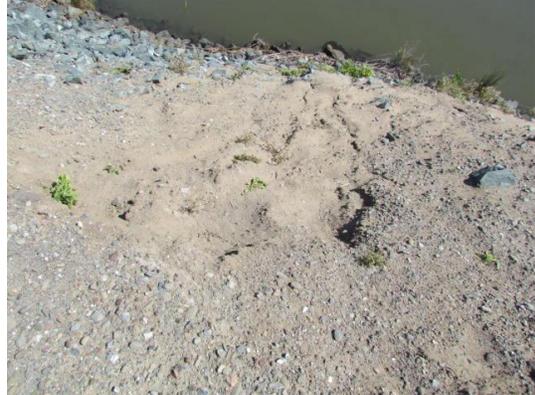
Photo 1 of 3 : SP\_2016\_RD0524\_107\_10\_20160404\_00013.jpg

LM Start	<b>0.63</b>	Rating **	U	Issue No.	<b>10</b>
LM End	<b>0.63</b>	Issue Type +	Ma	Location *	WS
Category	Earthen Levee			GPS Latitude/Longitude	
				Start	End
Item	Erosion / Bank Caving			37.938247 °	37.938247 °
				-121.336503 °	-121.336503 °
DWR ID	DWR_RD0524_01_f_2015_10				
Comment Code					
E2 : Schedule repair of erosion site prior to the next inspection.					
Inspector Comment					
Erosion located next to and under bamboo.

Looking east at waterside erosion appears to be caused by runoff.

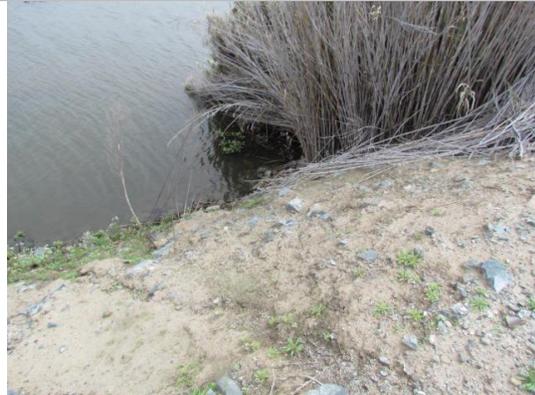
Photo 3 of 3 : SP\_2016\_RD0524\_107\_10\_20160414\_00346.jpg

Looking east at erosion under bamboo on waterward slope.

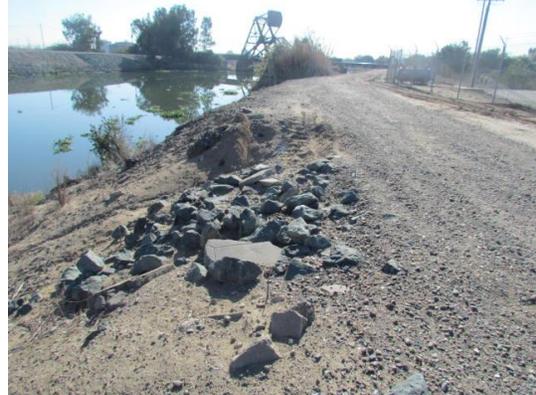
Photo 1 of 4 : SP\_2016\_RD0524\_107\_13\_20160404\_00019.jpg

LM Start	<b>0.64</b>	Rating **	M	Issue No.	<b>13</b>
LM End	<b>0.65</b>	Issue Type +	Ma	Location *	WS
Category	Earthen Levee			GPS Latitude/Longitude	
				Start	End
Item	Slope Stability			37.938105°	37.938023°
				-121.336288°	-121.336173°
DWR ID	DWR_RD0524_01_s_2012_13				
Comment Code					
S1 : Repair slope instability.					
Inspector Comment					
Depression extend from shoulder to mid levee slope two site with this section.

Looking southeast at depression on waterward shoulder fall 2015

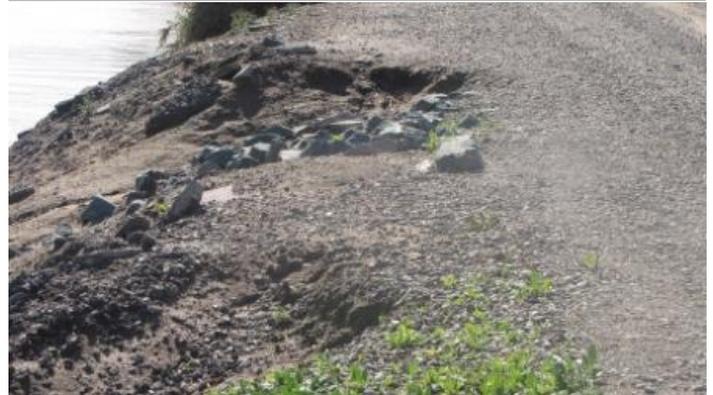
Photo 2 of 4 : SP\_2016\_RD0524\_107\_13\_20160404\_00020.jpg

Looking south at erosion on waterside shoulder.

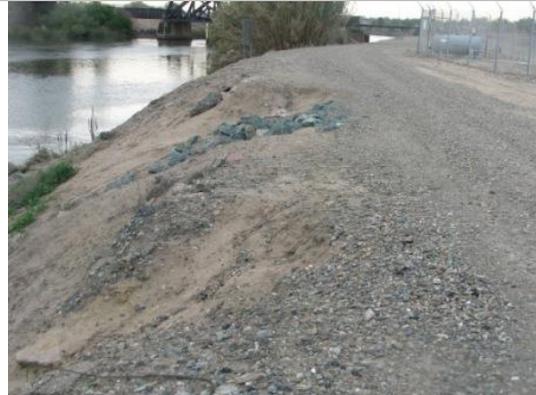
Photo 3 of 4 : SP\_2016\_RD0524\_107\_13\_20160404\_00021.jpg

View of the erosion.

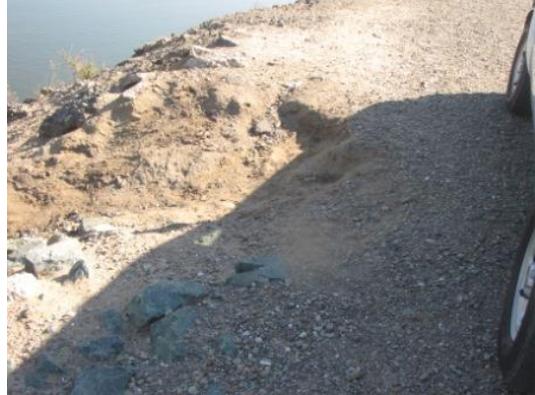
Photo 4 of 4 : SP\_2016\_RD0524\_107\_13\_20160404\_00022.jpg

LM Start	<b>0.64</b>	Rating **	M	Issue No.	<b>13 (cont)</b>
LM End	<b>0.65</b>	Issue Type +	Ma	Location *	WS
Category	Earthen Levee		GPS Latitude/Longitude		
			Start	End	
Item	Slope Stability		37.938105°	37.938023°	
			-121.336288°	-121.336173°	
DWR ID	DWR_RD0524_01_s_2012_13				
Comment Code					
S1 : Repair slope instability.					
Inspector Comment					
Depression extend from shoulder to mid levee slope two site with this section.

Update view of the erosion site.

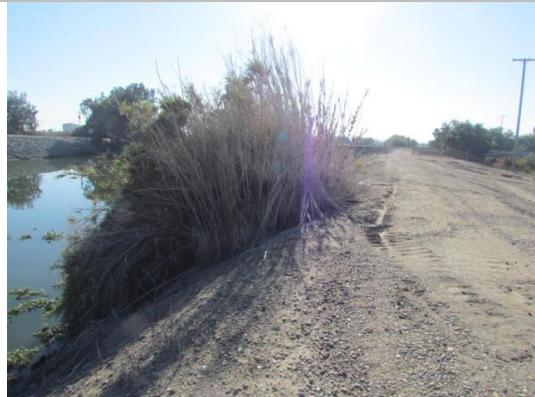
Photo 1 of 3 : SP\_2016\_RD0524\_107\_14\_20160404\_00023.jpg

LM Start	<b>0.67</b>	Rating **	U	Issue No.	<b>14</b>
LM End	<b>0.67</b>	Issue Type +	Ma	Location *	WS
Category	Earthen Levee		GPS Latitude/Longitude		
			Start	End	
Item	Vegetation		37.937808°	37.937808°	
			-121.335913°	-121.335913°	
DWR ID	DWR_RD0524_01_s_2012_14				
Comment Code					
V2 : Remove the wild growth other than native grasses from the levee slopes.					
Inspector Comment					
Bamboo on waterward slope. Bamboo has been killed but still blocking view of levee slope.

Looking south at dying bamboo on waterward slope. Fall 2015

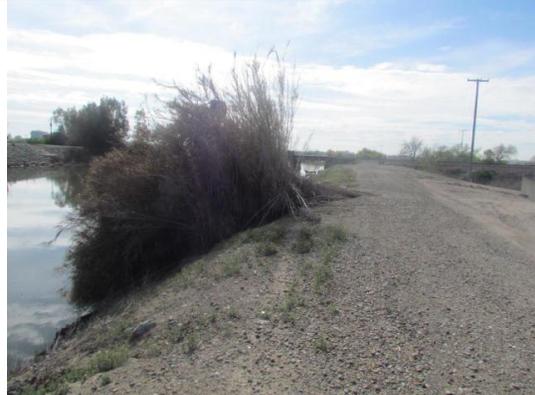
Photo 2 of 3 : SP\_2016\_RD0524\_107\_14\_20160404\_00024.jpg

Looking south at dying bamboo on waterward slope. (Spring 2013)

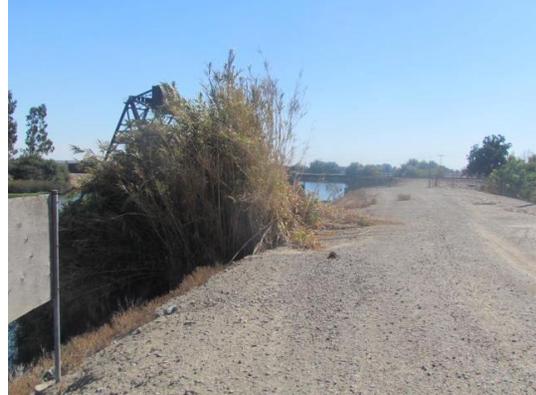
Photo 3 of 3 : SP\_2016\_RD0524\_107\_14\_20160404\_00025.jpg

LM Start	<b>0.67</b>	Rating **	U	Issue No.	<b>14 (cont)</b>
LM End	<b>0.67</b>	Issue Type +	Ma	Location *	WS
Category	Earthen Levee			GPS Latitude/Longitude	
				Start	End
Item	Vegetation			37.937808 °	37.937808 °
				-121.335913 °	-121.335913 °
DWR ID	DWR_RD0524_01_s_2012_14				
Comment Code					
V2 : Remove the wild growth other than native grasses from the levee slopes.					
Inspector Comment					
Bamboo on waterward slope. Bamboo has been killed but still blocking view of levee slope.

Looking south at bamboo on waterside slope. (Fall 2012)

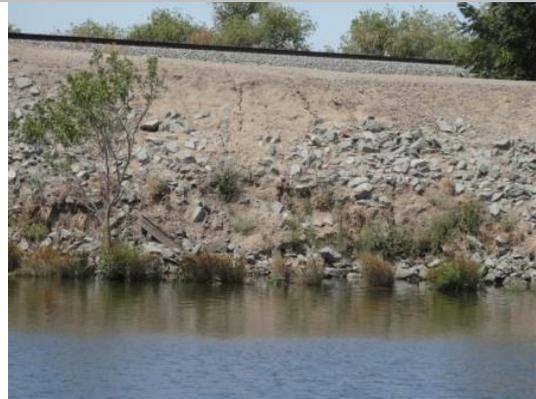
Photo 1 of 2 : SP\_2016\_RD0524\_107\_132\_20160404\_00173.jpg

LM Start	<b>0.71</b>	Rating **	M	Issue No.	<b>132</b>
LM End	<b>0.73</b>	Issue Type +	Ma	Location *	WS
Category	Supplemental			GPS Latitude/Longitude	
				Start	End
Item	DWR Erosion Survey			37.937222 °	37.937222 °
				-121.335277 °	-121.335277 °
DWR ID	DWR_RD0524_01_s_2016_132				
Comment Code					
Inspector Comment					
06/24/2015: The erosion site is immediately downstream of the RR bridge. [2015 Site ID:RD0524U01RM41.36]

Close view of the erosion.

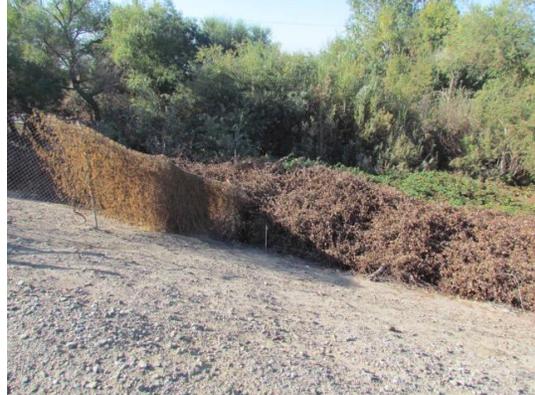
Photo 1 of 3 : SP\_2016\_RD0524\_107\_262\_20160404\_00223.jpg

Looking west at dense vegetation at landward slope and toe fall 2015.

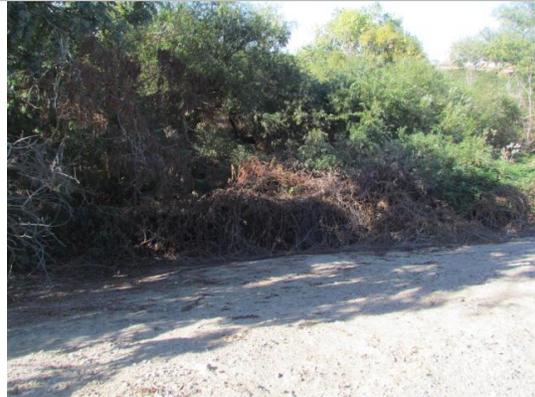
Photo 2 of 3 : SP\_2016\_RD0524\_107\_262\_20160404\_00224.jpg

Looking west at dense vegetation on landside toe. Spring 2014

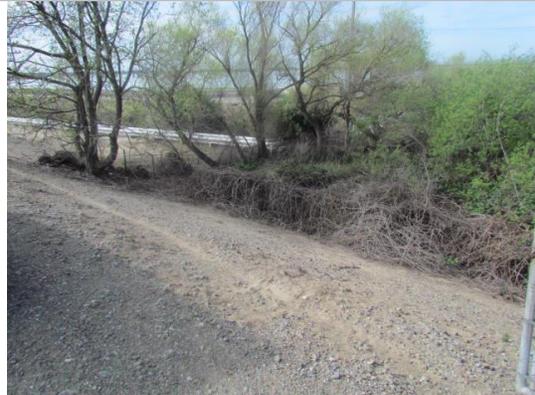
Photo 3 of 3 : SP\_2016\_RD0524\_107\_262\_20160404\_00225.jpg

Looking southwest at vegetation on landward slope and toe. (Spring 2013)

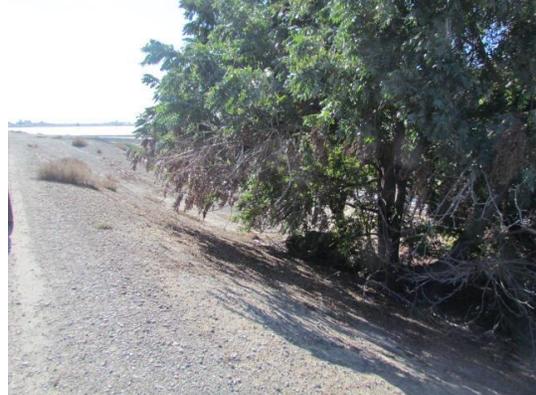
Photo 1 of 1 : SP\_2016\_RD0524\_107\_76\_20160404\_00111.jpg

Looking southwest at low hanging tree branches at landside toe.

LM Start	<b>0.78</b>	Rating **	U	Issue No.	<b>76</b>
LM End	<b>0.78</b>	Issue Type +	Ma	Location *	LS
Category	Earthen Levee		GPS Latitude/Longitude		
			Start	End	
Item	Trim / Thin Trees		37.936444 °	37.936444 °	
			-121.334797 °	-121.334797 °	
DWR ID	DWR_RD0524_01_s_2012_76				
Comment Code					
T1 : Trim trees to at least five feet above ground level.					
Inspector Comment

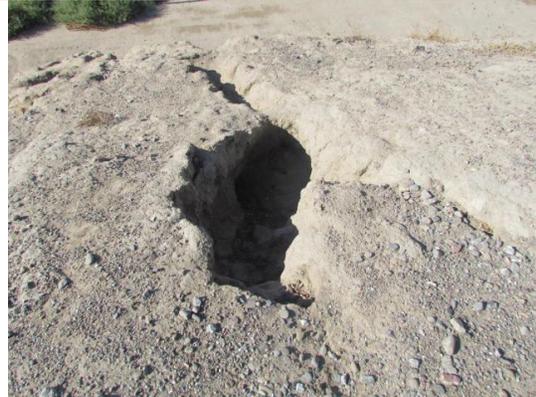
Photo 3 of 6 : SP\_2016\_RD0524\_107\_2\_20160404\_00002.jpg

LM Start	<b>0.81</b>	Rating **	U	Issue No.	<b>2 (cont)</b>
LM End	<b>0.81</b>	Issue Type +	Ma	Location *	LS
Category	Earthen Levee			GPS Latitude/Longitude	
				Start	End
Item	Erosion / Bank Caving			37.936093 °	37.936004 °
				-121.334648 °	-121.334615 °
DWR ID	DWR_RD0524_01_f_2013_2				
Comment Code					
E2 : Schedule repair of erosion site prior to the next inspection.					
Inspector Comment					
One large hole. Hole is over 12" deep and 12" wide and several holes and finger erosions on landward slope.

Looking west at hole on landward shoulder.

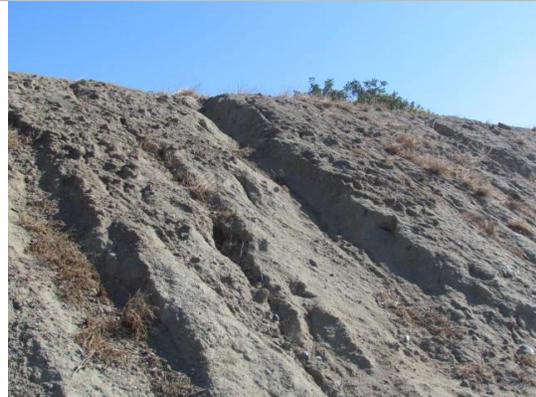
Photo 4 of 6 : SP\_2016\_RD0524\_107\_2\_20160404\_00003.jpg

Looking southeast at finger erosion on landward slope.

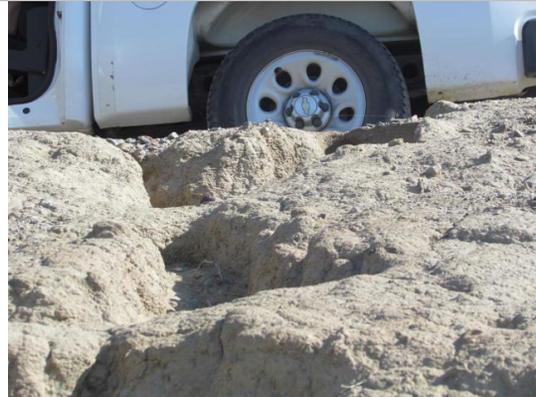
Photo 5 of 6 : SP\_2016\_RD0524\_107\_2\_20160404\_00004.jpg

Looking east at erosion on landward slope.

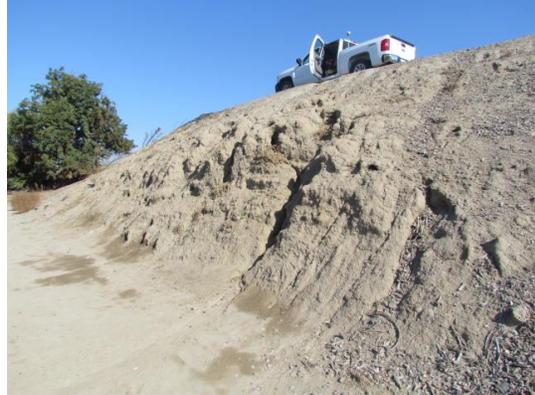
Photo 6 of 6 : SP\_2016\_RD0524\_107\_2\_20160404\_00005.jpg

LM Start	<b>0.81</b>	Rating **	U	Issue No.	<b>2 (cont)</b>
LM End	<b>0.81</b>	Issue Type +	Ma	Location *	LS
Category	Earthen Levee			GPS Latitude/Longitude	
				Start	End
Item	Erosion / Bank Caving			37.936093 °	37.936004 °
				-121.334648 °	-121.334615 °
DWR ID	DWR_RD0524_01_f_2013_2				
Comment Code					
E2 : Schedule repair of erosion site prior to the next inspection.					
Inspector Comment					
One large hole. Hole is over 12" deep and 12" wide and several holes and finger erosions on landward slope.

Looking northeast at several finger erosion on landward slope.

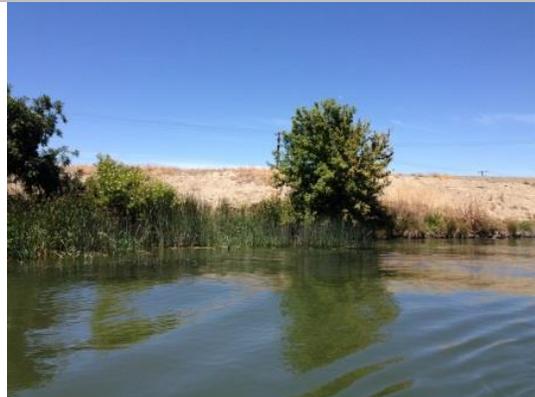
Photo 1 of 2 : SP\_2016\_RD0524\_107\_134\_20160404\_00177.jpg

LM Start	<b>0.83</b>	Rating **	U	Issue No.	<b>134</b>
LM End	<b>0.84</b>	Issue Type +	Ma	Location *	WS
Category	Supplemental			GPS Latitude/Longitude	
				Start	End
Item	DWR Erosion Survey			37.935930 °	37.935930 °
				-121.334133 °	-121.334133 °
DWR ID	DWR_RD0524_01_s_2016_134				
Comment Code					
Inspector Comment					
06/24/2015: No significant change observed. 06/19/2014: No significant change observed. 08/13/2013: Site was discovered during boat survey. The dense vegetation blocks a clear view of the erosion. Size of erosion site was very roughly estimated. [2015 Site ID:RD0524U01RM41.44]

Front view of the erosion. The tree and vegetation block the view of the site.

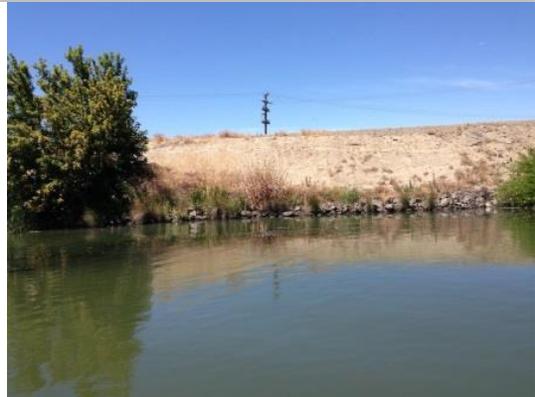
Photo 2 of 2 : SP\_2016\_RD0524\_107\_134\_20160404\_00178.jpg

The erosion is invisible because of the dense vegetation.

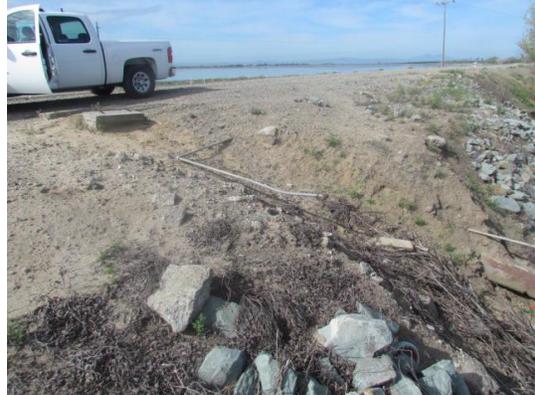
Photo 1 of 1 : SP\_2016\_RD0524\_107\_122\_20160404\_00164.jpg

LM Start	<b>0.92</b>	Rating **	M	Issue No.	<b>122</b>
LM End	<b>0.92</b>	Issue Type +	Ma	Location *	WS
Category	Earthen Levee		GPS Latitude/Longitude		
			Start	End	
Item	Encroachments		37.935267 °	37.935267 °	
			-121.332985 °	-121.332985 °	
DWR ID	DWR_RD0524_01_s_2013_122				
Comment Code					
PI : Pipe					
Inspector Comment					
Inch and half metal pipe should be removed.

Looking northwest at inch and half metal pipe on waterward slope.

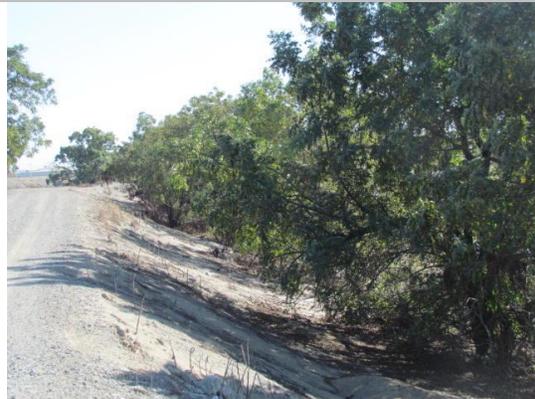
Photo 1 of 1 : SP\_2016\_RD0524\_107\_77\_20160404\_00112.jpg

Looking south at low hanging tree branches at landside toe.

LM Start	<b>0.93</b>	Rating **	U	Issue No.	<b>77</b>
LM End	<b>1.01</b>	Issue Type +	Ma	Location *	LS
Category	Earthen Levee		GPS Latitude/Longitude		
			Start	End	
Item	Trim / Thin Trees		37.935259 °	37.935049 °	
			-121.332864 °	-121.331334 °	
DWR ID	DWR_RD0524_01_s_2012_77				
Comment Code					
T1 : Trim trees to at least five feet above ground level.					
Inspector Comment

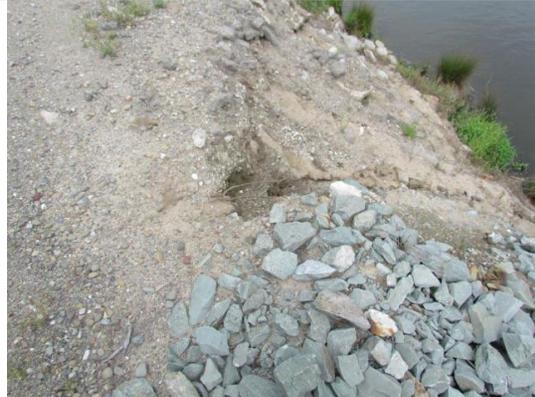
Photo 1 of 4 : SP\_2016\_RD0524\_107\_17\_20160414\_00349.jpg

LM Start	<b>1.00</b>	Rating **	U	Issue No.	<b>17</b>
LM End	<b>1.02</b>	Issue Type +	Ma	Location *	WS
Category	Earthen Levee			GPS Latitude/Longitude	
				Start	End
Item	Erosion / Bank Caving			37.935098 °	37.935018 °
				-121.331645 °	-121.331248 °
DWR ID	DWR_RD0524_01_s_2012_17				
Comment Code					
E2 : Schedule repair of erosion site prior to the next inspection.					
Inspector Comment					
Erosion was noted next to repaired site.

Looking northeast at erosion next to repaired site. (Spring 2016)

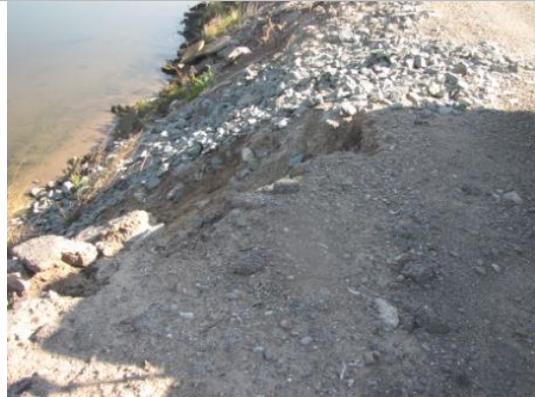
Photo 2 of 4 : SP\_2016\_RD0524\_107\_17\_20160404\_00028.jpg

Looking upstream (south) at erosion site. (Spring 2015)

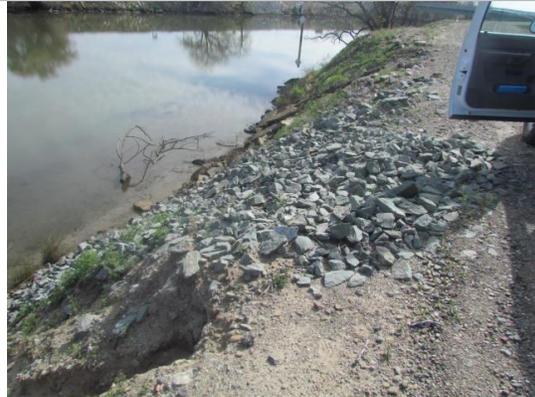
Photo 3 of 4 : SP\_2016\_RD0524\_107\_17\_20160404\_00029.jpg

Looking southeast at erosion next to repaired site on waterward slope (Spring 2013)

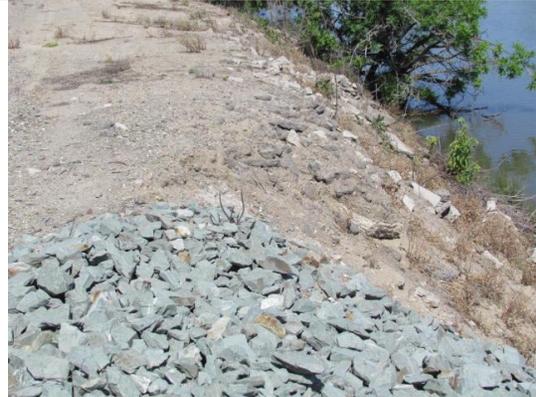
Photo 4 of 4 : SP\_2016\_RD0524\_107\_17\_20160404\_00030.jpg

LM Start	<b>1.00</b>	Rating **	U	Issue No.	<b>17 (cont)</b>
LM End	<b>1.02</b>	Issue Type +	Ma	Location *	WS
Category	Earthen Levee			GPS Latitude/Longitude	
				Start	End
Item	Erosion / Bank Caving			37.935098 °	37.935018 °
				-121.331645 °	-121.331248 °
DWR ID	DWR_RD0524_01_s_2012_17				
Comment Code					
E2 : Schedule repair of erosion site prior to the next inspection.					
Inspector Comment					
Erosion was noted next to repaired site.

Looking north at erosion site next to repaired site. (Spring 2012)

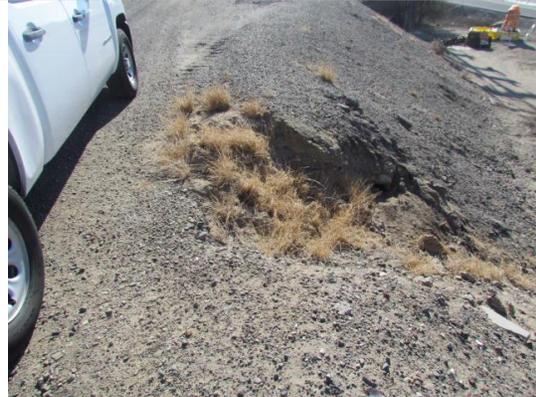
Photo 1 of 7 : SP\_2016\_RD0524\_107\_18\_20160404\_00031.jpg

LM Start	<b>1.08</b>	Rating **	U	Issue No.	<b>18</b>
LM End	<b>1.08</b>	Issue Type +	Ma	Location *	LS
Category	Earthen Levee			GPS Latitude/Longitude	
				Start	End
Item	Slope Stability			37.934645 °	37.934645 °
				-121.330310 °	-121.330310 °
DWR ID	DWR_RD0524_01_s_2012_18				
Comment Code					
S1 : Repair slope instability.					
Inspector Comment					
Slope damage extend from shoulder to middle of slope.

Looking south at caving on landward shoulder. (Fall 2015)

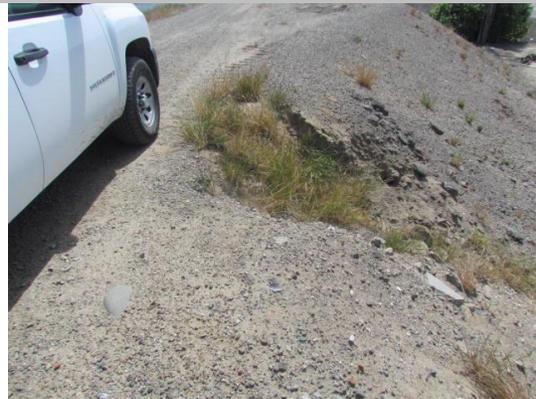
Photo 2 of 7 : SP\_2016\_RD0524\_107\_18\_20160404\_00032.jpg

Looking south at caving on landward shoulder. (Spring 2015)

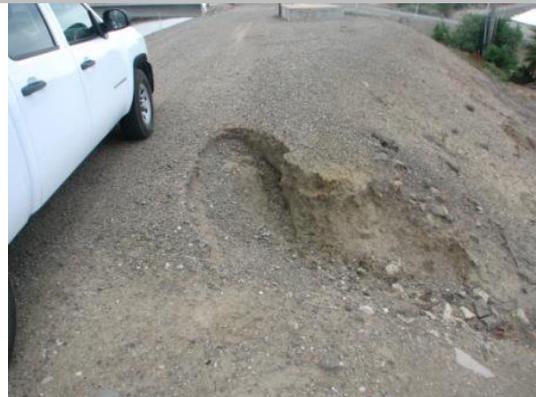
Photo 3 of 7 : SP\_2016\_RD0524\_107\_18\_20160404\_00033.jpg

Landward slope damage. Spring 2014

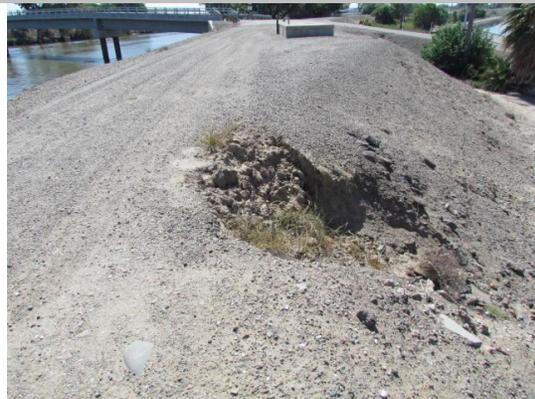
Photo 5 of 7 : SP\_2016\_RD0524\_107\_18\_20160404\_00035.jpg

Looking south at caving on landside shoulder. (Spring 2013)

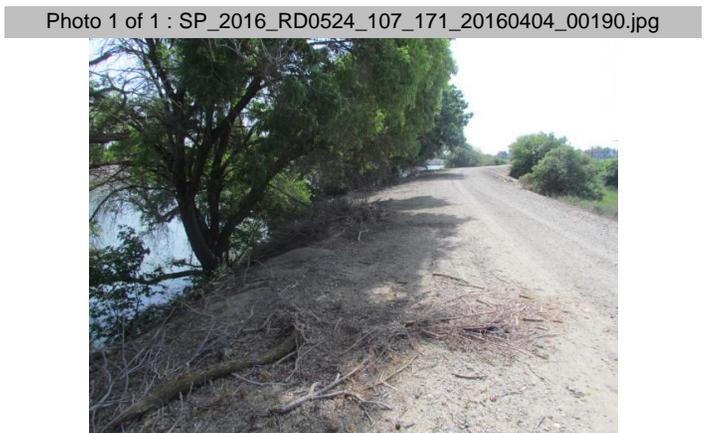
LM Start	<b>1.12</b>	Rating **	M	Issue No.	<b>171</b>
LM End	<b>1.16</b>	Issue Type +	Ma	Location *	WS
Category	Earthen Levee			GPS Latitude/Longitude	
				Start	End
Item	Encroachments			37.934225 °	37.933815 °
				-121.329693 °	-121.329242 °
DWR ID	DWR_RD0524_01_s_2015_171				
Comment Code					
PR : Prunings					
Inspector Comment					
Prunings left on waterward shoulder and slope.

Looking south at prunings on waterward shoulders.

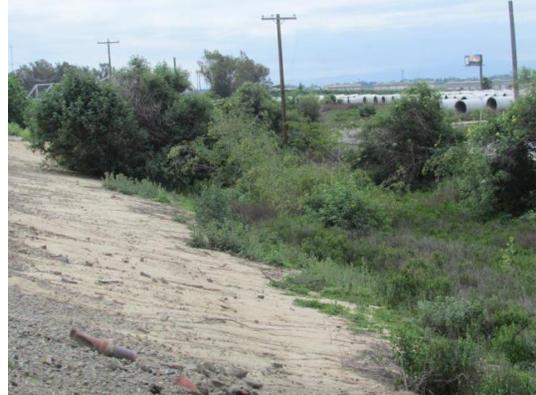
Photo 2 of 3 : SP\_2016\_RD0524\_107\_915\_20160414\_00351.jpg

LM Start	<b>1.16</b>	Rating **	U	Issue No.	<b>915 (cont)</b>
LM End	<b>1.23</b>	Issue Type +	Ma	Location *	LS
Category	Earthen Levee			GPS Latitude/Longitude	
				Start	End
Item	Vegetation			37.933775 °	37.932784 °
				-121.329250 °	-121.328765 °
DWR ID	DWR_RD0524_01_s_2012_915				
Comment Code					
V2 : Remove the wild growth other than native grasses from the levee slopes.					
Inspector Comment					
Control veg at landward toe and berm.

Looking southwest at dense veg at landward toe and berm. (Spring 2016)

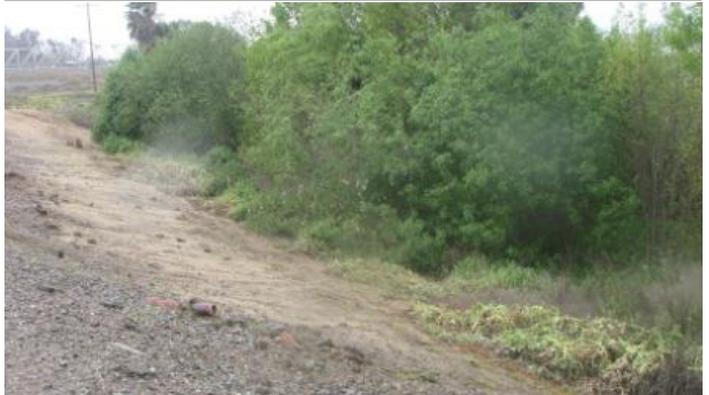
Photo 3 of 3 : SP\_2016\_RD0524\_107\_915\_20160404\_00234.jpg

Looking southwest at dense veg. on landside toe. (Spring 2015)

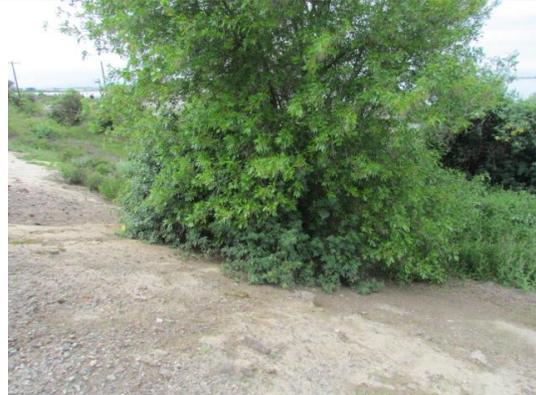
Photo 1 of 1 : SP\_2016\_RD0524\_107\_206\_20160414\_00352.jpg

Looking southwest a untrimmed tree at landward toe. (Spring 2016)

LM Start	<b>1.17</b>	Rating **	U	Issue No.	<b>206</b>
LM End	<b>1.17</b>	Issue Type +	Ma	Location *	LS
Category	Earthen Levee			GPS Latitude/Longitude	
				Start	End
Item	Trim / Thin Trees			37.933591 °	37.933591 °
				-121.329154 °	-121.329154 °
DWR ID	DWR_RD0524_01_s_2016_206				
Comment Code					
T1 : Trim trees to at least five feet above ground level.					
Inspector Comment

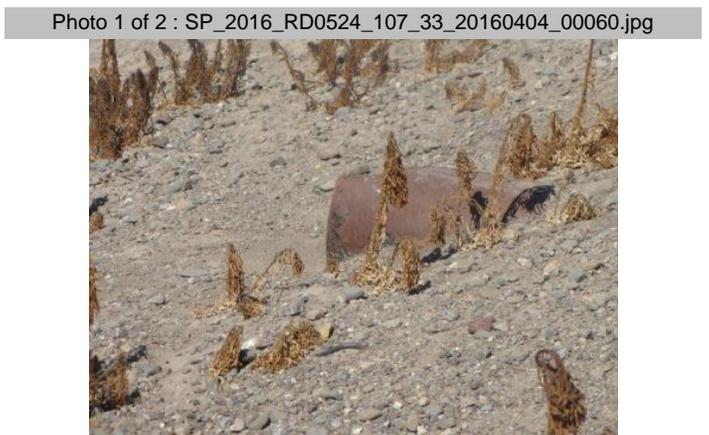
LM Start	<b>1.30</b>	Rating **	U	Issue No.	<b>33</b>
LM End	<b>1.30</b>	Issue Type +	Ma	Location *	WS
Category	Earthen Levee			GPS Latitude/Longitude	
				Start	End
Item	Encroachments			37.931948 °	37.931948 °
				-121.328387 °	-121.328387 °
DWR ID	DWR_RD0524_01_s_2012_33				
Comment Code					
PI : Pipe					
Inspector Comment					
Pipe is not in use and should be properly removed.

Looking west at pipe on landside slope.

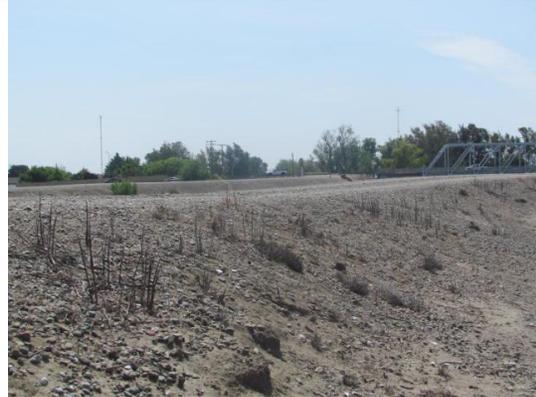
Photo 1 of 2 : SP\_2016\_RD0524\_107\_172\_20160404\_00191.jpg

LM Start	<b>1.36</b>	Rating **	U	Issue No.	<b>172</b>
LM End	<b>1.40</b>	Issue Type +	Ma	Location *	CR
Category	Earthen Levee		GPS Latitude/Longitude		
			Start	End	
Item	Crown Surface / Depressions / Rutting		37.931085 °	37.930517 °	
			-121.328112 °	-121.328072 °	
DWR ID	DWR_RD0524_01_s_2015_172				
Comment Code					
C2 : Repair depressions or ruts in the crown or slope.					
Inspector Comment					
Levee crown depression several inches below original crown elevation. Section should be survey to determine proper elevation.

Looking east at depression on levee crown.

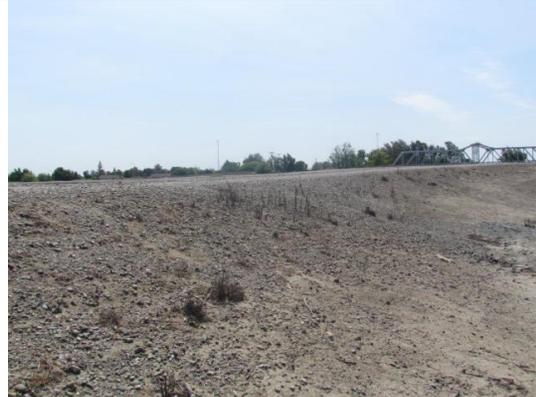
Photo 2 of 2 : SP\_2016\_RD0524\_107\_172\_20160404\_00192.jpg

Looking southeast at depression on levee crown.

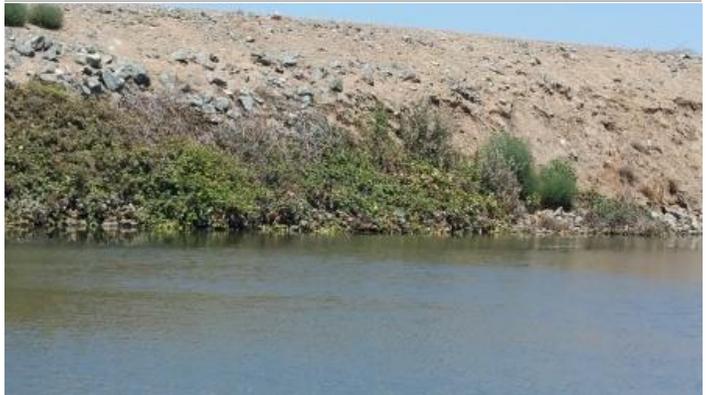
Photo 3 of 3 : SP\_2016\_RD0524\_107\_89\_20160404\_00127.jpg

LM Start	<b>1.45</b>	Rating **	U	Issue No.	<b>89 (cont)</b>
LM End	<b>1.47</b>	Issue Type +	Ma	Location *	WS
Category	Supplemental			GPS Latitude/Longitude	
				Start	End
Item	DWR Erosion Survey			37.929650 °	37.929650 °
				-121.328110 °	-121.328110 °
DWR ID	DWR_RD0524_01_s_2016_89				
Comment Code					
Inspector Comment					
06/24/2015: No significant change observed. 6/19/2014: No significant change observed. 08/13/2013: The site is located approximately 400 ft. downstream SR 4 Bridge. Dense vegetation is visible at the toe. [2015 Site ID:RD0524U01RM42.09]

Close view of the erosion. Note the vegetation at the site.

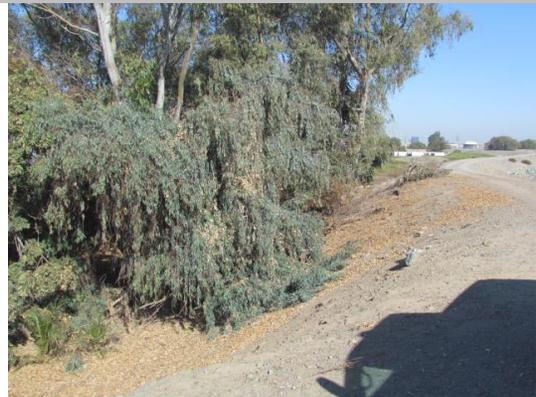
Photo 1 of 4 : SP\_2016\_RD0524\_107\_916\_20160404\_00235.jpg

LM Start	<b>1.49</b>	Rating **	U	Issue No.	<b>916</b>
LM End	<b>1.49</b>	Issue Type +	Ma	Location *	LS
Category	Earthen Levee			GPS Latitude/Longitude	
				Start	End
Item	Trim / Thin Trees			37.929118 °	37.929118 °
				-121.328368 °	-121.328368 °
DWR ID	DWR_RD0524_01_s_2012_916				
Comment Code					
T3 : Trim and thin trees to allow visibility of the ground and room to flood fight.					
Inspector Comment					
Untrimmed trees and dense vegetation on landward toe.

Looking southwest at dense trees on landward slope and toe fall 2015

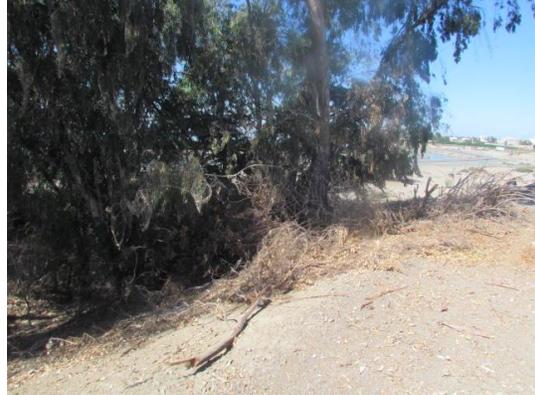
Photo 2 of 4 : SP\_2016\_RD0524\_107\_916\_20160404\_00236.jpg

Looking south at trees on landside slope. (Fall 2012)

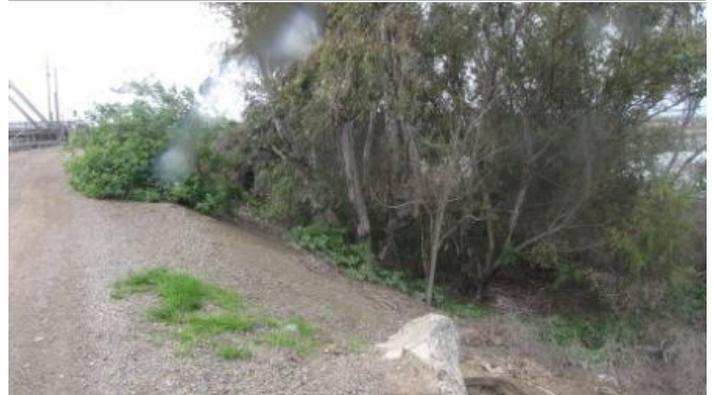
Photo 3 of 4 : SP\_2016\_RD0524\_107\_916\_20160404\_00237.jpg

Looking south at dense veg. on landside slope and toe.

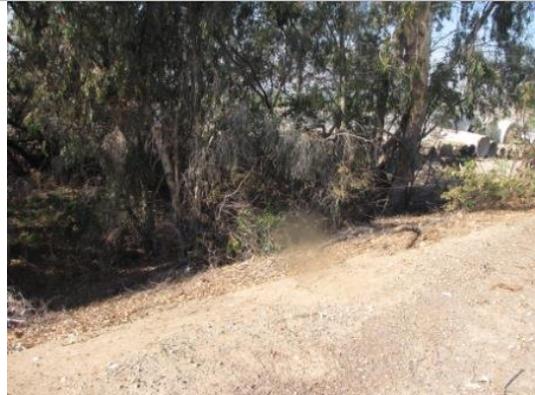
Photo 4 of 4 : SP\_2016\_RD0524\_107\_916\_20160404\_00238.jpg

Dense vegetation on landside toe.

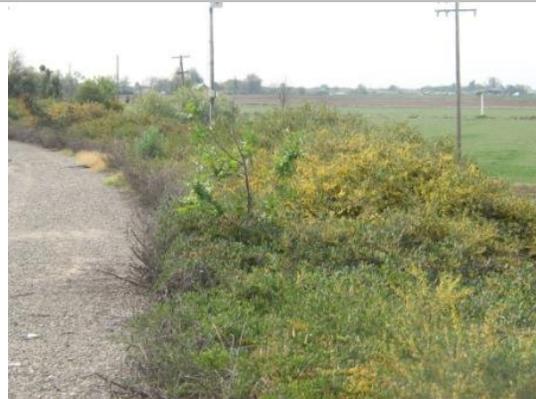
Photo 1 of 5 : SP\_2016\_RD0524\_107\_23\_20160404\_00043.jpg

LM Start	<b>1.55</b>	Rating **	A/W	Issue No.	<b>23</b>
LM End	<b>1.59</b>	Issue Type +	Ma	Location *	LS
Category	Earthen Levee			GPS Latitude/Longitude	
				Start	End
Item	Vegetation			37.928388 °	37.927797 °
				-121.328280 °	-121.327854 °
DWR ID	DWR_RD0524_01_s_2012_23				
Comment Code					
V2 : Remove the wild growth other than native grasses from the levee slopes.					
Inspector Comment

Overgrown landscaping on landward slope from LM 1.56 to 1.74

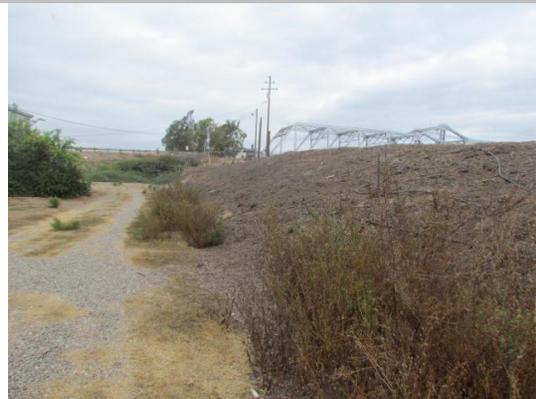
Photo 2 of 5 : SP\_2016\_RD0524\_107\_23\_20160404\_00044.jpg

Looking north from landward berm at corrected site.

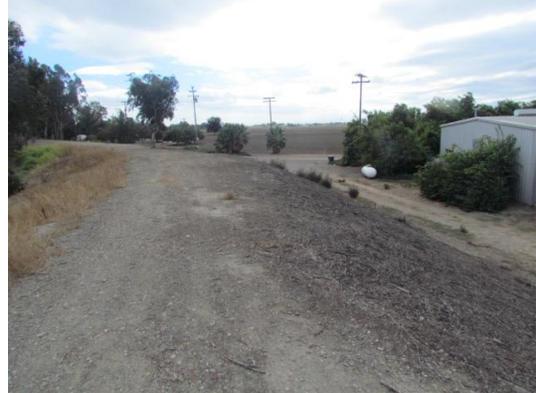
Photo 4 of 5 : SP\_2016\_RD0524\_107\_23\_20160404\_00046.jpg

Looking south from levee crown at corrected site.

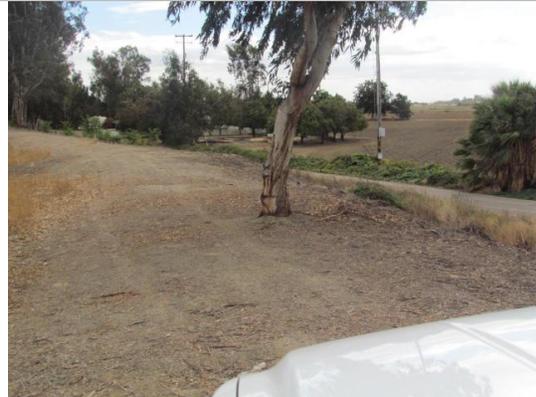
Photo 5 of 5 : SP\_2016\_RD0524\_107\_23\_20160404\_00047.jpg

Looking south from levee crown at upstream end of corrected site.

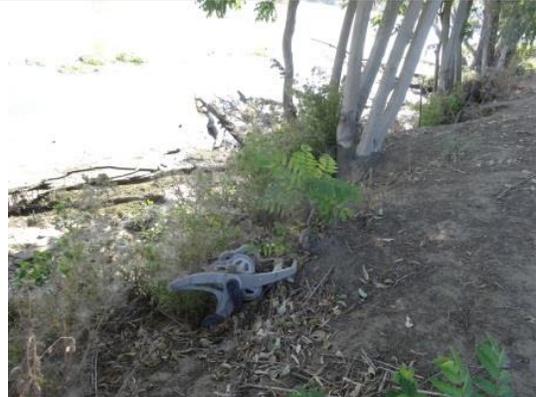
Photo 1 of 2 : SP\_2016\_RD0524\_107\_90\_20160404\_00128.jpg

Item	DWR Erosion Survey			37.927770 °	37.927770 °
				-121.327870 °	-121.327870 °
DWR ID	DWR_RD0524_01_s_2016_90				
Comment Code					
Inspector Comment					
<p>06/24/2015: No significant change observed.                  6/19/2014: No significant change observed.                  08/13/2013: No significant change observed.                  08/07/2012: : The site has been visited by boat survey. No significant change observed                  08/23/2011: No significant change observed on site. Trees concerned still in place.                  09/07/2010: No significant change observed on site. The concern here is the undermining of the levee toe where most of trees are. There are erosion pockets lined along the lower slope and at the base of the trees, exposing tree roots. There is minimal slope protection.                  09/29/2009: The lower slope is lined with minor erosion pockets; some tree roots are exposed; there is visible undermining of the levee toe; site is immediately upstream of the Highway 4 Bridge; the bridge is possibly causing a scour to occur, eroding the bank. [2015 Site ID:RD0524U01RM42.2]</p>

Front view of the site where undermining has occurred.

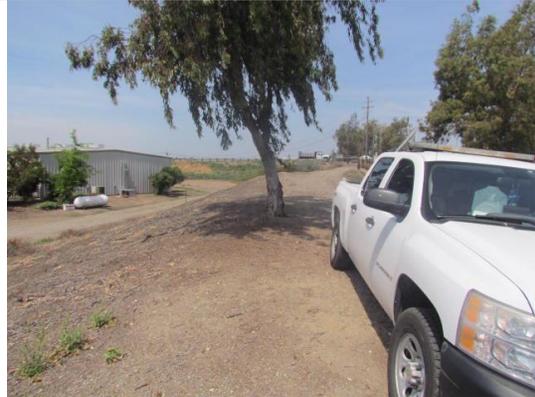
Photo 1 of 1 : SP\_2016\_RD0524\_107\_173\_20160404\_00193.jpg

LM Start	<b>1.58</b>	Rating **	U	Issue No.	<b>173</b>
LM End	<b>1.58</b>	Issue Type +	Ma	Location *	LS
Category	Earthen Levee		GPS Latitude/Longitude		
			Start	End	
Item	Trim / Thin Trees		37.927975 °	37.927975 °	
			-121.328088 °	-121.328088 °	
DWR ID	DWR_RD0524_01_s_2015_173				
Comment Code					
T1 : Trim trees to at least five feet above ground level.					
Inspector Comment					
Tree is located on landward shoulder and crown should be removed.

Looking northwest at tree on within levee crown.

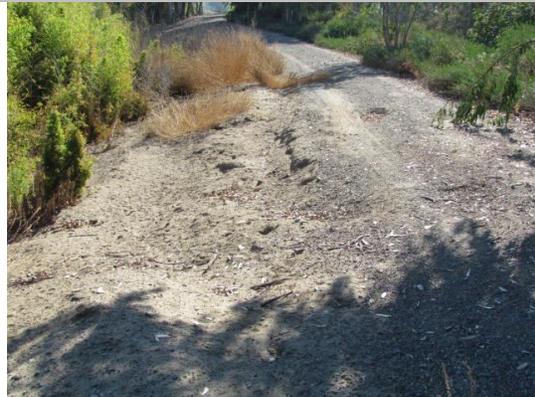
Photo 1 of 1 : SP\_2016\_RD0524\_107\_136\_20160404\_00181.jpg

LM Start	<b>1.59</b>	Rating **	M	Issue No.	<b>136</b>
LM End	<b>1.59</b>	Issue Type +	Ma	Location *	CR
Category	Earthen Levee		GPS Latitude/Longitude		
			Start	End	
Item	Slope Stability		37.927775 °	37.927775 °	
			-121.327860 °	-121.327860 °	
DWR ID	DWR_RD0524_01_s_2013_136				
Comment Code					
S2 : Repair the levee slope damaged by foot traffic and prevent access where possible.					
Inspector Comment					
Waterward shoulder caving.

Looking south at depression on levee crown near waterward shoulder.

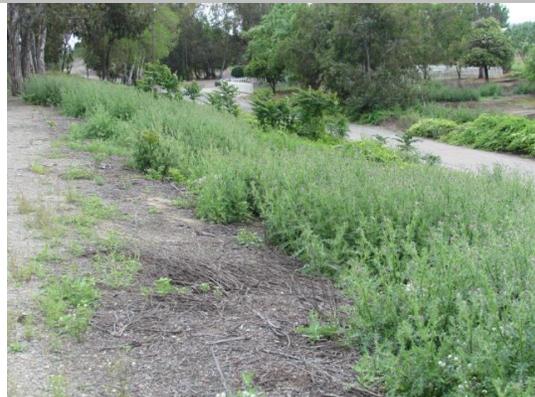
Photo 1 of 4 : SP\_2016\_RD0524\_107\_24\_20160414\_00353.jpg

LM Start	<b>1.60</b>	Rating **	U	Issue No.	<b>24</b>
LM End	<b>1.61</b>	Issue Type +	Ma	Location *	LS
Category	Earthen Levee		GPS Latitude/Longitude		
			Start	End	
Item	Vegetation		37.927635 °	37.927540 °	
			-121.327812 °	-121.327648 °	
DWR ID	DWR_RD0524_01_s_2012_24				
Comment Code					
V2 : Remove the wild growth other than native grasses from the levee slopes.					
Inspector Comment					
Vegetation blocking landward toe.

Looking southwest at dense veg on landward slope and toe. (Spring 2016)

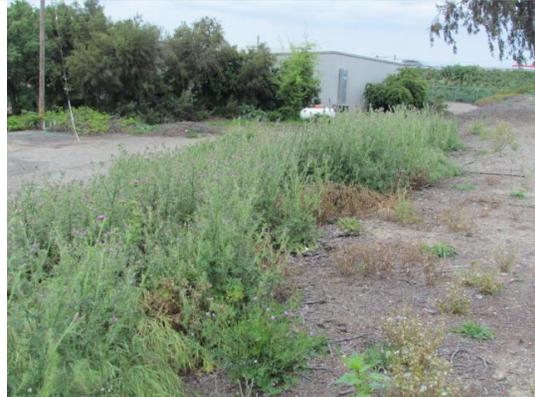
Photo 2 of 4 : SP\_2016\_RD0524\_107\_24\_20160414\_00354.jpg

Looking northwest at dense veg on landward slope and toe. (Spring 2016)

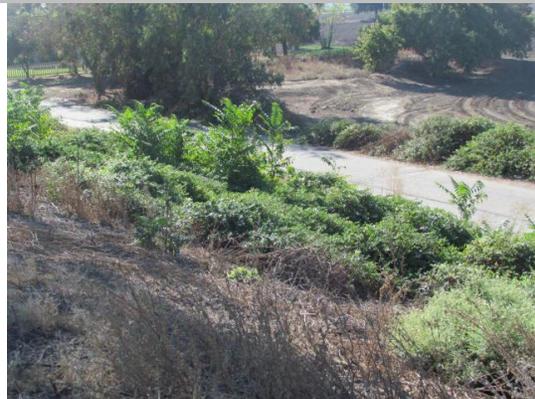
Photo 3 of 4 : SP\_2016\_RD0524\_107\_24\_20160404\_00048.jpg

Looking southwest at dense vegetation on landward slope fall 2015
