**Flood Control Project Maintenance  
Levee Inspections**

**Maintenance Issue Types Only, Levee Inspection Report By Mile - Spring 2016**

**Reclamation District No. 0524 Middle Roberts Island**

Waterway	Bank	Unit Miles	Inspection Start/End	Inspector
Unit No. 01 San Joaquin River	Left	6.20	04/12/2016 04/13/2016	Richard Willoughby

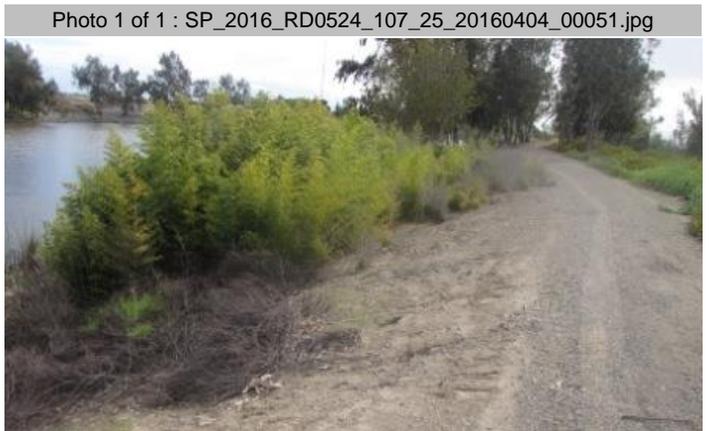
LM Start	<b>1.60</b>	Rating **	A/W	Issue No.	<b>25</b>
LM End	<b>1.61</b>	Issue Type +	Ma	Location *	WS
Category	Earthen Levee		GPS Latitude/Longitude		
			Start	End	
Item	Vegetation		37.927635 °	37.927540 °	
			-121.327812 °	-121.327648 °	
DWR ID	DWR_RD0524_01_s_2012_25				
Comment Code					
V2 : Remove the wild growth other than native grasses from the levee slopes.					
Inspector Comment

Looking southeast at dense vegetation on the waterside slope.

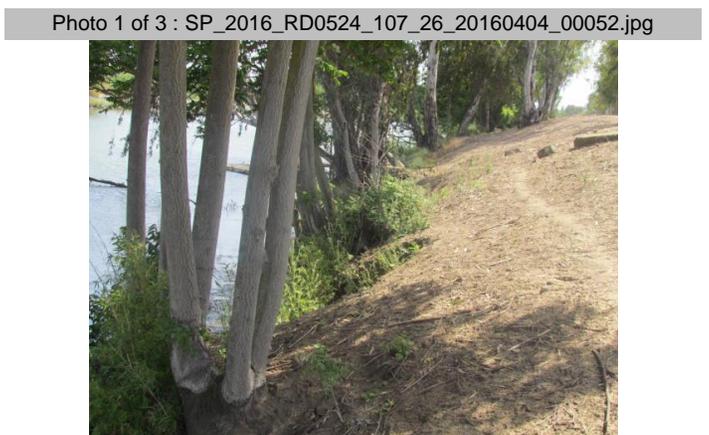
LM Start	<b>1.62</b>	Rating **	M	Issue No.	<b>26</b>
LM End	<b>1.64</b>	Issue Type +	Ma	Location *	WS
Category	Earthen Levee		GPS Latitude/Longitude		
			Start	End	
Item	Erosion / Bank Caving		37.927507 °	37.927295 °	
			-121.327593 °	-121.327298 °	
DWR ID	DWR_RD0524_01_s_2012_26				
Comment Code					
E1 : Note and monitor erosion site.					
Inspector Comment					
Several erosions along this reach.

Looking south at waterward erosion.

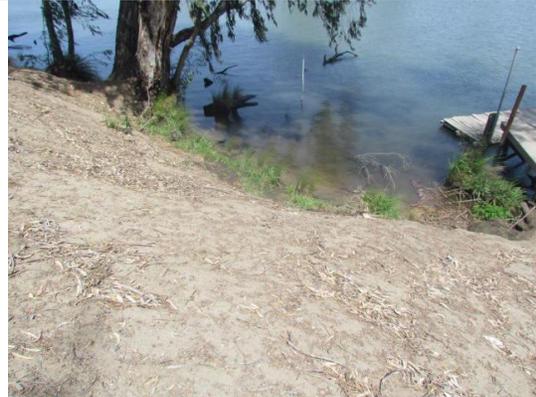
Photo 3 of 3 : SP\_2016\_RD0524\_107\_26\_20160404\_00054.jpg

LM Start	<b>1.62</b>	Rating **	M	Issue No.	<b>26 (cont)</b>
LM End	<b>1.64</b>	Issue Type +	Ma	Location *	WS
Category	Earthen Levee			GPS Latitude/Longitude	
				Start	End
Item	Erosion / Bank Caving			37.927507 °	37.927295 °
				-121.327593 °	-121.327298 °
DWR ID	DWR_RD0524_01_s_2012_26				
Comment Code					
E1 : Note and monitor erosion site.					
Inspector Comment					
Several erosions along this reach.

Looking east at waterward erosion and depression.

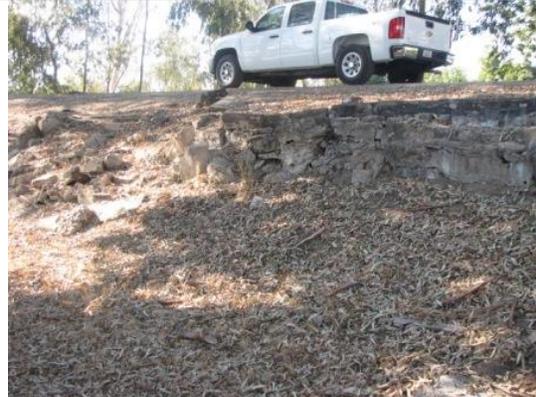
Photo 2 of 3 : SP\_2016\_RD0524\_107\_45\_20160404\_00078.jpg

LM Start	<b>1.67</b>	Rating **	U	Issue No.	<b>45 (cont)</b>
LM End	<b>1.67</b>	Issue Type +	Ma	Location *	WS
Category	Earthen Levee			GPS Latitude/Longitude	
				Start	End
Item	Encroachments			37.927018 °	37.927018 °
				-121.326872 °	-121.326872 °
DWR ID	DWR_RD0524_01_s_2012_45				
Comment Code					
ST : Stairway					
Inspector Comment					
Stairs and retaining wall

Looking southwest at retaning wall connected to concrete stairs.

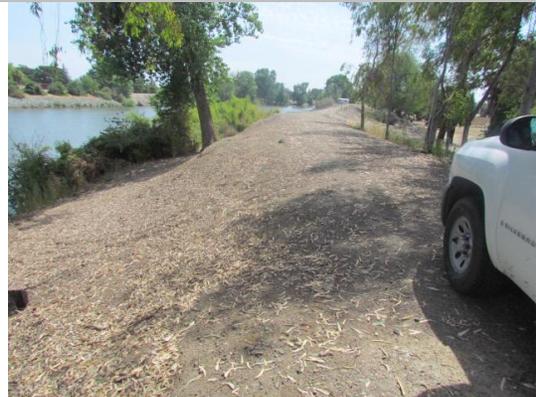
Photo 1 of 1 : SP\_2016\_RD0524\_107\_27\_20160404\_00055.jpg

LM Start	<b>1.69</b>	Rating **	M	Issue No.	<b>27</b>
LM End	<b>1.70</b>	Issue Type +	Ma	Location *	WS
Category	Earthen Levee			GPS Latitude/Longitude	
				Start	End
Item	Slope Stability			37.926728 °	37.926730 °
				-121.326597 °	-121.326508 °
DWR ID	DWR_RD0524_01_s_2012_27				
Comment Code					
S1 : Repair slope instability.					
Inspector Comment					
Slope damage several feet long and greater than one inch deep.

Looking south at landward slope depression.

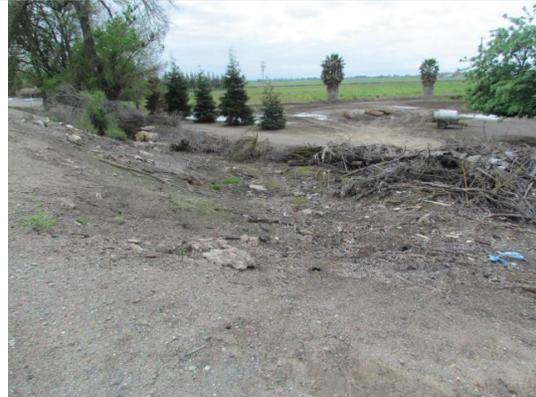
Photo 1 of 2 : SP\_2016\_RD0524\_107\_28\_20160414\_00357.jpg

LM Start	<b>1.73</b>	Rating **	U	Issue No.	<b>28</b>
LM End	<b>1.73</b>	Issue Type +	Ma	Location *	LS
Category	Earthen Levee			GPS Latitude/Longitude	
				Start	End
Item	Encroachments			37.926322 °	37.926322 °
				-121.326115 °	-121.326115 °
DWR ID	DWR_RD0524_01_s_2012_28				
Comment Code					
GA : Garbage					
Inspector Comment					
Large pruning piles on landside slope.

Looking west at prunings at landward toe. (Spring 2016)

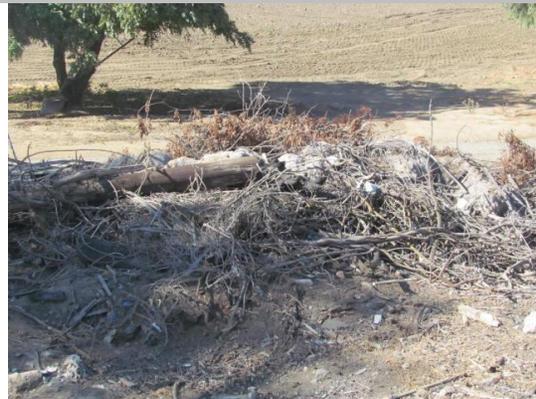
Photo 2 of 2 : SP\_2016\_RD0524\_107\_28\_20160404\_00056.jpg

Looking west at pruning pile at landward toe fall 2015.

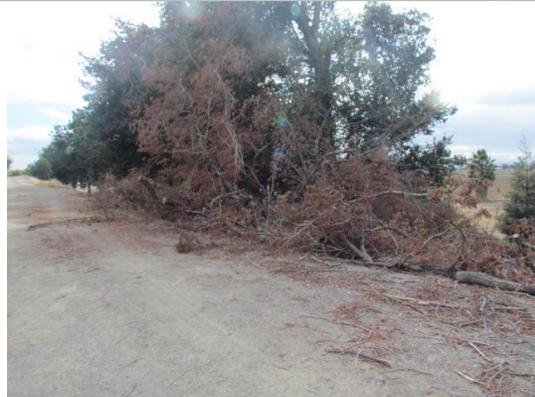
Photo 3 of 4 : SP\_2016\_RD0524\_107\_46\_20160404\_00082.jpg

Looking south at tree limbs on landward slope.

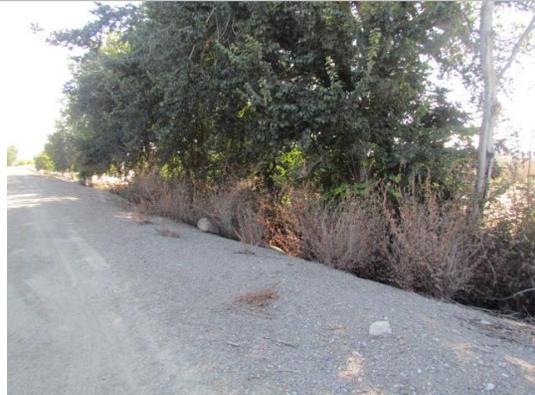
Photo 4 of 4 : SP\_2016\_RD0524\_107\_46\_20160404\_00083.jpg

LM Start	<b>1.75</b>	Rating **	U	Issue No.	<b>46 (cont)</b>
LM End	<b>1.76</b>	Issue Type +	Ma	Location *	LS

Looking southwest at dense vegetation and low hanging tree branches on landside slope and toe.

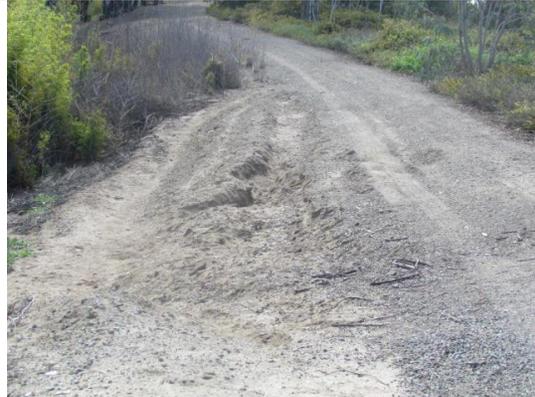
Photo 3 of 3 : SP\_2016\_RD0524\_107\_31\_20160404\_00057.jpg

LM Start	<b>2.25</b>	Rating **	U	Issue No.	<b>31 (cont)</b>
LM End	<b>2.25</b>	Issue Type +	Ma	Location *	WS
Category	Earthen Levee			GPS Latitude/Longitude	
				Start	End
Item	Slope Stability			37.920493 °	37.920493 °
				-121.320565 °	-121.320565 °
DWR ID	DWR_RD0524_01_s_2012_31				
Comment Code					
S1 : Repair slope instability.					
Inspector Comment					
Slope instability probably cause by leak in irrigation pipe. Pipe should be inspected internally.

Looking south slope damage on waterward shoulder and slope.

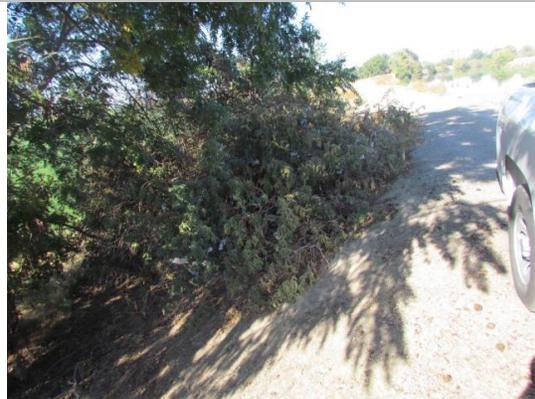
Photo 1 of 2 : SP\_2016\_RD0524\_107\_32\_20160404\_00058.jpg

LM Start	<b>2.27</b>	Rating **	U	Issue No.	<b>32</b>
LM End	<b>2.29</b>	Issue Type +	Ma	Location *	LS
Category	Earthen Levee			GPS Latitude/Longitude	
				Start	End
Item	Vegetation			37.920372 °	37.920167 °
				-121.320230 °	-121.319890 °
DWR ID	DWR_RD0524_01_s_2012_32				
Comment Code					
V4 : Elderberries are blocking visibility and flood fight capability.					
Inspector Comment					
Dense elderberry bushes on landward slope and toe.

Looking northwest at dense veg on landward slope and toe fall 2015.

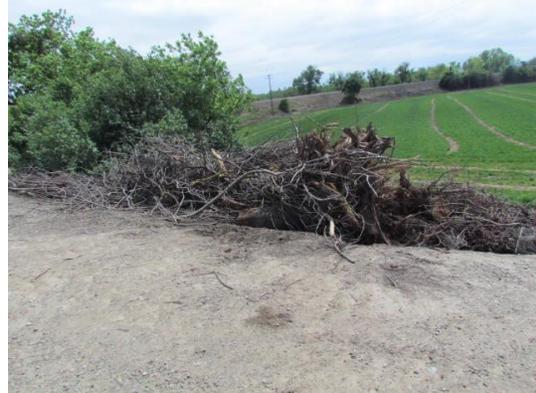
Photo 1 of 1 : SP\_2016\_RD0524\_107\_208\_20160414\_00360.jpg

LM Start	<b>2.27</b>	Rating **	U	Issue No.	<b>208</b>
LM End	<b>2.27</b>	Issue Type +	Ma	Location *	LS
Category	Earthen Levee			GPS Latitude/Longitude	
				Start	End
Item	Encroachments			37.920341 °	37.920341 °
				-121.320244 °	-121.320244 °
DWR ID	DWR_RD0524_01_s_2016_208				
Comment Code					
PR : Prunings					
Inspector Comment					
Large pruning pile on landward shoulder and slope.

Looking west at large pruning pile on landward slope.

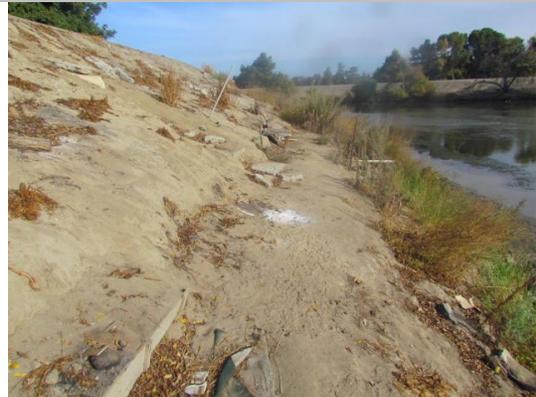
Photo 1 of 1 : SP\_2016\_RD0524\_107\_34\_20160404\_00062.jpg

LM Start	<b>2.32</b>	Rating **	M	Issue No.	<b>34</b>
LM End	<b>2.33</b>	Issue Type +	Ma	Location *	WS
Category	Earthen Levee			GPS Latitude/Longitude	
				Start	End
Item	Slope Stability			37.919885 °	37.919703 °
				-121.319713 °	-121.319702 °
DWR ID	DWR_RD0524_01_s_2012_34				
Comment Code					
S2 : Repair the levee slope damaged by foot traffic and prevent access where possible.					
Inspector Comment					
Slope damage caused by walking traffic and using bank as a fishing platform.

Looking northeast at damage to the slope possibly caused by human activity.

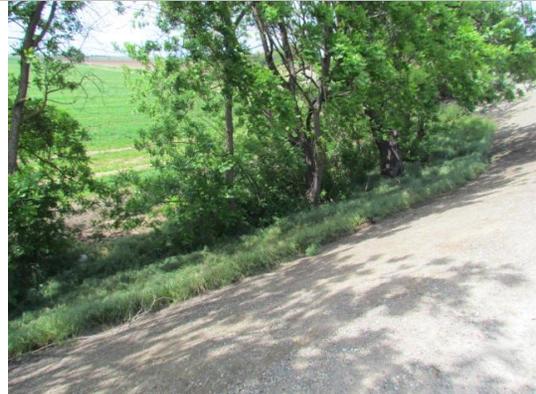
Photo 1 of 1 : SP\_2016\_RD0524\_107\_107\_20160414\_00361.jpg

LM Start	<b>2.33</b>	Rating **	U	Issue No.	<b>107</b>
LM End	<b>2.33</b>	Issue Type +	Ma	Location *	LS
Category	Earthen Levee			GPS Latitude/Longitude	
				Start	End
Item	Trim / Thin Trees			37.919742 °	37.919742 °
				-121.319623 °	-121.319623 °
DWR ID	DWR_RD0524_01_s_2012_107				
Comment Code					
T1 : Trim trees to at least five feet above ground level.					
Inspector Comment

Looking northwest at untrimmed trees at landward toe.

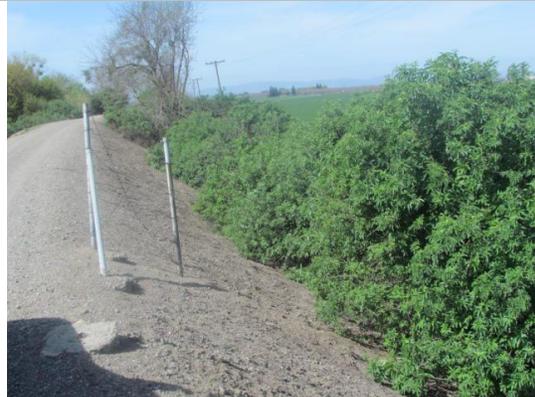
Photo 1 of 1 : SP\_2016\_RD0524\_107\_35\_20160404\_00063.jpg

LM Start	<b>2.41</b>	Rating **	U	Issue No.	<b>35</b>
LM End	<b>2.45</b>	Issue Type +	Ma	Location *	LS
Category	Earthen Levee			GPS Latitude/Longitude	
				Start	End
Item	Vegetation			37.918785 °	37.918515 °
				-121.320417 °	-121.321110 °
DWR ID	DWR_RD0524_01_s_2012_35				
Comment Code					
V4 : Elderberries are blocking visibility and flood fight capability.					
Inspector Comment

Looking southwest at dense vegetation on landward toe.

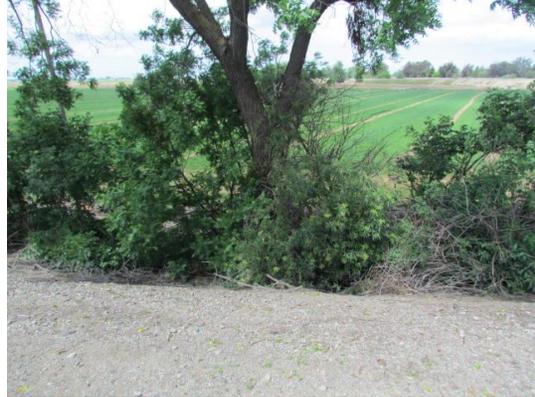
Photo 1 of 1 : SP\_2016\_RD0524\_107\_80\_20160414\_00362.jpg

LM Start	<b>2.45</b>	Rating **	U	Issue No.	<b>80</b>
LM End	<b>2.45</b>	Issue Type +	Ma	Location *	LS
Category	Earthen Levee			GPS Latitude/Longitude	
				Start	End
Item	Trim / Thin Trees			37.918480 °	37.918480 °
				-121.321114 °	-121.321114 °
DWR ID	DWR_RD0524_01_s_2012_80				
Comment Code					
T1 : Trim trees to at least five feet above ground level.					
Inspector Comment

Looking west at untrimmed trees at landward toe.

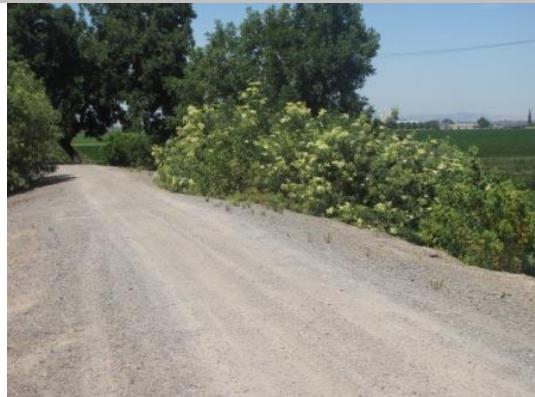
Photo 1 of 4 : SP\_2016\_RD0524\_107\_37\_20160404\_00065.jpg

LM Start	<b>2.49</b>	Rating **	U	Issue No.	<b>37</b>
LM End	<b>2.50</b>	Issue Type +	Ma	Location *	LS
Category	Earthen Levee			GPS Latitude/Longitude	
				Start	End
Item	Vegetation			37.918345 °	37.918302 °
				-121.321765 °	-121.321923 °
DWR ID	DWR_RD0524_01_s_2012_37				
Comment Code					
V4 : Elderberries are blocking visibility and flood fight capability.					
Inspector Comment

Looking south at elderberry on landside slope.

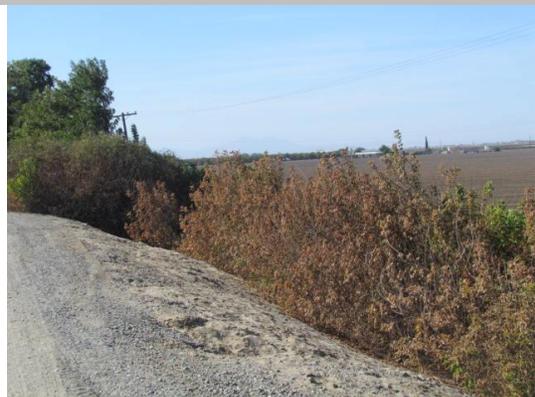
Photo 2 of 4 : SP\_2016\_RD0524\_107\_37\_20160404\_00066.jpg

LM Start	<b>2.49</b>	Rating **	U	Issue No.	<b>37 (cont)</b>
LM End	<b>2.50</b>	Issue Type +	Ma	Location *	LS

Looking southwest at dense vegetation on landside toe.

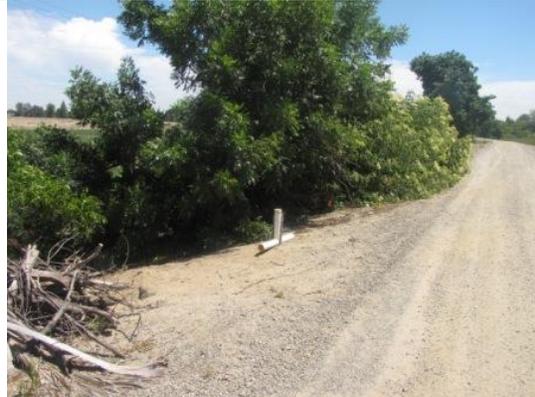
Photo 3 of 4 : SP\_2016\_RD0524\_107\_37\_20160404\_00067.jpg

LM Start	<b>2.49</b>	Rating **	U	Issue No.	<b>37 (cont)</b>
LM End	<b>2.50</b>	Issue Type +	Ma	Location *	LS
Category	Earthen Levee			GPS Latitude/Longitude	
				Start	End
Item	Vegetation			37.918345 °	37.918302 °
				-121.321765 °	-121.321923 °
DWR ID	DWR_RD0524_01_s_2012_37				
Comment Code					
V4 : Elderberries are blocking visibility and flood fight capability.					
Inspector Comment

Looking north at elderberry and trees on landside slope.

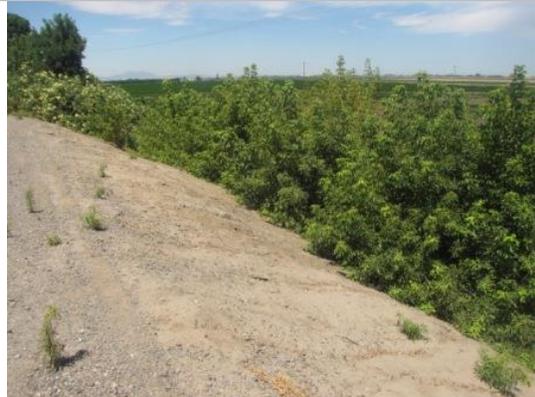
Photo 4 of 4 : SP\_2016\_RD0524\_107\_37\_20160404\_00068.jpg

LM Start	<b>2.49</b>	Rating **	U	Issue No.	<b>37 (cont)</b>
LM End	<b>2.50</b>	Issue Type +	Ma	Location *	LS

Looking southwest at trees along levee landside toe.

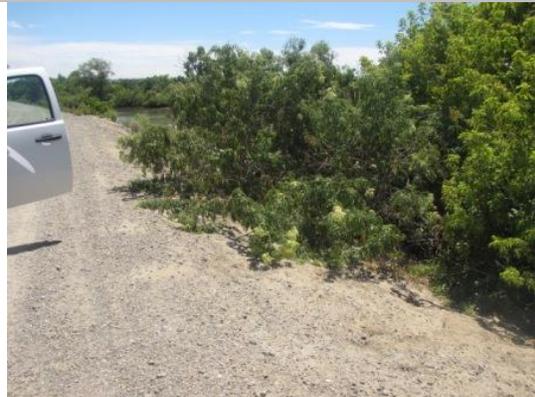
Photo 1 of 2 : SP\_2016\_RD0524\_107\_38\_20160404\_00069.jpg

LM Start	<b>2.50</b>	Rating **	U	Issue No.	<b>38</b>
LM End	<b>2.50</b>	Issue Type +	Ma	Location *	WS
Category	Earthen Levee			GPS Latitude/Longitude	
				Start	End
Item	Vegetation			37.918287 °	37.918287 °
				-121.321980 °	-121.321980 °
DWR ID	DWR_RD0524_01_s_2012_38				
Comment Code					
V4 : Elderberries are blocking visibility and flood fight capability.					
Inspector Comment

Looking north at elderberry on waterside slope.

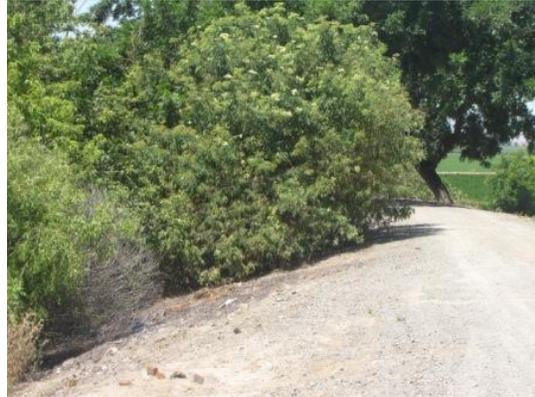
Photo 2 of 2 : SP\_2016\_RD0524\_107\_38\_20160404\_00070.jpg

LM Start	<b>2.50</b>	Rating **	U	Issue No.	<b>38 (cont)</b>
LM End	<b>2.50</b>	Issue Type +	Ma	Location *	WS
Category	Earthen Levee		GPS Latitude/Longitude		
			Start	End	
Item	Vegetation		37.918287 °	37.918287 °	
			-121.321980 °	-121.321980 °	
DWR ID	DWR_RD0524_01_s_2012_38				
Comment Code					
V4 : Elderberries are blocking visibility and flood fight capability.					
Inspector Comment

Looking south at elderberry on waterside slope.

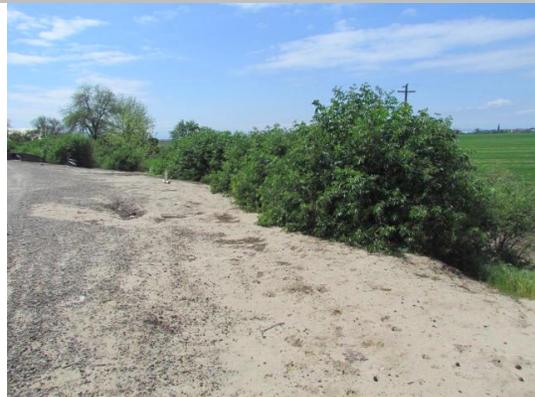
Photo 1 of 1 : SP\_2016\_RD0524\_107\_40\_20160414\_00363.jpg

LM Start	<b>2.53</b>	Rating **	U	Issue No.	<b>40</b>
LM End	<b>2.57</b>	Issue Type +	Ma	Location *	LS
Category	Earthen Levee		GPS Latitude/Longitude		
			Start	End	
Item	Vegetation		37.918047 °	37.917498 °	
			-121.322415 °	-121.322797 °	
DWR ID	DWR_RD0524_01_s_2012_40				
Comment Code					
V4 : Elderberries are blocking visibility and flood fight capability.					
Inspector Comment

Looking southwest at dense veg on landward slope.

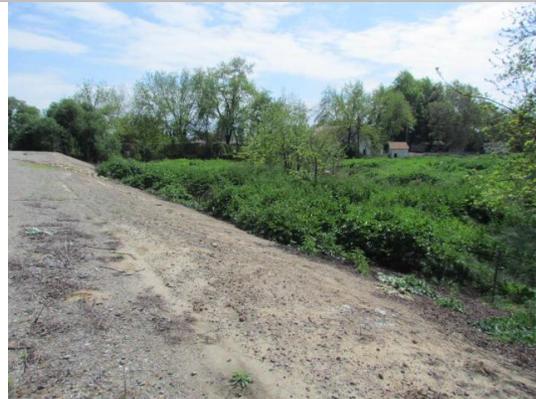
Photo 1 of 1 : SP\_2016\_RD0524\_107\_9\_20160414\_00364.jpg

LM Start	<b>2.59</b>	Rating **	U	Issue No.	<b>9</b>
LM End	<b>2.63</b>	Issue Type +	Ma	Location *	LS
Category	Earthen Levee		GPS Latitude/Longitude		
			Start	End	
Item	Vegetation		37.917228 °	37.916858 °	
			-121.322730 °	-121.322168 °	
DWR ID	DWR_RD0524_01_s_2012_9				
Comment Code					
V2 : Remove the wild growth other than native grasses from the levee slopes.					
Inspector Comment

Looking southwest at dense veg at landward toe.

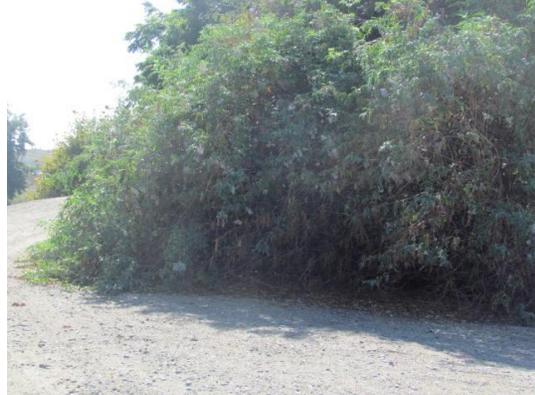
Photo 1 of 1 : SP\_2016\_RD0524\_107\_43\_20160404\_00075.jpg

LM Start	<b>2.64</b>	Rating **	U	Issue No.	<b>43</b>
LM End	<b>2.64</b>	Issue Type +	Ma	Location *	LS
Category	Earthen Levee		GPS Latitude/Longitude		
			Start	End	
Item	Vegetation		37.916780 °	37.916780 °	
			-121.322095 °	-121.322095 °	
DWR ID	DWR_RD0524_01_s_2012_43				
Comment Code					
V4 : Elderberries are blocking visibility and flood fight capability.					
Inspector Comment					
Dense elderberry on landward shoulder, slope, and toe.

Looking southeast at dense veg on landward slope and toe fall 2015.

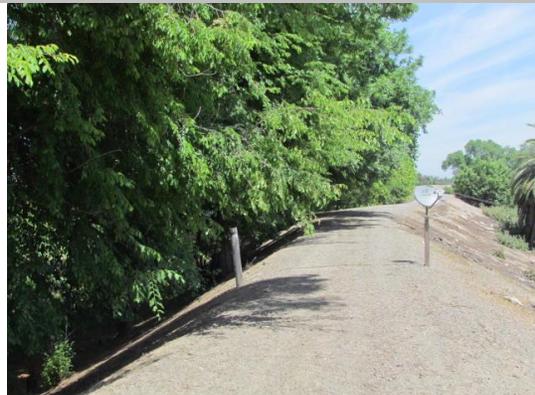
Photo 1 of 1 : SP\_2016\_RD0524\_107\_44\_20160404\_00076.jpg

LM Start	<b>2.67</b>	Rating **	M	Issue No.	<b>44</b>
LM End	<b>2.77</b>	Issue Type +	Ma	Location *	LS
Category	Earthen Levee		GPS Latitude/Longitude		
			Start	End	
Item	Trim / Thin Trees		37.916418 °	37.915142 °	
			-121.321963 °	-121.323018 °	
DWR ID	DWR_RD0524_01_s_2012_44				
Comment Code					
T4 : Trim trees over roadway to at least 12 feet above ground level.					
Inspector Comment					
Trim over hanging trees at least 12 feet above ground level.

Looking north at dense trees overhanging levee crown.

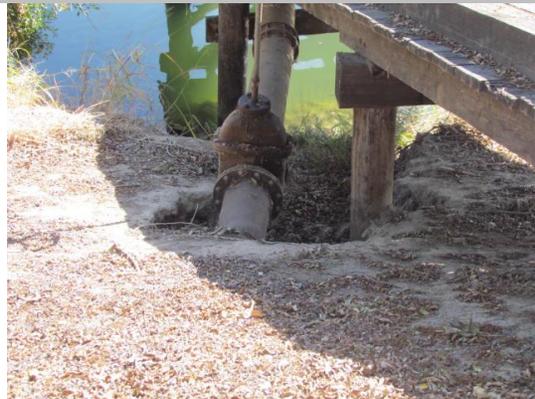
Photo 2 of 2 : SP\_2016\_RD0524\_107\_21\_20160404\_00040.jpg

LM Start	<b>2.68</b>	Rating **	U	Issue No.	<b>21</b>
LM End	<b>2.68</b>	Issue Type +	Ma	Location *	WS
Category	Earthen Levee			GPS Latitude/Longitude	
				Start	End
Item	Erosion / Bank Caving			37.916224 °	37.916224 °
				-121.322115 °	-121.322115 °
DWR ID	DWR_RD0524_01_f_2013_21				
Comment Code					
E2 : Schedule repair of erosion site prior to the next inspection.					
Inspector Comment					
Large erosion around irrigation pipe.

LM Start	<b>2.68</b>	Rating **	U	Issue No.	<b>21 (cont)</b>
LM End	<b>2.68</b>	Issue Type +	Ma	Location *	WS

Looking east at erosion around irrigation pipe on waterward slope.

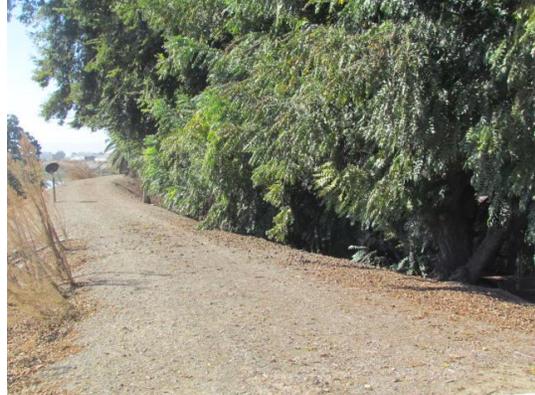
Photo 1 of 1 : SP\_2016\_RD0524\_107\_60\_20160404\_00098.jpg

LM Start	<b>2.72</b>	Rating **	U	Issue No.	<b>60</b>
LM End	<b>2.74</b>	Issue Type +	Ma	Location *	LS
Category	Earthen Levee			GPS Latitude/Longitude	
				Start	End
Item	Trim / Thin Trees			37.915747 °	37.915492 °
				-121.322470 °	-121.322639 °
DWR ID	DWR_RD0524_01_s_2012_60				
Comment Code					
T1 : Trim trees to at least five feet above ground level.					
Inspector Comment					
Untrimmed trees on landward slope.

Looking southwest at dense untrimmed trees on landward slope and toe fall 2015.

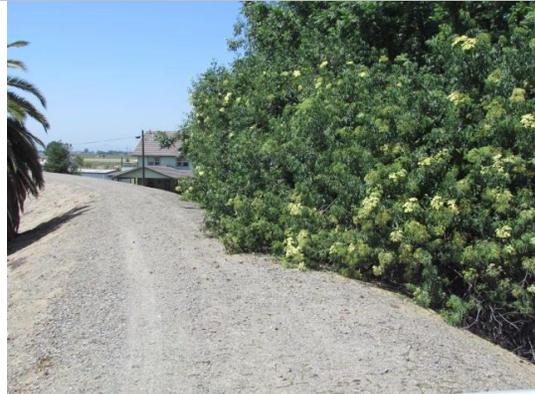
Photo 1 of 2 : SP\_2016\_RD0524\_107\_48\_20160404\_00086.jpg

LM Start	<b>2.80</b>	Rating **	U	Issue No.	<b>48</b>
LM End	<b>2.80</b>	Issue Type +	Ma	Location *	LS
Category	Earthen Levee			GPS Latitude/Longitude	
				Start	End
Item	Vegetation			37.915022 °	37.915022 °
				-121.323443 °	-121.323443 °
DWR ID	DWR_RD0524_01_s_2012_48				
Comment Code					
V4 : Elderberries are blocking visibility and flood fight capability.					
Inspector Comment

Looking south at dense elderberry on landside slope. (Spring 2012)

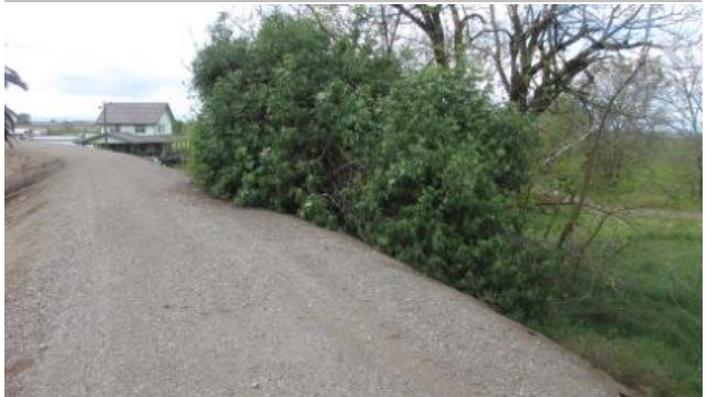
Photo 2 of 2 : SP\_2016\_RD0524\_107\_48\_20160404\_00087.jpg

LM Start	<b>2.80</b>	Rating **	U	Issue No.	<b>48 (cont)</b>
LM End	<b>2.80</b>	Issue Type +	Ma	Location *	LS
Category	Earthen Levee		GPS Latitude/Longitude		
			Start	End	
Item	Vegetation		37.915022 °	37.915022 °	
			-121.323443 °	-121.323443 °	
DWR ID	DWR_RD0524_01_s_2012_48				
Comment Code					
V4 : Elderberries are blocking visibility and flood fight capability.					
Inspector Comment

Looking south at elderberry on landside slope.(Spring 2011)

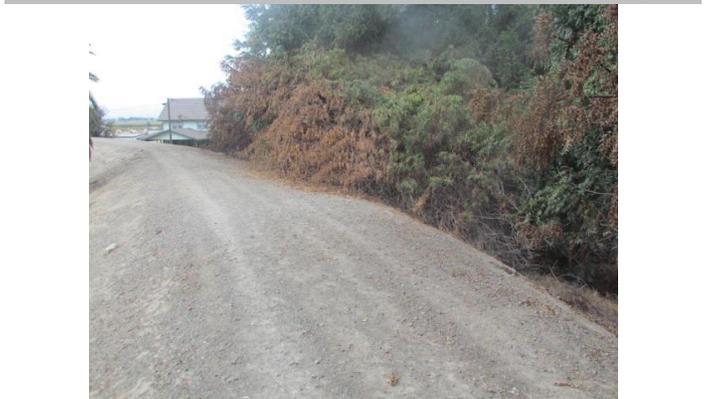
Photo 1 of 1 : SP\_2016\_RD0524\_107\_91\_20160404\_00130.jpg

LM Start	<b>2.80</b>	Rating **	U	Issue No.	<b>91</b>
LM End	<b>2.80</b>	Issue Type +	Ma	Location *	LS
Category	Earthen Levee		GPS Latitude/Longitude		
			Start	End	
Item	Trim / Thin Trees		37.915063 °	37.915063 °	
			-121.323585 °	-121.323585 °	
DWR ID	DWR_RD0524_01_s_2012_91				
Comment Code					
T2 : Thin trees to allow visibility of the ground and room to flood fight.					
Inspector Comment

Looking southwest at dense vegetation on landside slope.

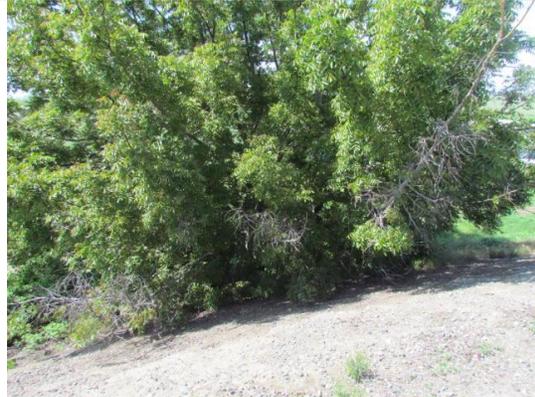
Photo 1 of 1 : SP\_2016\_RD0524\_107\_209\_20160414\_00367.jpg

LM Start	<b>2.87</b>	Rating **	U	Issue No.	<b>209</b>
LM End	<b>2.87</b>	Issue Type +	Ma	Location *	LS
Category	Earthen Levee		GPS Latitude/Longitude		
			Start	End	
Item	Trim / Thin Trees		37.914257 °	37.914257 °	
			-121.324317 °	-121.324317 °	
DWR ID	DWR_RD0524_01_s_2016_209				
Comment Code					
T1 : Trim trees to at least five feet above ground level.					
Inspector Comment					
Untrimmed walnut tree on landward slope and toe.

Looking northwest at untrimmed tree at landward toe.

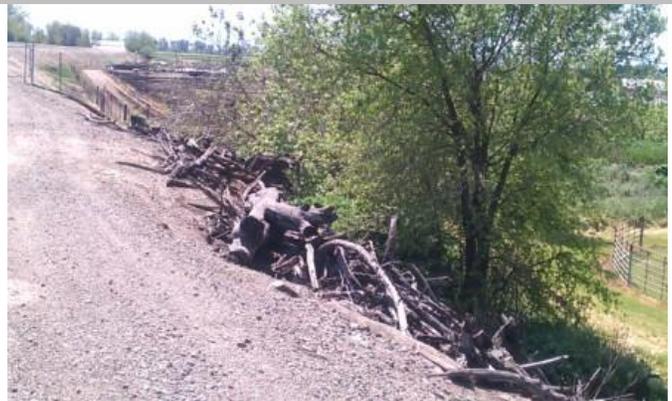
Photo 1 of 1 : SP\_2016\_RD0524\_107\_50\_20160404\_00089.jpg

LM Start	<b>2.90</b>	Rating **	U	Issue No.	<b>50</b>
LM End	<b>2.92</b>	Issue Type +	Ma	Location *	LS
Category	Earthen Levee		GPS Latitude/Longitude		
			Start	End	
Item	Encroachments		37.913767 °	37.913503 °	
			-121.324427 °	-121.324488 °	
DWR ID	DWR_RD0524_01_s_2012_50				
Comment Code					
PR : Prunings					
Inspector Comment

Looking southwest at prunings on landside slope.

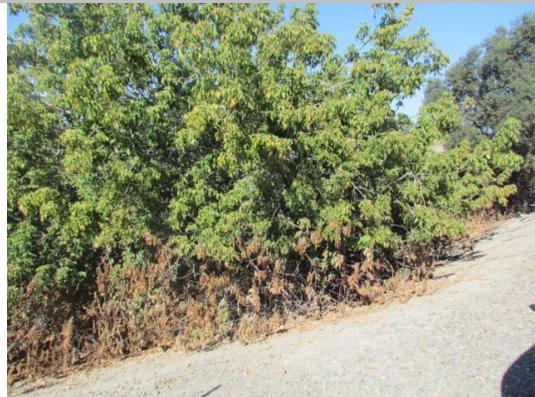
Photo 1 of 2 : SP\_2016\_RD0524\_107\_51\_20160404\_00090.jpg

LM Start	<b>2.93</b>	Rating **	U	Issue No.	<b>51</b>
LM End	<b>2.93</b>	Issue Type +	Ma	Location *	LS
Category	Earthen Levee		GPS Latitude/Longitude		
			Start	End	
Item	Trim / Thin Trees		37.913415 °	37.913415 °	
			-121.324503 °	-121.324503 °	
DWR ID	DWR_RD0524_01_s_2012_51				
Comment Code					
T1 : Trim trees to at least five feet above ground level.					
Inspector Comment					
Untrimmed trees on landward slope and toe.

Looking south at dense trees on landward slope fall 2015

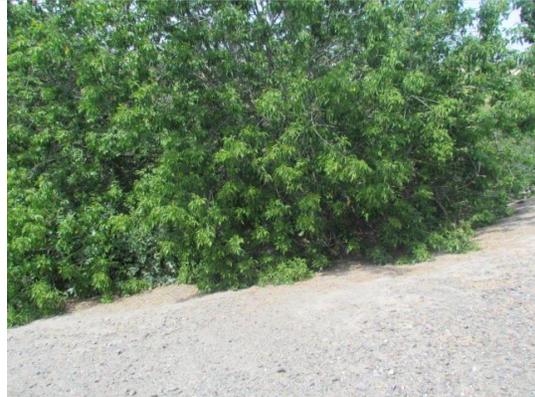
Photo 2 of 2 : SP\_2016\_RD0524\_107\_51\_20160404\_00091.jpg

LM Start	<b>2.93</b>	Rating **	U	Issue No.	<b>51 (cont)</b>
LM End	<b>2.93</b>	Issue Type +	Ma	Location *	LS
Category	Earthen Levee			GPS Latitude/Longitude	
				Start	End
Item	Trim / Thin Trees			37.913415 °	37.913415 °
				-121.324503 °	-121.324503 °
DWR ID	DWR_RD0524_01_s_2012_51				
Comment Code					
T1 : Trim trees to at least five feet above ground level.					
Inspector Comment					
Untrimmed trees on landward slope and toe.

Looking south at dense trees on landward slope spring 2015

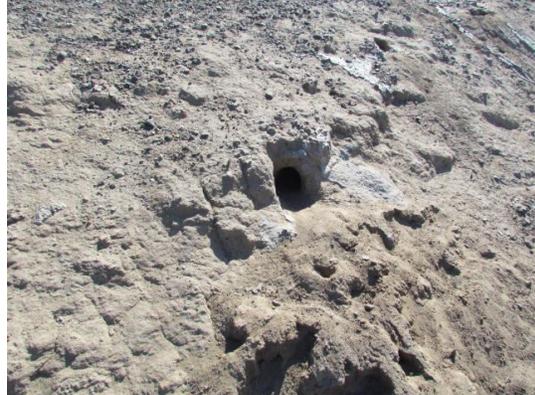
Photo 1 of 2 : SP\_2016\_RD0524\_107\_925\_20160404\_00240.jpg

LM Start	<b>3.07</b>	Rating **	M	Issue No.	<b>925</b>
LM End	<b>3.27</b>	Issue Type +	Ma	Location *	LS
Category	Earthen Levee			GPS Latitude/Longitude	
				Start	End
Item	Animal Control			37.911382 °	37.908602 °
				-121.324928 °	-121.325395 °
DWR ID	DWR_RD0524_01_s_2012_925				
Comment Code					
A1 : Exterminate rodents and backfill and compact or grout burrows.					
Inspector Comment					
Several rodent holes on levee slopes.

Looking at typical view of rodent hole with this section fall 2015.

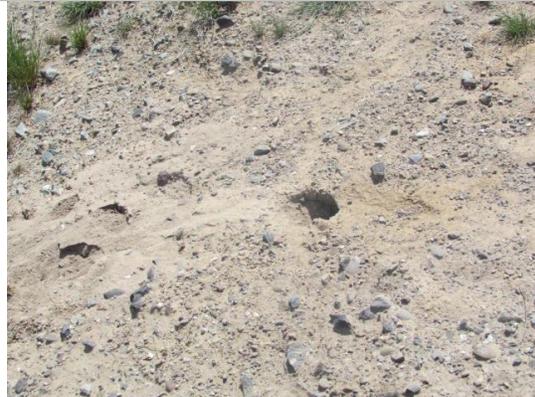
Photo 2 of 2 : SP\_2016\_RD0524\_107\_925\_20160404\_00241.jpg

LM Start	<b>3.07</b>	Rating **	M	Issue No.	<b>925 (cont)</b>
LM End	<b>3.27</b>	Issue Type +	Ma	Location *	LS

Looking at typical rodent holes on landward slope along this reach.

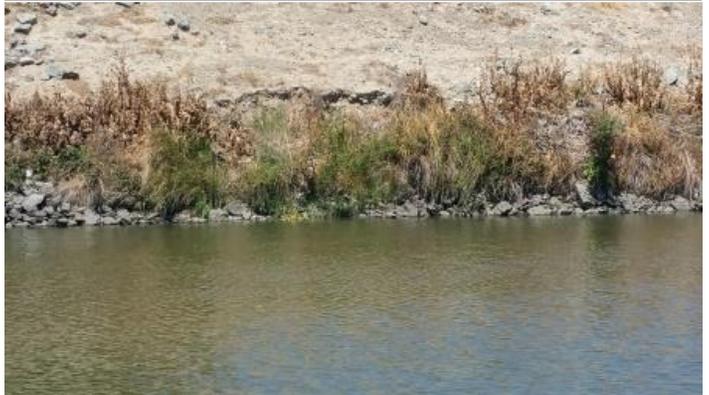
Photo 2 of 2 : SP\_2016\_RD0524\_107\_128\_20160404\_00168.jpg

LM Start	<b>3.30</b>	Rating **	U	Issue No.	<b>128 (cont)</b>
LM End	<b>3.32</b>	Issue Type +	Ma	Location *	WS

Close view of the erosion.

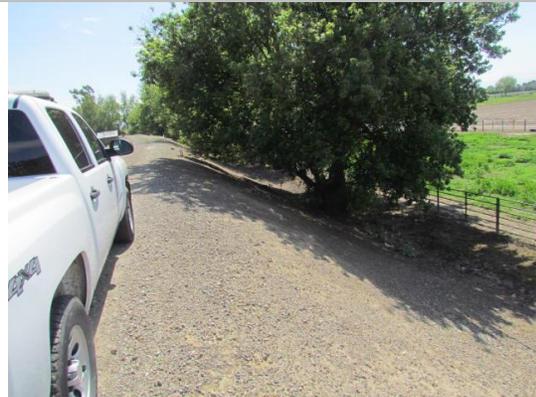
Photo 1 of 2 : SP\_2016\_RD0524\_107\_926\_20160414\_00374.jpg

LM Start	<b>3.30</b>	Rating **	U	Issue No.	<b>926</b>
LM End	<b>3.38</b>	Issue Type +	Ma	Location *	LS
Category	Earthen Levee			GPS Latitude/Longitude	
				Start	End
Item	Trim / Thin Trees			37.908158 °	37.907080 °
				-121.325418 °	-121.325366 °
DWR ID	DWR_RD0524_01_s_2012_926				
Comment Code					
T1 : Trim trees to at least five feet above ground level.					
Inspector Comment

Looking northwest at untrimmed trees on landward slope and toe.

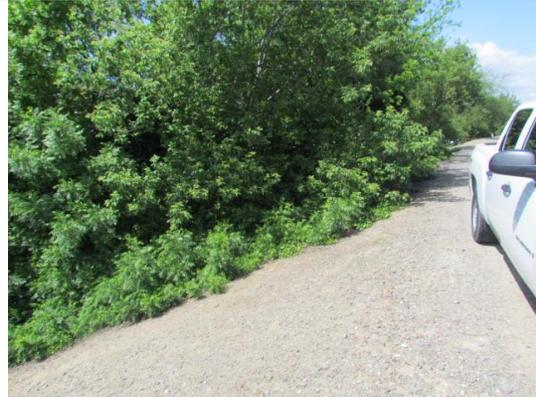
Photo 2 of 2 : SP\_2016\_RD0524\_107\_926\_20160414\_00375.jpg

LM Start	<b>3.30</b>	Rating **	U	Issue No.	<b>926 (cont)</b>
LM End	<b>3.38</b>	Issue Type +	Ma	Location *	LS
Category	Earthen Levee			GPS Latitude/Longitude	
				Start	End
Item	Trim / Thin Trees			37.908158 °	37.907080 °
				-121.325418 °	-121.325366 °
DWR ID	DWR_RD0524_01_s_2012_926				
Comment Code					
T1 : Trim trees to at least five feet above ground level.					
Inspector Comment

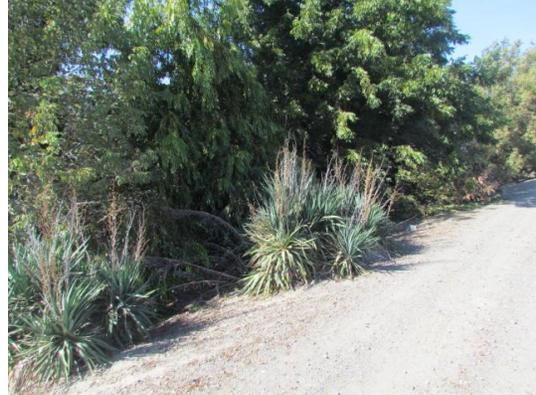
Photo 1 of 1 : SP\_2016\_RD0524\_107\_54\_20160404\_00092.jpg

LM Start	<b>3.45</b>	Rating **	U	Issue No.	<b>54</b>
LM End	<b>3.45</b>	Issue Type +	Ma	Location *	LS
Category	Earthen Levee		GPS Latitude/Longitude		
			Start	End	
Item	Trim / Thin Trees		37.906227 °	37.906227 °	
			-121.324683 °	-121.324683 °	
DWR ID	DWR_RD0524_01_s_2012_54				
Comment Code					
T3 : Trim and thin trees to allow visibility of the ground and room to flood fight.					
Inspector Comment					
Dense untrimmed trees on landward slope.

Looking northwest at dense vegetation on landside slope.

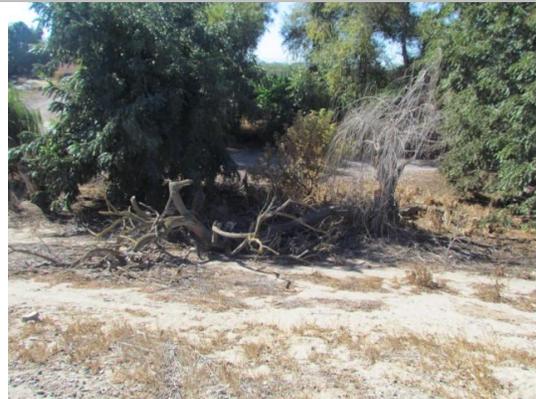
Photo 1 of 1 : SP\_2016\_RD0524\_107\_177\_20160404\_00199.jpg

LM Start	<b>3.48</b>	Rating **	M	Issue No.	<b>177</b>
LM End	<b>3.48</b>	Issue Type +	Ma	Location *	LS
Category	Earthen Levee		GPS Latitude/Longitude		
			Start	End	
Item	Encroachments		37.905994 °	37.905994 °	
			-121.324194 °	-121.324194 °	
DWR ID	DWR_RD0524_01_f_2014_177				
Comment Code					
TR : Tree or limb					
Inspector Comment					
Dead tree on landward toe.

Looking at dead tree limb at landward toe fall 2015.

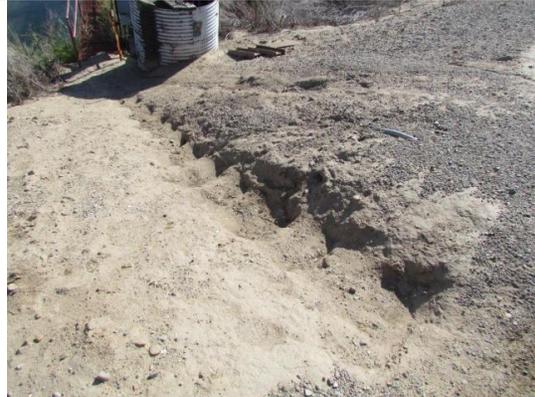
Photo 1 of 1 : SP\_2016\_RD0524\_107\_58\_20160404\_00096.jpg

LM Start	<b>3.64</b>	Rating **	M	Issue No.	<b>58</b>
LM End	<b>3.64</b>	Issue Type +	Ma	Location *	WS
Category	Earthen Levee		GPS Latitude/Longitude		
			Start	End	
Item	Slope Stability		37.904113 °	37.904113 °	
			-121.325080 °	-121.325080 °	
DWR ID	DWR_RD0524_01_s_2012_58				
Comment Code					
S2 : Repair the levee slope damaged by foot traffic and prevent access where possible.					
Inspector Comment					
Landowner cut steps into waterside slope.

Looking southeast steps cut into waterside slope.

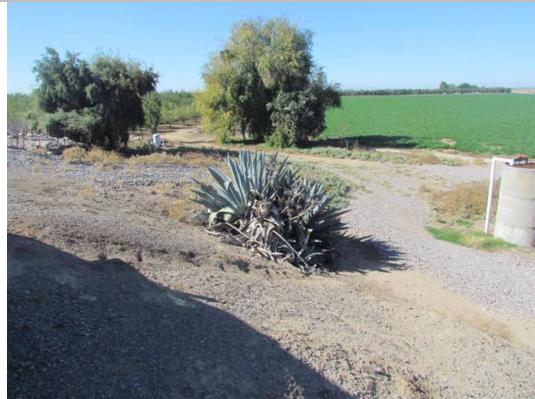
Photo 1 of 1 : SP\_2016\_RD0524\_107\_190\_20160404\_00210.jpg

LM Start	<b>3.65</b>	Rating **	U	Issue No.	<b>190</b>
LM End	<b>3.65</b>	Issue Type +	Ma	Location *	LS
Category	Earthen Levee		GPS Latitude/Longitude		
			Start	End	
Item	Vegetation		37.904070 °	37.904070 °	
			-121.325118 °	-121.325118 °	
DWR ID	DWR_RD0524_01_f_2015_190				
Comment Code					
V2 : Remove the wild growth other than native grasses from the levee slopes.					
Inspector Comment					
Large century plant at landward toe.

Looking southwest at century plant at landward toe fall 2015.

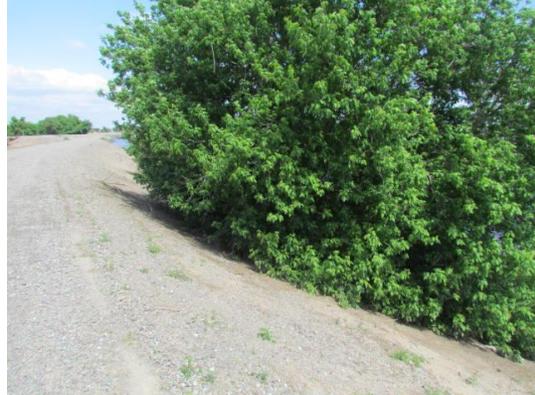
Photo 1 of 1 : SP\_2016\_RD0524\_107\_52\_20160414\_00376.jpg

LM Start	<b>3.75</b>	Rating **	U	Issue No.	<b>52</b>
LM End	<b>3.75</b>	Issue Type +	Ma	Location *	WS
Category	Earthen Levee		GPS Latitude/Longitude		
			Start	End	
Item	Trim / Thin Trees		37.902828 °	37.902828 °	
			-121.326170 °	-121.326170 °	
DWR ID	DWR_RD0524_01_s_2016_52				
Comment Code					
T1 : Trim trees to at least five feet above ground level.					
Inspector Comment

Looking south at untrimmed tree on landward slope and toe.

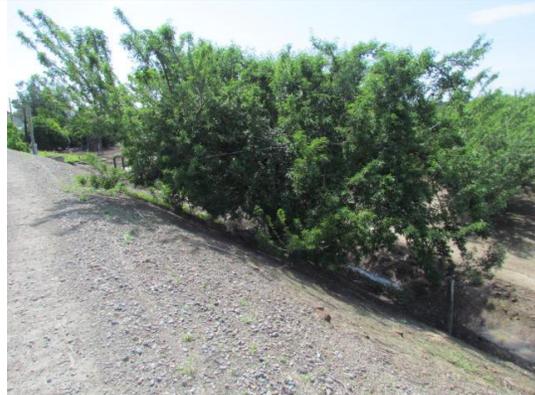
Photo 1 of 1 : SP\_2016\_RD0524\_107\_927\_20160414\_00377.jpg

LM Start	<b>3.77</b>	Rating **	U	Issue No.	<b>927</b>
LM End	<b>3.77</b>	Issue Type +	Ma	Location *	LS
Category	Earthen Levee		GPS Latitude/Longitude		
			Start	End	
Item	Trim / Thin Trees		37.902645 °	37.902645 °	
			-121.326340 °	-121.326340 °	
DWR ID	DWR_RD0524_01_s_2012_927				
Comment Code					
T1 : Trim trees to at least five feet above ground level.					
Inspector Comment					
Untrimmed almond tree on landward slope.

Looking southwest at untrimmed tree at landward toe.

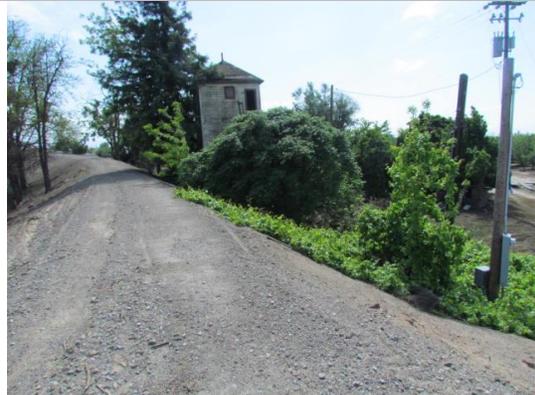
Photo 1 of 1 : SP\_2016\_RD0524\_107\_59\_20160414\_00378.jpg

LM Start	<b>3.78</b>	Rating **	U	Issue No.	<b>59</b>
LM End	<b>3.78</b>	Issue Type +	Ma	Location *	LS
Category	Earthen Levee		GPS Latitude/Longitude		
			Start	End	
Item	Trim / Thin Trees		37.902417 °	37.902417 °	
			-121.326482 °	-121.326482 °	
DWR ID	DWR_RD0524_01_s_2012_59				
Comment Code					
T1 : Trim trees to at least five feet above ground level.					
Inspector Comment

Looking south at dense veg on landward slope and toe.

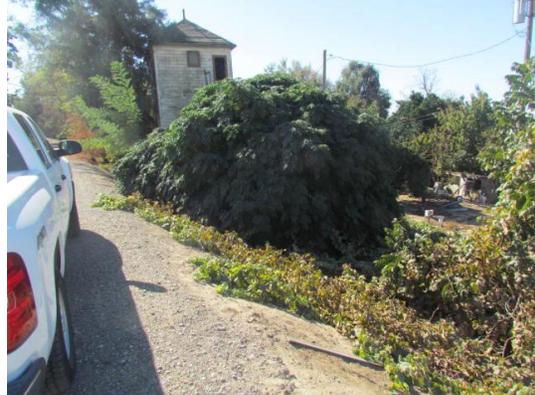
Photo 1 of 1 : SP\_2016\_RD0524\_107\_928\_20160404\_00243.jpg

LM Start	<b>3.80</b>	Rating **	U	Issue No.	<b>928</b>
LM End	<b>3.81</b>	Issue Type +	Ma	Location *	LS
Category	Earthen Levee		GPS Latitude/Longitude		
			Start	End	
Item	Trim / Thin Trees		37.902155 °	37.902002 °	
			-121.326523 °	-121.326550 °	
DWR ID	DWR_RD0524_01_s_2012_928				
Comment Code					
T1 : Trim trees to at least five feet above ground level.					
Inspector Comment					
Several trees on landward slope.

Looking south at dense vegetation on landward slope and toe.

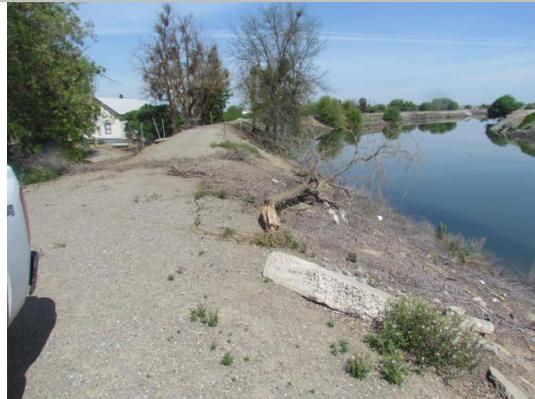
Photo 1 of 1 : SP\_2016\_RD0524\_107\_187\_20160404\_00208.jpg

LM Start	<b>3.85</b>	Rating **	A/W	Issue No.	<b>187</b>
LM End	<b>3.85</b>	Issue Type +	Ma	Location *	WS
Category	Earthen Levee		GPS Latitude/Longitude		
			Start	End	
Item	Encroachments		37.901447 °	37.901447 °	
			-121.326500 °	-121.326500 °	
DWR ID	DWR_RD0524_01_s_2014_187				
Comment Code					
TR : Tree or limb					
Inspector Comment					
Tree limb on waterward shoulder.

Looking northeast at tree limb on waterward slope.

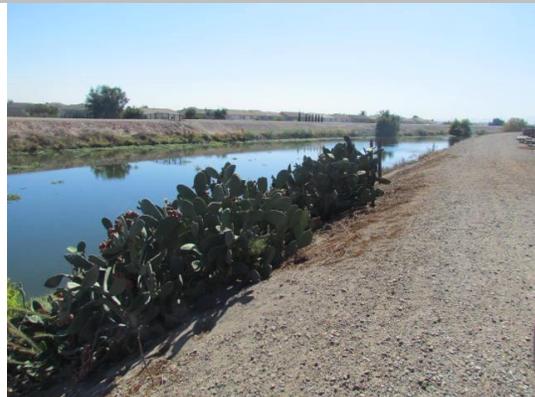
Photo 1 of 2 : SP\_2016\_RD0524\_107\_94\_20160404\_00132.jpg

LM Start	<b>3.88</b>	Rating **	U	Issue No.	<b>94</b>
LM End	<b>3.88</b>	Issue Type +	Ma	Location *	WS
Category	Earthen Levee		GPS Latitude/Longitude		
			Start	End	
Item	Vegetation		37.900952 °	37.900952 °	
			-121.326443 °	-121.326443 °	
DWR ID	DWR_RD0524_01_s_2012_94				
Comment Code					
V2 : Remove the wild growth other than native grasses from the levee slopes.					
Inspector Comment					
Remove cactus from waterward slope.

Looking southeast at cactus on waterward slope fall 2015

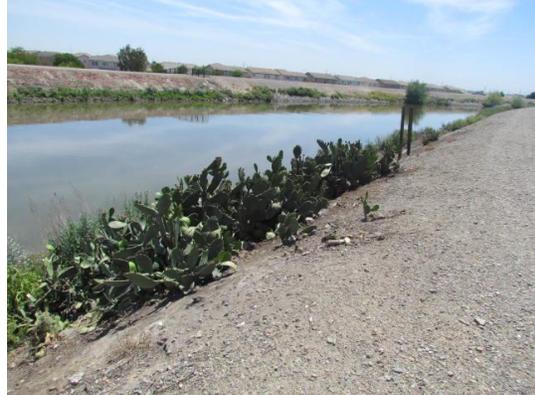
Photo 2 of 2 : SP\_2016\_RD0524\_107\_94\_20160404\_00133.jpg

LM Start	<b>3.88</b>	Rating **	U	Issue No.	<b>94 (cont)</b>
LM End	<b>3.88</b>	Issue Type +	Ma	Location *	WS
Category	Earthen Levee		GPS Latitude/Longitude		
			Start	End	
Item	Vegetation		37.900952 °	37.900952 °	
			-121.326443 °	-121.326443 °	
DWR ID	DWR_RD0524_01_s_2012_94				
Comment Code					
V2 : Remove the wild growth other than native grasses from the levee slopes.					
Inspector Comment					
Remove cactus from waterward slope.

Looking southeast at cactus on waterside slope. Fall 2013

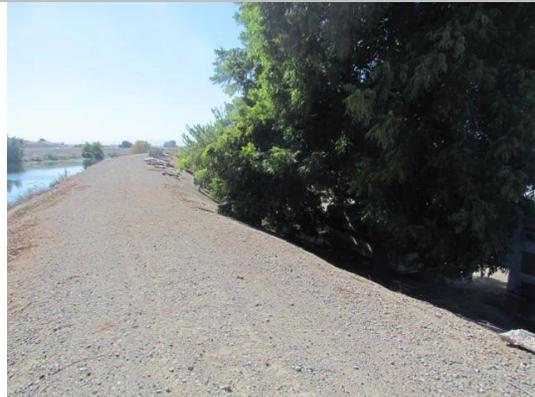
Photo 1 of 1 : SP\_2016\_RD0524\_107\_83\_20160404\_00121.jpg

LM Start	<b>3.89</b>	Rating **	U	Issue No.	<b>83</b>
LM End	<b>3.89</b>	Issue Type +	Ma	Location *	LS
Category	Earthen Levee		GPS Latitude/Longitude		
			Start	End	
Item	Trim / Thin Trees		37.900854 °	37.900854 °	
			-121.326438 °	-121.326438 °	
DWR ID	DWR_RD0524_01_s_2012_83				
Comment Code					
T1 : Trim trees to at least five feet above ground level.					
Inspector Comment					
Untrimmed tree on landward slope.

Looking south at untrimmed trees on landward slope and toe.

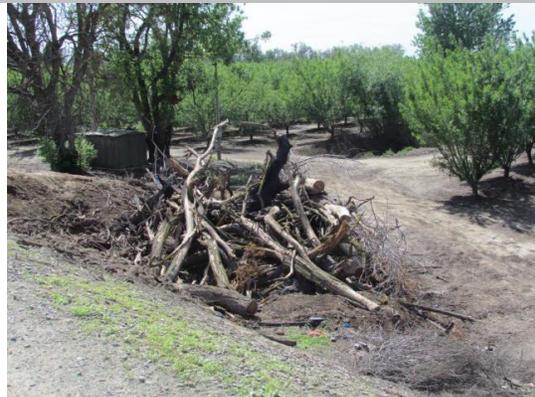
Photo 1 of 1 : SP\_2016\_RD0524\_107\_195\_20160414\_00382.jpg

LM Start	<b>4.02</b>	Rating **	U	Issue No.	<b>195</b>
LM End	<b>4.02</b>	Issue Type +	Ma	Location *	LS
Category	Earthen Levee		GPS Latitude/Longitude		
			Start	End	
Item	Encroachments		37.899093 °	37.899093 °	
			-121.326933 °	-121.326933 °	
DWR ID	DWR_RD0524_01_s_2015_195				
Comment Code					
PR : Prunings					
Inspector Comment					
Pruning pile blocking view of landward slope.

Looking at pruning pile at landward toe. (Spring 2016)

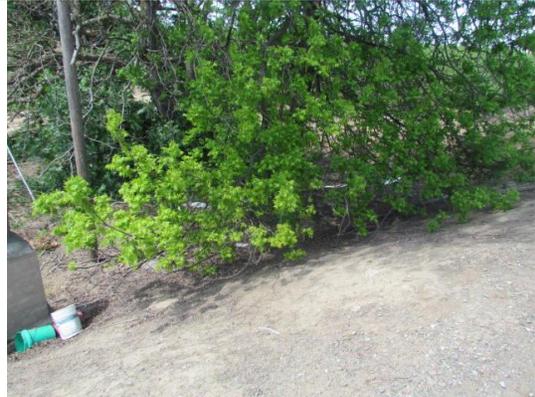
Photo 1 of 1 : SP\_2016\_RD0524\_107\_61\_20160404\_00099.jpg

LM Start	<b>4.03</b>	Rating **	M	Issue No.	<b>61</b>
LM End	<b>4.03</b>	Issue Type +	Ma	Location *	LS
Category	Earthen Levee		GPS Latitude/Longitude		
			Start	End	
Item	Trim / Thin Trees		37.898925 °	37.898925 °	
			-121.327015 °	-121.327015 °	
DWR ID	DWR_RD0524_01_s_2012_61				
Comment Code					
T1 : Trim trees to at least five feet above ground level.					
Inspector Comment

Looking east at untrimmed tree at landward toe.

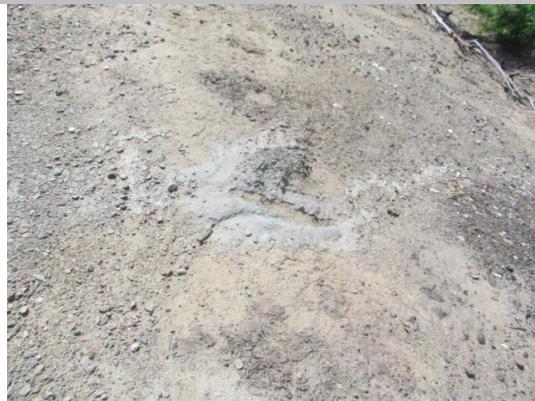
Photo 1 of 1 : SP\_2016\_RD0524\_107\_64\_20160404\_00101.jpg

LM Start	<b>4.04</b>	Rating **	A/W	Issue No.	<b>64</b>
LM End	<b>4.09</b>	Issue Type +	Ma	Location *	LS
Category	Earthen Levee		GPS Latitude/Longitude		
			Start	End	
Item	Animal Control		37.898832 °	37.898090 °	
			-121.327092 °	-121.327457 °	
DWR ID	DWR_RD0524_01_s_2012_64				
Comment Code					
A3 : No rodents visible, but rodent burrows visible; need to backfill and compact or grout burrows.					
Inspector Comment

Looking at typical view of grouted rodent holes on landward slope.

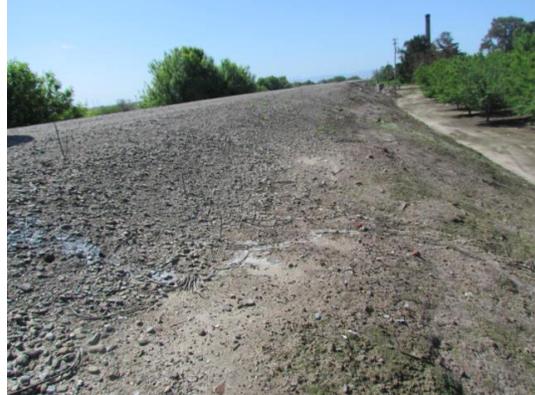
Photo 1 of 3 : SP\_2016\_RD0524\_107\_108\_20160414\_00383.jpg

LM Start	<b>4.10</b>	Rating **	U	Issue No.	<b>108</b>
LM End	<b>4.10</b>	Issue Type +	Ma	Location *	LS
Category	Earthen Levee			GPS Latitude/Longitude	
				Start	End
Item	Slope Stability			37.898035 °	37.898035 °
				-121.327447 °	-121.327447 °
DWR ID	DWR_RD0524_01_s_2012_108				
Comment Code					
S1 : Repair slope instability.					
Inspector Comment					
Slope depression is greater than 1" and longer than 200'.

Looking north at caving slope on landside of levee.

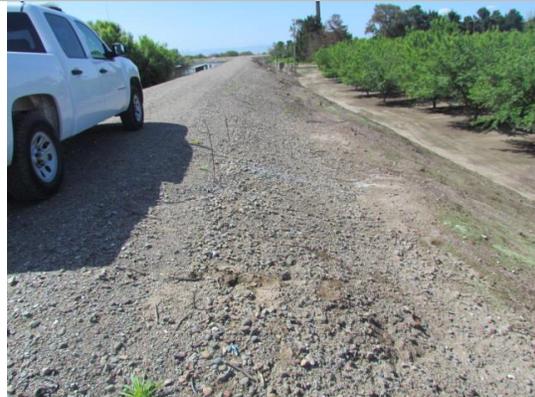
Photo 2 of 3 : SP\_2016\_RD0524\_107\_108\_20160414\_00384.jpg

LM Start	<b>4.10</b>	Rating **	U	Issue No.	<b>108 (cont)</b>
LM End	<b>4.10</b>	Issue Type +	Ma	Location *	LS

Looking south at damage slope on landside of levee.

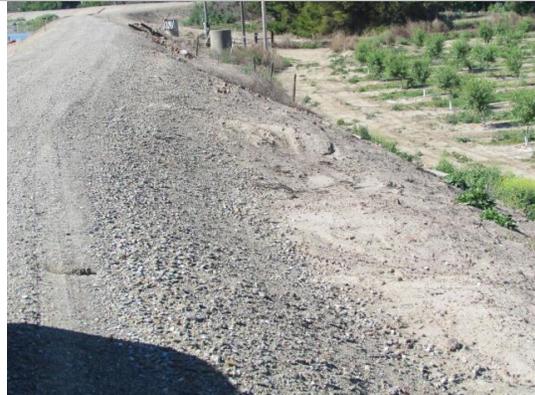
Photo 3 of 3 : SP\_2016\_RD0524\_107\_108\_20160404\_00150.jpg

LM Start	<b>4.10</b>	Rating **	U	Issue No.	<b>108 (cont)</b>
LM End	<b>4.10</b>	Issue Type +	Ma	Location *	LS

Looking southwest at caving slope on landside of levee. (Spring 2014)

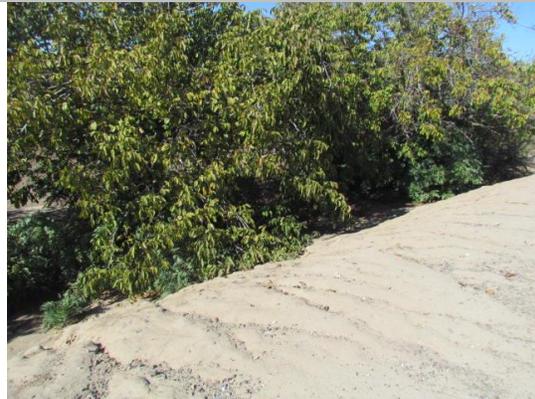
Photo 1 of 2 : SP\_2016\_RD0524\_107\_112\_20160404\_00153.jpg

LM Start	<b>4.40</b>	Rating **	U	Issue No.	<b>112</b>
LM End	<b>4.53</b>	Issue Type +	Ma	Location *	LS
Category	Earthen Levee		GPS Latitude/Longitude		
			Start	End	
Item	Trim / Thin Trees		37.893928 °	37.892230 °	
			-121.329203 °	-121.328187 °	
DWR ID	DWR_RD0524_01_s_2012_112				
Comment Code					
T1 : Trim trees to at least five feet above ground level.					
Inspector Comment					
Untrimmed trees along landward slope and toe.

Looking northeast at untrimmed tree on landward slope and toe fall 2015.

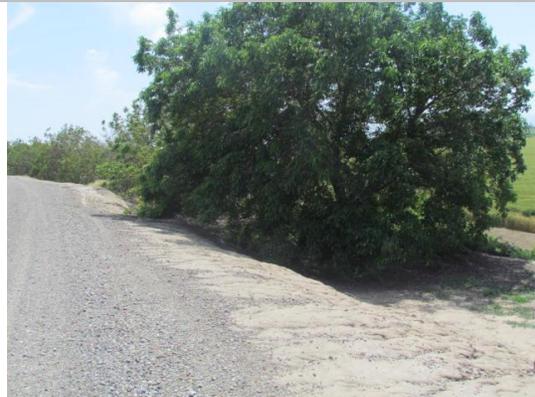
Photo 2 of 2 : SP\_2016\_RD0524\_107\_112\_20160404\_00154.jpg

LM Start	<b>4.40</b>	Rating **	U	Issue No.	<b>112 (cont)</b>
LM End	<b>4.53</b>	Issue Type +	Ma	Location *	LS

Looking southeast at untrimmed tree at landward toe.

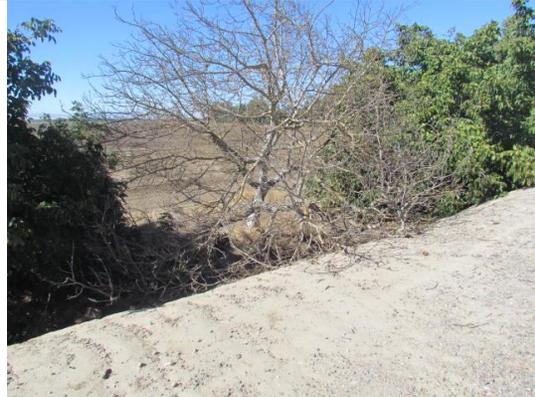
Photo 1 of 1 : SP\_2016\_RD0524\_107\_199\_20160404\_00221.jpg

LM Start	<b>4.43</b>	Rating **	U	Issue No.	<b>199</b>
LM End	<b>4.43</b>	Issue Type +	Ma	Location *	LS
Category	Earthen Levee		GPS Latitude/Longitude		
			Start	End	
Item	Encroachments		37.893582 °	37.893582 °	
			-121.329108 °	-121.329108 °	
DWR ID	DWR_RD0524_01_f_2015_199				
Comment Code					
TR : Tree or limb					
Inspector Comment					
Remove dead tree from landward toe.

Looking west at dead tree on landward slope and toe fall 2015.

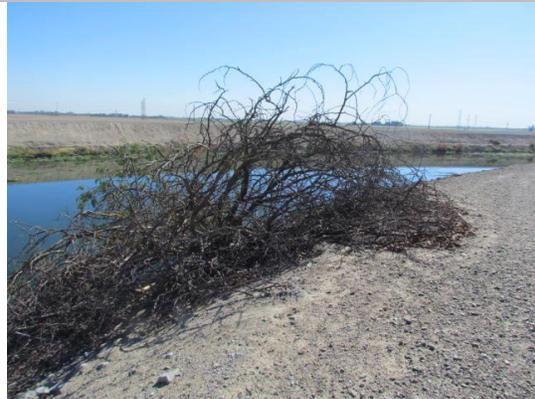
Photo 1 of 2 : SP\_2016\_RD0524\_107\_102\_20160404\_00142.jpg

LM Start	<b>4.52</b>	Rating **	U	Issue No.	<b>102</b>
LM End	<b>4.52</b>	Issue Type +	Ma	Location *	WS
Category	Earthen Levee		GPS Latitude/Longitude		
			Start	End	
Item	Encroachments		37.892368 °	37.892368 °	
			-121.328200 °	-121.328200 °	
DWR ID	DWR_RD0524_01_s_2012_102				
Comment Code					
PR : Prunings					
Inspector Comment					
Dead tree on waterward slope.

Looking southeast at dead tree on waterside slope fall 2015

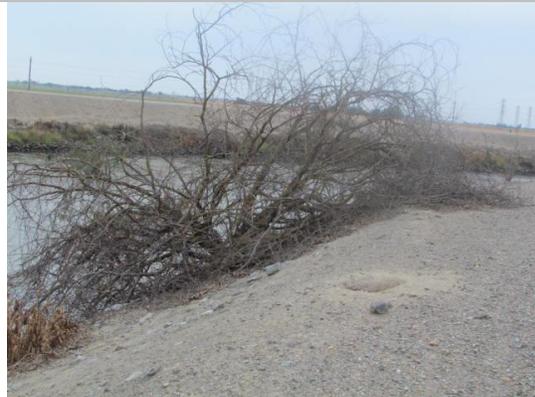
Photo 2 of 2 : SP\_2016\_RD0524\_107\_102\_20160404\_00143.jpg

LM Start	<b>4.52</b>	Rating **	U	Issue No.	<b>102 (cont)</b>
LM End	<b>4.52</b>	Issue Type +	Ma	Location *	WS

Looking southeast at dead tree on waterside slope.
