**Flood Control Project Maintenance  
Levee Inspections**

**Maintenance Issue Types Only, Levee Inspection Report By Mile - Spring 2016**

**Reclamation District No. 0524 Middle Roberts Island**

Waterway	Bank	Unit Miles	Inspection Start/End	Inspector
Unit No. 01 San Joaquin River	Left	6.20	04/12/2016 04/13/2016	Richard Willoughby

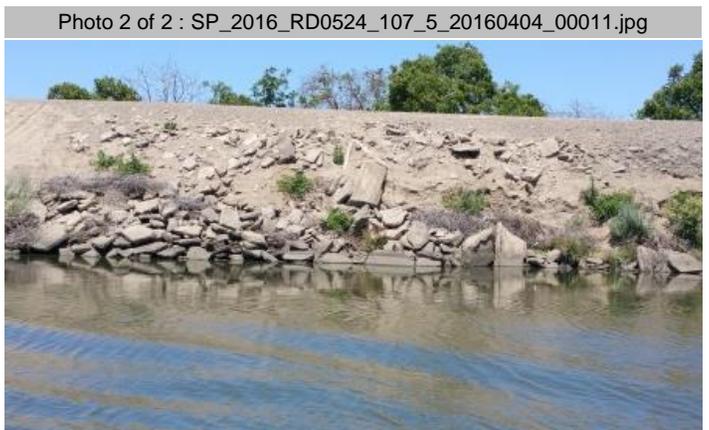
LM Start	<b>4.53</b>	Rating **	U	Issue No.	<b>5 (cont)</b>
LM End	<b>4.54</b>	Issue Type +	Ma	Location *	WS

Close view of the site.

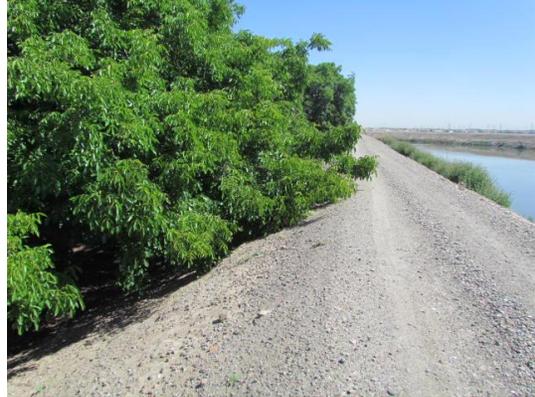
Photo 1 of 1 : SP\_2016\_RD0524\_107\_113\_20160404\_00155.jpg

LM Start	<b>4.63</b>	Rating **	M	Issue No.	<b>113</b>
LM End	<b>4.63</b>	Issue Type +	Ma	Location *	LS
Category	Earthen Levee			GPS Latitude/Longitude	
				Start	End
Item	Trim / Thin Trees			37.890973 °	37.890973 °
				-121.328970 °	-121.328970 °
DWR ID	DWR_RD0524_01_s_2012_113				
Comment Code					
T1 : Trim trees to at least five feet above ground level.					
Inspector Comment

Looking north at dense trees on landside slope.

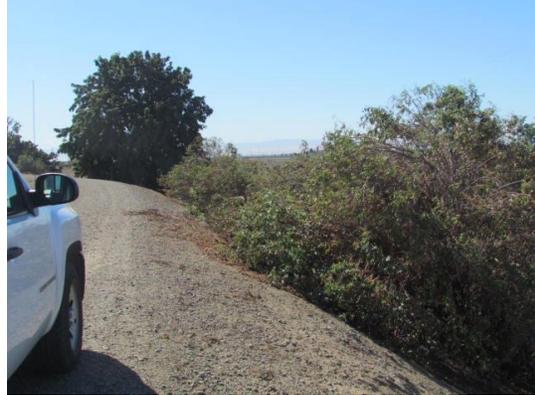
Photo 1 of 1 : SP\_2016\_RD0524\_107\_114\_20160404\_00156.jpg

LM Start	<b>4.96</b>	Rating **	U	Issue No.	<b>114</b>
LM End	<b>4.98</b>	Issue Type +	Ma	Location *	LS
Category	Earthen Levee			GPS Latitude/Longitude	
				Start	End
Item	Vegetation			37.886907 °	37.886673 °
				-121.331862 °	-121.331965 °
DWR ID	DWR_RD0524_01_s_2012_114				
Comment Code					
V4 : Elderberries are blocking visibility and flood fight capability.					
Inspector Comment					
Dense elderberry on landward slope.

Looking southwest at dense elderberry bush on landward slope and toe fall 2015.

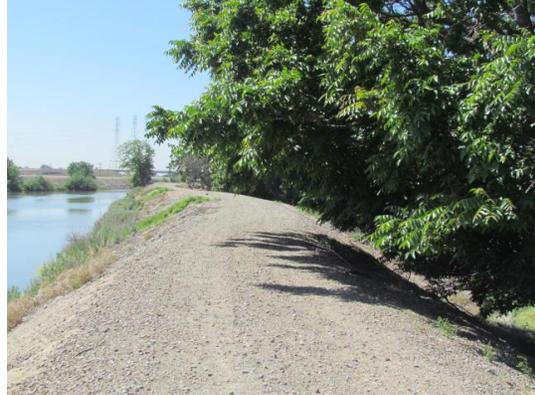
Photo 1 of 1 : SP\_2016\_RD0524\_107\_68\_20160404\_00103.jpg

LM Start	<b>5.07</b>	Rating **	U	Issue No.	<b>68</b>
LM End	<b>5.07</b>	Issue Type +	Ma	Location *	LS
Category	Earthen Levee		GPS Latitude/Longitude		
			Start	End	
Item	Trim / Thin Trees		37.885400 °	37.885400 °	
			-121.332153 °	-121.332153 °	
DWR ID	DWR_RD0524_01_s_2012_68				
Comment Code					
T4 : Trim trees over roadway to at least 12 feet above ground level.					
Inspector Comment

Looking south at overhanging trees.

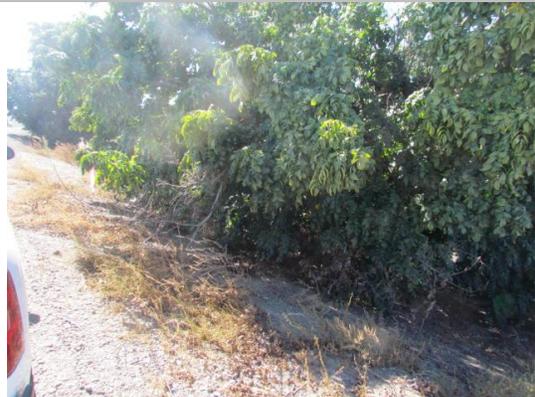
Photo 1 of 1 : SP\_2016\_RD0524\_107\_188\_20160404\_00209.jpg

LM Start	<b>5.12</b>	Rating **	U	Issue No.	<b>188</b>
LM End	<b>5.17</b>	Issue Type +	Ma	Location *	LS
Category	Earthen Levee		GPS Latitude/Longitude		
			Start	End	
Item	Trim / Thin Trees		37.884627 °	37.883965 °	
			-121.332172 °	-121.332152 °	
DWR ID	DWR_RD0524_01_s_2014_188				
Comment Code					
T1 : Trim trees to at least five feet above ground level.					
Inspector Comment					
Untrimmed trees on landward slope and toe.

Looking southwest at untrimmed trees on landward slope and toe.

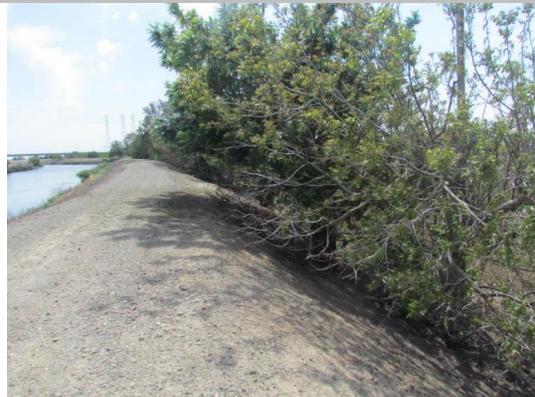
Photo 1 of 1 : SP\_2016\_RD0524\_107\_85\_20160404\_00123.jpg

LM Start	<b>5.28</b>	Rating **	U	Issue No.	<b>85</b>
LM End	<b>5.34</b>	Issue Type +	Ma	Location *	LS
Category	Earthen Levee		GPS Latitude/Longitude		
			Start	End	
Item	Trim / Thin Trees		37.882377°	37.881498°	
			-121.332598°	-121.332800°	
DWR ID	DWR_RD0524_01_s_2012_85				
Comment Code					
T1 : Trim trees to at least five feet above ground level.					
Inspector Comment

Looking south at untrimmed trees on landward slope.

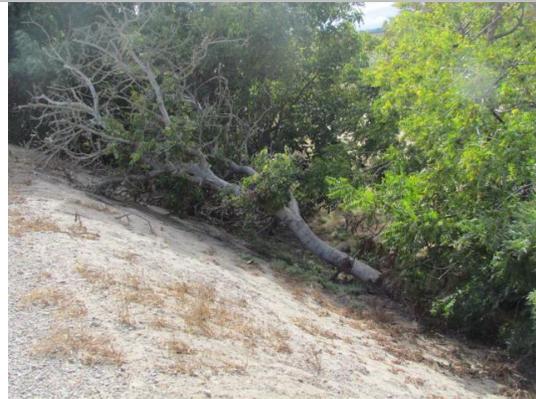
Photo 1 of 1 : SP\_2016\_RD0524\_107\_178\_20160404\_00200.jpg

LM Start	<b>5.39</b>	Rating **	M	Issue No.	<b>178</b>
LM End	<b>5.39</b>	Issue Type +	Ma	Location *	LS
Category	Earthen Levee		GPS Latitude/Longitude		
			Start	End	
Item	Encroachments		37.880806 °	37.880806 °	
			-121.332833 °	-121.332833 °	
DWR ID	DWR_RD0524_01_f_2014_178				
Comment Code					
TR : Tree or limb					
Inspector Comment					
Downed tree on landward toe.

Looking south at downed tree on landward slope.

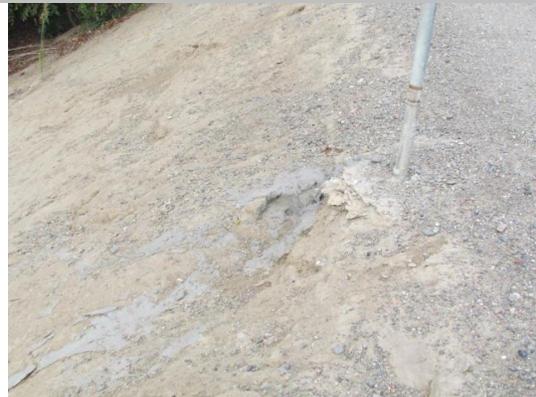
Photo 1 of 2 : SP\_2016\_RD0524\_107\_931\_20160404\_00244.jpg

LM Start	<b>5.41</b>	Rating **	A/W	Issue No.	<b>931</b>
LM End	<b>5.41</b>	Issue Type +	Ma	Location *	LS
Category	Earthen Levee		GPS Latitude/Longitude		
			Start	End	
Item	Animal Control		37.880575 °	37.880575 °	
			-121.332890 °	-121.332890 °	
DWR ID	DWR_RD0524_01_s_2012_931				
Comment Code					
A1 : Exterminate rodents and backfill and compact or grout burrows.					
Inspector Comment					
LMA grouted rodent holes.

Looking north at typical view of grouted rodent holes on landward shoulder and slope.

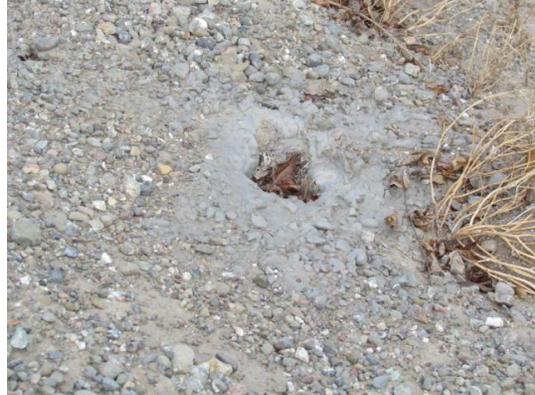
Photo 2 of 2 : SP\_2016\_RD0524\_107\_931\_20160404\_00245.jpg

LM Start	<b>5.41</b>	Rating **	A/W	Issue No.	<b>931 (cont)</b>
LM End	<b>5.41</b>	Issue Type +	Ma	Location *	LS
Category	Earthen Levee			GPS Latitude/Longitude	
				Start	End
Item	Animal Control			37.880575 °	37.880575 °
				-121.332890 °	-121.332890 °
DWR ID	DWR_RD0524_01_s_2012_931				
Comment Code					
A1 : Exterminate rodents and backfill and compact or grout burrows.					
Inspector Comment					
LMA grouted rodent holes.

Looking north at typical view of grouted rodent holes on waterward slope.

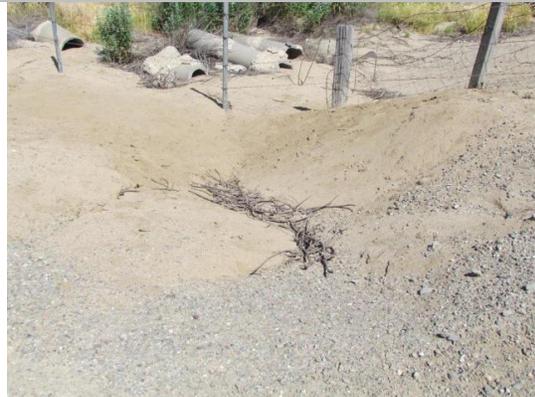
Photo 1 of 3 : SP\_2016\_RD0524\_107\_118\_20160404\_00158.jpg

LM Start	<b>5.42</b>	Rating **	M	Issue No.	<b>118</b>
LM End	<b>5.42</b>	Issue Type +	Ma	Location *	LS
Category	Earthen Levee			GPS Latitude/Longitude	
				Start	End
Item	Slope Stability			37.880323 °	37.880323 °
				-121.332968 °	-121.332968 °
DWR ID	DWR_RD0524_01_s_2012_118				
Comment Code					
S1 : Repair slope instability.					
Inspector Comment					
Slope damage caused by human activity.

Looking west at slope damage on landside slope.

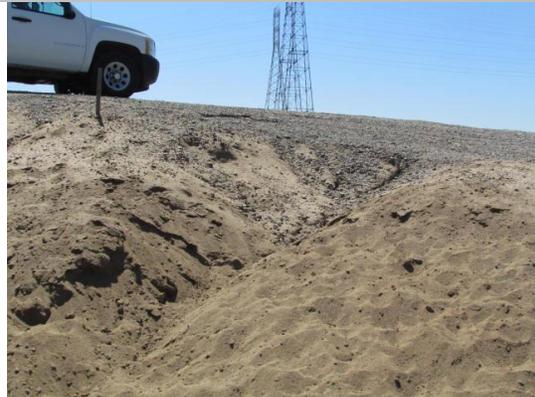
Photo 2 of 3 : SP\_2016\_RD0524\_107\_118\_20160404\_00159.jpg

Looking southeast at damaged slope.

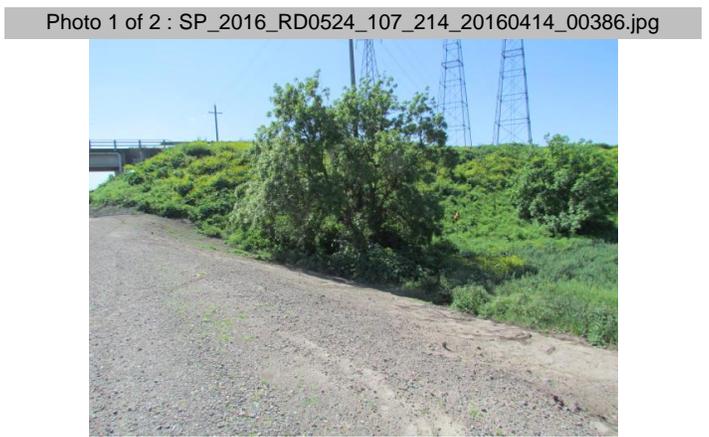
LM Start	<b>5.58</b>	Rating **	U	Issue No.	<b>214</b>
LM End	<b>5.58</b>	Issue Type +	Ma	Location *	LS
Category	Earthen Levee			GPS Latitude/Longitude	
				Start	End
Item	Vegetation			37.878083 °	37.878083 °
				-121.332717 °	-121.332717 °
DWR ID	DWR_RD0524_01_s_2016_214				
Comment Code					
V2 : Remove the wild growth other than native grasses from the levee slopes.					
Inspector Comment					
Tall weeds, grasses and trees blocking view of landward toe.

Looking west at dense veg at landward toe.

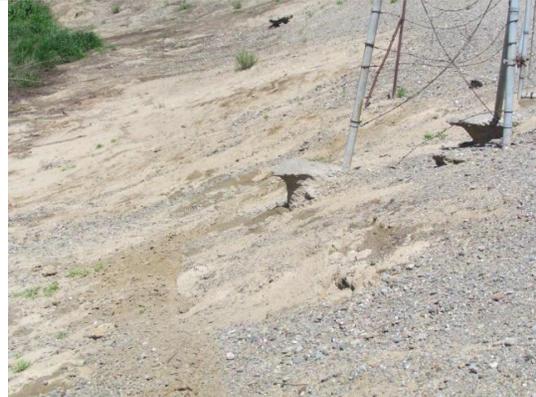
Photo 1 of 3 : SP\_2016\_RD0524\_107\_215\_20160414\_00389.jpg

LM Start	<b>5.64</b>	Rating **	U	Issue No.	<b>215</b>
LM End	<b>5.64</b>	Issue Type +	Ma	Location *	LS
Category	Earthen Levee			GPS Latitude/Longitude	
				Start	End
Item	Slope Stability			37.877378 °	37.877378 °
				-121.332343 °	-121.332343 °
DWR ID	DWR_RD0524_01_s_2016_215				
Comment Code					
S1 : Repair slope instability.					
Inspector Comment					
Levee slope damage is due vehicle traffic and foot traffic. Vehicle traffic created a ramp on landward slope.

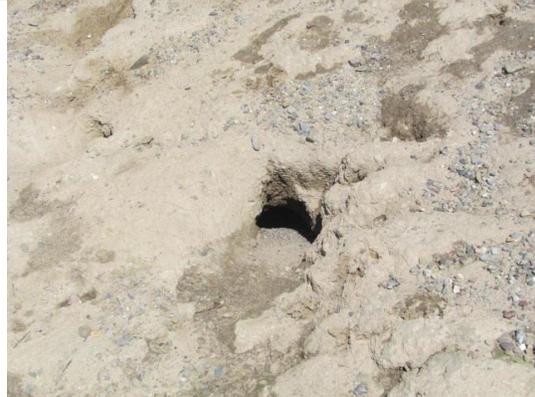
Photo 1 of 2 : SP\_2016\_RD0524\_107\_69\_20160414\_00391.jpg

LM Start	<b>5.64</b>	Rating **	U	Issue No.	<b>69</b>
LM End	<b>5.80</b>	Issue Type +	Ma	Location *	LS
Category	Earthen Levee			GPS Latitude/Longitude	
				Start	End
Item	Animal Control			37.877298 °	37.875073 °
				-121.332343 °	-121.333168 °
DWR ID	DWR_RD0524_01_s_2012_69				
Comment Code					
A3 : No rodents visible, but rodent burrows visible; need to backfill and compact or grout burrows.					
Inspector Comment					
District has grouted rodent holes. But rodents has re-appear.

Looking south at rodent holes on landward slope.

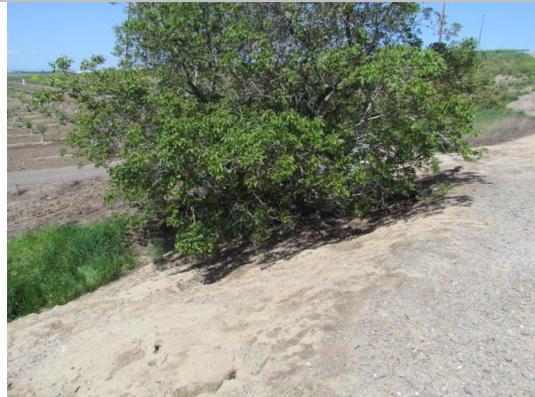
Photo 1 of 1 : SP\_2016\_RD0524\_107\_117\_20160414\_00393.jpg

LM Start	<b>5.64</b>	Rating **	U	Issue No.	<b>117</b>
LM End	<b>5.64</b>	Issue Type +	Ma	Location *	LS
Category	Earthen Levee			GPS Latitude/Longitude	
				Start	End
Item	Trim / Thin Trees			37.877272 °	37.877272 °
				-121.332400 °	-121.332400 °
DWR ID	DWR_RD0524_01_f_2013_117				
Comment Code					
T1 : Trim trees to at least five feet above ground level.					
Inspector Comment

Looking northwest at untrimmed tree on landward slope.

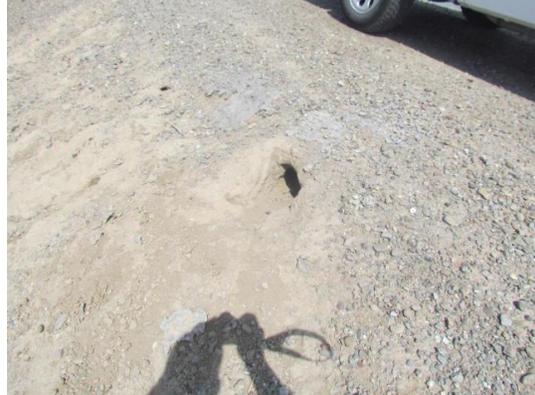
Photo 2 of 2 : SP\_2016\_RD0524\_107\_197\_20160404\_00217.jpg

LM Start	<b>5.79</b>	Rating **	M	Issue No.	<b>197 (cont)</b>
LM End	<b>5.79</b>	Issue Type +	Ma	Location *	LS
Category	Earthen Levee		GPS Latitude/Longitude		
			Start	End	
Item	Animal Control		37.875310 °	37.875310 °	
			-121.333065 °	-121.333065 °	
DWR ID	DWR_RD0524_01_s_2015_197				
Comment Code					
A1 : Exterminate rodents and backfill and compact or grout burrows.					
Inspector Comment					
Several rodent holes on landward slope and levee crown.

Looking southwest at typical view of rodent hole at landward shoulder.

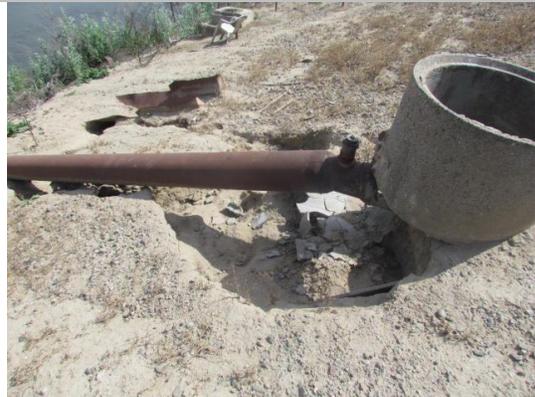
Photo 1 of 3 : SP\_2016\_RD0524\_107\_198\_20160404\_00218.jpg

LM Start	<b>5.81</b>	Rating **	U	Issue No.	<b>198</b>
LM End	<b>5.81</b>	Issue Type +	Ma	Location *	WS
Category	Interior Drainage & Piping Systems		GPS Latitude/Longitude		
			Start	End	
Item	Erosion Areas		37.874950 °	37.874950 °	
			-121.333273 °	-121.333273 °	
DWR ID	DWR_RD0524_01_s_2015_198				
Comment Code					
Inspector Comment					
Large erosion around irrigation pipe on waterward slope.

Looking south at erosion around irrigation pipe on waterward slope.

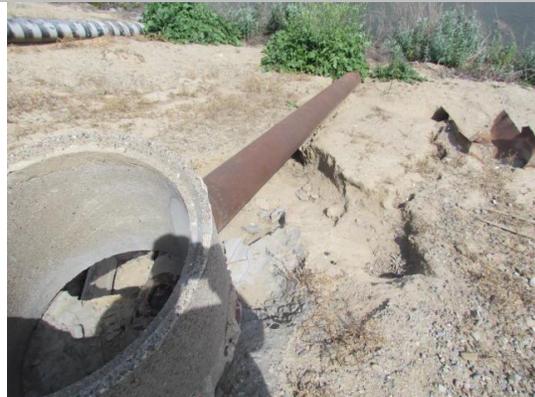
Photo 2 of 3 : SP\_2016\_RD0524\_107\_198\_20160404\_00219.jpg

Looking east at erosion around irrigation pipe.

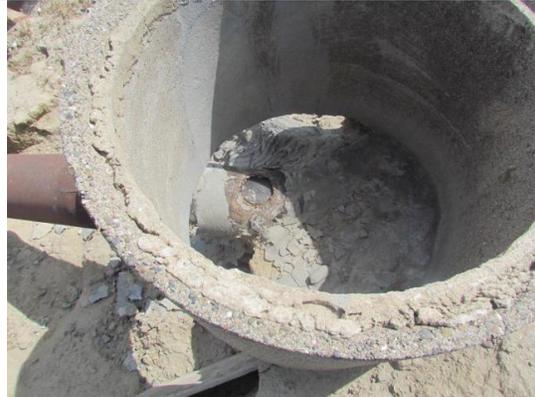
Photo 3 of 3 : SP\_2016\_RD0524\_107\_198\_20160404\_00220.jpg

LM Start	<b>5.81</b>	Rating **	U	Issue No.	<b>198 (cont)</b>
LM End	<b>5.81</b>	Issue Type +	Ma	Location *	WS
Category	Interior Drainage & Piping Systems			GPS Latitude/Longitude	
				Start	End
Item	Erosion Areas			37.874950 °	37.874950 °
				-121.333273 °	-121.333273 °
DWR ID	DWR_RD0524_01_s_2015_198				
Comment Code					
Inspector Comment					
Large erosion around irrigation pipe on waterward slope.

Looking at erosion around pipe inside concrete collar.

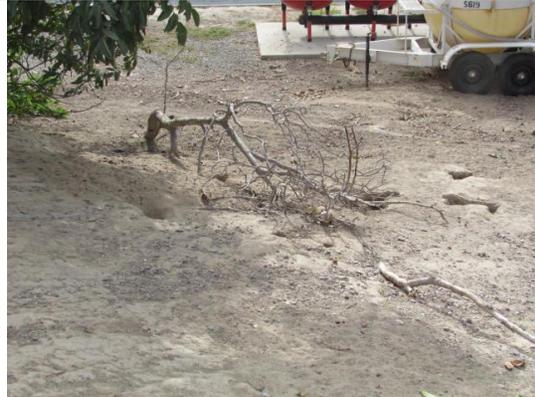
Photo 1 of 2 : SP\_2016\_RD0524\_107\_75\_20160404\_00109.jpg

LM Start	<b>5.86</b>	Rating **	M	Issue No.	<b>75</b>
LM End	<b>5.88</b>	Issue Type +	Ma	Location *	WS
Category	Earthen Levee			GPS Latitude/Longitude	
				Start	End
Item	Animal Control			37.874240 °	37.874002 °
				-121.333187 °	-121.333027 °
DWR ID	DWR_RD0524_01_s_2012_75				
Comment Code					
A3 : No rodents visible, but rodent burrows visible; need to backfill and compact or grout burrows.					
Inspector Comment					
District has grouted rodent holes, but other rodent holes have appeared.

Looking typical view of several rodent holes on landward slope and toe.

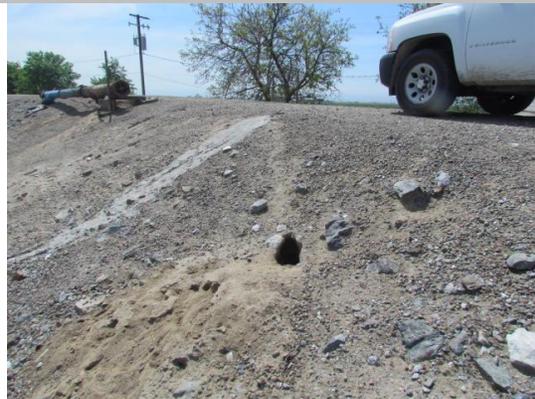
Photo 2 of 2 : SP\_2016\_RD0524\_107\_75\_20160404\_00110.jpg

Looking southwest at typical rodent holes on waterward slope.

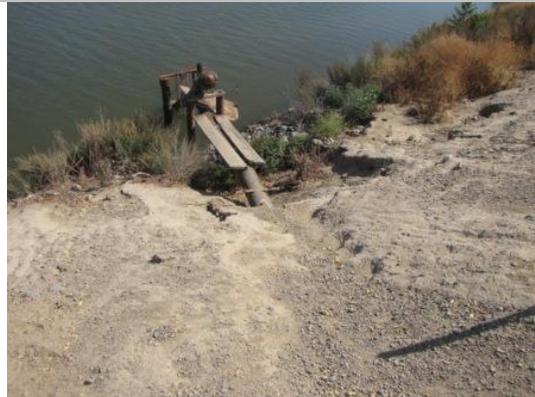
Photo 1 of 3 : SP\_2016\_RD0524\_107\_74\_20160404\_00106.jpg

LM Start	<b>5.86</b>	Rating **	U	Issue No.	<b>74</b>
LM End	<b>5.87</b>	Issue Type +	Ma	Location *	WS
Category	Earthen Levee			GPS Latitude/Longitude	
				Start	End
Item	Erosion / Bank Caving			37.874240 °	37.874165 °
				-121.333185 °	-121.333155 °
DWR ID	DWR_RD0524_01_s_2012_74				
Comment Code					
E1 : Note and monitor erosion site.					
Inspector Comment					
Erosion on landward slope around intake pipe.

Looking southeast at erosion around pipe.

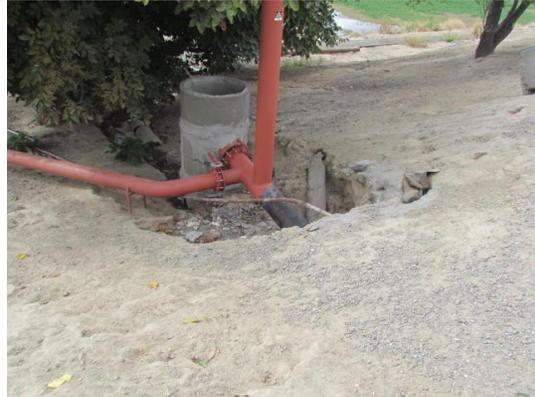
Photo 2 of 3 : SP\_2016\_RD0524\_107\_74\_20160404\_00107.jpg

LM Start	<b>5.86</b>	Rating **	U	Issue No.	<b>74 (cont)</b>
LM End	<b>5.87</b>	Issue Type +	Ma	Location *	WS
Category	Earthen Levee			GPS Latitude/Longitude	
				Start	End
Item	Erosion / Bank Caving			37.874240 °	37.874165 °
				-121.333185 °	-121.333155 °
DWR ID	DWR_RD0524_01_s_2012_74				
Comment Code					
E1 : Note and monitor erosion site.					
Inspector Comment					
Erosion on landward slope around intake pipe.

Looking west at erosion around intake pipe on landward slope.

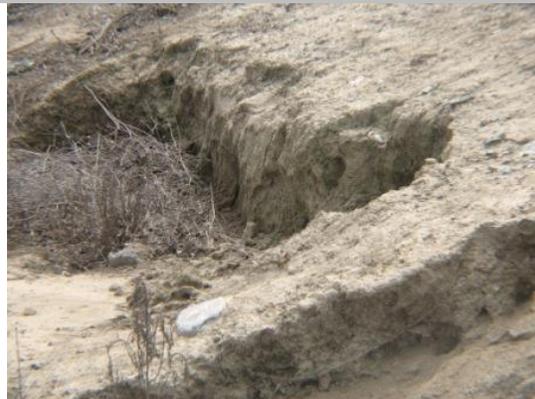
Photo 3 of 3 : SP\_2016\_RD0524\_107\_74\_20160404\_00108.jpg

Erosion at waterward toe and around irrigation pipe at LM 5.92

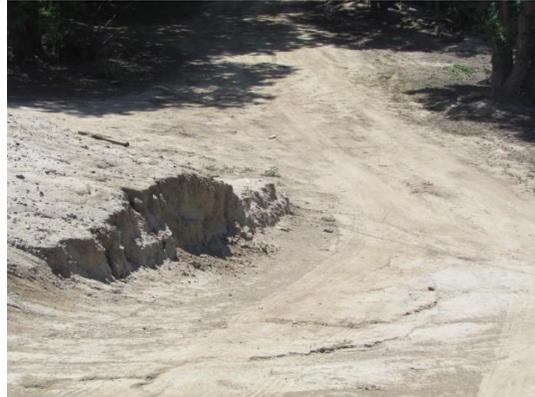
Photo 1 of 2 : SP\_2016\_RD0524\_107\_119\_20160404\_00161.jpg

LM Start	<b>5.89</b>	Rating **	U	Issue No.	<b>119</b>
LM End	<b>5.89</b>	Issue Type +	Ma	Location *	LS
Category	Earthen Levee			GPS Latitude/Longitude	
				Start	End
Item	Slope Stability			37.873893 °	37.873893 °
				-121.332978 °	-121.332978 °
DWR ID	DWR_RD0524_01_s_2012_119				
Comment Code					
S3 : Repair the levee slope damaged by vehicle traffic and prevent access where possible.					
Inspector Comment					
Landowner is using damaged area as a ramp.

Looking west at unauthorized ramp and landside slope damage.

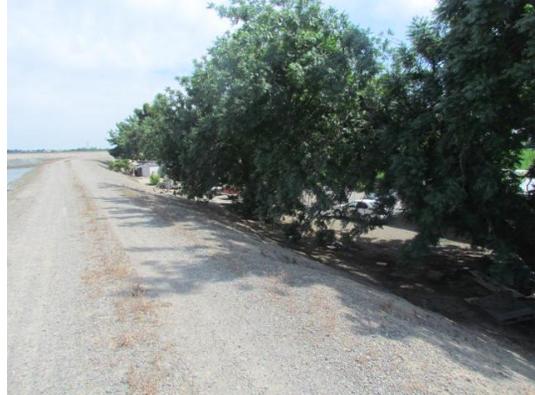
Photo 1 of 1 : SP\_2016\_RD0524\_107\_120\_20160404\_00163.jpg

LM Start	<b>5.96</b>	Rating **	U	Issue No.	<b>120</b>
LM End	<b>5.96</b>	Issue Type +	Ma	Location *	LS
Category	Earthen Levee		GPS Latitude/Longitude		
			Start	End	
Item	Trim / Thin Trees		37.873347 °	37.873347 °	
			-121.332028 °	-121.332028 °	
DWR ID	DWR_RD0524_01_s_2012_120				
Comment Code					
T1 : Trim trees to at least five feet above ground level.					
Inspector Comment

Looking south at untrimmed trees on landward slope and toe.

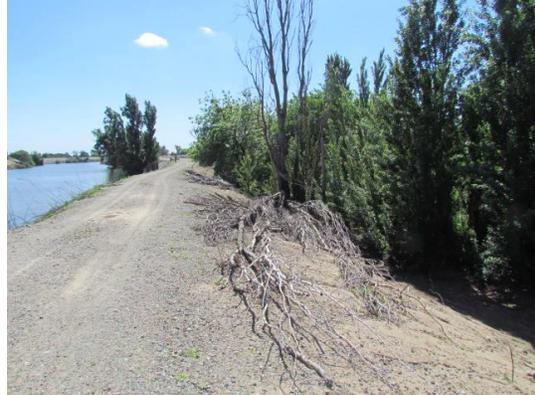
Photo 1 of 4 : SP\_2016\_RD0524\_107\_81\_20160414\_00396.jpg

Looking south at tree branches and limbs left on landward shoulder and slope. (Spring 2016)

LM Start	<b>6.15</b>	Rating **	U	Issue No.	<b>81 (cont)</b>
LM End	<b>6.15</b>	Issue Type +	Ma	Location *	LS
Category	Earthen Levee			GPS Latitude/Longitude	
				Start	End
Item	Encroachments			37.871097 °	37.871097 °
				-121.330100 °	-121.330100 °
DWR ID	DWR_RD0524_01_s_2015_81				
Comment Code					
TR : Tree or limb					
Inspector Comment					
Large tree fallen across levee crown blocking access. Fallen tree branches and limbs left on landward slope.

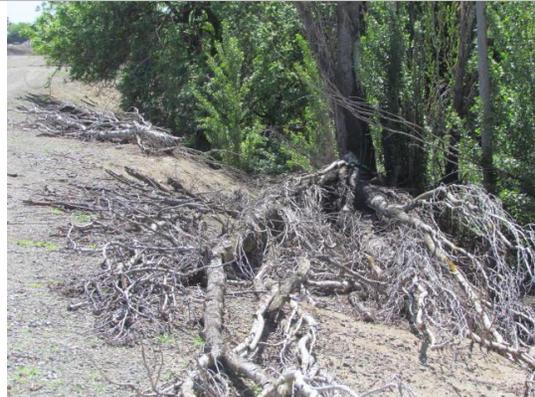
Photo 2 of 4 : SP\_2016\_RD0524\_107\_81\_20160414\_00397.jpg

Looking west at tree branches and limbs left on landward shoulder and slope. (Spring 2016)

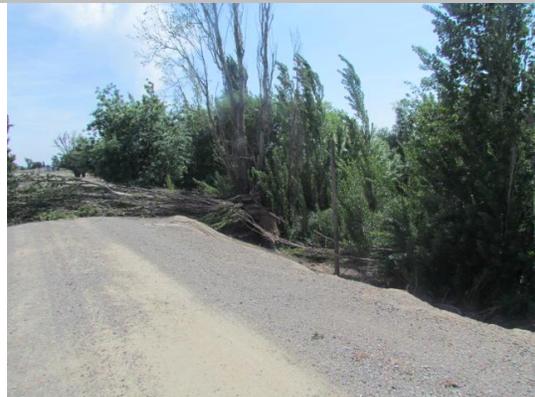
Photo 3 of 4 : SP\_2016\_RD0524\_107\_81\_20160404\_00118.jpg

Looking southwest at large tree across levee crown. (Fall 2015)

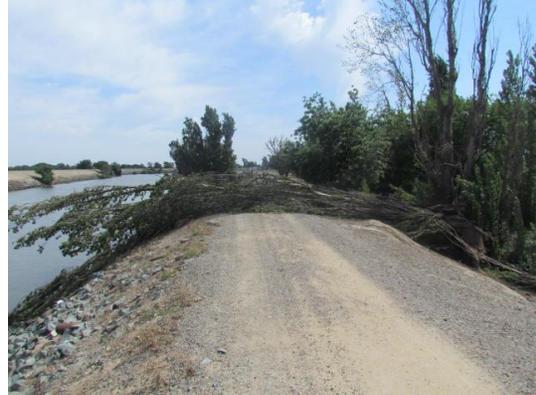
Photo 4 of 4 : SP\_2016\_RD0524\_107\_81\_20160404\_00119.jpg

Looking south at large tree across levee crown. (Fall 2015)

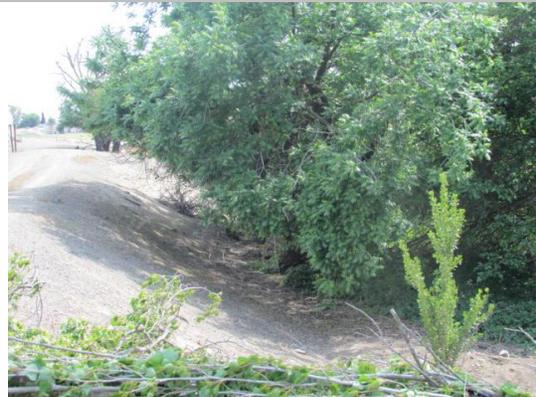
Photo 1 of 1 : SP\_2016\_RD0524\_107\_98\_20160404\_00137.jpg

LM Start	<b>6.17</b>	Rating **	U	Issue No.	<b>98</b>
LM End	<b>6.17</b>	Issue Type +	Ma	Location *	LS
Category	Earthen Levee			GPS Latitude/Longitude	
				Start	End
Item	Trim / Thin Trees			37.870842 °	37.870842 °
				-121.330000 °	-121.330000 °
DWR ID	DWR_RD0524_01_s_2012_98				
Comment Code					
T1 : Trim trees to at least five feet above ground level.					
Inspector Comment

Looking southeast at untrimmed trees at landward toe.

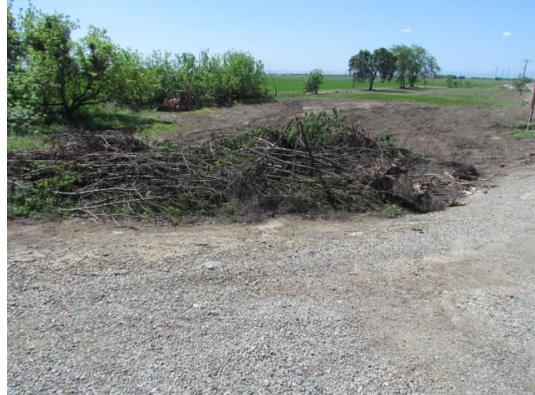
Photo 1 of 1 : SP\_2016\_RD0524\_107\_86\_20160414\_00398.jpg

LM Start	<b>6.20</b>	Rating **	U	Issue No.	<b>86</b>
LM End	<b>6.20</b>	Issue Type +	Ma	Location *	LS
Category	Earthen Levee		GPS Latitude/Longitude		
			Start	End	
Item	Encroachments		37.870388 °	37.870388 °	
			-121.329840 °	-121.329840 °	
DWR ID	DWR_RD0524_01_s_2016_86				
Comment Code					
PR : Prunings					
Inspector Comment					
Large pruning pile left at landward toe. After farmer cleared field.

Looking west at prunings at landward toe and berm.
