**Flood Control Project Maintenance
Levee Inspections**
LMA District Cover Sheet
Spring 2016 Levee Inspection Results

Reclamation District No. 1001 Nicolaus

Spring 2016 Levee Inspection Results

Waterway		Bank	Unit Miles
Unit No. 01 Yankee Slough		Right	4.12

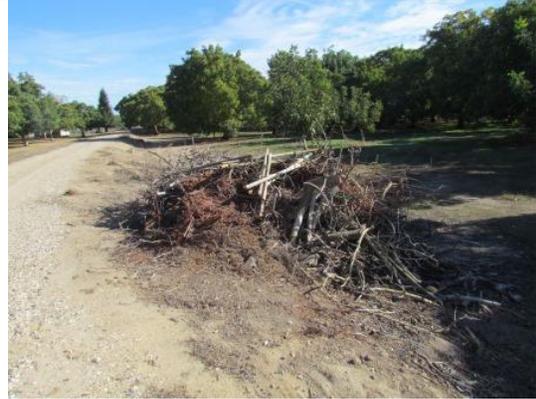
Photo 1 of 1 : SP_2016_RD1001_36_12_20160307_00008.jpg

LM Start	0.19	Rating **	M	Issue No.	12
LM End	0.19	Issue Type +	En	Location *	WS
Category	Earthen Levee		GPS Latitude/Longitude		
			Start	End	
Item	Encroachments		38.978248 °	38.978248 °	
			-121.472628 °	-121.472628 °	
DWR ID	DWR_RD1001_01_f_2013_12				
Comment Code					
PR : Prunings					
Inspector Comment

This photo was taken from the levee crown facing east looking down the waterward slope at prunings stacked up at the toe. Fall 2014.

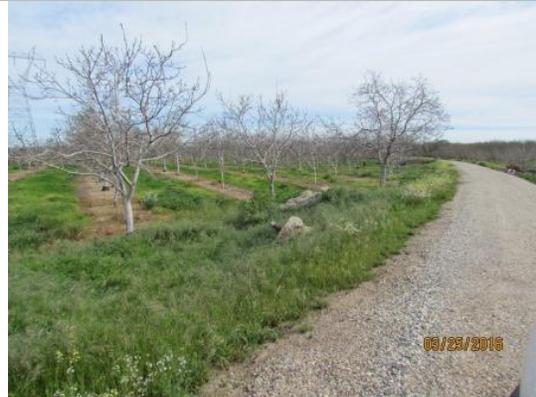
Photo 1 of 1 : SP_2016_RD1001_36_16_20160404_00014.jpg

LM Start	0.42	Rating **	M	Issue No.	16
LM End	0.42	Issue Type +	En	Location *	LS
Category	Earthen Levee		GPS Latitude/Longitude		
			Start	End	
Item	Encroachments		38.975784 °	38.975784 °	
			-121.475332 °	-121.475332 °	
DWR ID	DWR_RD1001_01_s_2015_16				
Comment Code					
DE : Debris					
Inspector Comment

Concrete debris on landside slope looking downstream.

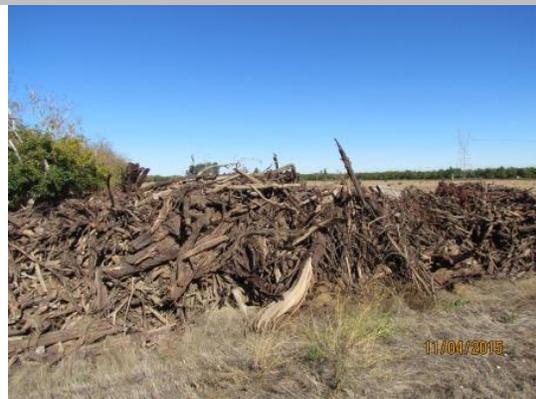
Photo 1 of 2 : SP_2016_RD1001_36_14_20160307_00009.jpg

LM Start	0.59	Rating **	M	Issue No.	14
LM End	0.59	Issue Type +	En	Location *	LS
Category	Earthen Levee		GPS Latitude/Longitude		
			Start	End	
Item	Encroachments		38.975115 °	38.975115 °	
			-121.478247 °	-121.478247 °	
DWR ID	DWR_RD1001_01_f_2015_14				
Comment Code					
PR : Prunings					
Inspector Comment

View of the prunings at the landside levee toe Fall 2015.

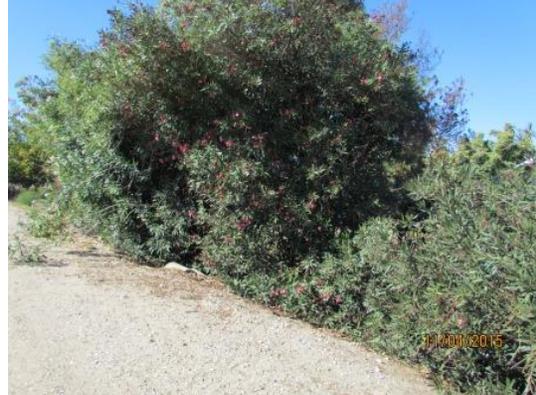
Photo 1 of 1 : SP_2016_RD1001_36_15_20160307_00010.jpg

LM Start	0.95	Rating **	U	Issue No.	15
LM End	0.95	Issue Type +	En	Location *	LS
Category	Earthen Levee		GPS Latitude/Longitude		
			Start	End	
Item	Vegetation		38.974569 °	38.974569 °	
			-121.484815 °	-121.484815 °	
DWR ID	DWR_RD1001_01_s_2012_15				
Comment Code					
V6 : Landscaping					
Inspector Comment

View of the landscaping on the landside levee slope.

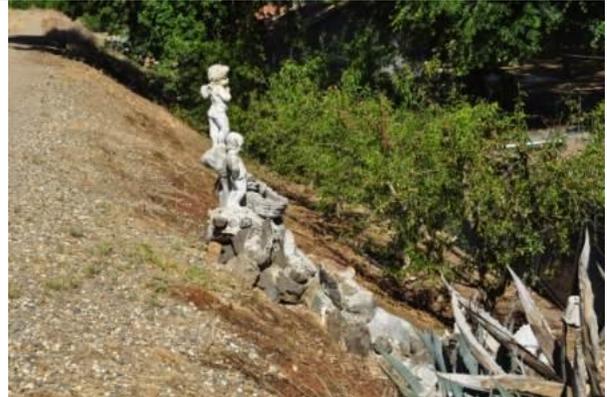
Photo 1 of 2 : SP_2016_RD1001_36_5_20160307_00002.jpg

LM Start	3.12	Rating **	M	Issue No.	5
LM End	3.17	Issue Type +	En	Location *	LS
Category	Earthen Levee		GPS Latitude/Longitude		
			Start	End	
Item	Vegetation		38.965663 °	38.965705 °	
			-121.521023 °	-121.522098 °	
DWR ID	DWR_RD1001_01_s_2012_5				
Comment Code					
V6 : Landscaping					
Inspector Comment

Unit 1 Landscaping on levee slope. L/S

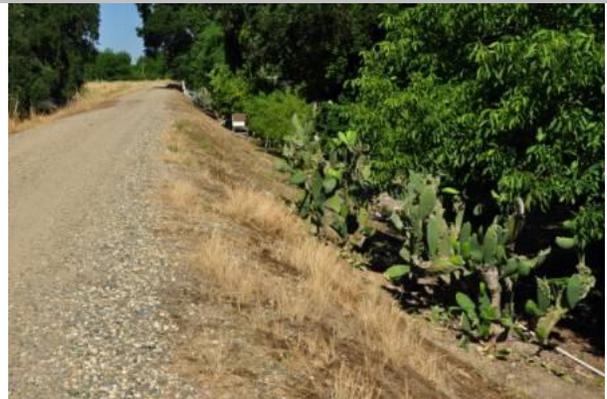
Photo 2 of 2 : SP_2016_RD1001_36_5_20160307_00003.jpg

LM Start	3.12	Rating **	M	Issue No.	5 (cont)
LM End	3.17	Issue Type +	En	Location *	LS

View of landscaping on landside slope.

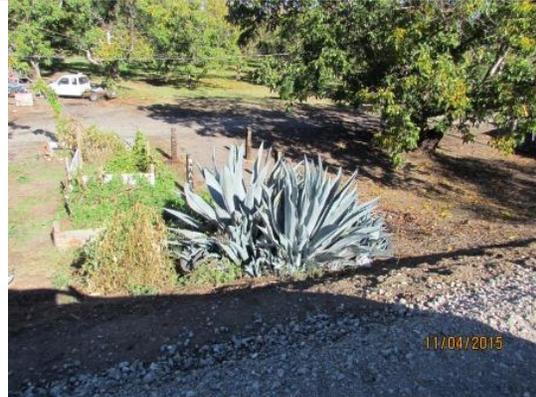
Photo 1 of 1 : SP_2016_RD1001_36_4_20160307_00001.jpg

LM Start	3.21	Rating **	U	Issue No.	4
LM End	3.21	Issue Type +	En	Location *	LS
Category	Earthen Levee		GPS Latitude/Longitude		
			Start	End	
Item	Vegetation		38.965699 °	38.965699 °	
			-121.522790 °	-121.522790 °	
DWR ID	DWR_RD1001_01_f_2015_4				
Comment Code					
V6 : Landscaping					
Inspector Comment

View of the landscaping at the landside levee toe.

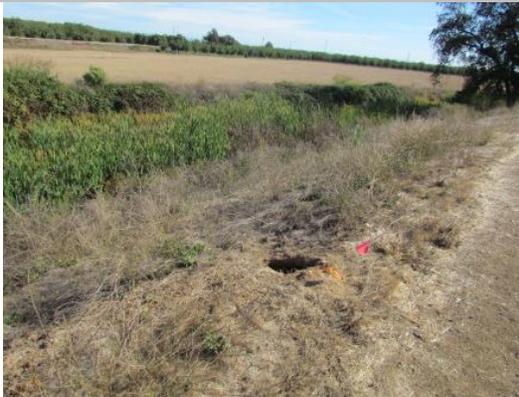
Photo 1 of 2 : SP_2016_RD1001_35_4_20160307_00001.jpg

LM Start	0.27	Rating **	A/W	Issue No.	4
LM End	0.27	Issue Type +	Ma	Location *	WS
Category	Earthen Levee			GPS Latitude/Longitude	
				Start	End
Item	Animal Control			38.974323 °	38.974323 °
				-121.476442 °	-121.476442 °
DWR ID	DWR_RD1001_02_f_2014_4				
Comment Code					
A3 : No rodents visible, but rodent burrows visible; need to backfill and compact or grout burrows.					
Inspector Comment					
There was an animal hole on waterward levee slope near the crown. Hole was approximately 1' in diameter and 8" deep but has been repaired, Spring 2016. This area should still be monitored for further animal activity.

This photo was taken from the levee crown facing east looking down the waterward slope at an animal burrow. Fall 2014.

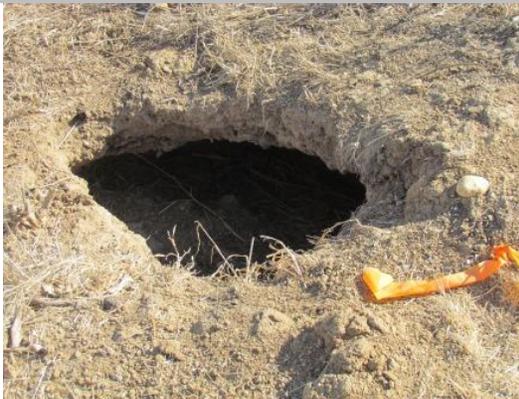
Photo 2 of 2 : SP_2016_RD1001_35_4_20160307_00002.jpg

Another picture of the animal burrow. Fall 2014.

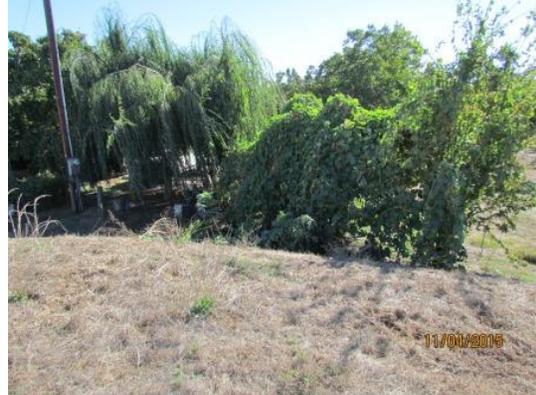
Photo 1 of 1 : SP_2016_RD1001_35_16_20160307_00008.jpg

LM Start	0.63	Rating **	M	Issue No.	16
LM End	0.63	Issue Type +	En	Location *	LS
Category	Earthen Levee		GPS Latitude/Longitude		
			Start	End	
Item	Vegetation		38.974198 °	38.974198 °	
			-121.483150 °	-121.483150 °	
DWR ID	DWR_RD1001_02_s_2012_16				
Comment Code					
V6 : Landscaping					
Inspector Comment

View of the landscaping at the landside levee toe.

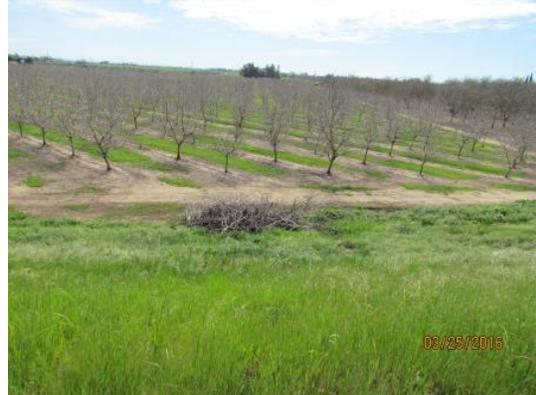
Photo 1 of 1 : SP_2016_RD1001_35_7_20160404_00022.jpg

LM Start	0.78	Rating **	M	Issue No.	7
LM End	0.78	Issue Type +	En	Location *	LS
Category	Earthen Levee		GPS Latitude/Longitude		
			Start	End	
Item	Encroachments		38.973605 °	38.973605 °	
			-121.485728 °	-121.485728 °	
DWR ID	DWR_RD1001_02_s_2012_7				
Comment Code					
PR : Prunings					
Inspector Comment

Prunings at landside toe.

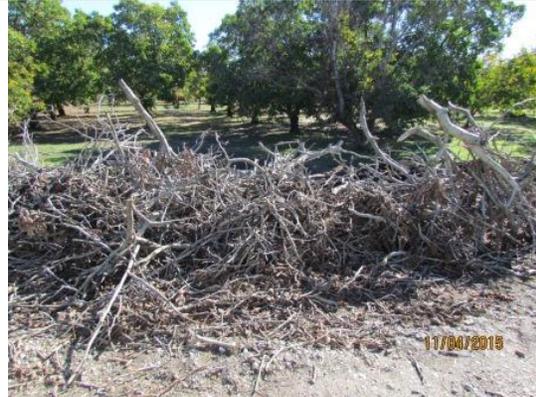
Photo 1 of 1 : SP_2016_RD1001_35_9_20160307_00004.jpg

LM Start	1.20	Rating **	M	Issue No.	9
LM End	1.20	Issue Type +	En	Location *	LS
Category	Earthen Levee		GPS Latitude/Longitude		
			Start	End	
Item	Encroachments		38.970712 °	38.970712 °	
			-121.492348 °	-121.492348 °	
DWR ID	DWR_RD1001_02_f_2013_9				
Comment Code					
DE : Debris					
Inspector Comment

View of the prunings at the landside levee toe.

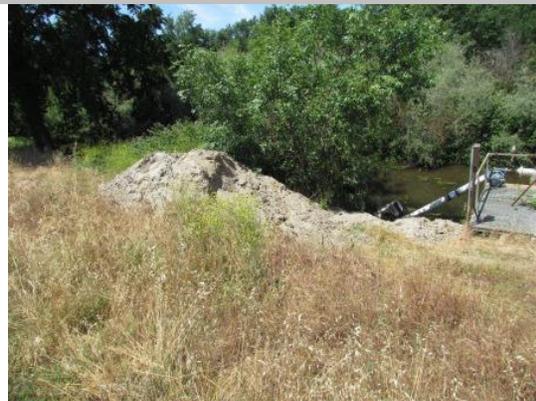
Photo 1 of 1 : SP_2016_RD1001_35_12_20160307_00007.jpg

LM Start	1.31	Rating **	M	Issue No.	12
LM End	1.31	Issue Type +	En	Location *	WS
Category	Earthen Levee		GPS Latitude/Longitude		
			Start	End	
Item	Encroachments		38.969830 °	38.969830 °	
			-121.493994 °	-121.493994 °	
DWR ID	DWR_RD1001_02_s_2015_12				
Comment Code					
MA : Material					
Inspector Comment

View of the material on the waterside of the levee from the crown.

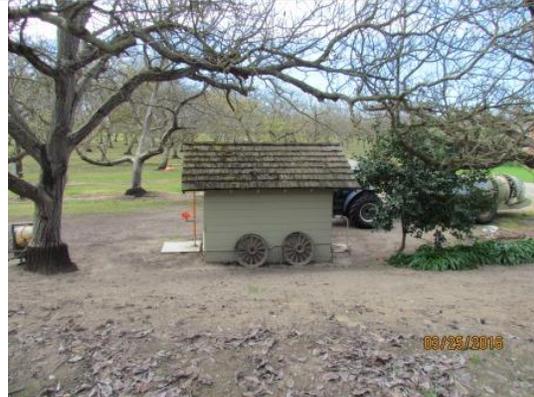
Photo 1 of 1 : SP_2016_RD1001_35_18_20160404_00021.jpg

LM Start	1.71	Rating **	M	Issue No.	18
LM End	1.71	Issue Type +	En	Location *	LS
Category	Earthen Levee		GPS Latitude/Longitude		
			Start	End	
Item	Encroachments		38.970264 °	38.970264 °	
			-121.501343 °	-121.501343 °	
DWR ID	DWR_RD1001_02_s_2016_18				
Comment Code					
BU : Building					
Inspector Comment

Shed at landside toe.

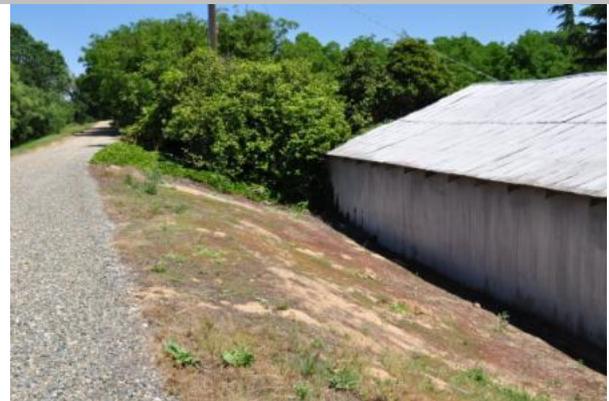
Photo 1 of 1 : SP_2016_RD1001_35_10_20160307_00005.jpg

LM Start	1.74	Rating **	U	Issue No.	10
LM End	1.74	Issue Type +	En	Location *	LS
Category	Earthen Levee		GPS Latitude/Longitude		
			Start	End	
Item	Vegetation		38.970353 °	38.970353 °	
			-121.501935 °	-121.501935 °	
DWR ID	DWR_RD1001_02_s_2012_10				
Comment Code					
V6 : Landscaping					
Inspector Comment

RD 1001 Unit 2 - L/S -Landscaping - Trees

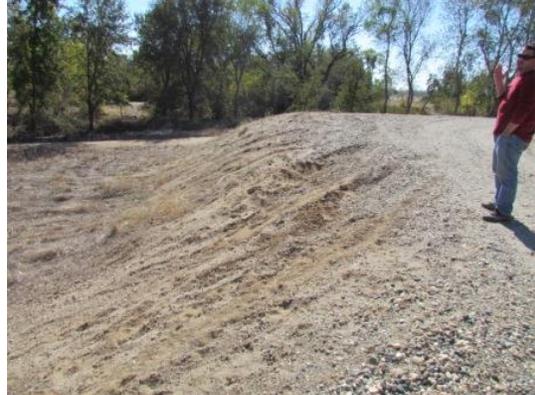
Photo 1 of 2 : SP_2016_RD1001_37_2_20160307_00002.jpg

LM Start	0.11	Rating **	A/W	Issue No.	2 (cont)
LM End	0.11	Issue Type +	Ma	Location *	CR

This photo was taken from the crown of the levee facing west looking down the slope at rutting caused by vehicles driving up the landward levee slope.

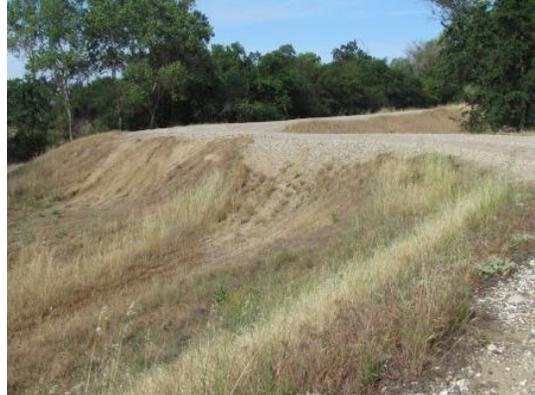
Photo 2 of 2 : SP_2016_RD1001_37_2_20160307_00003.jpg

View of the rutting on the landside of the levee facing upstream.

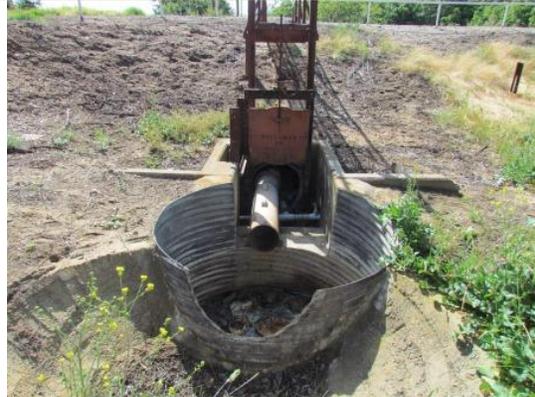
Photo 1 of 2 : SP_2016_RD1001_37_669_20160307_00021.jpg

LM Start	1.85	Rating **	U	Issue No.	669 (cont)
LM End	1.85	Issue Type +	En	Location *	WS

This photo shows a pipe within a pipe on the on the waterward side of the levee. Spring 2014.

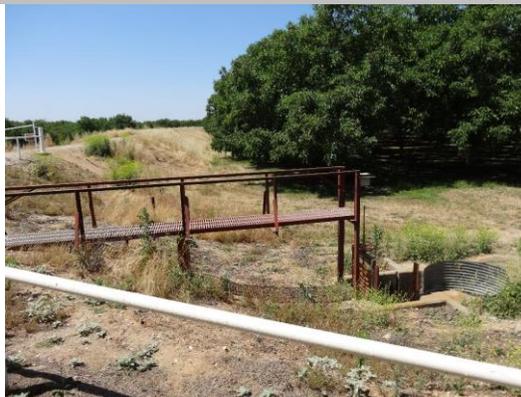
Photo 1 of 2 : UCIP_SP_2016_41727_23325.jpg

LM Start	1.85	Rating **	M	Issue No.	913 (cont)
LM End	1.85	Issue Type +	En	Location *	WS

WS- steel walkway, CMP and concrete headwall

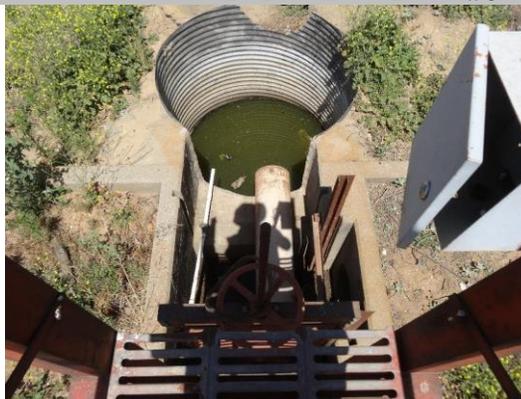
Photo 2 of 2 : UCIP_SP_2016_41727_23324.jpg

WS- CMP standpipe, pipes and concrete headwall.

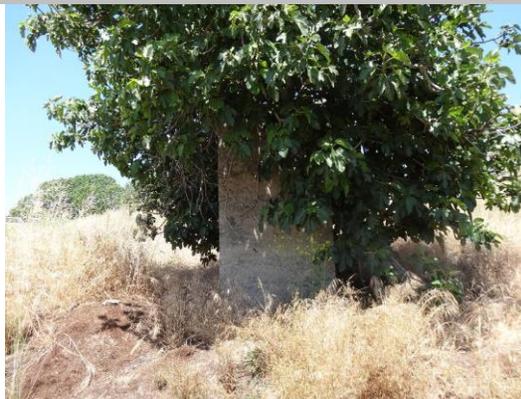
Photo 2 of 2 : UCIP_SP_2016_41722_23337.jpg

Comment Code					
Inspector Comment					
FS_ID:41722 DS_ID:22562 EP_NO: N/A Repair Type: Non-Urgent Crossing Status: Found UCIP Comments: Verify pipe has been abandoned properly.- pump mounted on the riverbank not found, - butterfly valve in a 30-inch concrete riser at the waterward toe not found,- concrete box on landside not found- a big tree inside concrete standpipe on landside found. FIELD_STRUCT_DESC: Abandoned 22-inch steel pipe through the levee, 18.3 feet below the crown, pump mounted on the riverbank, butterfly valve in a 30-inch concrete riser at the waterward toe, pipe discharges into a concrete box and concrete standpipe on the landward side, steel plate bolted on the waterward end of the pipe during the winter months (California Packing Co.) FS Date: 5/21/2013

LS- a big tree inside concrete standpipe.

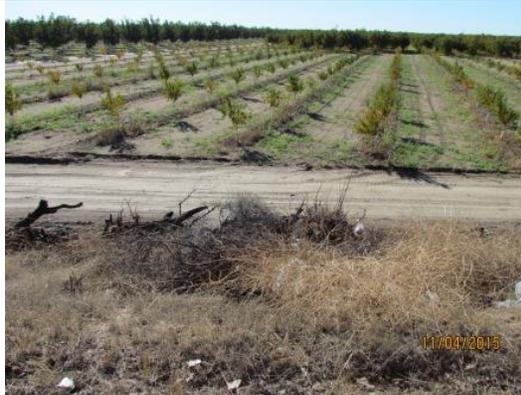
Photo 1 of 1 : SP_2016_RD1001_37_5_20160307_00006.jpg

LM Start	2.76	Rating **	M	Issue No.	5
LM End	2.76	Issue Type +	En	Location *	LS
Category	Earthen Levee		GPS Latitude/Longitude		
			Start	End	
Item	Encroachments		38.994999 °	38.994999 °	
			-121.421047 °	-121.421047 °	
DWR ID	DWR_RD1001_03_f_2015_5				
Comment Code					
PR : Prunings					
Inspector Comment

View of the prunings at the landside levee toe.

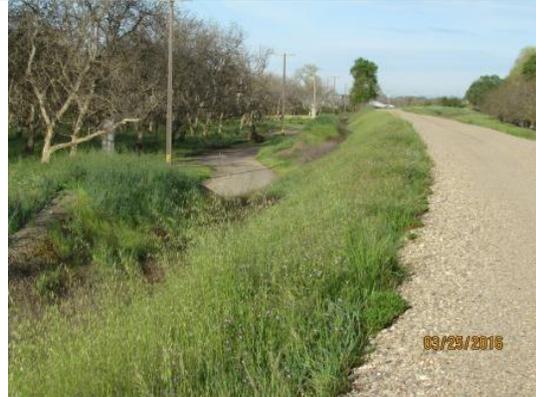
Photo 1 of 1 : SP_2016_RD1001_37_24_20160404_00034.jpg

LM Start	3.68	Rating **	M	Issue No.	24
LM End	4.50	Issue Type +	Ma	Location *	LS
Category	Earthen Levee		GPS Latitude/Longitude		
			Start	End	
Item	Vegetation		38.991200 °	38.991822 °	
			-121.437283 °	-121.452422 °	
DWR ID	DWR_RD1001_03_s_2016_24				
Comment Code					
V1 : Control annual grass and weeds on the levee slopes and easements.					
Inspector Comment

View of vegetation on landside slope.

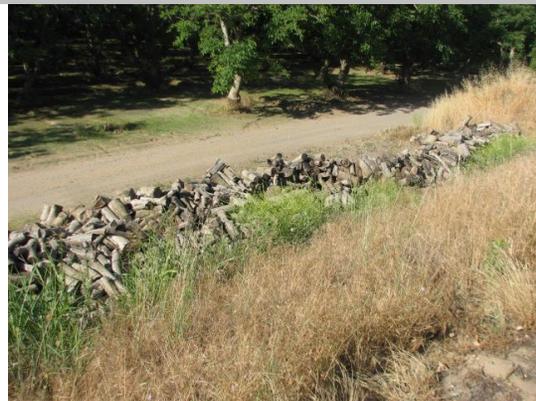
Photo 1 of 1 : SP_2016_RD1001_37_35_20160307_00018.jpg

LM Start	3.82	Rating **	M	Issue No.	35
LM End	3.82	Issue Type +	En	Location *	LS
Category	Earthen Levee		GPS Latitude/Longitude		
			Start	End	
Item	Encroachments		38.991208 °	38.991208 °	
			-121.439943 °	-121.439943 °	
DWR ID	DWR_RD1001_03_s_2013_35				
Comment Code					
FW : Firewood					
Inspector Comment

Firewood piled up at the levee toe. Spring 2013

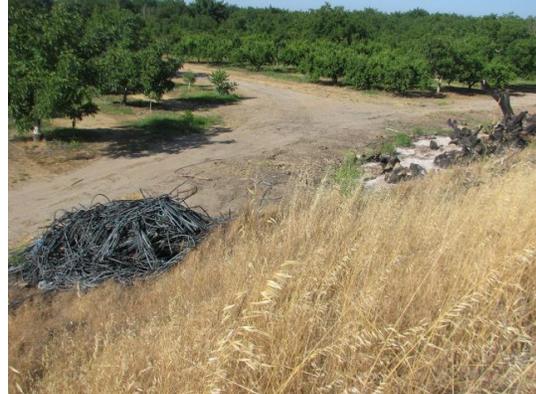
Photo 1 of 1 : SP_2016_RD1001_37_9_20160307_00008.jpg

LM Start	4.46	Rating **	M	Issue No.	9
LM End	4.46	Issue Type +	En	Location *	LS
Category	Earthen Levee		GPS Latitude/Longitude		
			Start	End	
Item	Encroachments		38.991867 °	38.991867 °	
			-121.451743 °	-121.451743 °	
DWR ID	DWR_RD1001_03_s_2013_9				
Comment Code					
MA : Material					
Inspector Comment

Drip irrigation tubing within the easement of the levee. Spring 2013

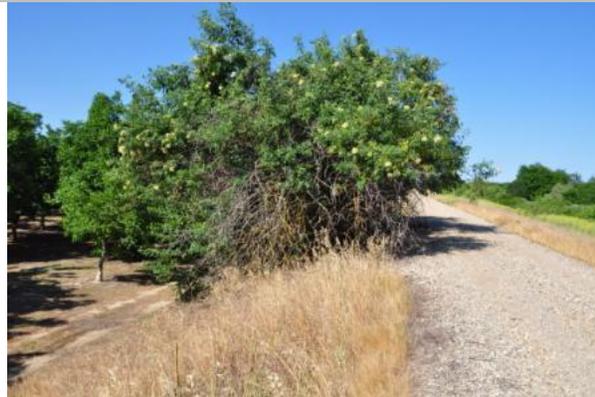
Photo 1 of 1 : SP_2016_RD1001_37_910_20160307_00023.jpg

LM Start	4.82	Rating **	M	Issue No.	910
LM End	4.82	Issue Type +	Ma	Location *	LS
Category	Earthen Levee		GPS Latitude/Longitude		
			Start	End	
Item	Vegetation		38.990773 °	38.990773 °	
			-121.458203 °	-121.458203 °	
DWR ID	DWR_RD1001_03_s_2012_910				
Comment Code					
V4 : Elderberries are blocking visibility and flood fight capability.					
Inspector Comment

RD 1001 Unit 3 - L/S slope -Elderberries

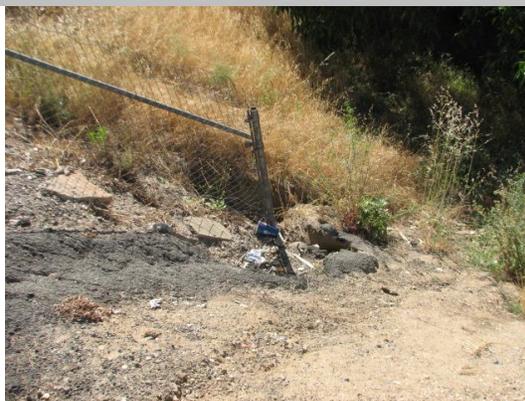
Photo 1 of 1 : SP_2016_RD1001_37_38_20160307_00019.jpg

LM Start	6.47	Rating **	M	Issue No.	38
LM End	6.51	Issue Type +	Ma	Location *	LS
Category	Earthen Levee		GPS Latitude/Longitude		
			Start	End	
Item	Erosion / Bank Caving		38.984010 °	38.983955 °	
			-121.487420 °	-121.488083 °	
DWR ID	DWR_RD1001_03_s_2013_38				
Comment Code					
E2 : Schedule repair of erosion site prior to the next inspection.					
Inspector Comment

Erosion caused by run off from the roadway. Spring 2013

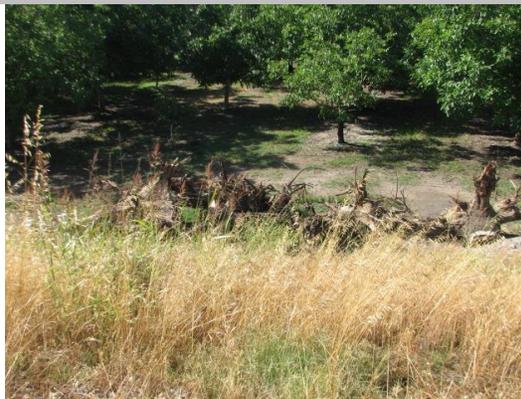
Photo 1 of 1 : SP_2016_RD1001_37_39_20160307_00020.jpg

LM Start	6.85	Rating **	M	Issue No.	39
LM End	6.85	Issue Type +	En	Location *	LS
Category	Earthen Levee		GPS Latitude/Longitude		
			Start	End	
Item	Encroachments		38.983328 °	38.983328 °	
			-121.494400 °	-121.494400 °	
DWR ID	DWR_RD1001_03_s_2013_39				
Comment Code					
PR : Prunings					
Inspector Comment

Walnut stumps within the easement of the levee. Spring 2013

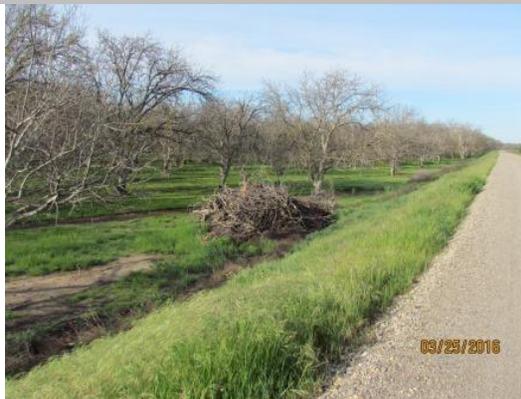
Photo 1 of 1 : SP_2016_RD1001_37_46_20160404_00035.jpg

LM Start	7.07	Rating **	M	Issue No.	46
LM End	7.07	Issue Type +	En	Location *	LS
Category	Earthen Levee		GPS Latitude/Longitude		
			Start	End	
Item	Encroachments		38.982850 °	38.982850 °	
			-121.498516 °	-121.498516 °	
DWR ID	DWR_RD1001_03_s_2016_46				
Comment Code					
DE : Debris					
Inspector Comment

Prunings at landside toe.

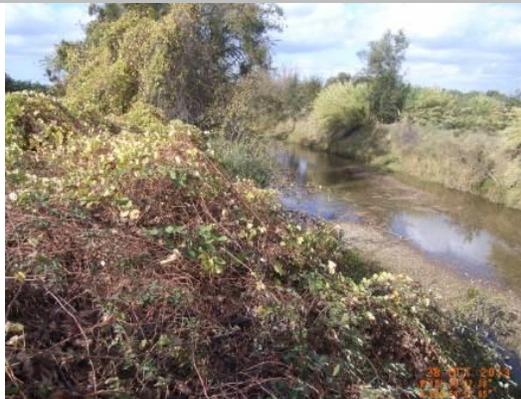
Photo 1 of 1 : SP_2016_RD1001_37_17_20160307_00010.jpg

LM Start	7.22	Rating **	M	Issue No.	17
LM End	7.31	Issue Type +	Ma	Location *	WS
Category	Supplemental		GPS Latitude/Longitude		
			Start	End	
Item	2015 USACE Erosion Survey, DRAFT		38.982737 °	38.982572 °	
			-121.501144 °	-121.502797 °	
DWR ID	DWR_RD1001_03_s_2016_17				
Comment Code					
Inspector Comment					
2008 - Sandy/silty banks with rotational slab failures creating near vertical bank with pop-outs due to tree failures. Narrow berm. 2015: Last observed in 2013. [2015 Site ID: BER_5-7_L]

USACE 2013 Photo #1

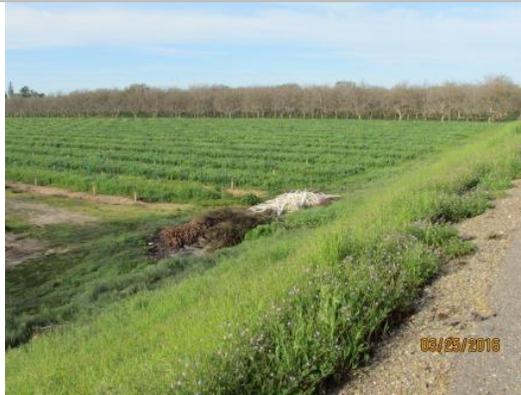
Photo 1 of 1 : SP_2016_RD1001_37_45_20160404_00036.jpg

LM Start	7.54	Rating **	M	Issue No.	45
LM End	7.54	Issue Type +	En	Location *	WS
Category	Earthen Levee		GPS Latitude/Longitude		
			Start	End	
Item	Encroachments		38.981824 °	38.981824 °	
			-121.507072 °	-121.507072 °	
DWR ID	DWR_RD1001_03_s_2015_45				
Comment Code					
PI : Pipe					
Inspector Comment

PVC pipe and debris at landside toe.

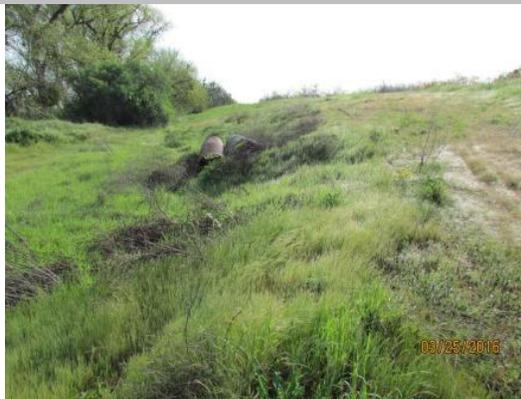
Photo 1 of 1 : SP_2016_RD1001_37_8_20160404_00037.jpg

LM Start	9.22	Rating **	M	Issue No.	8
LM End	9.34	Issue Type +	En	Location *	LS
Category	Earthen Levee		GPS Latitude/Longitude		
			Start	End	
Item	Encroachments		38.970024 °	38.970719 °	
			-121.531848 °	-121.533859 °	
DWR ID	DWR_RD1001_03_f_2015_8				
Comment Code					
PI : Pipe					
Inspector Comment					
Large CM pipe laying on the waterside slope.

View of large CM pipe lying on the waterside toe.

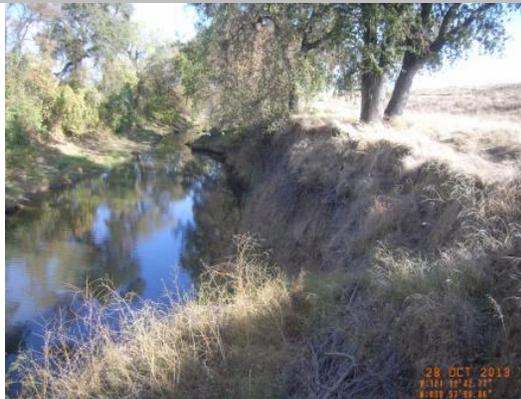
Photo 1 of 1 : SP_2016_RD1001_37_10_20160307_00009.jpg

LM Start	10.36	Rating **	M	Issue No.	10
LM End	10.40	Issue Type +	Ma	Location *	WS
Category	Supplemental		GPS Latitude/Longitude		
			Start	End	
Item	2015 USACE Erosion Survey, DRAFT		38.964583 °	38.964010 °	
			-121.544967 °	-121.545228 °	
DWR ID	DWR_RD1001_03_s_2016_10				
Comment Code					
Inspector Comment					
2011 - Large section of bank has slumped off. RD has flagged and appears to be watching. 2012 - Slopes slightly steeper. 2013 - Minor new erosion observed. 2015: Last observed in 2013. [2015 Site ID: BER_2-5_L]

USACE 2013 Photo #1

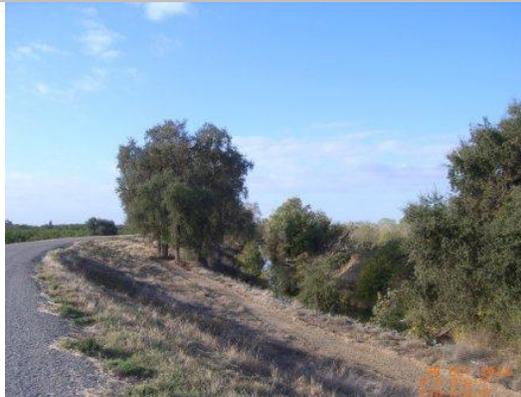
Photo 1 of 1 : SP_2016_RD1001_37_1_20160307_00001.jpg

LM Start	11.08	Rating **	M	Issue No.	1
LM End	11.16	Issue Type +	Ma	Location *	WS
Category	Supplemental		GPS Latitude/Longitude		
			Start	End	
Item	2015 USACE Erosion Survey, DRAFT		38.955070 °	38.954227 °	
			-121.549528 °	-121.550592 °	
DWR ID	DWR_RD1001_03_s_2016_1				
Comment Code					
Inspector Comment					
2011 - Large slumped sections of bank. 2012 - Slopes slightly steeper. 2015: Last observed in 2013. [2015 Site ID: BER_1-9_L]

USACE 2013 Photo #1

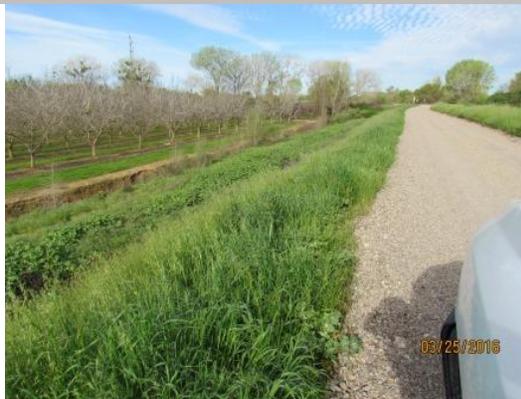
Photo 1 of 1 : SP_2016_RD1001_37_6_20160404_00038.jpg

LM Start	11.15	Rating **	M	Issue No.	6
LM End	11.15	Issue Type +	Ma	Location *	LS
Category	Earthen Levee		GPS Latitude/Longitude		
			Start	End	
Item	Vegetation		38.954167 °	38.954167 °	
			-121.550304 °	-121.550304 °	
DWR ID	DWR_RD1001_03_s_2016_6				
Comment Code					
V2 : Remove the wild growth other than native grasses from the levee slopes.					
Inspector Comment

View of wild growth at landside toe.

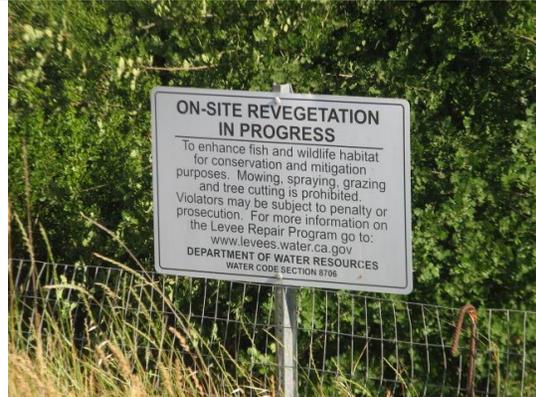
Photo 1 of 1 : SP_2016_RD1001_37_25_20160307_00012.jpg

LM Start	11.59	Rating **	A/W	Issue No.	25
LM End	11.80	Issue Type +	Ma	Location *	WS
Category	Earthen Levee		GPS Latitude/Longitude		
			Start	End	
Item	Vegetation		38.951302 °	38.950960 °	
			-121.556872 °	-121.560717 °	
DWR ID	DWR_RD1001_03_s_2013_25				
Comment Code					
V8 : Environmental Requirements.					
Inspector Comment

Revegetation site in progress. Spring 2013

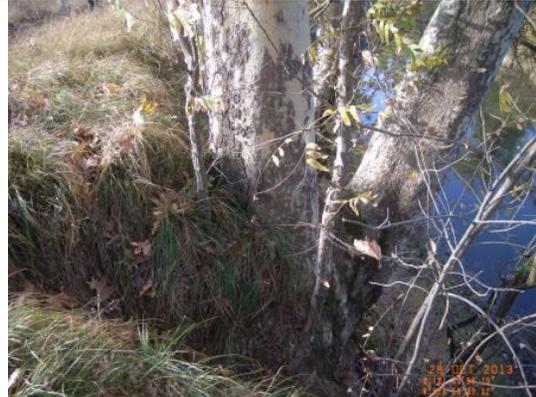
Photo 1 of 1 : SP_2016_RD1001_37_4_20160307_00005.jpg

LM Start	12.07	Rating **	M	Issue No.	4
LM End	12.16	Issue Type +	Ma	Location *	WS
Category	Supplemental			GPS Latitude/Longitude	
				Start	End
Item	2015 USACE Erosion Survey, DRAFT			38.947591 °	38.946477 °
				-121.563390 °	-121.564094 °
DWR ID	DWR_RD1001_03_s_2016_4				
Comment Code					
Inspector Comment					
2006 - Multiple rotational failures in the berm. Erosion is into the levee toe and lower slope. Tension cracks extensive at top of bank. Cohesive toe creates a bench on which failures occur. 2007 - Still steep bank with some berm with pistol-butted reeds. 2012 - Site extended upstream due to additional slumping. Slopes slightly steeper. 2015: Last observed in 2013. [2015 Site ID: BER_0-8_L]

USACE 2013 Photo #1

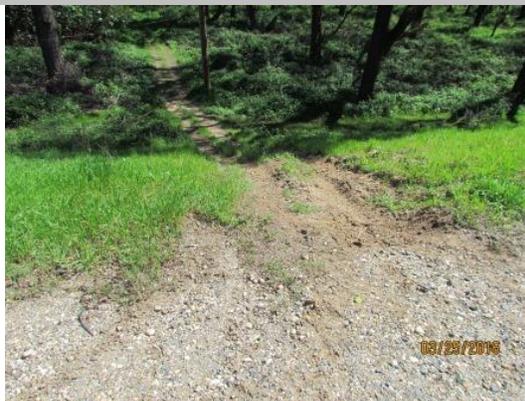
Photo 1 of 1 : SP_2016_RD1001_38_63_20160404_00043.jpg

LM Start	0.18	Rating **	M	Issue No.	63
LM End	0.18	Issue Type +	Ma	Location *	LS
Category	Earthen Levee		GPS Latitude/Longitude		
			Start	End	
Item	Slope Stability		38.938534°	38.938534°	
			-121.567729°	-121.567729°	
DWR ID	DWR_RD1001_04_s_2016_63				
Comment Code					
S3 : Repair the levee slope damaged by vehicle traffic and prevent access where possible.					
Inspector Comment

Landside slope erosion caused by vehicles.

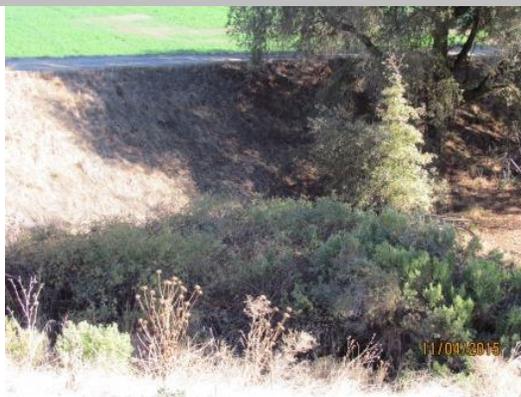
Photo 1 of 1 : SP_2016_RD1001_38_31_20160307_00018.jpg

LM Start	0.78	Rating **	M	Issue No.	31
LM End	0.78	Issue Type +	Ma	Location *	LS
Category	Earthen Levee		GPS Latitude/Longitude		
			Start	End	
Item	Vegetation		38.930026 °	38.930026 °	
			-121.567918 °	-121.567918 °	
DWR ID	DWR_RD1001_04_f_2015_31				
Comment Code					
V2 : Remove the wild growth other than native grasses from the levee slopes.					
Inspector Comment

View of the tall vegetation at the landside levee toe.

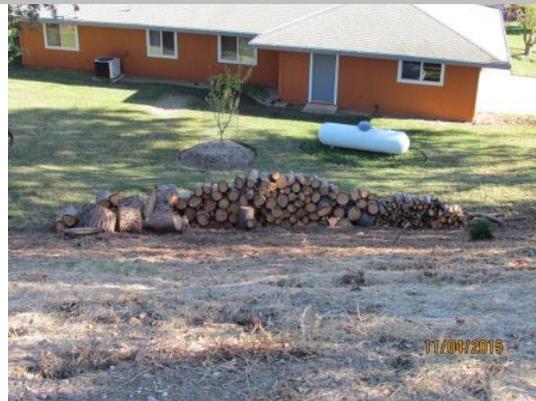
Photo 1 of 1 : SP_2016_RD1001_38_35_20160307_00019.jpg

LM Start	2.44	Rating **	M	Issue No.	35
LM End	2.44	Issue Type +	En	Location *	LS
Category	Earthen Levee			GPS Latitude/Longitude	
				Start	End
Item	Encroachments			38.907517 °	38.907517 °
				-121.575391 °	-121.575391 °
DWR ID	DWR_RD1001_04_f_2015_35				
Comment Code					
FW : Firewood					
Inspector Comment					
Firewood blocking view of landside toe.

View of the firewood at the landside levee toe.

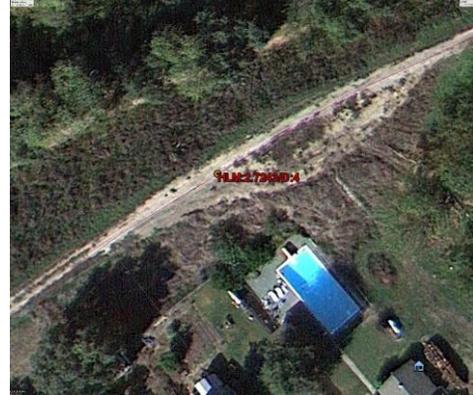
Photo 1 of 1 : UCIP_SP_2016_41987_24126.jpg

LM Start	2.68	Rating **	M	Issue No.	157
LM End	2.68	Issue Type +	En	Location *	LS
Category	Supplemental			GPS Latitude/Longitude	
				Start	End
Item	DWR UCIP Field Study			38.905089 °	38.905089 °
				-121.578477 °	-121.578477 °
DWR ID					
Comment Code					
Inspector Comment					
FS_ID:41987 DS_ID:22568 EP_NO: N/A Repair Type: Non-Urgent Crossing Status: Indicator Found UCIP Comments: Dense vegetation on slopes should be cleared. FIELD_STRUCT_DESC: 4-inch steel swimming-pool drainage pipe through the levee, 3.0 feet below the crown, open on waterward end (Nate Wise) Swimming pool on LS toe. FS Date: 5/16/2013

LS- only a private swimming pool found.

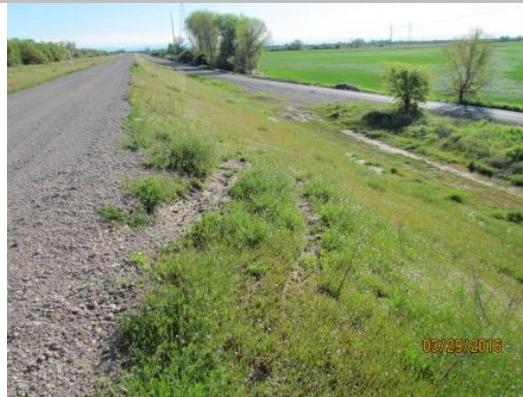
Photo 1 of 1 : SP_2016_RD1001_38_75_20160404_00045.jpg

LM Start	4.10	Rating **	M	Issue No.	75
LM End	4.10	Issue Type +	Ma	Location *	LS
Category	Earthen Levee		GPS Latitude/Longitude		
			Start	End	
Item	Slope Stability		38.892533 °	38.892533 °	
			-121.598700 °	-121.598700 °	
DWR ID	DWR_RD1001_04_s_2016_75				
Comment Code					
S3 : Repair the levee slope damaged by vehicle traffic and prevent access where possible.					
Inspector Comment

Landside slope damage caused by a vehicle.

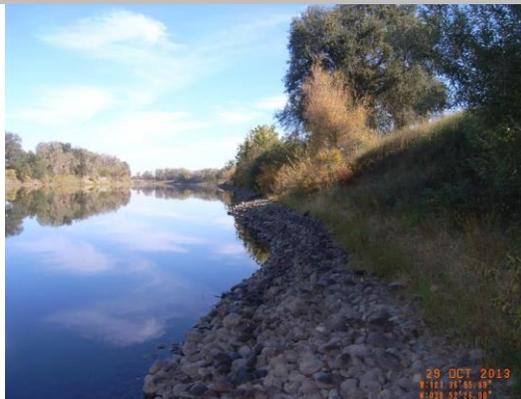
Photo 1 of 1 : SP_2016_RD1001_38_2_20160307_00002.jpg

LM Start	5.80	Rating **	M	Issue No.	2
LM End	5.93	Issue Type +	Ma	Location *	WS
Category	Supplemental			GPS Latitude/Longitude	
				Start	End
Item	2015 USACE Erosion Survey, DRAFT			38.874113 °	38.872373 °
				-121.615380 °	-121.616504 °
DWR ID	DWR_RD1001_04_s_2016_2				
Comment Code					
Inspector Comment					
2011 - Erosion pockets from tree popouts. Sections of the lower bank have slumped off. 2013 - Scallop from tree popouts no longer visible on site. Minor new erosion at the middle of the bank. 2015: Fresh erosion from human use. [2015 Site ID: FHR_6-6_L]

USACE 2013 Photo #1

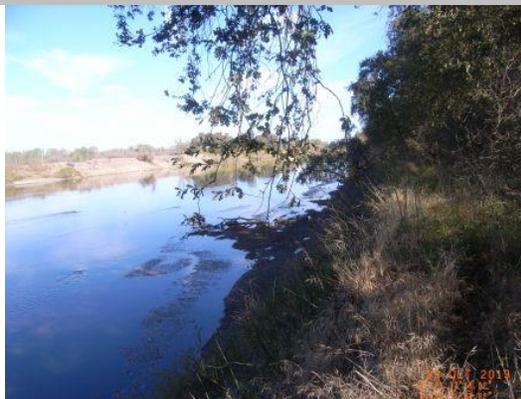
Photo 1 of 1 : SP_2016_RD1001_38_5_20160307_00005.jpg

LM Start	6.42	Rating **	M	Issue No.	5
LM End	6.51	Issue Type +	Ma	Location *	WS
Category	Supplemental			GPS Latitude/Longitude	
				Start	End
Item	2015 USACE Erosion Survey, DRAFT			38.865875 °	38.864706 °
				-121.619983 °	-121.620813 °
DWR ID	DWR_RD1001_04_s_2016_5				
Comment Code					
Inspector Comment					
2011 - Tall slumping sections. Scour around trees has exposed most of the roots. 2015: Recent large slope failure observed. [2015 Site ID: FHR_6-0_L]

USACE 2013 Photo #1

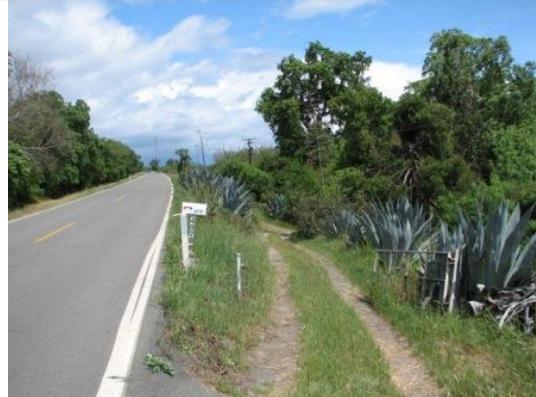
Photo 1 of 2 : SP_2016_RD1001_38_17_20160307_00009.jpg

LM Start	6.42	Rating **	U	Issue No.	17
LM End	6.42	Issue Type +	En	Location *	LS
Category	Earthen Levee		GPS Latitude/Longitude		
			Start	End	
Item	Vegetation		38.865653 °	38.865653 °	
			-121.619742 °	-121.619742 °	
DWR ID	DWR_RD1001_04_s_2012_17				
Comment Code					
V6 : Landscaping					
Inspector Comment

Landscaping on the landside shoulder and slope.

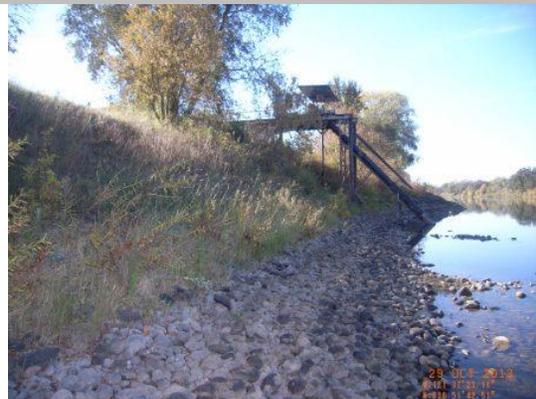
Photo 1 of 1 : SP_2016_RD1001_38_4_20160307_00004.jpg

LM Start	6.57	Rating **	M	Issue No.	4
LM End	6.77	Issue Type +	Ma	Location *	WS
Category	Supplemental		GPS Latitude/Longitude		
			Start	End	
Item	2015 USACE Erosion Survey, DRAFT		38.863946 °	38.861558 °	
			-121.621388 °	-121.623316 °	
DWR ID	DWR_RD1001_04_s_2016_4				
Comment Code					
Inspector Comment					
2011 - Large slumped sections on the lower bank. 2012 - New cracks observed. 2015: No observed changes. [2015 Site ID: FHR_5-8_L]

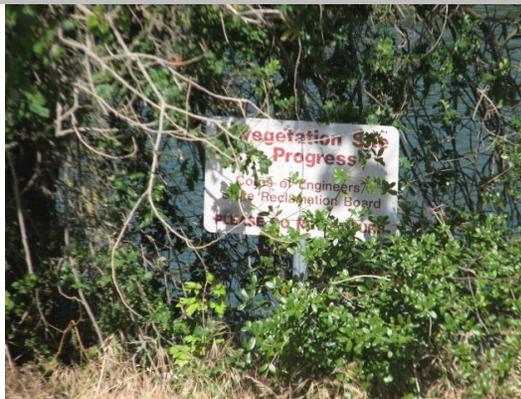
Photo 1 of 1 : SP_2016_RD1001_38_28_20160307_00015.jpg

LM Start	6.80	Rating **	A/W	Issue No.	28
LM End	6.80	Issue Type +	Ob	Location *	WS
Category	Earthen Levee		GPS Latitude/Longitude		
			Start	End	
Item	Vegetation		38.861071 °	38.861071 °	
			-121.623332 °	-121.623332 °	
DWR ID	DWR_RD1001_04_s_2013_28				
Comment Code					
V8 : Environmental Requirements.					
Inspector Comment

Revegetation site. Spring 2013

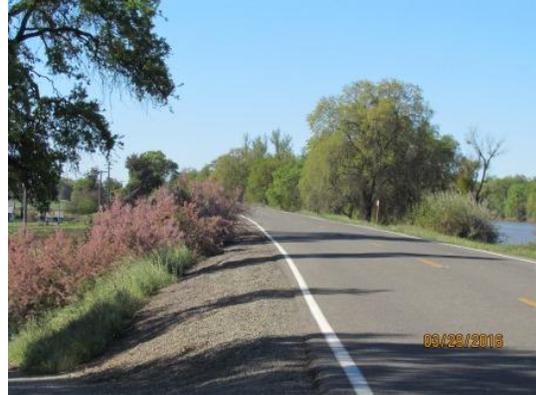
Photo 1 of 1 : SP_2016_RD1001_38_43_20160404_00050.jpg

LM Start	7.41	Rating **	M	Issue No.	43
LM End	7.41	Issue Type +	En	Location *	LS
Category	Earthen Levee		GPS Latitude/Longitude		
			Start	End	
Item	Vegetation		38.853221 °	38.853221 °	
			-121.628469 °	-121.628469 °	
DWR ID	DWR_RD1001_04_f_2013_43				
Comment Code					
V6 : Landscaping					
Inspector Comment

View of vegetation on landside slope, looking downstream.

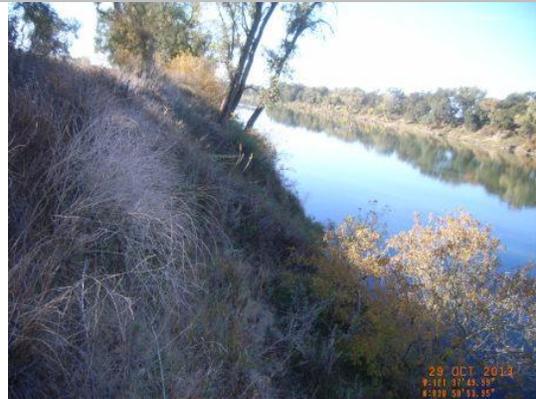
Photo 1 of 1 : SP_2016_RD1001_38_8_20160307_00008.jpg

LM Start	7.47	Rating **	M	Issue No.	8
LM End	7.79	Issue Type +	Ma	Location *	WS
Category	Supplemental		GPS Latitude/Longitude		
			Start	End	
Item	2015 USACE Erosion Survey, DRAFT		38.852394 °	38.848004 °	
			-121.629231 °	-121.630873 °	
DWR ID	DWR_RD1001_04_s_2016_8				
Comment Code					
Inspector Comment					
2000 - Steep bank off berm with some slumps and fallen trees, continued erosion. 2002 - Site lengthened upstream and downstream due to vertical bank along most of the reach. 2010 - Site extended upstream. 2011 - Minimal new erosion. 2012 - Site extended on the upstream end, new tree pop-out, and bank erosion continues to worsen. 2013 - Minor new erosion at the toe and top of bank. 2015: No observed changes. [2015 Site ID: FHR_5-0_L]

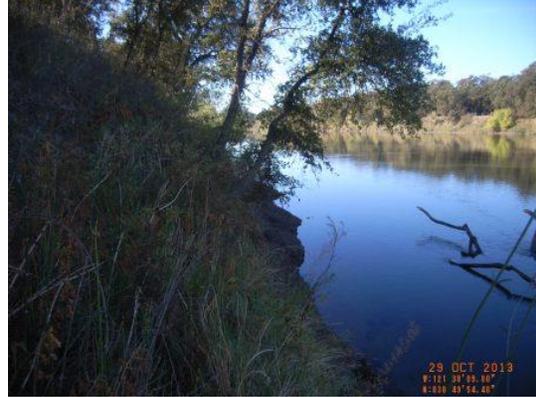
Photo 1 of 1 : SP_2016_RD1001_38_7_20160307_00007.jpg

LM Start	8.57	Rating **	M	Issue No.	7
LM End	8.97	Issue Type +	Ma	Location *	WS
Category	Supplemental			GPS Latitude/Longitude	
				Start	End
Item	2015 USACE Erosion Survey, DRAFT			38.836966 °	38.831498 °
				-121.634128 °	-121.636371 °
DWR ID	DWR_RD1001_04_s_2016_7				
Comment Code					
Inspector Comment					
2006 - Sandy, silty bank with intermittent pockets of erosion. Rotational failure and tree pop outs are most of the problem. Some upper slope fluvial erosion. 2010 - Site extended upstream. The lower Feather may benefit from a regional repair. 2011 - Site combined with 3.6. Minimal new erosion. 2013 - New erosion observed at bank toe. Trees on site now have exposed roots. 2015: No observed changes. [2015 Site ID: FHR_3-8_L]

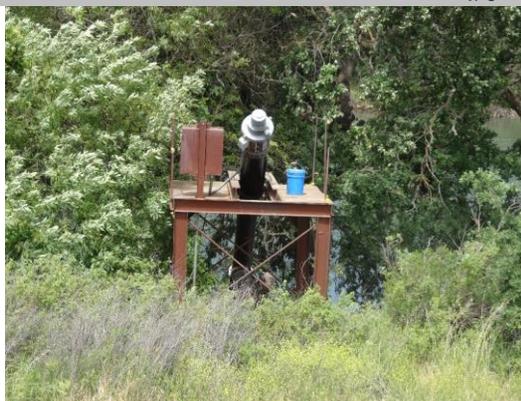
Photo 1 of 2 : UCIP_SP_2016_14563_24002.jpg

LM Start	9.15	Rating **	M	Issue No.	156
LM End	9.15	Issue Type +	En	Location *	LS
Category	Supplemental			GPS Latitude/Longitude	
				Start	End
Item	DWR UCIP Field Study			38.828893 °	38.828893 °
				-121.637219 °	-121.637219 °
DWR ID					
Comment Code					
Inspector Comment					
FS_ID:14563 DS_ID:22577 EP_NO: 12828 Repair Type: Non-Urgent Crossing Status: Found UCIP Comments: - needs detailed investigation for road surface cracks FIELD_STRUCT_DESC: 16-inch asphalt-coated steel irrigation pipe through the levee, 4.3 feet below the crown, 30-horsepower slant pump and platform on the bank (Permit No. 12828, 1979). O&M Manual Sac 141.1, August 1955. FS Date: 5/16/2013

WS- slanted pipe in steel structure on river bank.

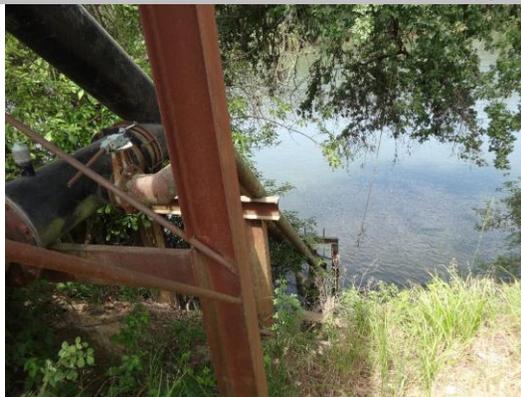
Photo 2 of 2 : UCIP_SP_2016_14563_24001.jpg

LM Start	9.15	Rating **	M	Issue No.	156 (cont)
LM End	9.15	Issue Type +	En	Location *	LS
Category	Supplemental			GPS Latitude/Longitude	
				Start	End
Item	DWR UCIP Field Study			38.828893 °	38.828893 °
				-121.637219 °	-121.637219 °
DWR ID					
Comment Code					
Inspector Comment					
FS_ID:14563 DS_ID:22577 EP_NO: 12828 Repair Type: Non-Urgent Crossing Status: Found UCIP Comments: - needs detailed investigation for road surface cracks FIELD_STRUCT_DESC: 16-inch asphalt-coated steel irrigation pipe through the levee, 4.3 feet below the crown, 30-horsepower slant pump and platform on the bank (Permit No. 12828, 1979). O&M Manual Sac 141.1, August 1955. FS Date: 5/16/2013

WS- inlet pipe and main pipe in pump station on river bank.

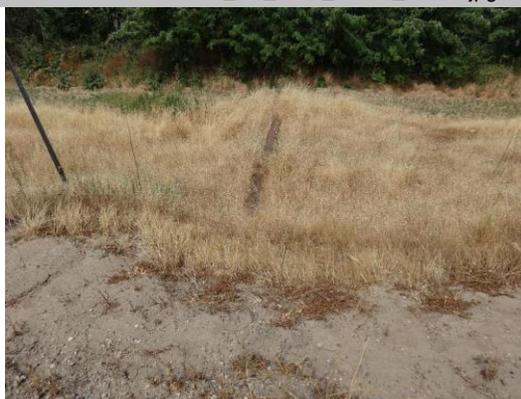
Photo 1 of 2 : UCIP_SP_2016_14544_23966.jpg

LM Start	9.44	Rating **	M	Issue No.	153
LM End	9.44	Issue Type +	En	Location *	LS
Category	Supplemental			GPS Latitude/Longitude	
				Start	End
Item	DWR UCIP Field Study			38.825107 °	38.825107 °
				-121.639369 °	-121.639369 °
DWR ID					
Comment Code					
Inspector Comment					
FS_ID:14544 DS_ID:22592 EP_NO: N/A Repair Type: Non-Urgent Crossing Status: Found UCIP Comments: - seems abandoned pipe crossing.- needs properly abandoned.- a 48" steel tank not found on landside. FIELD_STRUCT_DESC: 12-inch steel irrigation pipe through the levee, 5.0 feet below the crown, pump on the bank, pipe discharges into a 48-inch steel tank at the landward toe (Johnston) FS Date: 5/16/2013

WS- damaged pipe with holes, cracks on levee slope. River bank is not visible due to dense vegetation (top)

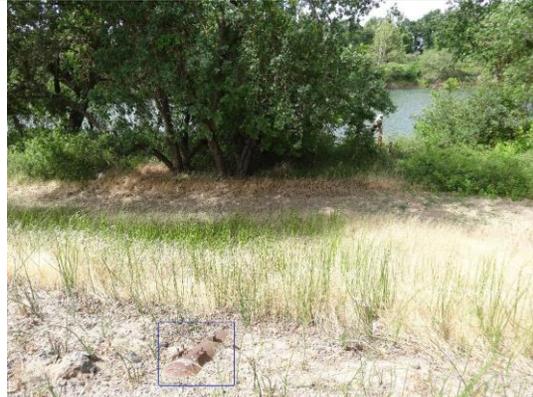
Photo 1 of 2 : UCIP_SP_2016_14627_24134.jpg

LM Start	9.92	Rating **	M	Issue No.	152
LM End	9.92	Issue Type +	En	Location *	WS
Category	Supplemental			GPS Latitude/Longitude	
				Start	End
Item	DWR UCIP Field Study			38.818341 °	38.818341 °
				-121.638890 °	-121.638890 °
DWR ID					
Comment Code					
Inspector Comment					
FS_ID:14627 DS_ID:22578 EP_NO: 3297 Repair Type: Non-Urgent Crossing Status: Found UCIP Comments: - needs properly abandoned.- dismantled standpipe found on LS levee slope FIELD_STRUCT_DESC: 12-inch steel pipe through the levee, 3.0 feet below the crown, slant pump mounted on a steel structure on the bank, siphon breaker on the landward shoulder, pipe discharges into a 24-inch concrete standpipe at the landward toe (Permit No. 3297, 1960). FS Date: 5/16/2013

WS- exposed pipe on levee slope and pump station in river bank.

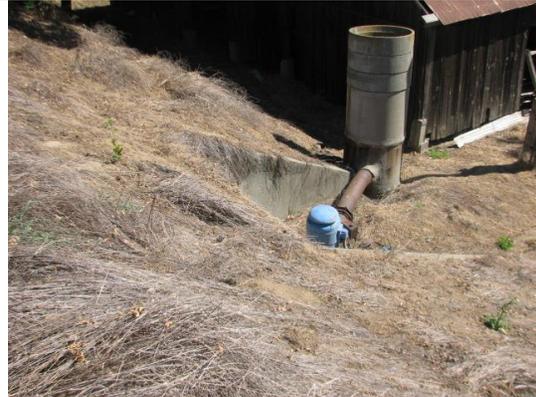
Photo 1 of 1 : SP_2016_RD1001_38_30_20160307_00017.jpg

LM Start	10.61	Rating **	M	Issue No.	30
LM End	10.61	Issue Type +	En	Location *	LS
Category	Earthen Levee		GPS Latitude/Longitude		
			Start	End	
Item	Encroachments		38.809212 °	38.809212 °	
			-121.633910 °	-121.633910 °	
DWR ID	DWR_RD1001_04_s_2013_30				
Comment Code					
RW : Retaining Wall					
Inspector Comment

A retaining wall is within the profile of the slope. Spring 2013

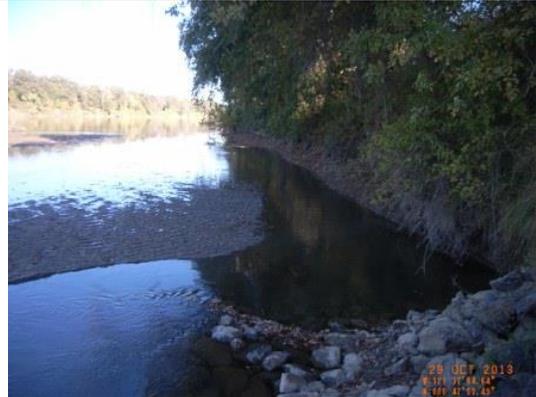
Photo 1 of 1 : SP_2016_RD1001_38_6_20160307_00006.jpg

LM Start	11.18	Rating **	M	Issue No.	6
LM End	11.37	Issue Type +	Ma	Location *	WS
Category	Supplemental		GPS Latitude/Longitude		
			Start	End	
Item	2015 USACE Erosion Survey, DRAFT		38.800920 °	38.798165 °	
			-121.633050 °	-121.631939 °	
DWR ID	DWR_RD1001_04_s_2016_6				
Comment Code					
Inspector Comment					
2000 - Site is relatively stable except for some toe erosion at the upstream end, recommend monitoring the upstream end. 2004 - Some new block failures (10ft deep) at the toe of the upstream end. 2007 - Some minor new slumping at the waterline. 2013 - Minor new erosion along the bank toe. 2015: No observed changes. [2015 Site ID: FHR_1-0_L]

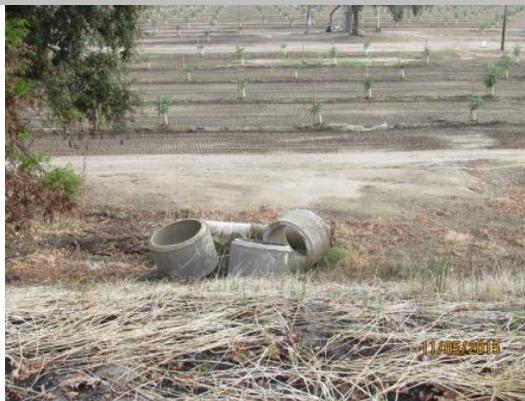
Photo 1 of 1 : SP_2016_RD1001_38_41_20160307_00021.jpg

LM Start	11.28	Rating **	M	Issue No.	41
LM End	11.28	Issue Type +	En	Location *	LS
Category	Earthen Levee		GPS Latitude/Longitude		
			Start	End	
Item	Encroachments		38.799635°	38.799635°	
			-121.631986°	-121.631986°	
DWR ID	DWR_RD1001_04_f_2015_41				
Comment Code					
MA : Material					
Inspector Comment

View of the material at the landside levee toe.

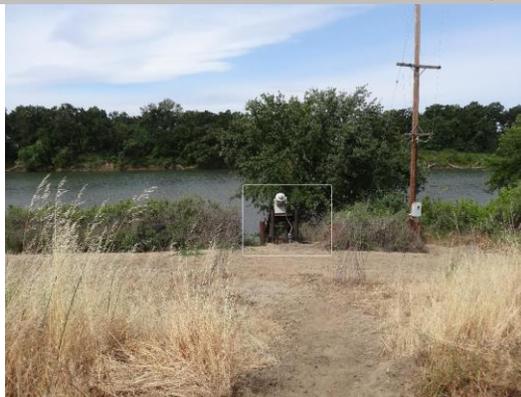
Photo 1 of 2 : UCIP_SP_2016_14548_23970.jpg

LM Start	11.28	Rating **	M	Issue No.	155
LM End	11.28	Issue Type +	En	Location *	LS
Category	Supplemental			GPS Latitude/Longitude	
				Start	End
Item	DWR UCIP Field Study			38.799561 °	38.799561 °
				-121.631964 °	-121.631964 °
DWR ID					
Comment Code					
Inspector Comment					
FS_ID:14548 DS_ID:22580 EP_NO: 3489 Repair Type: Non-Urgent Crossing Status: Found UCIP Comments: - siphon breaker on the landward shoulder not found.- cracked road surface along the pipe alienment. Needs more investigations. FIELD_STRUCT_DESC: 16-inch pipe through the levee, 3.0 feet below the crown, 40-horsepower slant pump mounted on a steel structure on the bank, pipe discharges into a 36-inch concrete standpipe on the landward toe (Permit No. 3489, 1960). FS Date: 5/16/2013

WS- sland pump on river bank.

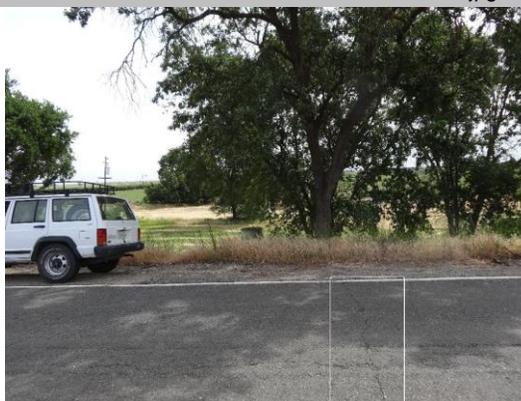
Photo 2 of 2 : UCIP_SP_2016_14548_23969.jpg

Levee Crown- surface crack along pipe crossing. Needs more investigation.

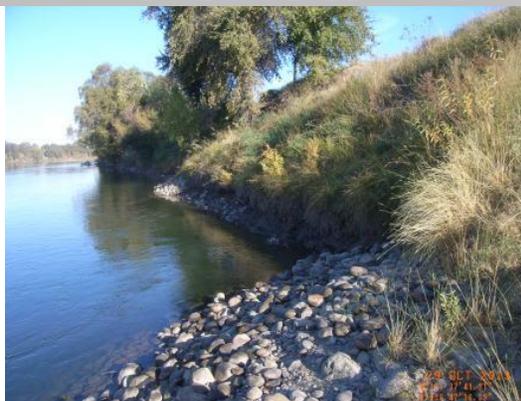
Photo 1 of 1 : SP_2016_RD1001_38_1_20160307_00001.jpg

LM Start	11.59	Rating **	M	Issue No.	1
LM End	11.75	Issue Type +	Ma	Location *	WS
Category	Supplemental			GPS Latitude/Longitude	
				Start	End
Item	2015 USACE Erosion Survey, DRAFT			38.795455 °	38.793394 °
				-121.629903 °	-121.628156 °
DWR ID	DWR_RD1001_04_s_2016_1				
Comment Code					
Inspector Comment					
1997- Deposits over top of cobble on the upper slope. 2000 - Old cobble site in poor shape; some toe retreat, but little change; steep bank. 2010 - Site extended upstream due to new toe erosion. 2012 - Minor new erosion at toe, new slumping, animals holes and cracks observed. 2015: No observed changes. [2015 Site ID: FHR_0-6_L]

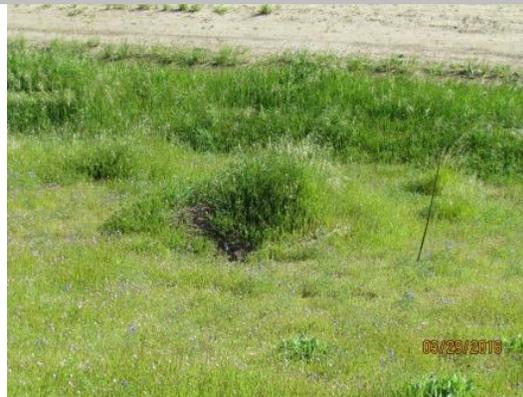
Photo 1 of 1 : SP_2016_RD1001_38_38_20160404_00048.jpg

LM Start	11.89	Rating **	U	Issue No.	38
LM End	11.89	Issue Type +	Ma	Location *	LS
Category	Earthen Levee		GPS Latitude/Longitude		
			Start	End	
Item	Animal Control		38.792080 °	38.792080 °	
			-121.626195 °	-121.626195 °	
DWR ID	DWR_RD1001_04_f_2015_38				
Comment Code					
A3 : No rodents visible, but rodent burrows visible; need to backfill and compact or grout burrows.					
Inspector Comment

View of rodent hole on landside slope.

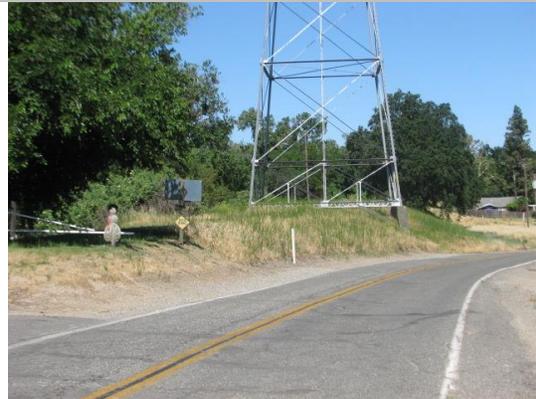
Photo 1 of 2 : SP_2016_RD1001_38_25_20160307_00013.jpg

LM Start	12.48	Rating **	U	Issue No.	25
LM End	12.48	Issue Type +	En	Location *	LS
Category	Earthen Levee		GPS Latitude/Longitude		
			Start	End	
Item	Encroachments		38.786073 °	38.786073 °	
			-121.618522 °	-121.618522 °	
DWR ID	DWR_RD1001_04_s_2012_25				
Comment Code					
BU : Building					
Inspector Comment

A short section of the levee has limited access. Spring 2013

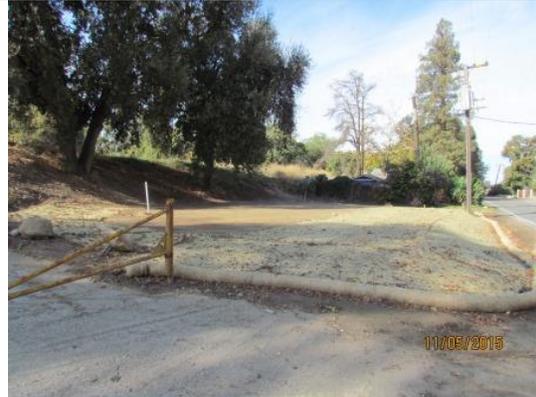
Photo 1 of 1 : SP_2016_RD1001_38_57_20160307_00022.jpg

LM Start	12.51	Rating **	A/W	Issue No.	57
LM End	12.51	Issue Type +	En	Location *	LS
Category	Earthen Levee		GPS Latitude/Longitude		
			Start	End	
Item	Encroachments		38.785850 °	38.785850 °	
			-121.618071 °	-121.618071 °	
DWR ID	DWR_RD1001_04_f_2015_57				
Comment Code					
BU : Building					
Inspector Comment					
New construction pending.

View of the house pad at the landside levee toe.

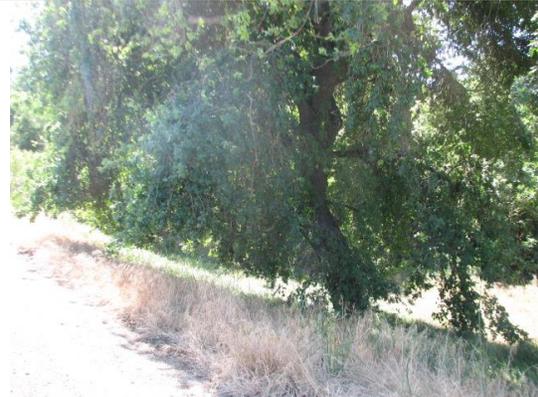
Photo 1 of 1 : SP_2016_RD1001_38_151_20160307_00023.jpg

LM Start	12.82	Rating **	M	Issue No.	151
LM End	12.82	Issue Type +	Ma	Location *	WS
Category	Earthen Levee		GPS Latitude/Longitude		
			Start	End	
Item	Trim / Thin Trees		38.783930 °	38.783930 °	
			-121.612952 °	-121.612952 °	
DWR ID	DWR_RD1001_04_s_2012_151				
Comment Code					
T1 : Trim trees to at least five feet above ground level.					
Inspector Comment

Trees need to be trimmed up at least 5 feet. Spring 2013
