**Flood Control Project Maintenance
Levee Inspections**
LMA District Cover Sheet
Spring 2016 Levee Inspection Results

Reclamation District No. 1001 Nicolaus

Spring 2016 Levee Inspection Results

Waterway		Bank	Unit Miles
Unit No. 01 Yankee Slough		Right	4.12

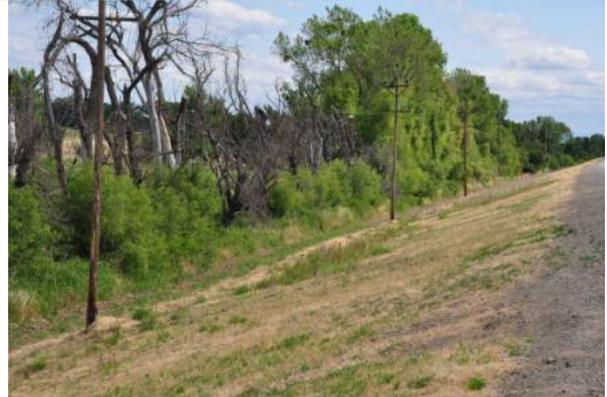
Photo 1 of 2 : SP_2016_RD1001_39_5_20160307_00005.jpg

LM Start	0.19	Rating **	M	Issue No.	5
LM End	0.85	Issue Type +	En	Location *	LS
Category	Earthen Levee		GPS Latitude/Longitude		
			Start	End	
Item	Encroachments		38.783758 °	38.791058 °	
			-121.604189 °	-121.596562 °	
DWR ID	DWR_RD1001_05_s_2012_5				
Comment Code					
PO : Pole					
Inspector Comment

RD 1001 Unit 5 - L/S Levee Toe - Poles

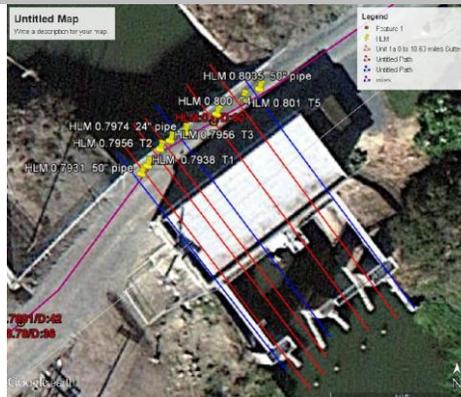
Photo 1 of 2 : UCIP_SP_2016_14393_23697.jpg

Comment Code					
Inspector Comment					
FS_ID:14393 DS_ID:22610 EP_NO: N/A Repair Type: Non-Urgent Crossing Status: Found UCIP Comments: - needs repair of concrete piers on waterside. Rebar exposed from the pier. Even though this pier is functionally not linked to the pipe, it needs repair. FIELD_STRUCT_DESC: 5 of 8: A 24-inch pipe through levee, 25 ft. below the levee crown. Five 5-foot-by-7-foot concrete tunnels through the levee, 25.0 feet below the crown, one tunnel has a 60-inch pump installed inside and is gated on the waterward end, two 50-inch pipes through the levee, 25.0 feet below the crown, all tunnels and pipes are gated, concrete headwall and railing along the landward side (R.D. No. 1001) FS Date: 5/15/2013

Location of pipes and tunnels. 24-inch steel pipe located at 5th from the left.

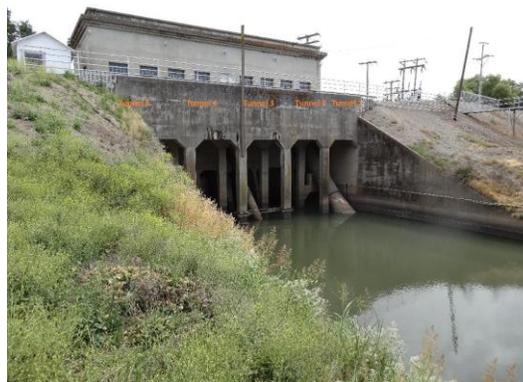
Photo 2 of 2 : UCIP_SP_2016_14393_23696.jpg

LS- Drainage structure with tunnels, pipes and pump house. Tunnel 1 at far right and tunnel 5 at far left. The pipe is located inside tunnel 3.

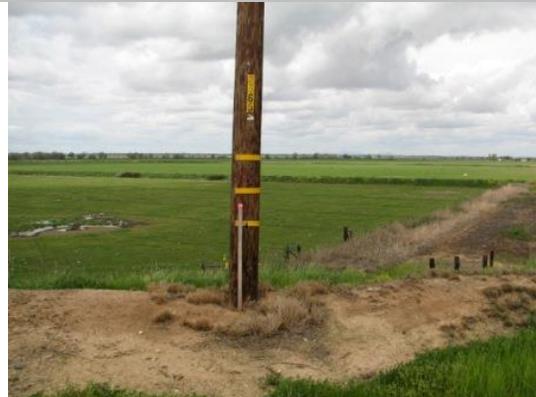
Photo 1 of 2 : SP_2016_RD1001_39_6_20160307_00007.jpg

LM Start	1.14	Rating **	M	Issue No.	6
LM End	1.14	Issue Type +	En	Location *	LS
Category	Earthen Levee			GPS Latitude/Longitude	
				Start	End
Item	Encroachments			38.793613 °	38.793613 °
				-121.592230 °	-121.592230 °
DWR ID	DWR_RD1001_05_s_2012_6				
Comment Code					
PO : Pole					
Inspector Comment

Pole on land side shoulder.

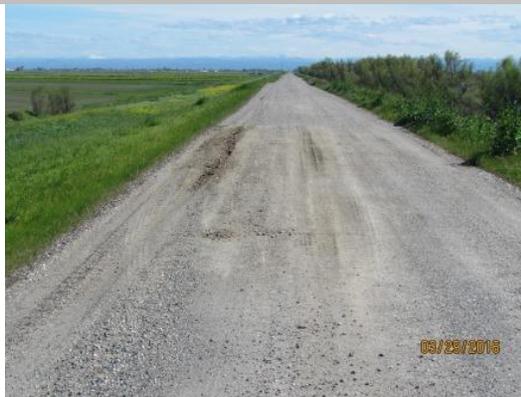
Photo 1 of 1 : SP_2016_RD1001_39_21_20160404_00032.jpg

LM Start	1.54	Rating **	M	Issue No.	21
LM End	1.54	Issue Type +	Ma	Location *	CR
Category	Earthen Levee		GPS Latitude/Longitude		
			Start	End	
Item	Crown Surface / Depressions / Rutting		38.797132 °	38.797132 °	
			-121.586400 °	-121.586400 °	
DWR ID	DWR_RD1001_05_s_2016_21				
Comment Code					
C2 : Repair depressions or ruts in the crown or slope.					
Inspector Comment

Vehicle ruts on levee crown where there is minimal aggregate.

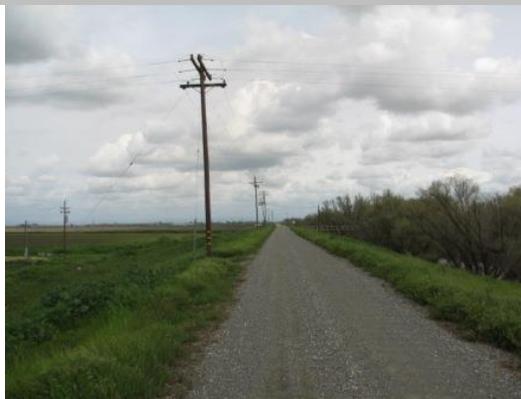
Photo 1 of 1 : SP_2016_RD1001_39_7_20160307_00009.jpg

LM Start	3.56	Rating **	M	Issue No.	7
LM End	3.81	Issue Type +	En	Location *	LS
Category	Earthen Levee		GPS Latitude/Longitude		
			Start	End	
Item	Encroachments		38.814919 °	38.817178 °	
			-121.556712 °	-121.552965 °	
DWR ID	DWR_RD1001_05_s_2012_7				
Comment Code					
PO : Pole					
Inspector Comment

Poles on the landside shoulder.

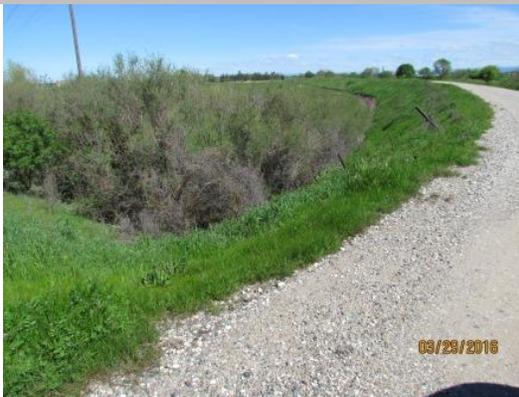
Photo 1 of 1 : SP_2016_RD1001_40_18_20160404_00034.jpg

LM Start	0.01	Rating **	M	Issue No.	18
LM End	0.01	Issue Type +	Ma	Location *	LS
Category	Earthen Levee			GPS Latitude/Longitude	
				Start	End
Item	Trim / Thin Trees			38.831192 °	38.831192 °
				-121.529580 °	-121.529580 °
DWR ID	DWR_RD1001_06_s_2016_18				
Comment Code					
T3 : Trim and thin trees to allow visibility of the ground and room to flood fight.					
Inspector Comment

View of trees that need to be trimmed for visibility on the landside looking upstream.

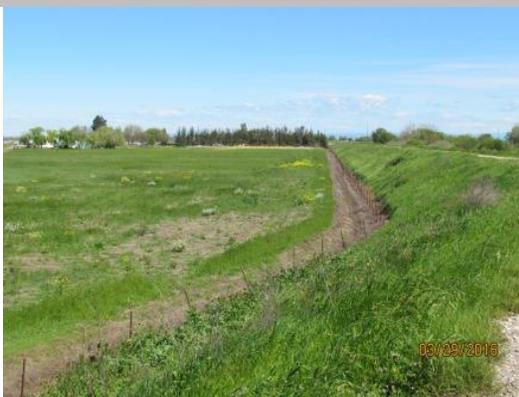
Photo 1 of 1 : SP_2016_RD1001_40_14_20160404_00035.jpg

LM Start	0.02	Rating **	M	Issue No.	14
LM End	0.39	Issue Type +	En	Location *	LS
Category	Earthen Levee			GPS Latitude/Longitude	
				Start	End
Item	Encroachments			38.831314 °	38.836243 °
				-121.529417 °	-121.527038 °
DWR ID	DWR_RD1001_06_f_2015_14				
Comment Code					
DT : Ditch					
Inspector Comment

Ditch at landside levee toe, view looking upstream.

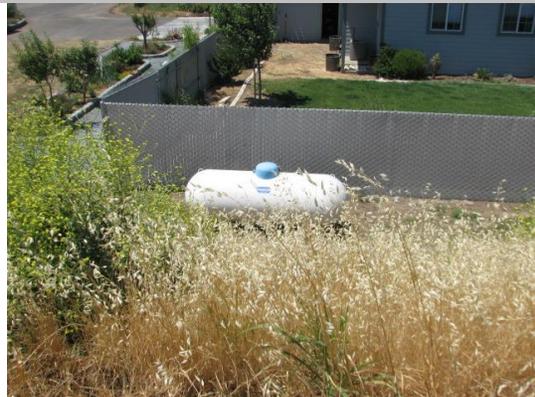
Photo 1 of 1 : SP_2016_RD1001_40_46_20160307_00007.jpg

LM Start	0.95	Rating **	M	Issue No.	46
LM End	0.95	Issue Type +	En	Location *	LS
Category	Earthen Levee		GPS Latitude/Longitude		
			Start	End	
Item	Encroachments		38.844013 °	38.844013 °	
			-121.524320 °	-121.524320 °	
DWR ID	DWR_RD1001_06_s_2012_46				
Comment Code					
TA : Tank					
Inspector Comment

A propane tank is within the easement of the levee. Spring 2013

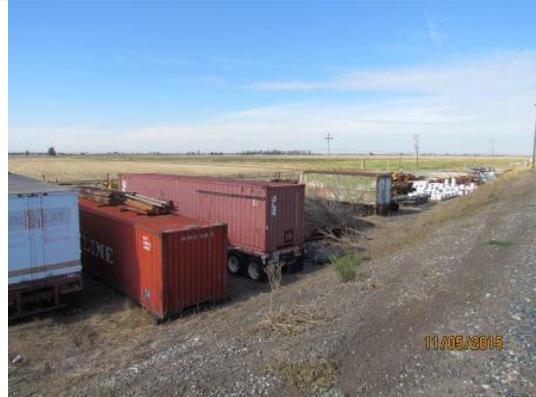
Photo 1 of 1 : SP_2016_RD1001_40_3_20160307_00001.jpg

LM Start	1.43	Rating **	M	Issue No.	3
LM End	1.53	Issue Type +	En	Location *	LS
Category	Earthen Levee		GPS Latitude/Longitude		
			Start	End	
Item	Encroachments		38.850945 °	38.852445 °	
			-121.524392 °	-121.524809 °	
DWR ID	DWR_RD1001_06_s_2012_3				
Comment Code					
EQ : Equipment					
Inspector Comment

View of the equipment at the landside levee toe.

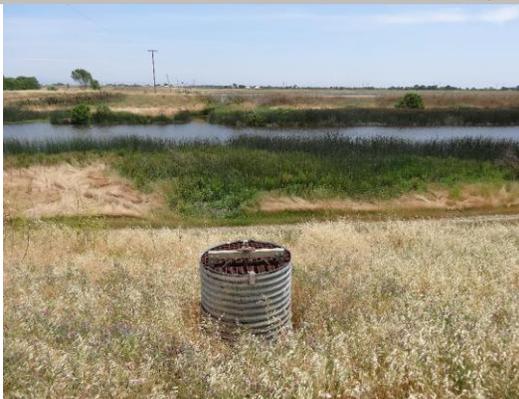
Photo 1 of 2 : UCIP_SP_2016_14223_23445.jpg

LM Start	2.03	Rating **	M	Issue No.	49
LM End	2.03	Issue Type +	En	Location *	LS
Category	Supplemental			GPS Latitude/Longitude	
				Start	End
Item	DWR UCIP Field Study			38.859601 °	38.859601 °
				-121.524885 °	-121.524885 °
DWR ID					
Comment Code					
Inspector Comment					
FS_ID:14223 DS_ID:22616 EP_NO: N/A Repair Type: Non-Urgent Crossing Status: Found UCIP Comments: - pipe burried/submerged on LS- needs cleaning of LS pipe end opening. FIELD_STRUCT_DESC: 24-inch corrugated-metal drainage pipe through the levee, 15.5 feet below the crown, slide gate in a 36-inch corrugated-metal pipe riser on the waterward slope, concrete headwall at the landward toe, the pipe crosses under the channel FS Date: 5/15/2013

WS- slide gate in CMP riser on levee slope.

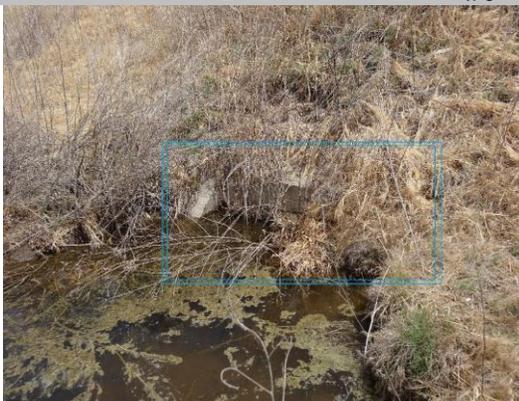
Photo 2 of 2 : UCIP_SP_2016_14223_23444.jpg

LS- concrete wing wall on levee toe

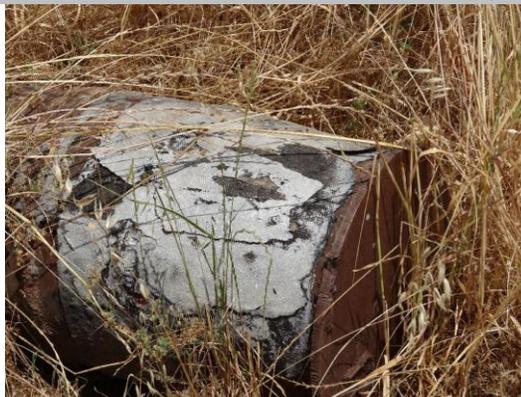
Photo 2 of 2 : UCIP_SP_2016_41674_23381.jpg

Comment Code					
Inspector Comment					
FS_ID:41674 DS_ID:22629 EP_NO: 2768 Repair Type: Non-Urgent Crossing Status: Found UCIP Comments: Pipe appears abandoned and if so should be done so properly.- Pipe capped on waterside.- a concrete pipe support saddle found on waterside levee slope.- also, an abandoned pipe found on landside levee slope. FIELD_STRUCT_DESC: 14-inch steel pipe through the levee, 1.3 feet below the crown, pump on the waterward toe removed, gate valve on the waterward slope removed, the pipe is exposed on both slopes and discharges into a culvert on the landward toe across and under Pacific Avenue (Permit No. 2768, 1958) FS Date: 5/15/2013

WS- an abandoned end capped pipe on levee slope

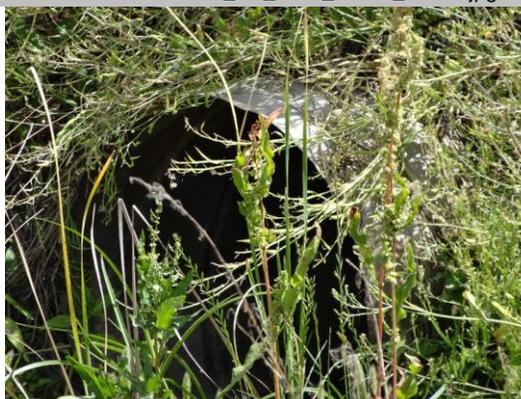
Photo 1 of 2 : UCIP_SP_2016_14167_23396.jpg

LM Start	3.28	Rating **	M	Issue No.	53
LM End	3.28	Issue Type +	En	Location *	WS
Category	Supplemental			GPS Latitude/Longitude	
				Start	End
Item	DWR UCIP Field Study			38.877706 °	38.877706 °
				-121.524787 °	-121.524787 °
DWR ID					
Comment Code					
Inspector Comment					
FS_ID:14167 DS_ID:22630 EP_NO: N/A Repair Type: Non-Urgent Crossing Status: Found UCIP Comments: - pipe opens in irrigation ditch on landside.- vegetation cleaning on LS pipe opening. FIELD_STRUCT_DESC: 24-inch corrugated-metal drainage pipe through the levee, 12.0 feet below the crown, slide gate in a 36-inch corrugated-metal pipe riser on the waterward slope, concrete headwall at the landward toe, the pipe crosses under the channel FS Date: 5/15/2013

LS- vegetation on CMP end.

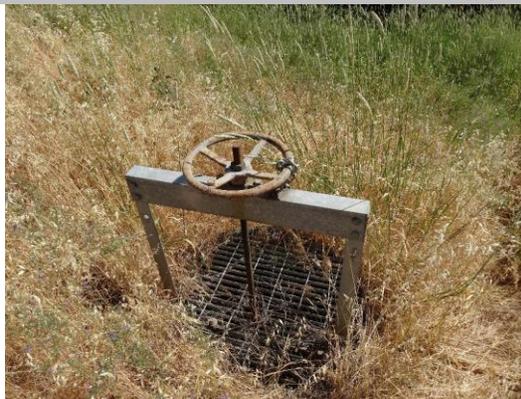
Photo 1 of 2 : UCIP_SP_2016_41724_22034.jpg

LM Start	4.36	Rating **	M	Issue No.	55
LM End	4.36	Issue Type +	En	Location *	CR
Category	Supplemental			GPS Latitude/Longitude	
				Start	End
Item	DWR UCIP Field Study			38.893448 °	38.893448 °
				-121.524719 °	-121.524719 °
DWR ID					
Comment Code					
Inspector Comment					
FS_ID:41724 DS_ID:22618 EP_NO: N/A Repair Type: Non-Urgent Crossing Status: Found UCIP Comments: - damaged head/wing wall in inlet structure. FIELD_STRUCT_DESC: 30-inch corrugated-metal gravity irrigation pipe through the levee, 15.9 feet below the crown, slide gate in a 36-inch corrugated-metal pipe riser on the waterward slope, the pipe discharges into a large irrigation ditch on the west side of Pacific Avenue (Joplin and South Sutter Water District) FS Date: 5/15/2013

WS- slide gate in CMP riser.

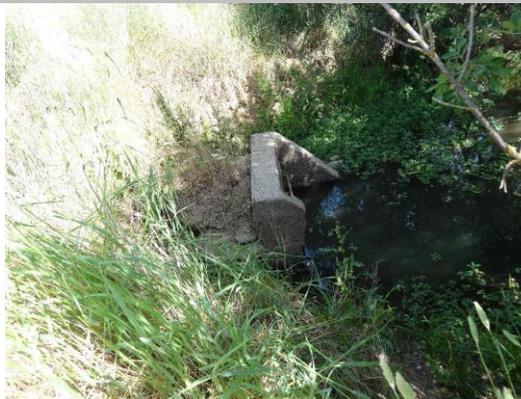
Photo 2 of 2 : UCIP_SP_2016_41724_22033.jpg

WS- inlet wing wall with trashrack
