**Flood Control Project Maintenance  
Levee Inspections**

**Fall 2015 Levee Maintenance Deficiency Summary Report**

**Reclamation District No. 2060 Hastings**

**Levee Inspection Report By Mile - Fall 2015**

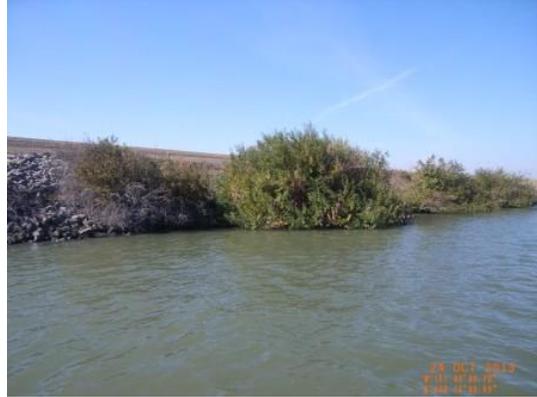
Photo 1 of 1 : USACE2013A\_CHS\_22-5\_R\_1.jpg

LM Start	<b>2.55</b>	Rating **	M	Issue No.	<b>5</b>
LM End	<b>2.58</b>	Issue Type +	Ma	Location *	WS
Category	Supplemental			GPS Latitude/Longitude	
				Start	End
Item	2015 USACE Erosion Survey, DRAFT			38.278145 °	38.277774 °
				-121.712609 °	-121.712137 °
DWR ID					
Action/Comments					
Inspector Comments: 2013 - Erosion pockets into the levee toe. 2015: Erosion pockets have increased in size. [2015 Site ID: CHS_22-5_R]

USACE 2013 Photo #1
