INSPECTION AND LOCAL MAINTAINING AGENCY REPORT OF THE CENTRAL VALLEY STATE-FEDERAL FLOOD PROTECTION SYSTEM

Department of Water Resources

Flood Project Integrity and Inspection Branch | Hydrology and Flood Operations Office | Division of Flood Management

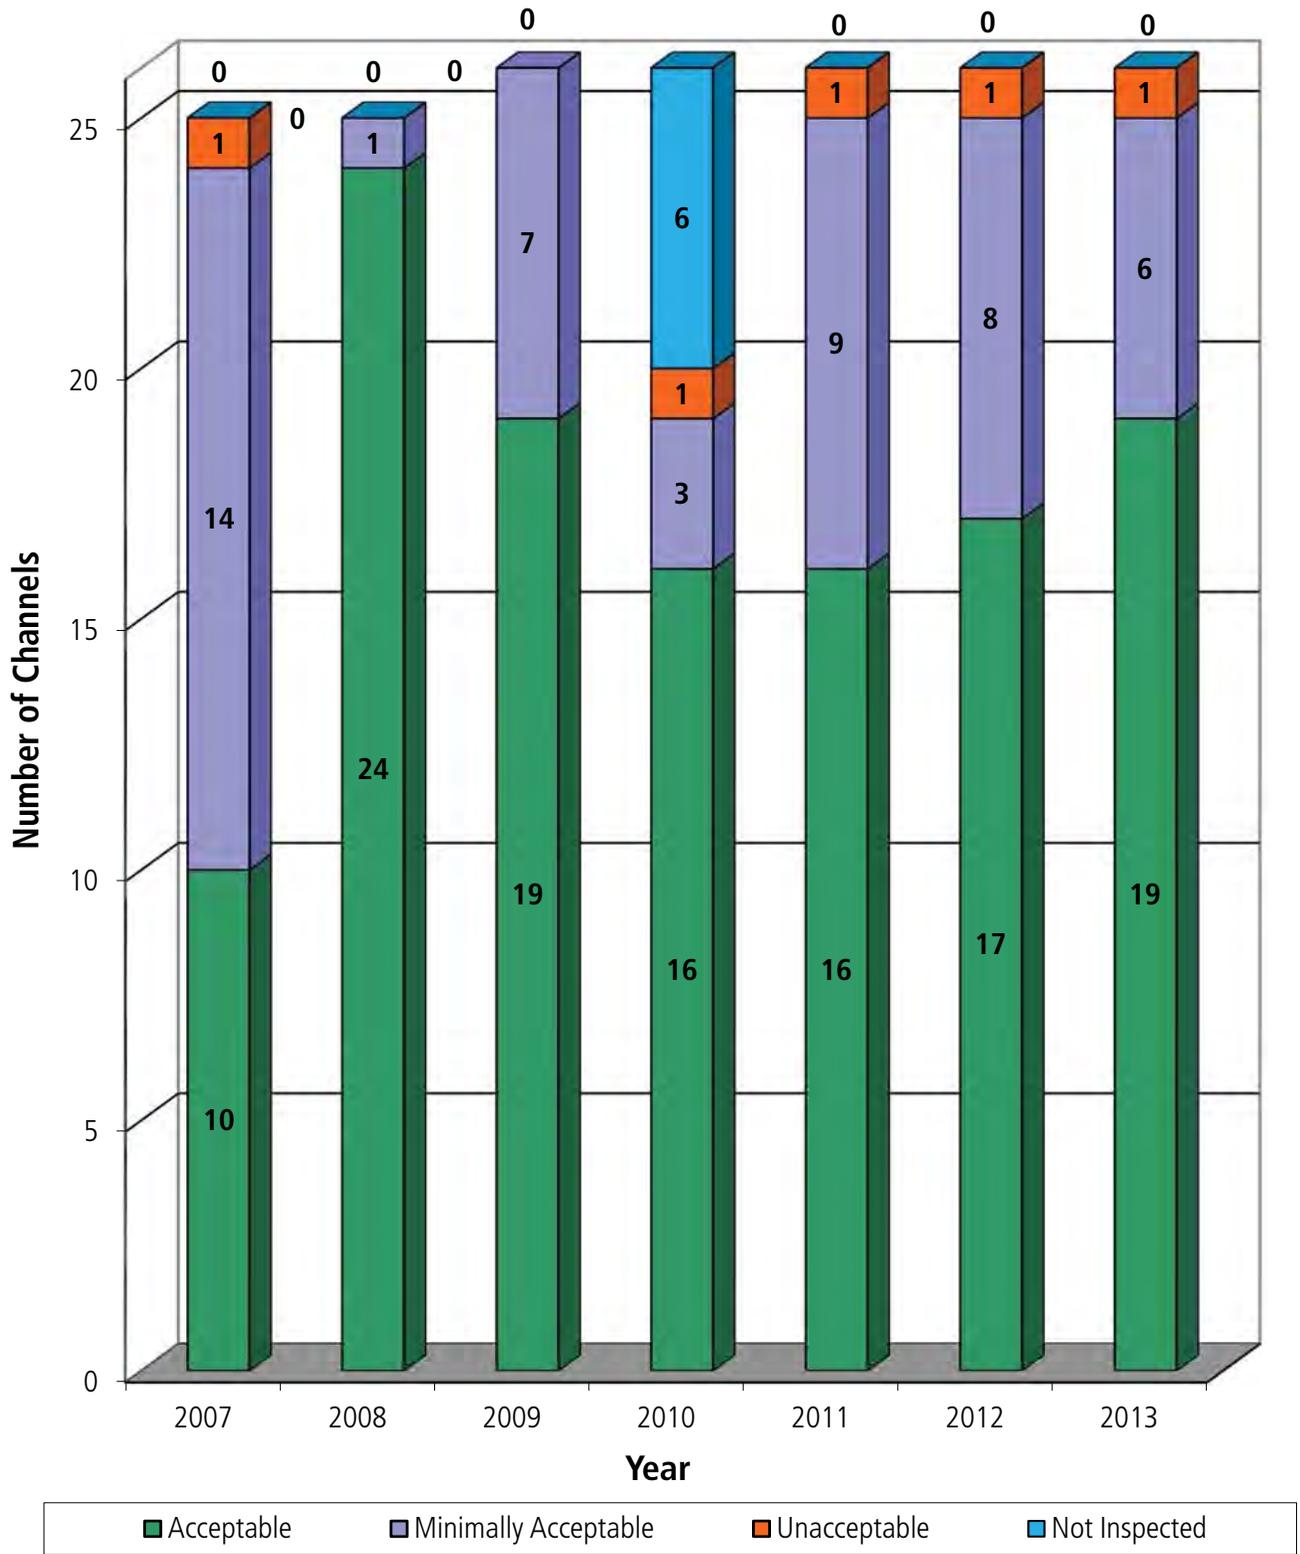
Figure 3-1: Comparison of Overall Channel Ratings for 2007 to 2013

One channel was rated as Unacceptable in 2013, while the number of Minimally Acceptable channels was six and nineteen channels were rated as acceptable, which is slightly better than 2012. This shows the similarity of maintenance found during inspection in 2013 as prior years. Figure 3-1 shows the progression of maintenance ratings from 2007 through 2013.

Appendix F details the method for determining overall ratings. Table 3-1 and Figure 3-1 show the numbers of each rating for the years 2007 through 2013.
