Appendix **A**

Sacramento River Individual Agency Summary Reports

A total of 61 LMAs and 82 local reporting areas for Project Levees/Structures/Channels are included in the Sacramento River Flood Control Project. Appendix A includes an index to Sacramento River System LMAs, a map to show the locations of each reporting area, and individual LMA summary profiles. Appendix A includes:

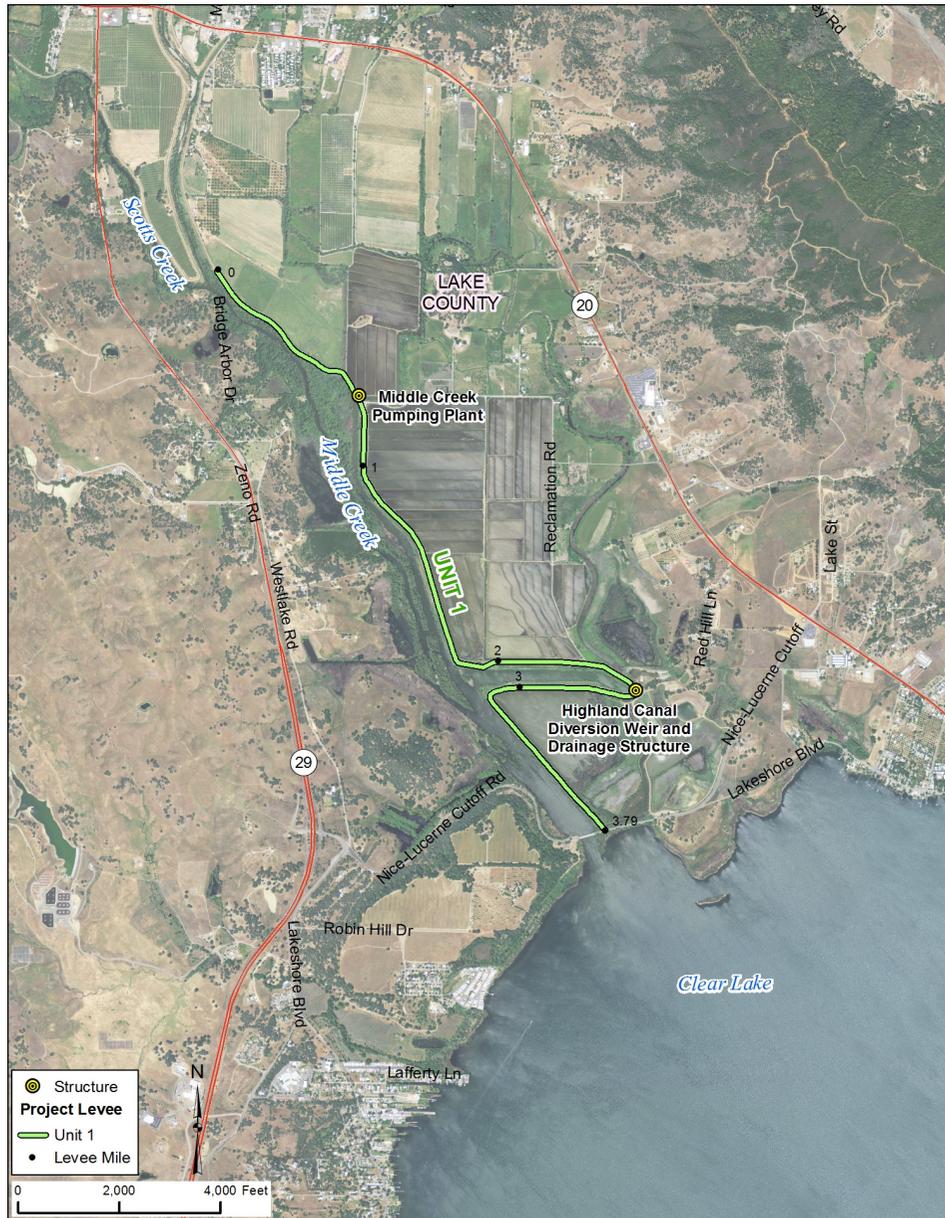
LMA Short Name : MA0017	Bank	Unit Length (Miles)
Unit No. 01 Lake County Sutter Maintenance Yard - Middle Creek	LB	3.90

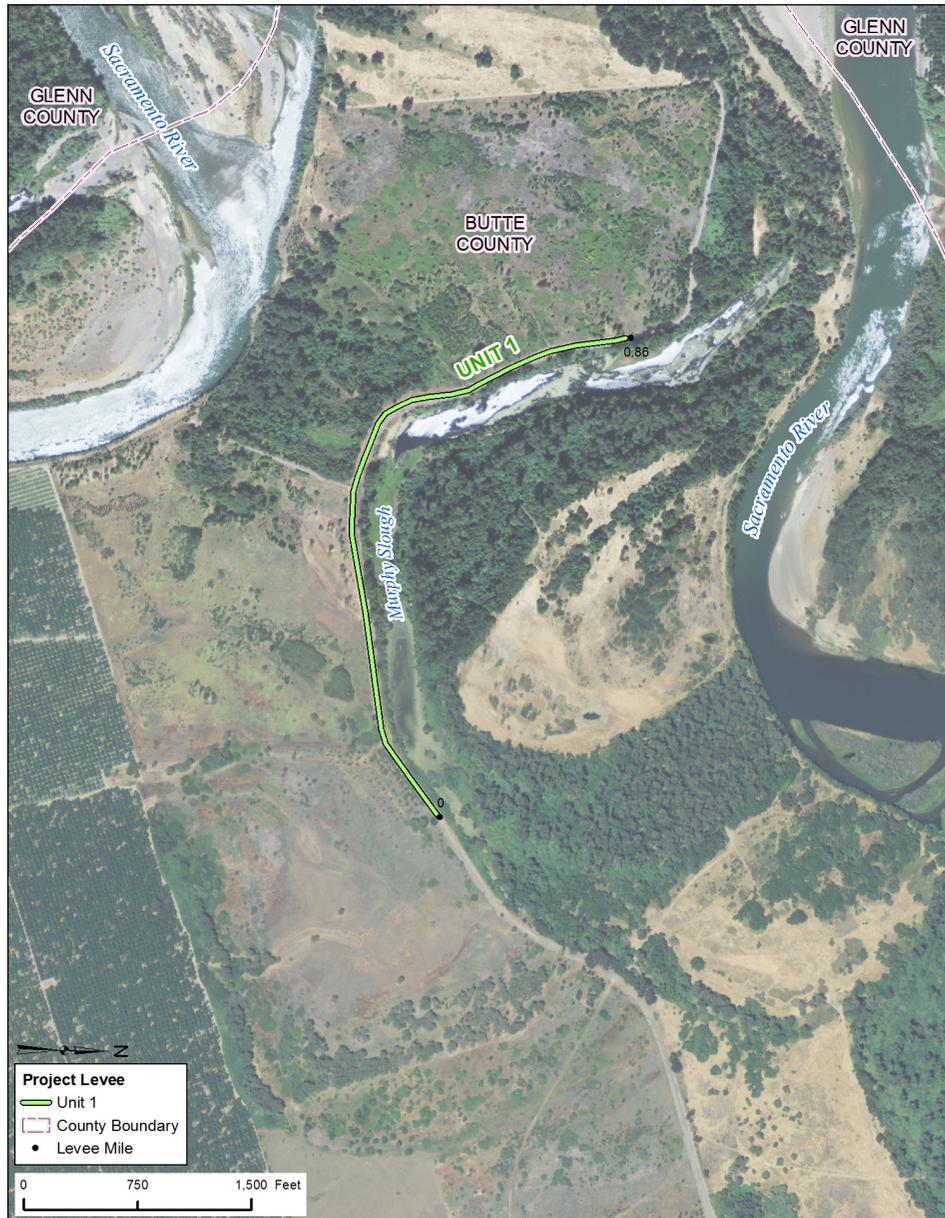
LMA Short Name : NA0014	Bank	Unit Length (Miles)
Unit No. 01 Murphy Slough at M&T Ranch	LB	0.78

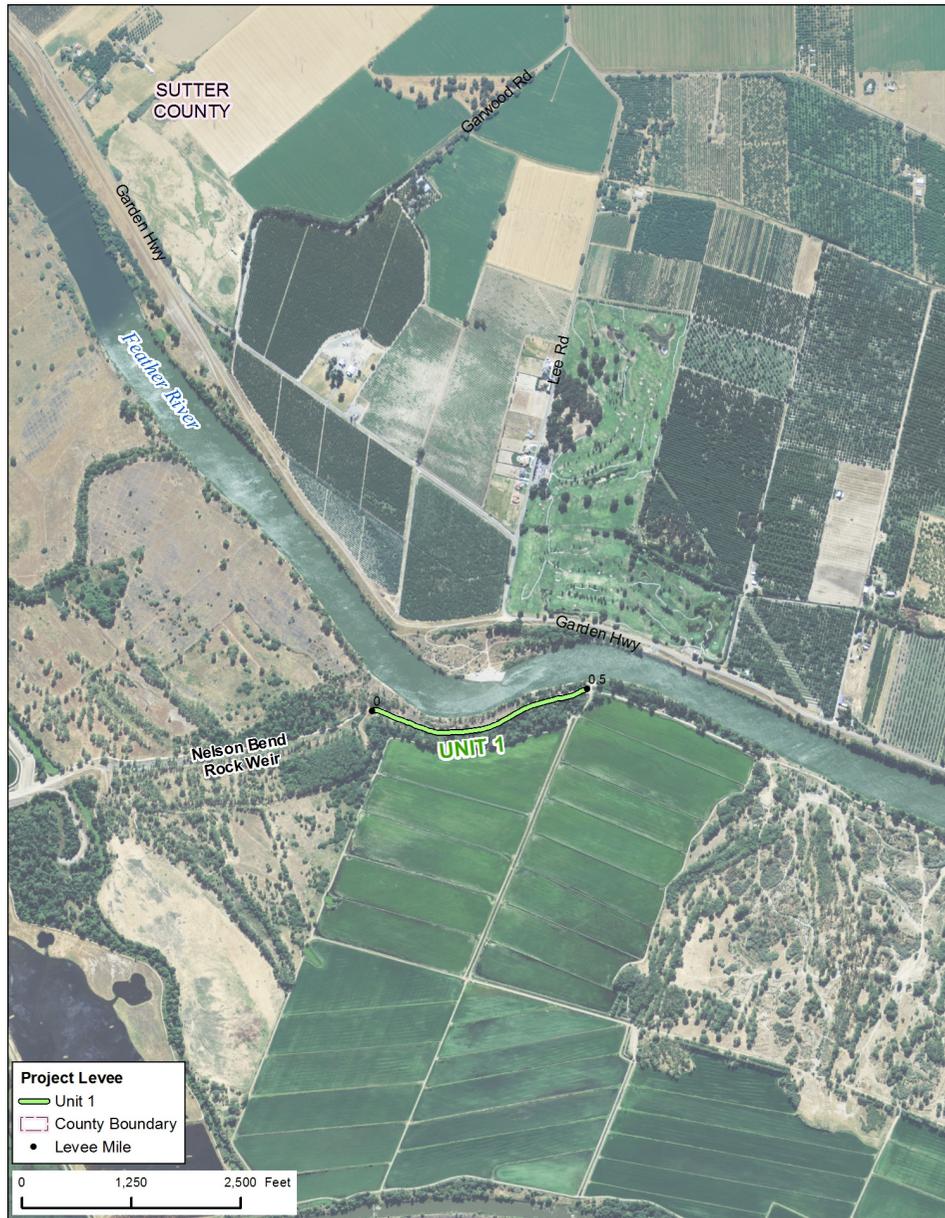
Nelson Bend

LMA Short Name : ST0006	Bank	Unit Length (Miles)
Unit No. 01 Feather River West Levee-Nelson Bend		0.50

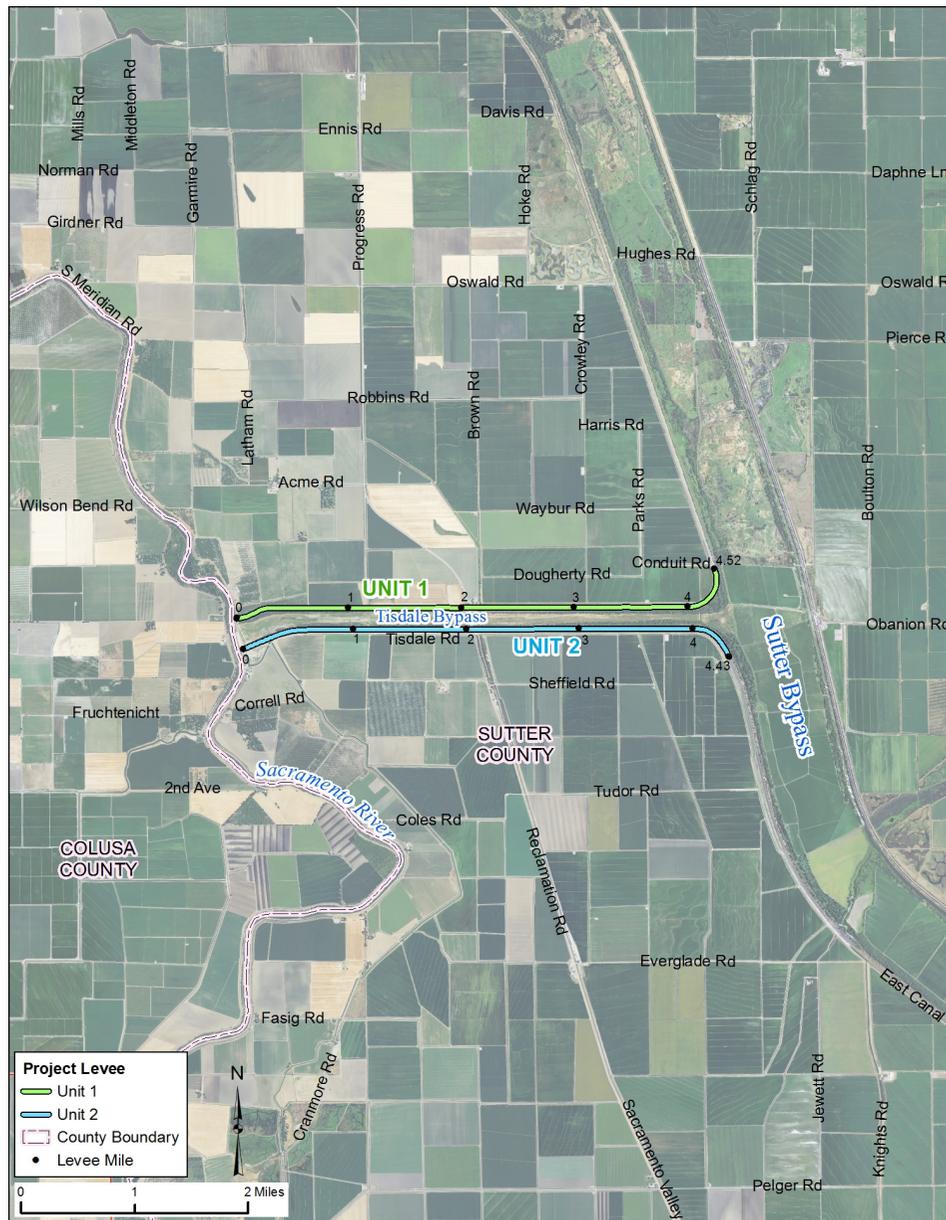
LMA Short Name : ST0009	Bank	Unit Length (Miles)
Unit No. 01 Tisdale Bypass	LB	4.50
Unit No. 02 Tisdale Bypass	RB	4.43

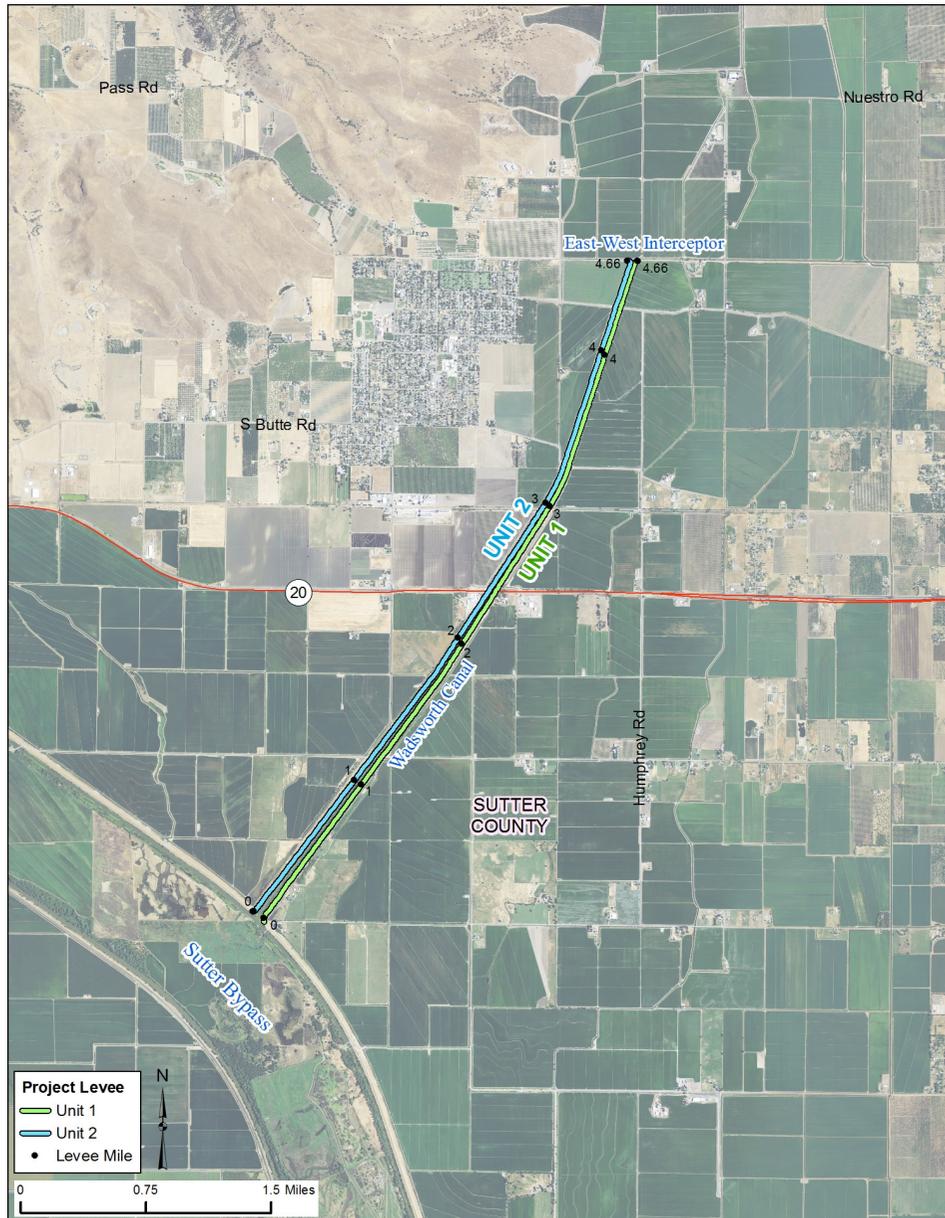
LMA Short Name : ST0010		Bank	Unit Length (Miles)
Unit No. 01	Wadsworth Canal	LB	4.66
Unit No. 02	Wadsworth Canal	RB	4.66
