INSPECTION AND LOCAL MAINTAINING AGENCY REPORT OF THE CENTRAL VALLEY STATE-FEDERAL FLOOD PROTECTION SYSTEM

Code of Federal Regulations, Title 33, Section 208.10

California Water Code Sections 9140 - 9141

Flood Project Integrity and Inspection Branch | Hydrology and Flood Operations Office | Division of Flood Management

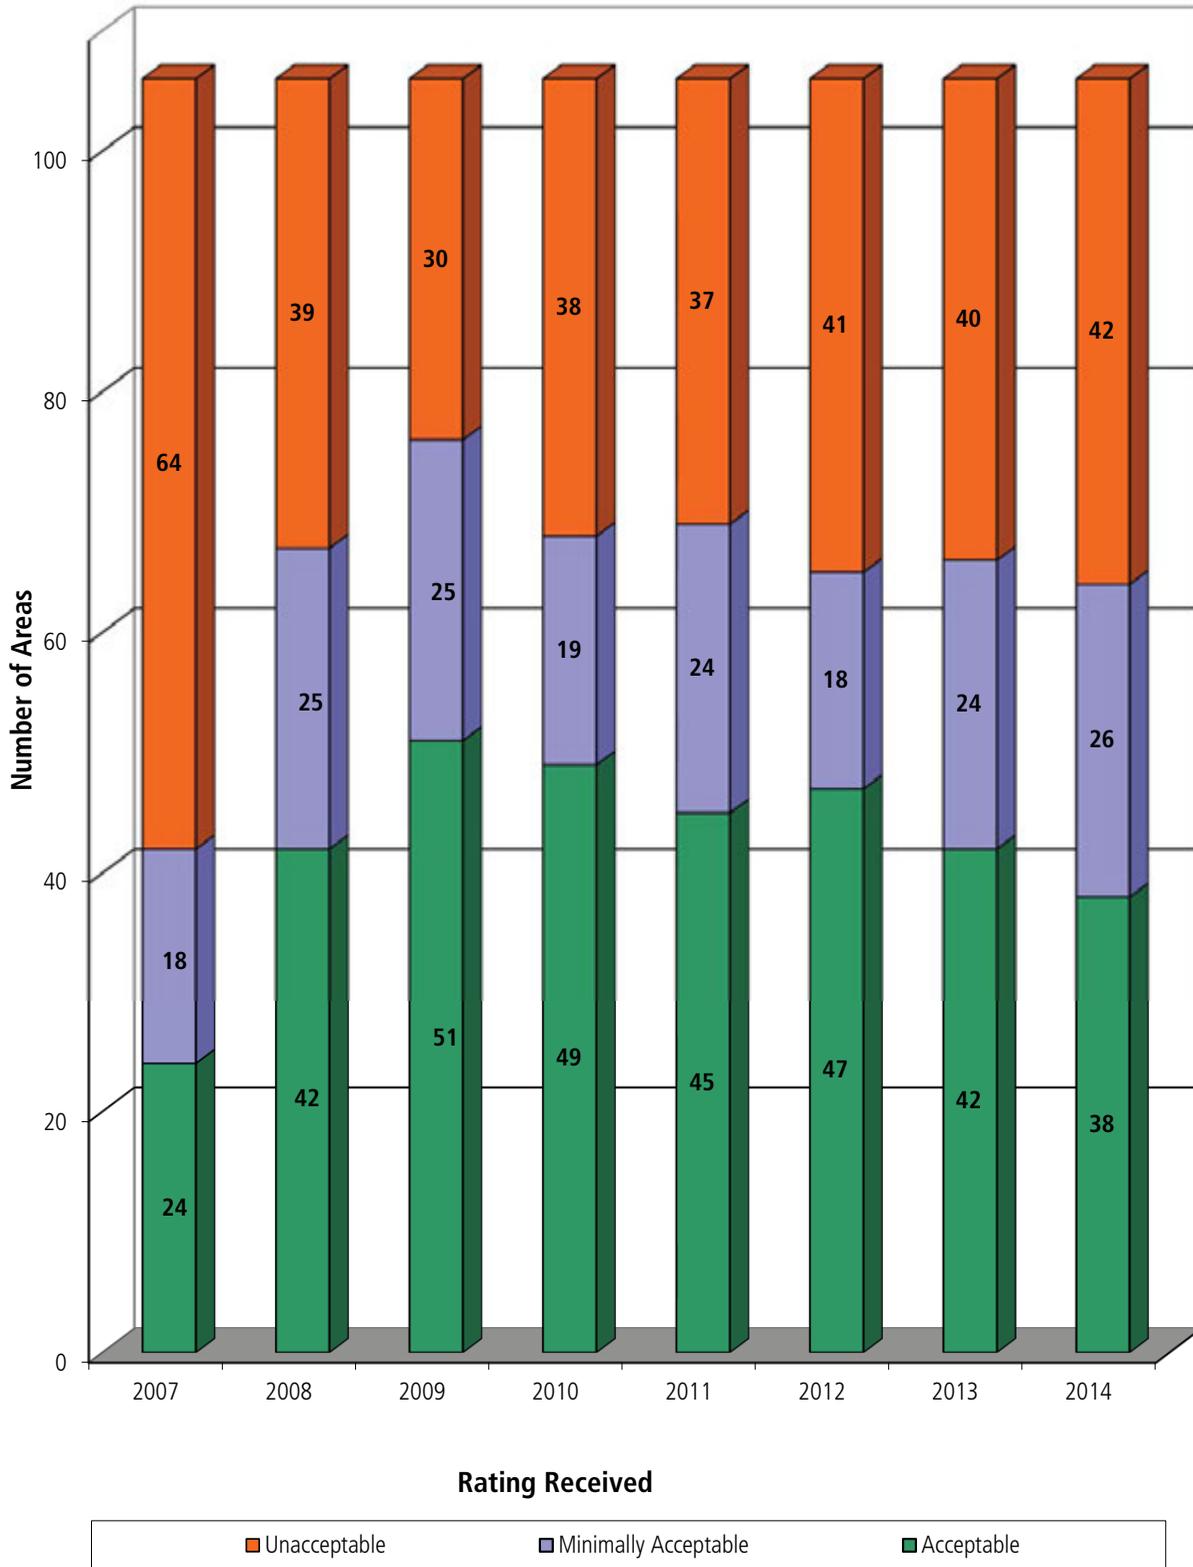
Figure 2-1: Summary of Area Maintenance Ratings for 2007 to 2014

Table 2-1 and Figure 2-1 show the numbers of Areas receiving each rating for 2007 through 2014.

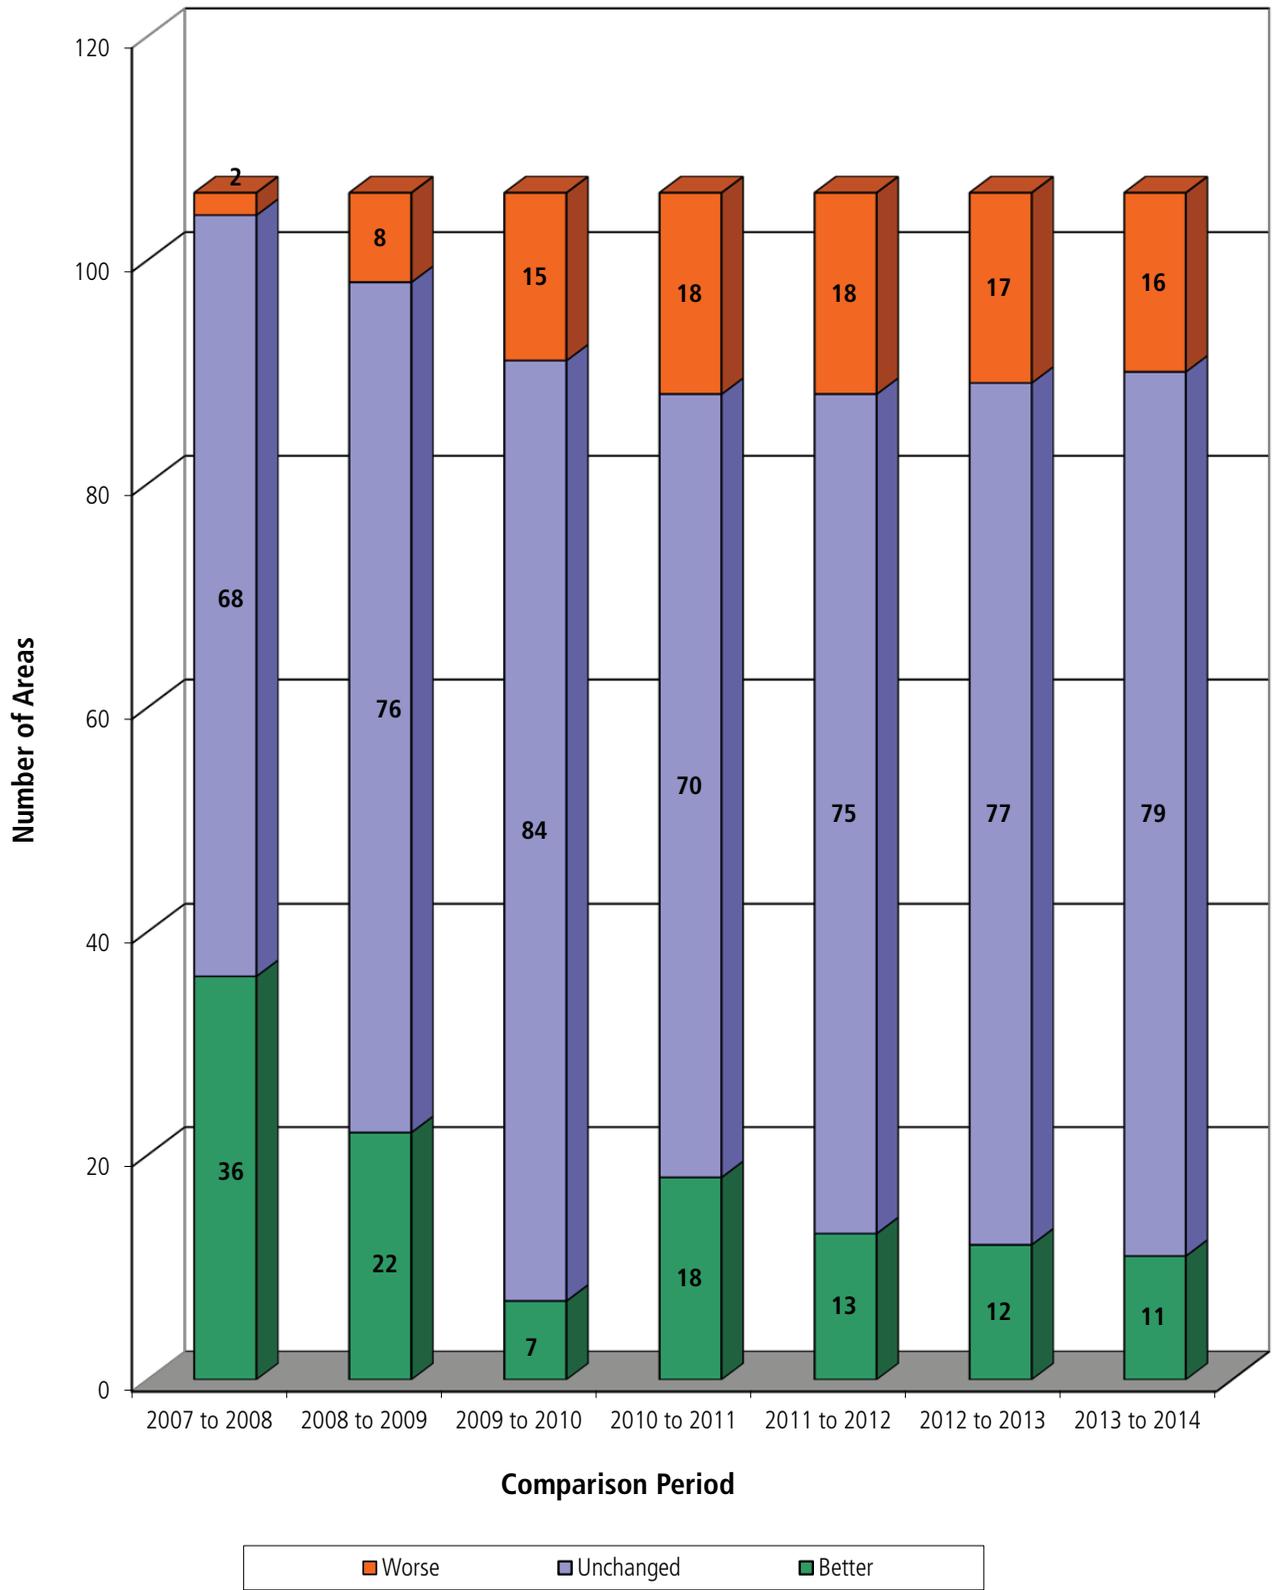
Figure 2-2: Area Maintenance Rating Changes for 2007 to 2014

Figure 2-2 shows the number of Areas that received better, unchanged, or worse ratings in 2014 compared with 2007 through 2013. Areas continue to generally receive better ratings than in 2007, but generally received lower ratings in 2014 compared to recent years. LMRs contain more detailed information about each LMA. Appendix F provides more explanation of threshold percentages and the determination of overall ratings.

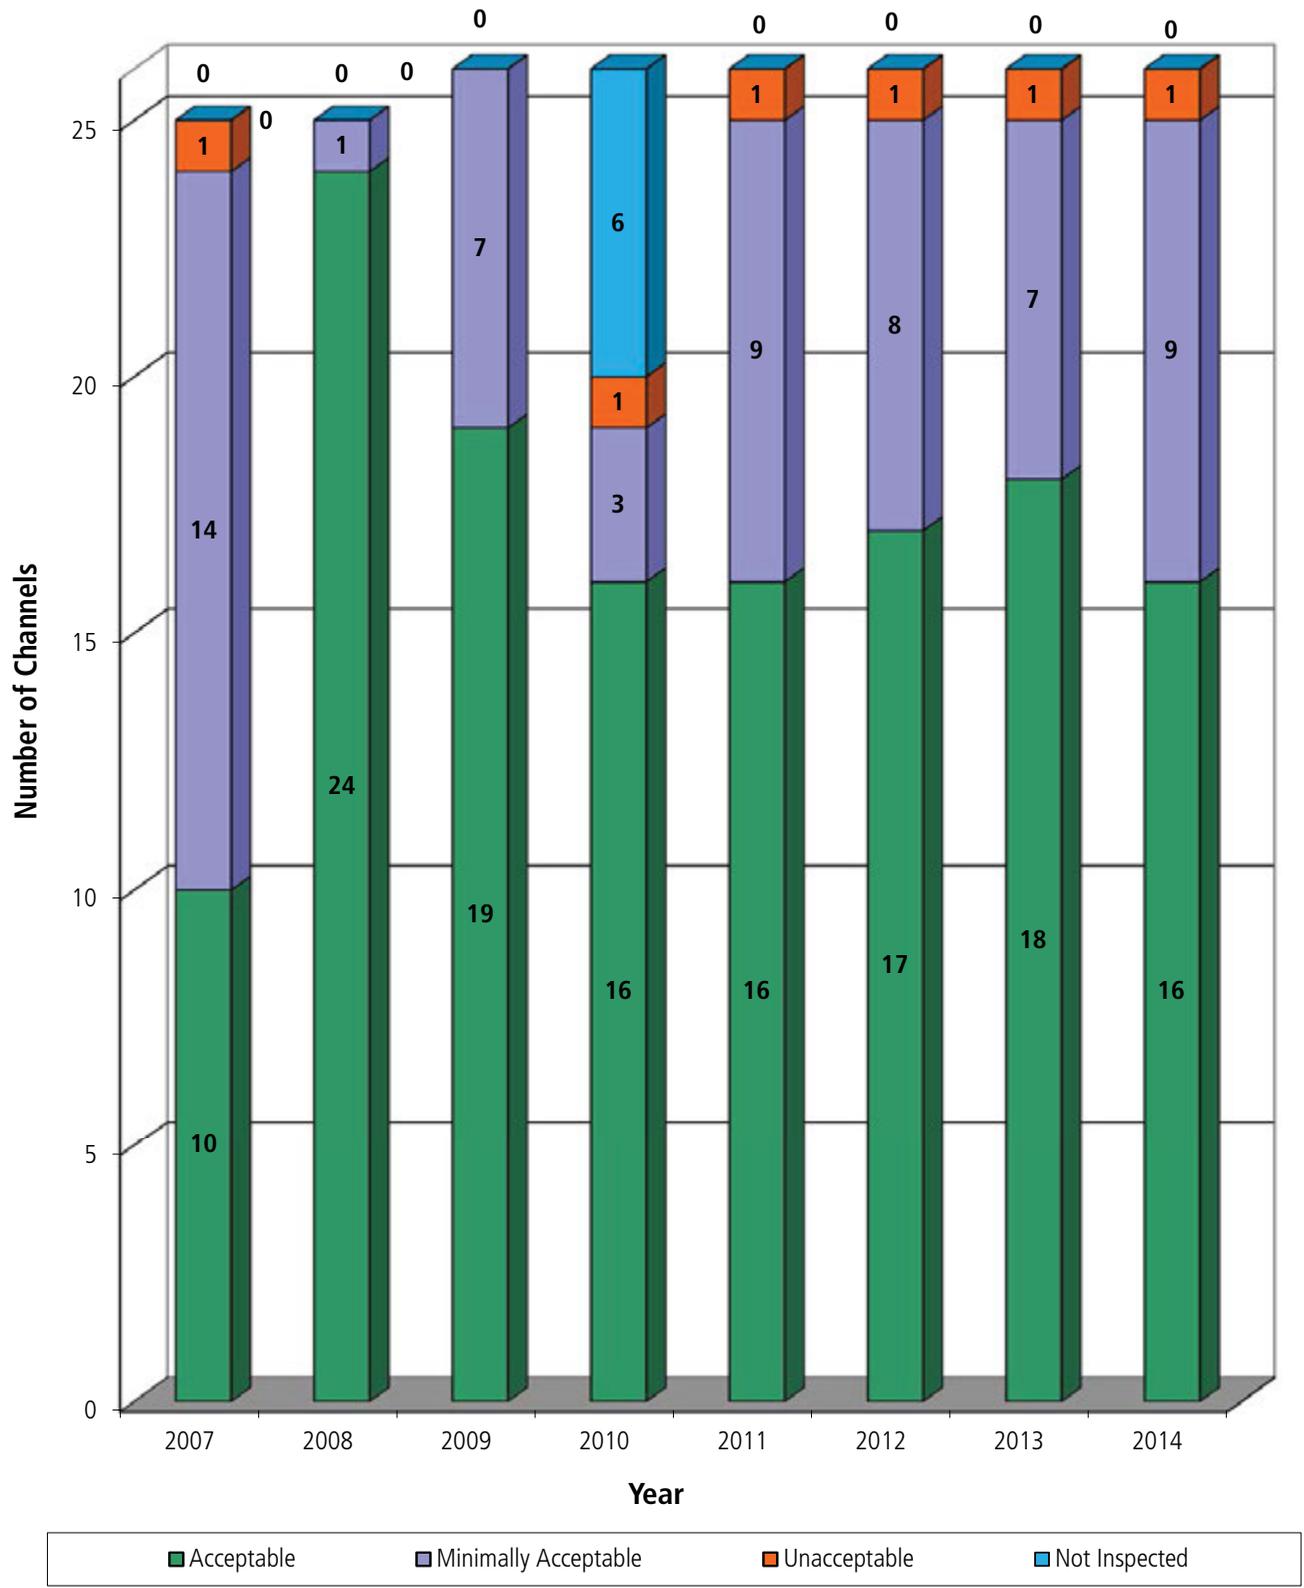
Figure 3-1: Comparison of Overall Channel Ratings for 2007 to 2014

Appendix F details the method for determining overall ratings. Table 3-1 and Figure 3-1 show the numbers of each rating for the years 2007 through 2014.

One channel was rated as Unacceptable in 2014, while the number of Minimally Acceptable channels was nine and sixteen channels were rated as acceptable, which is slightly worse than 2013. This shows the similarity of maintenance found during inspection in 2013 as prior years. Figure 3-1 shows the progression of maintenance ratings from 2007 through 2013.

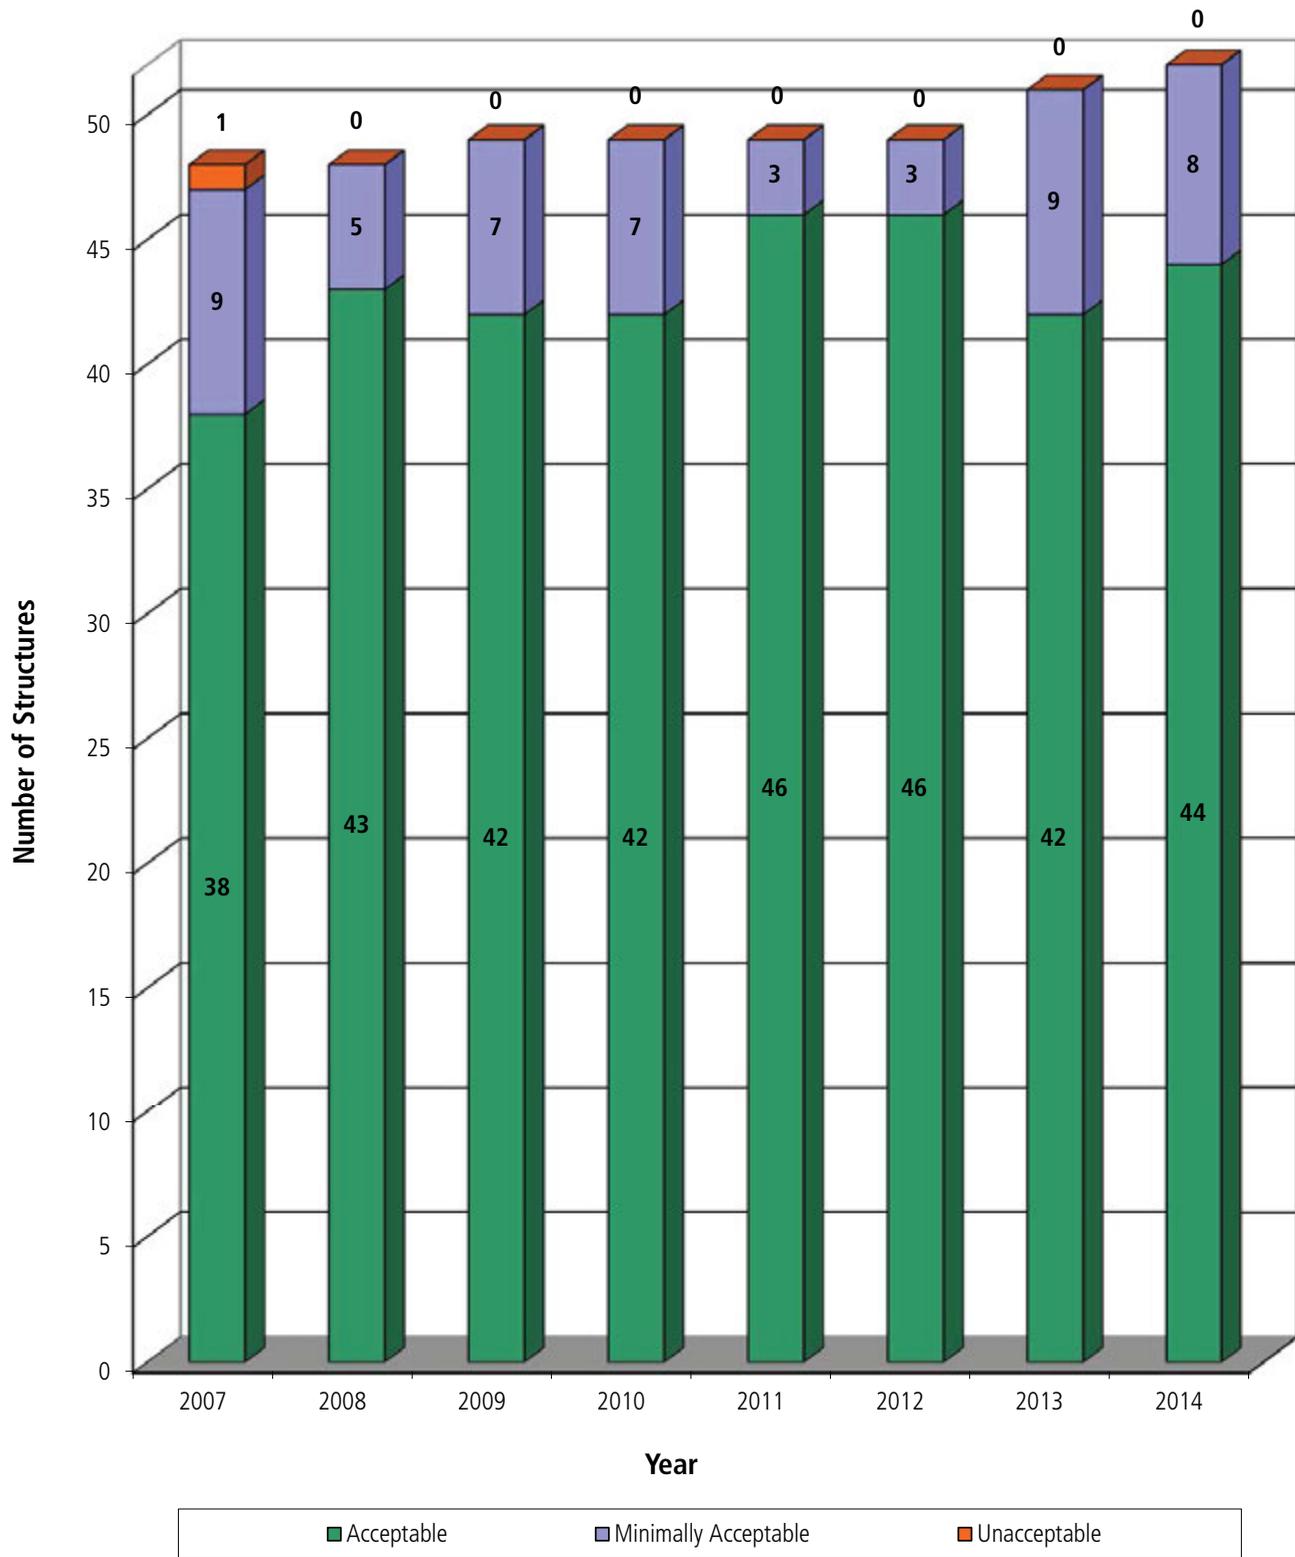
Figure 4-1: Comparison of Overall Structure Ratings for 2007 to 2014

The method for determining overall ratings is similar to the one used for channel inspections and is described in Appendix F. Table 4-1 shows the numbers of each rating for 2007-2014 for all structures. Figure 4-1 and Table 4-2 show ratings for each structure, while Figure 4-2 and Table 4-3 show ratings for each pumping plant. The LMAs have generally improved structure maintenance since 2007. FPIS staff have worked with DWR, the USACE, and the CVFPB staff to better understand responsibilities regarding structures. No maintaining agency has been identified for Paradise Dam, but attempts to clarify this are ongoing. FPIS staff continues to research authorizations for the structures and will continue to refine what structures are inspected during these inspections. In 2014 the seven North Fork Feather River Diversion Drop Structures were broken out into individual structures for consistency. This change has been made retroactively in this report for comparison purposes. Improvements to the flood protection system in the Sacramento area continue. The new Mayhew Drain Closure Structure was inspected during structure inspections for the first time and is included in this report this year.

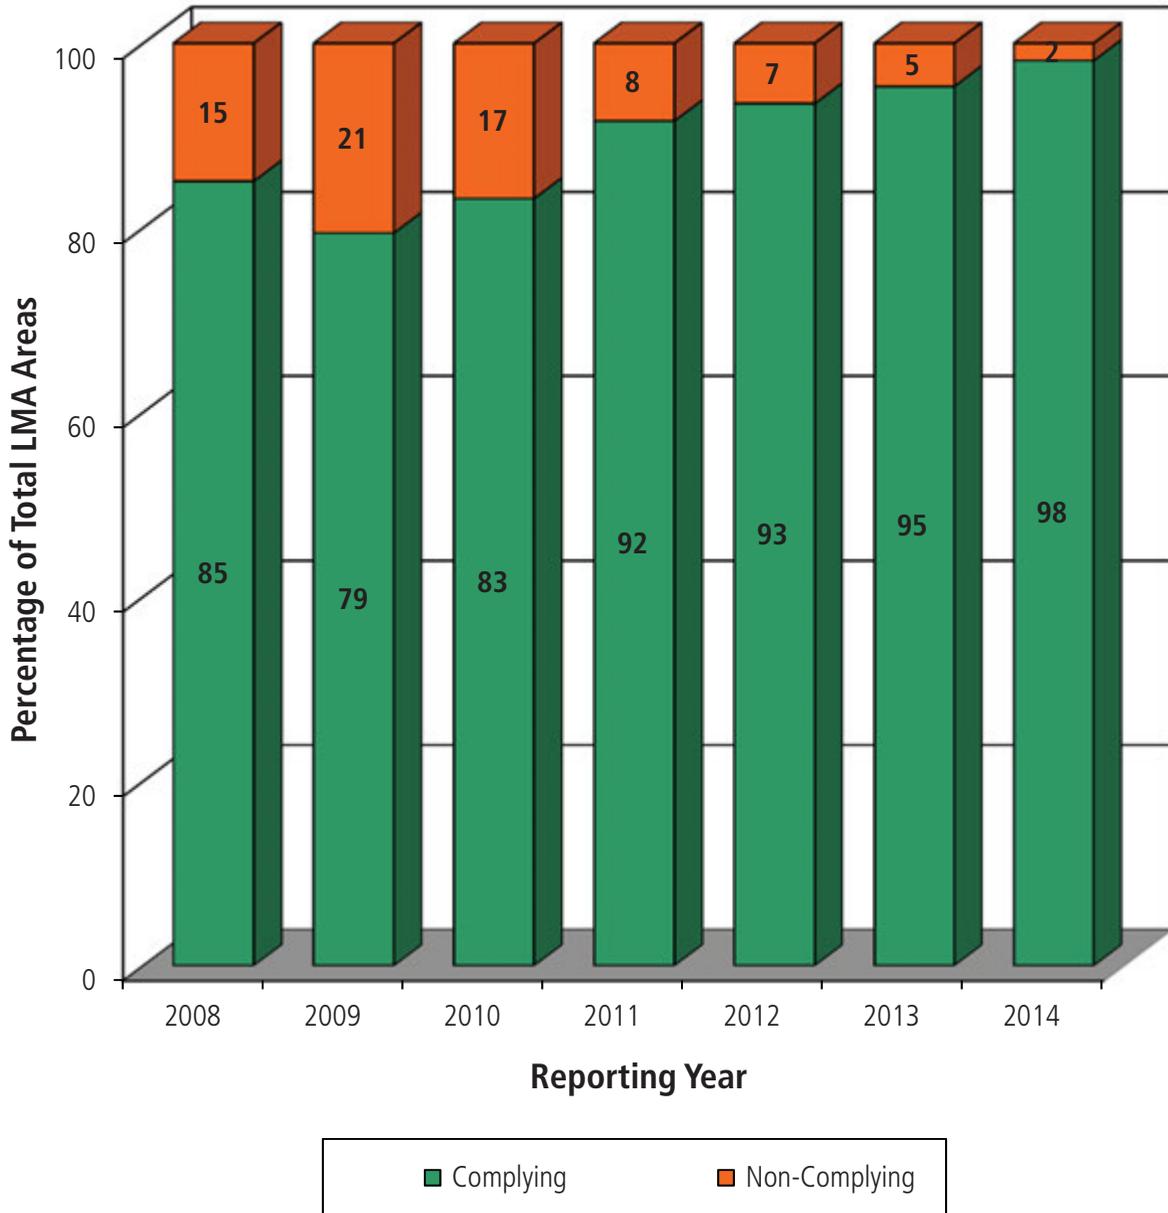
Figure 6-1: Reporting Compliance for 2008 to 2014

There has been an increasing trend (Figure 6-1) of reporting compliance by LMAs since the program started in 2008. A system wide comparison of reporting compliance (Figure 6-2) shows at least 94% of Areas belonging to the Sacramento system and 100% of Areas belonging to the San Joaquin system have reported in last two years. Overall, about 98% of Areas have submitted their report this year. The increasing trend of electronic reporting is continuing and is shown in Figure 6-3. This year, about 74% of the Areas submitted reports through DWR’s web-based LMA Reporting tool. Although there is one percent decrease in reporting this year compare to last year, one more Area reported through the LMA Reporting tool this year compared to last year. This is because 98% of the LMAs submitted reports this year compared to 95% last year. This may be attributed to continuous outreach activities and enhancement of reporting infrastructure since the inception of the tool.

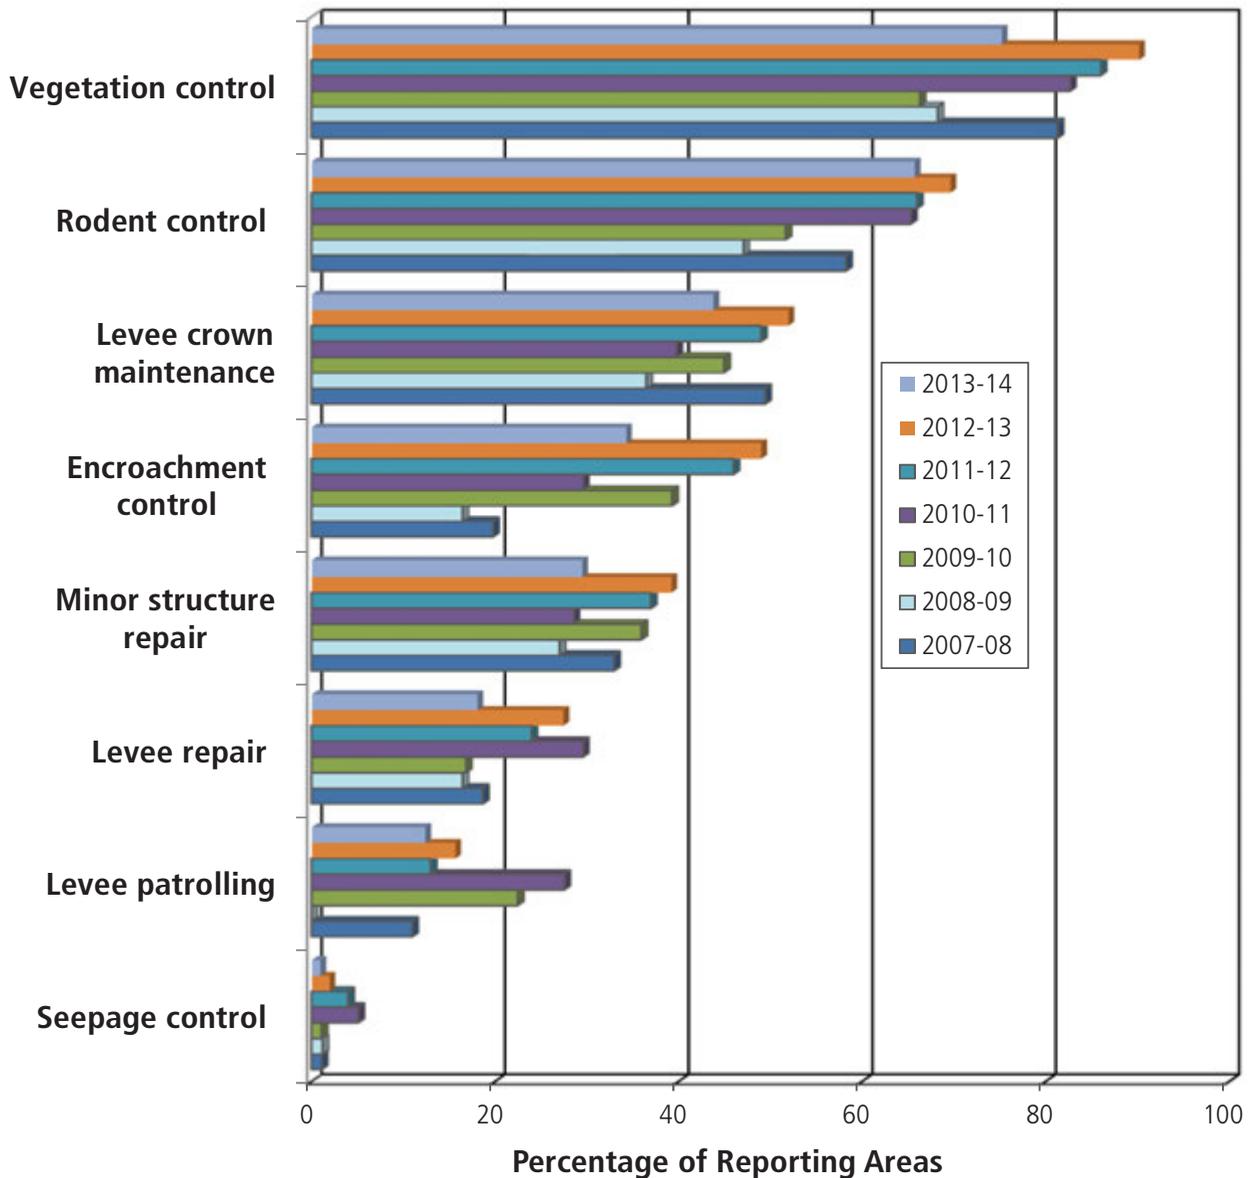
Figure 6-4: Key Performed Activities Reported for 2008 to 2014

About 98% of reporting Areas provided information on the summary of maintenance activities. As in the previous years, routine vegetation maintenance activities (burning, slope dragging, cutting, trimming, spraying), rodent control, levee crown grading, roadway maintenance and encroachment dominated LMA maintenance activities for fiscal year 2013-14. Figure 6-4 shows the activities Areas reported as having performed as a percentage of the total number of Areas who reported information during that year. Other reported key activities include minor structural repairs (mile markers, gates, barricades, and miscellaneous signs maintenance and repair), and minor levee repairs (erosion repair, hole grouting, revetment, rip-rap and slope repair). Some LMAs also reported levee patrolling and other planning activities such as preparation of five year maintenance plans.

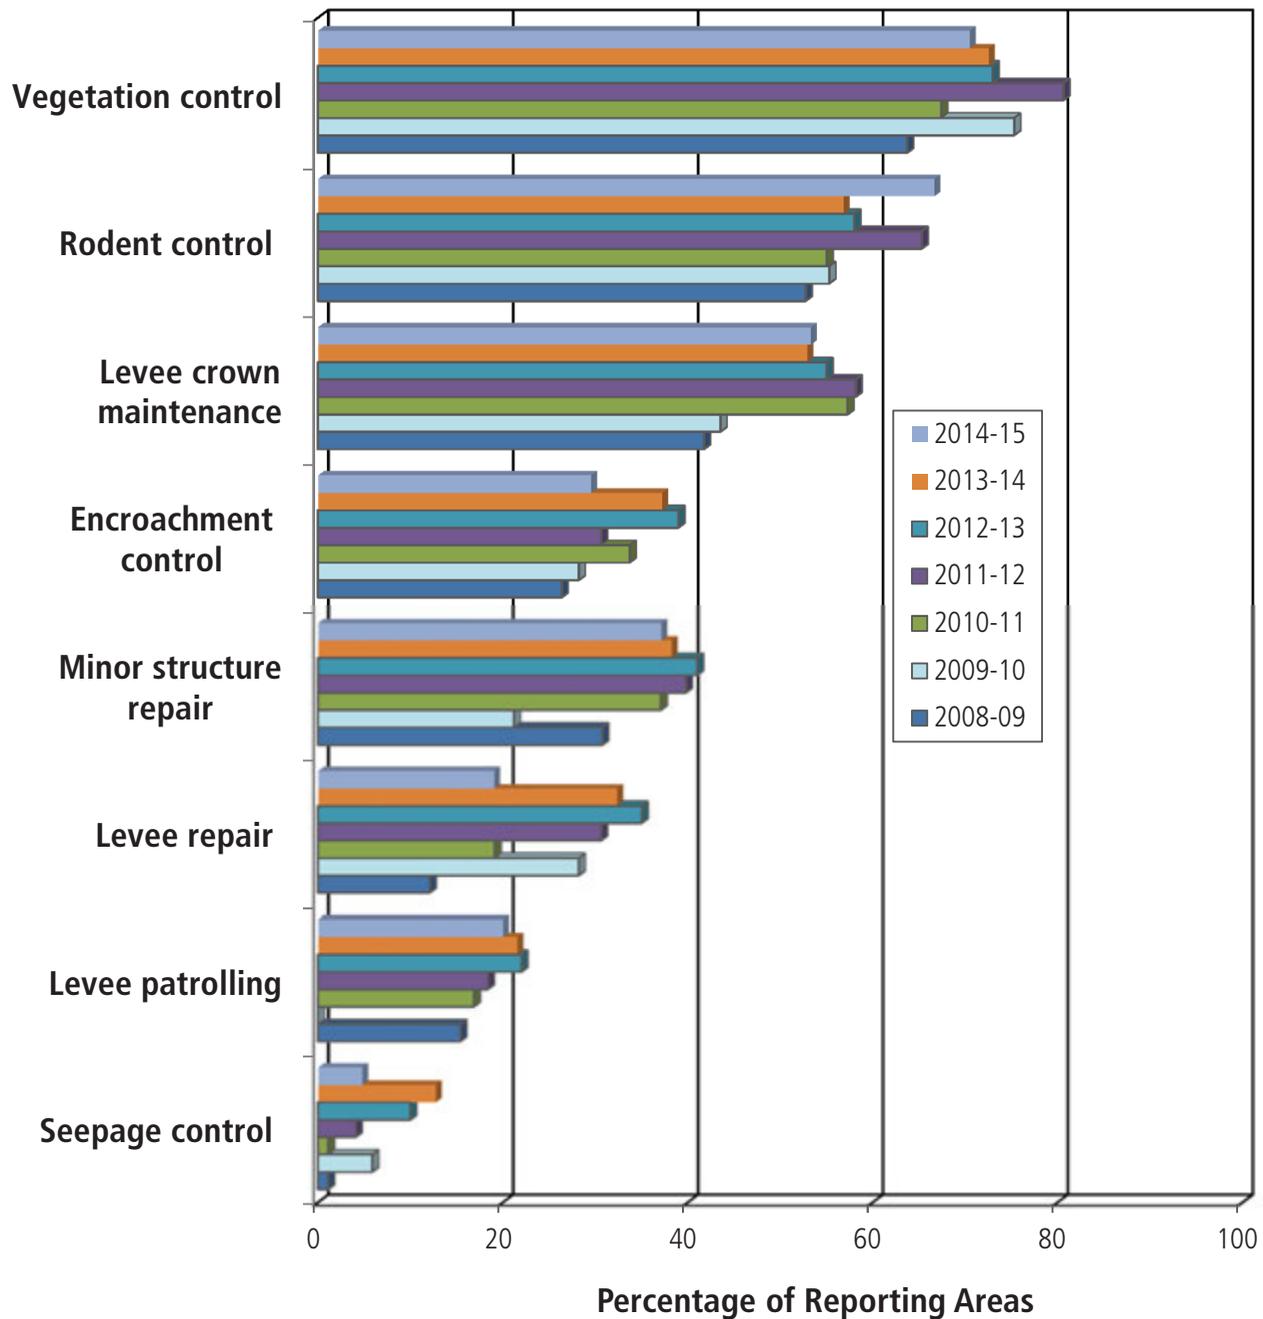
Figure 6-5: Key Planned Activities Reported for 2009 to 2015

A similar percentage of reporting Areas also provided information on the planned maintenance activities for the current fiscal year 2014-15. The planned activities reflect similar maintenance priorities as performed maintenance activities in fiscal year 2013-14. Figure 6-5 shows planned activities that were reported by LMAs.

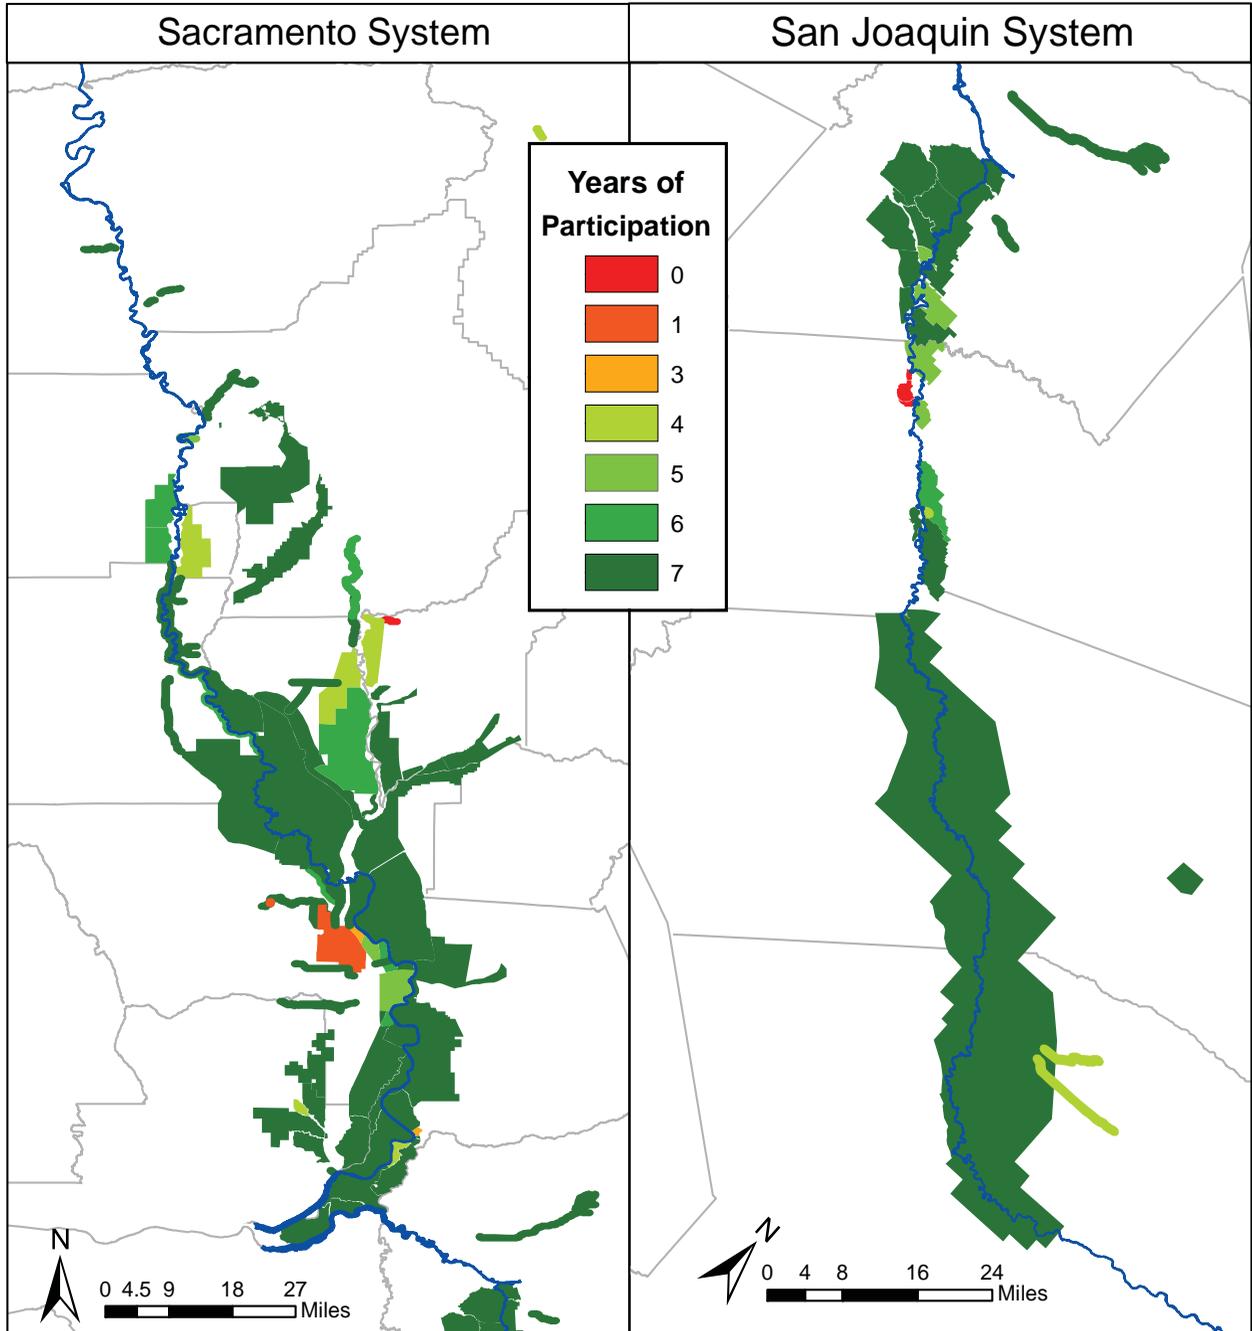
Figure 6-6: Compliance by Reporting Area for 2008 to 2014

Figure 6-6 shows a graphical representation of LMA’s compliance with the program for both the Sacramento and San Joaquin systems from 2008 through 2014. For the most part, both Sacramento and San Joaquin system LMAs complied with the

program for majority of the years since 2008. The figure also shows that there is only one LMA in the Sacramento system that never reported to the program. On the contrary, there are no single LMAs in the San Joaquin system that never reported to the program.

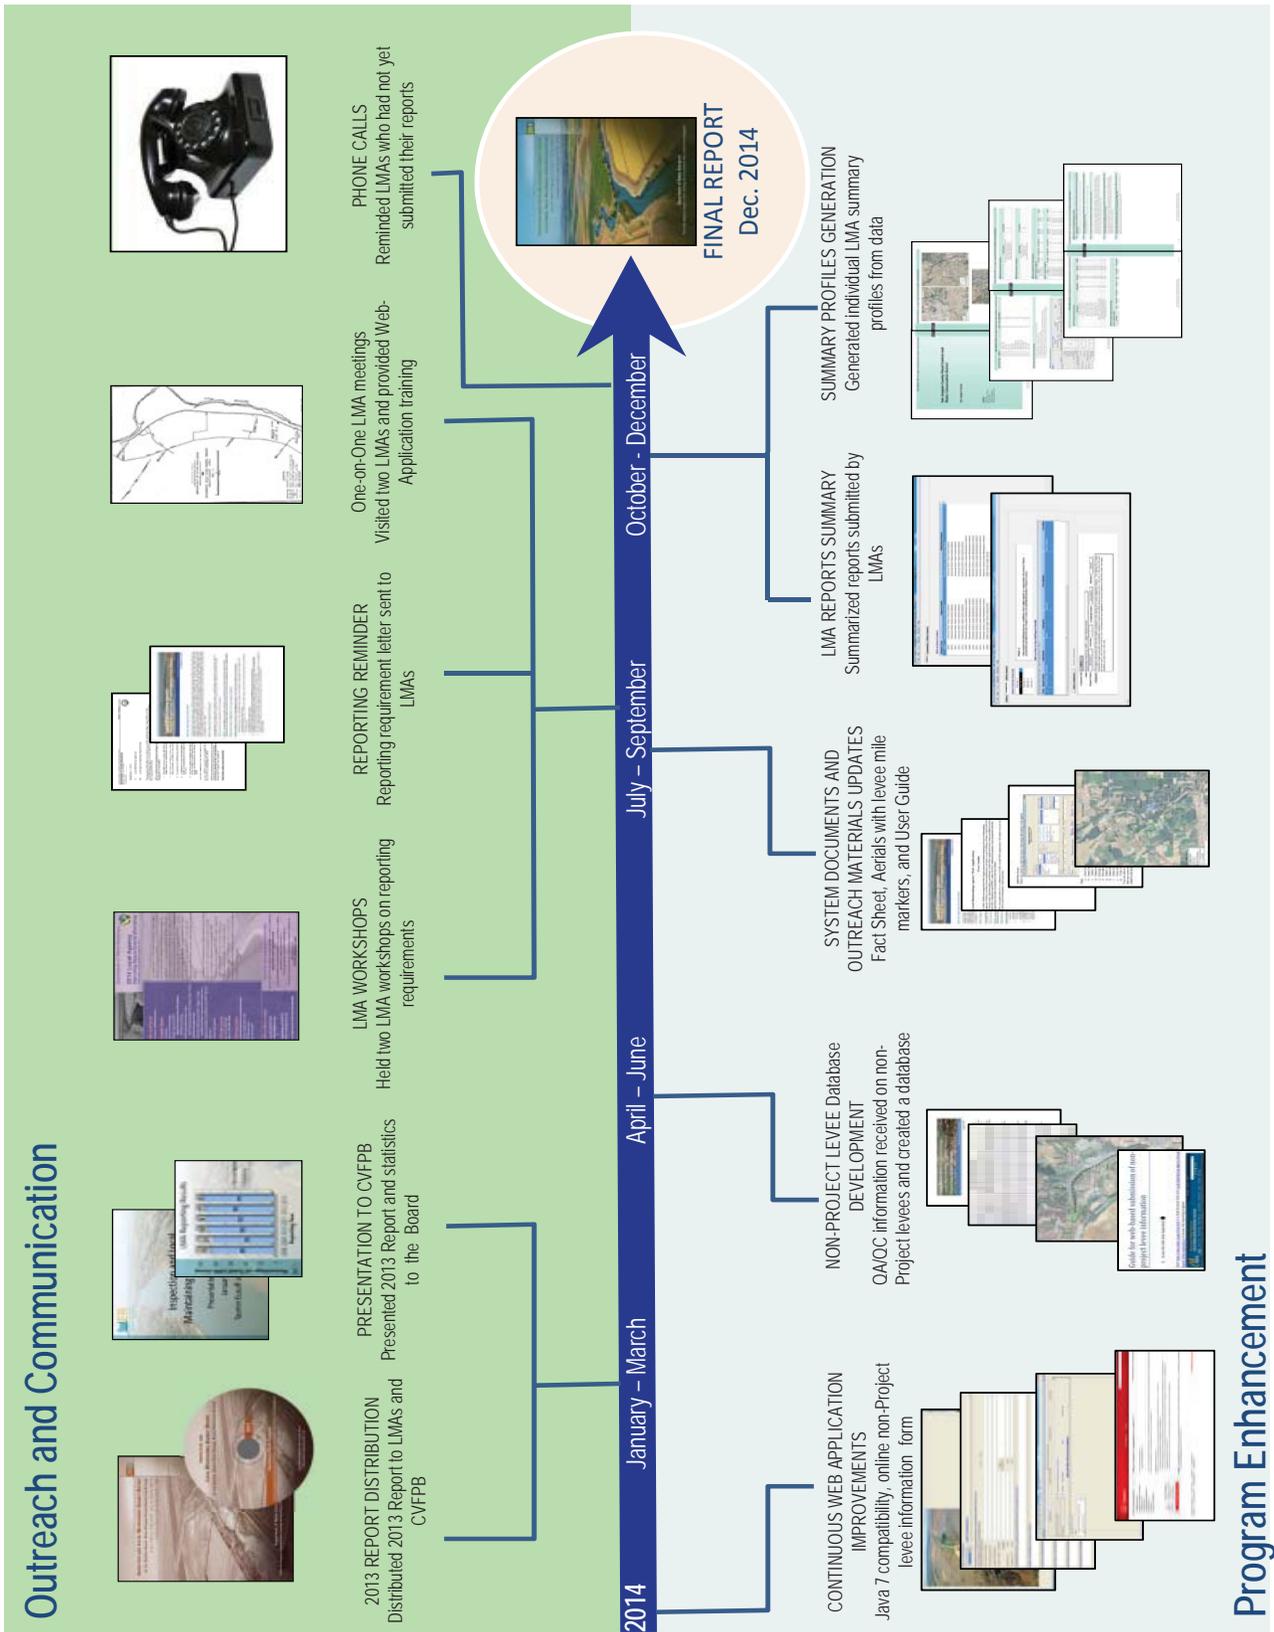
Figure 6-7: LMA Reporting Program Activities

DWR recognizes that the requirements of CWC Section 9140 placed a new reporting burden on LMAs. To help make reporting easier, DWR developed an outreach program and a web-based reporting tool to assist LMAs. DWR notified LMAs of the new reporting requirements, developed electronic and hard copy reporting options, and held a series of presentations and workshops. The process continues today, with DWR soliciting feedback from LMAs to improve the program. The following subsections and Figure 6-7 describe the chronology of the outreach process for 2014.
