# Appendix **A**

## **Sacramento River Individual Agency Summary Reports**

Sacramento River Basin include 85 local maintaining Areas that maintain Project Levees, Structures, and Channels. Out of 85 Areas, there are 37 RDs, 19 NAs, 14 STs, 10 MA and 5 LDs. Appendix A includes an index to the Sacramento River Basin Areas, a system map to show the locations of each reporting Area, and individual Area summary profiles.

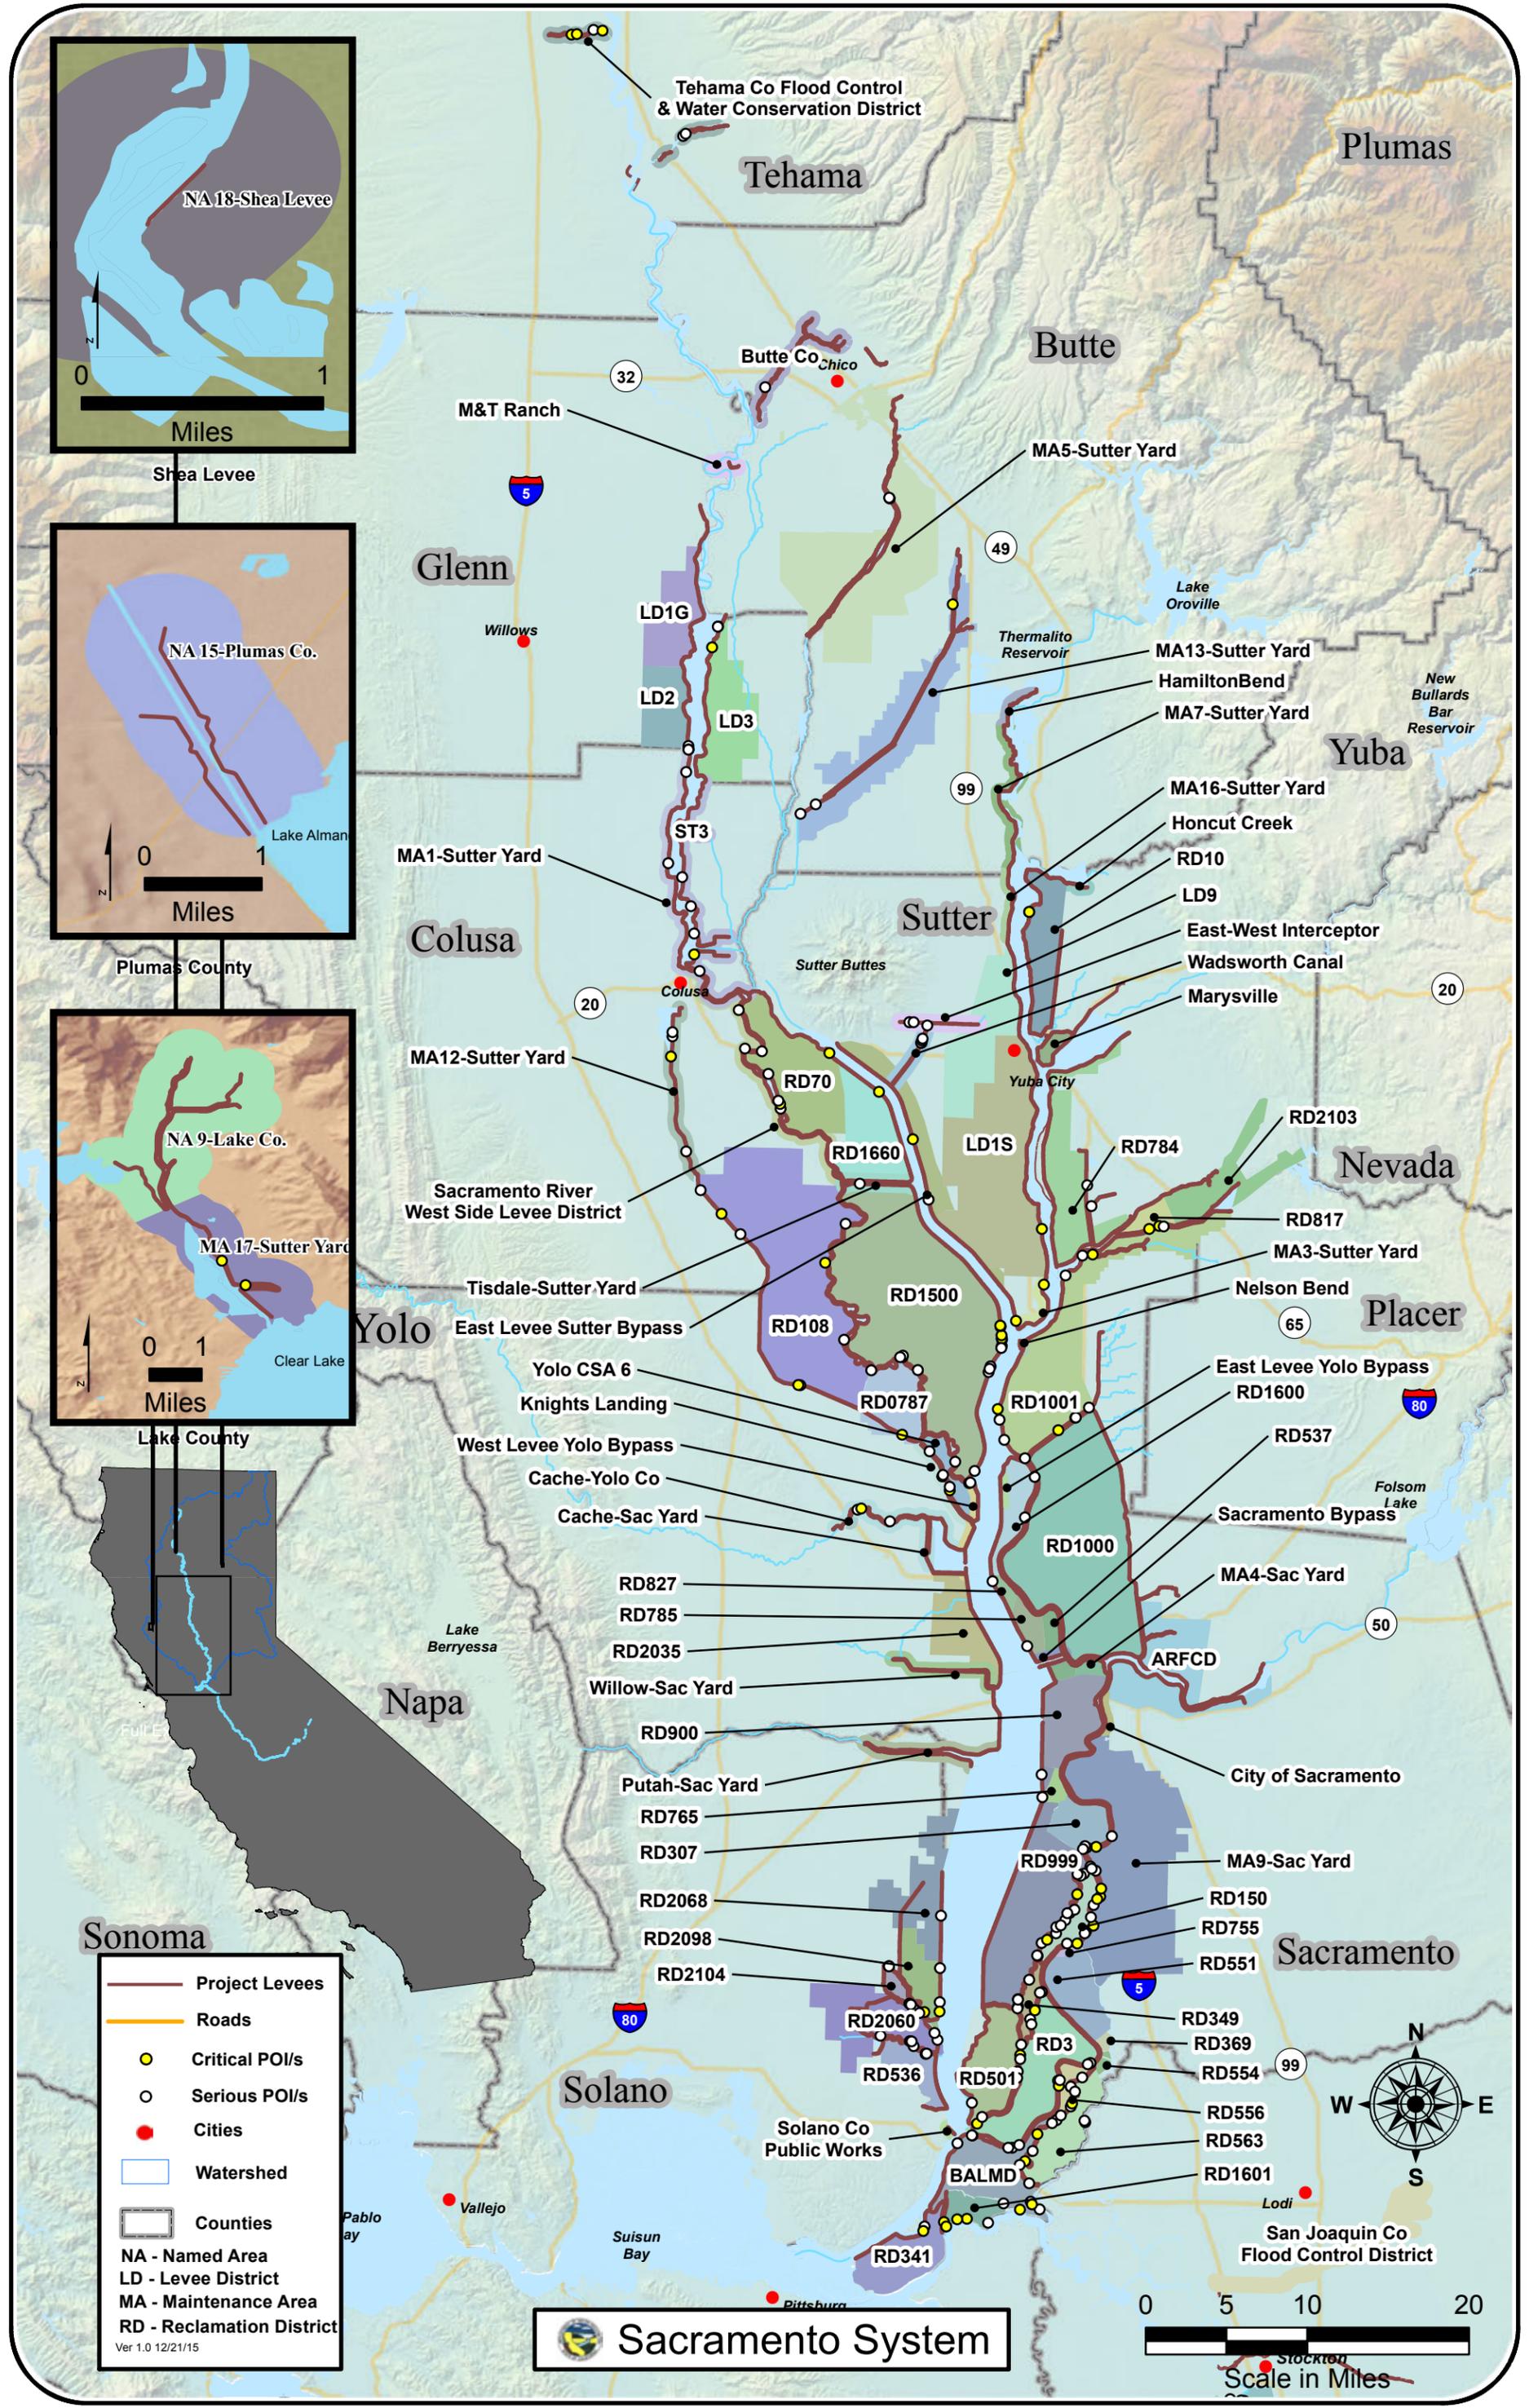
**Sacramento System**

Project Levees
	Roads
	Critical POI/s
	Serious POI/s
	Cities
	Watershed
	Counties
NA - Named Area	
LD - Levee District	
MA - Maintenance Area	
RD - Reclamation District	
Ver 1.0 12/21/15

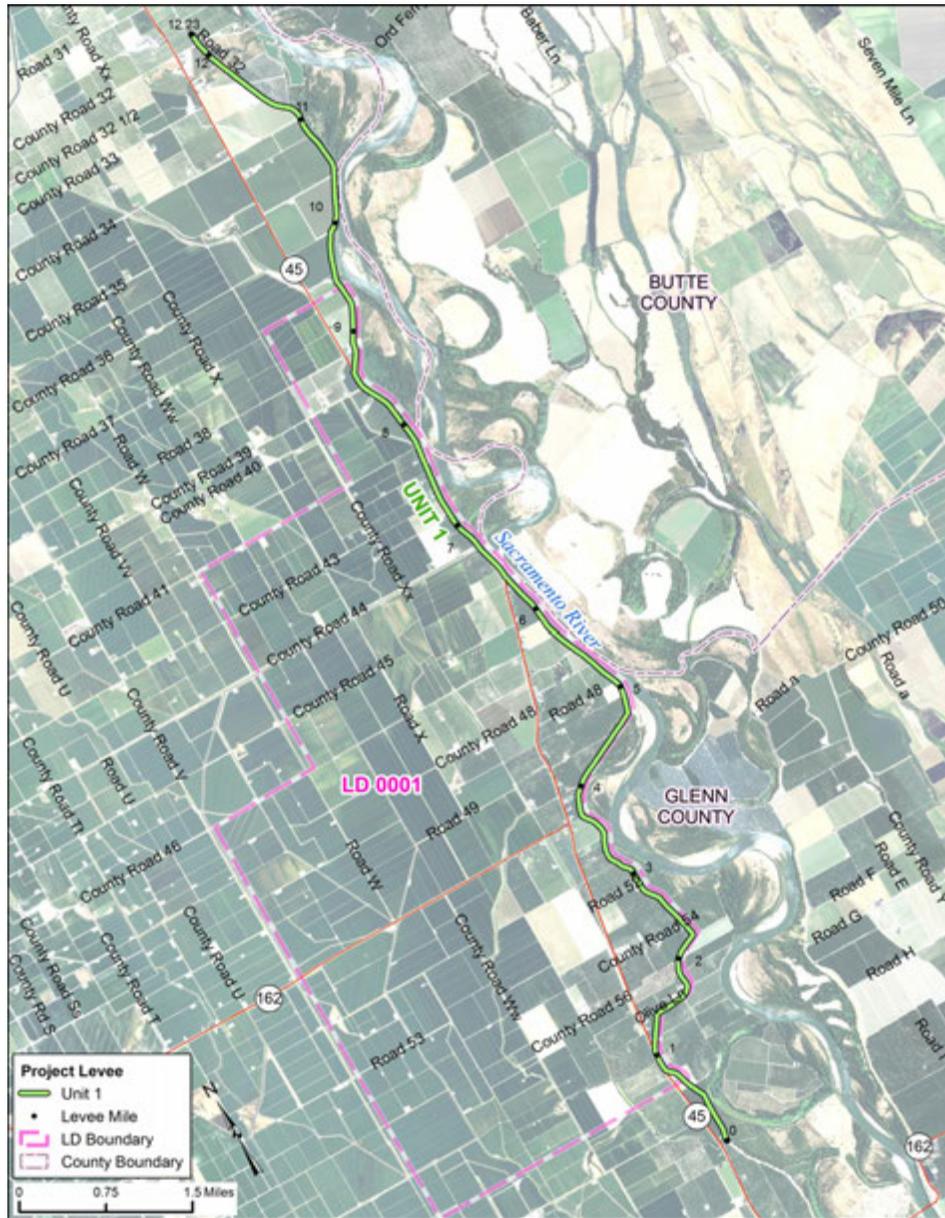
LMA Short Name : LD0001G		Bank	Unit Length (Miles)
Unit No. 01	Sacramento River	RB	12.23

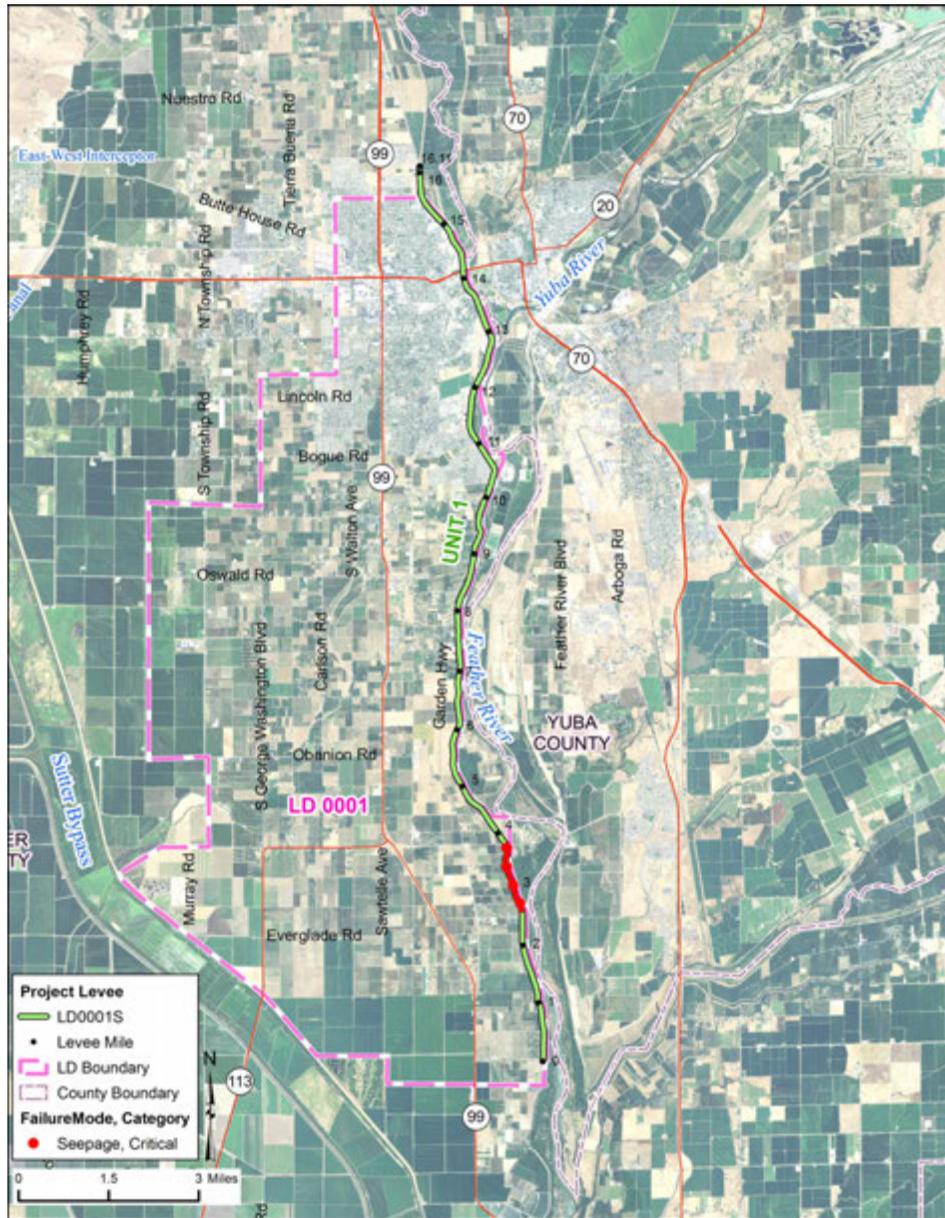
LMA Short Name : LD0001S	Bank	Unit Length (Miles)
Unit No. 01 Feather River	RB	16.11

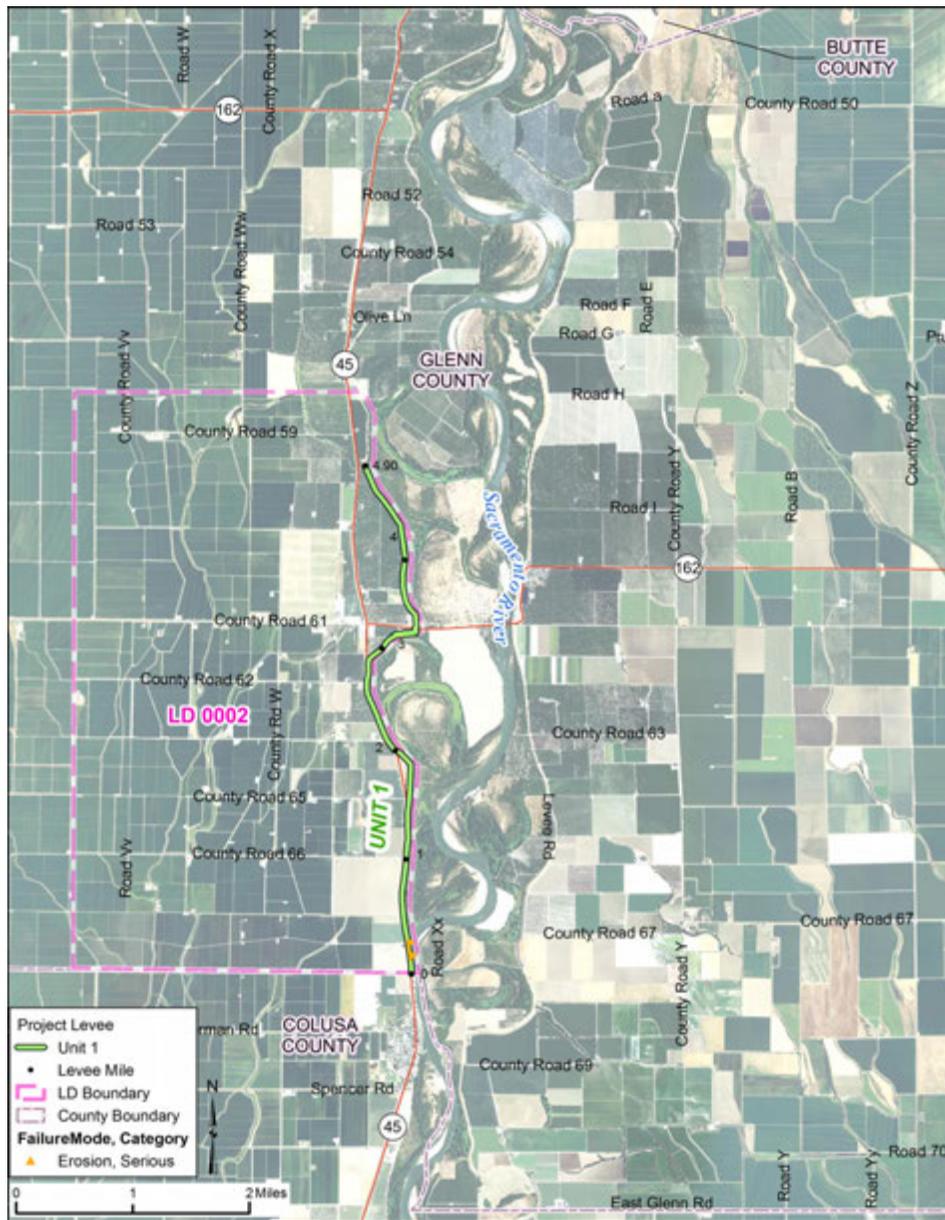
LMA Short Name : LD0002	Bank	Unit Length (Miles)
Unit No. 01 Glenn County Sacramento River	RB	4.90

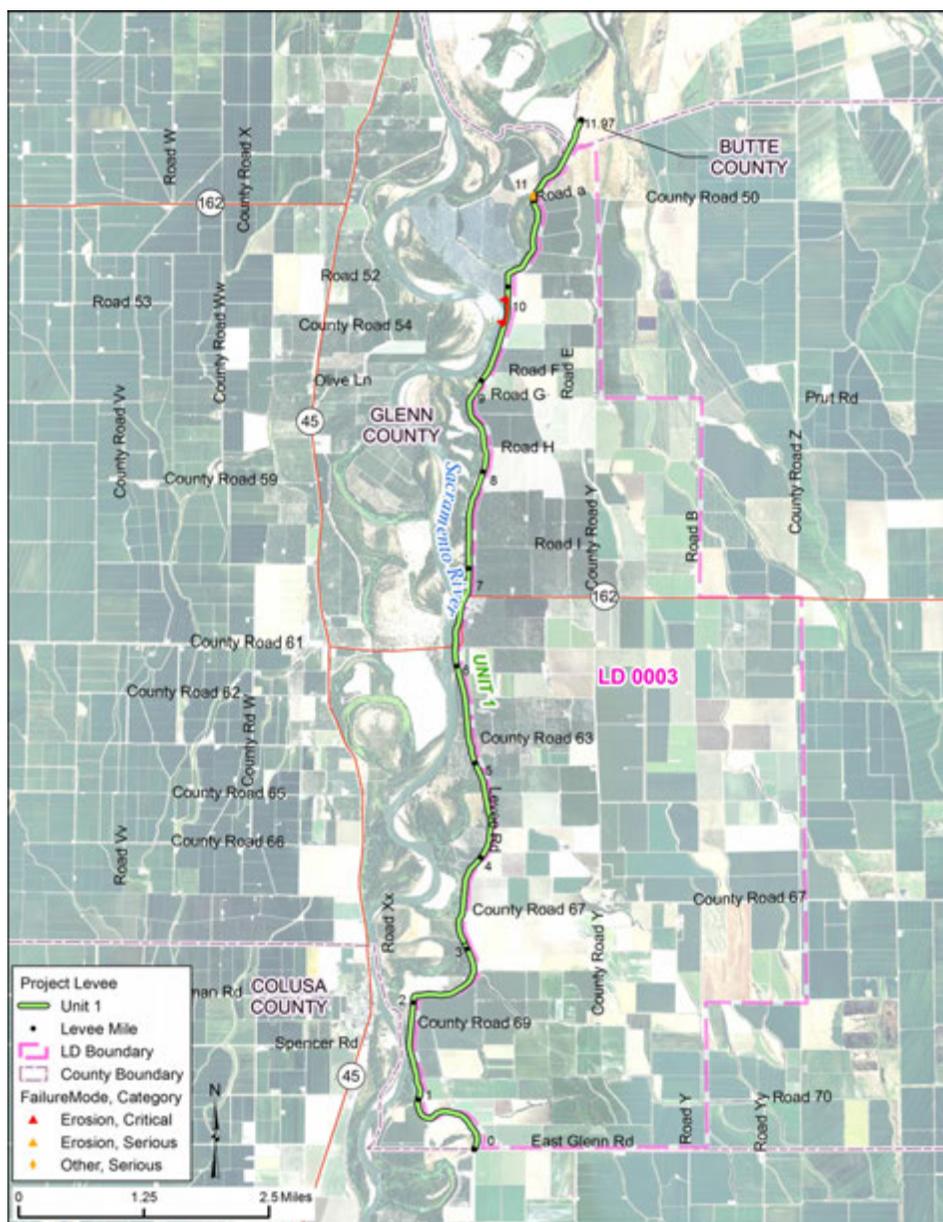
LMA Short Name : LD0003		Bank	Unit Length (Miles)
Unit No. 01	Glenn County Sacramento River	LB	11.97

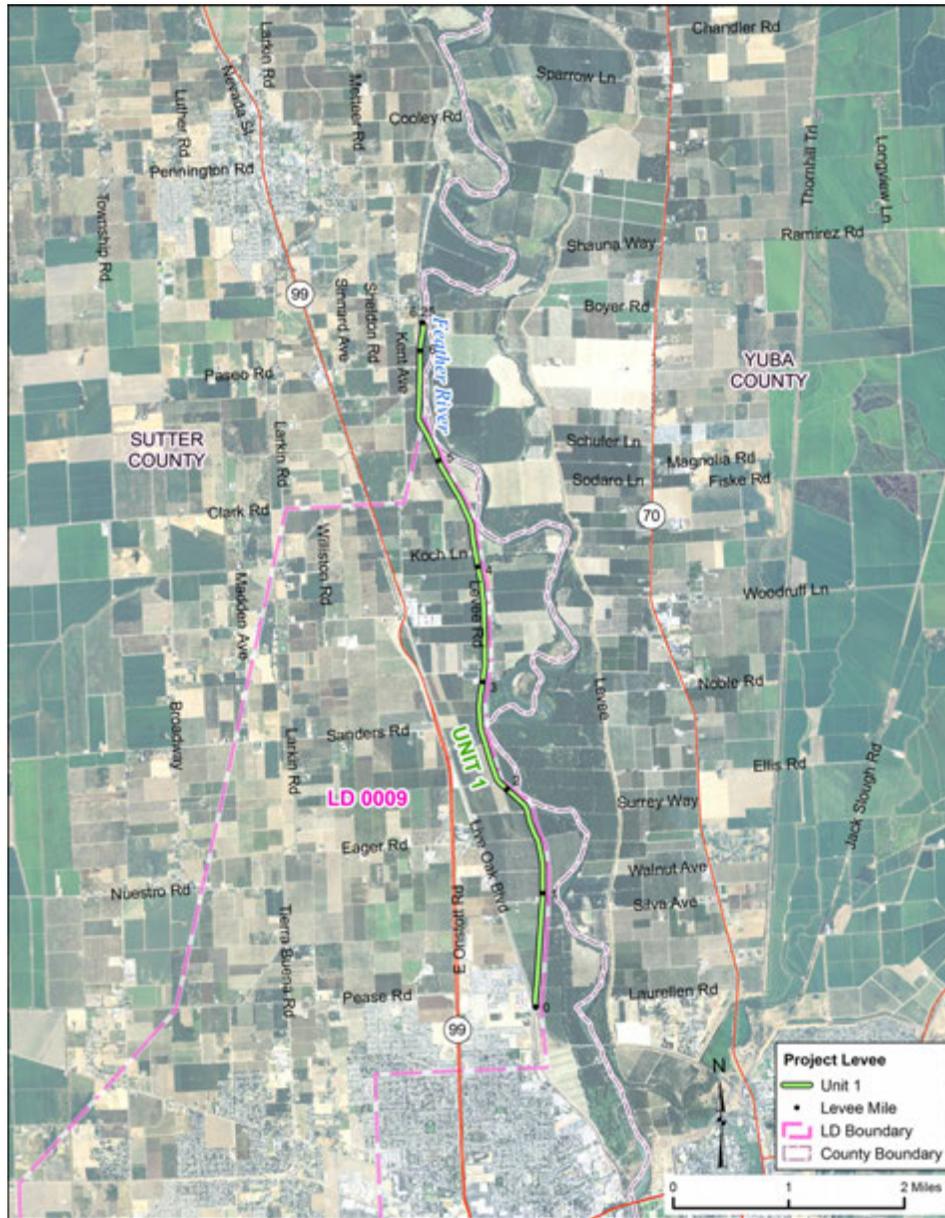
LMA Short Name : LD0009	Bank	Unit Length (Miles)
Unit No. 01 Sutter County, Feather River	RB	6.25

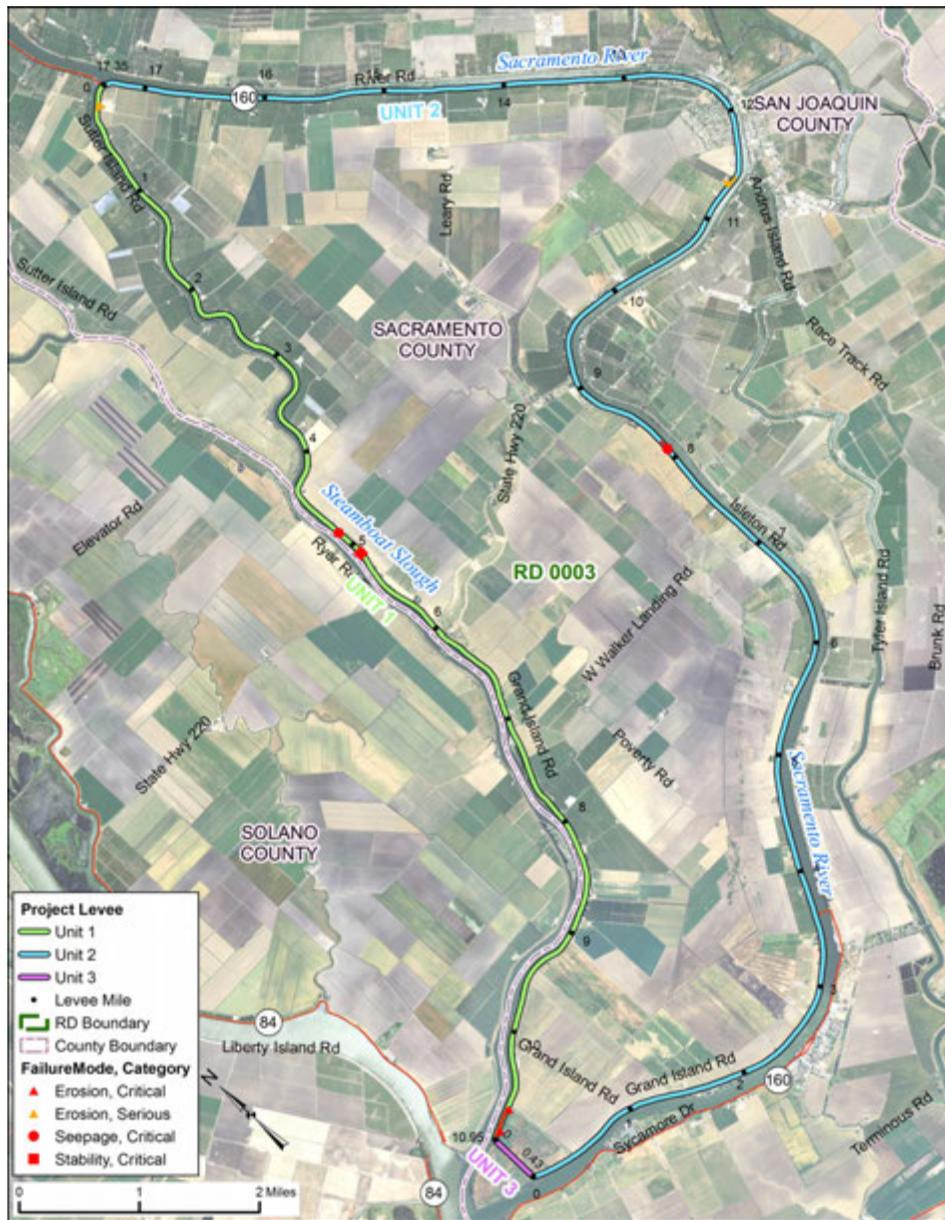
LMA Short Name : RD0003		Bank	Unit Length (Miles)
Unit No. 01	Left Bank Steamboat Slough	LB	10.95
Unit No. 02	Right Bank Sacramento River	RB	17.35
Unit No. 03	Cross Levee		0.43

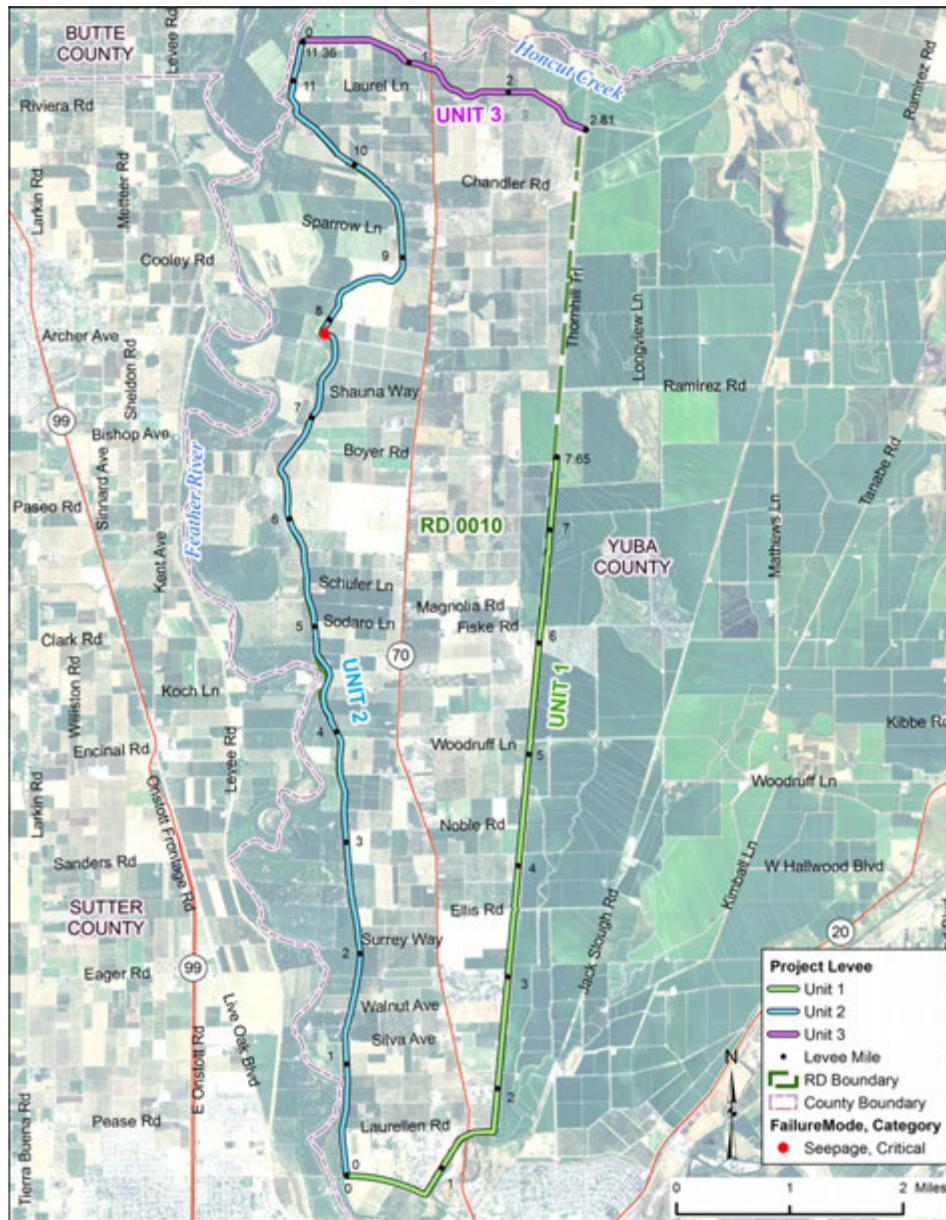
LMA Short Name : RD0010		Bank	Unit Length (Miles)
Unit No. 01	Simmerly Slough	RB	7.65
Unit No. 02	Feather River	LB	11.36
Unit No. 03	Honcut Creek	LB	2.81

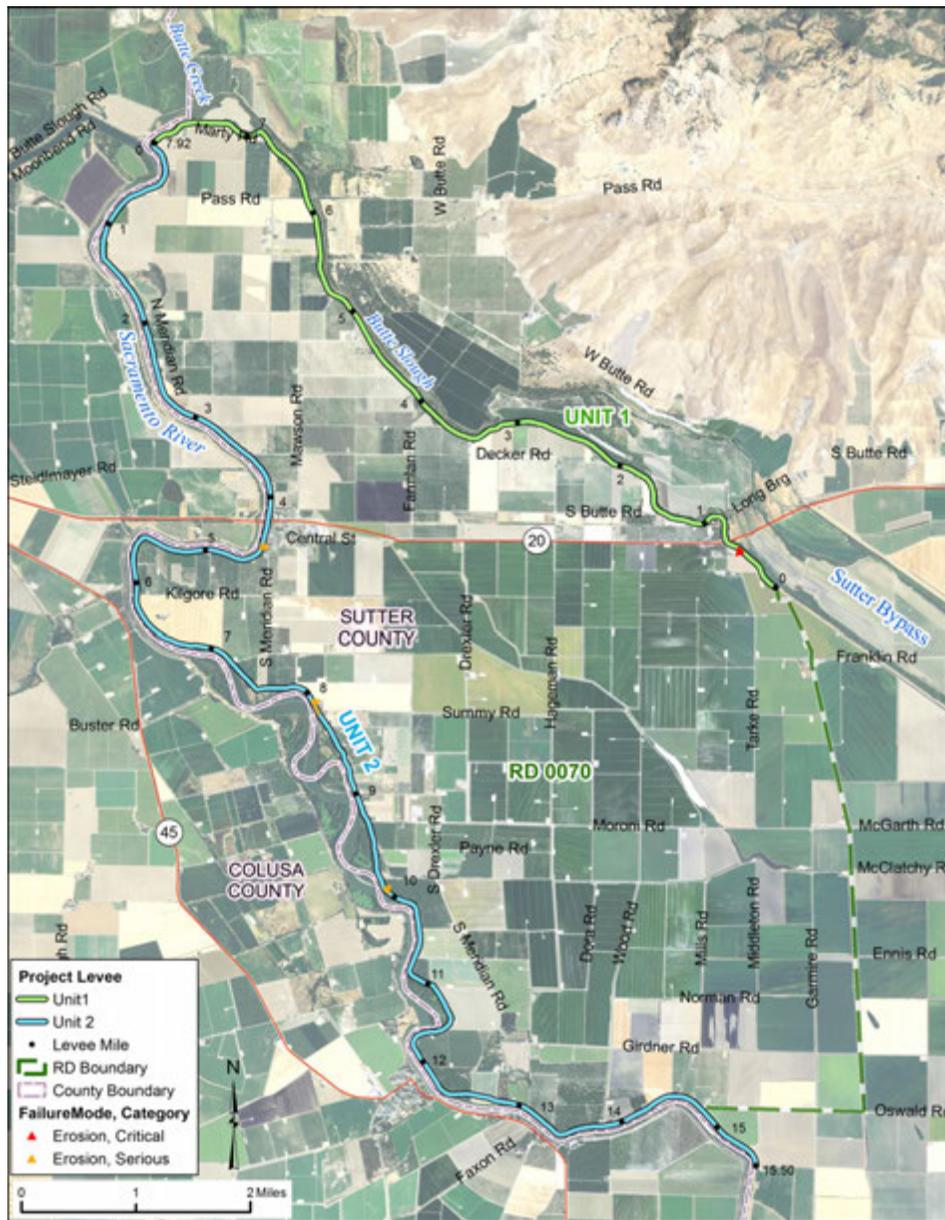
LMA Short Name : RD0070		Bank	Unit Length (Miles)
Unit No. 01	Sutter Bypass	RB	7.92
Unit No. 02	Sacramento River	LB	15.50

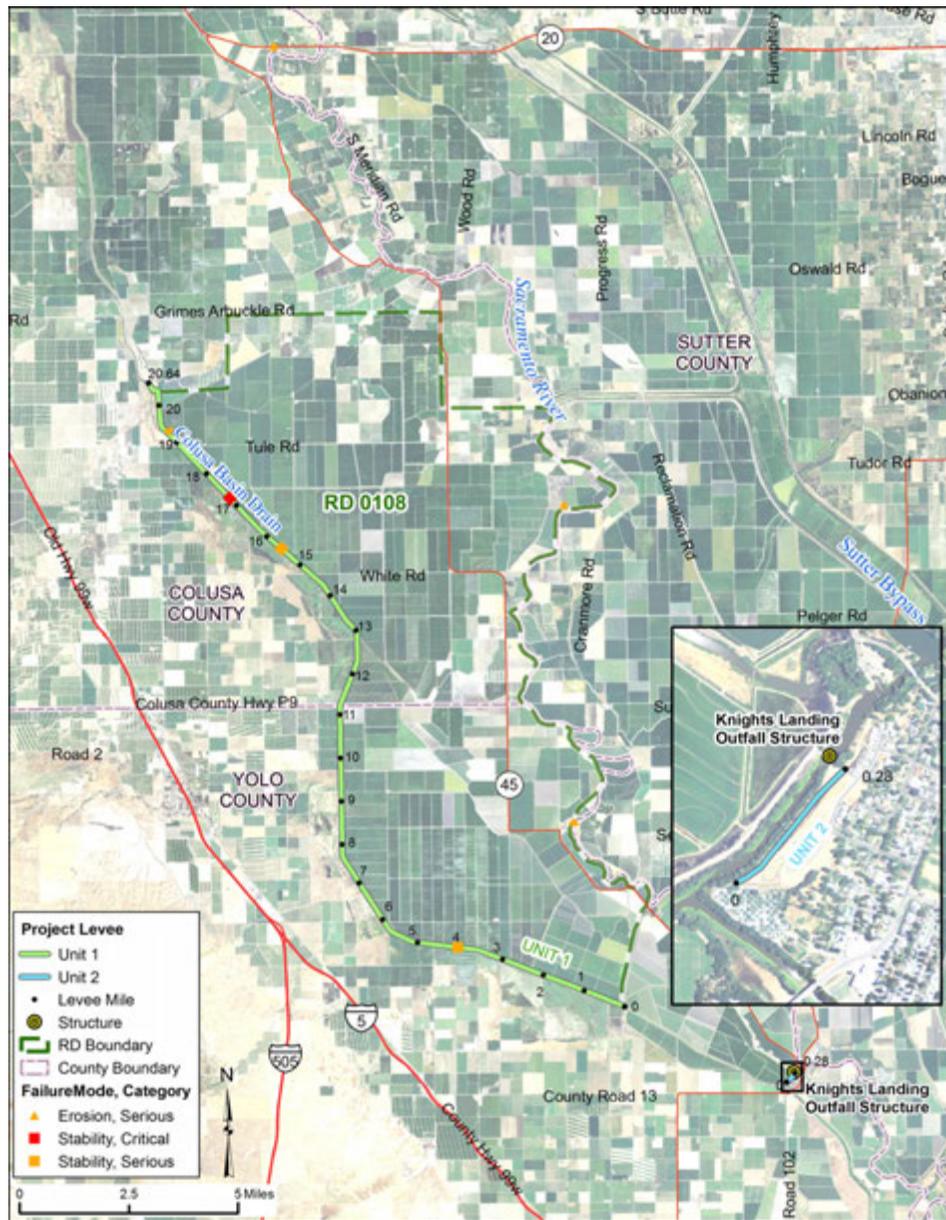
LMA Short Name : RD0108		Bank	Unit Length (Miles)
Unit No. 01	Colusa Basin Drain	LB	20.64
Unit No. 02	Castle Properties	RB	0.28

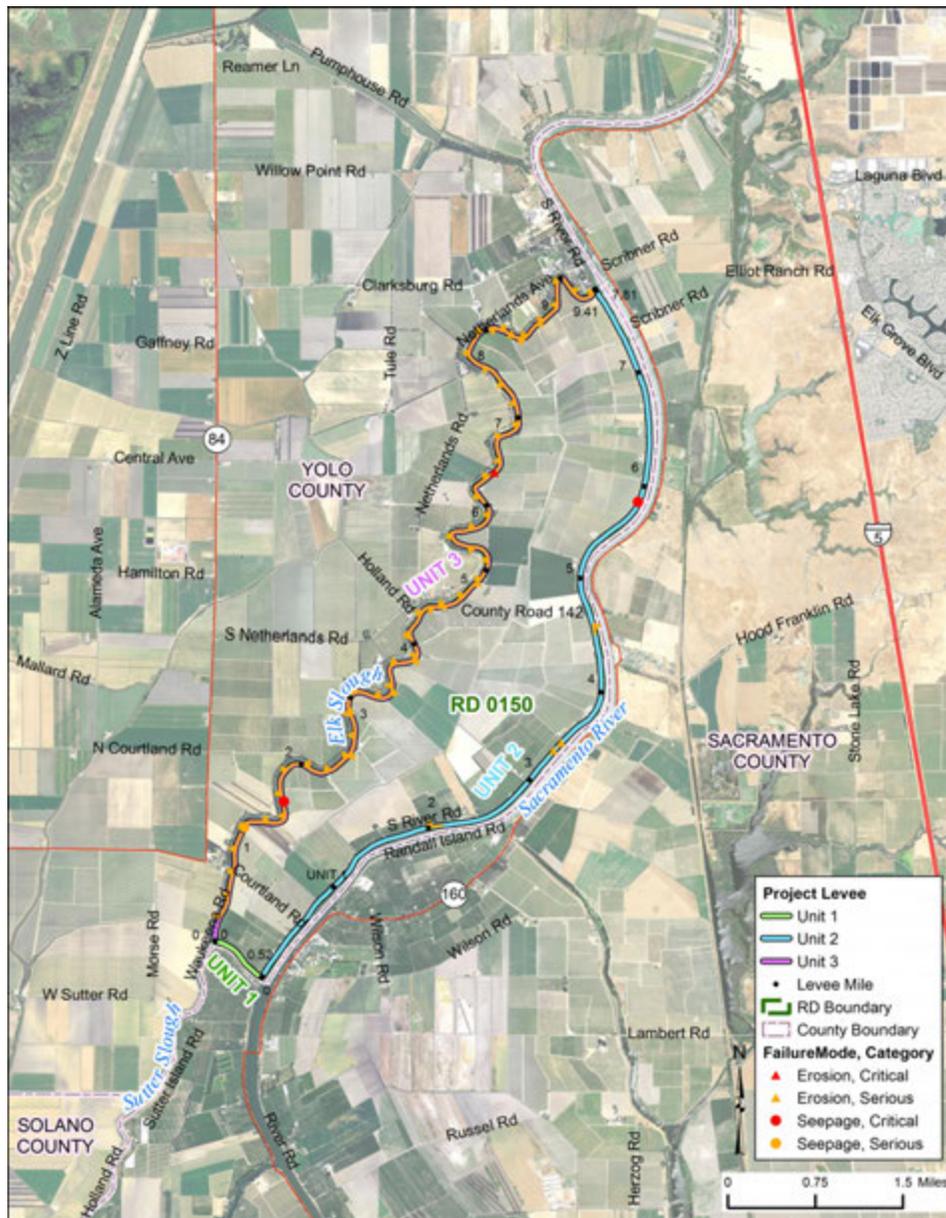
LMA Short Name : RD0150		Bank	Unit Length (Miles)
Unit No. 01	Sutter Slough	LB	0.52
Unit No. 02	Sacramento River	RB	7.81
Unit No. 03	Elk Slough	LB	9.41

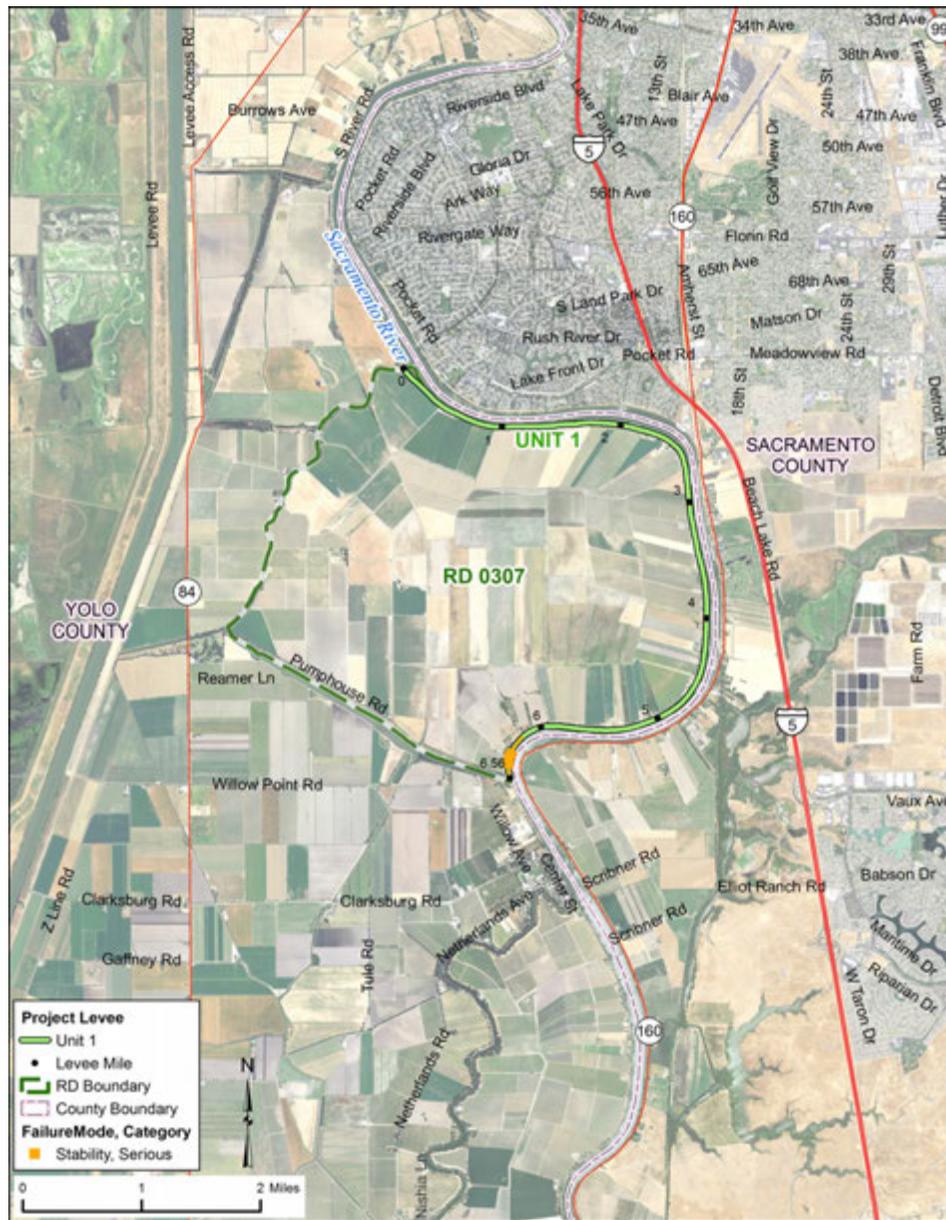
LMA Short Name : RD0307		Bank	Unit Length (Miles)
Unit No. 01	Sacramento River	RB	6.56

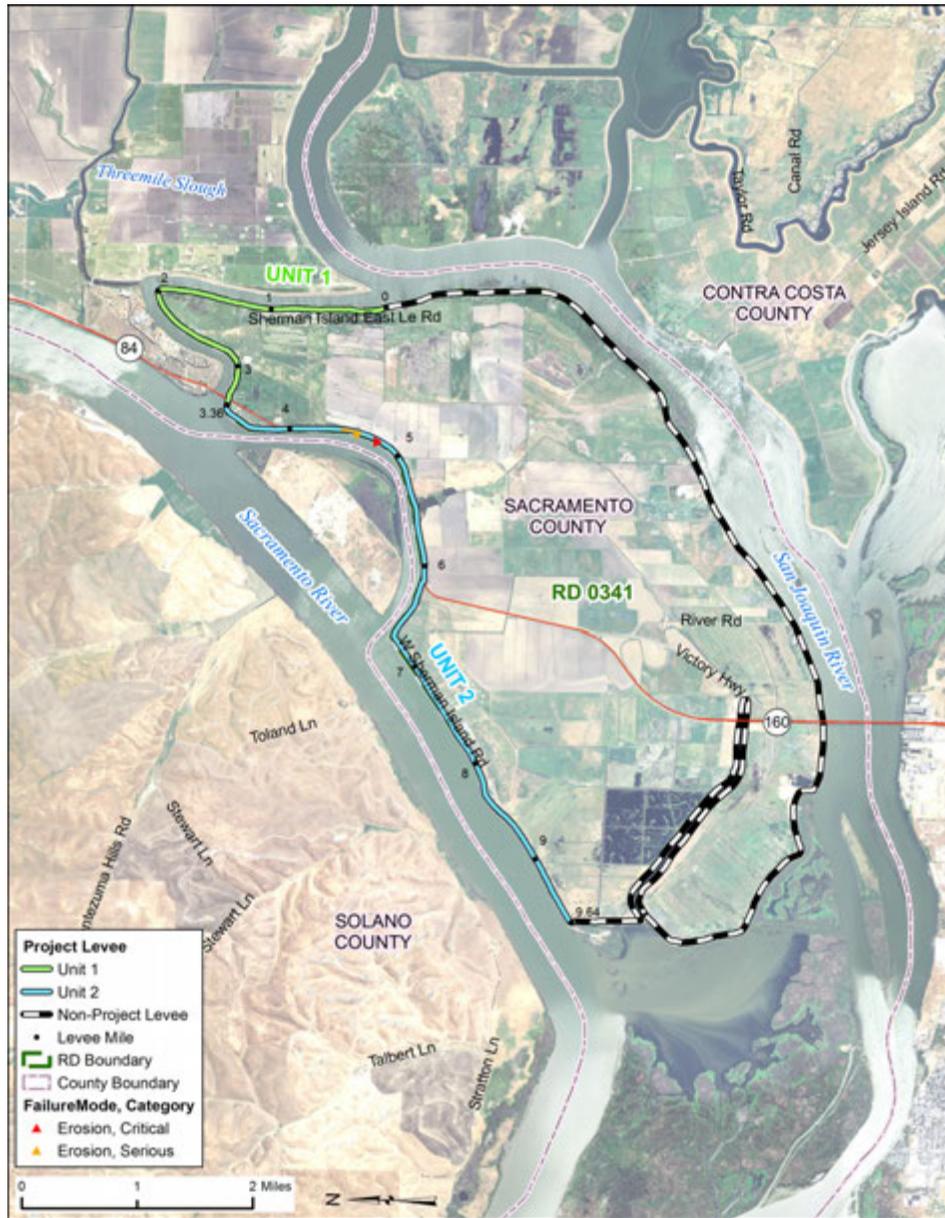
LMA Short Name : RD0341		Bank	Unit Length (Miles)
Unit No. 01	Threemile Slough	RB	3.36
Unit No. 02	Sacramento River	LB	6.28

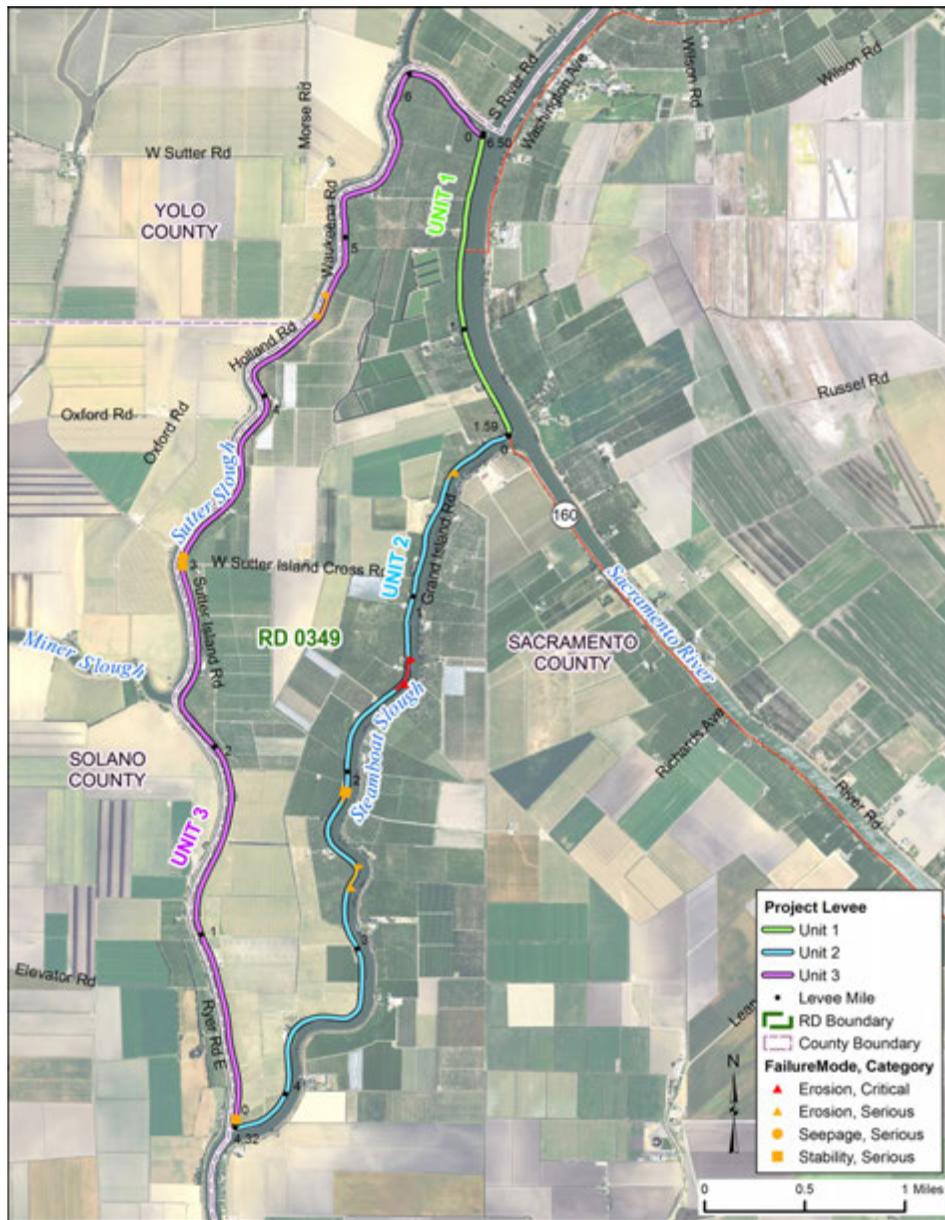
LMA Short Name : RD0349		Bank	Unit Length (Miles)
Unit No. 01	Sacramento River	RB	1.59
Unit No. 02	Steamboat Slough	RB	4.32
Unit No. 03	Sutter Slough	LB	6.50

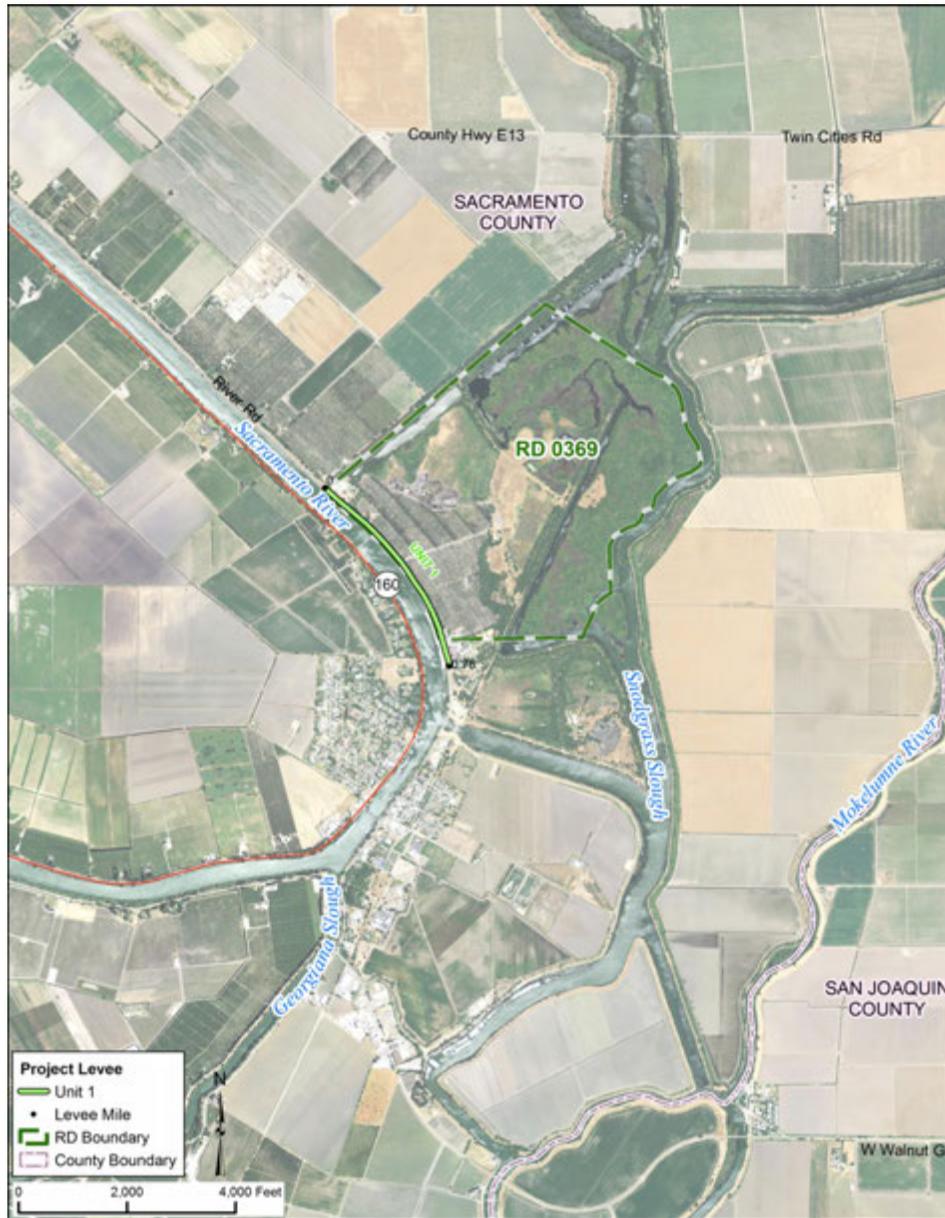
LMA Short Name : RD0369		Bank	Unit Length (Miles)
Unit No. 01	Sacramento River	LB	0.78

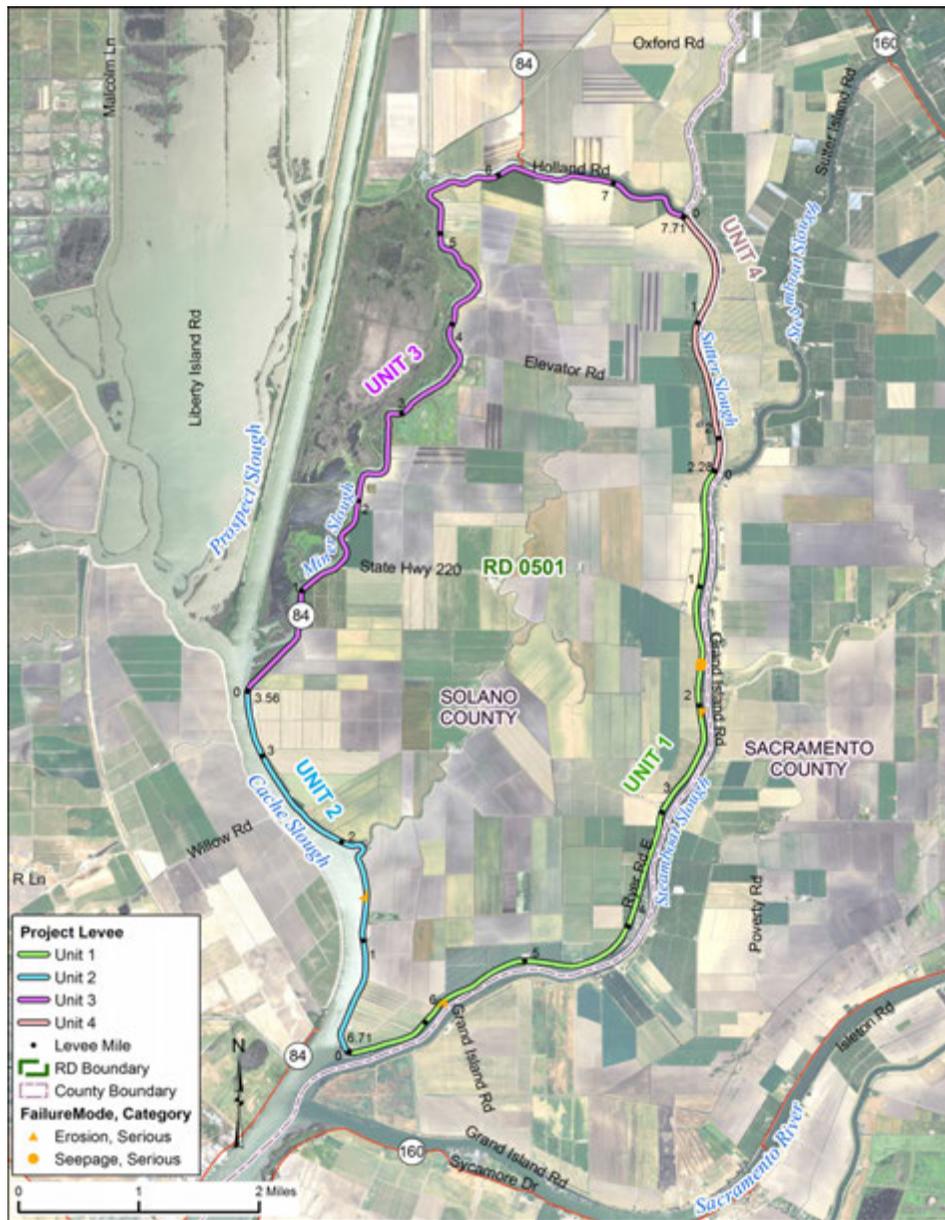
RD 501

LMA Short Name : RD0501		Bank	Unit Length (Miles)
Unit No. 01	Steamboat Slough	RB	6.71
Unit No. 02	Cache Slough	LB	3.56
Unit No. 03	Miner Slough	LB	7.71
Unit No. 04	Sutter Slough	RB	2.28

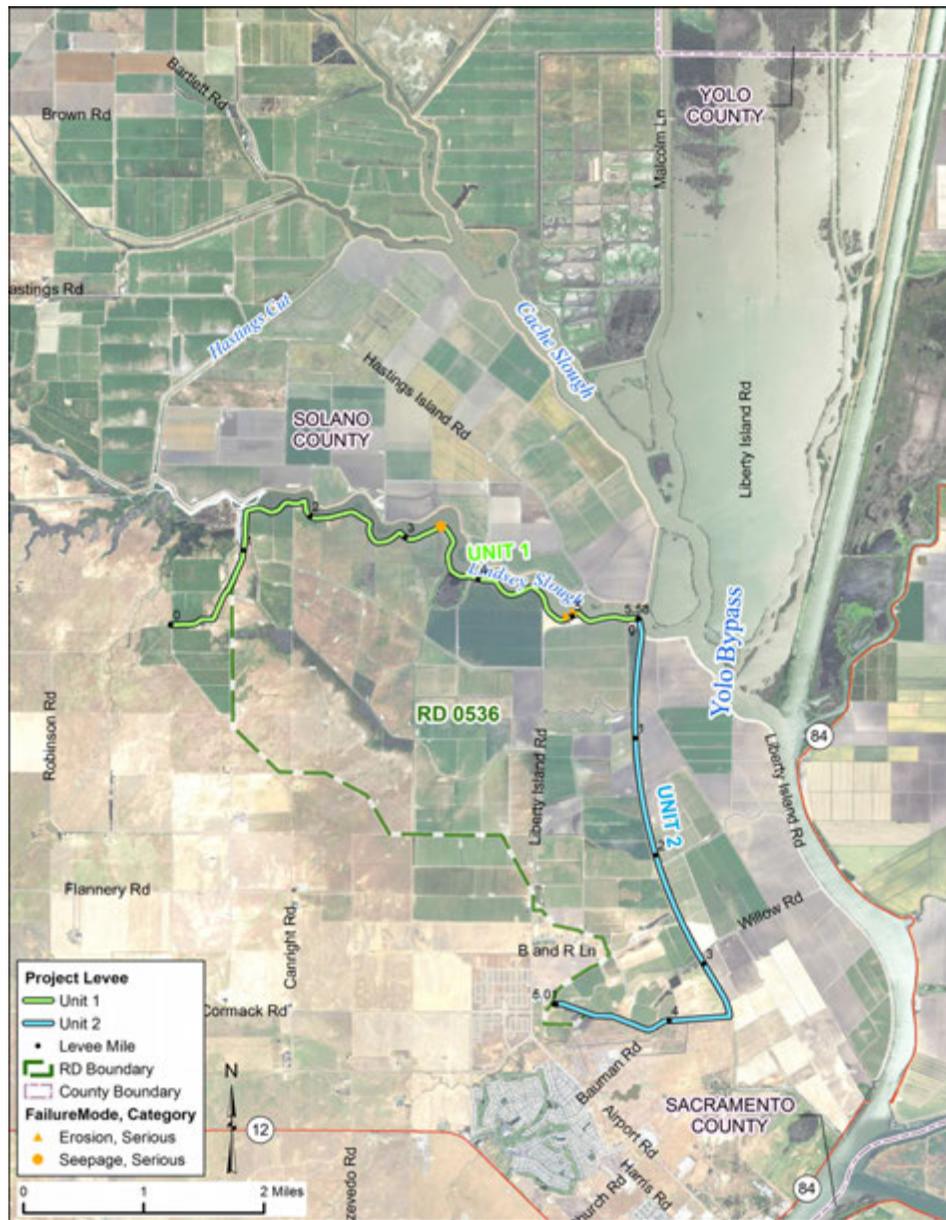
RD 536

LMA Short Name : RD0536		Bank	Unit Length (Miles)
Unit No. 01	Lindsey Slough	RB	5.58
Unit No. 02	Yolo Bypass	RB	5.01
