# Appendix **A**

## **Sacramento River Individual Agency Summary Reports**

Sacramento River Basin include 85 local maintaining Areas that maintain Project Levees, Structures, and Channels. Out of 85 Areas, there are 37 RDs, 19 NAs, 14 STs, 10 MA and 5 LDs. Appendix A includes an index to the Sacramento River Basin Areas, a system map to show the locations of each reporting Area, and individual Area summary profiles.

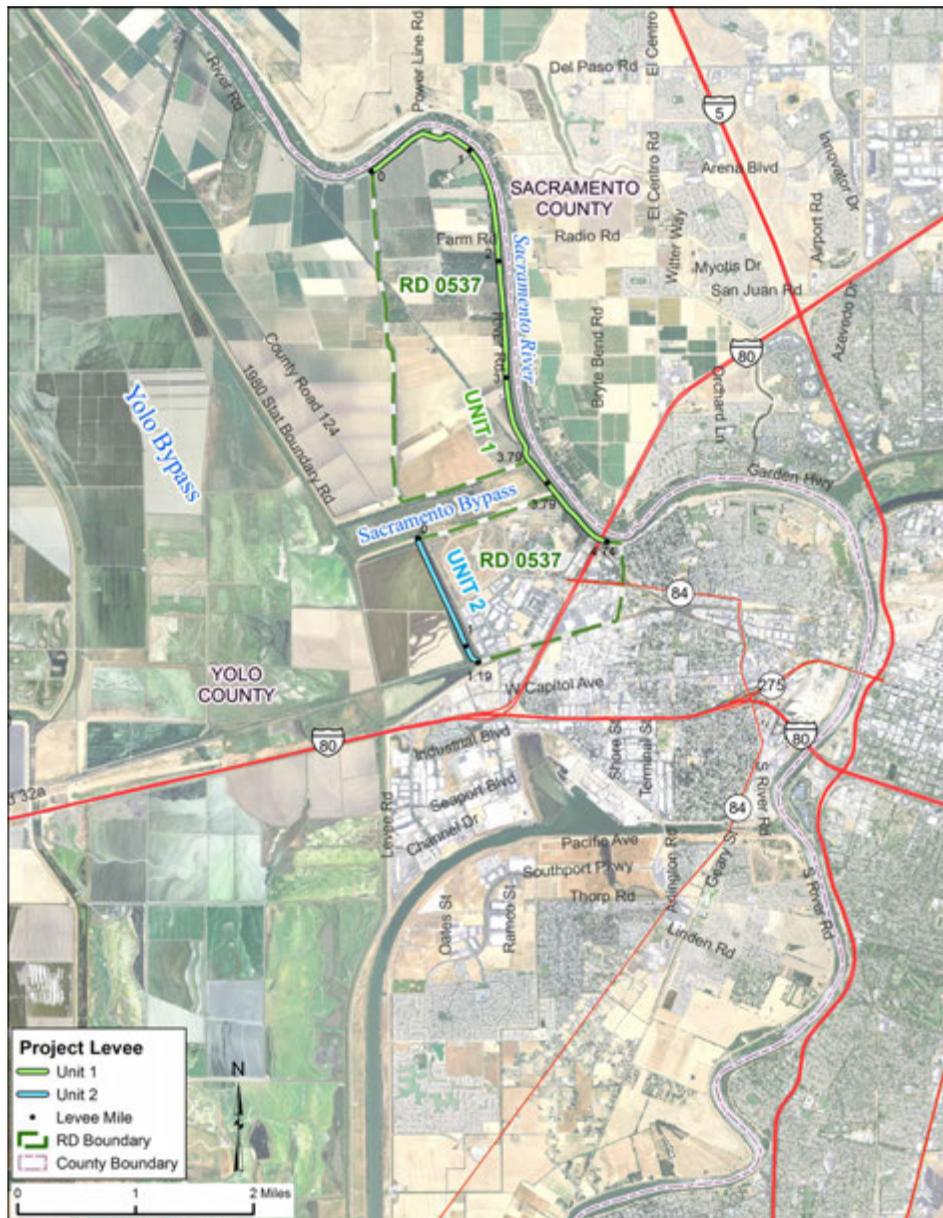
LMA Short Name : RD0537		Bank	Unit Length (Miles)
Unit No. 01	Sacramento River	RB	4.74
Unit No. 02	Yolo Bypass	LB	1.19

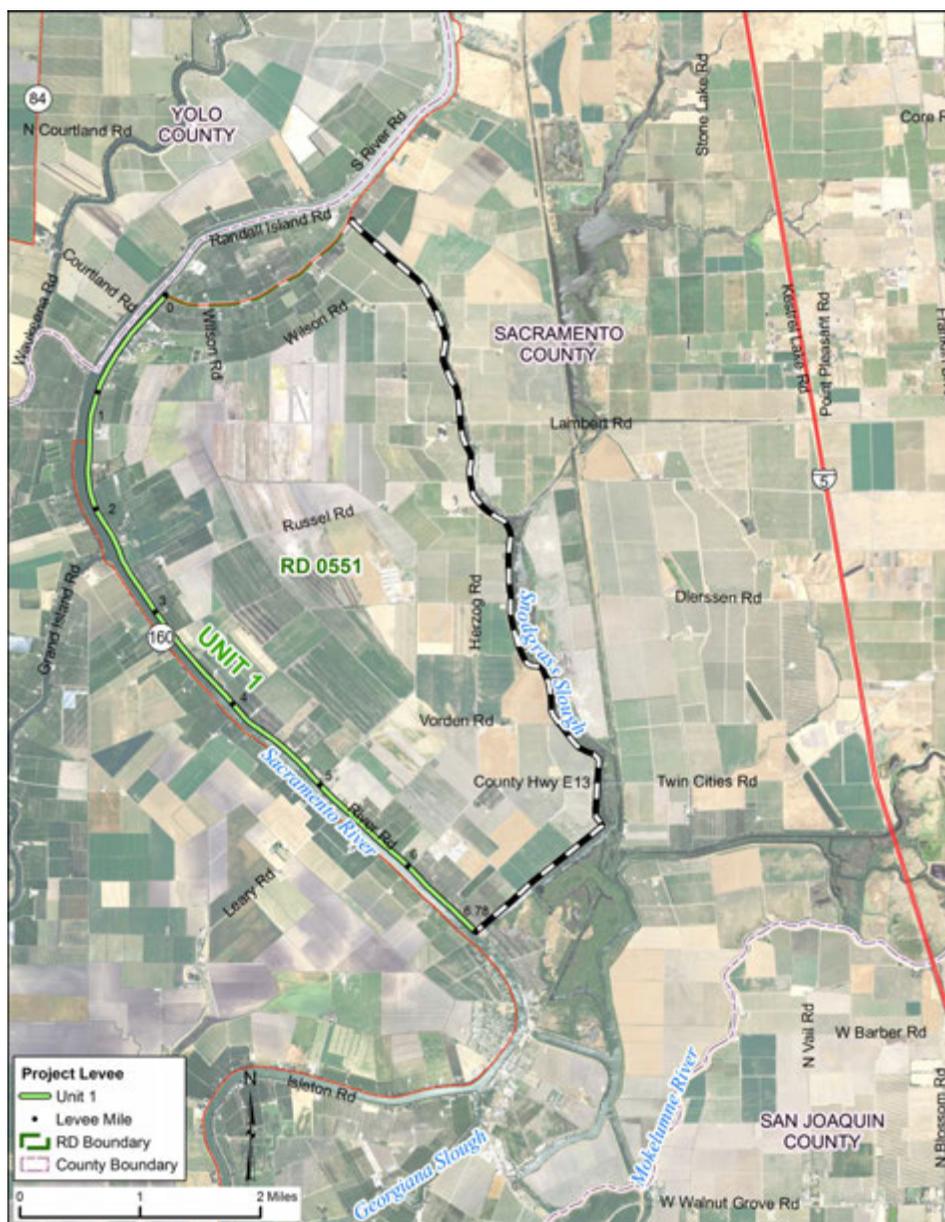
LMA Short Name : RD0551	Bank	Unit Length (Miles)
Unit No. 01 Sacramento River	LB	6.78

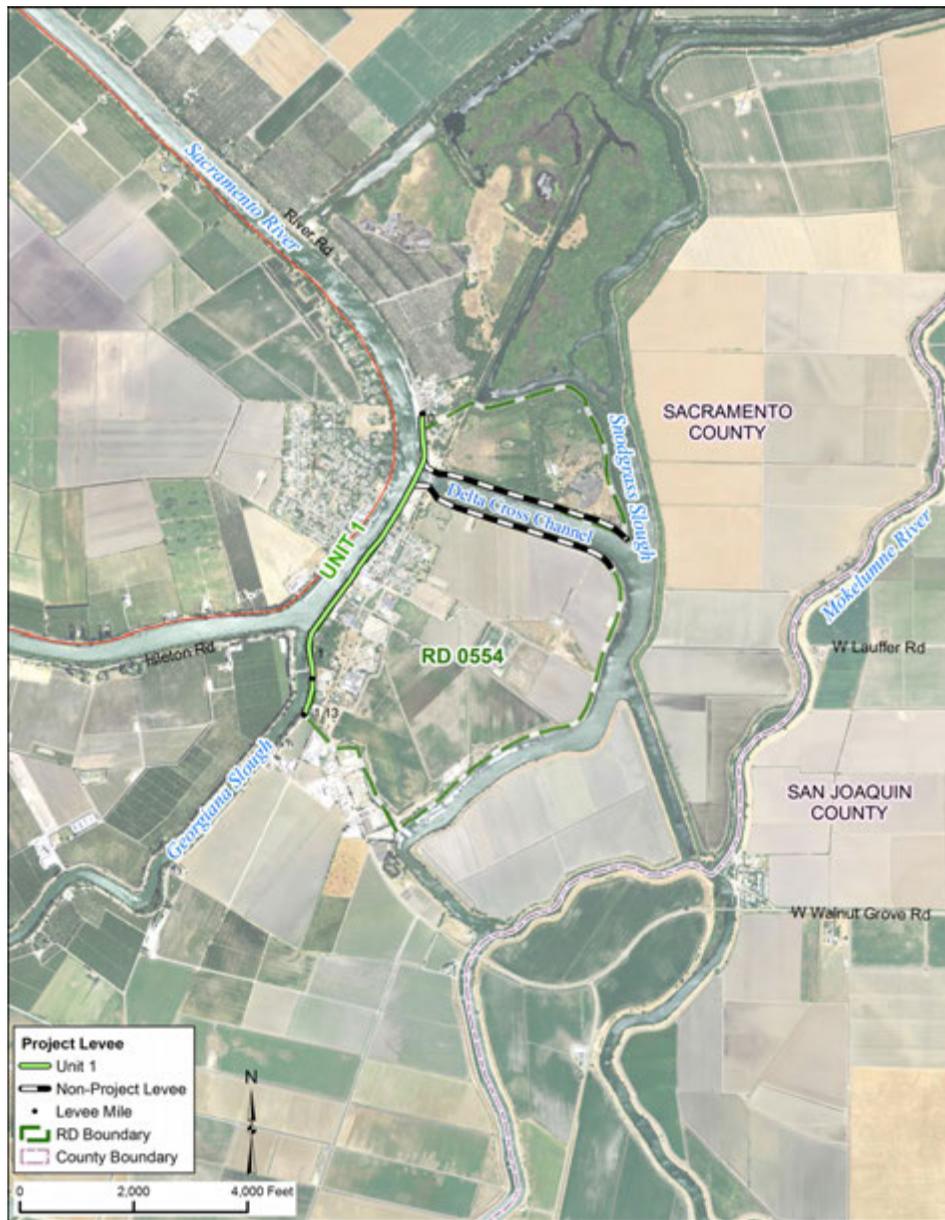
LMA Short Name : RD0554	Bank	Unit Length (Miles)
Unit No. 01 Sacramento River	LB	1.13

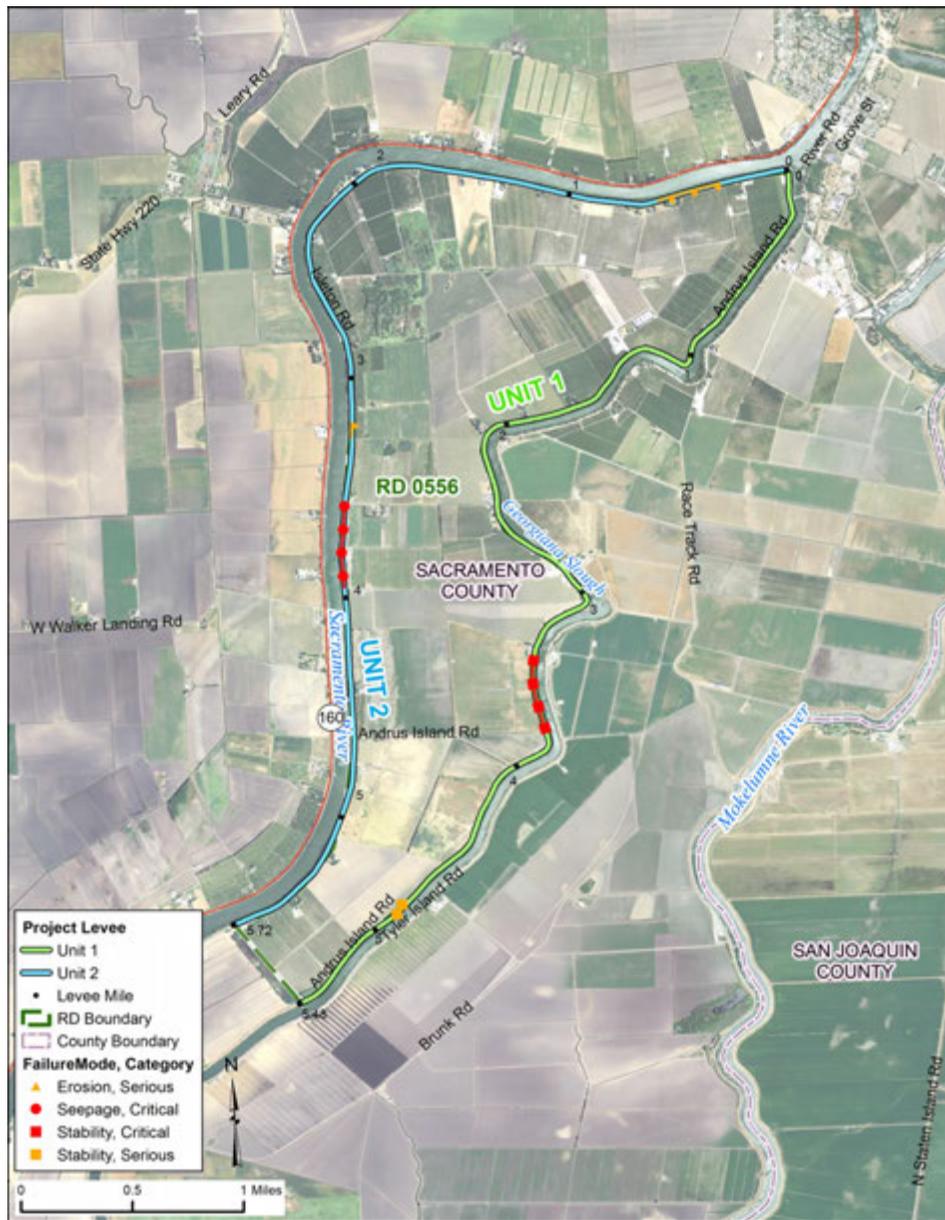
RD 556

LMA Short Name : RD0556		Bank	Unit Length (Miles)
Unit No. 01	Georgiana Slough	RB	5.48
Unit No. 02	Sacramento River	LB	5.72

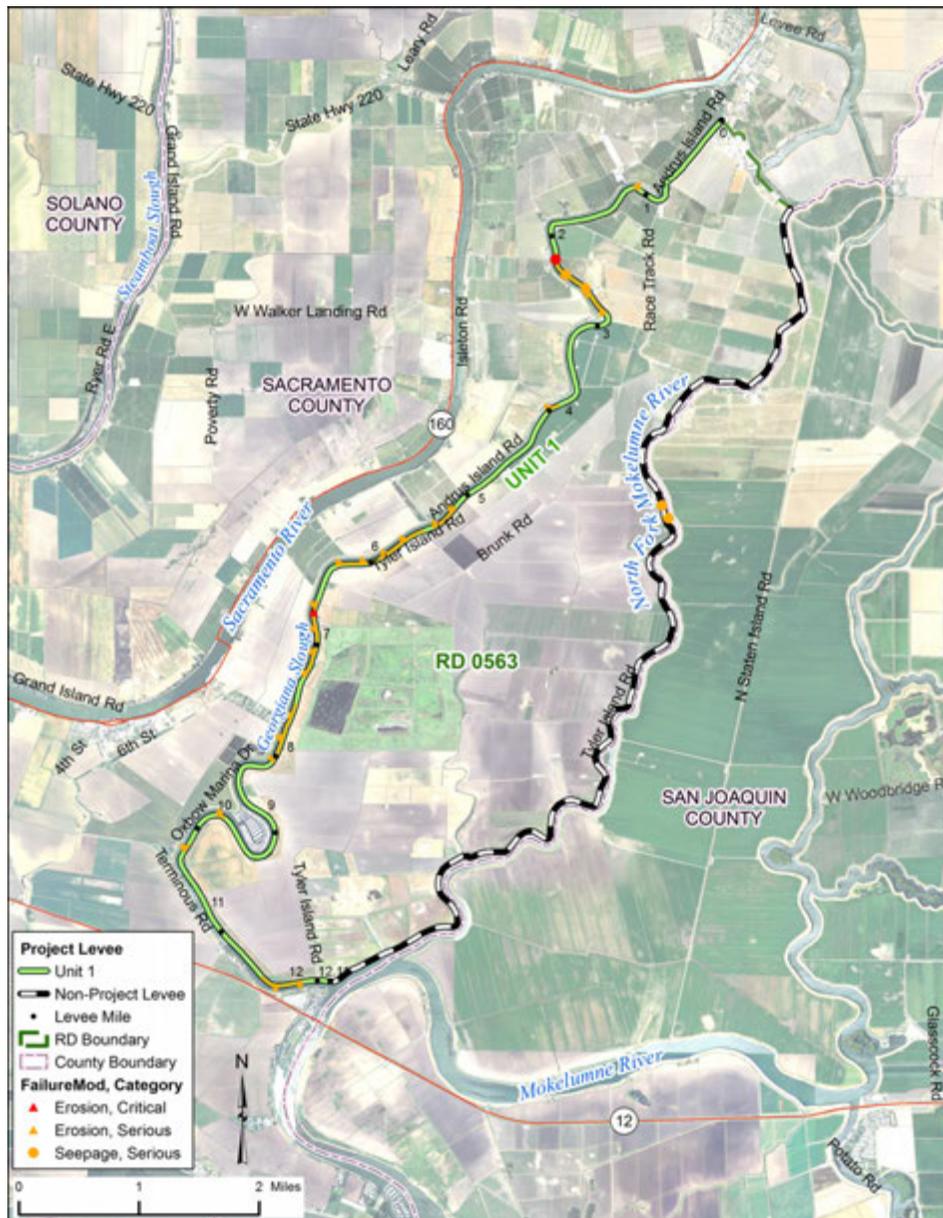
LMA Short Name : RD0563		Bank	Unit Length (Miles)
Unit No. 01	Georgiana Slough (Tyler Island)	LB	12.11

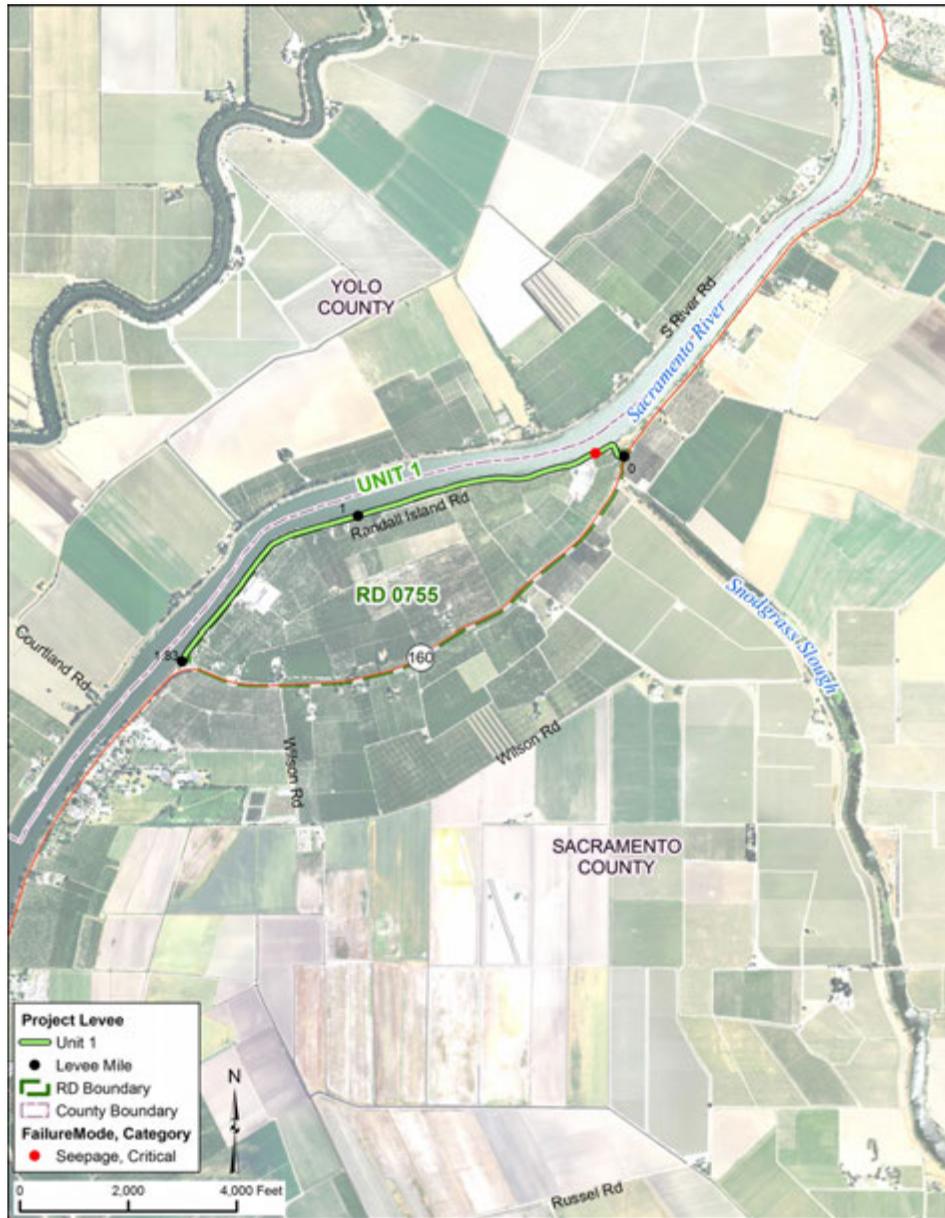
LMA Short Name : RD0755		Bank	Unit Length (Miles)
Unit No. 01	Sacramento River	LB	1.83

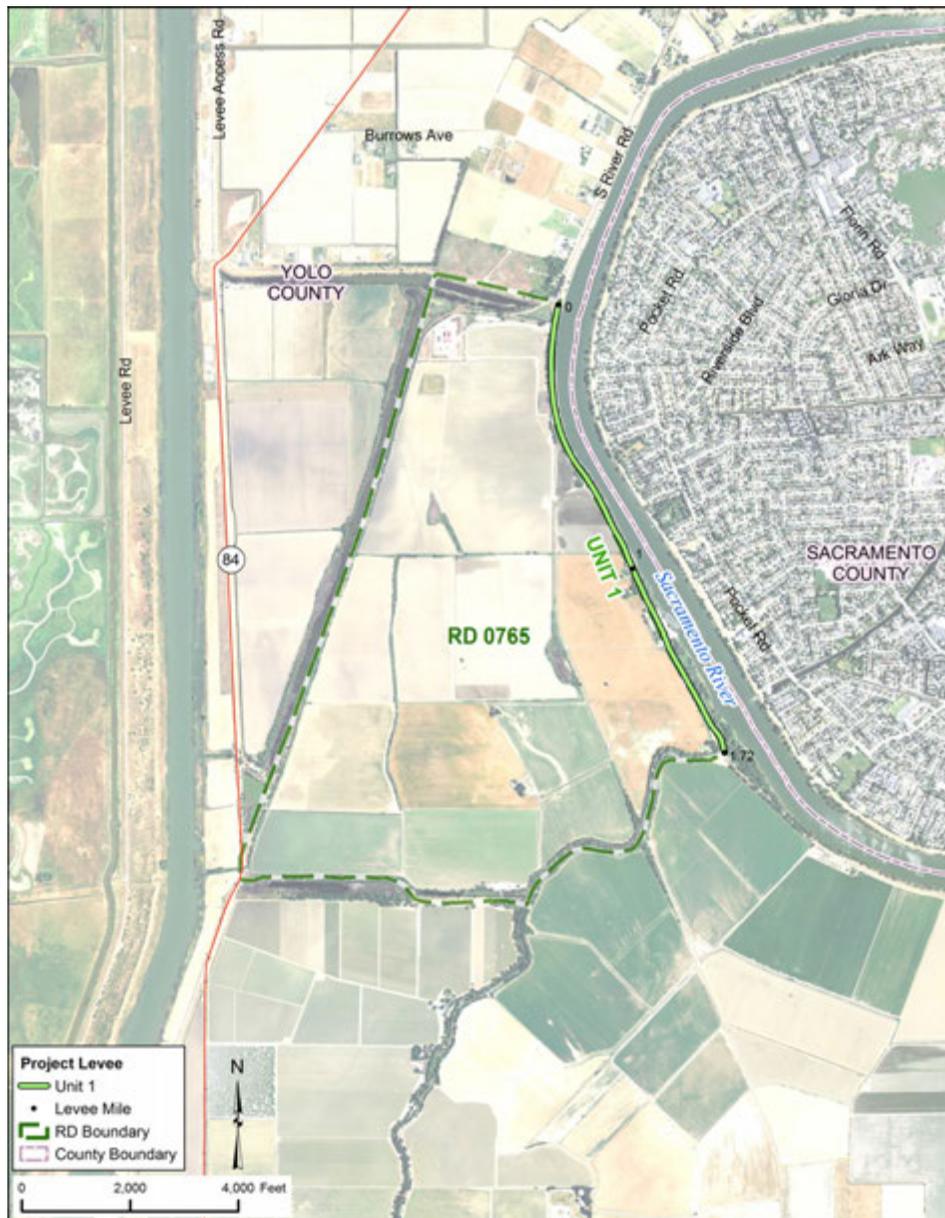
LMA Short Name : RD0765		Bank	Unit Length (Miles)
Unit No. 01	Sacramento River	RB	1.72

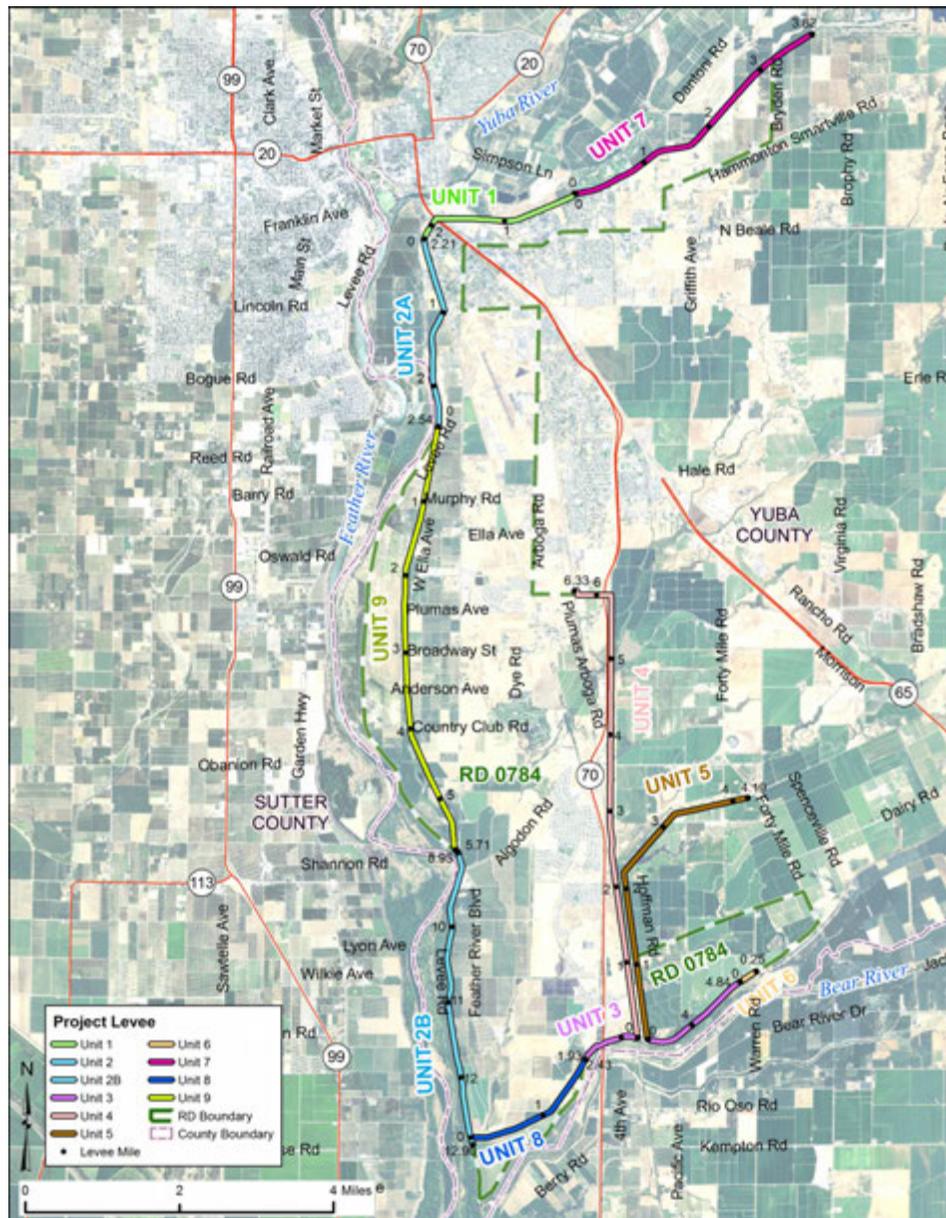
LMA Short Name : RD0784		Bank	Unit Length (Miles)
Unit No. 01	Yuba River	LB	2.21
Unit No. 02A	Feather River	LB	2.54
Unit No. 02B	Feather River	LB	3.95
Unit No. 03A	Bear River	RB	0.78
Unit No. 03B	Bear River	RB	1.49
Unit No. 04	Interceptor Canal	RB	6.33
Unit No. 05	Interceptor Canal	LB	4.19
Unit No. 06	South Dry Creek	RB	0.25
Unit No. 07	Yuba River	LB	3.82
Unit No. 08	Three Rivers	RB	1.93
Unit No. 09	Feather River	LB	5.71

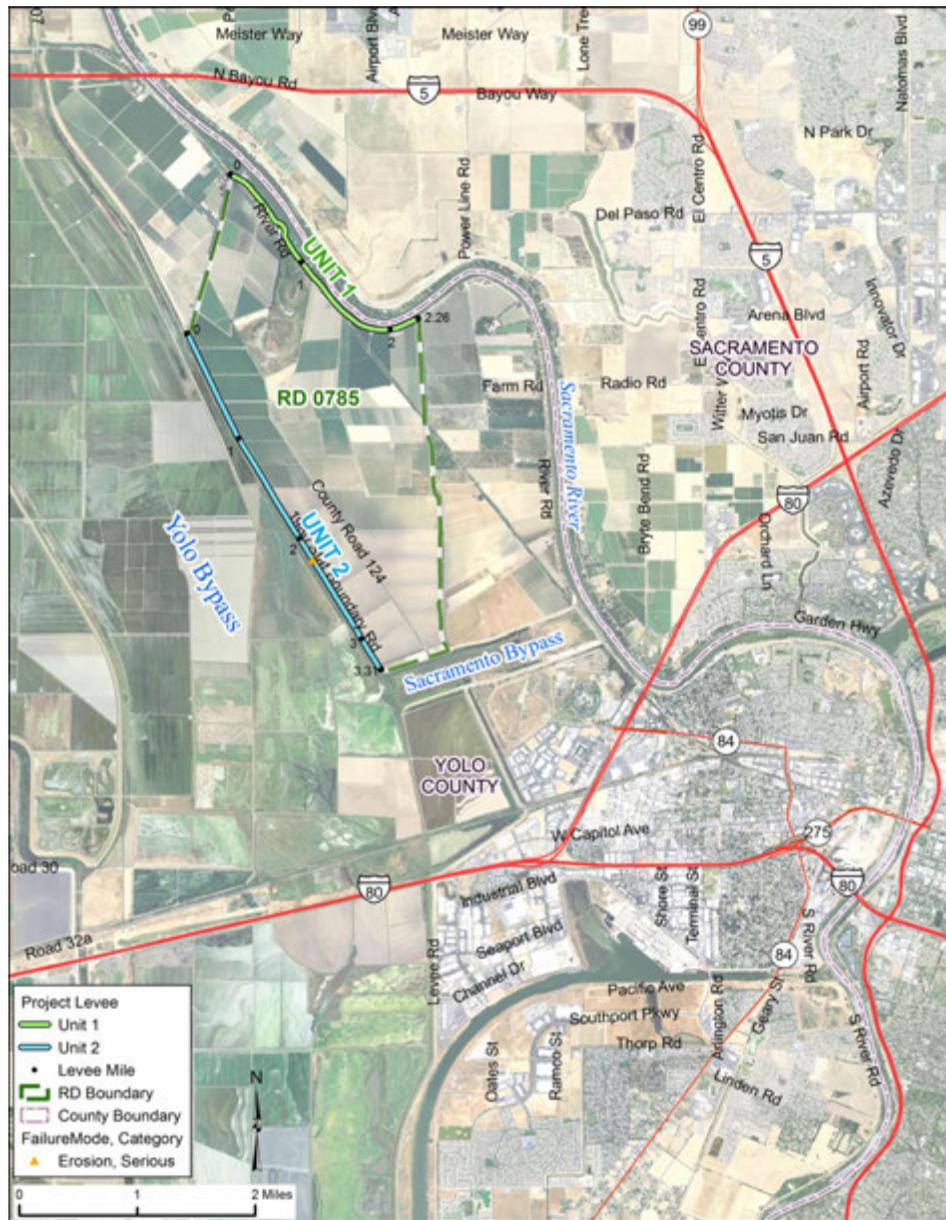
LMA Short Name : RD0785		Bank	Unit Length (Miles)
Unit No. 01	Sacramento River	RB	2.26
Unit No. 02	Yolo Bypass	LB	3.31

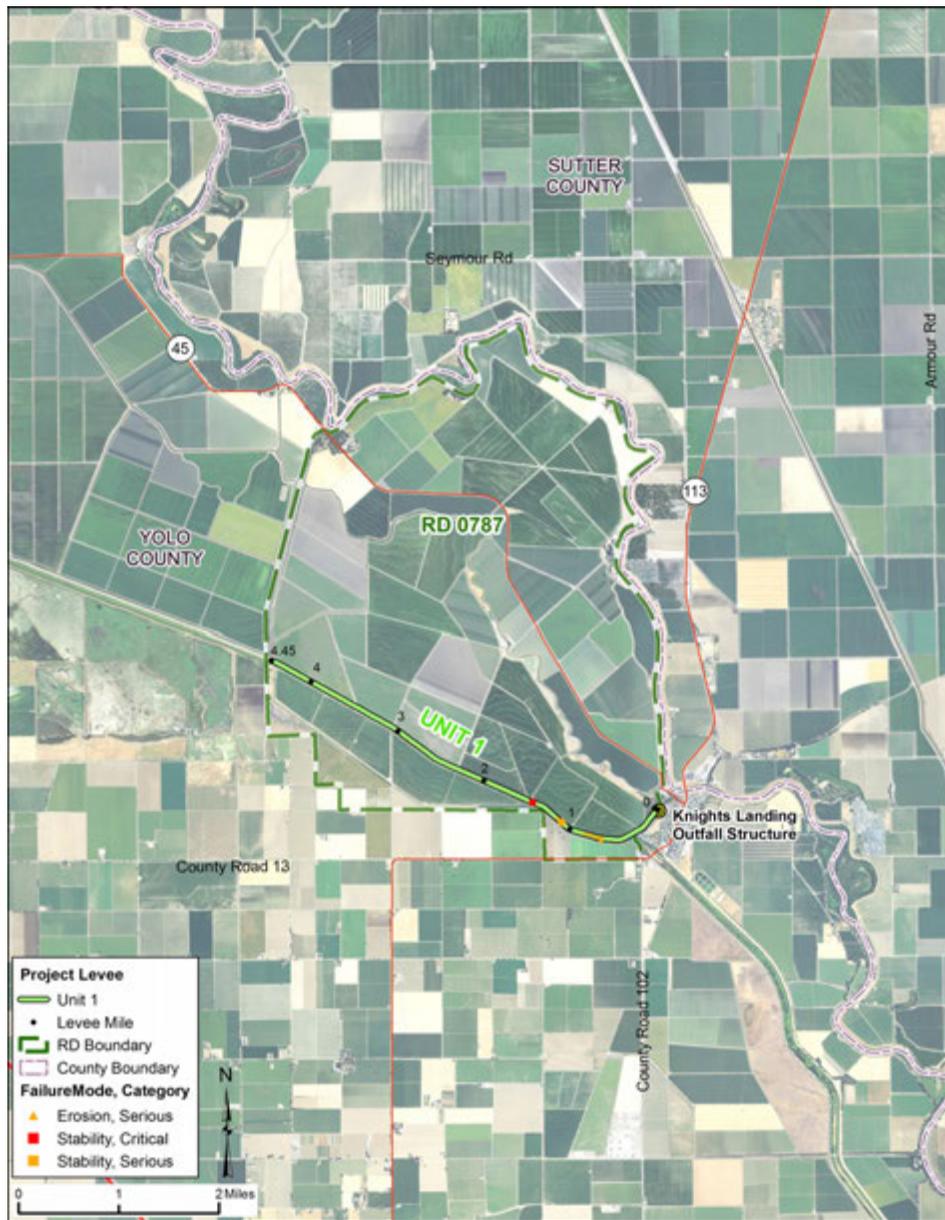
LMA Short Name : RD0787	Bank	Unit Length (Miles)
Unit No. 01 Colusa Basin Drain	LB	4.45

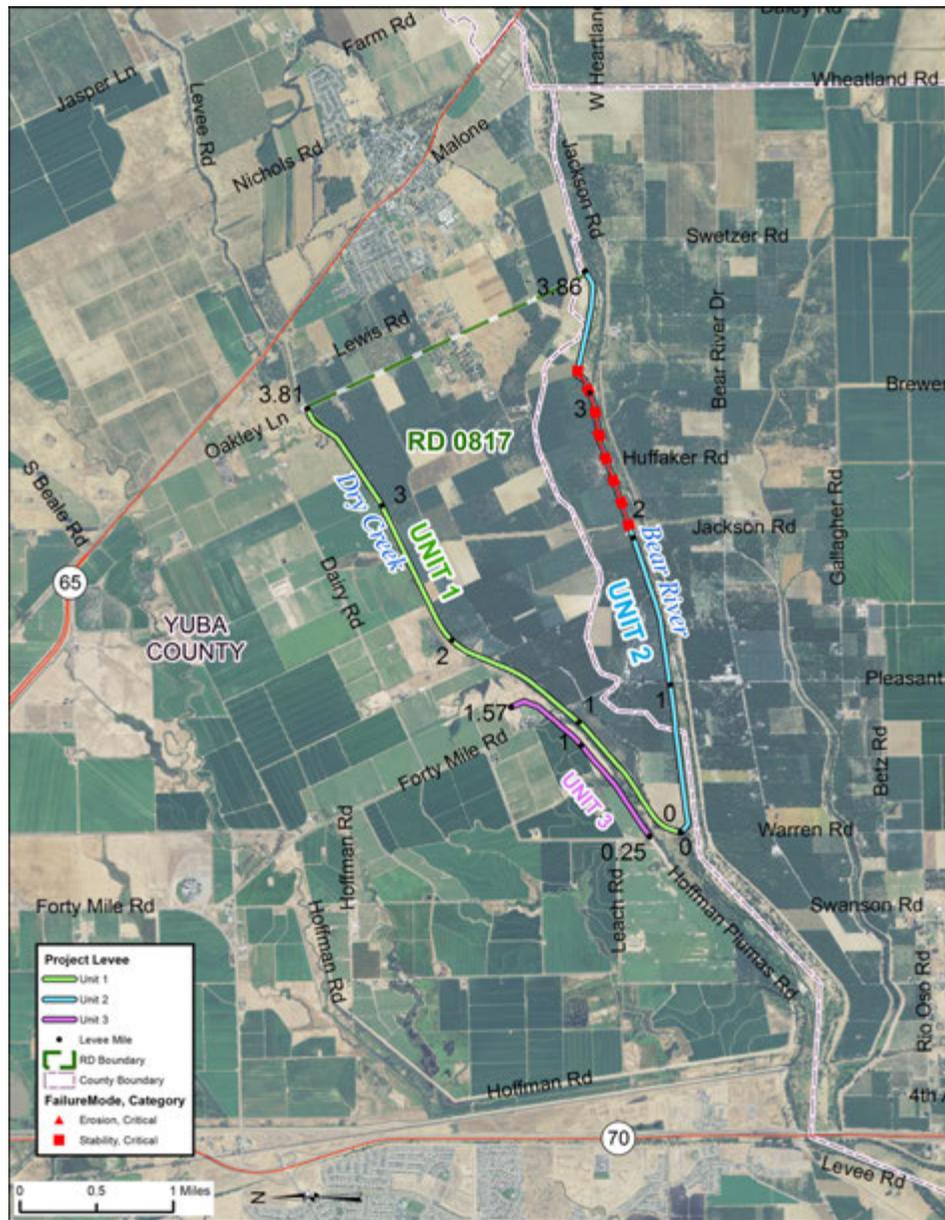
LMA Short Name : RD0817		Bank	Unit Length (Miles)
Unit No. 01	South Dry Creek	LB	3.81
Unit No. 02	Bear River	RB	3.86
Unit No. 03	South Dry Creek	RB	1.32

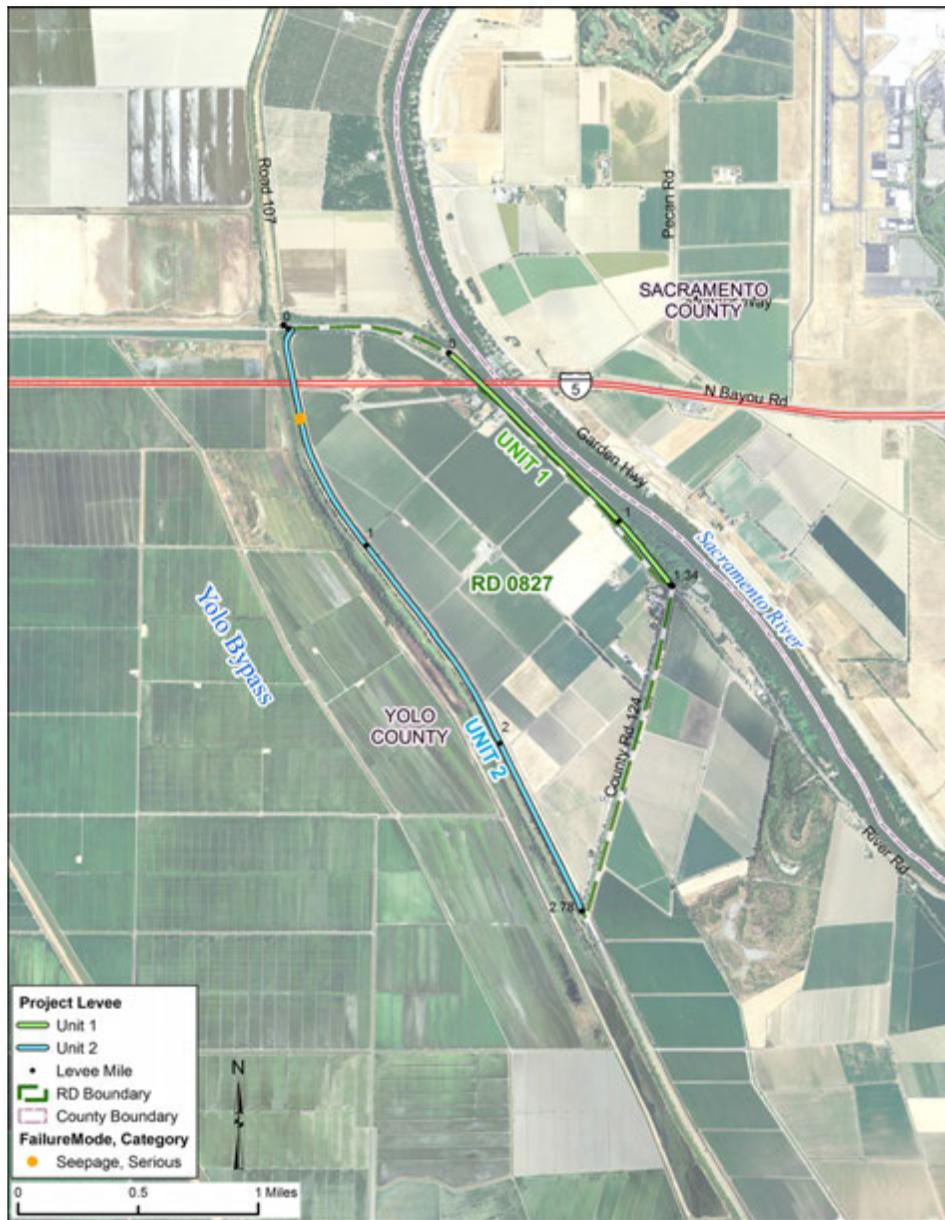
LMA Short Name : RD0827		Bank	Unit Length (Miles)
Unit No. 01	Sacramento River	RB	1.34
Unit No. 02	Yolo Bypass	LB	2.78

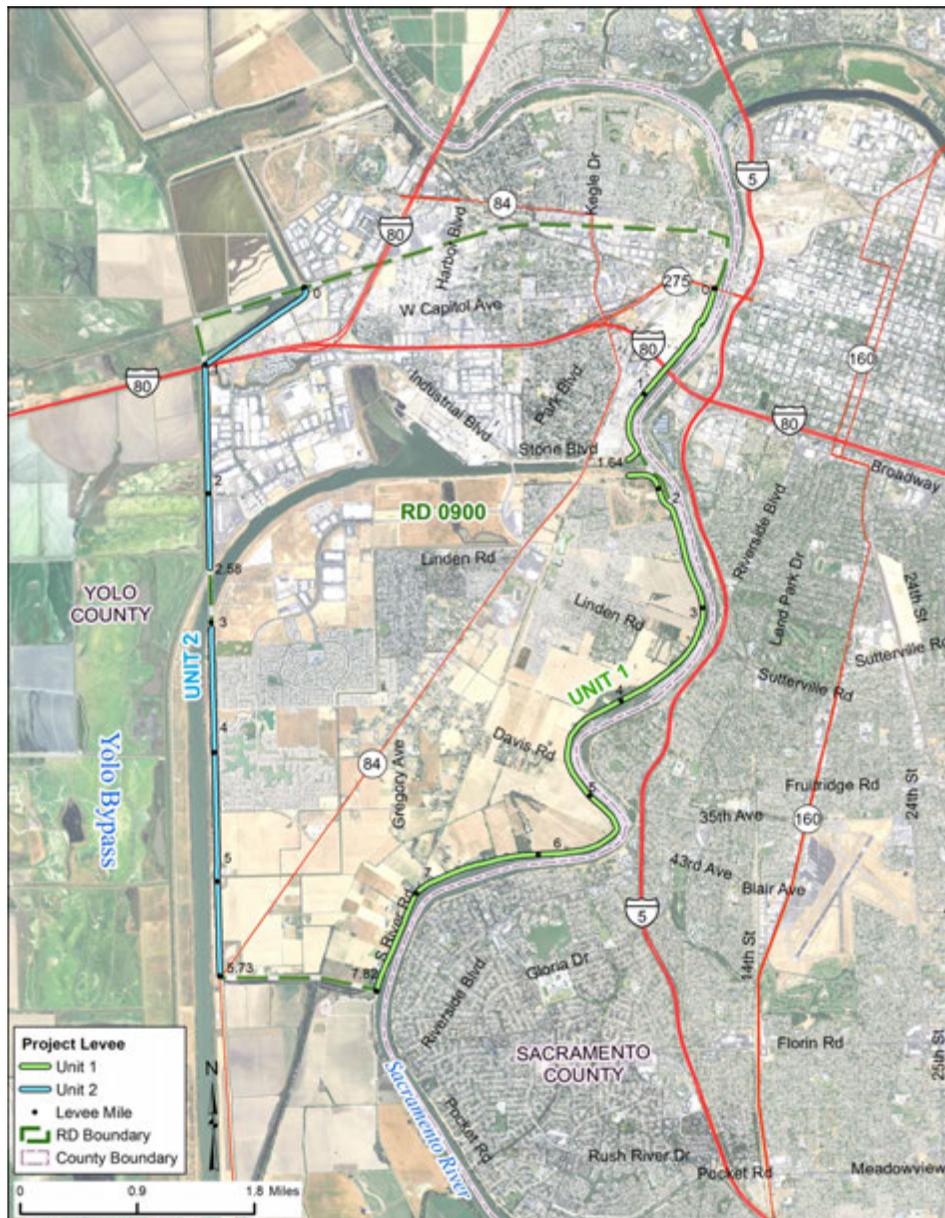
LMA Short Name : RD0900		Bank	Unit Length (Miles)
Unit No. 01	Sacramento River	RB	7.70
Unit No. 02	Yolo Bypass	LB	5.26

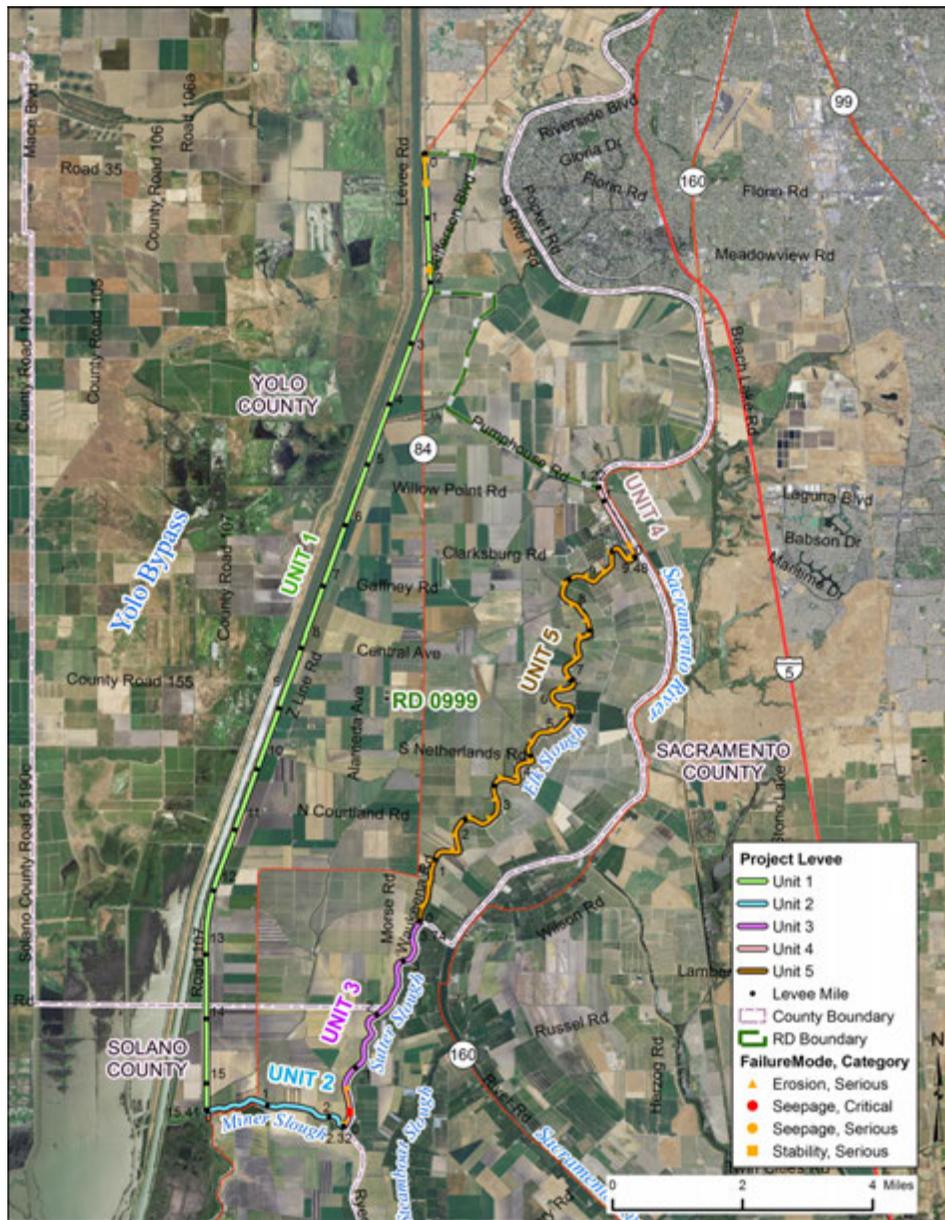
RD 999

LMA Short Name : RD0999		Bank	Unit Length (Miles)
Unit No. 01	Yolo Bypass	LB	15.41
Unit No. 02	Miner Slough	RB	2.31
Unit No. 03	Sutter Slough	RB	3.74
Unit No. 04	Sacramento River	RB	1.22
Unit No. 05	Elk Slough	RB	9.48

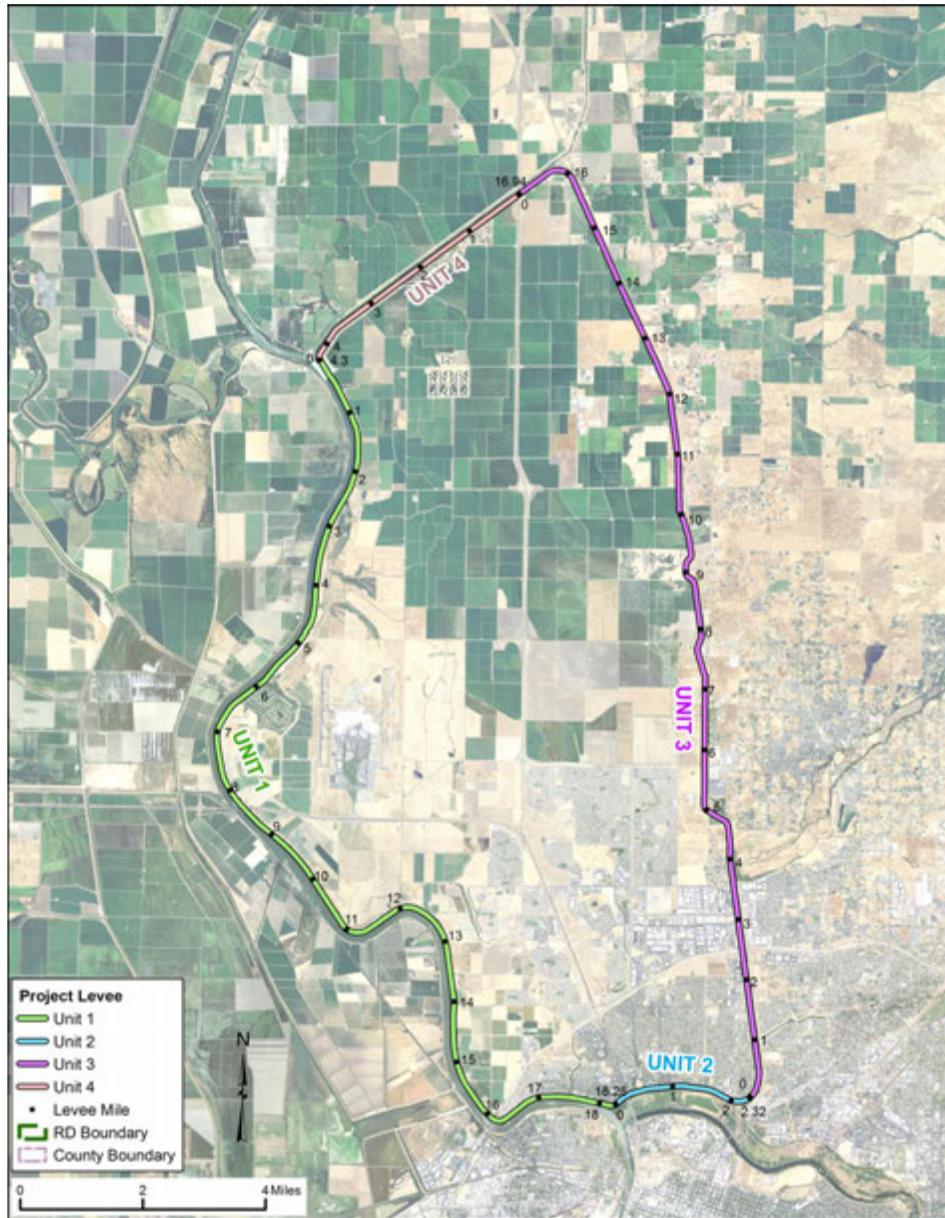
RD 1000

LMA Short Name : RD1000		Bank	Unit Length (Miles)
Unit No. 01	Sacramento River	LB	18.28
Unit No. 02	American River	RB	2.32
Unit No. 03	Natomas East Canal	RB	16.93
Unit No. 04	Natomas Cross Canal	LB	4.30

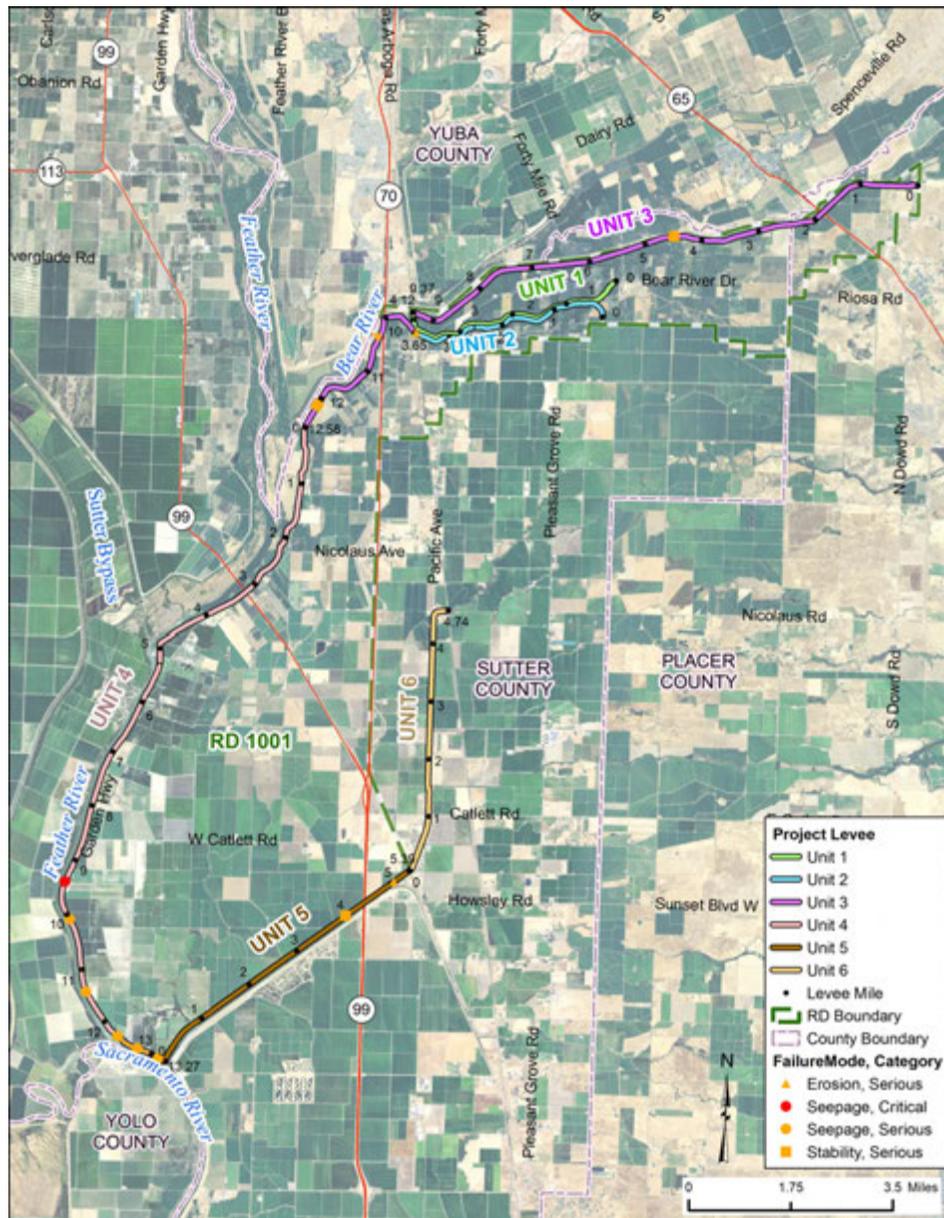
RD 1001

LMA Short Name : RD1001	Bank	Unit Length (Miles)
-------------------------	------	---------------------

Unit No. 01	Yankee Slough	RB	4.12
Unit No. 02	Yankee Slough	LB	3.65
Unit No. 03	Bear River	LB	12.58
Unit No. 04	Feather River	LB	13.27
Unit No. 05	Natomas Cross Canal	RB	5.39
Unit No. 06	East Side Canal	RB	4.74

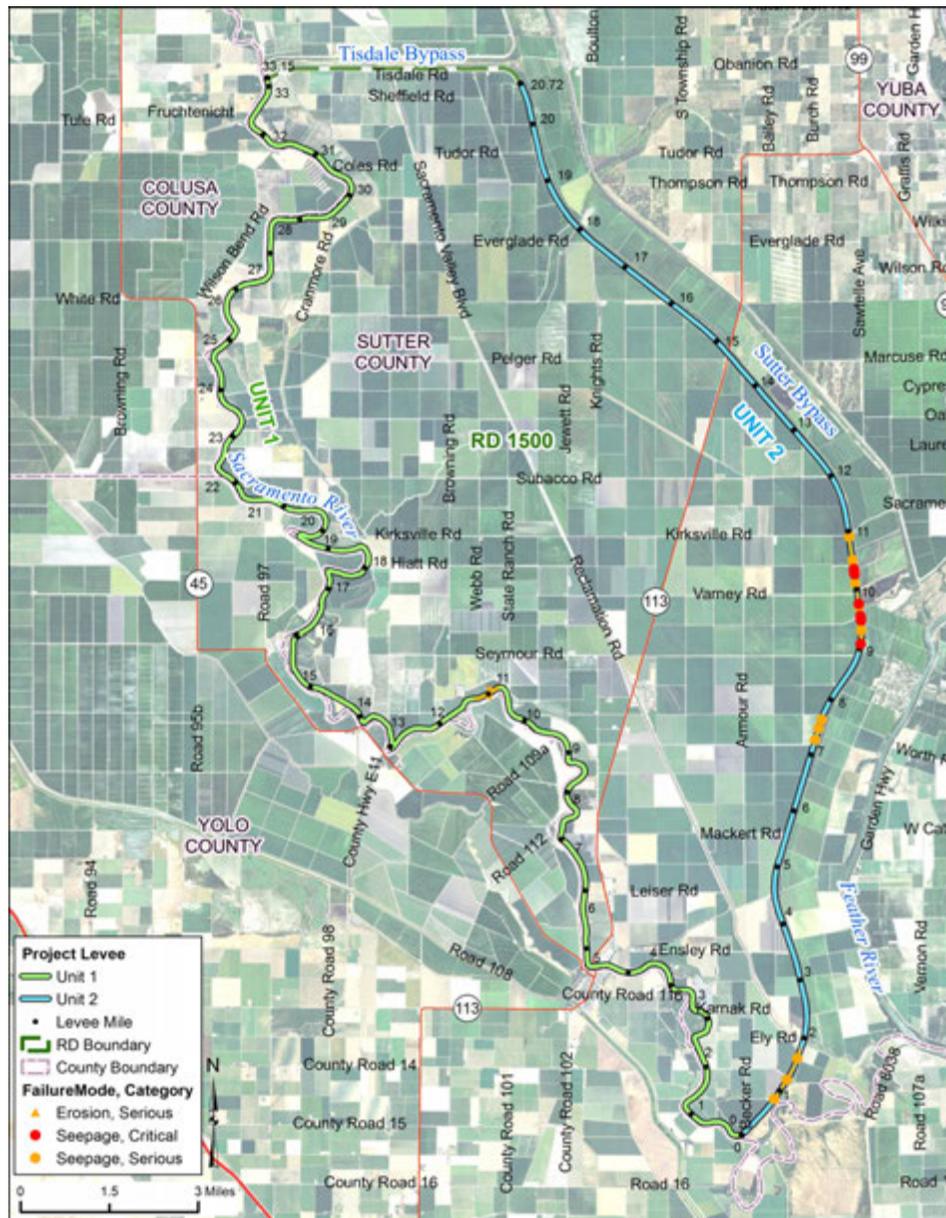
LMA Short Name : RD1500		Bank	Unit Length (Miles)
Unit No. 01	Sacramento River	LB	33.15
Unit No. 02	Sutter Bypass	RB	20.72

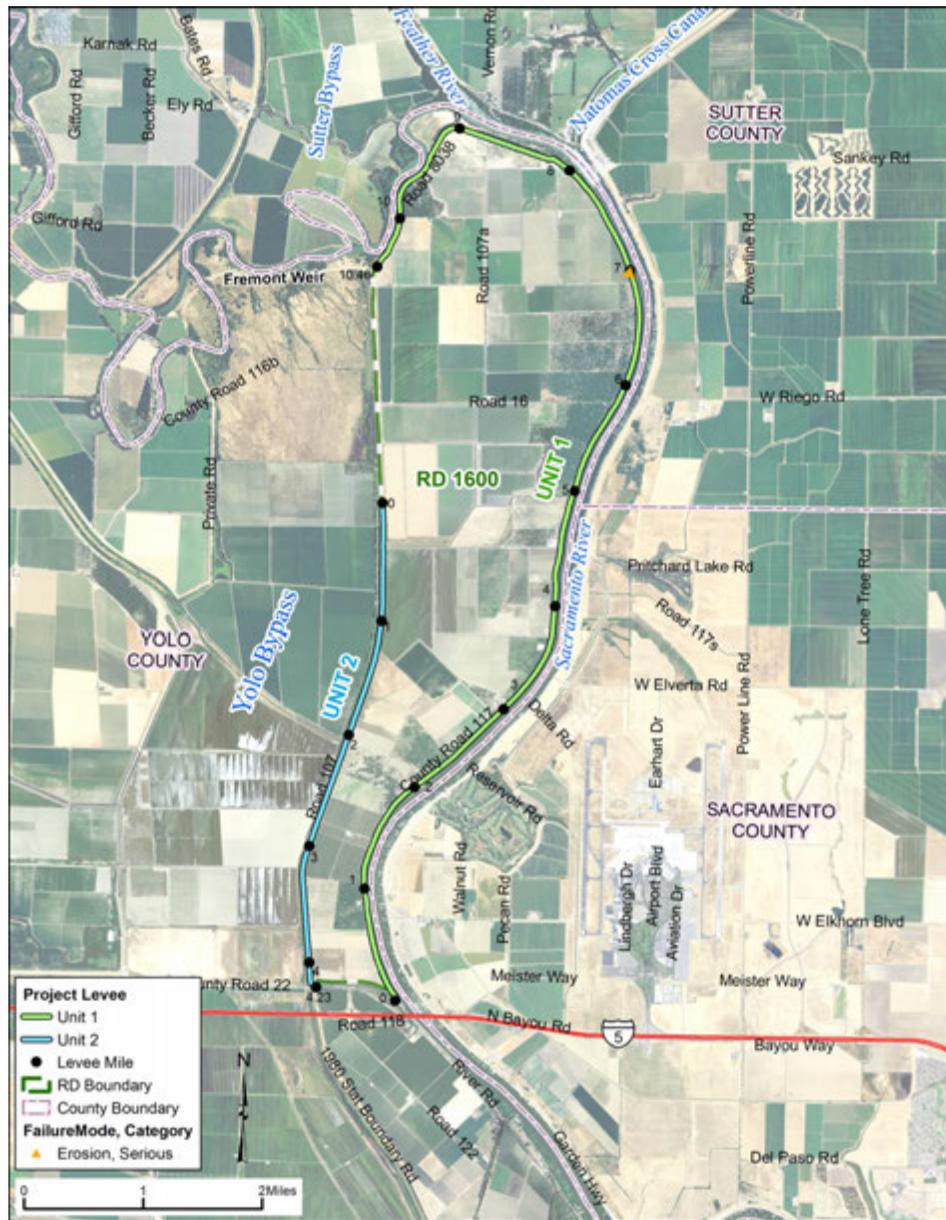
LMA Short Name : RD1600		Bank	Unit Length (Miles)
Unit No. 01	Sacramento River	RB	10.46
Unit No. 02	Yolo Bypass	LB	4.23

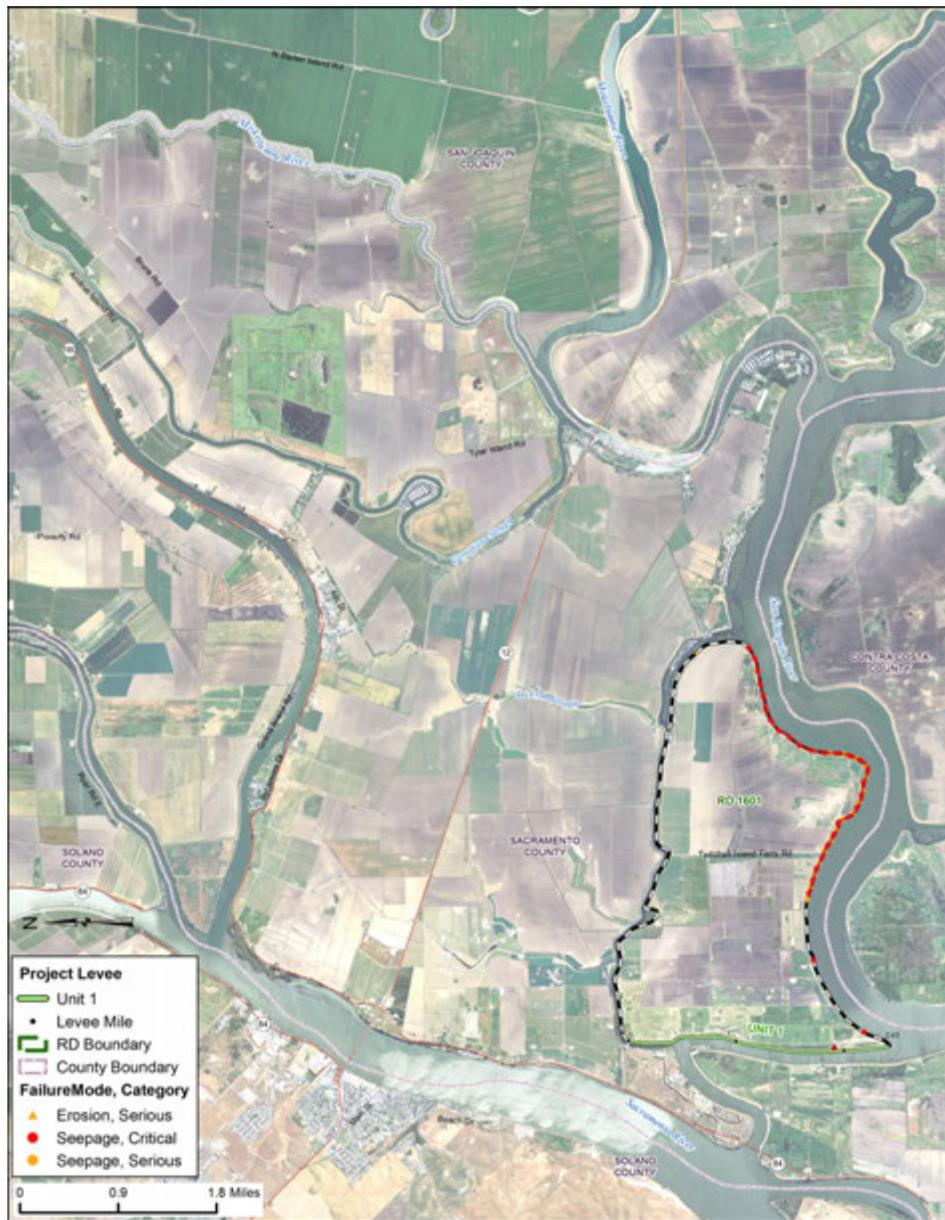
LMA Short Name : RD1601	Bank	Unit Length (Miles)
Unit No. 01 Threemile Slough	LB	2.43
