# Appendix **A**

## **Sacramento River Individual Agency Summary Reports**

Sacramento River Basin include 85 local maintaining Areas that maintain Project Levees, Structures, and Channels. Out of 85 Areas, there are 37 RDs, 19 NAs, 14 STs, 10 MA and 5 LDs. Appendix A includes an index to the Sacramento River Basin Areas, a system map to show the locations of each reporting Area, and individual Area summary profiles.

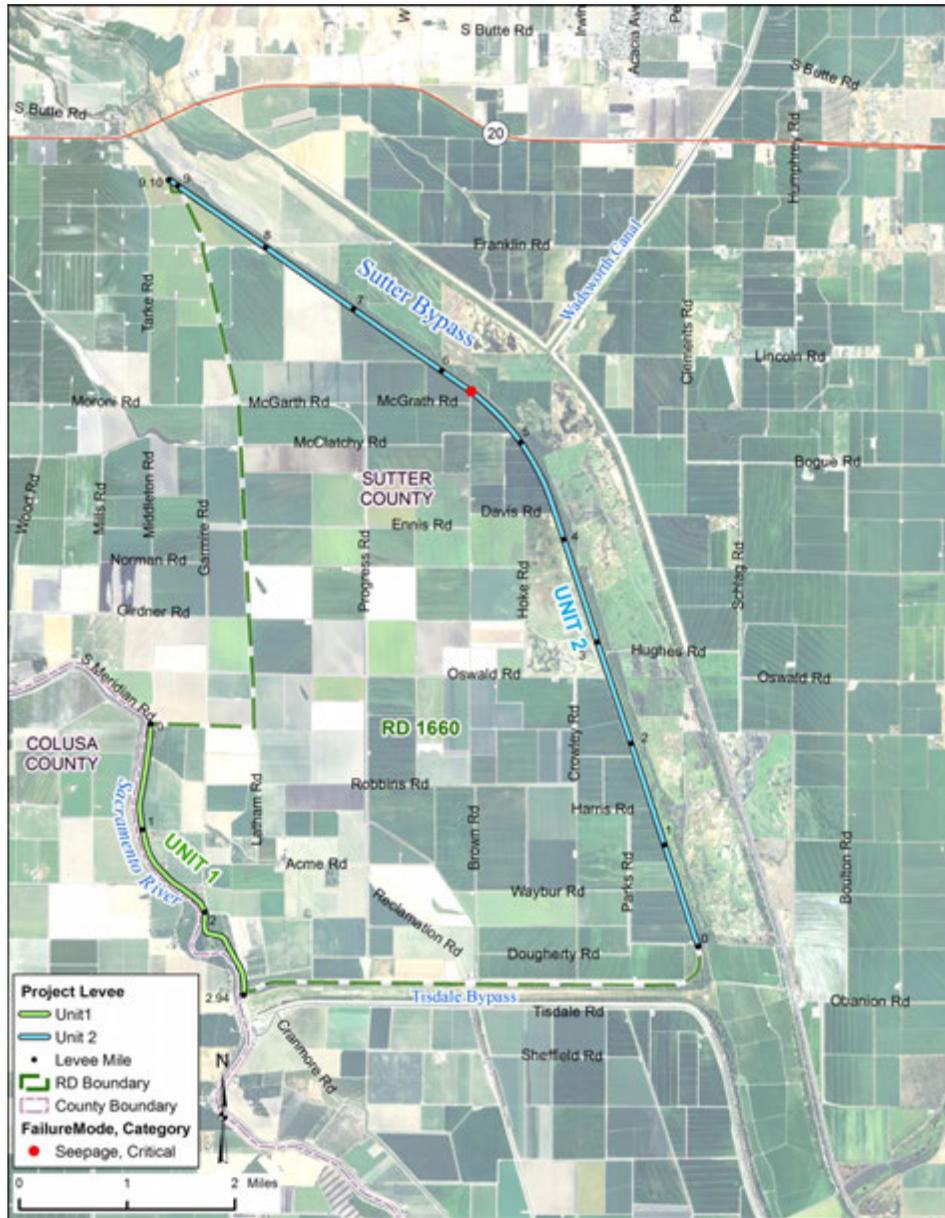
LMA Short Name : RD1660		Bank	Unit Length (Miles)
Unit No. 01	Sacramento River	LB	2.94
Unit No. 02	Sutter Bypass	RB	9.10

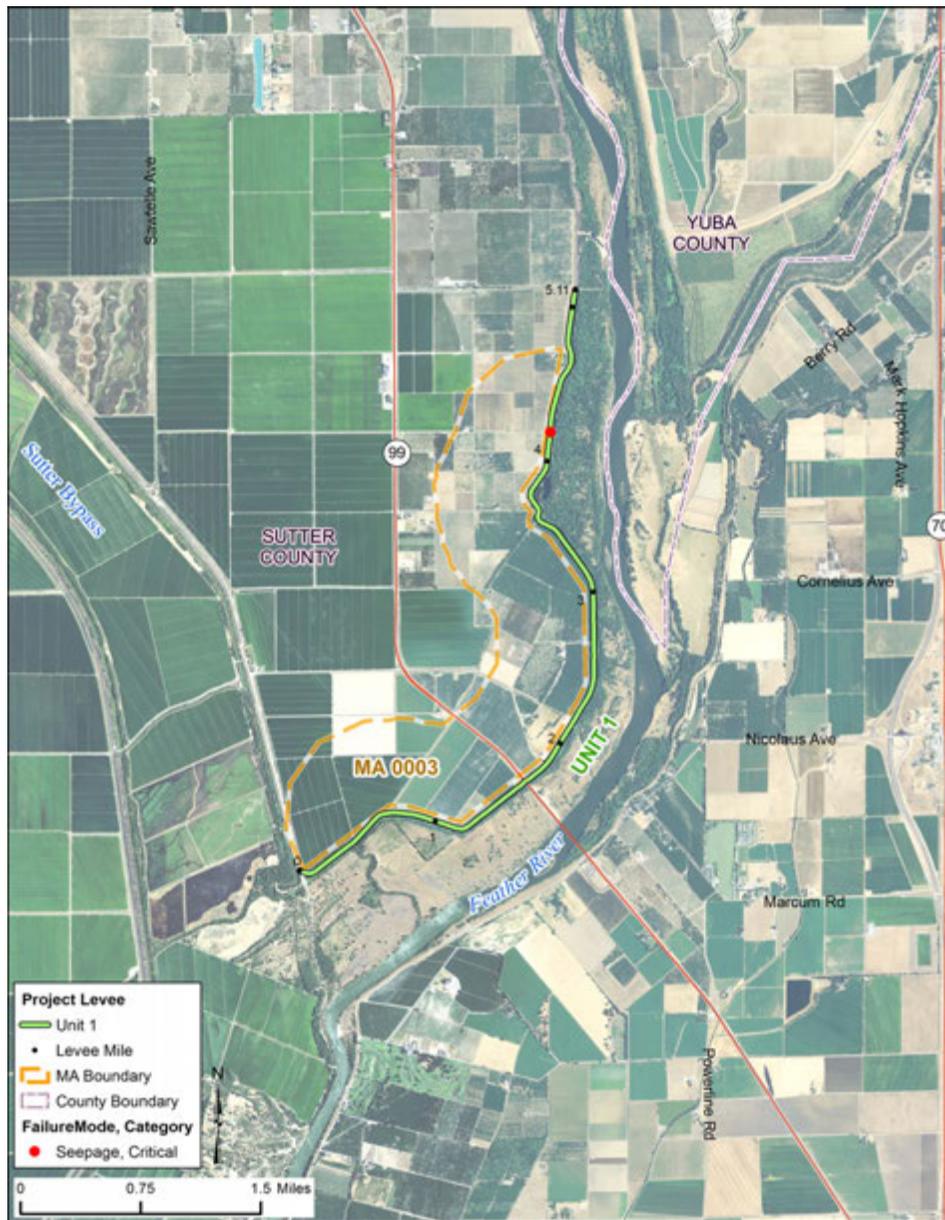
LMA Short Name : MA0003		Bank	Unit Length (Miles)
Unit No. 01	Feather River	RB	5.11

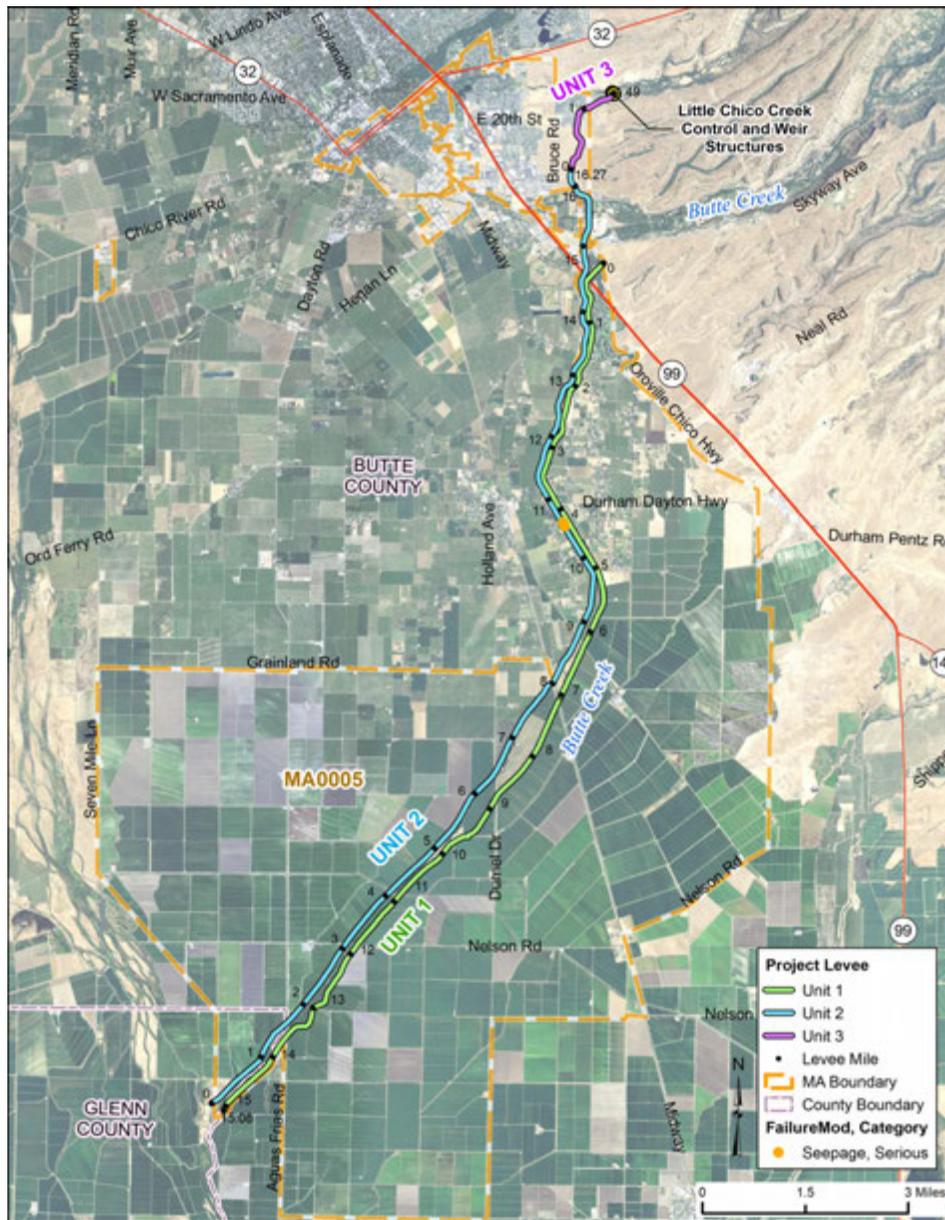
LMA Short Name : MA0005		Bank	Unit Length (Miles)
Unit No. 01	Butte Creek	LB	15.08
Unit No. 02	Butte Creek	RB	16.27
Unit No. 03	Little Chico Creek Diversion	LB	1.49

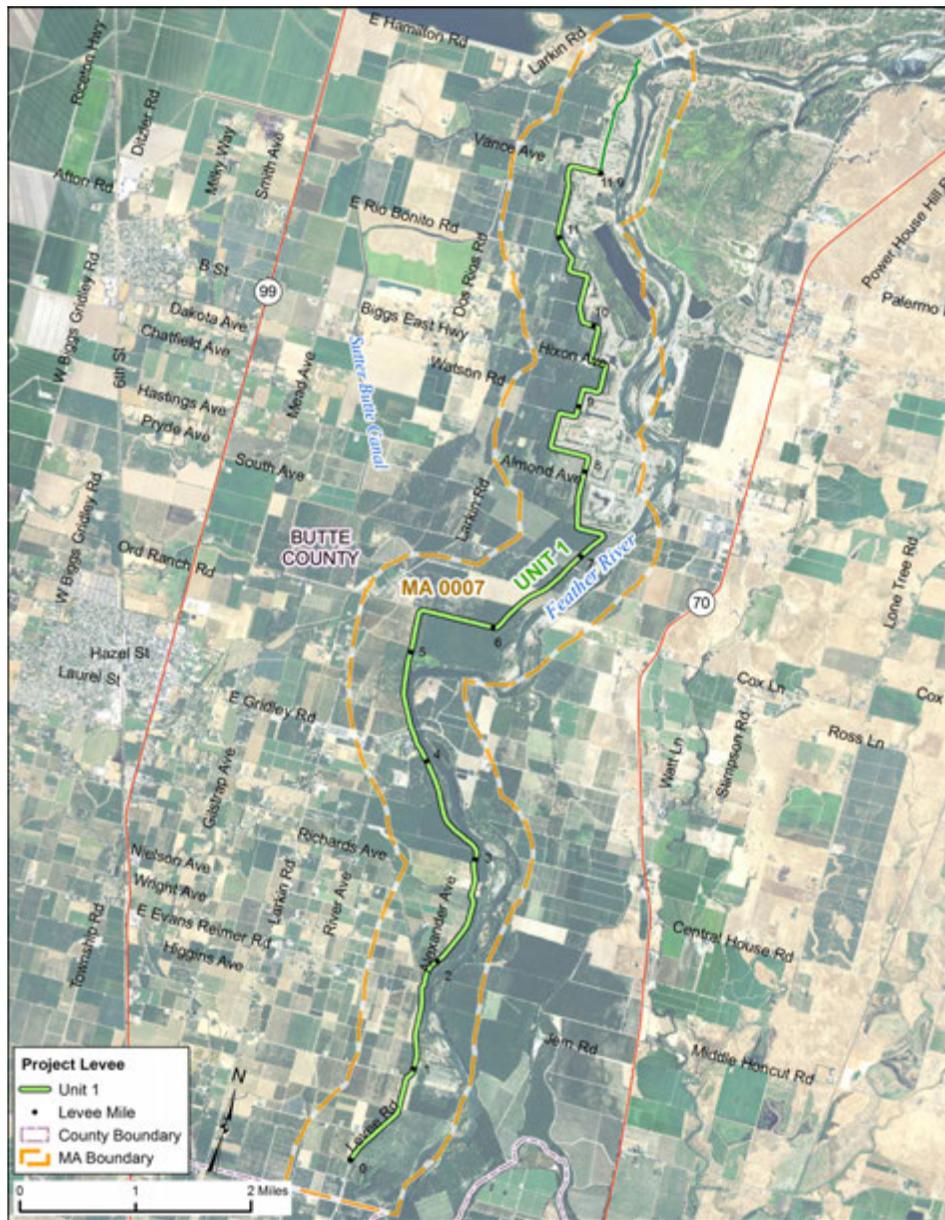
MA 7

LMA Short Name : MA0007		Bank	Unit Length (Miles)
Unit No. 01	Feather River	RB	11.90

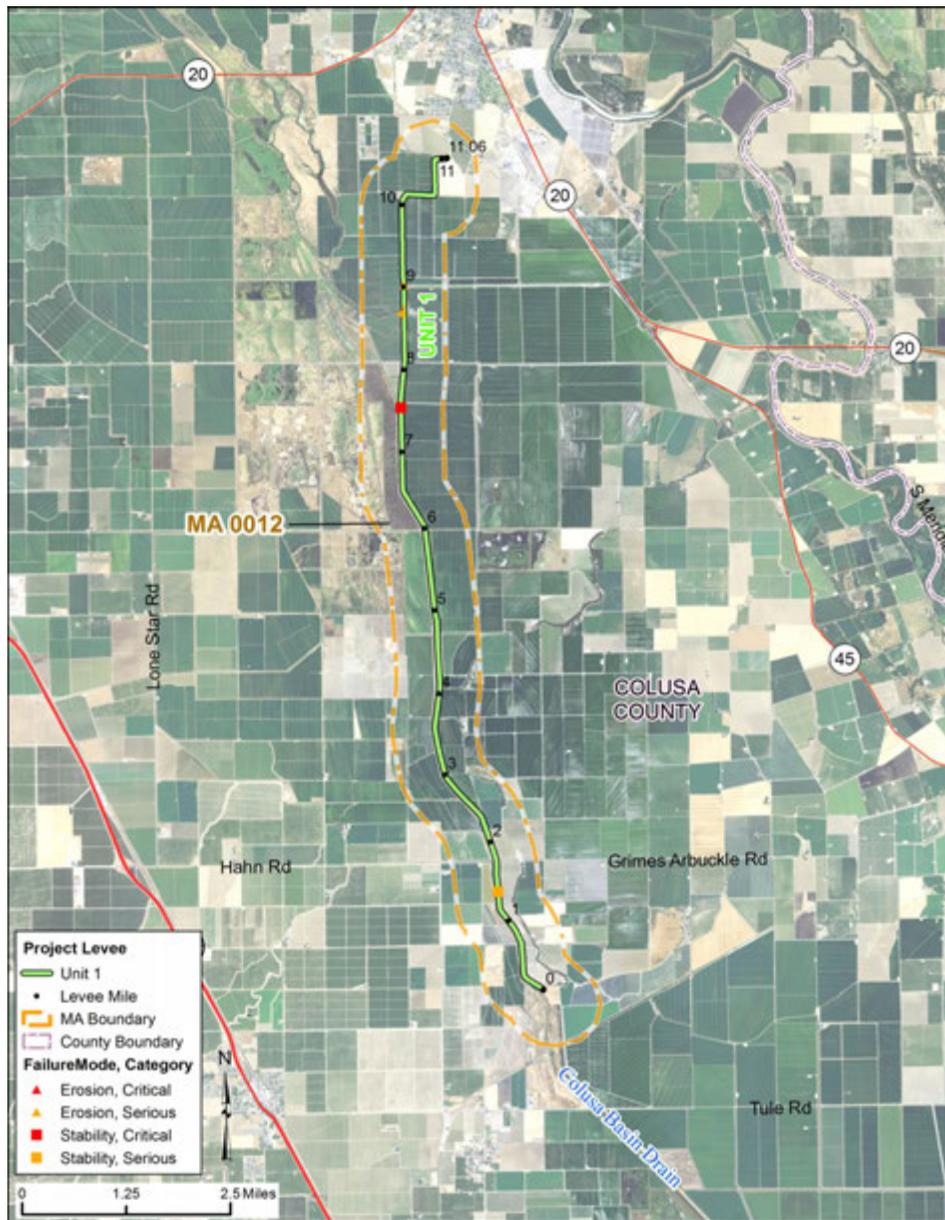
LMA Short Name : MA0012	Bank	Unit Length (Miles)
Unit No. 01 Colusa Drain	LB	11.06

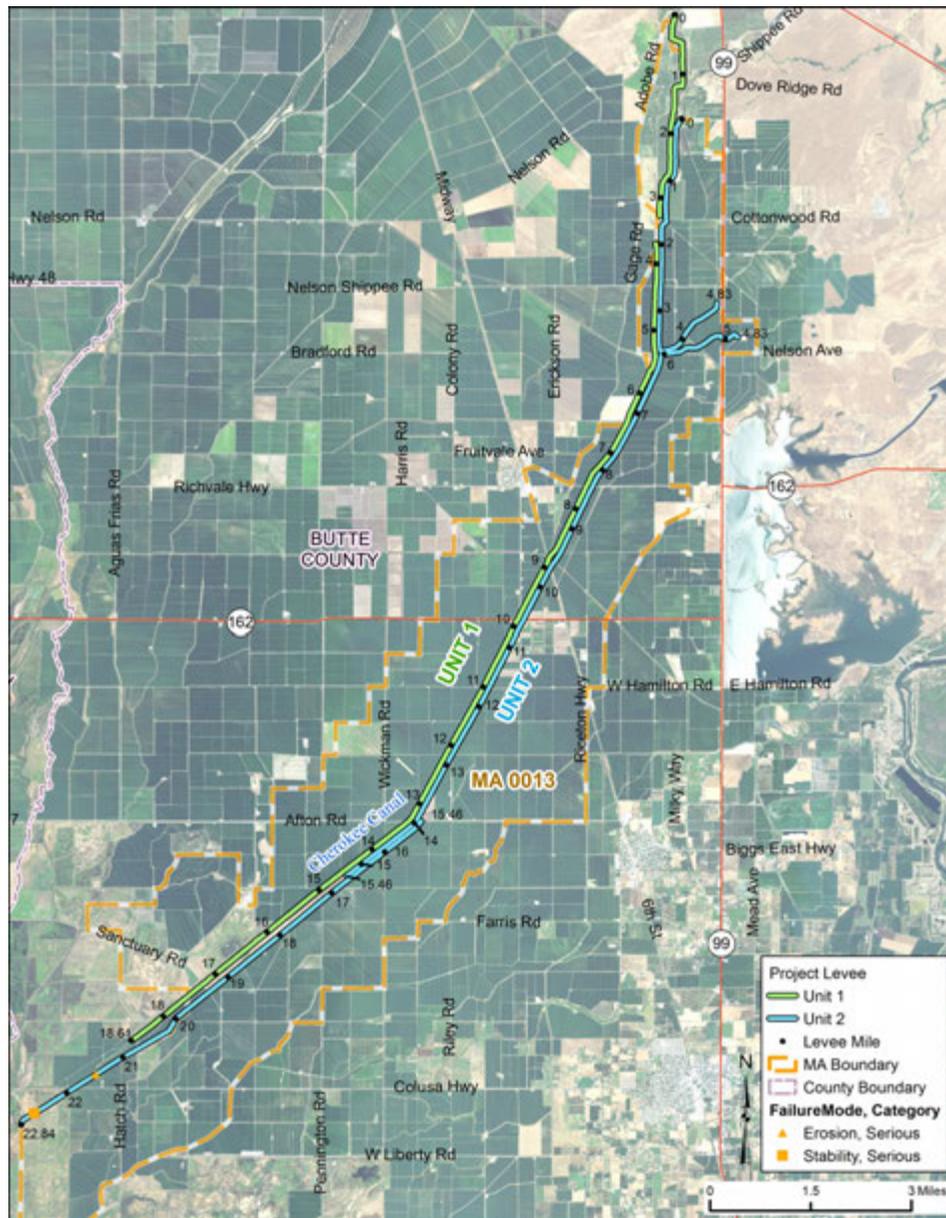
LMA Short Name : MA0013		Bank	Unit Length (Miles)
Unit No. 01	Cherokee Canal	RB	18.19
Unit No. 02	Cherokee Canal	LB	22.84

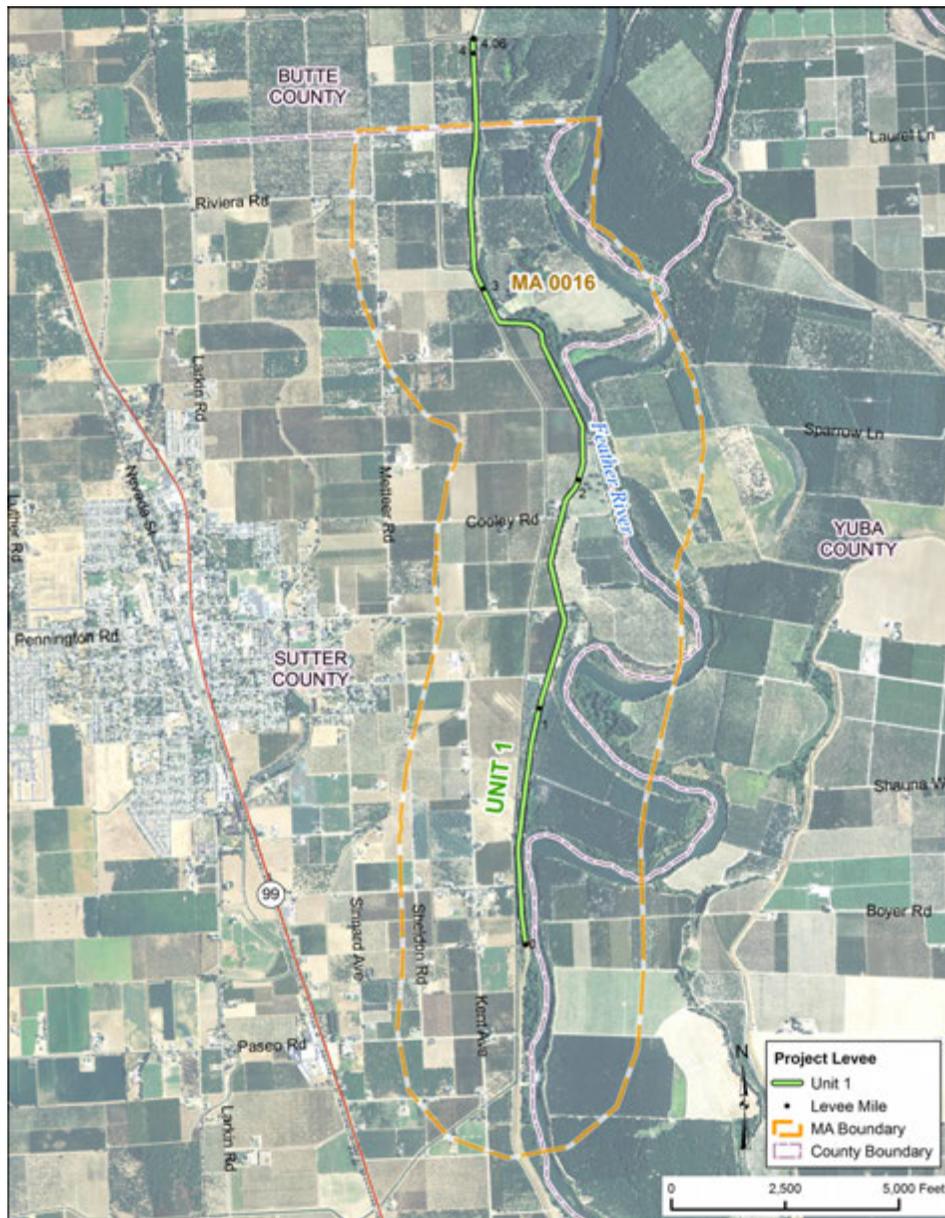
MA 16

LMA Short Name : MA0016		Bank	Unit Length (Miles)
Unit No. 01	Feather River	RB	4.06

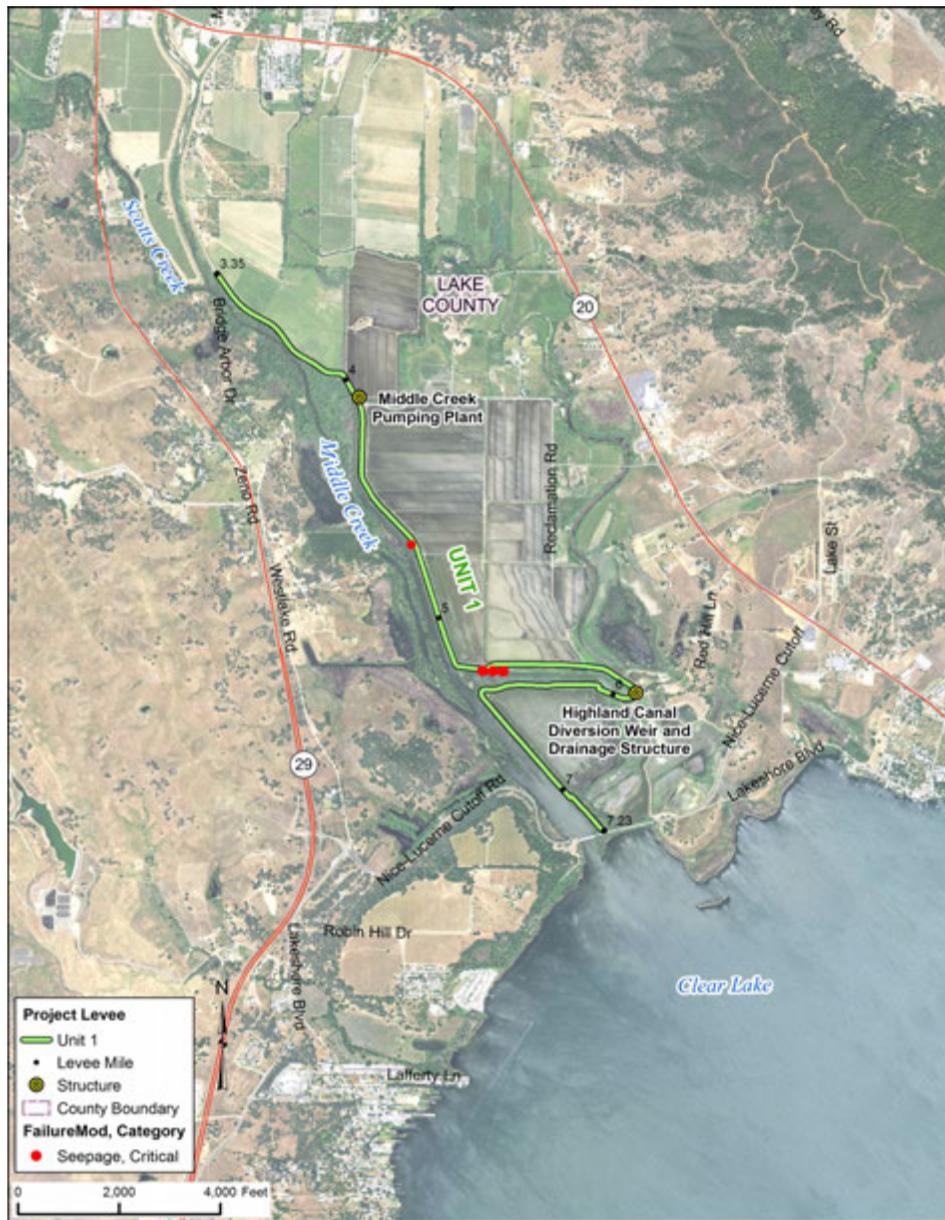
LMA Short Name : MA0017	Bank	Unit Length (Miles)
Unit No. 01 Lake County Sutter Maintenance Yard - Middle Creek	LB	3.87

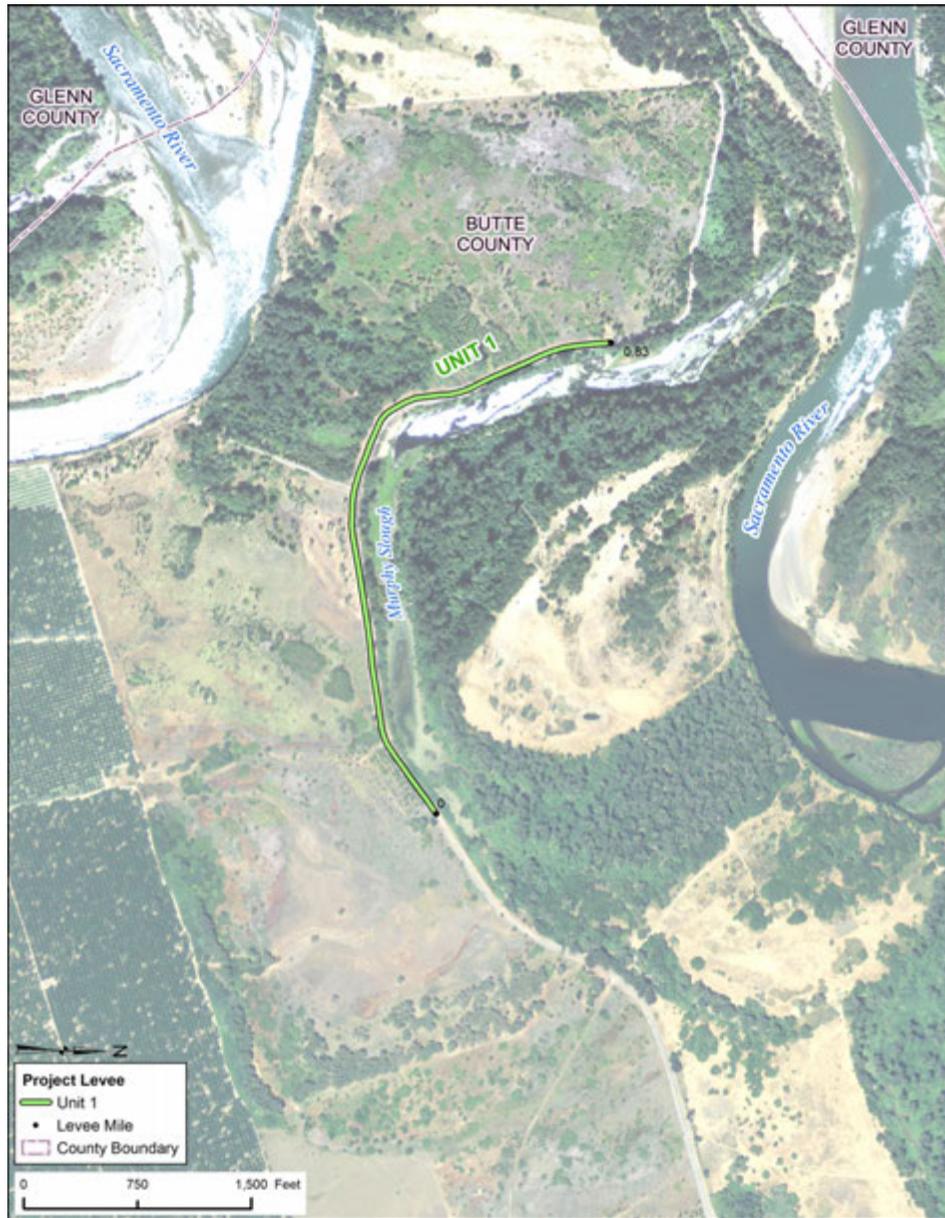
LMA Short Name : ST0014	Bank	Unit Length (Miles)
Unit No. 01 Murphy Slough at M&T Ranch	LB	0.83

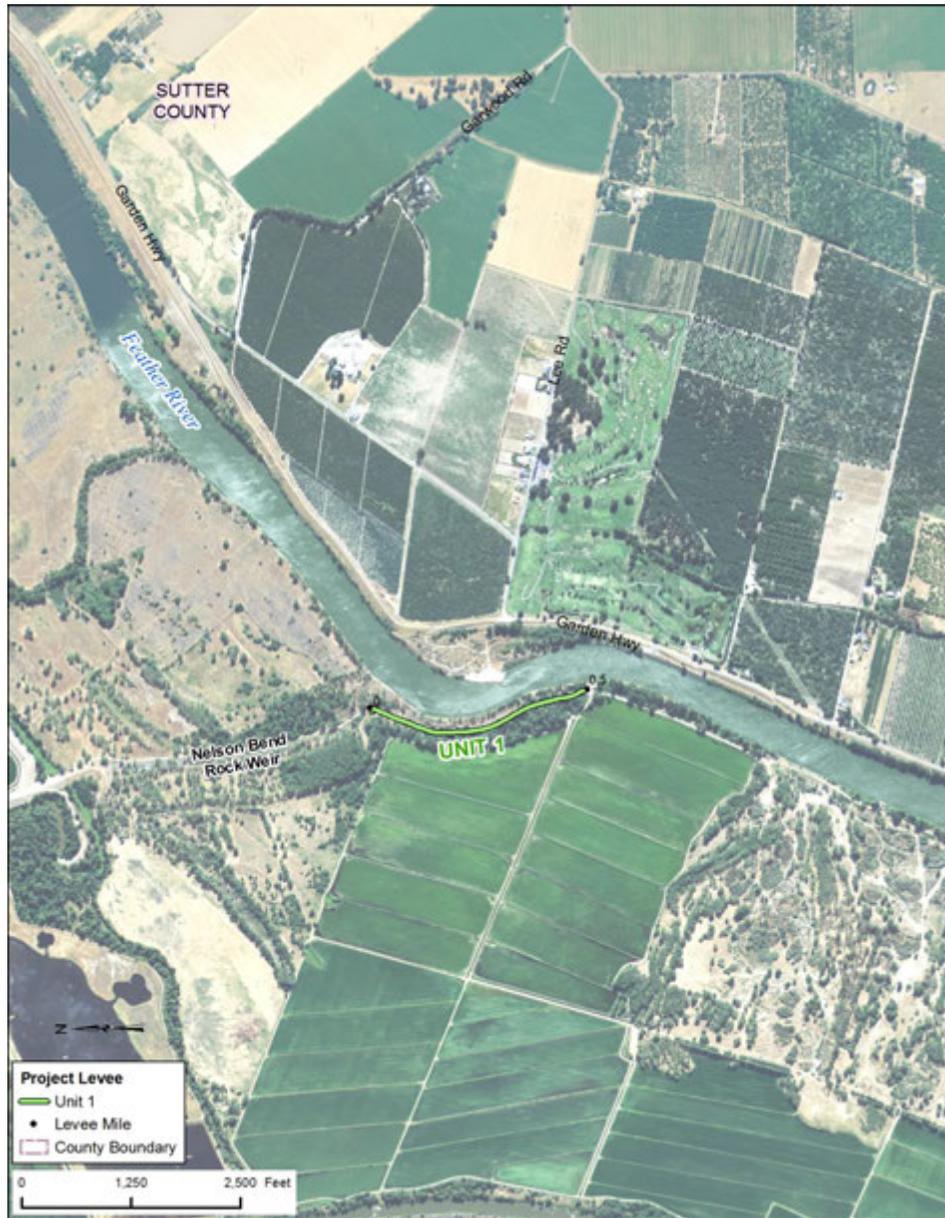
LMA Short Name : ST0006	Bank	Unit Length (Miles)
Unit No. 01 Feather River West Levee - Nelson Bend		0.50

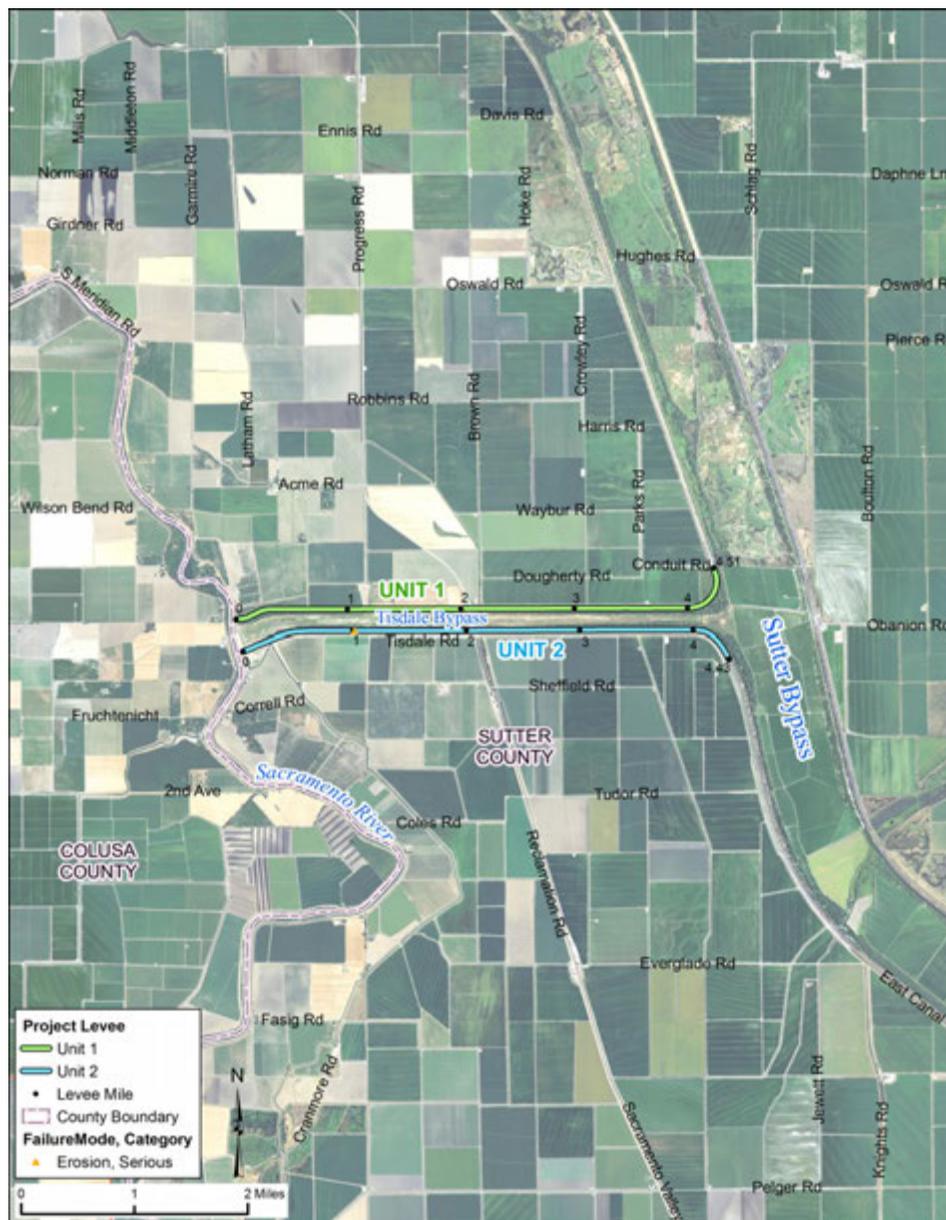
LMA Short Name : ST0009		Bank	Unit Length (Miles)
Unit No. 01	Tisdale Bypass	LB	4.51
Unit No. 02	Tisdale Bypass	RB	4.43

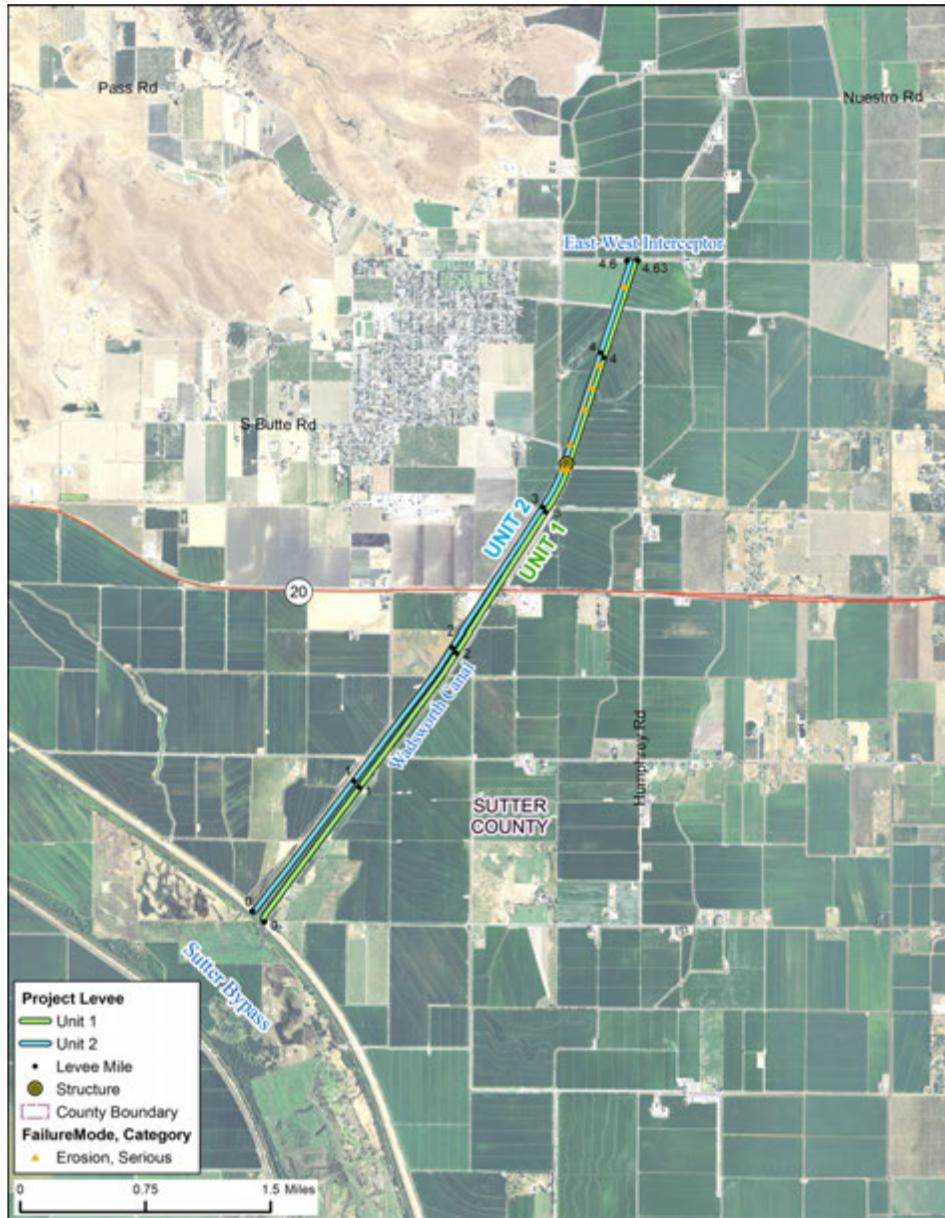
LMA Short Name : ST0010		Bank	Unit Length (Miles)
Unit No. 01	Wadsworth Canal	LB	4.63
Unit No. 02	Wadsworth Canal	RB	4.60
