2015

INSPECTION AND LOCAL MAINTAINING AGENCY REPORT OF THE CENTRAL VALLEY STATE-FEDERAL FLOOD PROTECTION SYSTEM

Department of Water Resources

Flood Project Integrity and Inspection Branch | Hydrology and Flood Operations Office | Division of Flood Management

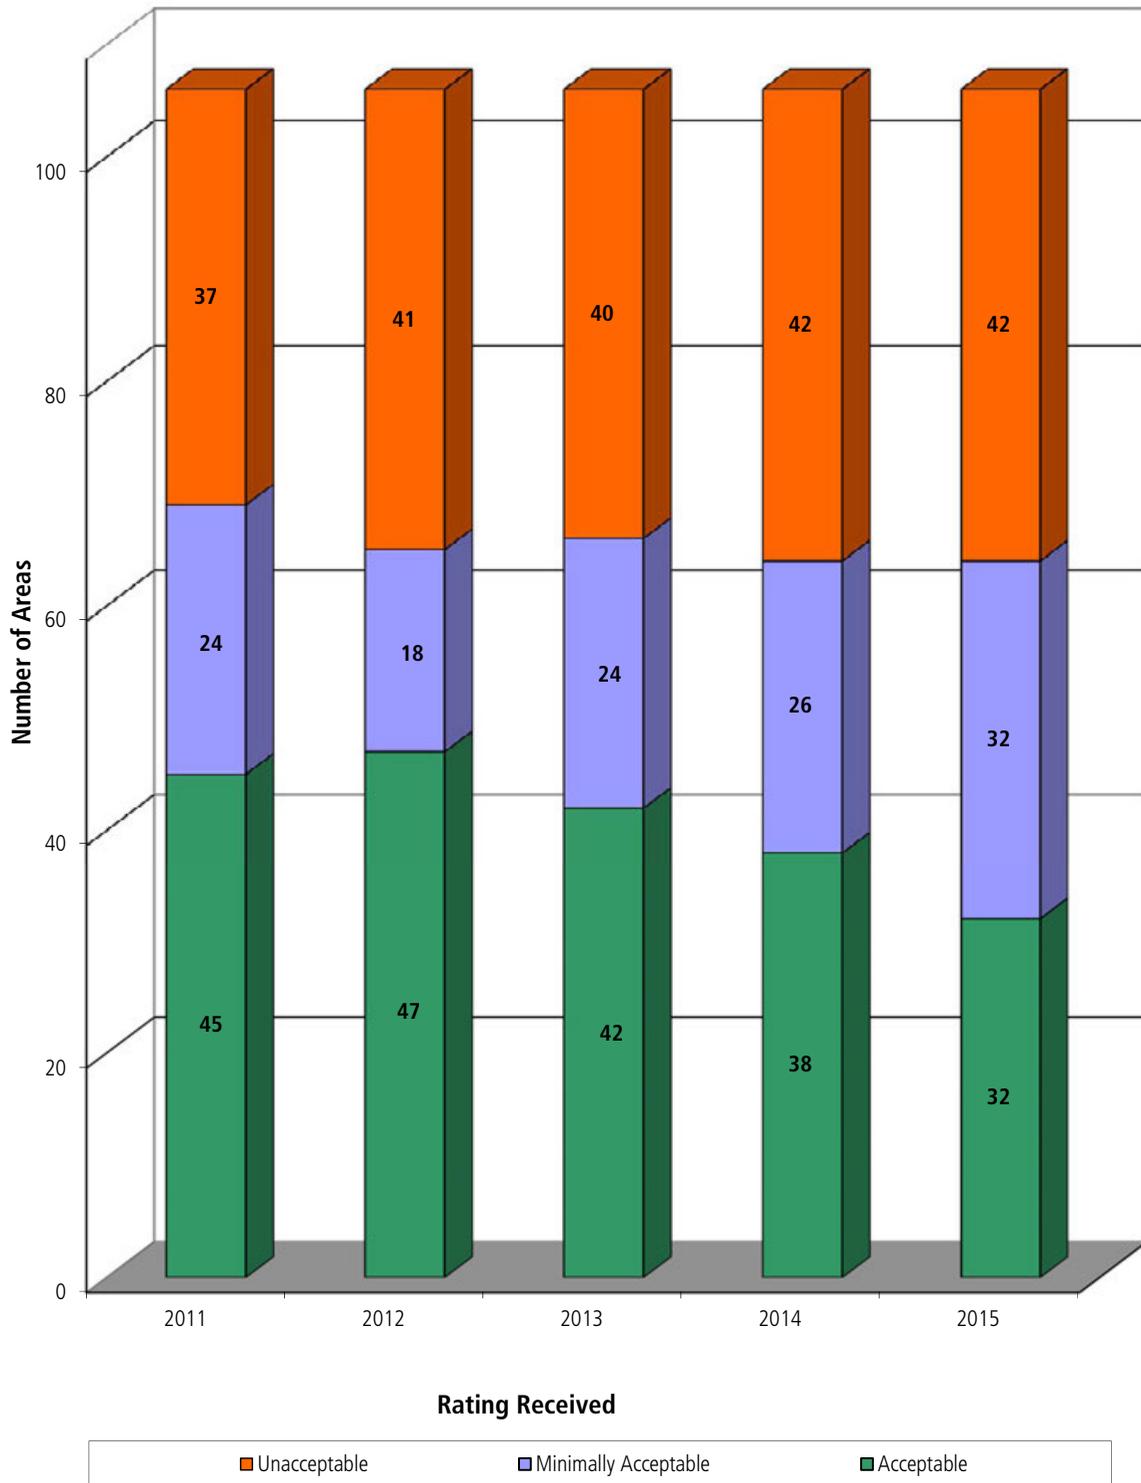
Figure 2-1: Summary of Area Maintenance Ratings for 2011 to 2015

Table 2-1 and Figure 2-1 show the numbers of Areas receiving each rating for 2011 through 2015.

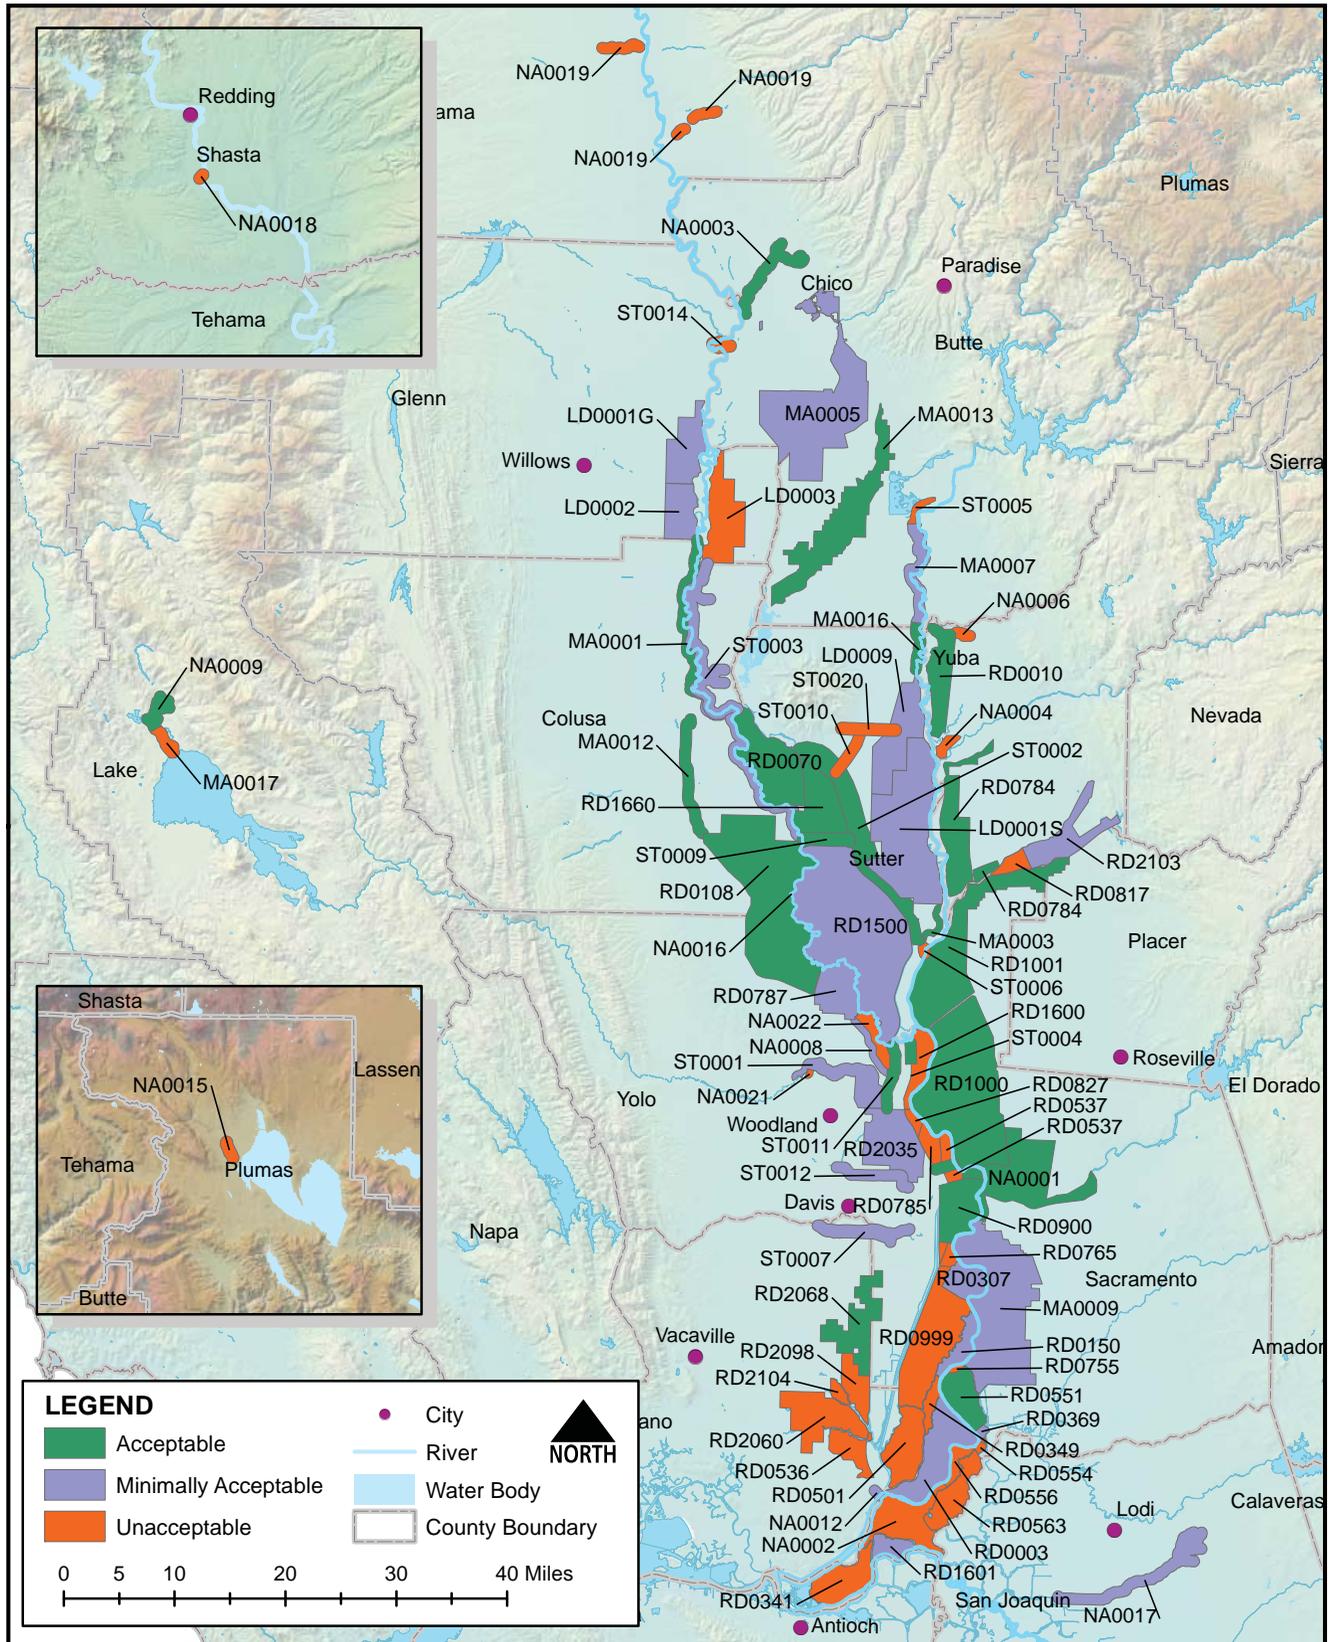
Figure E-5: Map of 2015 Local Maintaining Agency Ratings; Northern Area

- Figures E-5 and E-6 are maps of the Sacramento and San Joaquin systems, showing the location and rating of each LMA. To find the general location of an LMA, refer to Appendices A, B and C.
