# INSPECTION AND LOCAL MAINTAINING AGENCY REPORT OF THE CENTRAL VALLEY STATE-FEDERAL FLOOD PROTECTION SYSTEM

Code of Federal Regulations, Title 33, Section 208.10

Department of Water Resources

Flood Project Integrity and Inspection Branch | Hydrology and Flood Operations Office | Division of Flood Management

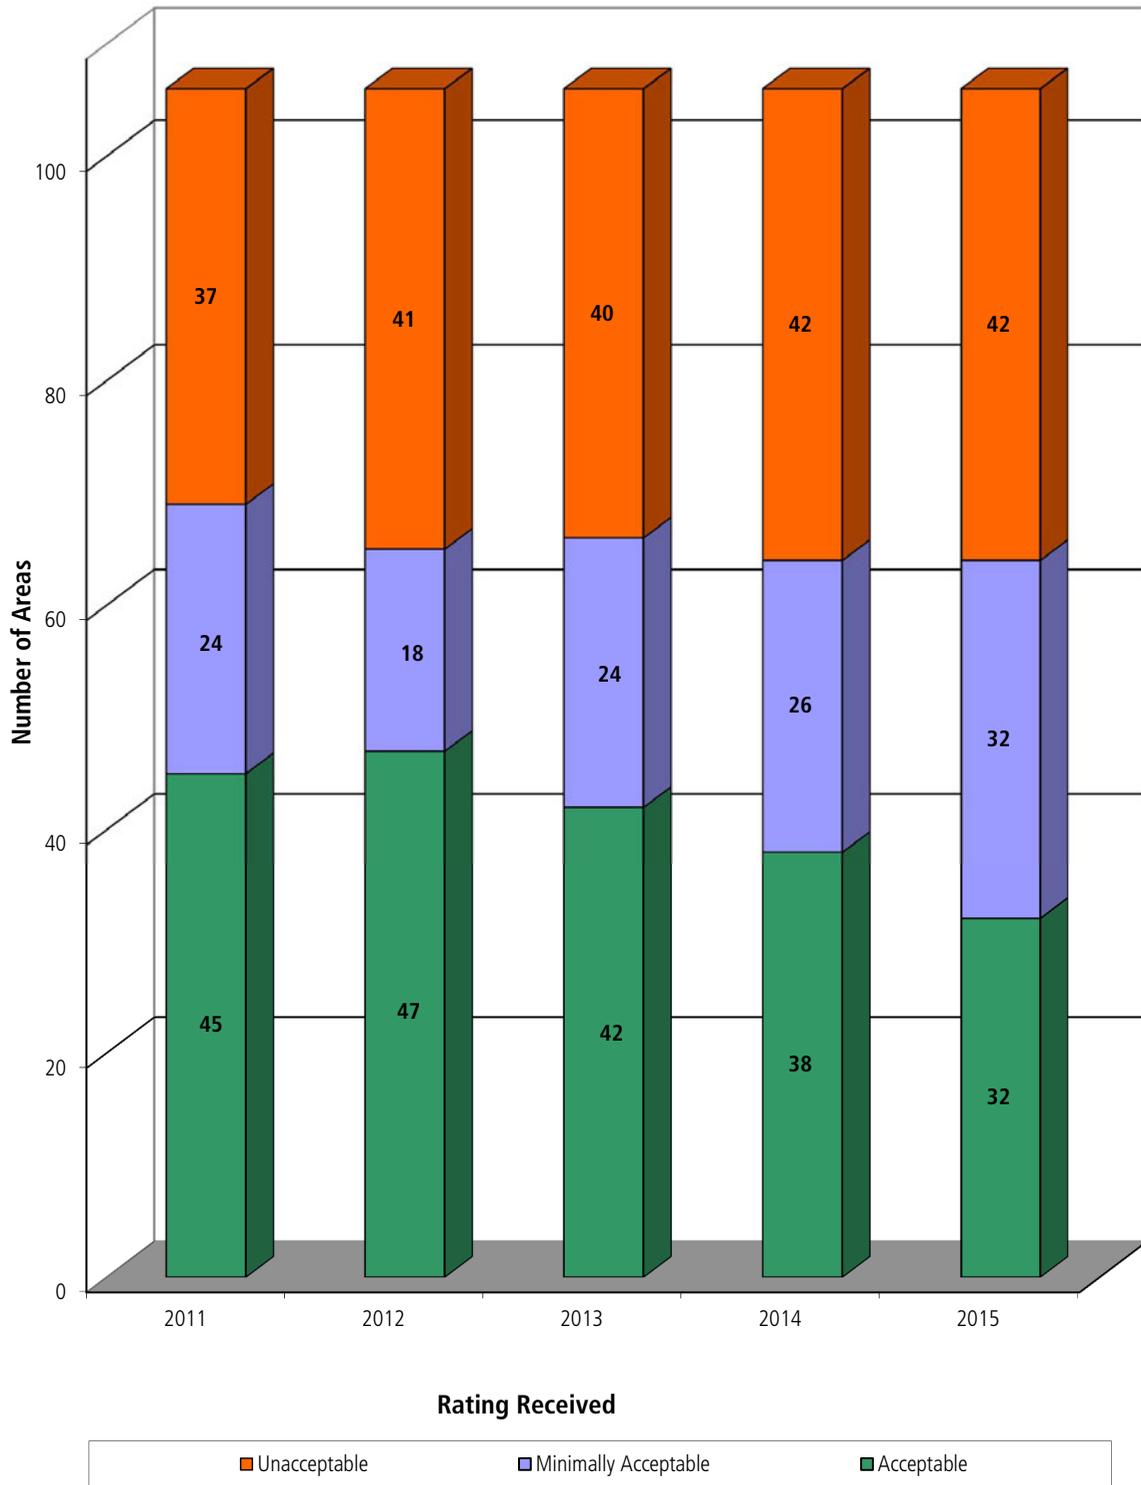
Figure 2-1: Summary of Area Maintenance Ratings for 2011 to 2015

Table 2-1 and Figure 2-1 show the numbers of Areas receiving each rating for 2011 through 2015.

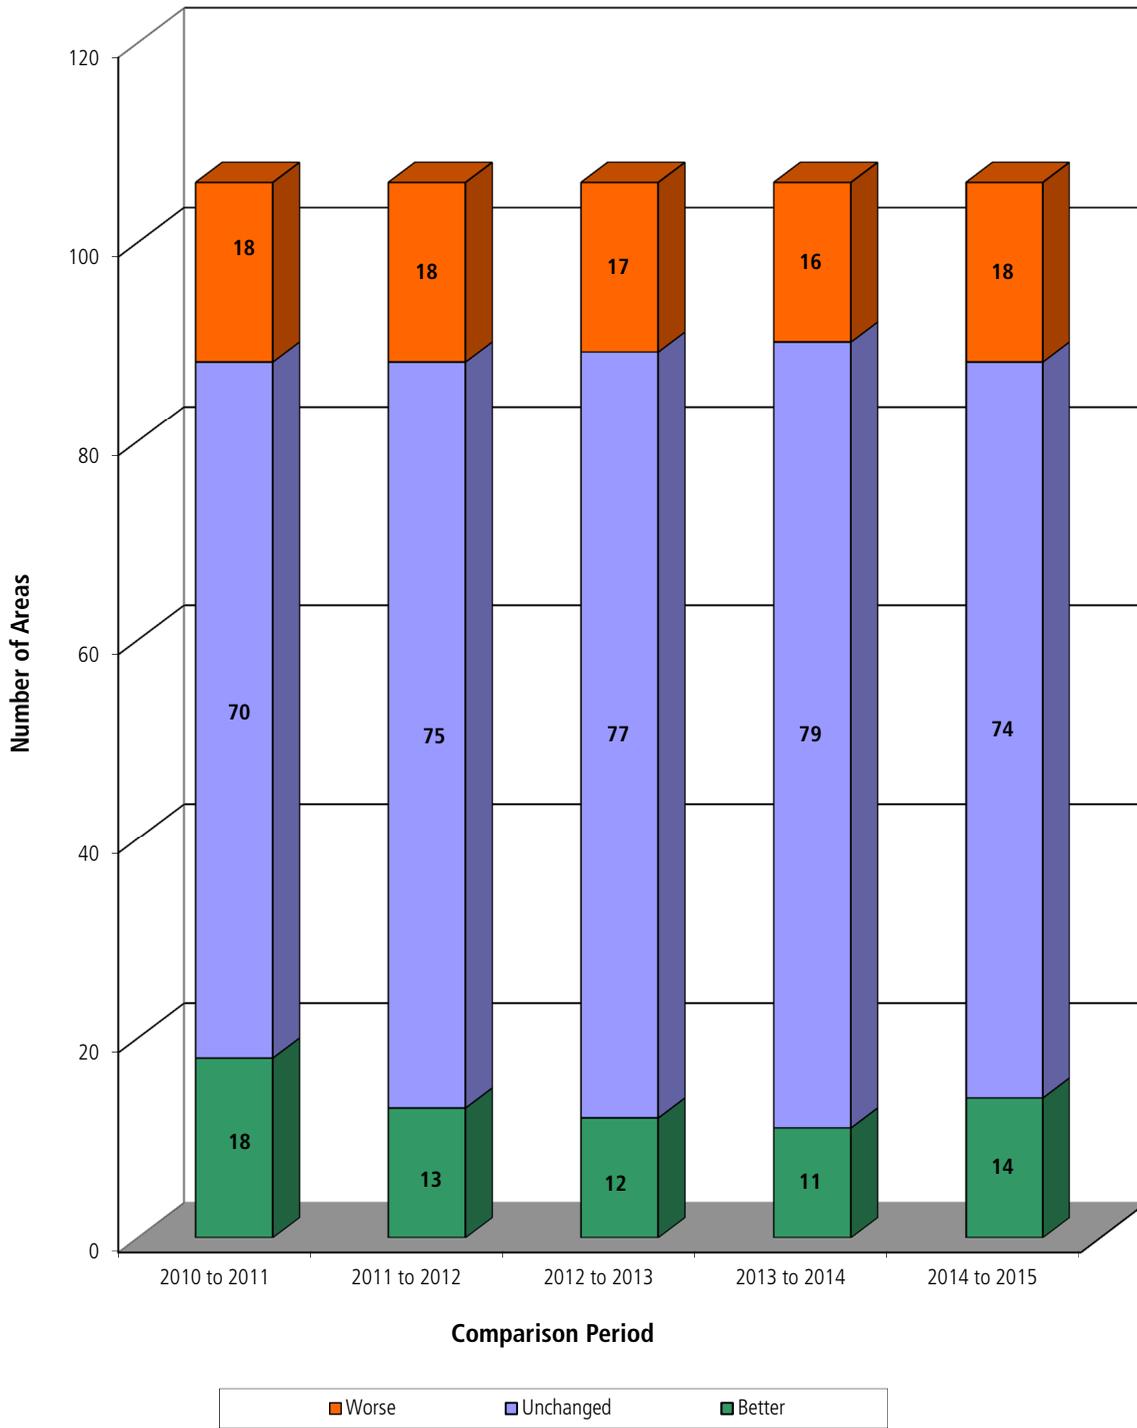
Figure 2-2: Area Maintenance Rating Changes for 2011 to 2015

Figure 2-2 shows the number of Areas that received better, unchanged, or worse ratings from 2011 through 2015. Ratings appear to be on a slight, but steady decline since 2012 with 2015 being no exception. LMRs contain more detailed information on each LMA's rating and the identified issues that lead to that rating. Appendix F provides a detailed explanation of the threshold percentages and the determination of overall ratings.

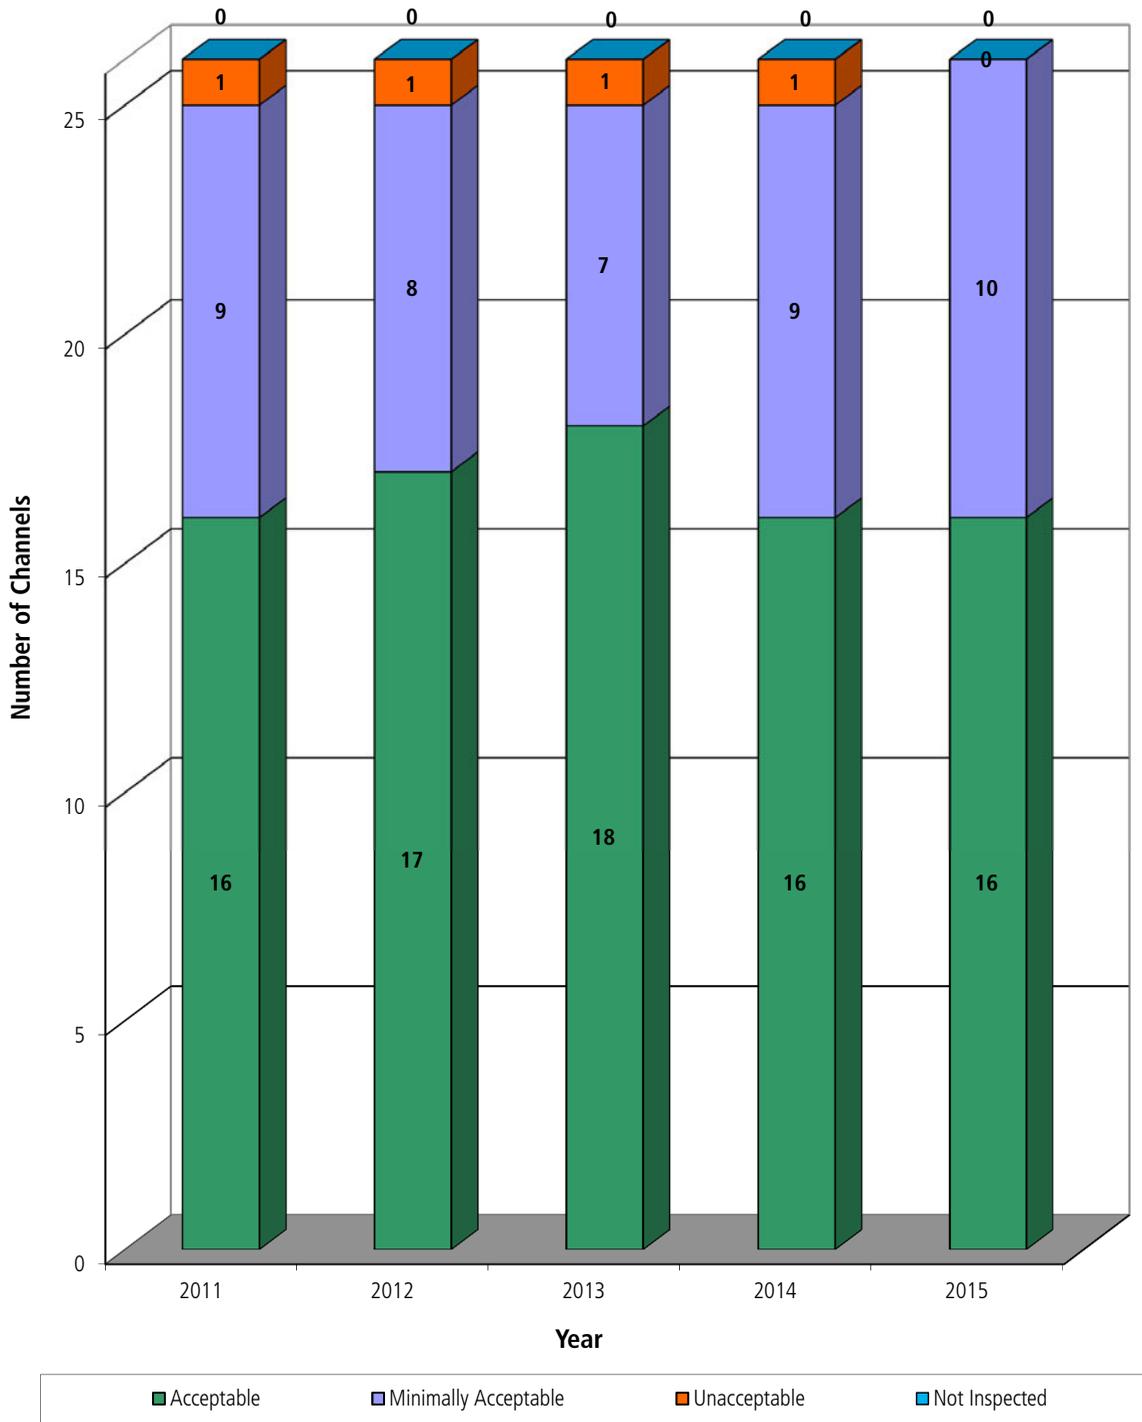
Figure 3-1: Comparison of Overall Channel Ratings for 2011 to 2015

No channels were rated as Unacceptable in 2015, 10 were rated as Minimally Acceptable and 16 channels were rated as acceptable, which is slightly better than 2014. Figure 3-1 shows the progression of maintenance ratings from 2011 through 2015.

Appendix F details the method for determining overall ratings. Table 3-1 and Figure 3-1 show the numbers of each rating for the years 2011 through 2015.

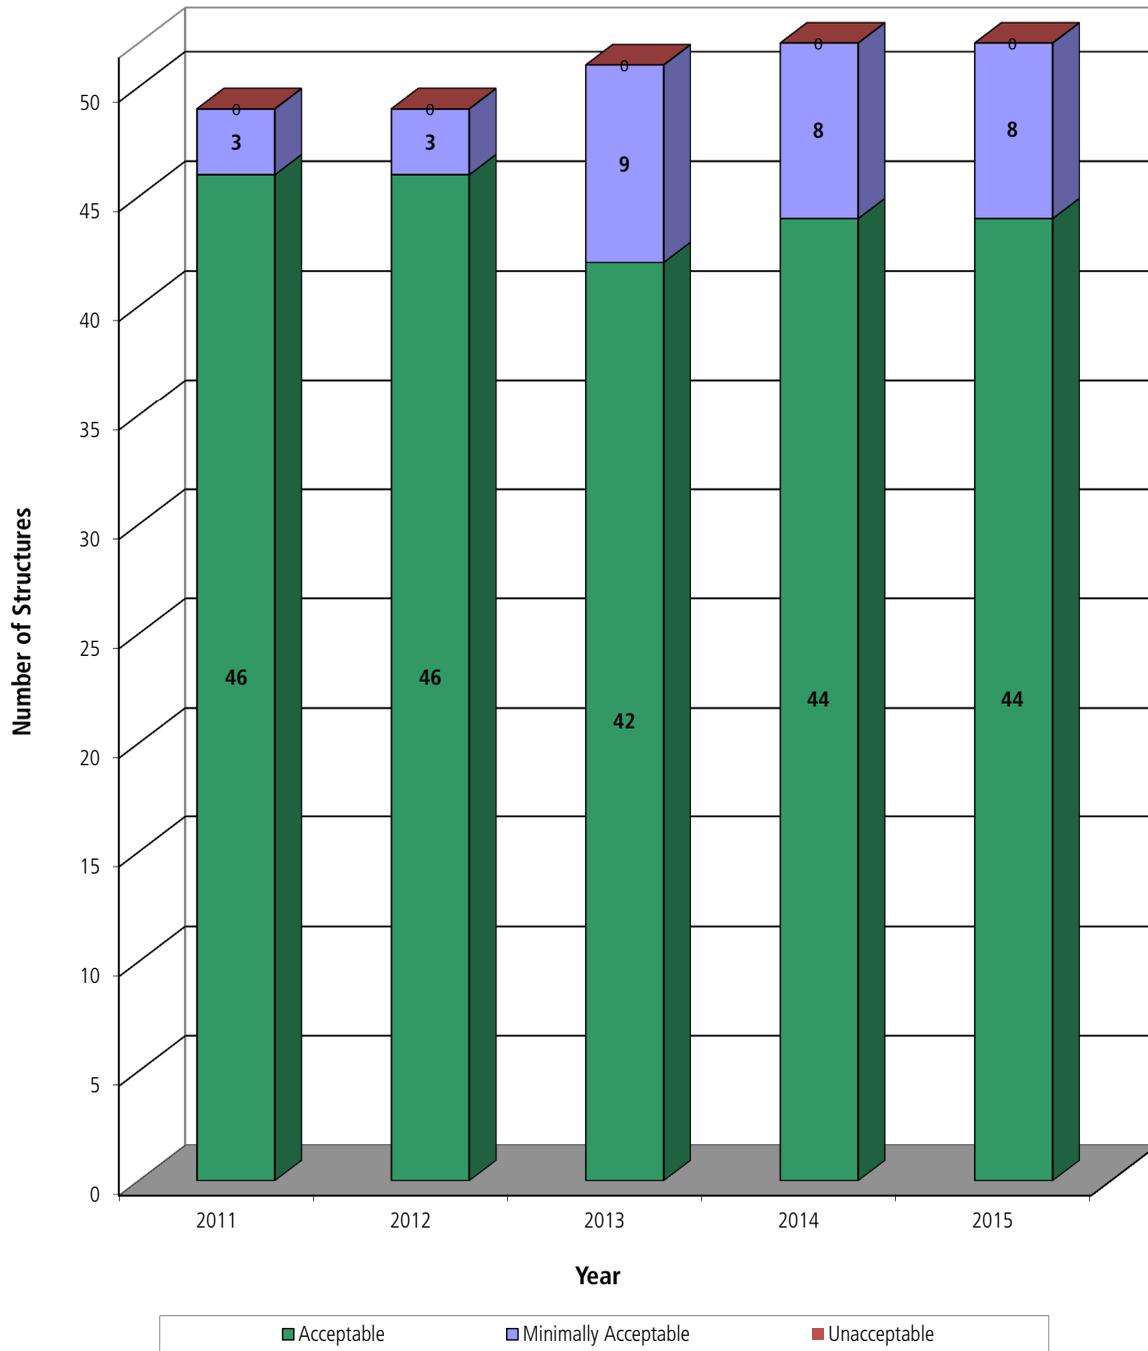
Figure 4-1: Comparison of Overall Structure Ratings for 2011 to 2015

The method for determining overall ratings is similar to the one used for channel inspections and is described in Appendix F. Table 4-1 shows the numbers of each rating for 2011-2015 for all structures. Figure 4-1 and Table 4-2 show ratings for each structure, while Figure 4-2 and Table 4-3 show ratings for each pumping plant. The LMAs performance on structure maintenance has fluctuated slightly since 2011, but not one has received an unacceptable rating in that time. FPIS staff have worked with DWR, the USACE, and the CVFPB staff to better understand responsibilities regarding structures. No maintaining agency has been identified for Paradise Dam, but attempts to clarify this are ongoing. FPIS staff continues to research authorizations for the structures and will continue to refine what structures are inspected during these inspections.

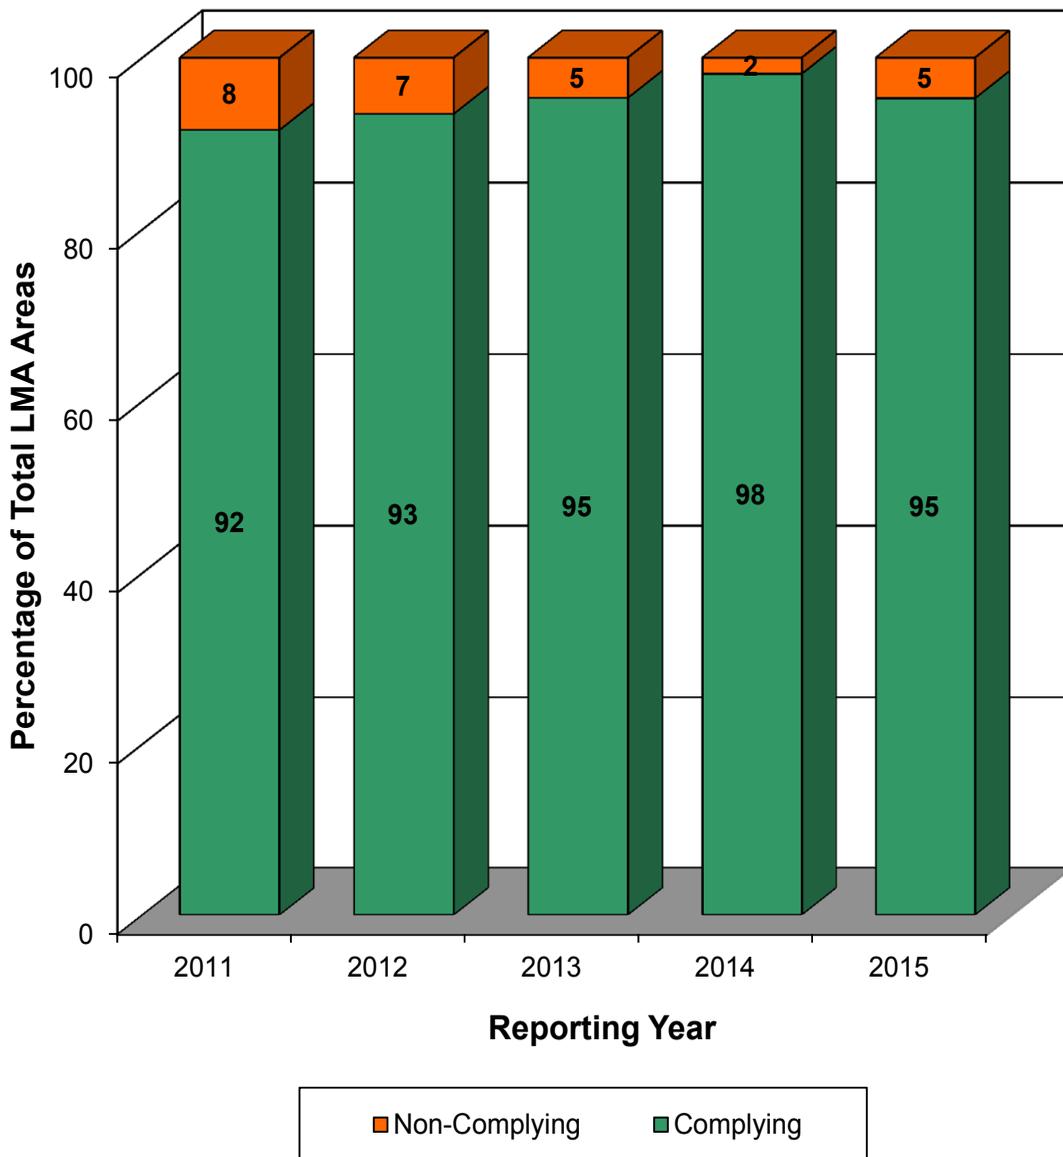
**Figure 6-1: Reporting Compliance for 2011 to 2015**

There has been an increasing trend (Figure 6-1) of reporting compliance by LMAs during the past five years. A system wide comparison of reporting compliance (Figure 6-2) shows at least 90% of Areas belonging to the Sacramento system and 92% of Areas belonging to the San Joaquin system have reported in the last five years. Overall, about 95% of Areas have submitted their report this year.

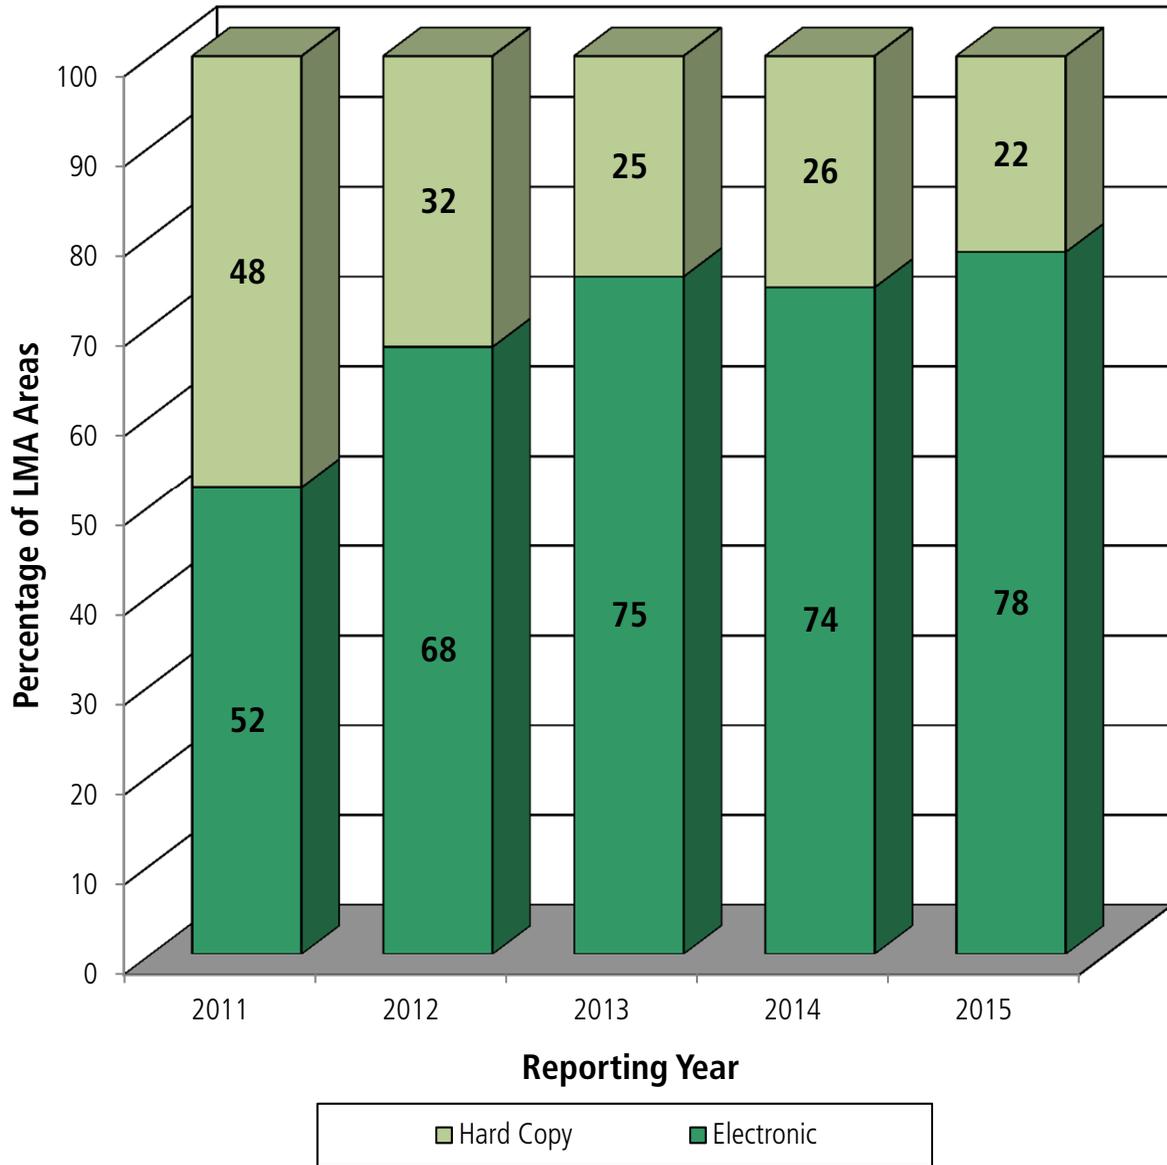
Figure 6-3: Reporting Mode for 2011 to 2015

The increasing trend of electronic reporting is continuing and is shown in Figure 6-3. This year, about 78% of the Areas submitted reports through DWR’s web-based LMA Reporting tool. This may be attributed to continuous outreach activities and enhancement of reporting infrastructure since the inception of the tool.

- Since 2008, DWR has been facilitating electronic submission and strongly encouraging LMAs to use the LMA Reporting Website. In 2015 about 78 percent of reporting LMAs reported electronically. Details of DWR outreach activities for electronic submission and other activities are provided in Figure 6-3.

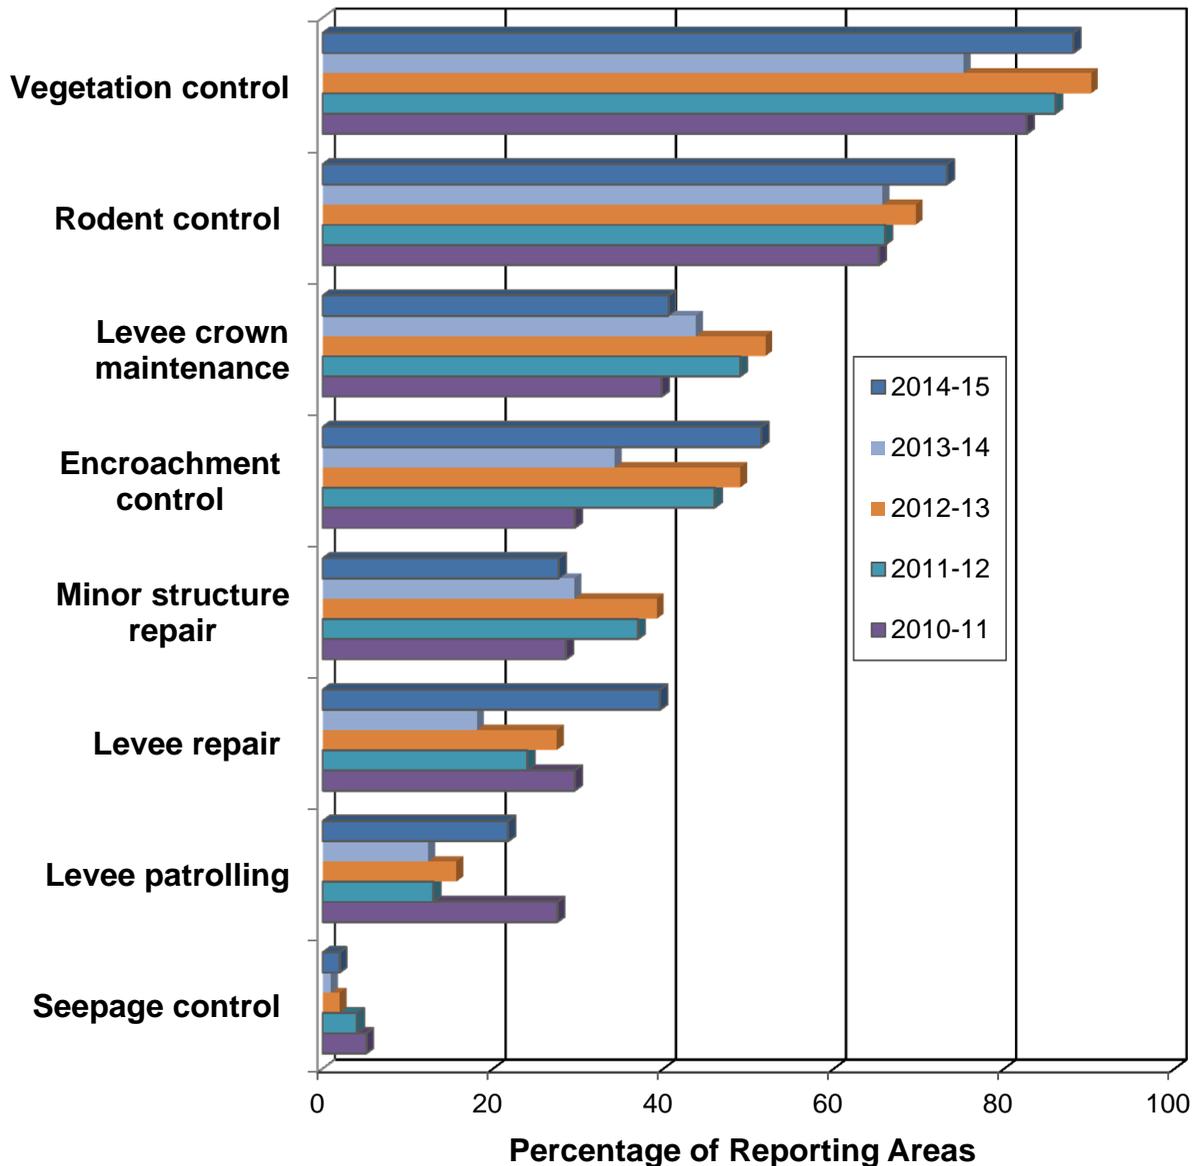
**Figure 6-4: Key Performed Activities Reported for 2011 to 2015**

About 99% of reporting Areas provided information on the summary of maintenance activities. As in the previous years, routine vegetation maintenance activities (burning, slope dragging, cutting, trimming, spraying), rodent control, levee crown grading, roadway maintenance and encroachment dominated LMA maintenance activities for fiscal year 2014-15. Figure 6-4 shows the activities Areas reported as having performed as a percentage of the total number of Areas who reported information during that year. Other reported key activities include minor structural repairs (mile markers, gates, barricades, and miscellaneous signs maintenance and repair), and minor levee repairs (erosion repair, hole grouting, revetment, rip-rap and slope repair). Some LMAs also reported levee patrolling and other planning activities such as preparation of five year maintenance plans.

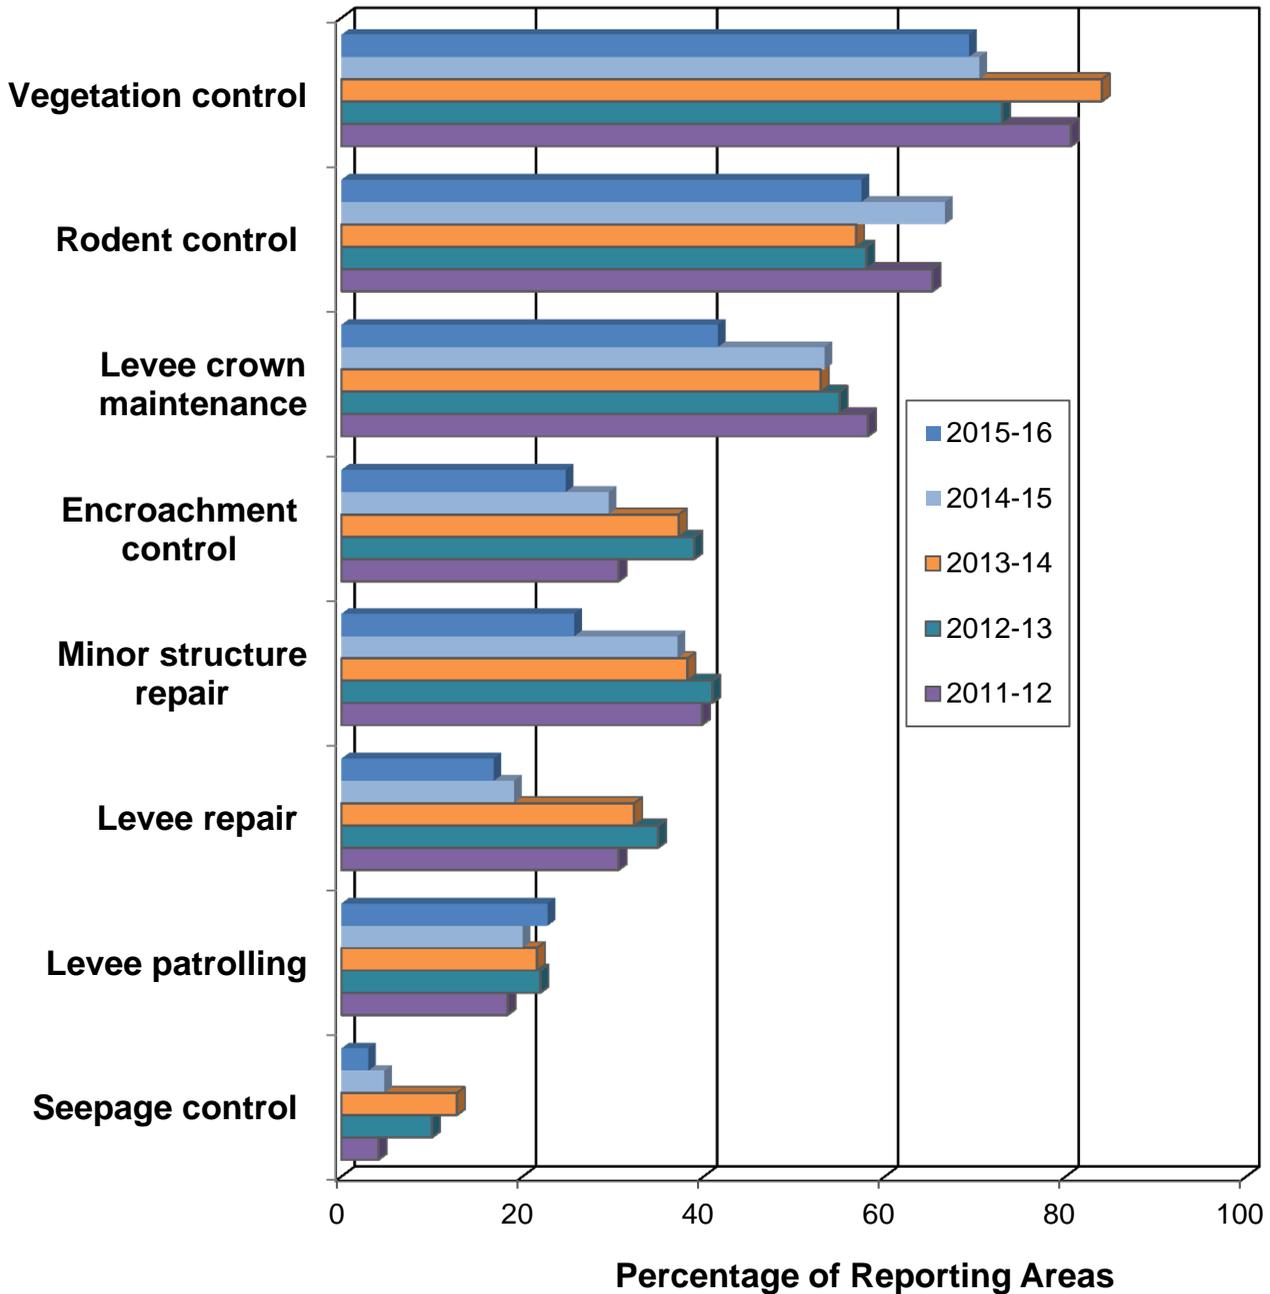
**Figure 6-5: Key Planned Activities Reported for 2012 to 2016**

A similar percentage of reporting Areas also provided information on the planned maintenance activities for the current fiscal year 2015-16. The planned activities reflect similar maintenance priorities as performed maintenance activities in fiscal year 2014-15. Figure 6-5 shows planned activities that were reported by LMAs.

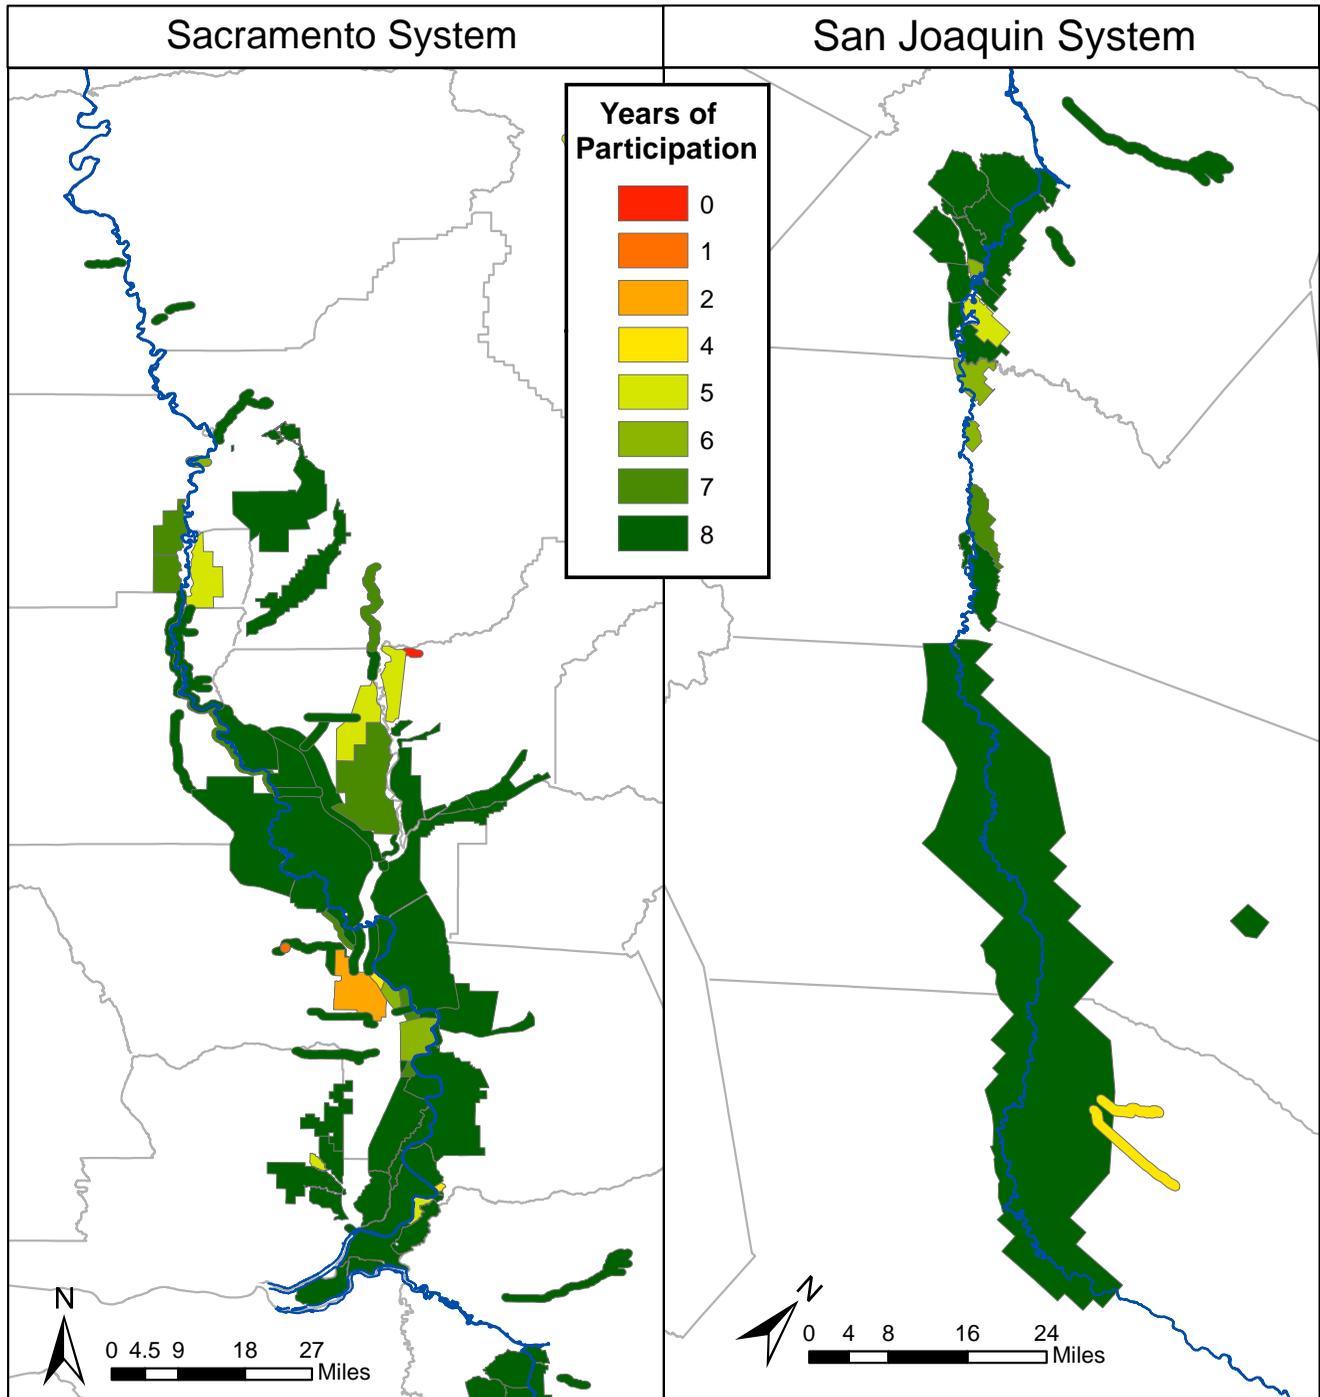
**Figure 6-6: Compliance by Reporting Area for 2008 to 2015**

Figure 6-6 shows a graphical representation of LMA’s compliance with the program for both the Sacramento and San Joaquin systems from 2008 through 2015. For the most part, both Sacramento and San Joaquin system LMAs complied with the

program for majority of the years since 2008. The figure also shows that there is only one LMA in the Sacramento system that never reported to the program. On the contrary, there are no single LMAs in the San Joaquin system that never reported to the program.

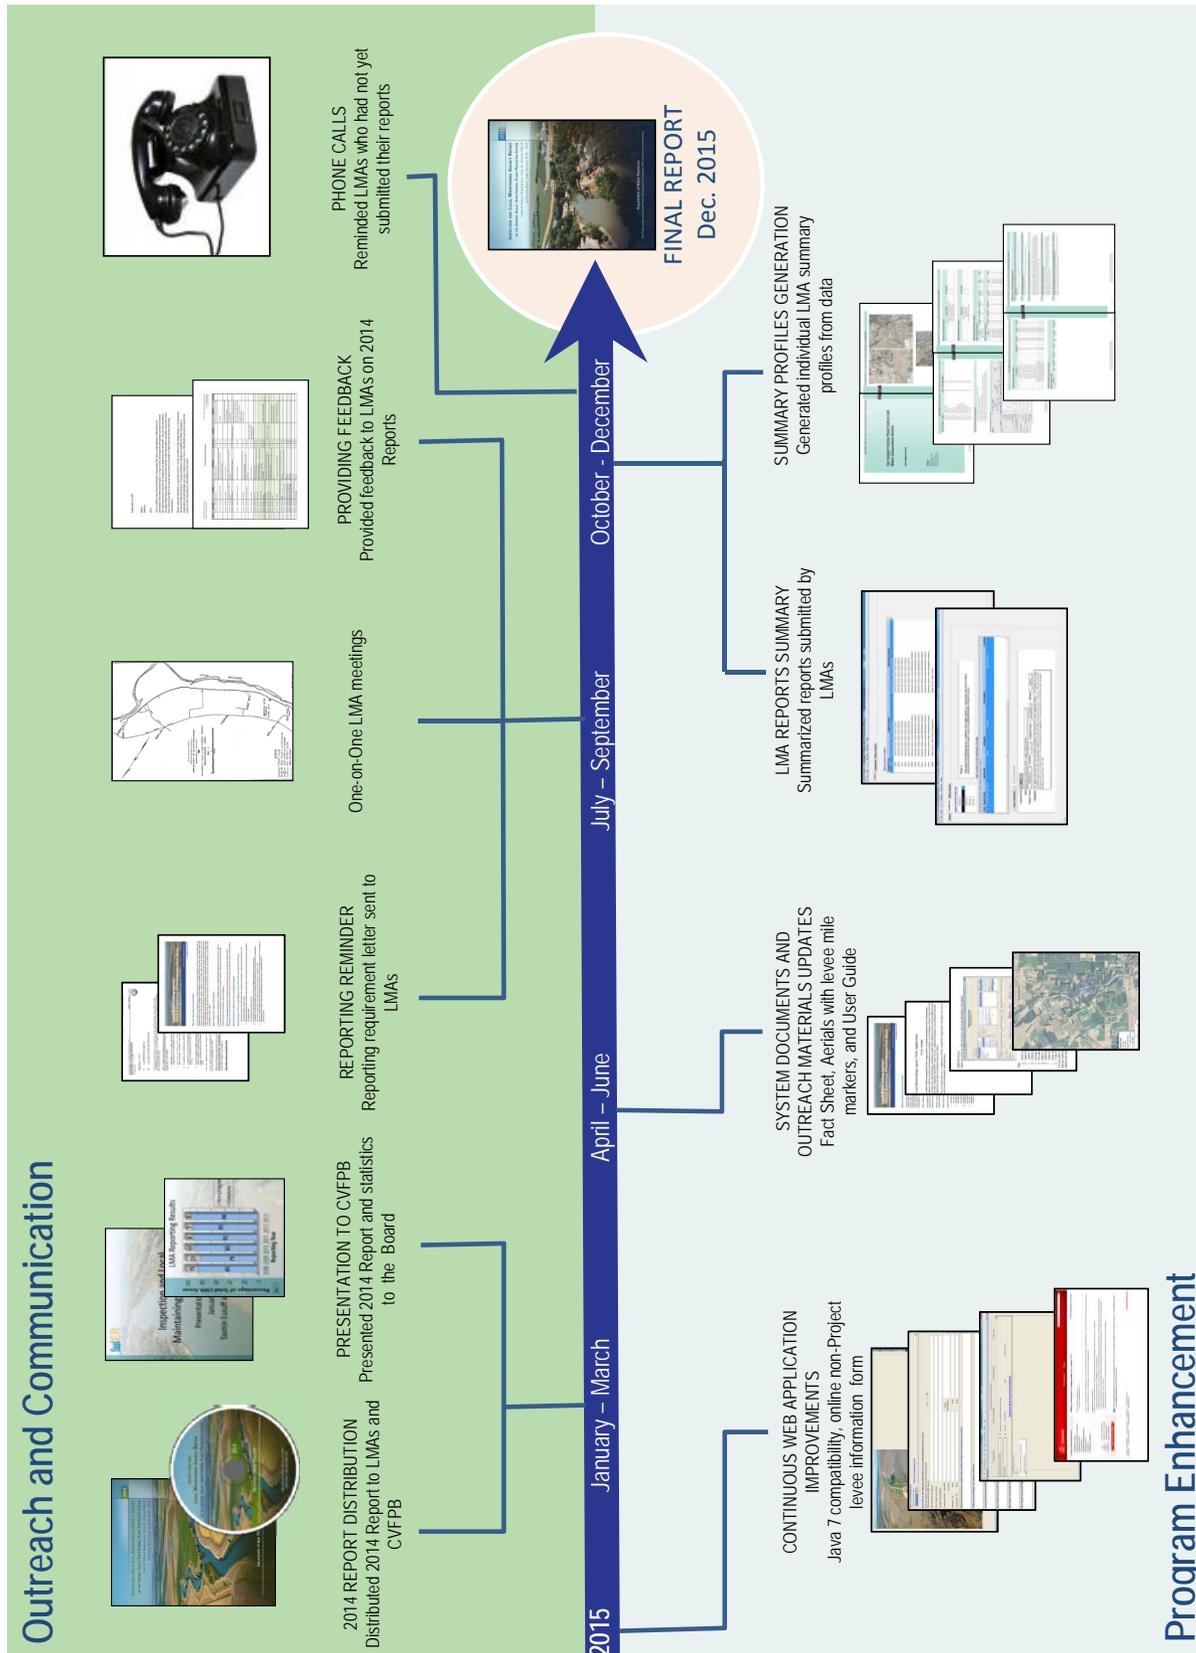
Figure 6-7: LMA Reporting Program Activities

DWR recognizes that the requirements of CWC Section 9140 placed a new reporting burden on LMAs. To help make reporting easier, DWR developed an outreach program and a web-based reporting tool to assist LMAs. DWR notified LMAs of the new reporting requirements, developed electronic and hard copy reporting options, and held a series of presentations and workshops. The process continues today, with DWR soliciting feedback from LMAs to improve the program. The following subsections and Figure 6-7 describe the chronology of the outreach process for 2015.
