Appendix **A**

Sacramento River Individual Agency Summary Reports

A total of 61 LMAs and 82 local reporting areas for Project Levees/Structures/Channels are included in the Sacramento River Flood Control Project. Appendix A includes an index to Sacramento River System LMAs, a map to show the locations of each reporting area, and individual LMA summary profiles. Appendix A includes:

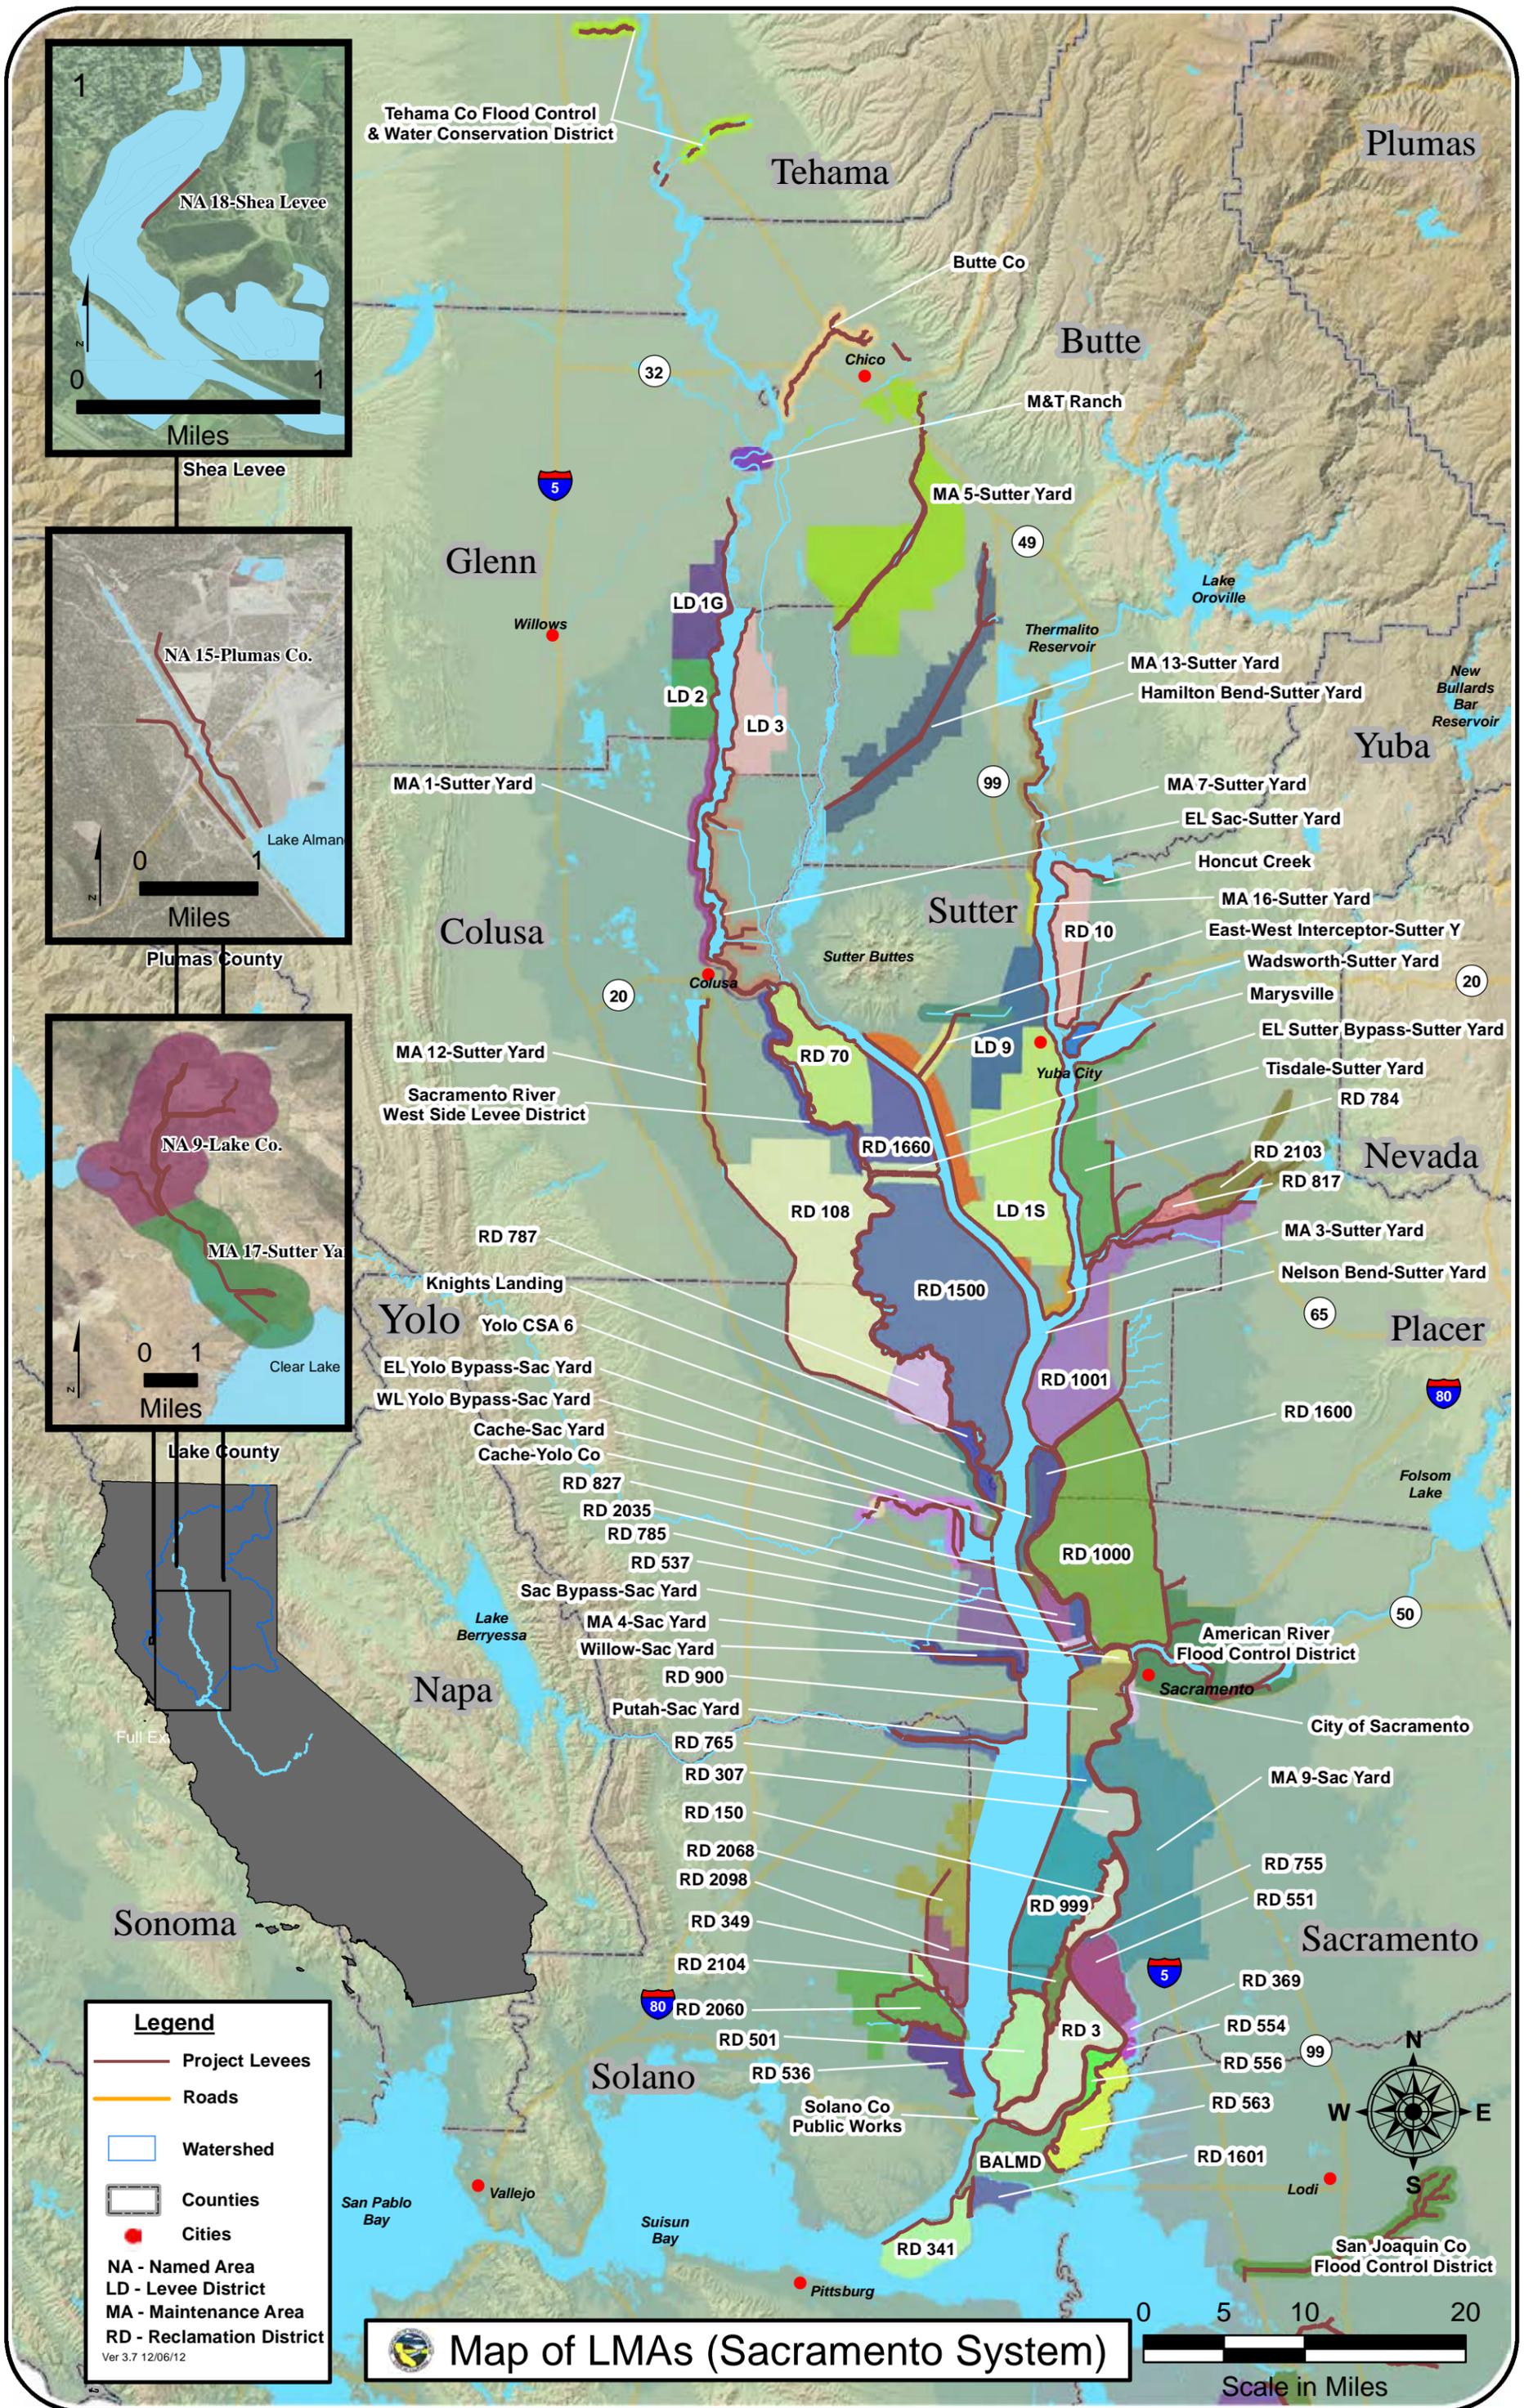
Map of LMAs (Sacramento System)

- Project Levees
- Roads
- Watershed
- Counties
- Cities
- NA - Named Area
- LD - Levee District
- MA - Maintenance Area
- RD - Reclamation District

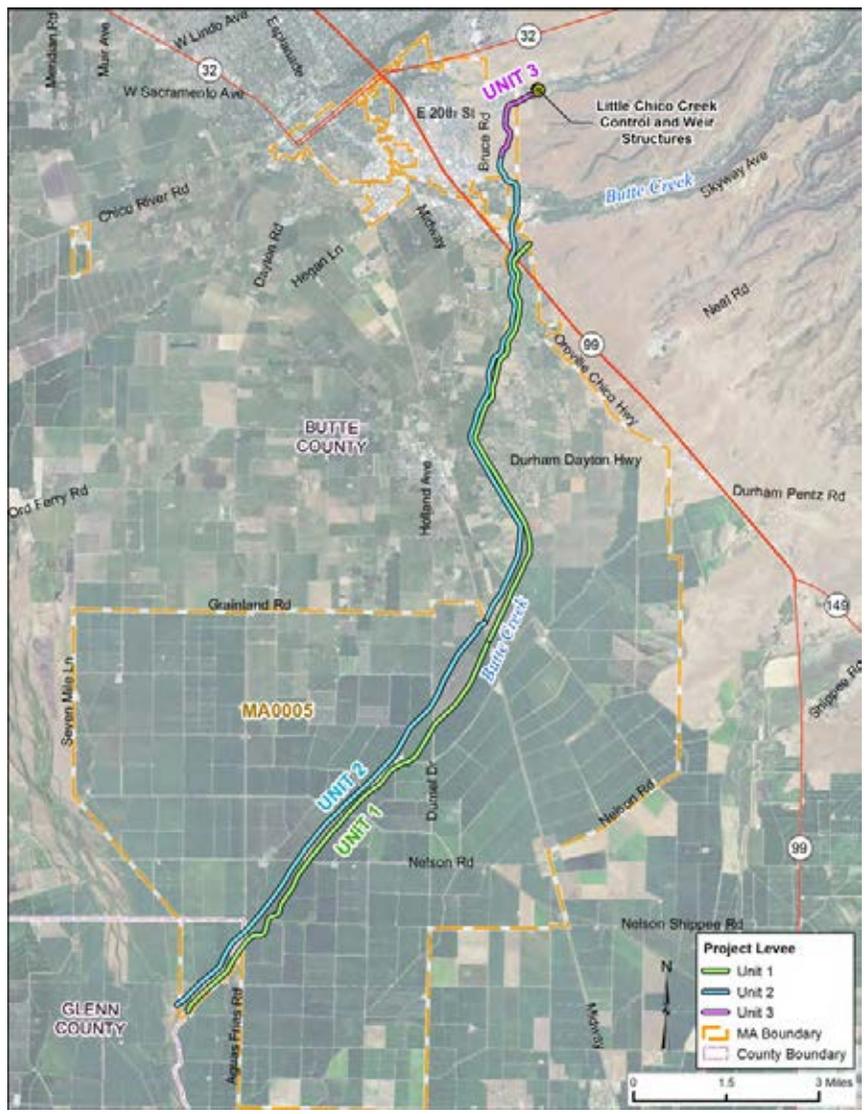
Levee Short Name : MA0005	Bank	Unit Length (Miles)
Unit No. 01 Butte Creek 1	LB	15.29
Unit No. 02 Butte Creek 1	RB	16.53
Unit No. 03 Little Chico Creek Diversion 1	LB	1.50

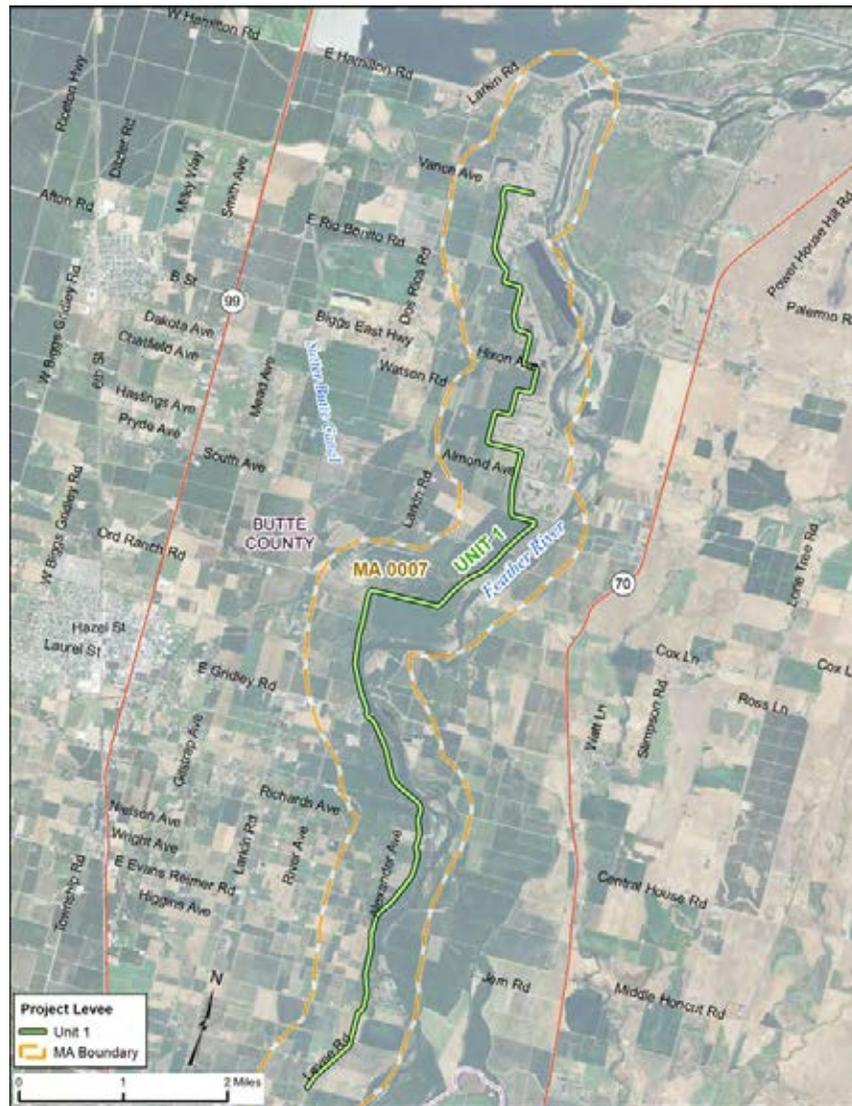
Levee Short Name : MA0007	Bank	Unit Length (Miles)
---------------------------	------	---------------------

Unit No. 01 Feather River	RB	12.07
---------------------------	----	-------

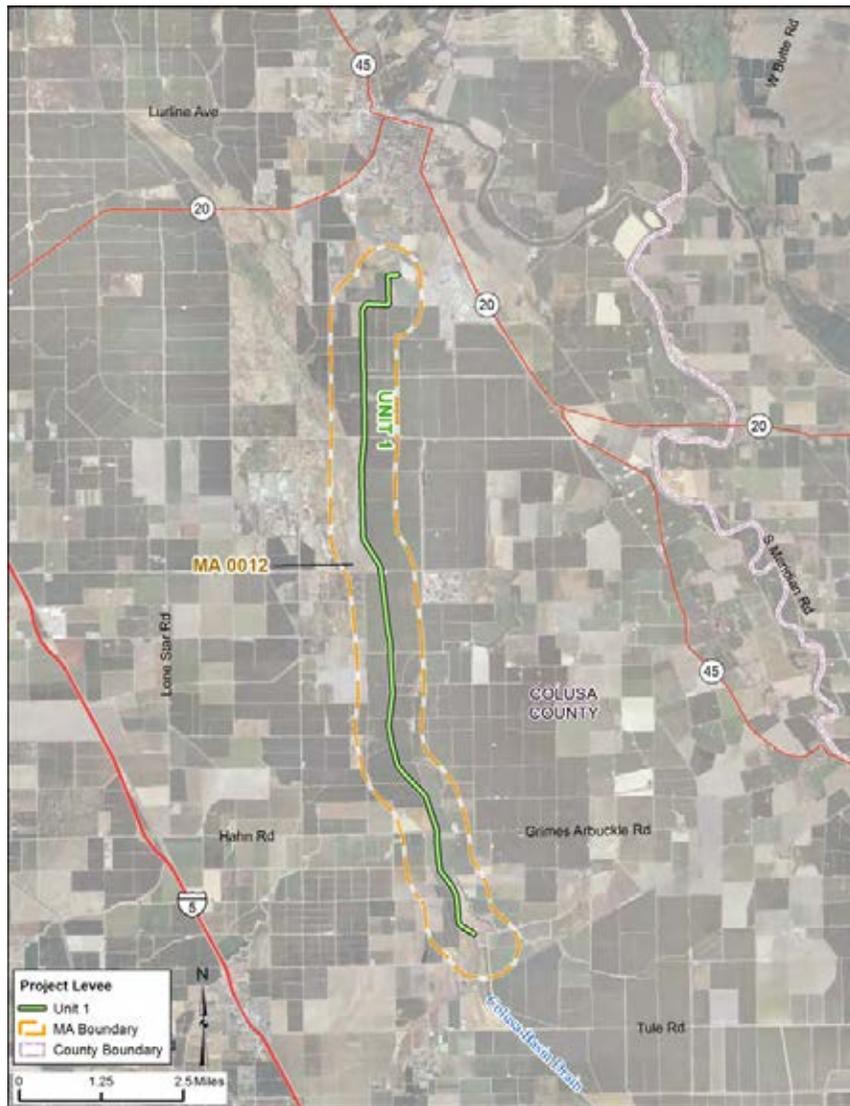
Levee Short Name : MA0012	Bank	Unit Length (Miles)
---------------------------	------	---------------------

Unit No. 01 Colusa Drain	LB	11.31
--------------------------	----	-------

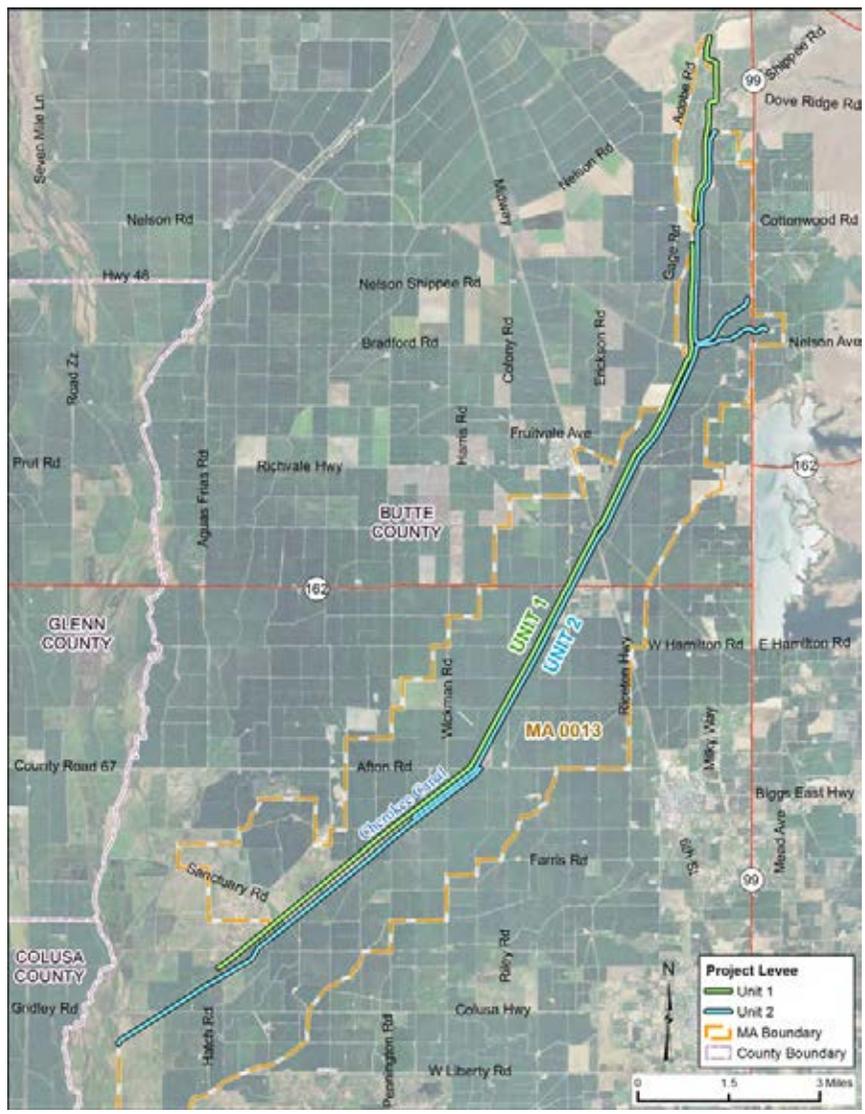
Levee Short Name : MA0013	Bank	Unit Length (Miles)
Unit No. 01 Cherokee Canal	RB	18.87
Unit No. 02 Cherokee Canal	LB	23.10

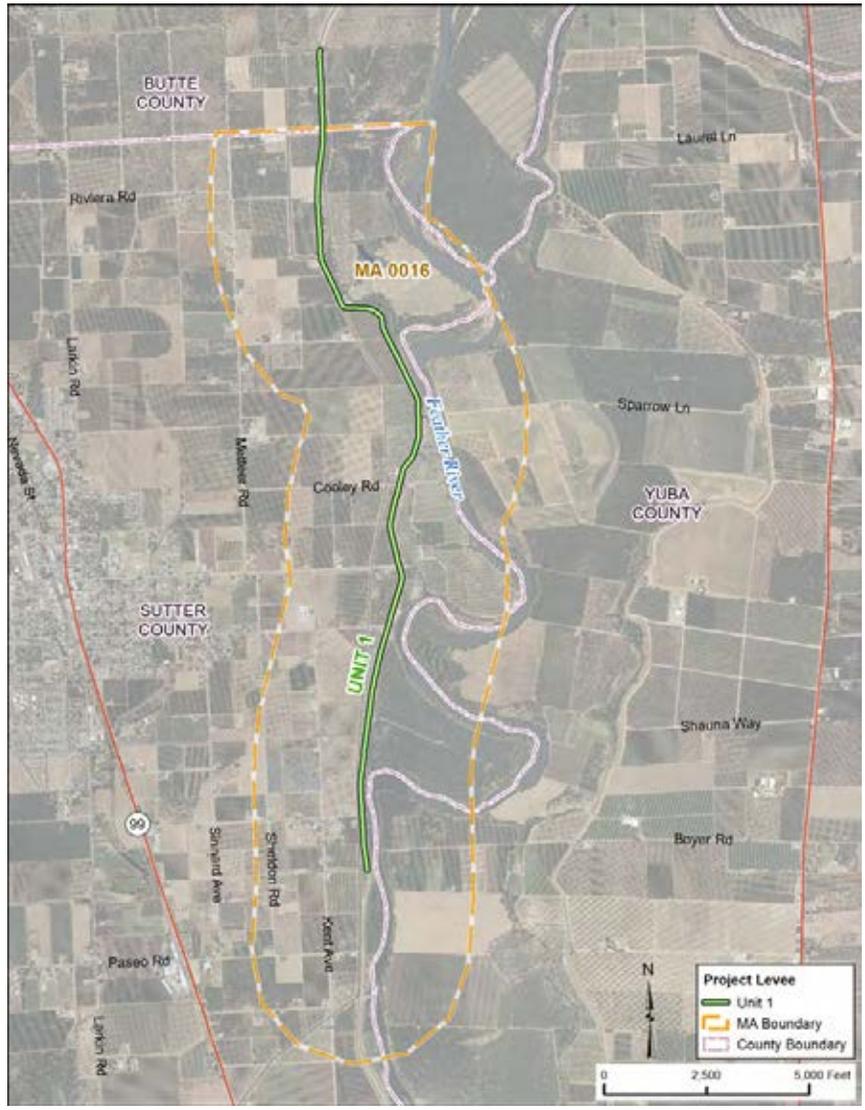
MA 16

Levee Short Name : MA0016	Bank	Unit Length (Miles)
Unit No. 01 Feather River	RB	4.09

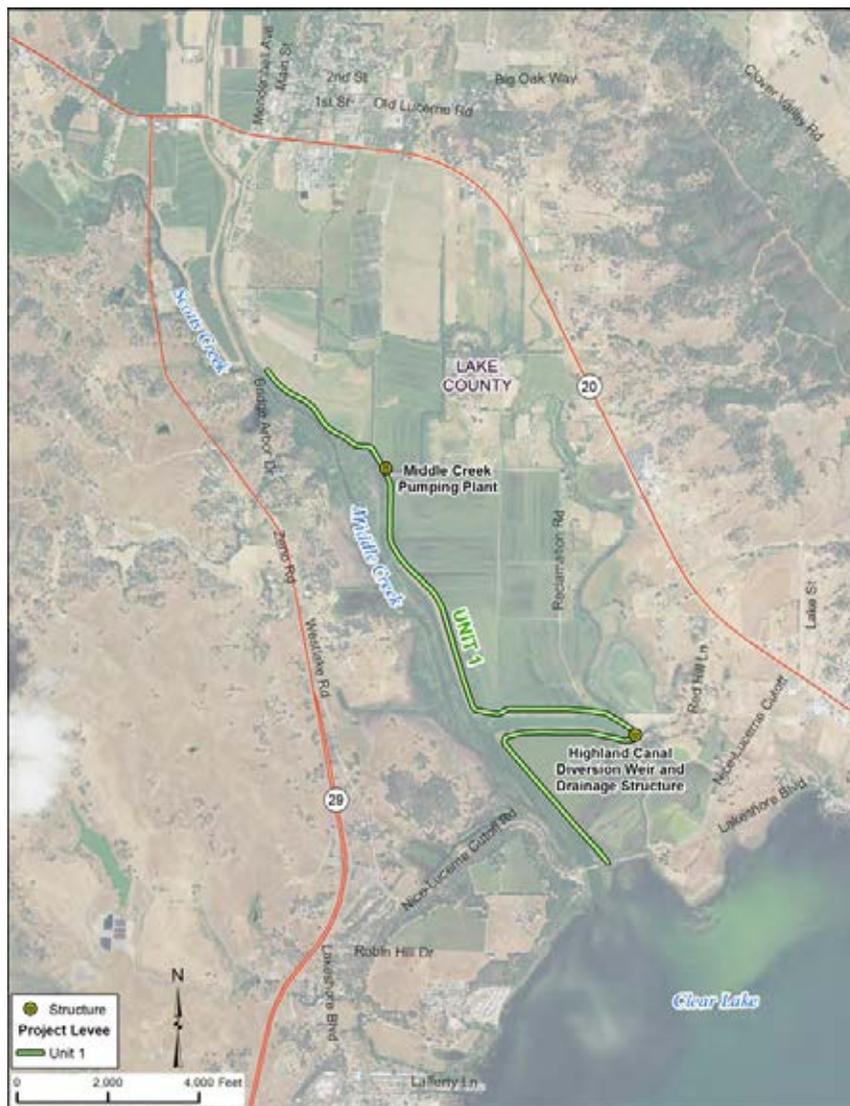
MA 17

Levee Short Name : MA0017	Bank	Unit Length (Miles)
---------------------------	------	---------------------

Unit No. 01 Lake County Sutter Maintenance Yard - Middle Creek	LB	3.90
--	----	------

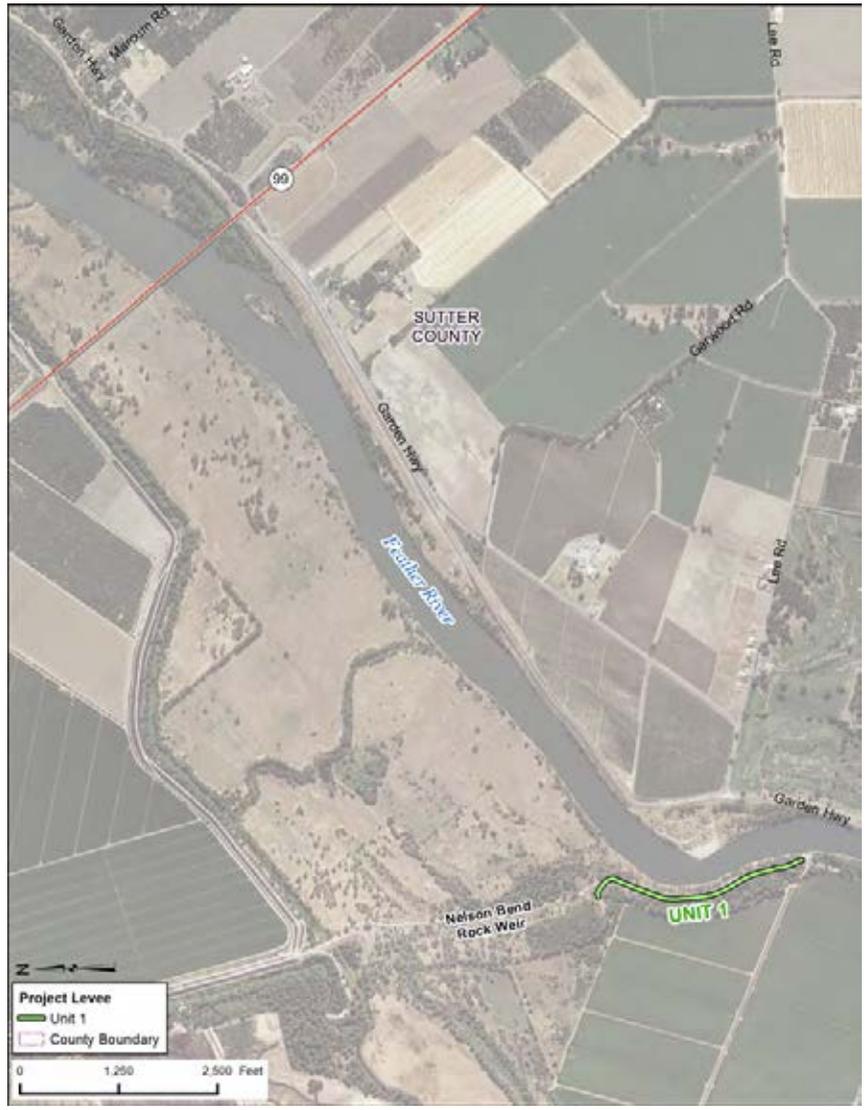
Nelson Bend

Levee Short Name : ST0006	Bank	Unit Length (Miles)
---------------------------	------	---------------------

Unit No. 01 Feather River West Levee-Nelson Bend		0.50
--	--	------

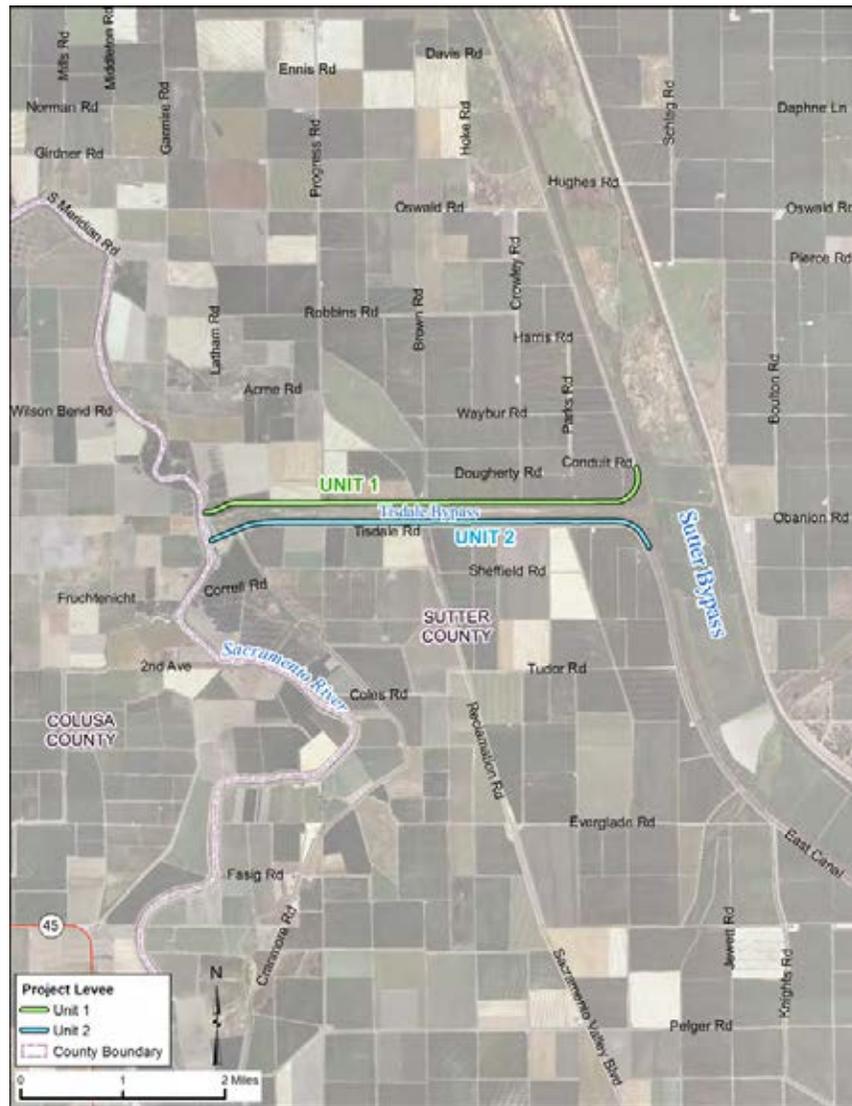
SACRAMENTO SYSTEM : Sutter Maintenance Yard Tisdale Bypass

Levee Short Name : ST0009	Bank	Unit Length (Miles)
---------------------------	------	---------------------

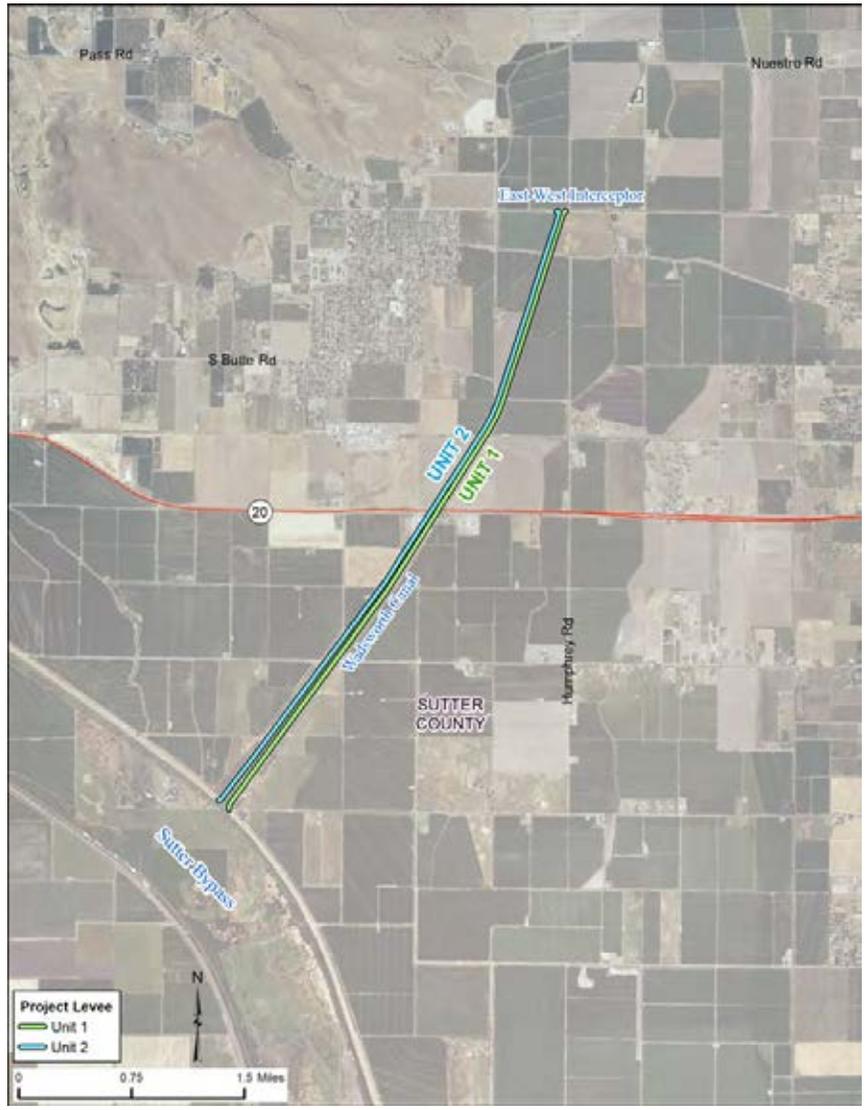
Levee Short Name : ST0010	Bank	Unit Length (Miles)
Unit No. 01 Wadsworth Canal	LB	4.66
Unit No. 02 Wadsworth Canal	RB	4.66
