2012

INSPECTION AND LOCAL MAINTAINING AGENCY REPORT OF THE CENTRAL VALLEY STATE-FEDERAL FLOOD PROTECTION SYSTEM

Department of Water Resources

Flood Project Integrity and Inspection Branch | Hydrology and Flood Operations Office | Division of Flood Management

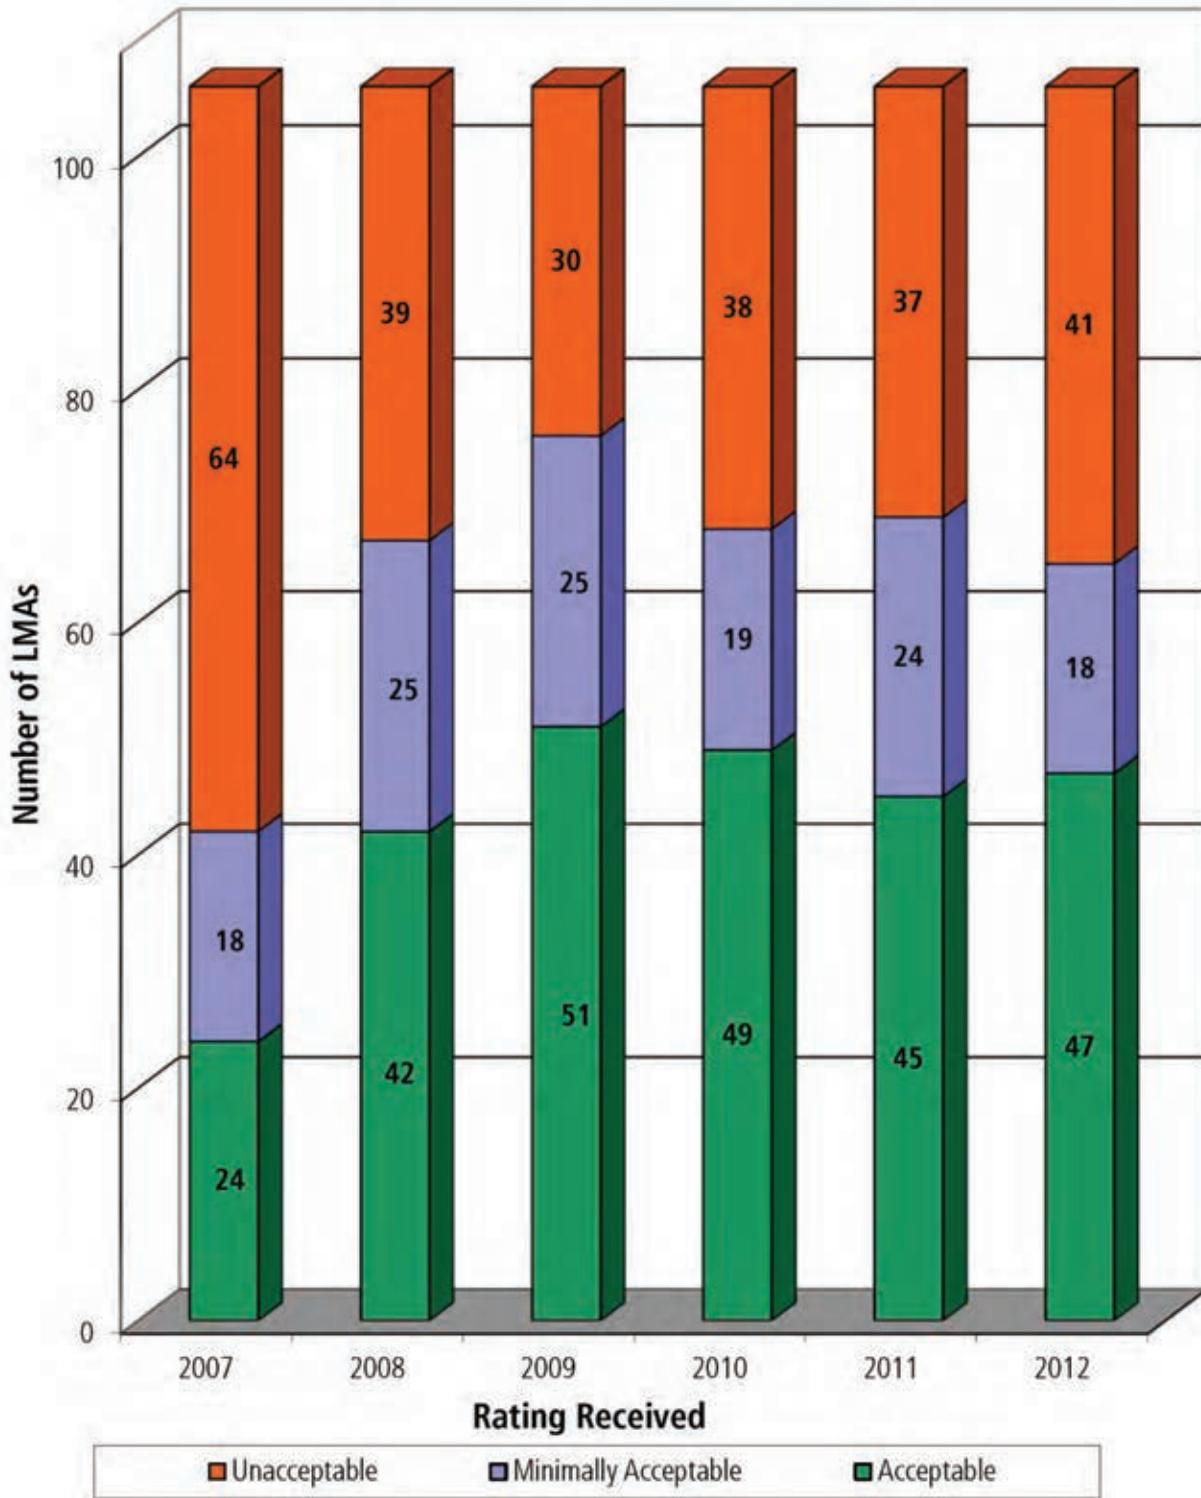
Figure 2-1: Summary of Area Maintenance Ratings for 2007 through 2012

Table 2-1 and Figure 2-1 show the numbers of Areas receiving each rating for 2007 through 2012. The length of vegetation deficiencies increased significantly compared to 2011, most notably in the San Joaquin River system. There was a significant increase in crown surface issues and a moderate increase in animal control issues. Other categories did not change significantly. Many of the LMAs have expressed limitations due to financial and environmental issues. Some LMAs are severely limited in what money they have been able to collect from residents to perform maintenance. Weather patterns that are different than prior years may also play a factor in the increase in deficiencies.

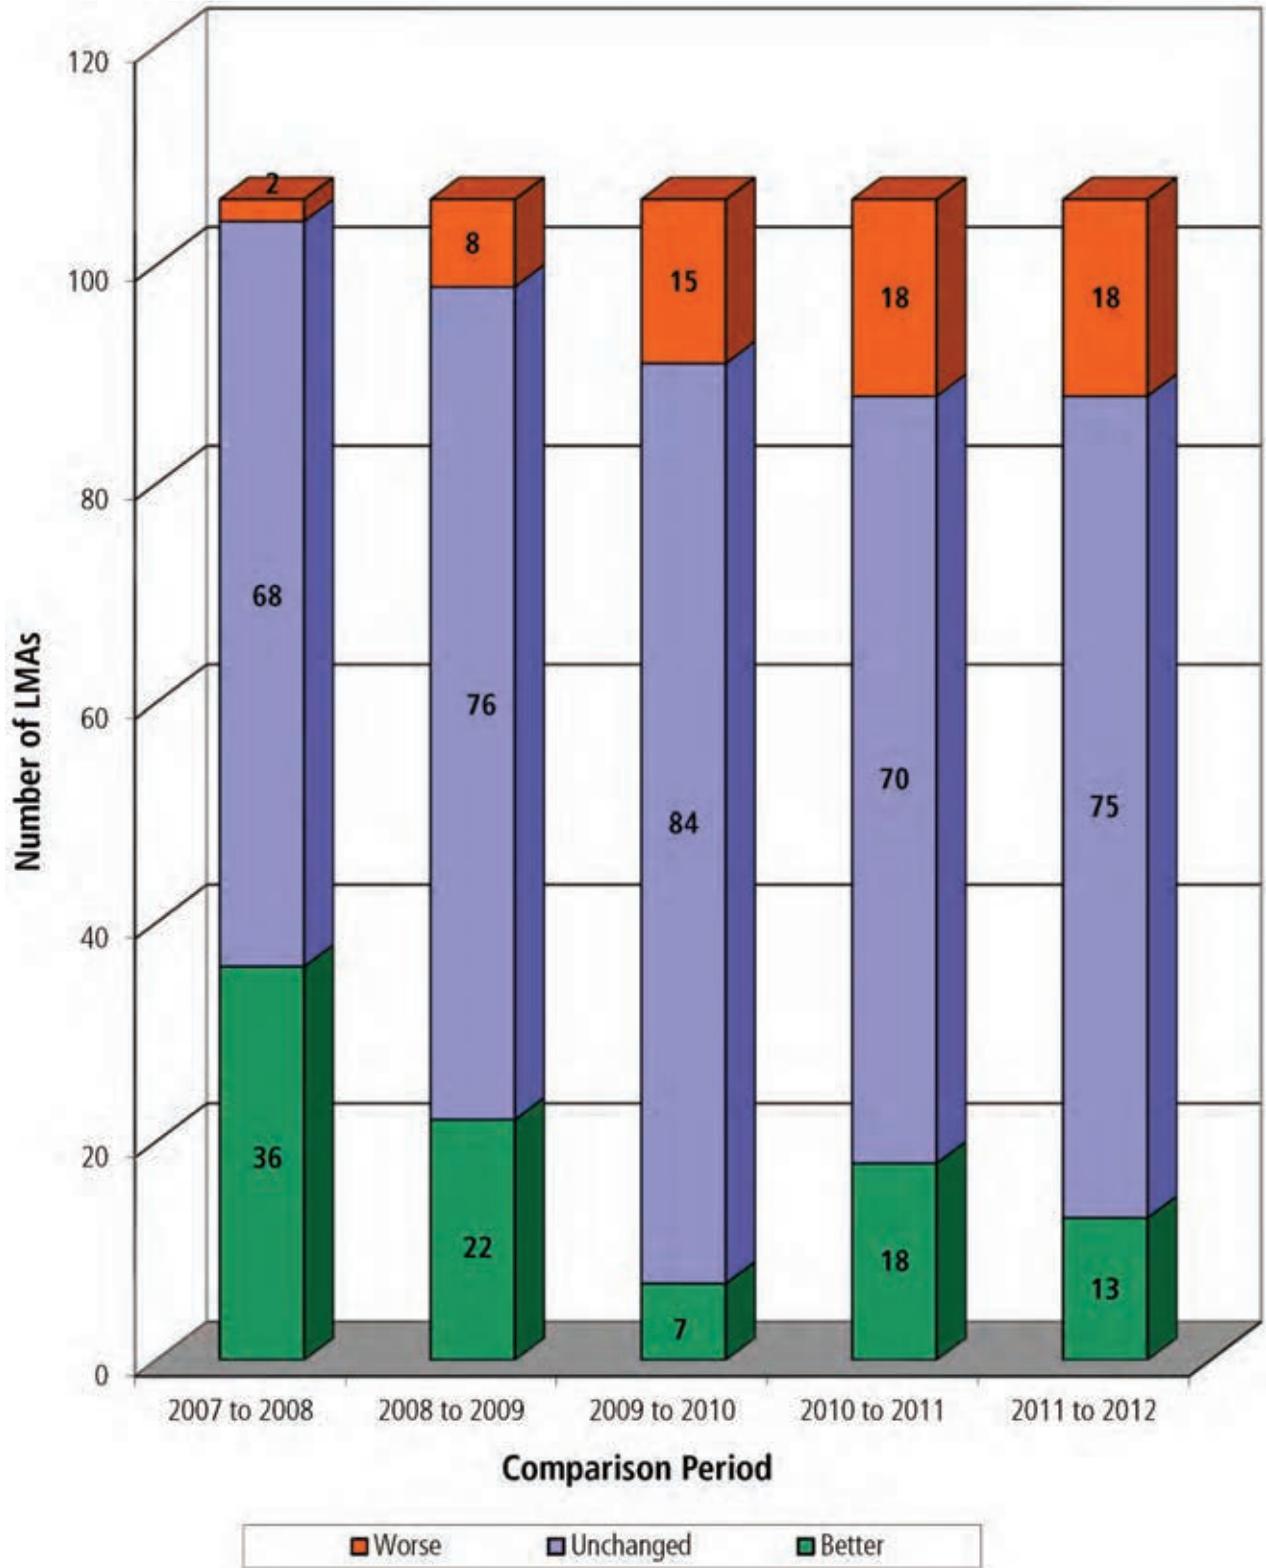
Figure 2-2: Area Maintenance Rating Changes from Fall 2007 to Fall 2012

Figure 2-2 shows the number of agencies that received better, unchanged, or worse ratings in 2012 compared with 2011, 2010, 2009, 2008, and 2007. The number of Areas receiving Acceptable ratings increased by two; however, the number of Areas rated as Unacceptable increased by four. The number of Areas rated as Minimally Acceptable decreased by six. This is likely due to fluctuations in maintenance and funding. Despite these changes, Areas continue to generally receive better ratings than in 2007 and 2008. Levee Mile Reports (LMRs) contain more detailed information about each LMA. Appendix F provides more an explanation of threshold percentages and the determination of overall ratings.

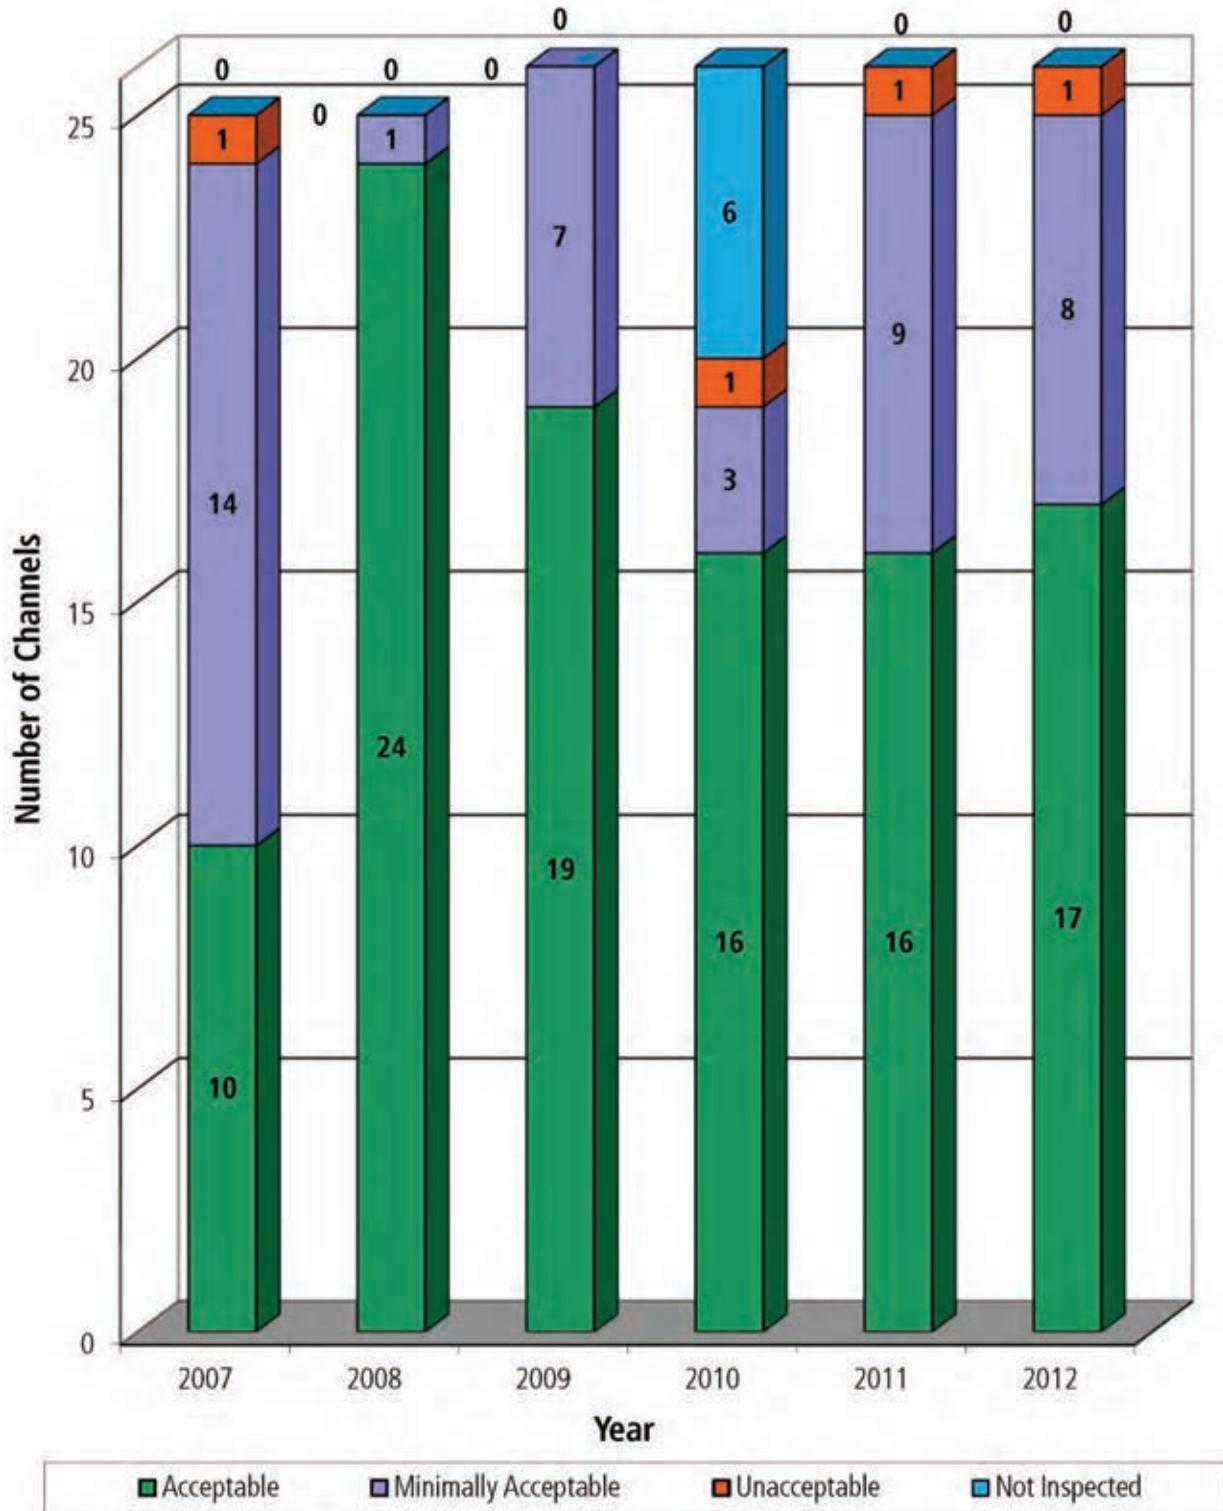
Figure 3-1: Comparison of Overall Channel Ratings, 2007 through 2012

One channel was rated as Unacceptable in 2012, while the number of Minimally Acceptable channels was eight, which is similar to 2011. This shows the similarity of maintenance found during inspection in 2012 as prior years. Figure 3-1 shows the progression of maintenance ratings from 2007 through 2012.

Appendix F details the method for determining overall ratings. Table 3-1 and Figure 3-1 show the numbers of each rating for the years 2007 through 2012.

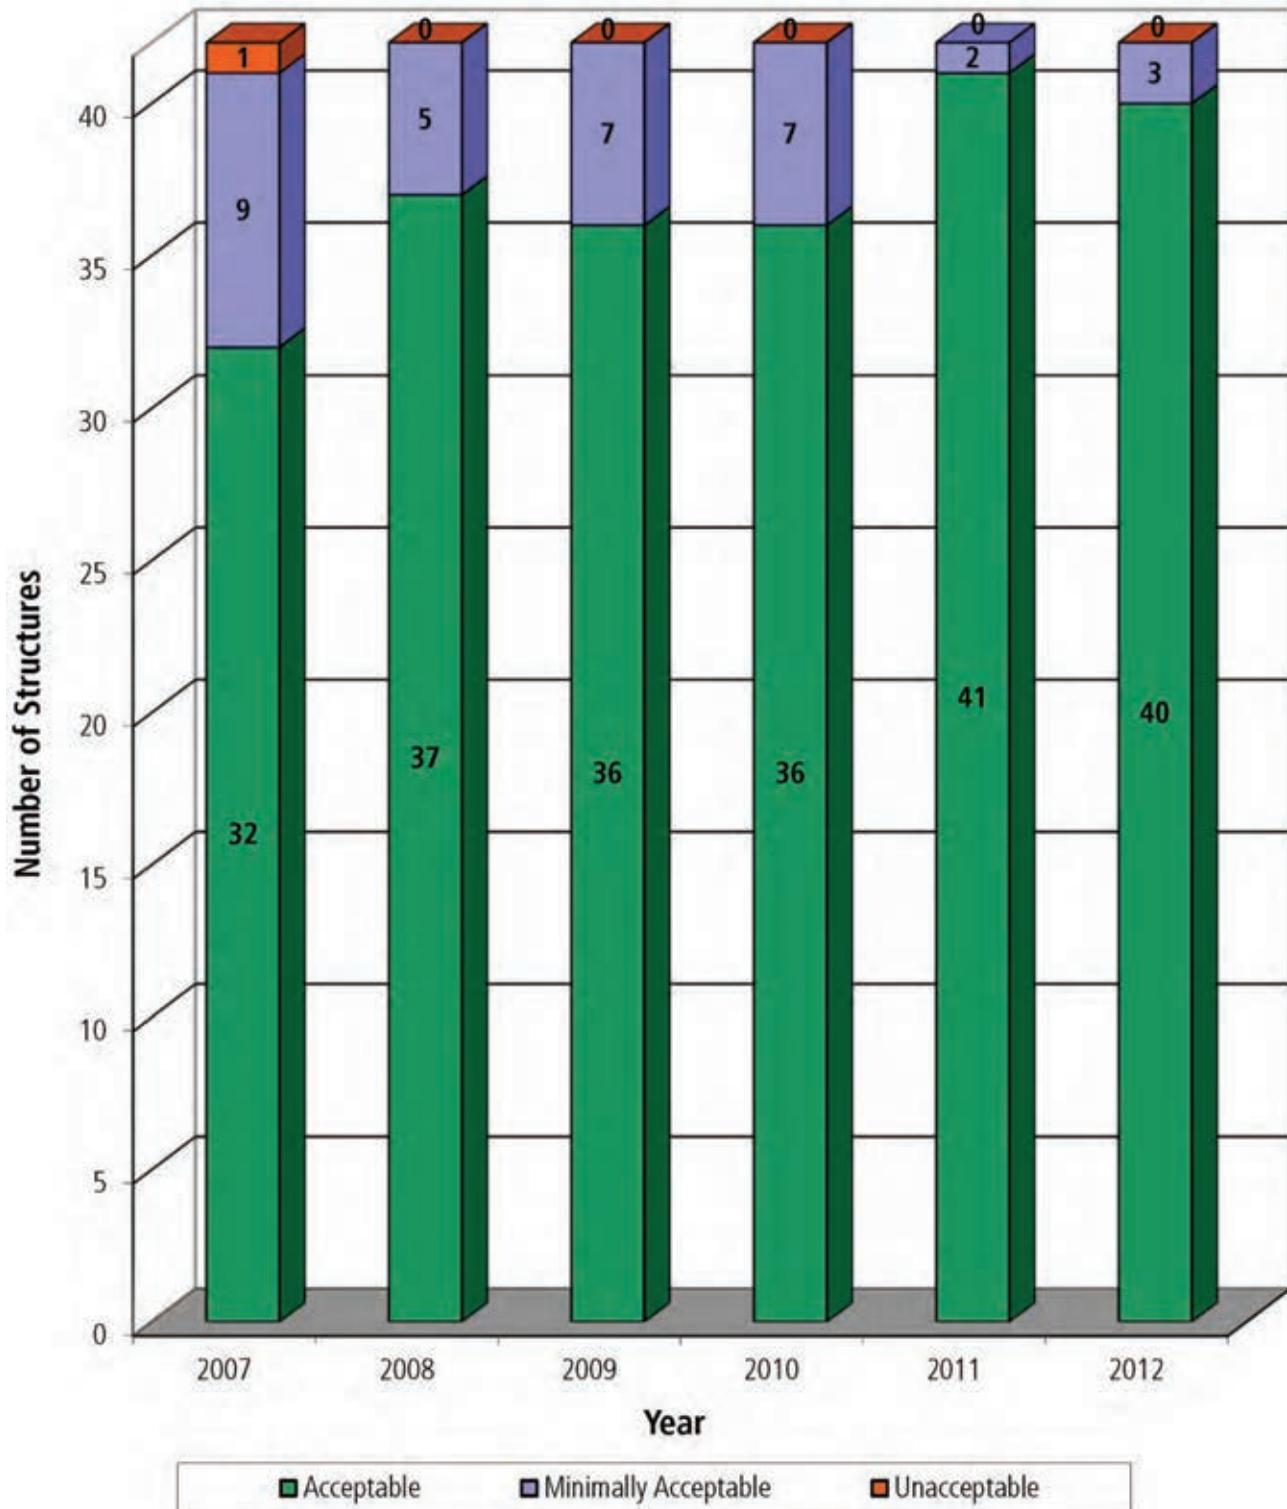
Figure 4-1: Comparison of Overall Structure Ratings from 2007 through 2012

The method for determining overall ratings is similar to the one used for channel inspections and is described in Appendix F. Table 4-1 shows the numbers of each rating for 2007-2012 for all structures. Figure 4-1 and Table 4-2 show ratings for each structure, while Figure 4-2 and Table 4-3 show ratings for each pumping plant. The LMAs have generally improved structure maintenance since 2007. The El Camino Avenue Bridge over Steelhead Creek in Sacramento was added to structure inspections in 2009.

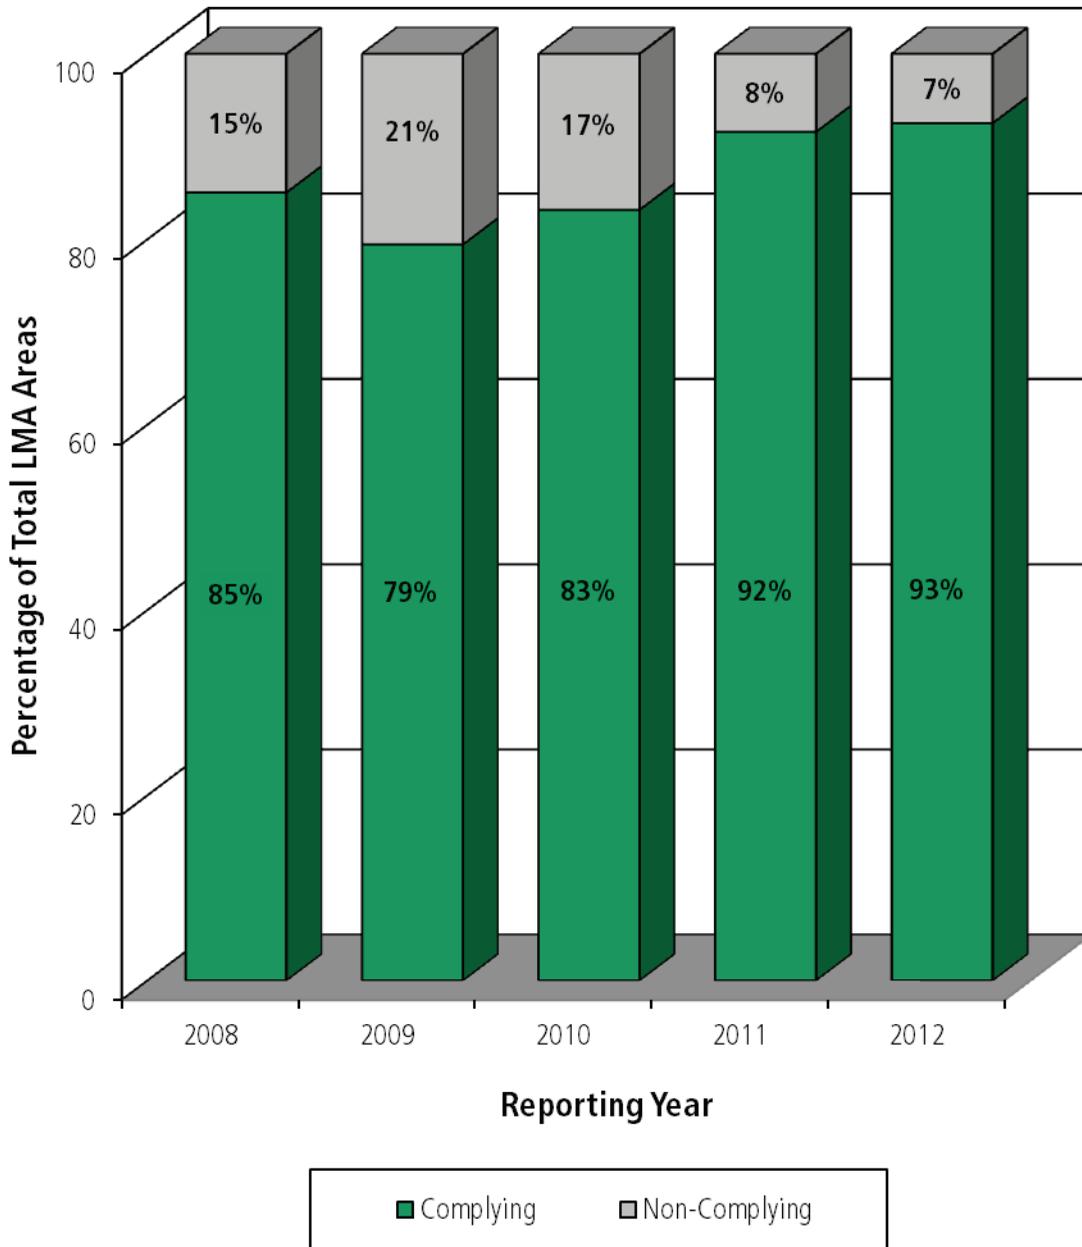
Figure 6-1: Reporting Compliance for 2008-2012

There is an increasing trend (Figure 6-1) of reporting compliance by LMAs since the program started in 2008. A systemwide comparison of reporting compliance (Figure 6-2) shows at least 90% LMAs belonging to the Sacramento system and 96% belonging to the San Joaquin system have reported in last two years. Overall, about 93% of Areas submitted their report this year. An increasing trend of electronic reporting is apparent in Figure 6-3. This year about 68% Areas submitted reports through DWR’s web-based LMA Reporting tool. This represents a 16% increase over last year’s electronic reporting. This could be attributed to continuous outreach activities and enhancement of reporting infrastructure since the inception of the tool.

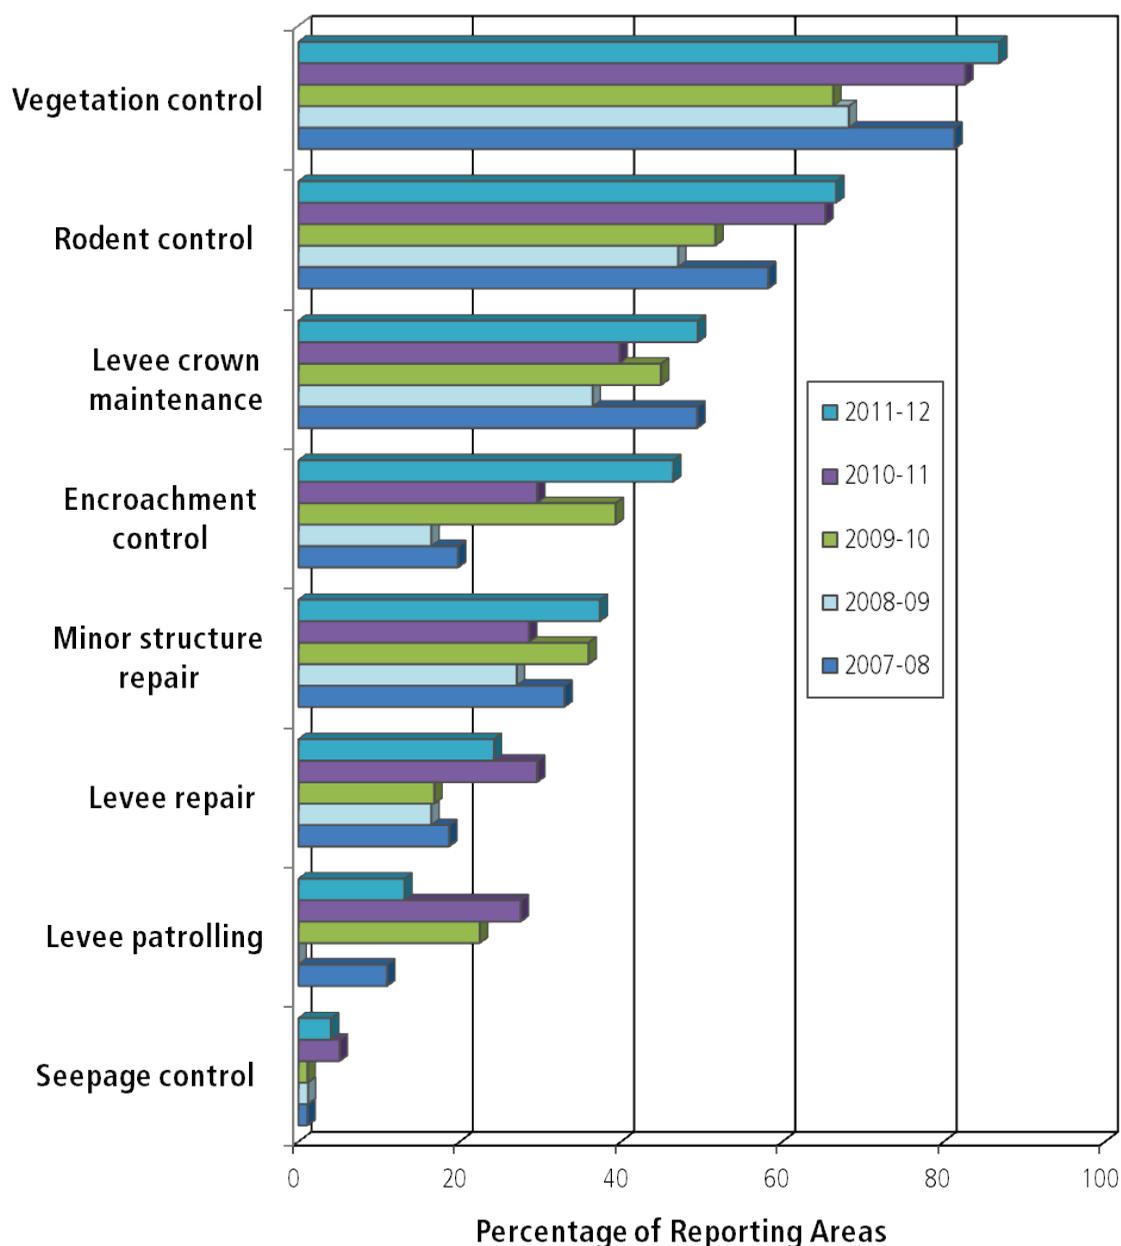
Figure 6-4: Key Performed Activities Reported for 2008-2012

About 90% of reporting Areas provided information on the summary of maintenance activities. As in the previous years, routine vegetation maintenance activities (burning, slope dragging, cutting, trimming, spraying), rodent control, levee crown grading, roadway maintenance and encroachment dominated LMA maintenance activities for fiscal year 2011-12. Figure 6-4 shows the activities Areas reported as having performed as a percentage of the total number of Areas who reported information during that year. Other reported key activities include minor structural repairs (mile markers, gates, barricades, and miscellaneous signs maintenance and repair), and minor levee repairs (erosion repair, hole grouting, revetment, rip-rap and slope repair). Some LMAs also reported levee patrolling and other planning activities such as preparation of five year maintenance plans.

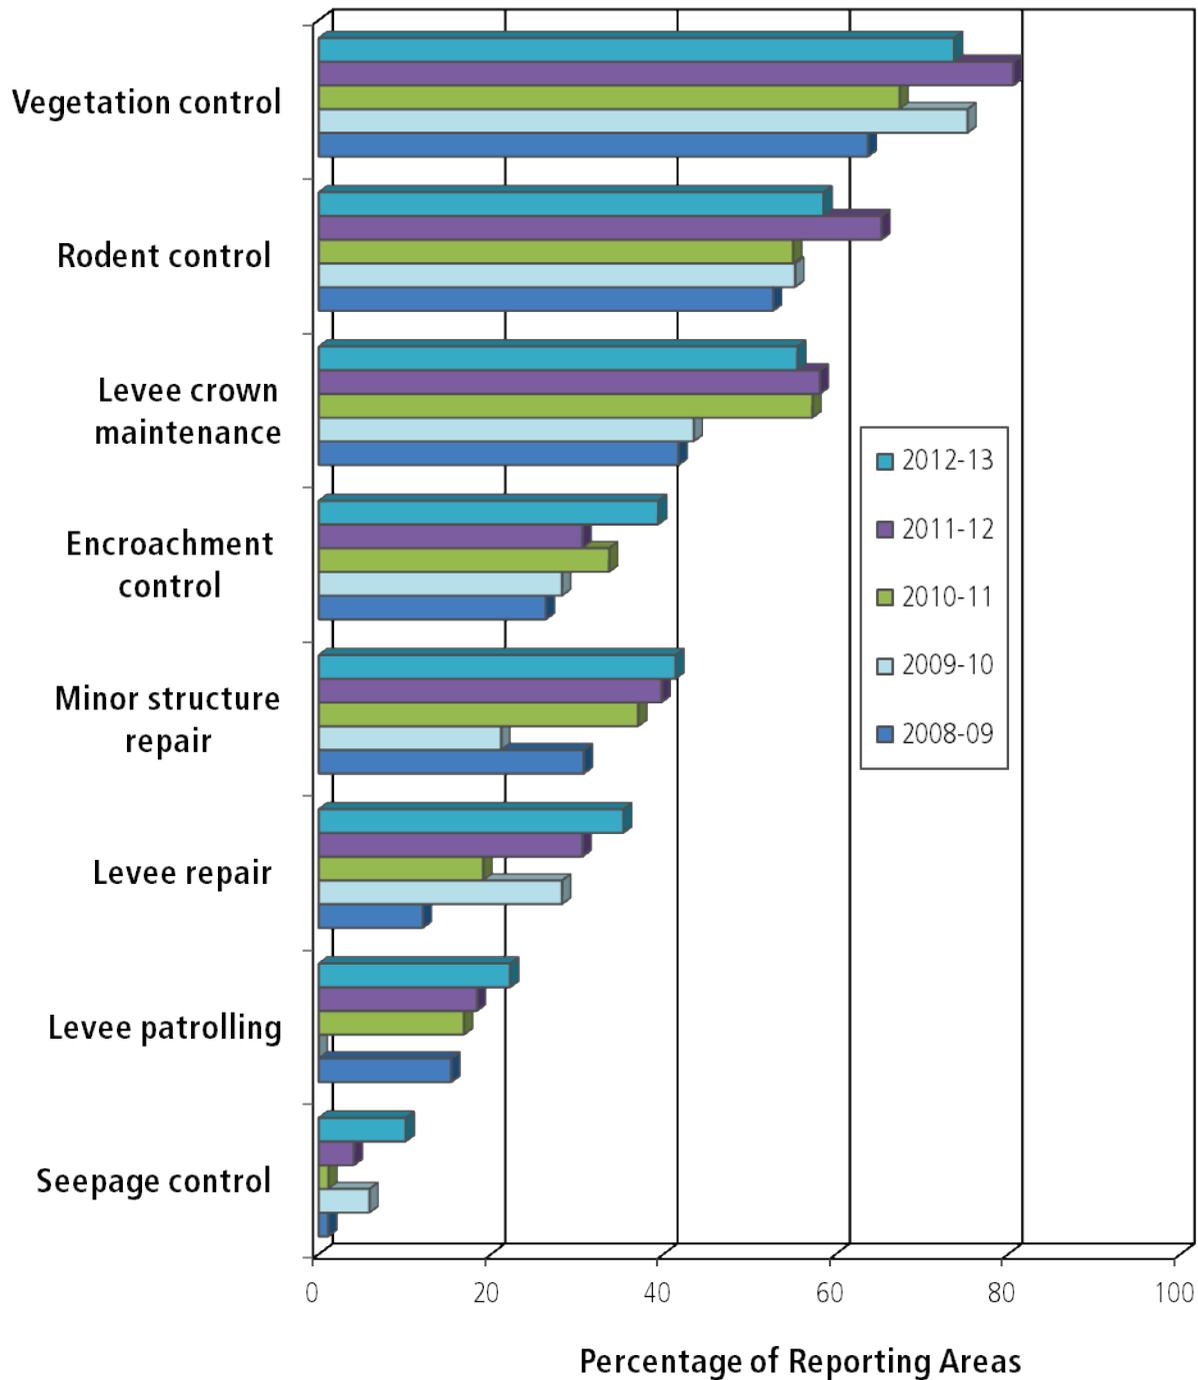
Figure 6-5: Key Planned Activities Reported for 2009-2013

A similar percentage of reporting Areas also provided information on the planned maintenance activities for the current fiscal year 2012-13. The planned activities reflect similar maintenance priorities as performed maintenance activities in fiscal year 2011-12. Figure 6-5 shows planned activities that were reported by LMAs.

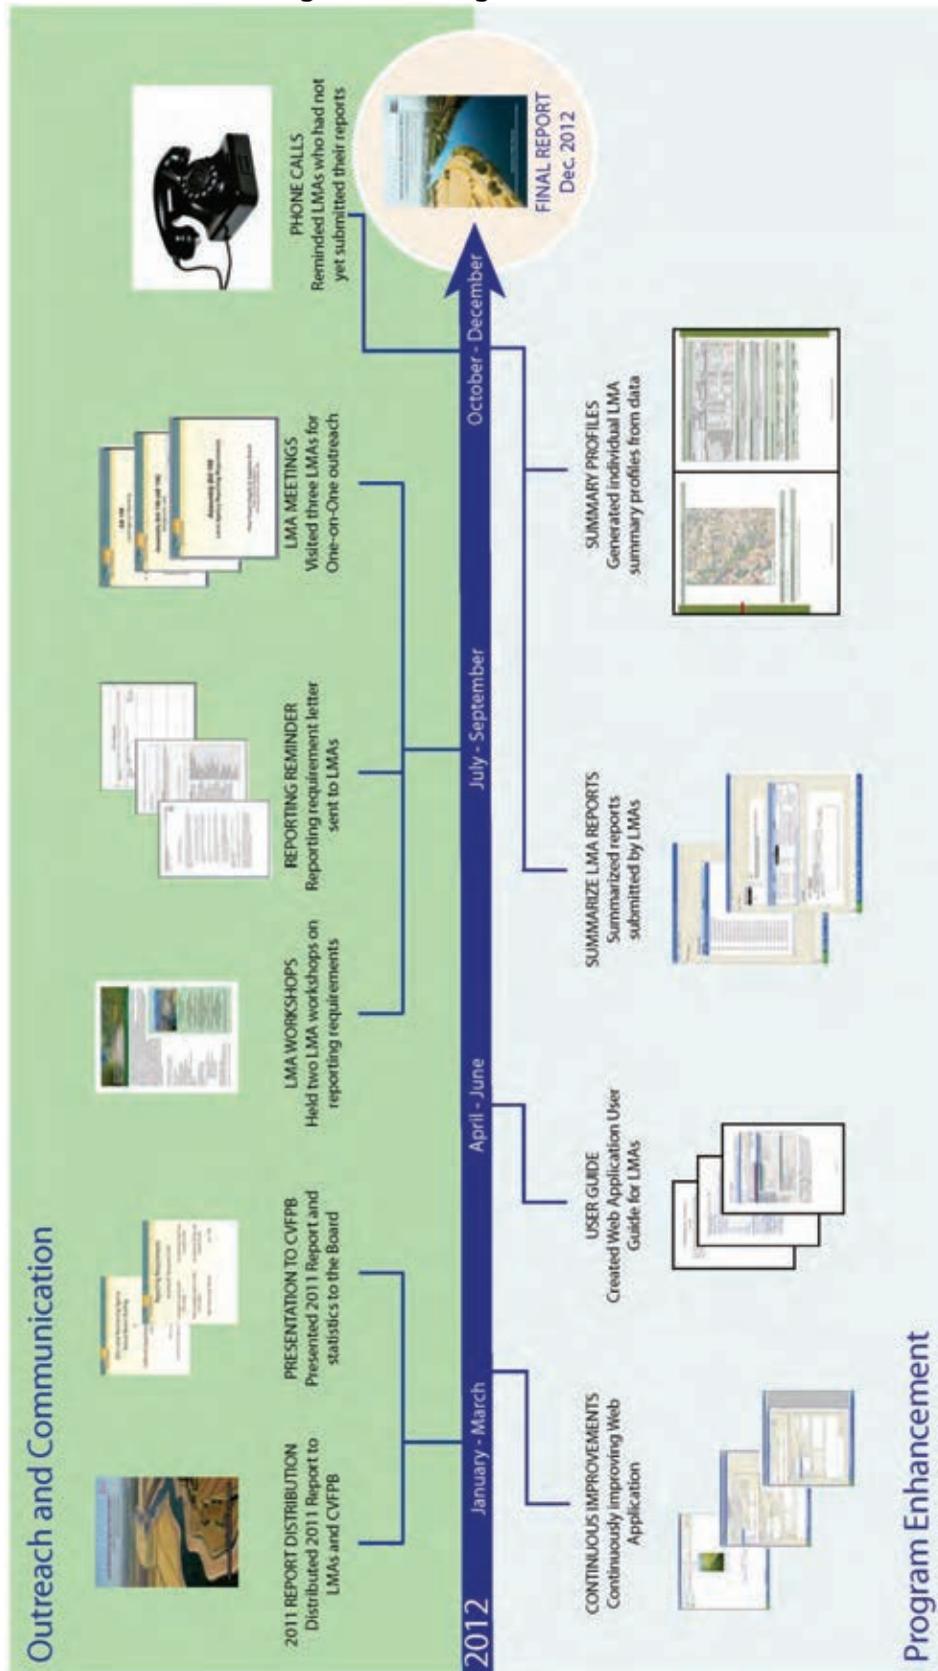
Figure 6-6: Program Activities

DWR recognizes that the requirements of CWC Section 9140 placed a new reporting burden on LMAs. To help make reporting easier, DWR developed an outreach program and a web-based reporting tool to assist LMAs. DWR notified LMAs of the new reporting requirements, developed electronic and hard copy reporting options, and held a series of presentations and workshops. The process continues today, with DWR soliciting feedback from LMAs to improve the program. The following subsections and Figure 6-6 describe the chronology of the outreach process for 2012.

- Since 2008, DWR has been facilitating electronic submission and strongly encouraging LMAs to use the LMA Reporting Website. In 2012 about 68 percent of reporting LMAs reported electronically, which is a 16 percent increase over 2011. Details of DWR outreach activities for electronic submission and others are provided Figure 6-6.
