2012

INSPECTION AND LOCAL MAINTAINING AGENCY REPORT OF THE CENTRAL VALLEY STATE-FEDERAL FLOOD PROTECTION SYSTEM

Draft Report

Department of Water Resources

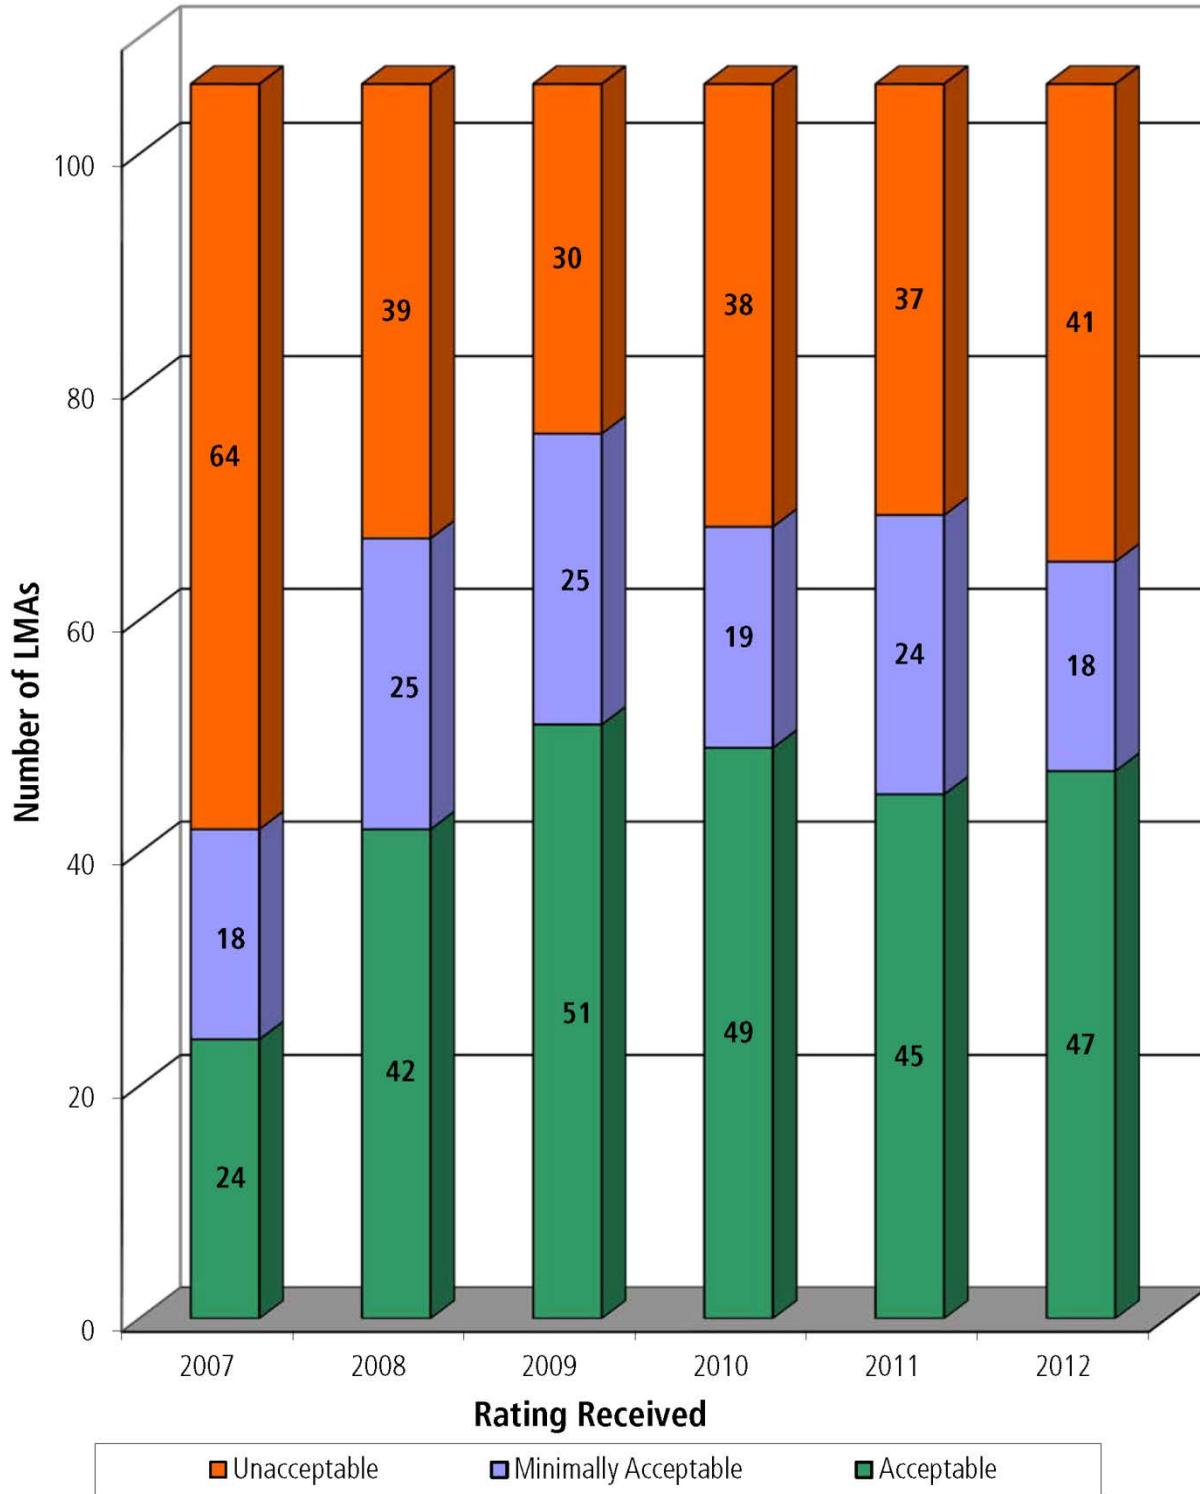
Figure 2-1: Summary of Area Maintenance Ratings for 2007 through 2012

Table 2-1 and Figure 2-1 show the numbers of Areas receiving each rating for 2007 through 2012. The length of vegetation deficiencies increased significantly compared to 2011, most notably in the San Joaquin River system. There was a significant increase in crown surface issues and a moderate increase in animal control issues. Other categories did not change significantly. Many of the LMAs have expressed limitations due to financial and environmental issues. Some LMAs are severely limited in what money they have been able to collect from residents to perform maintenance. Weather patterns that are different than prior years may also play a factor in the increase in deficiencies.

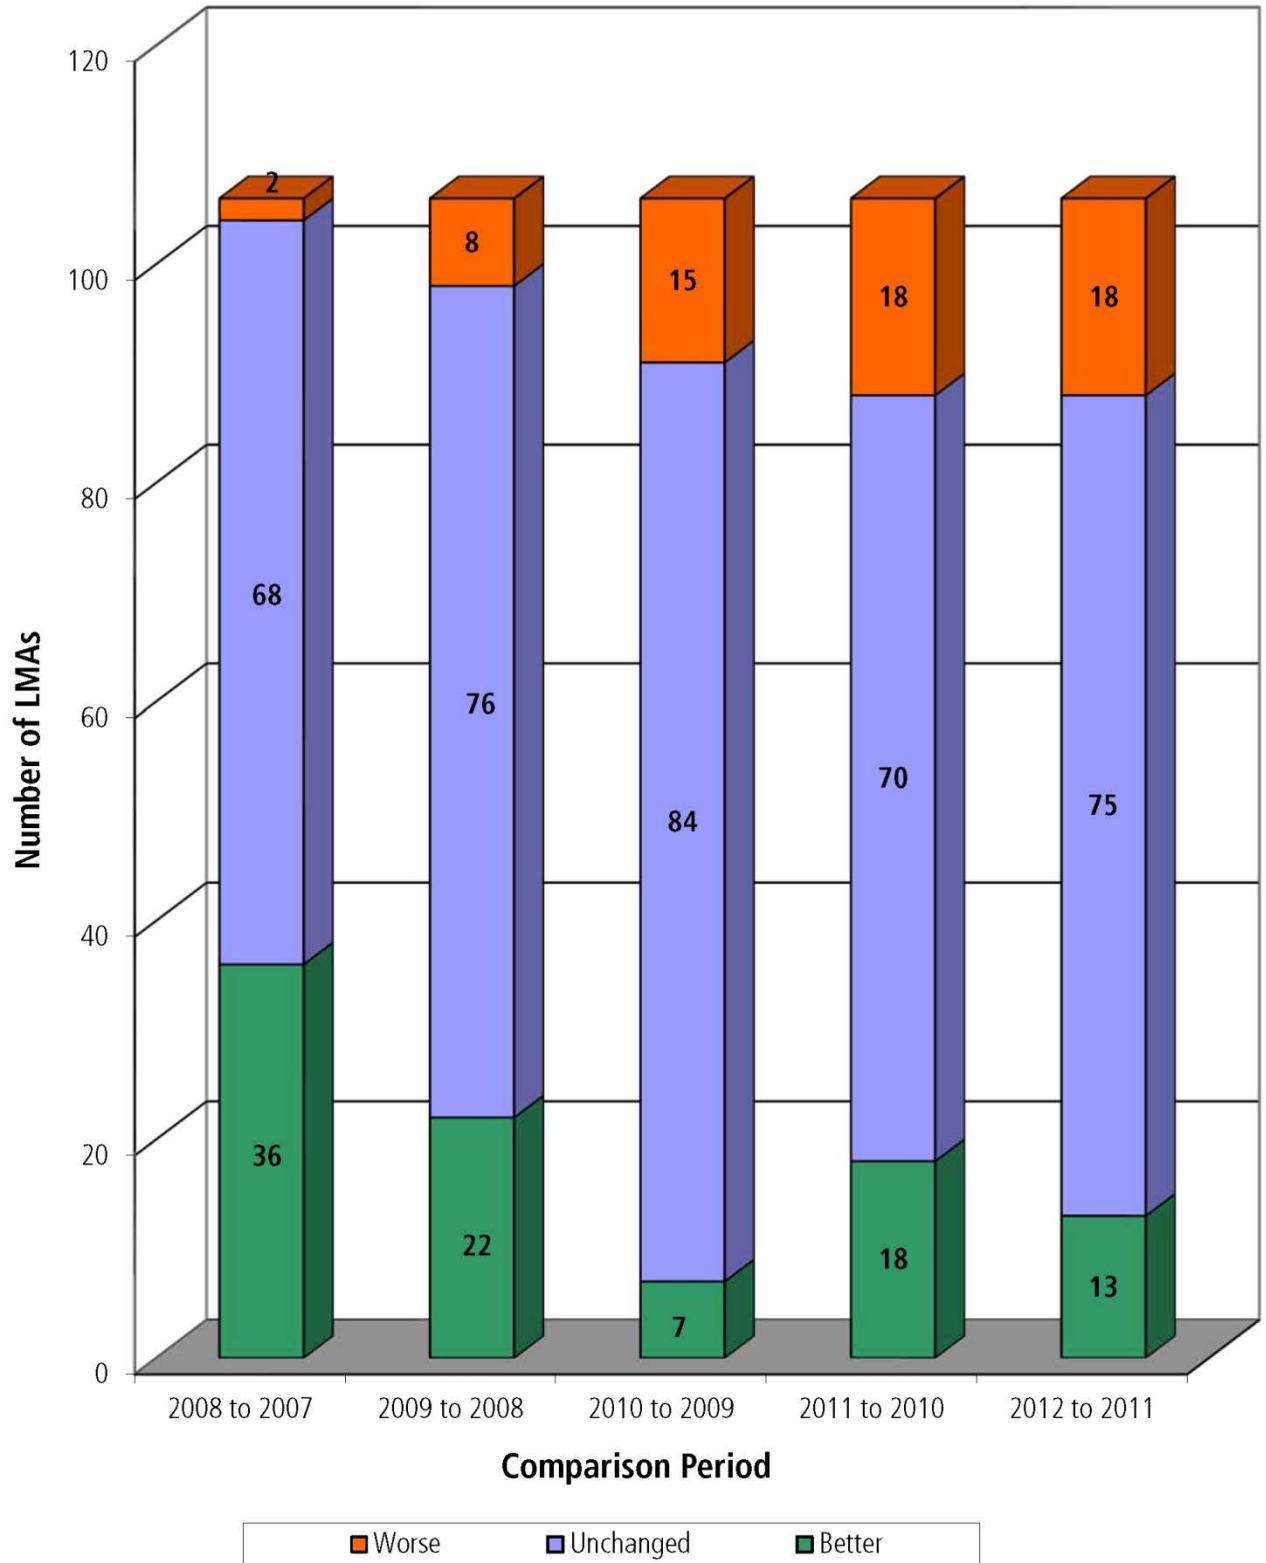
Figure 2-2: Area Maintenance Rating Changes from Fall 2007 to Fall 2012

Figure 2-2 shows the number of agencies that received better, unchanged, or worse ratings in 2012 compared with 2011, 2010, 2009, 2008, and 2007. The number of Areas receiving Acceptable ratings increased by two. However the number of Areas rated as Unacceptable increased by 4. The number of Areas rated as Minimally acceptable decreased by six. This is likely due to fluctuations in maintenance and funding as well as the way DWR determines overall ratings. More information can be found in the detailed Levee Mile Reports (LMR) and an explanation of threshold percentages and the determination of overall ratings is located in Appendix F. Despite these changes, Areas continue to generally receive better ratings than in 2007 and 2008.

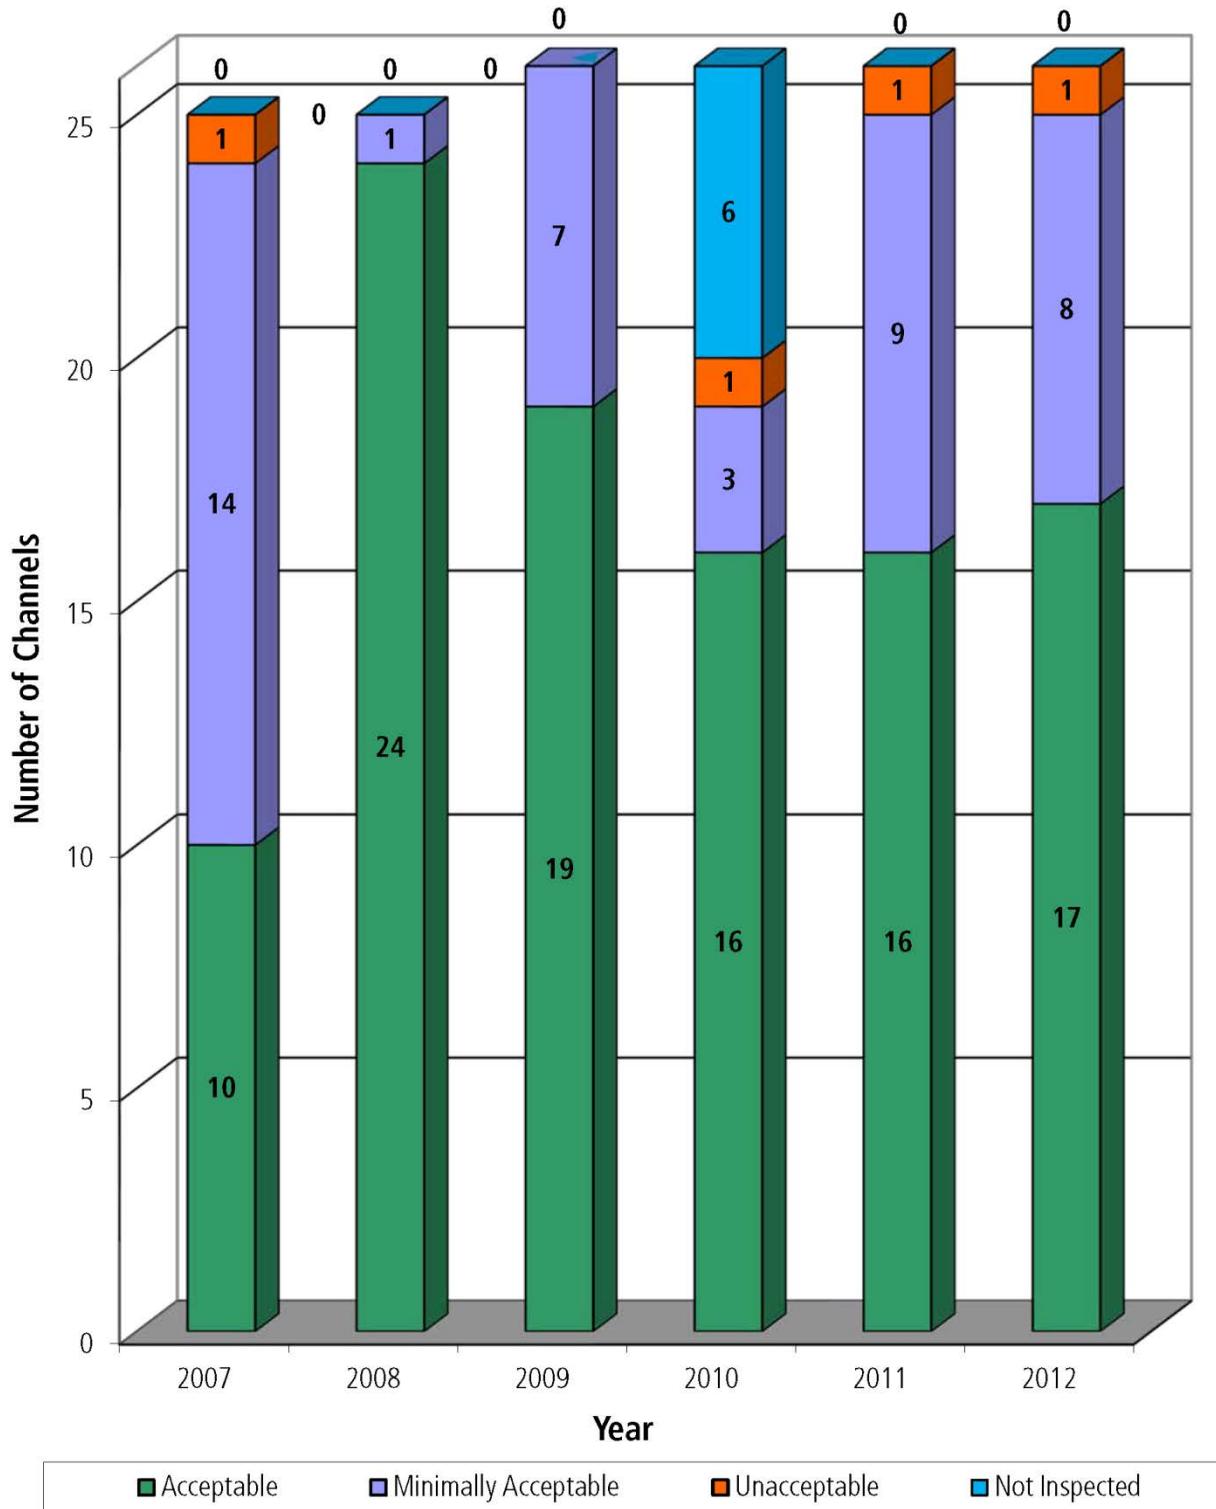
Figure 3-1: Channel Overall Ratings Comparison 2007 through 2012

The number of channels rated as Unacceptable remained at one in 2012 and the number of Minimally Acceptable channels was similar to 2011 at eight. This shows the similarity of maintenance found during inspection in 2012 as prior years. Figure 3-1 shows the progression of maintenance ratings from 2007 through 2012.

The method for determining overall ratings is described in Appendix B. Table 3-1 and Figure 3-1 show the numbers of each rating for the years 2007 through 2012.

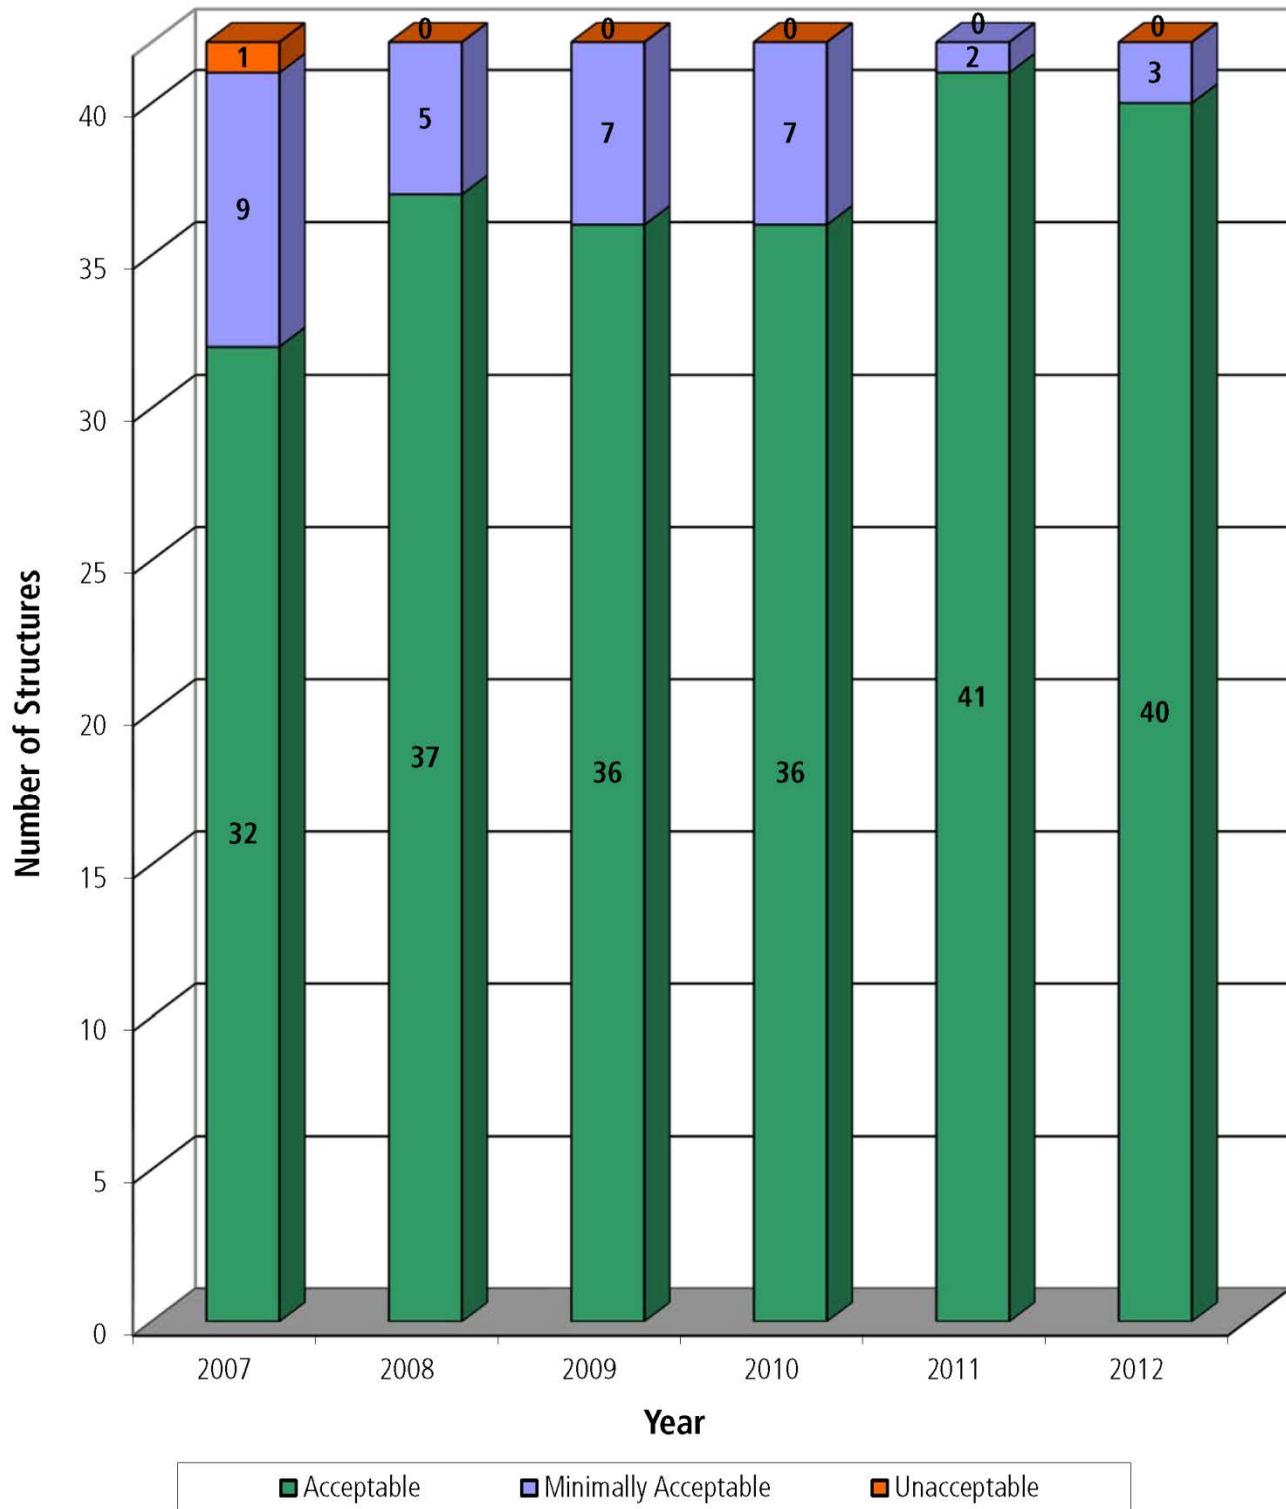
Figure 4-1: Comparison of Overall Structure Ratings from 2007 through 2012

Similar to the channel inspections, the method for determining overall ratings is described in Appendix F. Table 4-1 show the numbers of each rating for the years 2007-2012 for all structures. Figure 4-1 and Table 4-2 show ratings for each structure. Figure 4-2 and Table 4-3 show ratings for each pumping plants. The LMAs have generally improved structure maintenance since 2007.

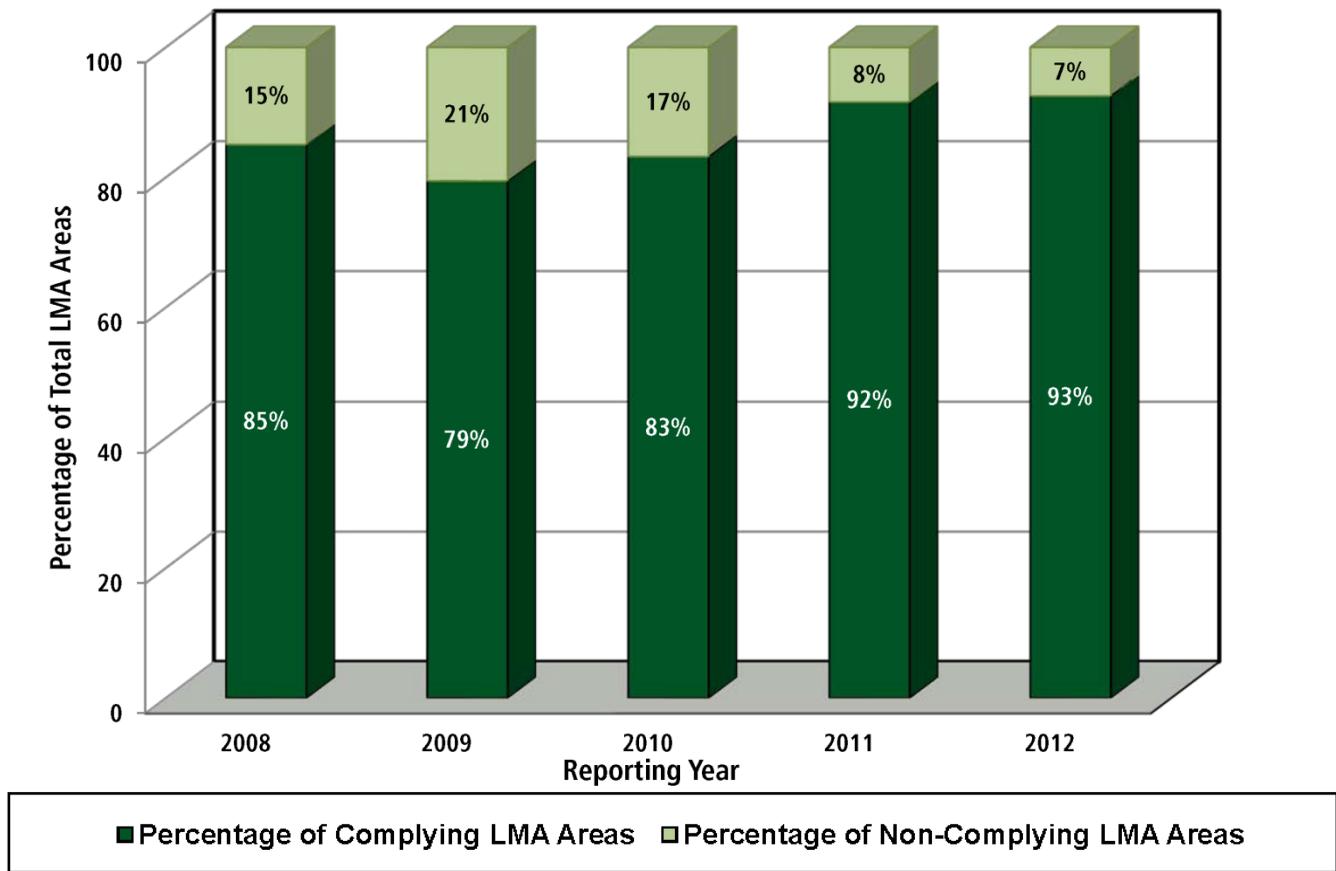
Figure 6-1 Annual Reporting Compliance by LMAs

There is an increasing trend (Figure 6.1) of reporting compliance by LMAs since the program started in 2008. Systemwide comparison of reporting compliance (Figure 6.2) shows about 90% LMAs belonging to SAC System and 96% belonging to SJ system have reported in last two years. In the overall, about 93% of LMA Areas submitted their report this year. An increasing trend of electronic reporting is apparent in Figure 6-3. This year about 68% LMA Areas submitted report through DWR’s Web-based LMA Reporting tool. This represents about 16% increase over last year’s electronic reporting. This could

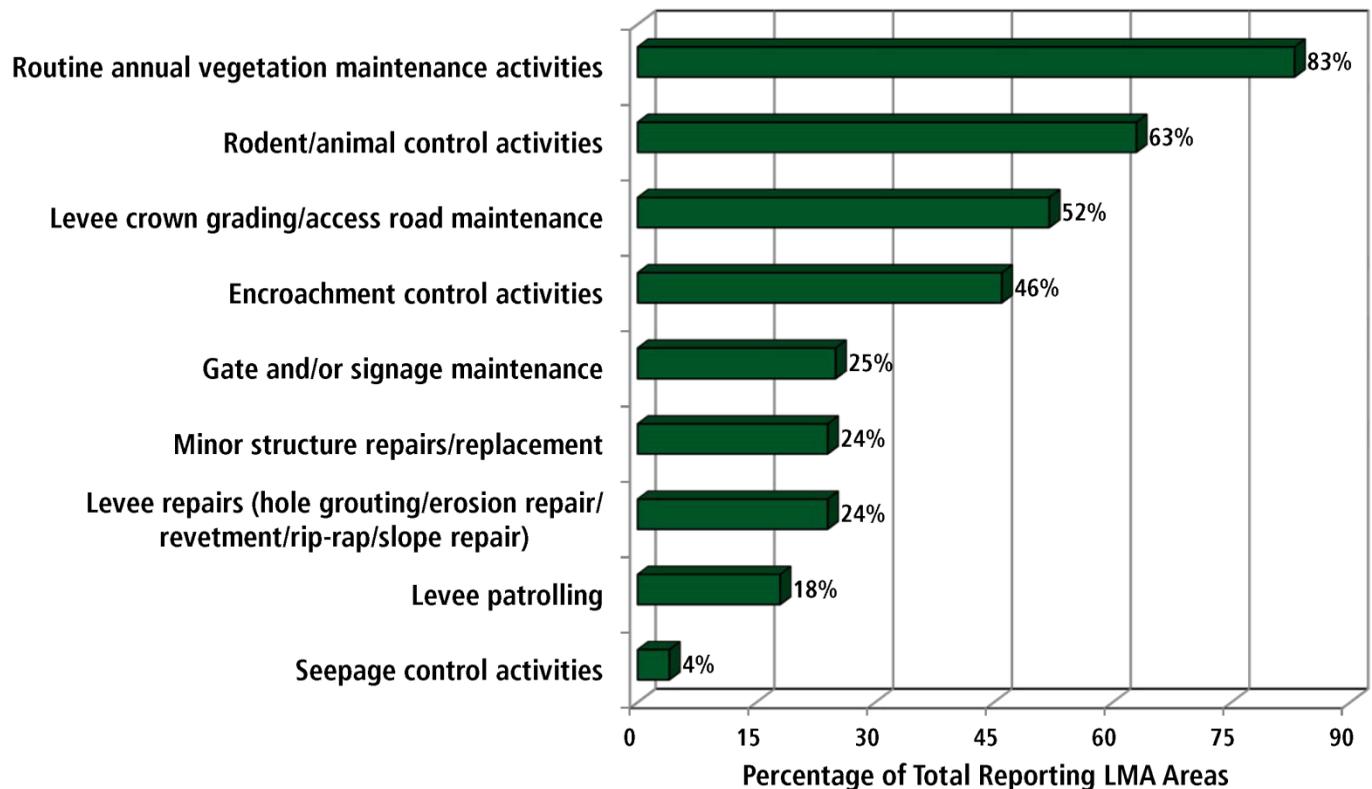
Figure 6-4 Reported Key Activities for Fiscal Year 2011-2012

About 90% of reporting LMA Areas provided information on the summary of maintenance activities. As in previous years, routine vegetation maintenance activities (burning, slope dragging, cutting, trimming, spraying), rodent control, levee crown grading, roadway maintenance and encroachment (Figure 6.4) dominated reported LMA maintenance activities for fiscal year 2011-12. Other reported key activities include gate/signage maintenance, minor structural repairs, and minor levee repairs. Some LMAs also reported levee patrolling and other planning activities such as preparation of five year maintenance plans.

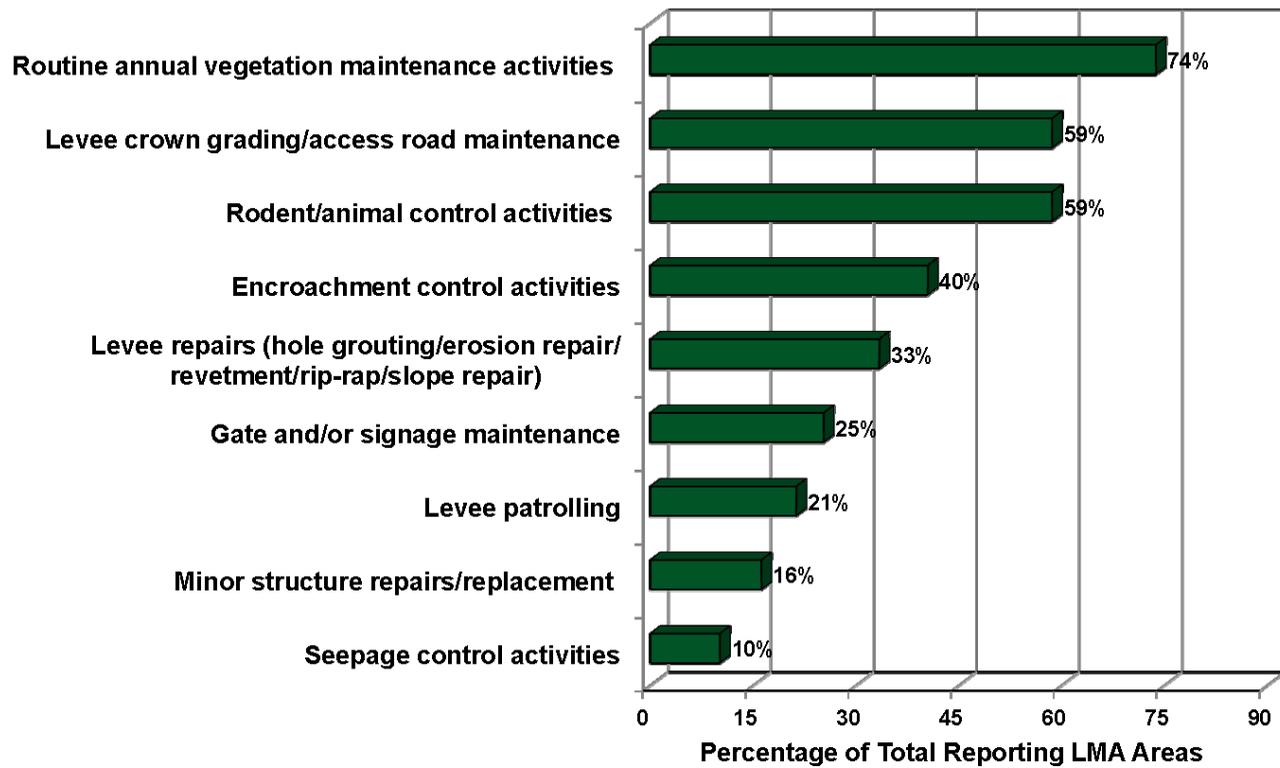
Figure 6-5 Reported Key Planned Activities for Fiscal Year 2012-2013

A similar percent of reporting LMA Areas also provided information on the summary of maintenance activities for the current fiscal year. The reported planned activities also reflect LMAs' similar maintenance priorities (Figure 6.5) in the current fiscal year also.

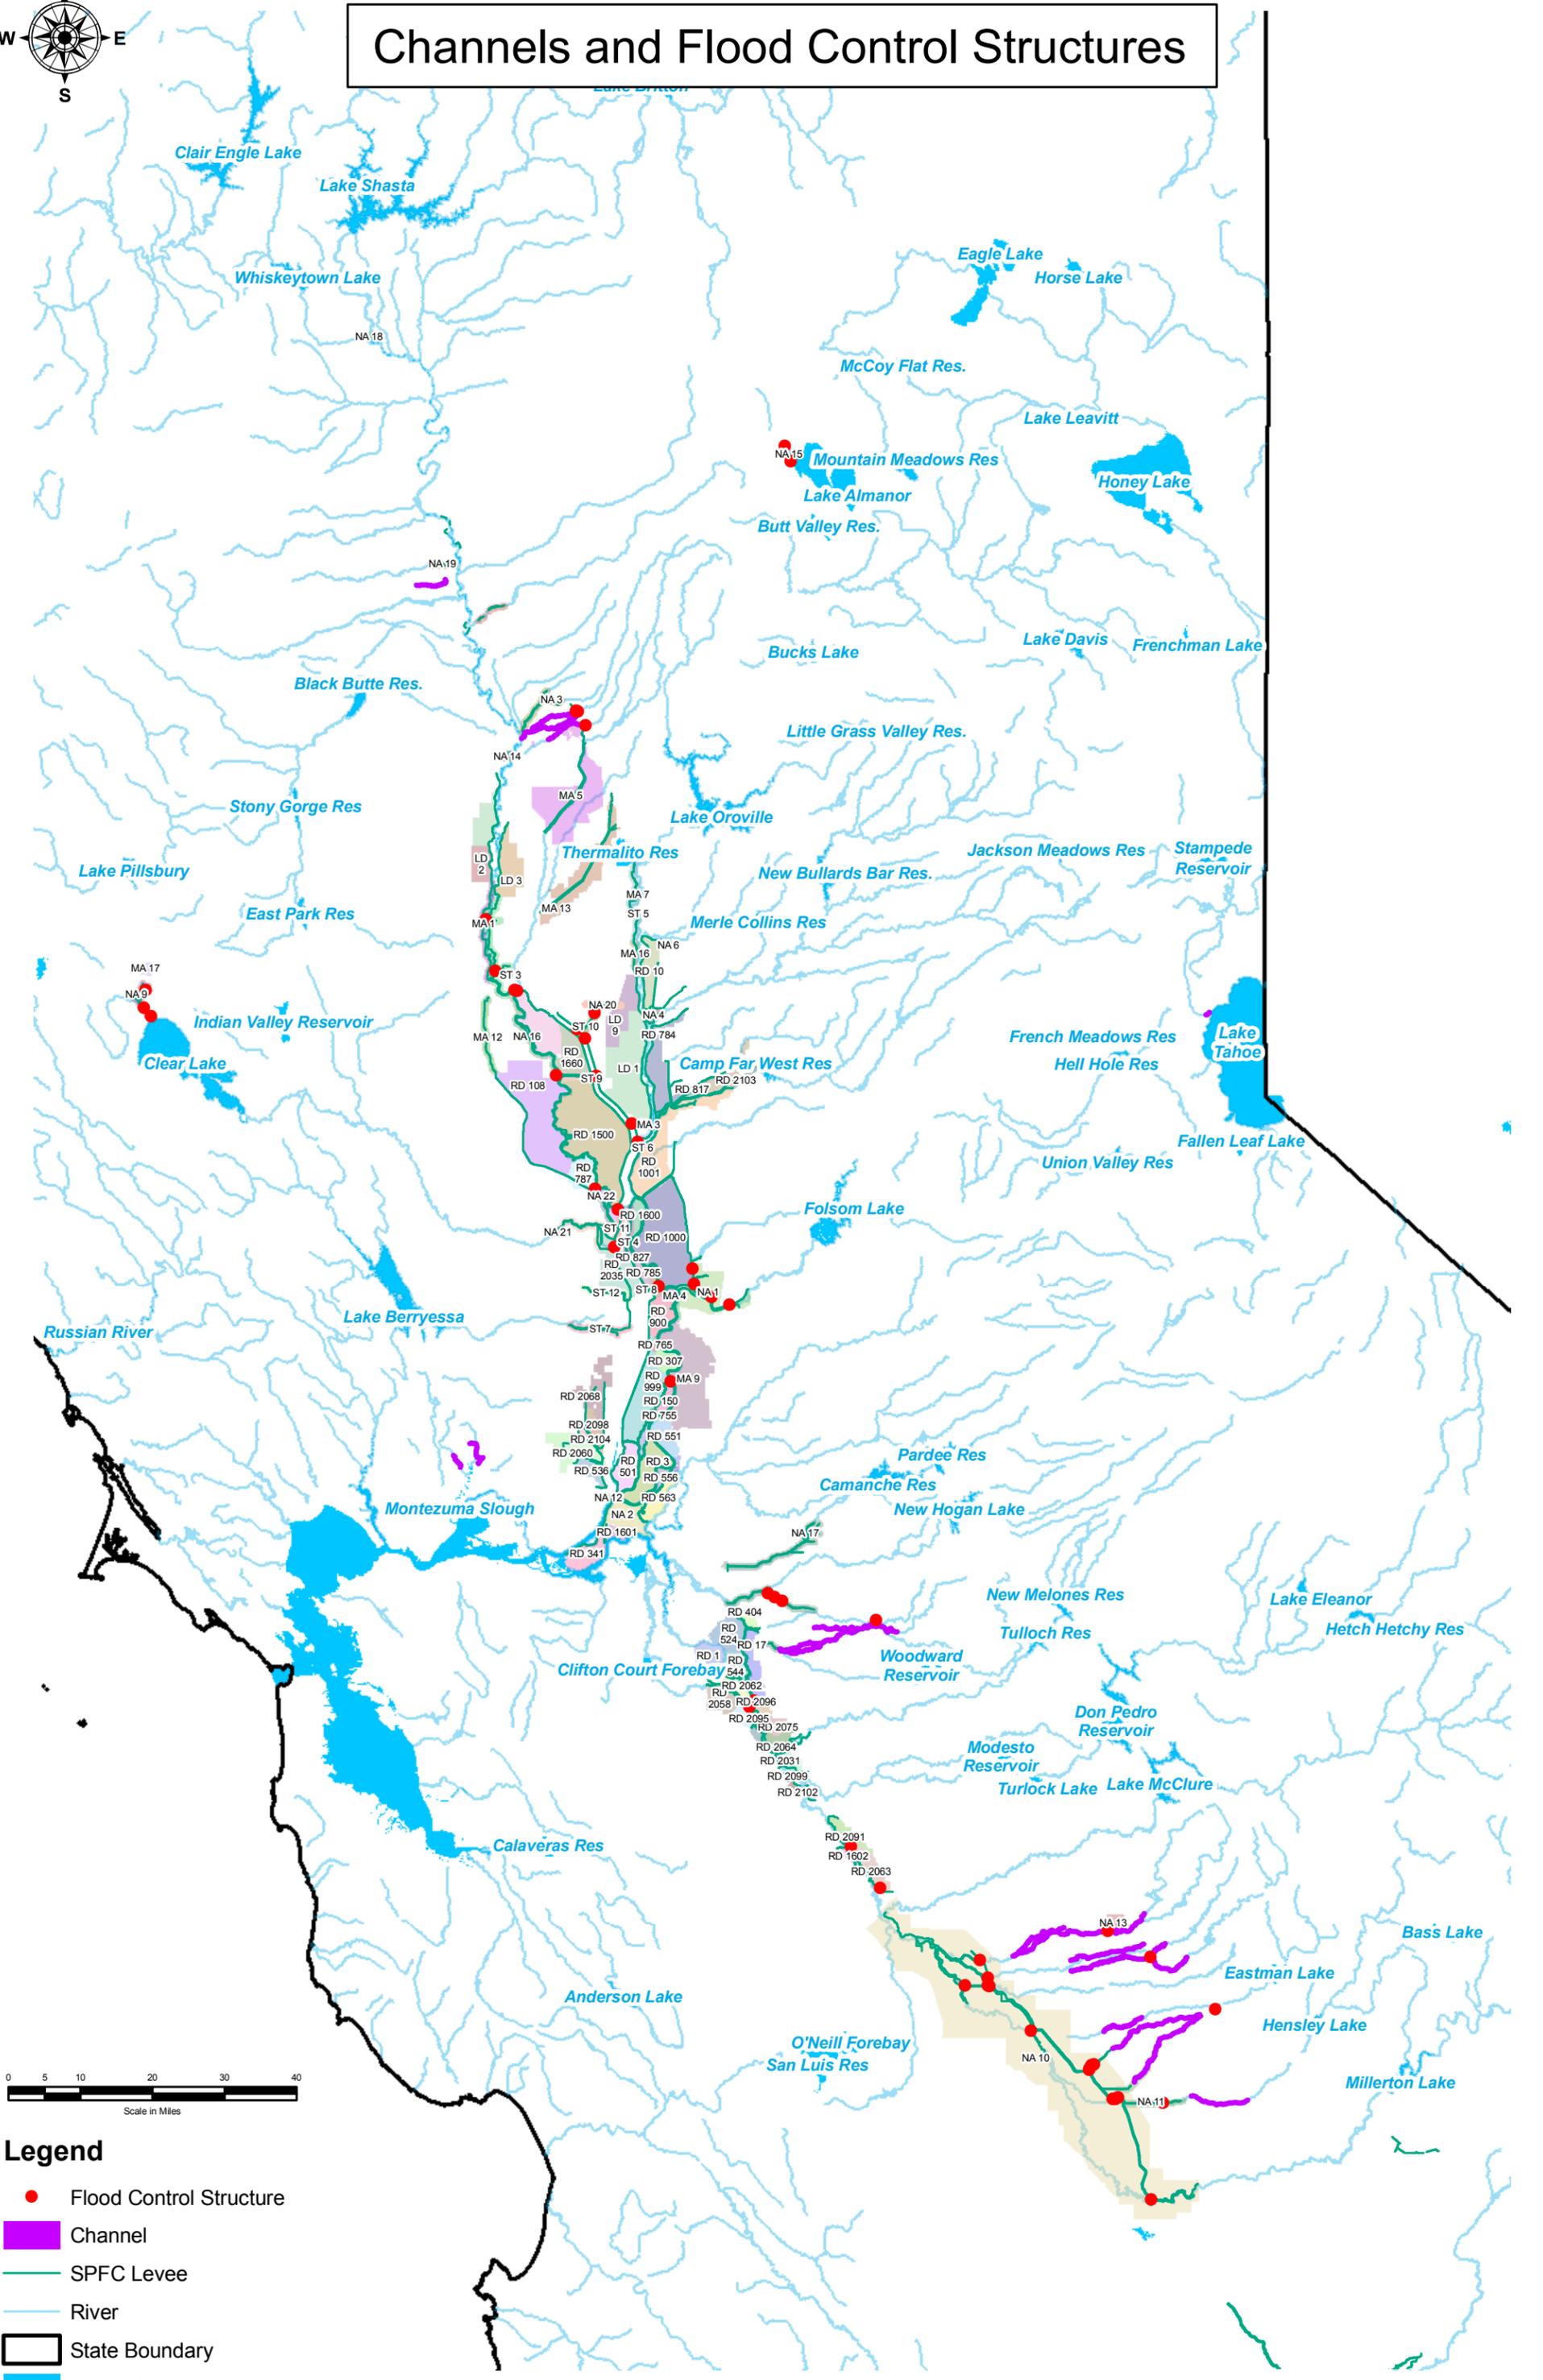
Channels and Flood Control Structures

- Legend**
- Flood Control Structure
 - Channel
 - SPFC Levee
 - River
 - State Boundary
 - Water Body

Locations of the structures inspected can be found on Figure 7-1.
