2012

INSPECTION AND LOCAL MAINTAINING AGENCY REPORT OF THE CENTRAL VALLEY STATE-FEDERAL FLOOD PROTECTION SYSTEM

Department of Water Resources

Flood Project Integrity and Inspection Branch | Hydrology and Flood Operations Office | Division of Flood Management

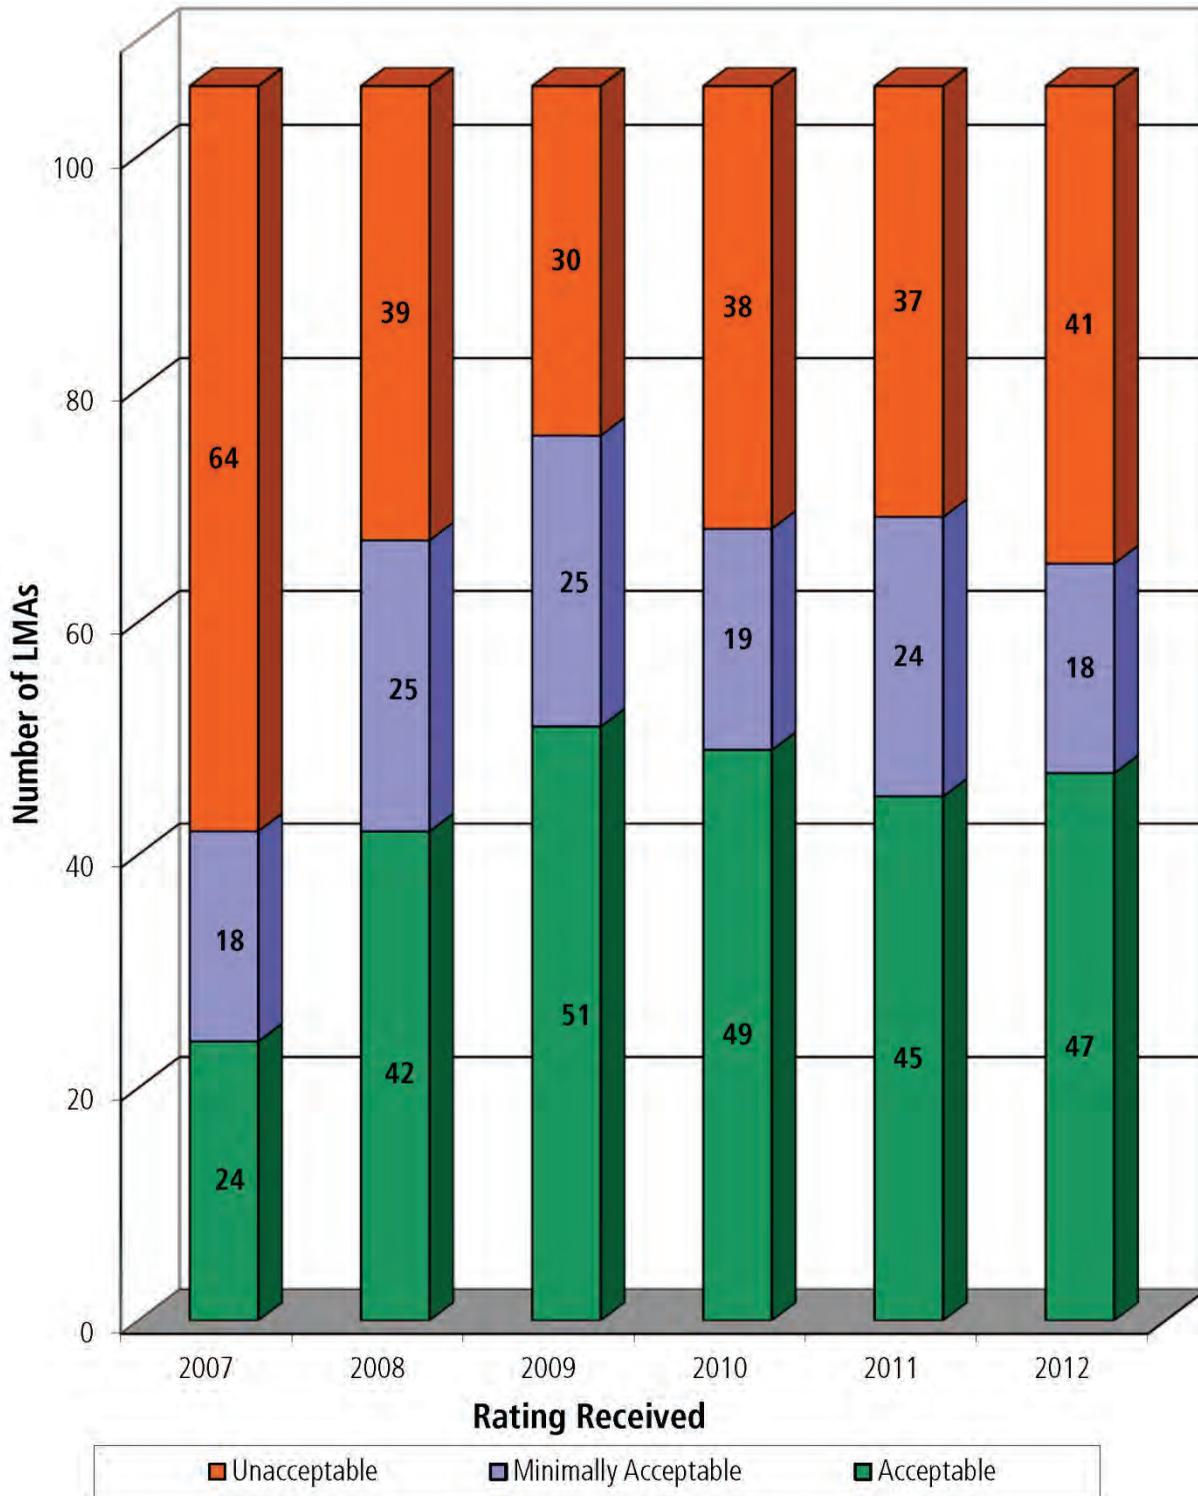
Figure 2-1: Summary of Area Maintenance Ratings for 2007 through 2012

Table 2-1 and Figure 2-1 show the numbers of Areas receiving each rating for 2007 through 2012. The length of vegetation deficiencies increased significantly compared to 2011, most notably in the San Joaquin River system. There was a significant increase in crown surface issues and a moderate increase in animal control issues. Other categories did not change significantly. Many of the LMAs have expressed limitations due to financial and environmental issues. Some LMAs are severely limited in what money they have been able to collect from residents to perform maintenance. Weather patterns that are different than prior years may also play a factor in the increase in deficiencies.

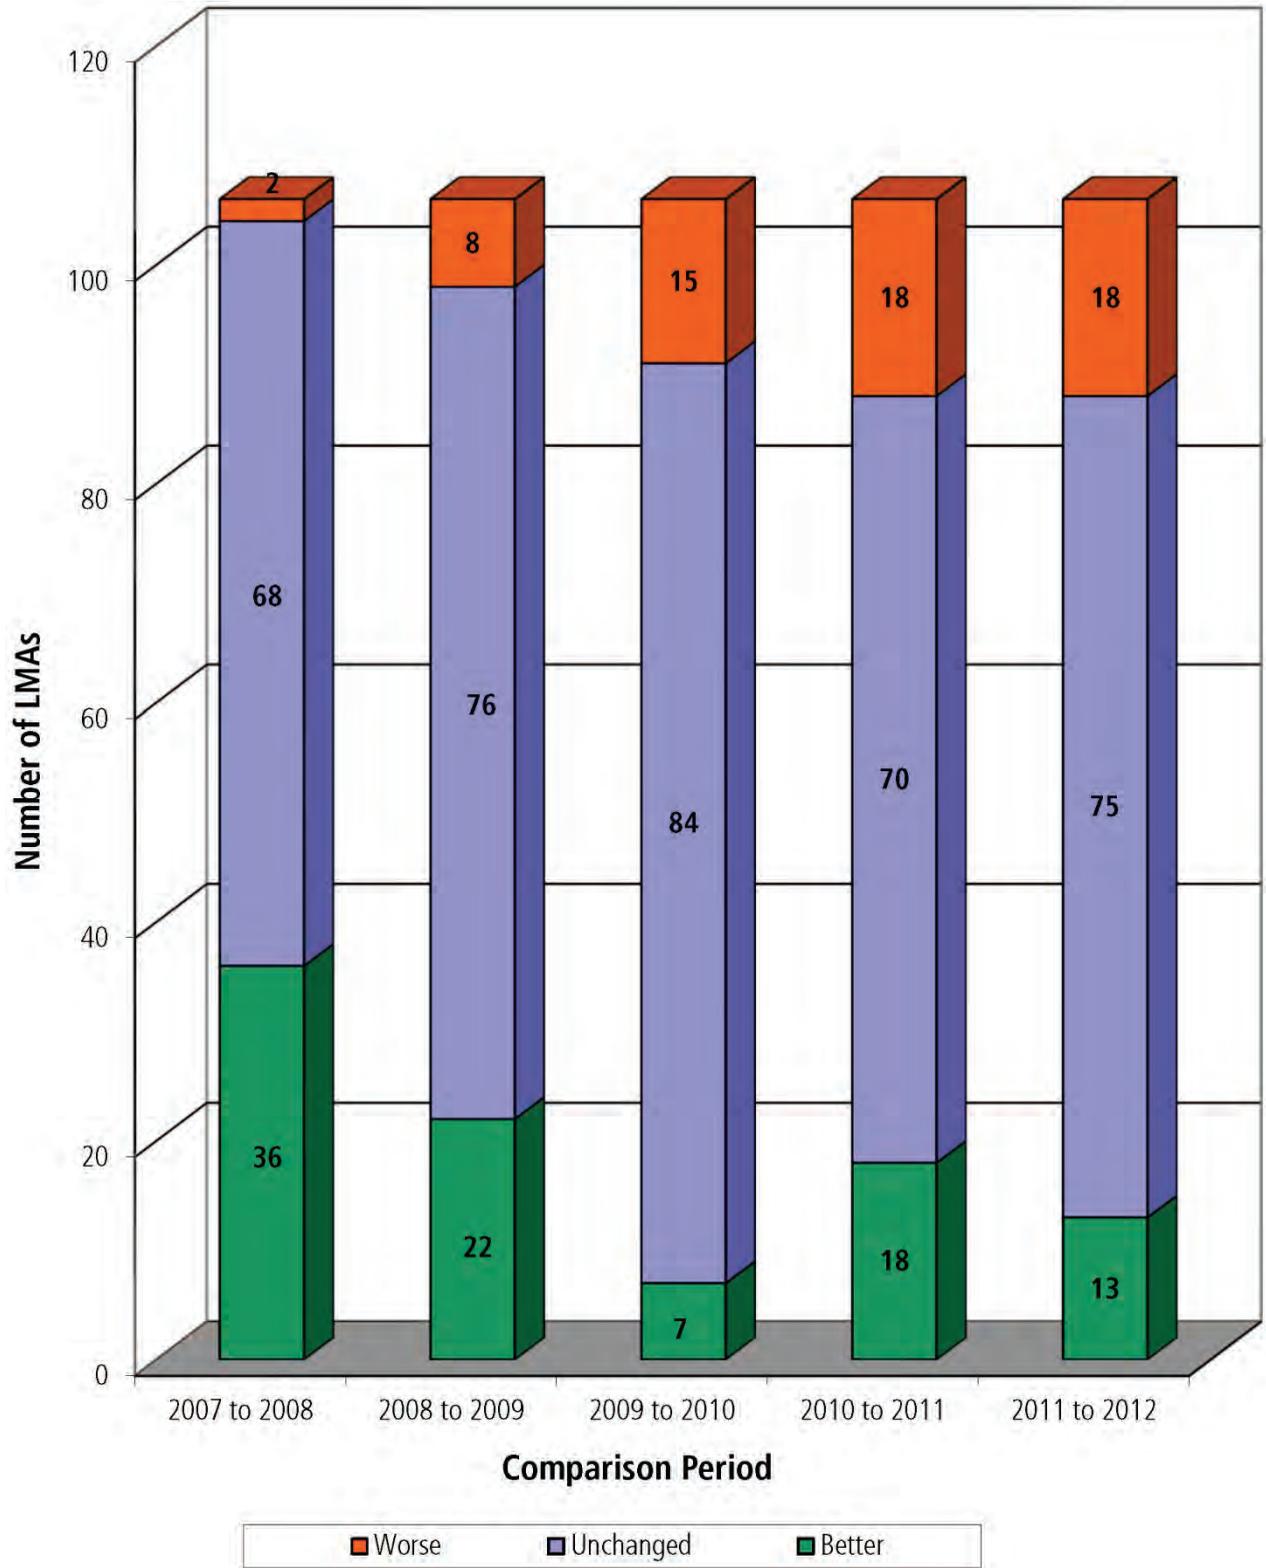
Figure 2-2: Area Maintenance Rating Changes from Fall 2007 to Fall 2012

Figure 2-2 shows the number of agencies that received better, unchanged, or worse ratings in 2012 compared with 2011, 2010, 2009, 2008, and 2007. The number of Areas receiving Acceptable ratings increased by two; however, the number of Areas rated as Unacceptable increased by four. The number of Areas rated as Minimally Acceptable decreased by six. This is likely due to fluctuations in maintenance and funding. Despite these changes, Areas continue to generally receive better ratings than in 2007 and 2008. Levee Mile Reports (LMRs) contain more detailed information about each LMA. Appendix F provides more an explanation of threshold percentages and the determination of overall ratings.

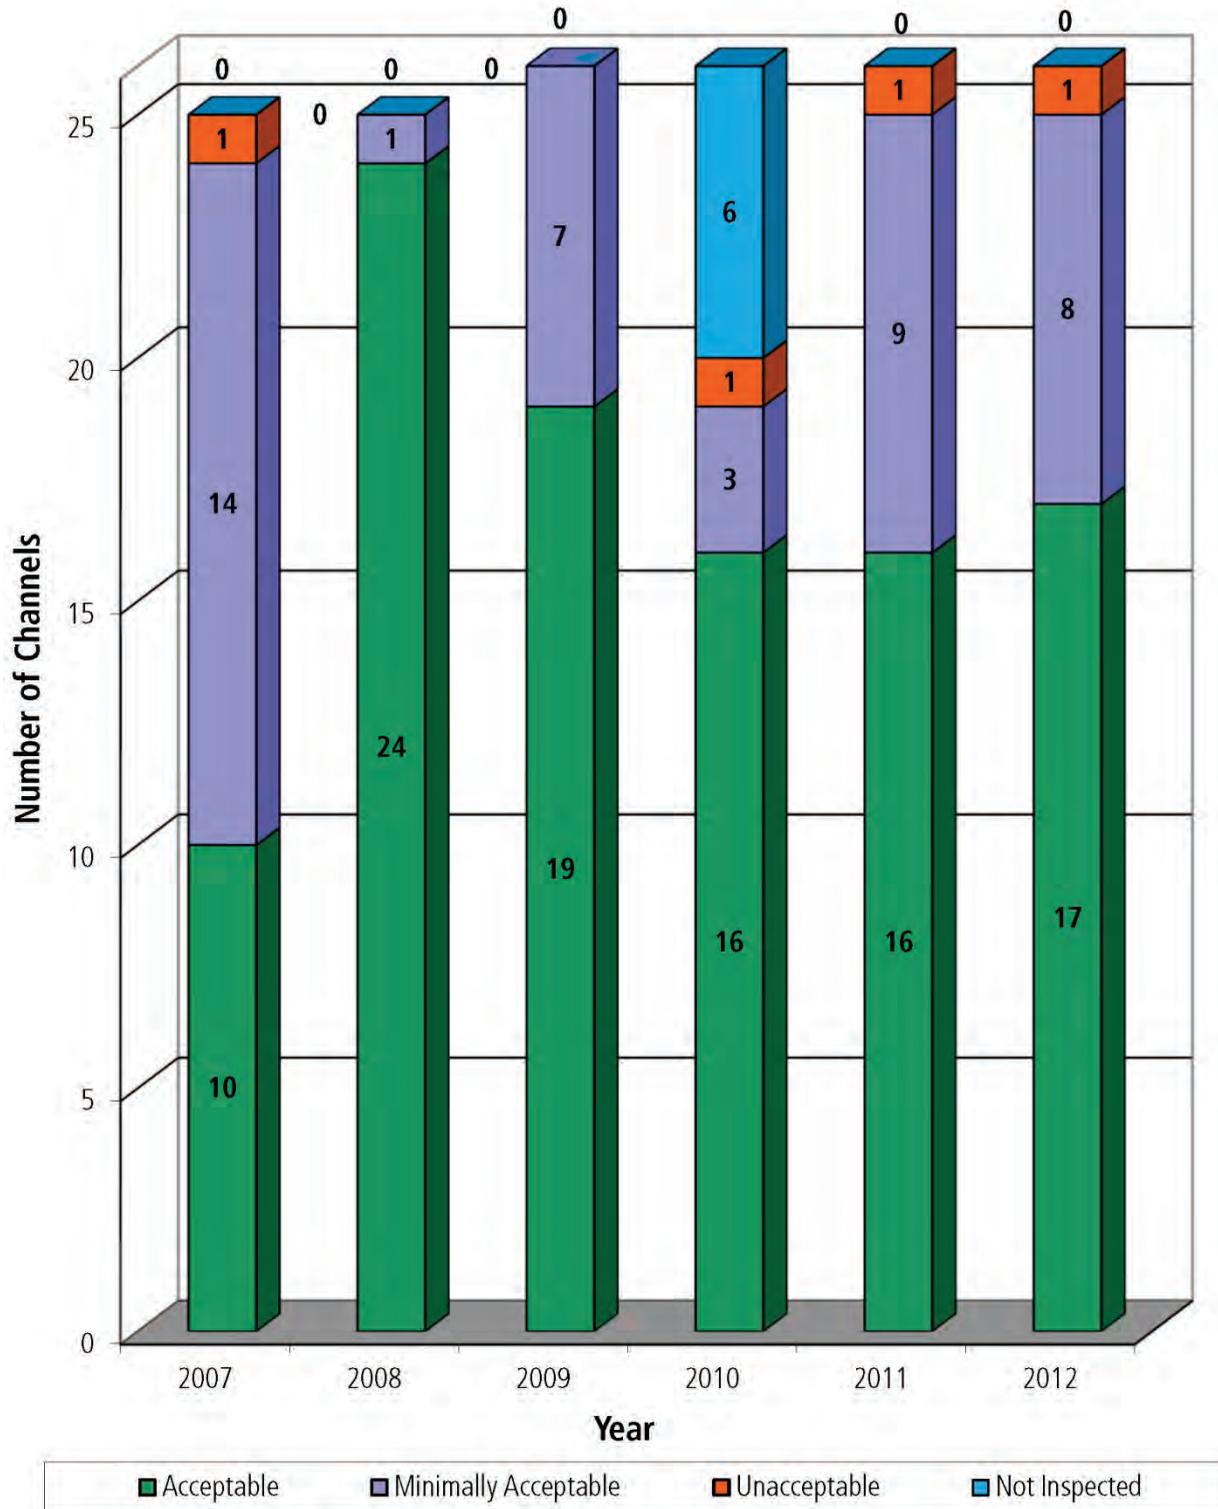
Figure 3-1: Comparison of Overall Channel Ratings, 2007 through 2012

One channel was rated as Unacceptable in 2012, while the number of Minimally Acceptable channels was eight, which is similar to 2011. This shows the similarity of maintenance found during inspection in 2012 as prior years. Figure 3-1 shows the progression of maintenance ratings from 2007 through 2012.

Appendix F details the method for determining overall ratings. Table 3-1 and Figure 3-1 show the numbers of each rating for the years 2007 through 2012.

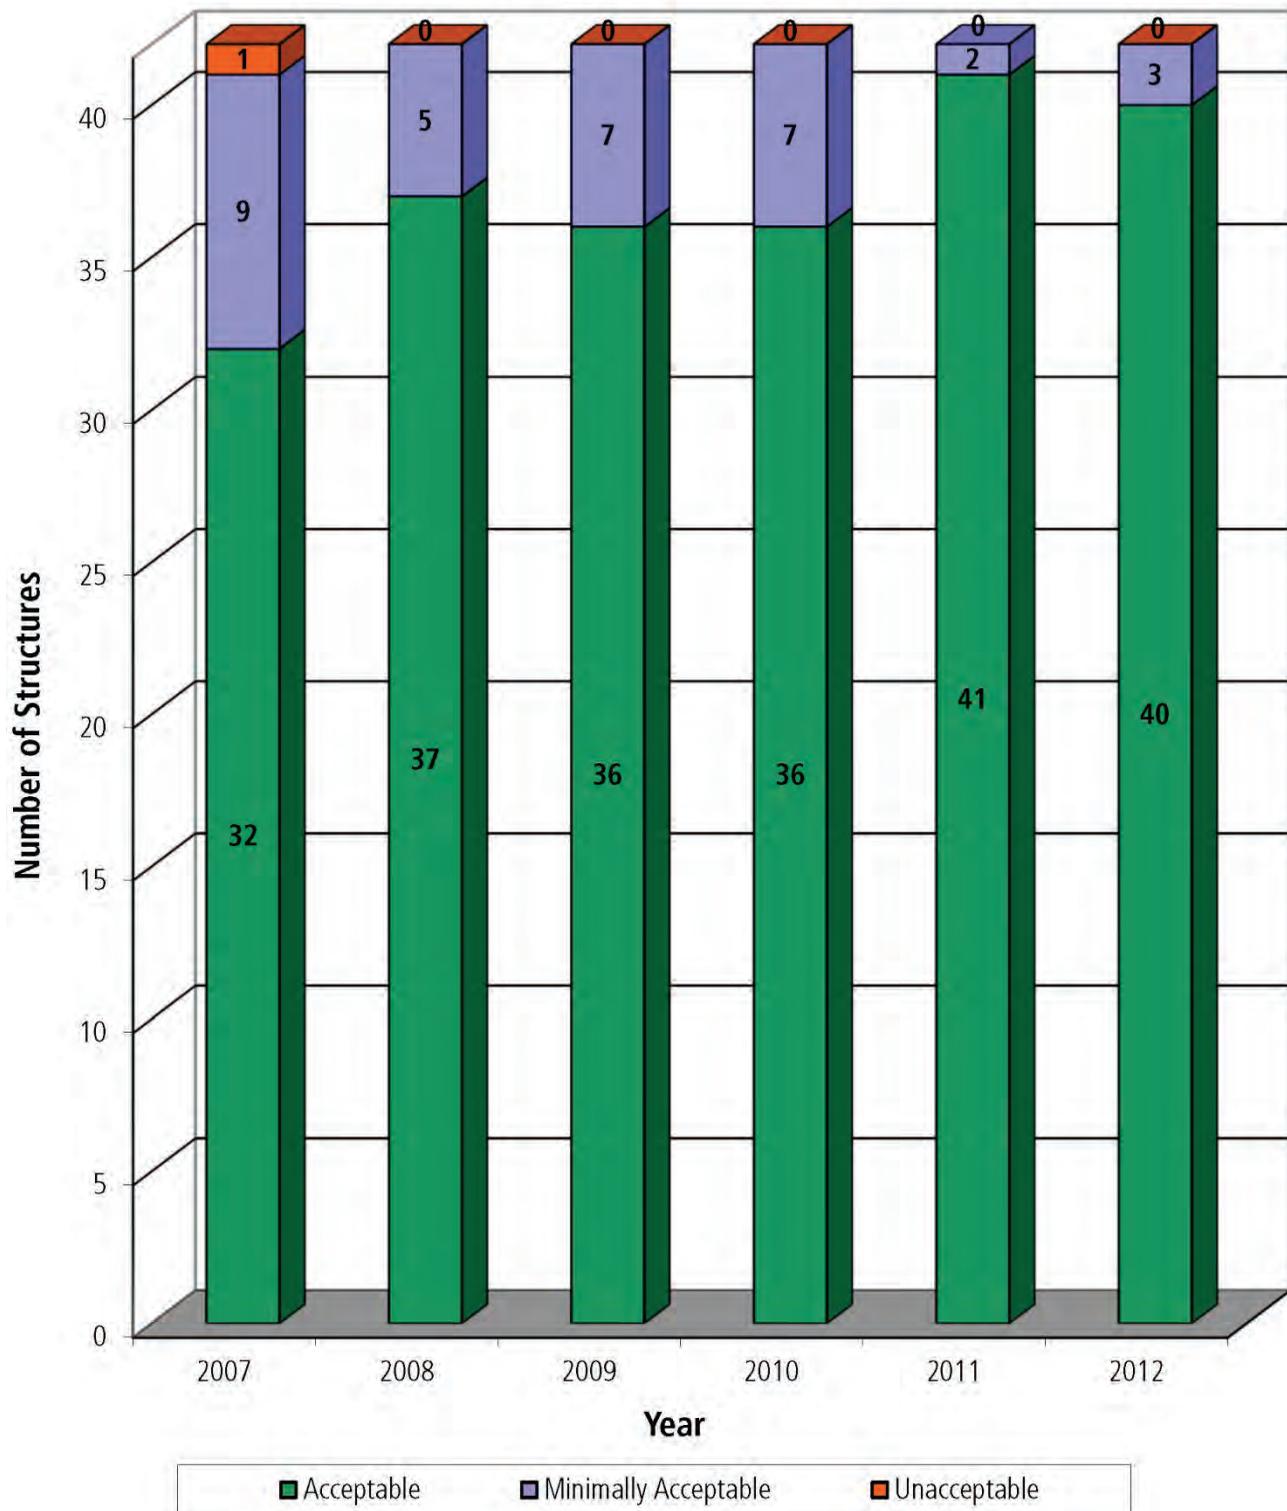
Figure 4-1: Comparison of Overall Structure Ratings from 2007 through 2012

The method for determining overall ratings is similar to the one used for channel inspections and is described in Appendix F. Table 4-1 shows the numbers of each rating for 2007-2012 for all structures. Figure 4-1 and Table 4-2 show ratings for each structure, while Figure 4-2 and Table 4-3 show ratings for each pumping plant. The LMAs have generally improved structure maintenance since 2007. The El Camino Avenue Bridge over Steelhead Creek in Sacramento was added to structure inspections in 2009.

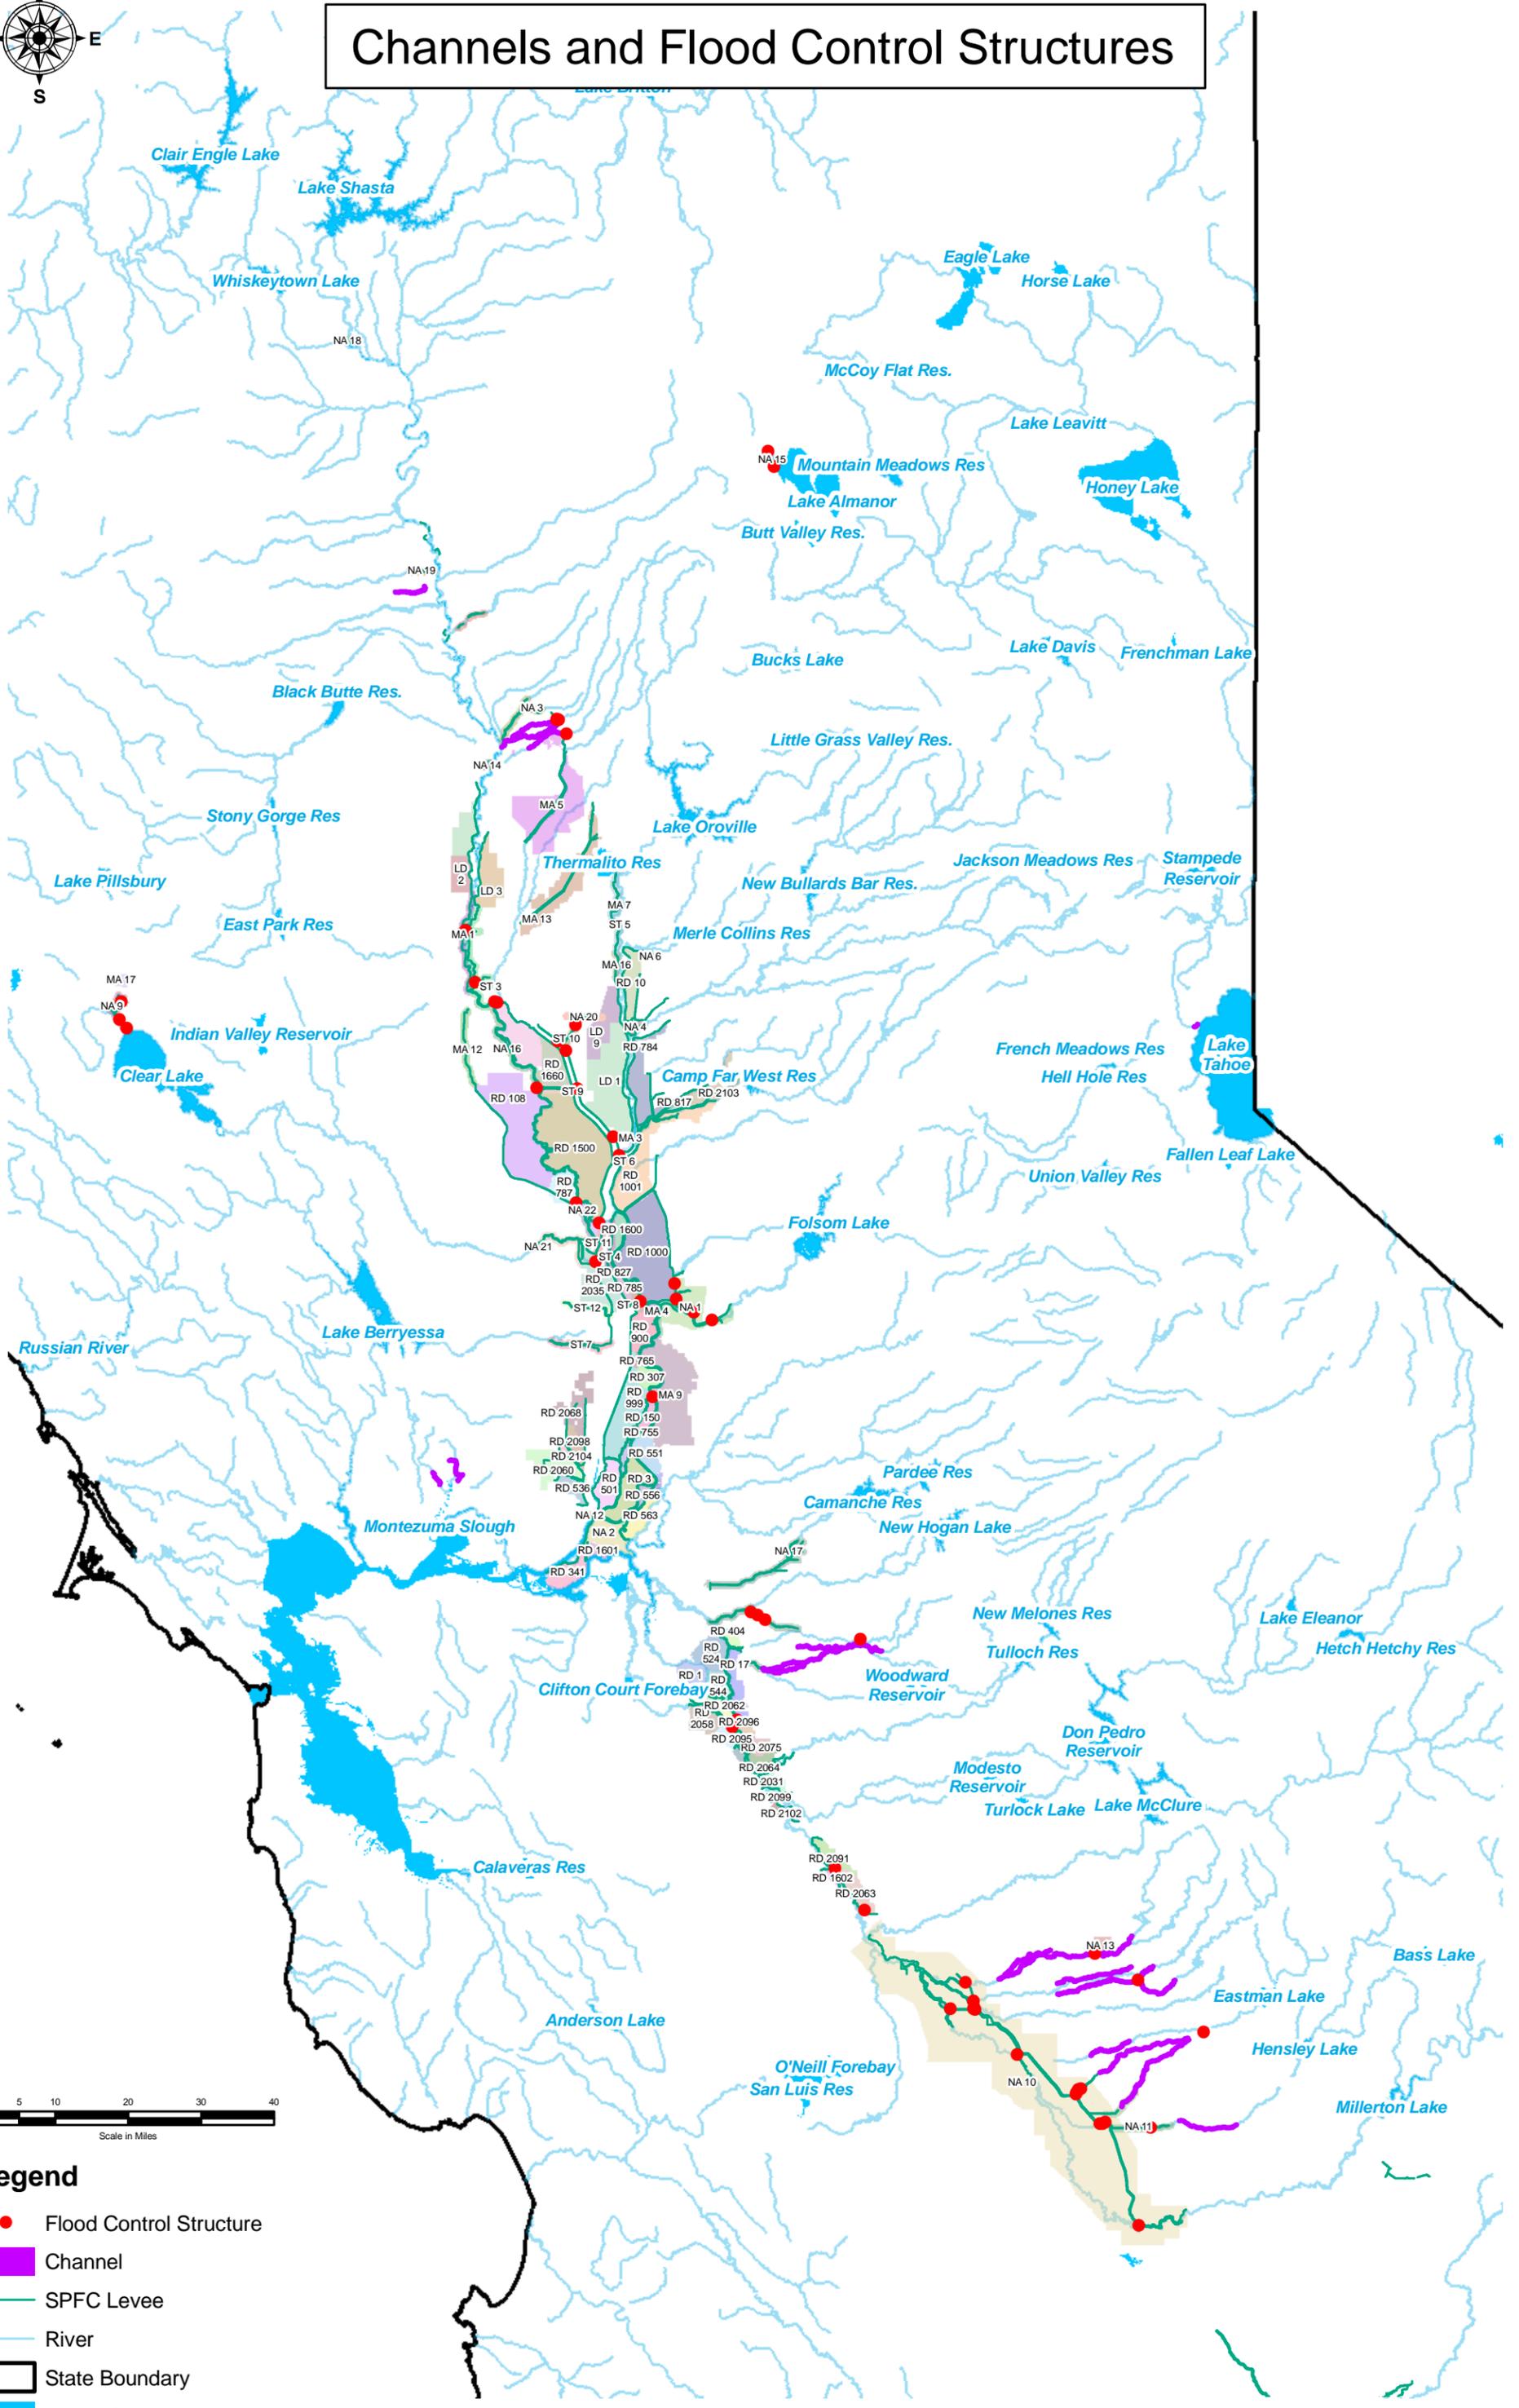
Channels and Flood Control Structures

- Legend**
- Flood Control Structure
 - Channel
 - SPFC Levee
 - River
 - State Boundary
 - Water Body

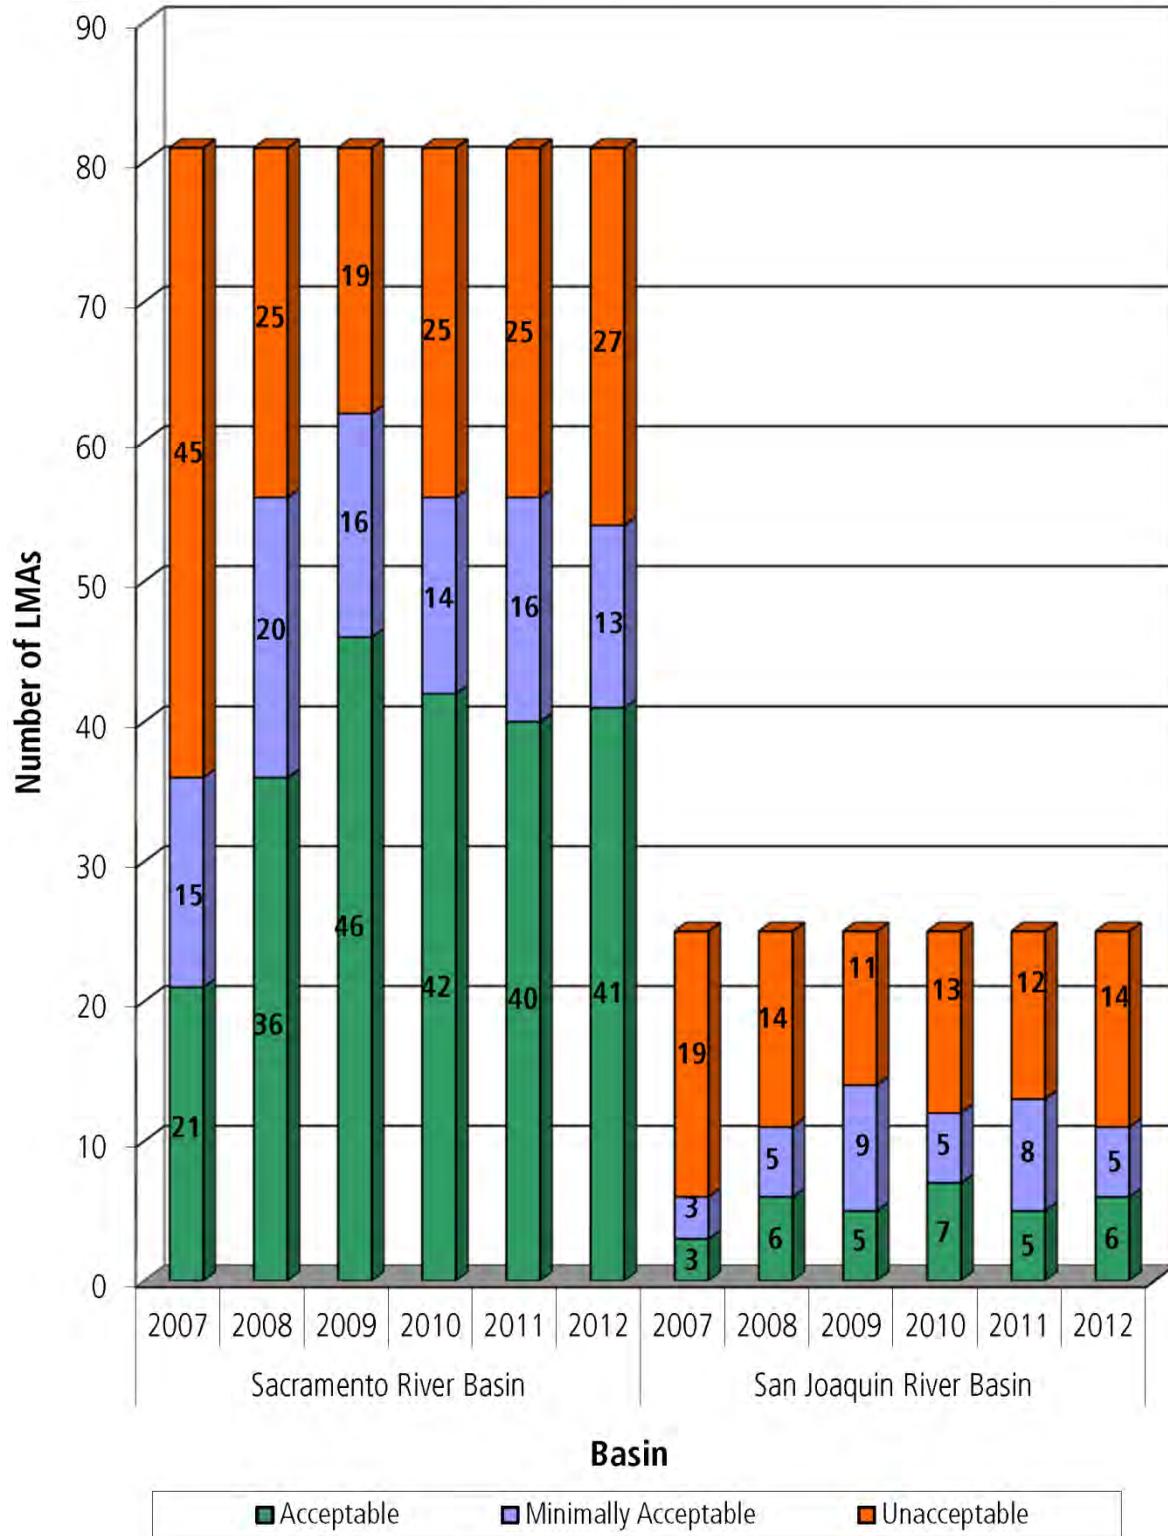
Figure E-1: LMA Maintenance Rating Comparison for 2007 through 2012 by Basin

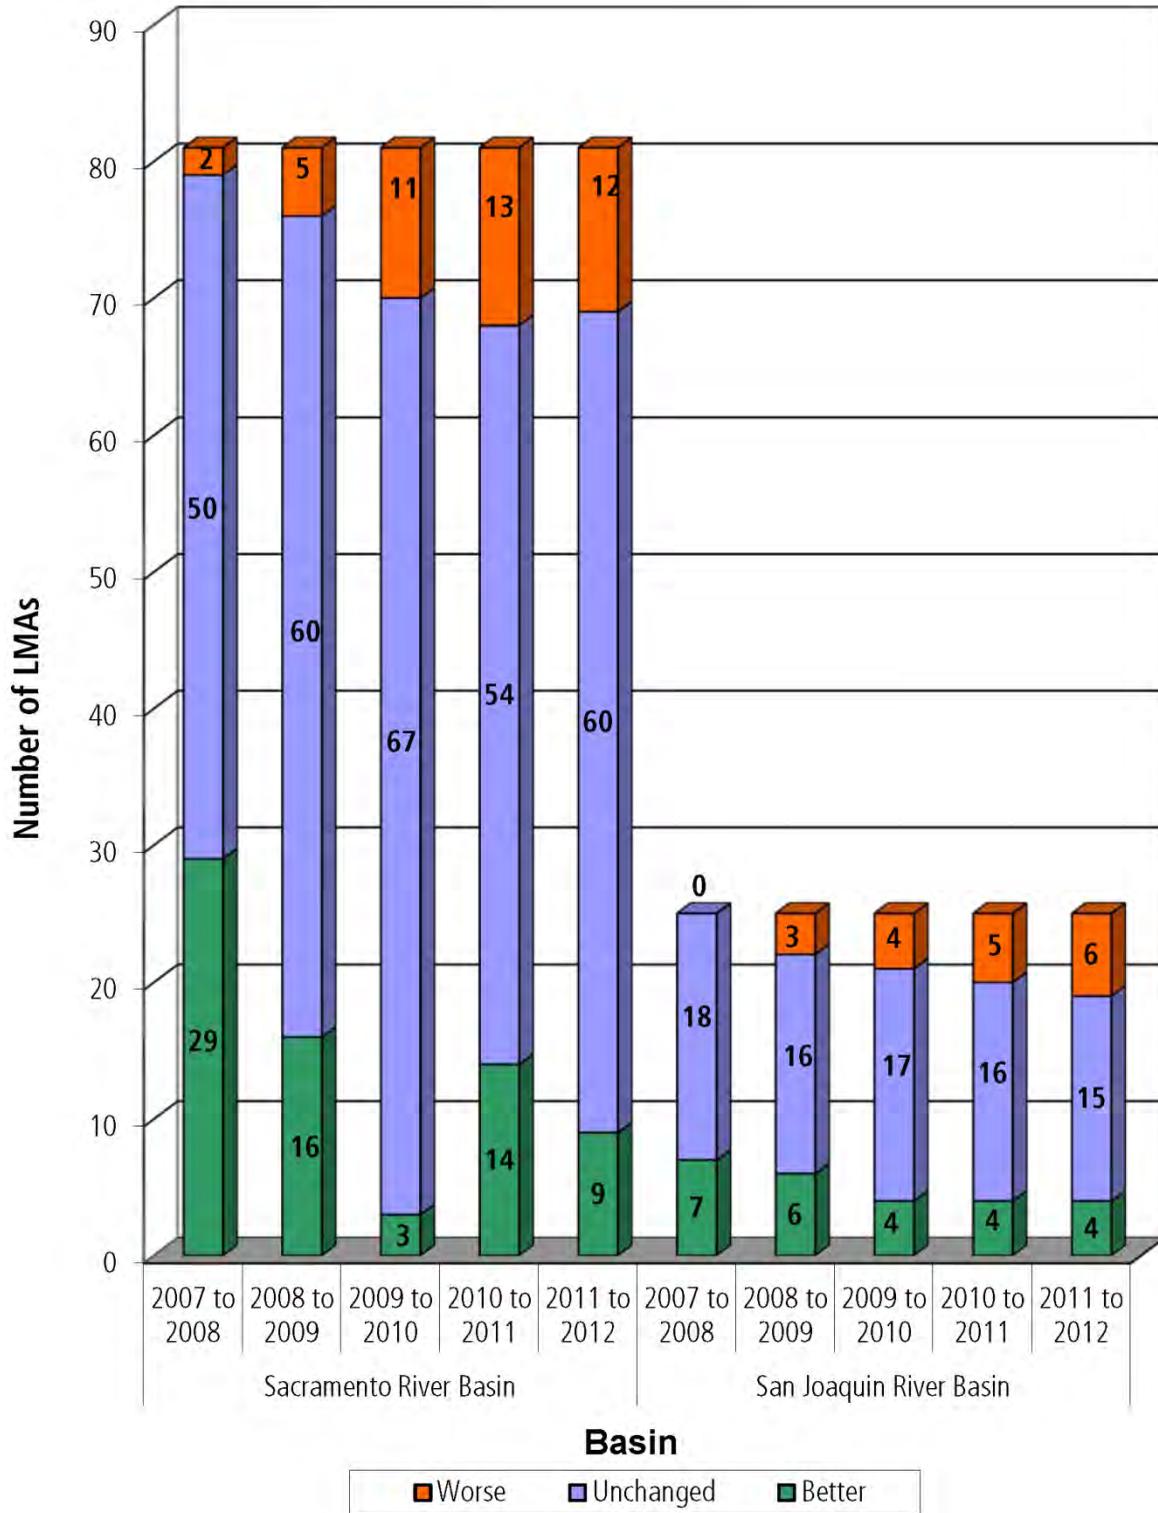
Figure E-2: LMA Maintenance Rating Changes from Fall 2007 to Fall 2012 by Basin

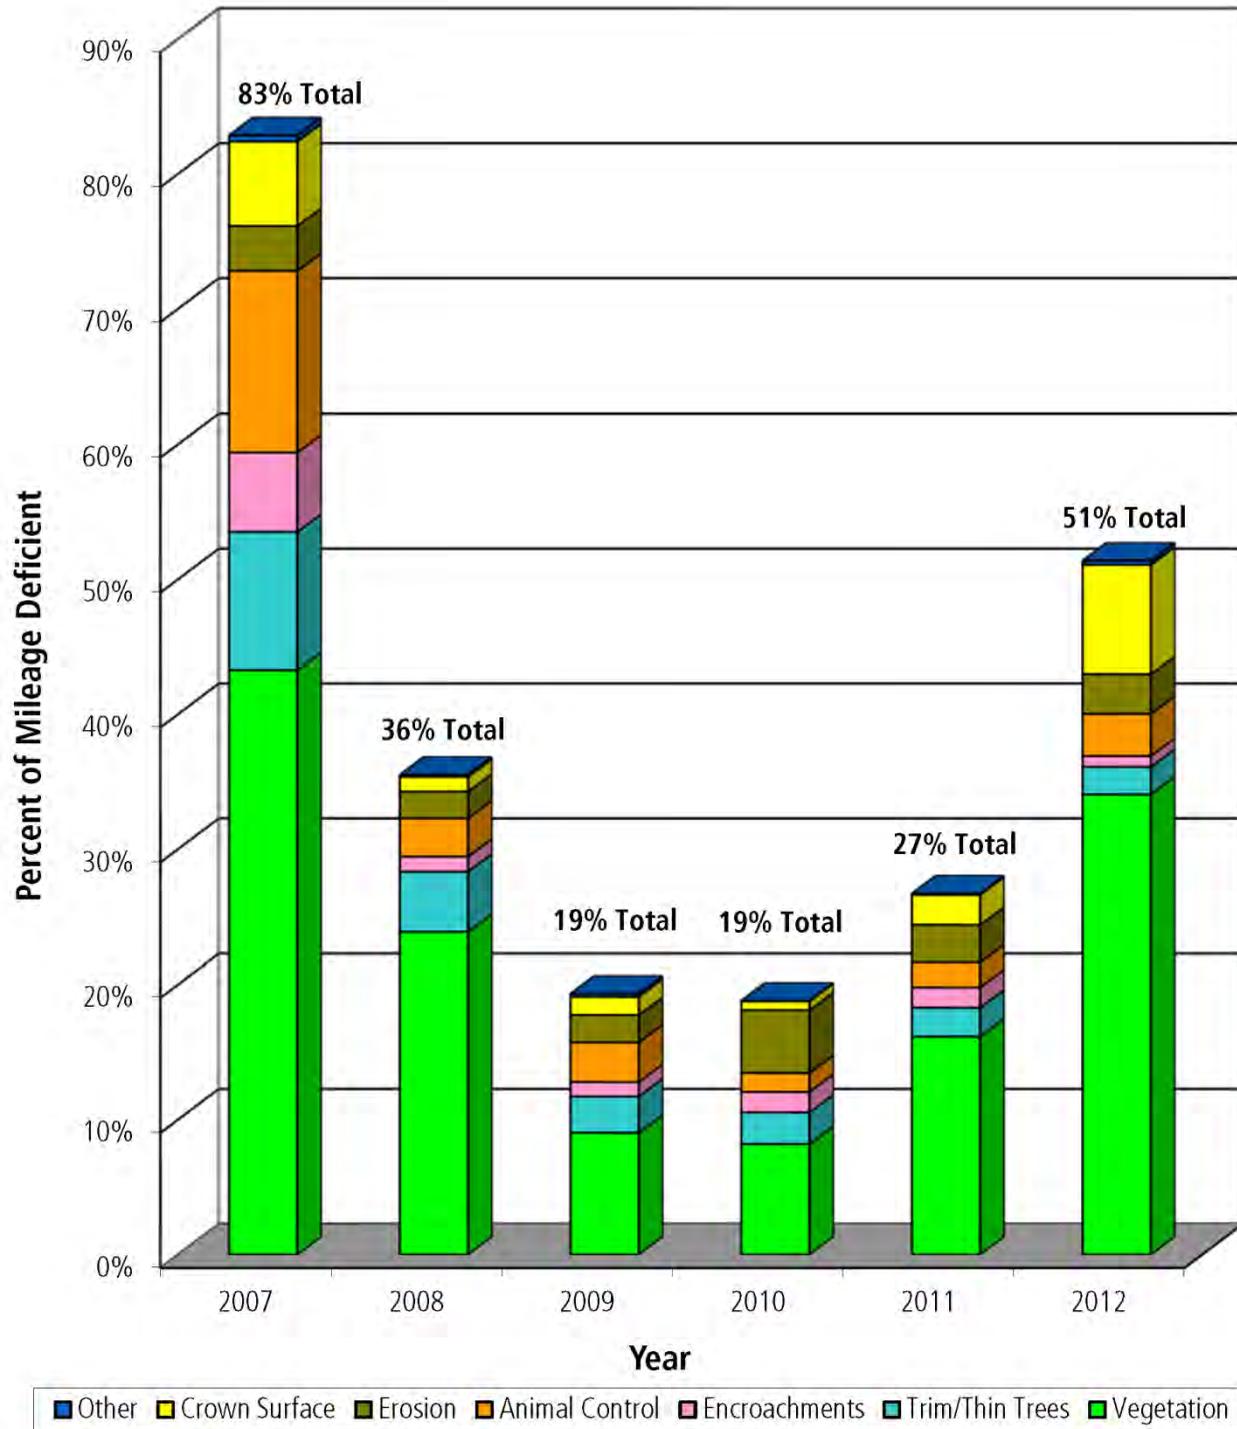
Figure E-3: Percentage of Total System Levee Miles with Maintenance Deficiencies

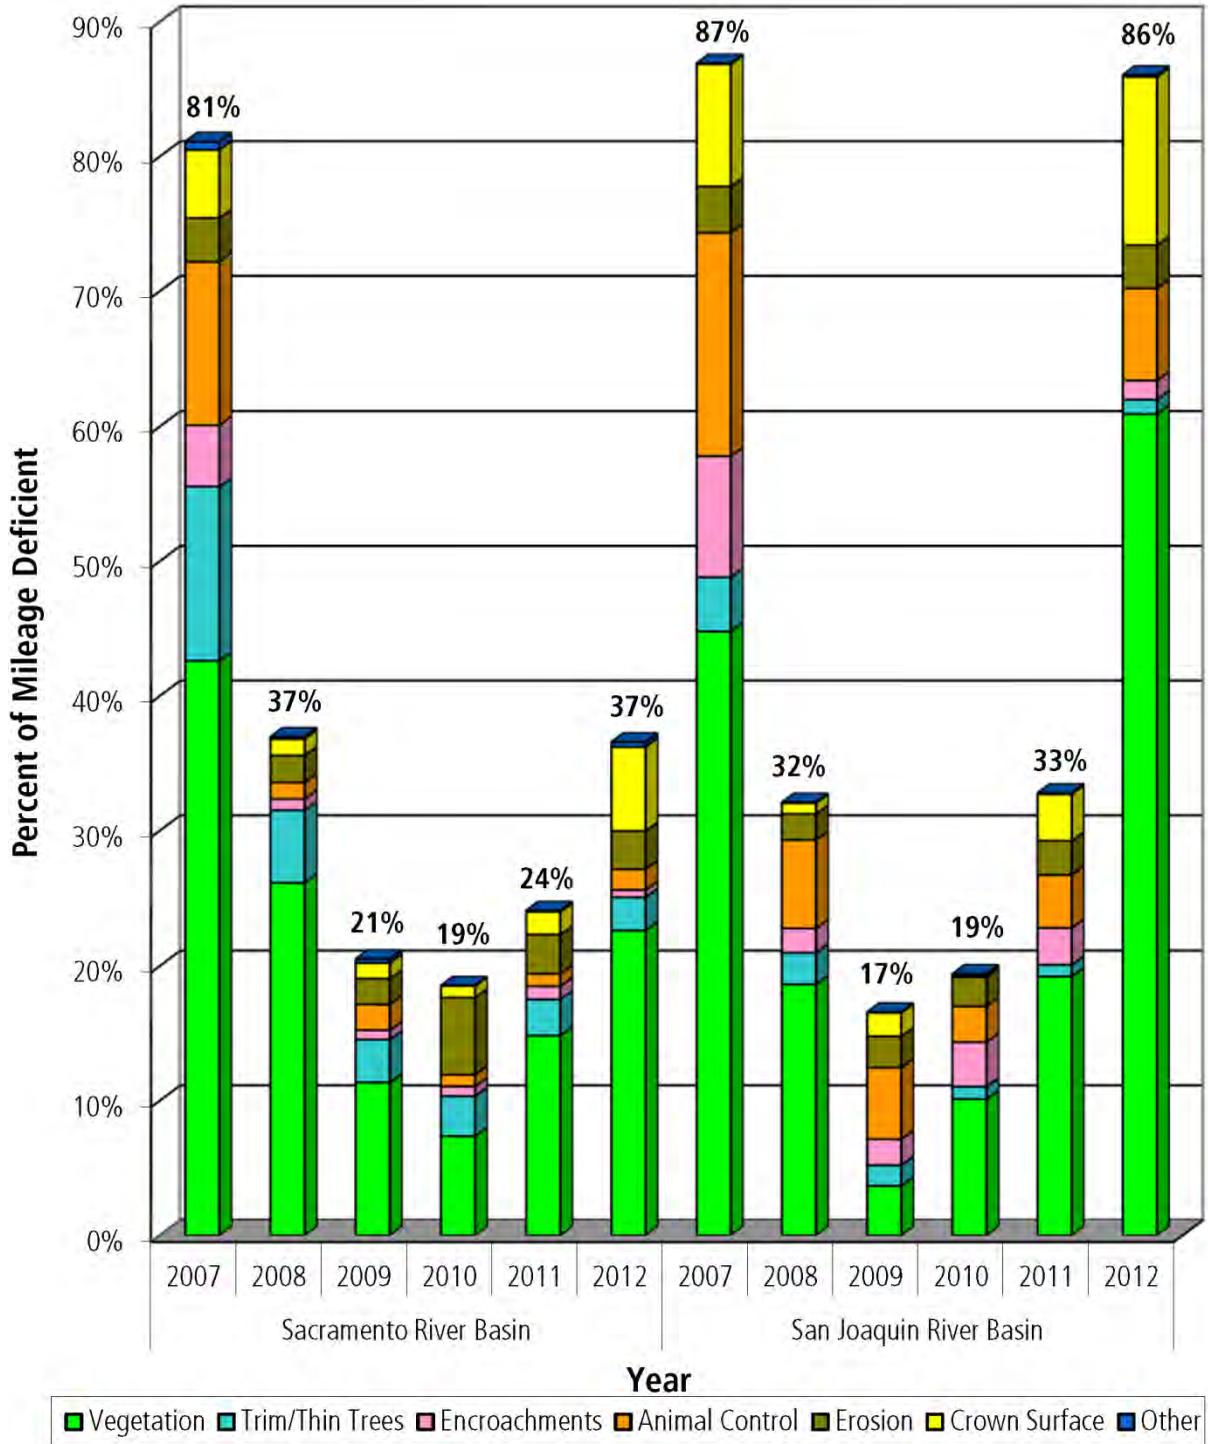
Figure E-4: Percentage of Levee Miles with Maintenance Deficiencies by Basin

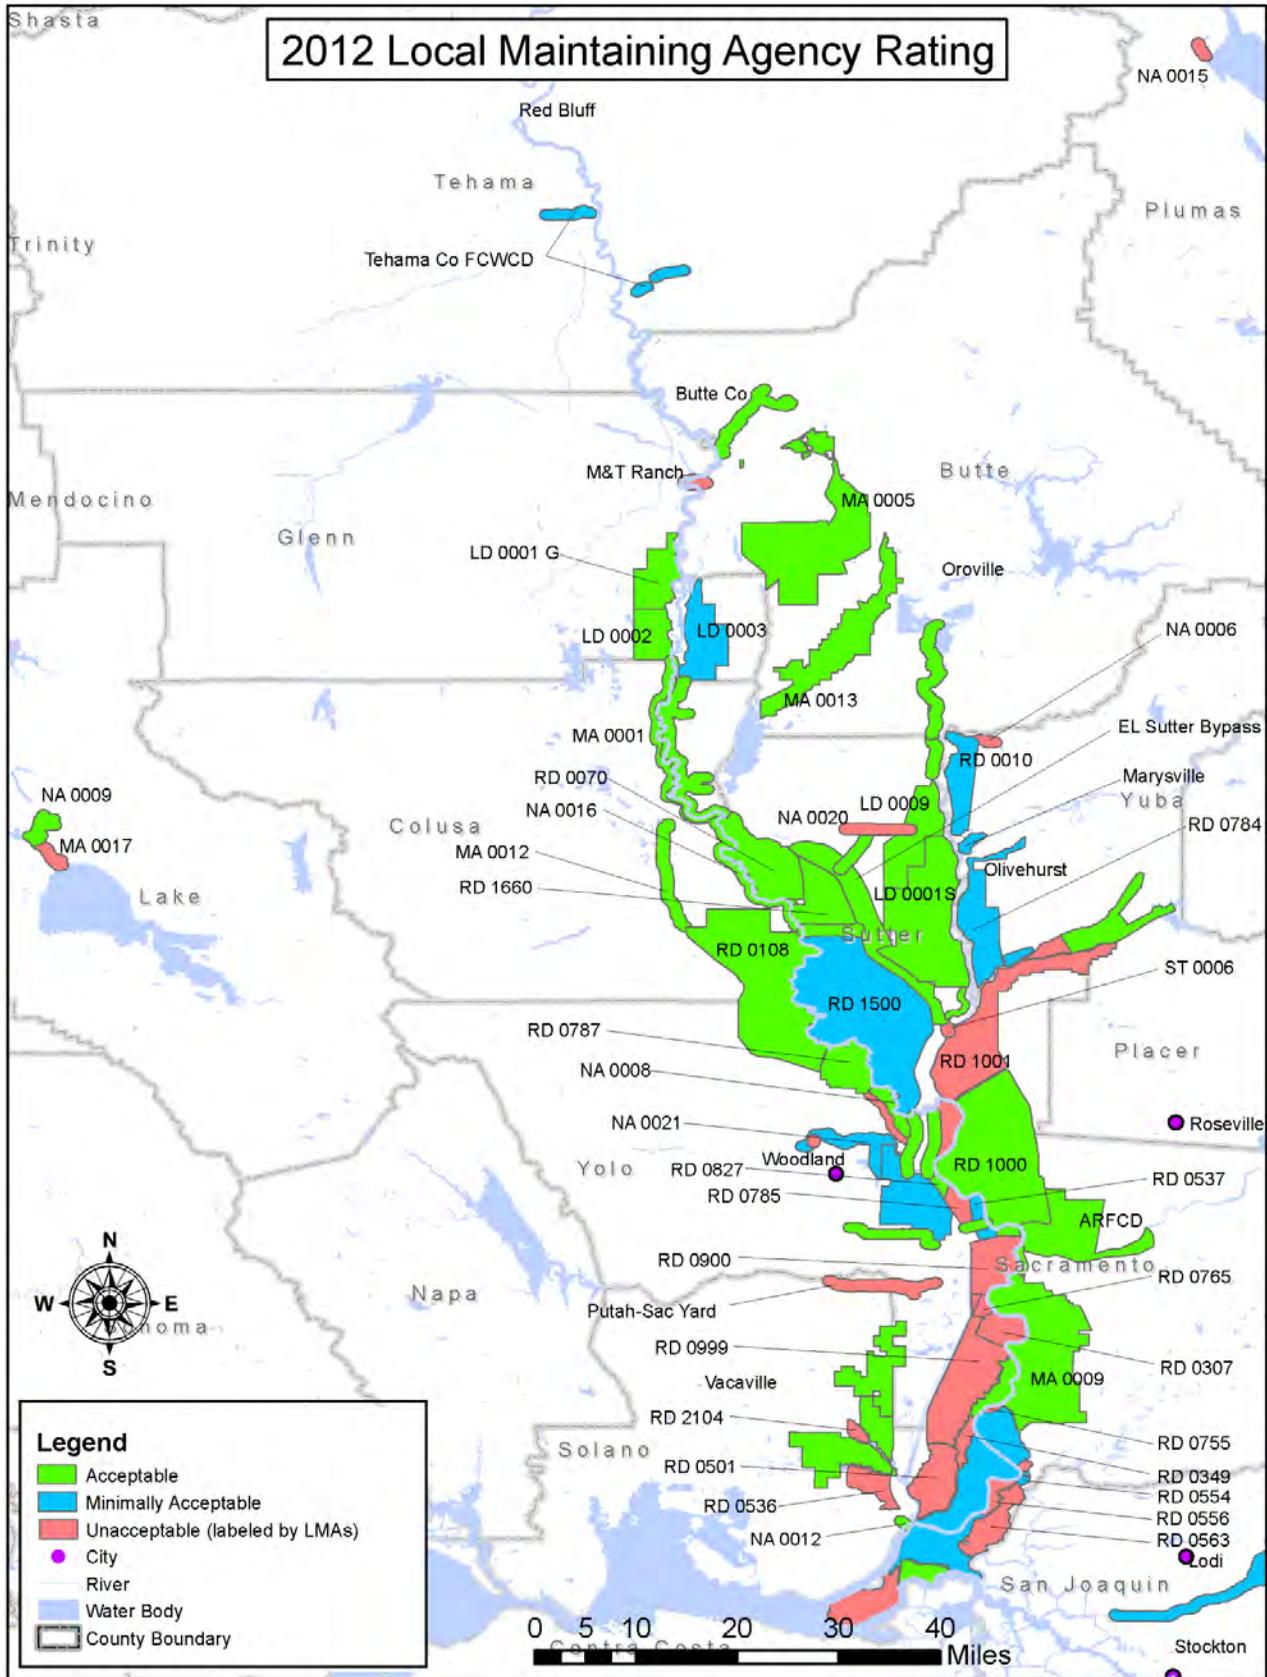
Figure E-5: Map of 2012 Local Maintaining Agency Ratings; Northern Area
