2012

INSPECTION AND LOCAL MAINTAINING AGENCY REPORT OF THE CENTRAL VALLEY STATE-FEDERAL FLOOD PROTECTION SYSTEM

Department of Water Resources

Flood Project Integrity and Inspection Branch | Hydrology and Flood Operations Office | Division of Flood Management

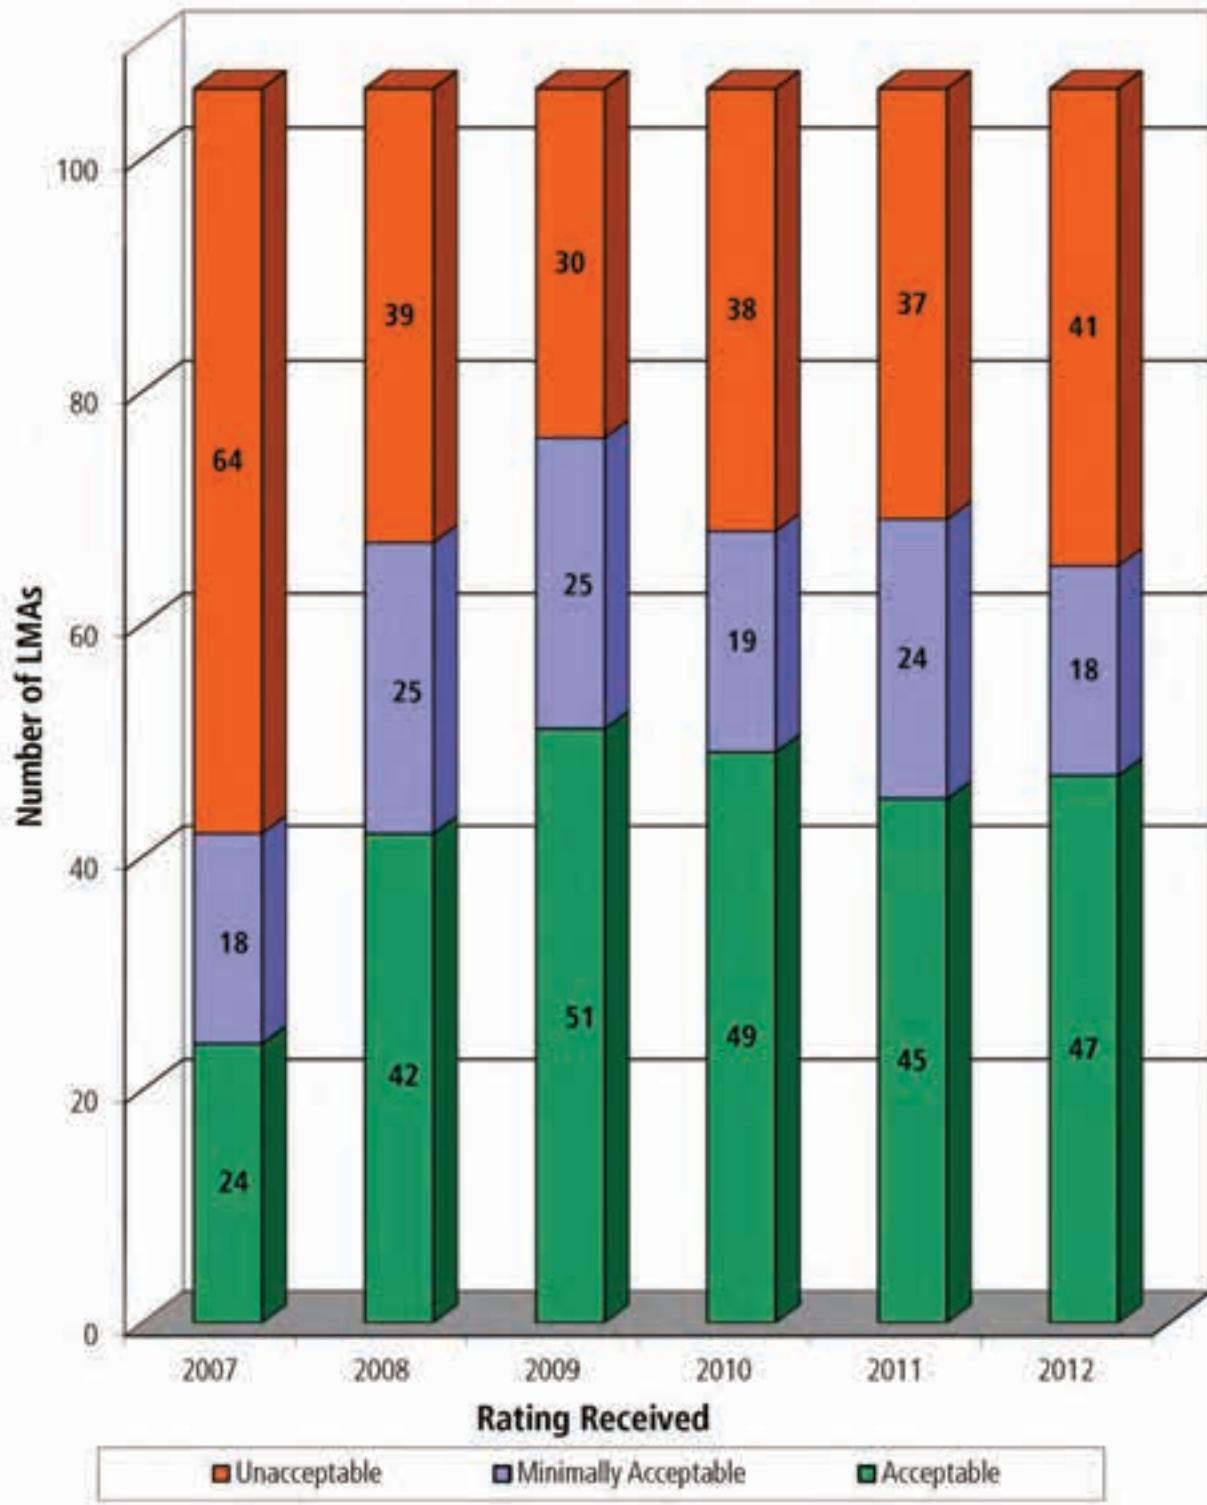
Figure 2-1: Summary of Area Maintenance Ratings for 2007 through 2012

Table 2-1 and Figure 2-1 show the numbers of Areas receiving each rating for 2007 through 2012. The length of vegetation deficiencies increased significantly compared to 2011, most notably in the San Joaquin River system. There was a significant increase in crown surface issues and a moderate increase in animal control issues. Other categories did not change significantly. Many of the LMAs have expressed limitations due to financial and environmental issues. Some LMAs are severely limited in what money they have been able to collect from residents to perform maintenance. Weather patterns that are different than prior years may also play a factor in the increase in deficiencies.

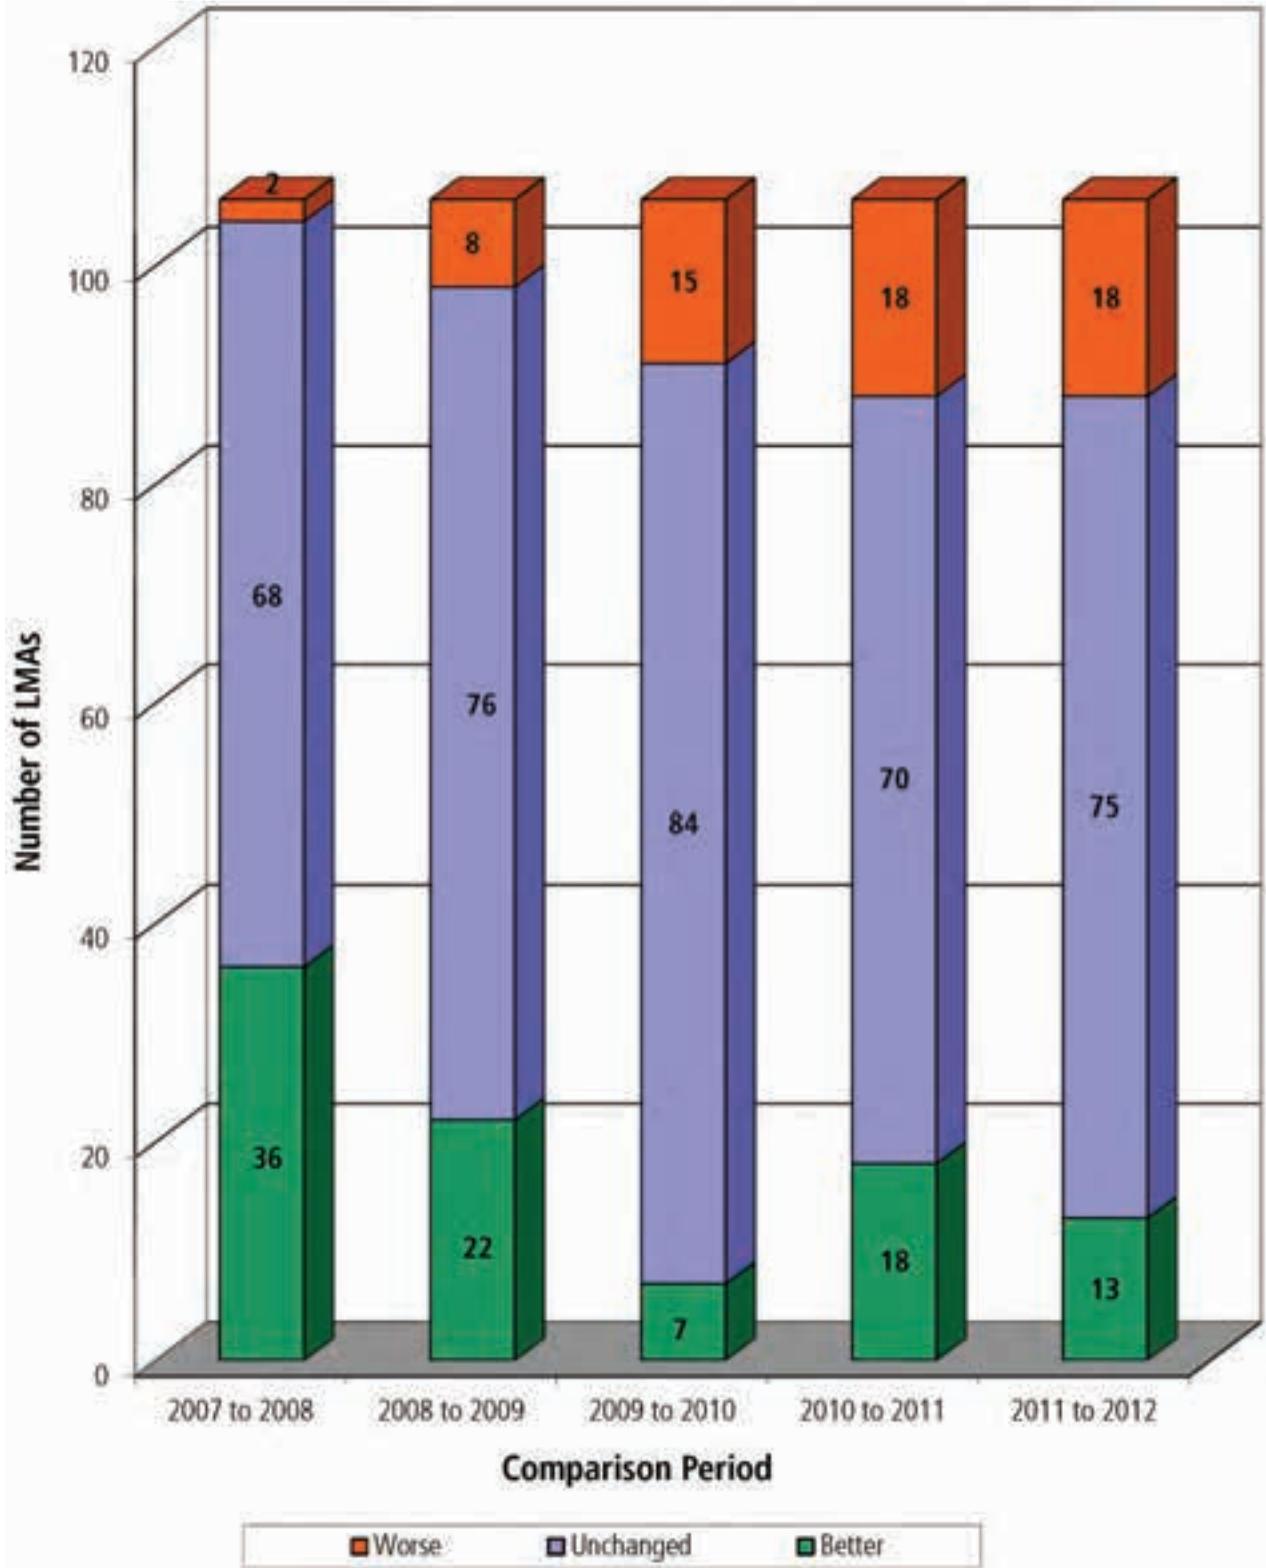
Figure 2-2: Area Maintenance Rating Changes from Fall 2007 to Fall 2012

Figure 2-2 shows the number of agencies that received better, unchanged, or worse ratings in 2012 compared with 2011, 2010, 2009, 2008, and 2007. The number of Areas receiving Acceptable ratings increased by two; however, the number of Areas rated as Unacceptable increased by four. The number of Areas rated as Minimally Acceptable decreased by six. This is likely due to fluctuations in maintenance and funding. Despite these changes, Areas continue to generally receive better ratings than in 2007 and 2008. Levee Mile Reports (LMRs) contain more detailed information about each LMA. Appendix F provides more an explanation of threshold percentages and the determination of overall ratings.

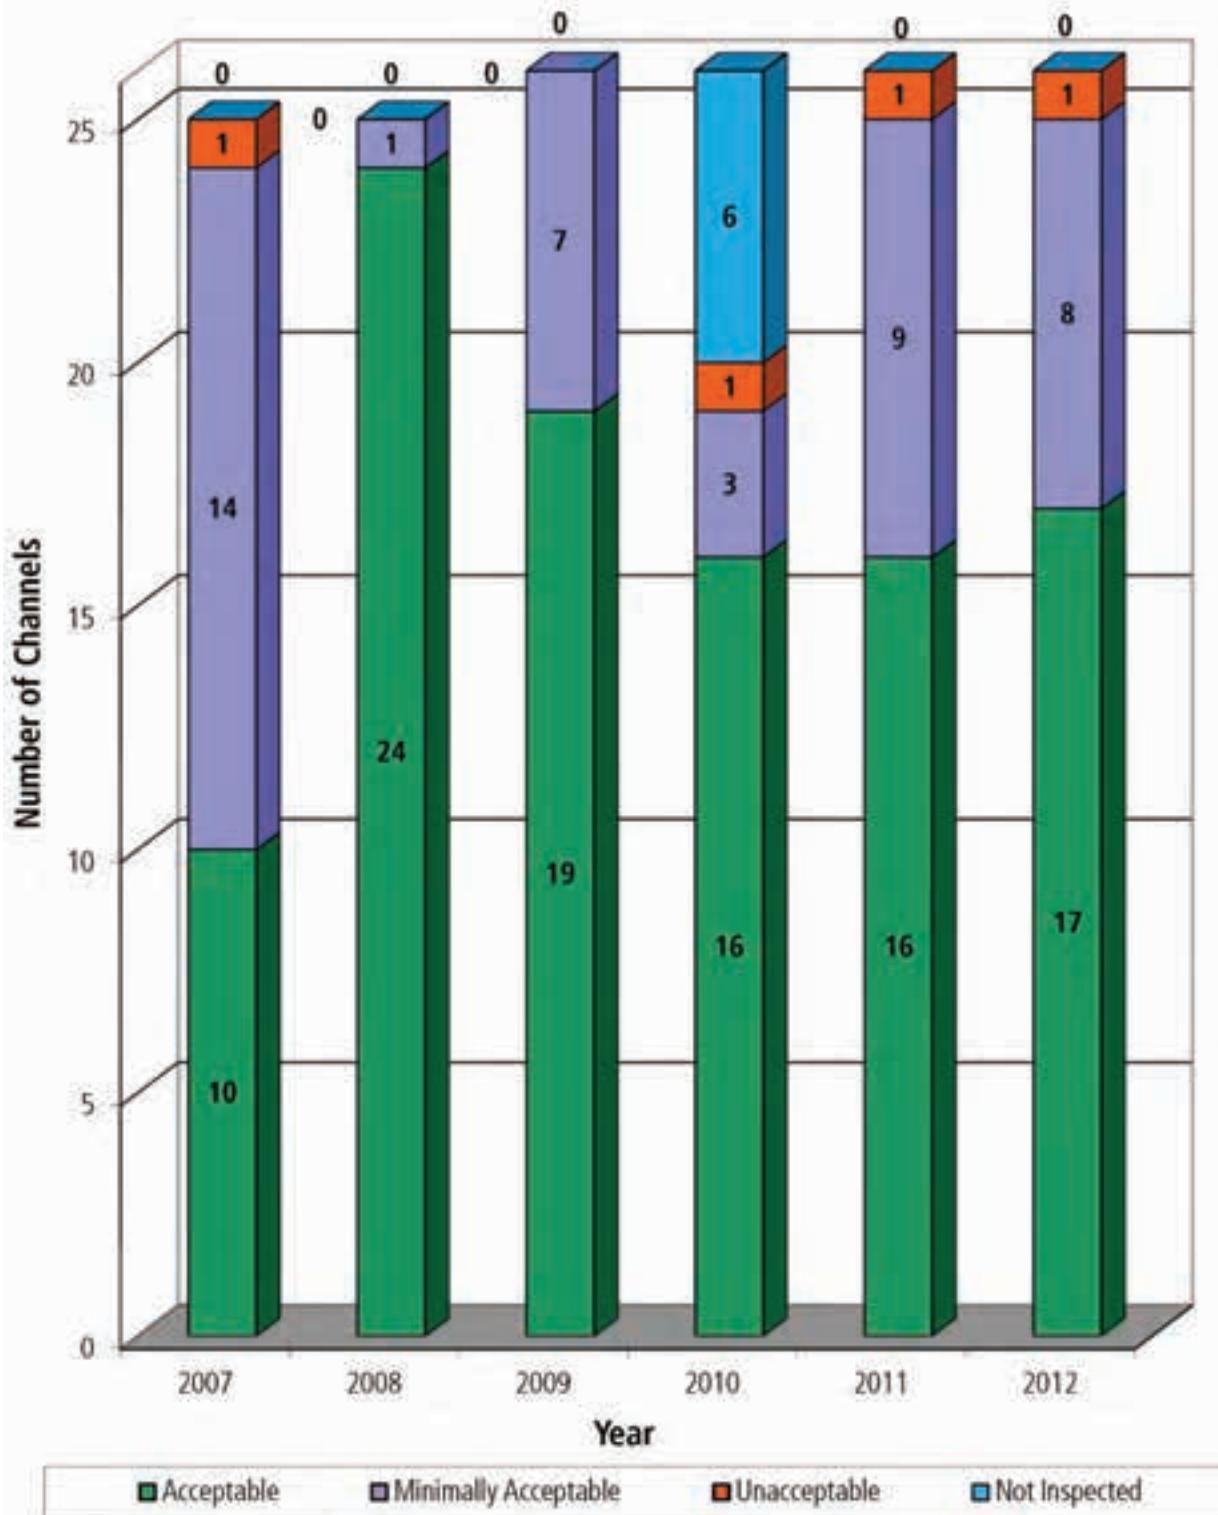
Figure 3-1: Comparison of Overall Channel Ratings, 2007 through 2012

One channel was rated as Unacceptable in 2012, while the number of Minimally Acceptable channels was eight, which is similar to 2011. This shows the similarity of maintenance found during inspection in 2012 as prior years. Figure 3-1 shows the progression of maintenance ratings from 2007 through 2012.

Appendix F details the method for determining overall ratings. Table 3-1 and Figure 3-1 show the numbers of each rating for the years 2007 through 2012.

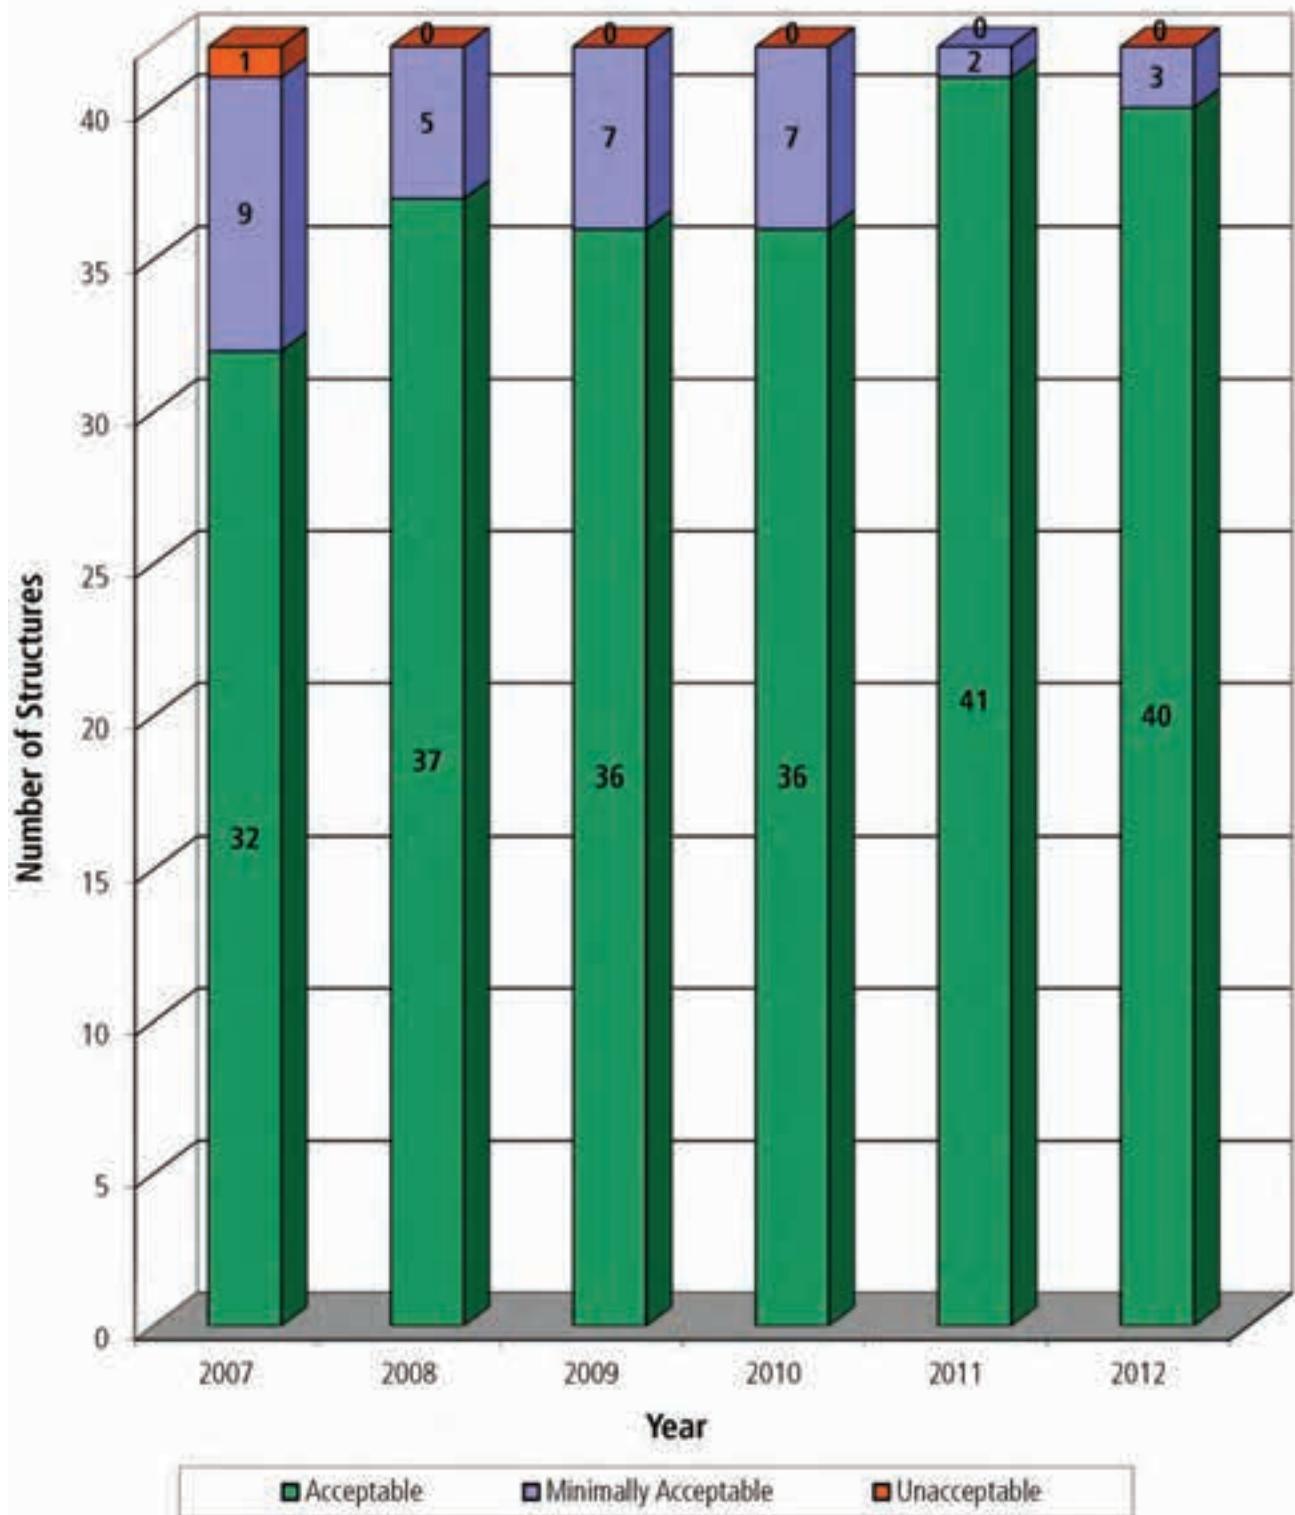
Figure 4-1: Comparison of Overall Structure Ratings from 2007 through 2012

The method for determining overall ratings is similar to the one used for channel inspections and is described in Appendix F. Table 4-1 shows the numbers of each rating for 2007-2012 for all structures. Figure 4-1 and Table 4-2 show ratings for each structure, while Figure 4-2 and Table 4-3 show ratings for each pumping plant. The LMAs have generally improved structure maintenance since 2007. The El Camino Avenue Bridge over Steelhead Creek in Sacramento was added to structure inspections in 2009.

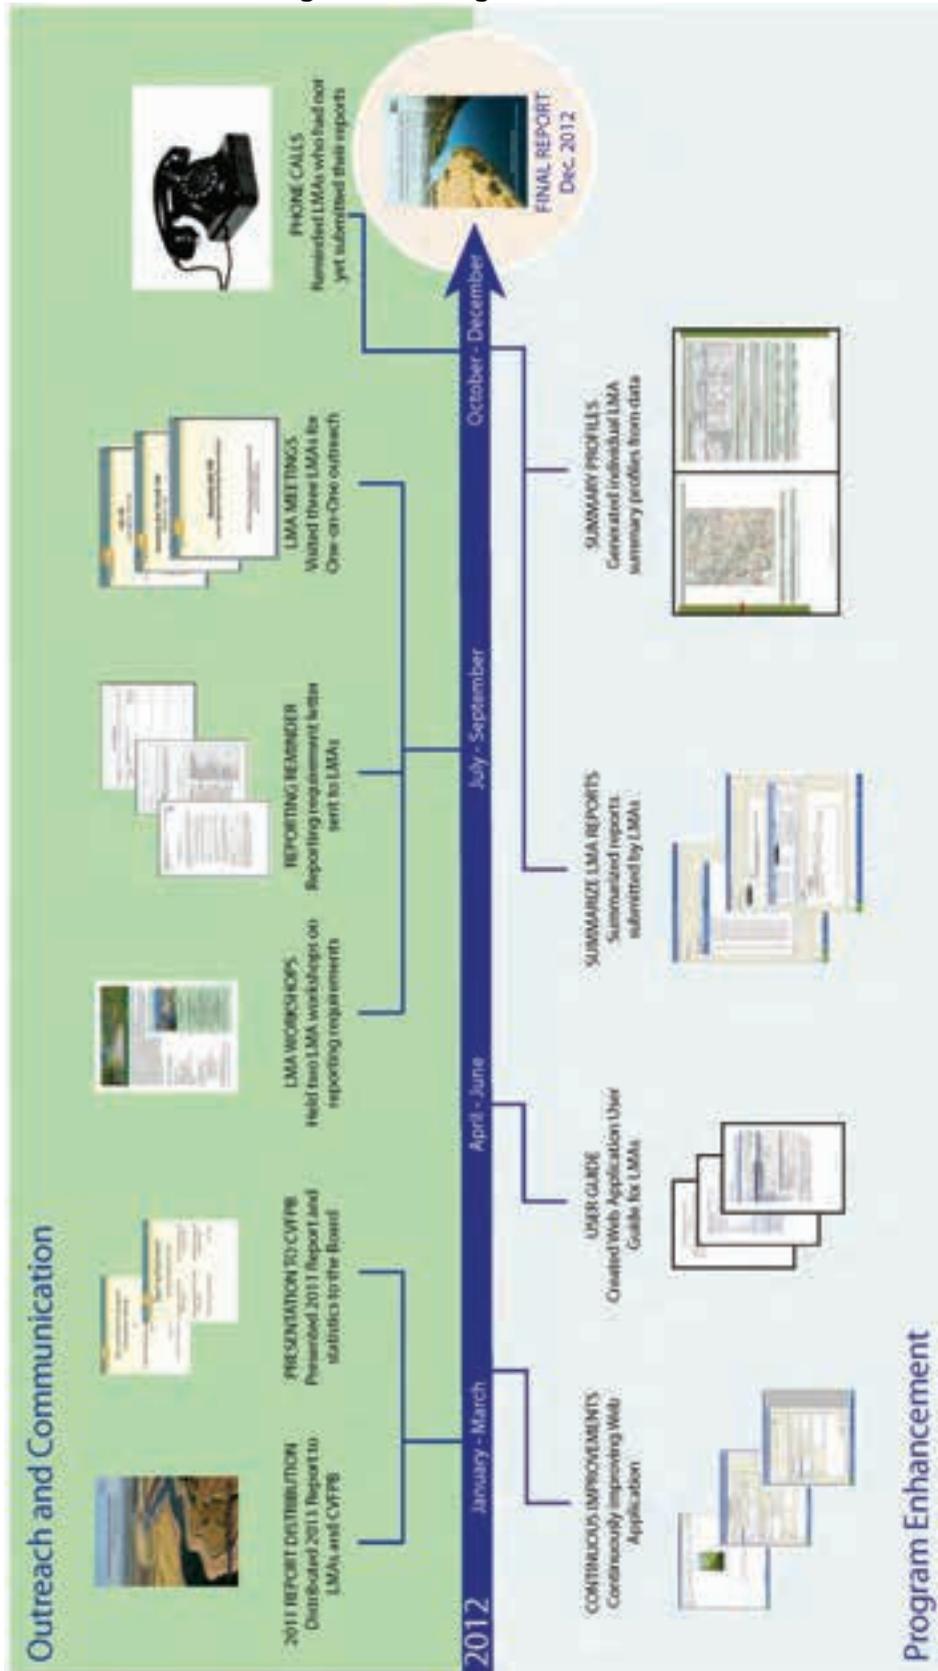
Figure 6-6: Program Activities

DWR recognizes that the requirements of CWC Section 9140 placed a new reporting burden on LMAs. To help make reporting easier, DWR developed an outreach program and a web-based reporting tool to assist LMAs. DWR notified LMAs of the new reporting requirements, developed electronic and hard copy reporting options, and held a series of presentations and workshops. The process continues today, with DWR soliciting feedback from LMAs to improve the program. The following subsections and Figure 6-6 describe the chronology of the outreach process for 2012.

- Since 2008, DWR has been facilitating electronic submission and strongly encouraging LMAs to use the LMA Reporting Website. In 2012 about 68 percent of reporting LMAs reported electronically, which is a 16 percent increase over 2011. Details of DWR outreach activities for electronic submission and others are provided Figure 6-6.

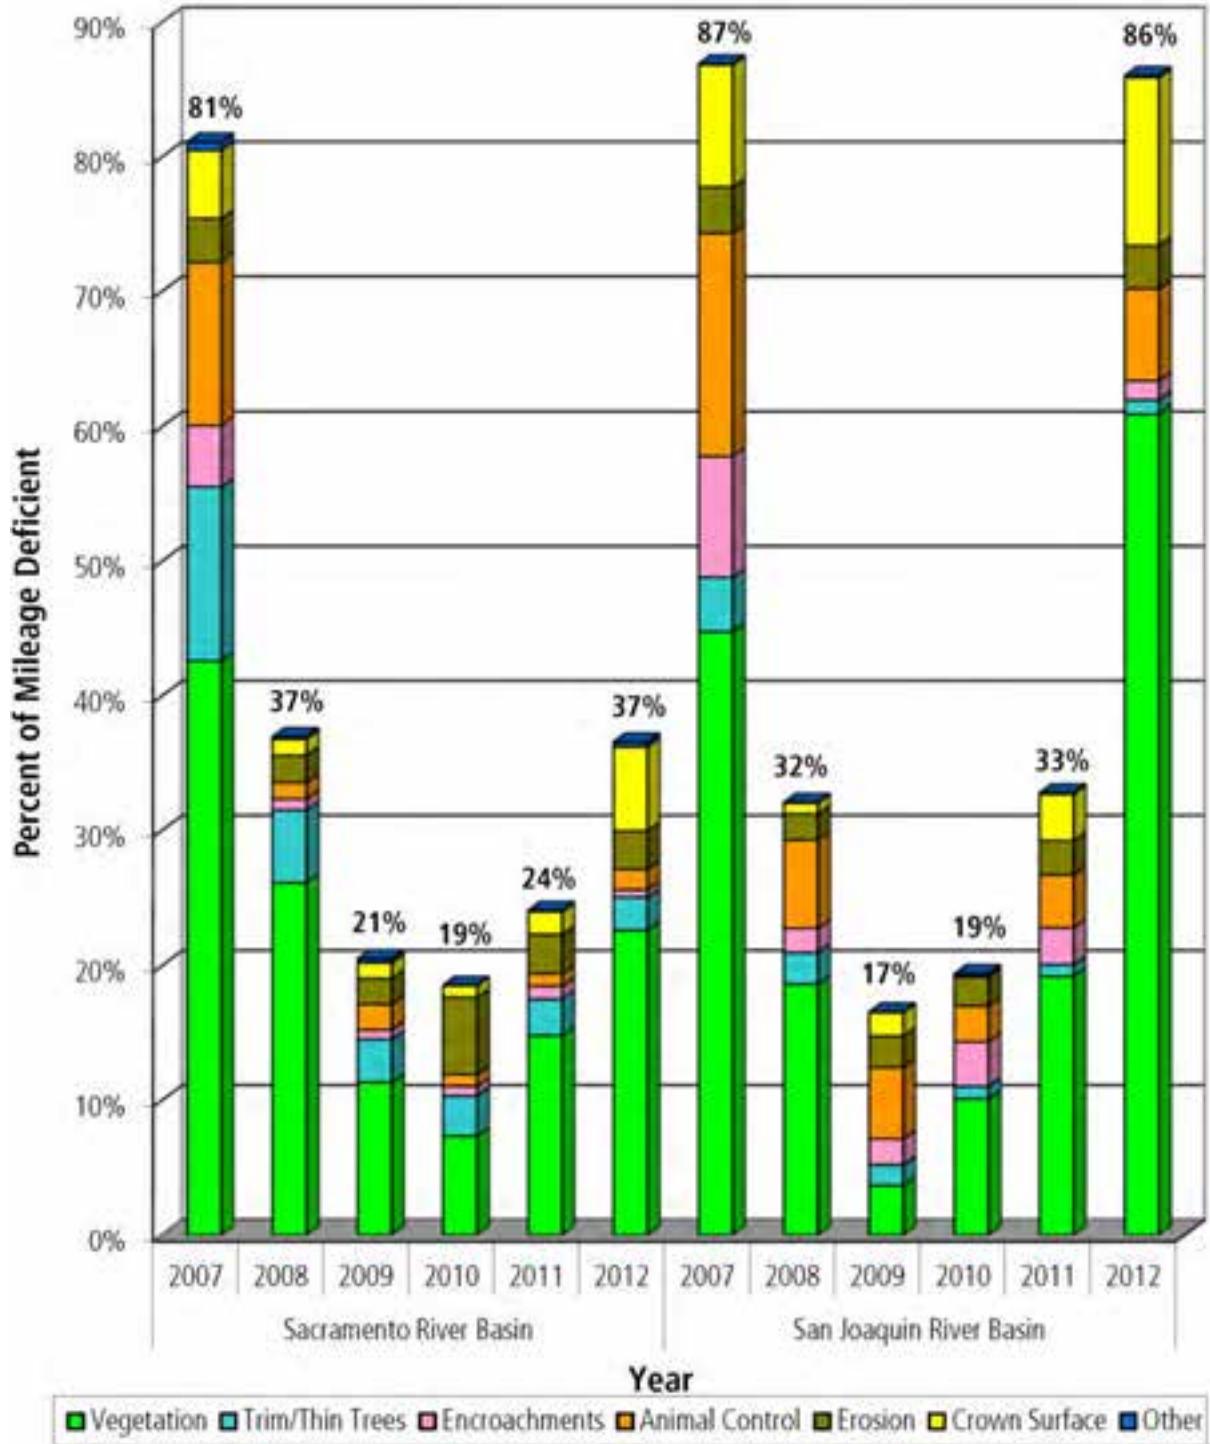
Figure E-4: Percentage of Levee Miles with Maintenance Deficiencies by Basin

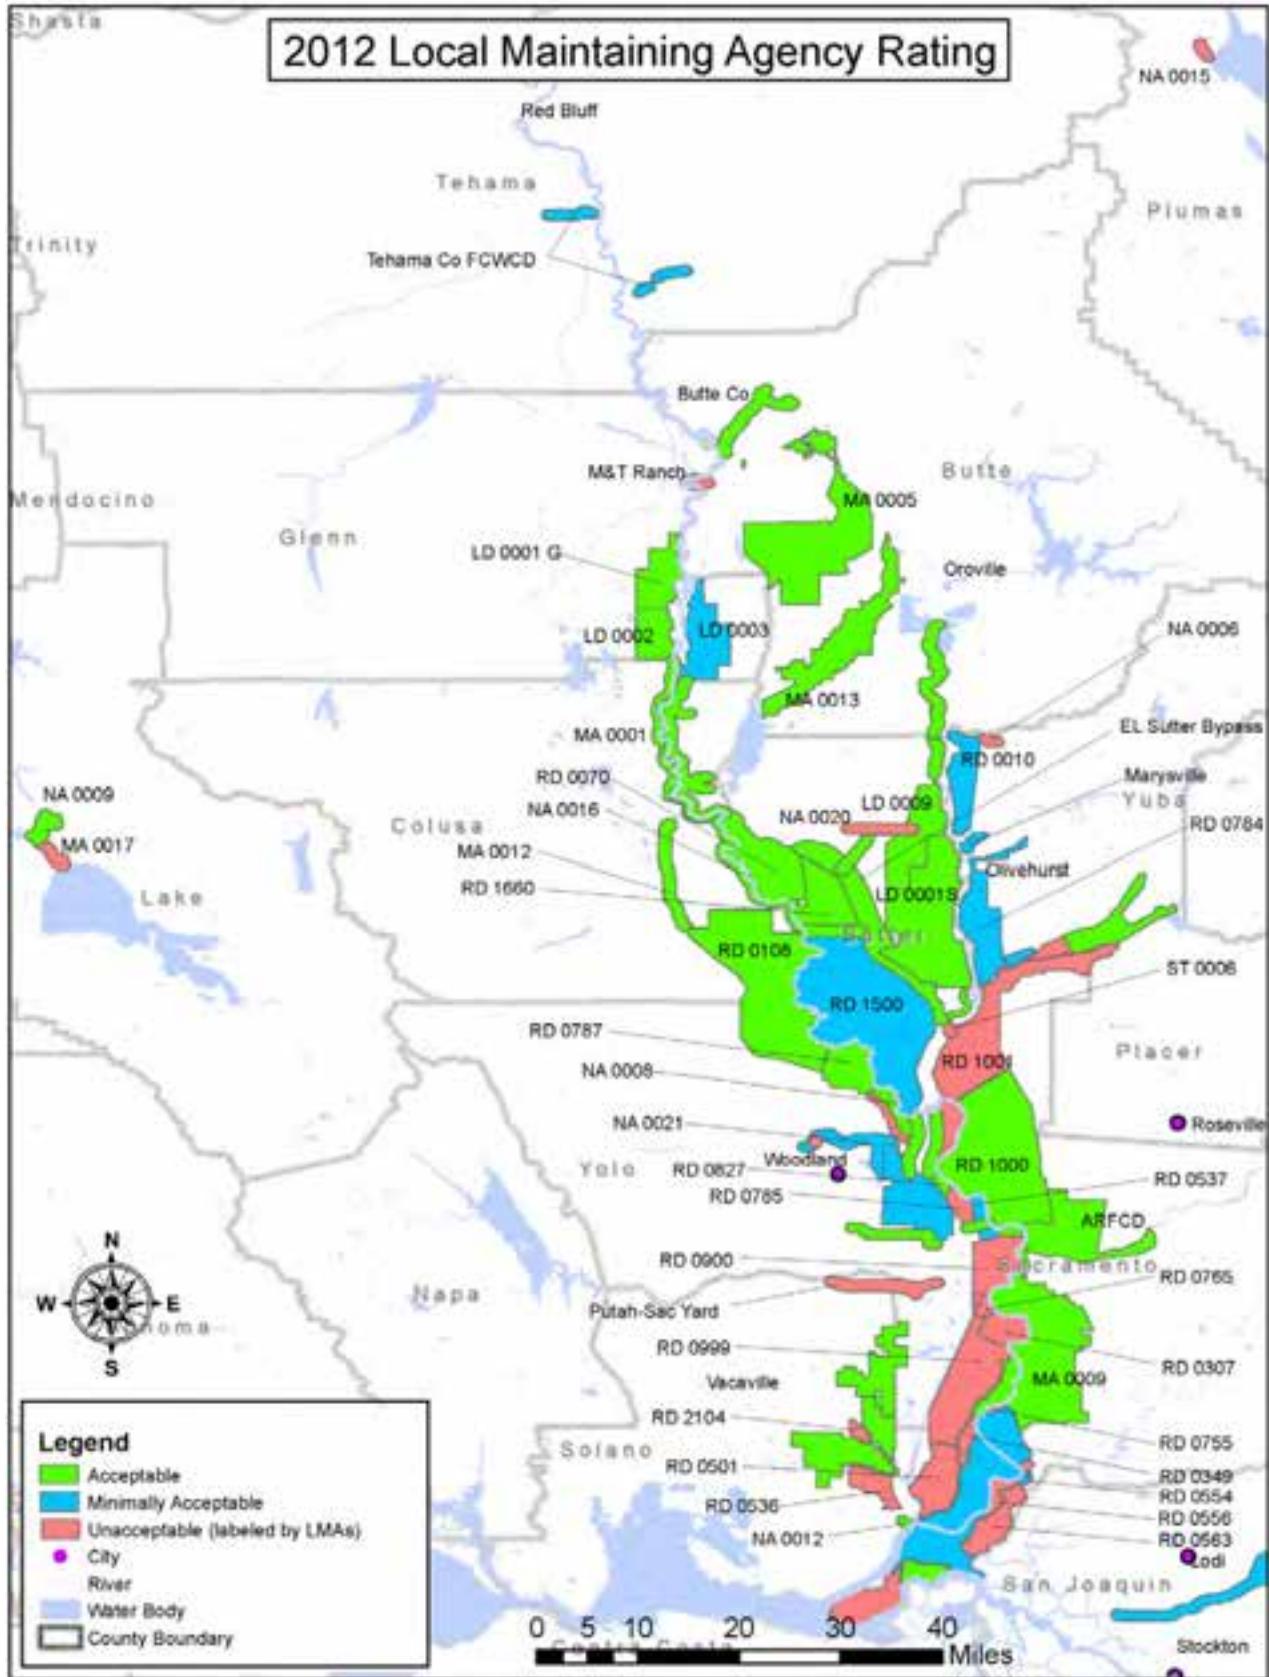
Figure E-5: Map of 2012 Local Maintaining Agency Ratings; Northern Area

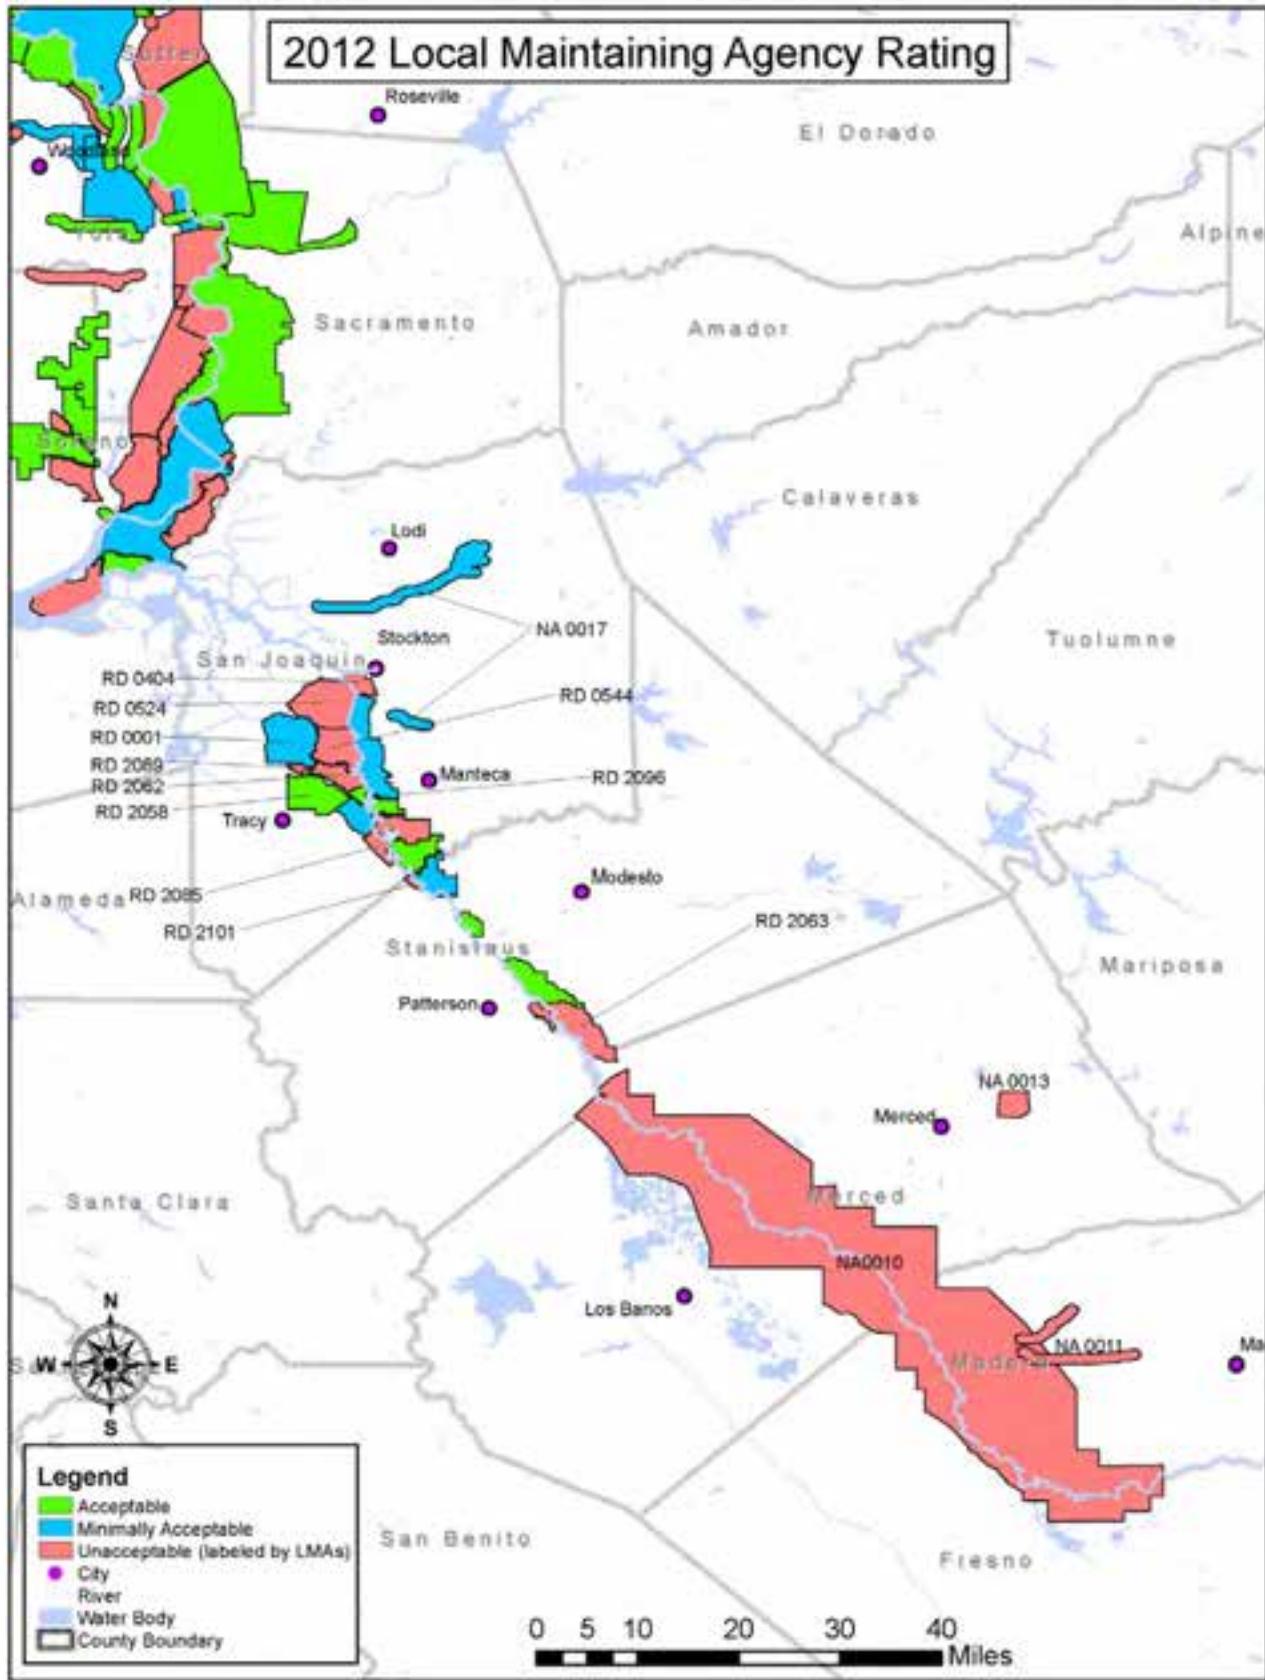
Figure E-5: Map of 2012 Local Maintaining Agency Ratings; Southern Area
